Rehabilitation of a Historic Structure as a Model for Resilient Design

GATEWAY NATIONAL RECREATION AREA
NATIONAL PARK SERVICE
U.S. DEPARTMENT OF THE INTERIOR

Project Overview

In order to assist in the development of a proactive approach to climate change, Gateway NRA is proposing to plan, design and rehabilitate one of the historic structures [building #7] along Officer's Row using new and green technologies and improved storm preparedness designs (YLCC).

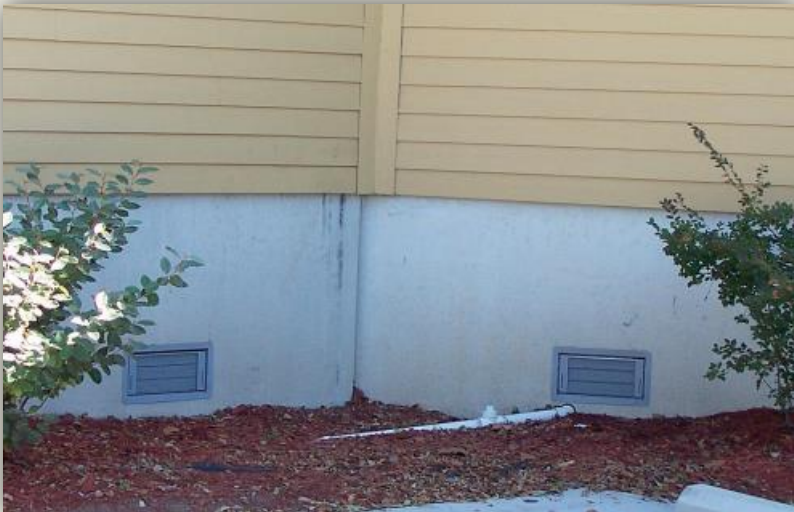
- Flood resistant materials
- Raise mechanical + utility equipment
- Basement fill
- Storm vents/doors
- Back flow valves
- Internal drainage systems

Example of Basement Flood Vents

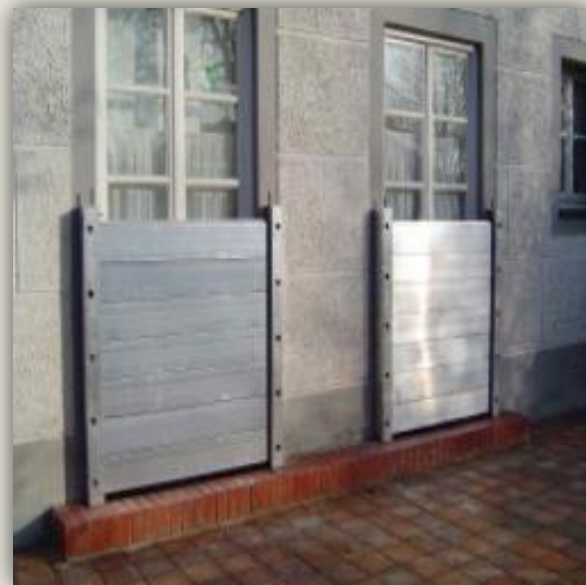
- Continuous impermeable walls
- Flood resistance in interior core areas
- Sealants for openings (windows + doors+ walls)
- Flood shields for openings in exterior walls
- Back flow valves
- Internal drainage systems

Example of Window Flood Shield

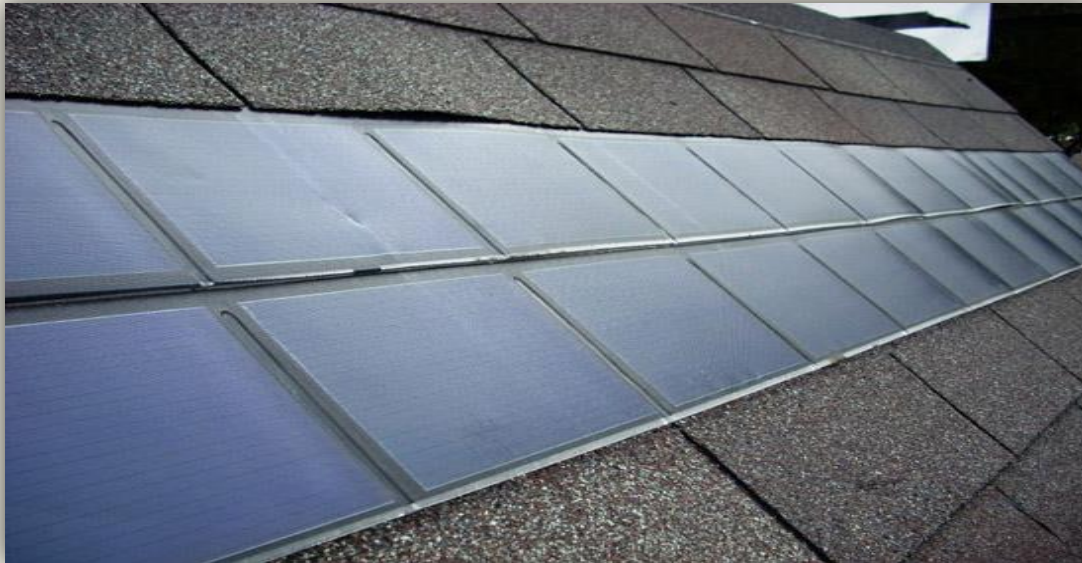
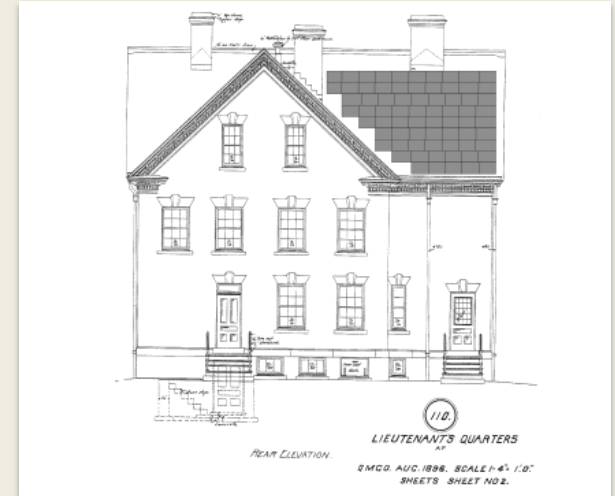
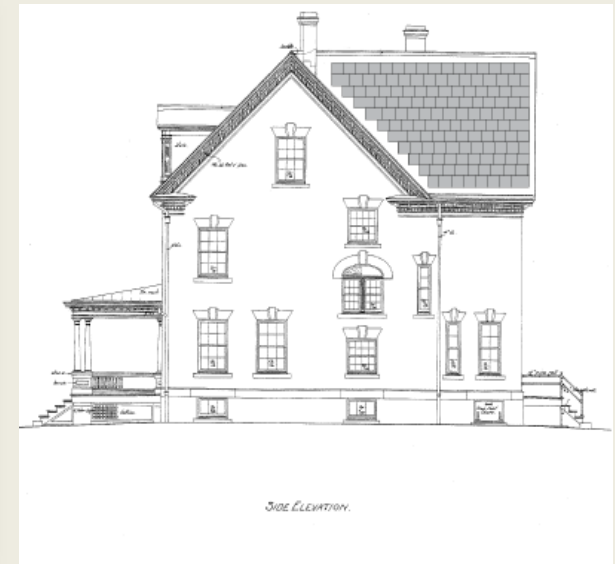
- Renewable Solar
- Solar Photovoltaic Shingles
- Grid Tie with Battery Backup

Example of PV Solar Shingles on Roof

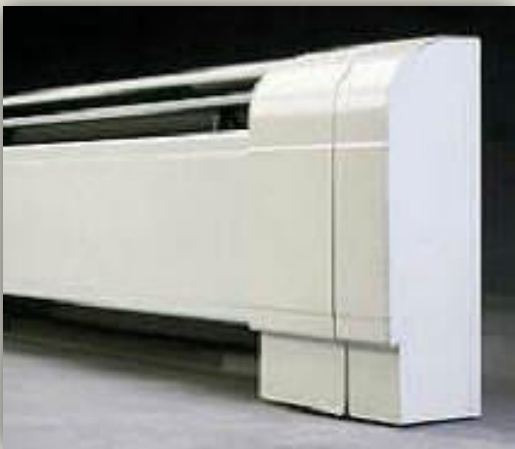
- Radiant heating reduces demand for conventional heating
- Excess hot water from solar water heater is used to distribute radiant heat
 - In-floor system
 - Hydronic baseboard
 - PEX wall radiator

Example of Hydronic Baseboard Radiator

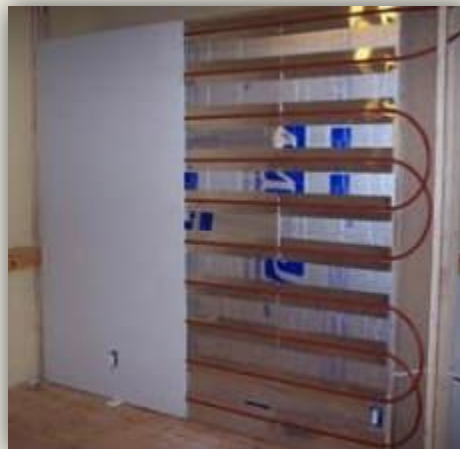
Example of PEX Wall Radiator

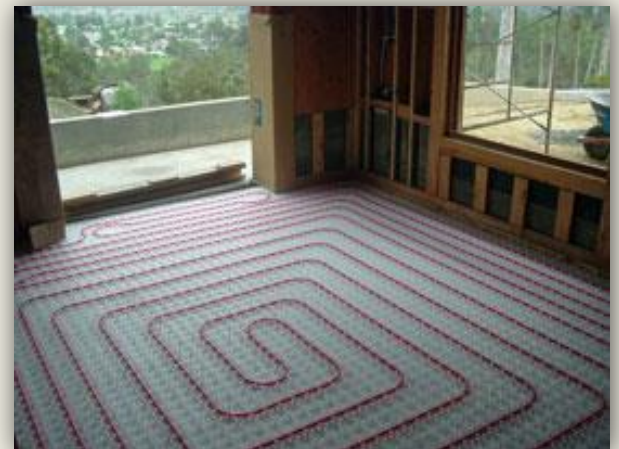
Example of In-Floor Radiant Heating

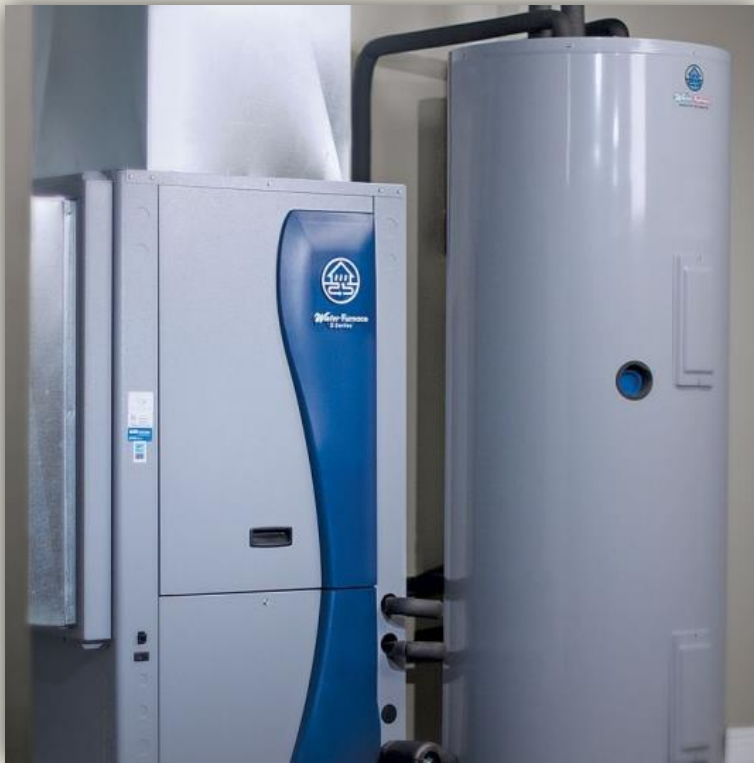
- Closed loop system
- Provides heating + cooling through an all-in-one or split system
- Potential to also provide hot water and radiant heating
- Vertical, horizontal or coiled pond loop system

Example of Geothermal Heat Pump + Water Heater

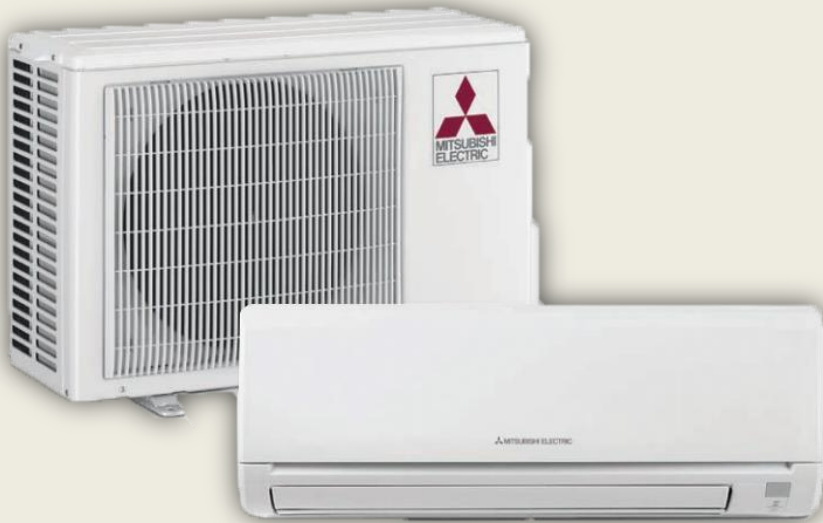
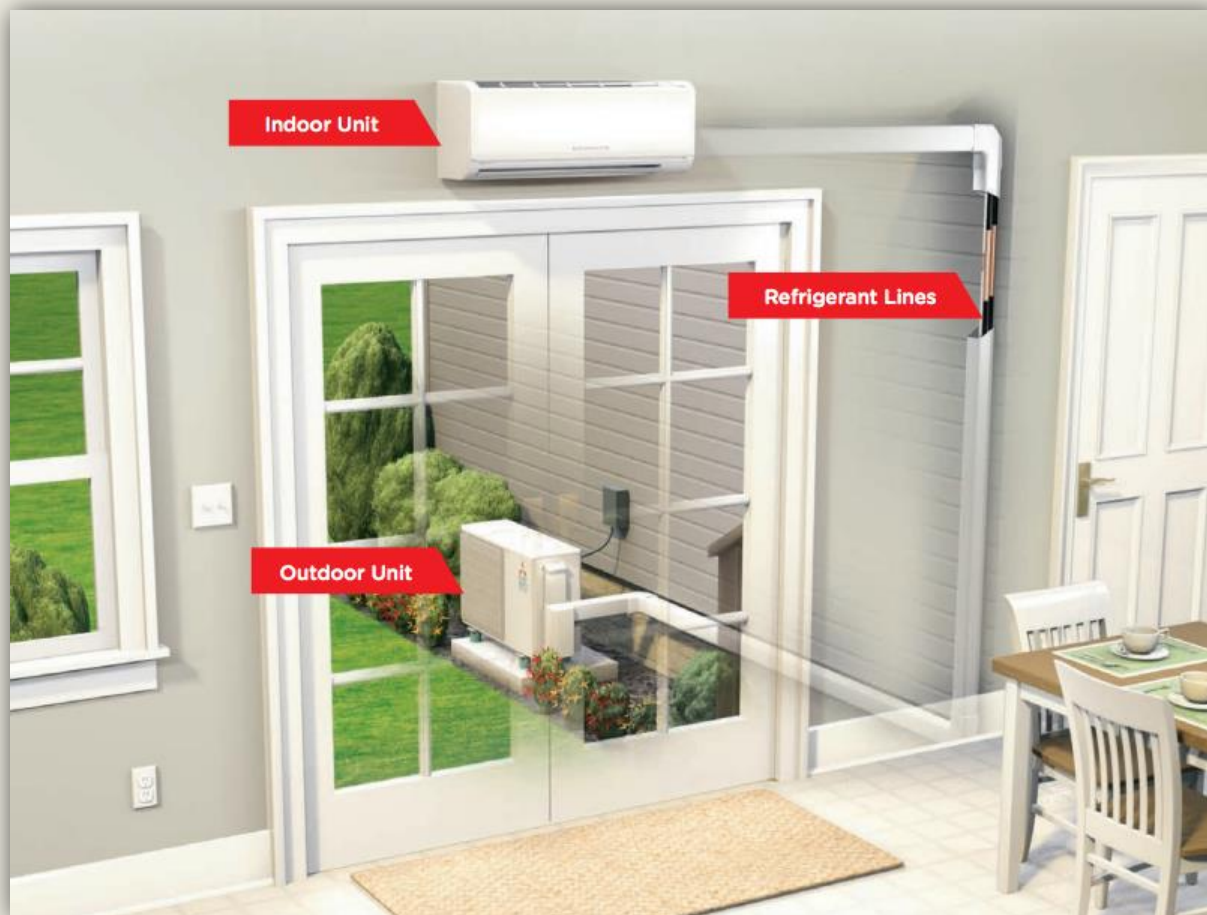
Outdoor + Indoor Mini Splits Unit

- Tied to solar energy collector
- Outdoor unit – heat compressor + exchanger
- No ductwork required
- Conditioning controlled by individual rooms or zones
- Energy efficient – control only the spaces being used
- Automation

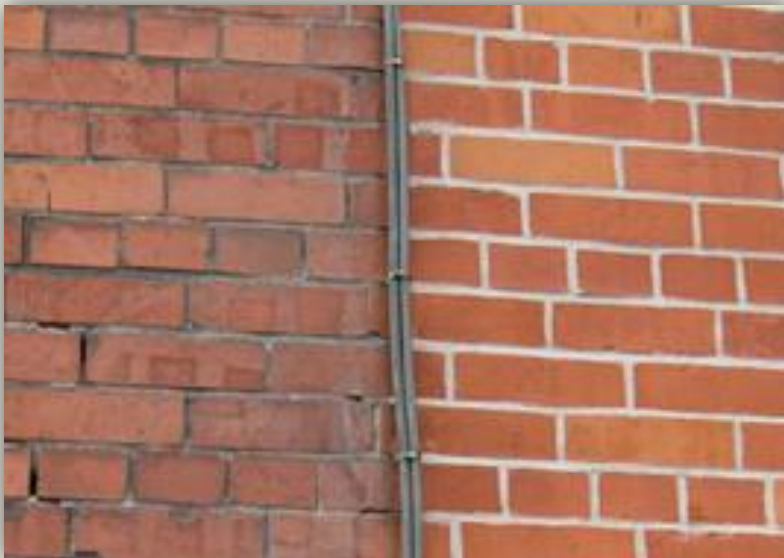
- Rehabilitation + Insulation
- Reduce Air + Water Infiltration

Example of Brick Repointing Before + After

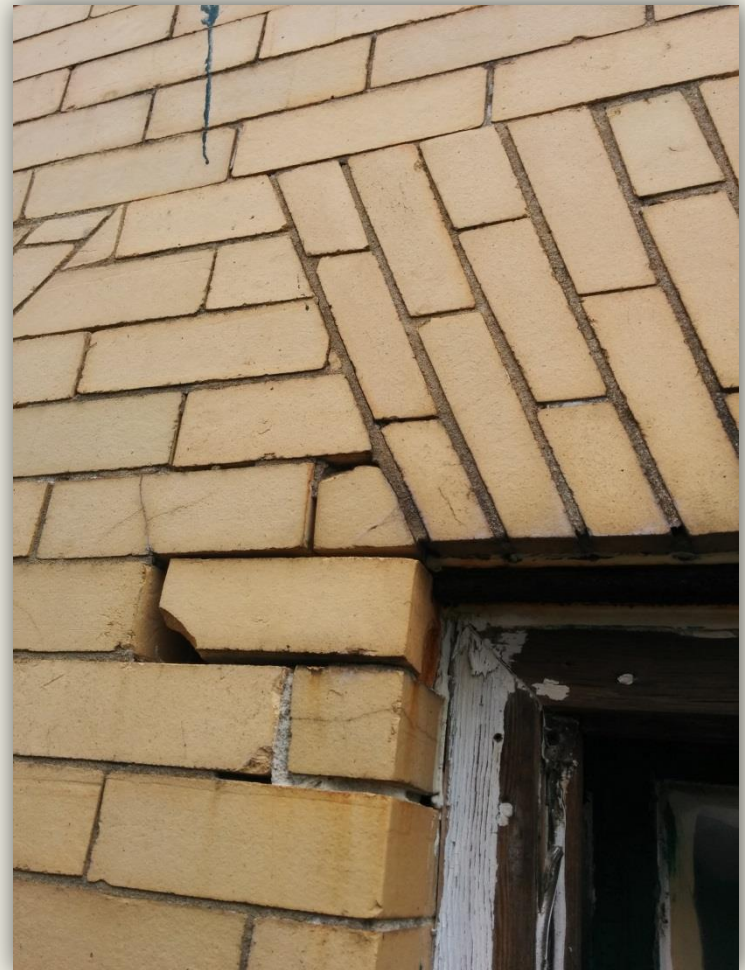
Building 7 Exterior - Loose Bricks Around Window

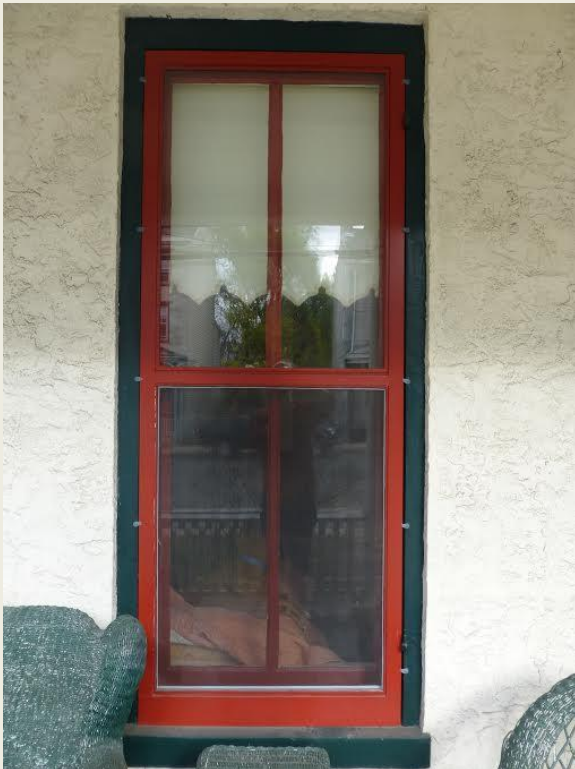
Example of Wood Style Exterior Storm Window

- Protect historic windows
- Decrease energy loss
- Wood style
- Storm window/screen combination
- Exterior storm windows can reduce air leakage by 45%-75%
- Single pane glass has an R value of R-1 - Single pane glass with a clear glass storm window has an R value of 2.

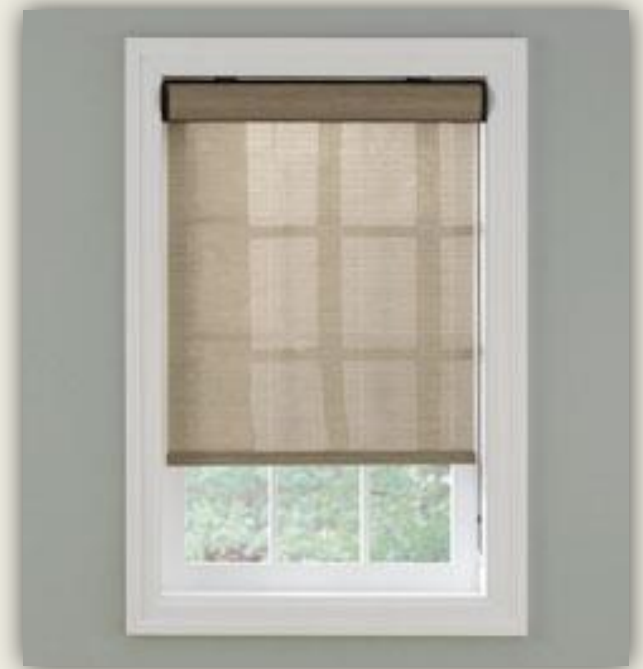
- Increase energy efficiency
- Protect interior from UV rays
- Preserve view
- Eco friendly materials
- Automation

Example of Interior Solar Shade

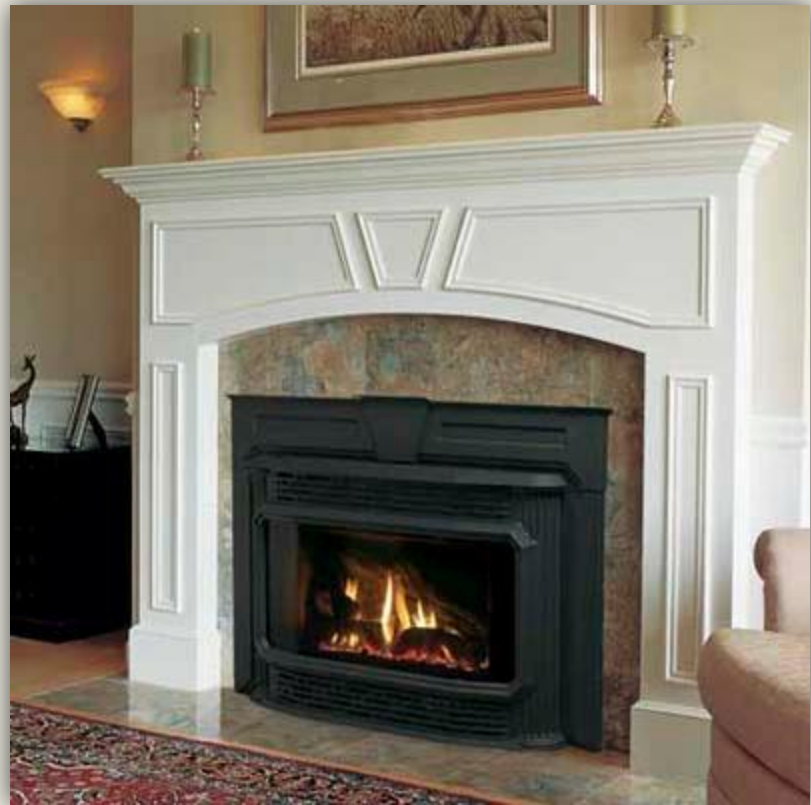
- Propane Gas Insert
- Blower - increases heat dispersion
- Automation
- Electronic ignition
- Battery backup

Example of Gas Insert Fireplace

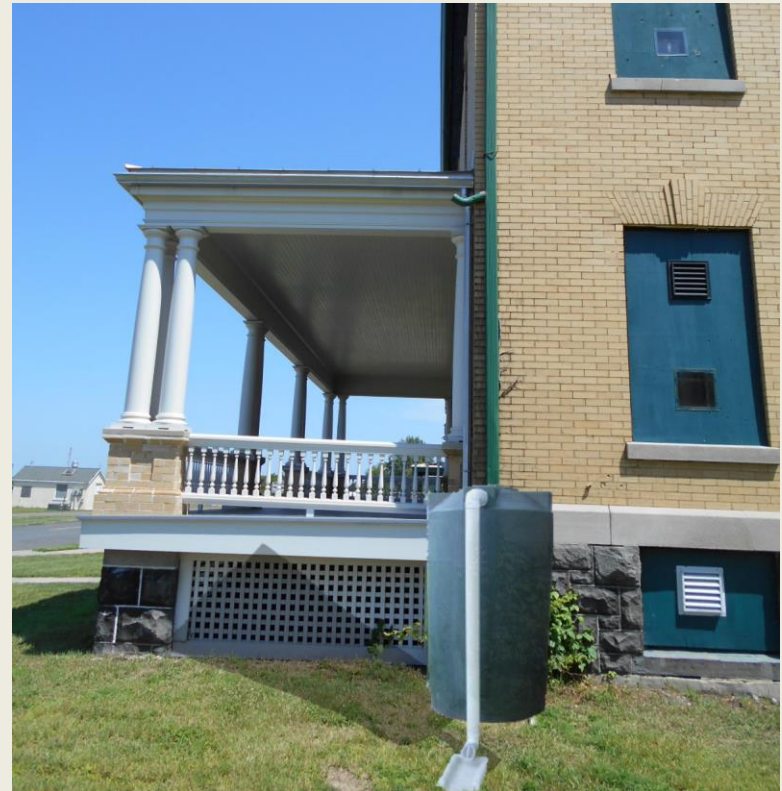
Example of Potential Rain Water Cistern at Building 7

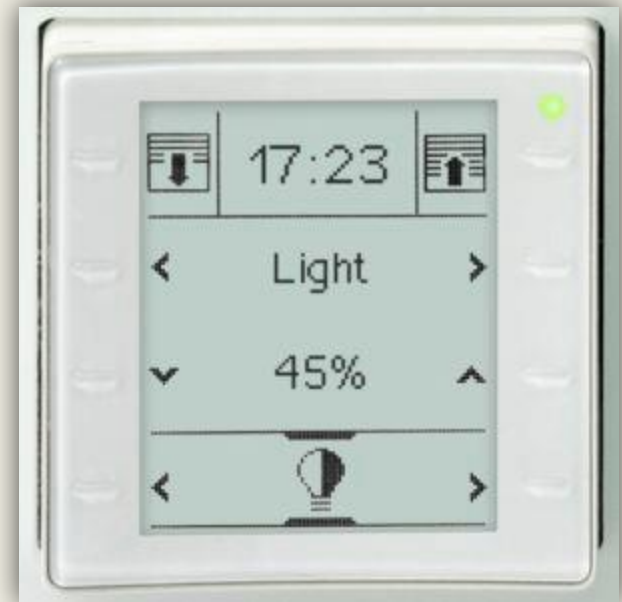
- Increases energy efficiency
- Controllability of interior + exterior
 - Lighting
 - HVAC
 - Solar shades
 - Appliances
 - Security

Example of Central Automation control system

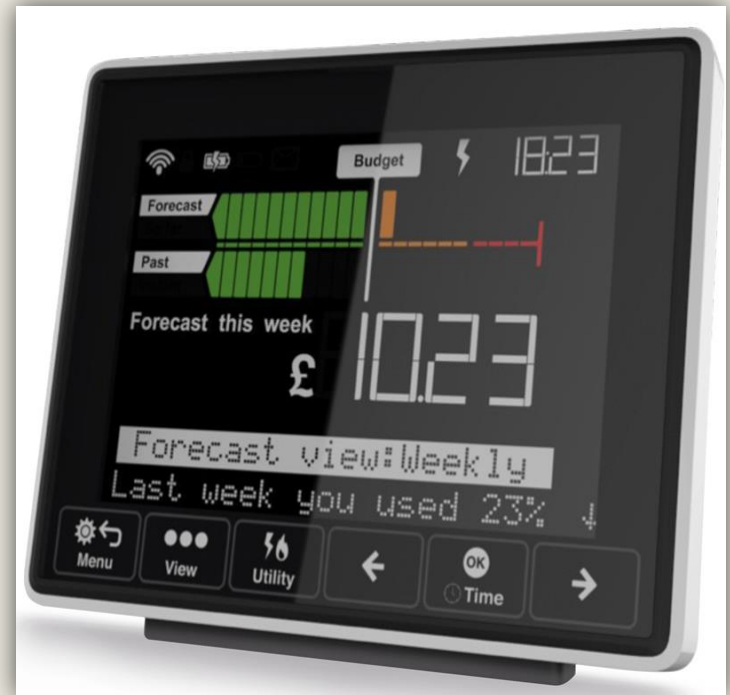
- Energy consumption
- Energy saved
- Energy advice
- Supports automation

Example of In-Home Display System
