## Shifting Sands of Sandy Hook

### Land in Motion

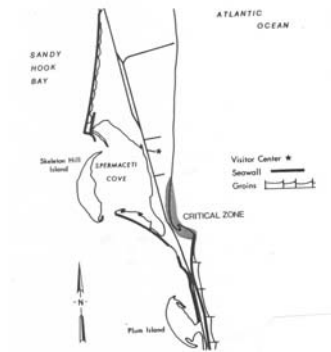
*The Critical Erosion Zone*

In 1975, the National Park Service and Rutgers University initiated a research study of Sandy Hook's beach erosion problems. The worst area, from the north end of the seawall to Beach Area D was designated the *critical erosion zone*, where the beach and sand dunes were rapidly washing away. To replenish them, it was recommended that sand be pumped onto the critical erosion zone beach using a dredge pipeline. However, no action was taken, and ocean currents continued to erode this beach area. Two major storms in 1981 and 1982 finally undermined and destroyed a long stretch of the park's main road located in the erosion

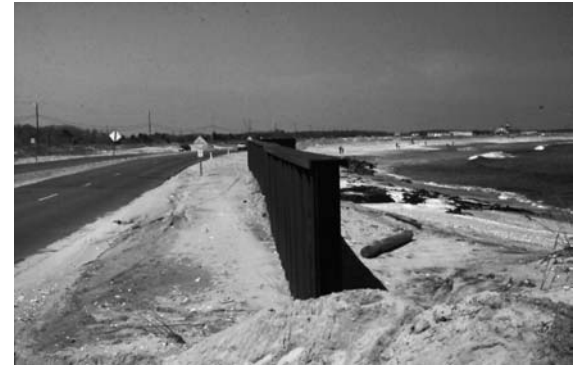
*Steel Wall at the Critical Zone*

zone. In 1983- 84, emergency funding provided for a sand replenishment project and the rebuilding of the park road, but by 1988 ocean currents had washed most of this sand away. During the fall of 1988, a steel bulkhead wall was pile- driven into the sand next to the main road to provide a buffer of protection until another sand replenishment project was conducted in 1989. After this project ended, the longshore currents continued to wash much of the sand north to the Gunnison Beach area of Sandy Hook. By 1996, the critical erosion zone had returned once again.
