## **ATTACHMENT B. DESCRIPTIONS, FLOOR PLANS, AND PHOTOS**

### Althoff Farmhouse

## Bushman Farmhouse

## Rose Farmhouse

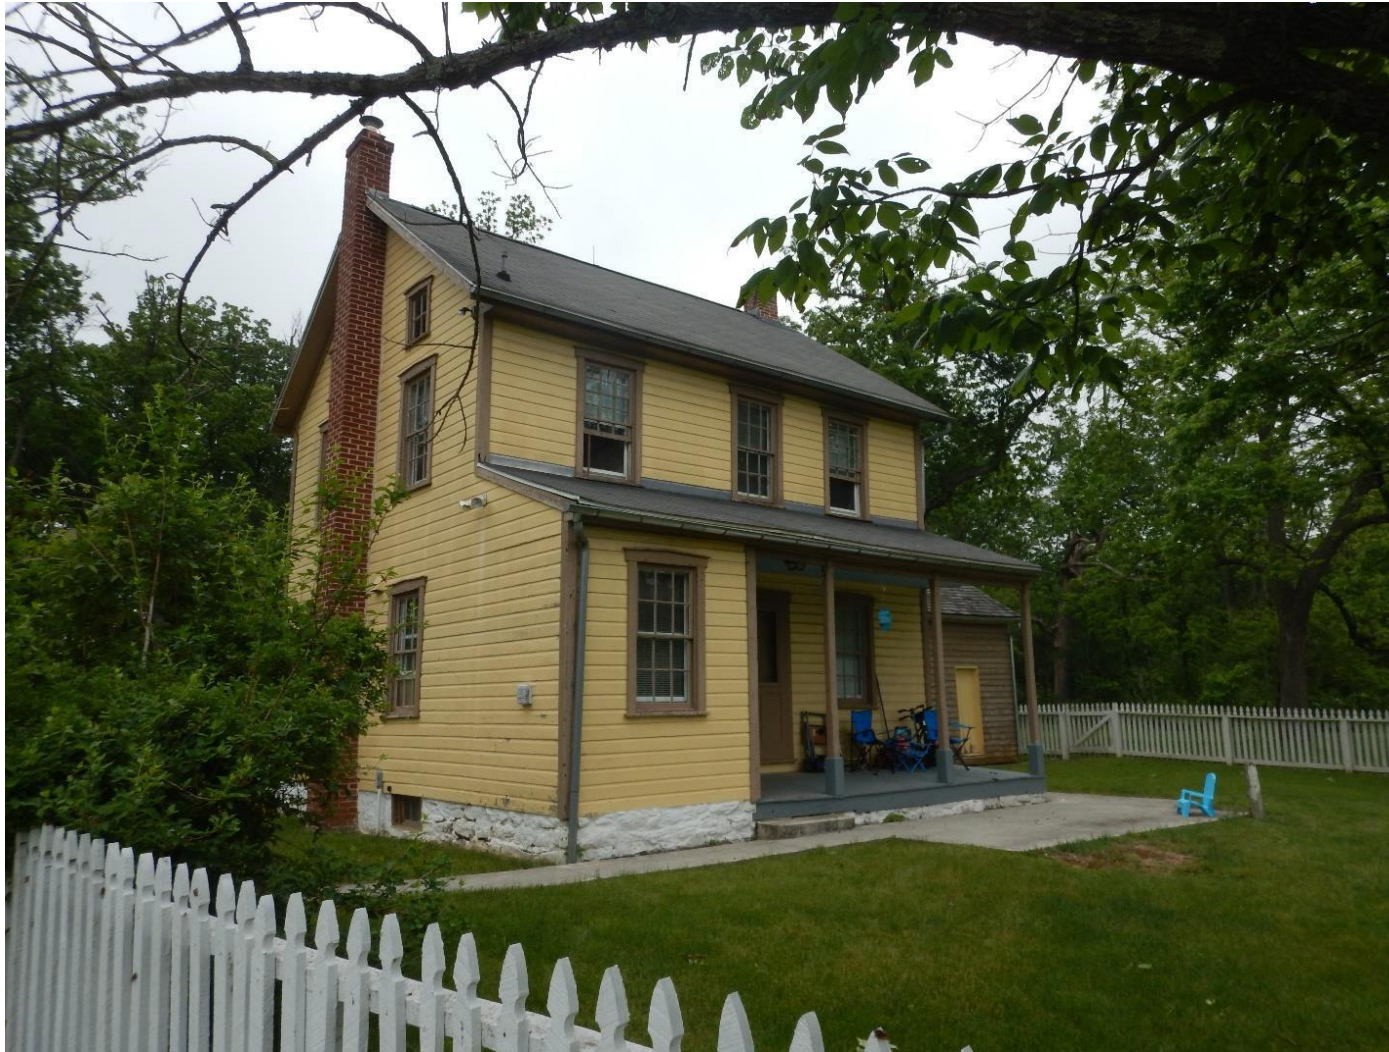
Figure 3. Front (south) and west elevations of the Althoff Farmhouse. The drop siding exterior, overall arrangement of windows and doors, and window type (divided light, wood double-hung) are considered historic features.

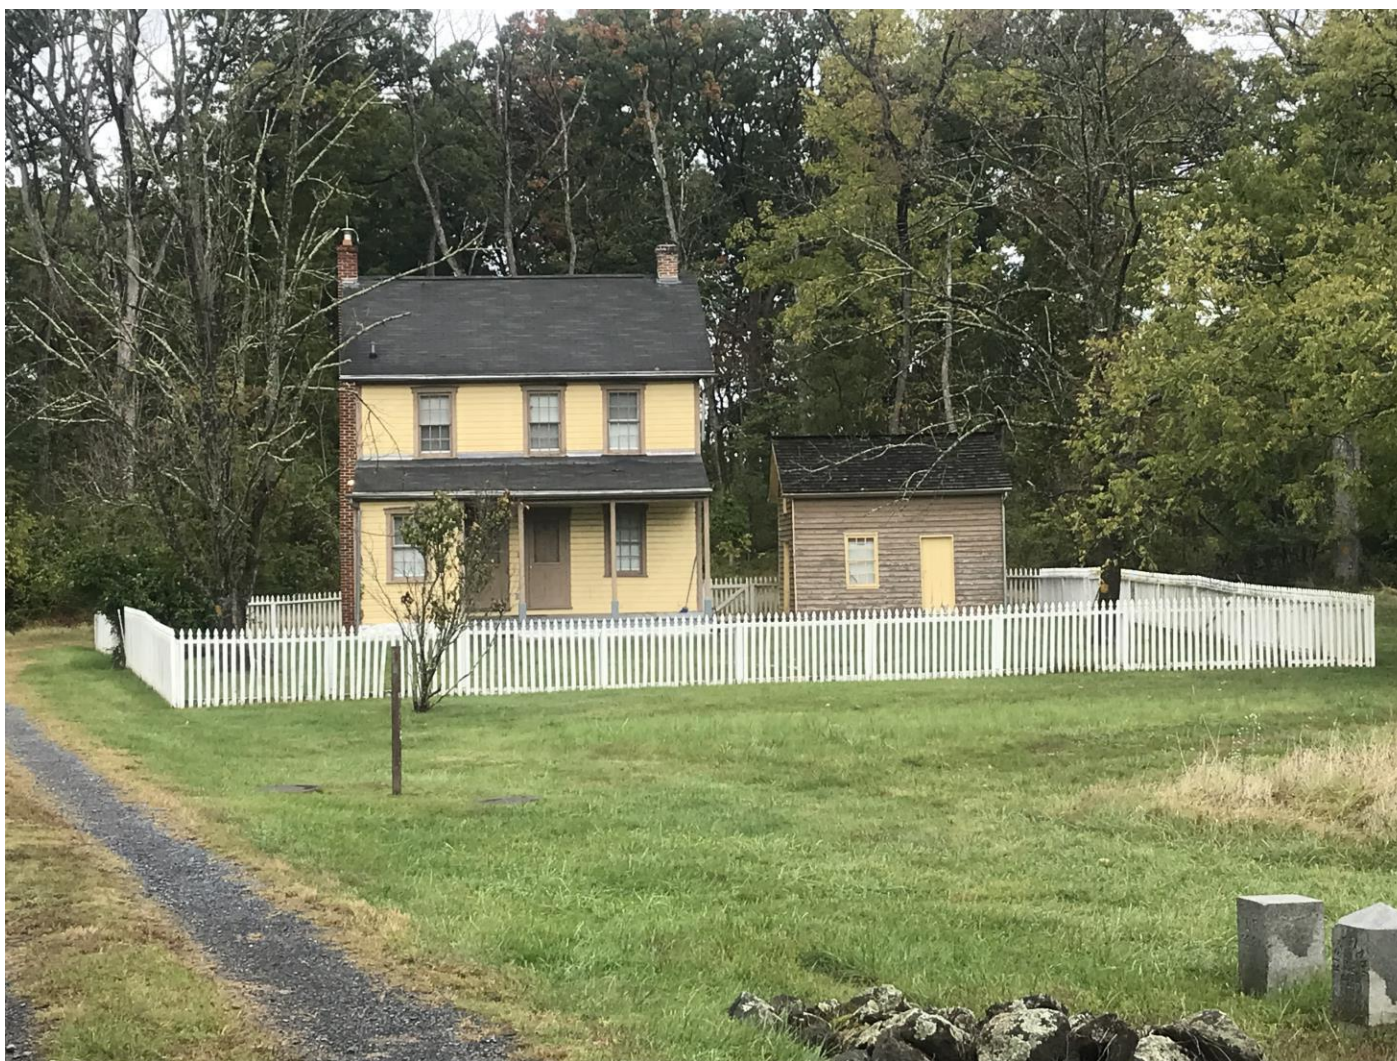
Figure 4. Althoff Farmhouse, summer kitchen (right), yard, picket fence, and driveway leading from Wheatfield Road. The farm is a contributing element to the cultural landscape of the battlefield.

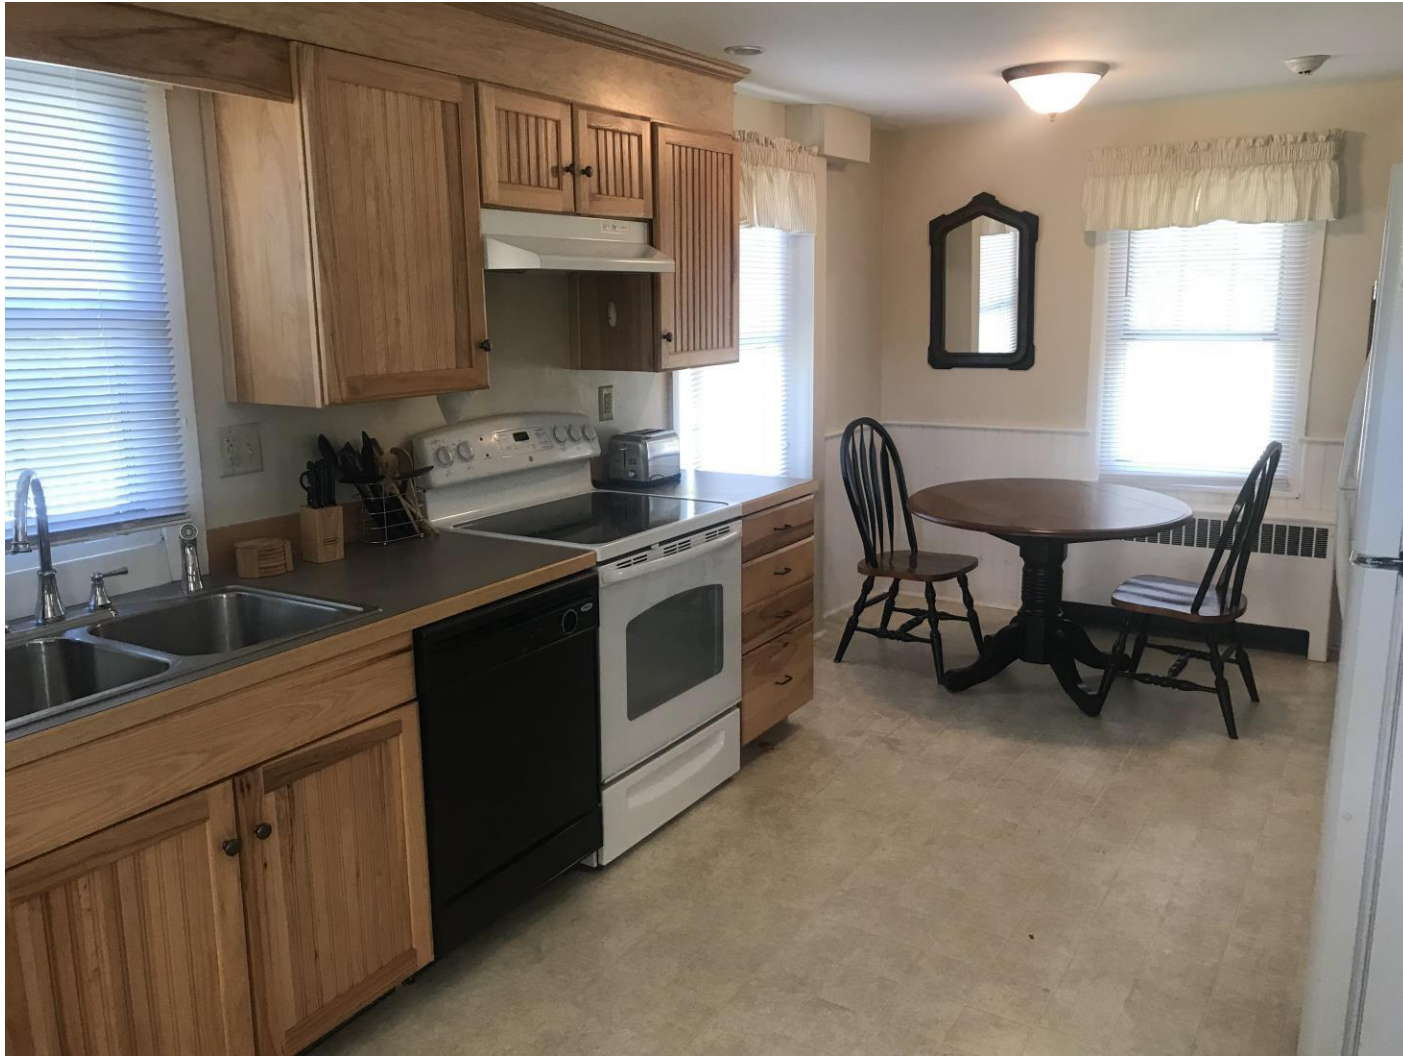
Figure 5. Althoff Farmhouse, modern renovated kitchen. Historic features and materials are limited to windows and molding, plaster walls and ceiling, where they remain.

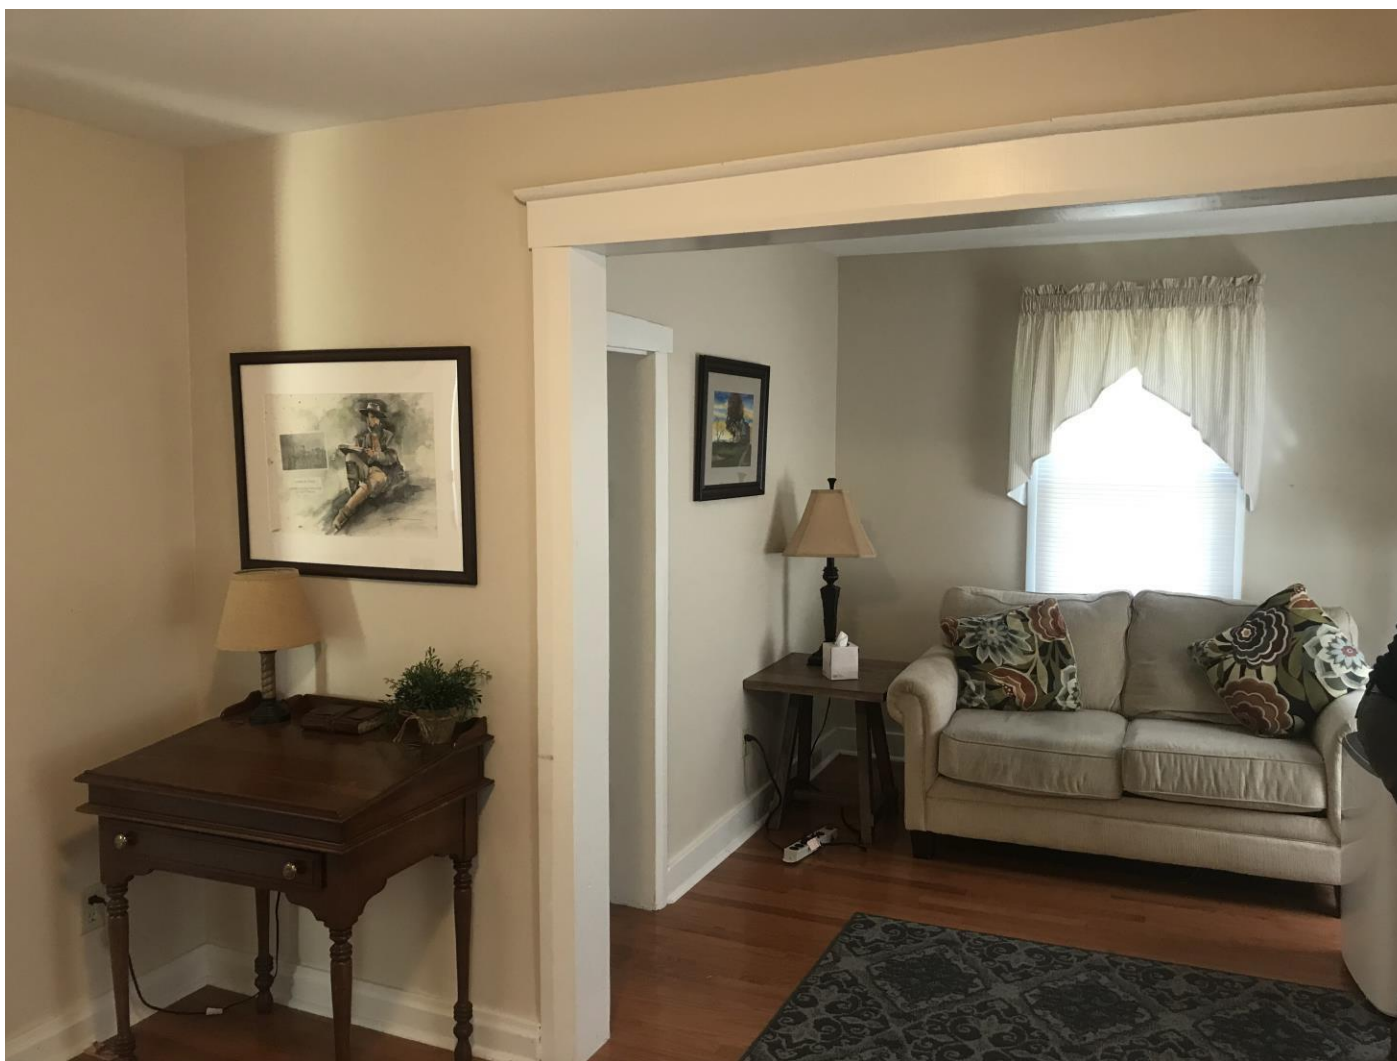
Figure 9. Sitting room, first floor. Wood floor and molding are not original but compatible with historic material/features.

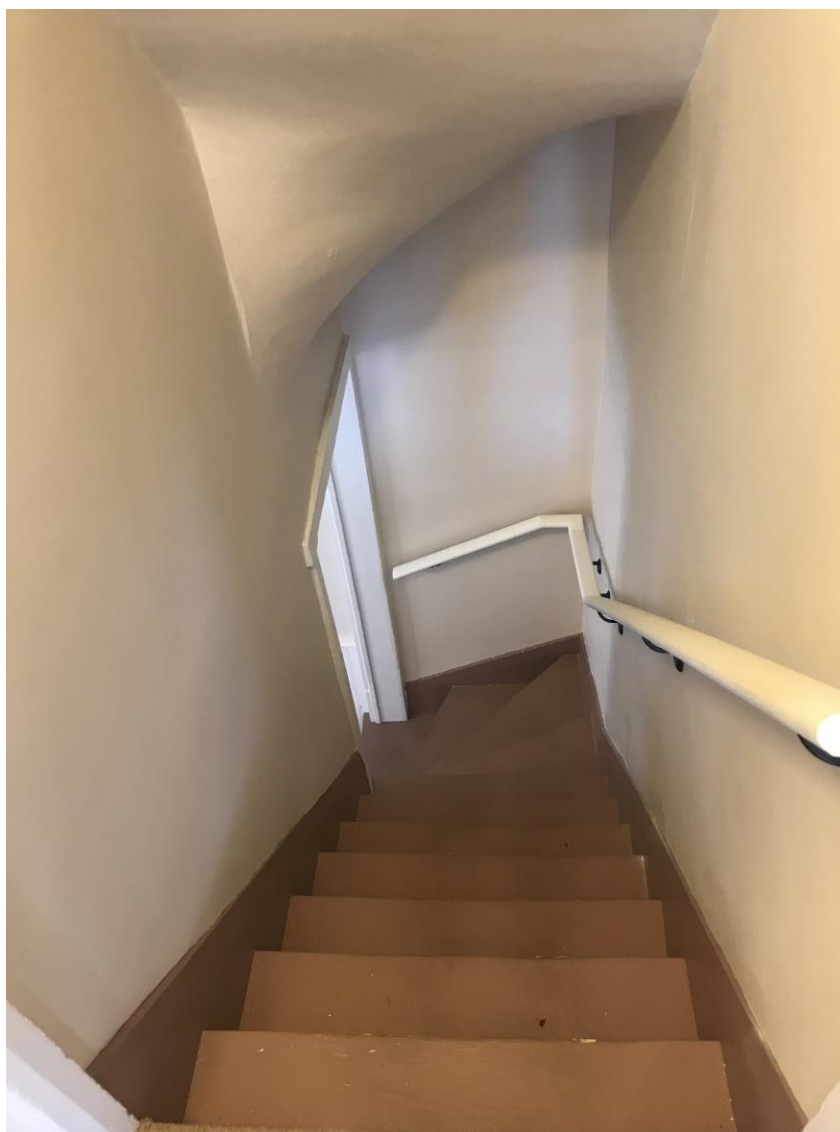
Figure 12. Kite winder staircase, a key historic feature.

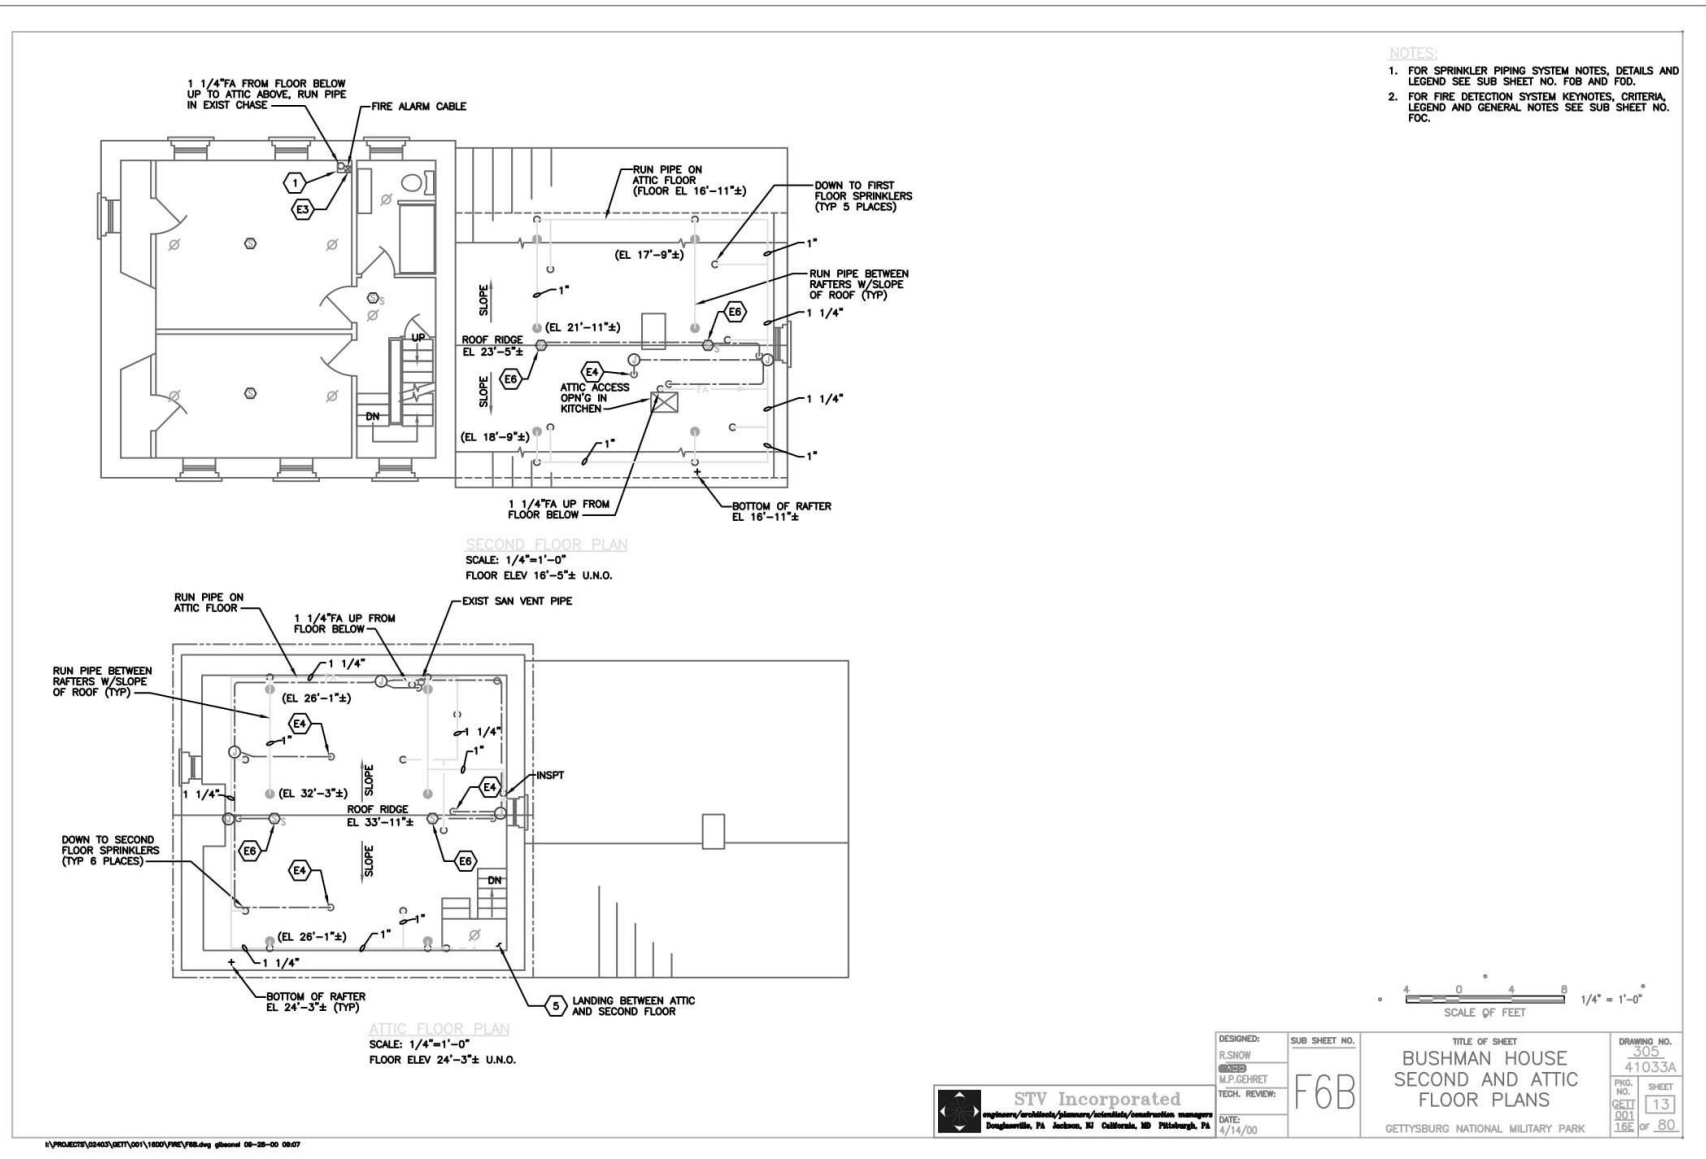
Figure 2. Bushman Farmhouse floor plans – second floor and attic.

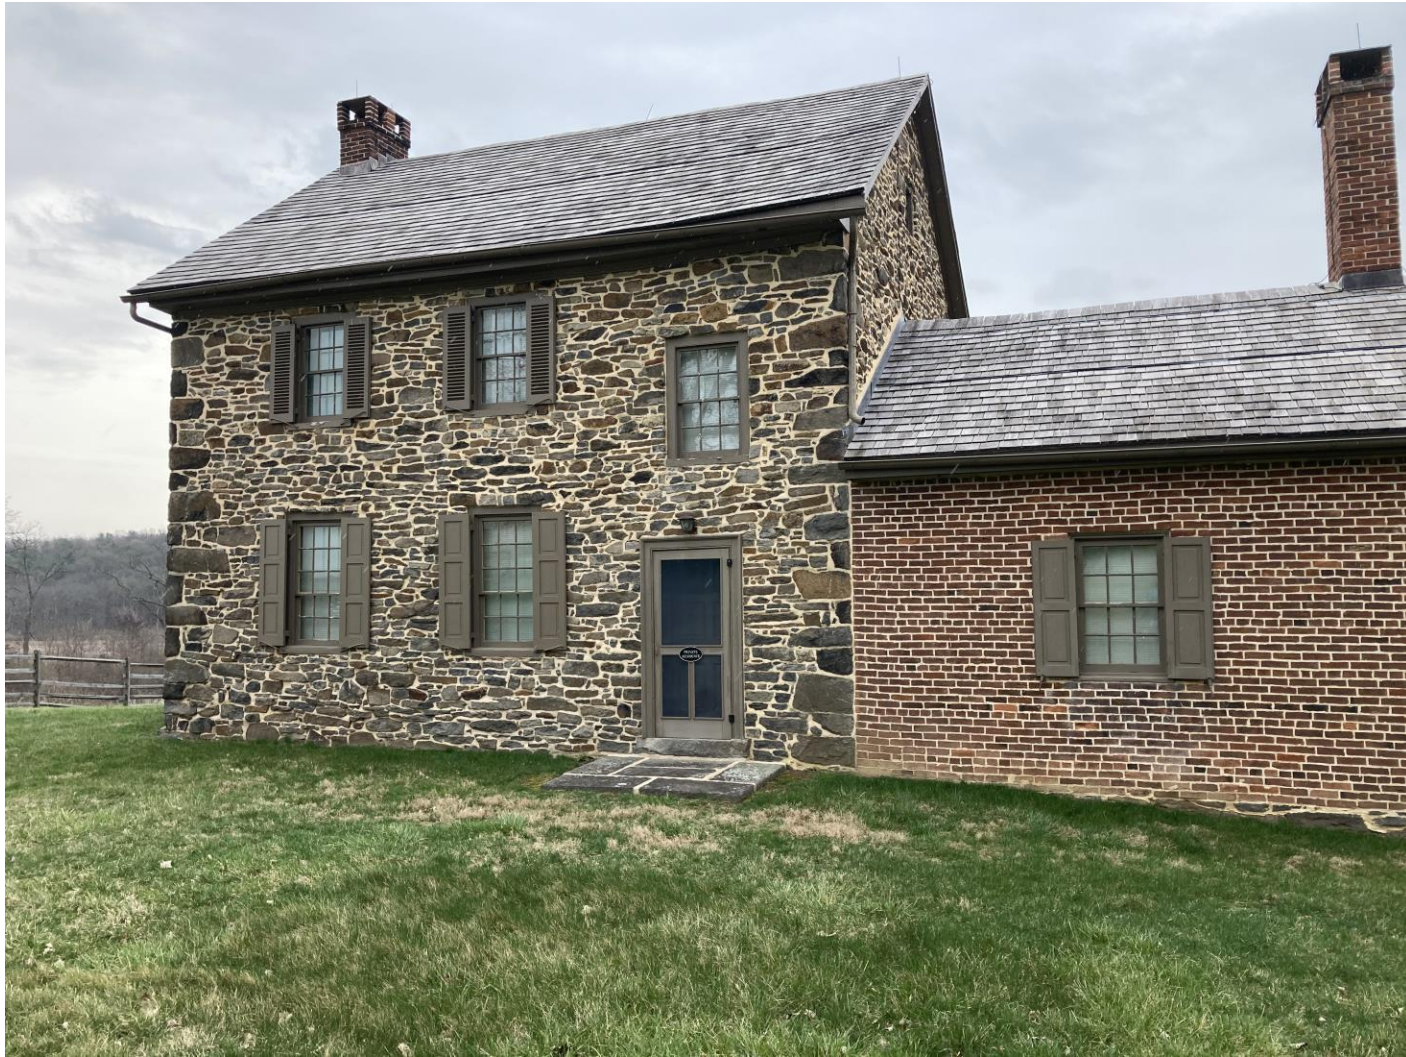
Figure 3. Bushman Farmhouse, west elevation. The original two-story native stone house on the left dates to ca. 1808, with oversize cut stone quoins (*right*) and original window and door configuration. The brick addition on the right dates to ca. 1860. The combination of stone and brick is unique among Civil War houses on the battlefield. Log smokehouse, painted white (now wellhouse), ca. 1808.

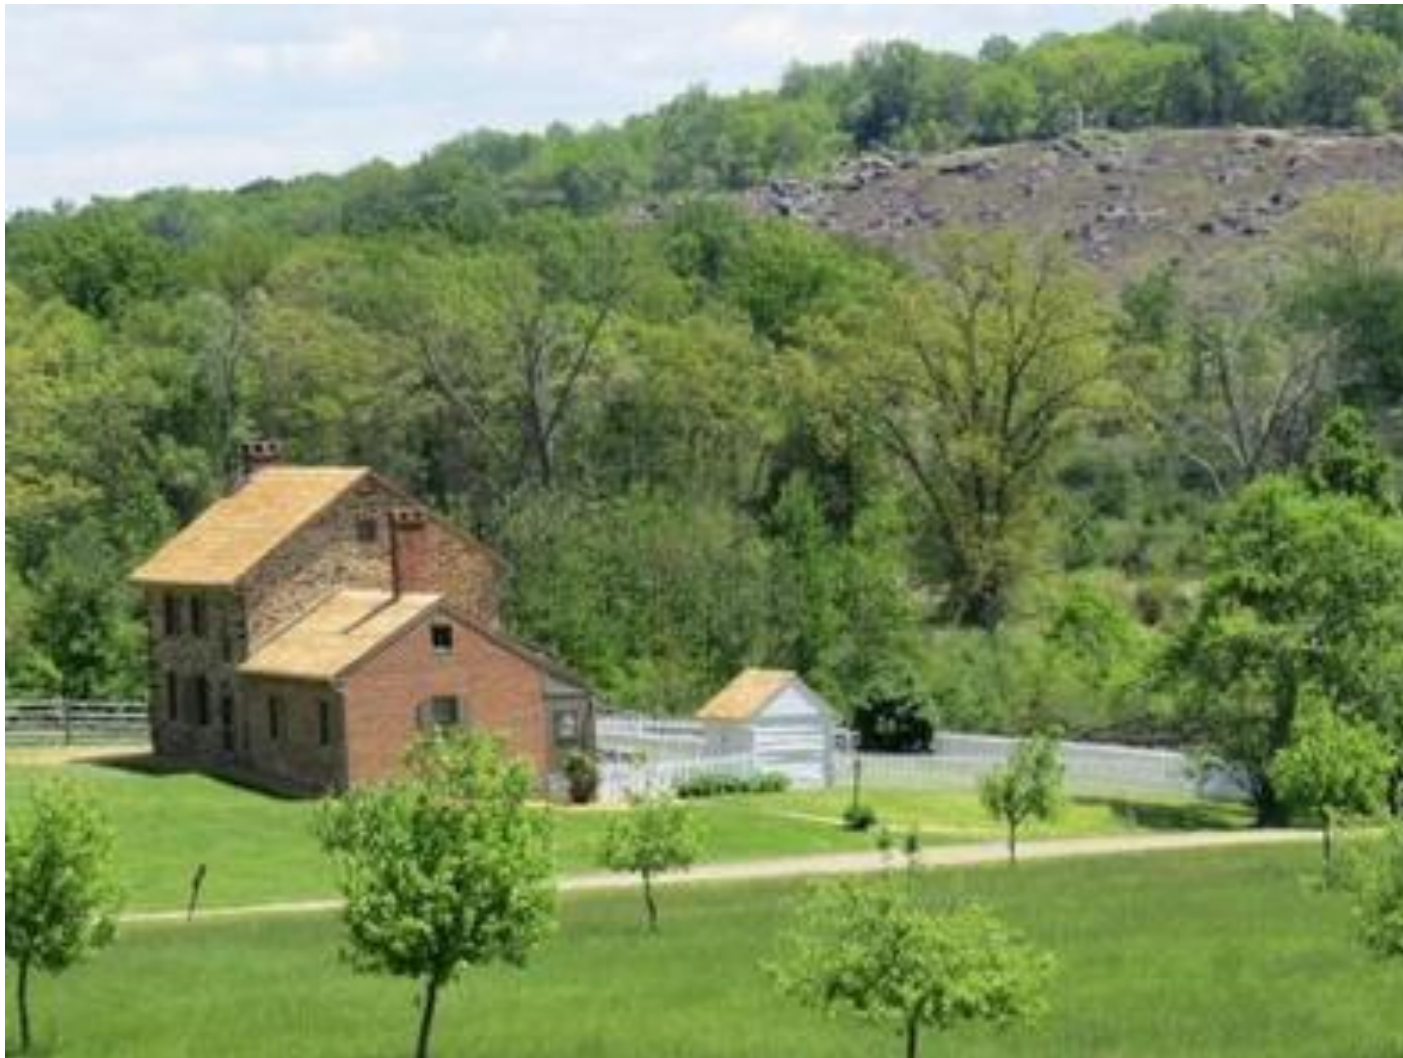
Figure 4. Overview of Bushman Farmhouse with surrounding cultural landscape including orchard in foreground and woods along Plum Creek and Little Round Top in the background.

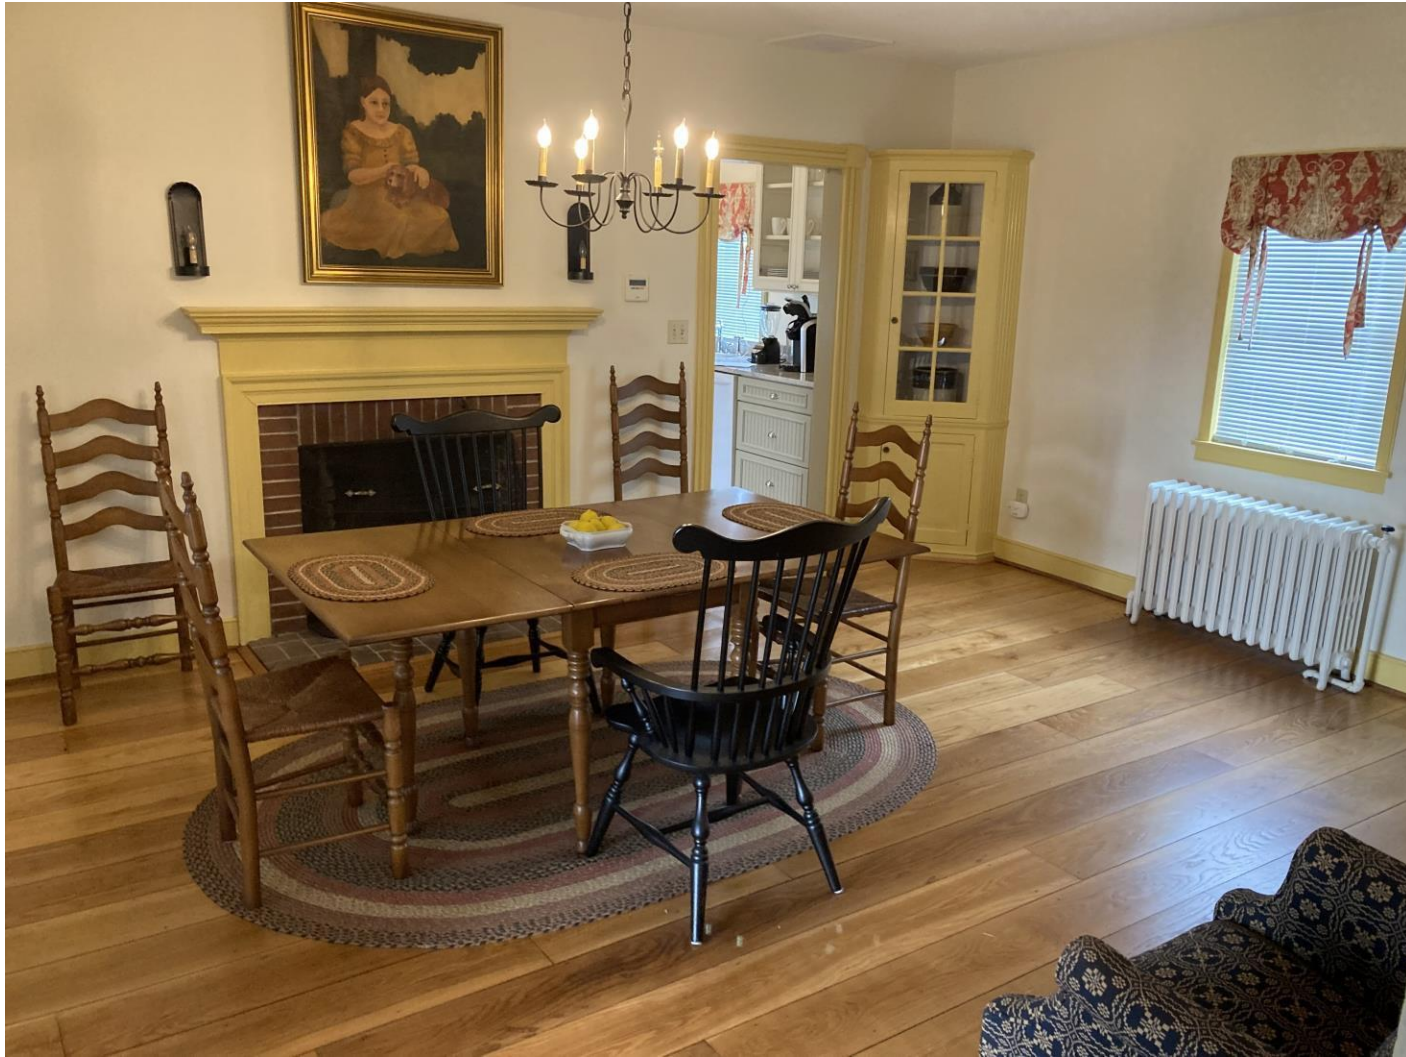
Figure 8. Dining room, rehabilitated 2017 and carefully furnished and decorated with a period theme. Historic features include the brick hearth and fireplace mantel, door and window casings and beaded molding, built-in corner cupboard. Modern tongue and groove wood flooring reflects the original floor material.

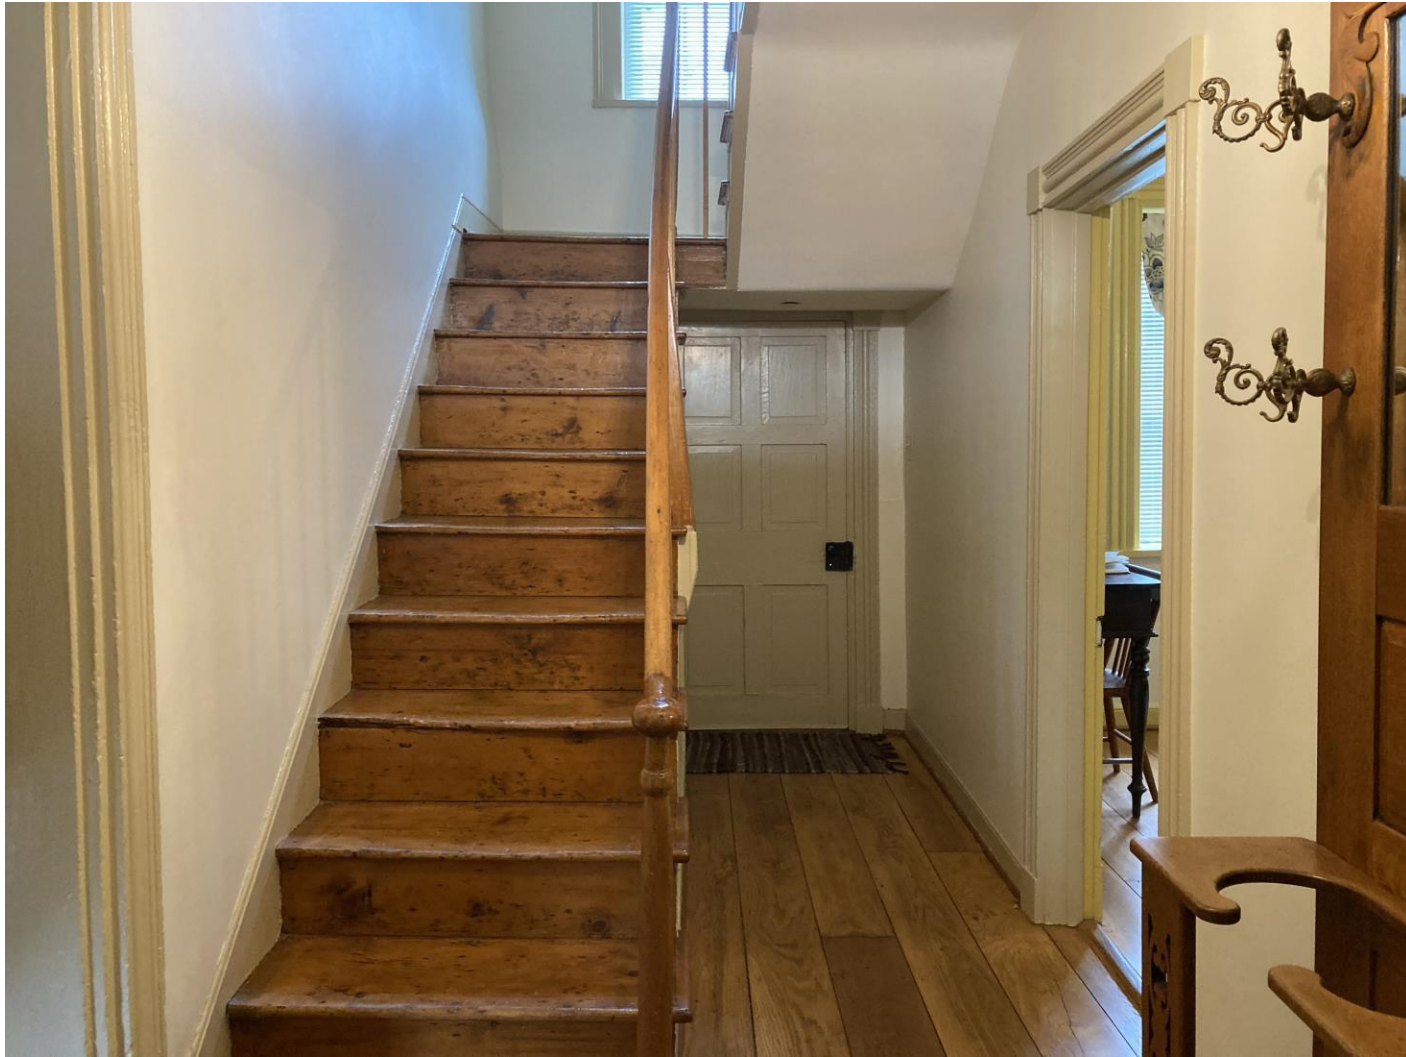
Figure 10. Central hall with original preserved staircase. While poor condition required installation of compatible material for flooring throughout the first floor in recent rehabilitation, the National Park Service was able to restore the original wood flooring in the staircase and on the second floor.

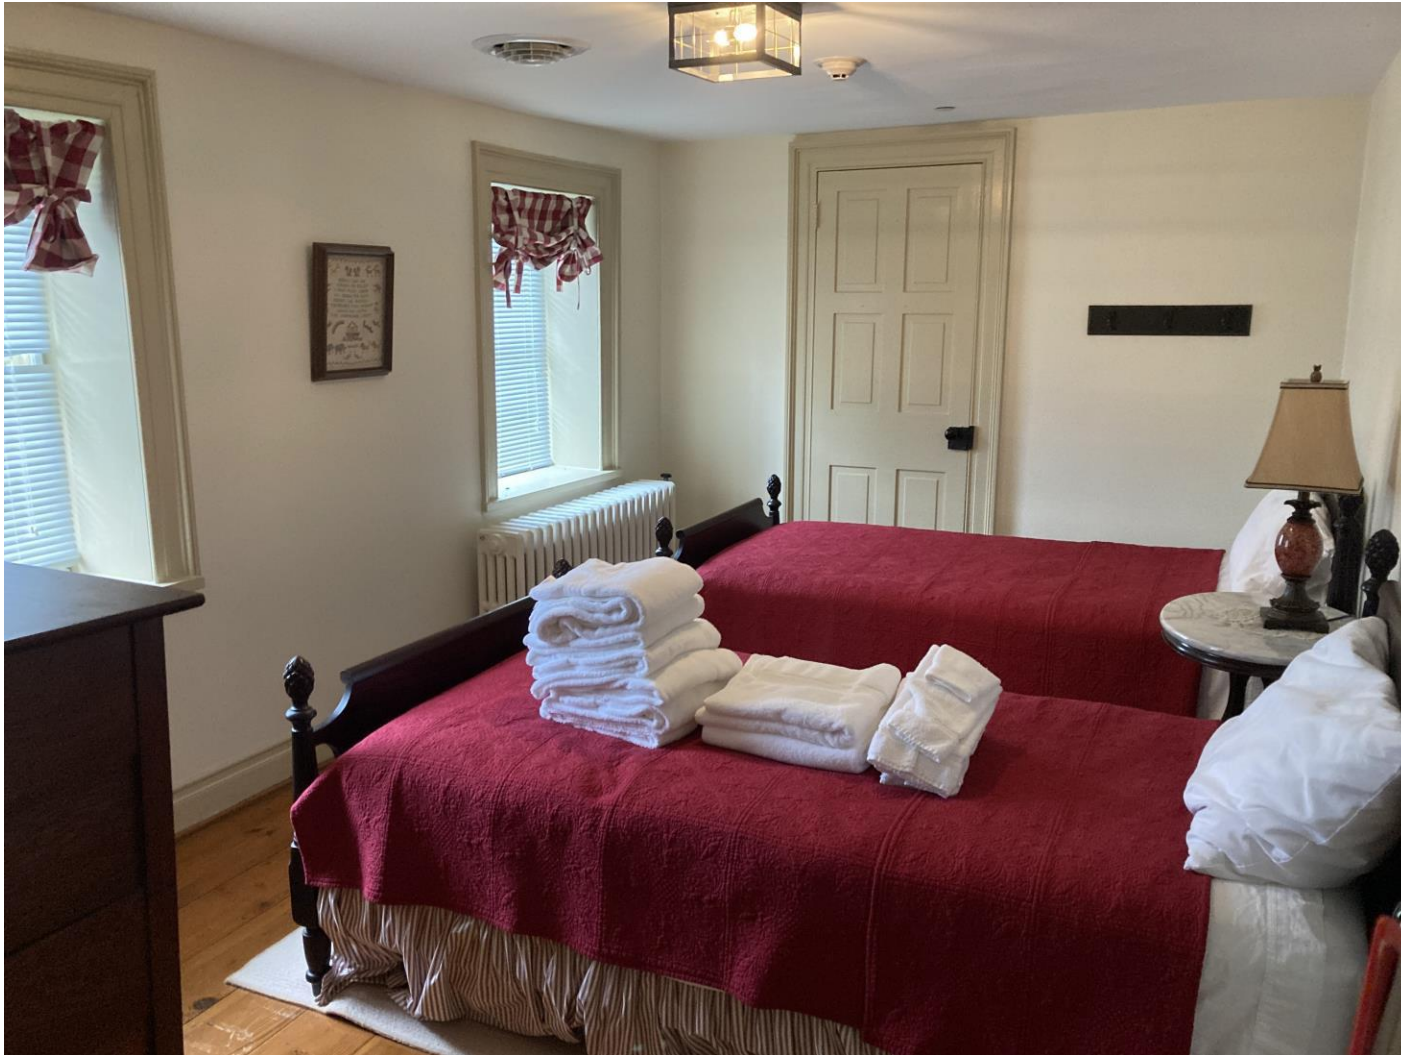
Figure 12. Furnished and decorated second floor bedroom with two beds and closet. Historic wood plank flooring, windows, plaster walls and ceiling contribute to the room's character.

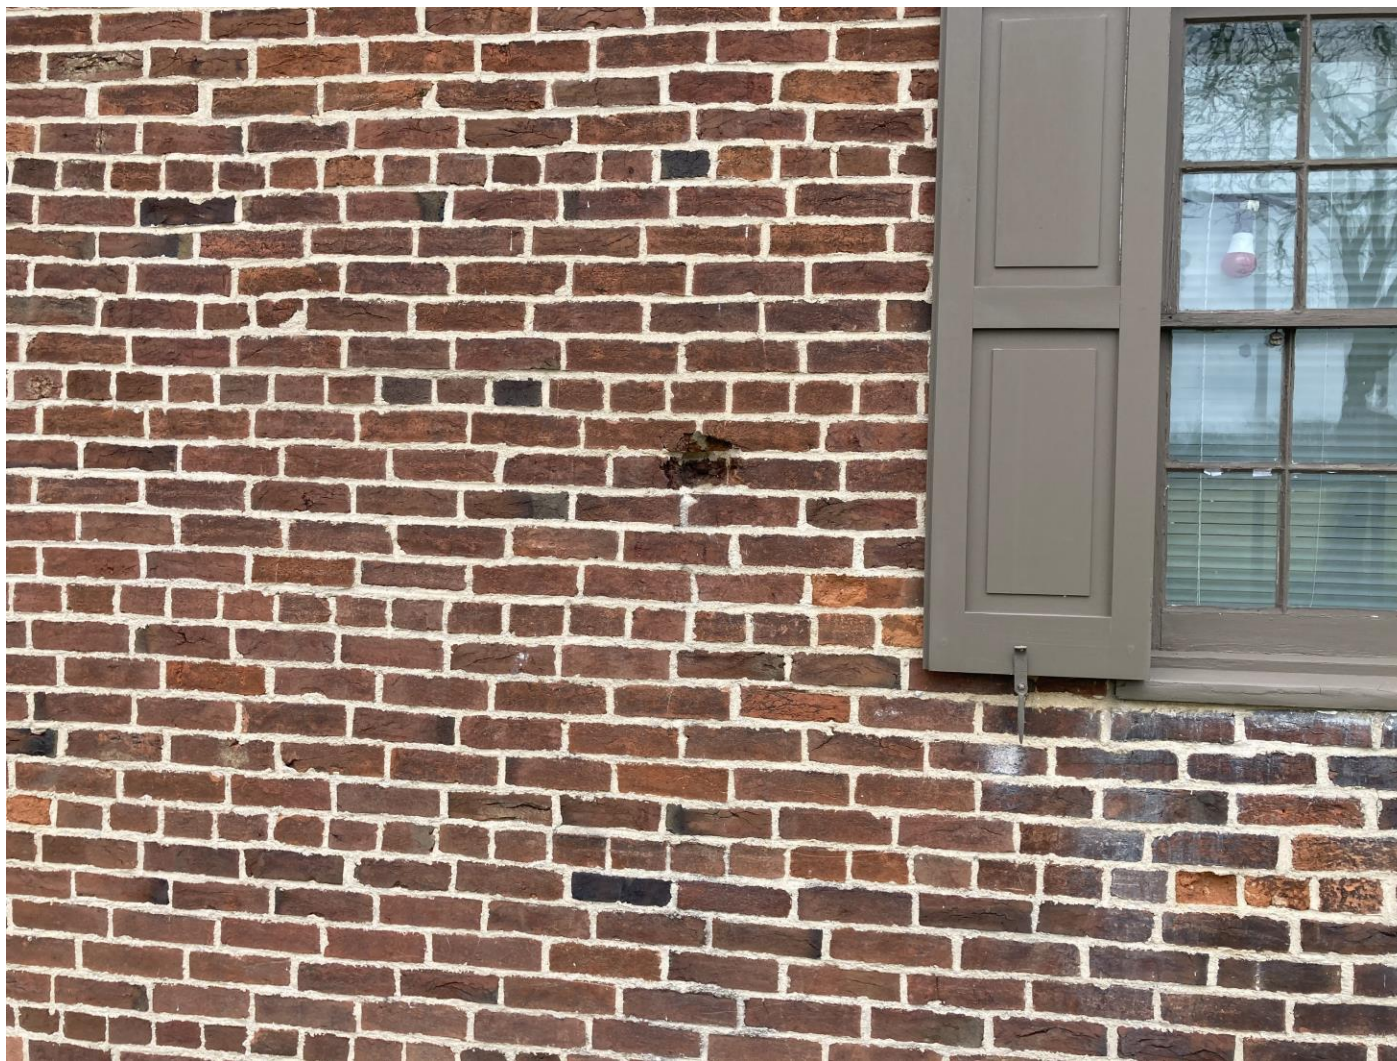
Figure 16. The Bushman Farmhouse is one of a few buildings with visible battle damage. This impact to the brick wall is on the south end of the house.

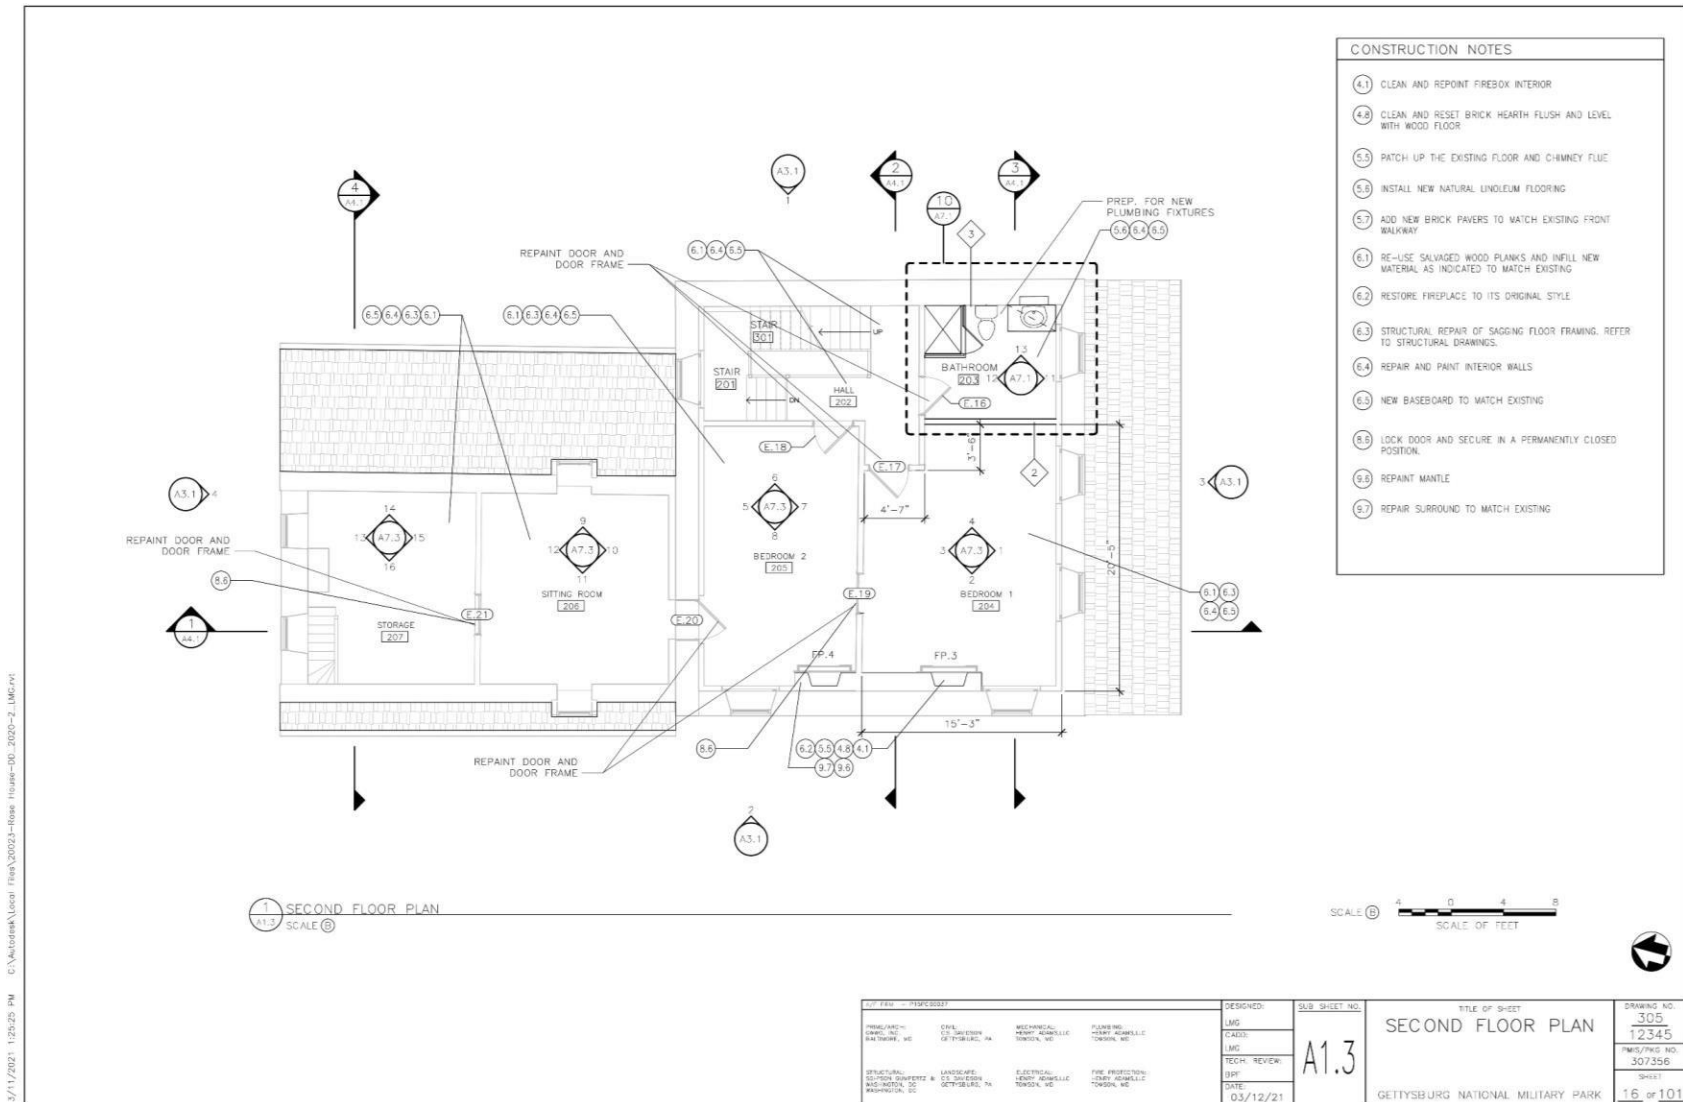
Figure 2. Rose Farmhouse, second floor plan.

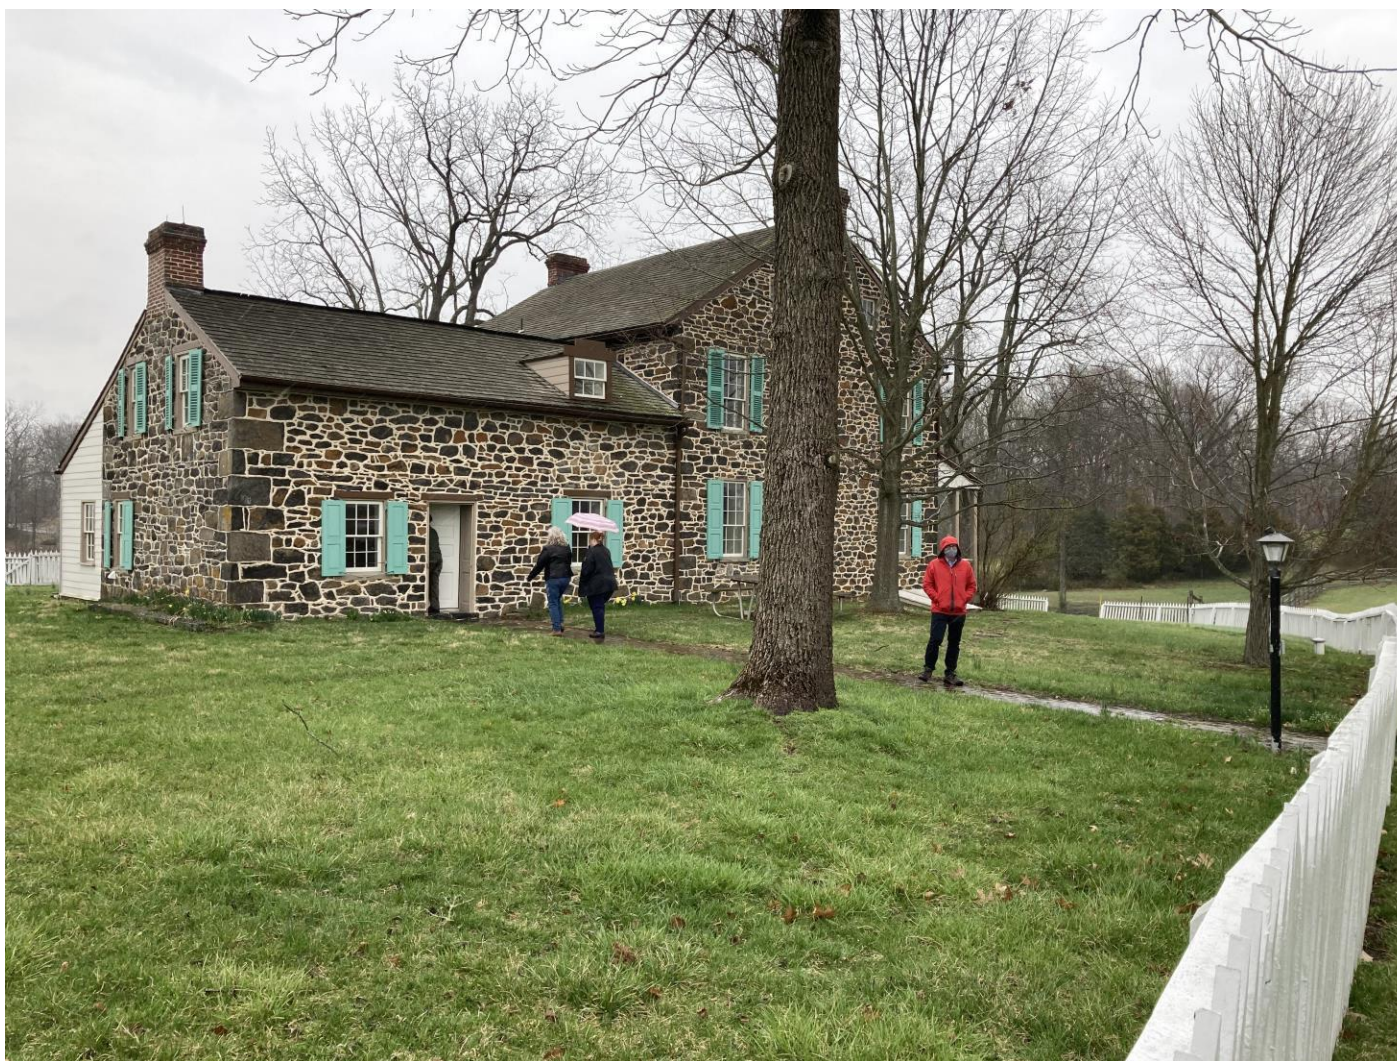
Figure 3. Rose Farmhouse, west elevation, with original two-story (ca. 1812-23) house to the right, built between 1812 and 1823, and rear stone kitchen block addition, built ca. 1851.

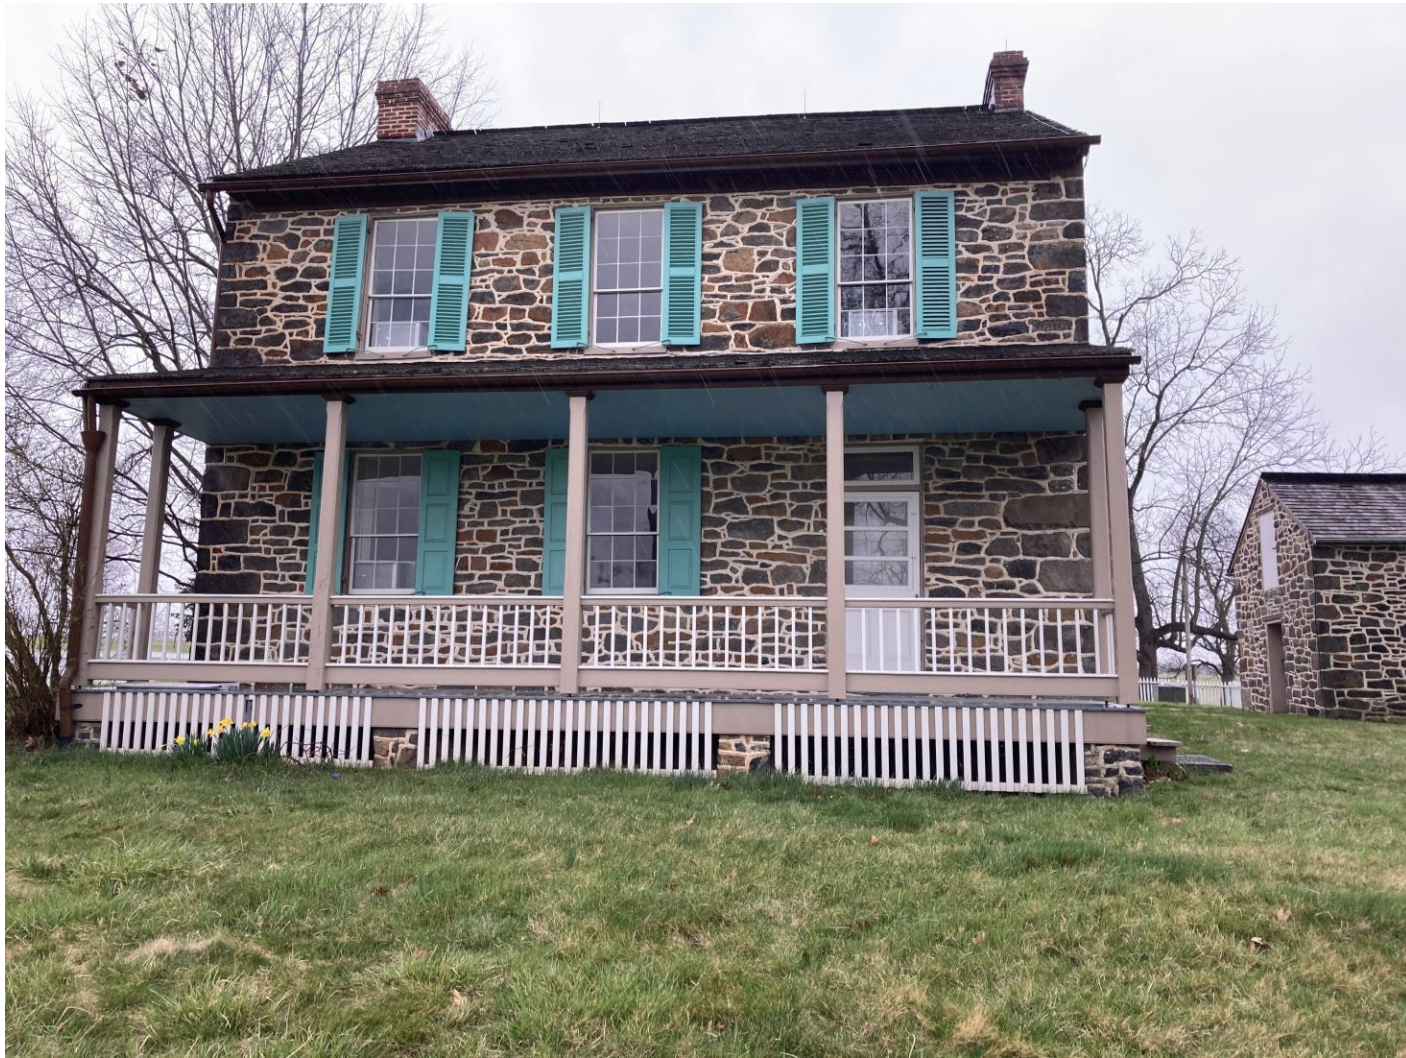
Figure 4. Rose Farmhouse, front, east elevation. Note historic, symmetrical window pattern, door with transom, and large porch. The native granite stone was likely collected nearby, including possibly the Devil's Den area.
