## **ATTACHMENT B. DESCRIPTIONS, FLOOR PLANS, AND PHOTOS**

### Althoff Farmhouse

## Bushman Farmhouse

## Rose Farmhouse

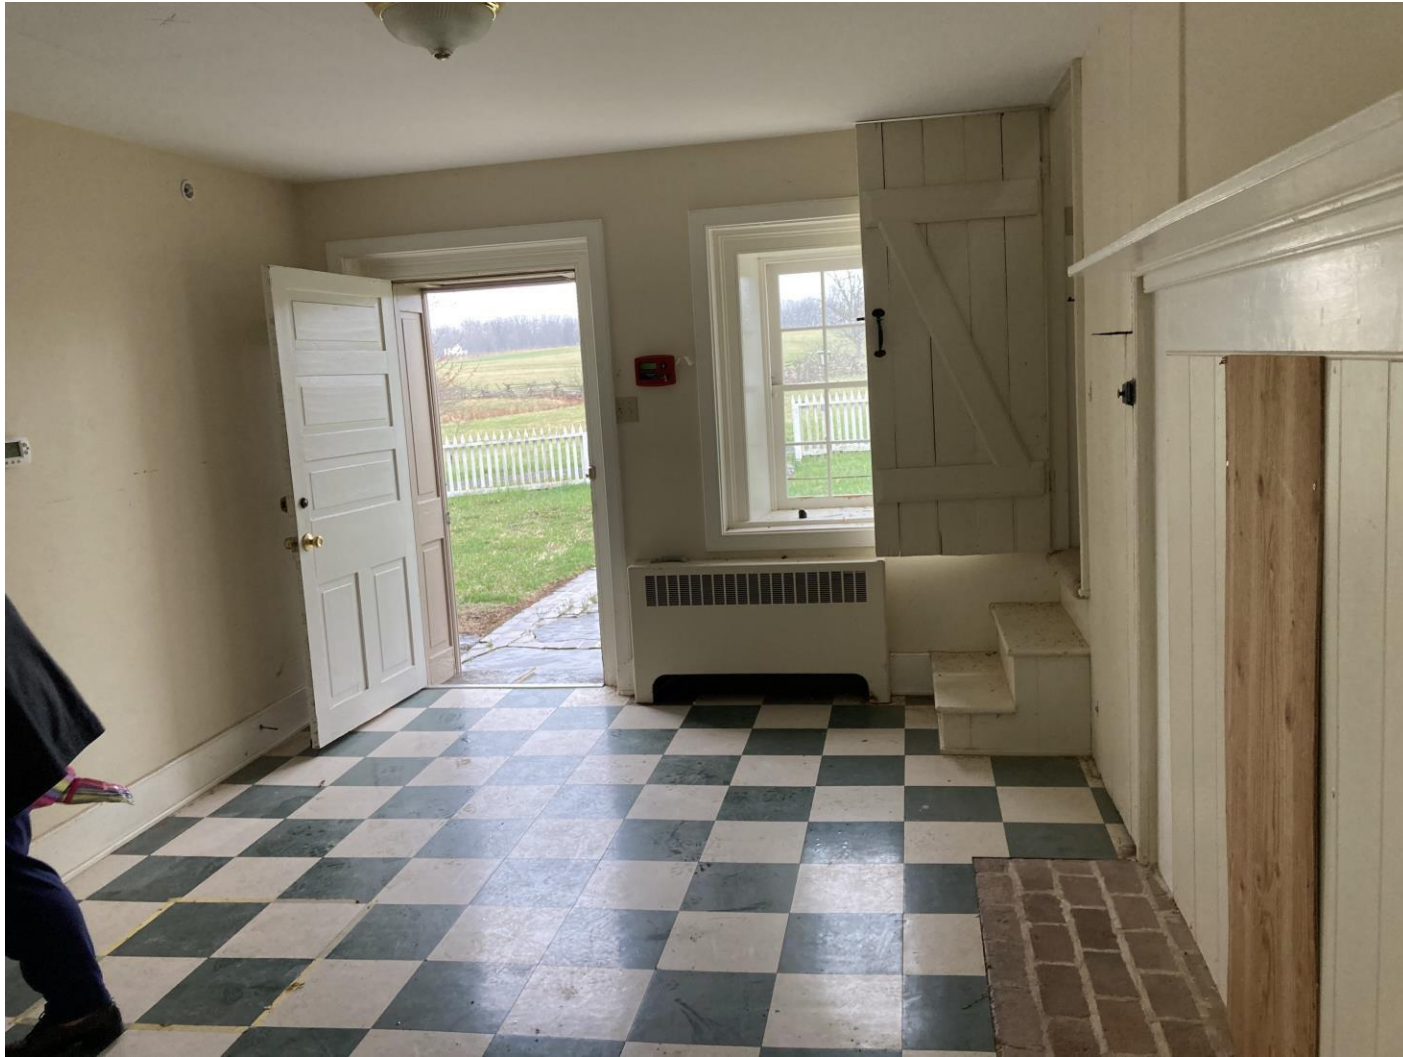
Figure 5. Rose Farmhouse, laundry (proposed sitting room), first floor addition. Note enclosed historic firebox, some original plaster on walls, 1980s vinyl floor and furred out exterior wall. This room is adjacent to the kitchen and pantry (proposed bathroom). Stairs visible on the right access the second-floor bedroom

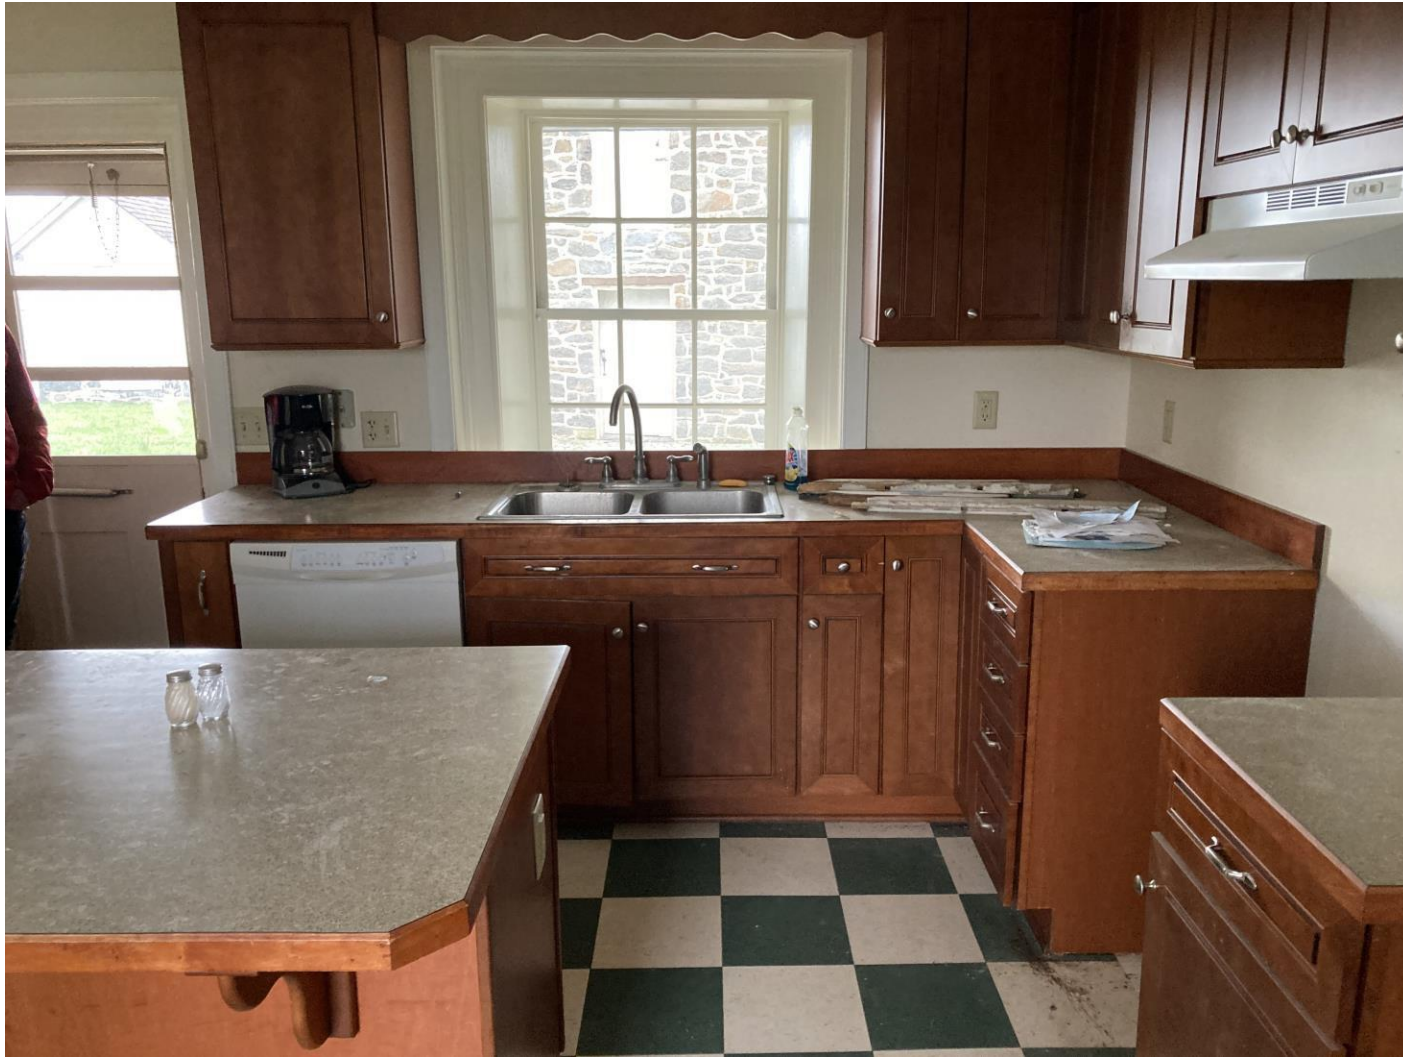
Figure 6. Rose Farmhouse kitchen renovated 1980s, planned for rehabilitation. Historic fabric exists behind furred out walls.

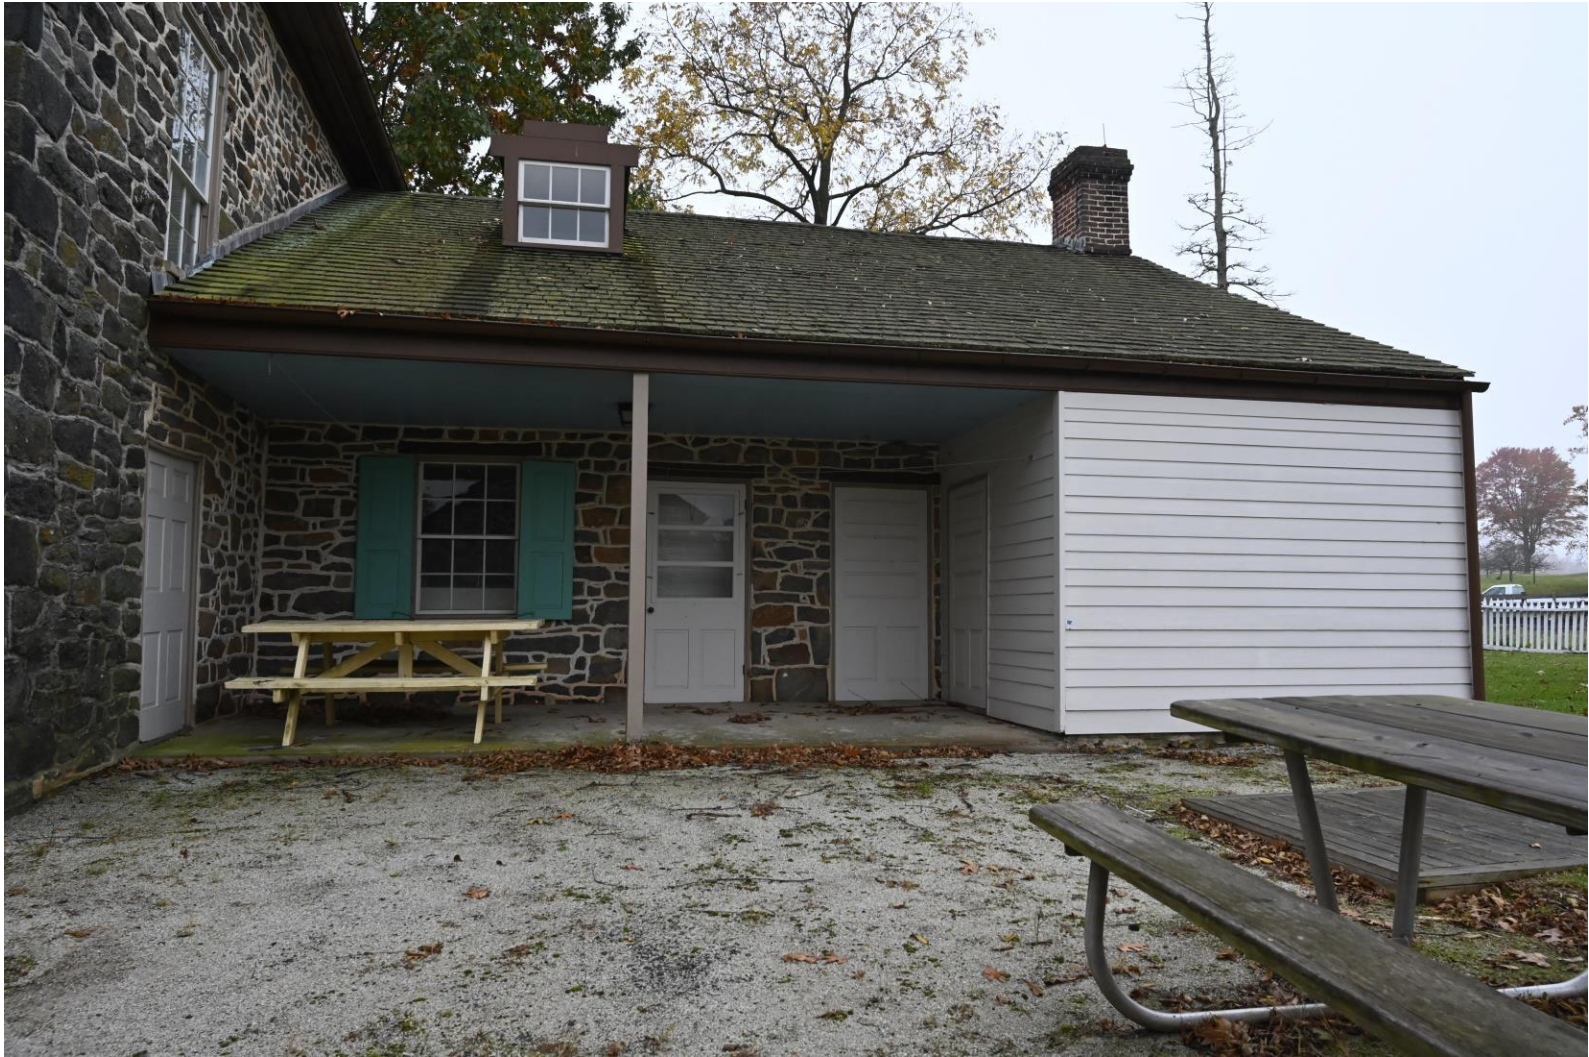
Figure 7. Rose Farmhouse, rear patio off kitchen, east elevation. A brick patio previously extended from the concrete. The horizontal wood siding addition is the previous pantry (proposed bathroom).

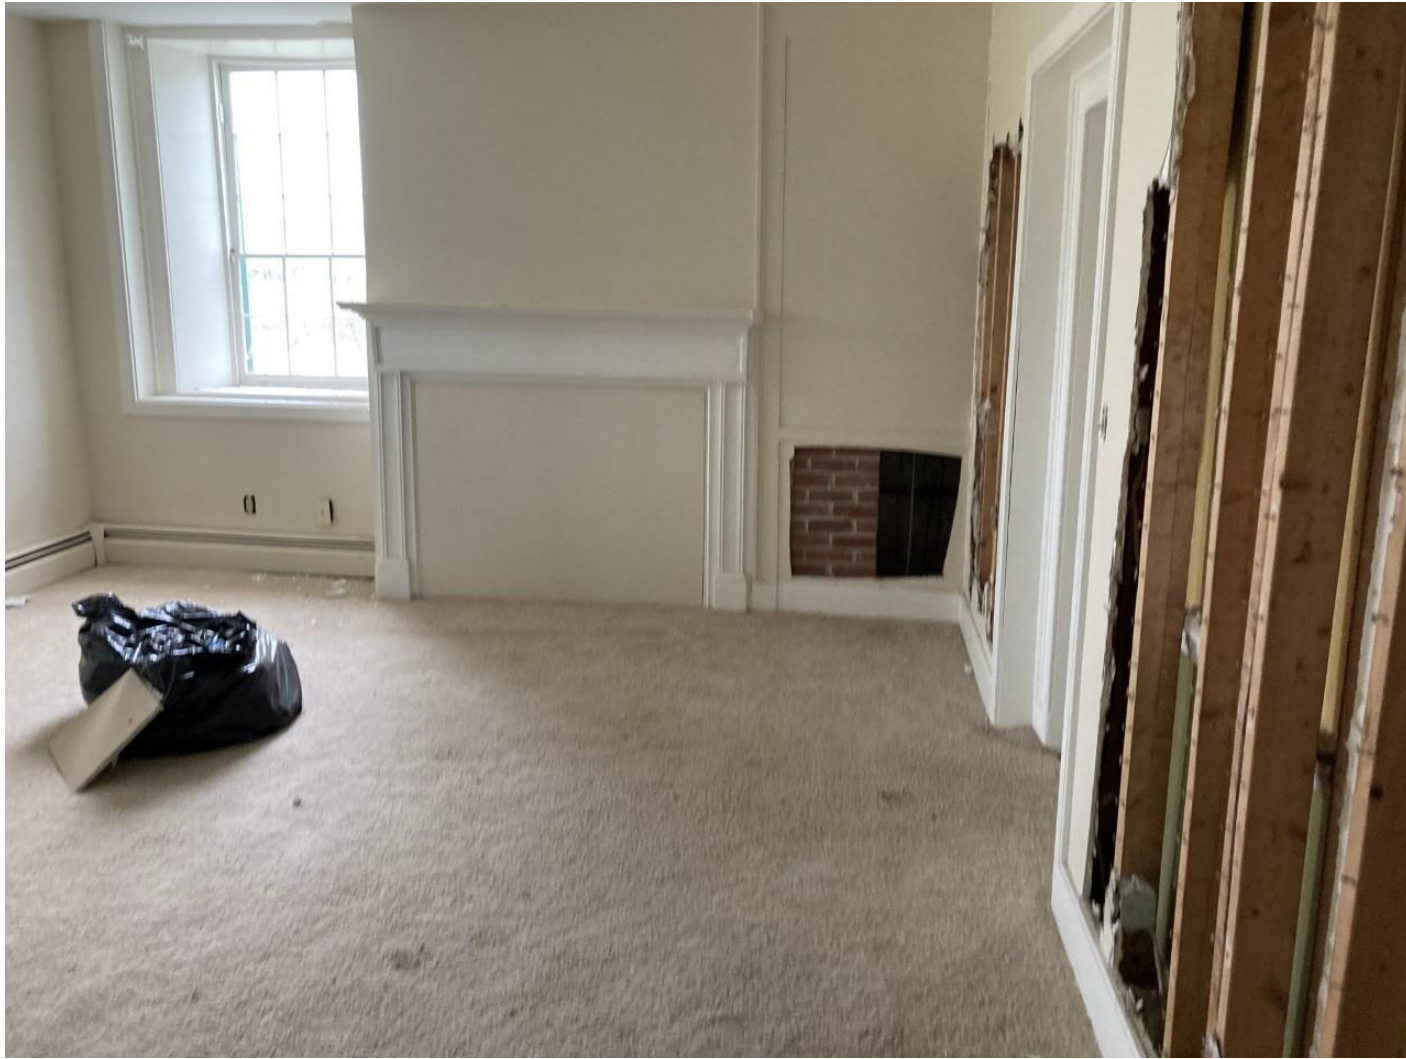
Figure 8. Rose Farmhouse, first floor parlor room. Proposed rehabilitation will return *this* room to *intact* original plaster walls (intact behind furred out walls), wood plank flooring, brick firebox and hearth.

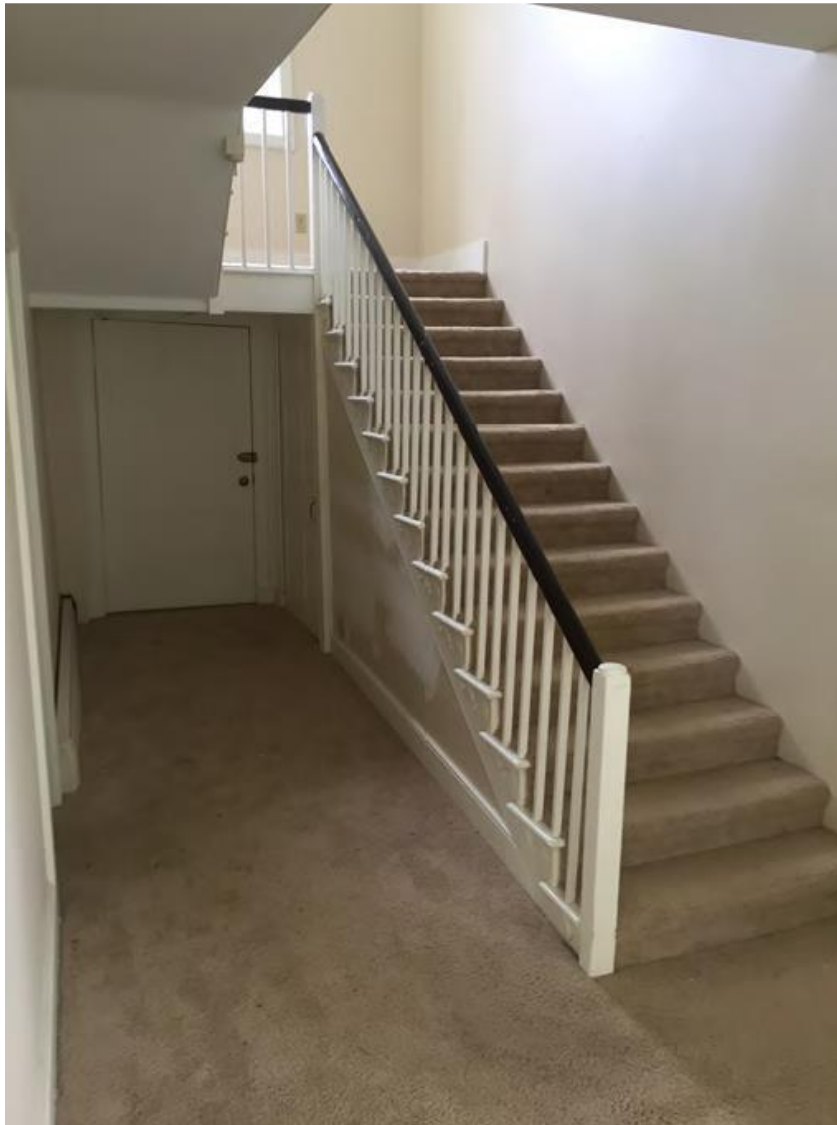
Figure 9. Entrance hall and staircase to second floor. This hall maintains original historic layout and staircase, concealed wood plank floor, and doors are considered historic features, to be preserved in rehabilitation.

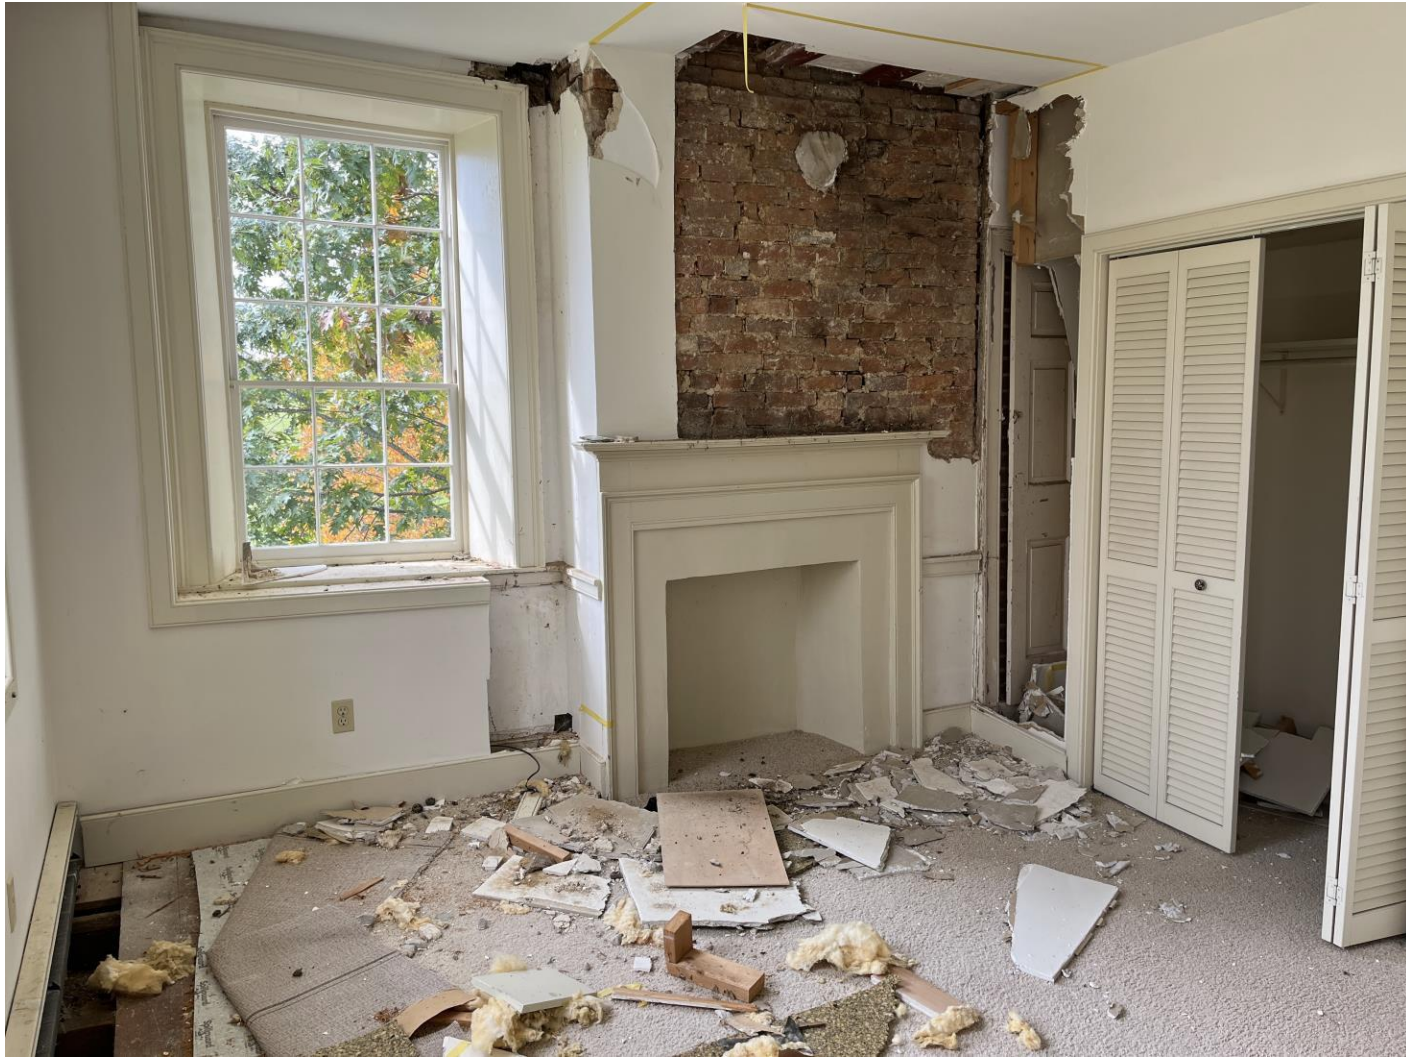
Figure 10. Bedroom #1, second floor. Walls and floor opened to expose historic fabric to help inform rehabilitation.

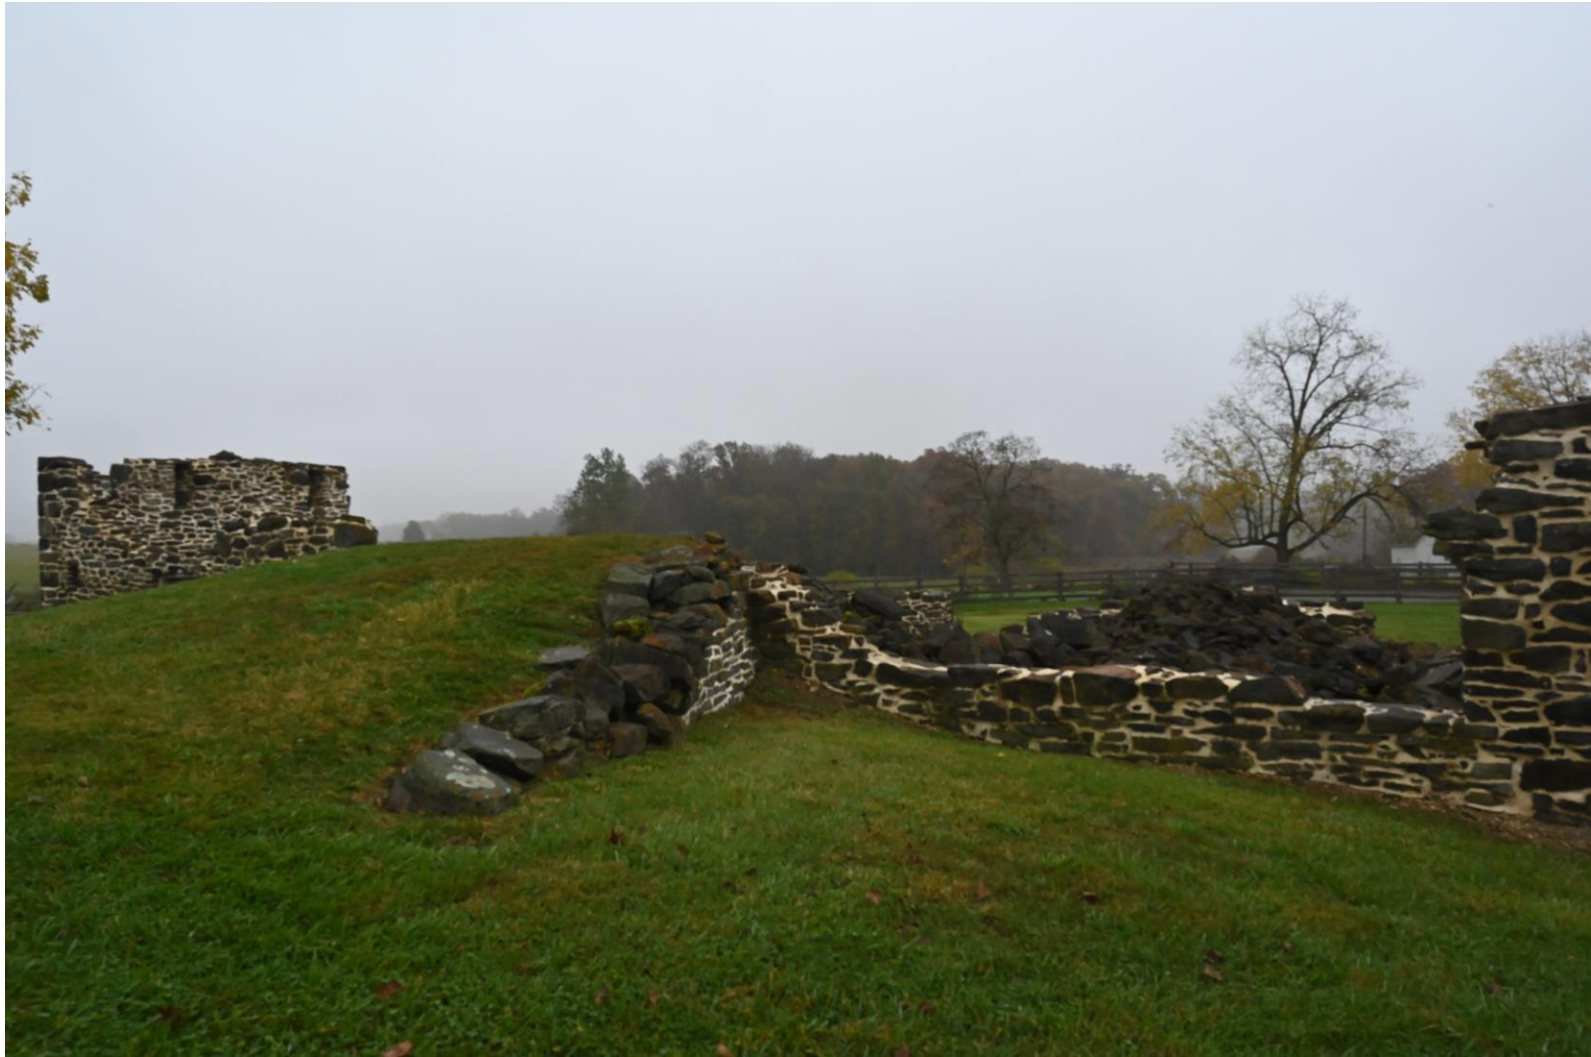
Figure 16. Bank barn ruins, northwest of the Rose Farmhouse. The barn first sheltered Union soldiers, then Confederates, for whom it served as a field hospital.

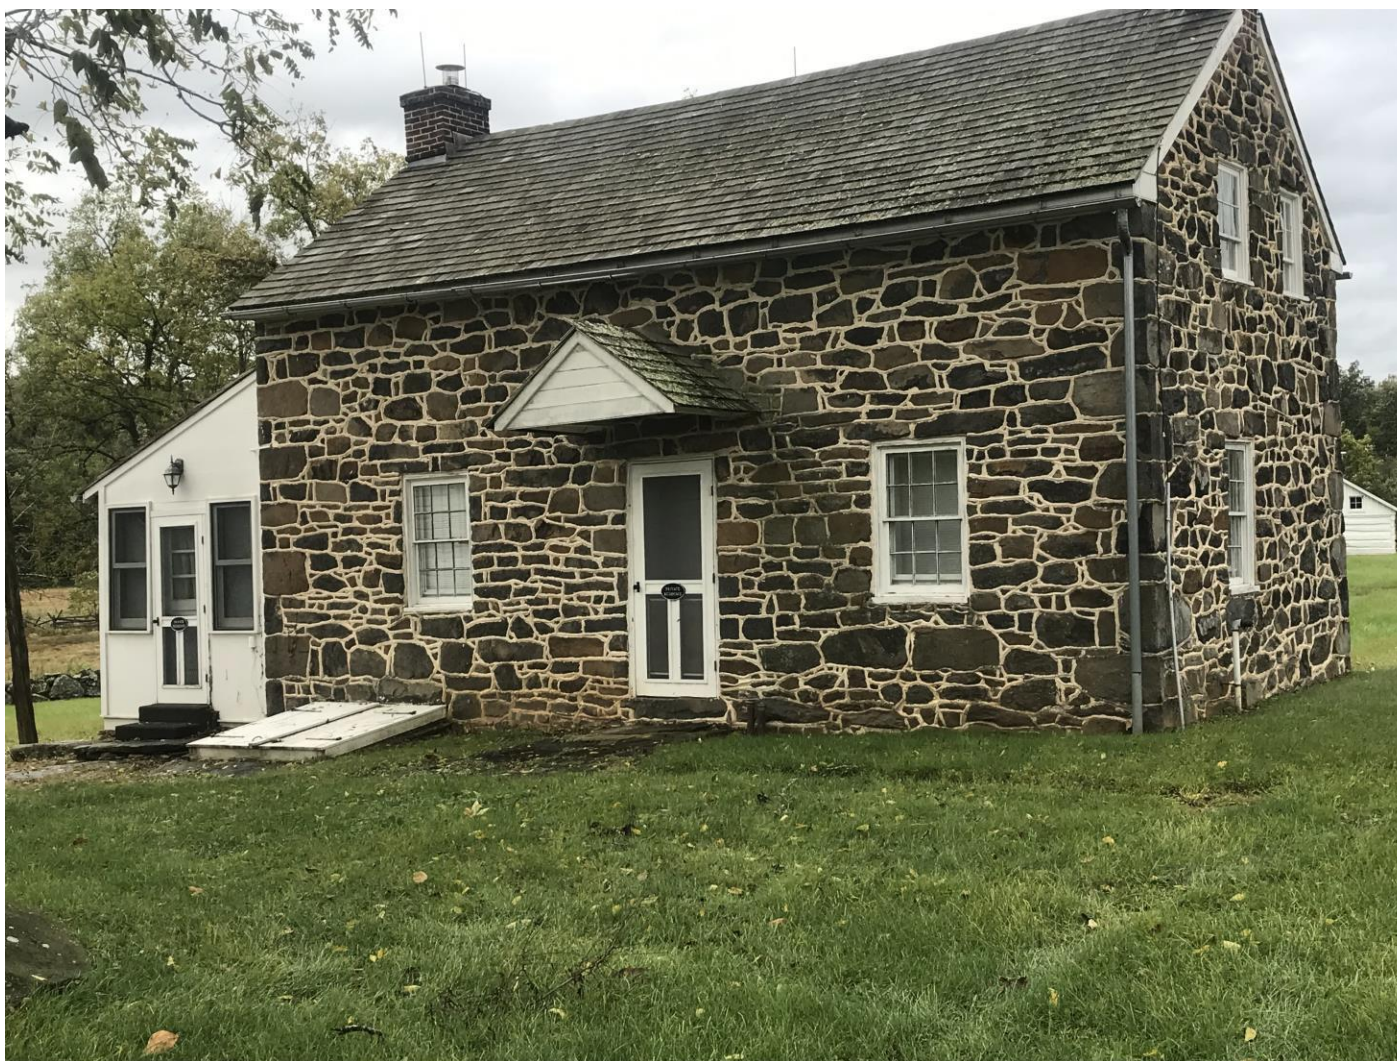
Figure 2. Two-bay, two story Slyder Farmhouse, south elevation. A two-story, two bay house with native stone exterior walls and rough-cut diabase stone wall edges. A non-historic frame addition on the west end includes sunporch and bathroom.

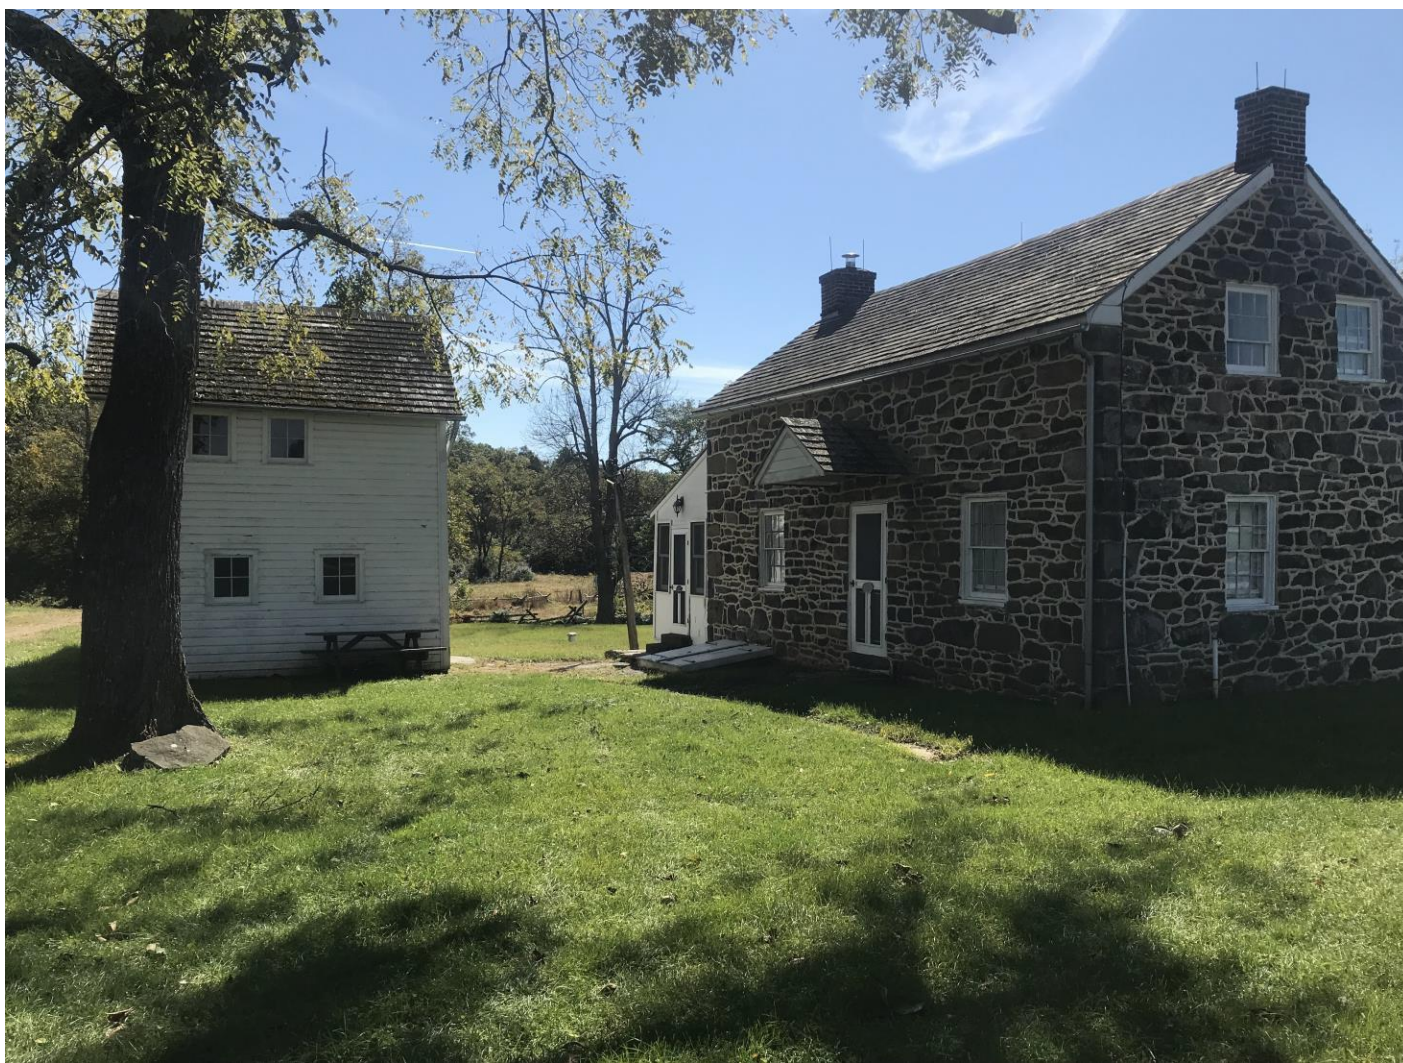
Figure 3. Snyder Farm, view west with house on right and historic summer kitchen on left. The summer kitchen was part of the farm in 1863 as a one-story building, the second story added ca. 1895. The kitchen may have been used as a hospital facility after the battle.

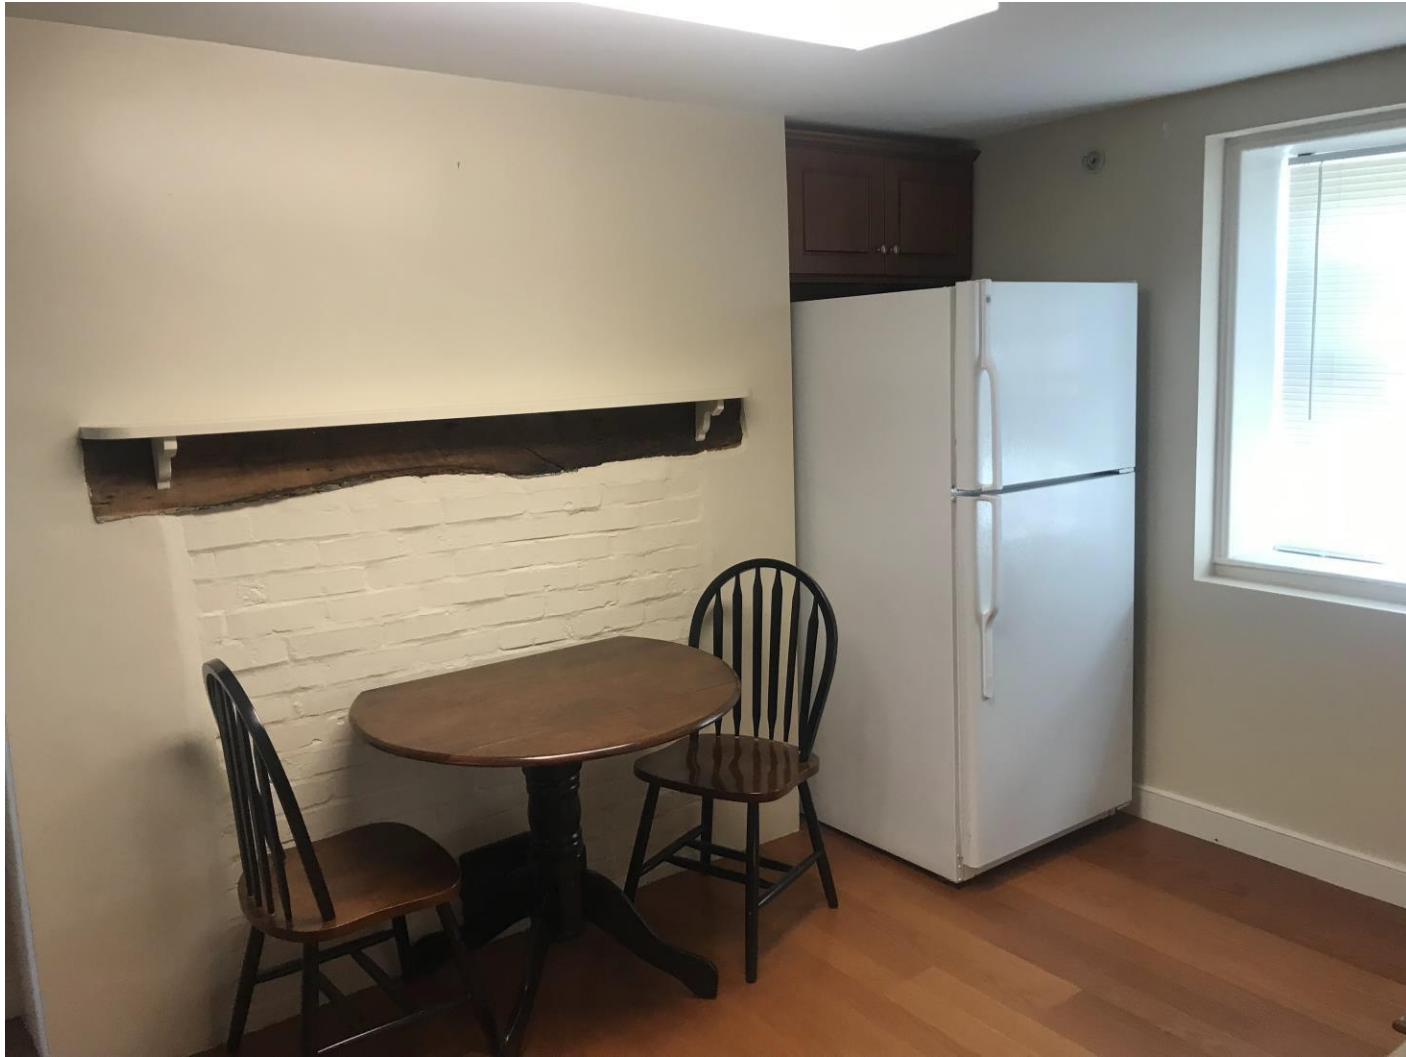
Figure 5. Renovated kitchen in the Slyder house. The historic fireplace has been sealed with brick.

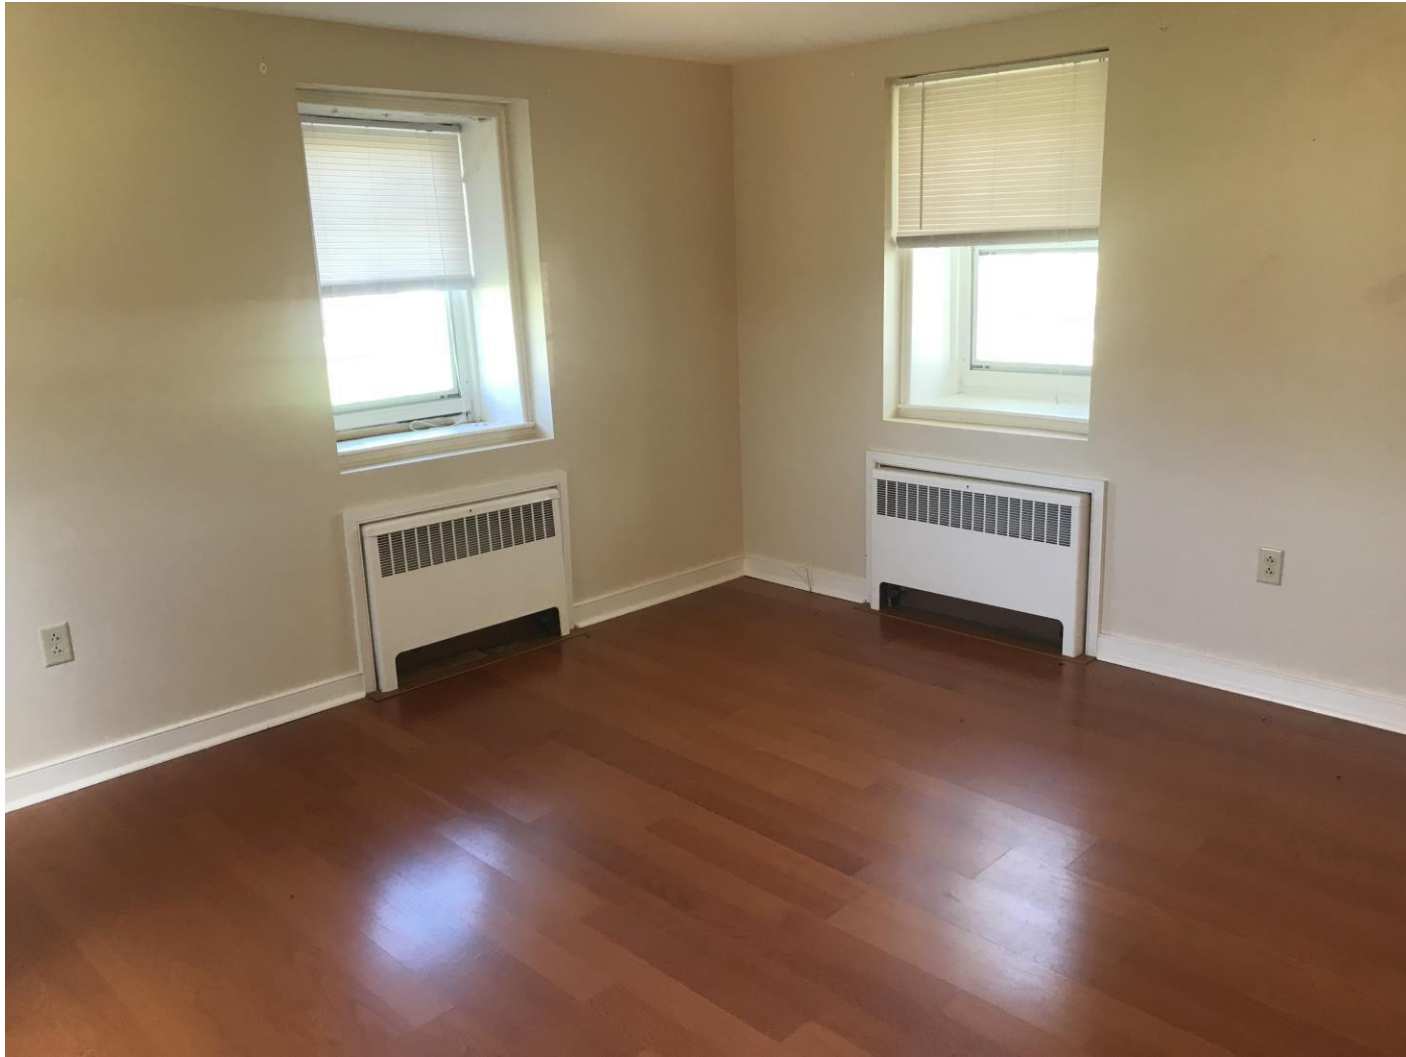
Figure 8. Parlor room, first floor. This renovated space includes largely non-historic features or materials (with exception of windows).

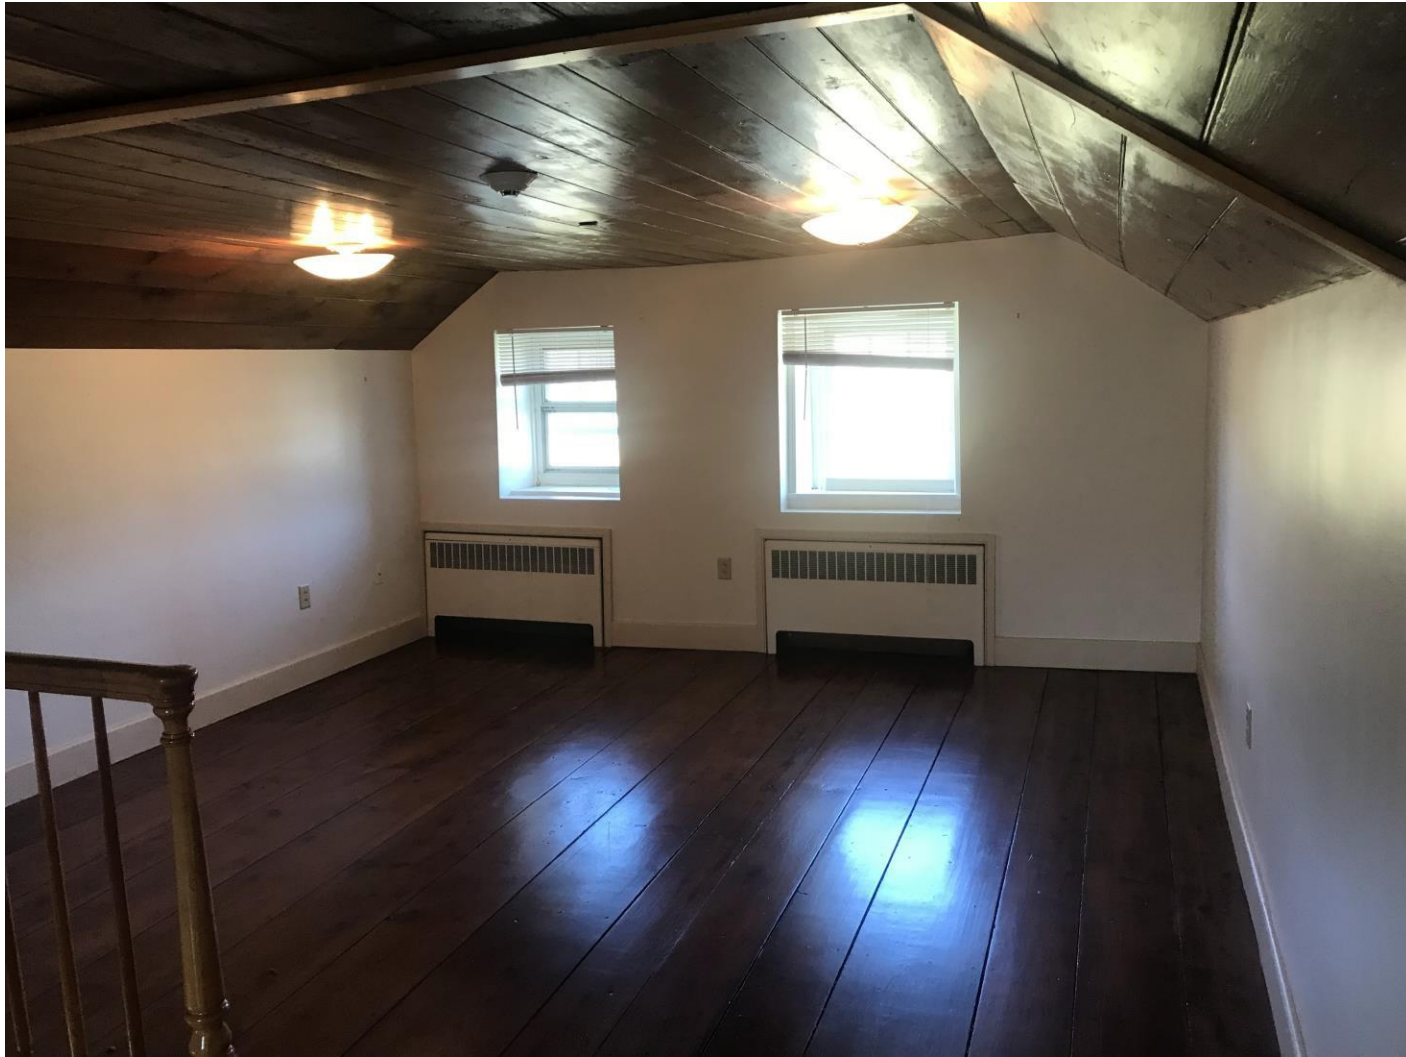
Figure 9. The open second floor bedroom of the Slyder house. Historic fabric consists of wood plank flooring and tongue and groove board ceiling.
