Fort Barry Balloon Hangar and Motor Vehicle Sheds

Abbreviated Historic Structures Report

Golden Gate National Recreation Area
San Francisco, California

Produced by the Cultural Resources and Museum Management Division
National Park Service

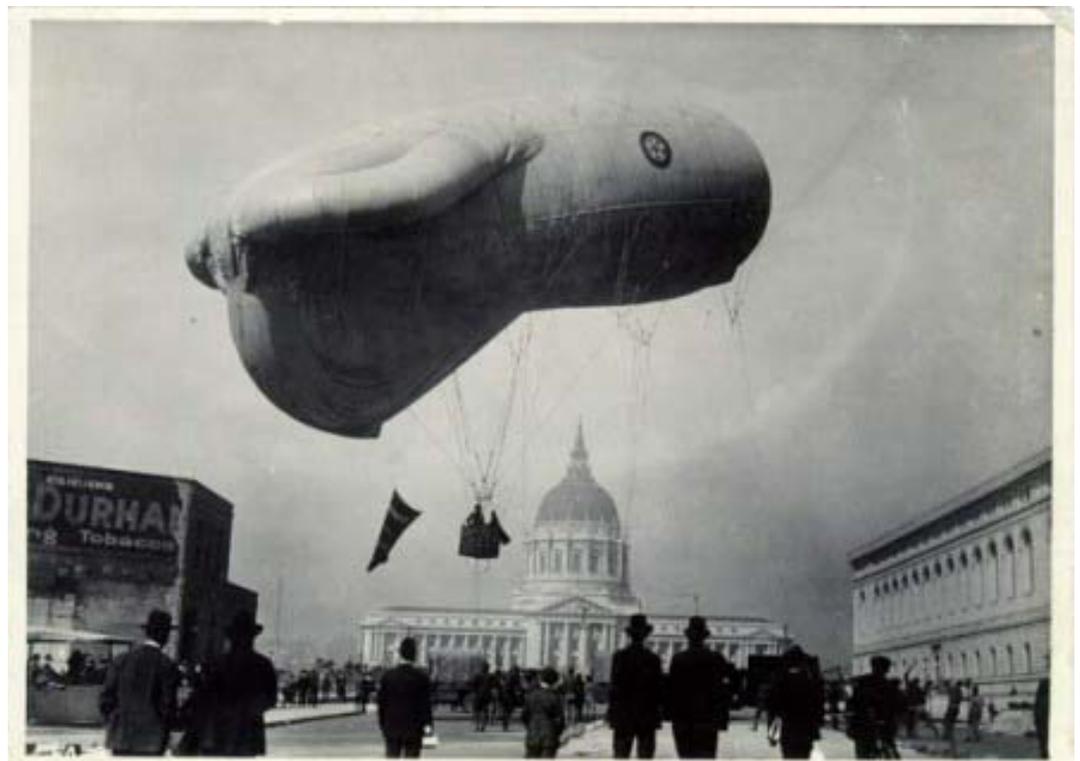
C3 Army Balloon at San Francisco City Hall, circa 1929. (San Francisco Public Library: SFPL AAB-7399)

The Americans did not have much of their own equipment, though, and instead adopted the French army's "Caquot Type R" observation balloons. Measuring 92 ft. long and 32 ft. diameter, the Type R could stay aloft in winds as high as 70 mph. These airships (sometimes derisively called "sausage balloons" because of their bulbous

shape) consisted of a hydrogen-filled body equipped with fins that provided stability in rough air, and a suspended wicker basket that held a two-man crew. Communication between the observers and the ground crew was via a telephone cable spliced onto the mooring line. Before long, the Americans began manufacturing their own version of the French balloons, which the army designated the Type C-3. During 1918-1919, nearly a thousand C-3s were manufactured in the U.S.³

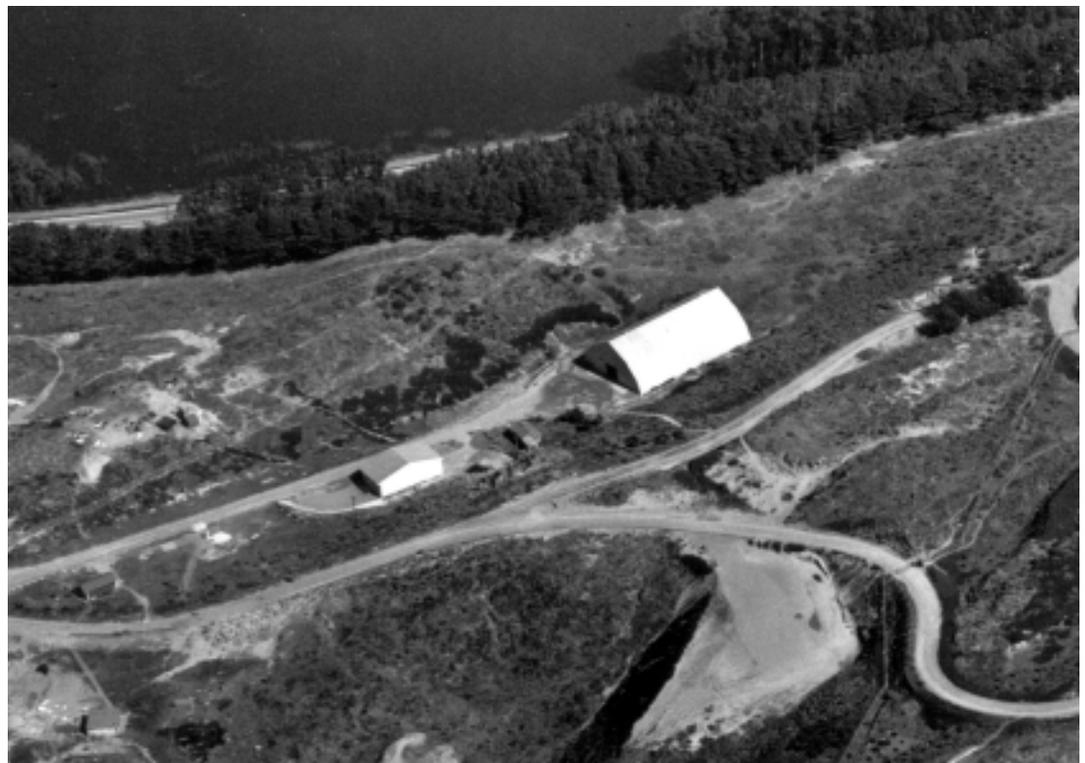
Ft. Funston Balloon Hangar, San Francisco, 1942 (now demolished). (PARC, GOGA)

The army was apparently satisfied that the balloons were going to be a permanent part of the Coast Artillery's arsenal, and in mid-1920 authorized the construction of permanent balloon hangars and associated "generator house" buildings at eight army posts around the country. Work subsequently began on the hangars at Fort Barry and Winfield Scott on 27 July 1920, and both were completed by 26 June 1921 at a total combined cost of \$199,787.⁷ (Shortly afterwards a third hangar was constructed at Fort Funston⁸, but it was of a different design from the Scott and Barry hangars.⁹)

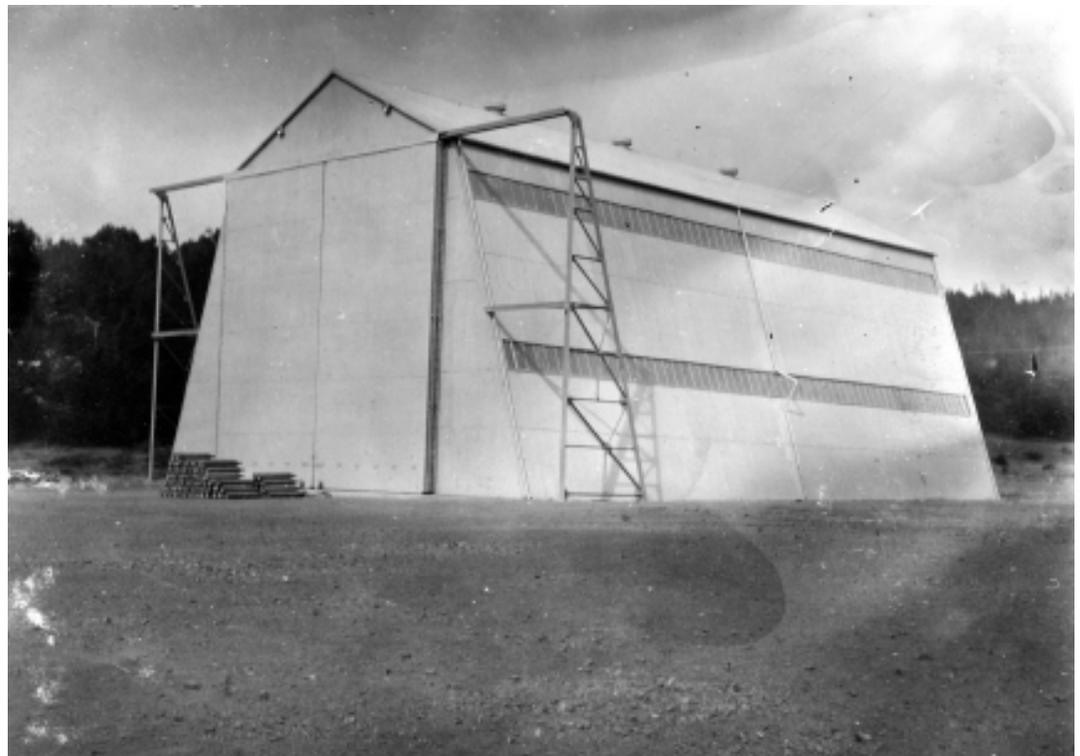
Ft. Scott Balloon Hangar, San Francisco, circa 1939 (now demolished). (PARC, GOGA 32422)

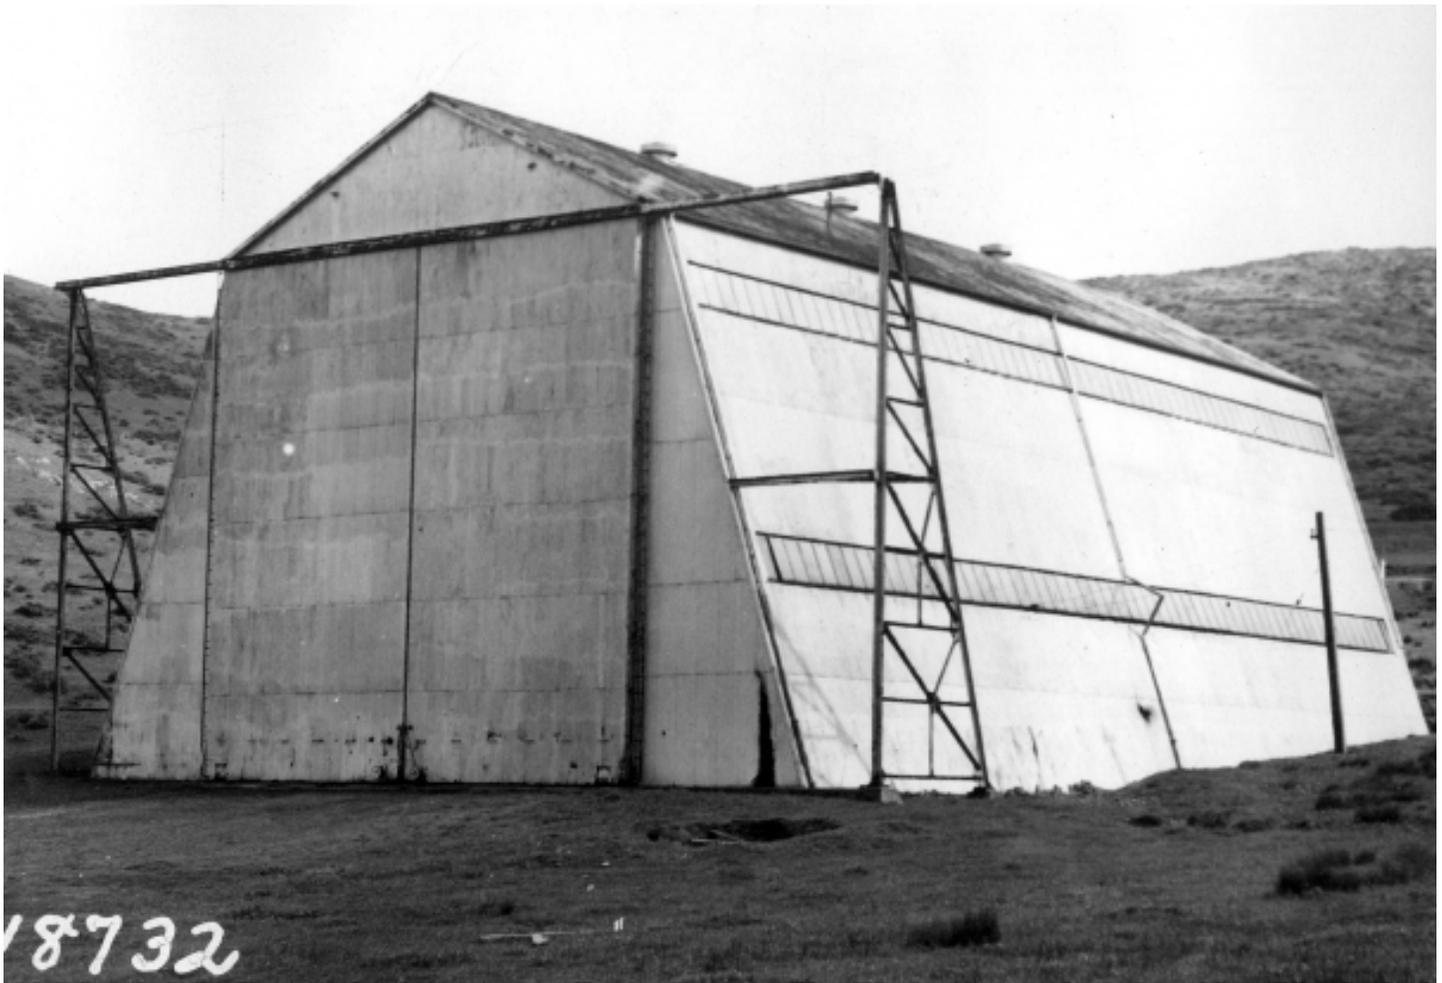
Fort Barry Balloon Hangar, 1939.
(PARC, GOGA 32423)

The specifications for each hangar complex were identical, calling for a steel hangar covered with galvanized iron, 120 by 76 feet, rising to an elevation of 60 feet; a generator house of steel construction on a concrete foundation, 80 feet square; a frame storehouse, 30 by 70 feet; and a frame garage 30 by 60 feet. In addition, each group of buildings required six acres of surrounding land, much of it for use as a landing field and staging area for the ground support and mooring equipment.⁸

The foundation consists of concrete piers at each column. There is a 6" high concrete curb and a 2'-0" x 6" concrete apron running around the perimeter of the building. There is a 10" concrete slab in the center of the structure while the slabs on the east and west wings of the building are only 4" thick.

Historic Building - The original sheathing used on both the roof and walls of the building was corrugated asbestos-coated sheet iron. This sheathing was partially removed in 1953 and the lower section was replaced with the current corrugated cement asbestos siding.

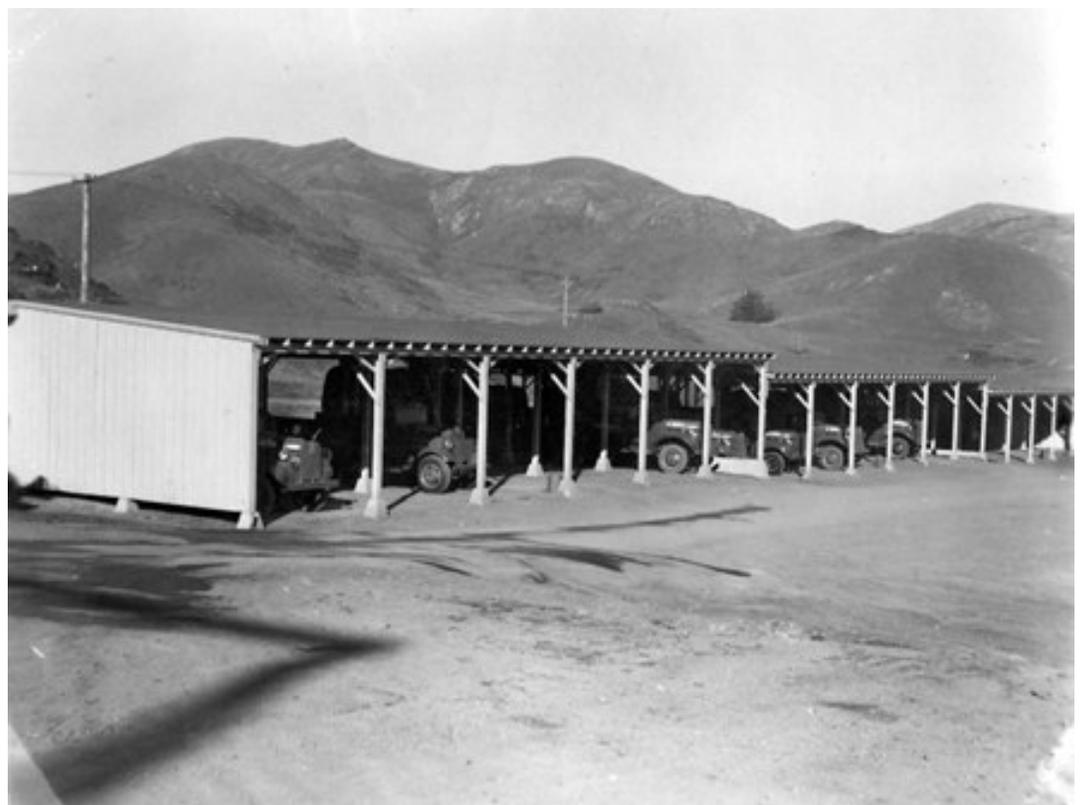
West Vehicle Shed, Ft Barry, 1942.
(PARC, GOGA 32423)

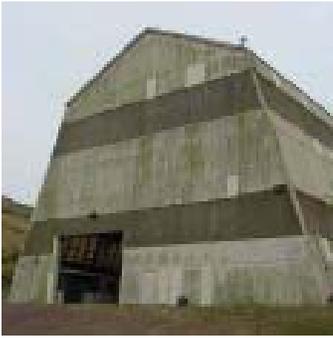
The north elevation of the Balloon Hangar showing the existing 15' x 20' opening and the two tiers of corrugated glass fiber sheets. (Jane Lehman, 2002)

The two 10' x 12' garage openings were replaced with one 15' x 20' opening which is still existing. The metal roll up door is still in place.

Two rows of translucent, colored corrugated glass fiber sheets exist in place of the original windows. When the sheathing on the first tier was replaced, the window heights were doubled to approximately 9' tall. These sheets are in fair condition.

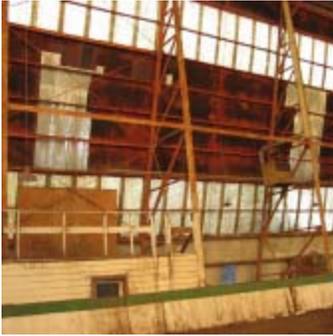
The vertical trusses form bays along the sides of the Balloon Hangar and the glass fiber sheets let in an ample amount of natural light. (John Martini, 2004)

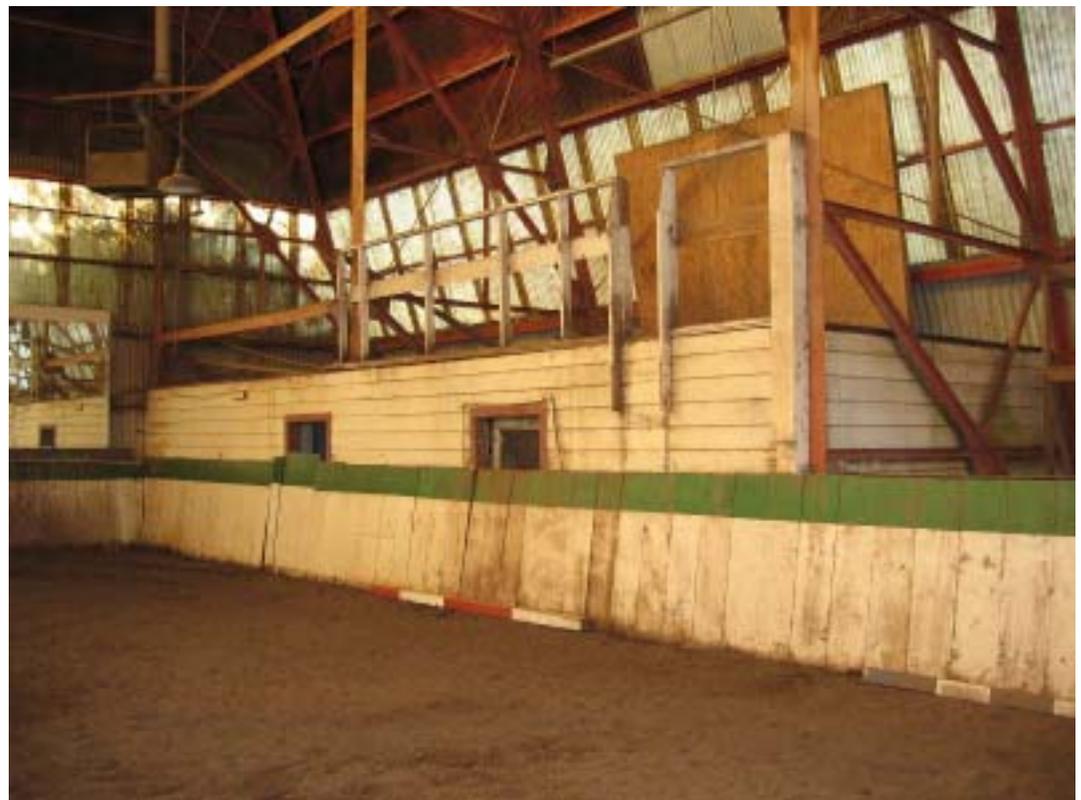
The southwest interior corner of the Balloon Hangar shows the original vertical trusses, rooms built during the Nike Assembly use of the building, plus the wall of the current indoor riding rink. (John Martini, 2003)

- Construction of a three small structures within the hangar: a new latrine in the northwest corner; a new tool room and parts room structure in the southwest corner; and a new office in the northeast corner that replaced the 1943 structure.²⁴

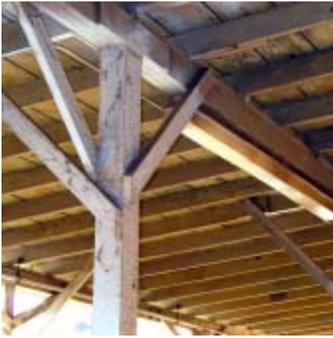
Motor Vehicle Shed interior showing 4x4 post and beam and cross bracing. (John Martini, 2004)

The vehicle sheds are constructed of 4x4 posts and beams, 12'-0" on center in both directions. There are 4x4 cross braces at the corners of all the columns. The foundations are individual precast concrete piers. The roof framing is 2x4 @ 16" on center with 2x6 sheathing on top.

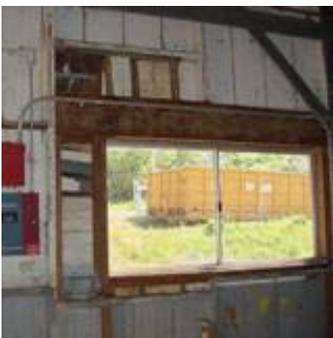
Aluminum sliding window installed in the area of former wood double-hung window. Note former rough opening. (Jane Lehman, 2004)

There was at least one wood frame, double-hung window in each end of the Vehicle Sheds. Several of them have been replaced with aluminum sliders of a different proportion than the original.

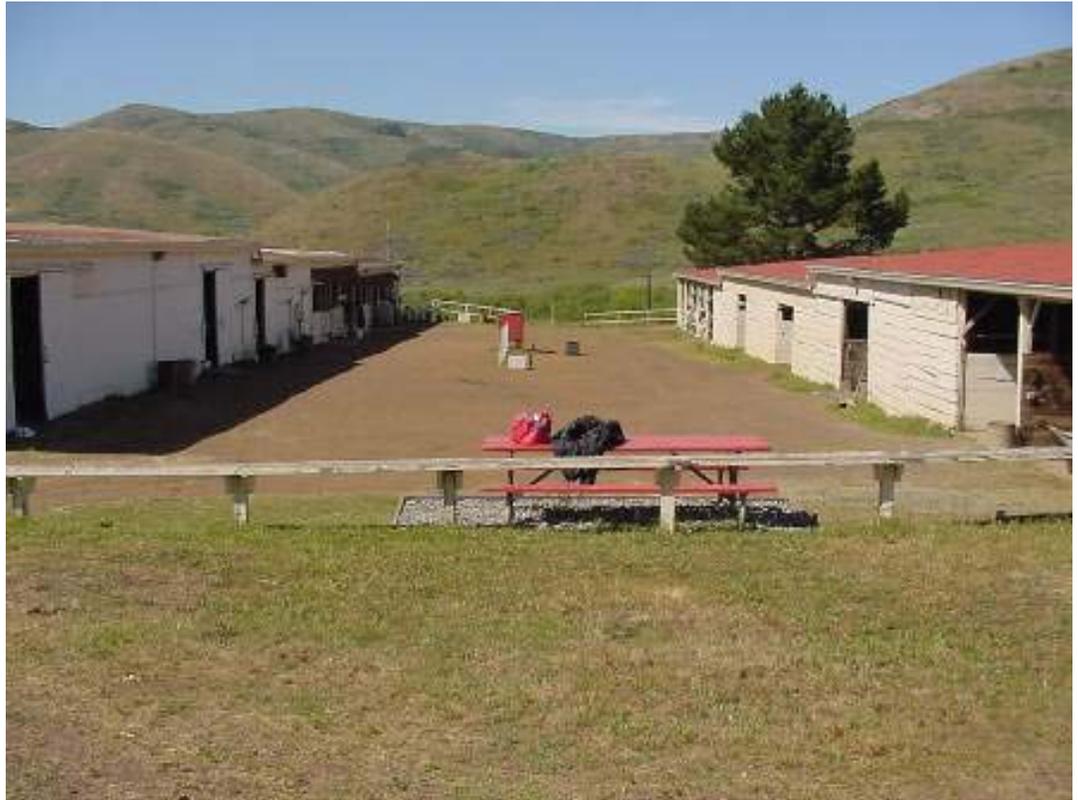
The current corral area in between the two former motor vehicle sheds. Building 906 is on the left and Building 905 is on the right. (Jane Lehman, 2004)

Originally there were no doors on the Vehicle Sheds because they were open carports. During the conversion to riding stables it became necessary to add walls and doors to the structures. It was at this time that sliding doors suspended from overhead tracks were installed. These are constructed out of vertical 1x8 siding to match the walls.

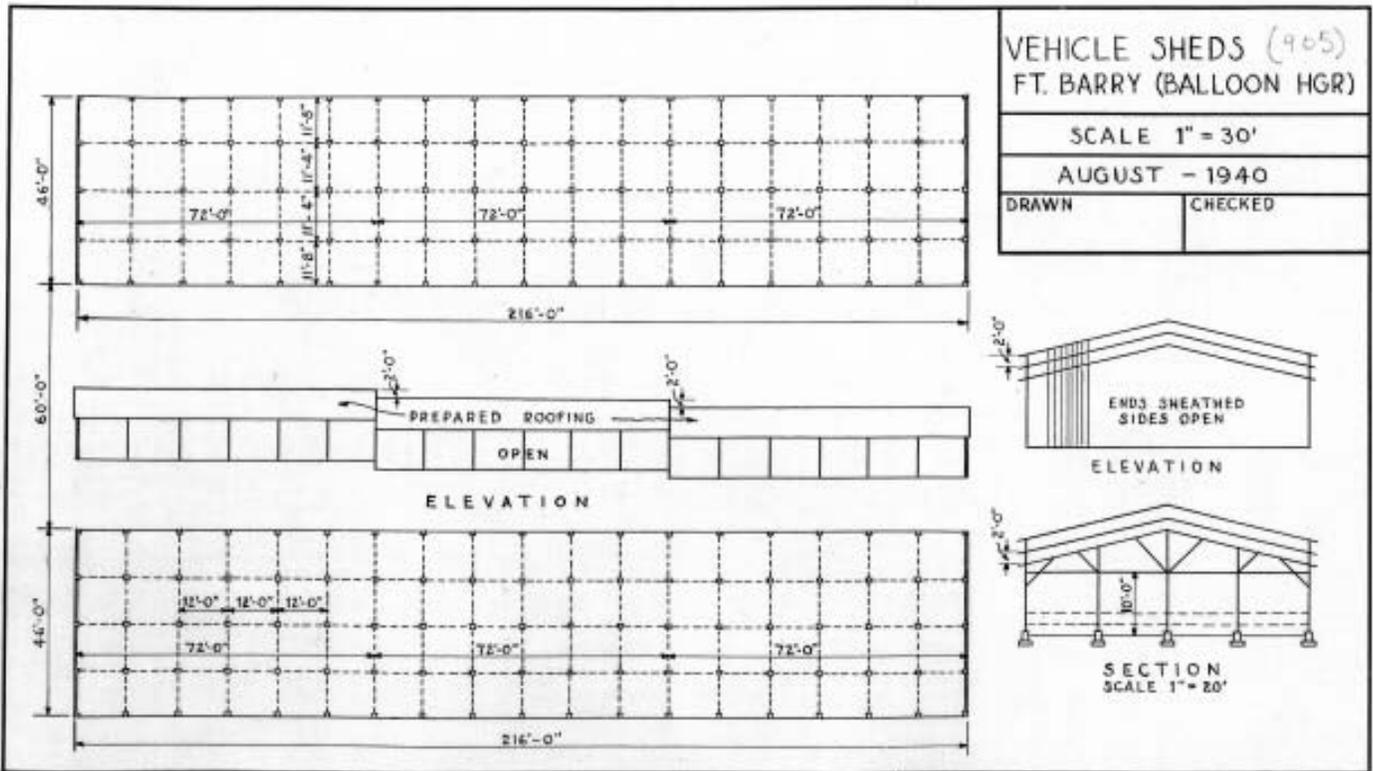
Plans of the original Motor Vehicle Sheds, August 1940. Part of the "Series 700" mobilization structures constructed just prior to the beginning of World War II.

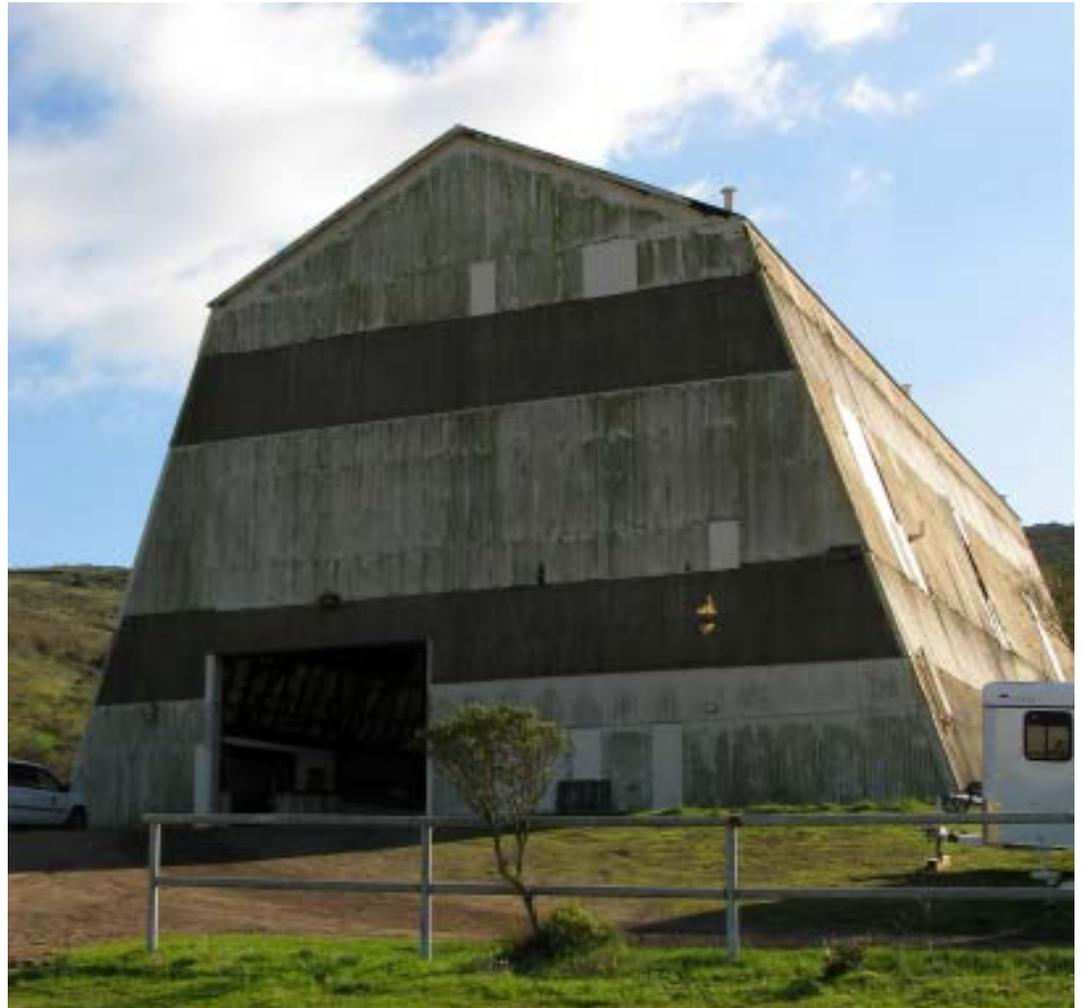
The Balloon Hangar's gambrel shape is a major character defining element. (John Martini, 2004)

The Fort Barry Balloon Hangar is a large, distinctive building nestled into a hillside in the Marin Headlands. The hangar is a gambrel-shaped structure. It has a rectangular floor plan 76'-2" x 120'-0", and is approximately 53' high at its ridge. The inside of the building is essentially one large open space and is currently being used as a riding ring by the Presidio Horse Stables. In front of the hangar are two long, low buildings that were originally constructed as Motor Vehicle Sheds, but are currently being used as horse stables with paddocks surrounding them.

The gambrel walls have an approximately 3:1 slope and are covered with corrugated siding. There are two bands of corrugated fiberglass on the walls of the building which serve to let natural light inside. Drainage is poor and shrubbery has grown up around the south, east and west sides of the building limiting access to these sides.
