Existing Conditions Assessment - Summit

Spatial Organization, Topography, Views and Vistas - Summit

Buildings - Summit

Structures - Summit

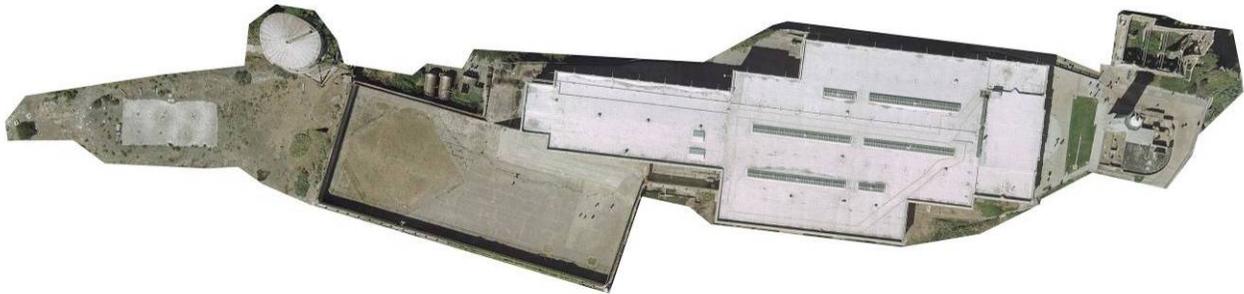
Figure 3 - 17. Aerial View of Summit Terrace. The Center Terrace is primarily occupied by the Main Prison and Stockade/Recreation Yard. South Terrace is the area in the image to the right of the Main Prison and the North Terrace the area to the left of the Stockade/Recreation Yard. (Photo Courtesy of Parks Conservancy (Summit.jpg))

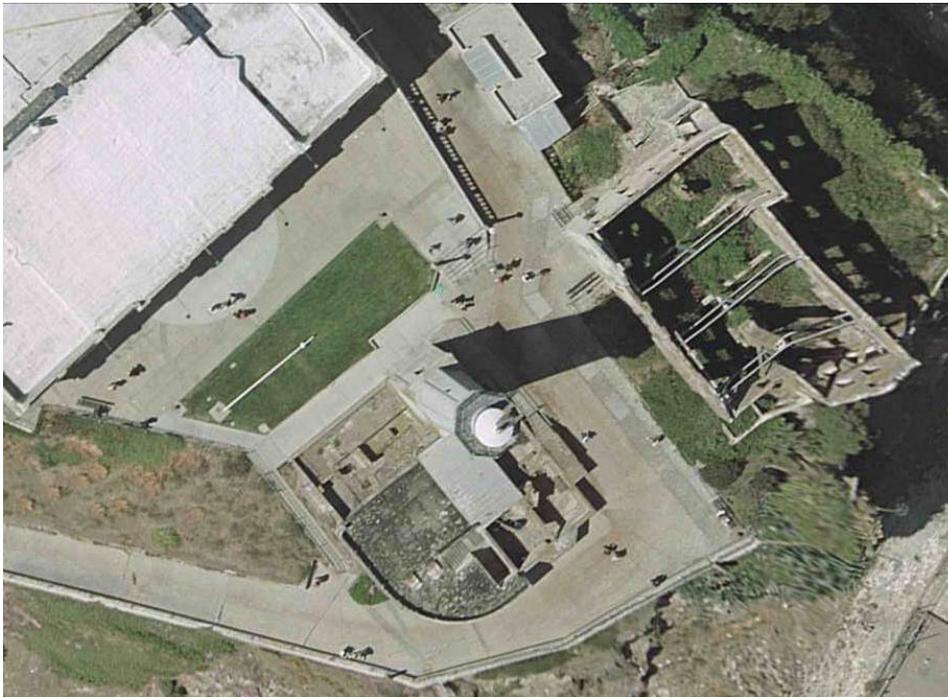
Figure 3 - 18. South Terrace, Aerial View (Photo Courtesy of Parks Conservancy (South Summit Terrace Aerial.jpg))

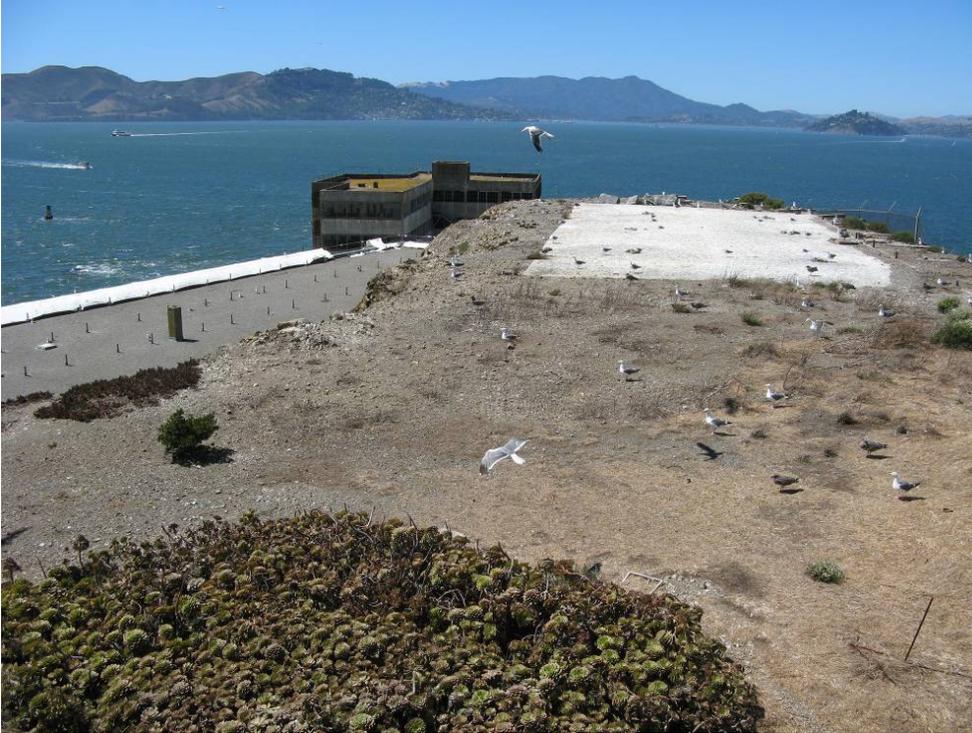
Figure 3 - 19. North Terrace with Concrete Cistern, New Industries, and Model Industries, as viewed from north side of Stockade/Recreation Yard Wall (MBD DSC03144.JPG)

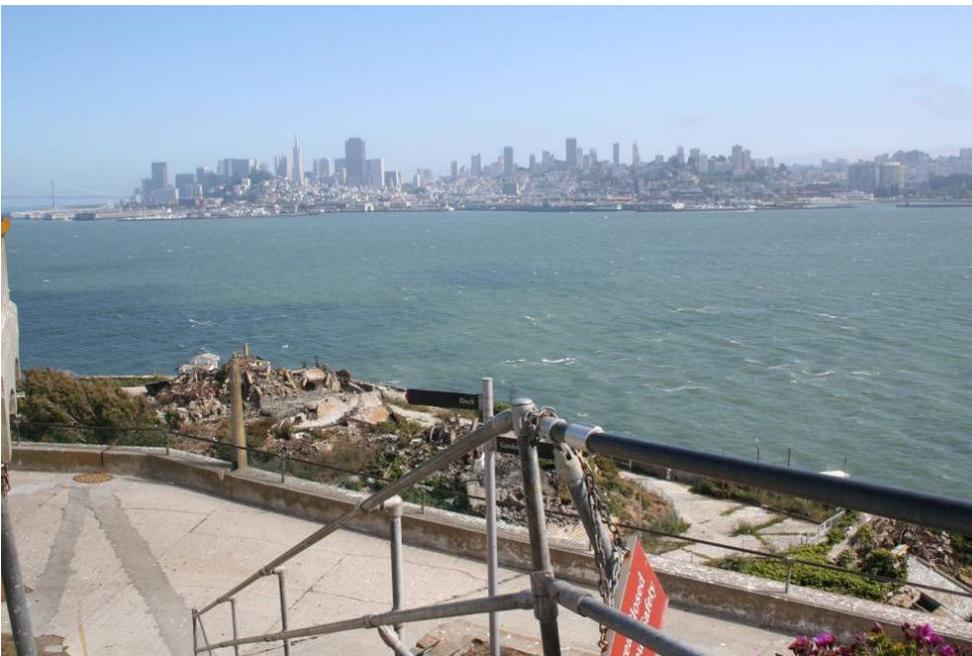
Figure 3 - 20. View towards San Francisco from Summit west of Lighthouse (MBD IMG_2917.JPG)

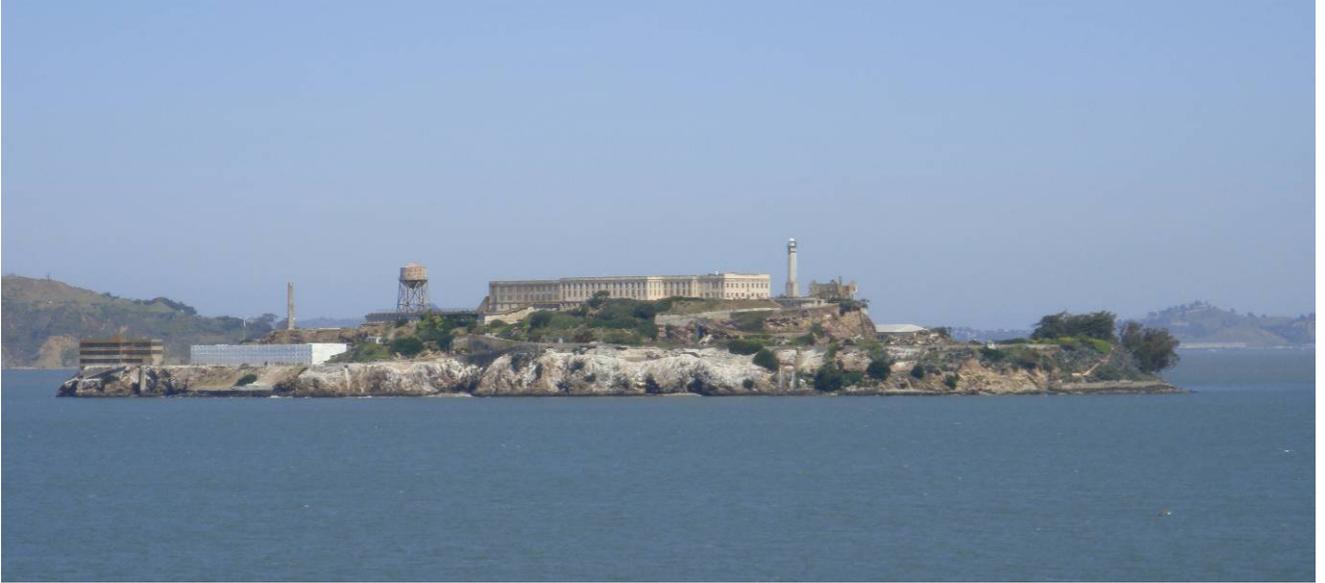
<i>Feature</i>	<i>Bldg #</i>	<i>Figure #</i>	<i>Description</i>	<i>Condition</i>
View of Main Prison and Lighthouse from San Francisco	68, LH	3-21	View to Alcatraz from Fort Mason	Good

Figure 3 - 21. View towards Alcatraz from Fort Mason (MBD DSC00218.JPG)

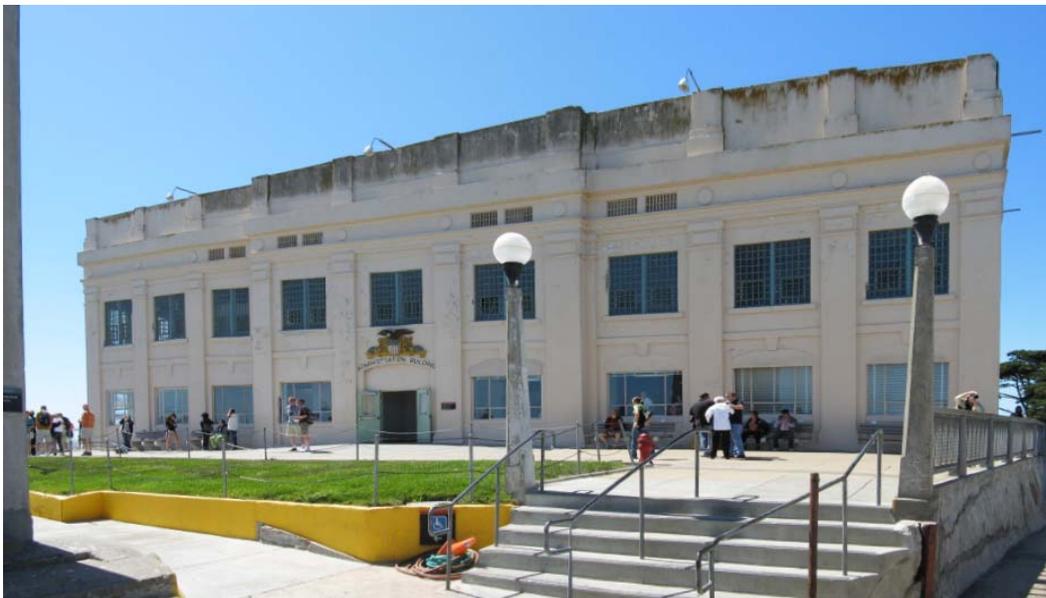
<i>Feature</i>	<i>Bldg #</i>	<i>Figure #</i>	<i>Description</i>	<i>Condition</i>
Main Prison (1912)	68	3-22 3-23	Reinforced concrete building on site of Citadel – the prison, while in operation, could function as a self-contained unit with its own kitchens, hospital, morgue, and water supply cisterns	Good
Citadel (1859) (under Main Prison) ASM15 GOGA00251				
Citadel Moat, Access Stairs, and Perimeter Wall	1	3-24	First floor, located under Main Prison Extant features include brick walls of the original moat, concrete access stairs from Main Prison, storage bins/latrines, brick paving in bottom of moat, sewer tunnels, cisterns, graffiti, and technological elements	Good
Citadel Basement	1 68	3-25	First floor, located under Main Prison Extant features include sewer tunnels, cisterns, graffiti, and technological elements	Fair
Lighthouse (1909)	LH	3-26 3-27	Adjacent to location of original 1854 Lighthouse; reinforced concrete tower <ul style="list-style-type: none"> • SR37 • SR38 Lighthouse provides an aid to navigation for ships plying the treacherous waters of the Golden Gate and San Francisco Bay.	Tower: Good Stairs: Good

Figure 3 - 22. Main Prison as viewed from east of Lighthouse (MBD Cellhouse_adj.JPG)

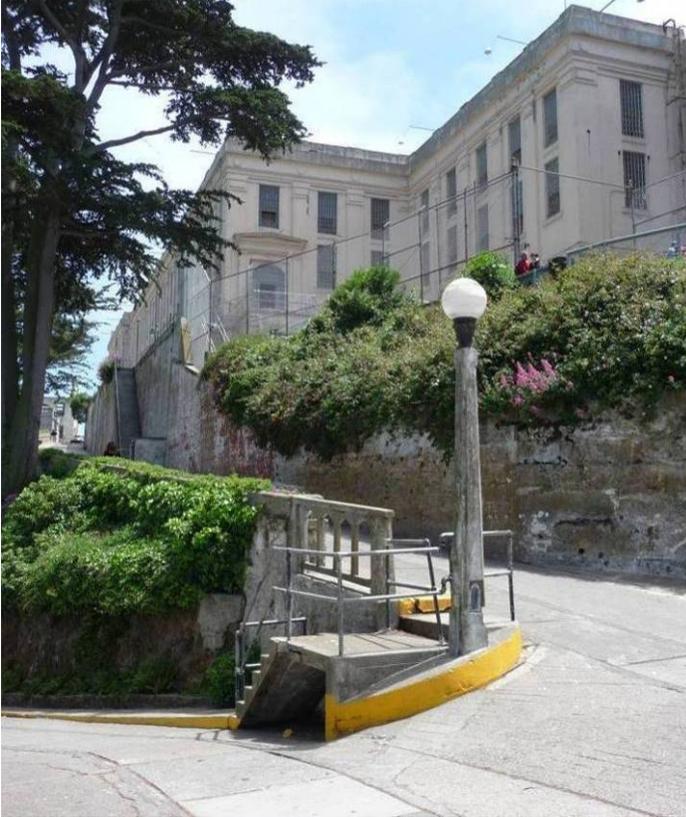
Figure 3 - 23. Main Prison as viewed from Main Road at Switchback three (MBD P1000368.JPG)

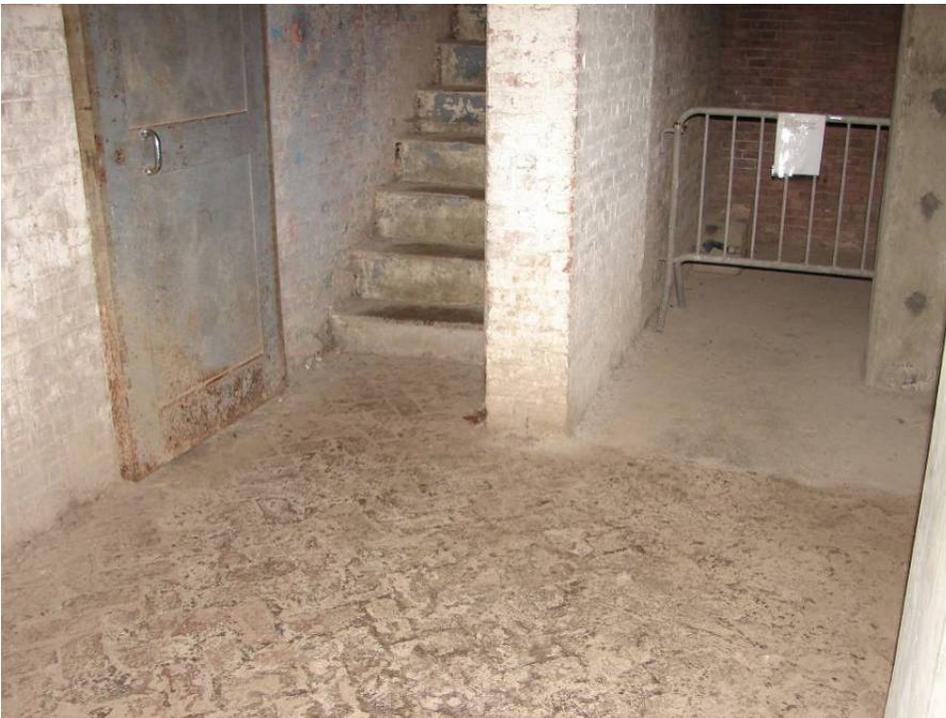
Figure 3 - 24. Citadel Moat and Perimeter Wall, as seen at east staircase from Main Prison main floor (MBD DSC03163.JPG)

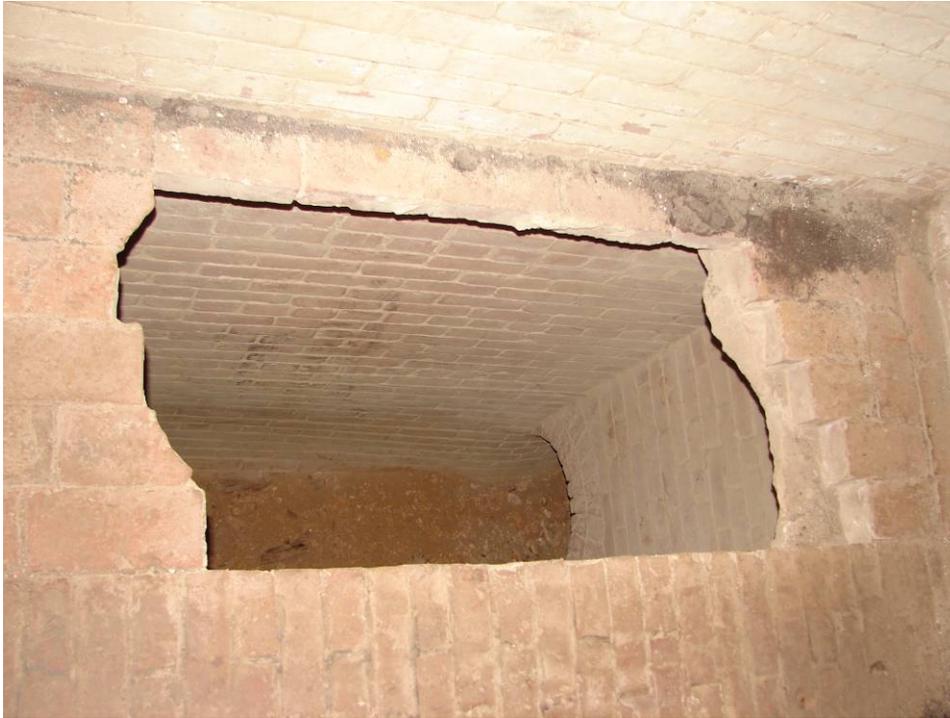
Figure 3 - 25. Citadel, Sewer Tunnel (MBD DSC03202.JPG)

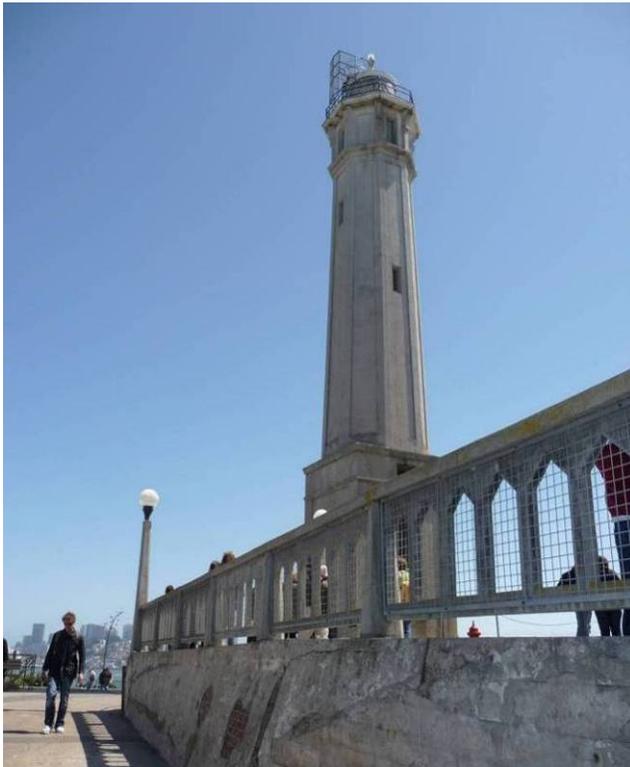
Figure 3 - 26. Lighthouse tower from Main Road looking south (MBD P1000432.JPG)

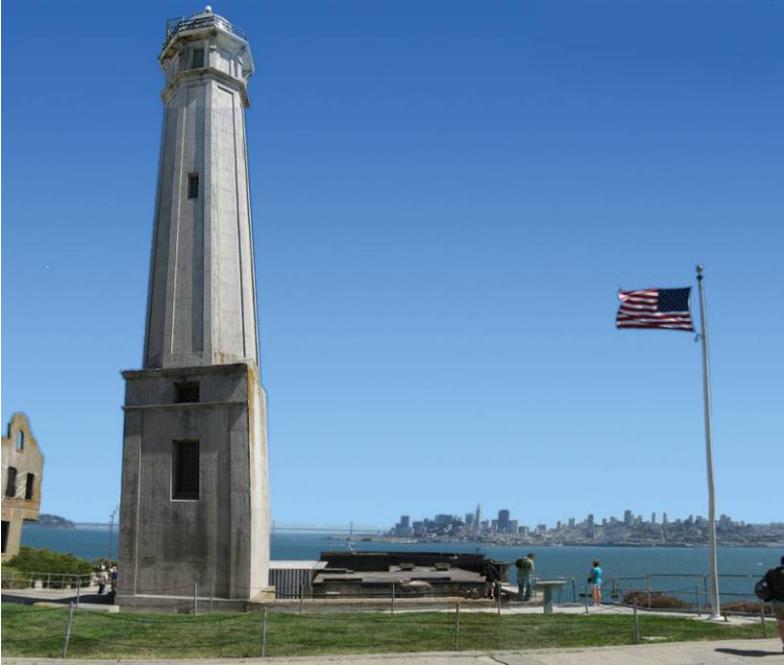
Figure 3 - 27. Lighthouse tower from Main Prison with view to San Francisco in background (MBD Lighthouse Pan.JPG)

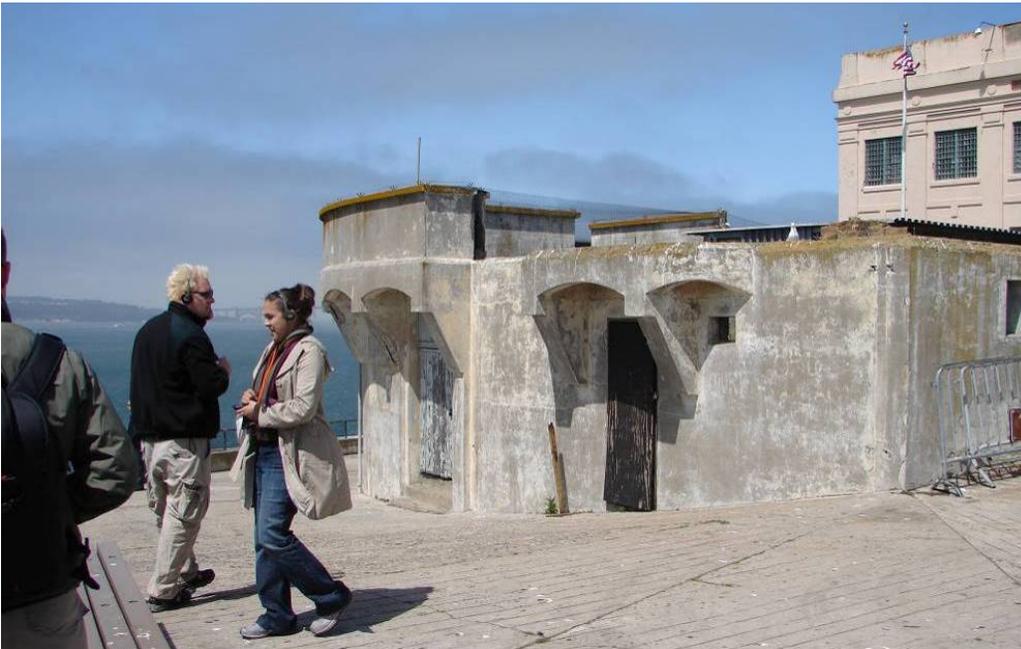
<i>Feature</i>	<i>Bldg #</i>	<i>Figure #</i>	<i>Description</i>	<i>Condition</i>
Lighthouse Keepers' Residences (2)		3-28	<ul style="list-style-type: none"> Concrete foundations of two Lighthouse keepers' residences (remnants) and adjacent concrete stairs to Main Prison 	Residence: Poor Stairs: Good
Warden's House (1921) with greenhouse foundation	76	3-29	Remnant Walls and Chimney remain from the Mission Revival Style building east of the Lighthouse Concrete foundations of its Greenhouse remain south of the building remnants	Poor
Morgue (1910), Magazine, Traverse Tunnel Entrance	66	3-30	Located east of the east wall of the Stockade/Recreation Yard. Accessed by the Main Road north of the third Switchback <ul style="list-style-type: none"> Building, covers the entrance to Fortification Bombproof Tunnel "J" 	Good

Figure 3 - 28. Remnants of two Lighthouse Keepers' Residences at base of Lighthouse tower from Main Road looking northwest; Main Prison in background at right (MBD DSC03060.JPG)

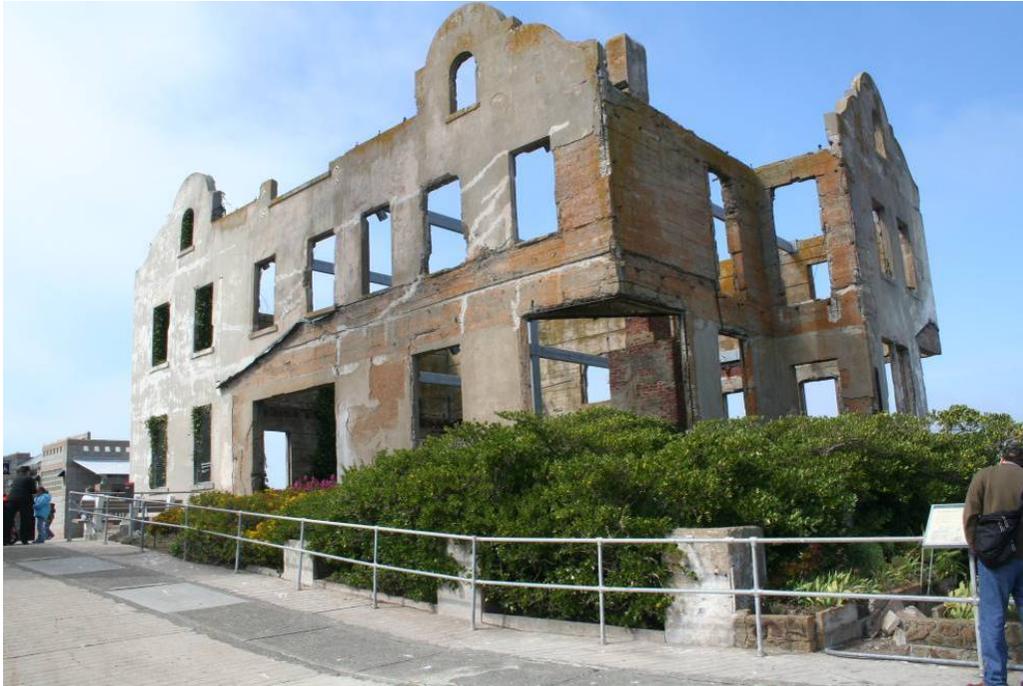
Figure 3 - 29. Warden's House with foundations of Warden's Greenhouse at far right. (MBD IMG_2895.JPG)

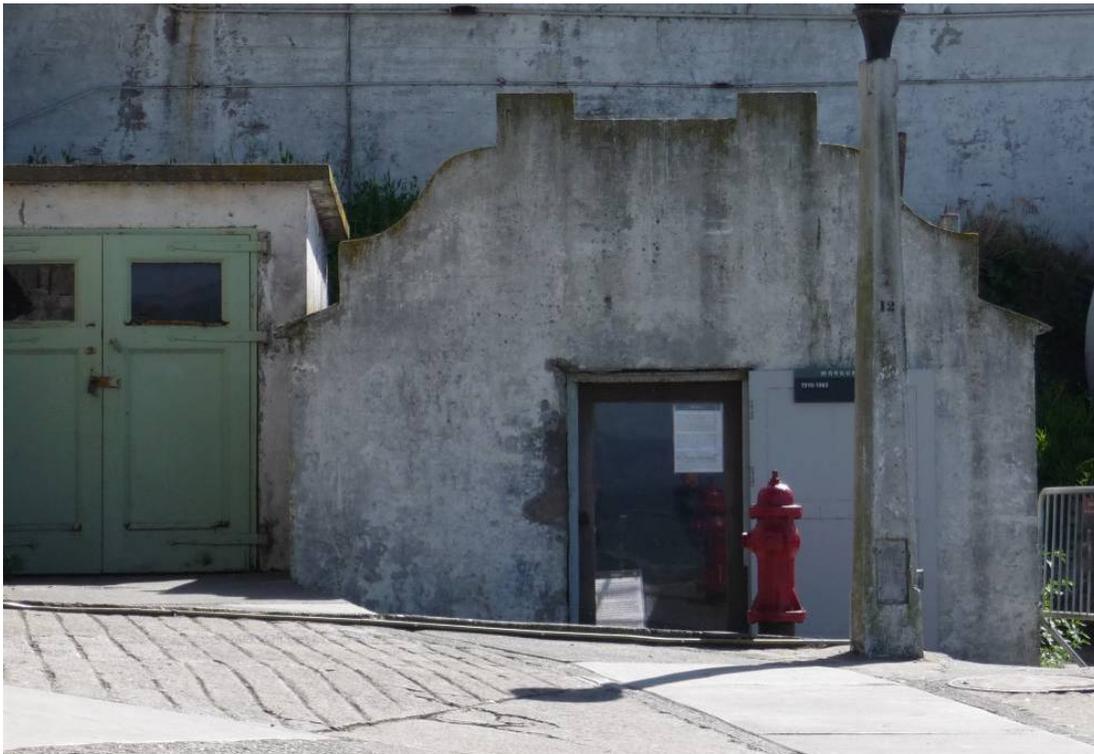
Figure 3 - 30. Morgue and Firebox #5 as viewed from Main Road, Switchback three - Fortification Tunnel and Bombproof "J" is located behind Morgue; Stockade/Recreation Yard in background (MBD P1000491.JPG)

Water Tower	WT	3-46 3-47	Steel tank with six steel legs and reinforced concrete foundation, located northeast of Stockade/Recreation Yard MBSR17 – Metal Pipe Handrail along south edge of stairs leading to Water Tower MBSR18 – Non Extant MBSR21 – Metal Pipe Handrail along northern outer edge of Water Tower Foundation.	Tank: Poor Legs and Base: Good Railings: Fair
Guard Station for Kitchen Basement Sallyport	68	3-48	Eight foot tall structure with a metal frame and glass insets	Poor
Firebox #5	66	3-30	Concrete structure with wooden doors located south of the Morgue	Good

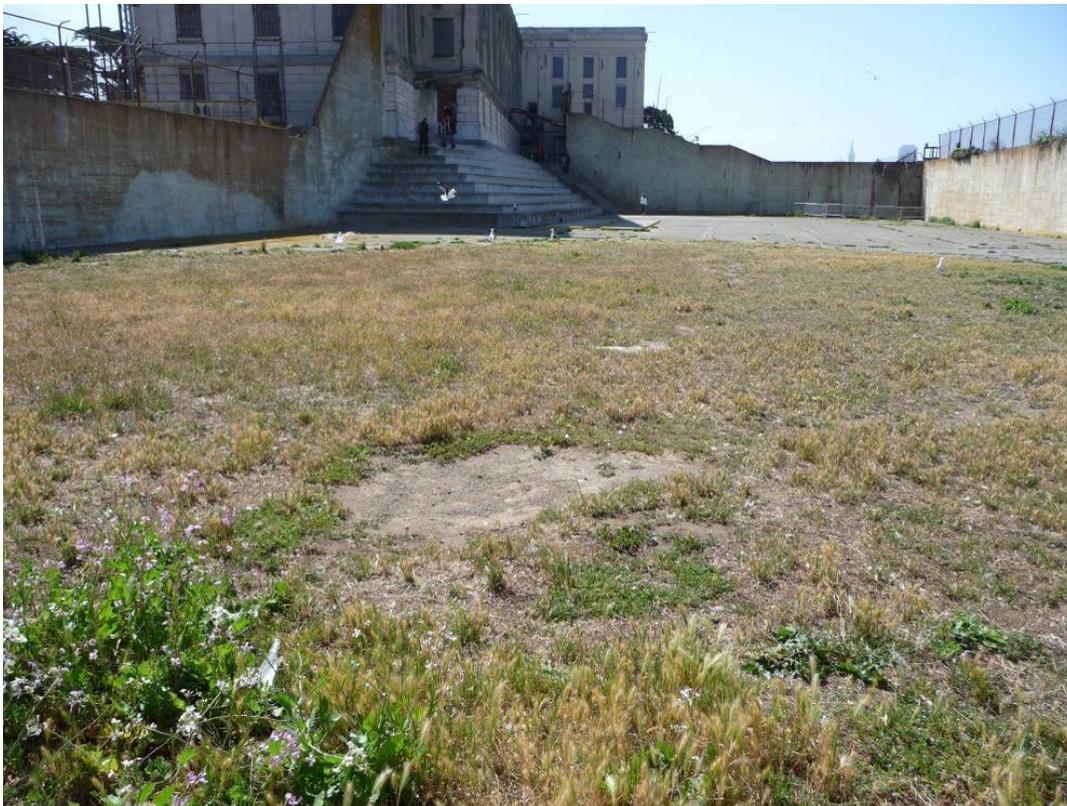
<i>Feature</i>	<i>Bldg #</i>	<i>Figure #</i>	<i>Description</i>	<i>Condition</i>
Stockade/Recreation Yard				Fair to Poor
Stockade/ Recreation Yard		3-31	Open area within four concrete walls and the Main Prison, includes access to Main Prison on south and access to Industries on west	Fair
Concrete Enclosure Walls with Metal Fencing: SR52, SR53, and SR55		3-32	Concrete walls enclose the yard on four sides; connect to Main Prison Building on east side Sentry walk on top is disintegrating SR52, SR53 and SR55: Prison cyclone fencing, circa 1943	Walls: Fair Sentry Walk: Poor Fencing: Poor
Catwalk/Sentry Walk on Concrete Enclosure Walls with SR53 and SR52		3-33	Concrete walk approximately 3 feet wide around perimeter of Yard Wall. Bordered by railing SR53 to the outside and security fence SR52 to the inside.	Poor
Guard Stations on Concrete Walls		3-34 3-35	Remnants of metal enclosures at the northeast and southwest corners of the Stockade/Recreation Yard.	Poor

Figure 3 - 31. Interior of Stockade/Recreation Yard with ballfield in foreground and terraced concrete stairs and concrete wall in background. Security fence SR52 borders the Stockade/Recreation Yard (MBD P1000552.JPG)

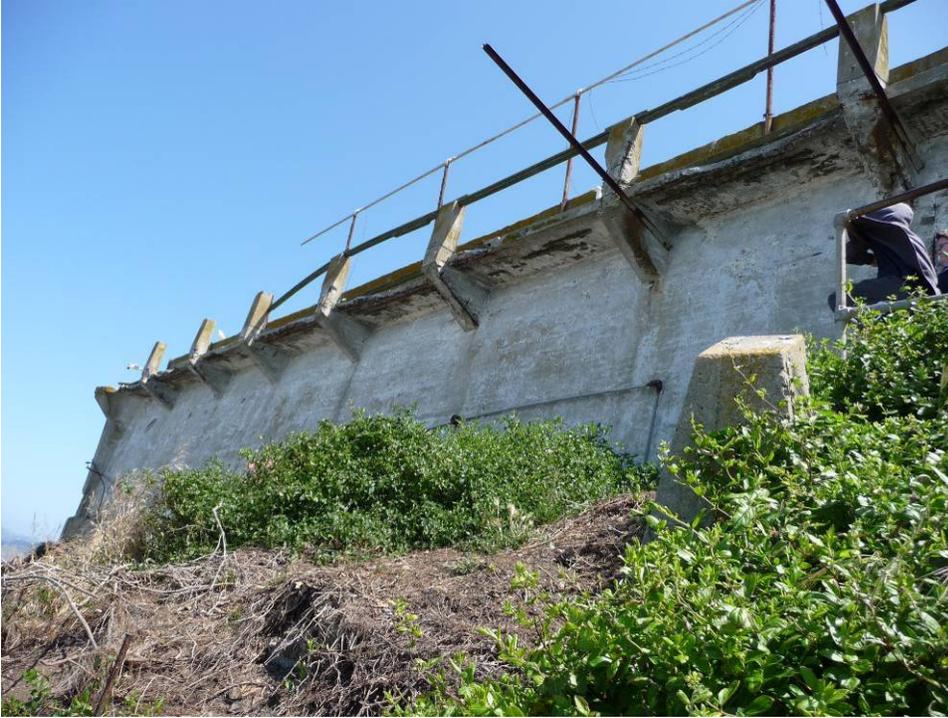
Figure 3 - 32. Stockade/Recreation Yard west wall, disintegrating cantilevered sentry walk, rails (SR 53) and fence (SR52) as viewed from below from stairs to Metal Detector Shed. Condition is typical of all sides of Stockade/Recreation Yard (MBD P1000630.JPG)

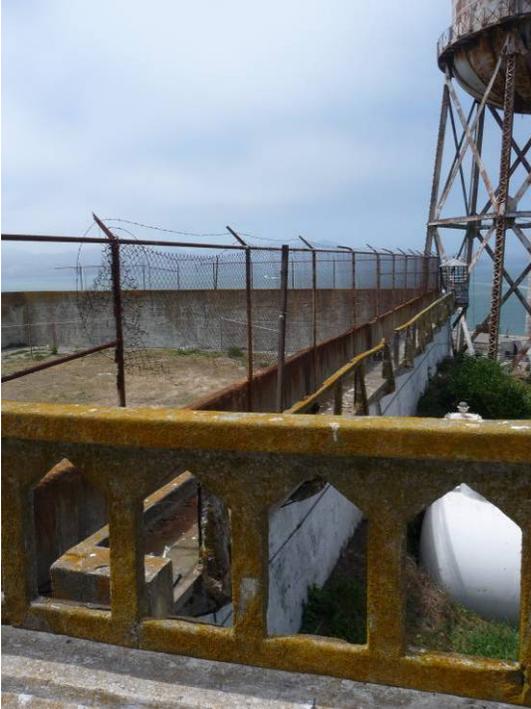
Figure 3 - 33. Sentry Catwalk around Stockade/Recreation Yard from balcony north of Main Prison. Decorative concrete railing SR53 and security fence SR52 border the walk (MBD P1010095.JPG)

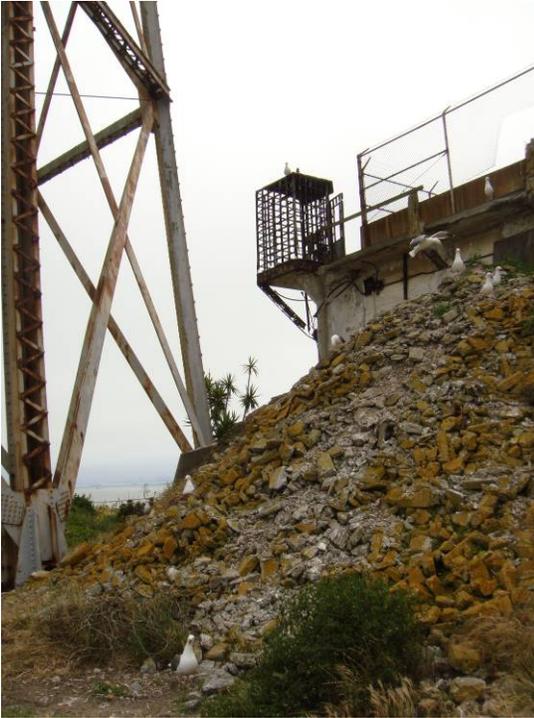
Figure 3 - 34. Stockade/Recreation Yard Wall and Water Tower base looking east from north terrace. Northeast Stockade/Recreation Yard Wall Guard Station in center of photo. (DSC00251.JPG)

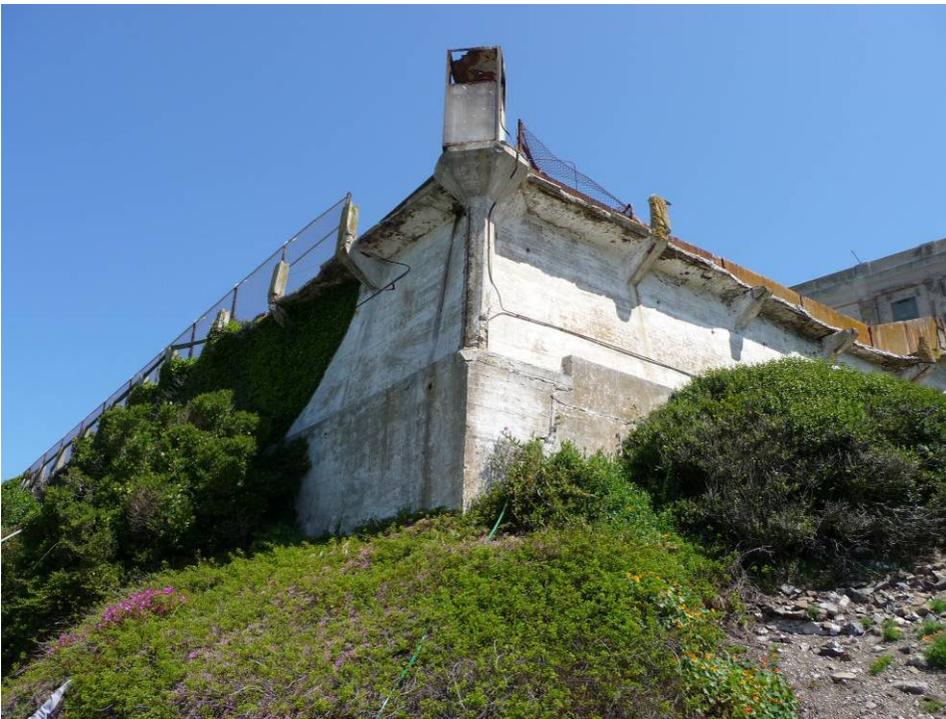
Figure 3 - 35. Stockade/Recreation Yard west wall, disintegrating cantilevered sentry walk, rails and fence (SR52) from West Road. Guard Station is at southwest corner. (MBD P1000649.JPG)

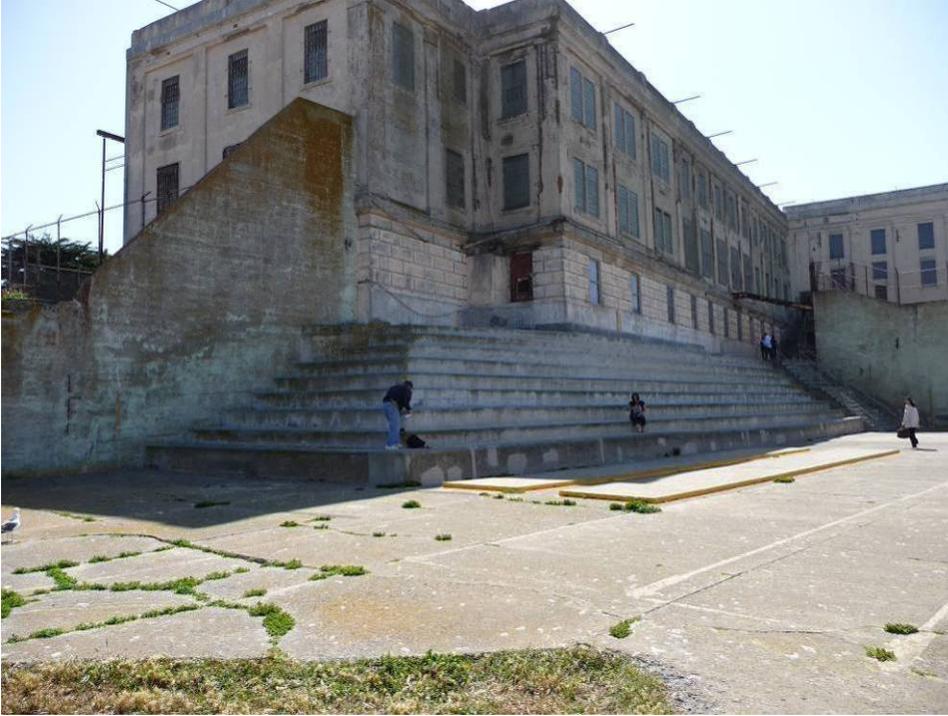
Concrete Terraced Steps		3-36	Located on east-side of Yard; with nine broad steps	Good
Concrete Steps from Main Prison to Stockade/Recreation Yard with SR56 railing		3-37	Located on the southeast side of the Stockade/Recreation Yard, leading to the Main Prison. SR56 Metal Pipe Railings are the handrails for these steps.	Steps: Good Handrail: Good

Figure 3 - 36. Stockade/Recreation Yard Paving and Terraced concrete steps. Northwest side of Main Prison with Stockade/Recreation Yard walls visible. (MBD P1000577.JPG)

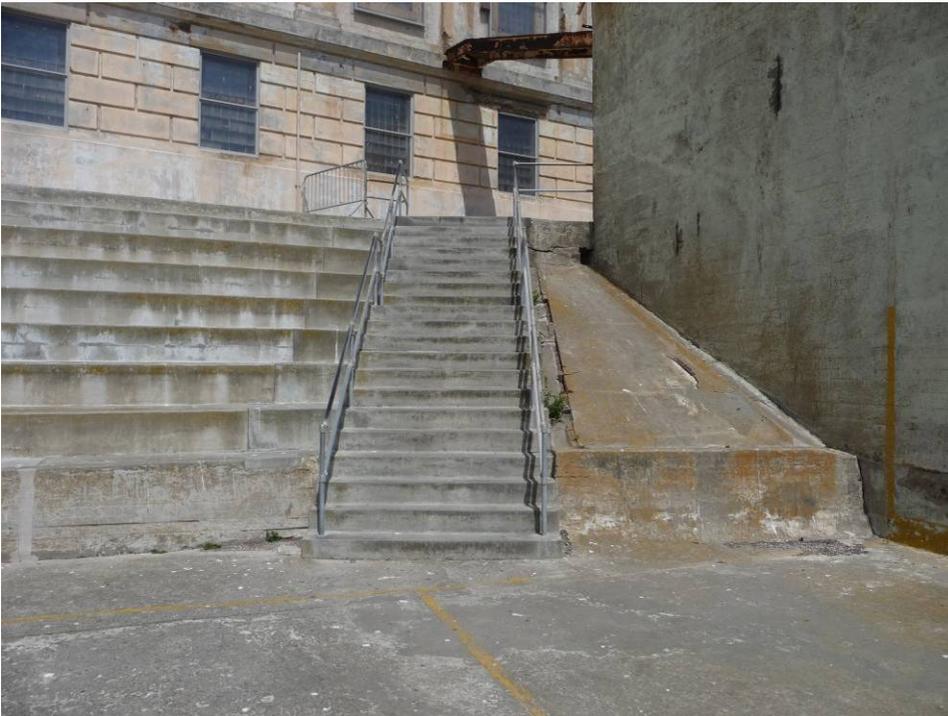
Figure 3 - 37. Steps from Main Prison to Stockade/Recreation Yard with NPS SR56 pipe railing. Steps originally had wooden handrails. (MBD P1010149.JPG)

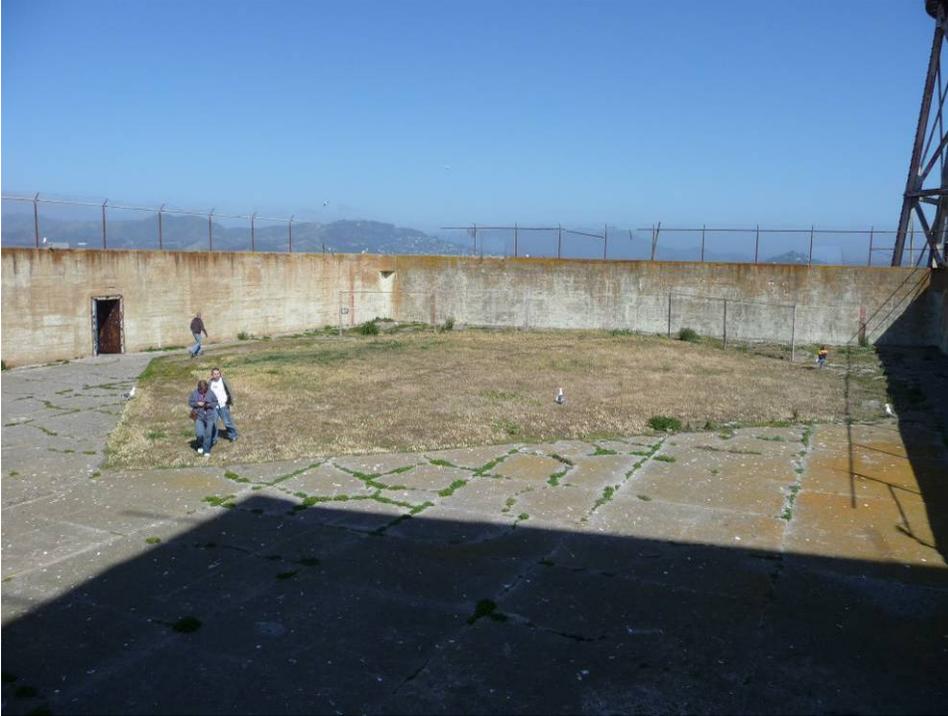
<i>Feature</i>	<i>Bldg #</i>	<i>Figure #</i>	<i>Description</i>	<i>Condition</i>
Stockade/Recreation Yard, continued				
Ballfield with SR54 fencing		3-38 3-39	Dirt ballfield on northern half of Yard; fences define northeast and northwest edge; paving defines south edge	Ballfield: Poor Railing: Good
Yellow Pavement Markings		3-40 3-41	Yellow Pavement markings signifying recreational activities including shuffleboard and horsehoes. Also are prisoner line-up markings for task details.	Poor
Fortification Bombproof Tunnel “I”		3-42	Masonry structure with Entrance below north wall of Stockade/Recreation Yard	Good
Fortification Bombproof Tunnel “J”		3-43	Masonry structure with Entrance via Morgue/east of Stockade/Recreation Yard	Good
Fortification Bombproof Tunnel “K”		3-44	Masonry structure with Entrance below south wall of Stockade /Recreation Yard	Good
Cistern	C	3-45	Concrete vault below grade; concrete cover visible on north terrace	Unknown

Figure 3 - 38. Stockade/Recreation Yard dirt ballfield and backstop fences as viewed from terraced steps; Stockade/Recreation Yard wall with door to staircase to Industries in background (MBD P1000538.JPG)

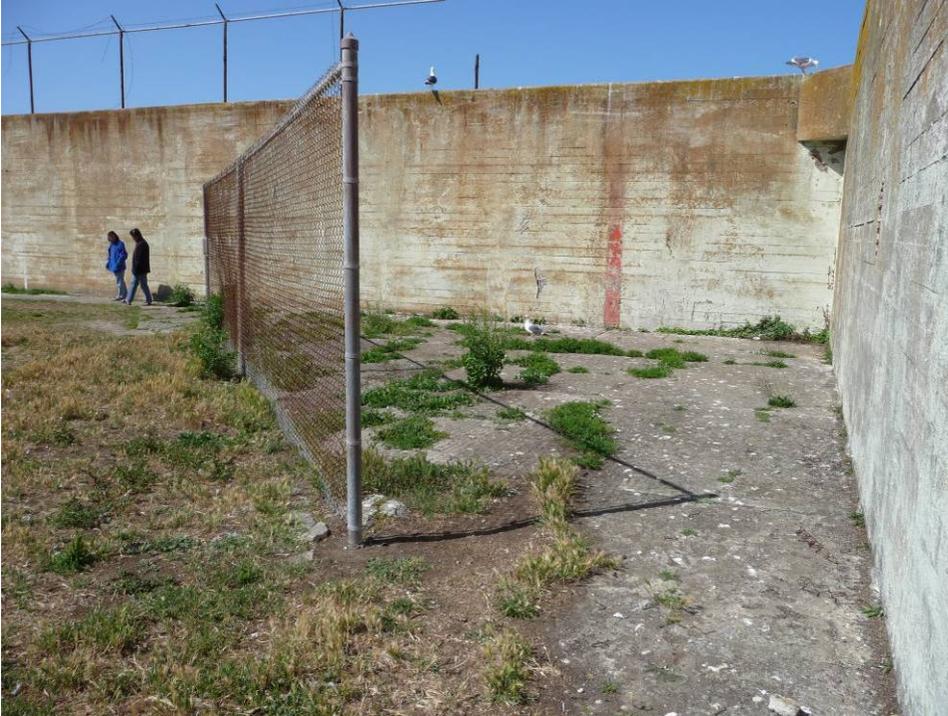
Figure 3 - 39. Stockade/Recreation Yard Ballfield west backstop fence SR54. (MBD P1000554.JPG)

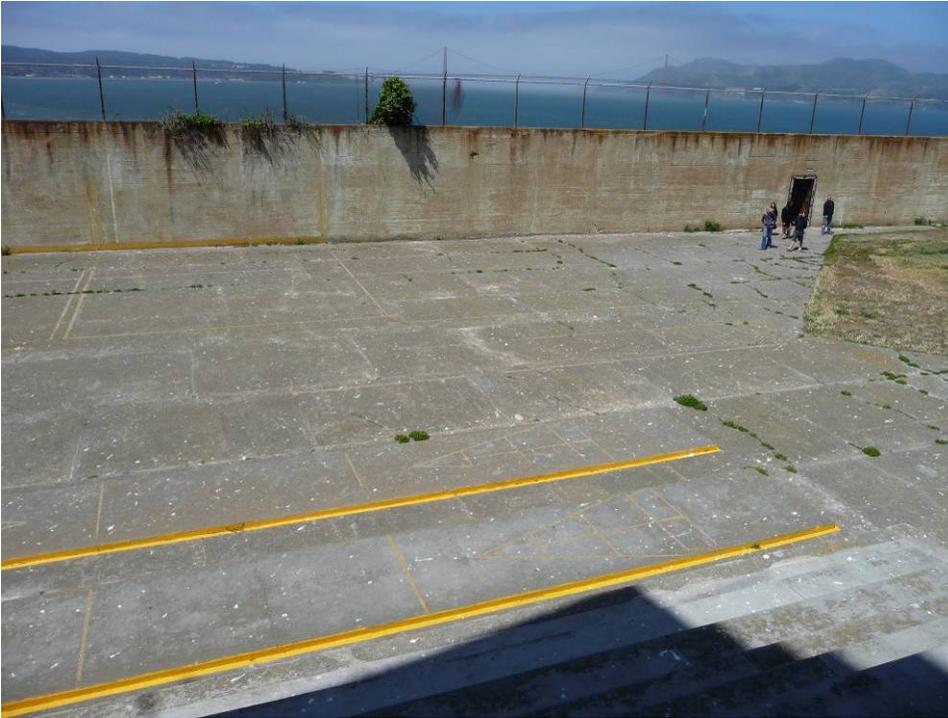
Figure 3 - 40. Stockade/Recreation Yard pavement markings as seen from terraced steps. Bright pavement markings around Shuffle Board Courts are non-historic safety measures (MBD P1000618.JPG)

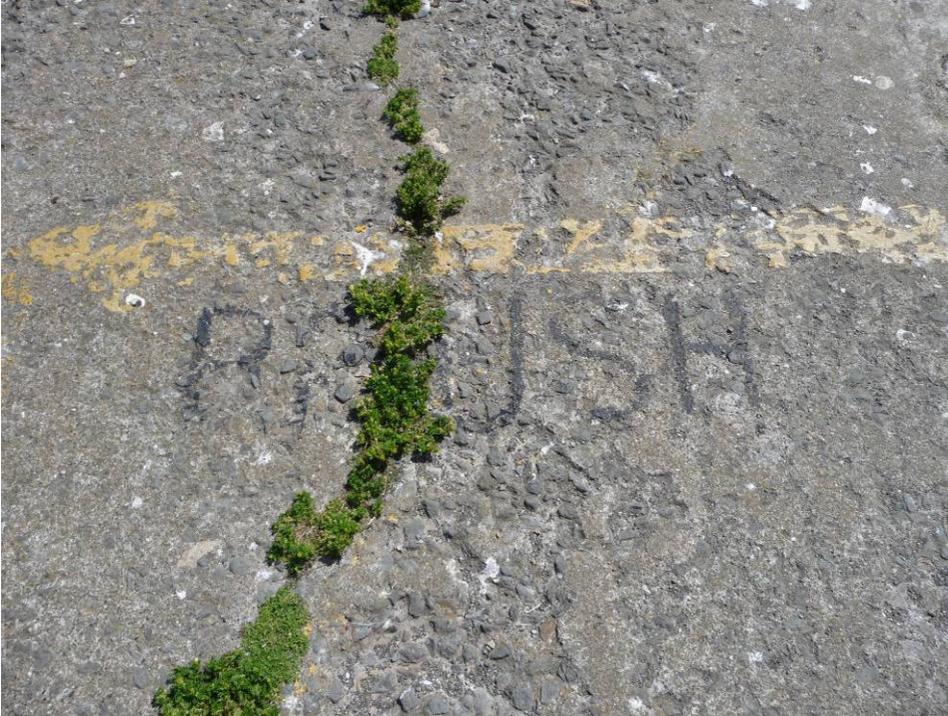
Figure 3 - 41. Stockade/Recreation Yard prisoner line-up markings (MBD P1000592.JPG)

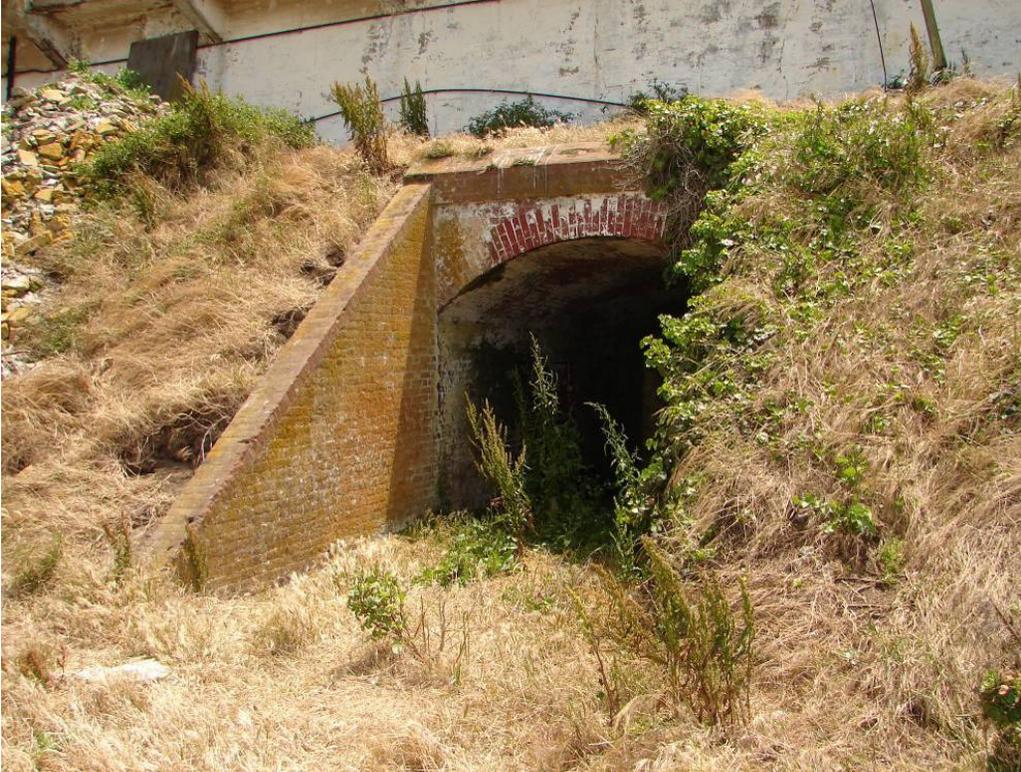
Figure 3 - 42. Fortification Bombproof Tunnel “I” and adjacent embankment, viewed from north of Stockade/Recreation Yard (MBD DSC03146.JPG)

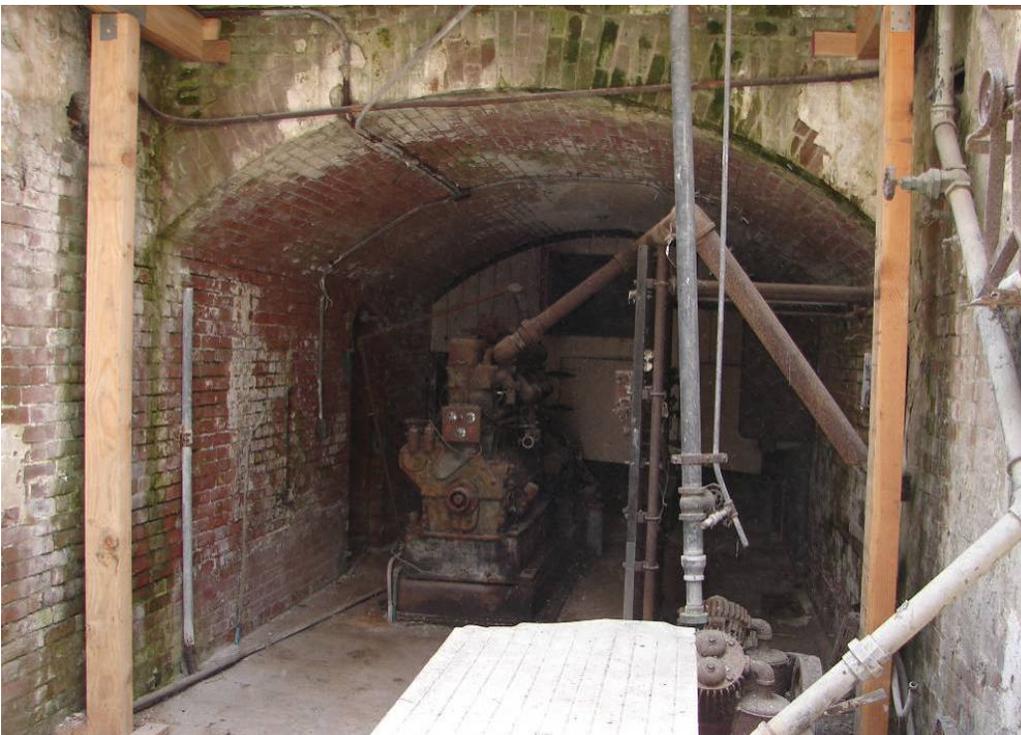
Figure 3 - 43. Fortification Bombproof Tunnel “J” with abandoned electrical generator, viewed from interior of Morgue (MBD DSC03218.JPG)

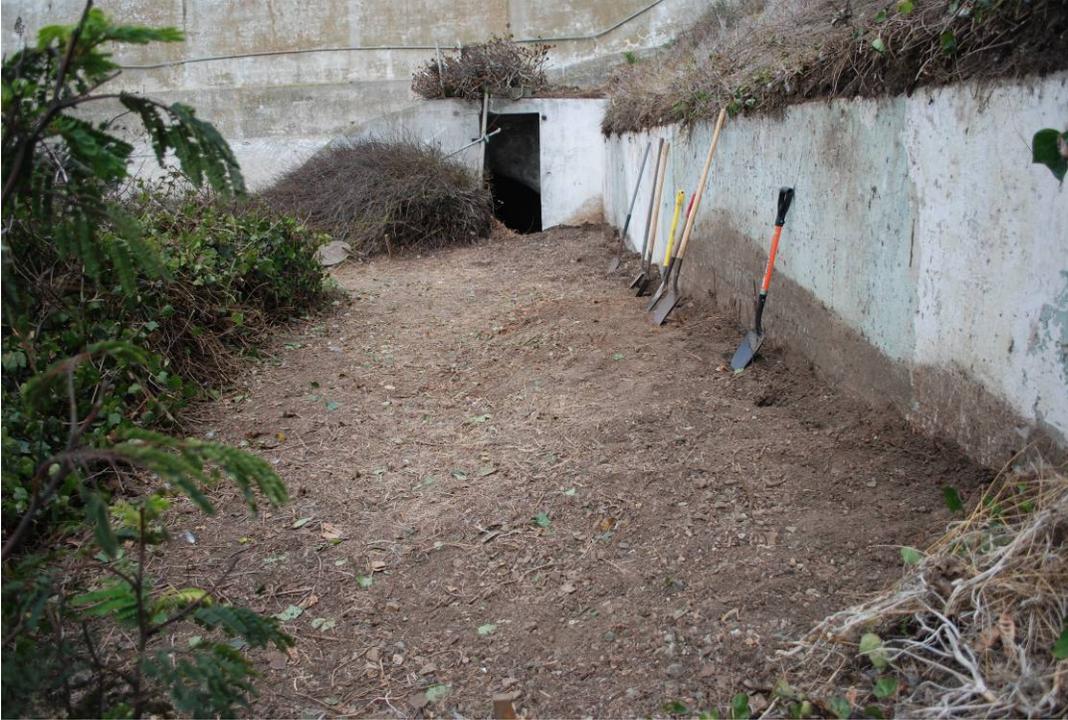
Figure 3 - 44. Fortification Bombproof Tunnel “K”, viewed from West Lawn area (Courtesy of Shelagh Fritz; Bombproof K.jpg)

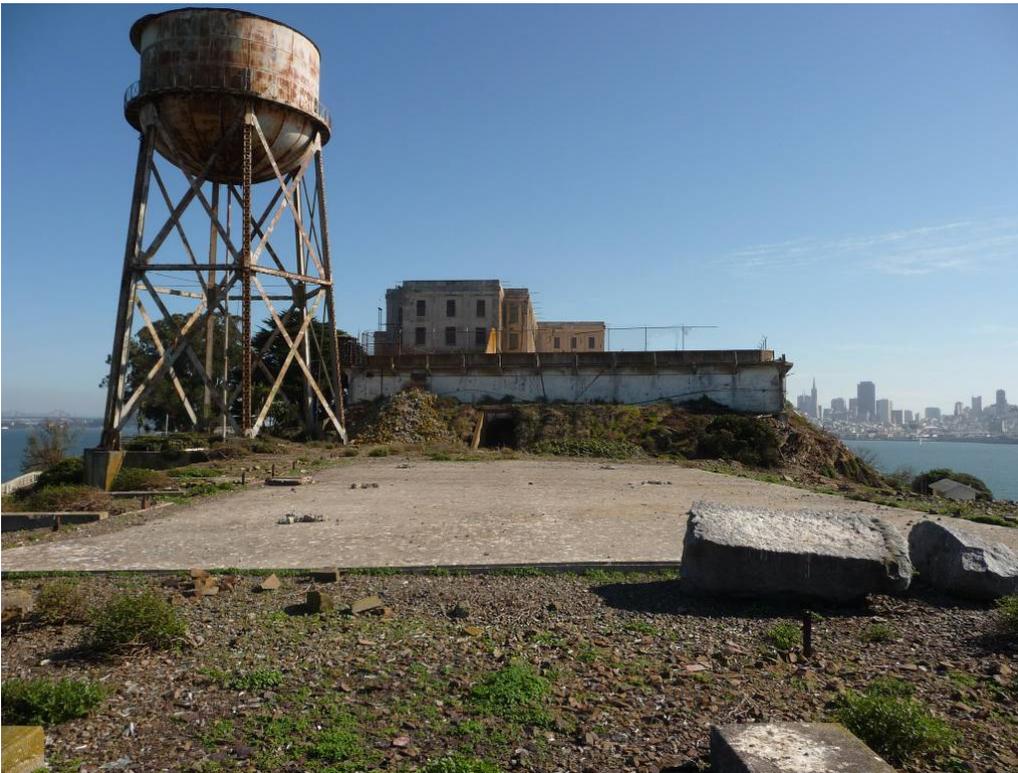
Figure 3 - 45. Concrete Cistern on North Terrace, Water Tower, and Stockade/Recreation Yard, as viewed from north end of terrace (MBD P1020964.JPG)

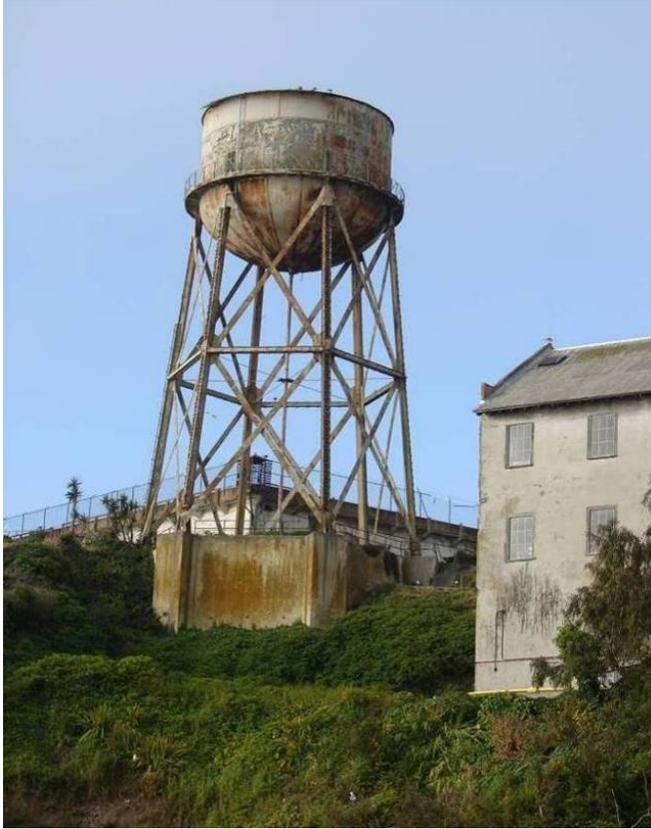
Figure 3 - 46. Water Tower (left) and Shops and Storage Building (right), view from water (MBD DSC02987.JPG)

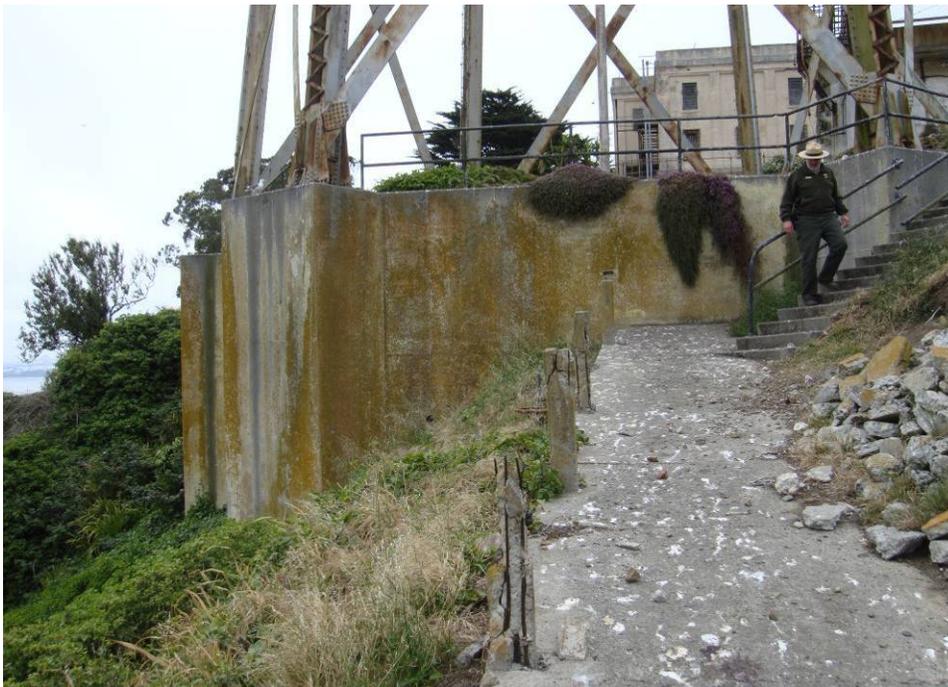
Figure 3 - 47. Water Tower Railings MBSR17, MBSR18, MBSR21 (MBD DSC00243.JPG)
