Existing Conditions Assessment - Summit

Spatial Organization, Topography, Views and Vistas - Summit

Buildings - Summit

Structures - Summit

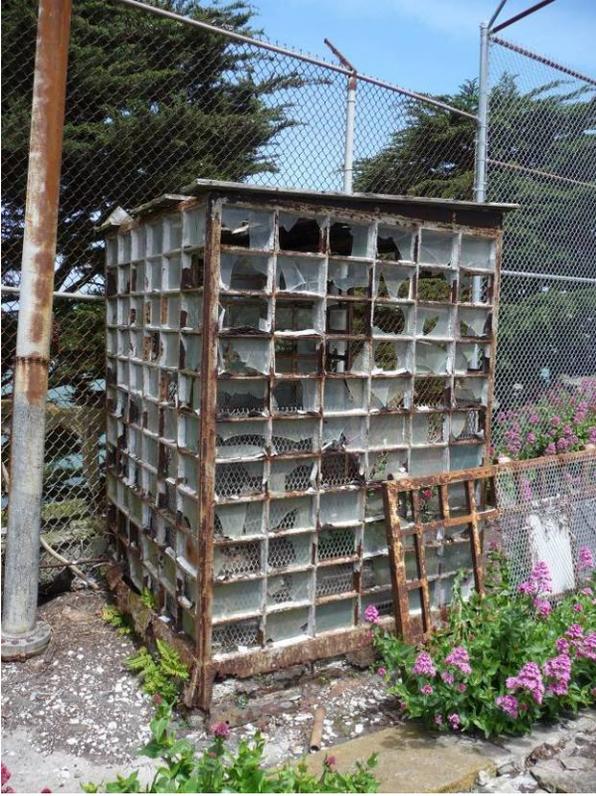
Figure 3 - 48. Guard Station for Kitchen Basement Sallyport (MBD P1010121.JPG)

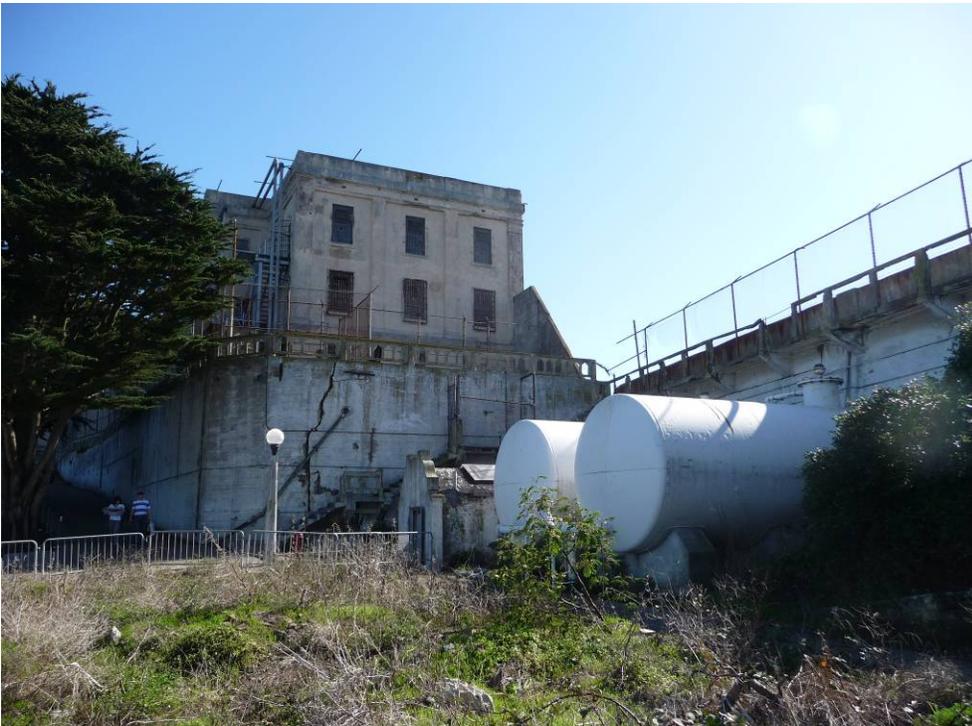
<i>Feature (Type)</i>	<i>Bldg #</i>	<i>Figure #</i>	<i>Description</i>	<i>Condition</i>
Oil Tanks No. 3		3-49	Two large, white oil tanks north of the Morgue	Good
Retaining Wall from Morgue to Shower Room Entrance		3-50	Concrete wall located on west side of walkway from Morgue to Main Prison Shower Room entrance	Poor
Foundations of Warden's Greenhouse		3-51	Concrete foundations south of Warden's House remnants.	Good
Warden's House Retaining Wall with SR35		3-52 3-53	Stone Retaining Wall with decorative concrete railing (SR35) Railing is deteriorating rapidly	Wall: Poor Railing: Poor
Collection Basin for Greywater System		3-53	Concrete basins on the west side of 68 south of the Recreation Yard	Fair

Figure 3 - 49. Looking south towards Morgue from Water Tank Terrace. Oil Tanks No. 3 located at right of photo. (MBD P1020973.JPG)

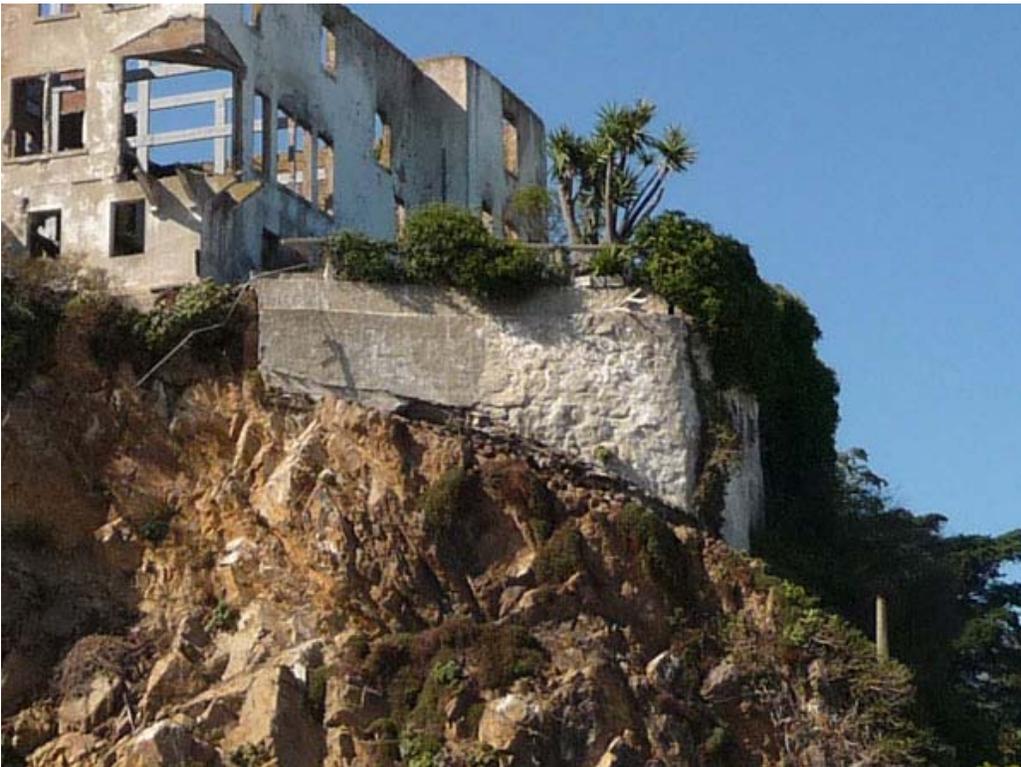
Figure 3 - 51. Warden's House Retaining Wall with remnants of decorative concrete railing SR35 (MBD WH Retaining Wall.JPG)

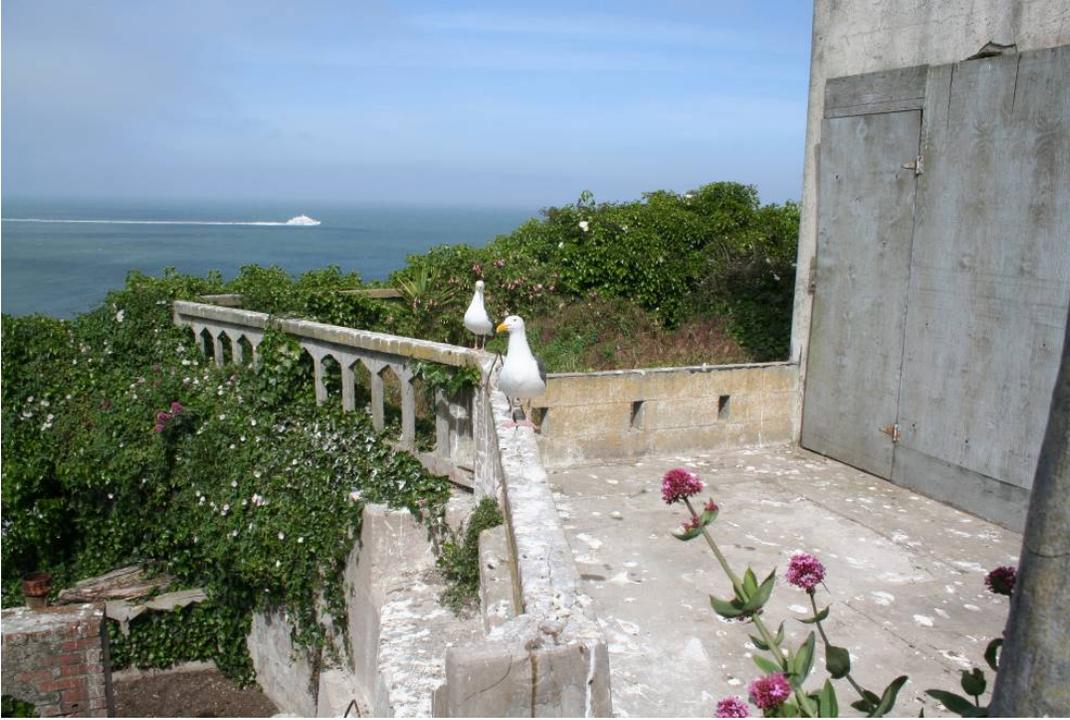
Figure 3 - 52. Warden's House retaining wall with decorative concrete railing SR35 (MBD IMG_2885.JPG)

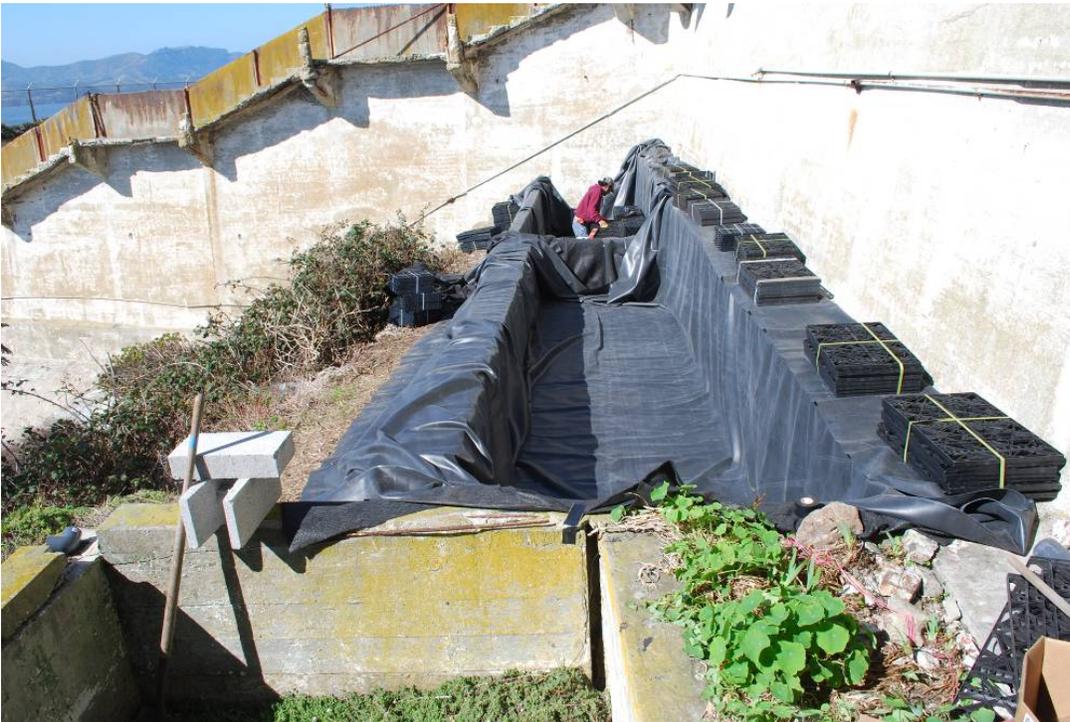
Figure 3 - 53. Collection Basins for Greywater System on west side of Main Prison, south of Stockade/Recreation Yard, looking north.(courtesy of Shelagh - Fritz Greywater catchment.jpg)
