Buildings - Main Road

Structures - Main Road

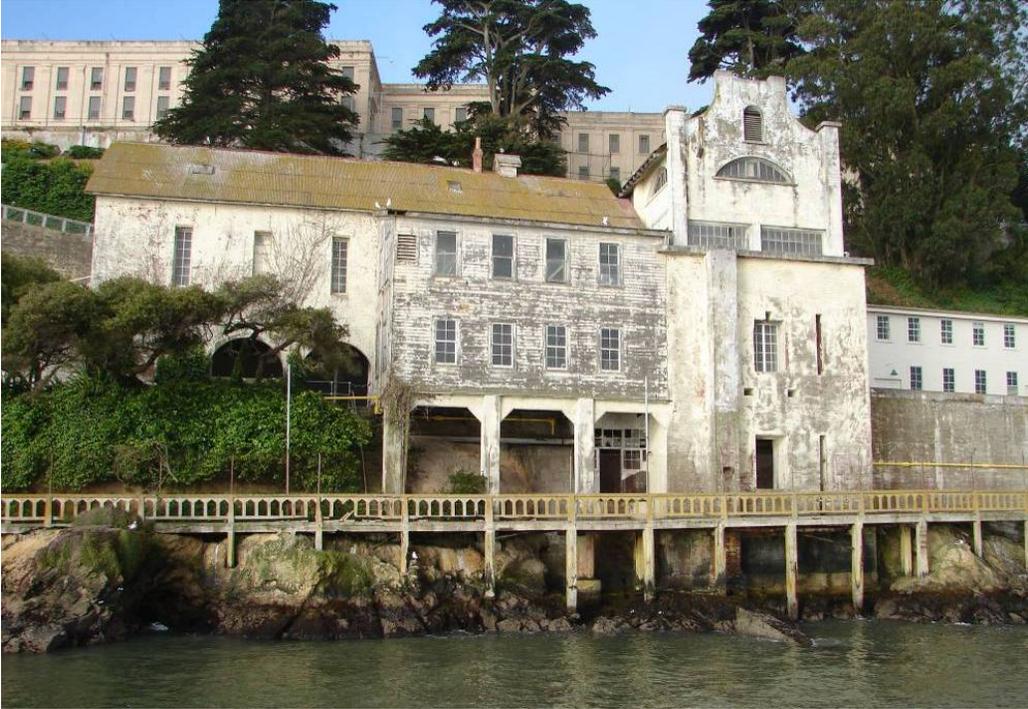
Figure 3 - 111. Guardhouse Complex with brick library, wood boathouse, and concrete schoolhouse additions (MBD DSC03006.JPG)

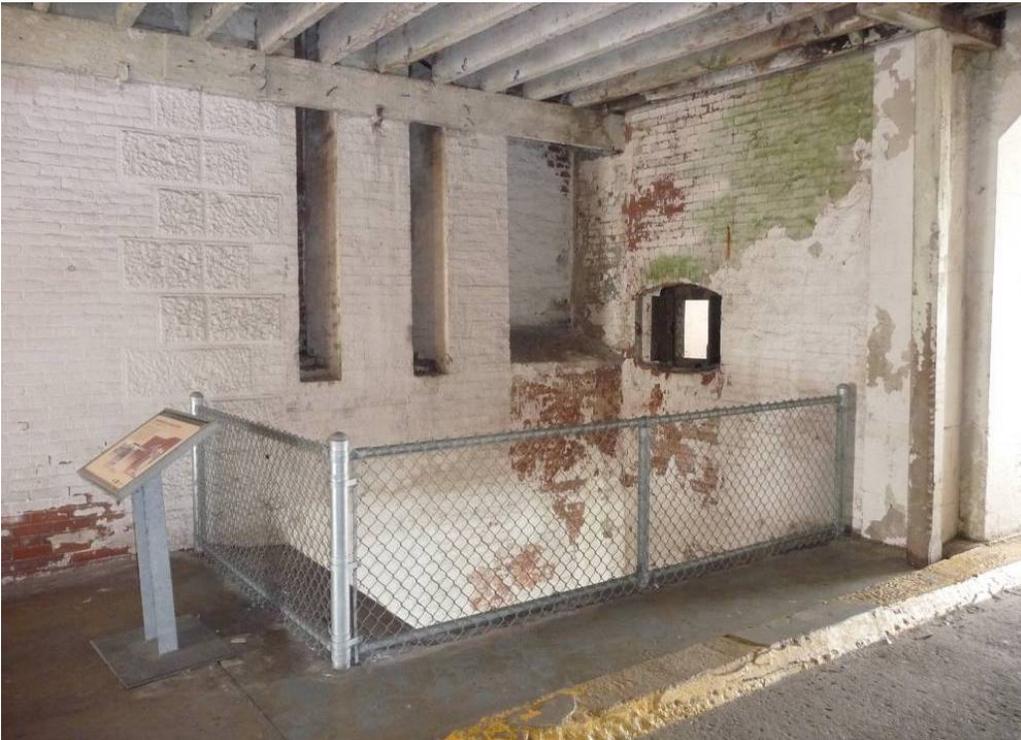
Figure 3 - 112. Fortification Wall (left) and Exterior (south) wall of Guardhouse Complex (right) with Dry Moat at Guardhouse Complex below; concrete bridge now spans moat originally crossed by a drawbridge (MBD DSC02501.JPG)

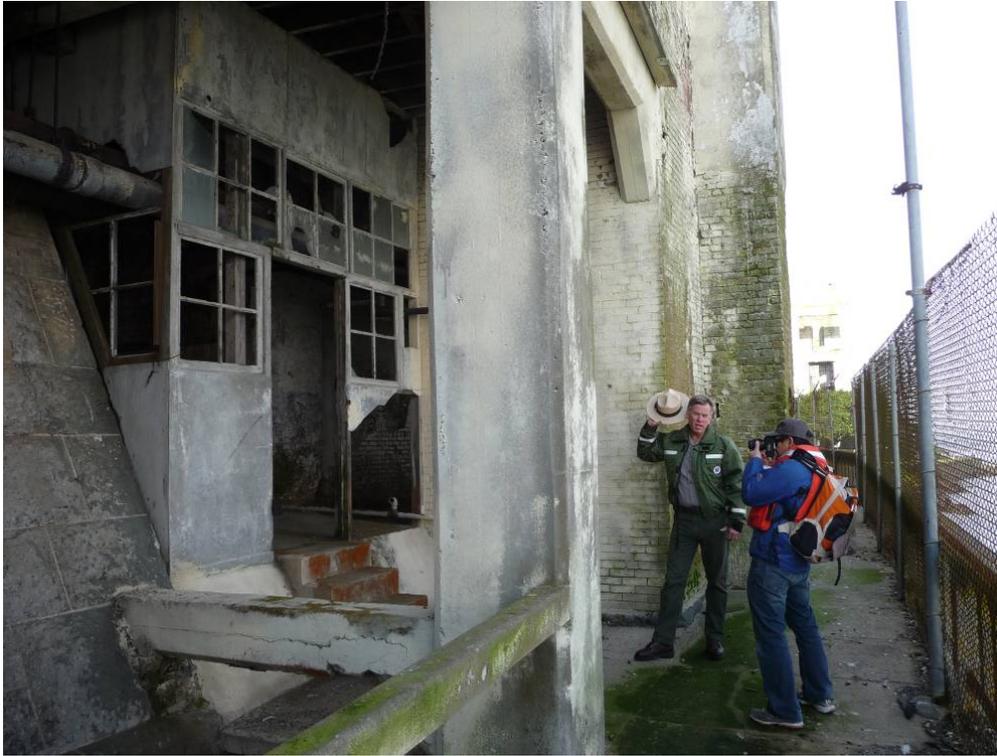
Figure 3 - 113. Dry Moat at Guardhouse Complex, viewed from the Perimeter Sentry Walk (MBD P1030424.JPG)

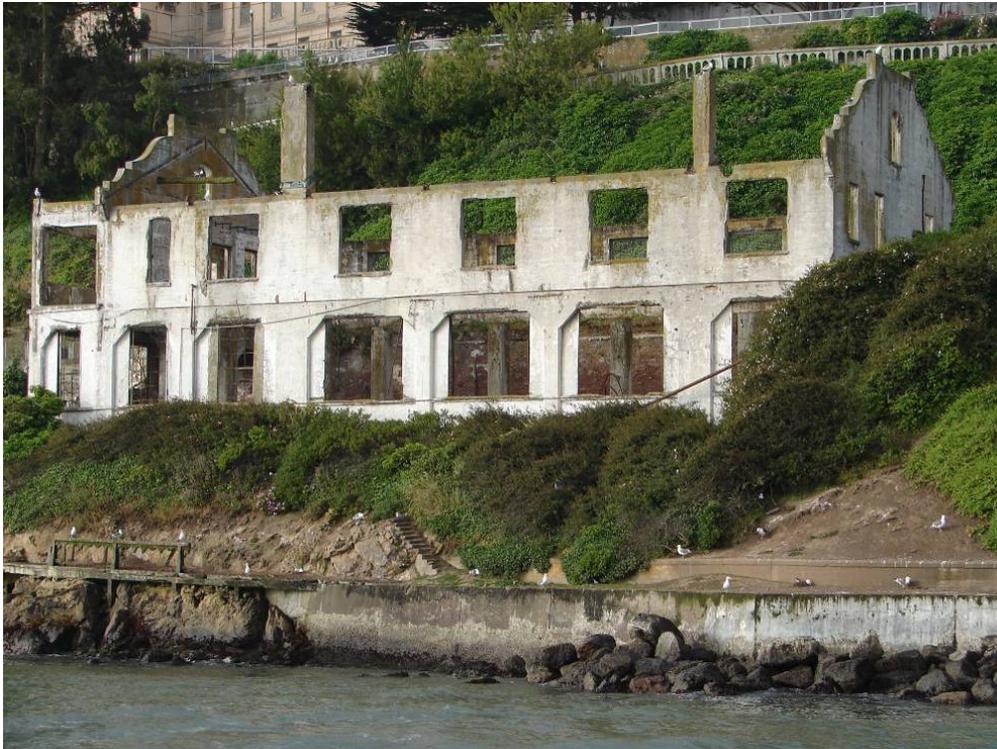
Figure 3 - 114. Post Exchange as viewed from the east; note brick fortification wall visible through lower windows of building (MBD DSC02992.JPG)

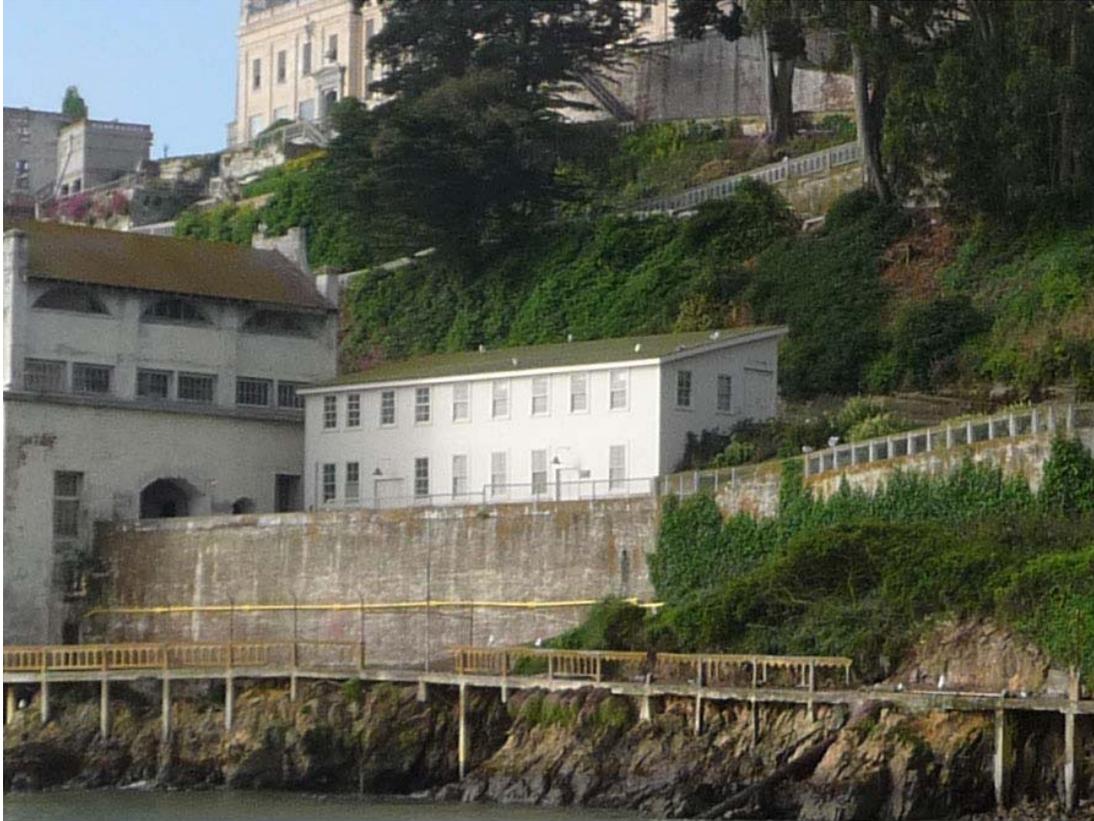
Figure 3 - 115. Prison Site/Electric Shop north of Guardhouse Complex (MBD P1010016.JPG)

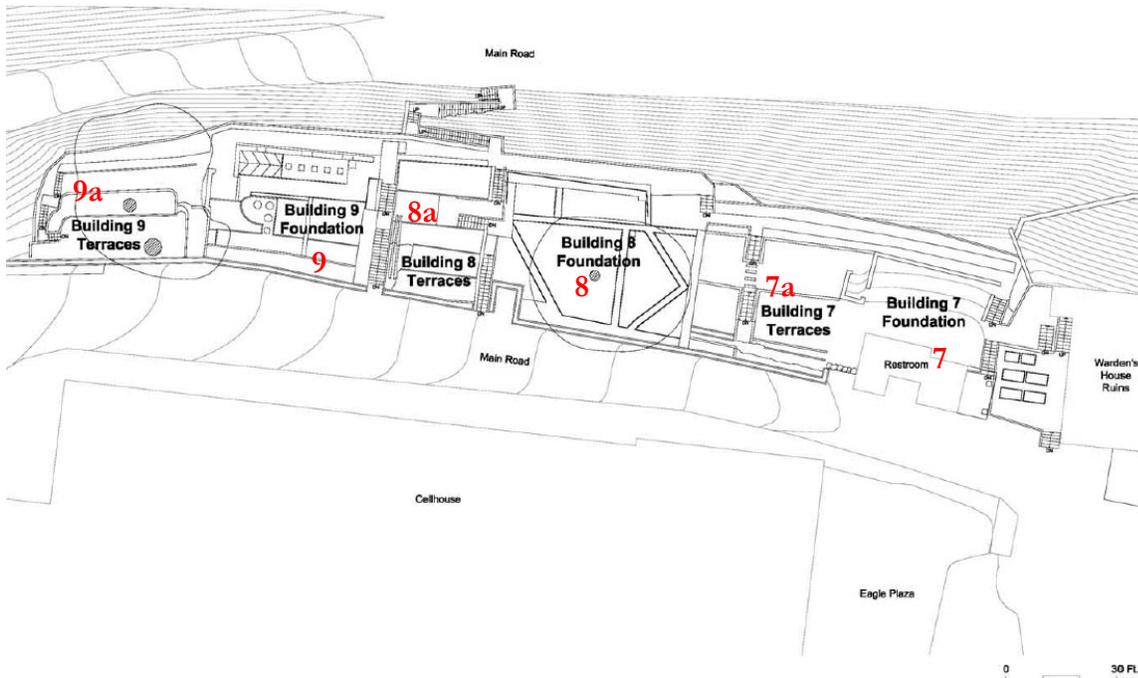
Figure 3 - 116. Officers' Row Building Foundations and Garden Terraces (Diagram Courtesy of the Parks Conservancy)

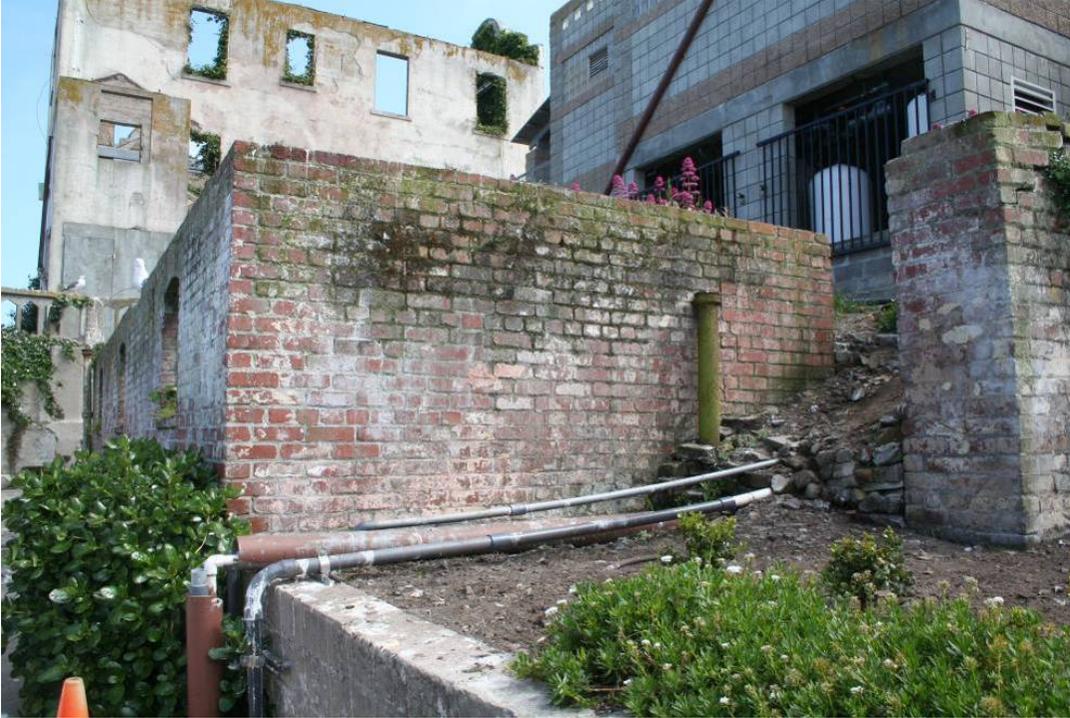
Officers' Quarters 7	7	3-117	Building found nearest to the Warden's House. Summit Restroom (built by NPS) is on a portion of the site	Poor
Garden Terrace- 7a	7a	3-118	Four foot tall block wall planting beds north of Officers' Quarters 7 remnants. Four foot tall retaining wall runs through the middle of the Garden.	Fair
Officers Quarters 8	8	3-119	Consists of brick foundations abutting the Trough Wall, remnant coal shed that a portion of the Trough Wall has been built on top of, and a staircase along its northern edge	Poor

Figure 3 - 117. Officers' Quarters 7 with Warden's House in background, and contemporary restroom at upper right (MBD IMG_2875.JPG)

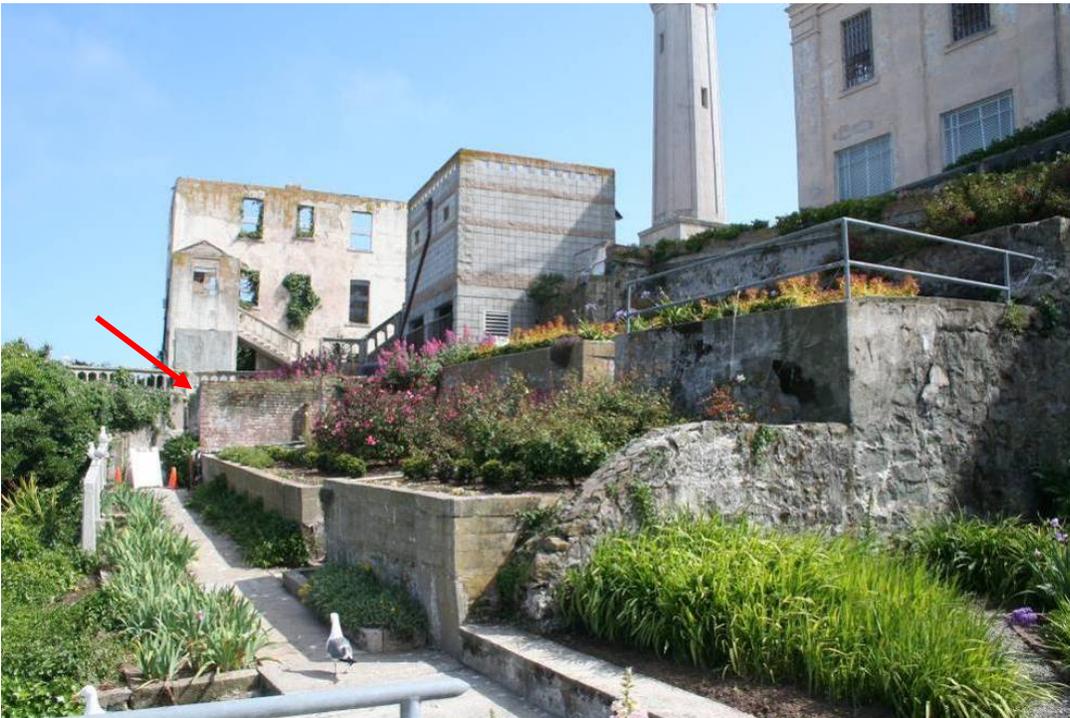
Figure 3 - 118. Officers' Quarters Garden Terrace 7a are the terraced beds with block walls just behind the arching stone wall, 7a ends at the brick wall indicated by the red arrow (MBD IMG_2863.JPG)

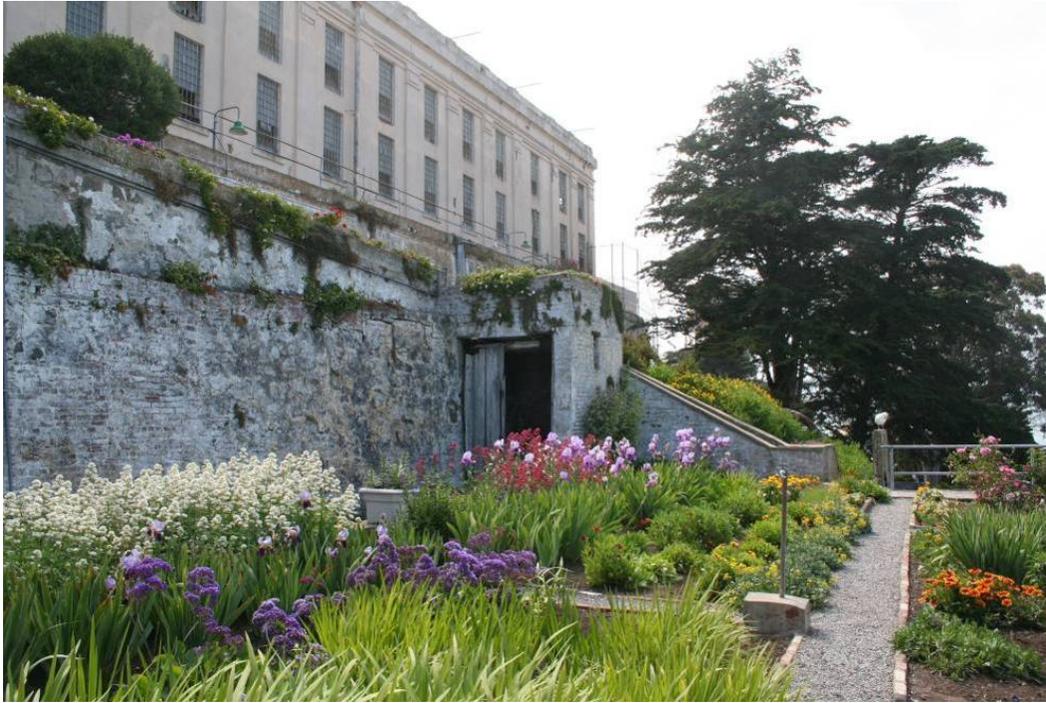
Figure 3 - 119. Officers' Quarters 8, looking northwest; Painted brick foundation wall at left of photo and remnant coal bin/garden storage in middle of photo (MBD IMG_2857.JPG)

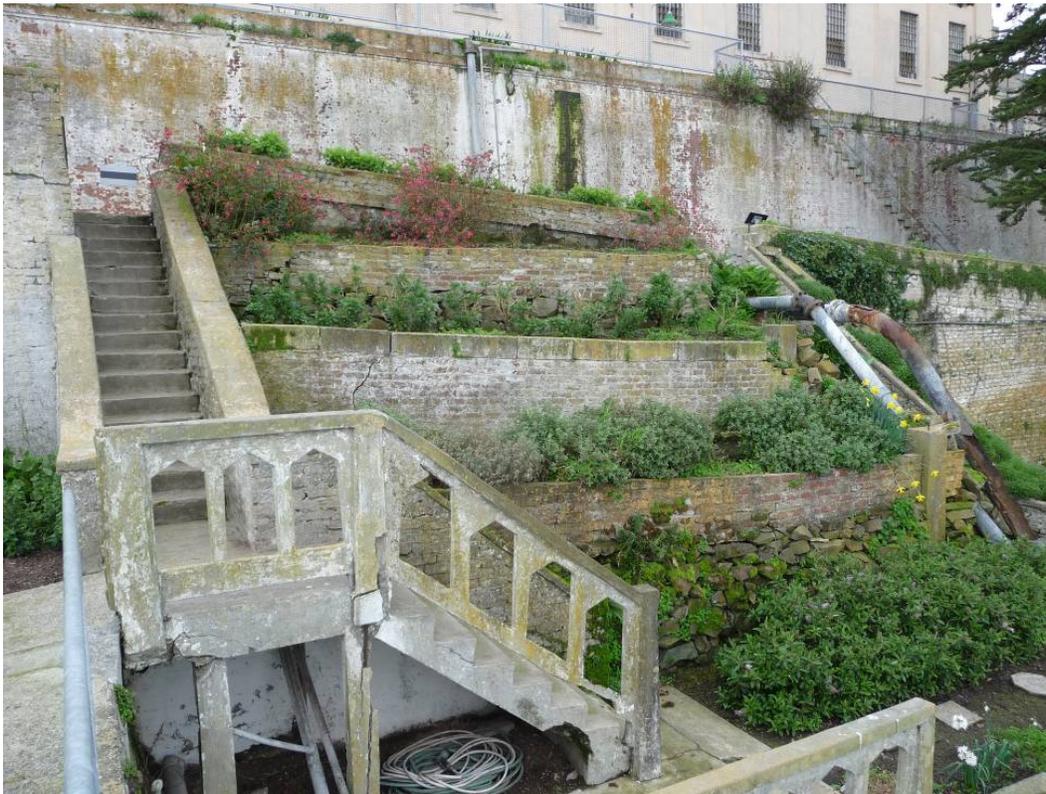
<i>Feature (Type)</i>	<i>Bldg #</i>	<i>Figure #</i>	<i>Description</i>	<i>Condition</i>
Officers' Row, continued				
Garden Terrace – 8a	8a	3-120	Terraced garden north of Officers' Quarters 8 foundation	Fair
Officers Quarters 9	9	3-121	Remnant brick foundation walls. Garden features include brick and stone planting beds. Garden and contemporary Hothouse occupy the site	Fair
Garden Terrace – 9a	9a	3-122	Consists of three terraced levels with rubble retaining walls. At north end of Officers' Row	Poor
Greenhouse Foundation	88	3-123	Concrete Foundation (c1920s) Contemporary Greenhouse similar in form and scale built inside this foundation in 2009-10	Fair
Hospital Foundation Wall - 1		3-124 3-125	Remnant brick Hospital foundations	Poor
Hospital Foundation Wall - 2 with SR25		3-126 3-127	Concrete retaining wall with decorative concrete railing SR25. Original railing is in disrepair. Some severely deteriorated portions replaced in kind in 2009	Wall: Fair Railing: Poor

Figure 3 - 120. Officers' Quarters Garden Terrace 8a, to the right of the staircase (MBD IMG_2858.JPG)

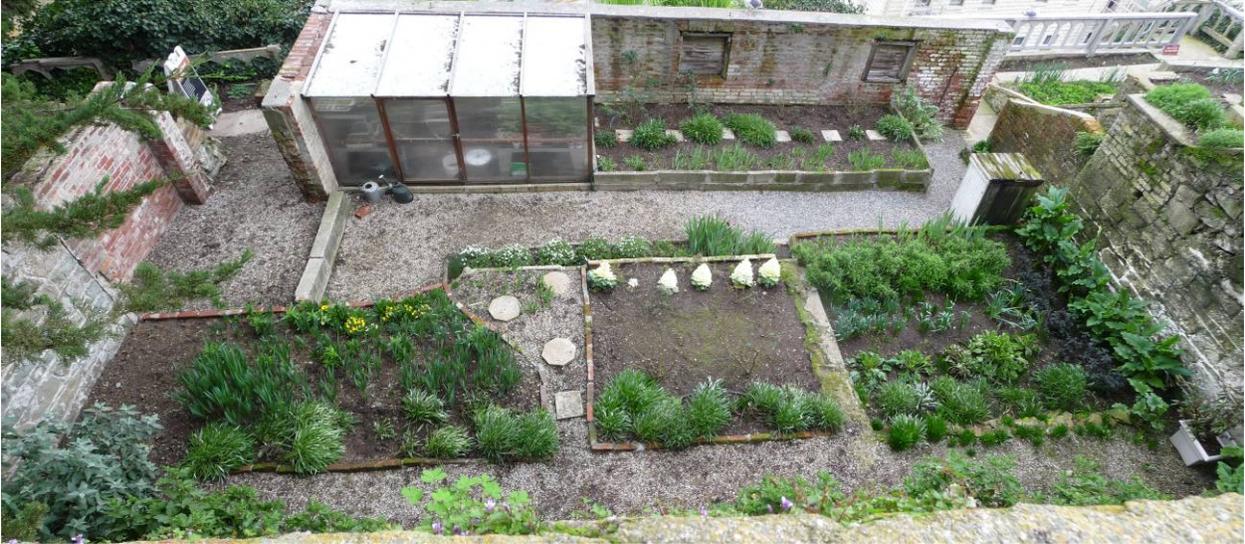
Figure 3 - 121. Officers' Quarters 9, looking east. Hothouse against foundation wall at left rear (MBD Building 9 Panorama.JPG)

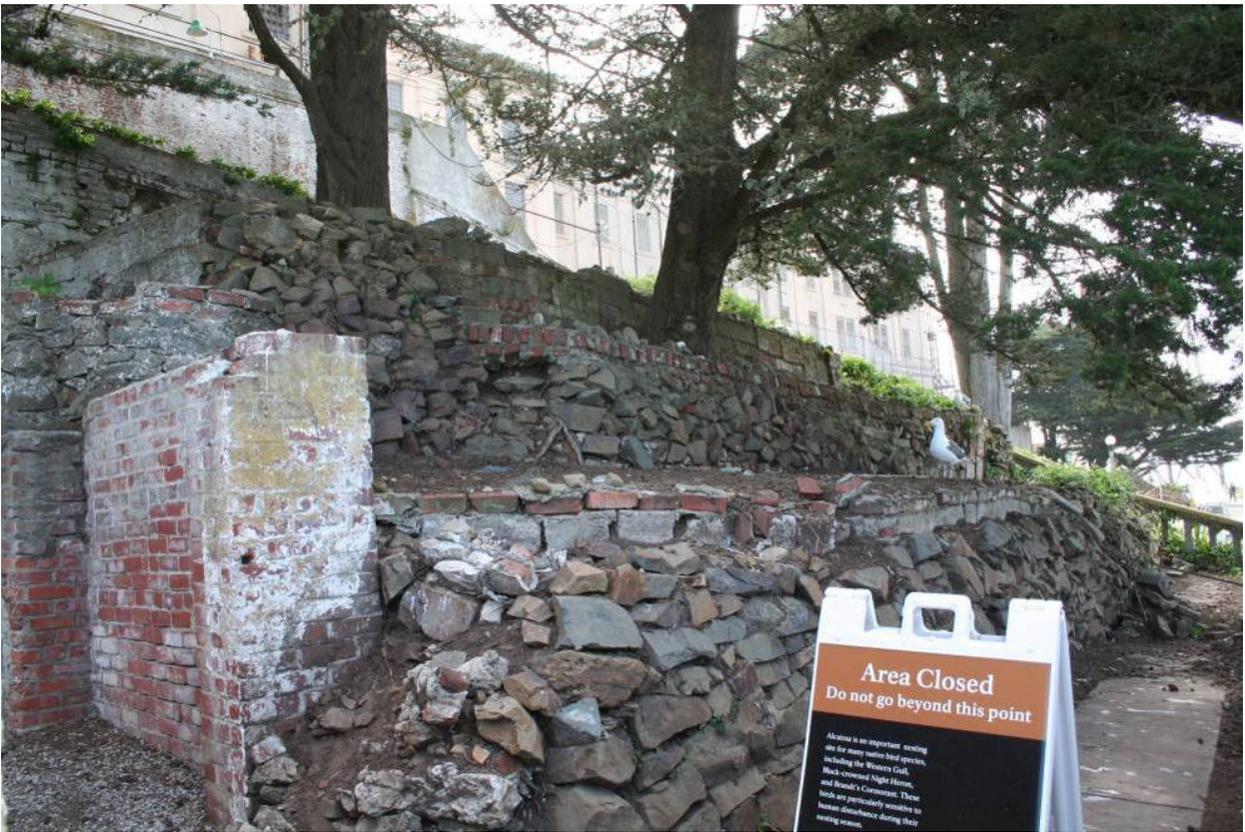
Figure 3 - 122. Officers' Quarters Garden Terrace 9a, Officers' Quarters 9 foundation wall at left of photo (MBD IMG_2842.JPG)

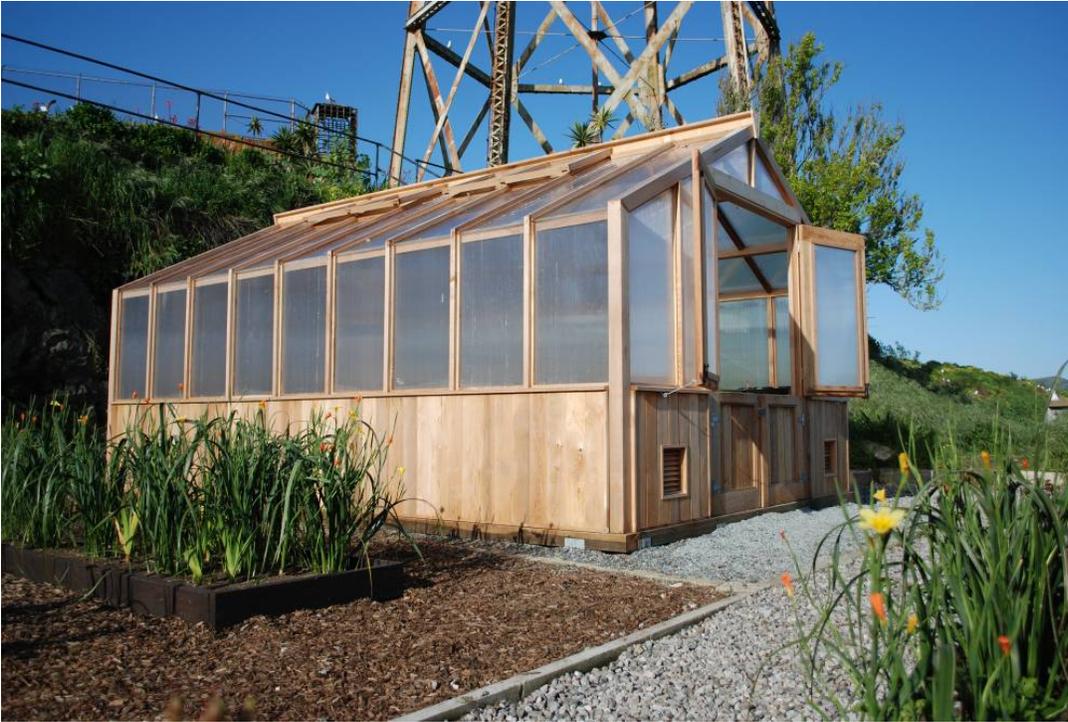
Figure 3 - 123. Reconstructed Greenhouse (c2010) in Rose Garden (Courtesy of Shelagh Fritz (Greenhouse site.jpg))

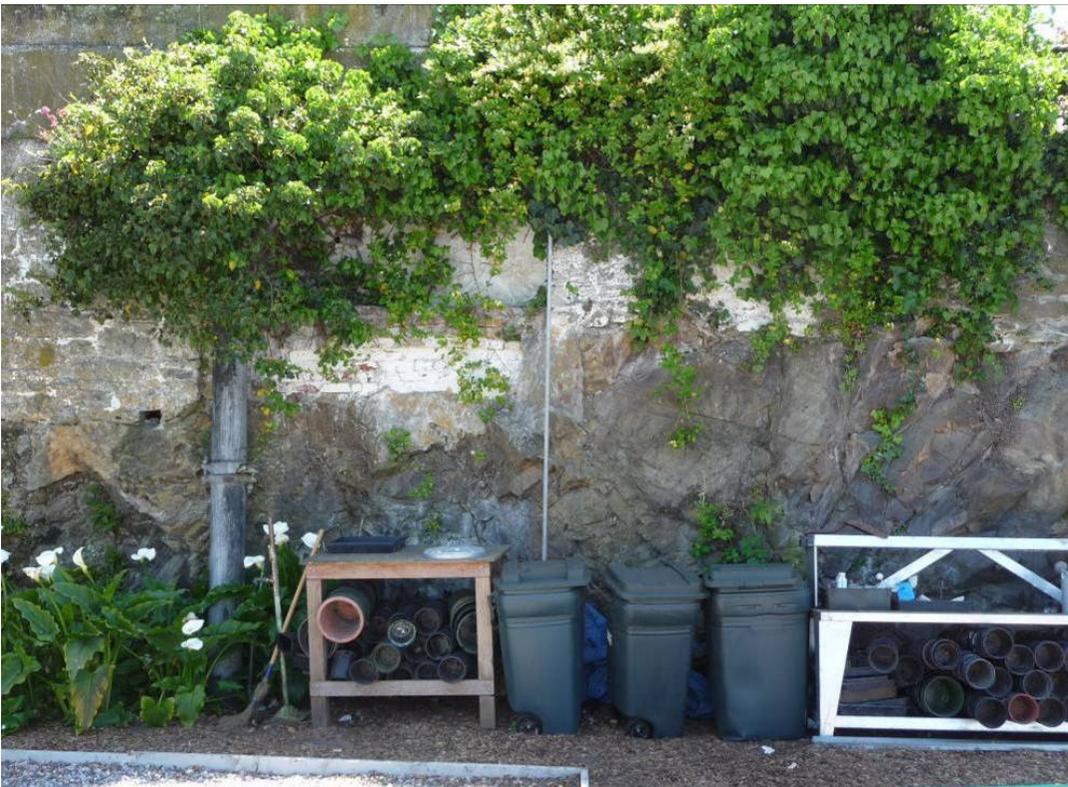
Figure 3 - 124. Remnant brick Hospital foundations, west side of Rose Garden (MBD P1000781.JPG)

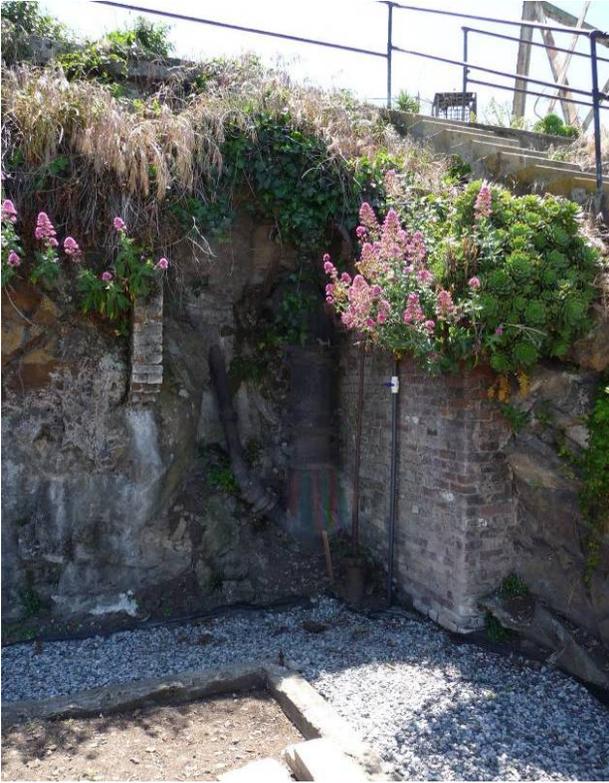
Figure 3 - 125. Remnant brick Hospital foundations, west side of Rose Garden (MBD P1000787.JPG)

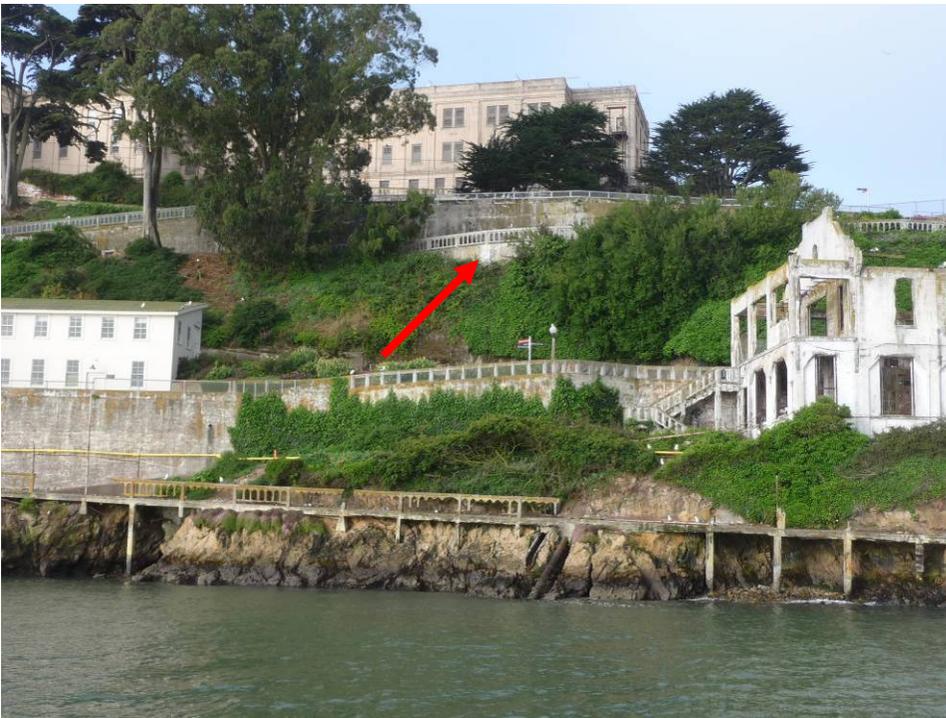
Figure 3 - 126. Hospital Foundation Wall - 2 with decorative concrete railing (SR25), viewed from the water (MBD P1010020.JPG)

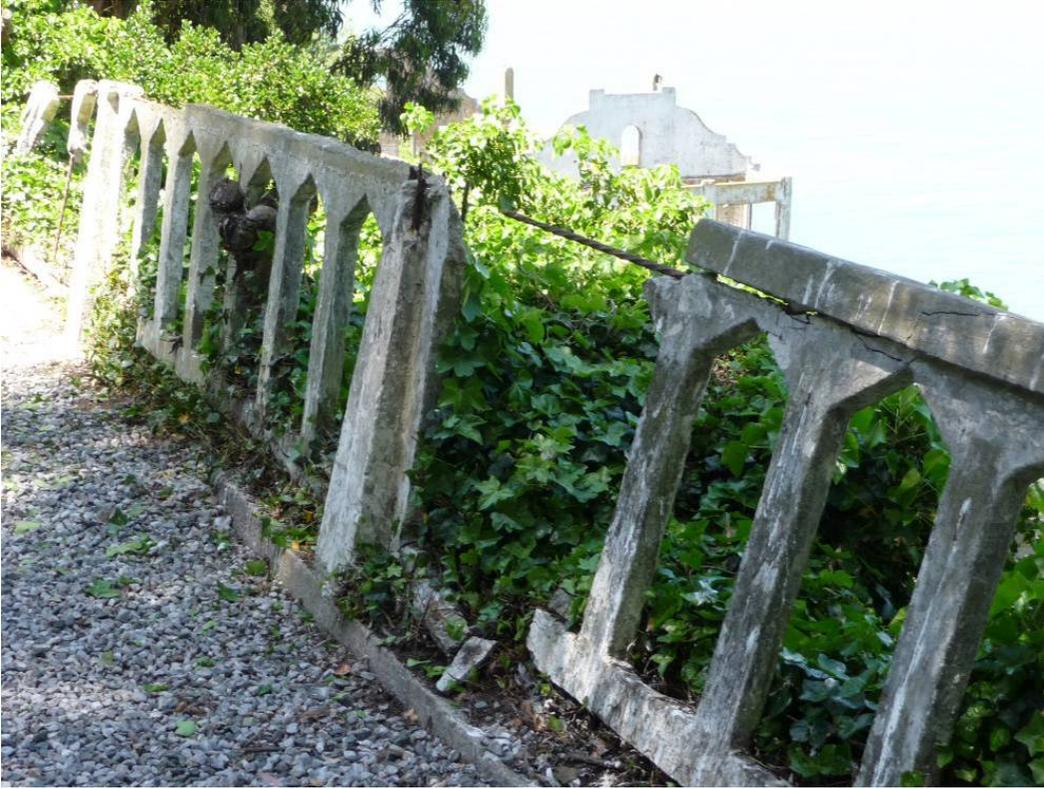
Figure 3 - 127. Decorative concrete railing (SR25) on Hospital Foundation Wall – 2 (MBD P1000738.JPG)

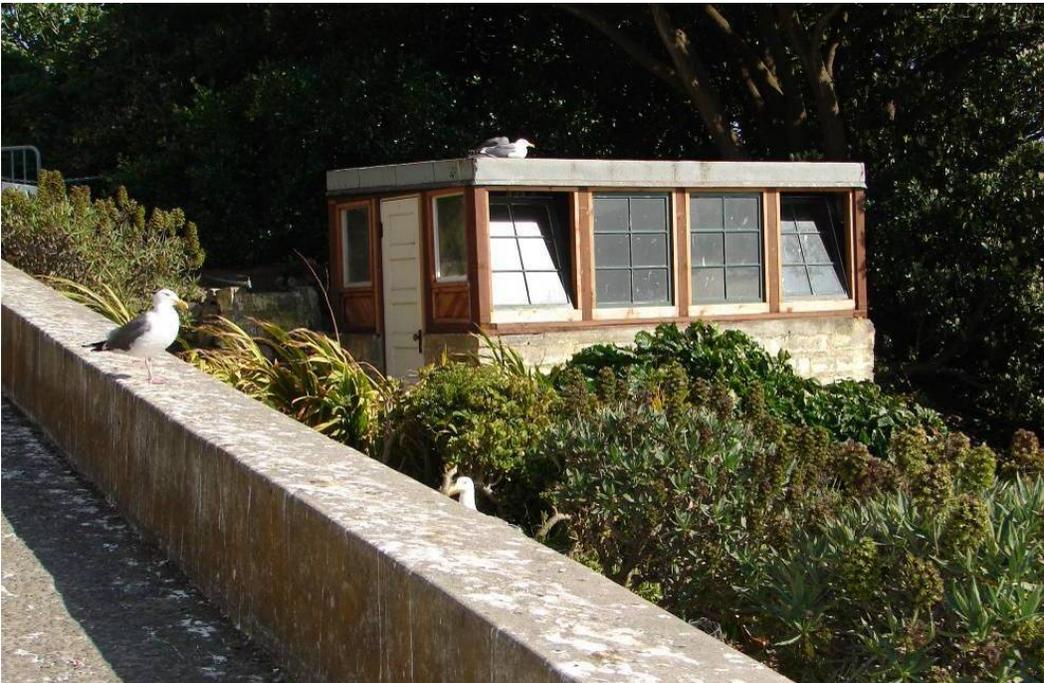
Toolshed		3-128	Reconstruction of upper wood portions and roof on original concrete foundations by NPS (c2009). Complete with working windows and doors.	Good
Summit Restroom		3-129	Contemporary Restroom North of Warden's House	Good

Figure 3 - 128. Reconstructed Toolshed in Toolshed Terraces, viewed from Upper West Road (MBD DSC02893.JPG)

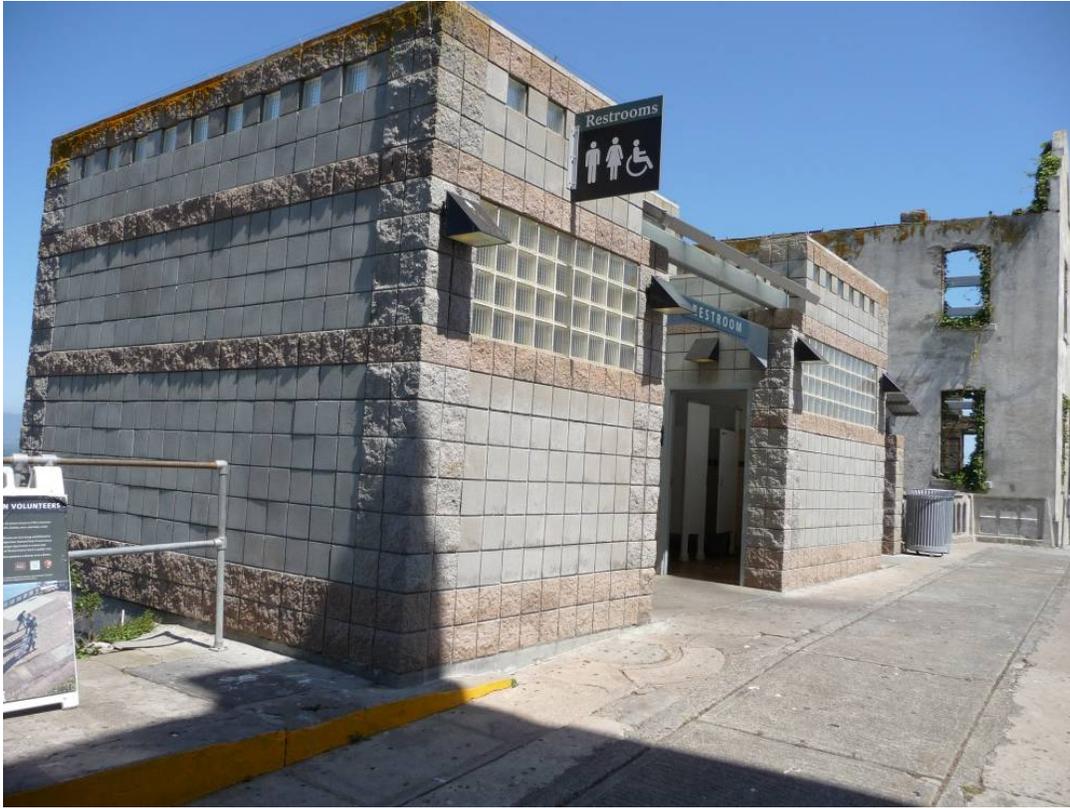
Figure 3 - 129. Restroom north of the Warden's House. (MBD P1000435.JPG)

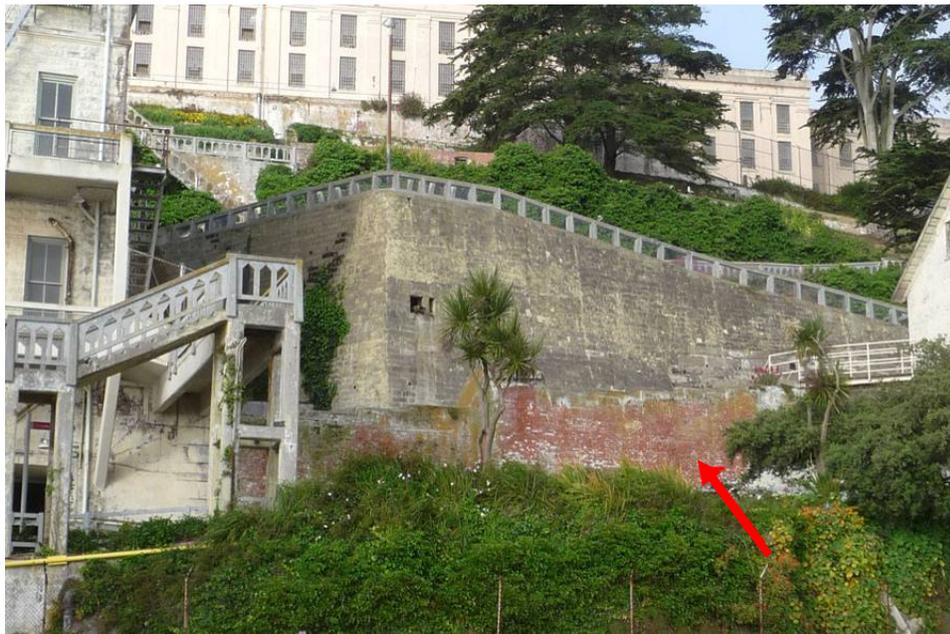
<i>Feature (Type)</i>	<i>Bldg #</i>	<i>Figure #</i>	<i>Description</i>	<i>Condition</i>
Main Road Walls: Wharf to Guardhouse Complex				
Fortification Wall - Barracks to Guardhouse with SR21	22	3-130	Brick and concrete retaining wall between Barracks and Guardhouse; brick wall is fortification wall Built in association with construction of road to Guardhouse, due to unstable rock, eroding (Barker, 2009). SR21 is a metal Pipe Rail	Wall: Fair SR21: Fair
Main Road Walls: Guardhouse Complex to Switchback One				
Lower Prison Site Fortification Wall with MBSR1, MBSR2, MBSR3	22	3-131	Brick Wall on shore side of Main Road from Guardhouse Complex to Post Exchange remnants. (Chappell 1993, Martini 2003) MBSR1 is a replica concrete railing with chain link screen MBSR2 and 3 are one to two feet tall Chain link security fences	Wall: Good MBSR1: Fair MBSR2,3: Good
Electric Shop Wall	89	3-132	Brick masonry wall, topped by concrete block	Good

Figure 3 - 130. West Wall (Brick Fortification Wall (red)) between Building 64 and Guardhouse Complex; Retaining Wall-Road to Barracks (gray) above (MBD P1010028.JPG)

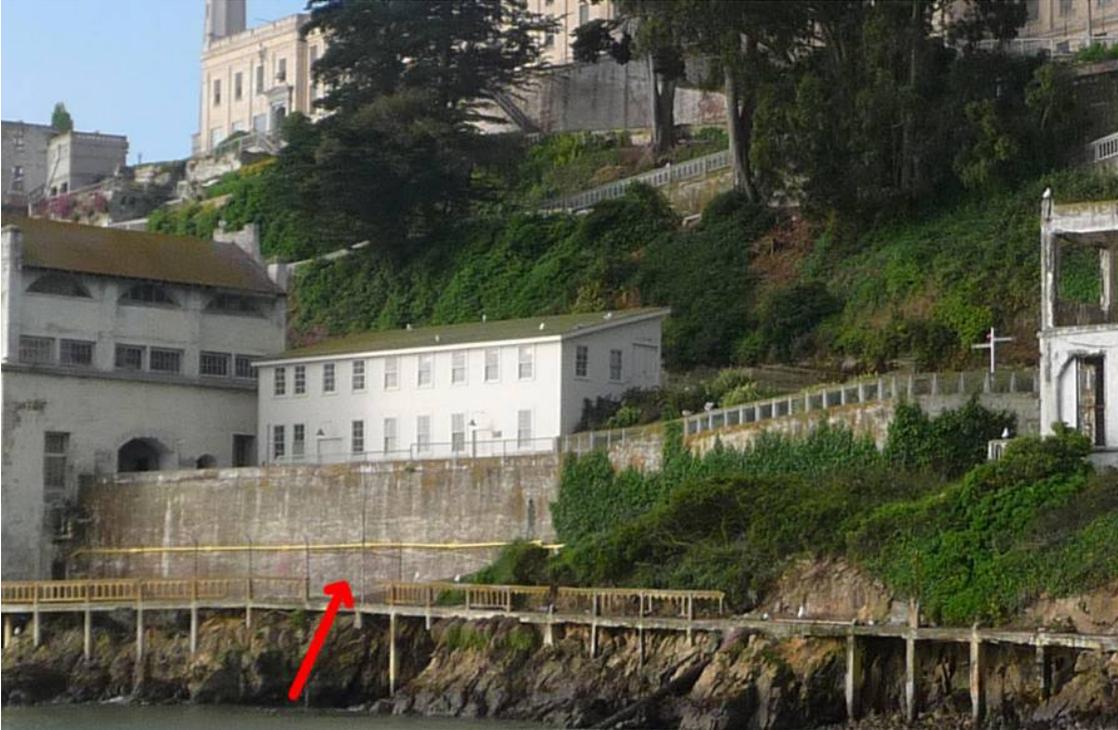
Figure 3 - 131. Lower Prison site brick Fortification Wall, north of Guardhouse Complex (MBD Fortification Wall by Guardhouse.JPG)

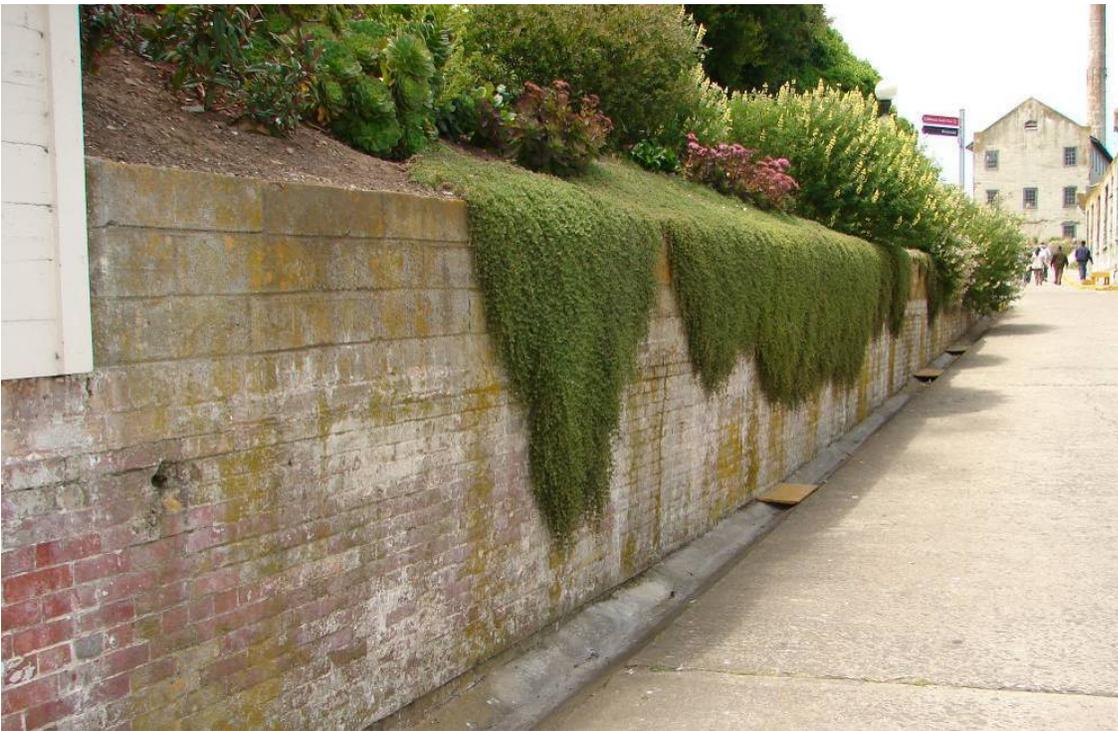
Figure 3 - 132. Electric Shop Wall looking north on west side of road from Guardhouse Complex to SB1 (MBD DSC02509.JPG)

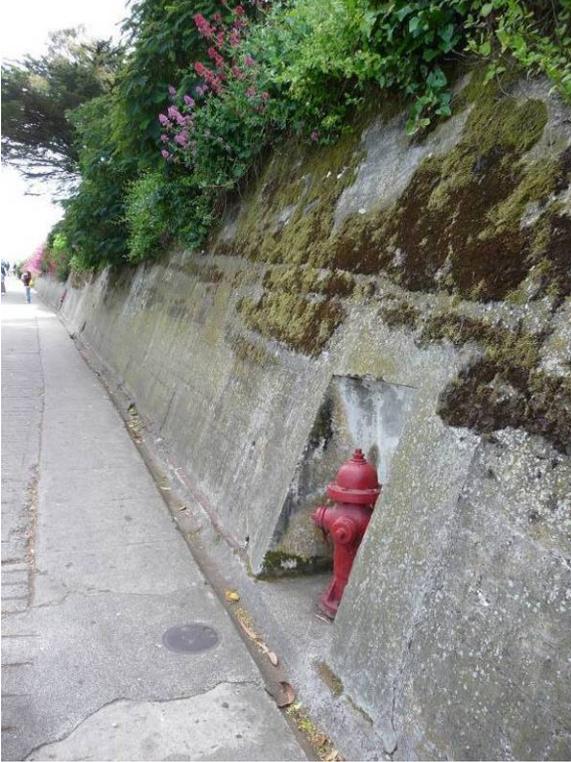
Main Road Walls: Switchback One to Switchback Two				
Block Wall		3-133	Retaining Wall on west side of Main Road with Rock Outcroppings above	Fair

Figure 3 - 133. Block Wall with concrete or masonry coating on west side of Main Road from Switchback One to Switchback Two (MBD P1000277.JPG)

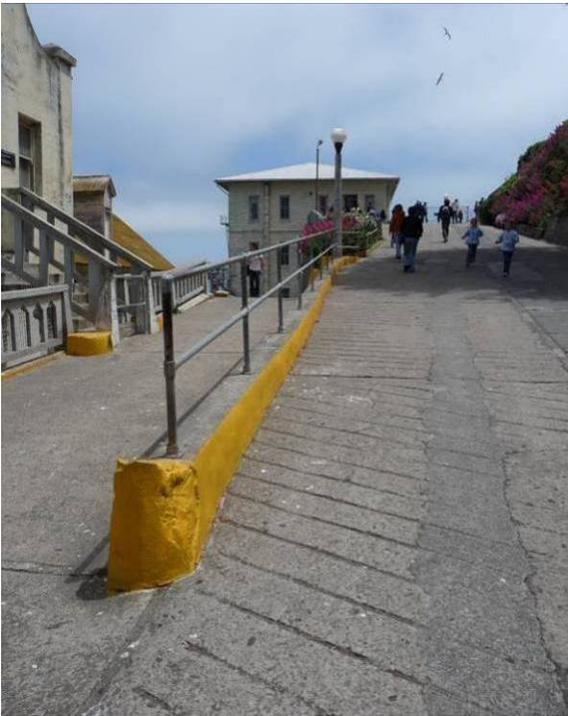
<i>Feature (Type)</i>	<i>Bldg #</i>	<i>Figure #</i>	<i>Description</i>	<i>Condition</i>
Main Road Walls: Electric Shop to Entrance to Chinatown				
Retaining Wall with SR17		3-134	Concrete retaining wall, painted yellow SR17 is a metal pipe railing	Wall: Fair SR17: Fair
Retaining Wall - Road to Barracks with SR22		3-135 3-136	Concrete block retaining wall with concrete security railing SR22 is a replica concrete railing with chain link screen	Fair
Main Road Walls: Switchback Two to Switchback Three				
Wall-8 with SR23		3-137	Concrete retaining wall with replica decorative concrete railing (SR23)	Fair
Block Wall-9		3-138	Concrete block wall on west side of Main Road near SB2	Poor
Rock Outcropping		3-139	Rock Outcropping between Wall 9 and Wall 11. 12" brick curb lines planting bed of about 12" wide in front of outcropping	Fair
Wall-11(Block Rubble Wall)		3-140	Block wall made of many different sizes of concrete blocks and stone.	Poor

Figure 3 - 134. Concrete Retaining Wall and metal pipe railing (SR17) looking south with Barracks in the background (MBD P1000288.JPG)

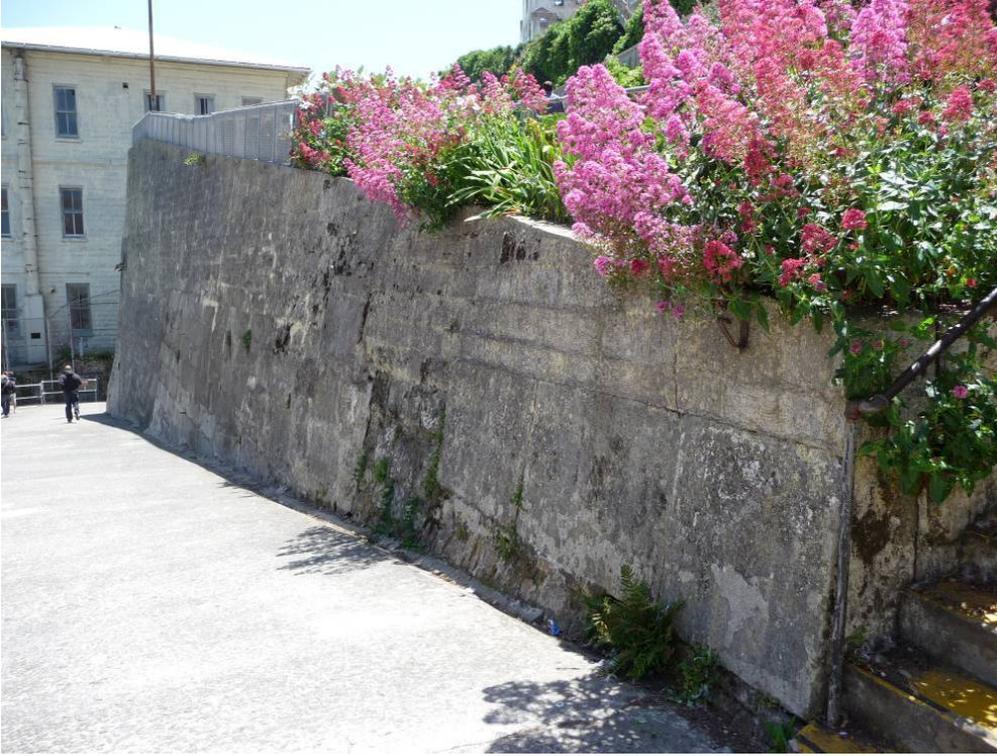
Figure 3 - 135. Retaining Wall-Road to Barracks with replica concrete railing and chain link screen (SR22) (MBD P1000676.JPG)

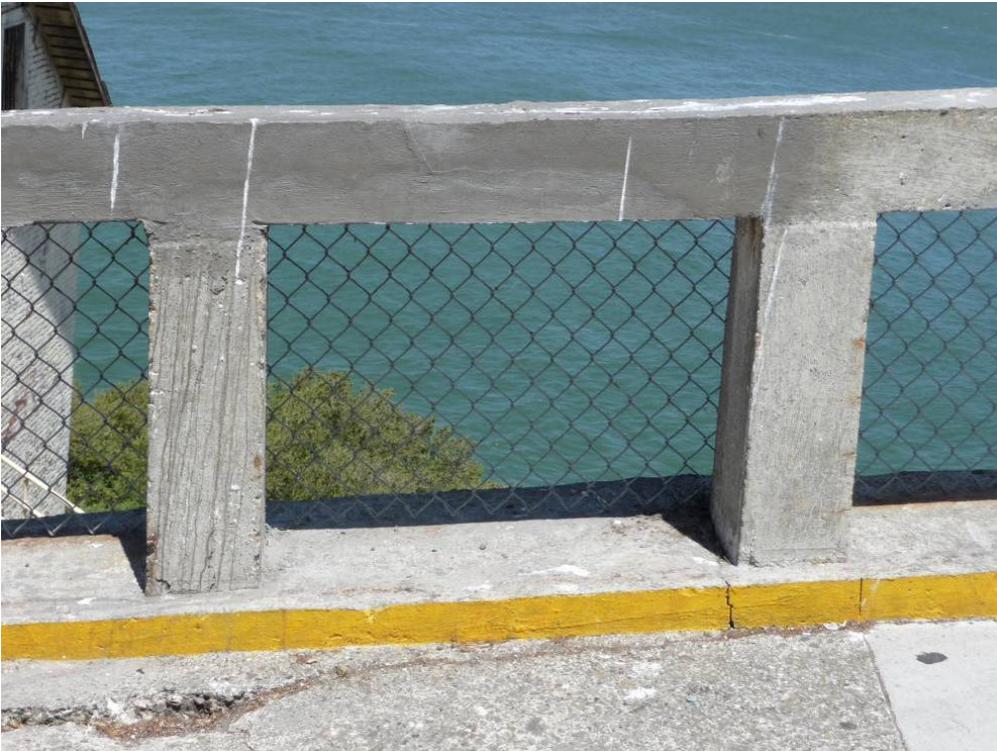
Figure 3 - 136. Replica concrete railing with new chain link screen (SR22) lining Retaining Wall – Road to Barracks (MBD P1000305.JPG)

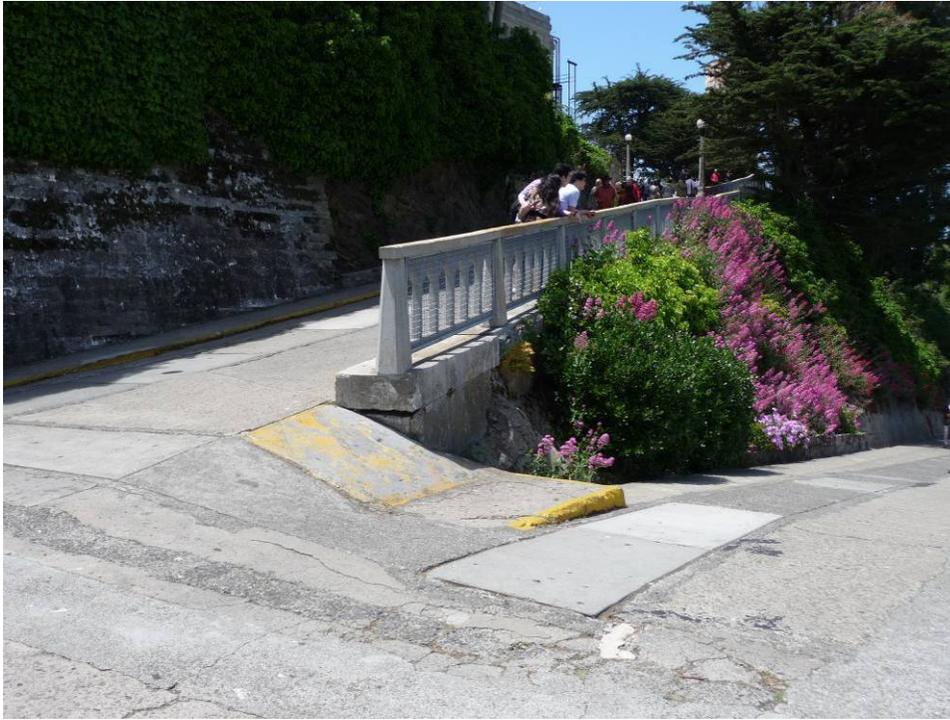
Figure 3 - 137. Wall 8 and replica concrete railing with steel mesh screen (SR23) at Switchback Two (MBD P1000307.JPG)

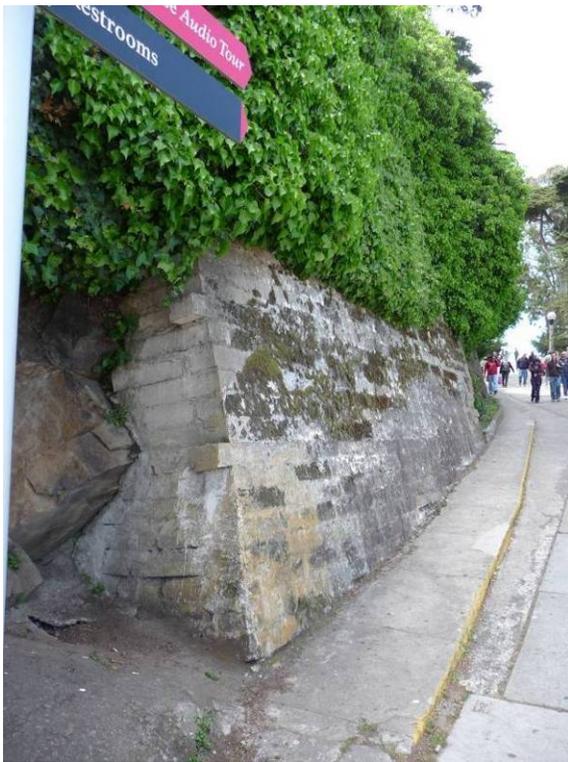
Figure 3 - 138. Block Wall 9 and sidewalk near Switchback Two (MBD P1000307.JPG)

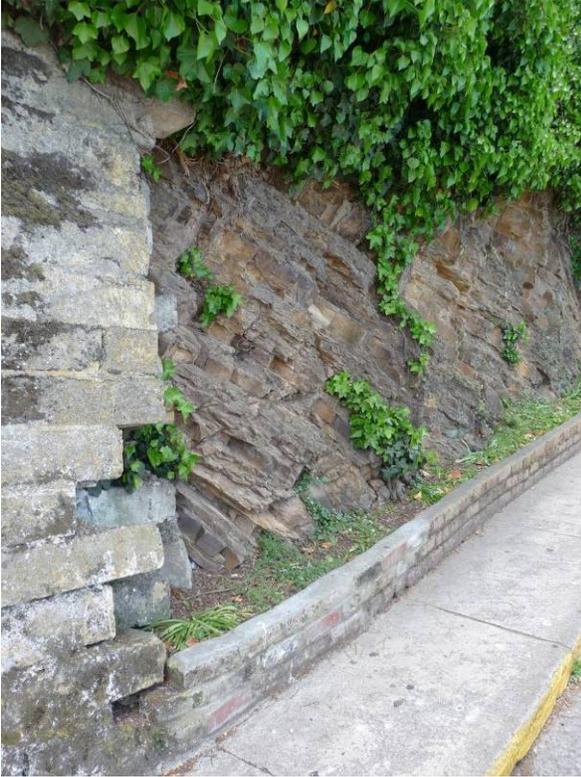
Figure 3 - 139. Block Wall 9 on left, Rock Outcropping, and Brick Curb in center of photograph on west side of Main Road between Switchback Two and Switchback Three (MBD P1000338.JPG)
