Buildings - Main Road

Structures - Main Road

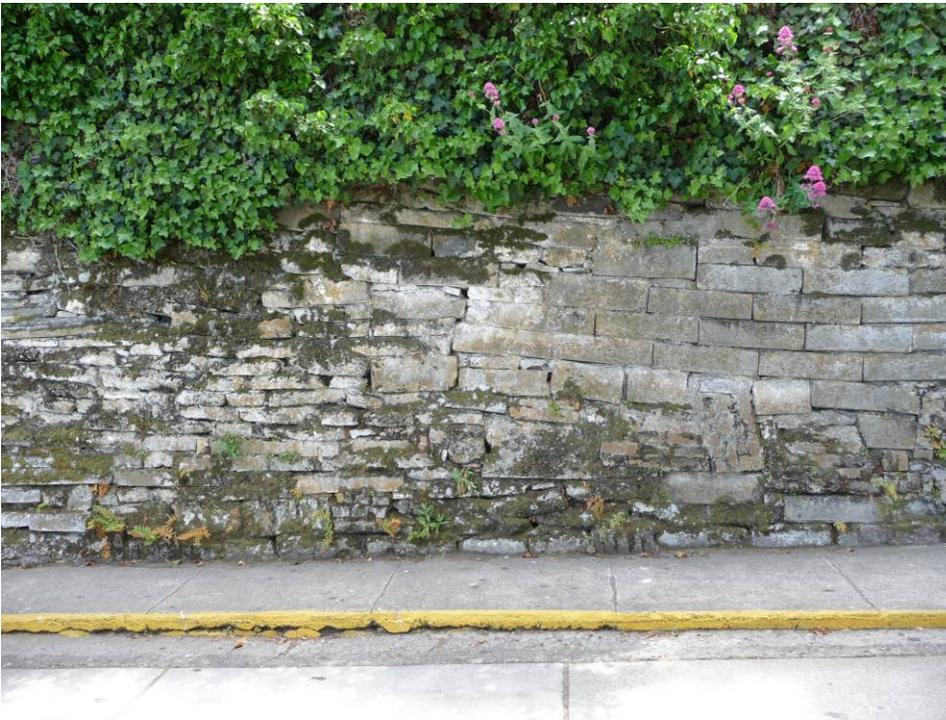
<i>Feature (Type)</i>	<i>Bldg #</i>	<i>Figure #</i>	<i>Description</i>	<i>Condition</i>
Main Road Walls: Electric Shop to Entrance to Chinatown				
Retaining Wall with SR17		3-134	Concrete retaining wall, painted yellow SR17 is a metal pipe railing	Wall: Fair SR17: Fair
Retaining Wall - Road to Barracks with SR22		3-135 3-136	Concrete block retaining wall with concrete security railing SR22 is a replica concrete railing with chain link screen	Fair
Main Road Walls: Switchback Two to Switchback Three				
Wall-8 with SR23		3-137	Concrete retaining wall with replica decorative concrete railing (SR23)	Fair
Block Wall-9		3-138	Concrete block wall on west side of Main Road near SB2	Poor
Rock Outcropping		3-139	Rock Outcropping between Wall 9 and Wall 11. 12" brick curb lines planting bed of about 12" wide in front of outcropping	Fair
Wall-11(Block Rubble Wall)		3-140	Block wall made of many different sizes of concrete blocks and stone.	Poor

Figure 3 - 140. Wall 11, Block Rubble Wall on west side of Main Road from Switchback Two to Switchback Three (MBD P1000349.JPG)

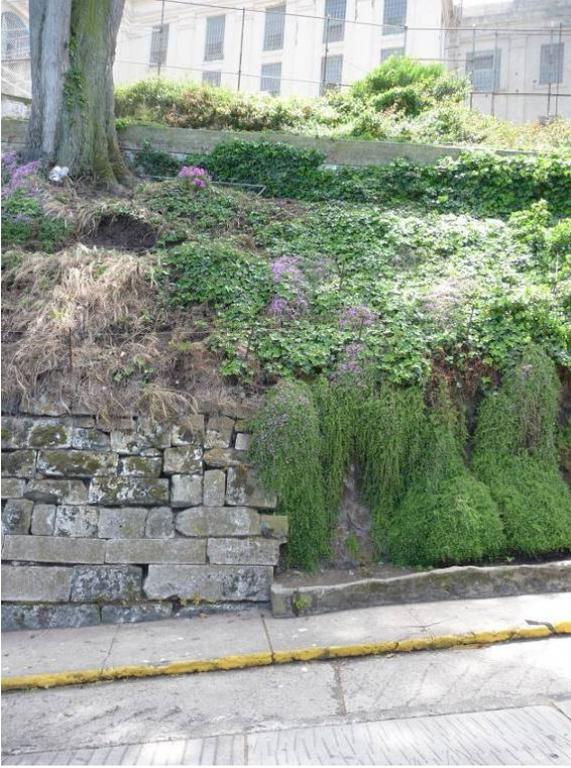
Rock Outcropping		3-141	Rock Outcropping below heavy vegetation north of Wall-11. 12" brick curb lines planting bed of about 12" wide in front of the outcropping	Fair
Main Road Walls: Road to Hospital				
Wall - 10 with SR27, MBSR22, SR28		3-142 3-143	Concrete Retaining Wall with replica decorative concrete railing (SR27), mesh railing (MBSR22)	Fair
Main Road Walls: Switchback Three to Lighthouse				
Citadel Wall with SR43, SR44, SR45, SR47, SR48, 49		3-144	Original brick masonry Fortification Wall, painted white, paint is peeling	Good
Main Prison South Retaining Wall with SR33		3-145	Retaining Wall south of Steps to Warden's office SR33 is replica decorative concrete railing	Good

Figure 3 - 141. Rock outcropping beneath heavy vegetation, next to and north of Wall 11, on west side of Main Road near Switchback Three (MBD P1000356.JPG)

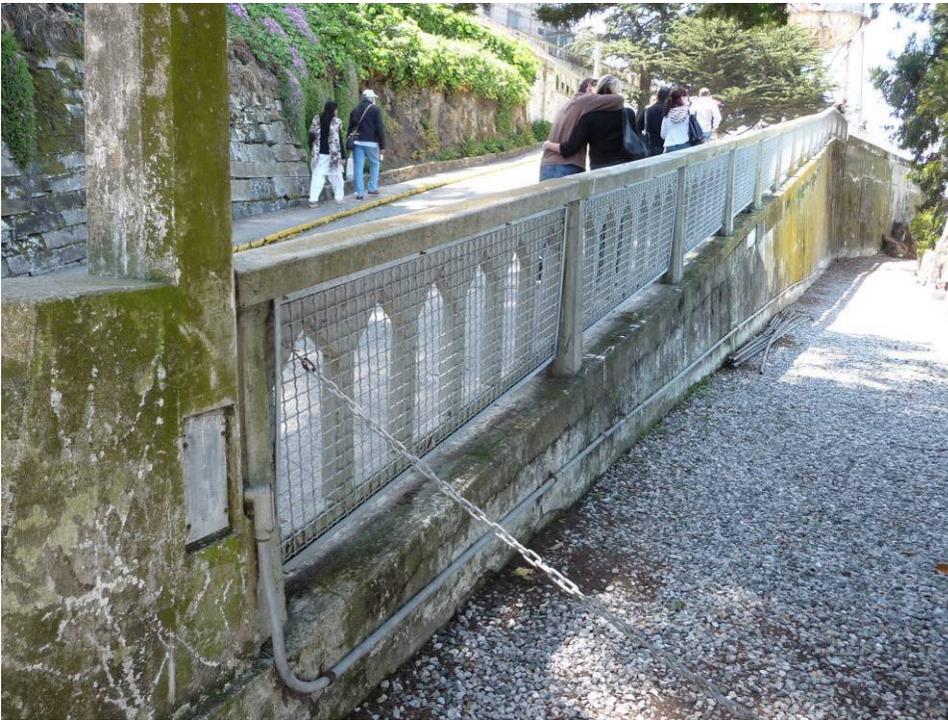
Figure 3 - 142. Wall -10 with Replica concrete railing (SR27), west side of Road to Hospital (MBD P1000737.JPG)

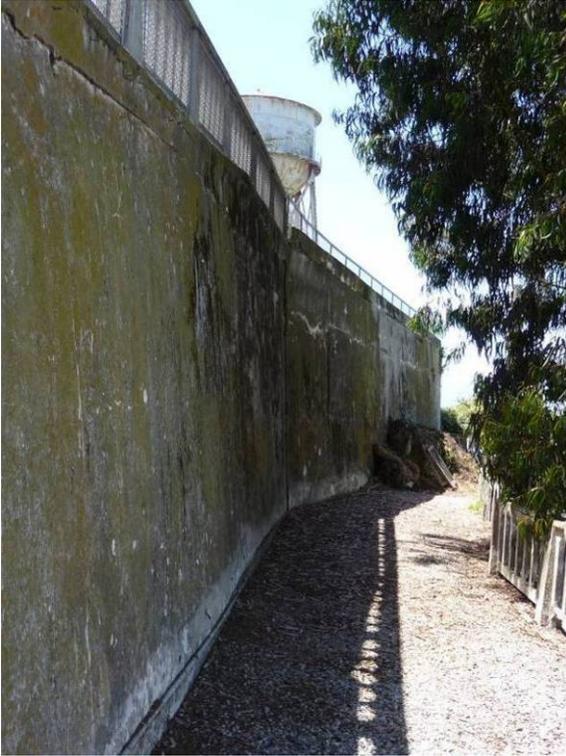
Figure 3 - 143. Wall -10 with replica decorative concrete railing (SR27) and MBSR22, west side of Road to Hospital (MBD P1000750.JPG)

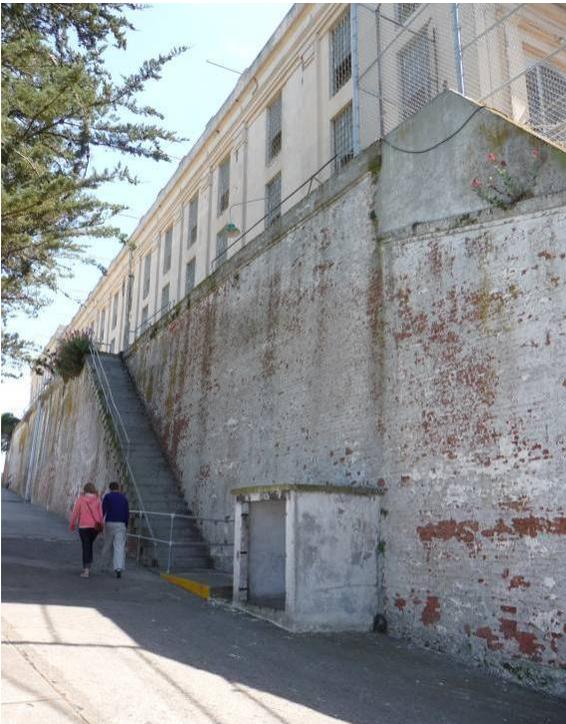
Figure 3 - 144. Citadel Wall (on right) with Main Prison wall and staircase on left (MBD P1000403.JPG)

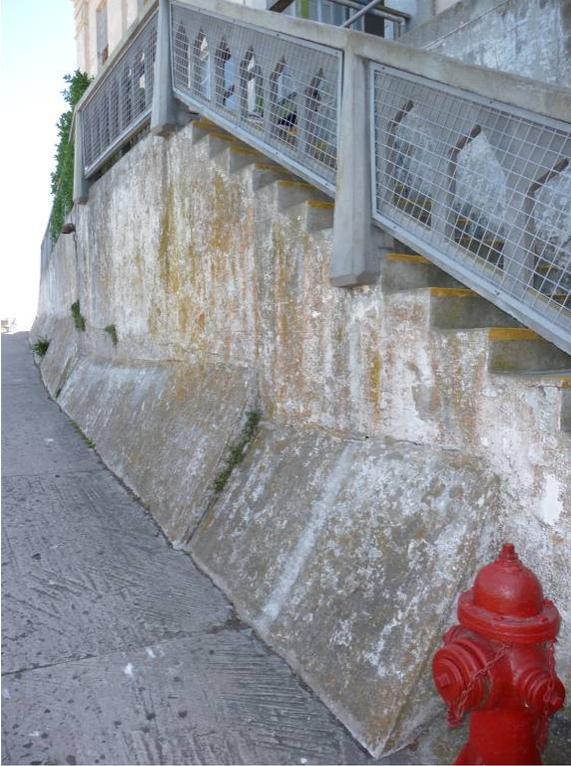
Figure 3 - 145. Main Prison south Retaining Wall with staircase to Warden's Office in Main Prison (MBD P1000428.JPG)

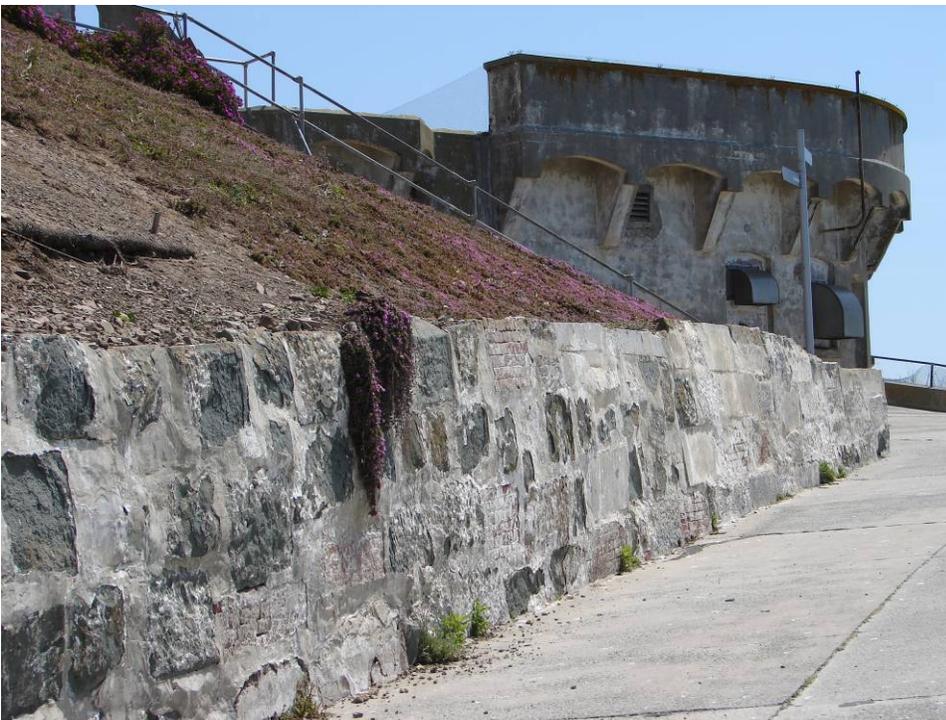
<i>Feature (Type)</i>	<i>Bldg #</i>	<i>Figure #</i>	<i>Description</i>	<i>Condition</i>
Main Road Walls: Upper West Road				
Brick masonry Wall with Stone Façade		3-146	Along the east side of the Upper West Road near Lighthouse	Fair
Main Road Walls: Lower West Road				
Brick Retaining Wall		3-147	Brick Retaining Wall with Warning Sign on west side of Road to Parade Ground	Fair
Stone Retaining Wall		3-147	Stone Retaining Wall supporting Lower West Road	Fair
West Lawn				
Concrete Retaining Wall	68	3-148	Concrete Retaining Wall on West side of Main Prison	Fair
West Lawn Retaining Wall	68	3-149	Concrete Retaining Wall near Fortification Bombproof Tunnel “k”	Fair
Cisterns (2010)	68	3-149	Cistern System (c2010) South of Fortification Bombproof	Fair
Firebox #1		3-150	Concrete shed adjacent to Citadel Wall and Steps	Fair

Figure 3 - 146. Brick Masonry Wall with Stone Façade near Lighthouse (MBD DSC03077.JPG)

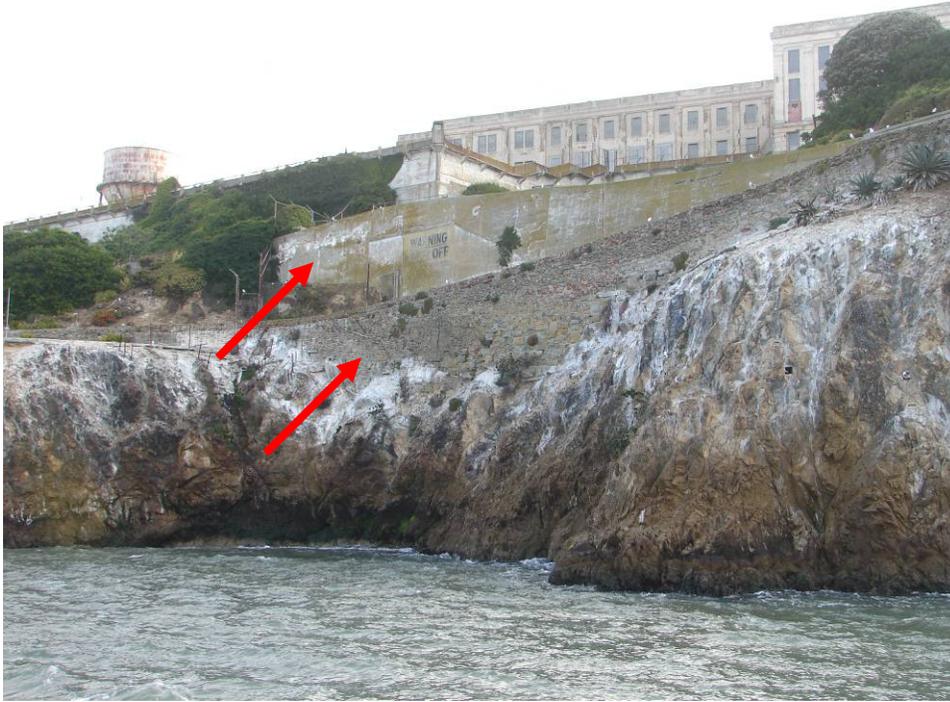
Figure 3 - 147. Brick Retaining Wall, above and Stone Wall below along Lower West Road (MBD DSC02948.JPG)

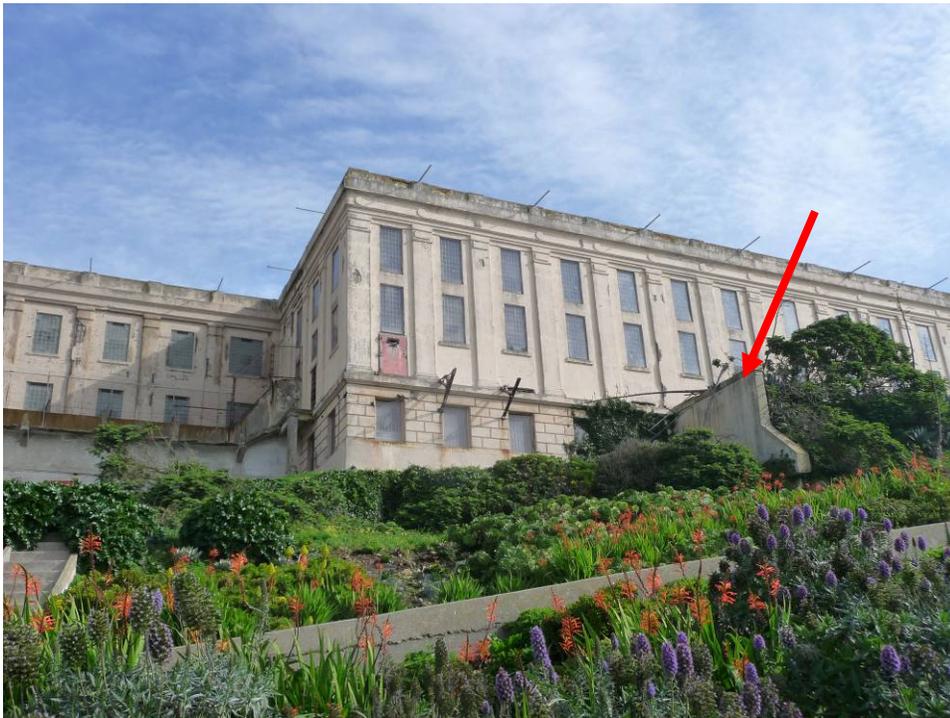
Figure 3 - 148. Concrete Retaining Wall perpendicular to Main Prison on West Side (MBD P1040049.JPG)

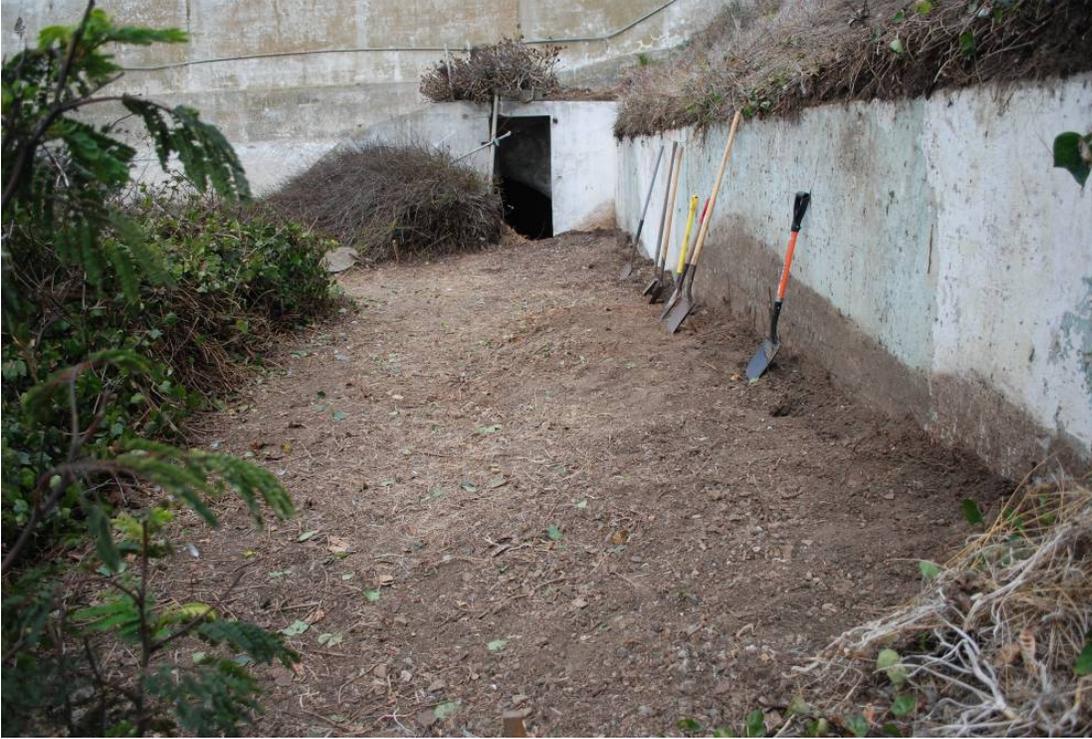
Figure 3 - 149. West Lawn Retaining Wall South of Fortification Bombproof “K.” 2010 Cistern System placed here. (Courtesy of Shelagh Fritz: Cistern Site. JPG)

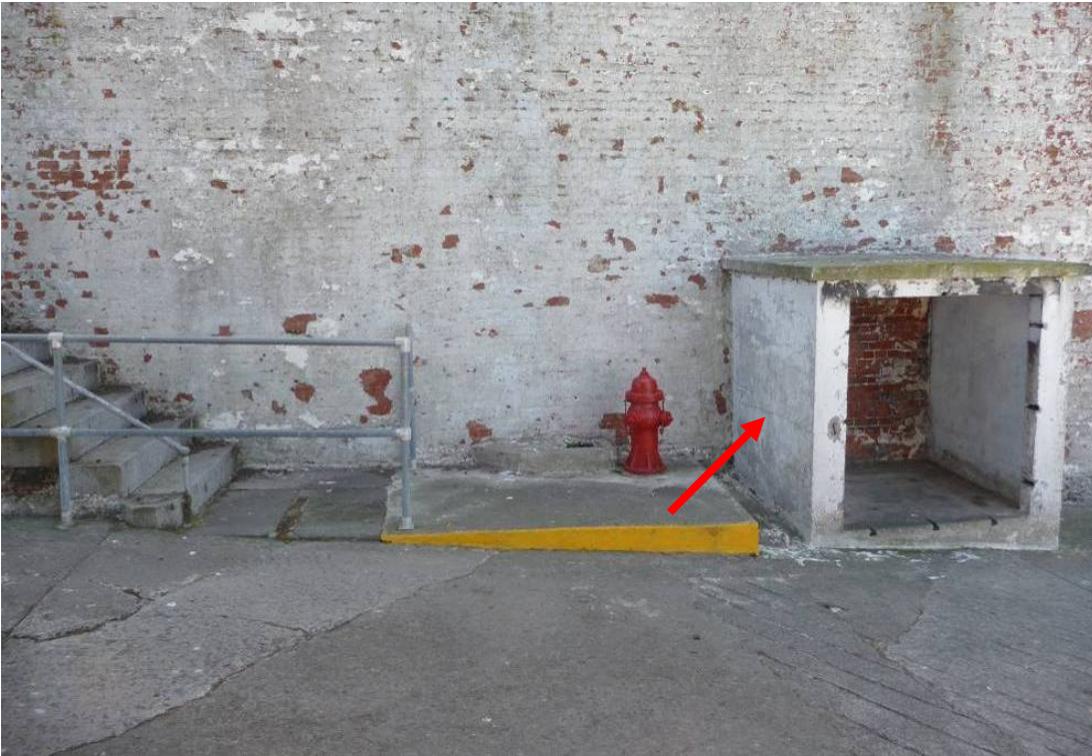
Figure 3 - 150. Firebox #1, at base of Staircase to Citadel (MBD P1000406.JPG)
