Vegetation - Parade Ground

TITLE OF PROJECT
CULTURAL LANDSCAPE REPORT
EXISTING CONDITIONS
TITLE OF DRAWING
PARADE GROUND & SOUTH SHORELINE
NAME OF PARK
ALCATRAZ ISLAND NATIONAL HISTORIC LANDMARK
REGION COUNTY STATE
PACIFIC SAN FRANCISCO CALIFORNIA

TITLE OF PROJECT
CULTURAL LANDSCAPE REPORT
TITLE OF DRAWING
PARADE GROUND & SOUTH SHORELINE
ARCHEOLOGICAL FEATURES
NAME OF PARK
ALCATRAZ ISLAND NATIONAL HISTORIC LANDMARK
REGION COUNTY STATE
PACIFIC SAN FRANCISCO CALIFORNIA

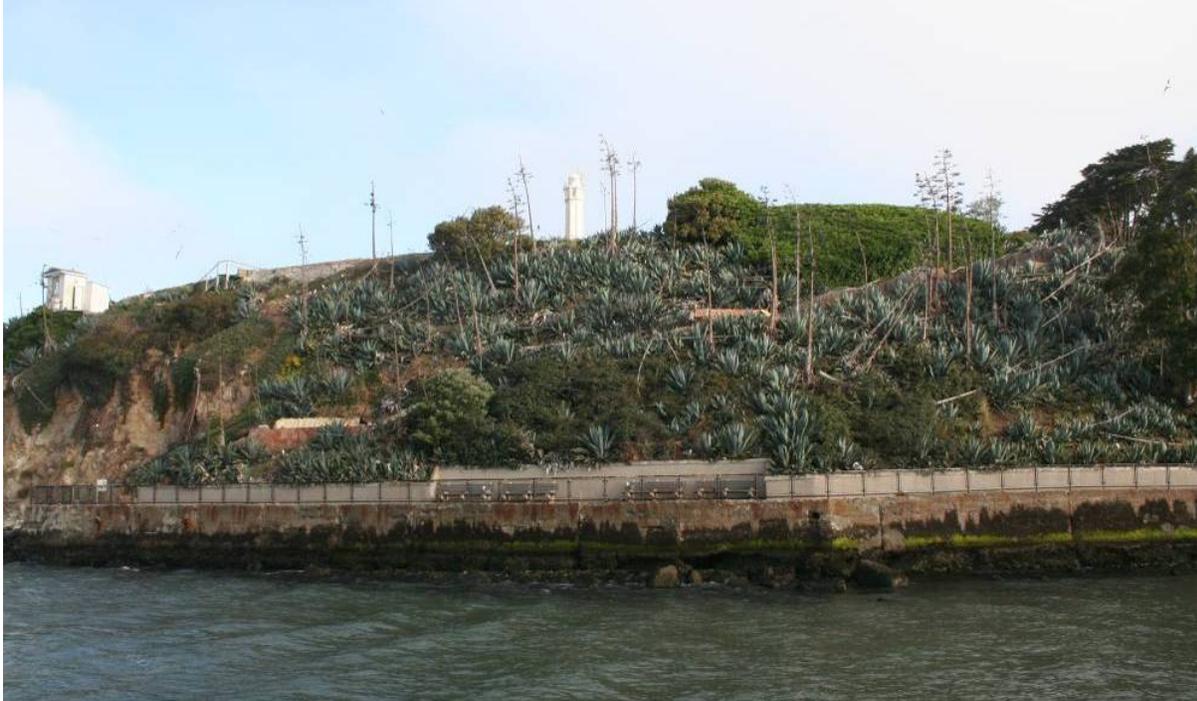
Figure 3 - 354. Agave Walk plantings (MBD IMG_2708.JPG)

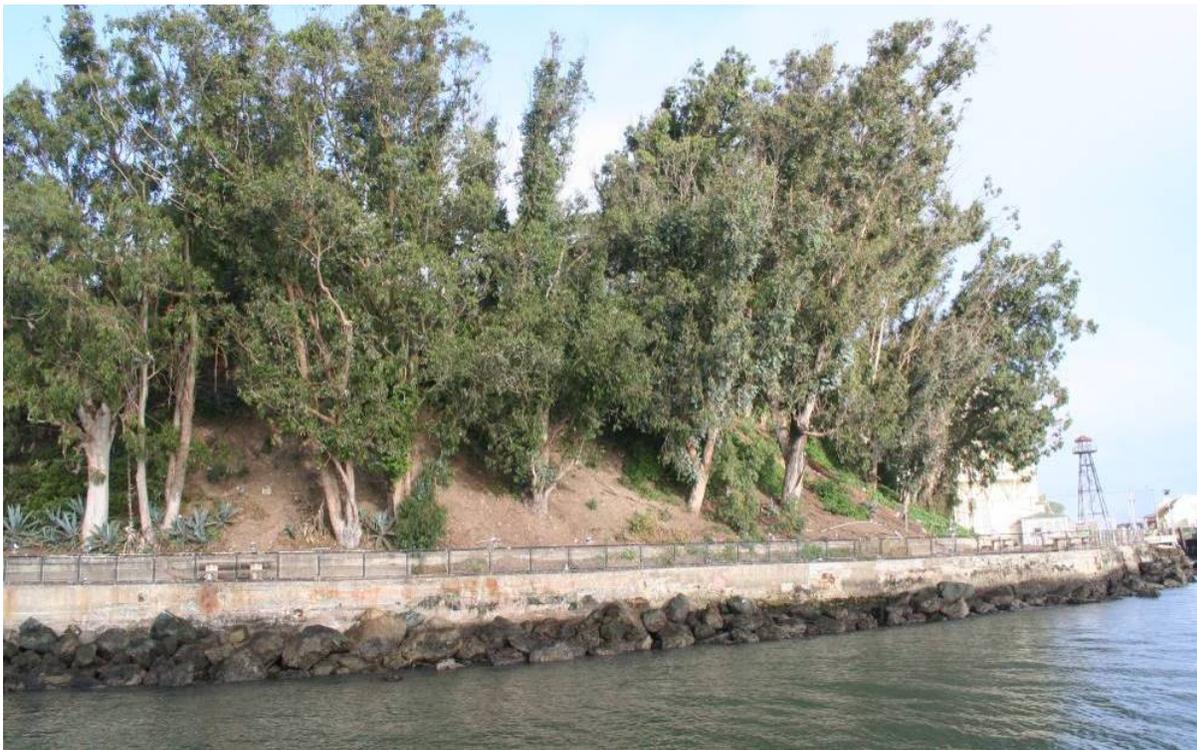
Figure 3 - 355. Eucalyptus Grove (MBD IMG_2702.JPG)

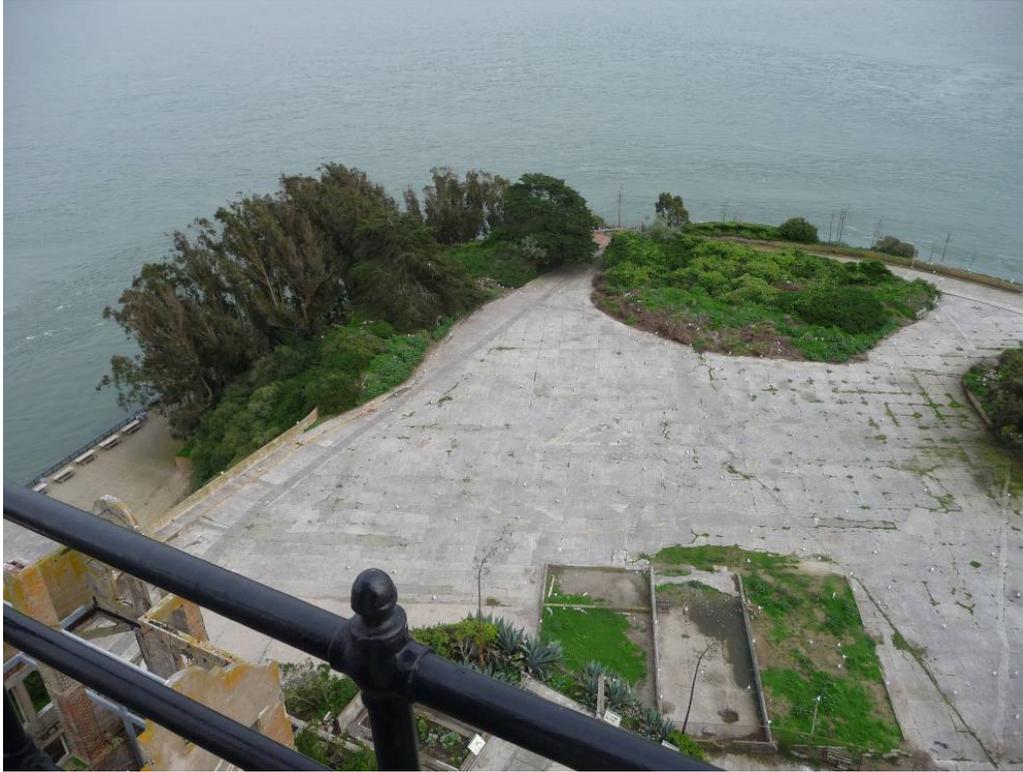
Yard at Officers' Quarters – Duplex (Building 83)	84	3-356	Remnant Pittosporum. Other species include: <i>Senecio mikanooides</i> , <i>Coprosma repens</i> , and <i>Hedera helix</i>	Poor
Vegetation at Seawall Planter		3-357	Existing vegetation includes: <i>Hedera helix</i> , <i>Rubus sp.</i> , <i>Acanthus mollis</i> and <i>Coprosma repens</i> . Seawall planter includes the planting bed at its base that runs the length of the planter.	Poor

Figure 3 - 356. Extant vegetation at Officers' Quarters (72-75 at top left) and Officers' Quarters - Duplex (Building 83 at top left) (MBD DSC01780.JPG)

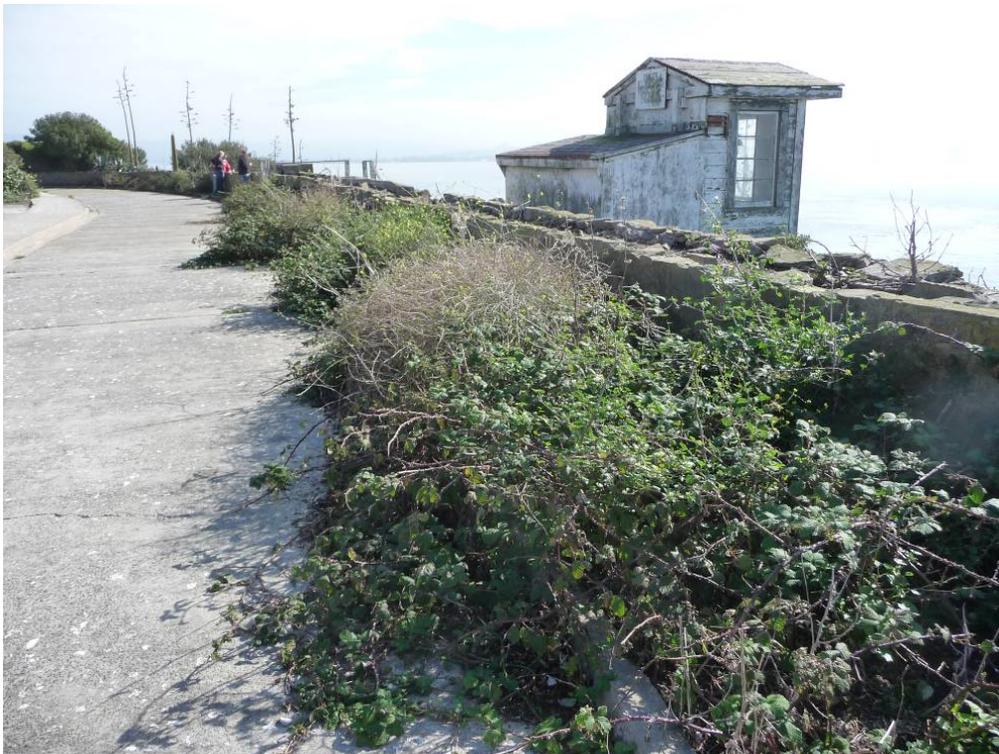
Figure 3 - 357. Vegetation at Seawall Planter (MBD P1020773.JPG)

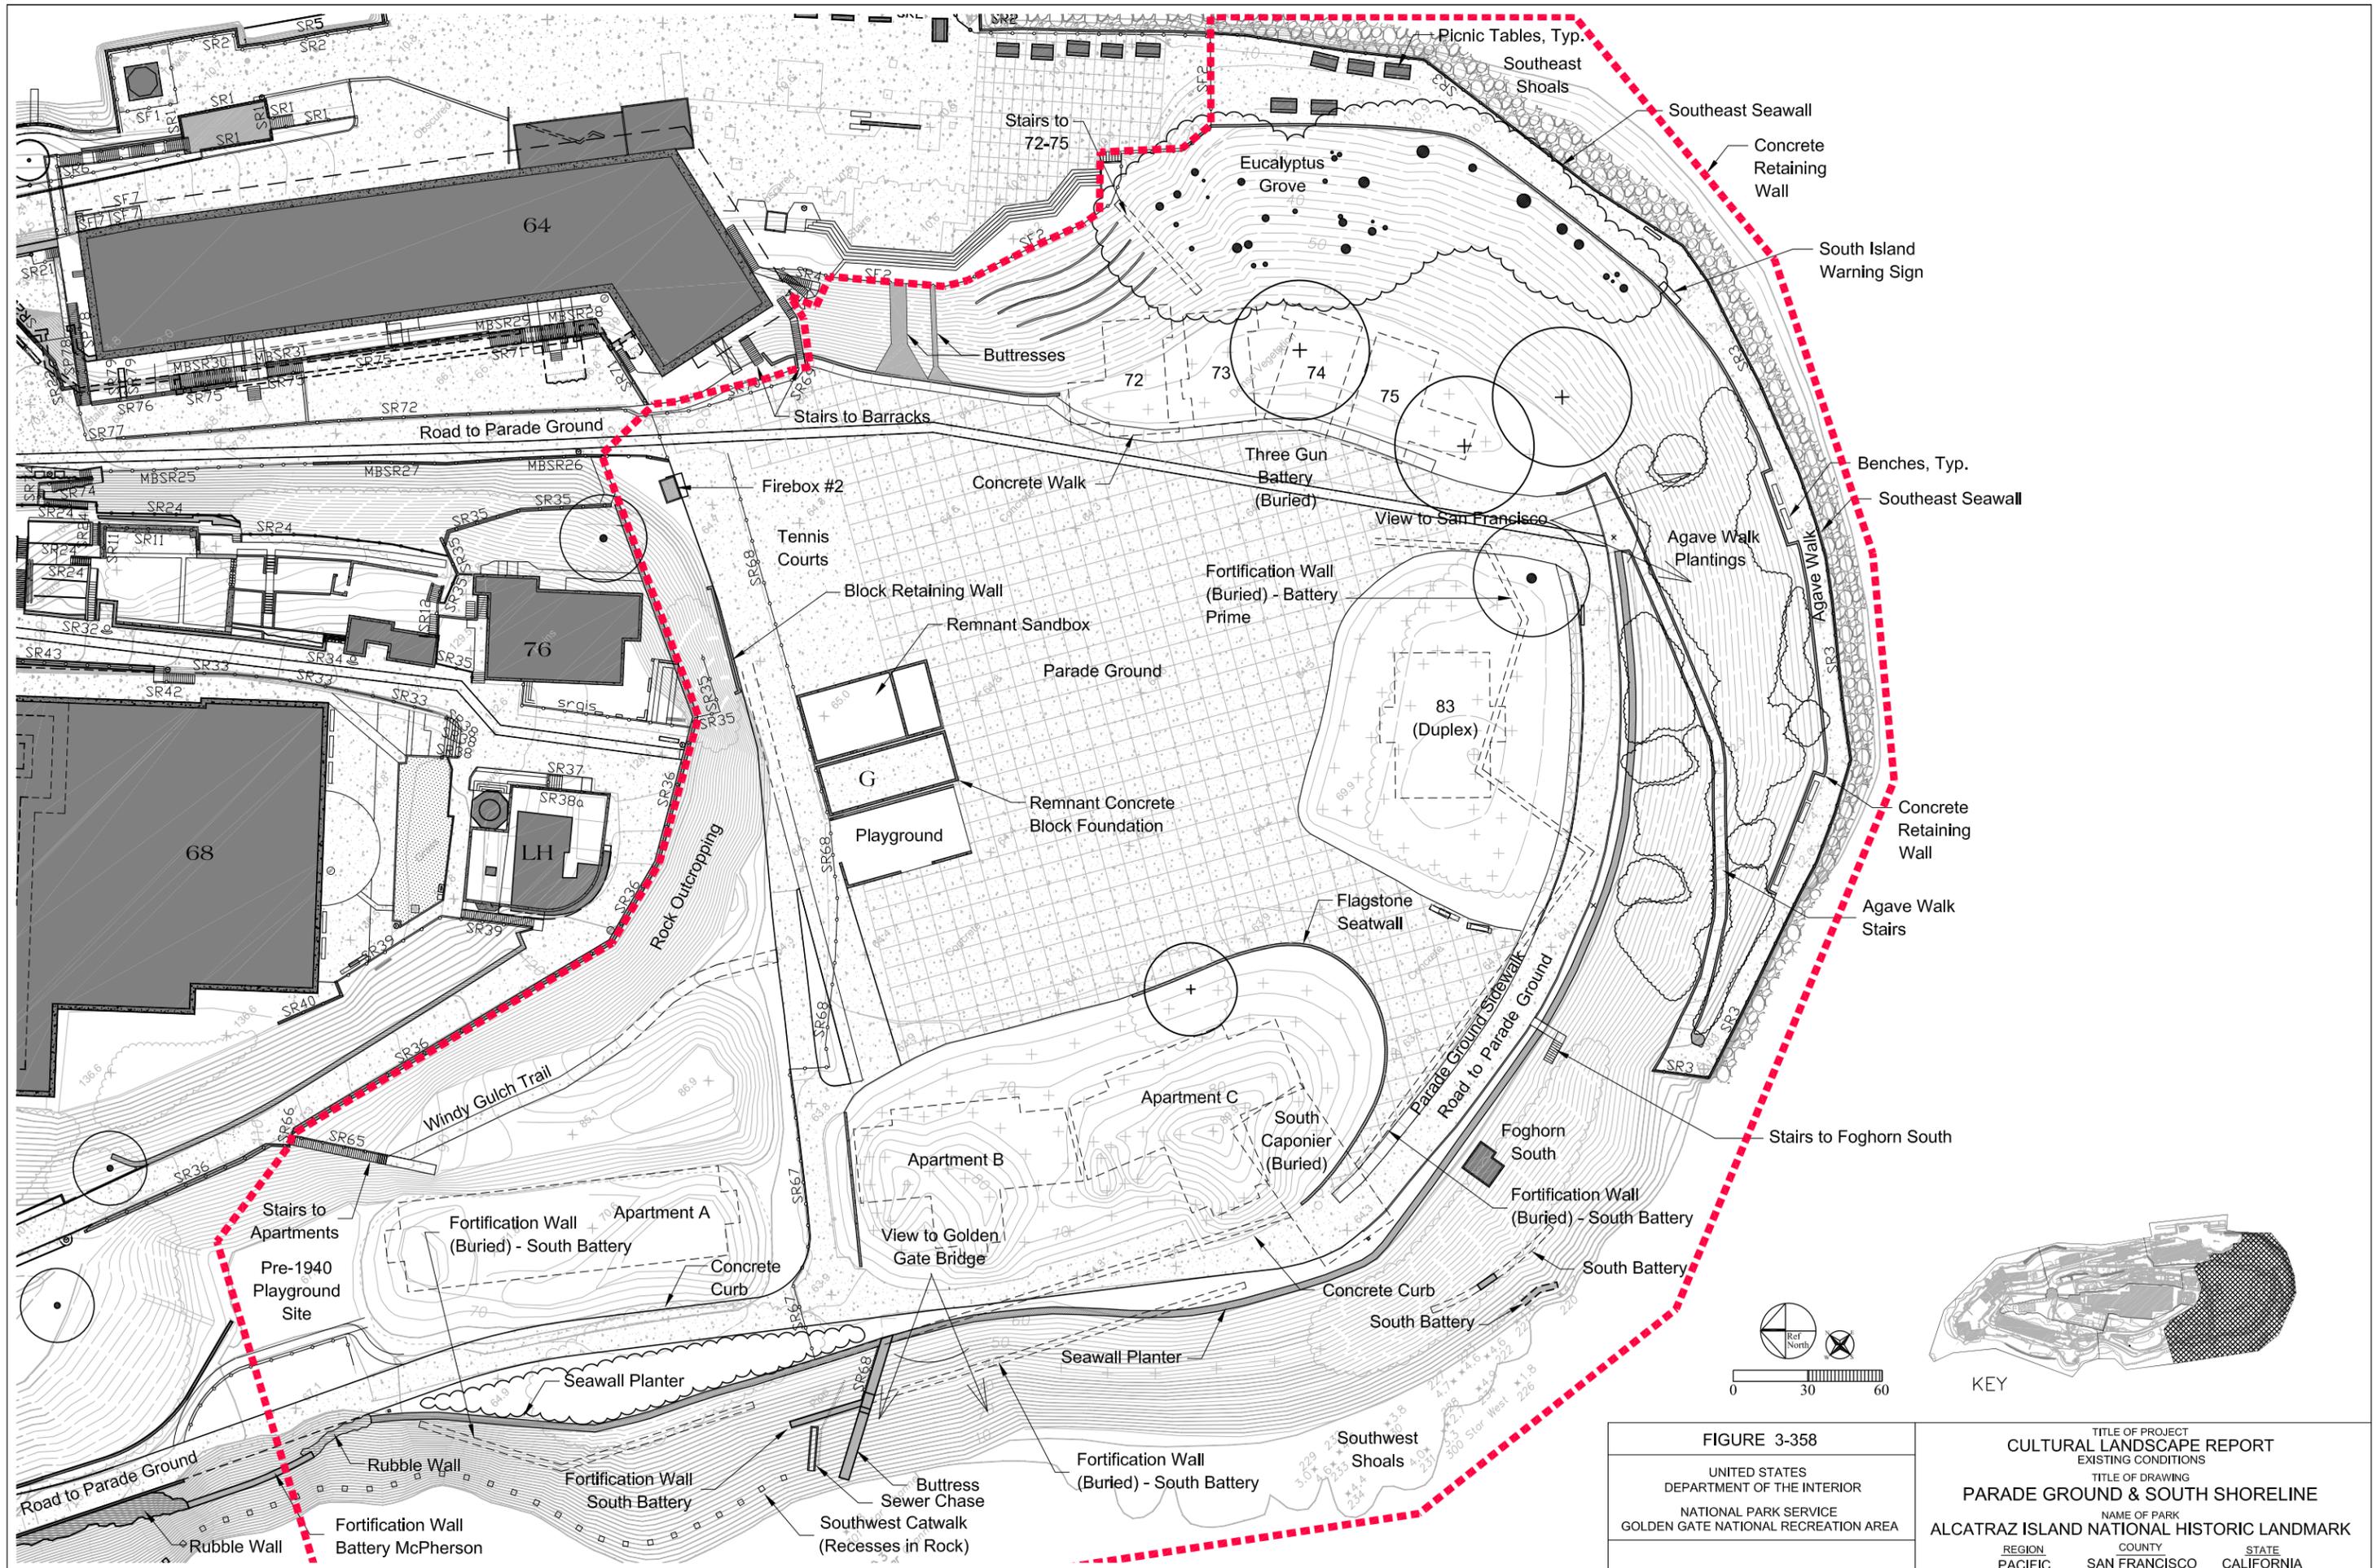
FIGURE 3-358

Vegetation consists mainly of plantings of Eucalyptus trees, Monterey cypress, *Agave americana*, and iceplant along the steep slope on the south side of the Island. Remnant vegetation remains in the areas surrounding the remnant residential buildings: Officers' Quarters 72-75, Officers' Quarters – Duplex, and Apartments A, B and C.

<i>Feature (Type)</i>	<i>Bldg #</i>	<i>Figure #</i>	<i>Description</i>	<i>Condition</i>
Agave Walk plantings		3-354	Plantings consist of <i>Agave Americana</i> . Other species include: one Eucalyptus tree, <i>Coprosma repens</i> , and <i>Oxalis pes-carprae</i>	Good
Eucalyptus Grove		3-355	Grove of Eucalyptus trees east of Parade Ground (approximately 35 trees of varying sizes. Invasive species - some planted, many not. Undergrowth species include: <i>Hedera helix</i> , <i>Senecio mikanooides</i> , and <i>Oxalis pes-carprae</i>	Poor Refer to Appendix 3: McBride 2007 report
Gardens with Officers' Quarters 72-75	72,73,74, 75, A	3-356	Garden terraces on hillside east of these remnants. Remnant Garden Terraces on slope behind Officers' Quarters 72-75. Surviving roses extant. <i>Coprosma repens</i> , <i>Hedera helix</i> , and <i>Senecio mikanooides</i> growing on foundations, rubble, and terraces. Monterey Cypress at south end of 74, 75	Terrace: Poor Roses: Fair

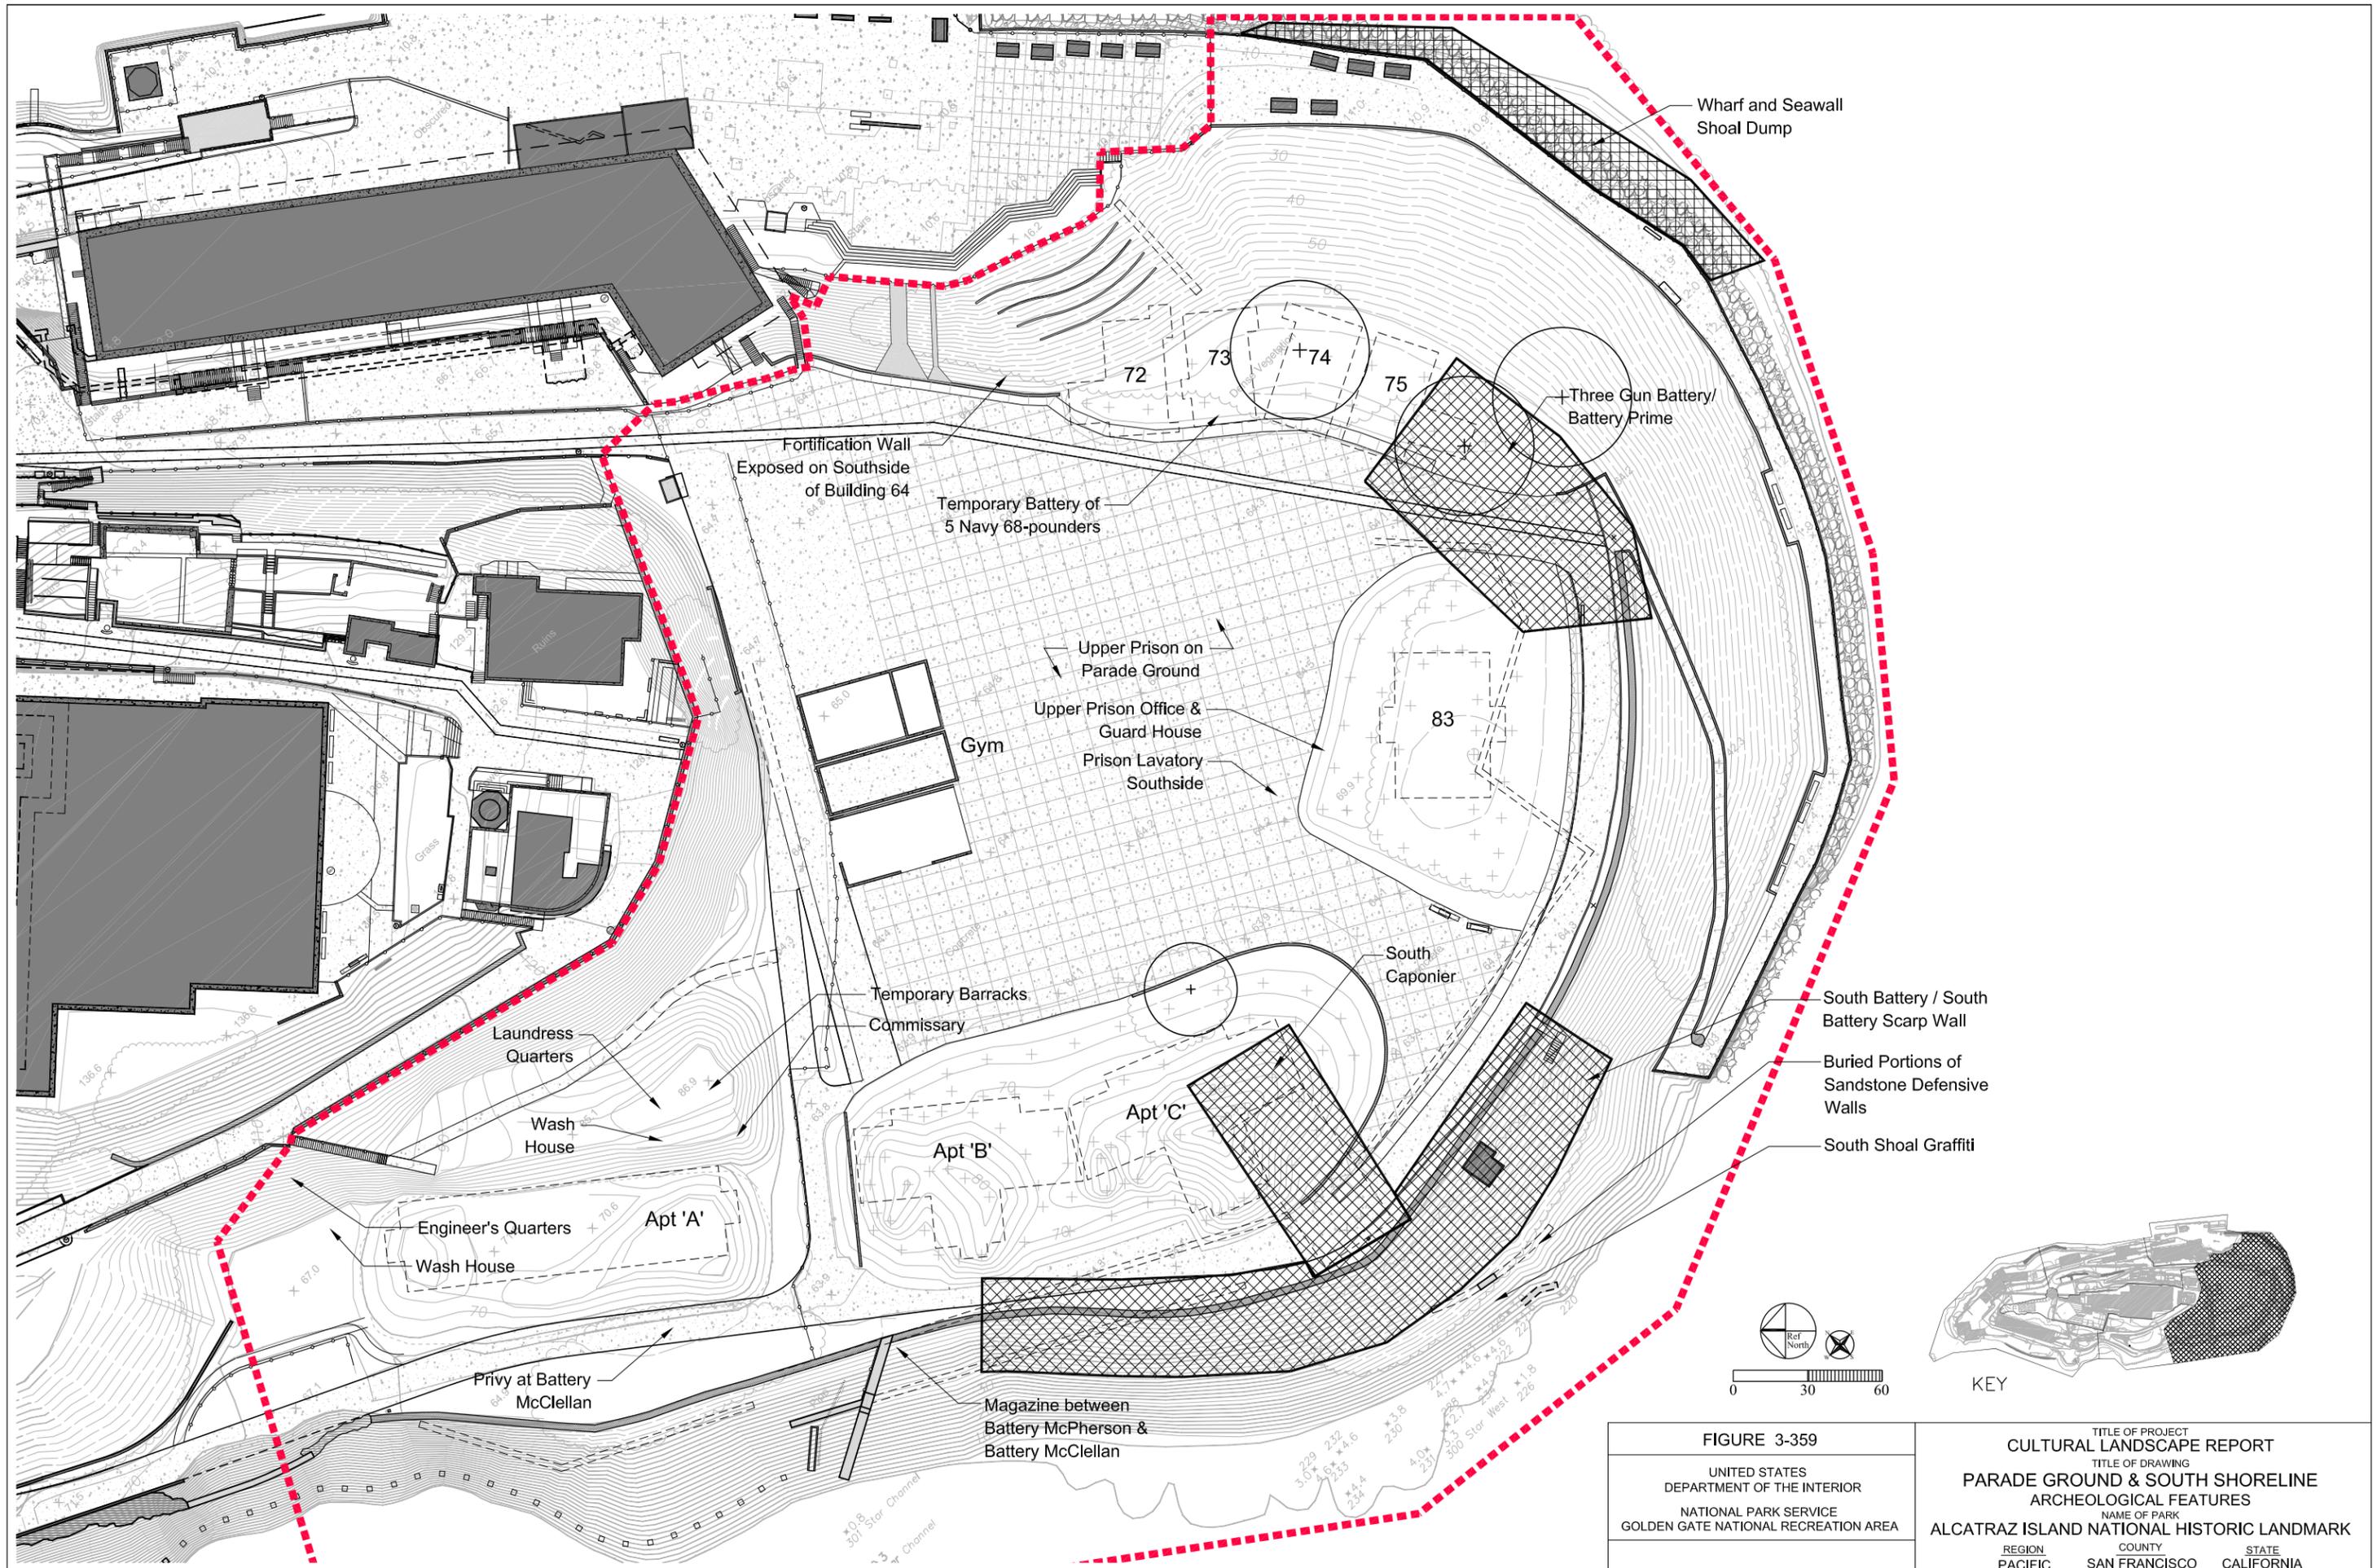
FIGURE 3-359

Archeological features include remnants of fortifications, and the sites of removed buildings. The archeological features of the Parade Ground include several batteries from the Initial Military Fortification and potential remnant prison buildings that existed on the site from the Initial Military Fortification and Early Military Prison periods.

<i>Feature</i>	<i>ASMIS #</i>	<i>Barker Inv #</i>	<i>Description</i>	<i>Condition</i>
South Caponier	GOGA 00069	57	<ul style="list-style-type: none"> • Not visible, below grade • Built of sandstone - The site condition is based on a compilation of historic documents that demonstrate the slow burial of the South Caponier and associated batteries from construction in the 1850s to completion of the Parade Ground that eventual covered the last vestiges of the South Caponier. John Martini, Jane Lehman, Jason Hagin, and Leo Barker conducted fieldwork in January 2007 to relocate the approximate location of the South Caponier. GIS work involved was also the first to use rectified historic photographs from 1867, 1894, 1909, and an orthophoto from 2000 to relocate the feature location. Next: a testing program! (Thompson 1979; Chappell 1993; Barker) 	Good 011507 (Barker, 2009)
Three Gun Battery/ Battery Prime (Battery XIII)	GOGA 00248	52	Recommended for archeological research by Thompson in 1977 (1867 map; 1875 Map; Thompson 1979, Barker 2009:52); includes sandstone exposed on hillside	Undetermined

Buried portions of sandstone defensive walls in front of South Battery and Three Gun Battery	GOGA 00066	43	(Martini 2009) Not visible, below grade. Potentially in excellent condition.	Undetermined
South Battery Scarp Wall - southeast side	GOGA 00237	40	(Thompson 1979:30, Barker 2009) (Leo #40) Not visible, below grade. Potentially in excellent condition	Undetermined
