Structures - Wharf

Table 10: Structures - Wharf - Figure 3-94

Existing Conditions Assessment - Main Road

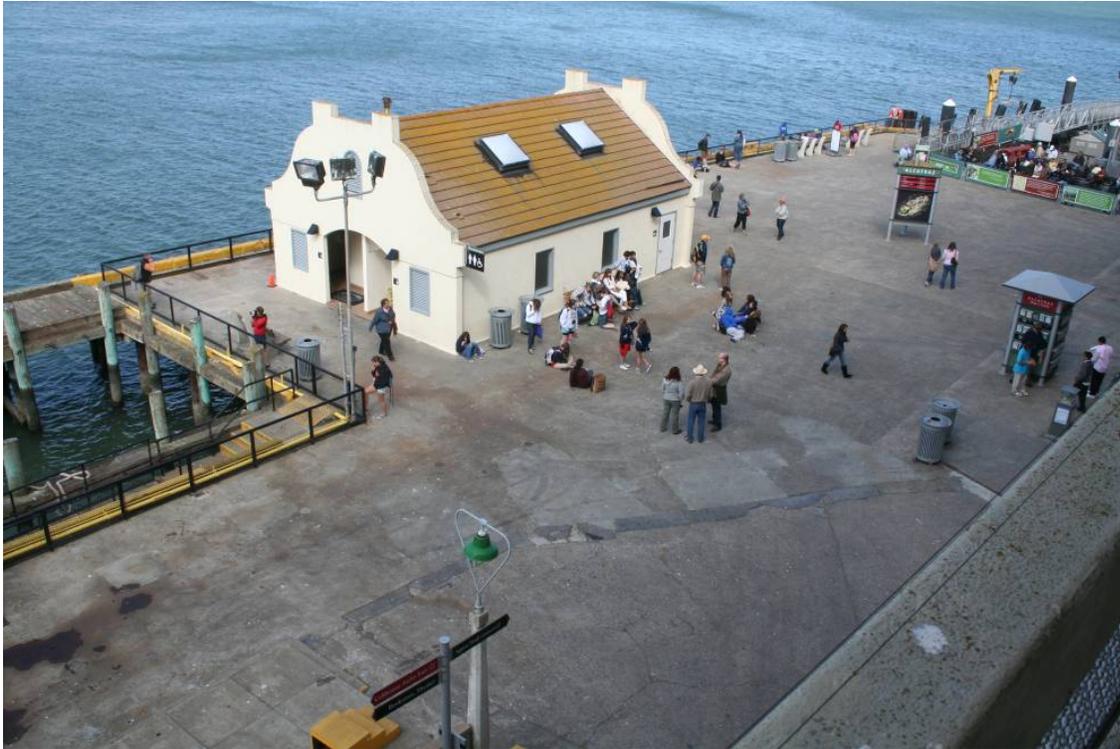
| <i>Feature (Type)</i> | <i>Bldg #</i> | <i>Figure #</i> | <i>Description</i> | <i>Condition</i> |
|--|---|---|--|--|
| Wharf | 33 | 3-83 | Constructed area east of Bombproof Barracks. Paved with concrete and bordered by metal railing SR2 | Fair |

Figure 3 - 83. Wharf and Restroom, viewed from deck of Building 64 balcony. Note top of stone seawall in pavement, middle of photo. (MBD IMG_2945.JPG)

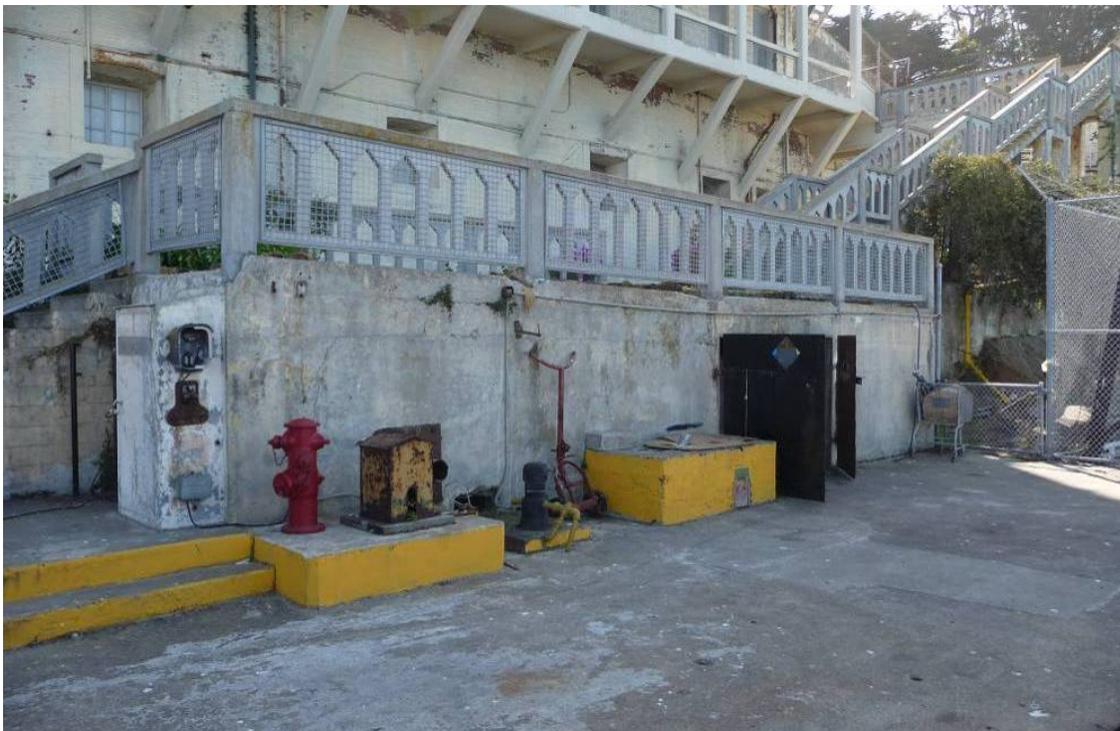
| <i>Feature (Type)</i> | <i>Bldg #</i> | <i>Figure #</i> | <i>Description</i> | <i>Condition</i> |
|--|---|---|--|--|
| Storage Vault with SR1 | | 3-84 | Concrete storage area at base of the stairs accessing the wharf from the second level of Barracks at the northeast side. Replica decorative concrete safety rail (SR1) lines the top outer edge of the vault | Vault: Fair SR1 Good Non-Historic |

Figure 3 - 84. Storage Vault on Wharf with plaza above with decorative concrete railings (SR1) (MBD P1000903.JPG)

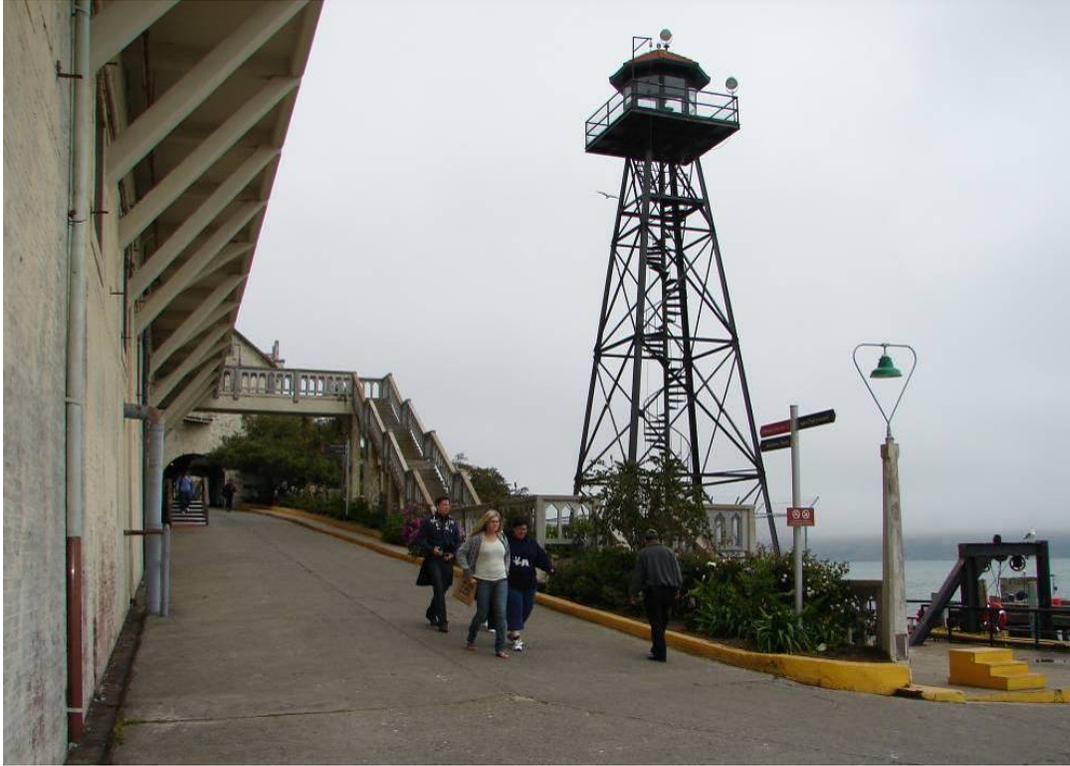
| <i>Feature (Type)</i> | <i>Bldg #</i> | <i>Figure #</i> | <i>Description</i> | <i>Condition</i> |
|--|---|---|--|--|
| Dock Tower (Partial Reconstruction) | | 3-85 | Metal tower with spiral staircase located east of the storage vault. Main legs, cross bracing, and part of shack are original | Good |

Figure 3 - 85. Dock Tower on Wharf; start of Main Road next to Building 64 (MBD DSC02454.JPG)

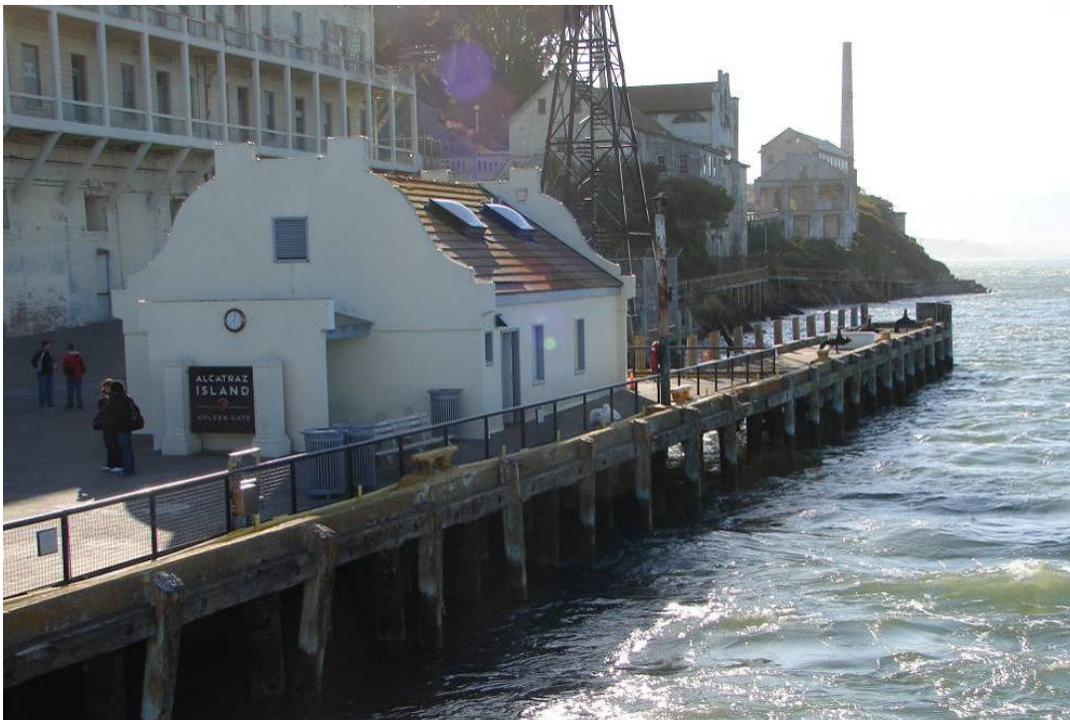
| <i>Feature (Type)</i> | <i>Bldg #</i> | <i>Figure #</i> | <i>Description</i> | <i>Condition</i> |
|--|---|---|--|--|
| Finger Pier (Reconstruction) | | 3-86 | Wooden pier defining docking space north of the Wharf Restroom | Good |

Figure 3 - 86. Finger Pier extends northward from Wharf near Restroom (MBD DSC02653.JPG)

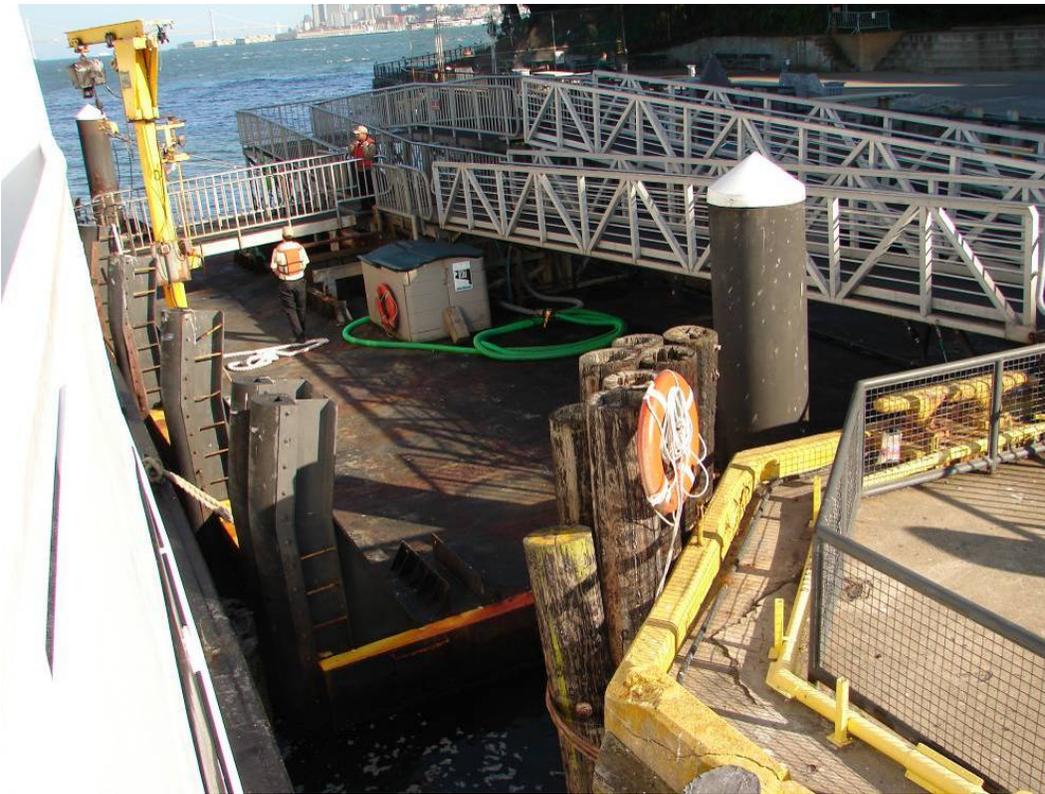
| <i>Feature (Type)</i> | <i>Bldg #</i> | <i>Figure #</i> | <i>Description</i> | <i>Condition</i> |
|--|---|---|--|--|
| Floating Pier | | 3-87 | Main pier for Ferry docks. Metal supports and pedestrian ramp access with metal safety rails | Good |

Figure 3 - 87. Modern Floating Pier serves ferries (MBD DSC02655.JPG)

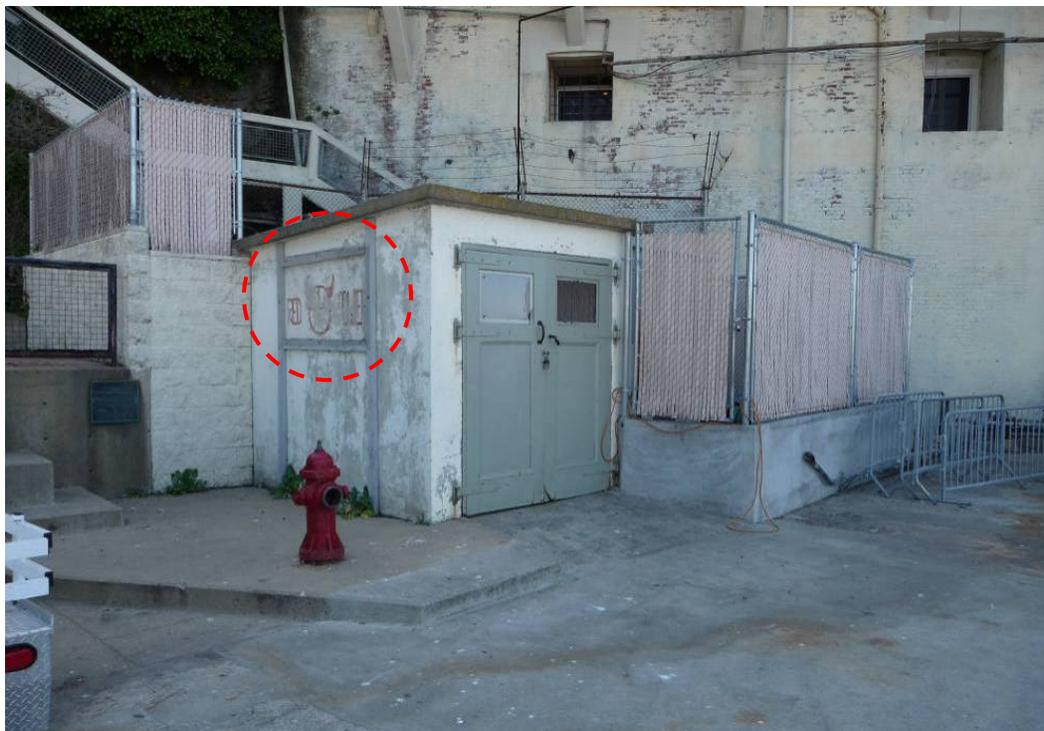
| <i>Feature (Type)</i> | <i>Bldg #</i> | <i>Figure #</i> | <i>Description</i> | <i>Condition</i> |
|--|---|---|--|--|
| Firebox #3 and Equipment Storage | | 3-88 | Concrete shed south of Maintenance Garage/Gift Shop with remnant symbols from the Indian Occupation on its south wall | Good |

Figure 3 - 88. Firebox #3 and Equipment Storage, south of Building 64 with remnant symbols from the Indian Occupation (MBD P1000866.JPG)

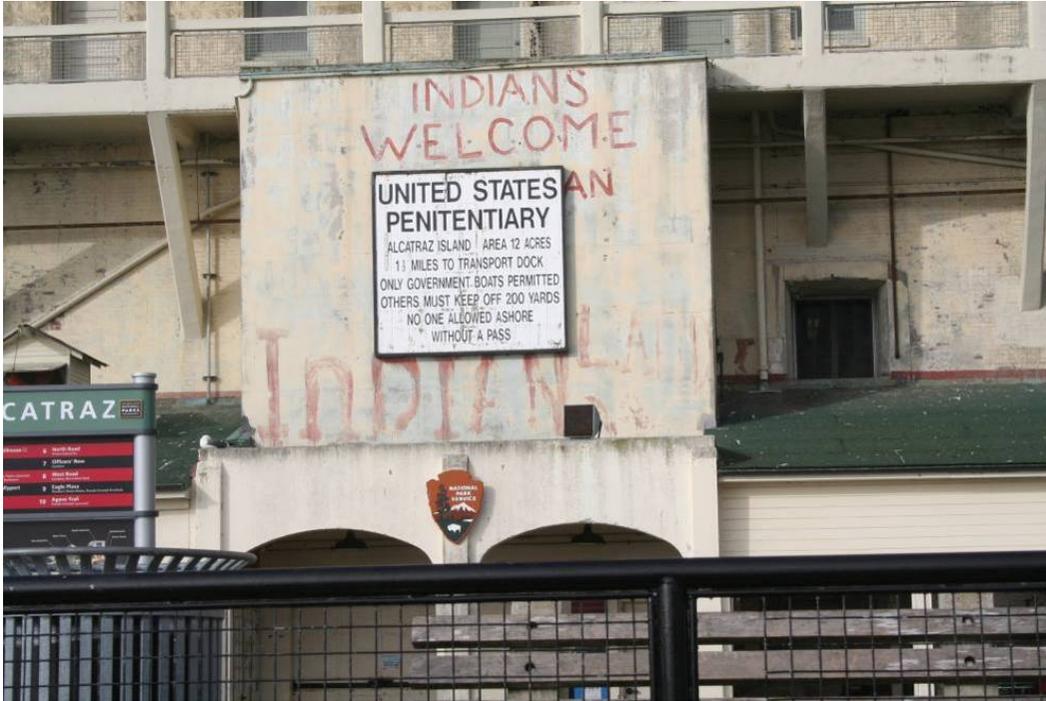
| <i>Feature (Type)</i> | <i>Bldg #</i> | <i>Figure #</i> | <i>Description</i> | <i>Condition</i> |
|--|---|---|--|---|
| ‘Warning’ Sign at Wharf | | 3-89 | Replica painted by movie company (Martini), dated hanging on east side of Building 64 between Ranger Office and Gift Shop | Fair, |
| “Indians Welcome” message at Wharf | 64 | 3-89 | Remnant symbols from Indian Occupation | Fair |

Figure 3 - 89. Replica 'Warning' Sign on Barracks at Wharf with "Indians Welcome" message behind. (MBD IMG_2818.JPG)

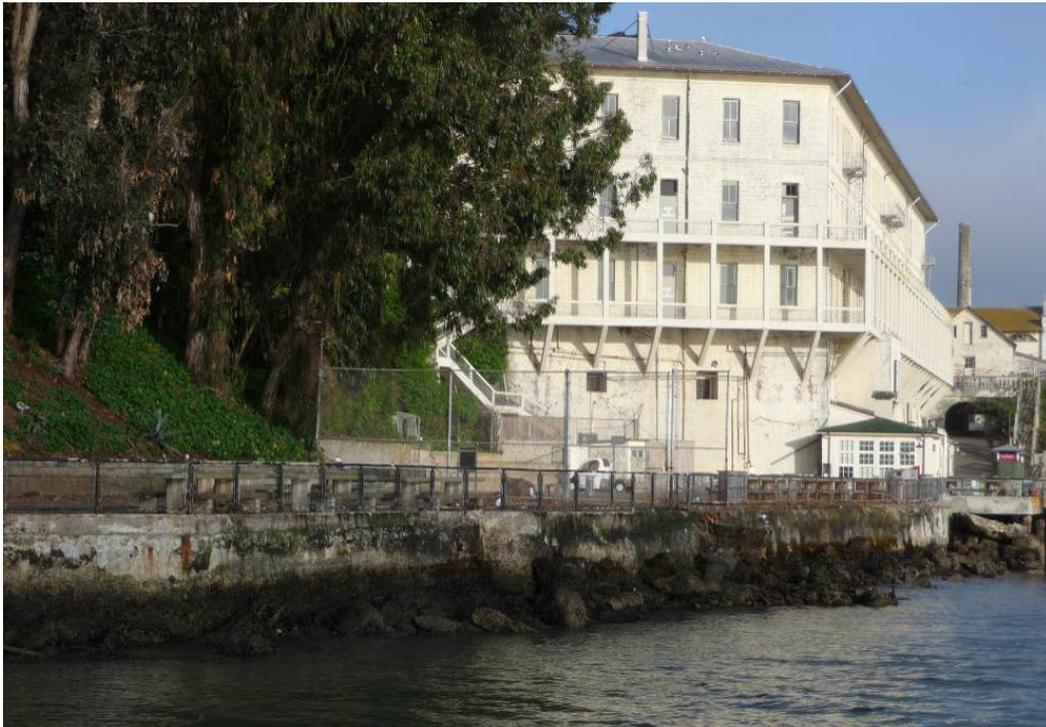
| <i>Feature (Type)</i> | <i>Bldg #</i> | <i>Figure #</i> | <i>Description</i> | <i>Condition</i> |
|--|---|---|--|---|
| Stone Seawall with SR2 | | 3-90 | Steel Railings, six inch Concrete Curb | Fair, Non-historic |

Figure 3 - 90. Masonry seawall with steel railing SR2 (MBD P1000939.JPG)

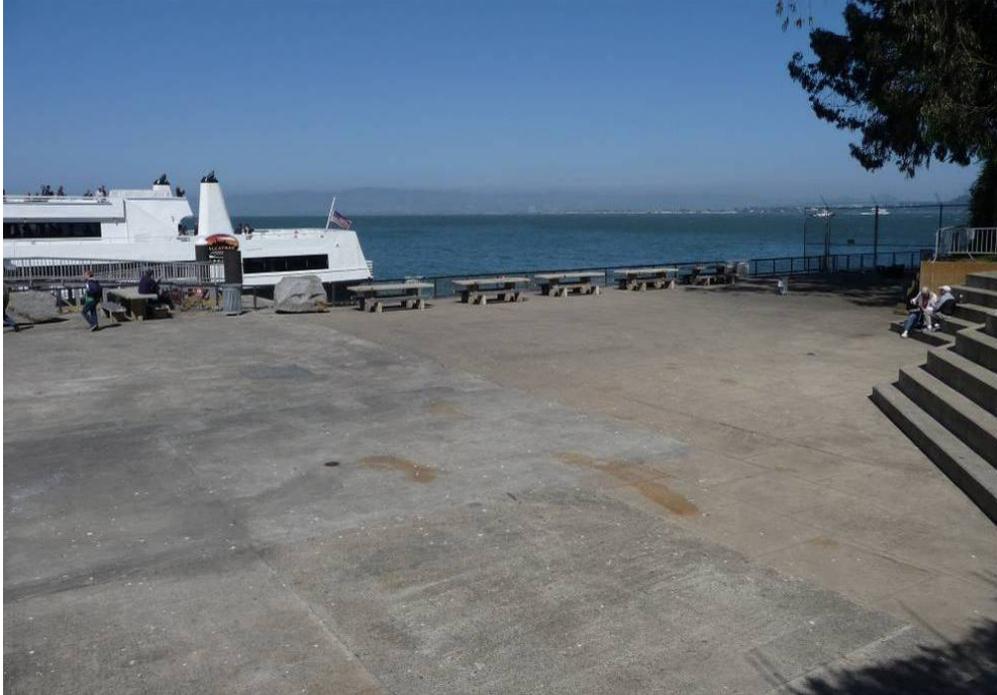
| <i>Feature (Type)</i> | <i>Bldg #</i> | <i>Figure #</i> | <i>Description</i> | <i>Condition</i> |
|--|---|---|--|---|
| Wharf Pavement Markings | | 3-91 | Yellow paint on concrete, lines possibly used for prisoner line up for orders (unsubstantiated); could also be markings for parking spaces (unsubstantiated) | Poor |

Figure 3 - 91. Wharf pavement markings, with paving from the historic periods on the left and c1980s paving and terraced steps of the amphitheater on the right (MBD P1000861.JPG)

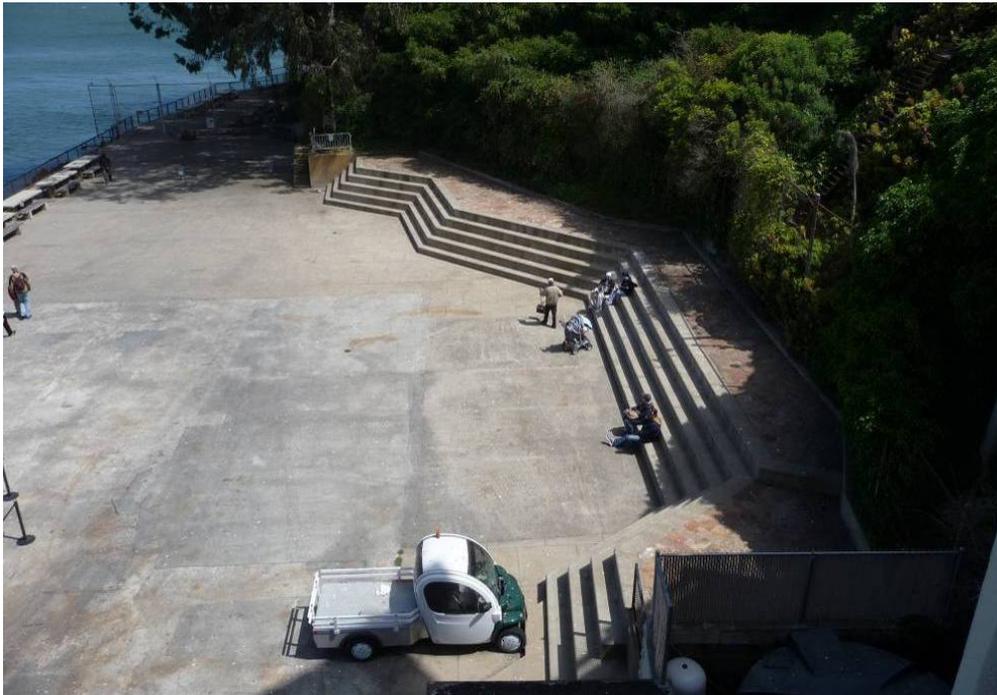
| <i>Feature (Type)</i> | <i>Bldg #</i> | <i>Figure #</i> | <i>Description</i> | <i>Condition</i> |
|--|---|---|--|---|
| Amphitheater (1980s) | | 3-92 | Concrete steps with five levels framing Wharf just south of Barracks with flagstone paving on top level. Constructed circa 1980s. | Good |

Figure 3 - 92. Wharf paving and amphitheater steps as viewed from balcony of Building 64 (MBD P1010155.JPG)

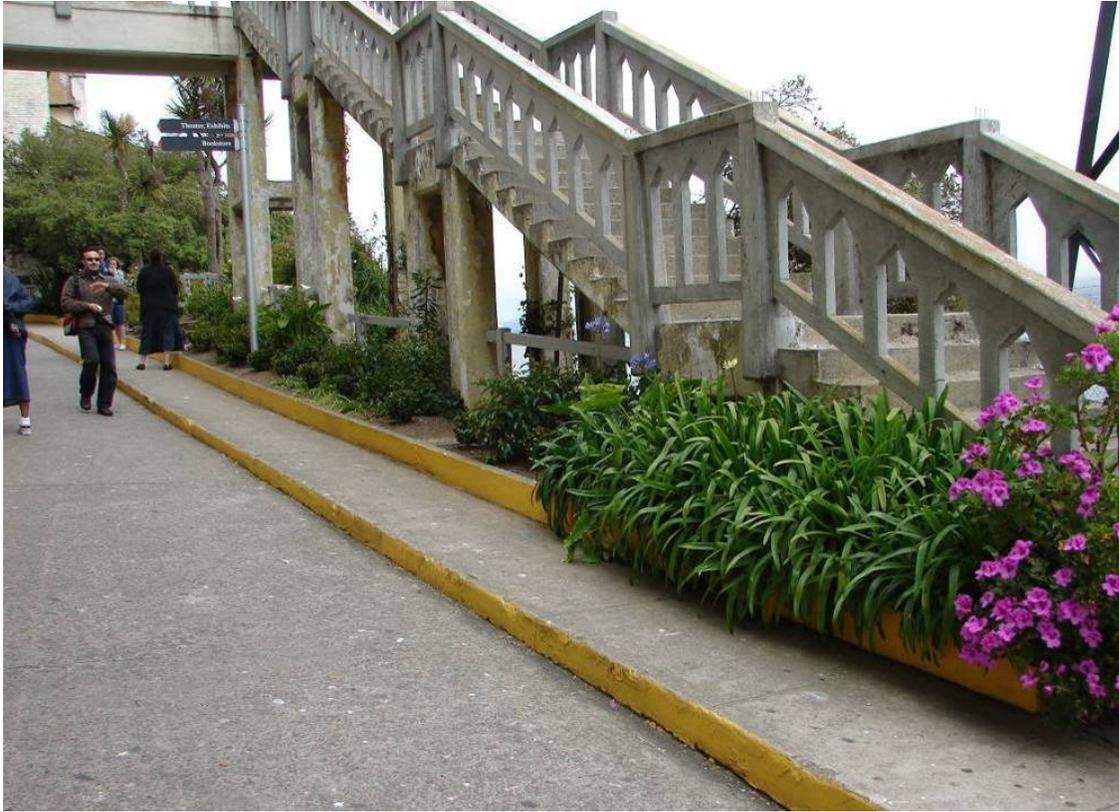
| <i>Feature (Type)</i> | <i>Bldg #</i> | <i>Figure #</i> | <i>Description</i> | <i>Condition</i> |
|--|---|---|--|---|
| Staircase from Storage Vault to Building 64 | | 3-93 | Concrete staircase with concrete cutout railings; ascending to balcony that crosses the main road and onto first floor of Building 64 | Good |

Figure 3 - 93. Staircase from Storage Vault to Building 64, with south end of Sallyport Garden below (description of Garden included in Main Road Character Area) (MBD DSC02483.JPG)

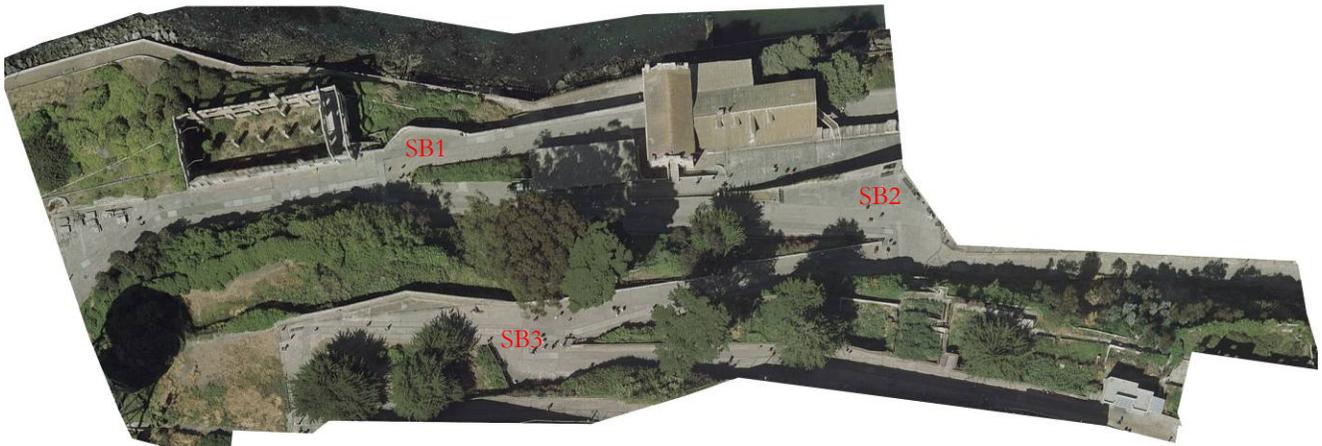
| <i>Feature (Type)</i> | <i>Bldg #</i> | <i>Figure #</i> | <i>Description</i> | <i>Condition</i> |
|--|---|---|---|---|
| Main Road with its three switchbacks (1853) | | 3-96 | Ramp, slopes and walls cut and graded for construction of road to access Summit from Wharf | Good |

Figure 3 - 96. Main Road - East with three switchbacks (MBD Main Road.JPG)

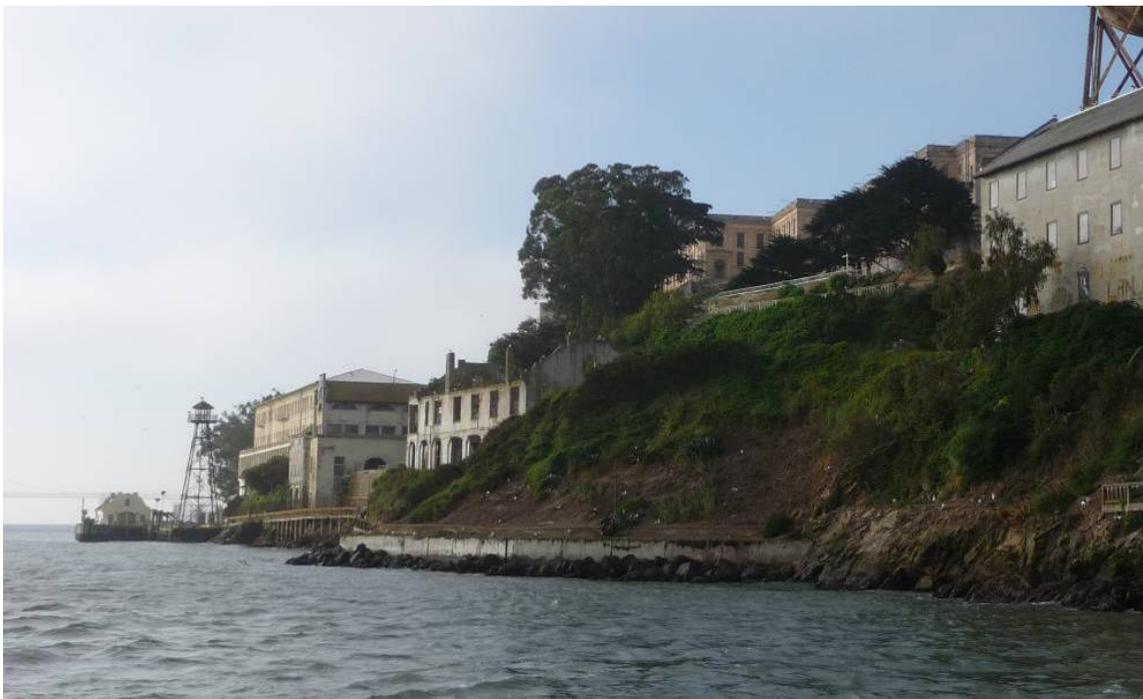
| <i>Feature (Type)</i> | <i>Bldg #</i> | <i>Figure #</i> | <i>Description</i> | <i>Condition</i> |
|--|---|---|---|---|
| Eastern shoreline path grade | | 3-97 | Grade altered to construct Perimeter Sentry Walk for circulation from the Wharf to Industries | Good |

Figure 3 - 97. Eastern shoreline path grade, with Perimeter Sentry Walk along the Shoreline (MBD P1010009.JPG)

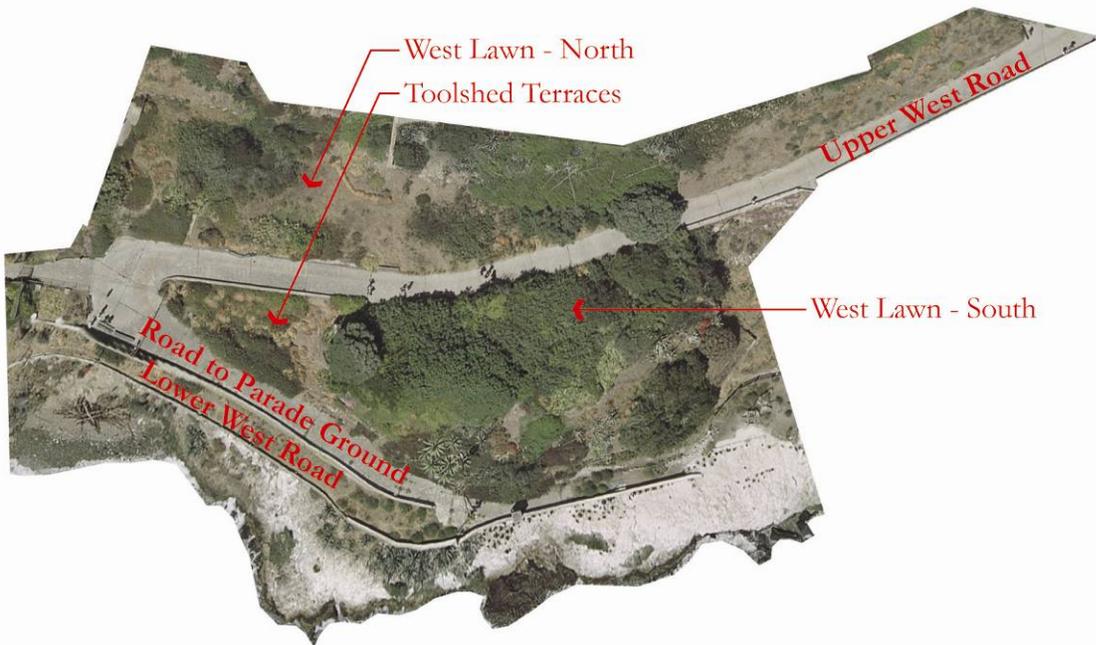
| <i>Feature (Type)</i> | <i>Bldg #</i> | <i>Figure #</i> | <i>Description</i> | <i>Condition</i> |
|--|---|---|---|---|
| West Roads | | 3-98 | Ramp and Slopes cut and graded for construction of road to access west side of Island. | Good |

Figure 3 - 98. Main Road – West Aerial Image (MBD West Road.JPG)

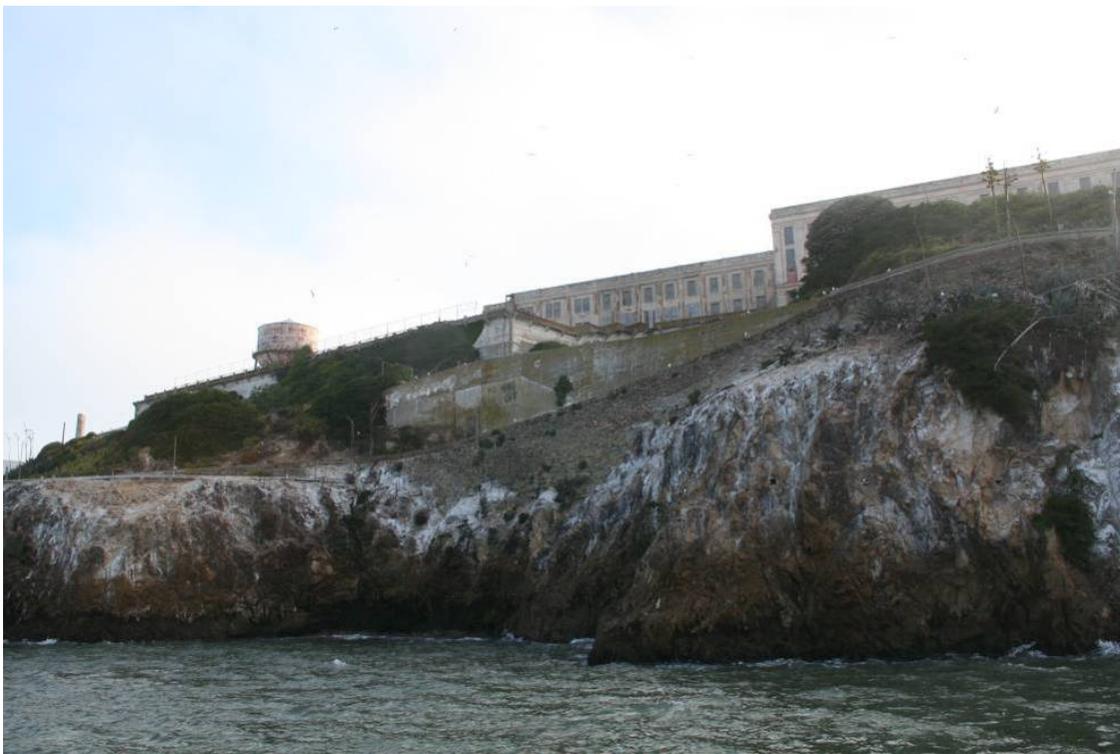
| <i>Feature (Type)</i> | <i>Bldg #</i> | <i>Figure #</i> | <i>Description</i> | <i>Condition</i> |
|--|---|---|---|---|
| Altered portions of the shoreline (west side) | | 3-99 | Grade altered to construct roads for circulation from Industries to Summit and Parade Ground. | Good |

Figure 3 - 99. Altered portions of shoreline along Lower West Road for construction of military fortifications. (MBD IMG_2745.JPG)

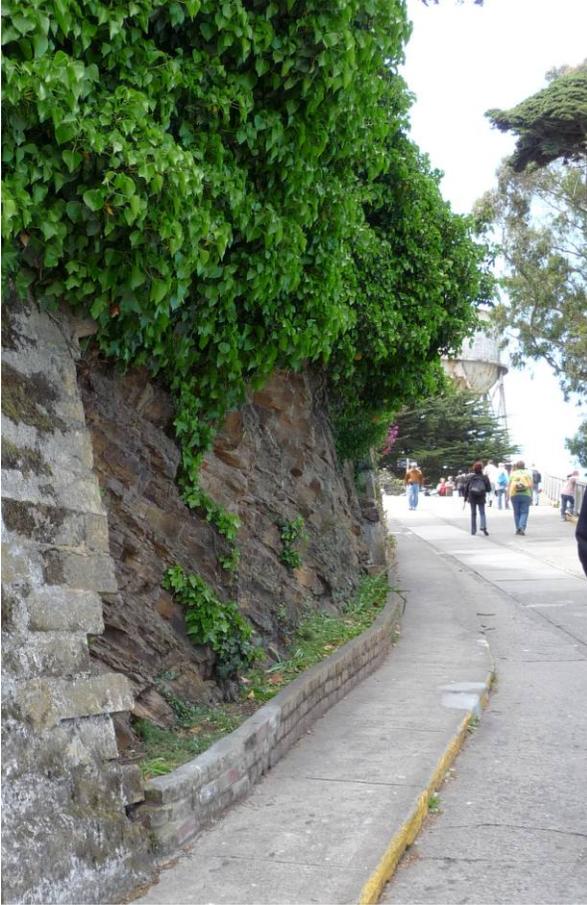
| <i>Feature (Type)</i> | <i>Bldg #</i> | <i>Figure #</i> | <i>Description</i> | <i>Condition</i> |
|--|---|---|---|---|
| Topographic Pits excavated in rocks for planting beds | | 3-100 | On road between switchback two and switchback three | |

Figure 3 - 100. Altered Rock Outcropping and planting bed looking north on west side of road from switchback two to switchback three (MBD Brick Curb.jpg)

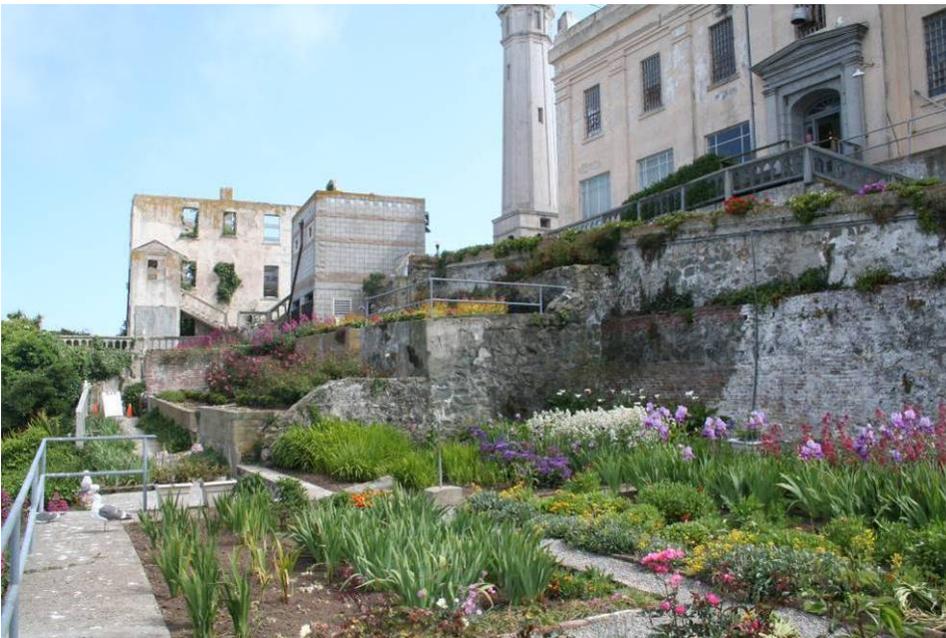
| <i>Feature (Type)</i> | <i>Bldg #</i> | <i>Figure #</i> | <i>Description</i> | <i>Condition</i> |
|---|---|---|---|---|
| Officers' Row Garden 7, 8, 9 Terraces | | 3-101 | Grade altered just west of Main Prison to build three Officers' Quarters (7, 8 and 9) and adjacent gardens. An Adjutant's Office and later the Warden's House and adjacent gardens were constructed in the same vicinity. | Good |

Figure 3 - 101. Officers' Row Garden Terraces (MBD IMG_2860.JPG)

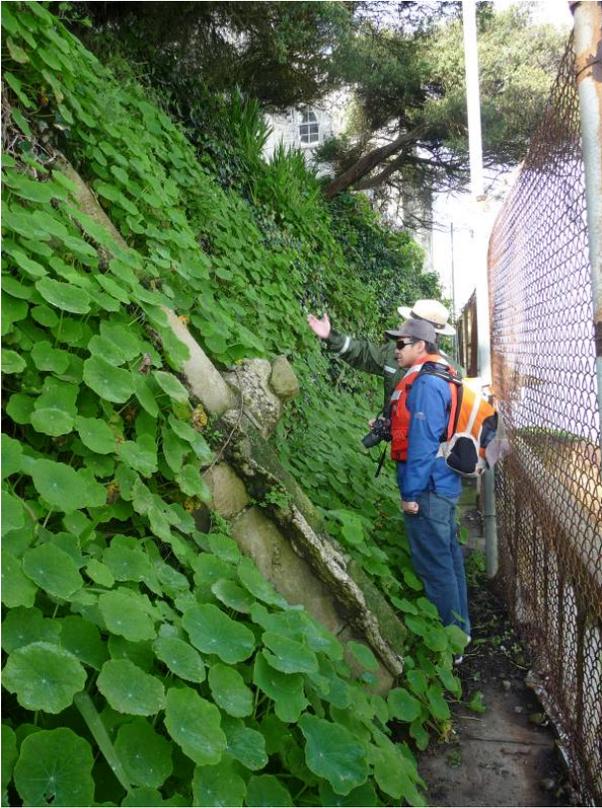
| <i>Feature (Type)</i> | <i>Bldg #</i> | <i>Figure #</i> | <i>Description</i> | <i>Condition</i> |
|---|---|---|---|---|
| Topographic Slope from Wharf to Guardhouse Complex | | 3-102 | Vegetated slope along east side of road from Wharf to Guardhouse Complex. Slope is east of the Sallyport Garden | Fair and eroding |

Figure 3 - 102. Slope east of Sallyport Garden to Perimeter Sentry Walk (MBD P1030417.JPG)

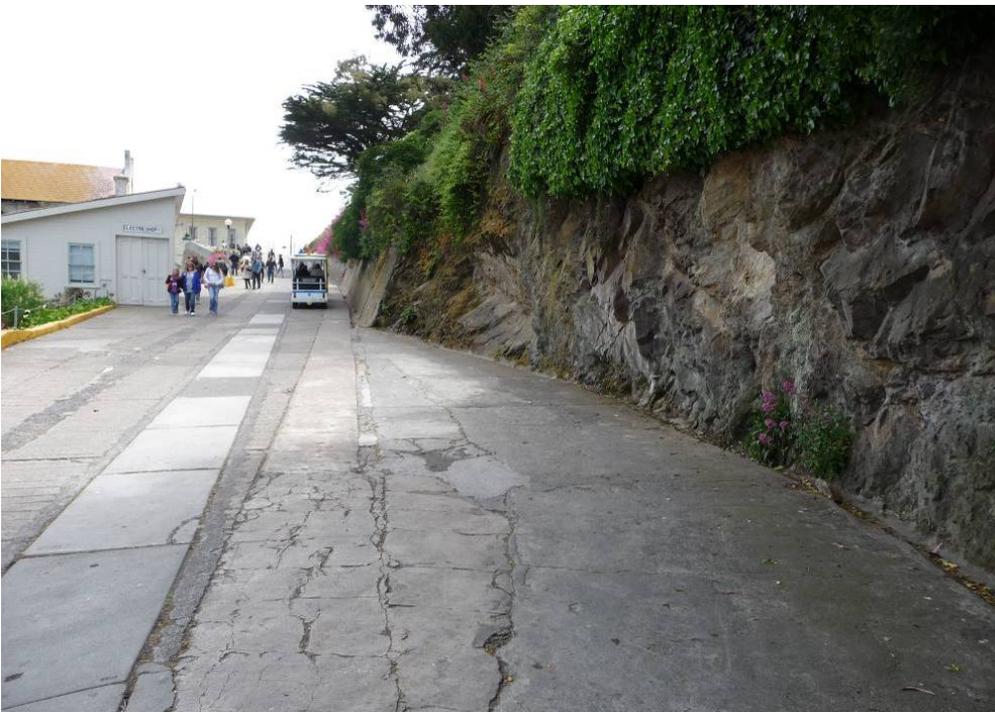
| <i>Feature (Type)</i> | <i>Bldg #</i> | <i>Figure #</i> | <i>Description</i> | <i>Condition</i> |
|---|---|---|---|---|
| Rock Outcroppings | | 3-103 | Along Main Road, several areas where altered rock outcroppings exist rather than retaining walls. | |

Figure 3 - 103. Altered Rock Outcroppings at widened portion of switchback one (P1000264.JPG)

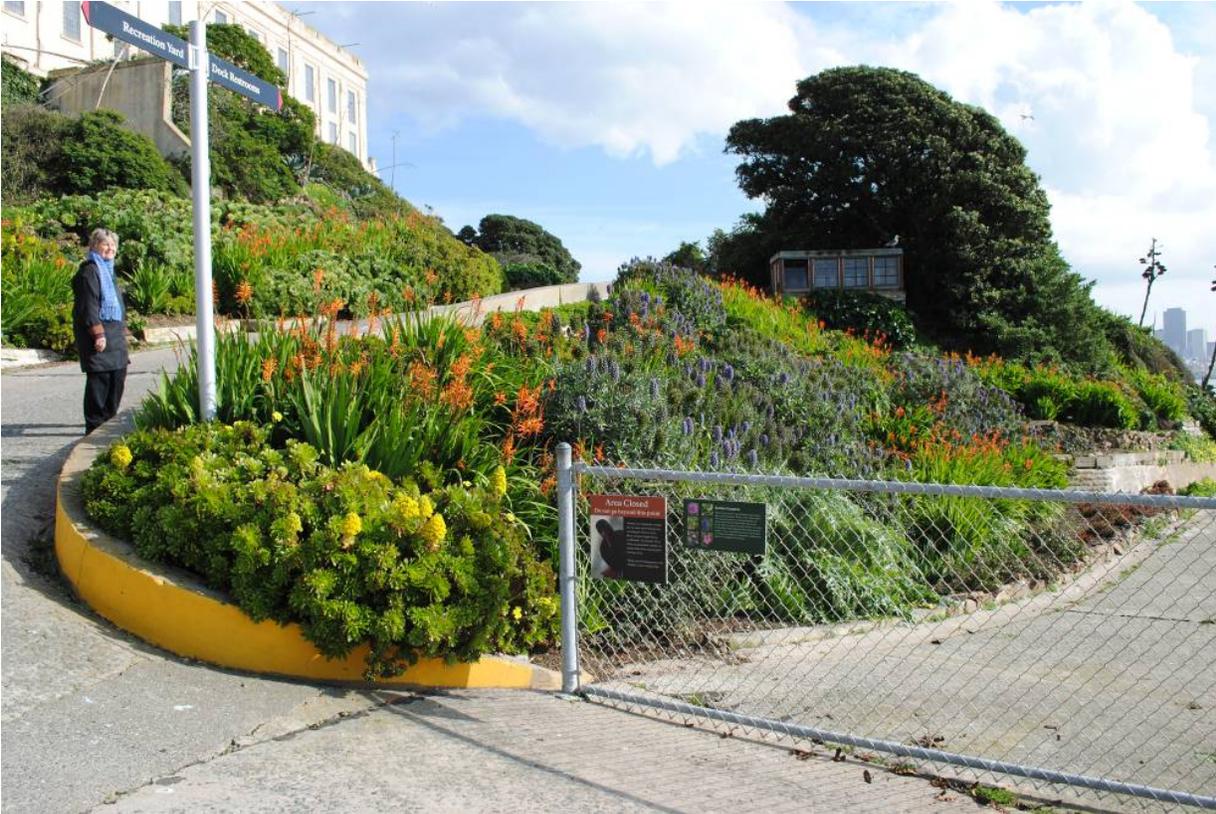
| <i>Feature (Type)</i> | <i>Bldg #</i> | <i>Figure #</i> | <i>Description</i> | <i>Condition</i> |
|---|---|---|---|---|
| Garden Terraces on west side of Island | | 3-104 | Created by prisoners as part of the Island beautification movement in the area west of the Main Prison | Good |

Figure 3 - 104. Garden terraces on west side of Island (Toolshed Terraces pictured above) (MBD DSC_0480.JPG)

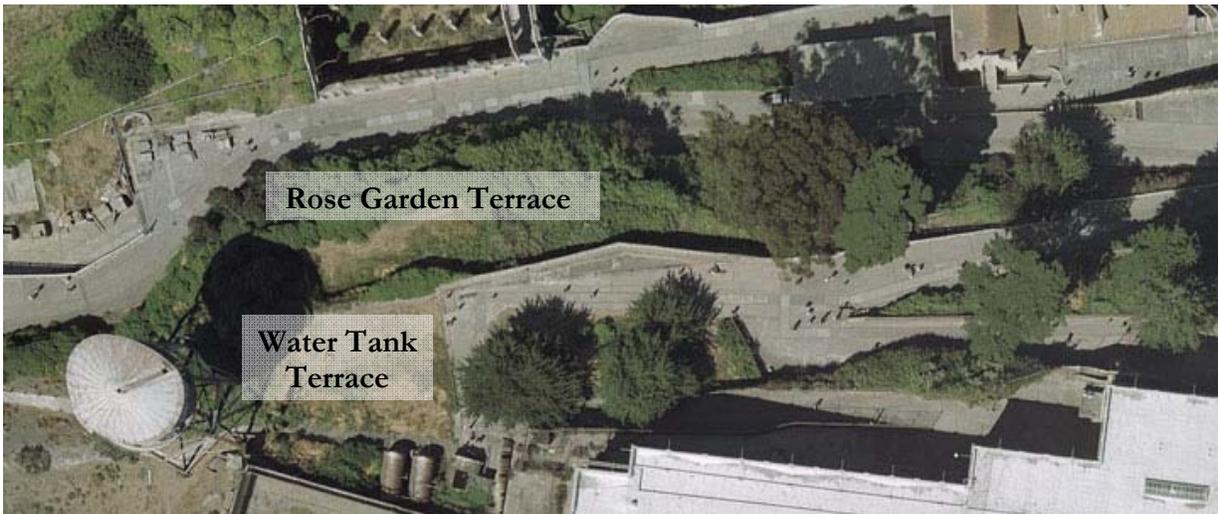
| <i>Feature (Type)</i> | <i>Bldg #</i> | <i>Figure #</i> | <i>Description</i> | <i>Condition</i> |
|---|---|---|---|---|
| Rose Garden Terrace | | 3-105 3-108 | Grade originally altered for Hospital construction. Area is located east of the Water Tank Terrace | Good |
| Water Tank Terrace | | 3-105 3-106 | Area is located south of the Water Tower and east of the Stockade/Recreation Yard. Grade originally altered for Hospital construction. | Good |

Figure 3 - 105. Aerial of Rose Garden Terrace east of the Main Prison. In this image, the Water Tank Terrace is between the Water Tower and concrete paving. The Rose Garden Terrace is the vegetated area to the top of the image. (Alcatraz-aerial_rotated_water tank terrace.JPG)

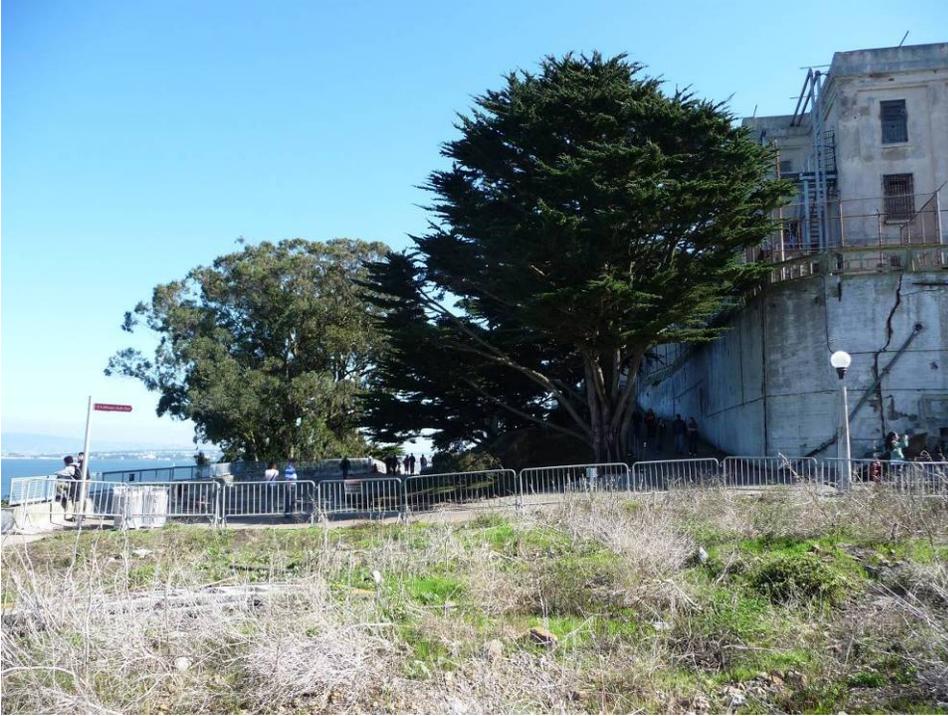
Figure 3 - 106. Water Tank Terrace looking South at Switchback 3 (MBD P1020975.JPG)

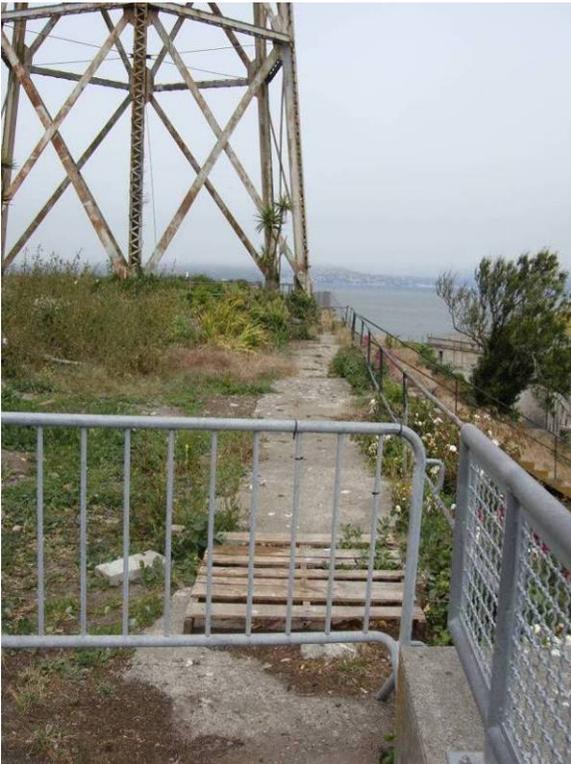
Figure 3 - 107. Water Tank Terrace, viewed from Main Road near the Morgue. Water Tower base and Stairs to Rose Garden are visible. Steel safety guardrail (SR28) is at bottom right of the image, connecting to historic pipe railing MBSR19 at the center right (MBD DSC00269.JPG)

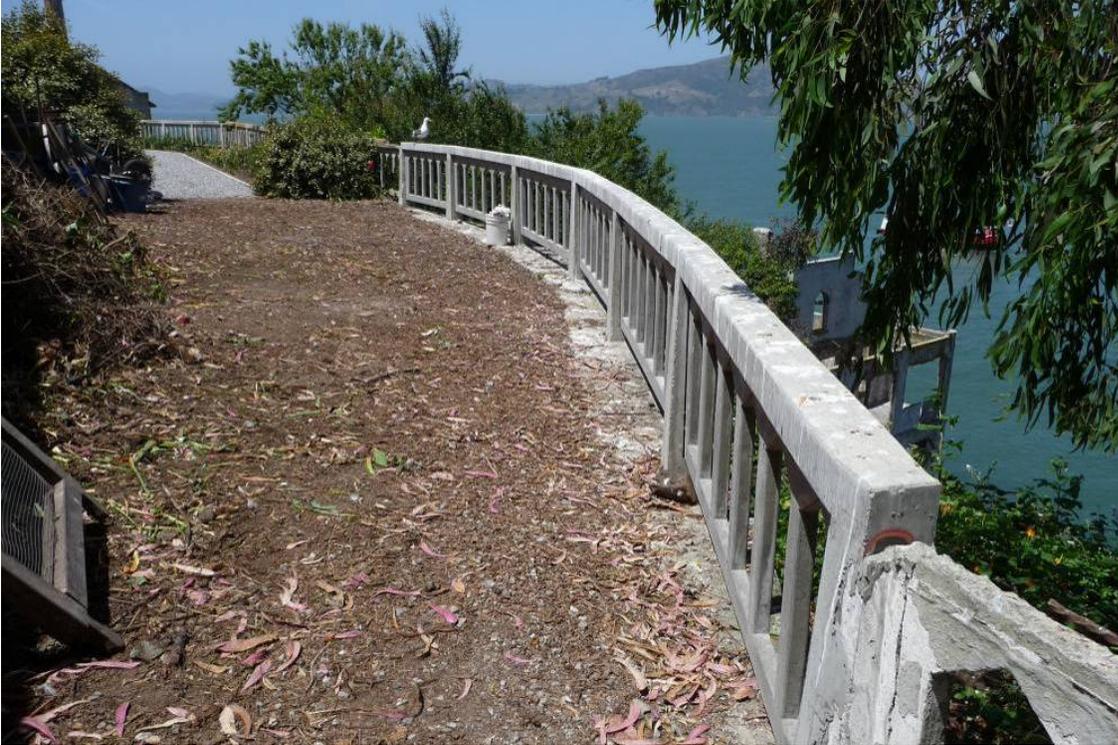
Figure 3 - 108. South portion of Rose Garden Terrace with replica decorative railing (MBD P1000806.JPG)
