# Parade Ground and Summit South Terrace Treatment Recommendations

# Main Road - East Treatment Recommendations

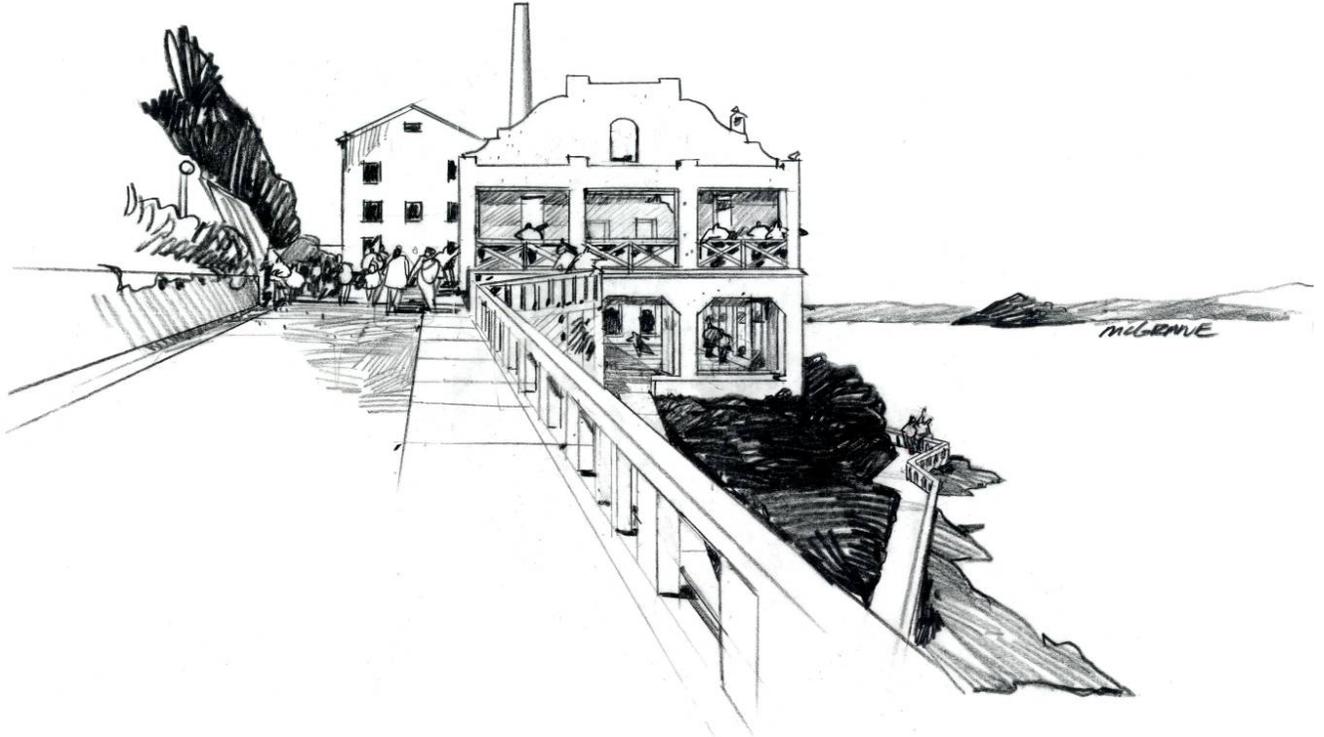
**Figure 6 - 5.** Concept sketch of Main Road and Perimeter Sentry Walk. Stabilize building walls and veranda of the Post Exchange, and add interior floor decking for visitor access. Allow year round access on Perimeter Sentry Walk from Wharf to Post Exchange.

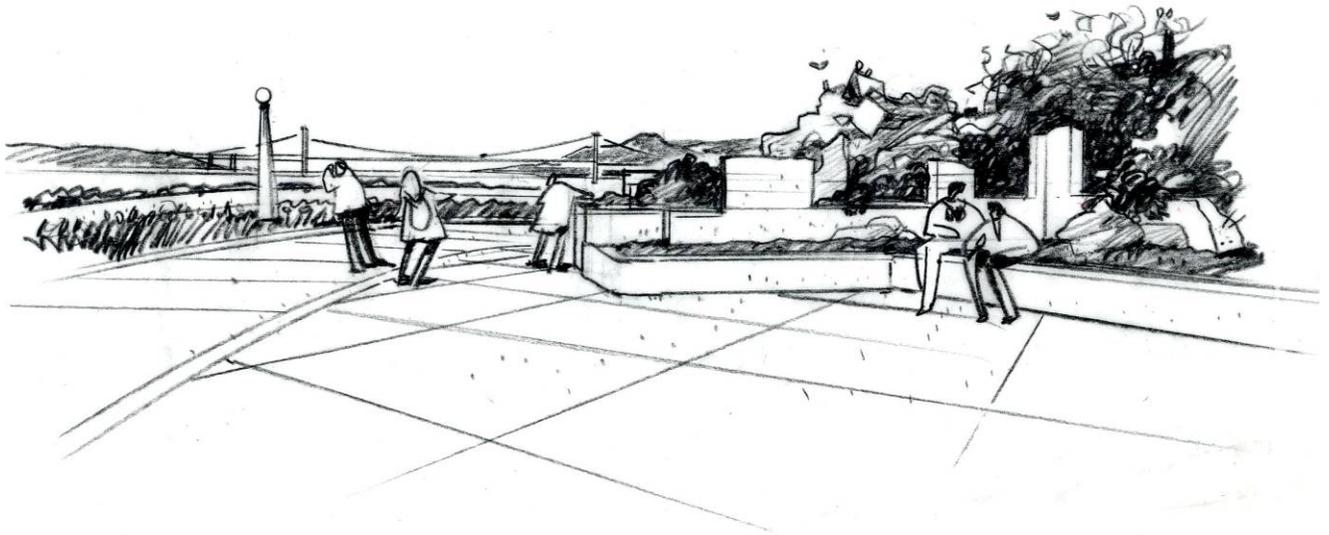
**Figure 6 - 6.** Concept sketch of Parade Ground, view towards Apartment C. Re-configure rubble mounds to reveal extant building walls and foundations. Stabilize building walls, rubble mounds and plantings. Maintain interior rubble as habitat for Black-crowned Night Heron and secure rubble to eliminate any access for visitor safety. Repair all extant contributing features: lights, curbs, sidewalks, Seawall Planter, building and site walls, and plantings to reflect historic character of the Federal Penitentiary period.

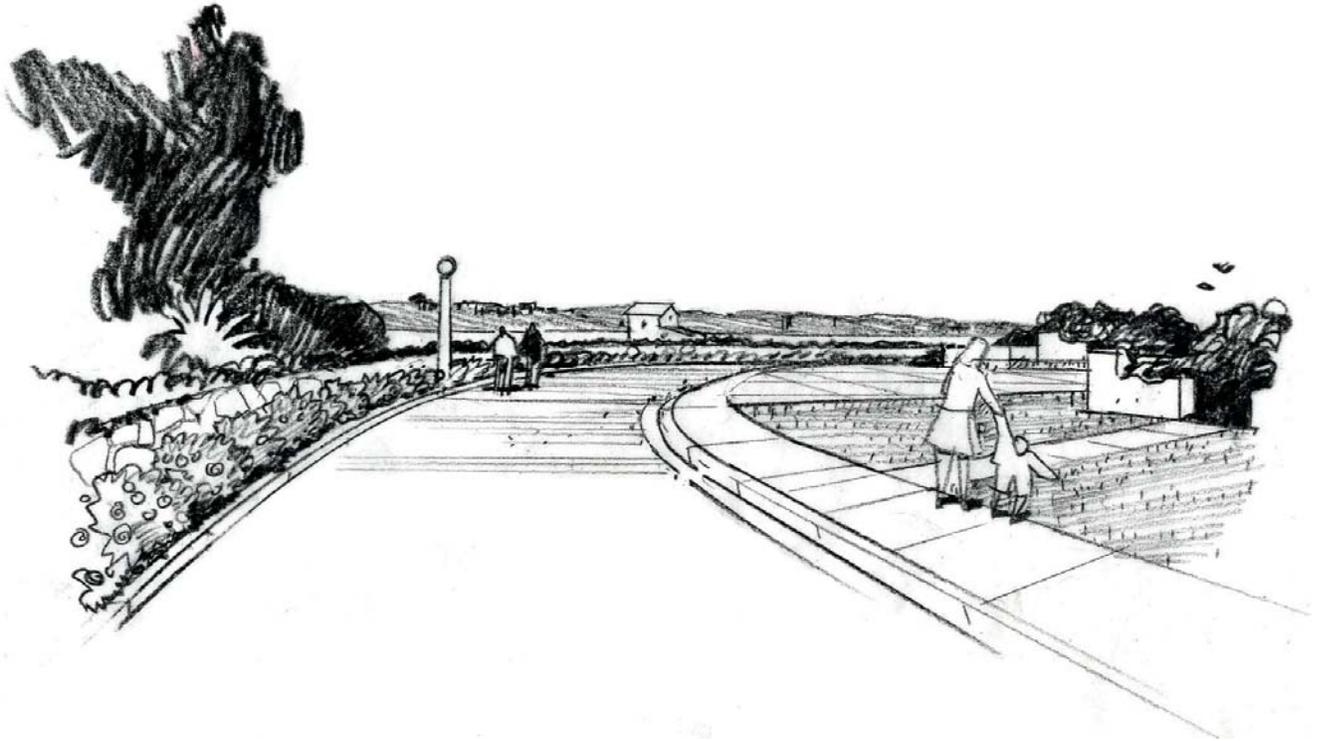
**Figure 6 - 7.** Concept sketch of the Parade Ground, view towards Officers' Quarters – Duplex remnants (Building 83). Restore historic plantings in top of Seawall Planter and add plantings in area in front of Seawall Planter to reflect historic character and to deter visitor access to wall.

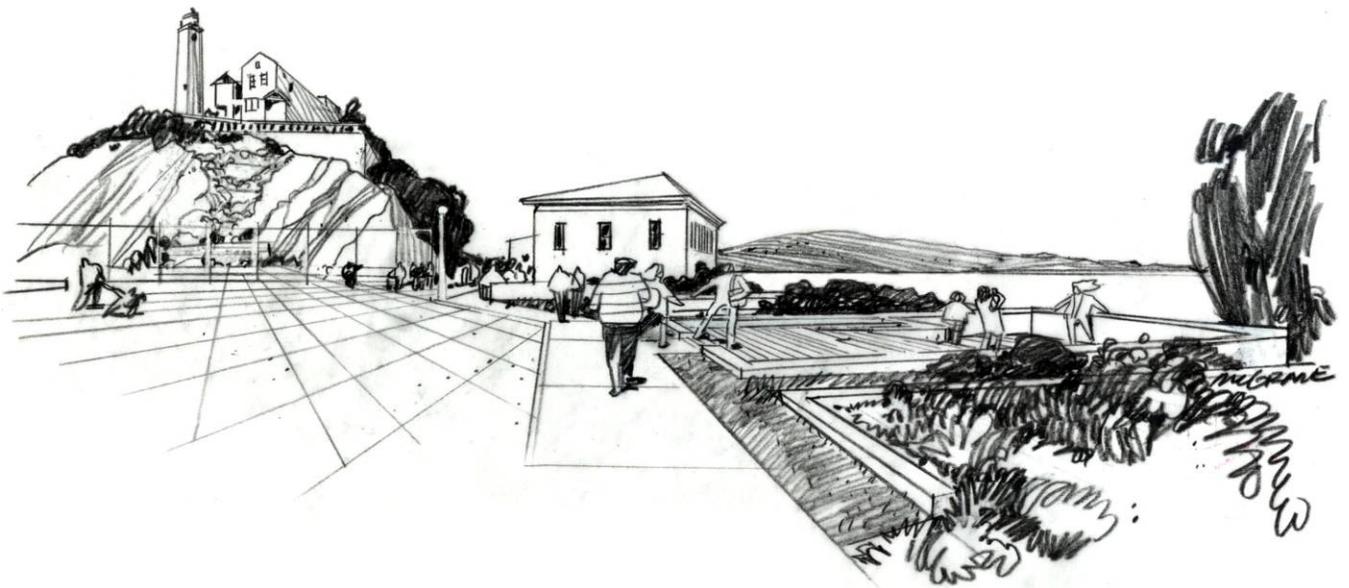
**Figure 6 - 8.** Concept sketch of Parade Ground. Allow year round visitor access. Repair Officers' Quarters 72 – 75 building foundations and foundation walls. Add decking and railings at first floor of Quarters 72 and 73 for visitor access. Repair escarpment slope.

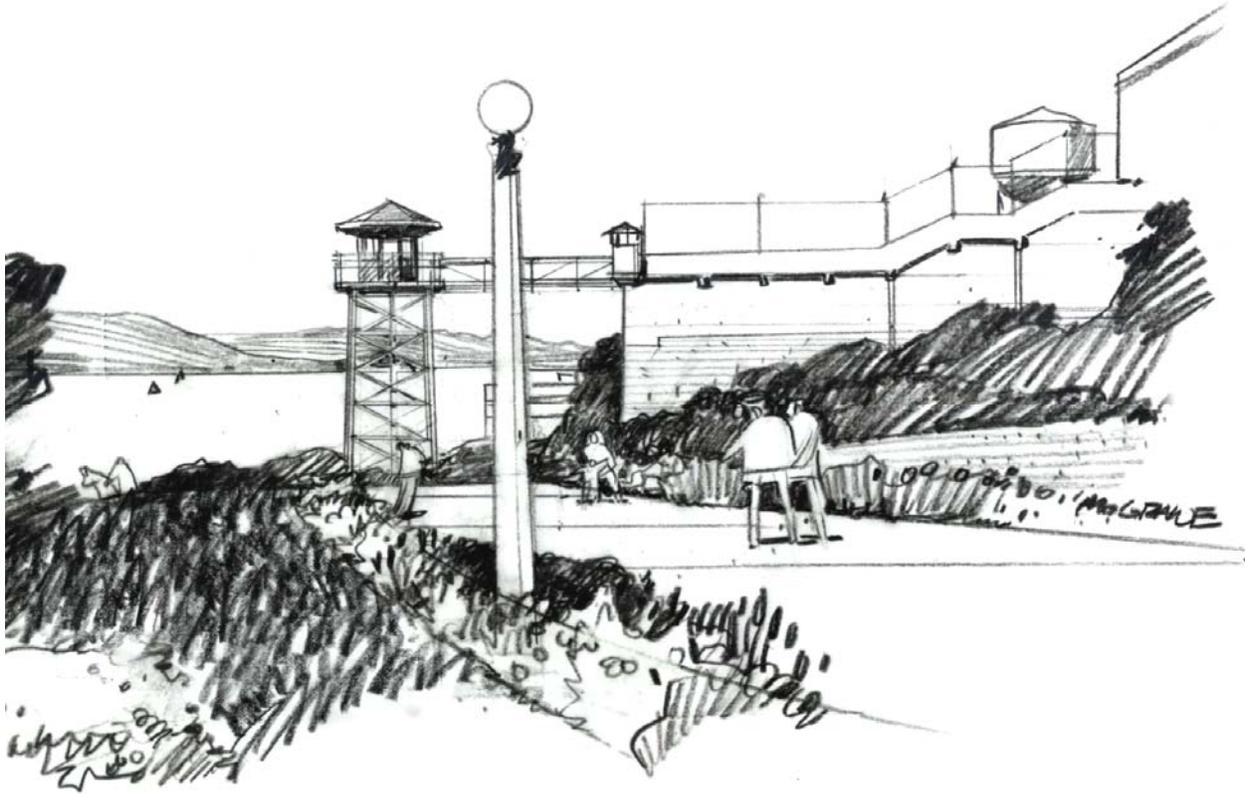
**Figure 6 - 9.** Concept sketch of Main Road - West showing the restoration of the Road Tower and Catwalk to the Stockade/Recreation Yard. Restore the guard station fencing; and catwalks of the Stockade/Recreation Yard. Repair the West Lawn - North, historic hillside plantings on upper slopes, and pedestrian lights. Maintain the perennial borders of the West Lawn. Maintain existing vegetation for Snowy Egret habitat.

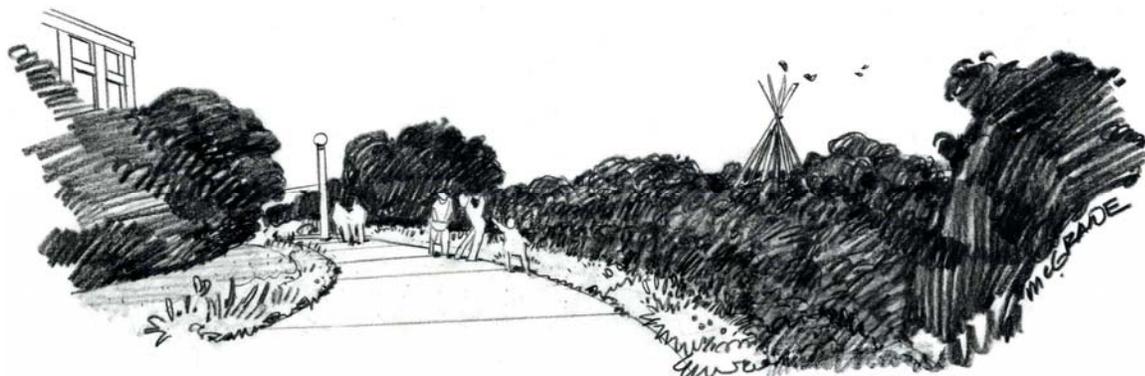
**Figure 6 - 10.** Concept sketch of Main Road - West. Maintain existing vegetation for Snowy Egret habitat at the West Lawn - South and allow for a new tipi structure to be built so it is visible. No visitor access to the Tipi site is allowed.

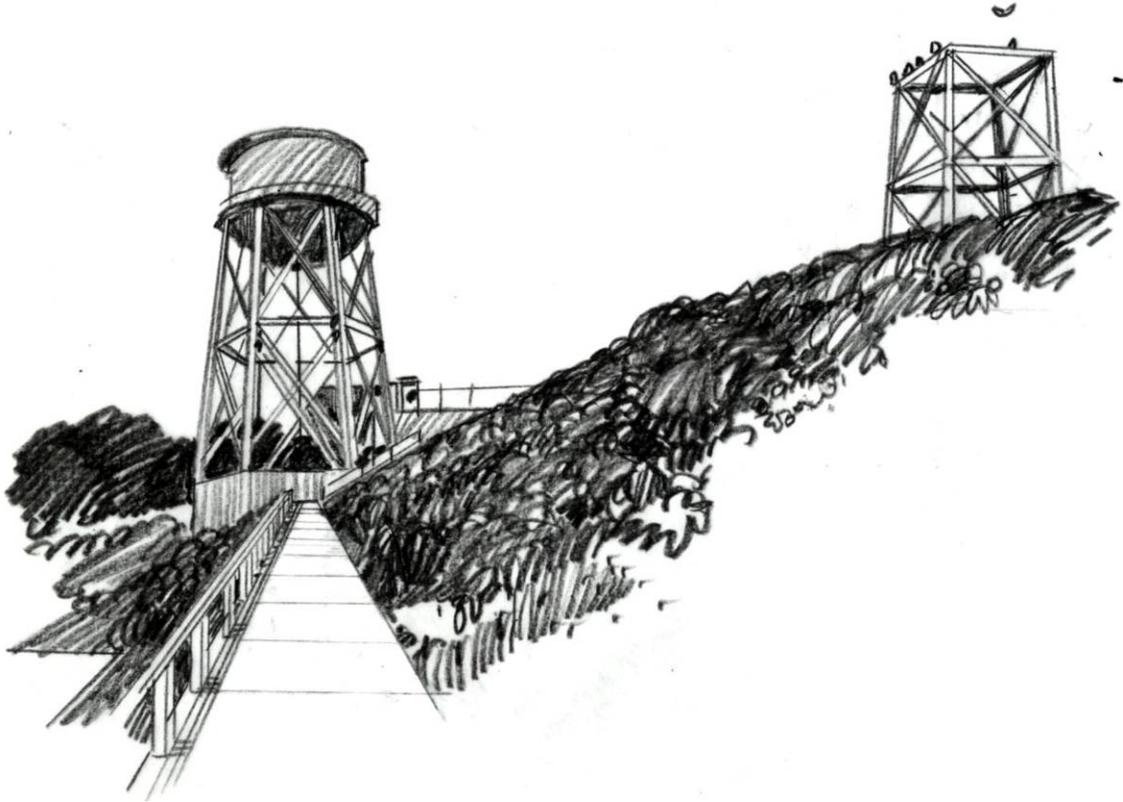
**Figure 6 - 11.** Concept sketch of Utility Chase and Walk from Powerhouse to Main Prison. Stabilize walk and railing and repair sections that are fully deteriorated. Restore the vertical structure of the guard tower and stabilize extant footings. Allow seasonal visitor access. Stabilize slope and add low understory planting as dual habitat areas that do not obscure views.

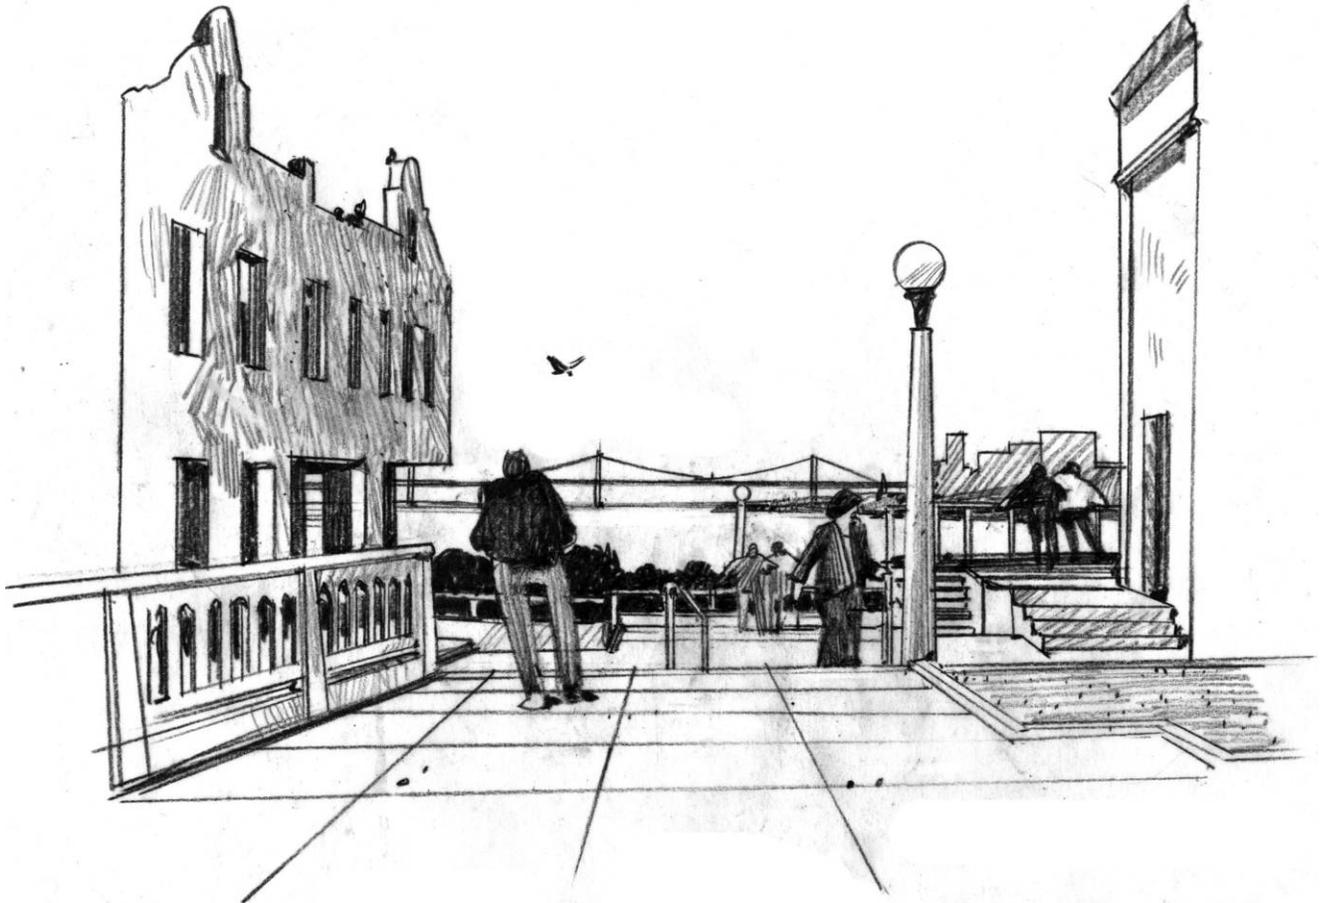
**Figure 6 - 12.** Concept sketch of Main Prison Plaza looking towards San Francisco. Remove pedestrian light on east side of staircase. Remove non-contributing railings at edge and restore historic concrete decorative railing, and repair extant wall at Summit edge.

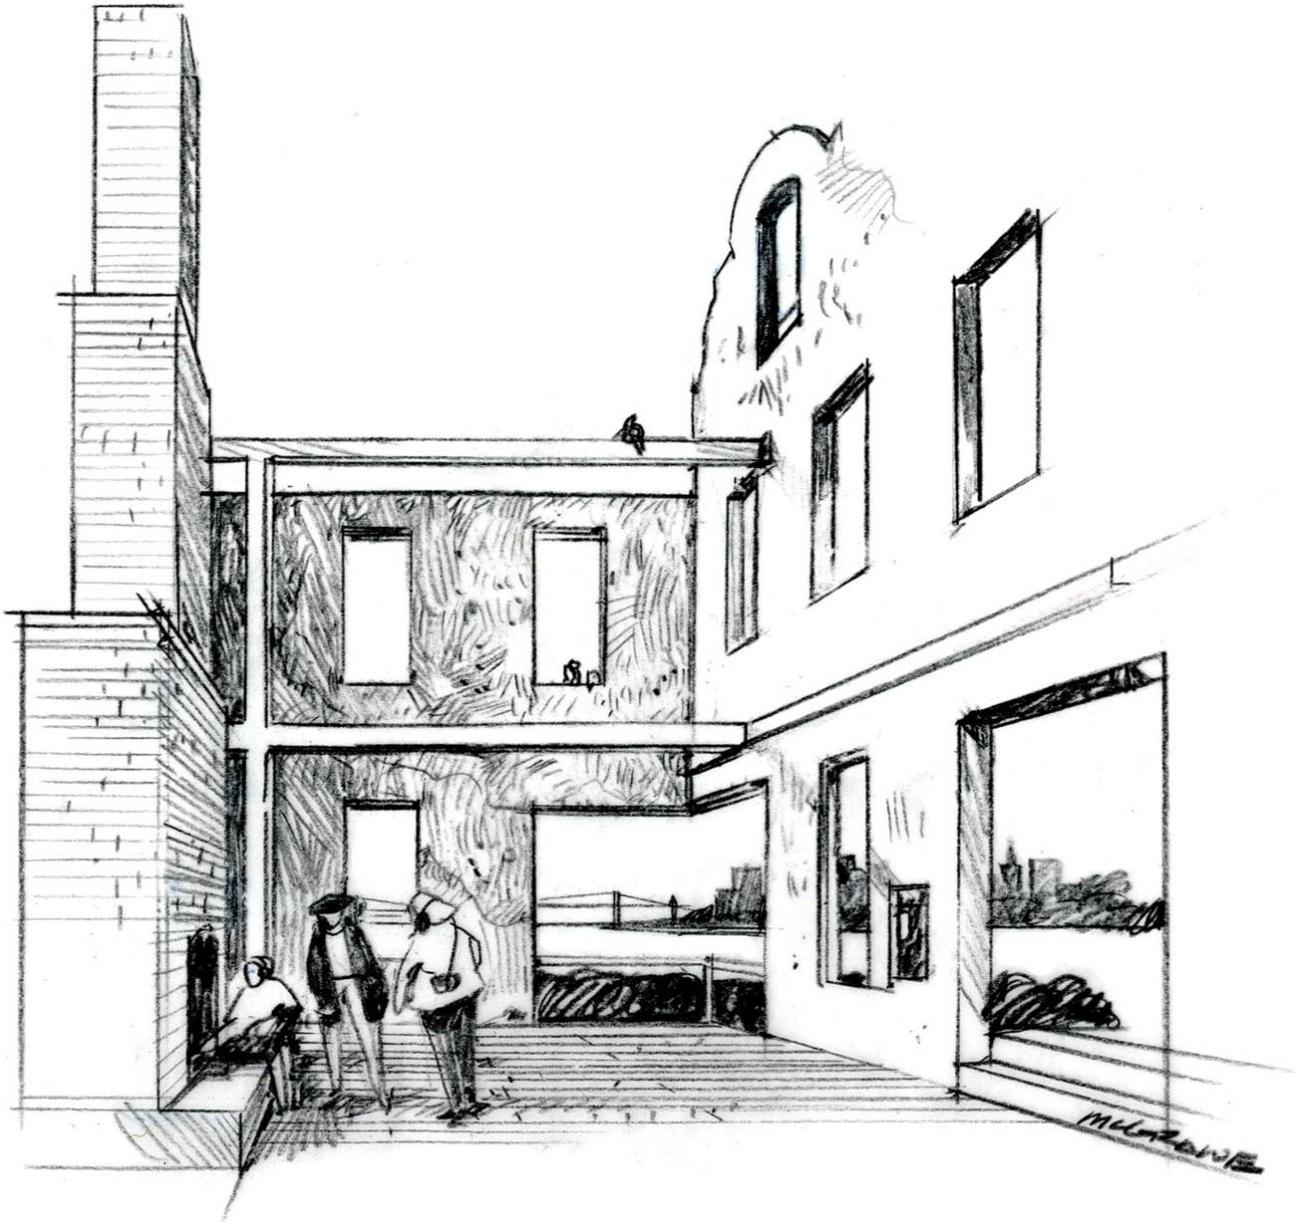
**Figure 6 - 13.** Concept sketch of Warden's House interior. Add decking on main level and stabilize building foundations and walls to allow for visitor access.

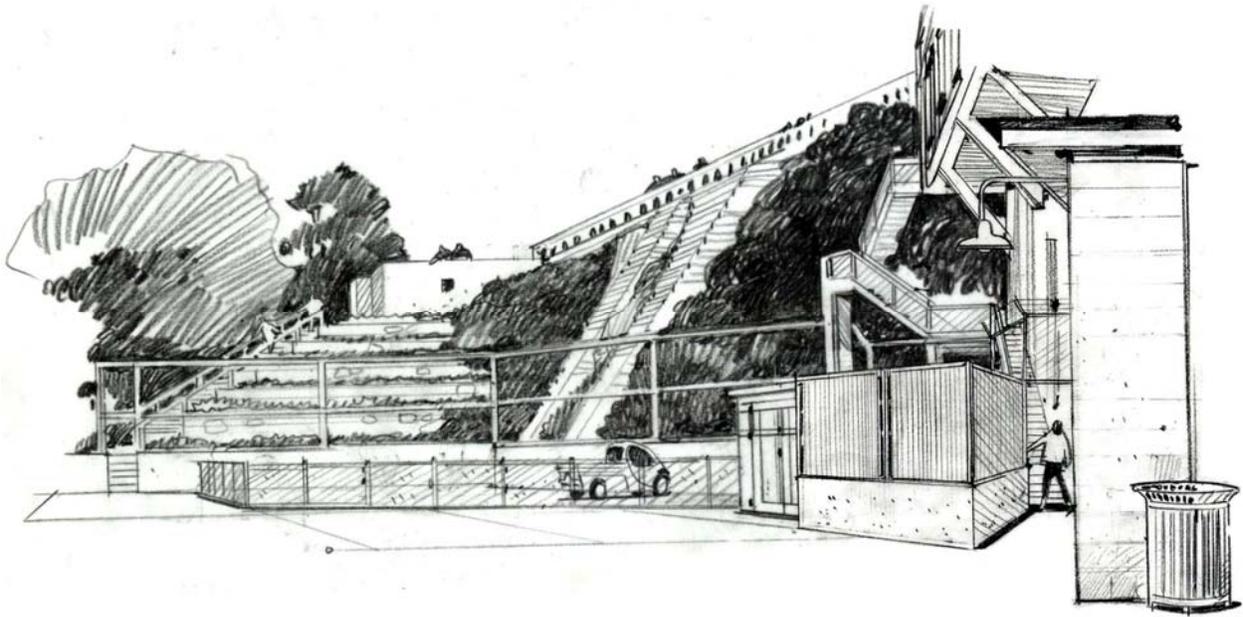
**Figure 6 - 14.** Concept sketch of Wharf. Remove amphitheater and restore Federal Penitentiary period security fencing and wall. Repair garden terraces, staircase, and railings and stabilize buttresses. Allow year-round visitor access to Parade Ground via extant staircase.

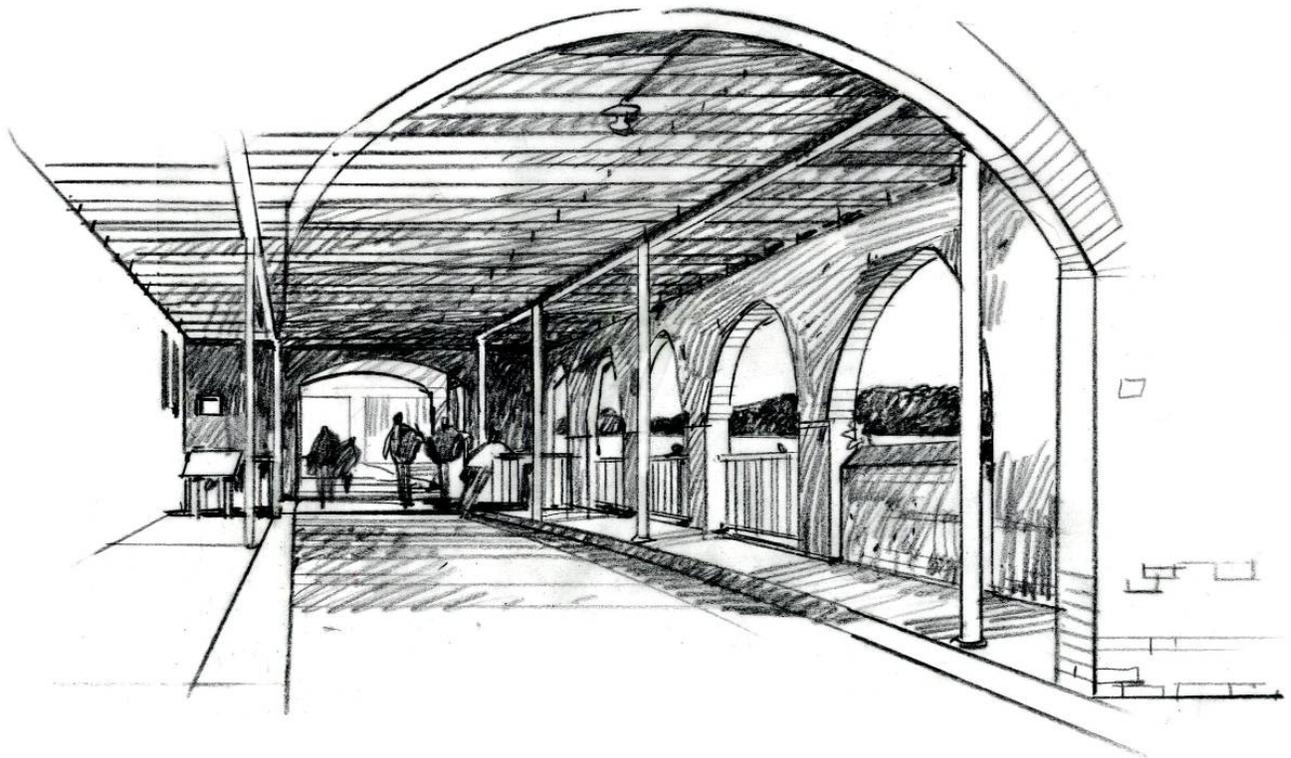
**Figure 6 - 15.** Concept sketch of Main Road through the Guardhouse Complex, looking north. Remove Wooden Boathouse Addition and restore Guardhouse Complex to Early Military Prison period.

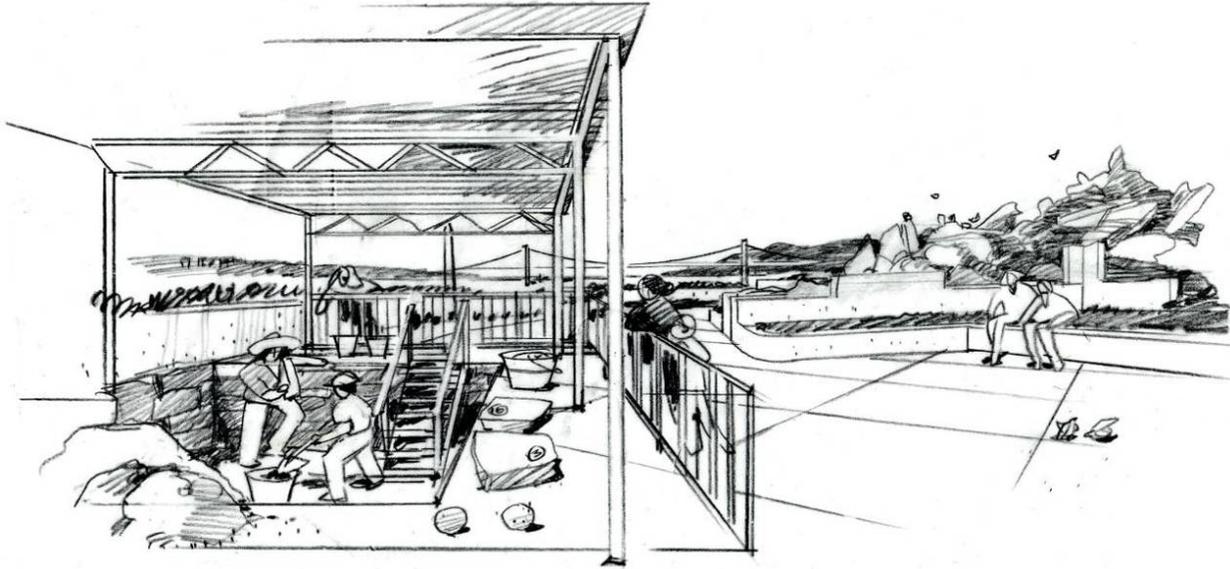
**Figure 6 - 16.** Concept sketch of Parade Ground. Encourage archeological excavations. Clean up rubble mounds to reveal extant building foundations and walls. Maintain rubble mounds for Black-crowned Night Heron habitat. Restore residential character including lights, curbs, sidewalks, Seawall Planter, walls, and landscape to Federal Penitentiary period.

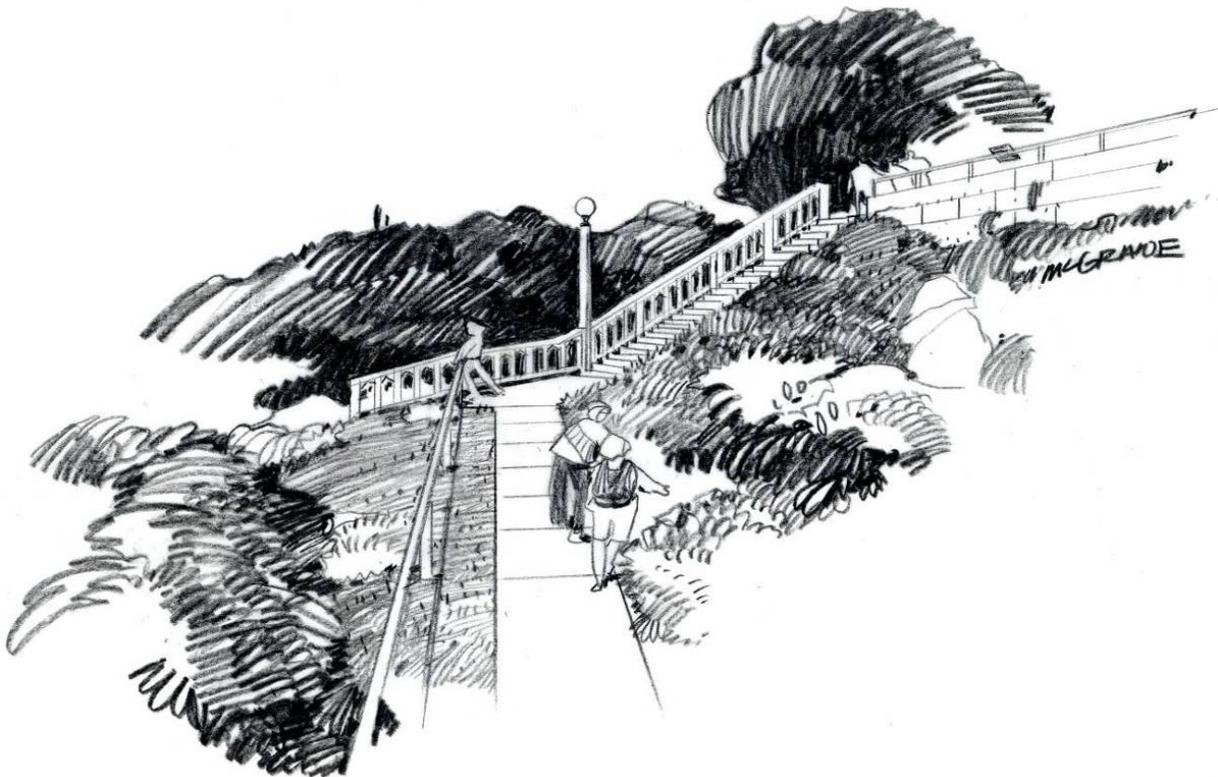
**Figure 6 - 17.** Concept sketch of Windy Gulch Trail. Restore staircase decorative concrete railings and walk to Federal Penitentiary period. Allow year round visitor access and add railings to walkway below staircase to deter visitor access into protected areas. Maintain vegetation for Black-crowned Night Heron habitat.
