Alcatraz Island

Treatment Recommendations

Summit Treatment Recommendations

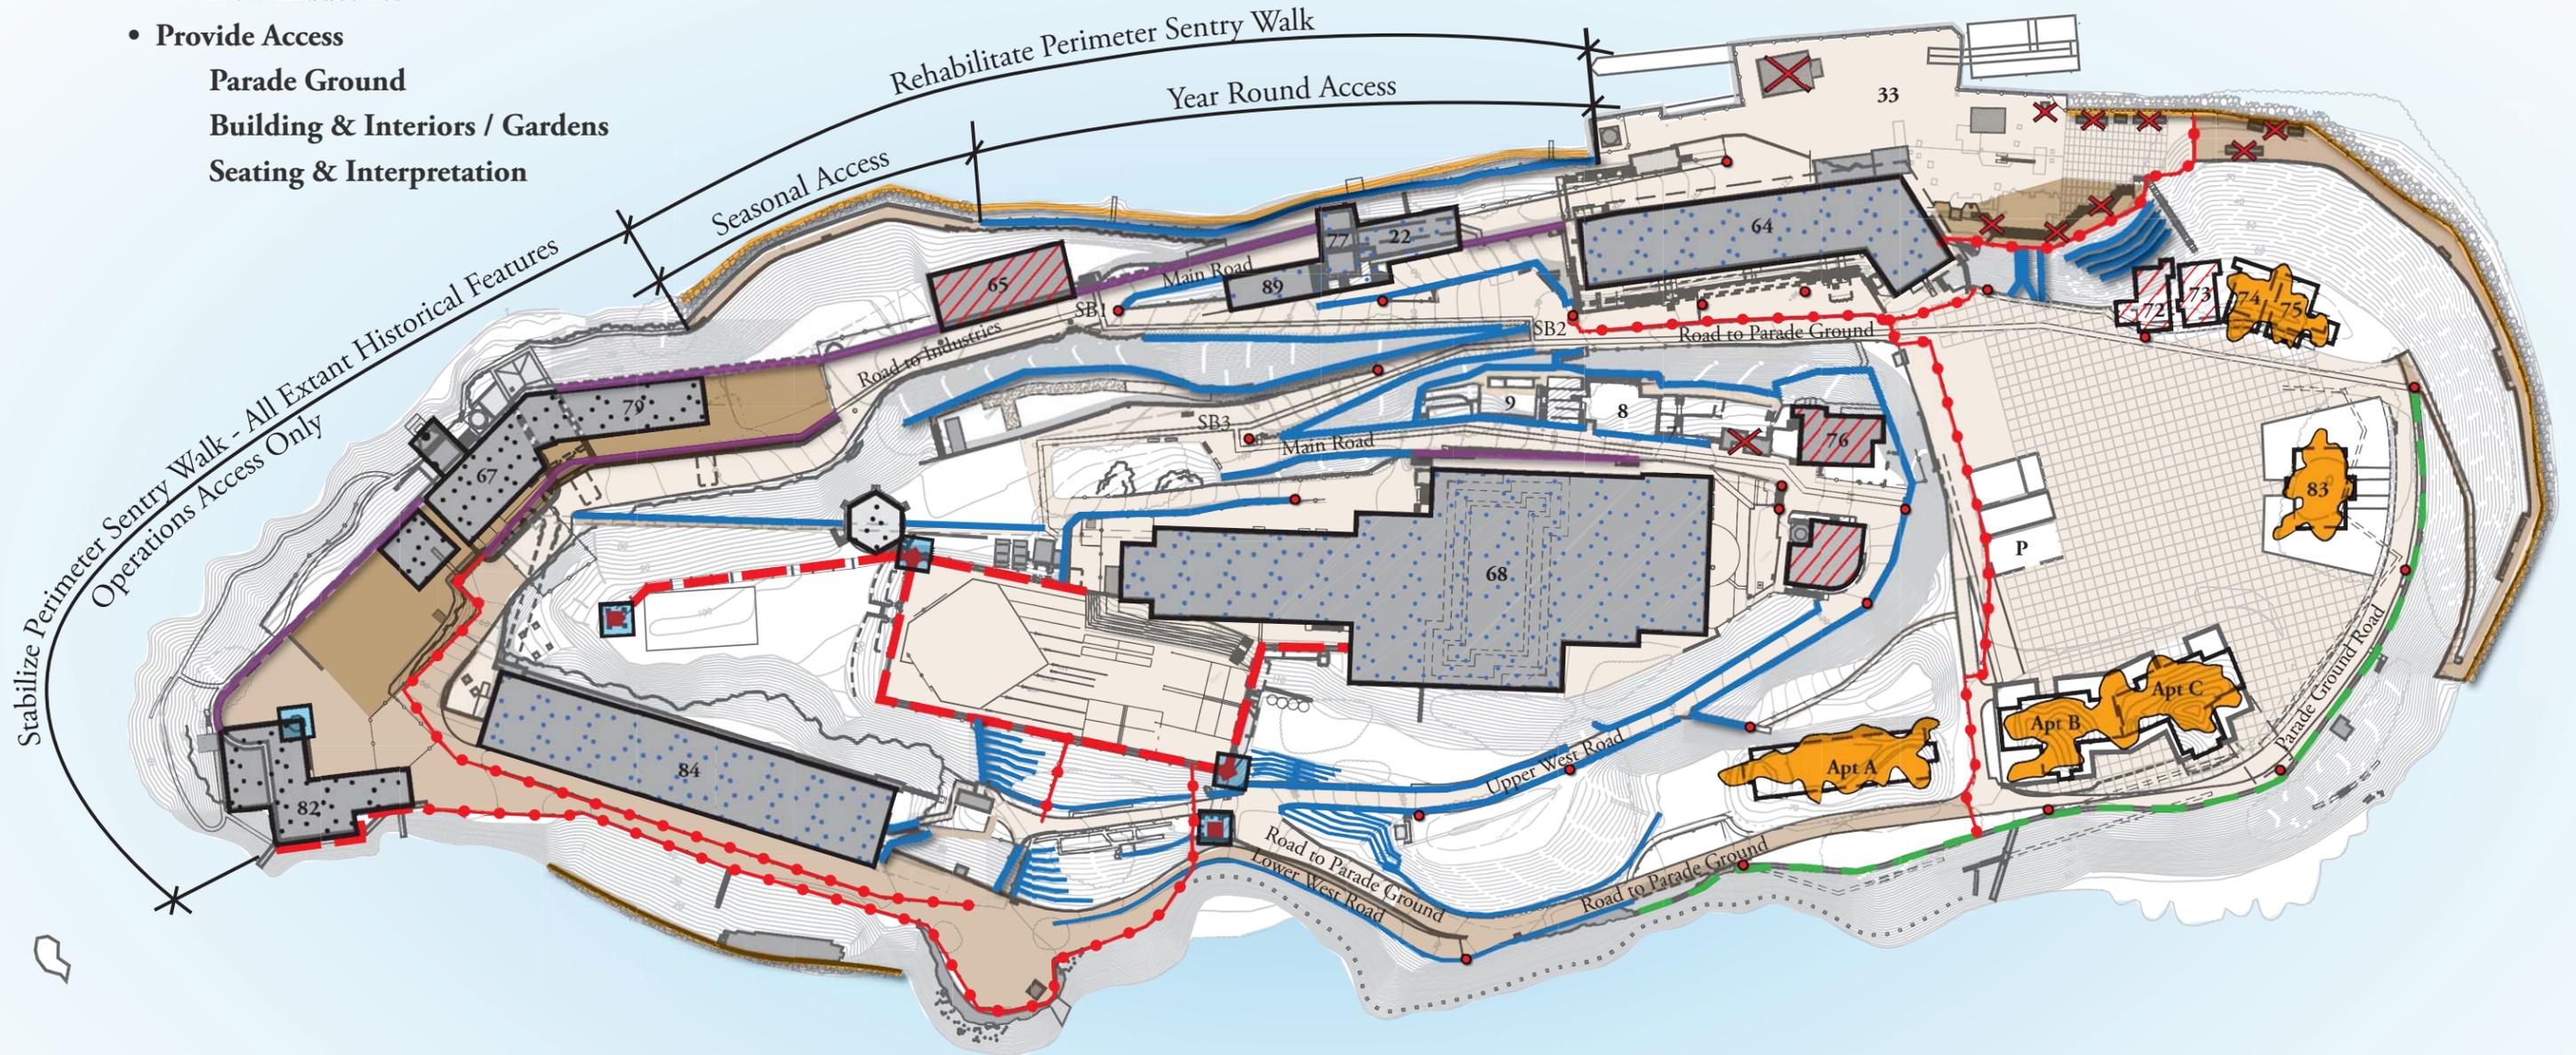
Figure 6-30

- Evoke Sense of Place
 - Main Street Character of Officers' Row
 - Residential Character of Parade Ground
 - Prisoner Enclosure
 - New Industries
- Provide Access
 - Parade Ground
 - Building & Interiors / Gardens
 - Seating & Interpretation

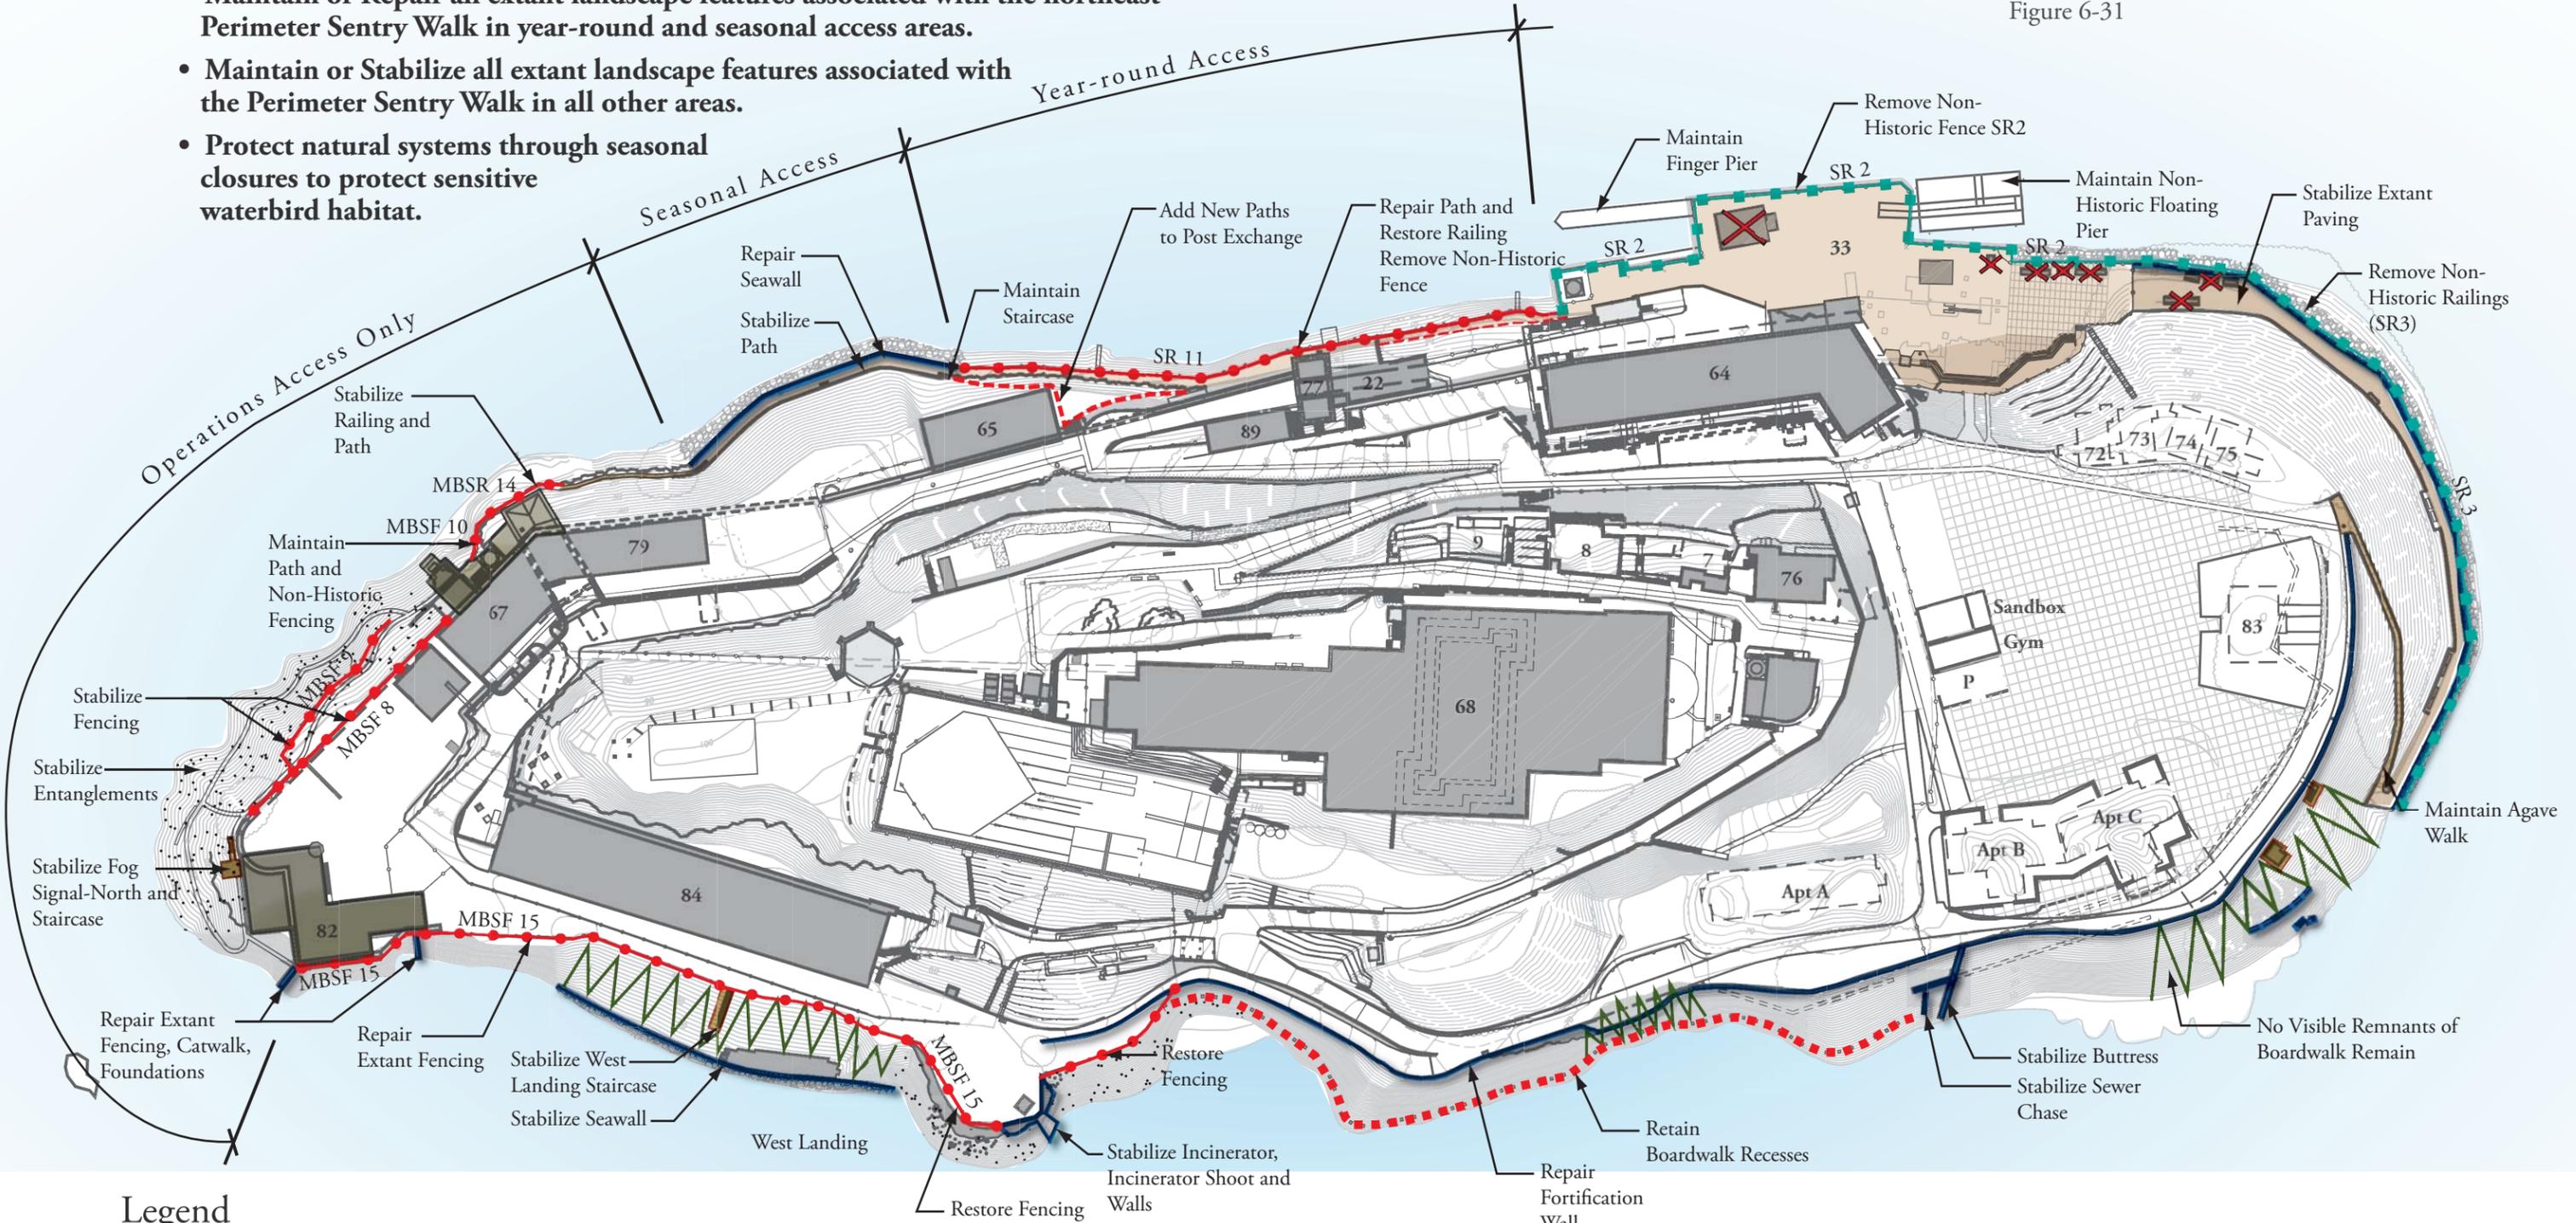
Figure 6-31

- **Maintain or Repair all extant landscape features associated with the northeast Perimeter Sentry Walk in year-round and seasonal access areas.**
- **Maintain or Stabilize all extant landscape features associated with the Perimeter Sentry Walk in all other areas.**
- **Protect natural systems through seasonal closures to protect sensitive waterbird habitat.**

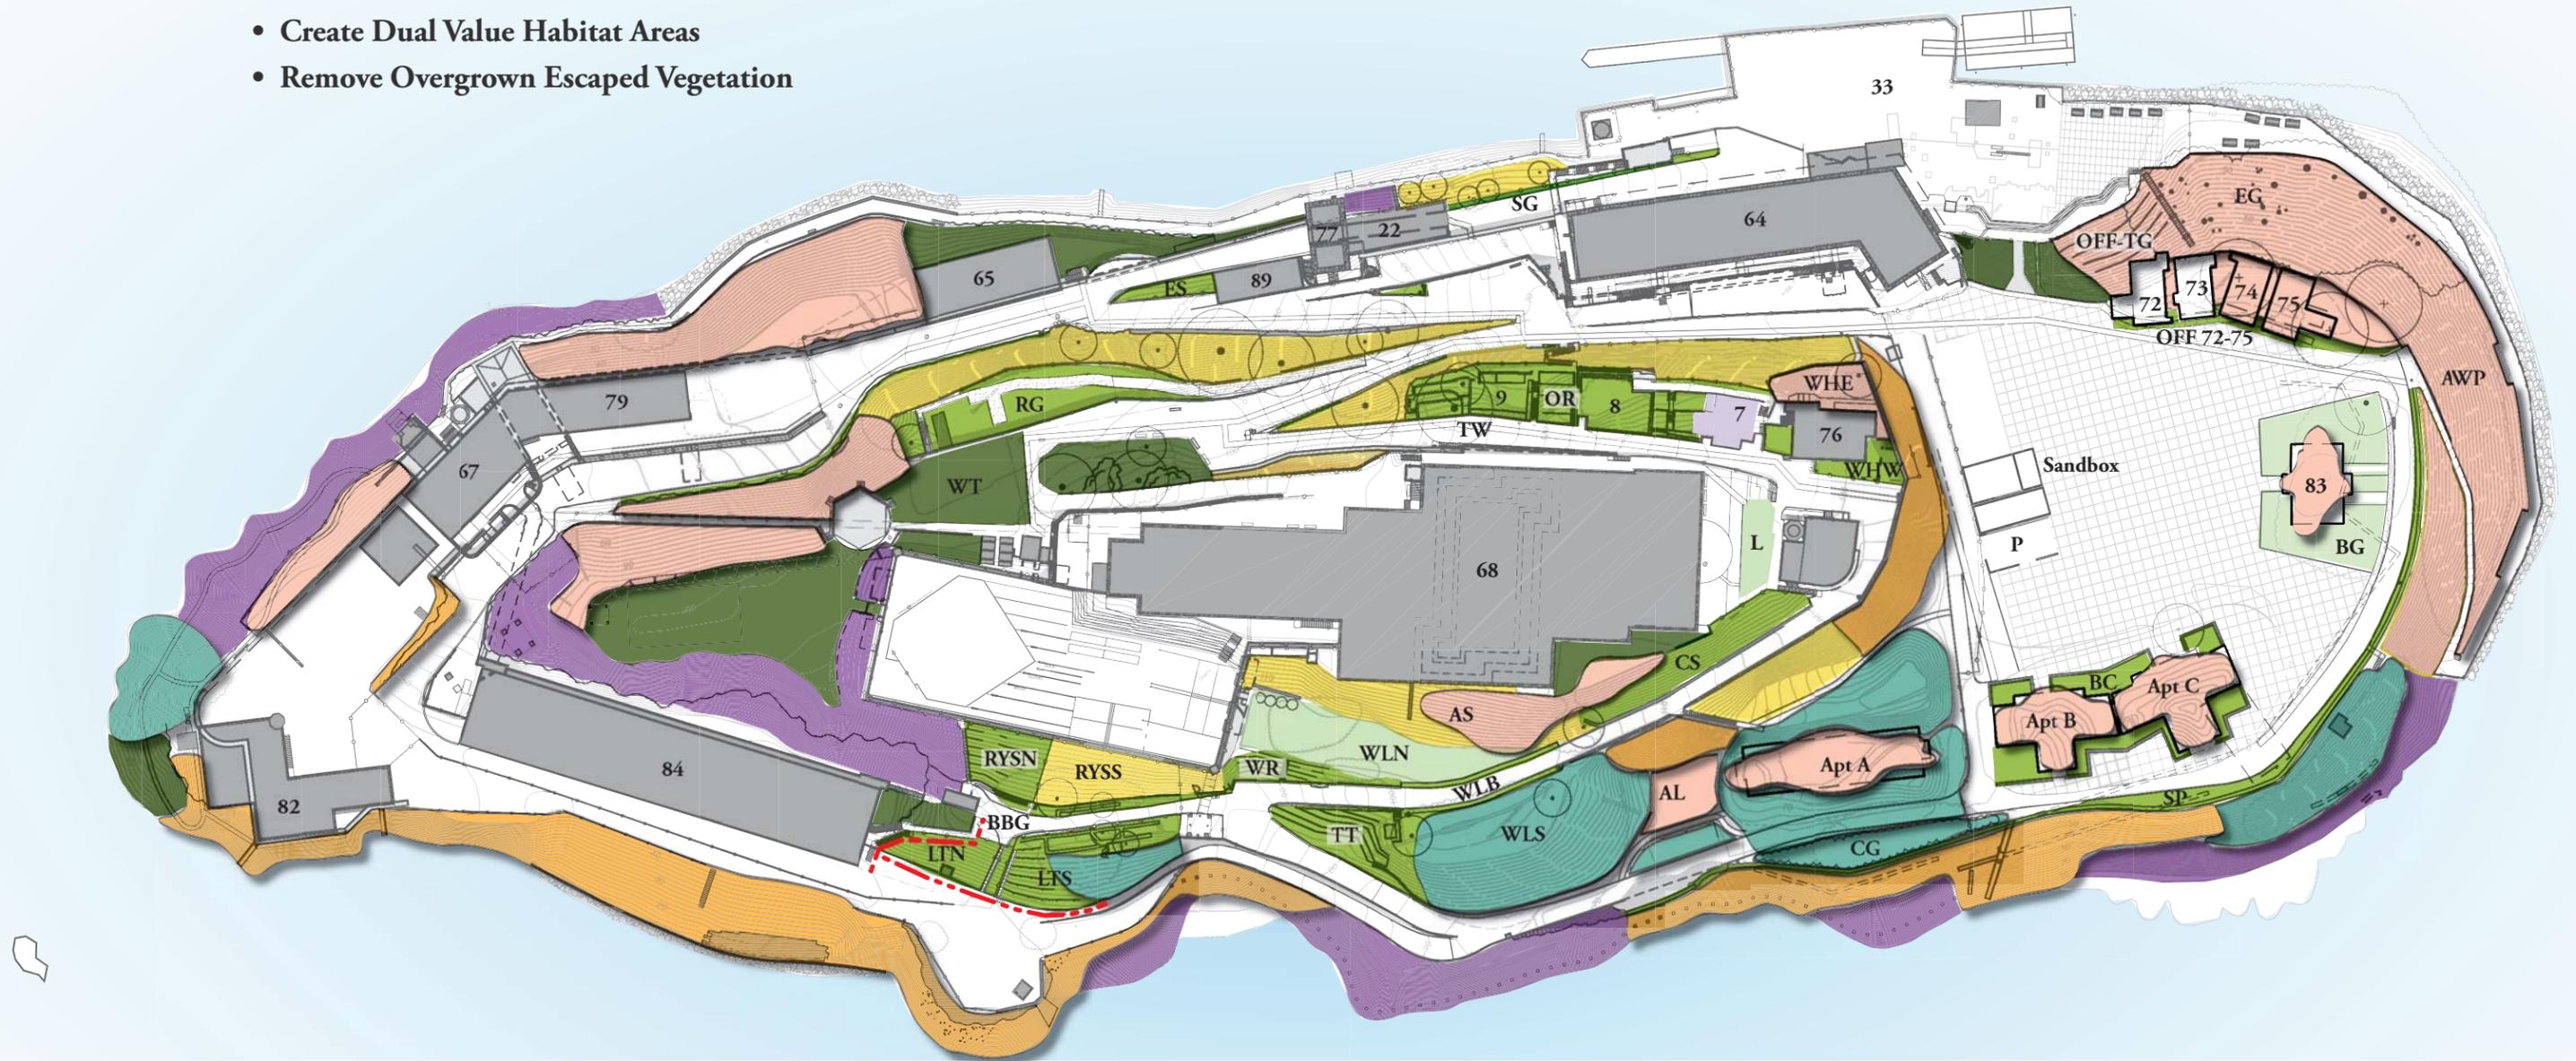
Figure 6-32

- Rehabilitate Historic Gardens and Lawns
- Rehabilitate Historic Hillside Plantings
- Repair, Maintain, and Stabilize Slopes
- Maintain Waterbird Habitat
- Create Dual Value Habitat Areas
- Remove Overgrown Escaped Vegetation

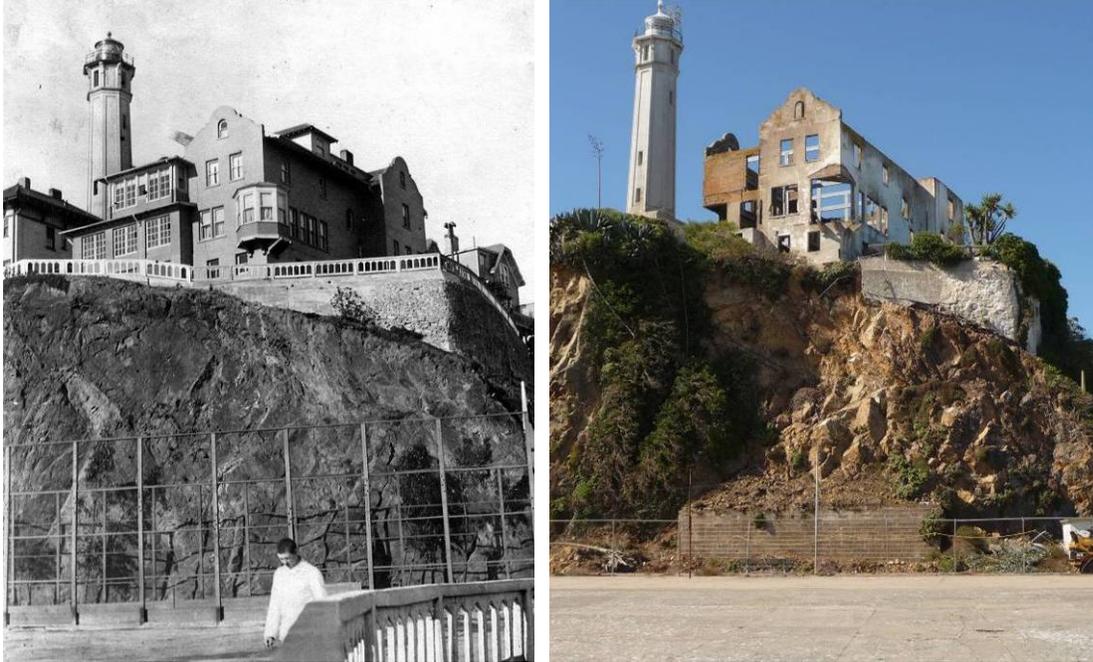
Figure 6 - 33. Repair Warden’s House retaining wall and decorative concrete railing: left. Repair Escarpment Slope. (c1920s) (source: GOGA-2316); right, (2009) (MBD P1020879.jpg)

- Repair the slope to stabilize the existing material; to ensure the long-term protection of the Summit’s cultural resources as well as the protection of the slope itself; and to restore the slope’s historic appearance.

- Use accepted engineering methods that include fill, tie-backs, soil nails, colloidal rock, polyurethane resin, rookery facing, rock bolts with shotcrete, and sculpted concrete. These offer a broad choice of methods for use in the underlying structure that is not visible.

- On the exterior of the slope, use only materials that provide a compatible, authentic appearance. Use of natural materials is preferred on the exterior (visible) face of the escarpment slope as it will achieve an authentic appearance.

- Repair concrete wall and restore the decorative concrete railing along the top of the escarpment slope. Ensure that restoration includes measures to address life safety and building code for the wall and railing.

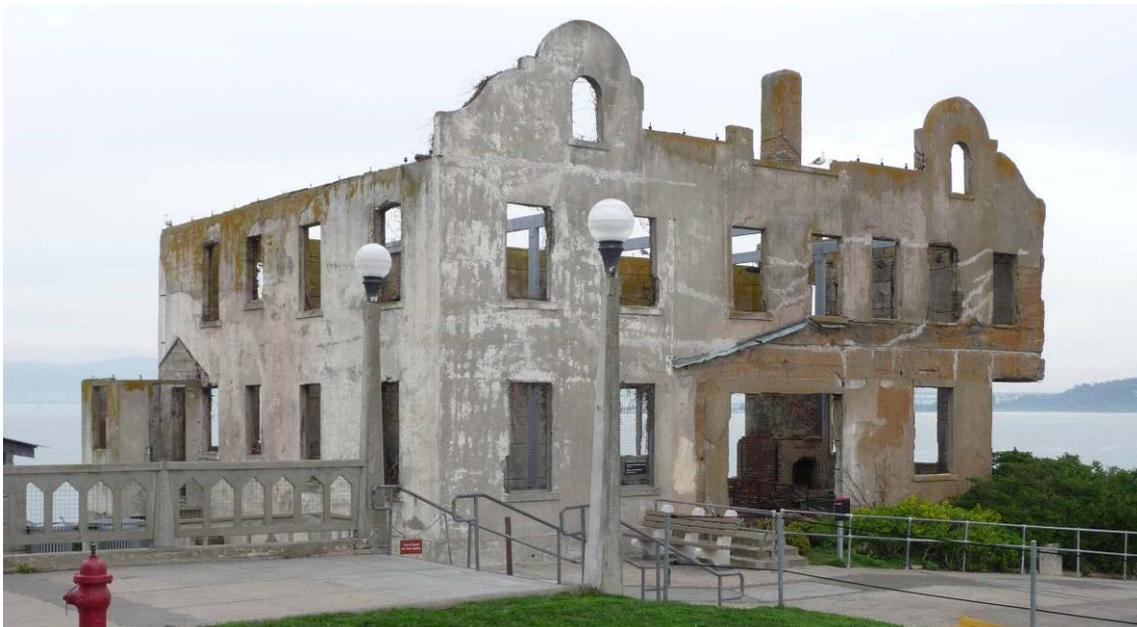
Figure 6 - 34. Repair Warden’s House building walls and foundations and add interior first floor deck to allow for visitor access. Remove non-contributing light pole, hand railing, and railing. Replace hand railing with railing that is compatible with historic character. (2010) (MBD P1030902.jpg)

- Remove escaped vegetation including English, Algerian and Cape Ivy from the building interior.
- Repair the Warden's House building walls and foundation as needed to stabilize the building and to allow for visitor access. Allow visitor access into the first level via a new deck suspended on the foundation walls and set at the buildings' original first floor elevation.
- Repair all extant historic staircases and decorative railings, and walls associated with the Warden's House.
- Repair the Warden's House Retaining Wall and decorative concrete railing (SR35). Restore all extant historic paving.

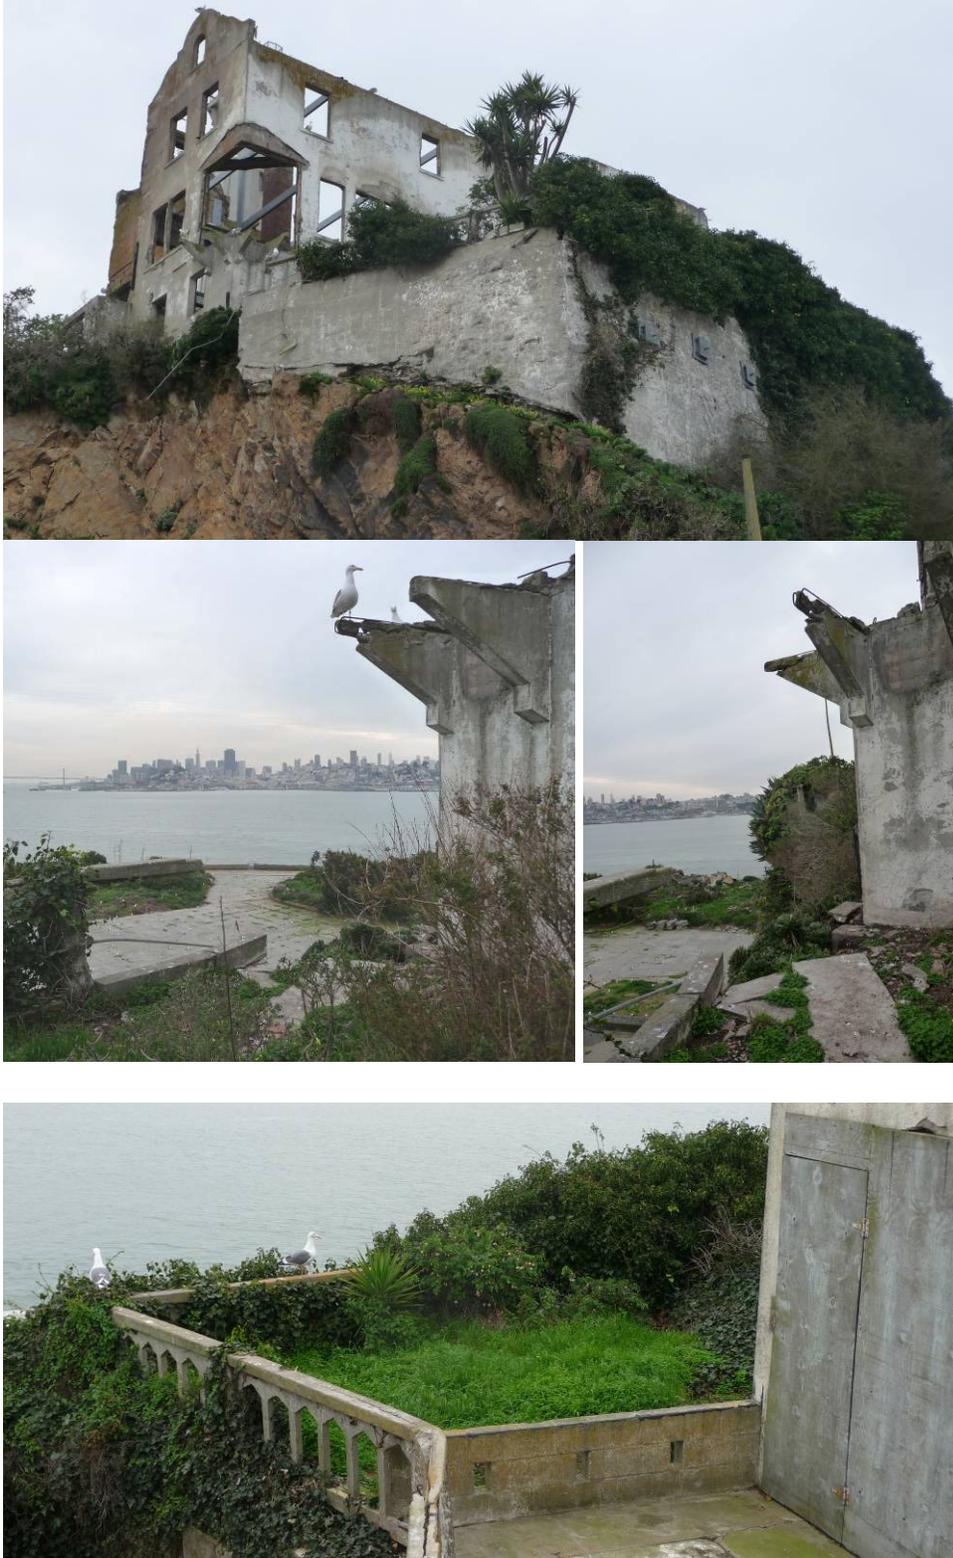
Figure 6 - 35. Repair the Warden's House building walls and foundations. Repair Retaining Wall and decorative concrete railings. (c 2010) (source: MBD); (P1030788.JPG, P1030892.JPG, P1030896.JPG, P1030884.JPG)

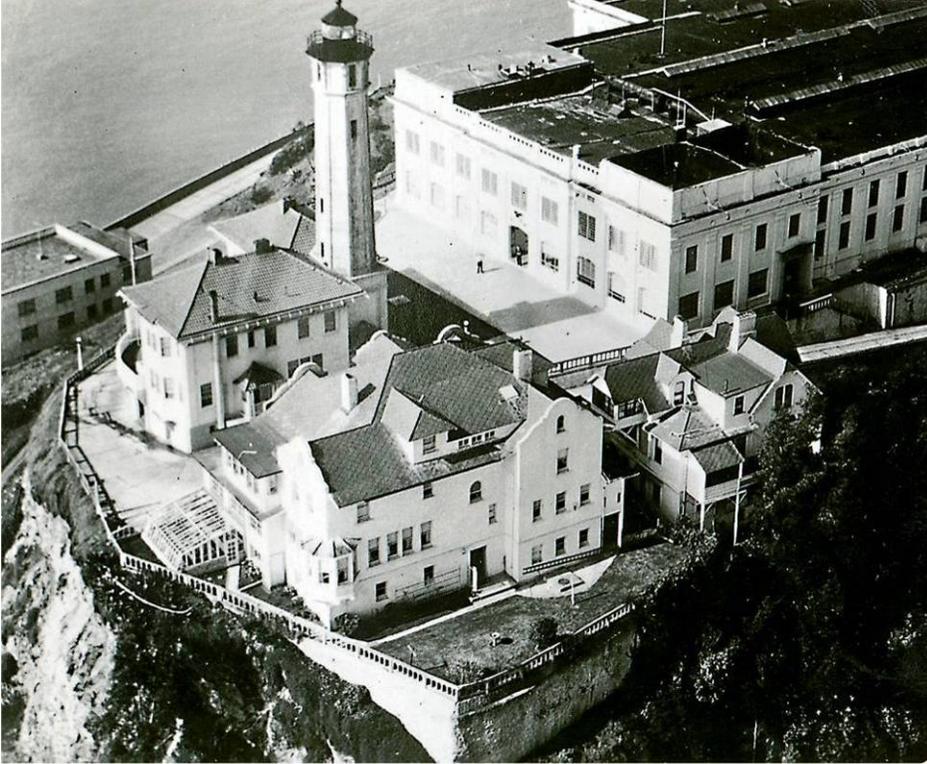
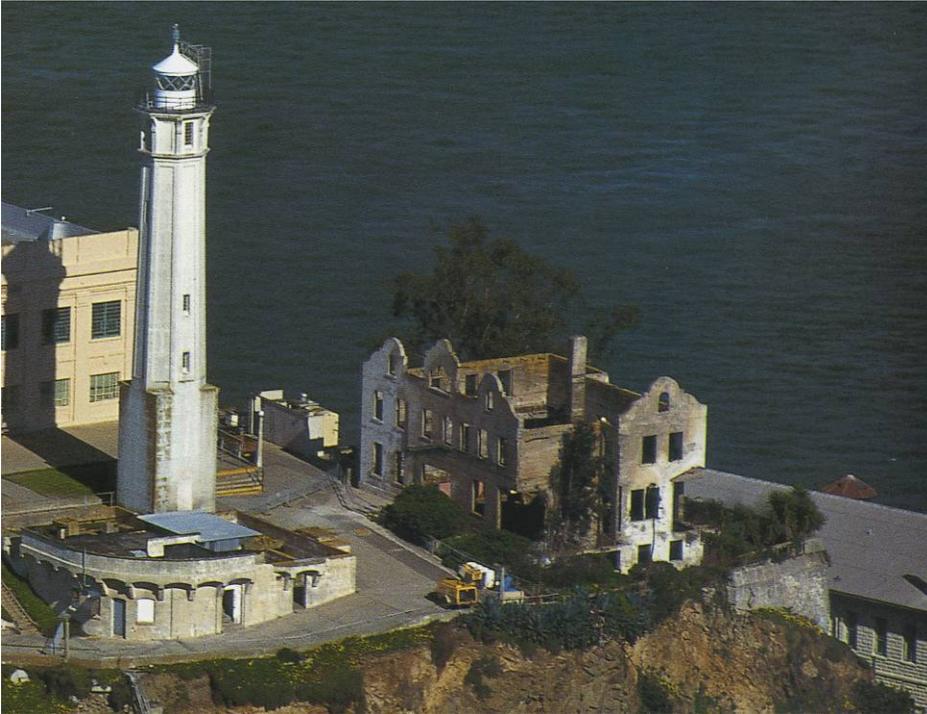
Figure 6 - 36. Repair east portion of Warden's House Garden and rehabilitate west portion for waterbird habitat. Remove restroom and restore Officers' Quarters 7 footprint; top, (c 1950) (wardens hse aerial (AAA).jpg); bottom, (2000s) (Summit-South Terrace_2000s)

- Remove escaped vegetation including English, Algerian and Cape Ivy.
- Repair the garden as a dual value habitat area, allowing for new plantings for waterbird habitat and that will also reflect the garden's historic character. Restore extant historic vegetation, and plant non-historic species to provide structure and density for Black-crowned Night Heron habitat.
- Conduct further investigations to document the extent of extant historic features and their condition.

- Repair extant paving, edging and portions of the lawn in the garden on the east half. Repair the Warden’s House Wall and restore the concrete decorative railing (SR35) that surround the garden.
- Maintain the west portion of the extant historic lawn, and allow the lawn to go dry during the summer. Focus historic plantings in the west half of the garden.
- Allow the east half of the Garden to serve as Black-crowned Night Heron habitat. Plant species such as mid-level mounding shrubs to maintain structure and diversity. Allow for shrubs of a mid-level height that may include Gardenia Rose (a historic species), and yucca.
- Repair Warden’s House Greenhouse Garden on the building’s south side. Maintain all extant historic features associated with the Warden’s House Greenhouse Garden. Remove *Coprosma repens* (mirror plant).

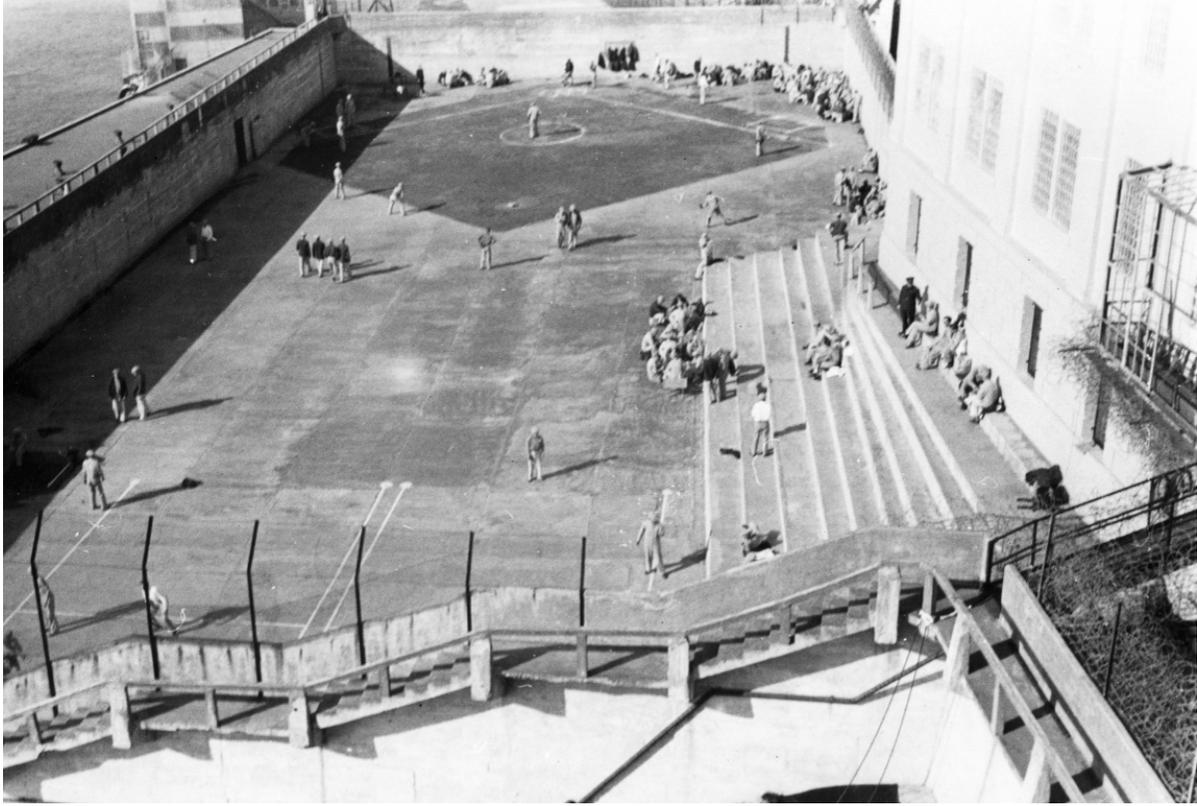
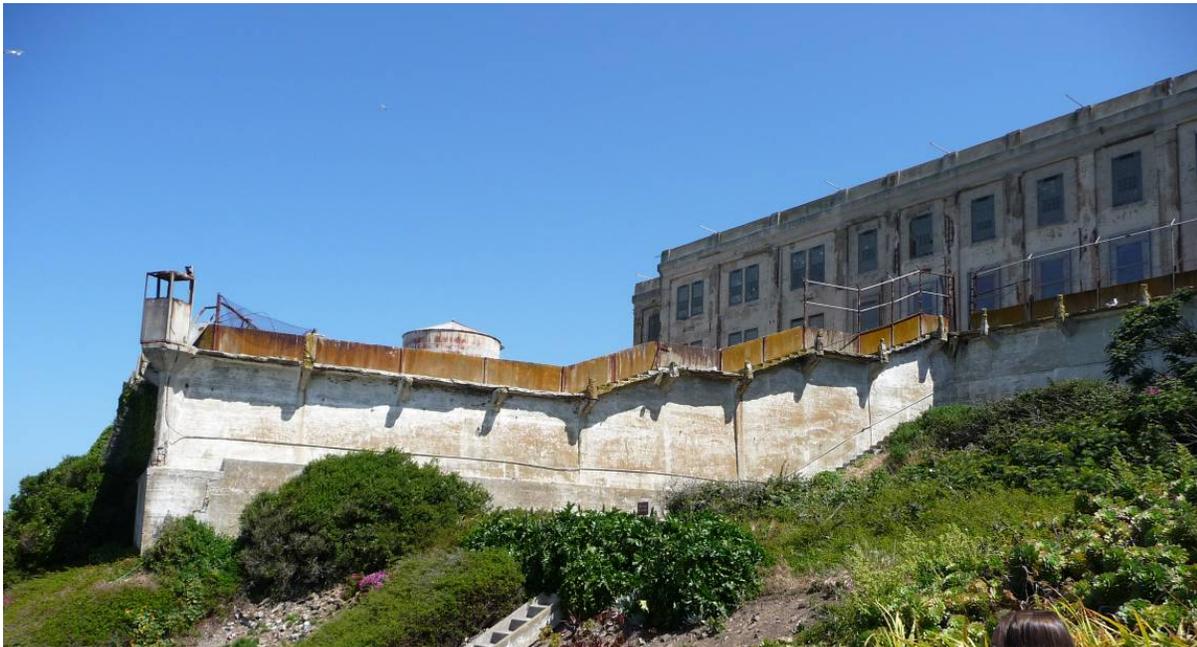
Figure 6 - 37. Repair Stockade/Recreation Yard Wall. Repair extant Sentry Walk railings, fencing, and restore missing sections. Restore dirt ballfield: top, (c Federal Penitentiary Period) (source: GOGA) (GOGA 19200-340 Recreation Yard.tif); bottom c 2009 (MBD P1000645.JPG)

- Restore two Guard Stations on the Stockade/Recreation Yard Wall; one at northeast corner and the other at the southwest corner. Allow for the non-extant Guard Station at the northwest corner to be restored.
- Repair the walls and Catwalk on top of the walls of the Stockade/Recreation Yard. Repair extant section of railings SR53 and Security Fence SR52; and restore missing sections of each to reflect the historic appearance of the Federal Penitentiary period.
- Repair the surface and all extant historic features associated with the Dirt Ball Field.
- Maintain all paving including the paving in the main portion of the yard and at the building entrance. Restore Pavement Markings to reflect the historic appearance.

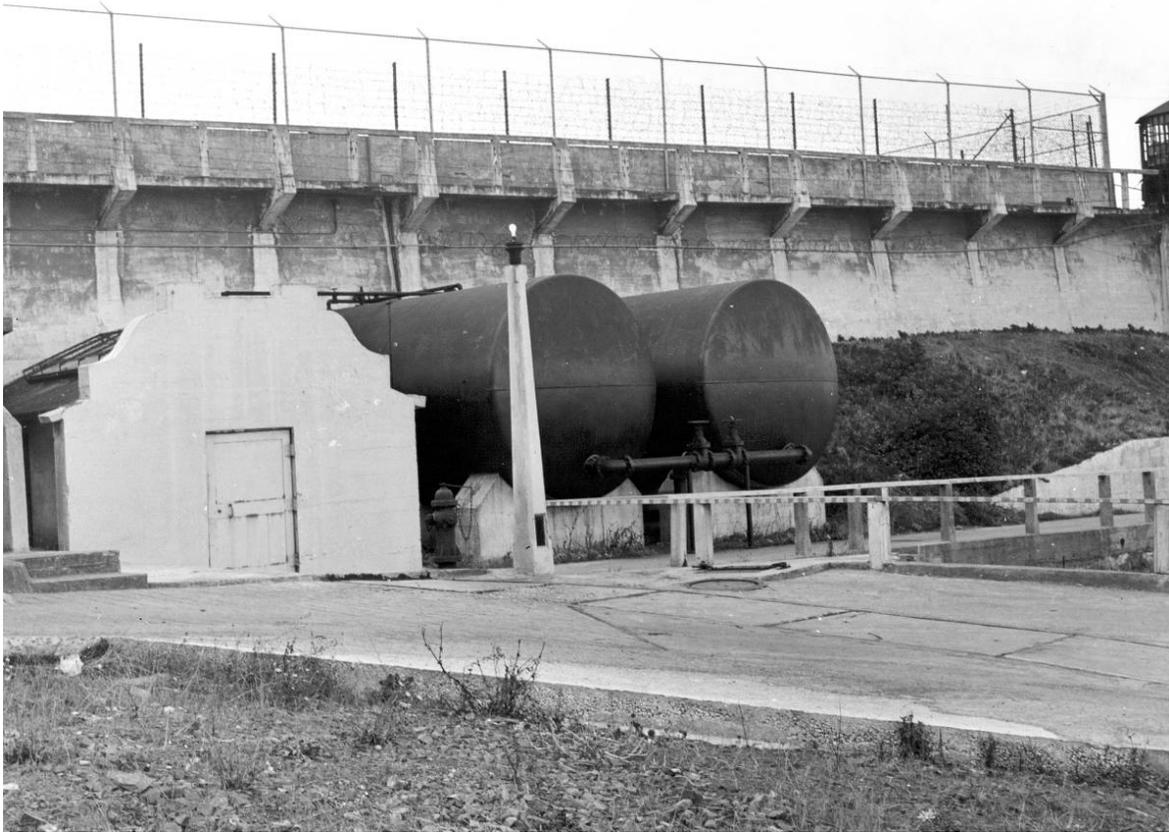
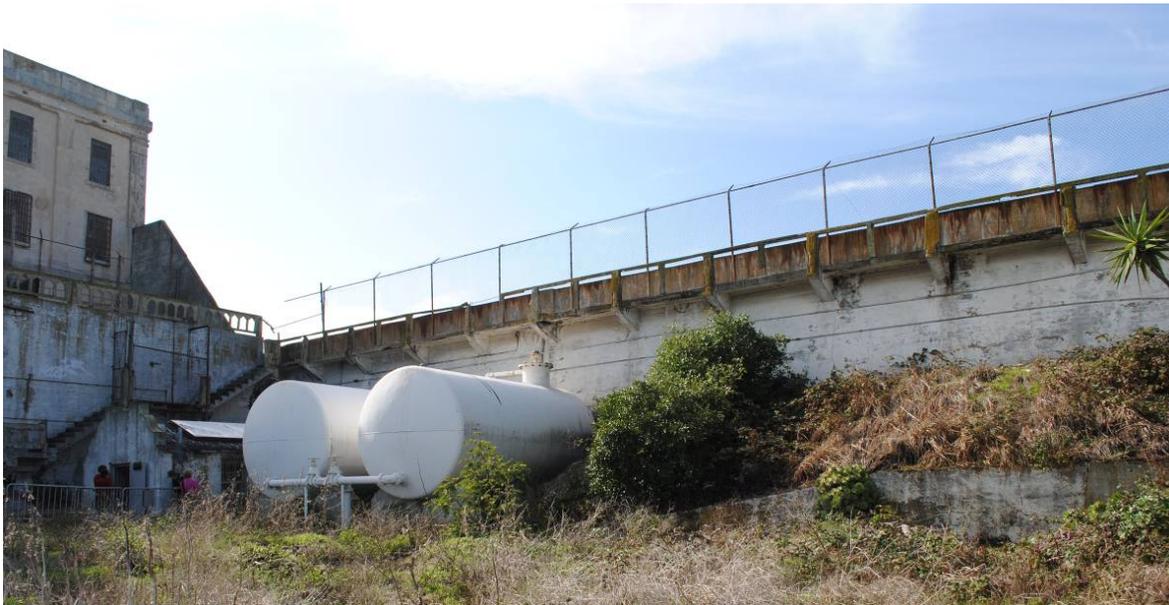
Figure 6 - 38. Repair Sentry Walk railings, walkway and fencing and restore missing sections on Stockade/Recreation Yard. Paint tank and repair Path. top, (c Federal Penitentiary Period) (Source GOGA); bottom, (2009) (MBD DSC_0096.jpg)

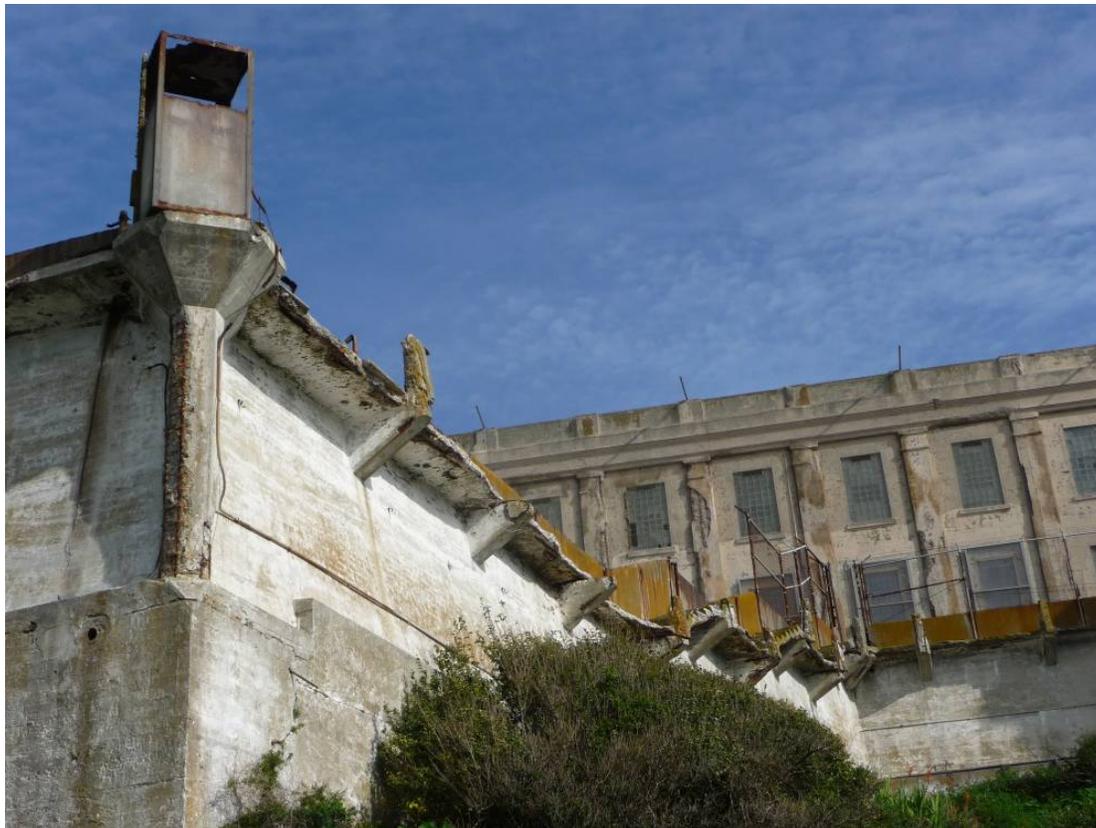
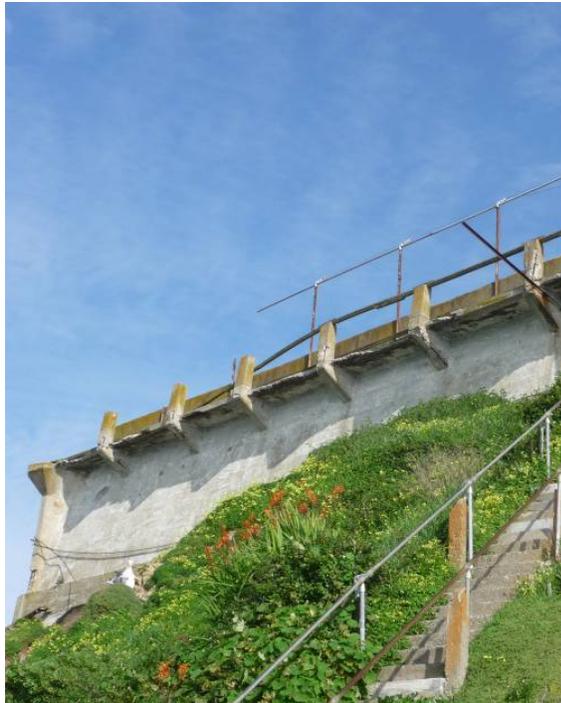
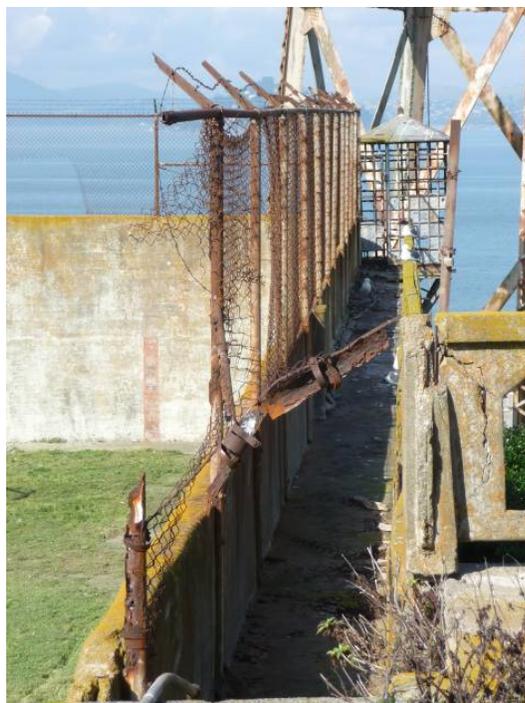
Figure 6 - 39. Repair extant features and restore missing features of Sentry Walk on Stockade/Recreation Yard Wall; restore northeast and southwest Guard Stations. (c 2009) (source: MBD); (P1040063.JPG, P1040086.JPG, P1040203.JPG)

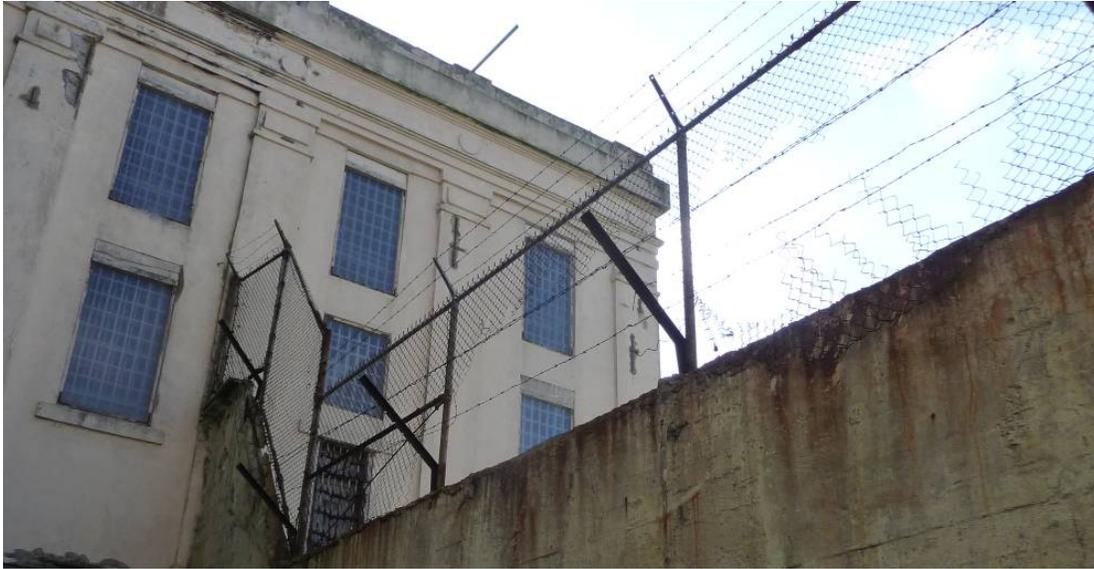
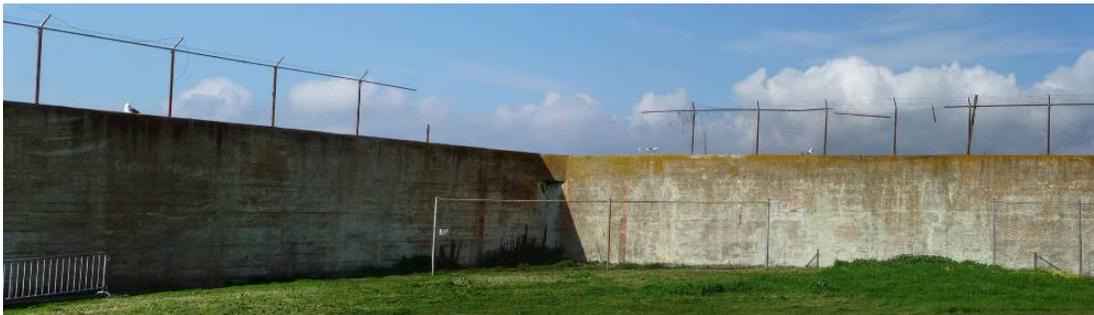
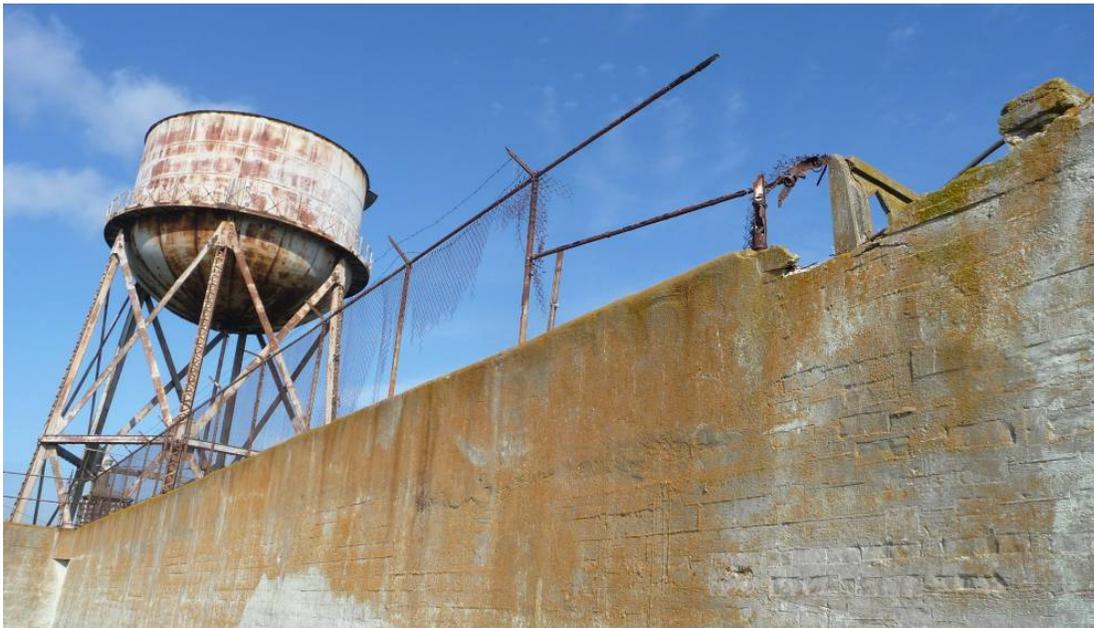
Figure 6 - 40. Repair Federal Penitentiary fences, extant features and restore missing features of Sentry Walk on Stockade/Recreation Yard Wall. Repair Water Tower. (c 2010) (source: MBD); (P1040115.JPG, Rec Yard Panorama1.JPG, P1040101.JPG)

- Repair Water Tower and railing, and all associated extant features.
- Repair concrete paving of sidewalk and concrete staircase and metal railing at base of Water Tower.

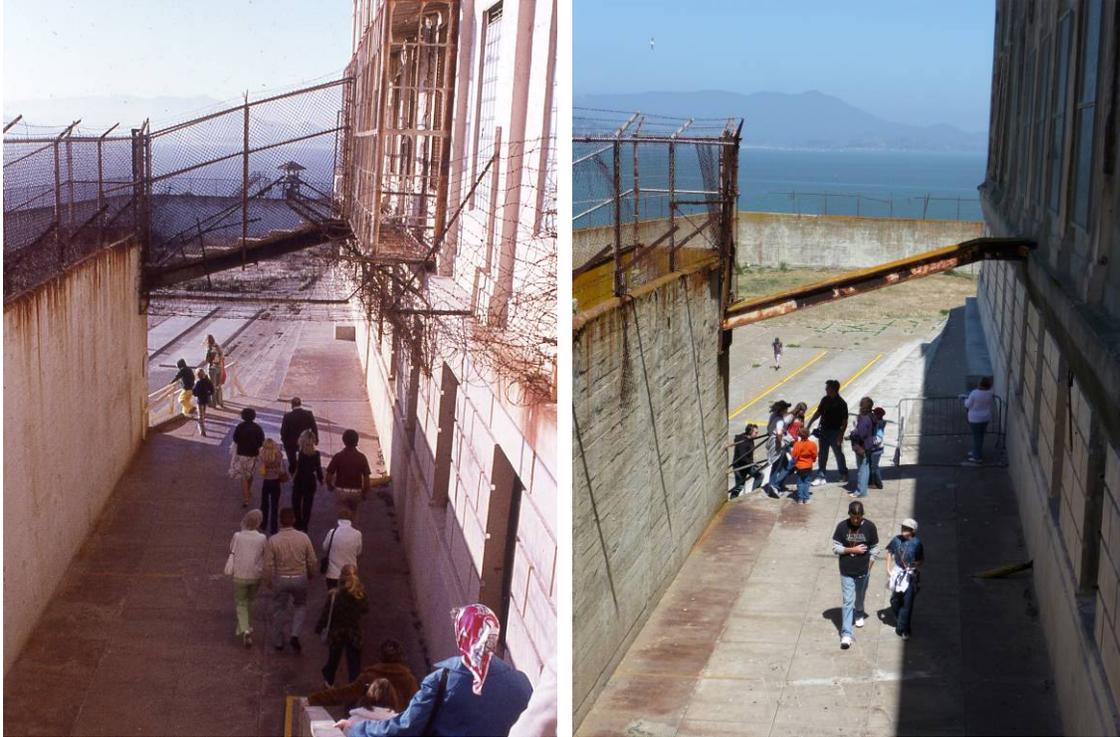
Figure 6 - 41. Restore Catwalk from Stockade/Recreation Yard to Main Prison; left, (c 1974) (Courtesy of J. Martini); right, (2009) (MBD P1000663.jpg)

- Maintain the form, spatial organization and topography of the north terrace.
- Maintain Bombproof I and its associated topography.
- Restore the Catwalk between the Main Prison and Hill Tower. Allow for a partial restoration of the catwalk that depicts its original scale, components and role.
- Restore Hill Tower including the extant footings and foundations. Allow for a full restoration of the foundation and tower, or for a partial restoration that that depicts its original scale, components and role.
- Maintain the Cistern.
- Allow seasonal closures, and maintain topography and vegetation as habitat for Western Gulls while also protecting extant historic features.
