Alcatraz Island

Treatment Recommendations

Summit Treatment Recommendations

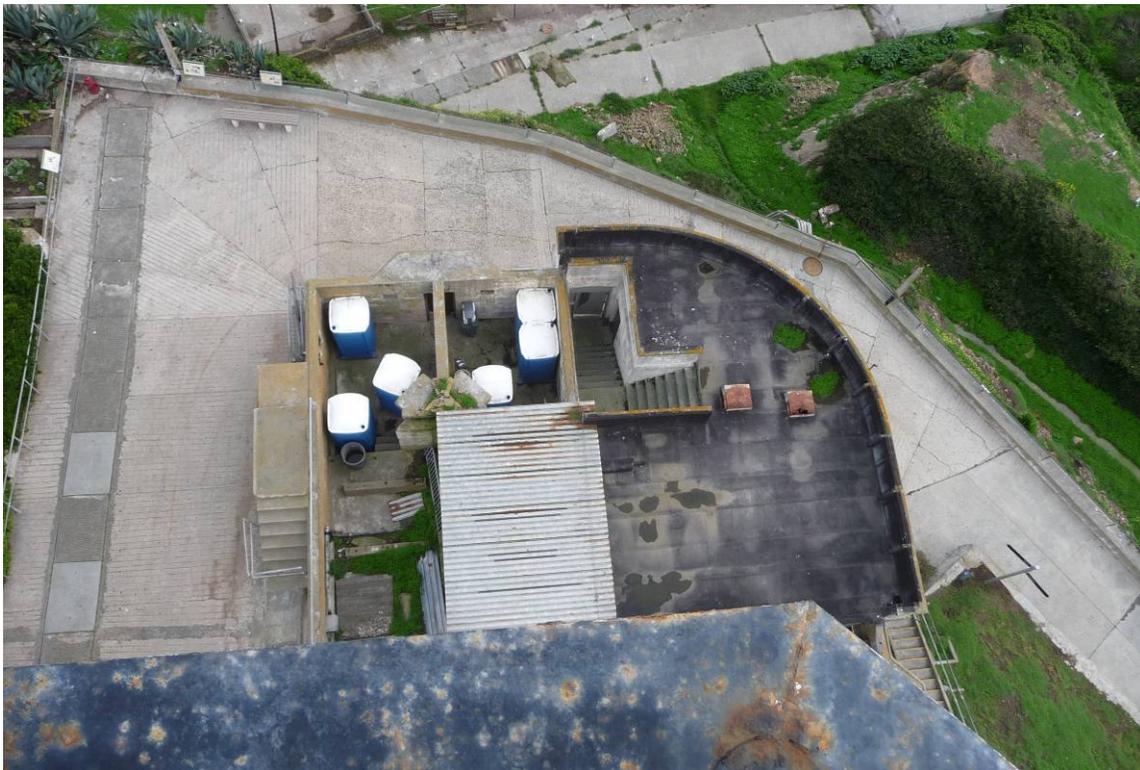
Figure 6 - 42. Maintain building walls of Lighthouse and add a deck to allow for visitor access; Remove corrugated metal roof. (2010) (MBD P1030925.jpg)

- Maintain building walls and foundation of the Lighthouse. Allow visitor access into one level. Remove corrugated metal structure and roof, and storage for port-a-potties in the

building interior. Repair extant historic staircase and railing and add a deck with railings as needed, suspended on the foundation walls, covering the extant open rooms to allow for visitor access.

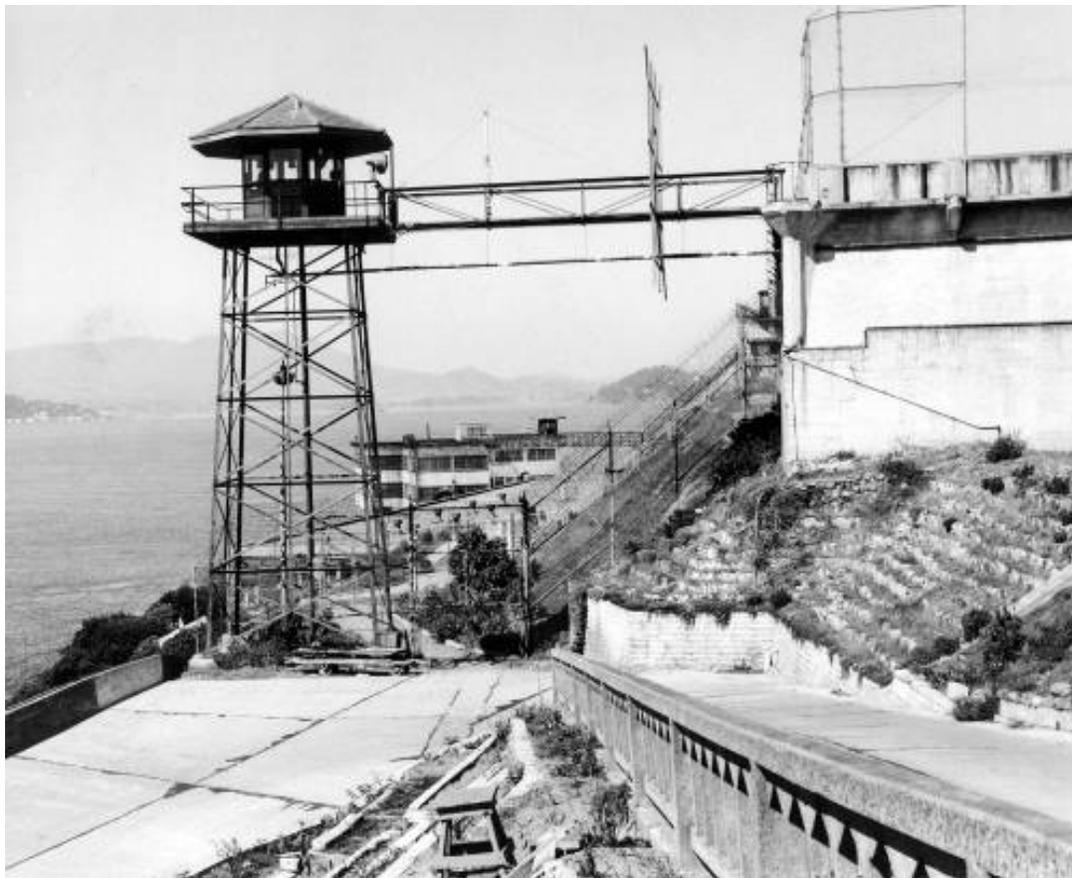
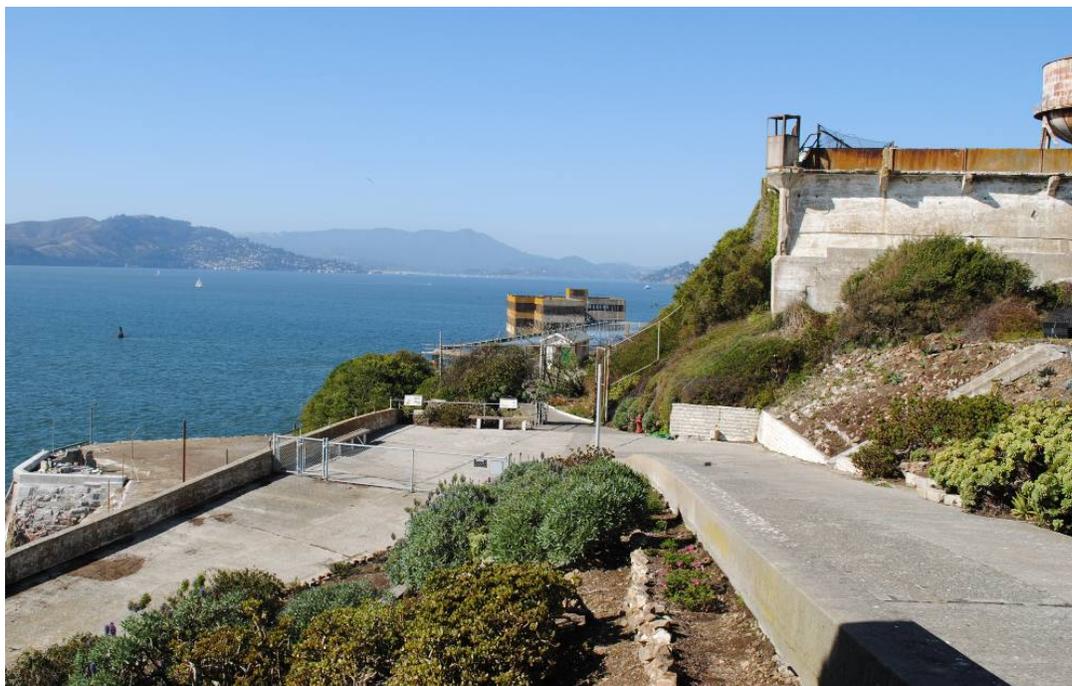
Figure 6 - 43. Restore Road Tower and catwalk to Stockade/Recreation Yard Wall; top, (c 1950) (source: GOGA-1567); bottom, (2009) (MBD DSC_0192.JPG)

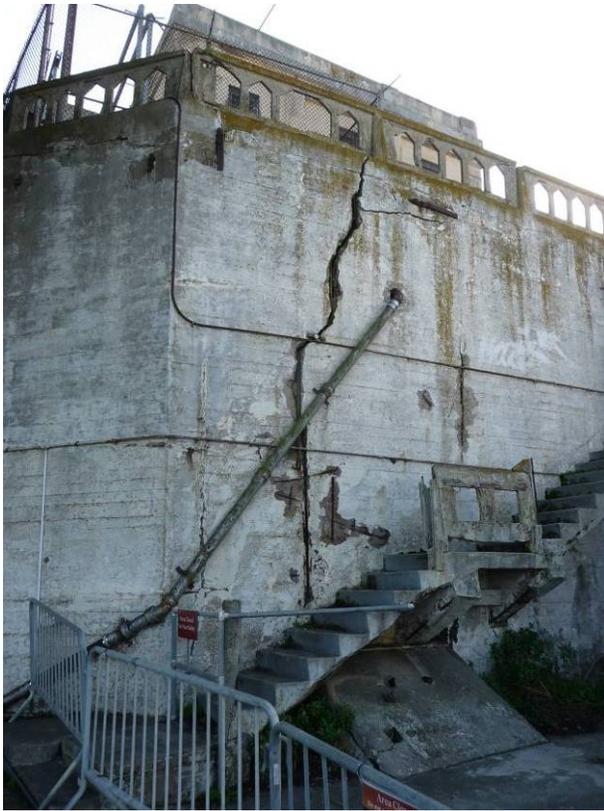
Figure 6 - 44. Repair Wall between Morgue and Main Prison (immediate need). (c 2010) (source: MBD); (P1040138.JPG)

- Repair terrace between the Main Prison and the Morgue (current route to the Main Prison’s entrance from the Main Road). Repair the Wall South of Morgue, the paving on the terrace, railings (SR50 and SR51) and the Guard Station for Kitchen Basement Sallyport. Allow for this area to be used as a site for a new restroom building in compliance with the new GMP. Maintain non-historic railing (SR45) along top of wall.
- Maintain the Morgue and Tanks, and repair walk between the Morgue and the Water Tank.
- Maintain staircases and railings that access the walkway along the east side of the Main Prison.
- Maintain paving, Staircase to Warden’s Office and associated railings, flagpole and Repair railing SR40 and maintain non-historic railing SR39 along the top of Cellhouse Slope, on the west side of the Main Prison Plaza and east of the Main Prison.

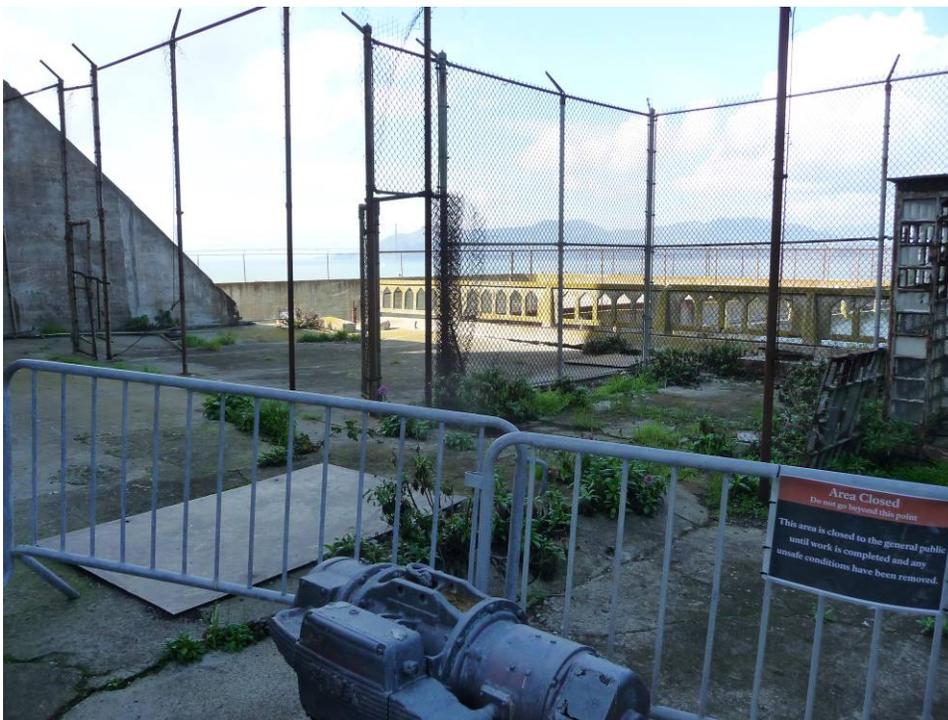
Figure 6 - 45. Repair Terrace north of Main Prison and restore railings SR50, SR51 and security fencing. (c 2010) (source: MBD); (P1040193.JPG)

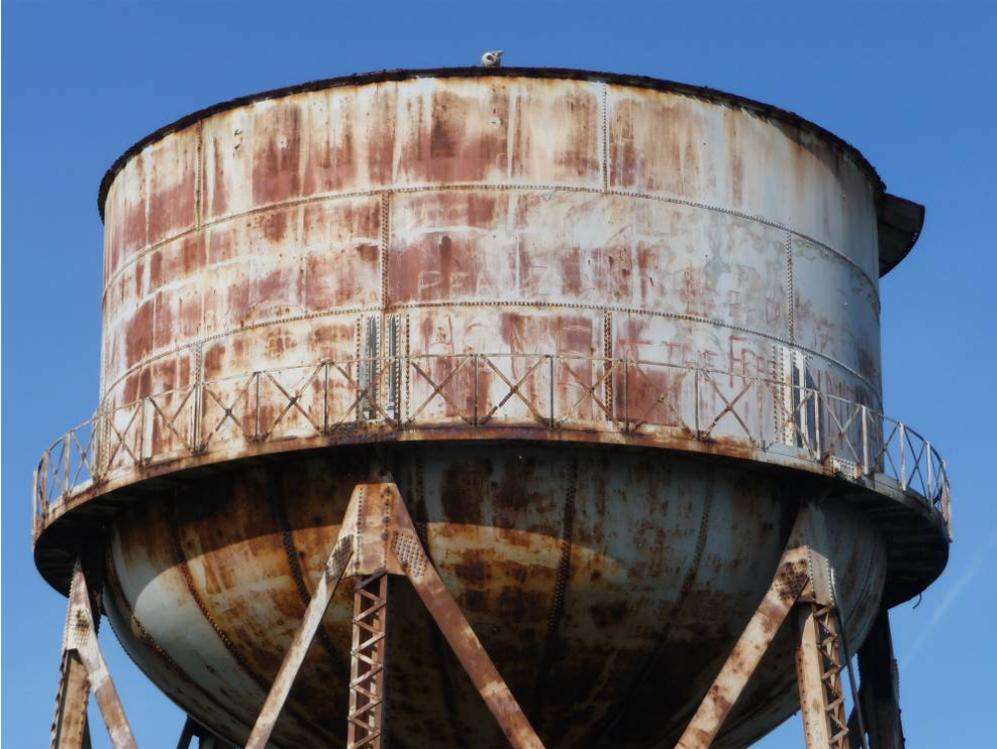
Figure 6 - 46. Repair Water Tower and restore graffiti from Indian Occupation Period (c 2010) (source: MBD); (P1040205.JPG)

- Repair Water Tower and railing, and all associated extant features.
- Repair concrete paving of sidewalk and concrete staircase and metal railing at base of Water Tower.

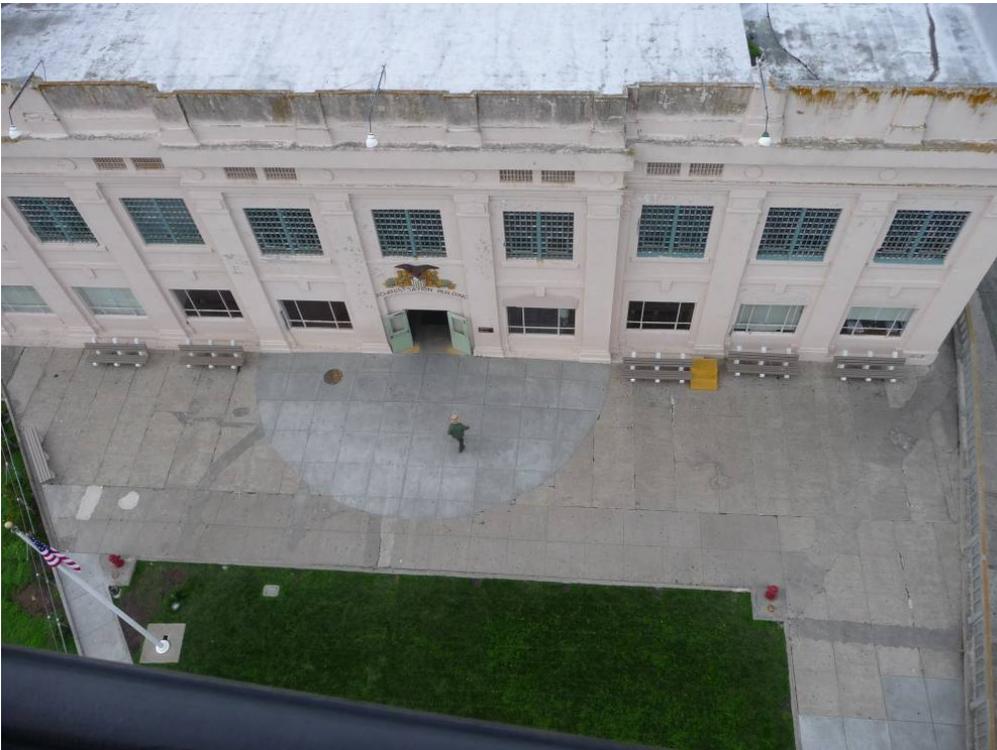
Figure 6 - 47. Maintain Main Prison Plaza paving and lawn (c 2010) (source: MBD); (P1030917.JPG)

- Restore metal post and railings at Main Prison Plaza (replacing those currently in place).
- Repair select sections of paving on Main Prison Plaza; and repair paving around Lighthouse.
- Remove non-contributing light pole (pedestrian light) at Main Prison Plaza.

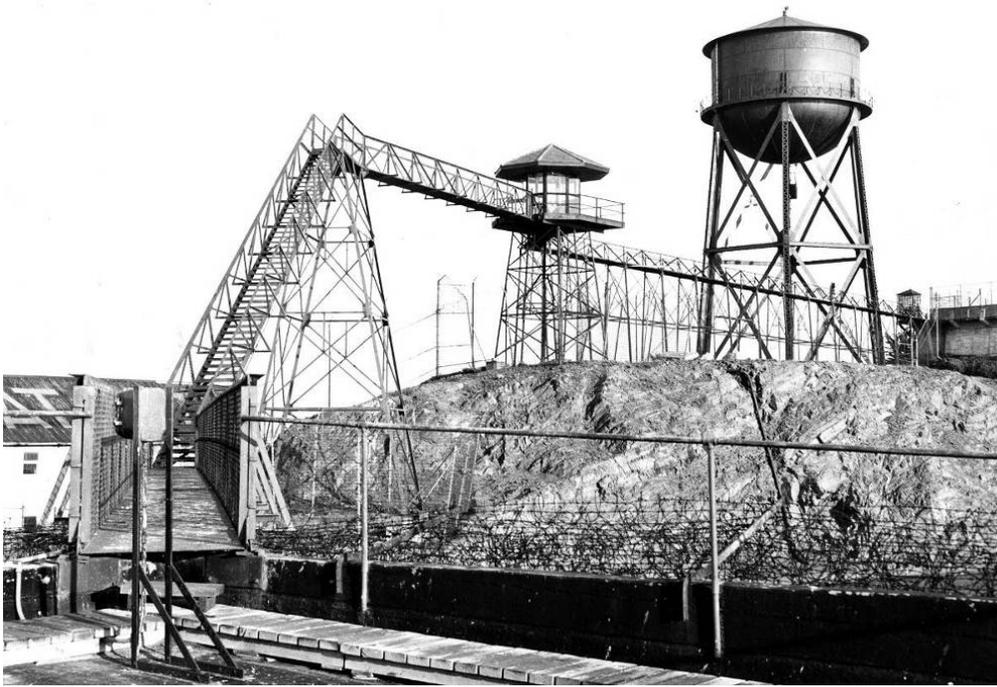
Figure 6 - 48. Restore Hill Tower and Catwalk on North Terrace; top, (c 1940) (GOGA-1567); bottom, (2009) (MBD P1020960.JPG)

- Maintain the form, spatial organization and topography of the north terrace.
- Maintain Bombproof I and its associated topography.
- Restore the Catwalk between the Main Prison and Hill Tower. Allow for a partial restoration of the catwalk that depicts its original scale, components and role.
- Restore Hill Tower including the extant footings and foundations. Allow for a full restoration of the foundation and tower, or for a partial restoration that that depicts its original scale, components and role.
- Maintain the Cistern.
- Allow seasonal closures, and maintain topography and vegetation as habitat for Western Gulls while also protecting extant historic features.
