# Officers' Row Treatment Recommendations

***Main Road – West***

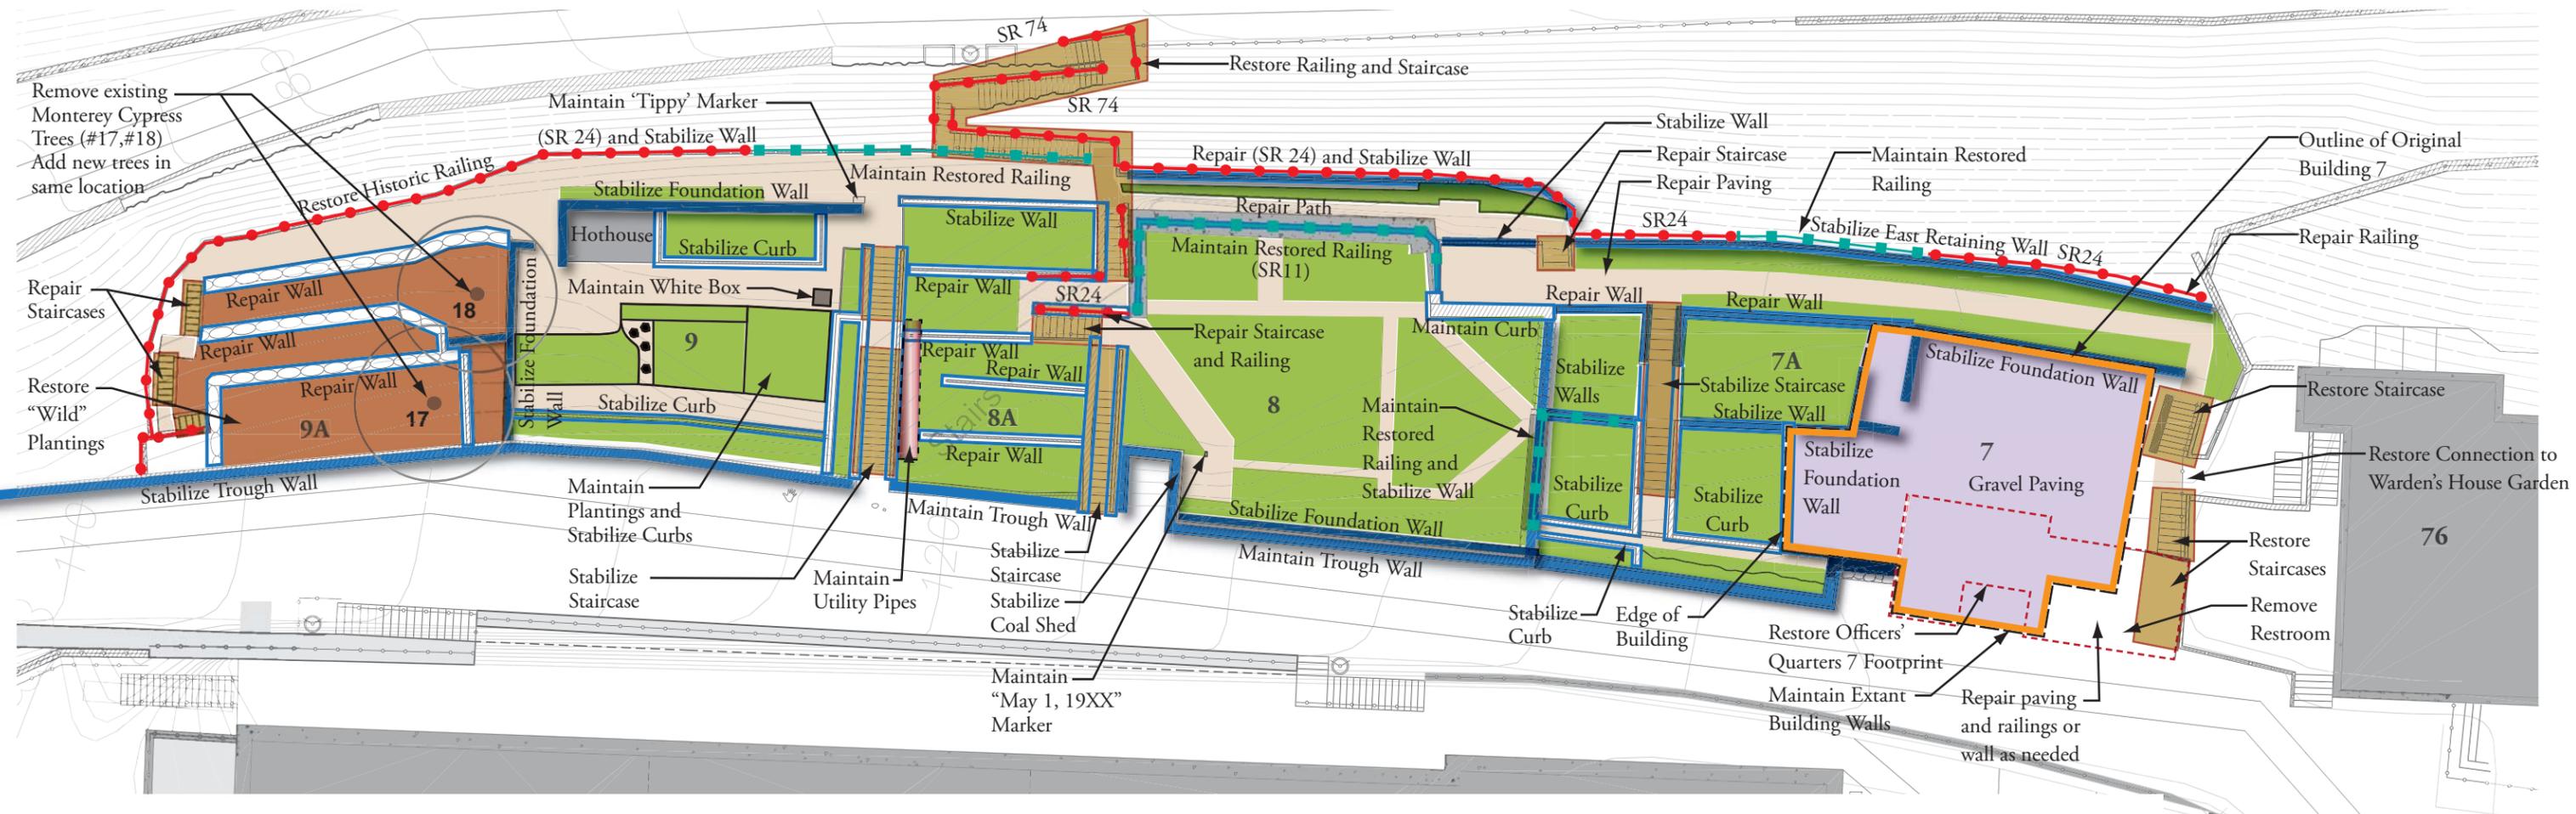
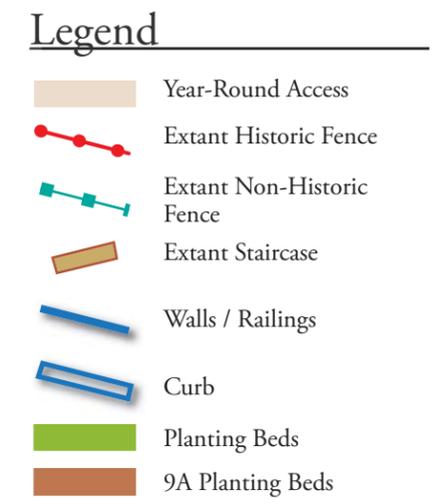
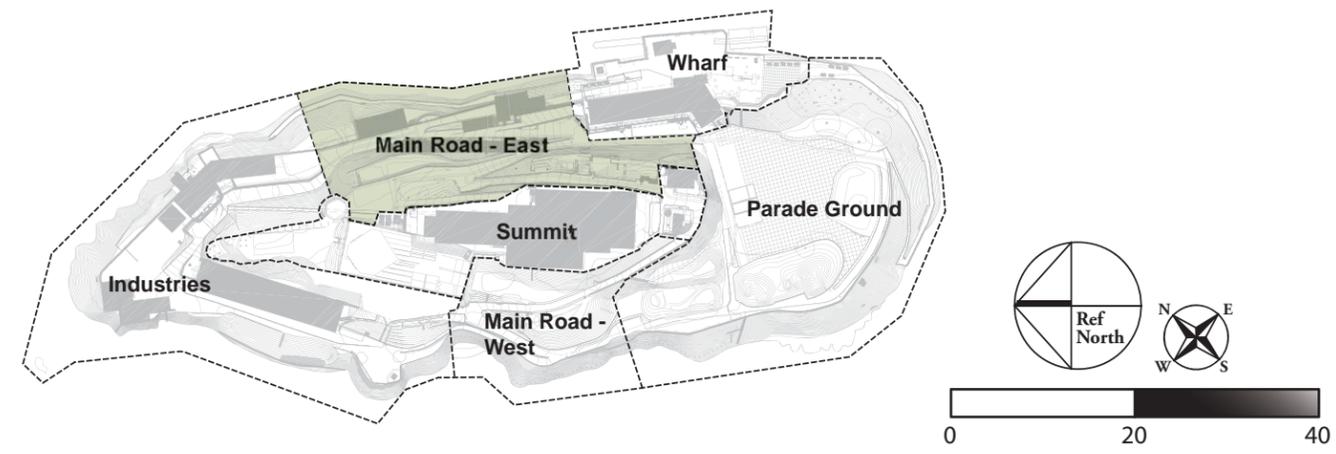
Figure 6-85

- Rehabilitate all extant contributing features associated with Officers' Row.
- Maintain the historic form, topography, and arrangement of Officers' Row.
- Allow for non-contributing compatible features such as railings and the restroom to remain and to be stabilized.

- Reflect the garden's "wild" character of the 1940s/50s at Garden Terrace 9a.
- Continue to implement 2006 Officers' Row Gardens Treatment Plan for plantings 9, 8, 8a and 7a.
- Remove non-contributing, compatible (and non-compatible) restroom and restore Officers' Quarters 7 footprint.

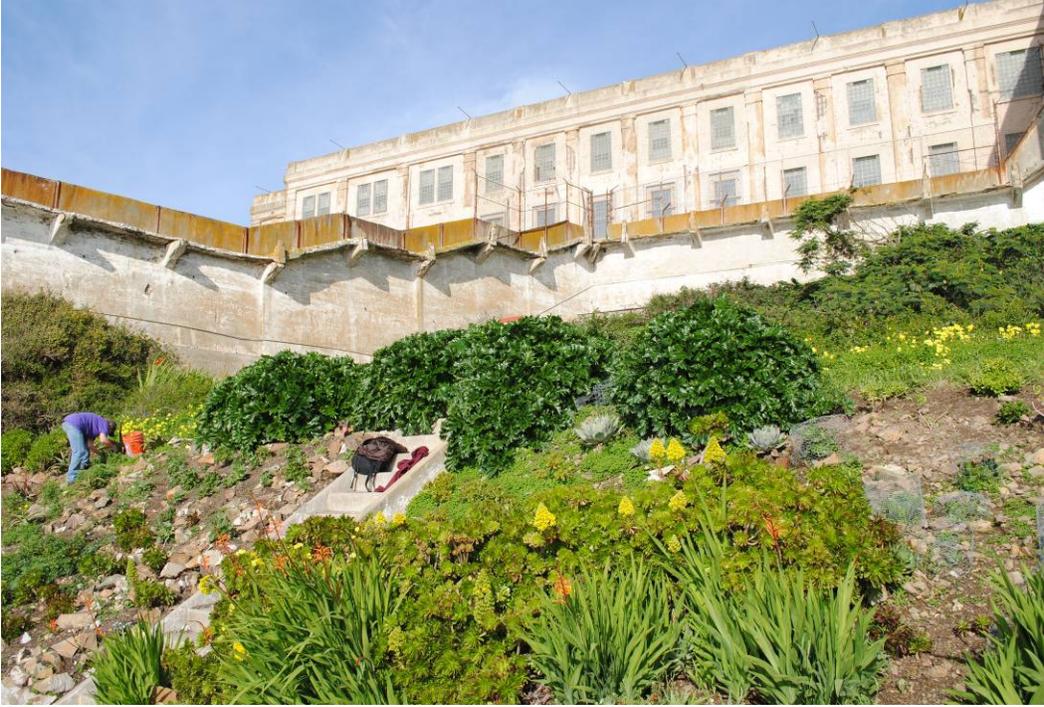
**Figure 6 - 86.** Repair West Road Terraces to Federal Penitentiary period (c 2010) (source: MBD); (DSC\_0477.jpg)

- Maintain concrete retaining wall near southwest corner of Stockade/Recreation Yard, east of New Cisterns on West Lawn - North.
- Maintain West Lawn North, including its historic form and topography, and extend lawn to edge of Stockade/Recreation Yard. Maintain new cisterns. Repair West Road Terraces and garden walls to reflect their historic appearance during the 1940s, 1950s, and early 1960s. Repair the staircase at the West Road Terraces.

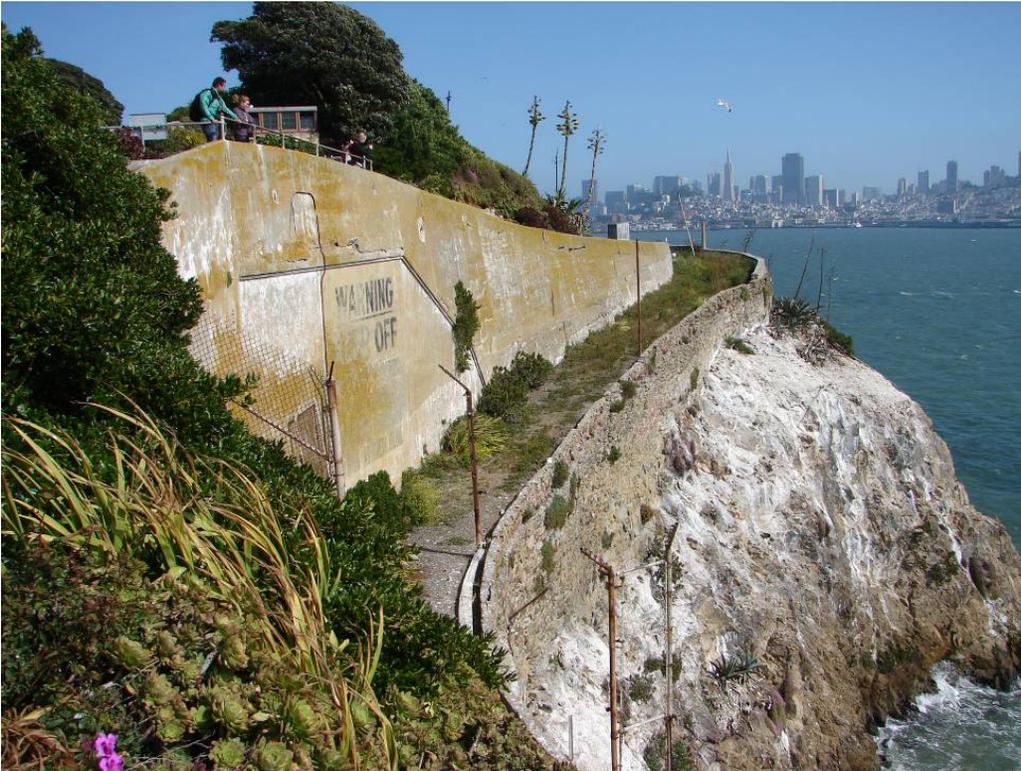
**Figure 6 - 87.** Repair Lower West Road; repair walls and maintain slope; restore “Warning” sign, Indian Occupation graffiti, and Federal Penitentiary period security fencing. (c 2009) (source: MBD); (DSC03249.JPG)

- Repair Lower West Road including the repair of the Lower West Wall and the brick wall.
- Install new Tipi at historic location on West Lawn South as placed during Indian Occupation Period. Consider elevating new Tipi to be visible over existing vegetation. Protect existing vegetation as Snowy Egret habitat. There will be no visitor access into this area.

- Stabilize the staircase and repair the walls from Upper West Road to the Toolshed (in the Toolshed Terraces). Maintain the Toolshed.
- Restore ‘Warning’ sign from the Federal Penitentiary period and repair the paint and graffiti on the wall below the Road Tower from the Indian Occupation period.
- Consider restoring the Road Tower and Catwalk to the Stockade/Recreation Yard to its fullest extent including all of the original elements. At a minimum, restore these features to a level adequate to evoke the mass, scale and use of the original Road Tower and Catwalk.

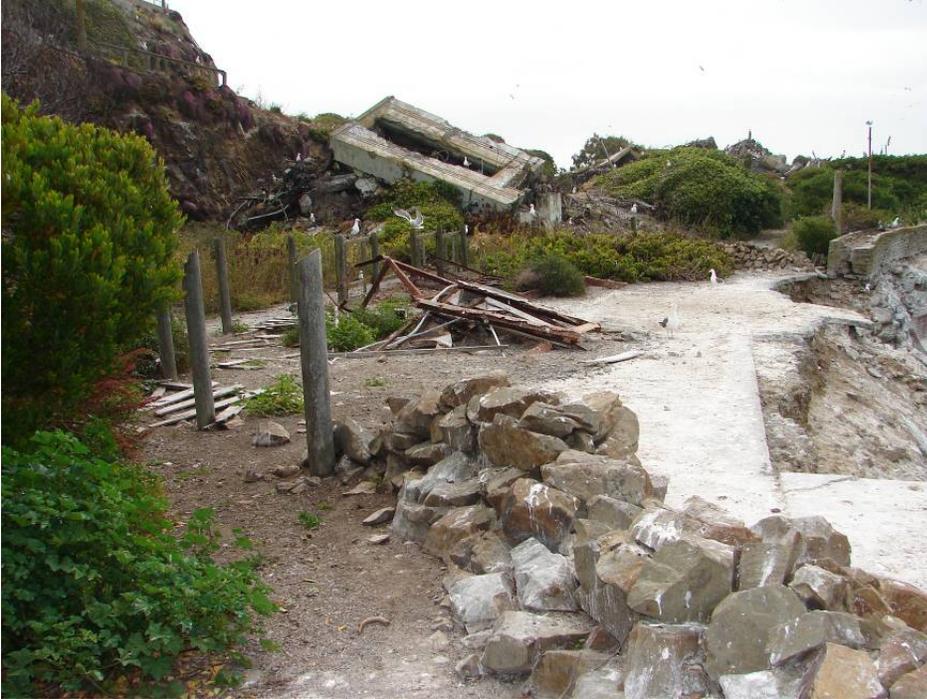
**Figure 6 - 88.** Repair Road to Parade Ground and stabilize wall. Remove debris and wooden safety posts, and provide new safety railing. Stabilize eroding slope. (c 2009) (source: MBD); (DSC03283.JPG)

- Repair the Road to Parade Ground including the repair of the concrete wall at the base of the Toolshed Terraces, the concrete rubble wall below the Snowy Egret habitat, and the brick retaining wall along the west edge of the road. Remove the observation blind.

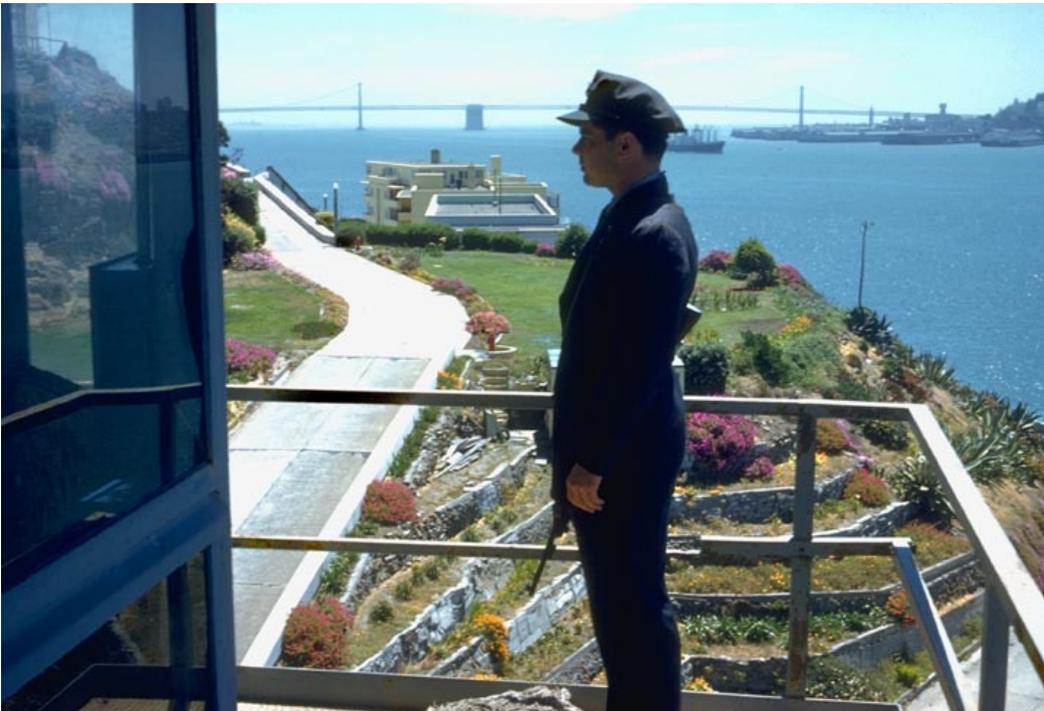
**Figure 6 - 89.** Repair Toolshed Terrace walls and concrete curb along Upper West Road. Restore perennial borders at West Lawns (along road), and vegetation in Toolshed Terraces. (c 1950s) (source: Parks Conservancy); (west side 1950s william long jr (goga35178).jpg)

- Repair Toolshed Terrace walls and gardens to reflect their historic appearance during the 1940s, 1950s, and early 1960s.
- Restore Federal Penitentiary period small scale features including security fencing (SR61), pedestrian lighting, staircases, railings and walks.

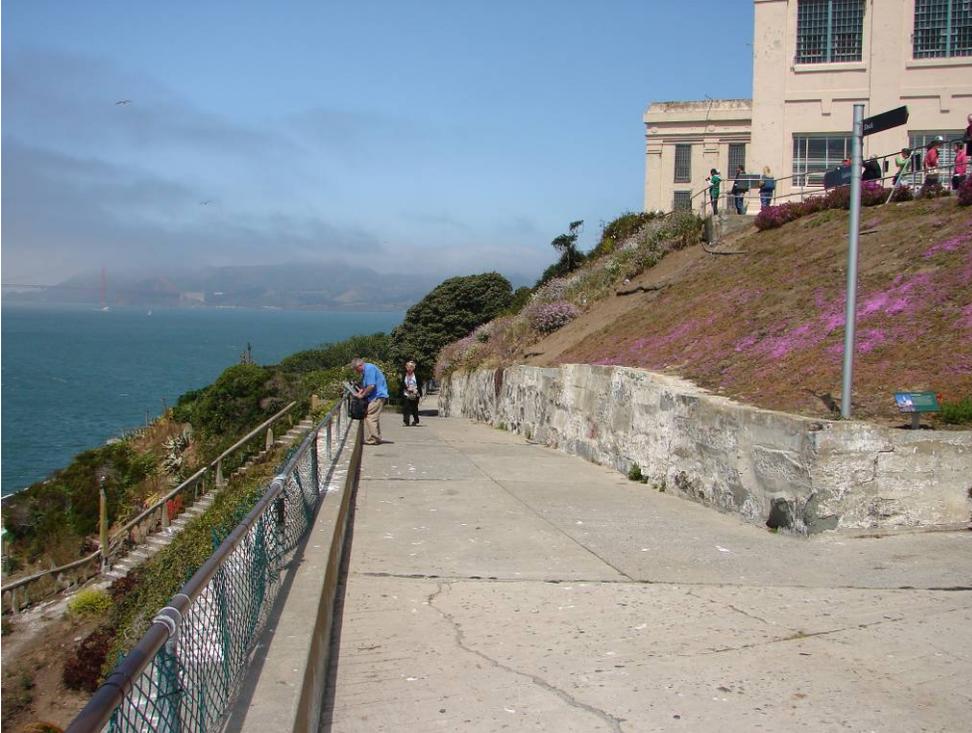
**Figure 6 - 90.** Maintain Upper West Road and repair Cellhouse Slope, curb and wall. Provide new compatible railing to improve visitor safety. (c 2009) (source: MBD); (DSC03249.JPG)

- Maintain the Upper West Road. Repair the curb and wall at the base of the Cellhouse Slope, the wall on the west side of the Upper West Road, and the curb above the Toolshed Terraces.

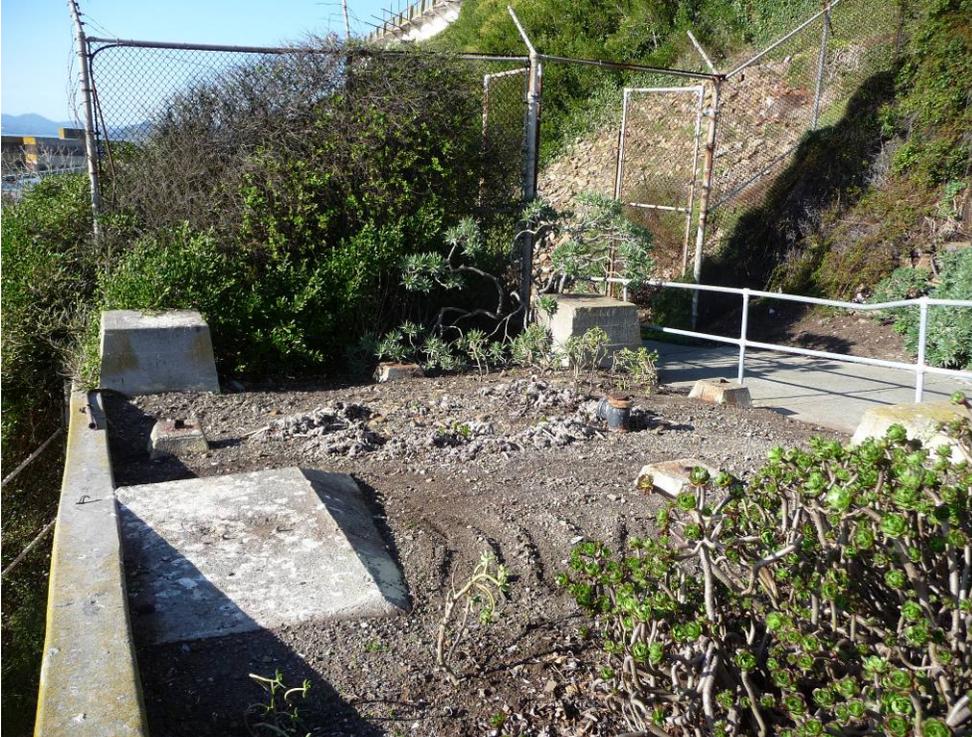
**Figure 6 - 91.** Restore the Road Tower and the Catwalk to Stockade/Recreation Yard. Repair Federal Penitentiary period fencing. (c 2009) (source: MBD); (P1030052.JPG)

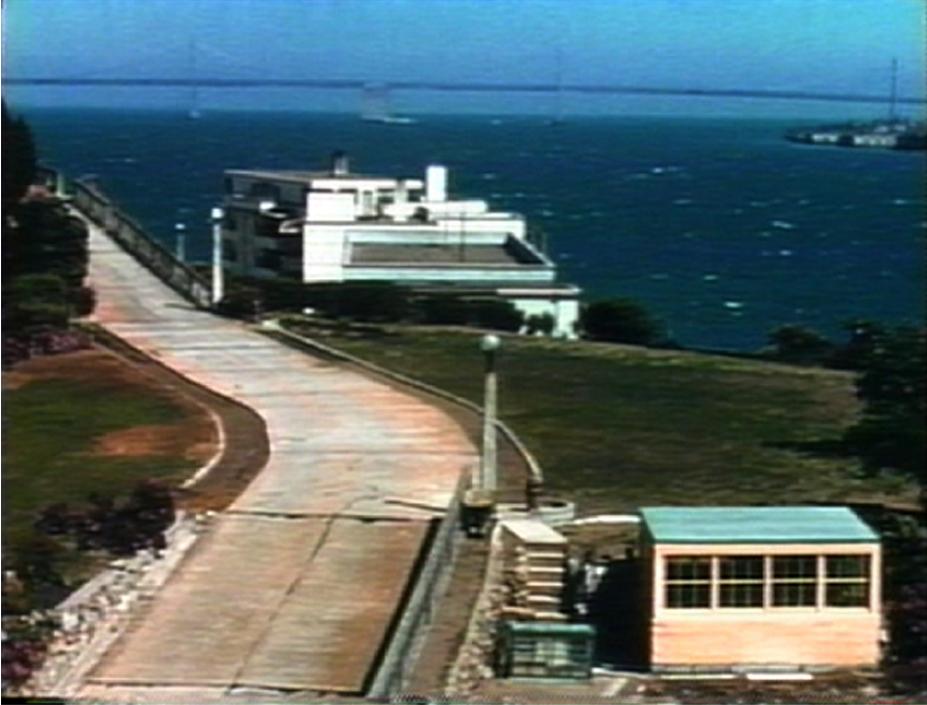
**Figure 6 - 92.** Maintain Toolshed and stabilize staircase from Upper Main Road to Toolshed. Restore Federal Penitentiary period security fencing and pedestrian lighting. Note: Treatment for West Lawn South differs from historic condition and photo. (c 1950s) (source: Phil Bergen's Video Stills (1955)); (DVD Movie Segment#10A.jpg)

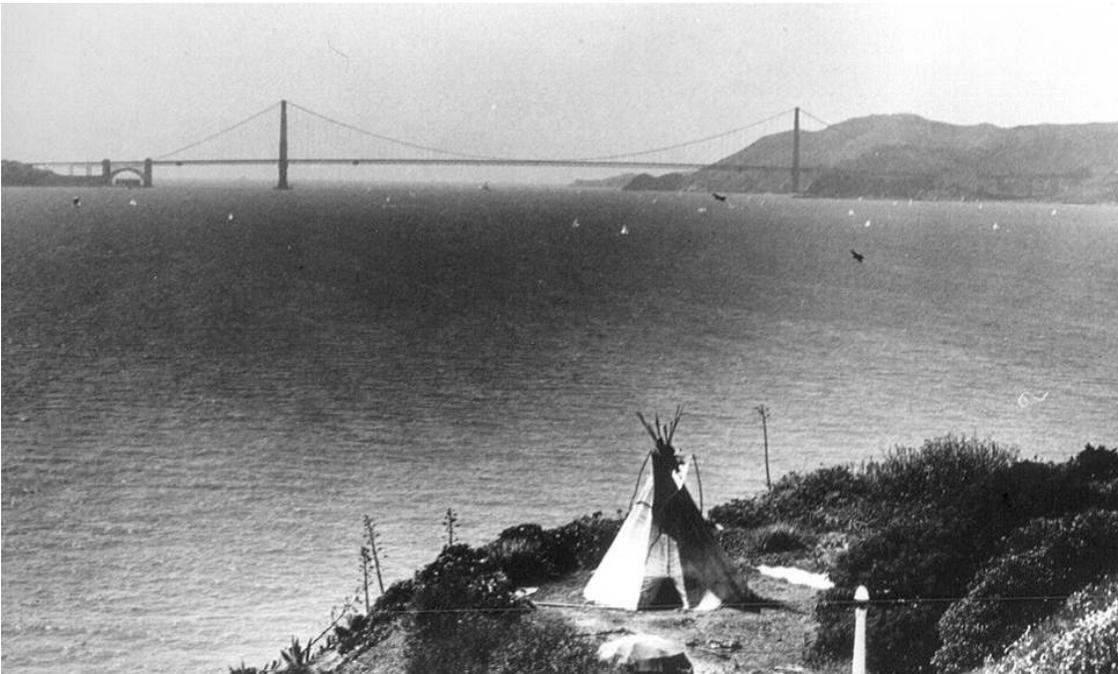
**Figure 6 - 93.** Add new Tipi structure only, to depict the historic tipi from the Indian Occupation period. Locate in area similar to historic location. Do not allow visitor access. Maintain vegetation for Snowy Egret habitat. (c 1970) (source: Parks Conservancy); (Tipi on West Road, occupation (GOGA Denevi).jpg)

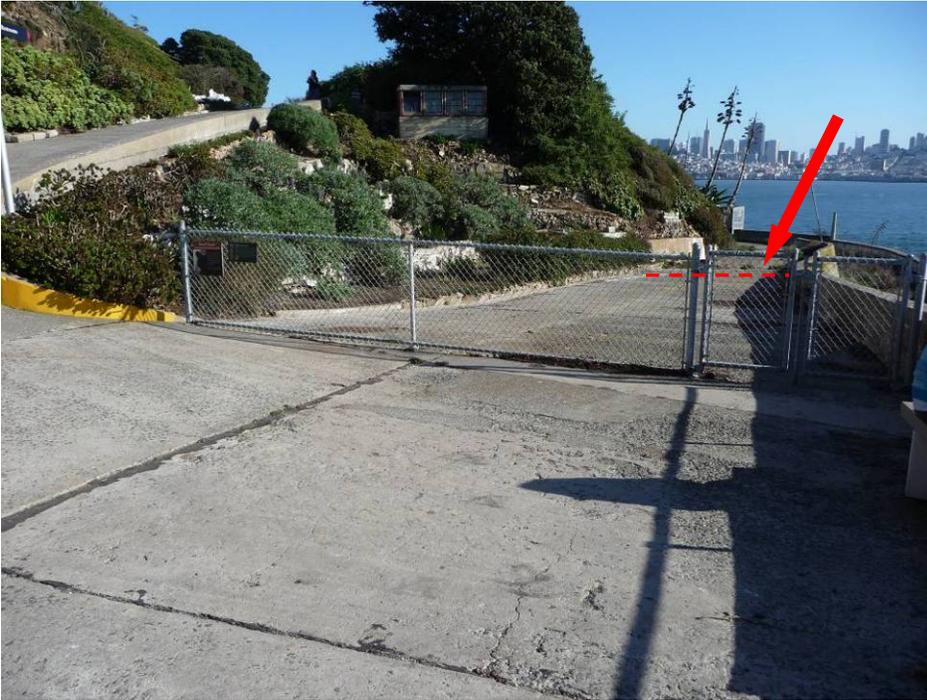
**Figure 6 - 94.** Relocate gate south to west edge of Toolshed Terraces. Allow year round visitor access up to gate and around Toolshed Terraces. New gate location indicated by red dashed line and arrow. (c 2009) (source: MBD); (P1030047.JPG)

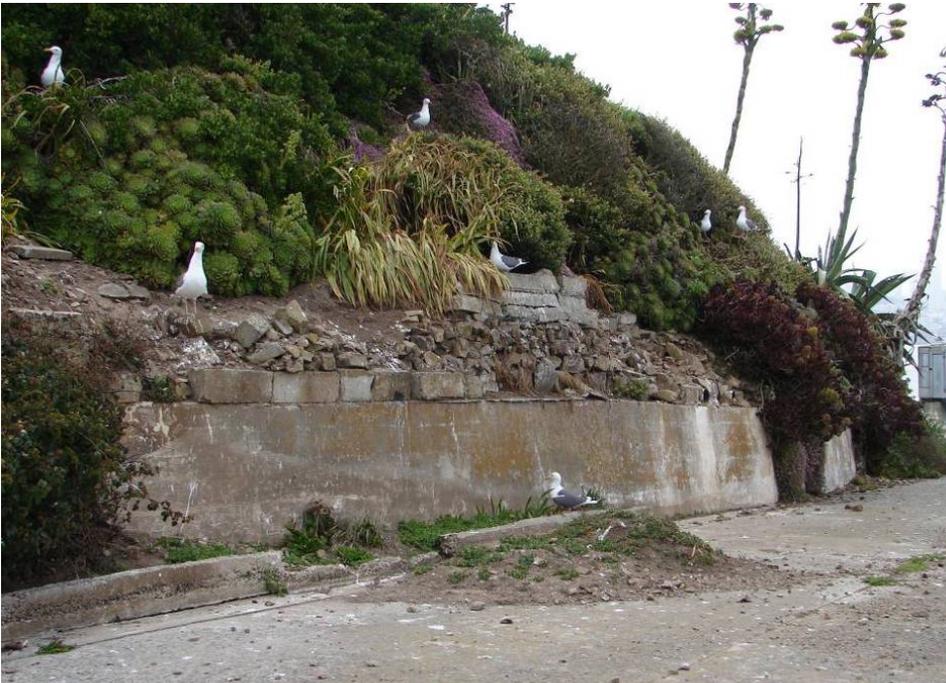
**Figure 6 - 95.** Repair concrete rubble wall and Road to Parade Ground curb. Remove debris and maintain vegetation for waterbird habitat. (c 2009) (source: MBD); (DSC03273.JPG)

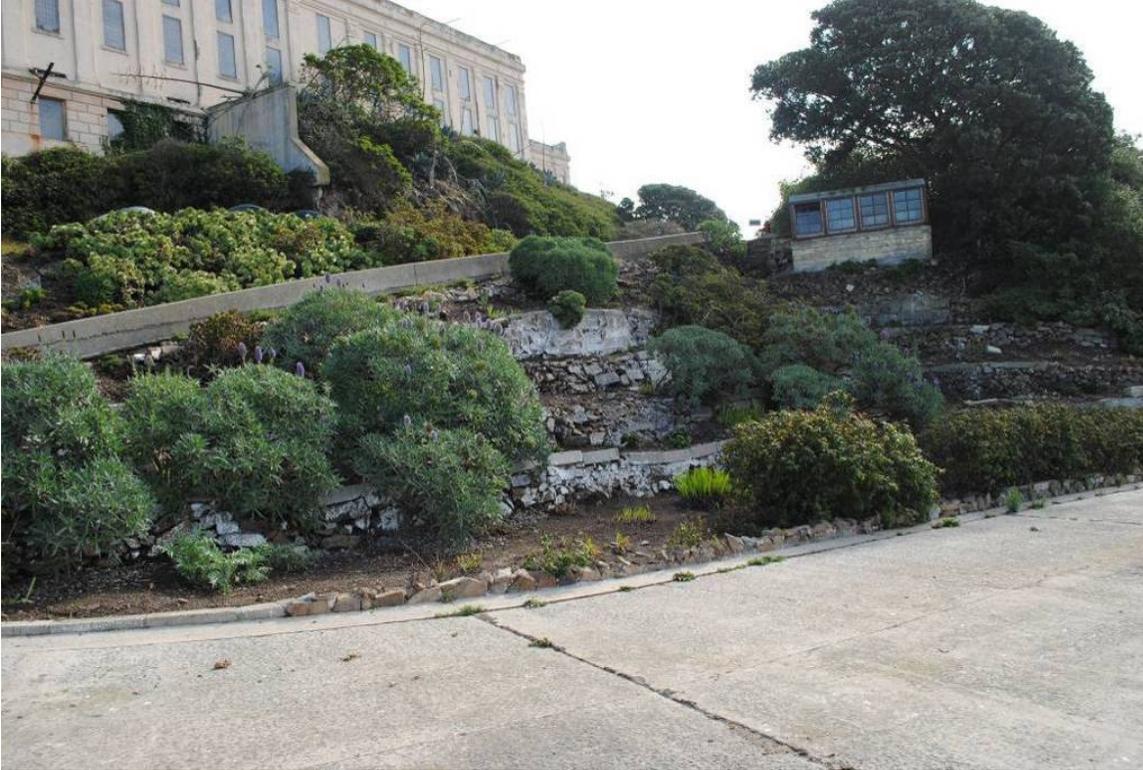
**Figure 6 - 96.** Repair Toolshed Terraces walls, slope and vegetation. (c 2009) (source: MBD); (DSC\_0072.JPG)

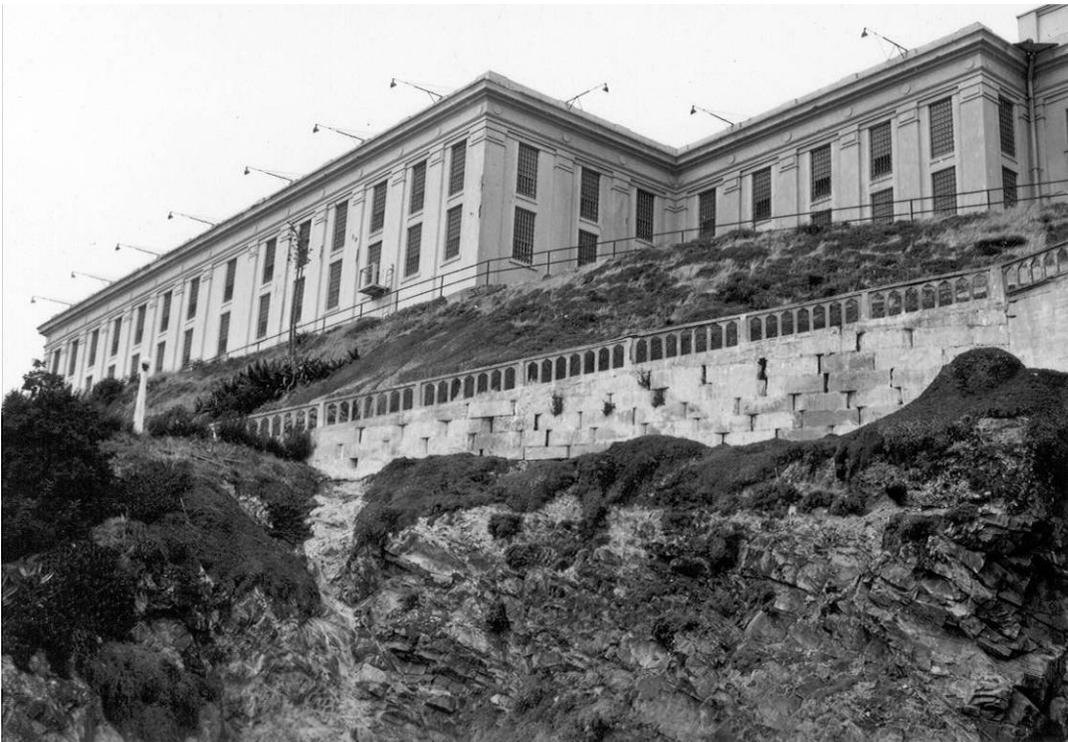
**Figure 6 - 97.** Repair concrete block wall and stabilize slope. Restore decorative railing and pedestrian lights. (c 1950s) (source: GOGA); (Retaining wall (GOGA-1510 Weed).jpg)

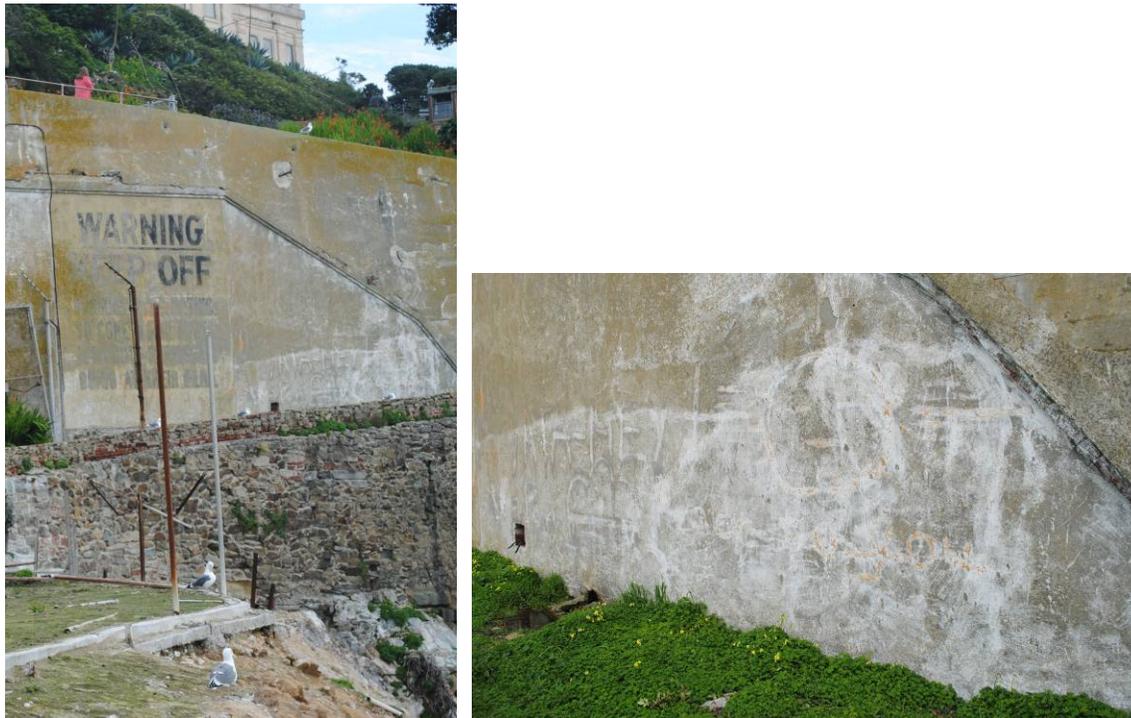
**Figure 6 - 98.** Repair Federal Penitentiary period ‘Warning’ sign and Indian Occupation period graffiti. (c 2010) (source: MBD); (DSC\_0260-2crop.jpg, DSC\_0274.JPG)
