## **Rodeo Valley Stables**

**(Balloon Hangar, Motor Vehicle Sheds and Rifle Range Camp)  
Forts Baker, Barry and Cronkhite National Register Historic  
District**

**Cultural Resource Reports and Site Treatments:  
Cultural Landscape Report  
Historic Structures Report  
Archeological Assessment and Treatment Report**

April 30, 2013  
United States National Park Service,  
Golden Gate National Recreation Area  
Division of Cultural Resources

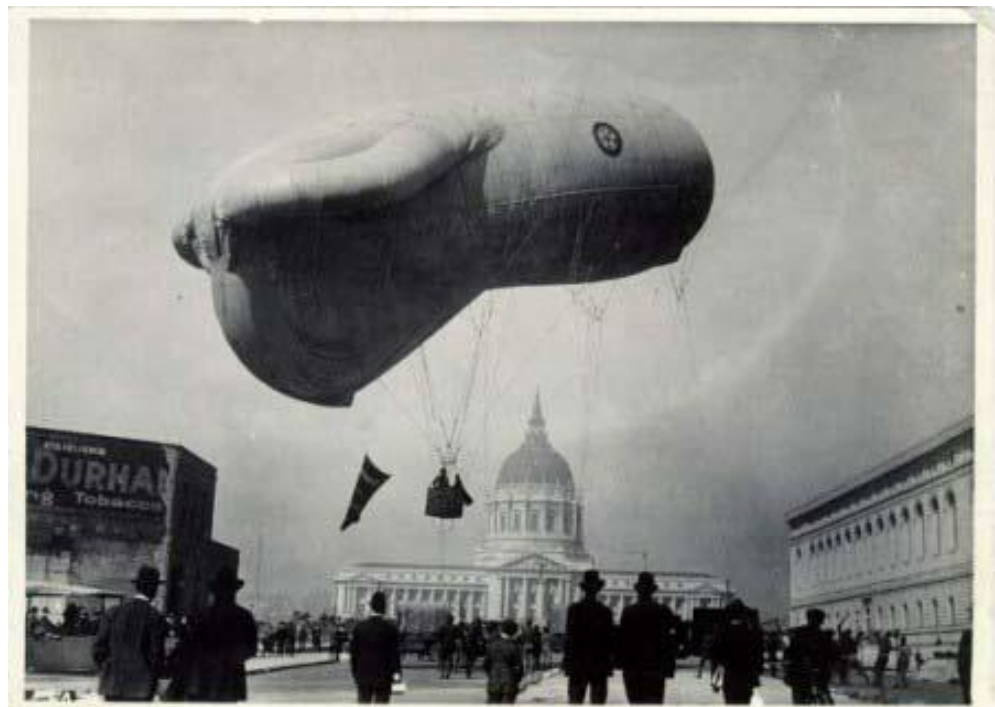
C3 Army Balloon at San Francisco City Hall, circa 1929. (San Francisco Public Library: SFPL AAB-7399)

shape) consisted of a hydrogen-filled body equipped with fins that provided stability in rough air, and a suspended wicker basket that held a two-man crew. Communication between the observers and the ground crew was via a telephone cable spliced onto the mooring line. Before long, the Americans began manufacturing their own version of the French balloons, which the army designated the Type C-3. During 1918-1919, nearly a thousand C-3s were manufactured in the U.S.<sup>3</sup>

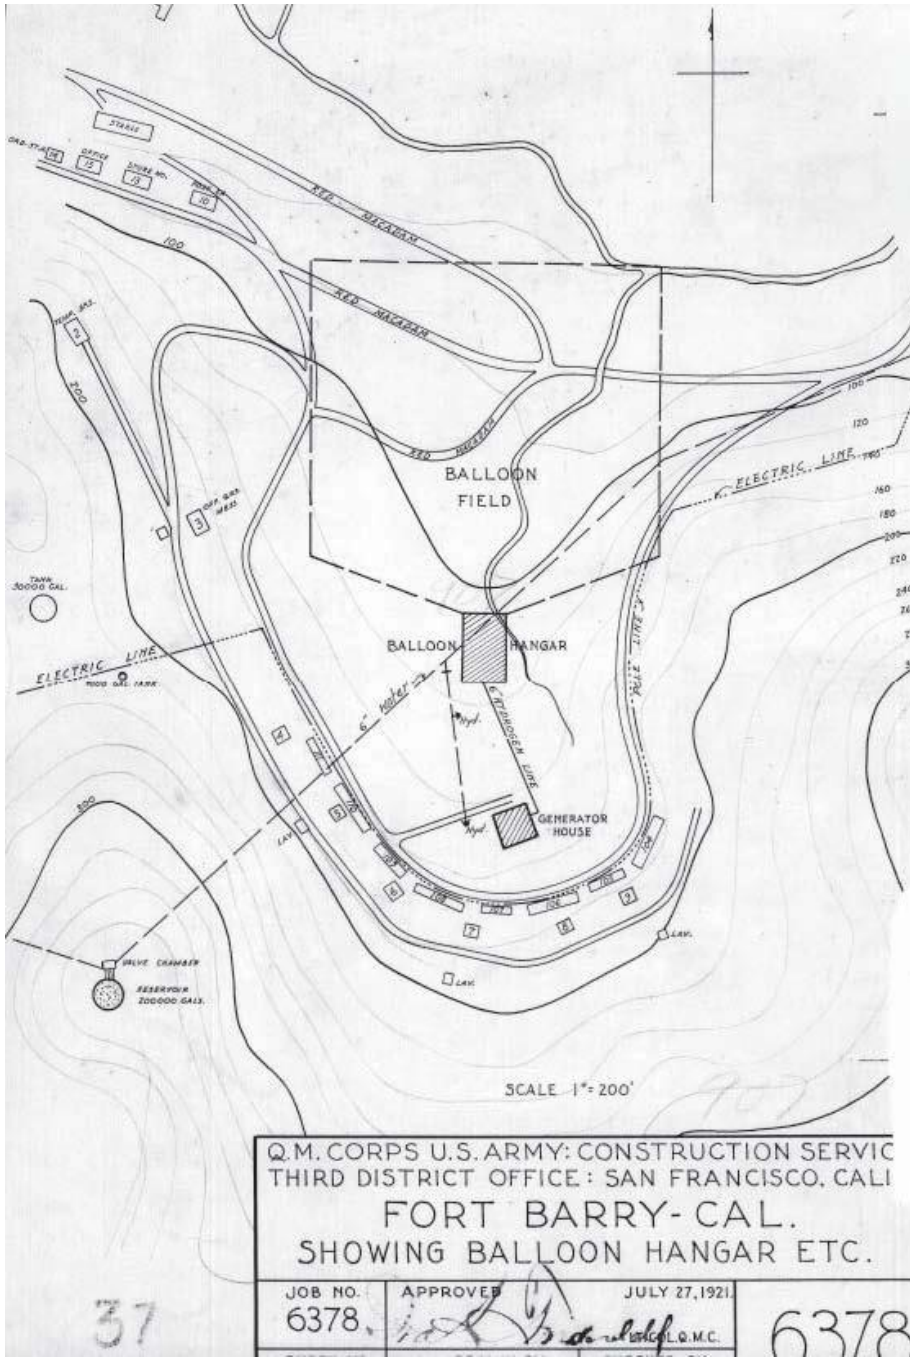
Site plan of Balloon Hangar and landing field showing buildings associated with the temporary camp site for the Departmental Rifle Range, July 27, 1921. (Drwr. 213, Folder 1, PARC, GOGA)

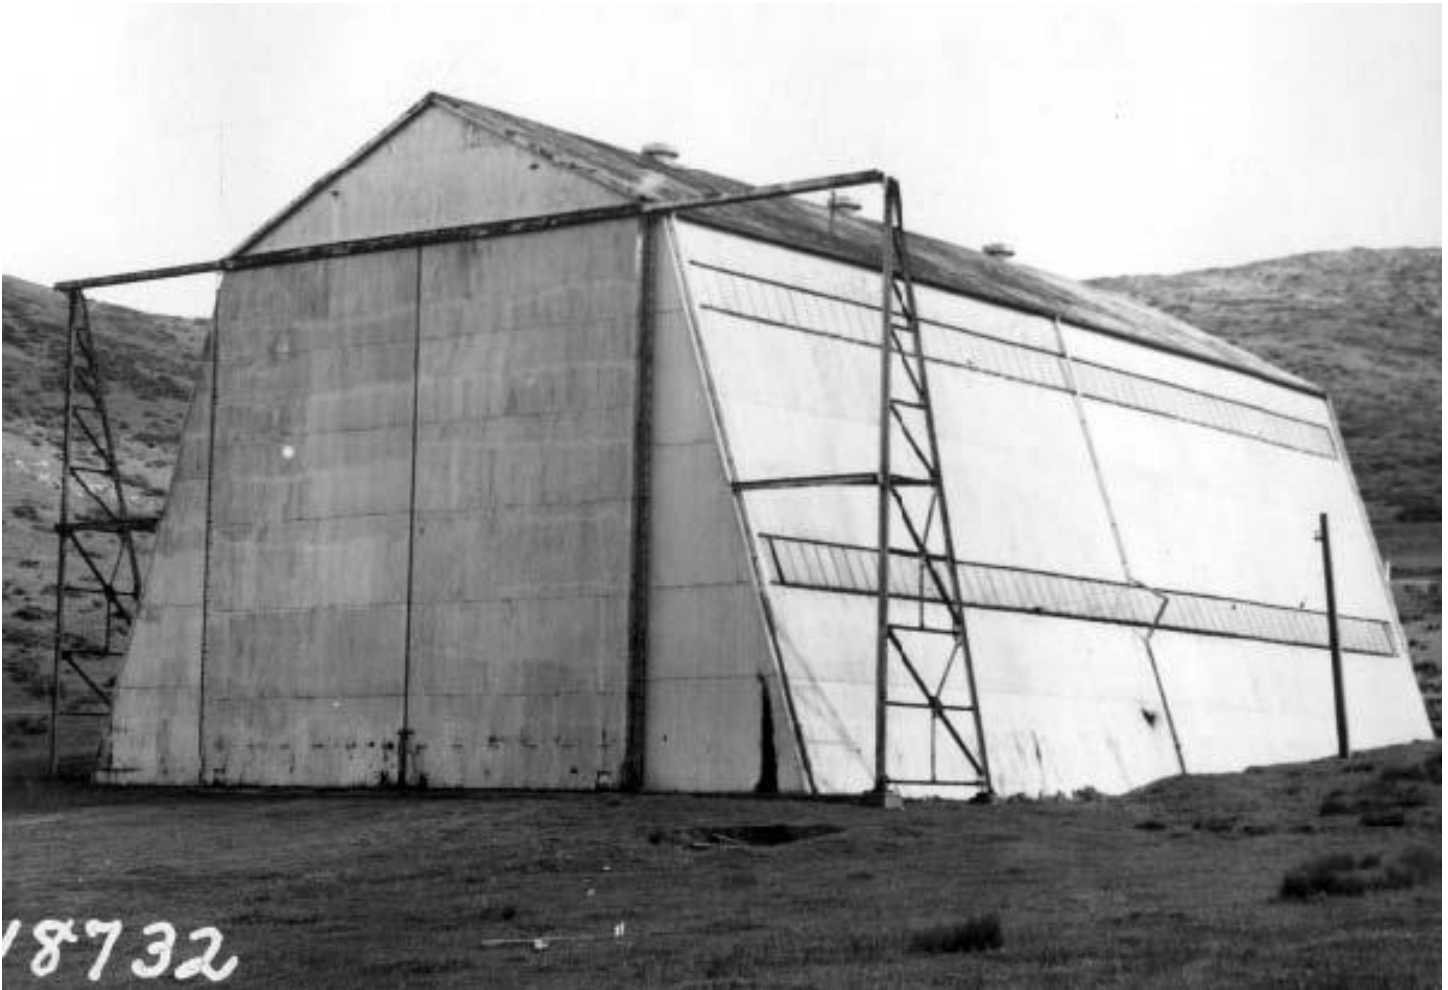
Fort Barry Balloon Hangar, 1939.  
(PARC, GOGA 32423)

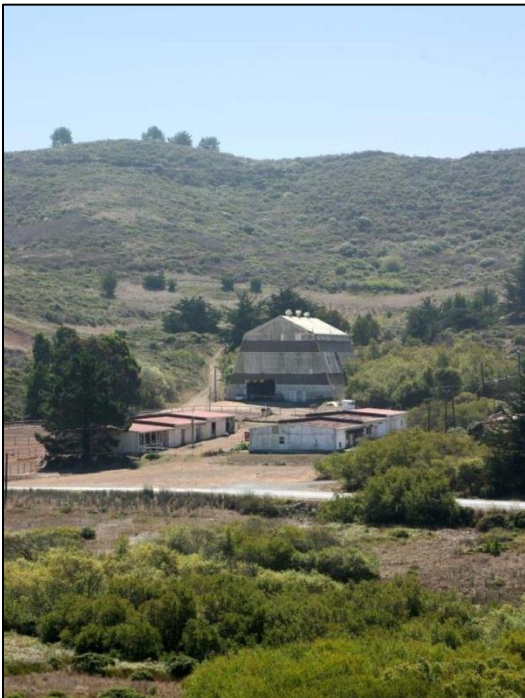
The Balloon Hangar, completed in 1921, towers over the adjacent landscape features. Though uses of the facility changed over the years, the landscape has retained its historic character.

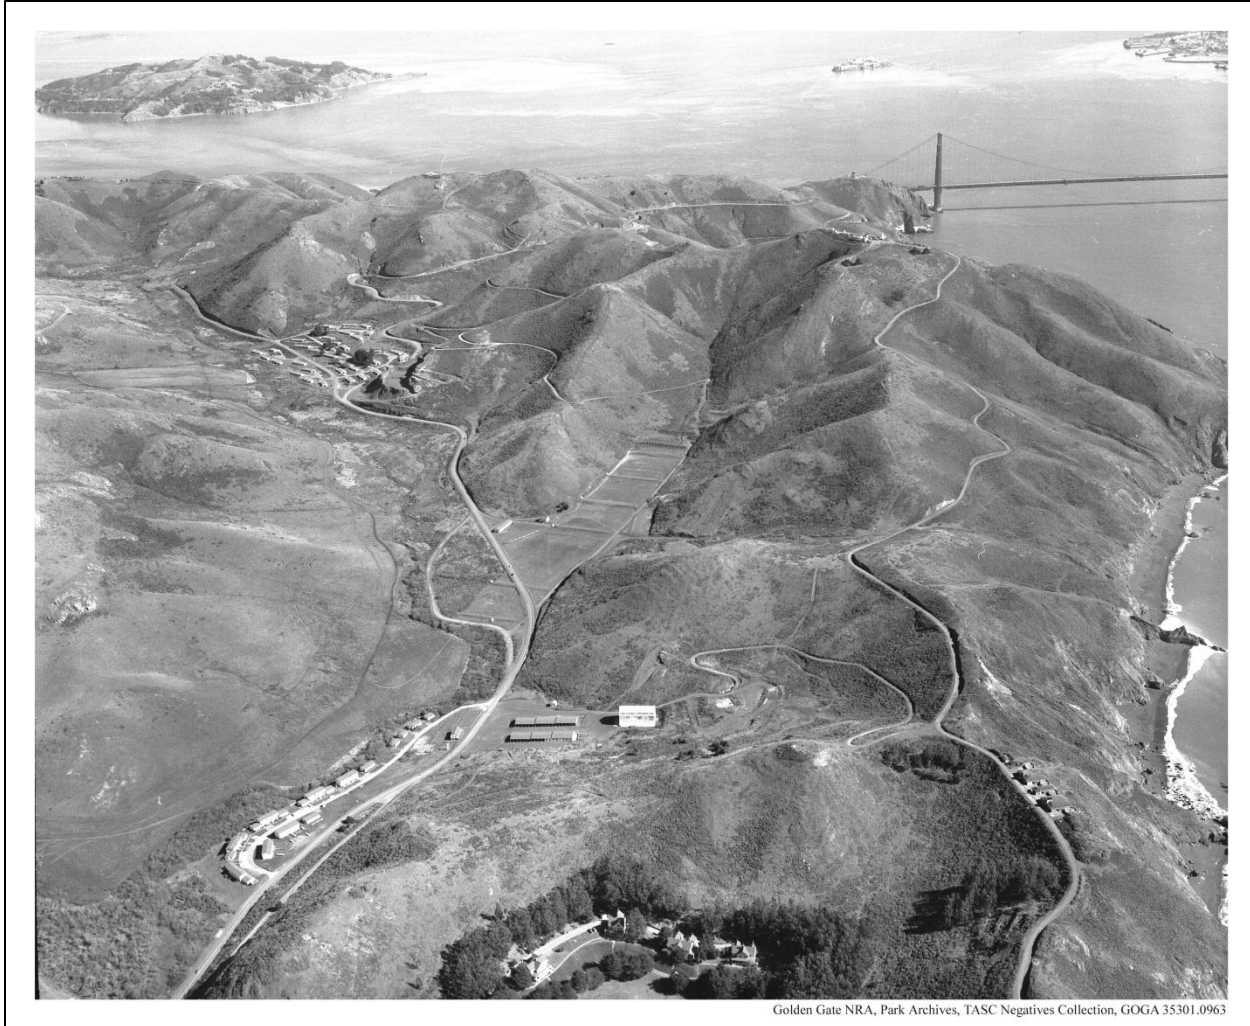
Golden Gate NRA, Park Archives, TASC Negatives Collection, GOGA 35301.0963

surrounded by planted Monterrey cypress and pines, is located at the bottom of the frame; the rifle range is seen just above the Balloon Hangar and Vehicle Sheds. Circa 1963

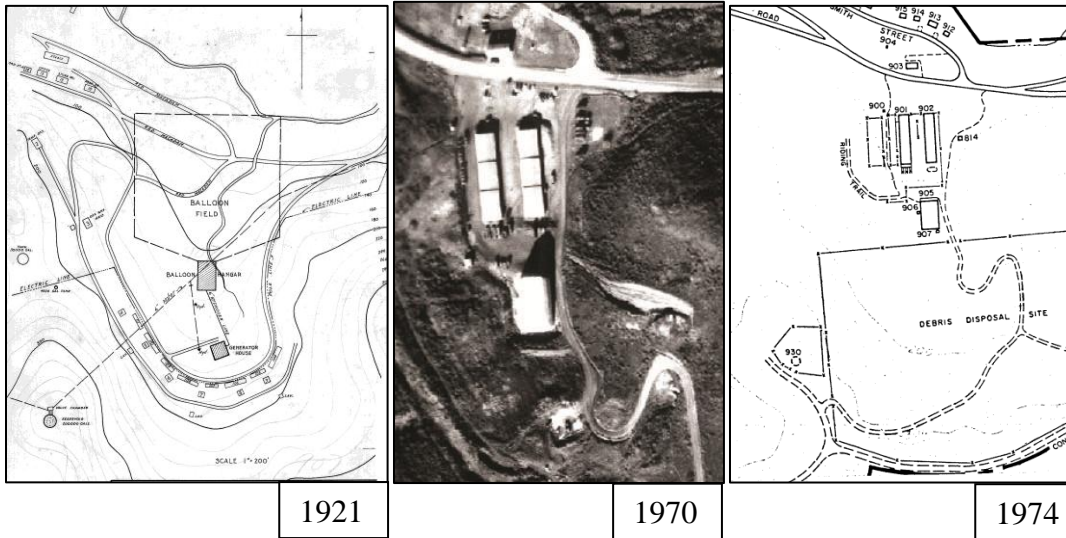
The Army granted use of the Motor Pool area to the Presidio Riding Club in 1966; the riding ring was installed by 1974.

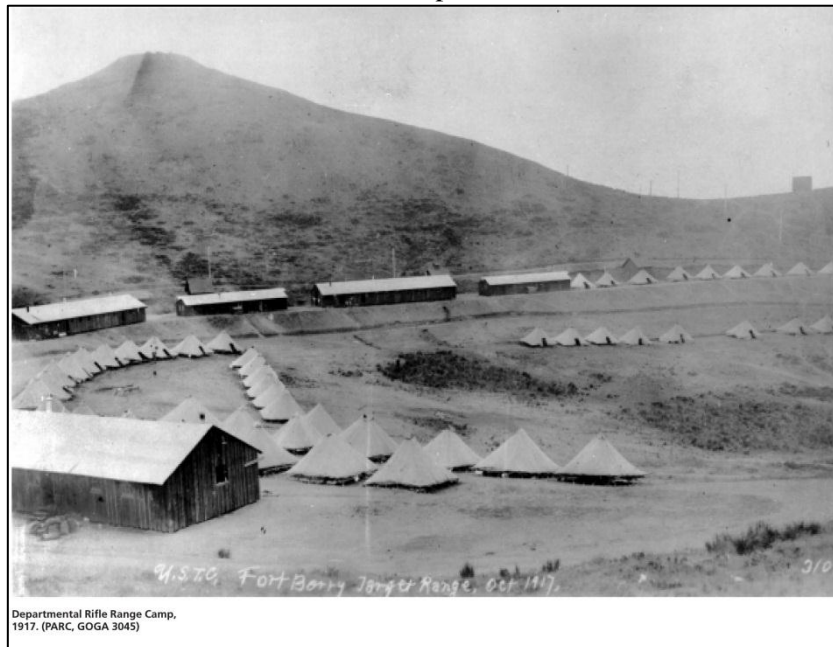
Though it has been somewhat modified over the years, the earliest topographic changes made to the site are still evident and contribute to the historic character.

As seen in photographs, the future balloon hangar site initially served as the temporary camp site for enlisted men and officers assigned to the Departmental Range, and during the course of constructing the range the curving perimeter of the valley was carved into two parallel benches or terraces for the quarters. The upper terrace held permanent (albeit crudely built) mess halls, latrines, and living quarters for officers while the lower bench held prepared platforms where enlisted men and NCOs would pitch tents for the duration of their stay at the range.

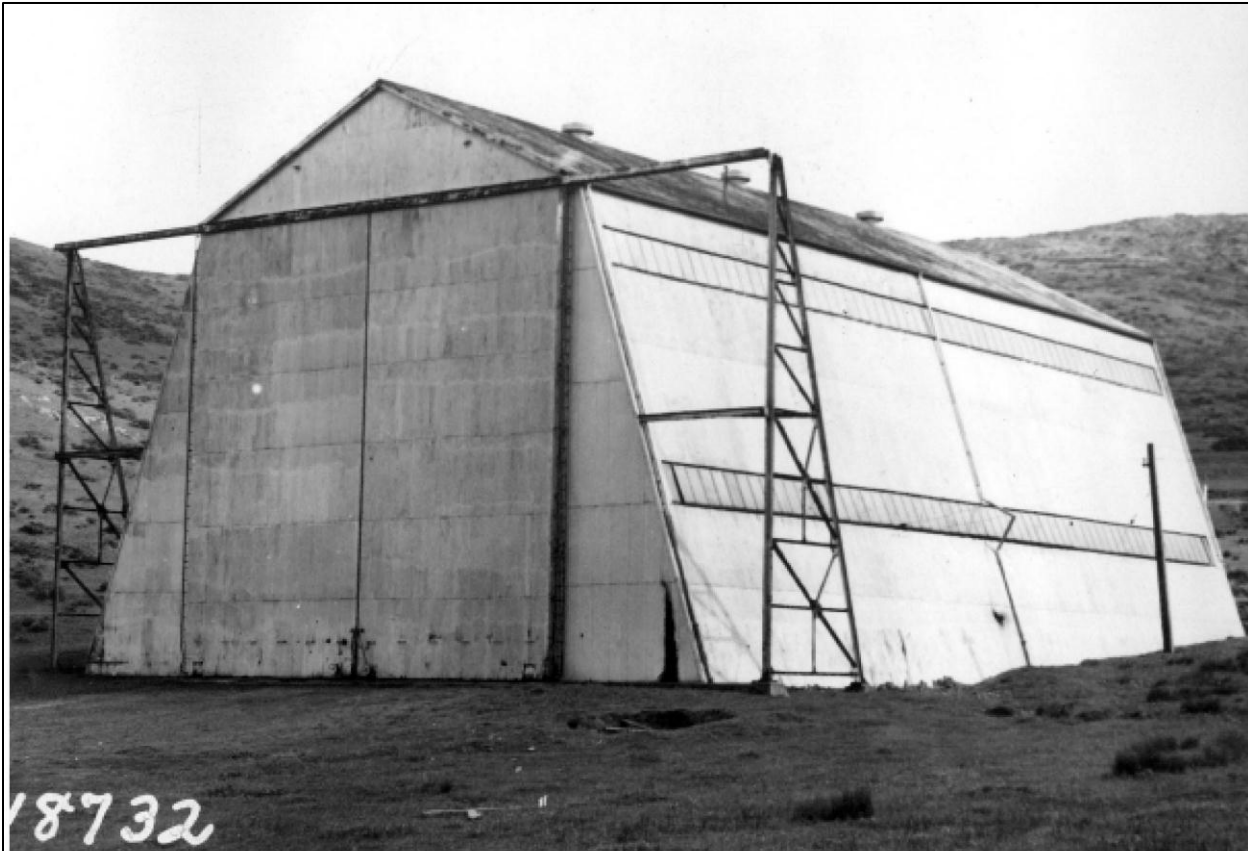
Fort Barry Balloon Hangar, 1939.  
(PARC, GOGA 32423)

In its original form, the Balloon Hangar was a rectangular building measuring 77' x 120' with sloping sides and a peaked roof, reaching a maximum interior height of approximately 65' 10". The most notable feature of the building was a pair of sliding doors on its north façade, each measuring approximately 22'9" wide x 44'9" high, which slid open a supporting gantry to allow entry of an inflated balloon. Original completion drawings for the hangar have not been located, but apparently the interior was entirely open in this initial configuration. With its 120' interior clear space, the hangar was easily large enough to accommodate simultaneously an inflated Type C3 observation balloon and a smaller free balloon.

Though it has undergone changes including removal of the doors to accommodate the Nike missile repairs and conversion to an indoor riding rink, the building has retained its integrity.

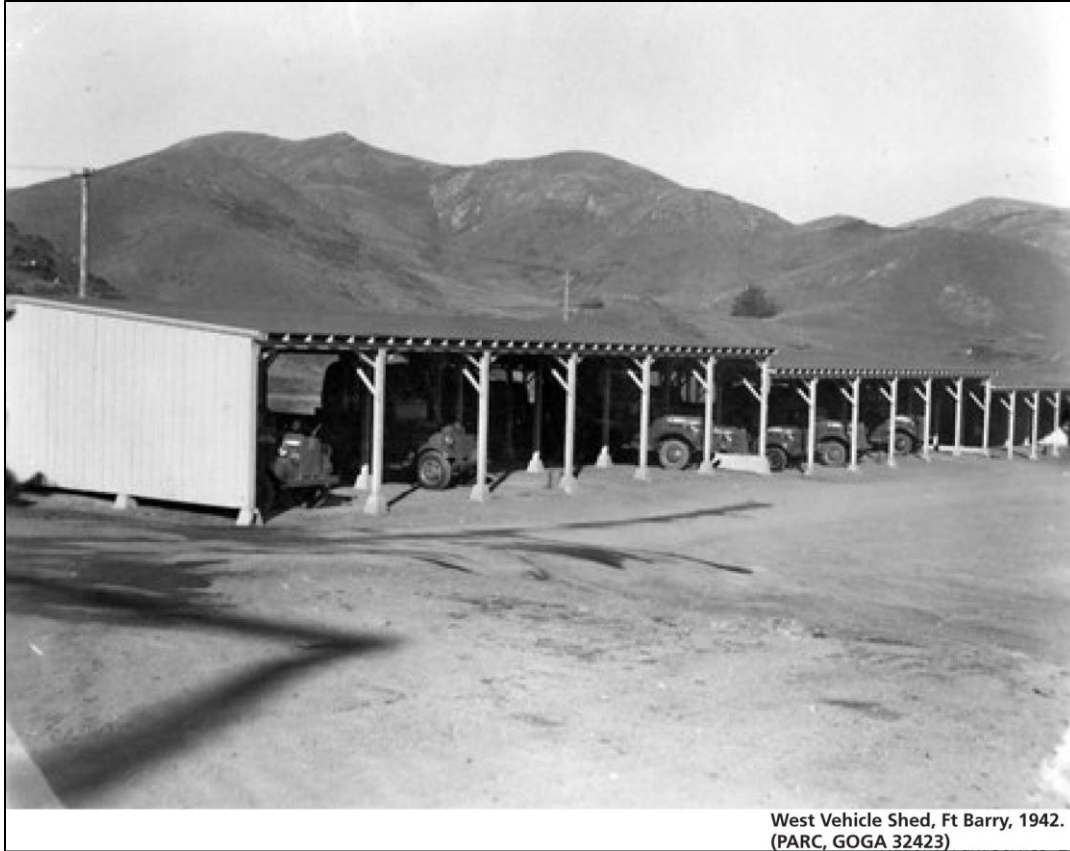
West Vehicle Shed, Ft Barry, 1942.  
(PARC, GOGA 32423)

During the ramp up to World War II, the old balloon field area north of the hangar became the site of two expansive vehicle sheds hastily constructed to house the growing fleet of vehicles assigned to the posts. These sheds were virtually identical, each measuring 46' x 216' and consisting of 18 covered bays arranged in three stair-stepped sections of six bays each. The sheds were constructed according to standardized drawing #700-329, and were completed in September 1940 at a total cost of \$8,976.28. Slight modifications have occurred, but the Vehicle Sheds retain their basic form and are considered to contribute to the historic character of the site.

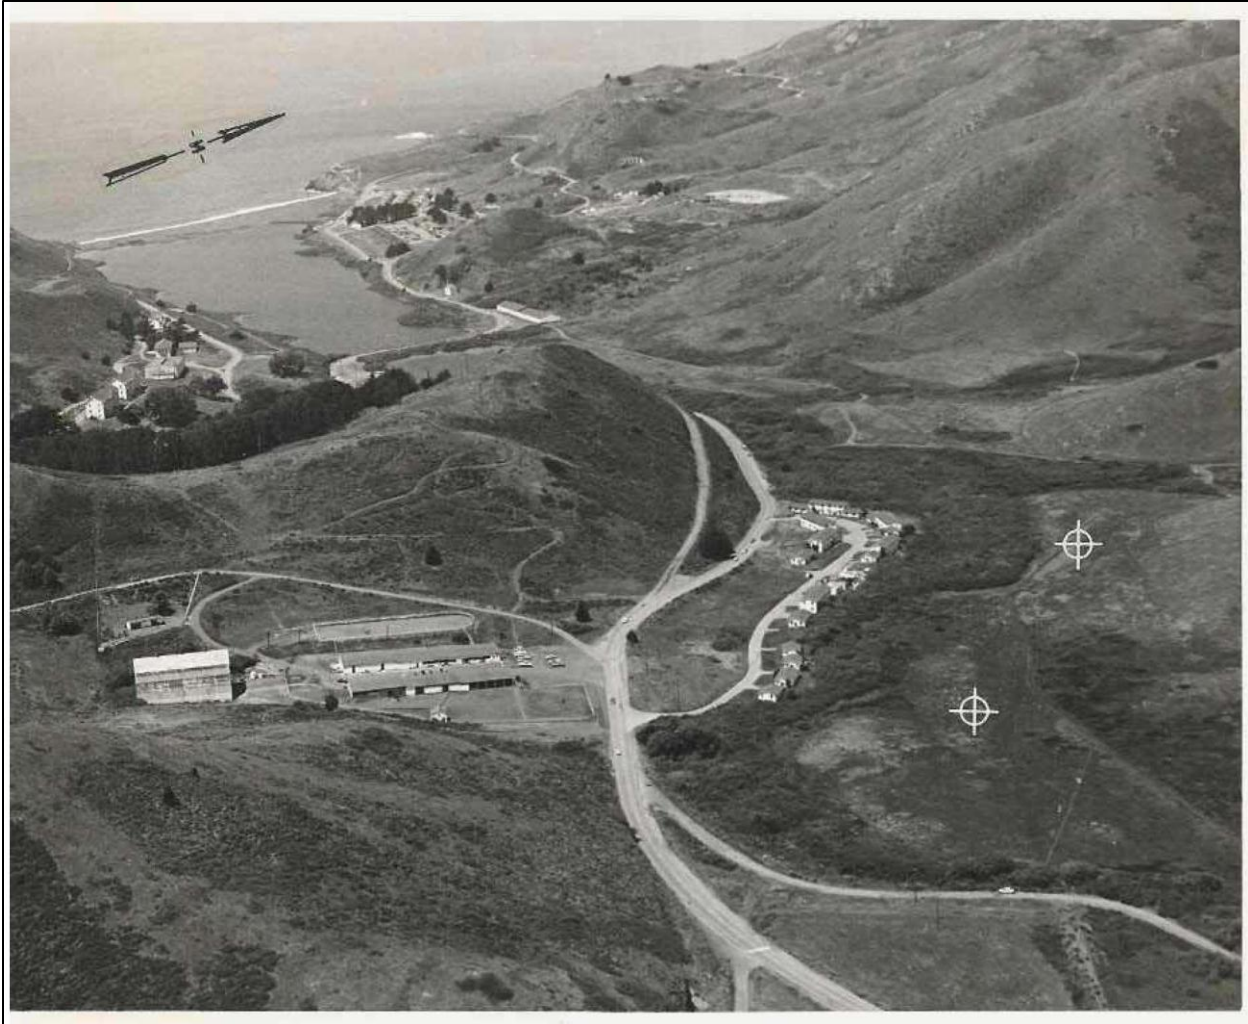
It is assumed that all roads on site today are contributing features of the circulation system, as evidenced by the circa 1970 photograph below.

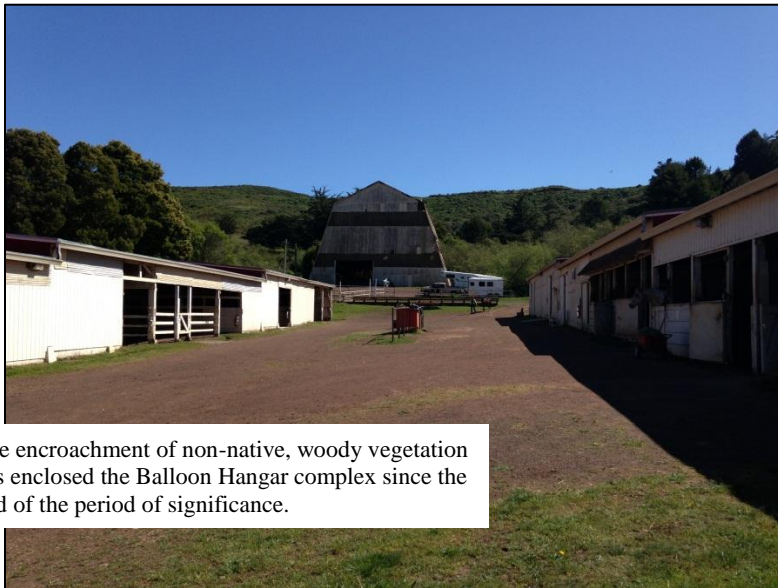
The encroachment of non-native, woody vegetation has enclosed the Balloon Hangar complex since the end of the period of significance.

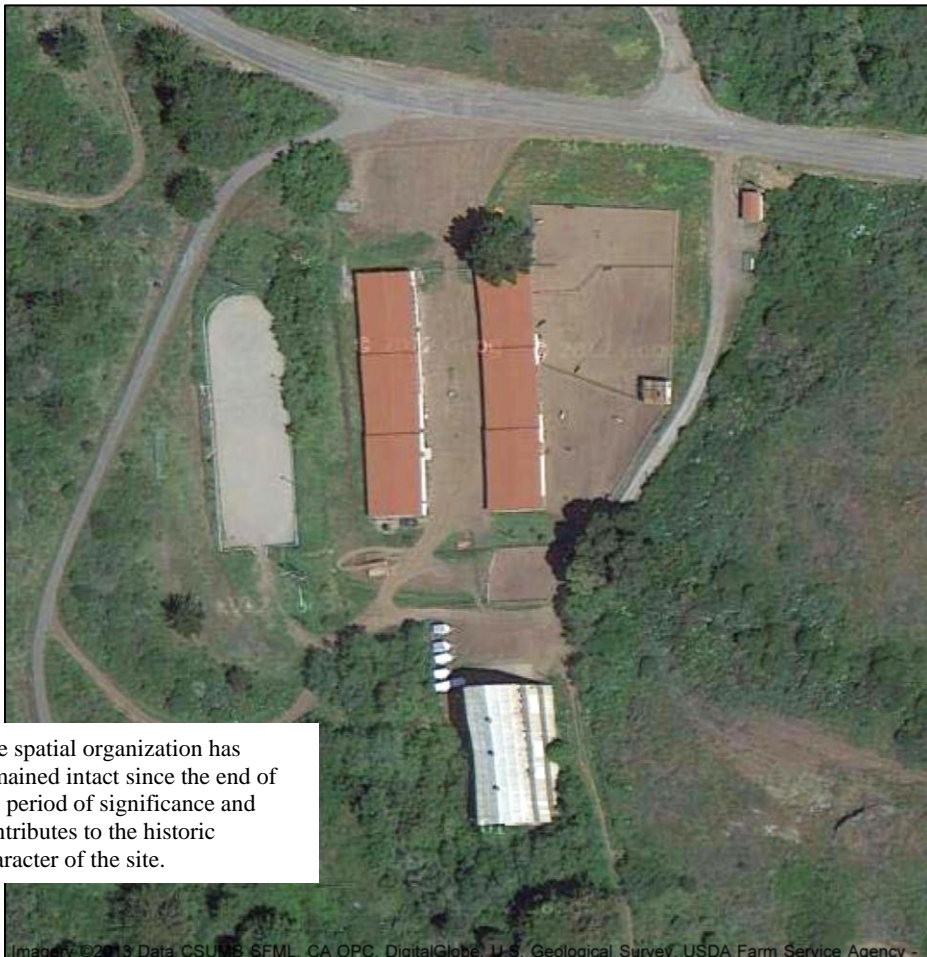
The spatial organization has remained intact since the end of the period of significance and contributes to the historic character of the site.

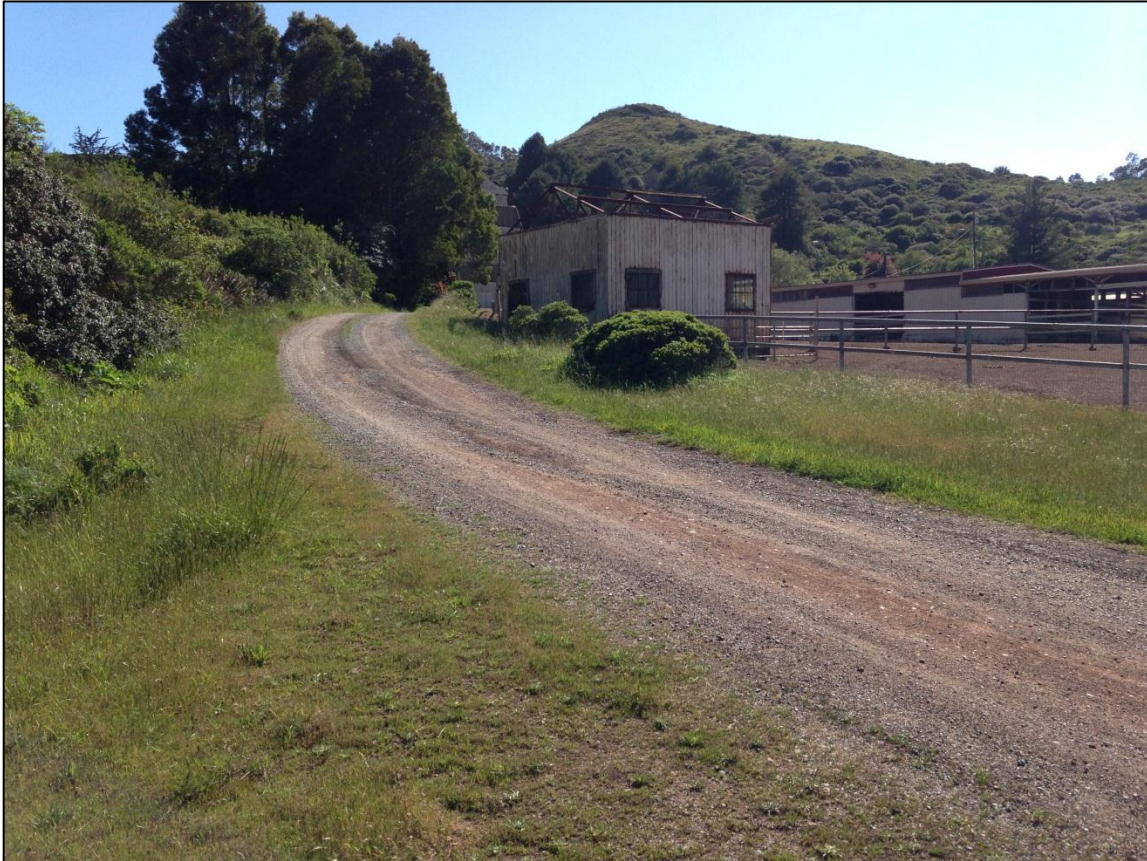
The circulation system is a character defining feature that should be maintained.

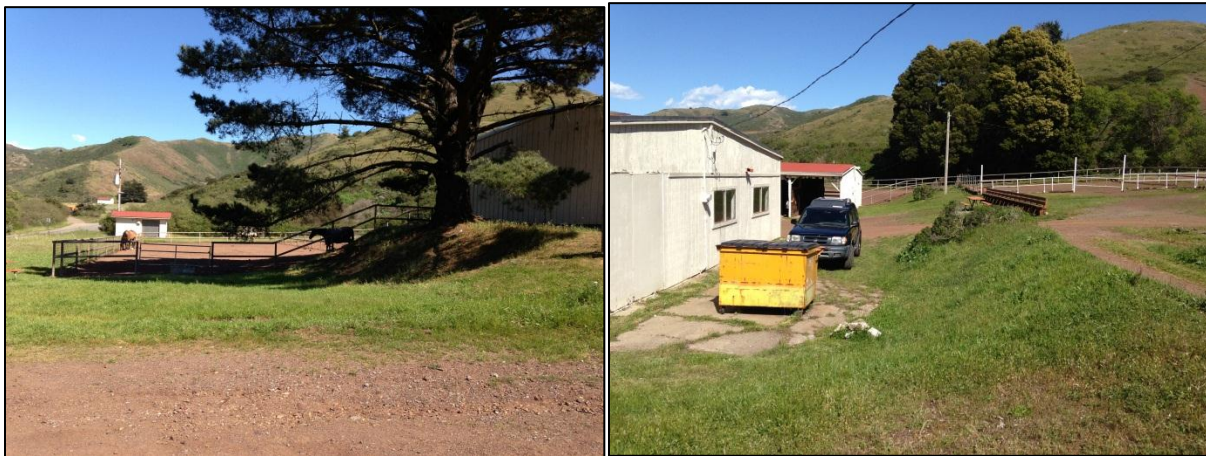
Topographic benches remain from the earliest military activity at the site and should be preserved intact.

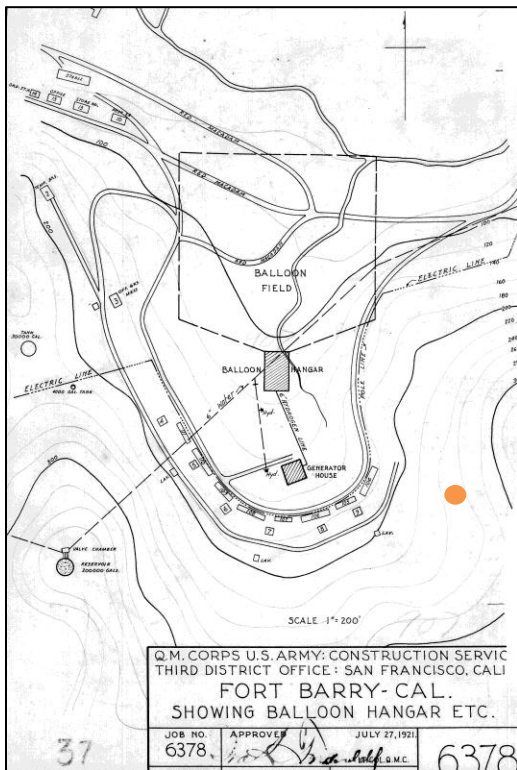
Historic location of the water tank is highlighted.

A new water tank with emergency pump and generator are required. (The tank may be eliminated if it is shown that sufficient firefighting water is available from pressurized water mains or the nearby reservoir west of the site.) Consideration should be given to re-establishing a tank in the historic location, seen in a site plan dated July 27, 1921 with a pump and generator housed in either of the small buildings west or south of the Balloon Hangar. If this proves impractical, locate facilities west of the existing riding ring, outside of the core.

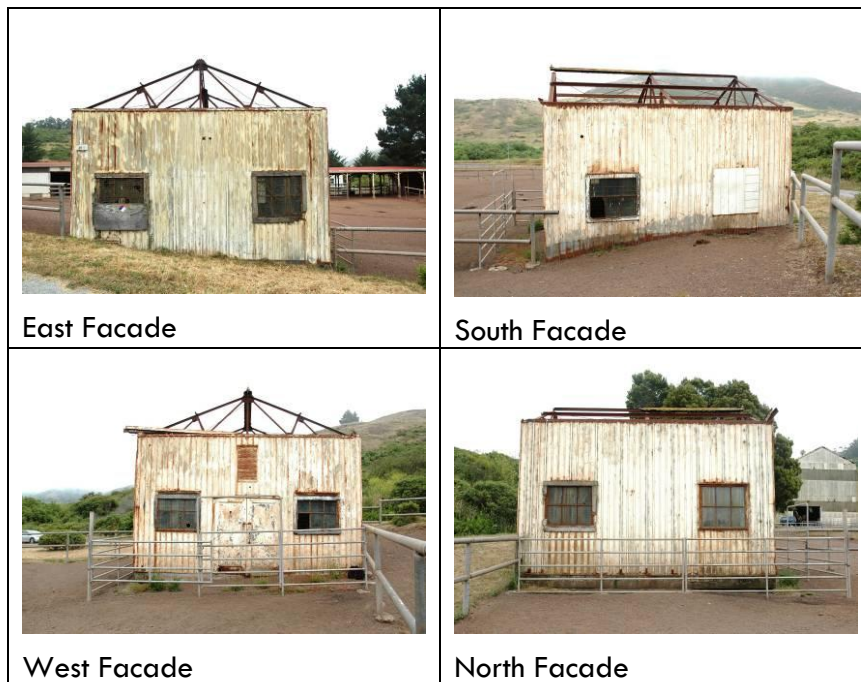
The building is one-story 20x20 ft., 12 ft. tall manufactured steel building with gable roof. The break-formed metal exterior wall panels have 2” wide standing seams on 6” centers and panels are 24 inches wide and 12 feet tall. Roof trusses are riveted assemblies and are bolted to columns formed from two steel channels bolted together. Wall panels are attached with flat head bolts to girt angles at top and bottom of the walls. The building has a 2x10 wood floor that is set onto incised heavy pressure treated wood timber (common since the 1950s) foundation. No manufacturer's plate could be located and the manufacture date of the building is unknown.

The roof is no longer extant although the ridge flashing remains; it was likely made of standing seam panels matching the walls. The interior ceiling is rusted and failing, interior walls are rusted and damaged and appear to be the back sides of the exterior standing seam wall panels. The interior ceiling was finished at the top of the wall/bottom of roof truss with standing seam panels facing up, for a smooth finish. The interior paint coating has delaminated and failed and there is graffiti on the walls. The wood floor is rotted and has failed in several locations. Windows are 42” square steel sash 3 over 3

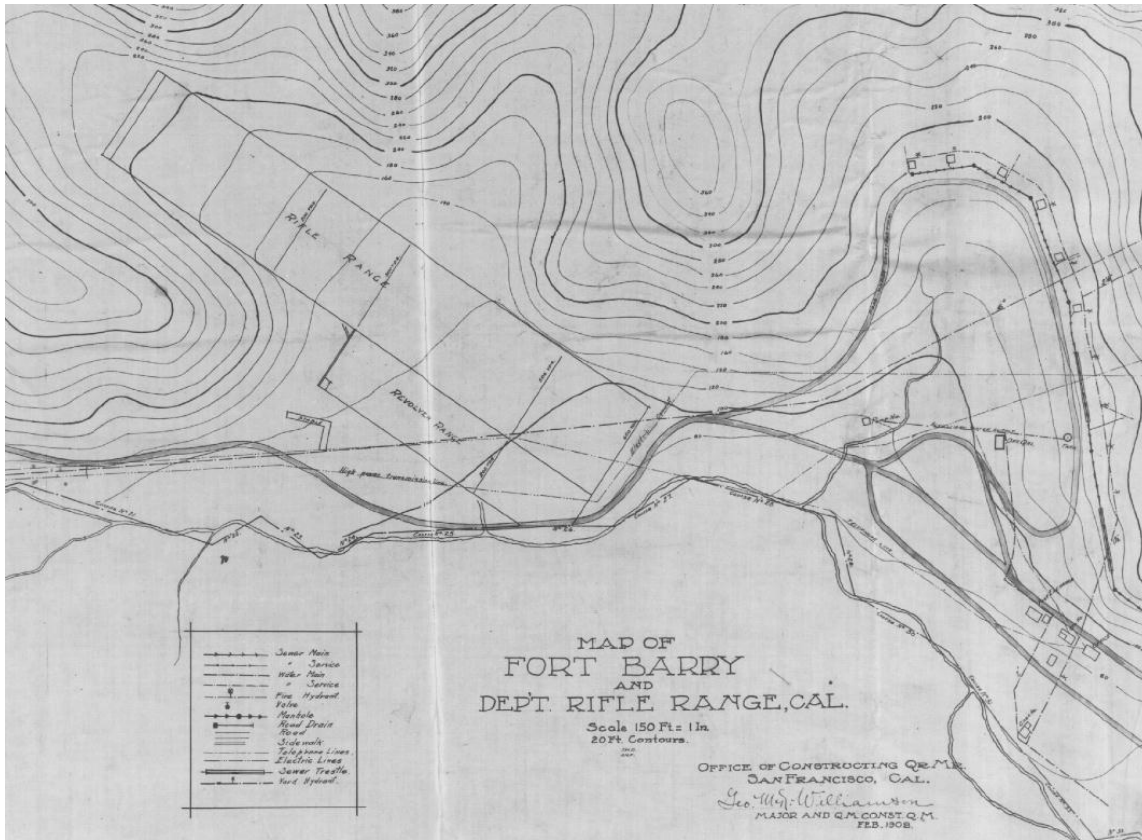
1908 Map of Fort Barry Departmental Rifle Range and adjacent Range Camp

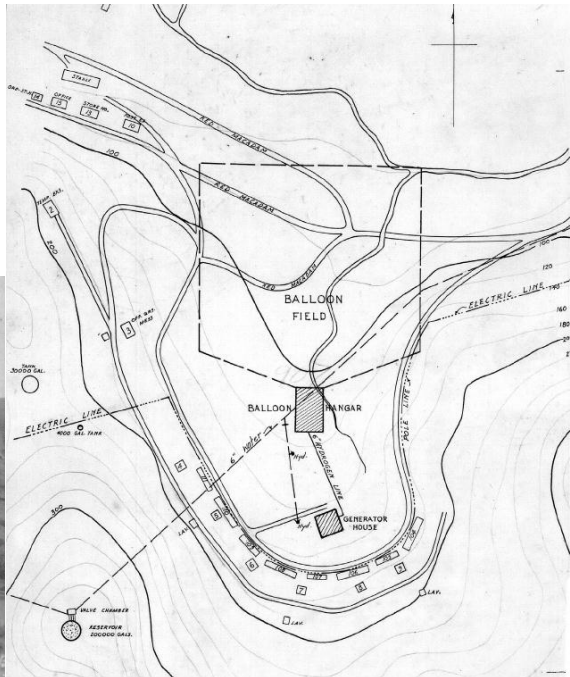
1921 Plan showing of encampment with Balloon Hangar

The Departmental Rifle Range Camp was still in use when the Balloon Hangar was constructed in early 1921. A map of the period shows the access road between the Rifle Range and the Camp skirted the edge of the Field defined for maneuvering the balloon (PARC 1921). The balloon companies were transferred to the Puget Sound in late 1921. After the closure of the balloon hangar subsequent plans for use of the valley included a new cantonment for the California National Guard. The Rifle Range Camp's continued use is obscure following 1921, with closure and demolition of the barracks and other structures before 1938.
