# PRELIMINARY REPORT ON THE HEADLANDS INSTITUTE CAMPUS LANDSCAPE

FORT CRONKHITE, MARIN HEADLANDS

PRELIMINARY ANALYSIS & EVALUATION

FEBRUARY 2008

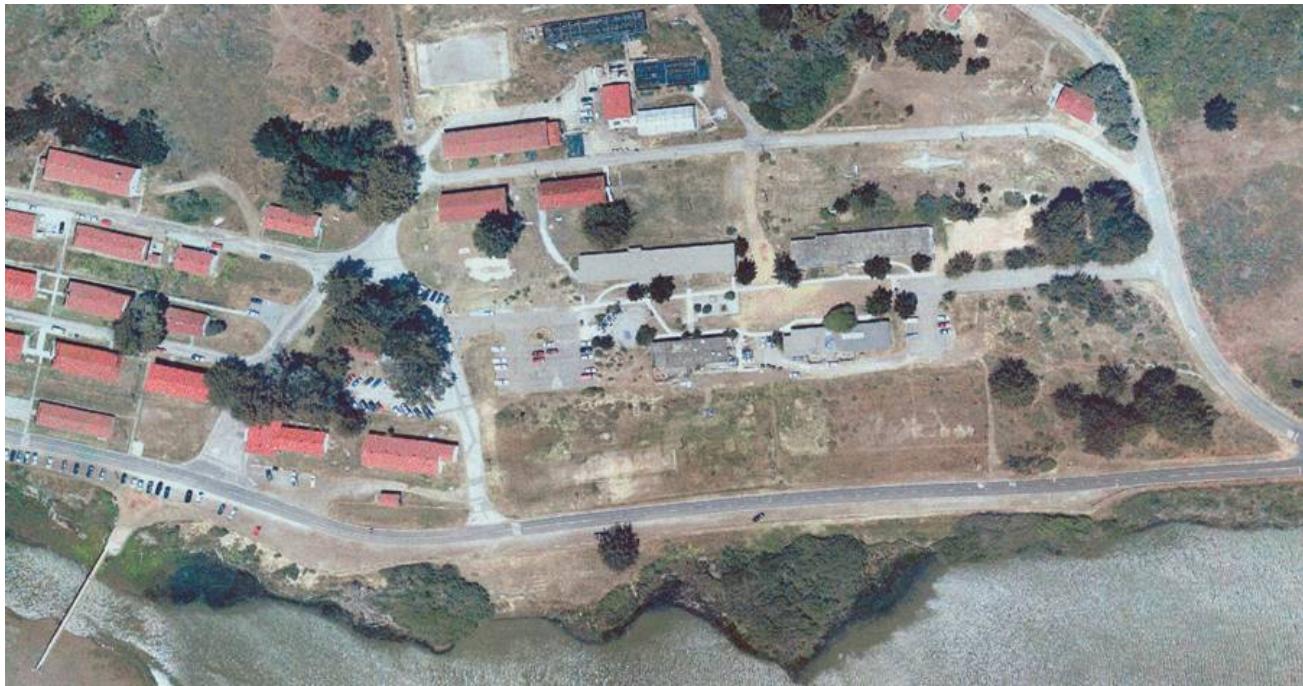
**Figure 1:** Current aerial view of Fort Cronkhite showing the project area focused on the east wing of the cantonment, 2006. This area contains the former Nike Missile administration complex, currently the core campus of the Headlands Institute. (Golden Gate National Recreation Area)

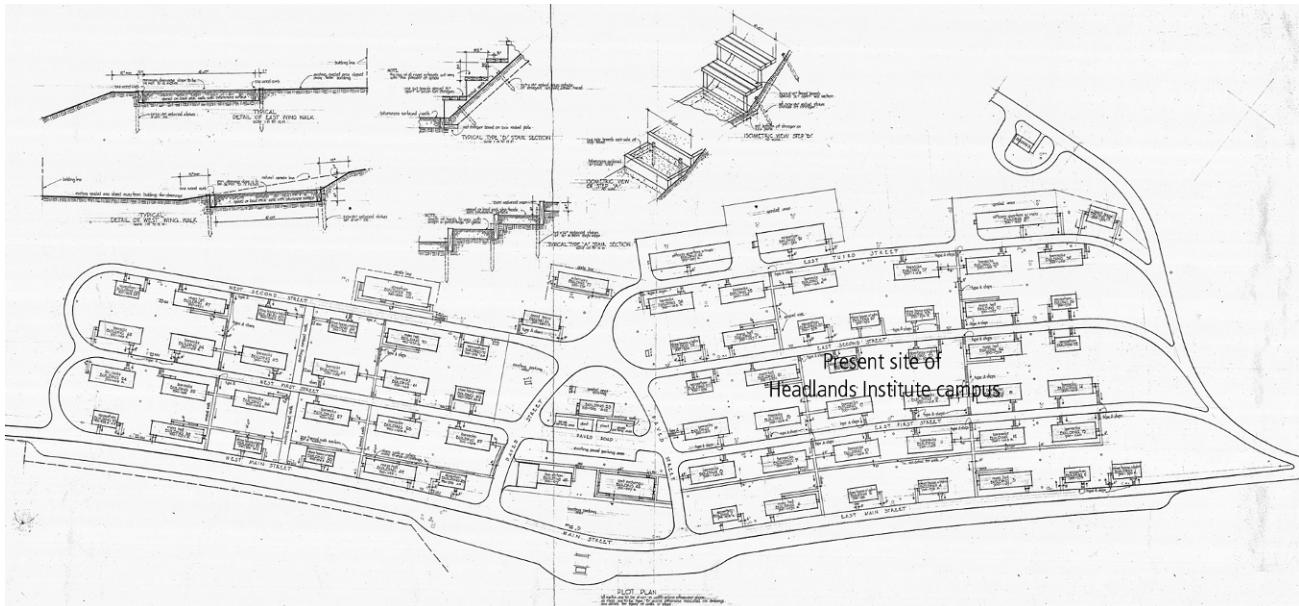
**Figure 2:** Site plan of the entire Fort Cronkhite cantonment during World War II. The existing core of the Headlands Institute campus is located in the east (right) side of the cantonment. Office of the Constructing Quartermaster, "Fort Cronkhite, Calif. Sidewalks for Temp. Housing," June 3, 1941. Golden Gate National Recreation Area.

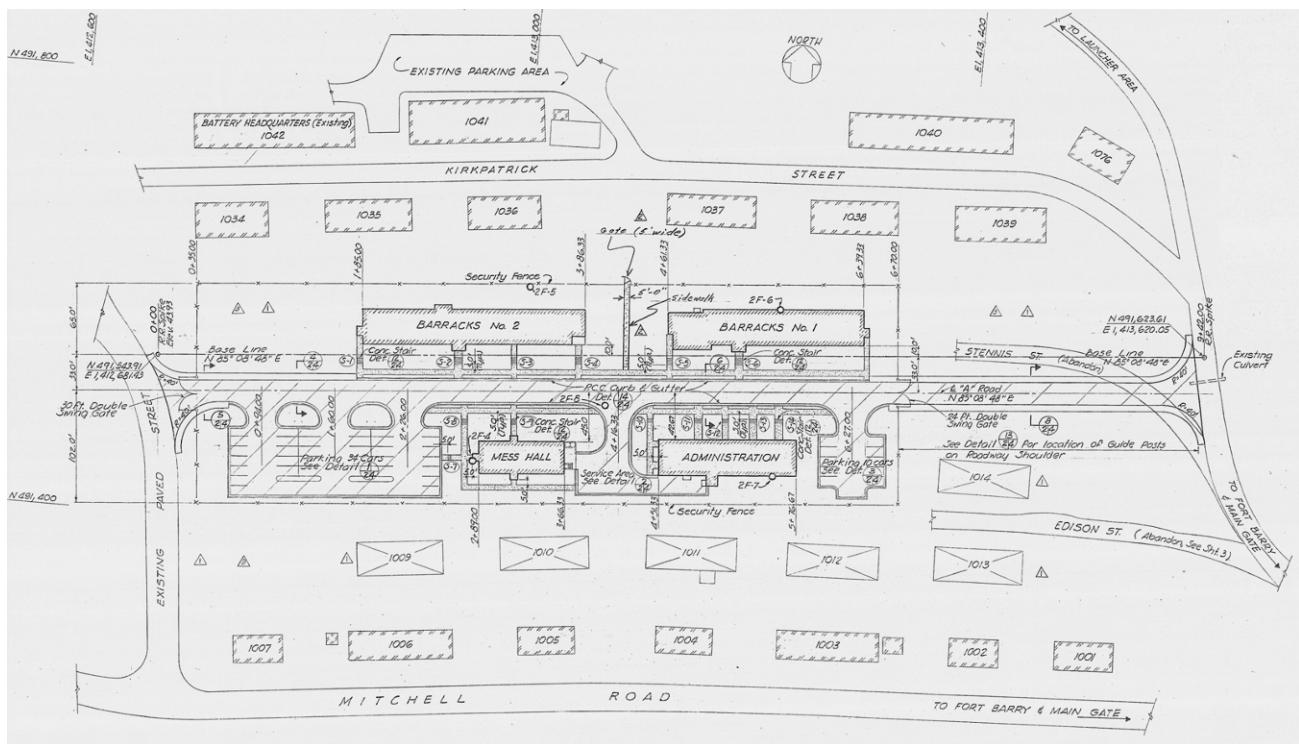
**Figure 4: As-built site plan of changes to the east wing of the Fort Cronkhite cantonment for construction of the Nike administration complex, begun in c.1964. This area is the existing Headlands Institute campus. The buildings with an "x" were demolished, while the row of buildings along Mitchell Road and three of the six along the south side of Kirkpatrick Street were removed at a later date. U. S. Army District Engineer, "SF-87 Fort Cronkhite, California Battery Facilities Site Plan-Test Boring Logs," January 27, 1964, revised April 8 1966. (Golden Gate National Recreation Area)**

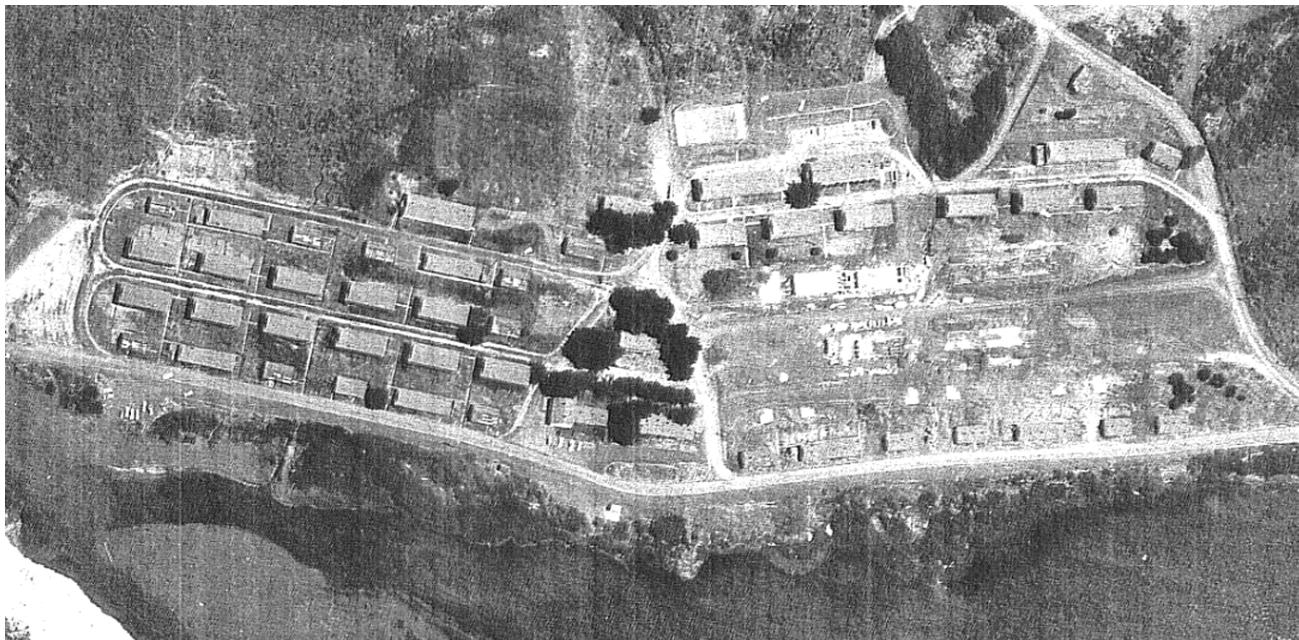
**Figure 3: Aerial view of Fort Cronkhite at the time of the construction of the Nike Missile administration complex, c.1964. Note the tree and shrub cover at the central area of the cantonment and on the upland riparian corridors. (Golden Gate National Recreation Area)**

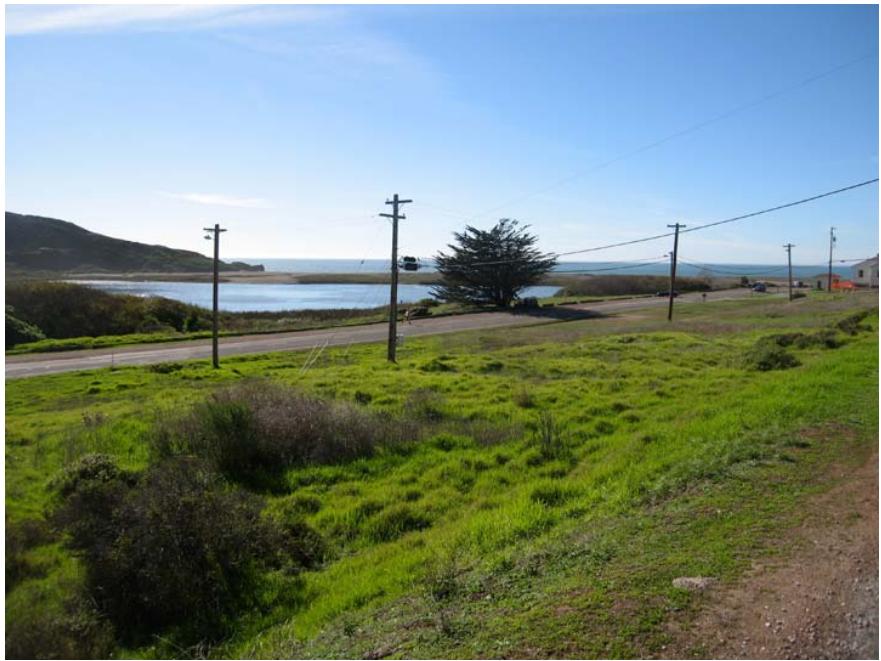
**Figure 5: Looking southwest across the east wing of the Fort Cronkhite cantonment, 2007. This photograph shows the natural setting and site of buildings on lower terrace along Mitchell Road, south of the Headlands Institute campus. (SUNY ESF)**

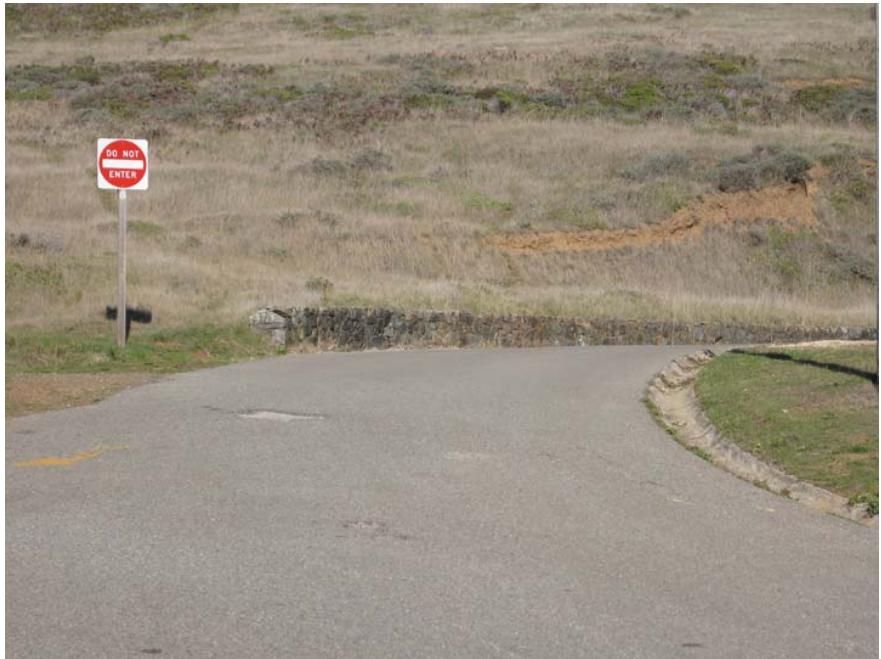
**Figure 6: Looking north at west end of west wing of the Fort Cronkhite cantonment, 2007. This photograph shows natural scrub and grassland, and the existing character of World War II-era roads, gutters, and retaining walls. (SUNY ESF)**

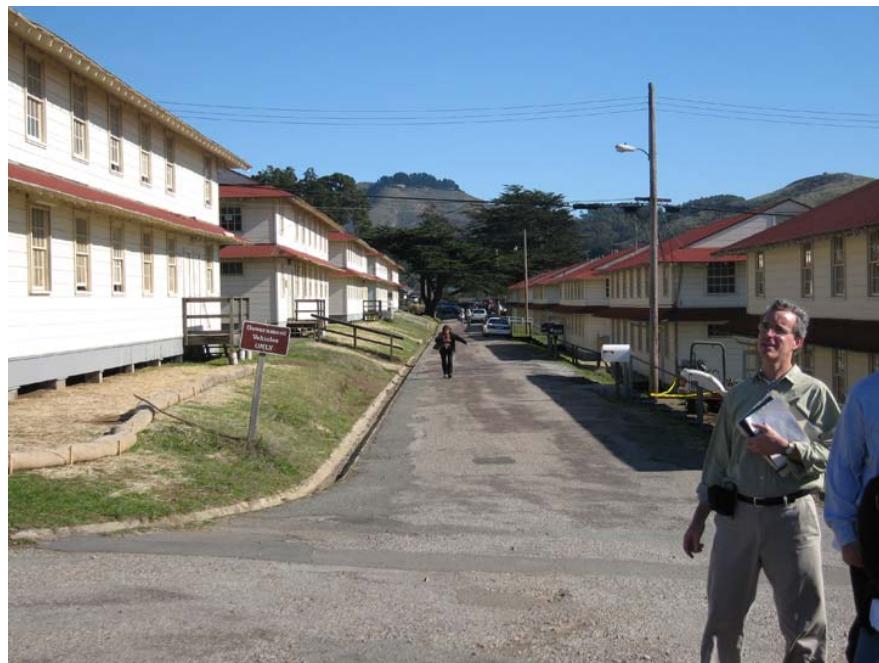
**Figure 7: Looking east through the west wing of Fort Cronkhite cantonment toward the central area, 2007. This photograph shows the existing character of buildings, roads, vegetation, topography, and small-scale features that remain largely intact from the World War II era. (SUNY ESF)**

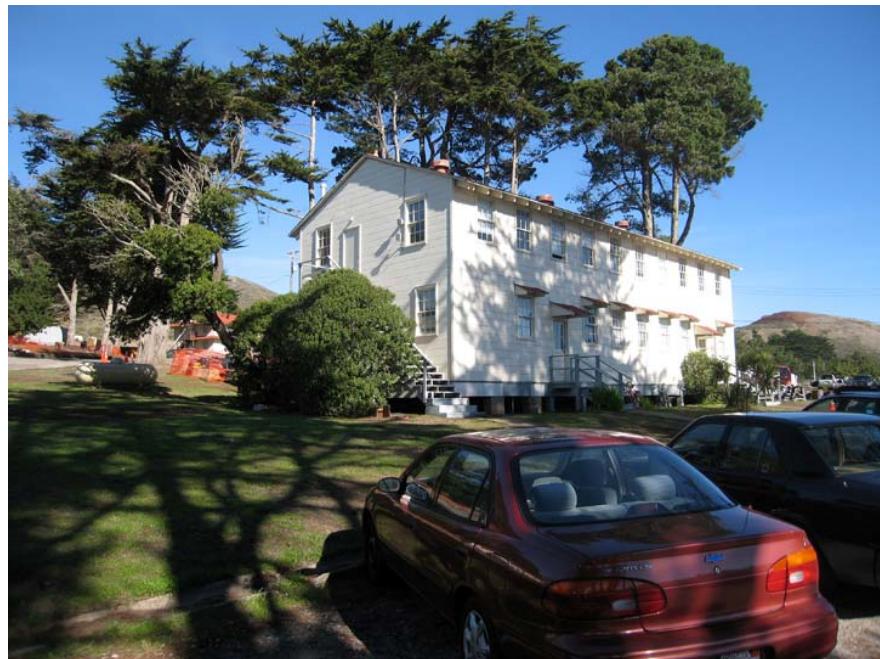
**Figure 8: The central area of the Fort Cronkhite cantonment, looking northeast at central administration building and surrounding lawn and specimen trees, 2007. (SUNY ESF)**

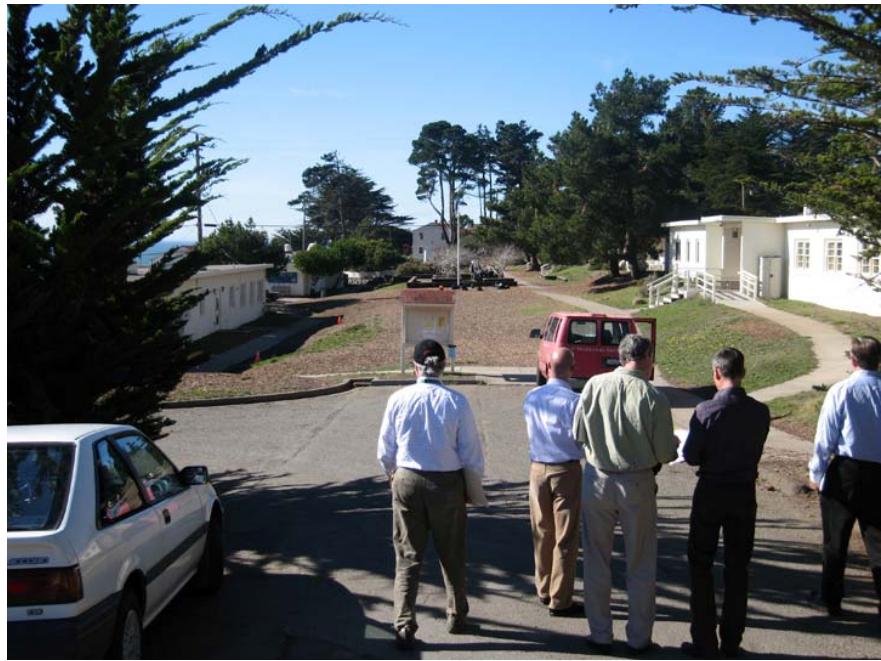
**Figure 9: The core of the Headlands Institute campus at the former Nike Missile administration complex looking west showing Nike buildings and changes to circulation, 2007. (SUNY ESF)**

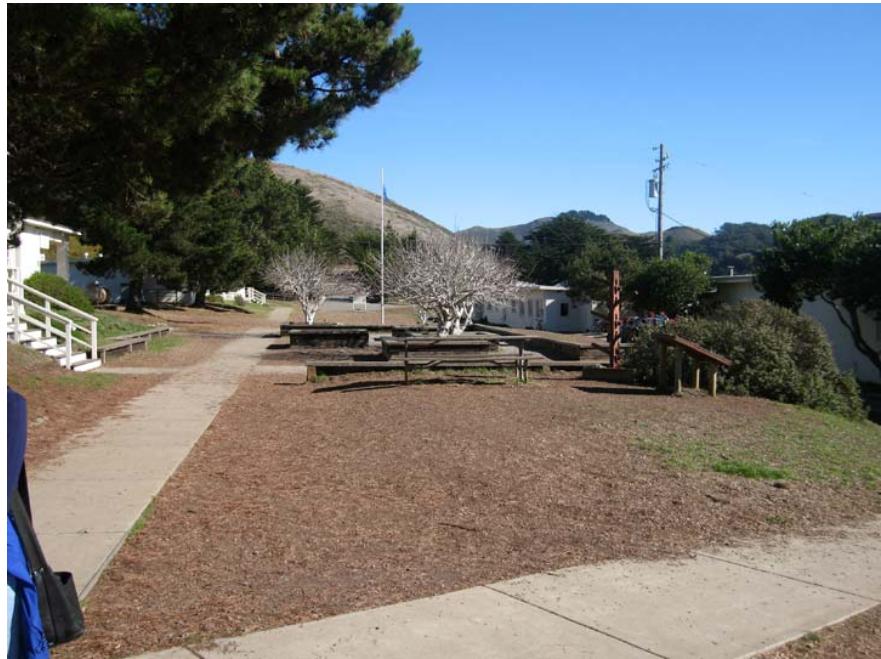
**Figure 10: The core of the Headlands Institute campus looking east, 2007. This photograph shows the mulch, shrubs, flagpole, sidewalks, and gathering area that have been added on former roadbed that ran through the center of the Nike complex. (SUNY ESF)**

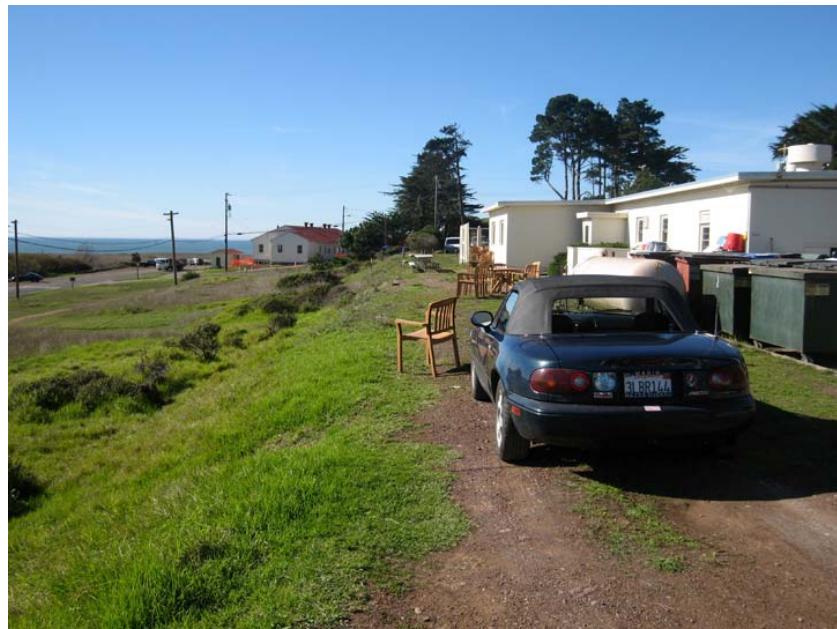
**Figure 11: Service area at the south side of the Headlands Institute showing location of parking, dumpsters, and seating placed to take advantage of ocean views, 2007. In the background are World War II-era buildings within the central area of the cantonment. The lower terrace contained a row of World War II-era buildings at the end of the historic period. (SUNY ESF)**

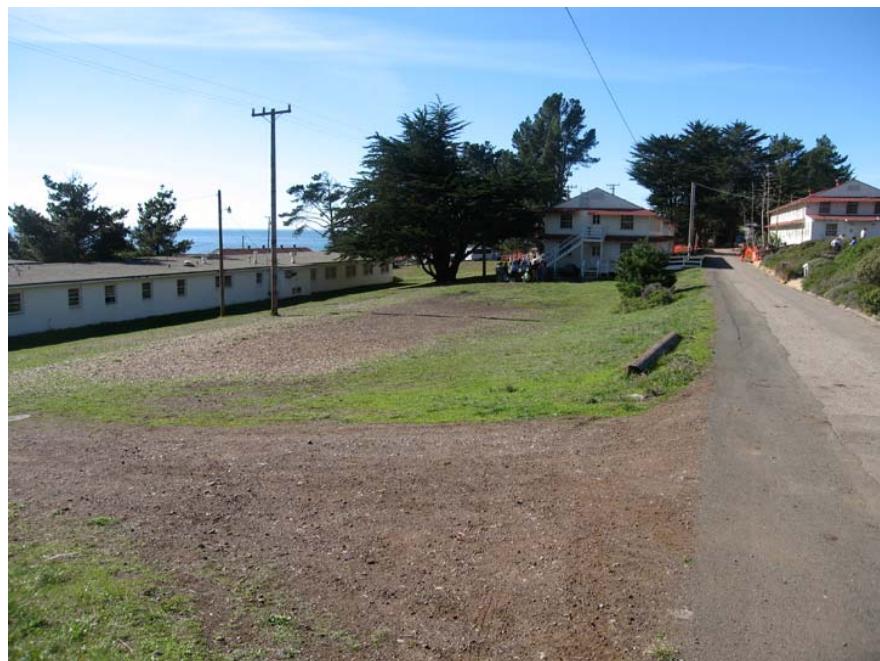
**Figure 12: The north side of the Headlands Institute campus showing conditions along Kirkpatrick Street looking west, 2007. This photograph shows a terrace that is the site of a World War II-era building that matched the ones in the background. Note the contrast in massing with the Nike administration buildings at left. (SUNY ESF)**
