Figure 2-1
Alternative 1 - No Project Alternative
Year 0

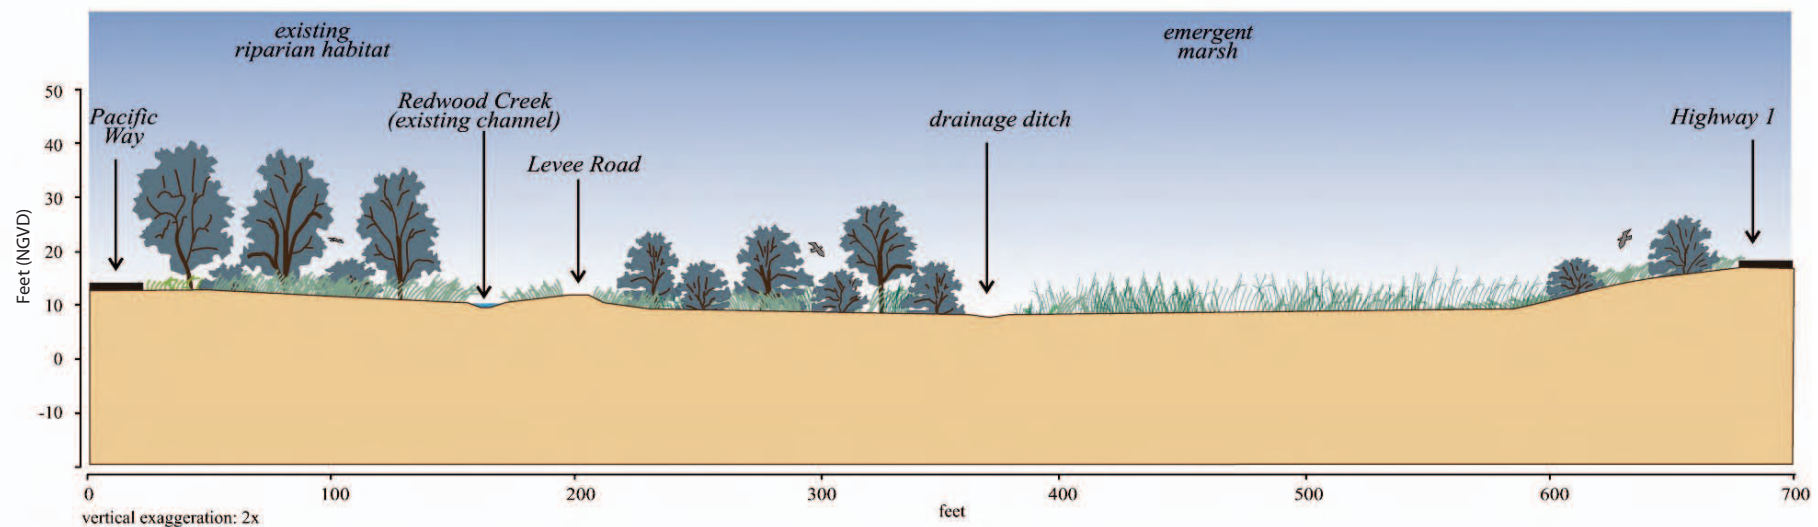
Note: Location of cross section is shown in Figure 2-1

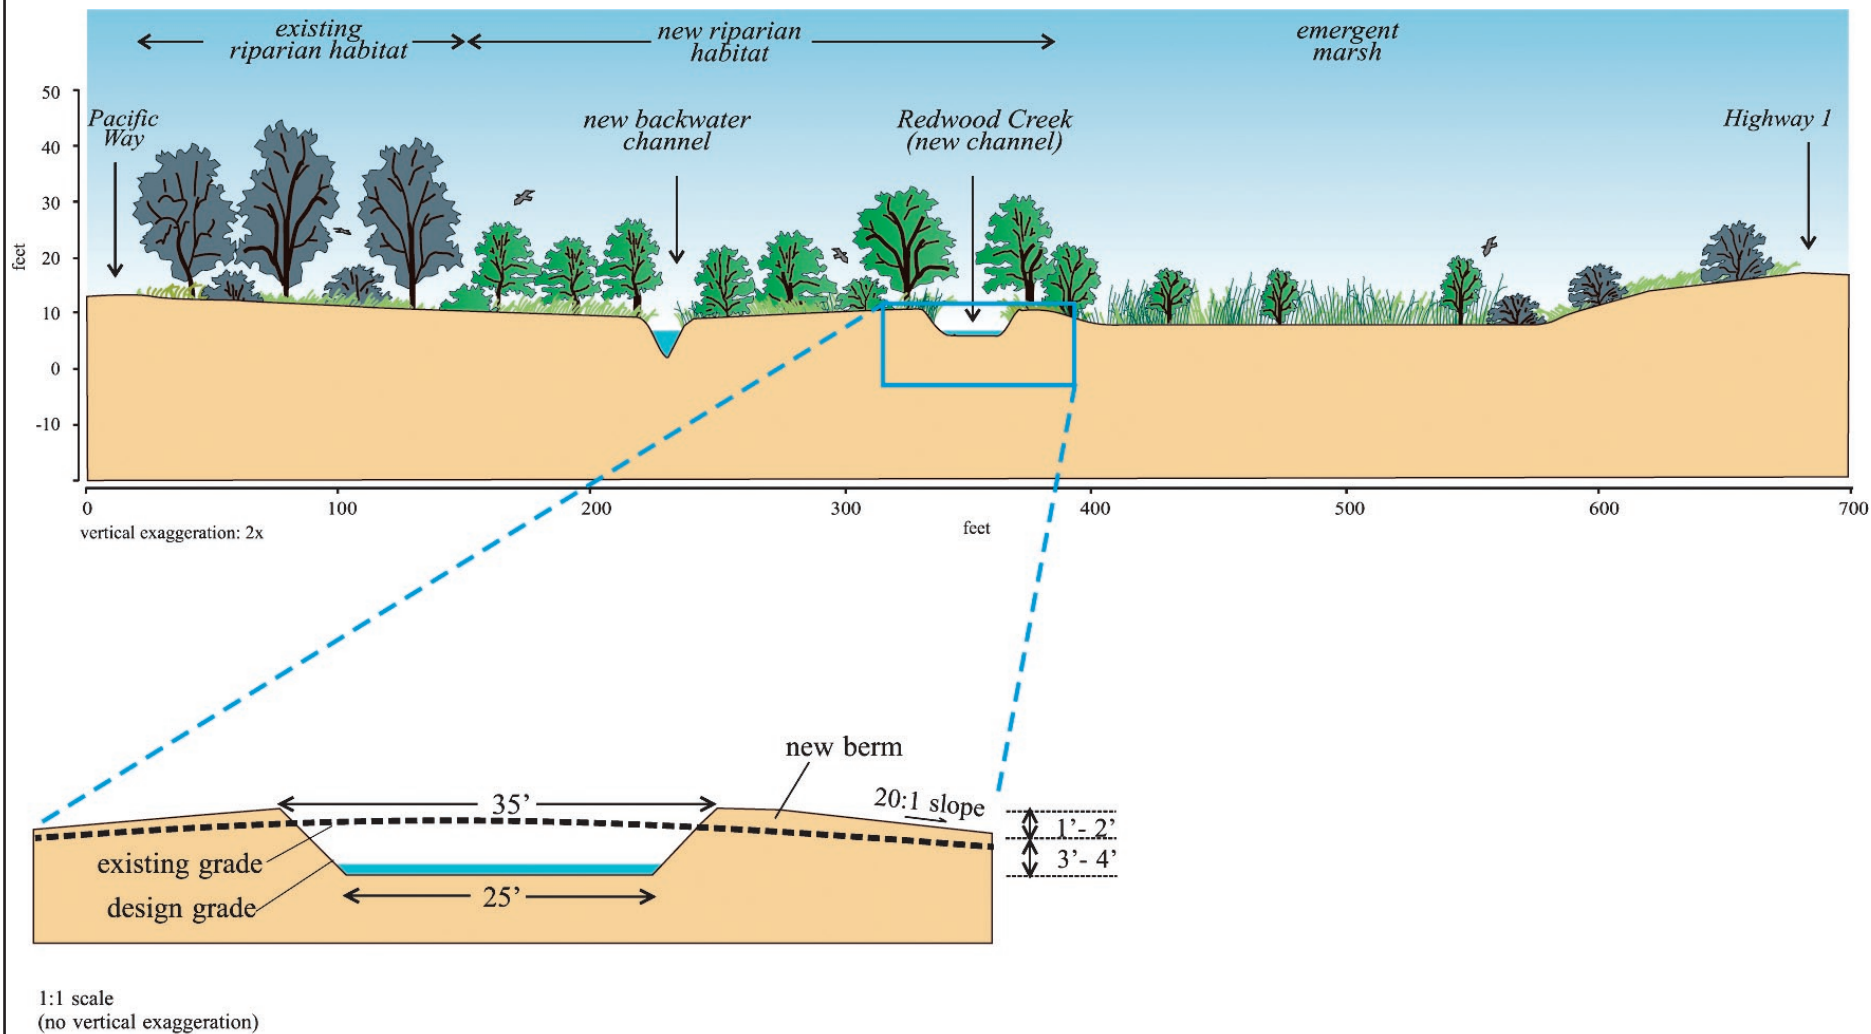
NOTE: The channel shown is over-simplified for purposes of this illustration. The channel bed would be expected to be irregular after installation of large woody debris to create channel features, such as deep pools.
