Figure 2-13 **Public Access Alternative B2**

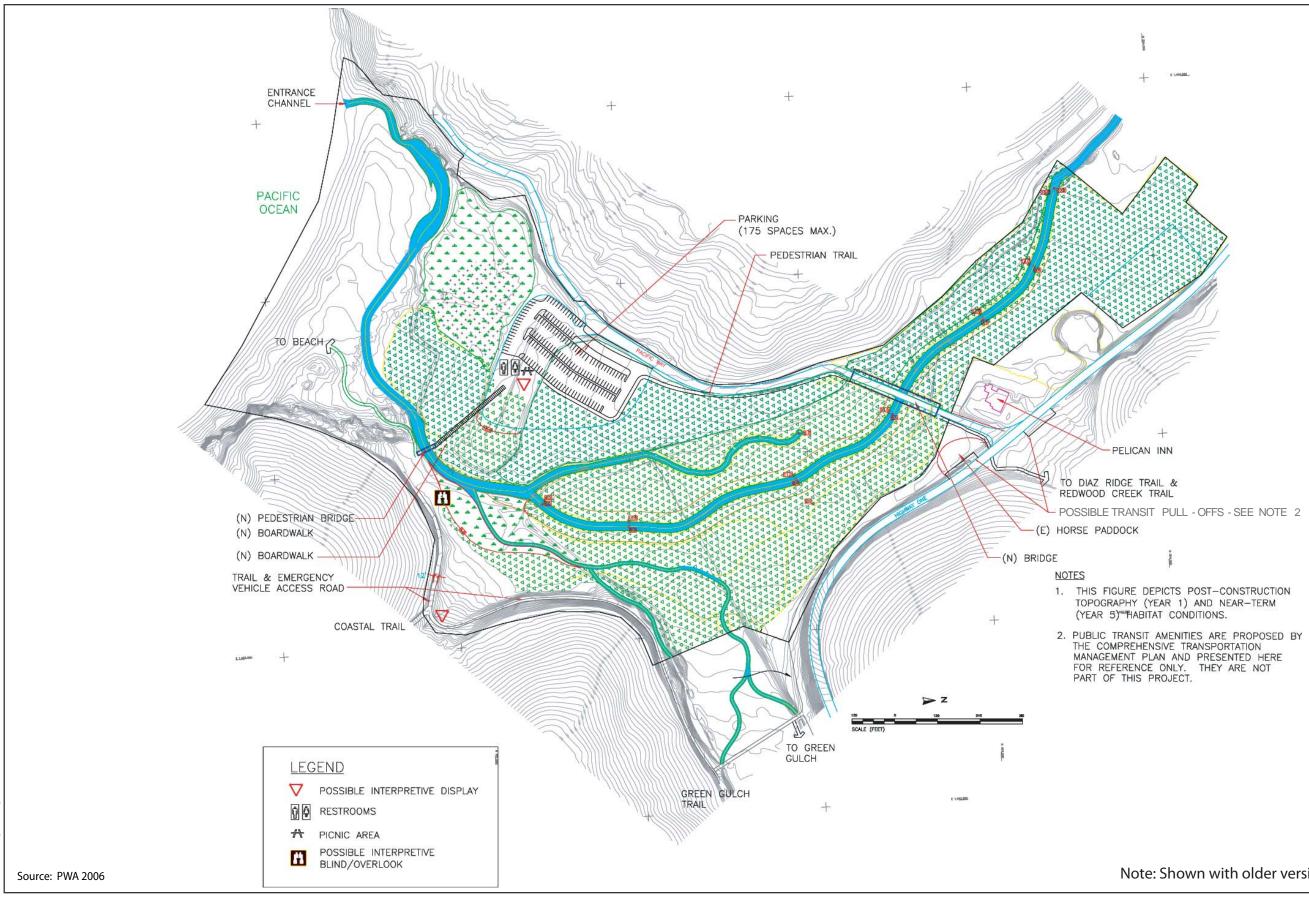
Figure 2-15 **Public Access Alternative B4** Shown with Alternative 2 – Creek Restoration

Note: Shown with older version of Restoration Alternative 2

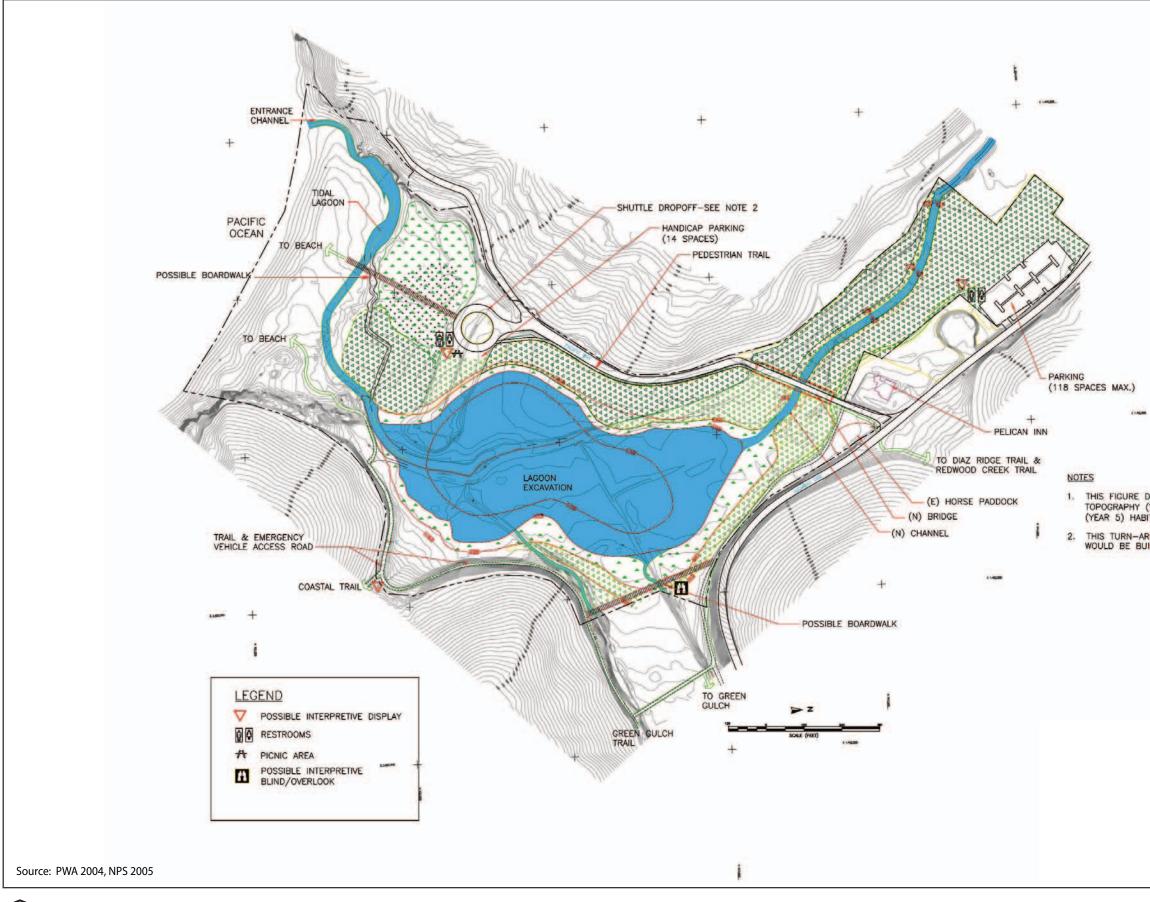
Figure 2-17 Public Access Alternative C

THIS FIGURE DEPICTS POST-CONSTRUCTION TOPOGRAPHY (YEAR 1) AND NEAR-TERM (YEAR 5) HABITAT CONDITIONS. 2. THIS TURN-AROUND AND HANDICAPPED PARTKING WOULD BE BUILT AS PART OF THIS PROJECT.

Note: Shown with older version of Alternative 4
