**COLORADO RIVER MANAGEMENT PLAN  
ANNUAL REPORT  
FOR FISCAL YEAR 2011**

**Project Number 133023**

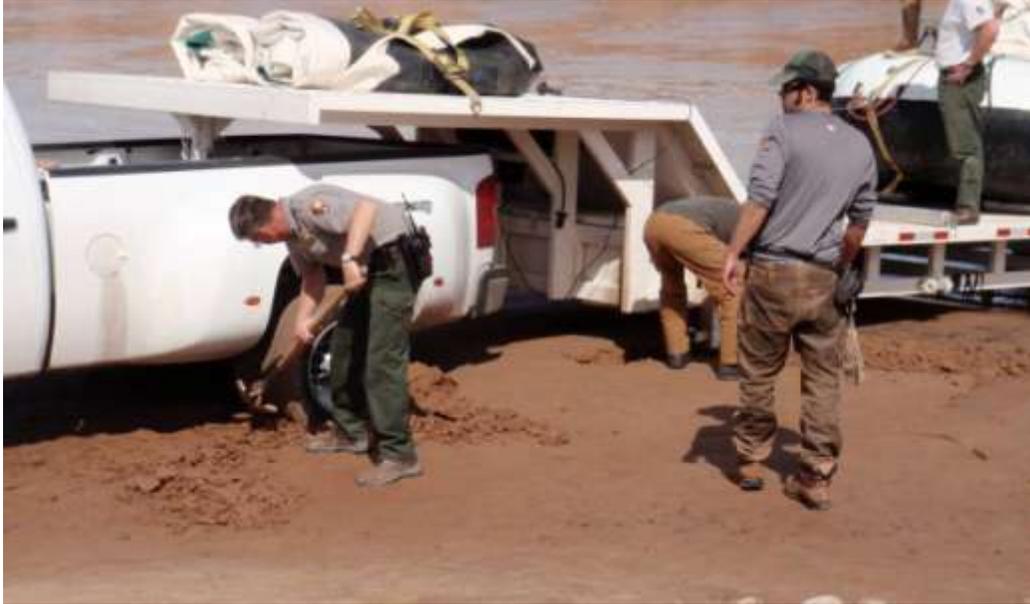
The Pearce Ferry takeout was an anticipated problem. The trip leader and shuttle drivers had previously arranged to be met by rangers from Lake Mead at the takeout in order to provide vehicles and winches necessary to extricate the truck and boat trailer in the event that either became mired in the silt sandbar that forms at the end of the ramp. After about an hour of trying to use the ramp, the group decided to try another spot adjacent to the ramp and was at last successful in getting the boat out of the water.

*Figure 1. Trying to get down to concrete at the Pearce Ferry boat ramp.*

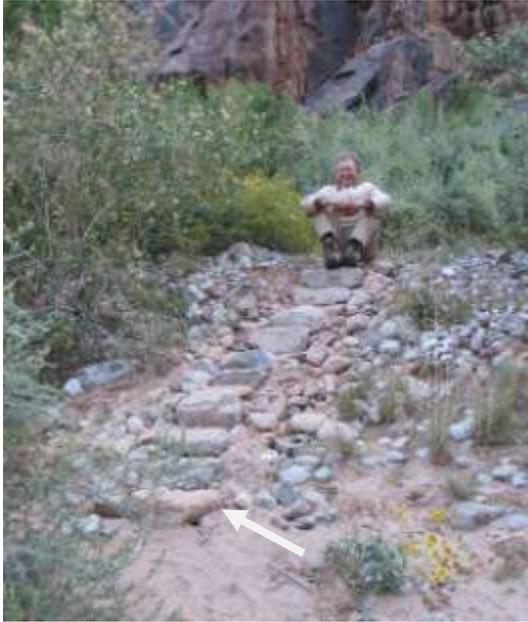
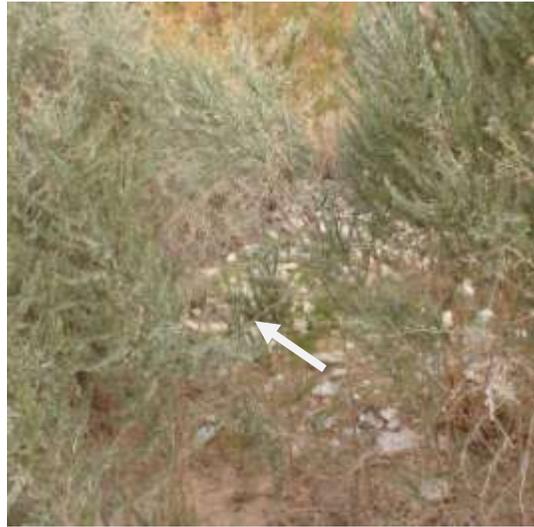
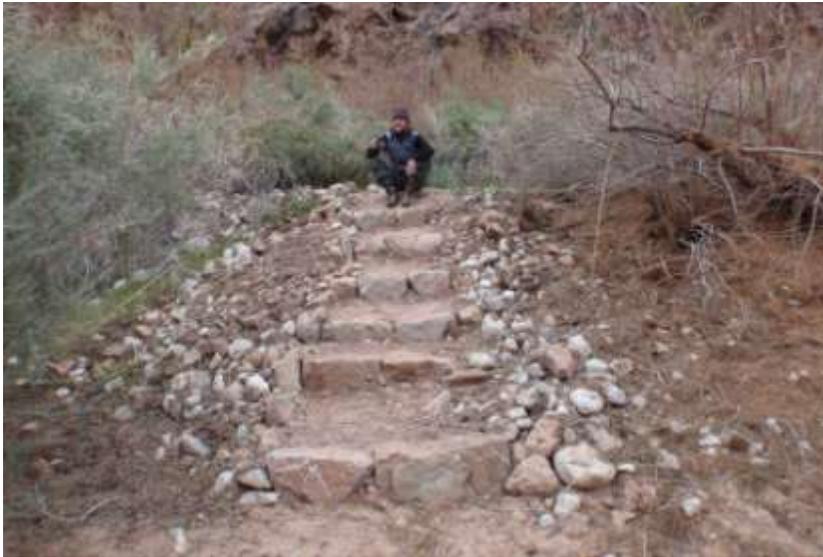
This is an established campsite that marks the last area suitable for camping until Lower Quartermaster at river mile 260.7. This campsite had been improved by river guides as part of the April 2009 Guides Training Seminar (GTS) field session. In the interim, much of the camp had become overgrown, and some of the access trails had become obscured. On this visit, the main kitchen and several campsites were reclaimed from vegetation encroachment, interconnecting camp trails were trimmed out and delineated, and substantial repairs were made to the work conducted by the 2009 GTS. In the example below, the access trail had been aligned in such a way that it terminated in a thicket of shrubs. The CRMP crew realigned the access trail into a logical clearing in the main kitchen area and reconstructed the stairway to make it more durable (see figures 2-4).

*Figure 2. Post-work, 250 mile. April 2009*

*Figure 3. 250 mile, February 2010*

*Figure 4. Post work, 250 mile, February 2011*

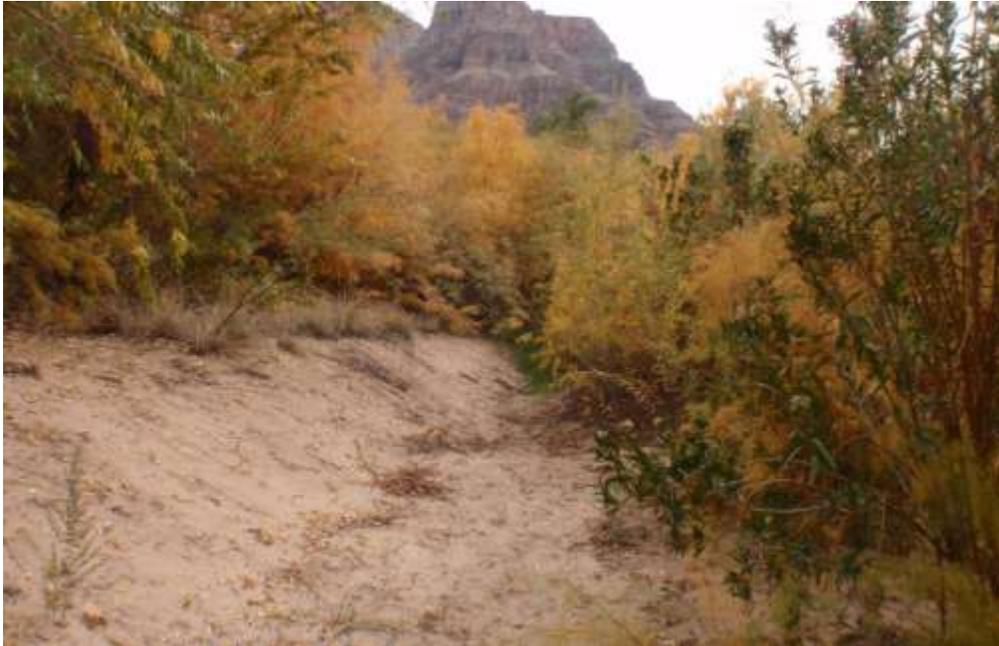
One of the sites where resource damage had been observed during the initial campsite monitoring trip in February 2010, the Dry Canyon camp was subsequently evaluated by the wildlife biologist and considered suitable for continued overnight use. The site is a comfortable day's row from 250-mile for the typical non-commercial oar group, is easy to locate due to the presence of a large boulder on river right, and offers decent mooring and access, ample shade from large willows and tamarisk, and opportunities to explore the peculiar landscape left behind as Lake Mead recedes. The site is arranged in a series of terraces that is the characteristic result of erosion, calving, and rotational slumping cycle common to the shoreline in this reach as the river carves its way through the former bottom of Lake Mead. The project consisted primarily of widening and leveling existing terraces, and pruning and improving access on the

*Figure 5. Middle terrace area at Dry Canyon Camp, pre-work. February 2011.*

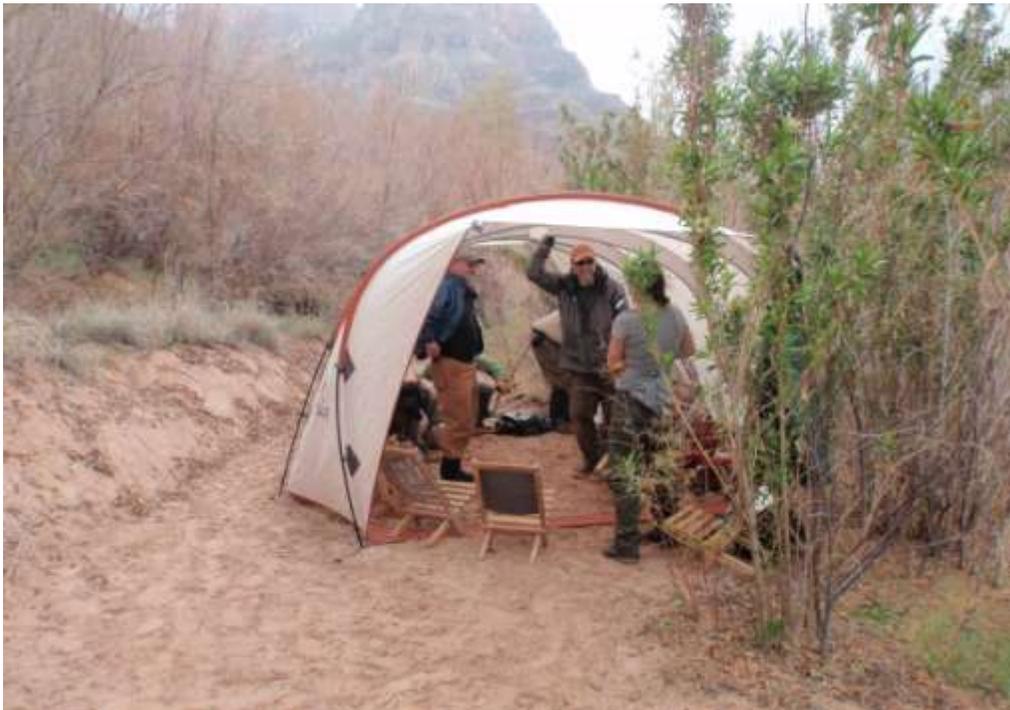
*Figure 6. Middle terrace area at Dry Canyon Camp, post-work. February 2011.*

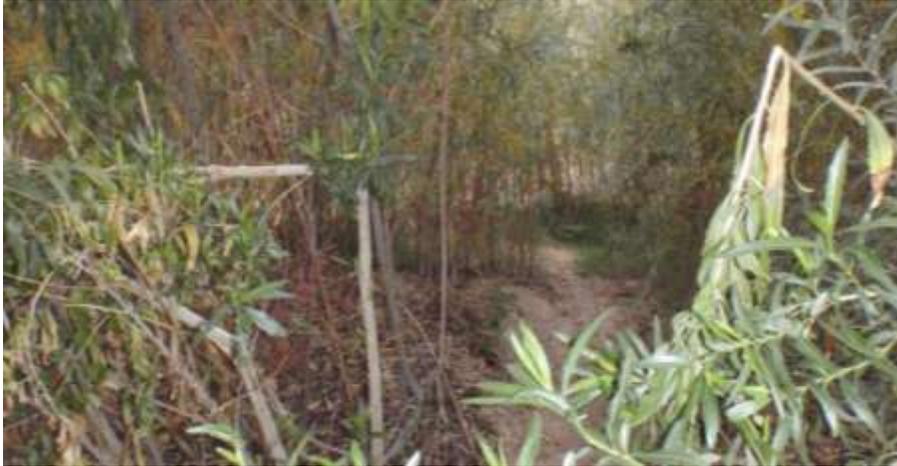
*Figure 7. Willow saplings broken adjacent to access trail at mile 273.5.*

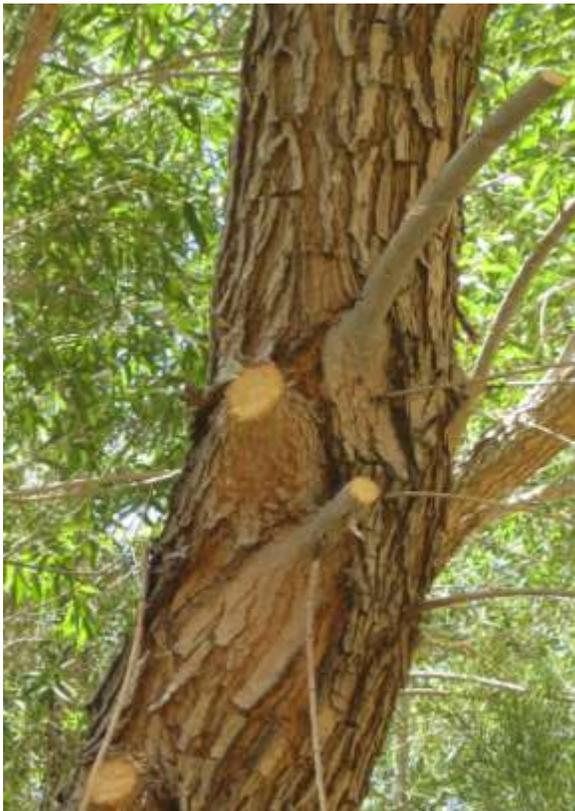
*Figure 8. Hazardous stobs left by user "pruning" at mile 273.5.*

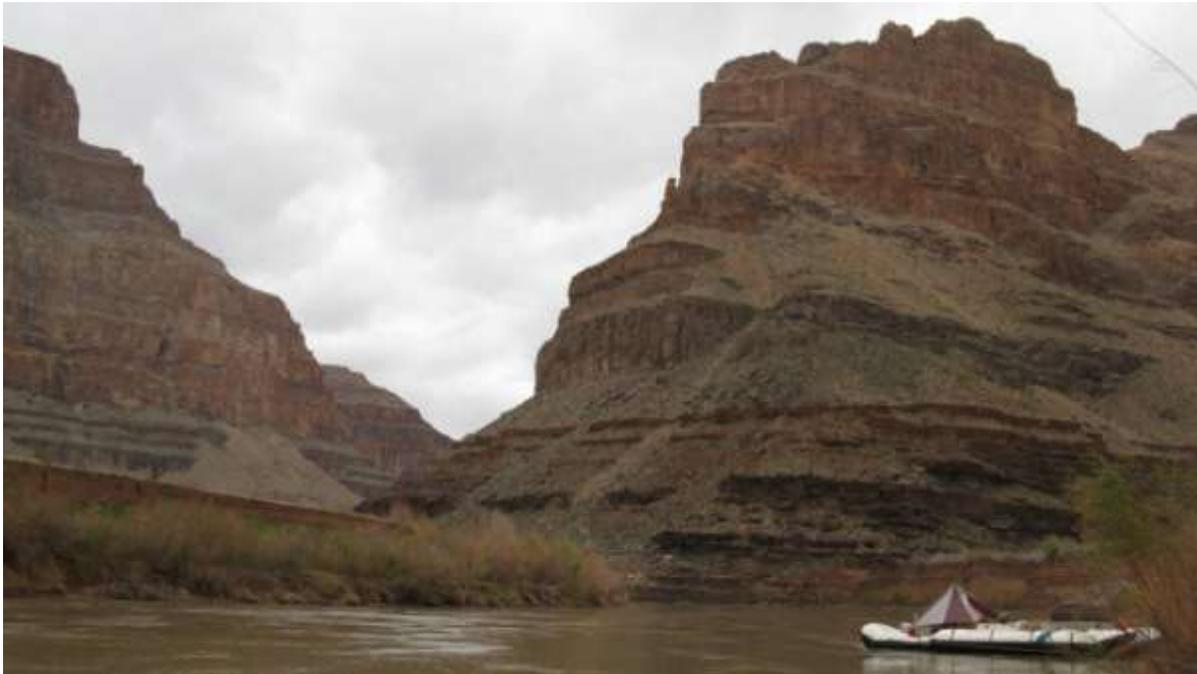
In other side tributaries such as Dry Canyon (river mile 265), the channel is experiencing a different type of channel adjustment. The lowering of Lake Mead has caused the Dry Canyon creek bed to become disconnected from the Colorado River. In response, the creek has begun to headcut (*A headcut is an abrupt step in the channel profile*) at its confluence with the Colorado River. The headcut advancement is also due to base level shifts in the Colorado River.

*Figure 1: High terrace deposits of former lake bottom sediments and the formation of a new floodplain through sloughing and slope failures (Lower Gorge, GRCA).*

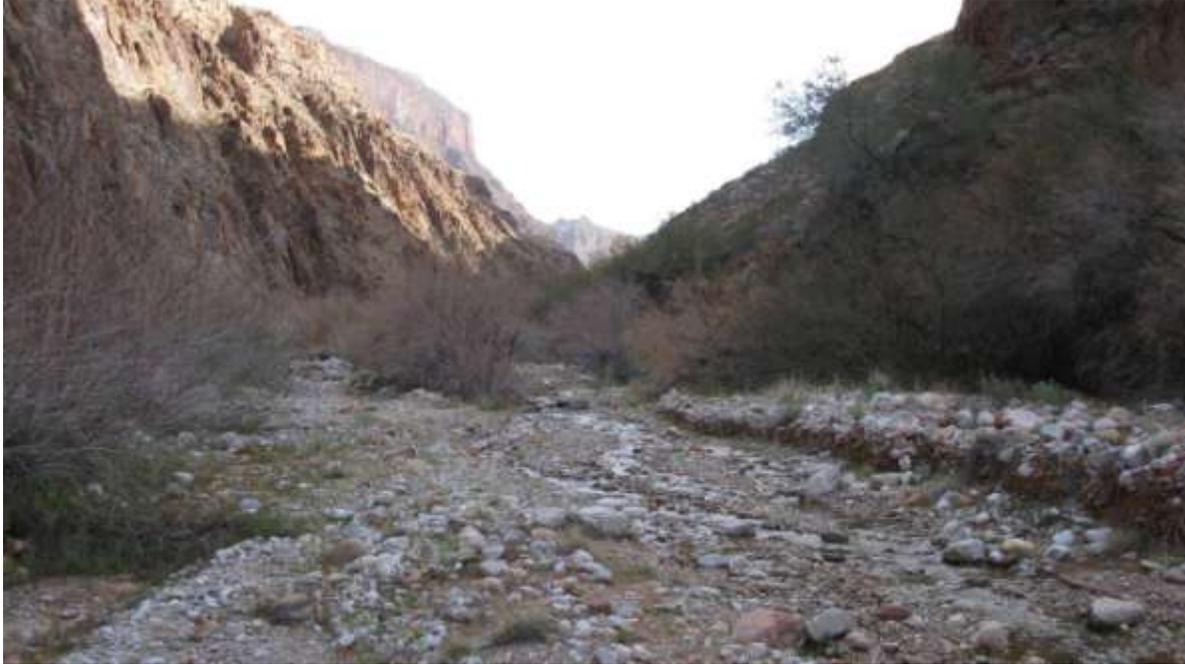
Many of the side tributaries in the Lower Gorge, such as Separation (river mile 240), Spencer (river mile 246) and Surprise Canyons (river mile 249) are exhibiting multi-channel features in the confluence area with the Colorado River. Braided channel patterns are found developing in very coarse materials in canyons with moderately steep slopes. These tributaries are susceptible to “flashy” runoff events and highly variable flow stages that occur annually and generate a very high source of sediment. The channel adjustments in these canyons are in response to base level changes in the Colorado River.

*Figure 2: Braided channel and coarse material bed load (Separation Canyon, Lower Gorge).*
