CULTURAL LANDSCAPE INVENTORY AND ANALYSIS

Grant-Kohrs Ranch National Historic Site

Deer Lodge, Montana

DIVISION OF CULTURAL RESOURCES * ROCKY MOUNTAIN REGIONAL OFFICE
NATIONAL PARK SERVICE
UNITED STATES DEPARTMENT OF THE INTERIOR
DENVER, COLORADO
1991

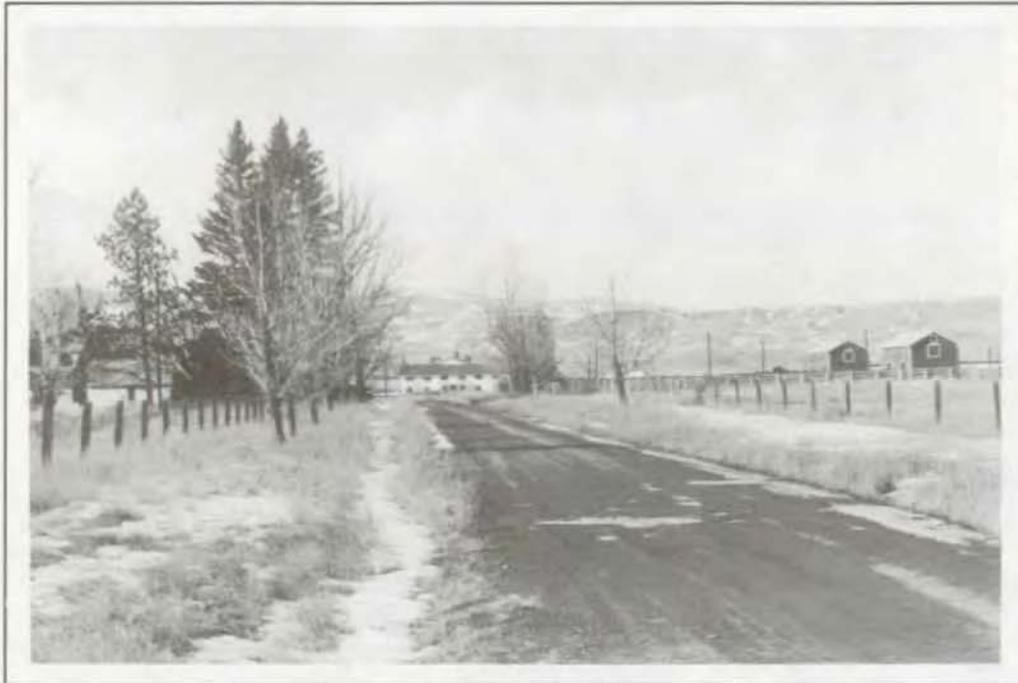
Figure 1. Historic entrance to the ranch. View of the Home Ranch looking west from U.S. Business 90. Note the historic tree lined drive and visual axis to the Kohrs ranch house. Horse corrals to the right are part of East Feed Lot/Warren Hereford Ranch.

It is recommended that any design for the new parking lot include the restoration of the historic tree lined entry drive to the ranch. The new design and paving material should be compatible with the historic features of the site. This may include the use of a "grass crete" type paving system allowing the visual qualities of the grass covered horse corrals to be maintained. Any new design for parking should also consider other historic features such as fences and the small horse barns on the north side of the corrals.

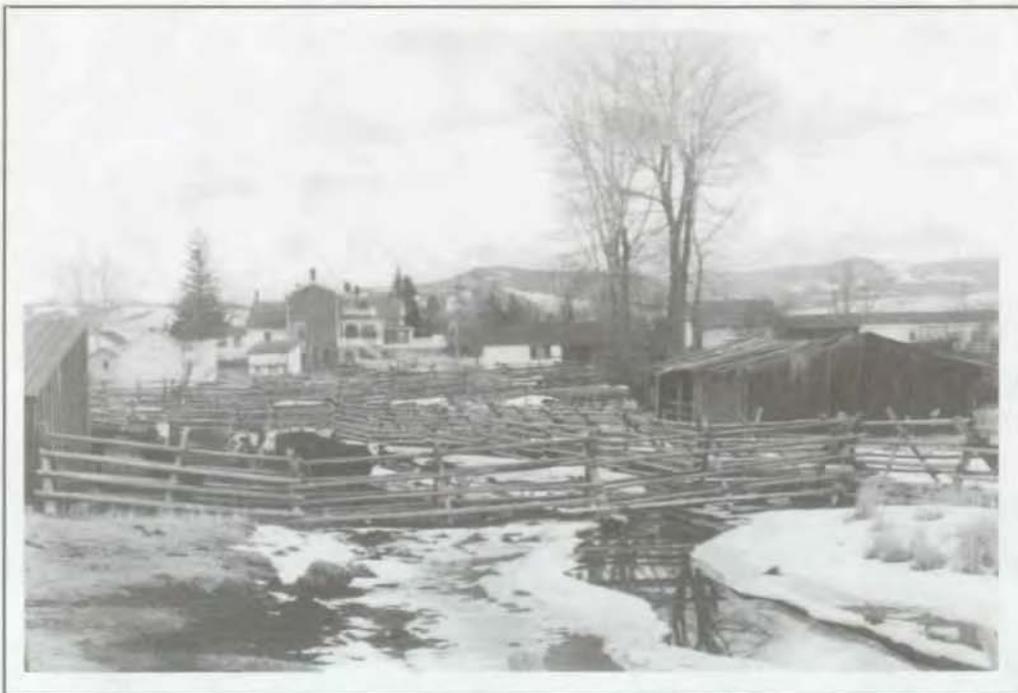
Figure 2. Looking east from the Kohrs-Manning ditch and flumes to the ranch house. Cattle pens, fence rows and buildings dominate the landscape. Johnson Creek can be seen in the foreground with Black Cottonwoods along its banks.

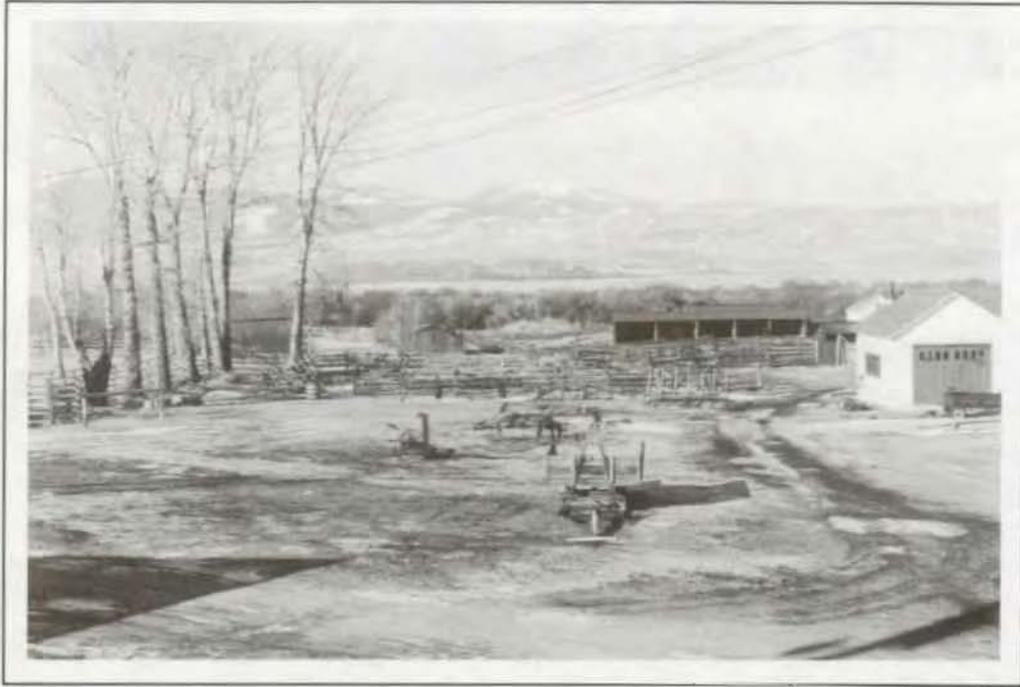
Figure 3. Lower yard, as seen from the rear porch of ranch house, showing spacial characteristics of the Home Ranch Complex established by building arrangement, fence and corral placement and natural features. Farm machinery in the yard helps interpret the historic landscape.

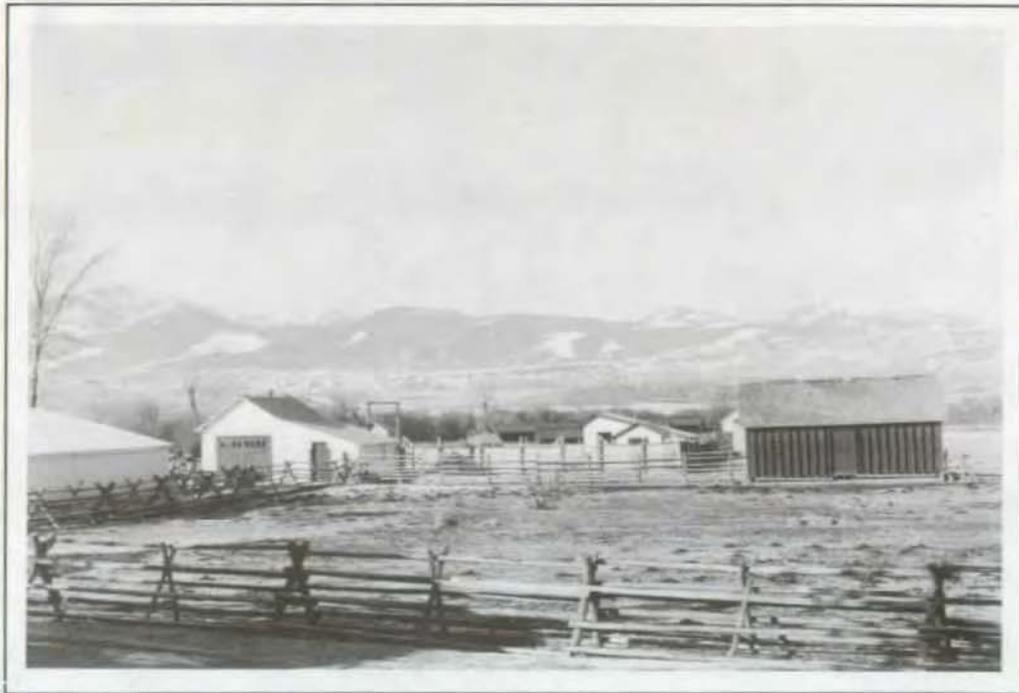
Figure 4. Corrals north of the ranch house looking west to the Pasture/Hay Field and Upland Pasture in background. Photograph shows evidence of a strong continuity and visual relationship between these different landscape types.

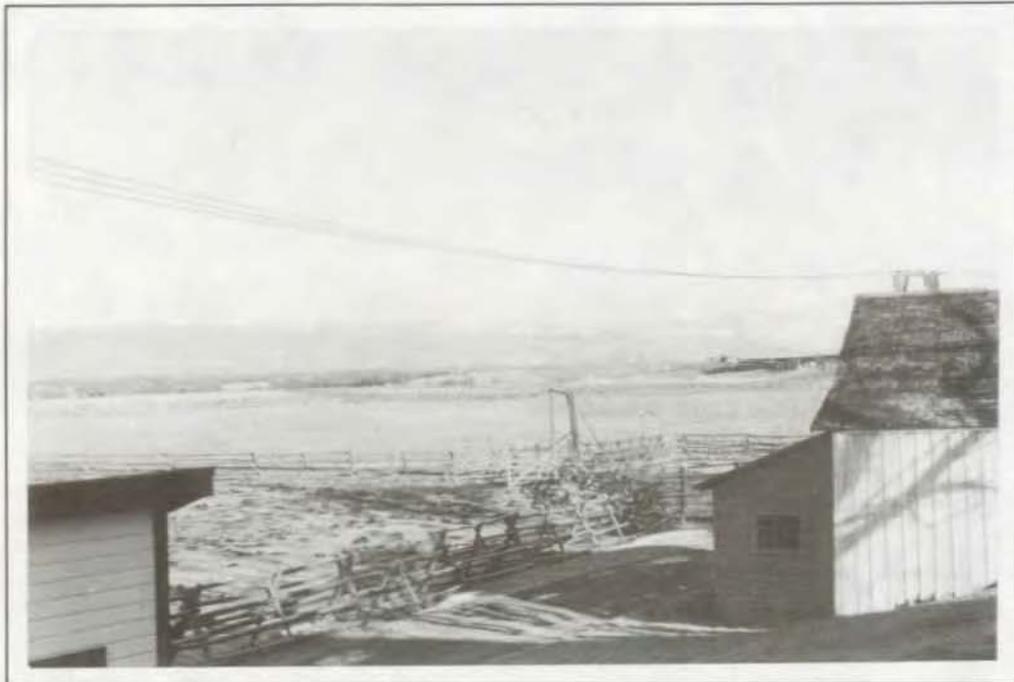
Figure 5. Looking northwest from the back porch of ranch house to larger corrals and "L" shaped barn in upper right corner. Historic "Jack-Leg" fence and gate in foreground. Bands of the Riparian/Woodland landscape and Upland Pasture can be seen in the background.

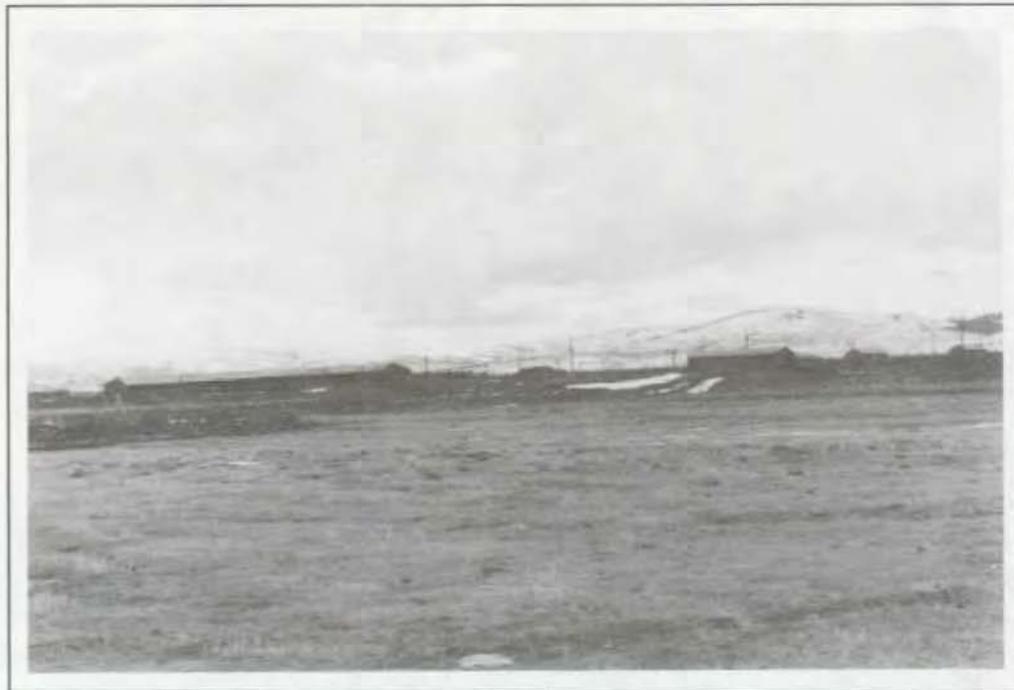
Figure 6. View looking northeast from north pasture to "L" shaped barn and smaller corrals. Natural landscape is relatively flat and gently sloping west to the Clark Fork River.

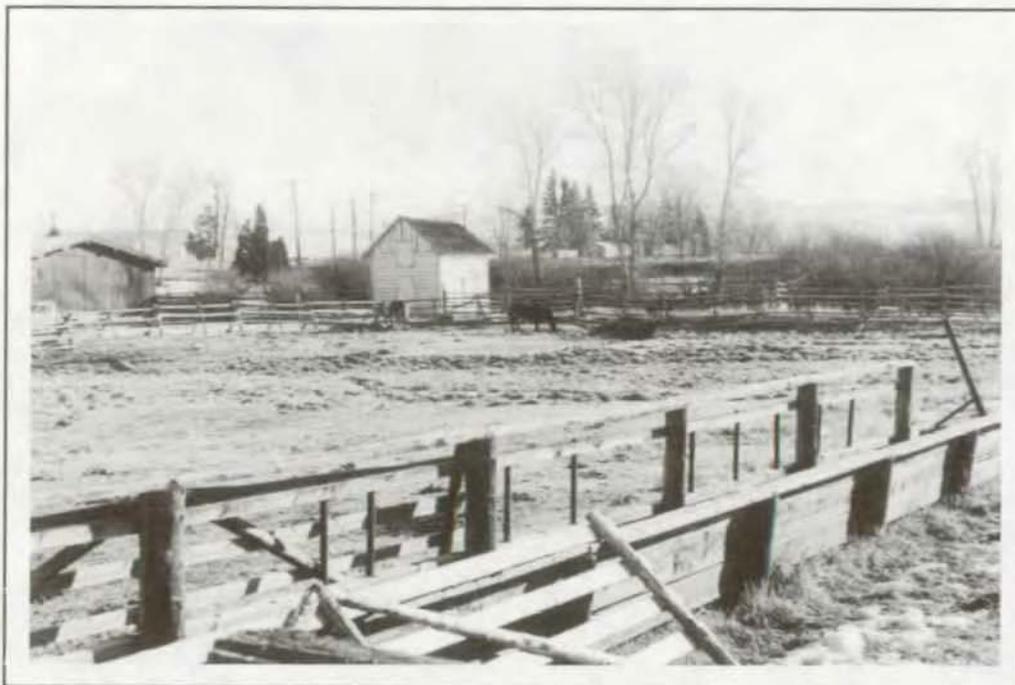
Figure 7. Looking from the southern perimeter road at the west feed lot with feed trough in foreground. A small section of the Riparian/Woodland landscape can be seen along Johnson Creek.

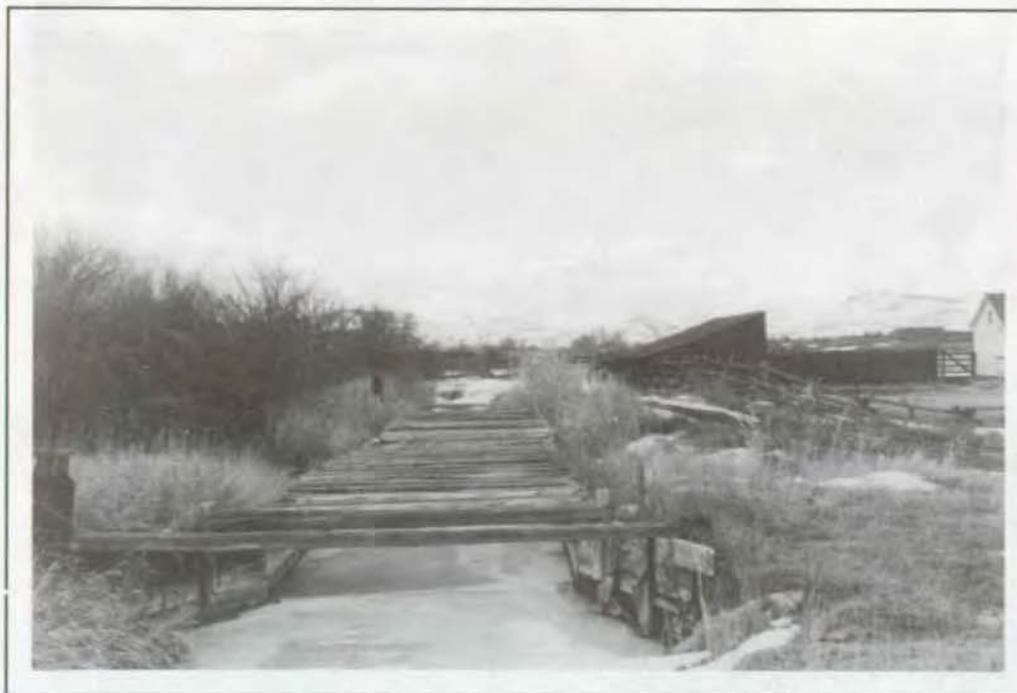
Figure 8. View looking north at the historic Kohrs-Manning flume as it crosses Johnson Creek. Willow thickets can be seen along the creek.

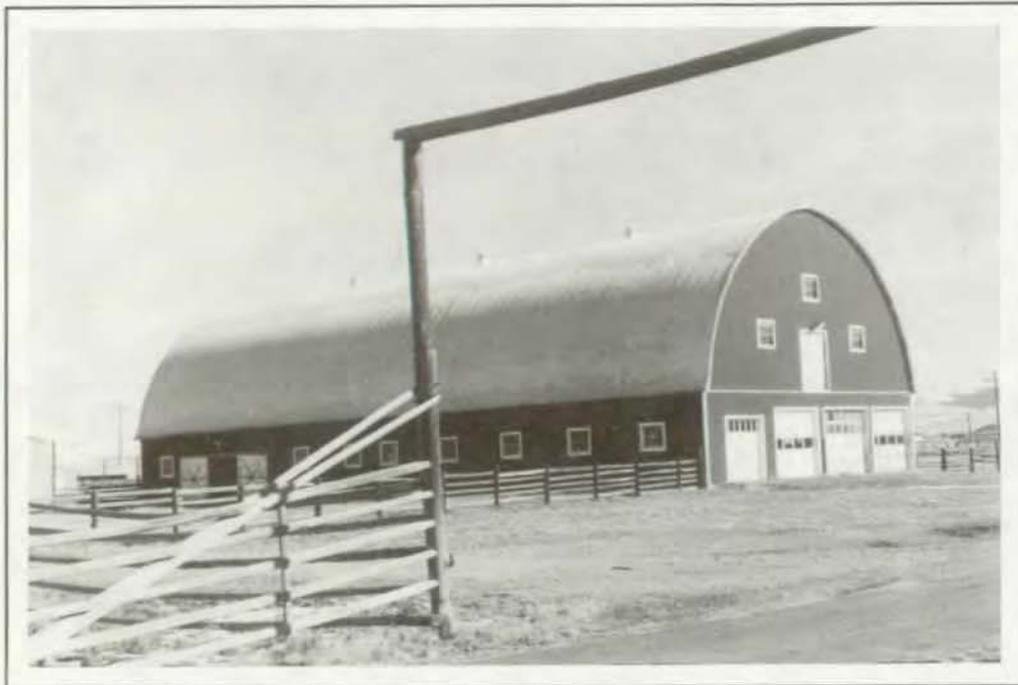
Figure 1. A large red barn dominates this landscape type as viewed through gate. The non-historic service road constructed by NPS in 1972 is seen in the foreground. Post and pole fencing contributes to the historic character of this landscape.

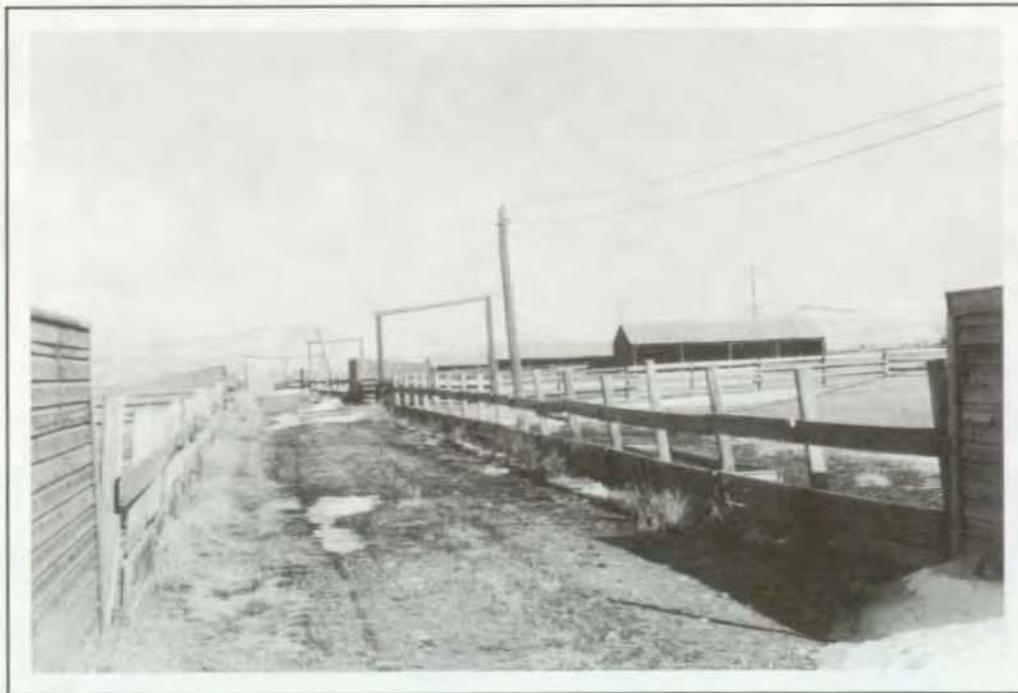
Figure 2. Looking north at the eastern alley and adjacent cattle pens. Cattle sheds are located within each pen while feed troughs are adjacent to the alley. Overhead electric lines and poles are part of the historic landscape.

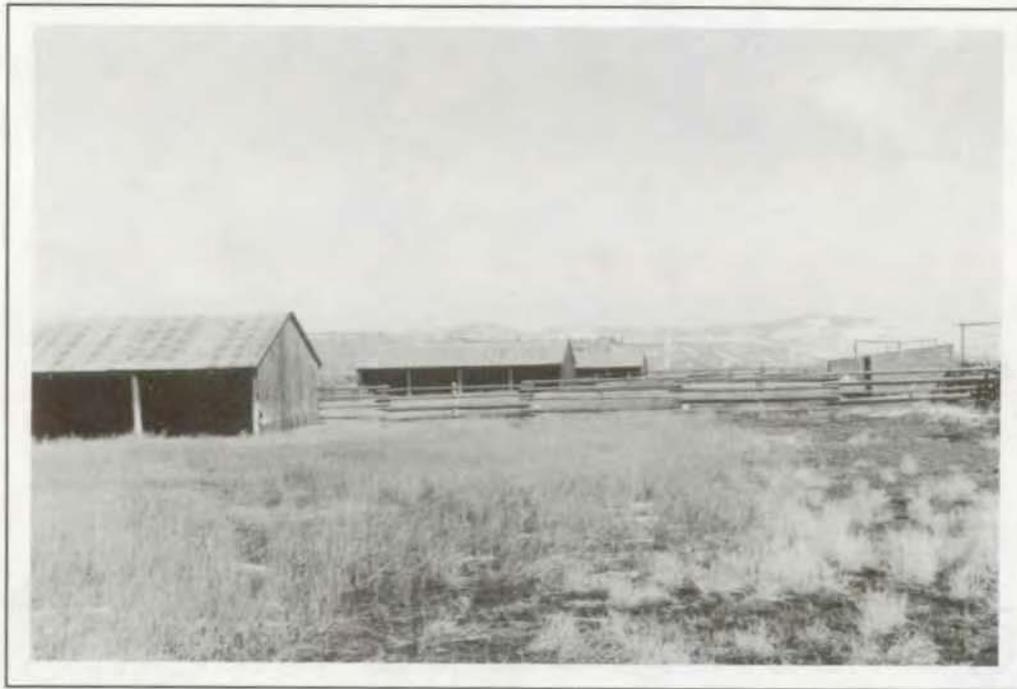
Figure 3. Cattle pens and sheds looking north. Post and pole fence and wood feed troughs can be seen at the right.

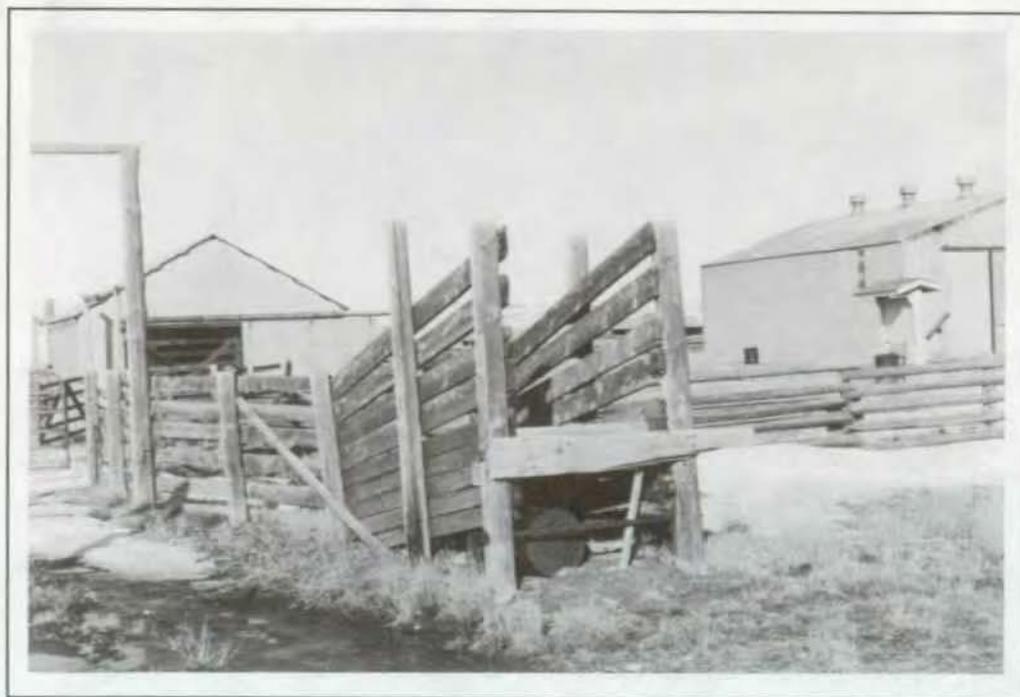
Figure 4. Loading chute with metal scale barn on the left. Metal sales barn can be seen on the right.

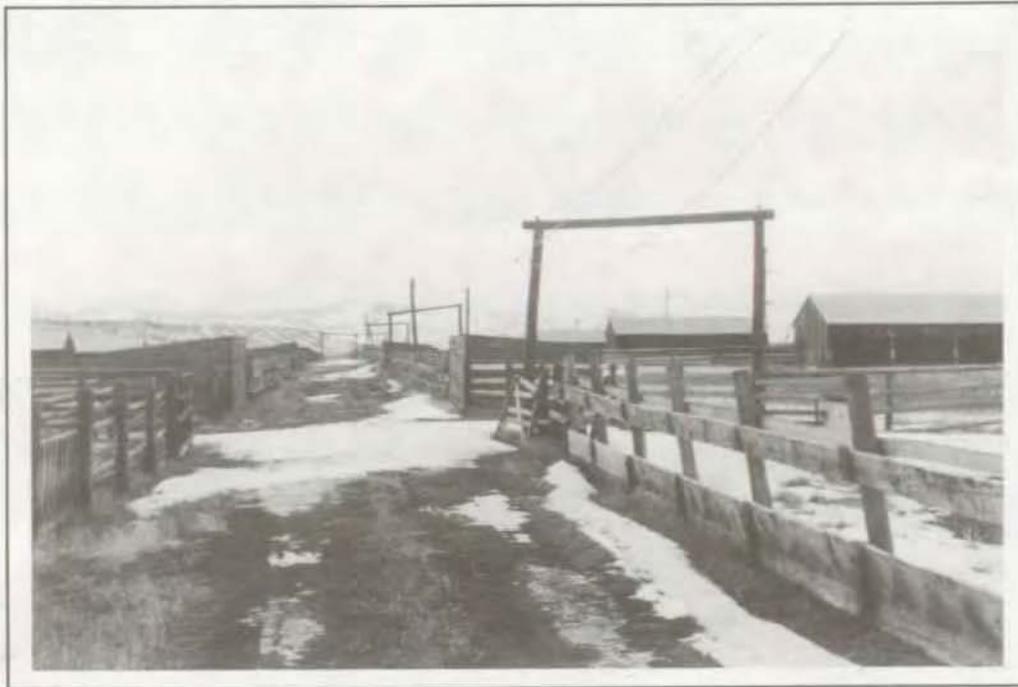
Figure 5. View of alley looking north showing gates that allow access to the cattle pens. Overhead electric lines and power poles with glass insulators add to the historic character of the site.

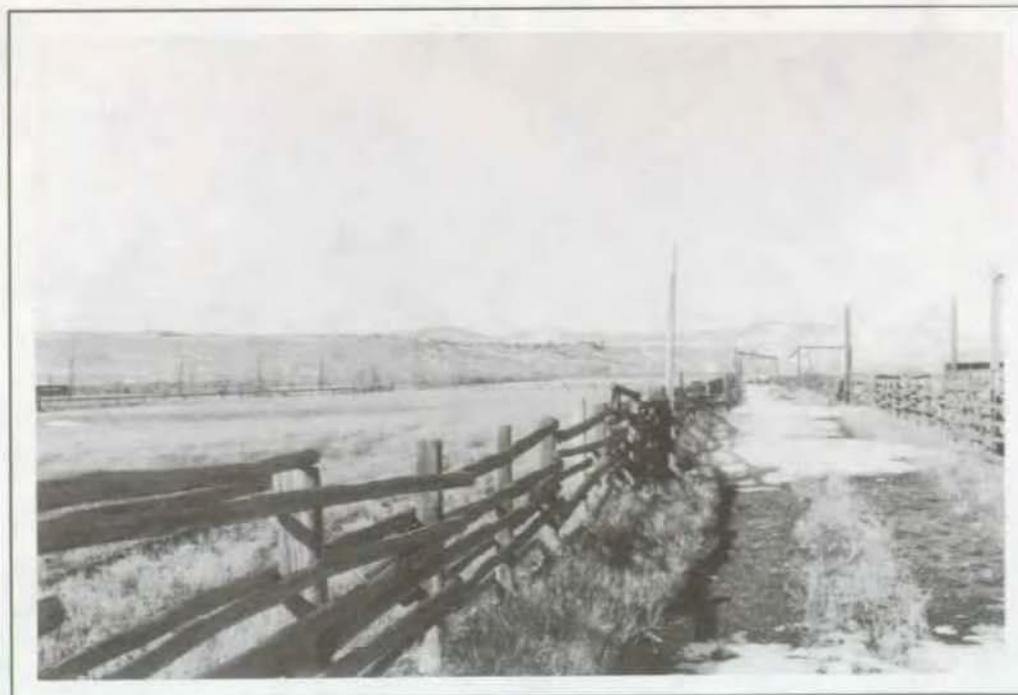
Figure 6. Western most alley looking north at pasture. The Railroad Bed and Upland Pasture landscape type can be seen on the left.

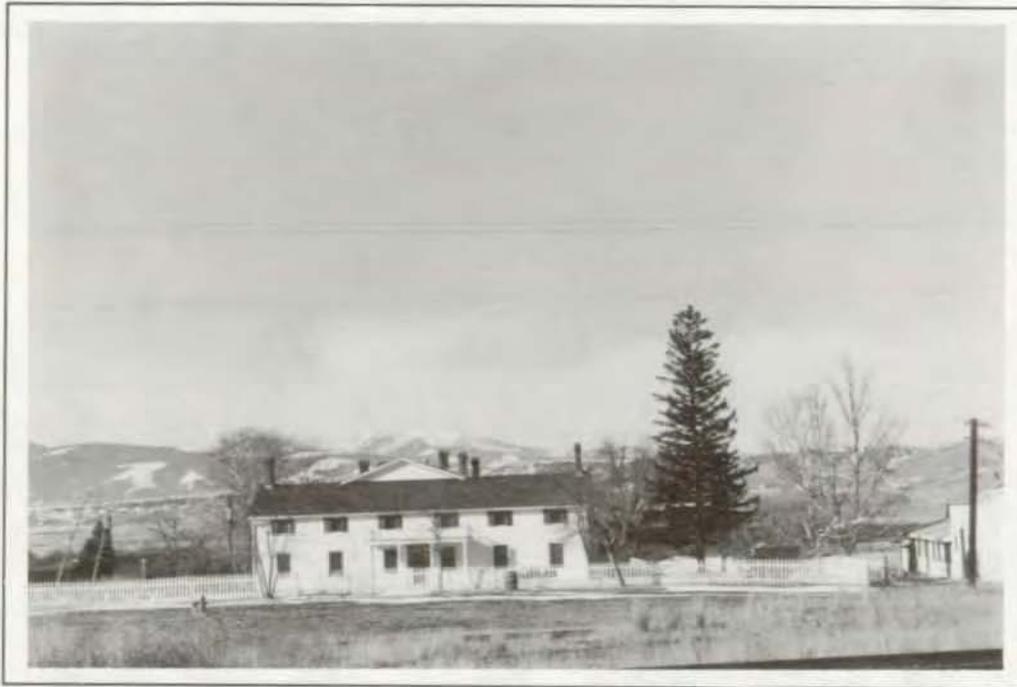
Figure 1. Kohrs ranch house with picket fence enclosure and tree planted east yard. Upland Pasture can be seen in the background.

Restore Kohrs Residential Landscape The Ranch house has been restored by the NPS, yet the residential landscape remains in its post 1972 condition. Several important historic features of this landscape have been identified as missing, such as the yard irrigation system, picket fence (the existing fence is non-historic) and yard trees. In addition, the finished grade of the yard was modified in the 1950's (outside the period of significance) with the addition of approximately 6" of fill, which should be removed in the restoration.

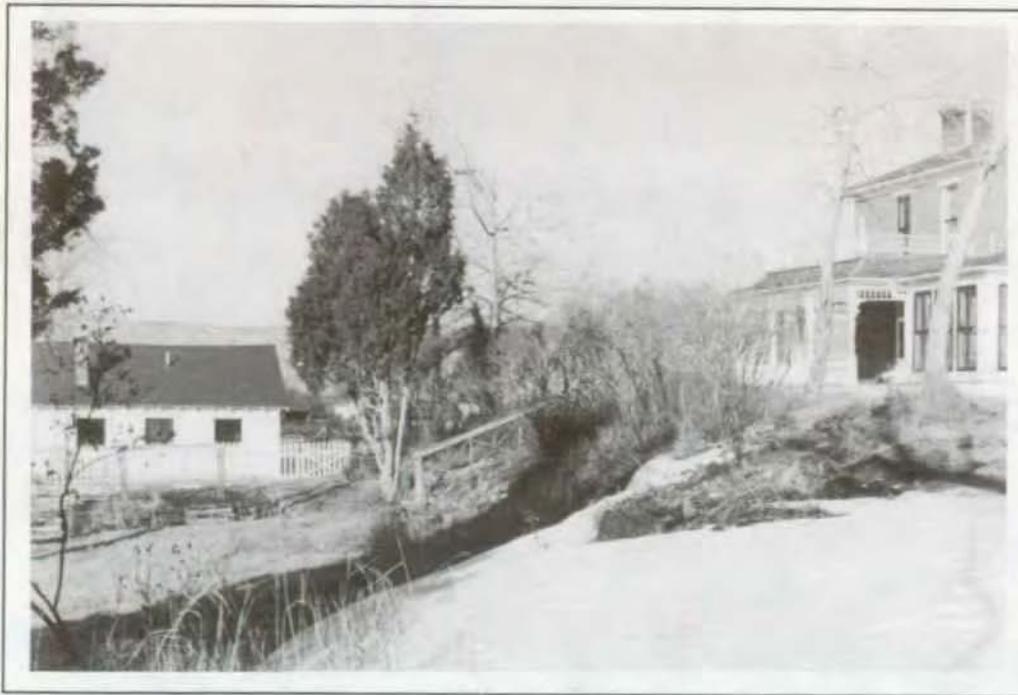
Figure 2. South side yard of the Kohrs ranch house showing drop from the upper bench. Stairs and rock wall can be seen along with flower garden in lower left. This landscape is part of the "private" space defined by the fenced yard.

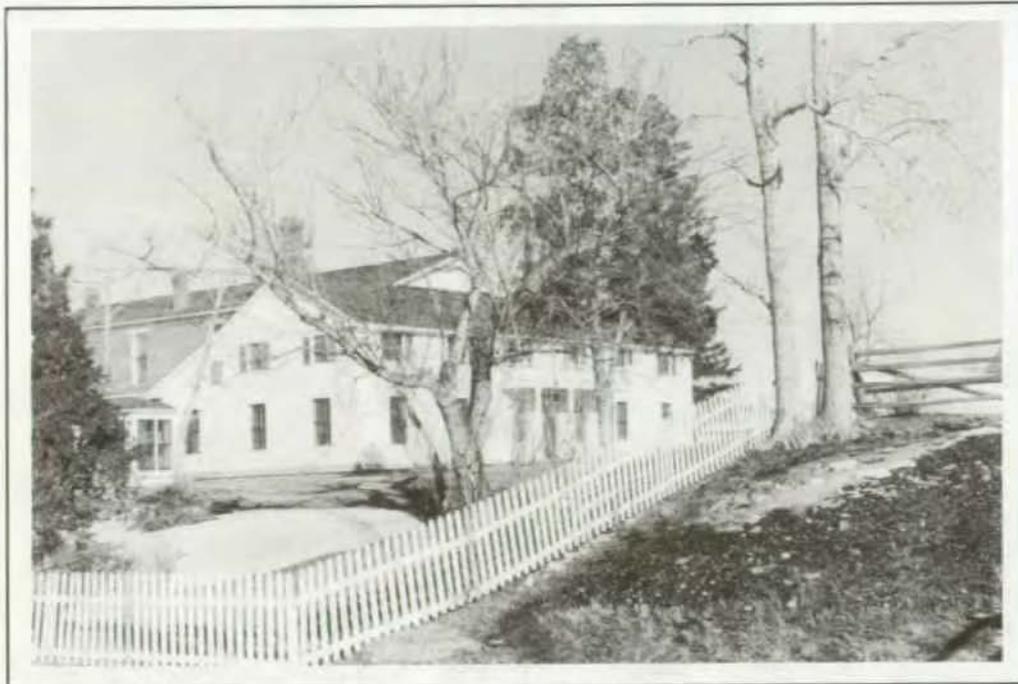
Figure 3. Kohrs residential landscape looking northwest at side yard. While several trees have been lost over the years, the existing mature deciduous and evergreen trees within the fenced yard contribute to the landscape's historic character.

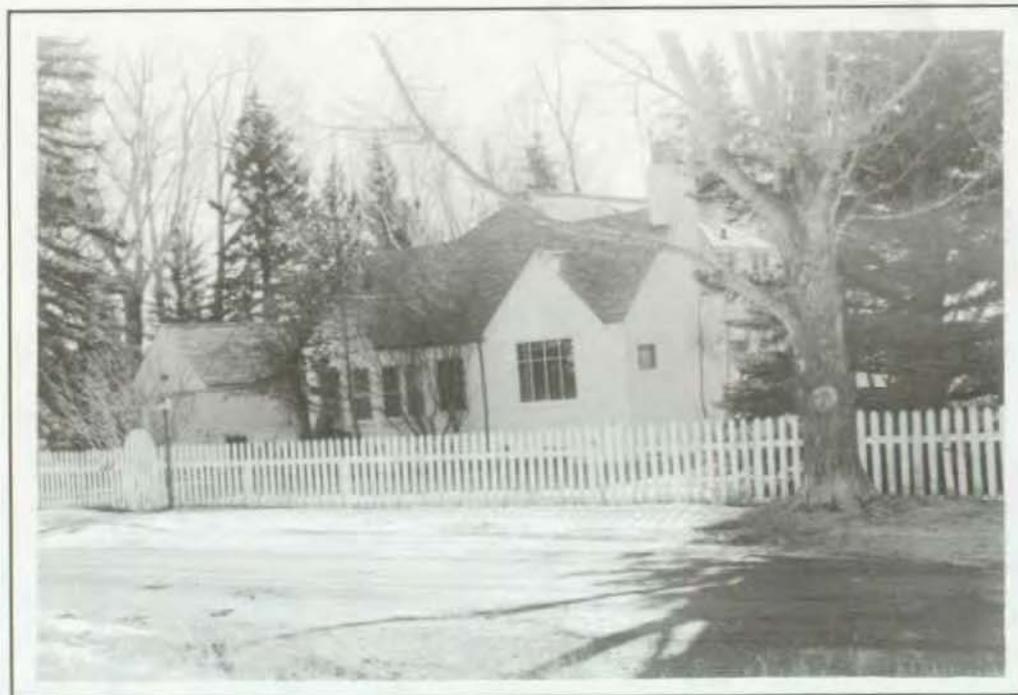
Figure 4. Con Warren residence looking south to house and fenced yard. Mature deciduous and evergreen trees dominate the landscape. Drive in foreground is the historic entrance to the ranch.

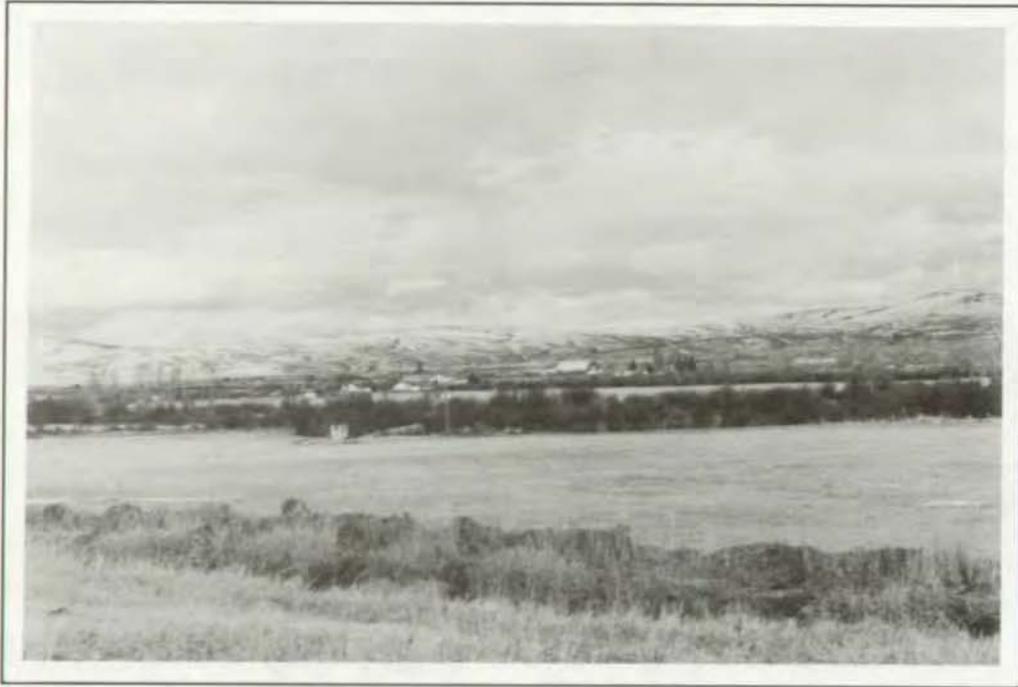
Figure 1. View looking east to the Home Ranch Complex from the western boundary of Pasture/Hay Field landscape. An irrigation ditch can be seen in the foreground and Riparian/Woodland landscape is shown in the middle ground. The large red barn from the East Feed Lot dominates the horizon.

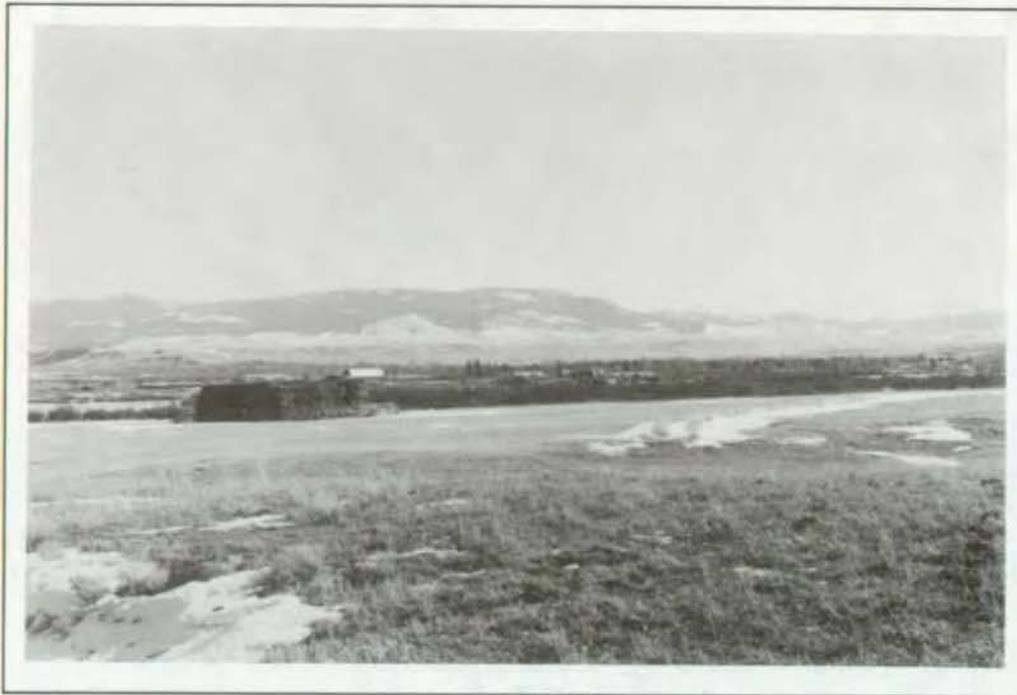
Figure 2. Looking southeast to the Home Ranch Complex. Rolling topography is characteristic of this landscape type. Historically, hay would be loose piled into stacks by a hay stacker or baled as shown here.

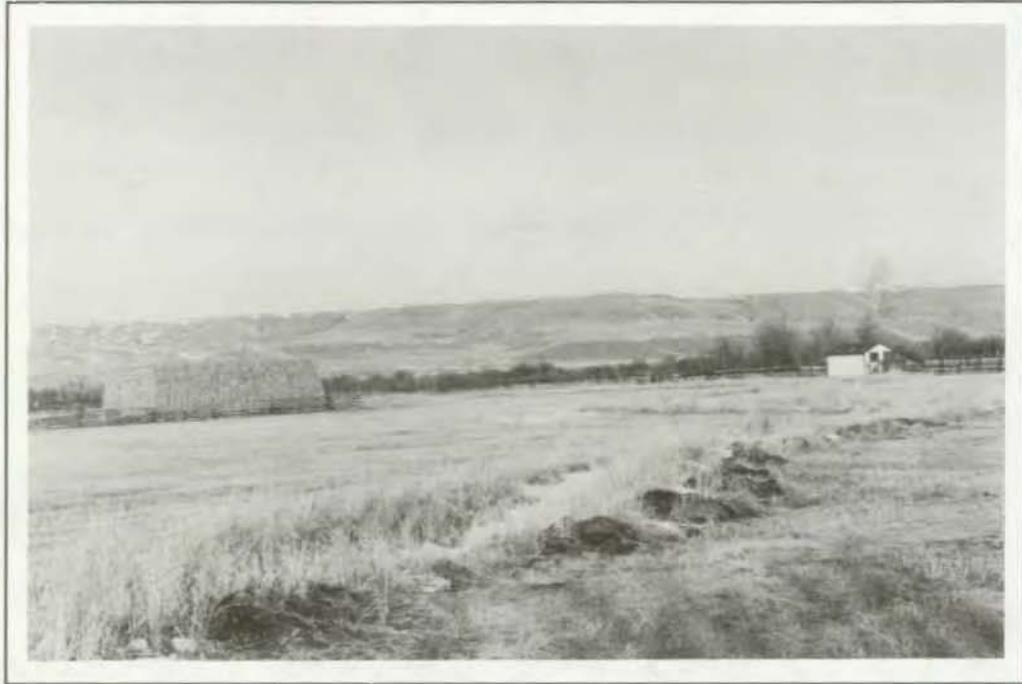
Figure 3. Area south of Home Ranch Complex showing Kohrs-Manning ditch and west feed lots of Home Ranch in background. Hay is harvested in late- June or early-July with grazing taking place after the harvest. The Upland Pasture landscape can be seen on the horizon.

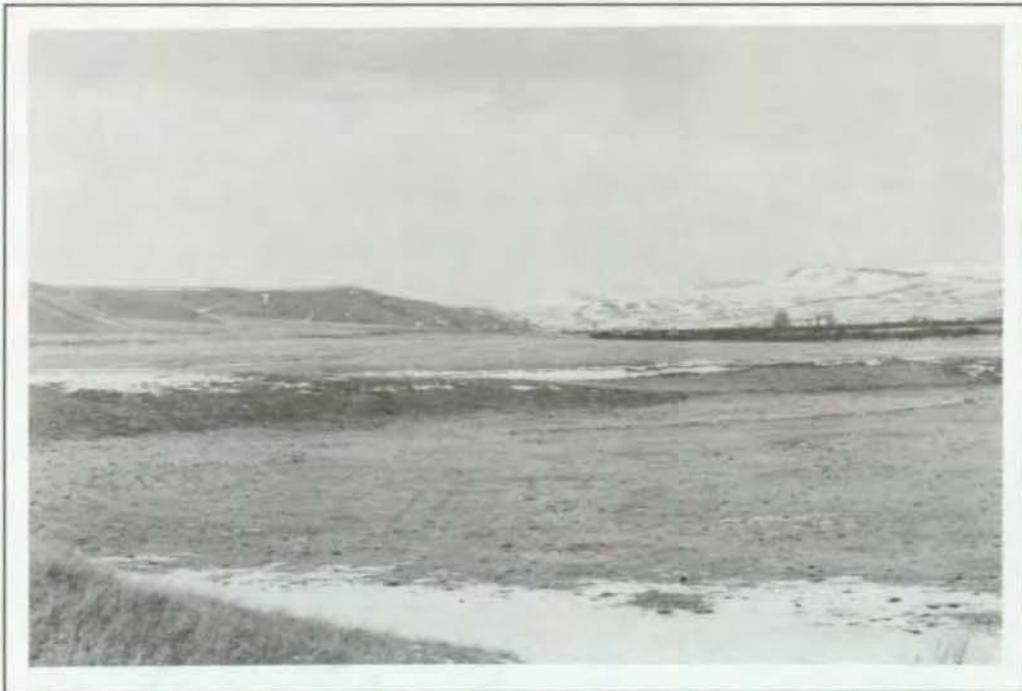
Figure 4. Gently rolling wide-open and isolated landscape is characteristic of the area west to the Home Ranch. Adjacent Upland Pasture dominates the background.

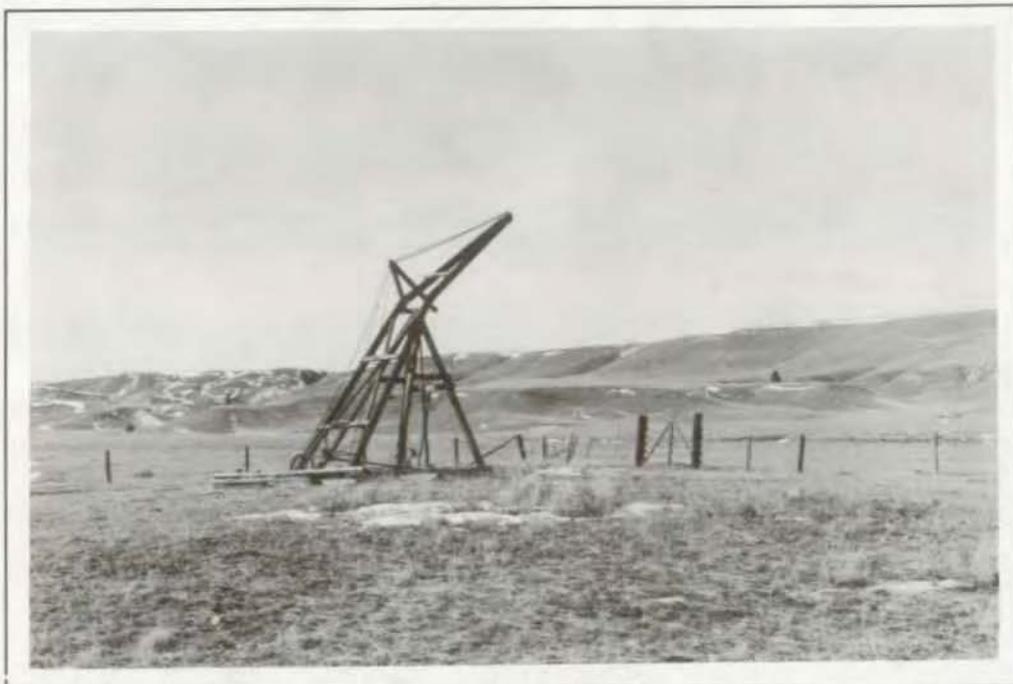
Figure 1. View of foothills forming the Upland Pasture landscape. Photograph is taken in front of the road separating the Pasture/Hayfield and Upland Pasture landscapes. Historic hay stacker in foreground adds to the integrity of the historic landscape and should be retained.

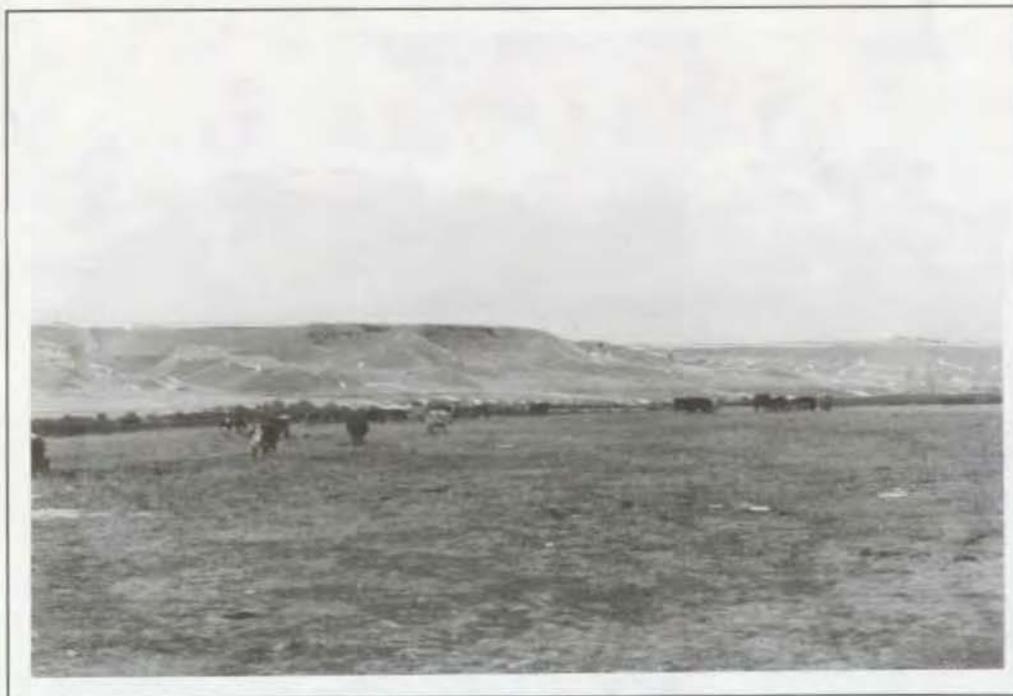
Figure 2. Looking northwest to the steep sloped hills, characteristic of this landscape type. Ridge line marks the western boundary of the Upland Pasture.

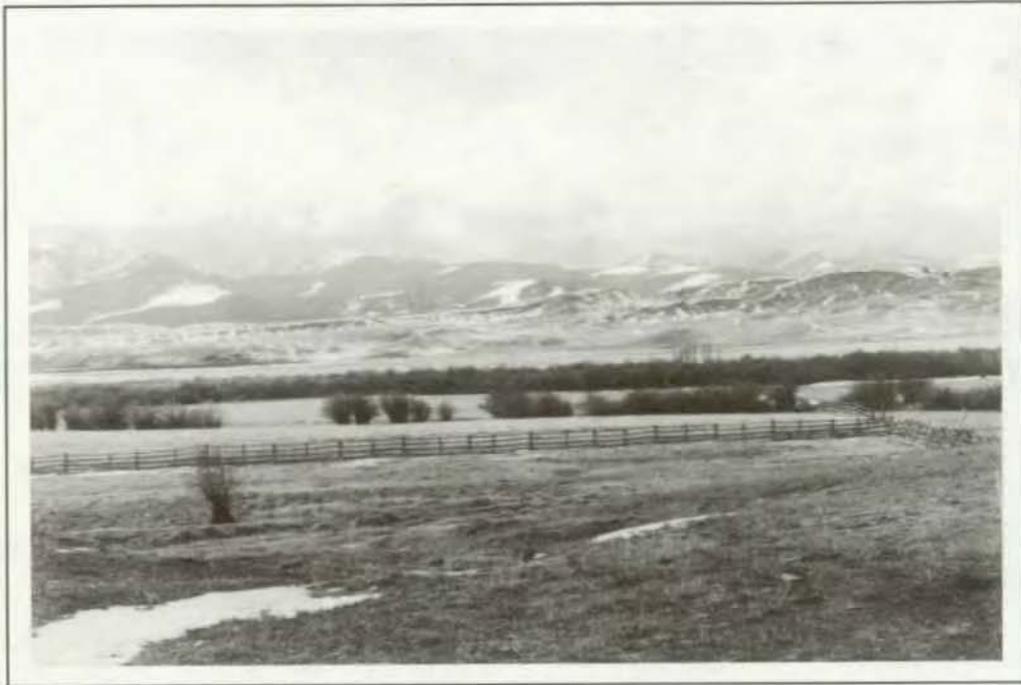
Figure 1. Heavily wooded character of this landscape type is illustrated as seen looking from the "L" shaped barn of the Home Ranch Complex. The linear characteristic of this landscape is also evident as seen here separated into long north/south bands.

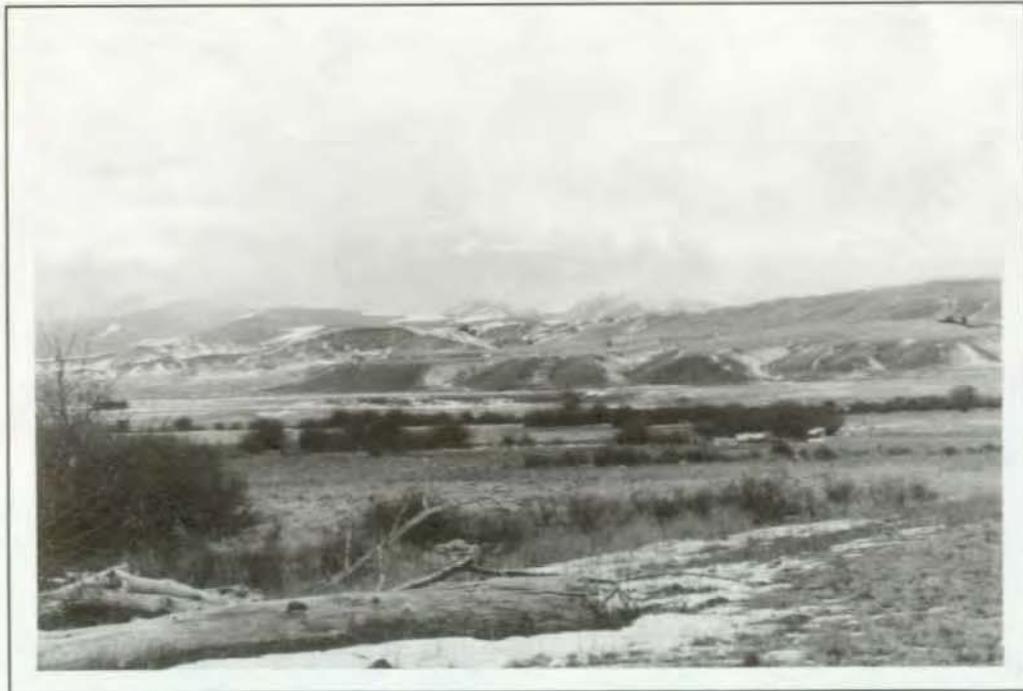
Figure 2. Thick woody bands of riparian area seen separating Pasture/Hay Fields looking southwest. The character of this area has remained predominantly unchanged from early ranch history.

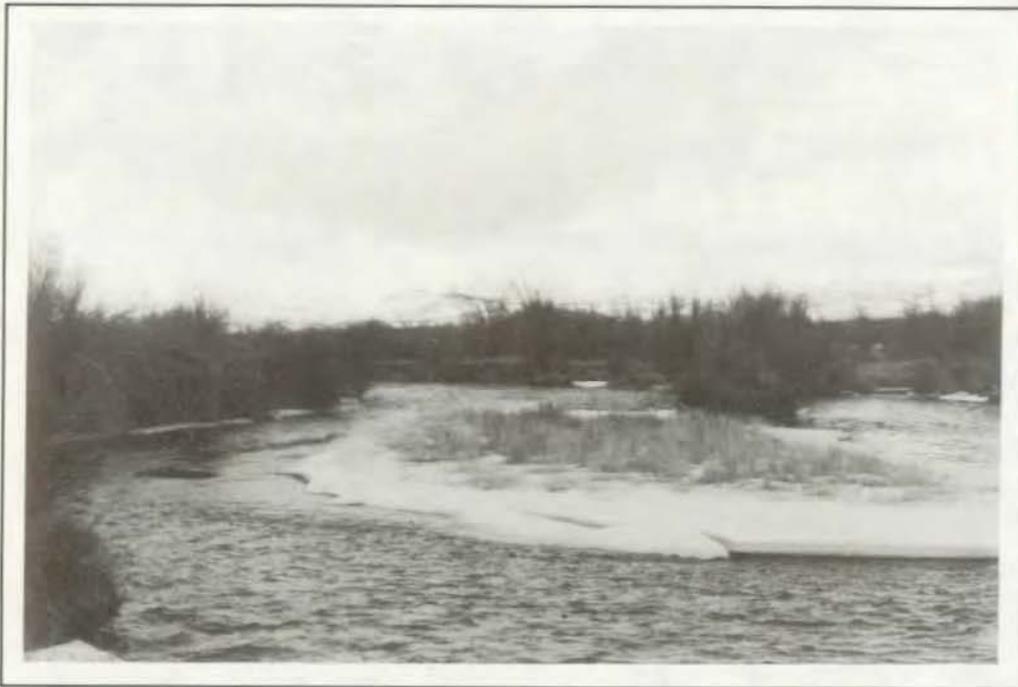
Figure 3. Central to this landscape is the Clark Fork River. Willow thicket and native grasses are the dominant vegetation types.

Restore Riparian/Woodland Wildlife Habitat Both the land and wildlife have suffered damage as the result of upstream mining activities. While the land has slowly regenerated, the wildlife has been slow to recover. Efforts to restore the once abundant wildlife that inhabited this landscape should be explored.

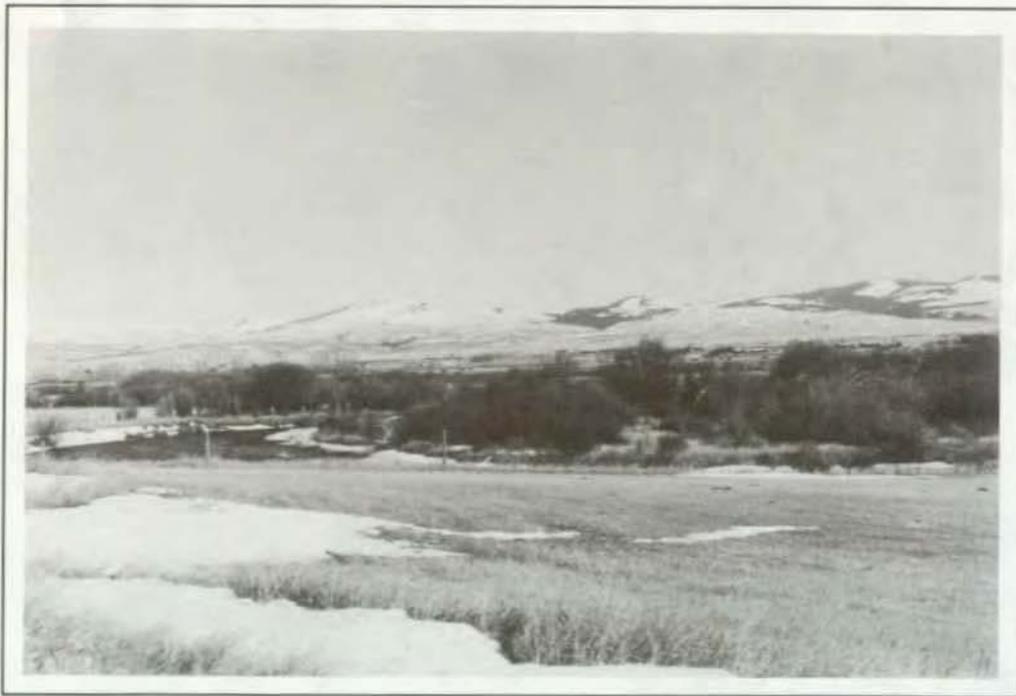
Figure 4. Looking east from Pasture/Hay Field to the Clark Fork River. Photo showing dense areas of woody shrubs and trees.

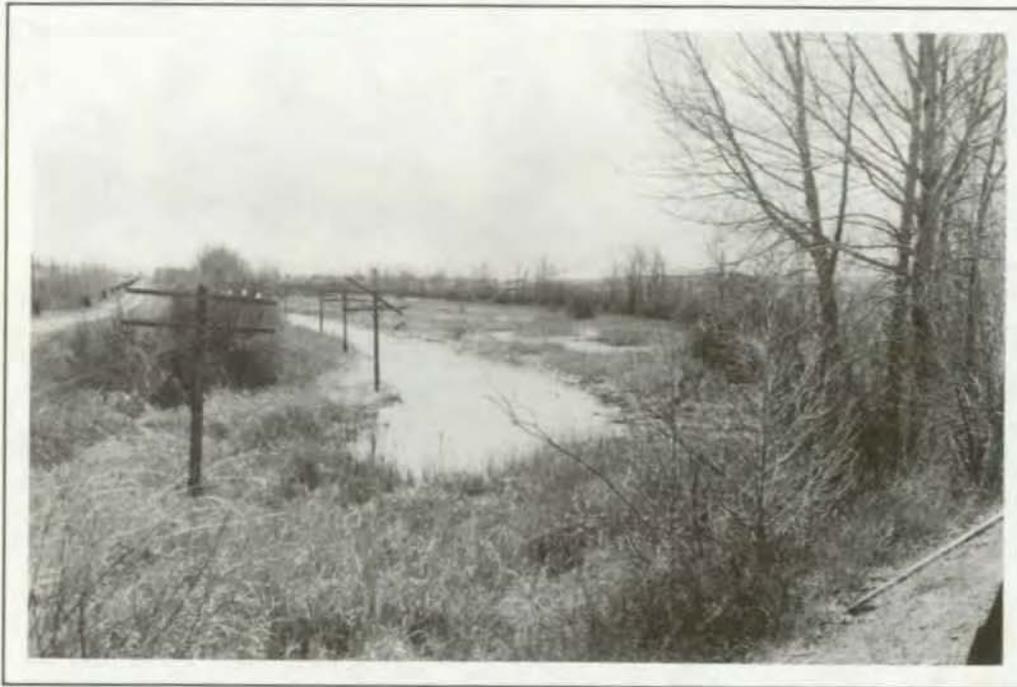
Figure 1. The marshy conditions of this landscape are evident by the thick cattails and standing water which are dominant features. Black Cottonwoods and willow also can be seen along the edge of the landscape type.

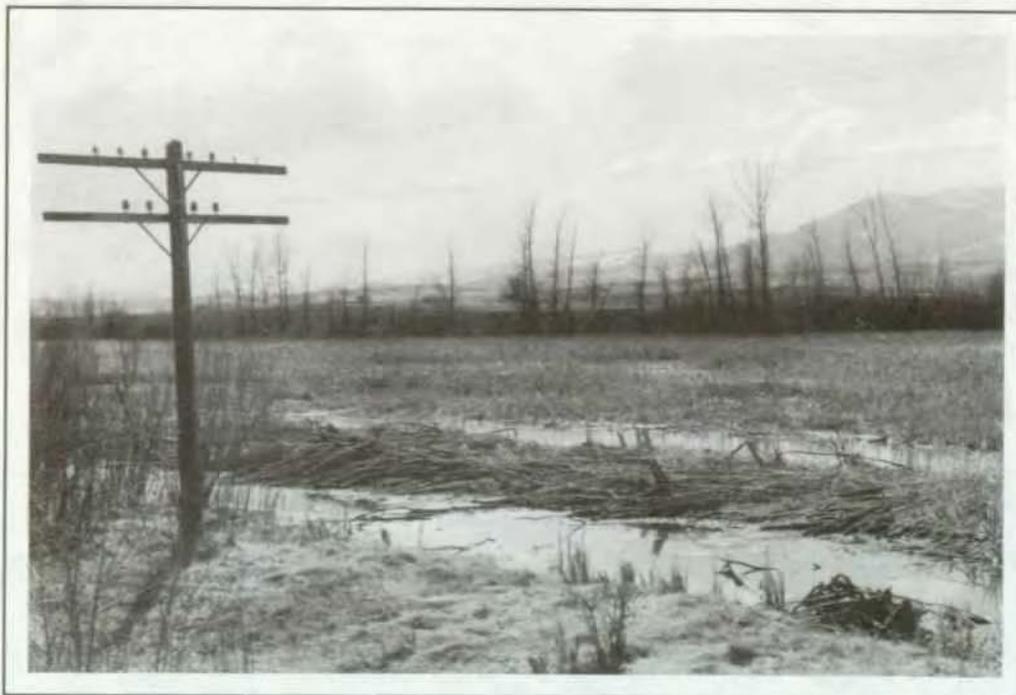
Figure 2. Depression from gravel dredging is noticeable in this view. Photograph taken from near the Railroad Bed which bisects the Barrow Pit/Wetland landscape.
