CULTURAL LANDSCAPE INVENTORY AND ANALYSIS

Grant-Kohrs Ranch National Historic Site

Deer Lodge, Montana

DIVISION OF CULTURAL RESOURCES * ROCKY MOUNTAIN REGIONAL OFFICE
NATIONAL PARK SERVICE
UNITED STATES DEPARTMENT OF THE INTERIOR
DENVER, COLORADO
1991

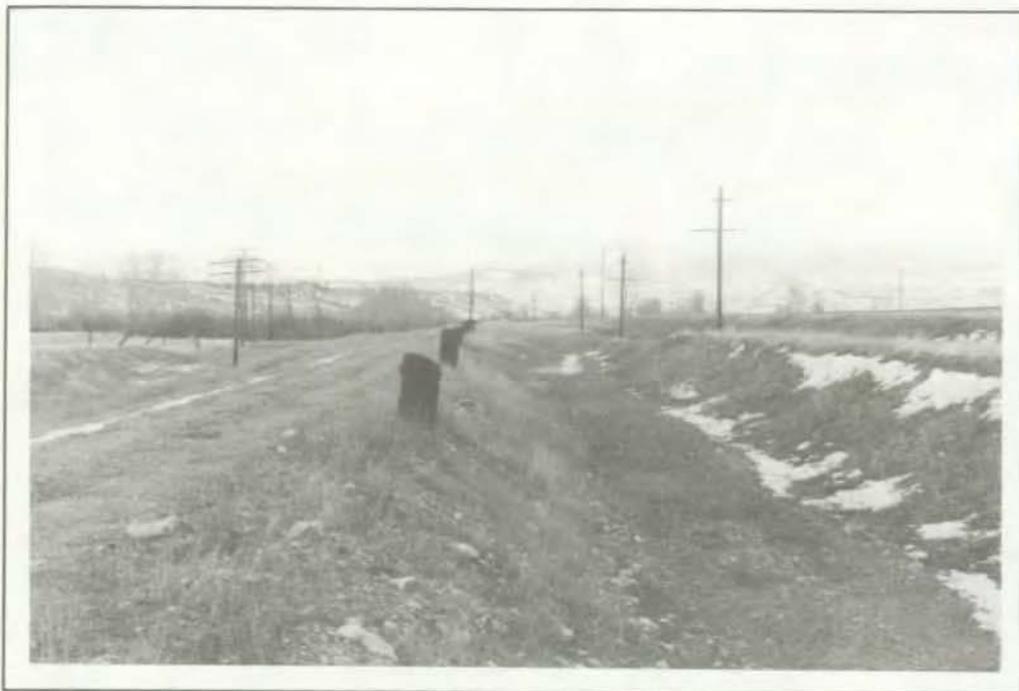
Figure 1. View looking north from the abandoned Milwaukee Railroad. The railroad bed is elevated with steep sided banks. Note that the historic train rails and power poles have been removed. The Montana Western Railroad can be seen to the right.

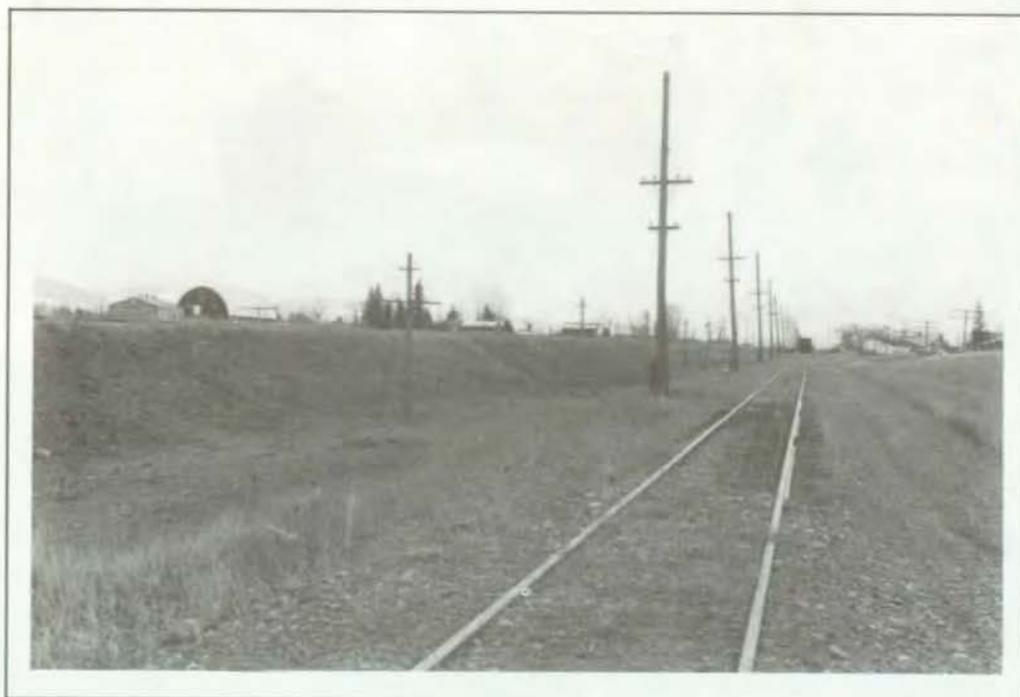
Figure 2. The heavily sculptured landscape is characteristic of the Railroad bed area. Elevated beds and tracks and overhead power lines can be seen in this photo.

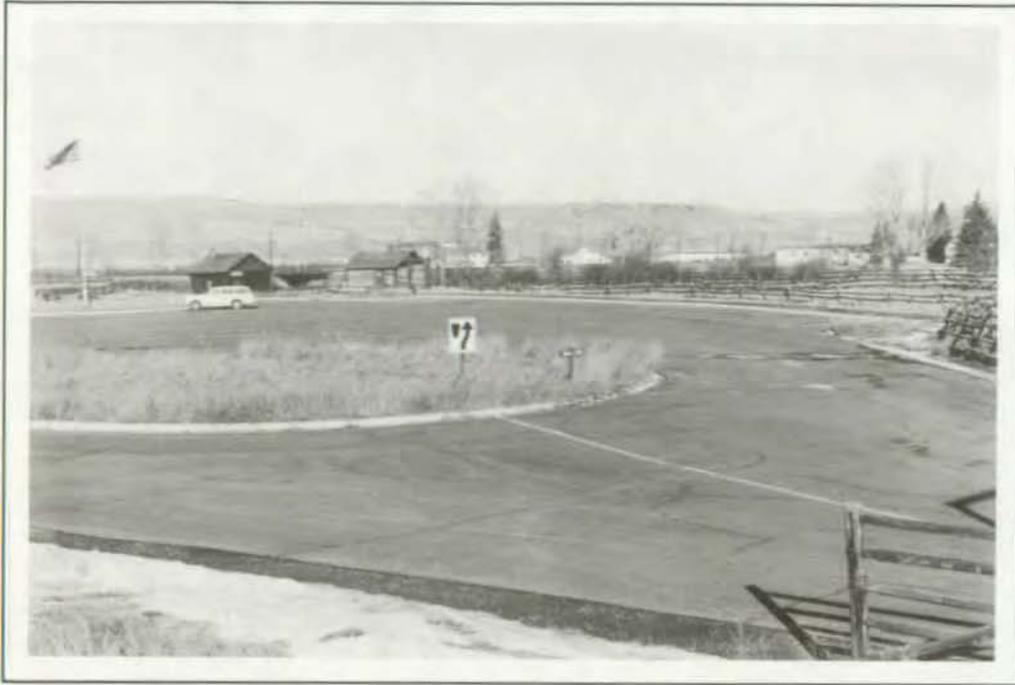
Figure 1. The visitor parking lot is constructed in the pasture south of the Home Ranch Complex. While a necessary element in the park, this function should be relocated to an area that would have less of an impact on the historic landscape.

It is recommended that any design for the new parking lot include the restoration of the historic tree lined entry drive to the ranch. The new design and paving material should be compatible with the historic features of the site. This may include the use of a "grass crete" type paving system allowing the visual qualities of the grass covered horse corrals to be maintained. Any new design for parking should also consider other historic features such as fences and the small horse barns on the north side of the corrals.

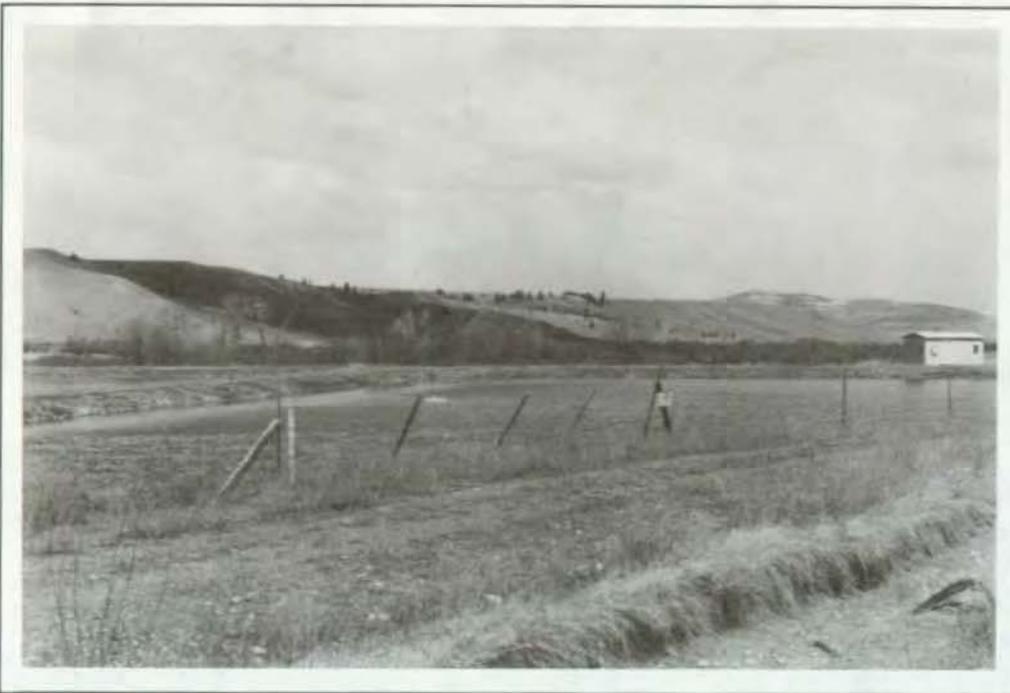
Figure 2. While not seen from public view corridors, the Deer Lodge sewage lagoon near the northern boundary of the site has a negative impact on the historic integrity of the Grant-Kohrs Ranch.

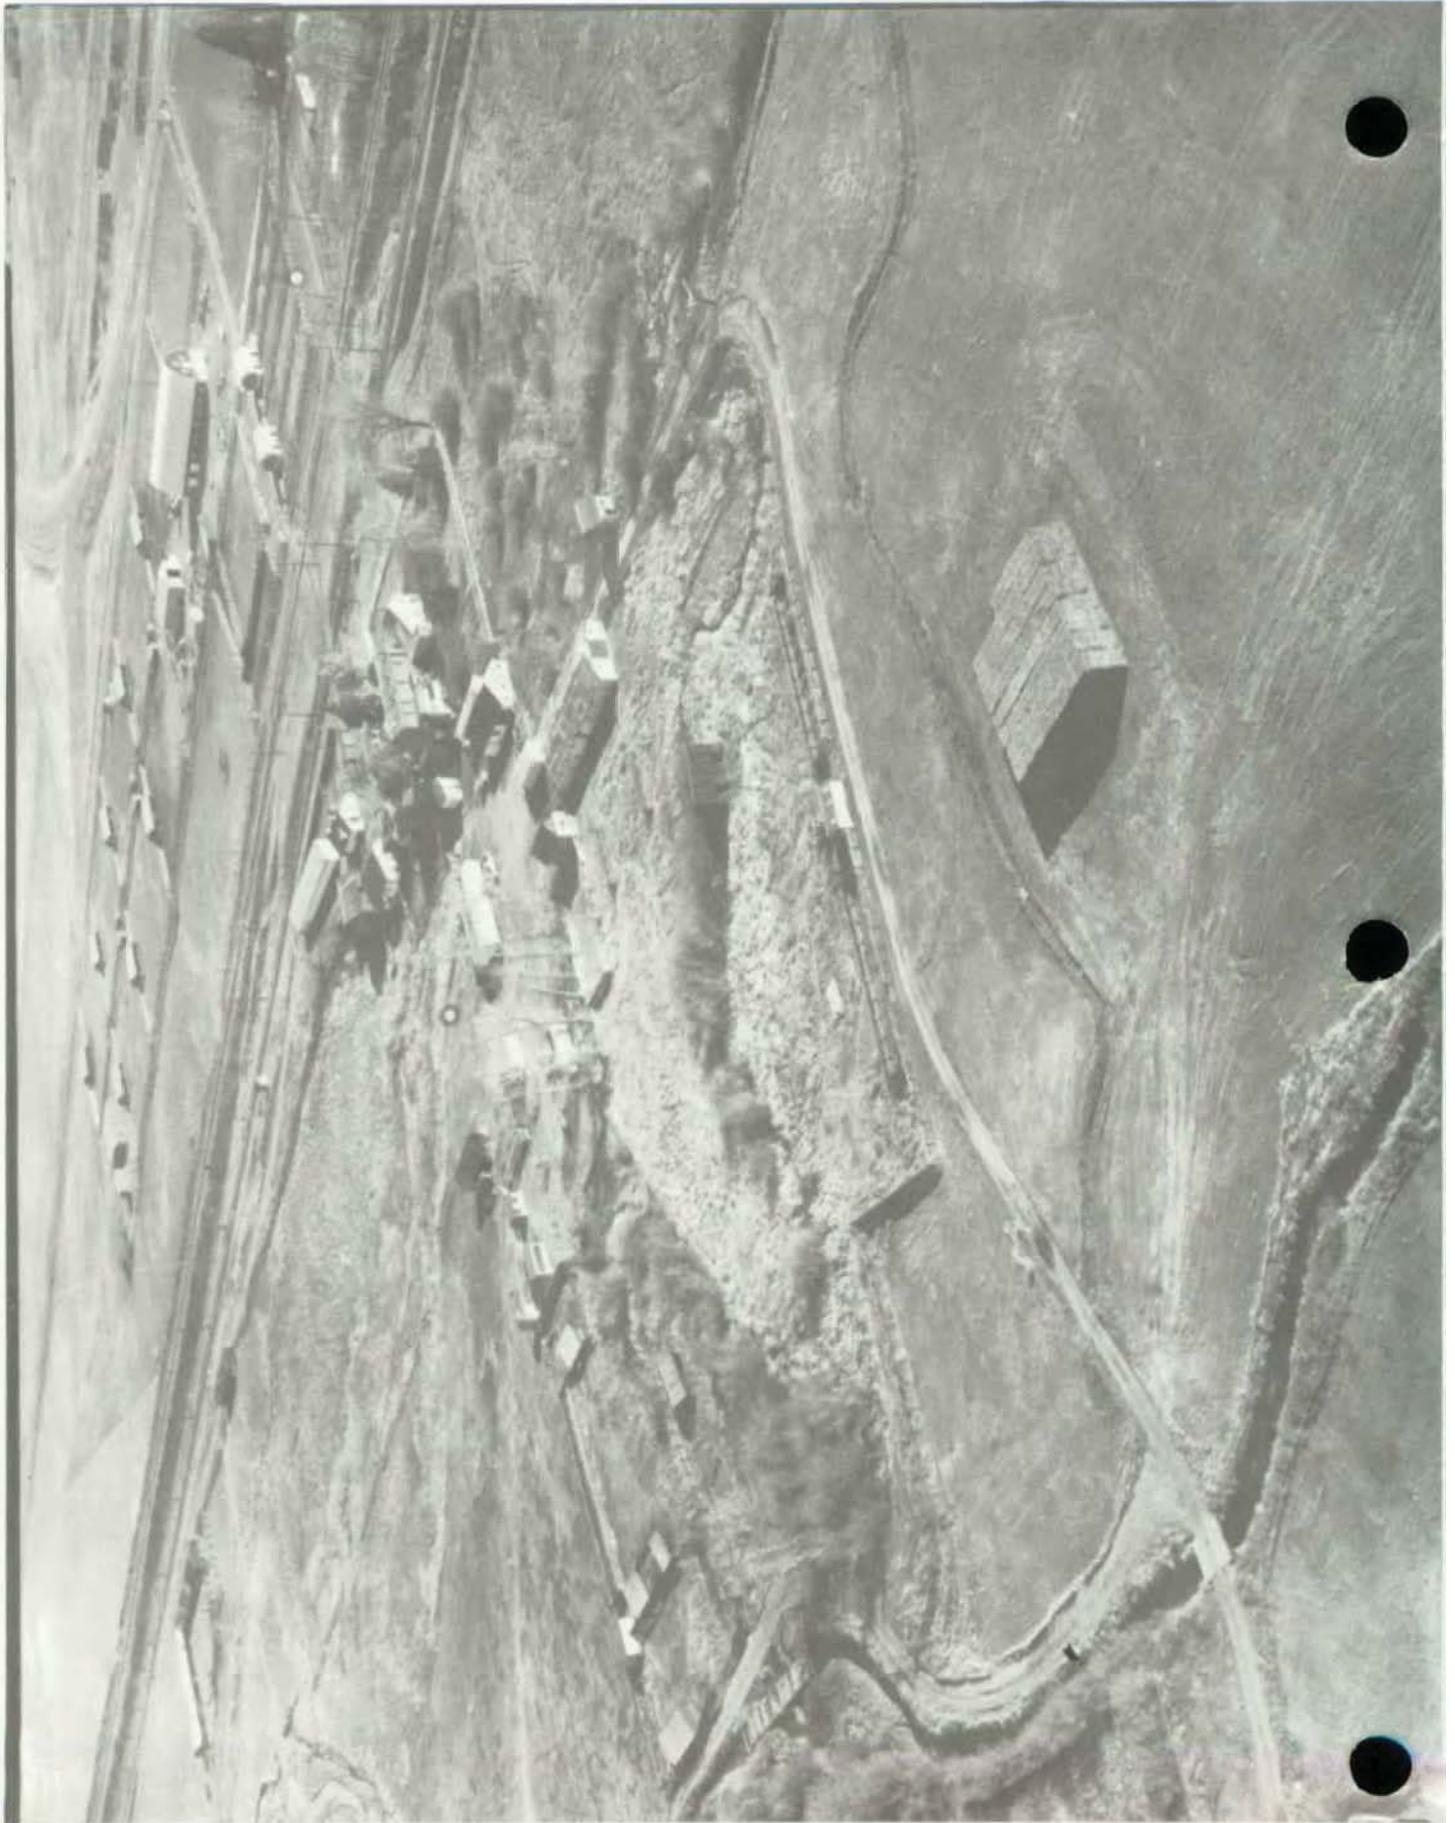
Figure 1. Home Ranch Complex and East Feedlot 1971.

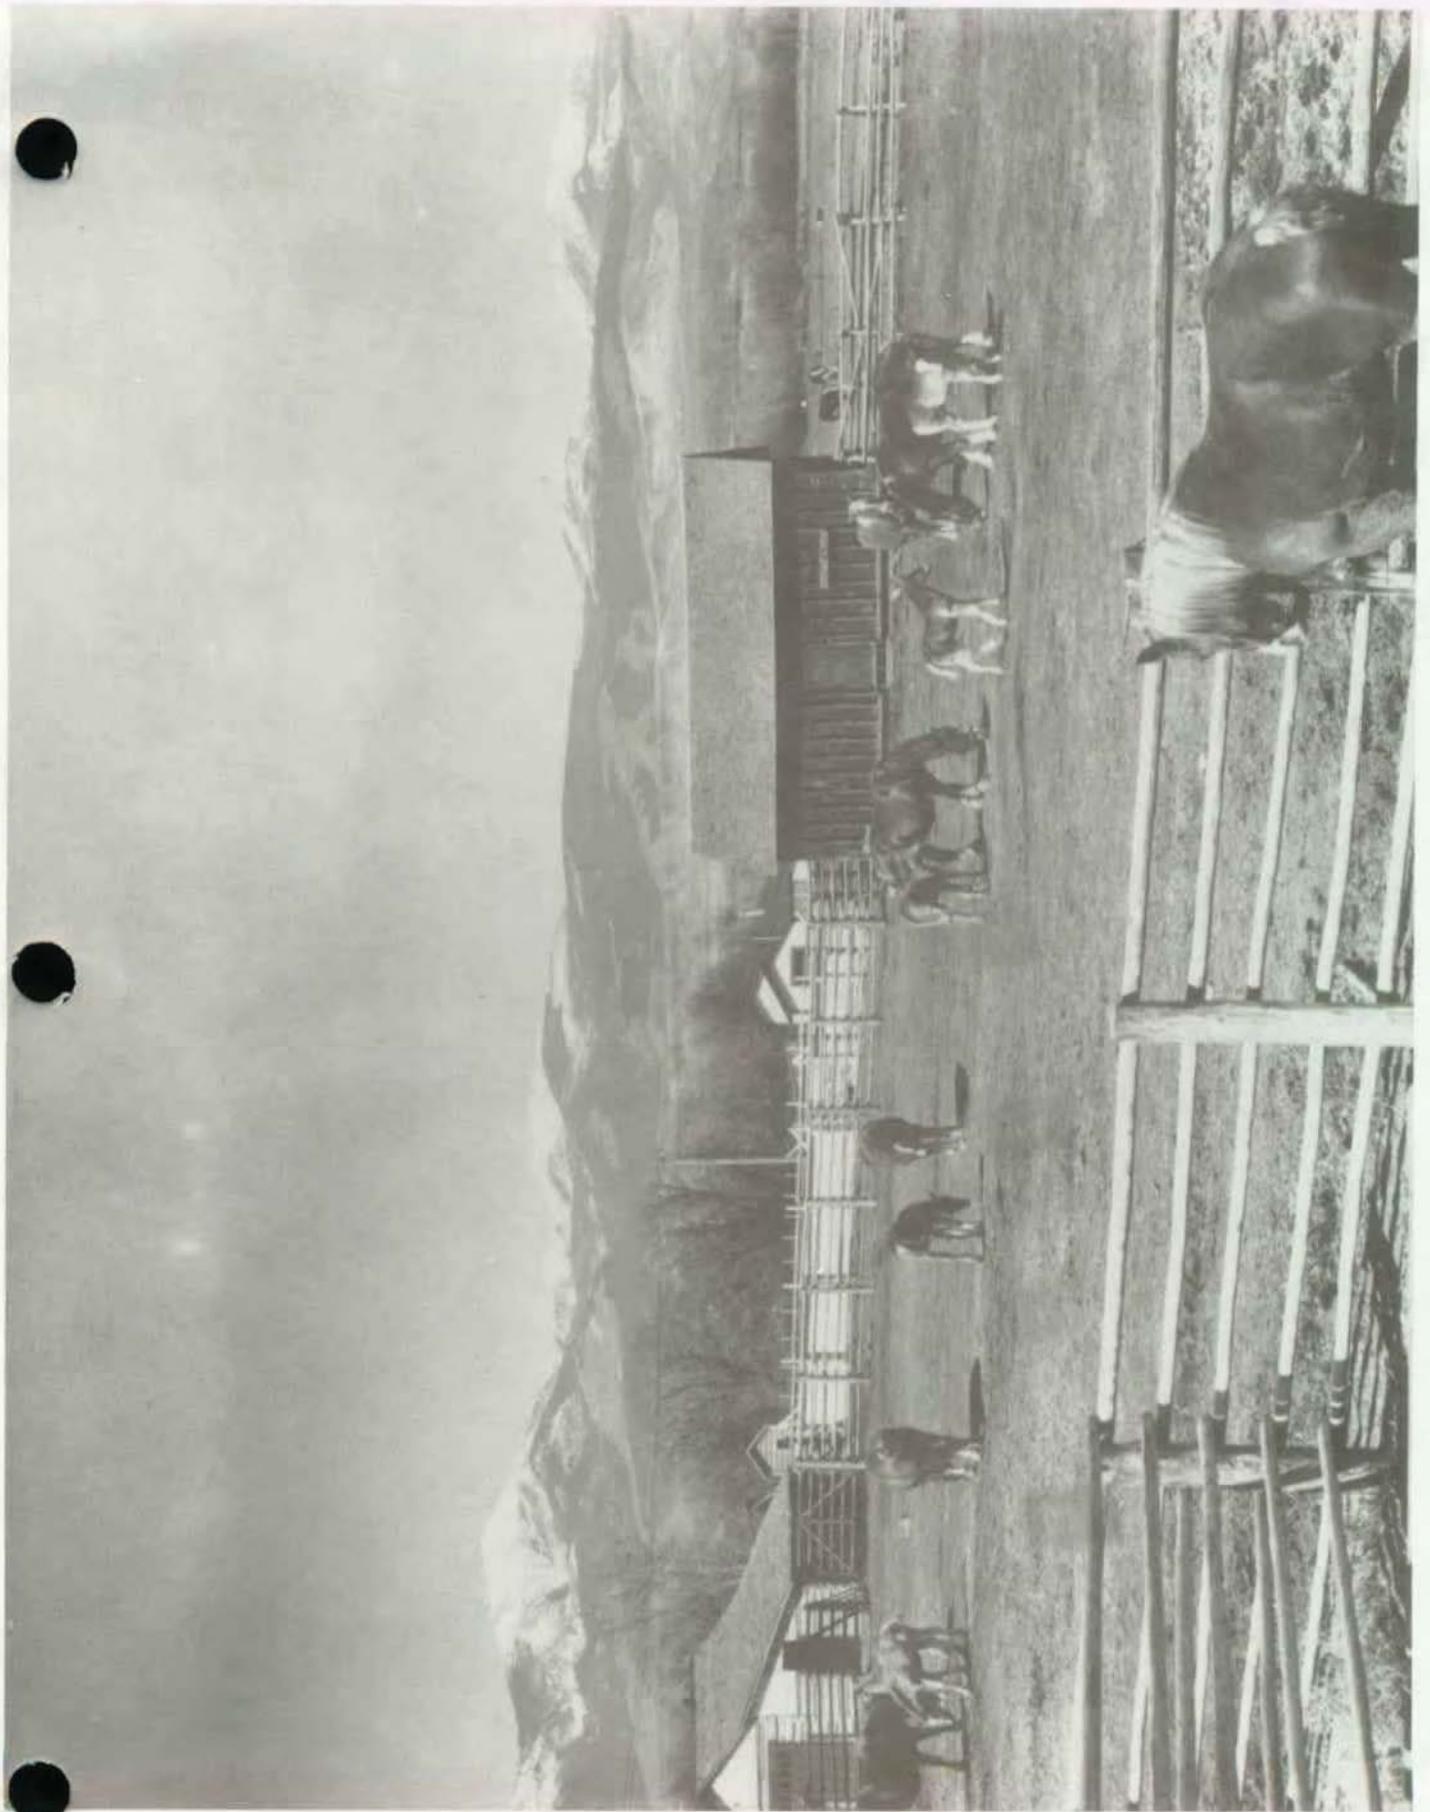
Figure 2. Corrals north of the ranch house in 1936. Compare with "Home Ranch Complex" figure 4.

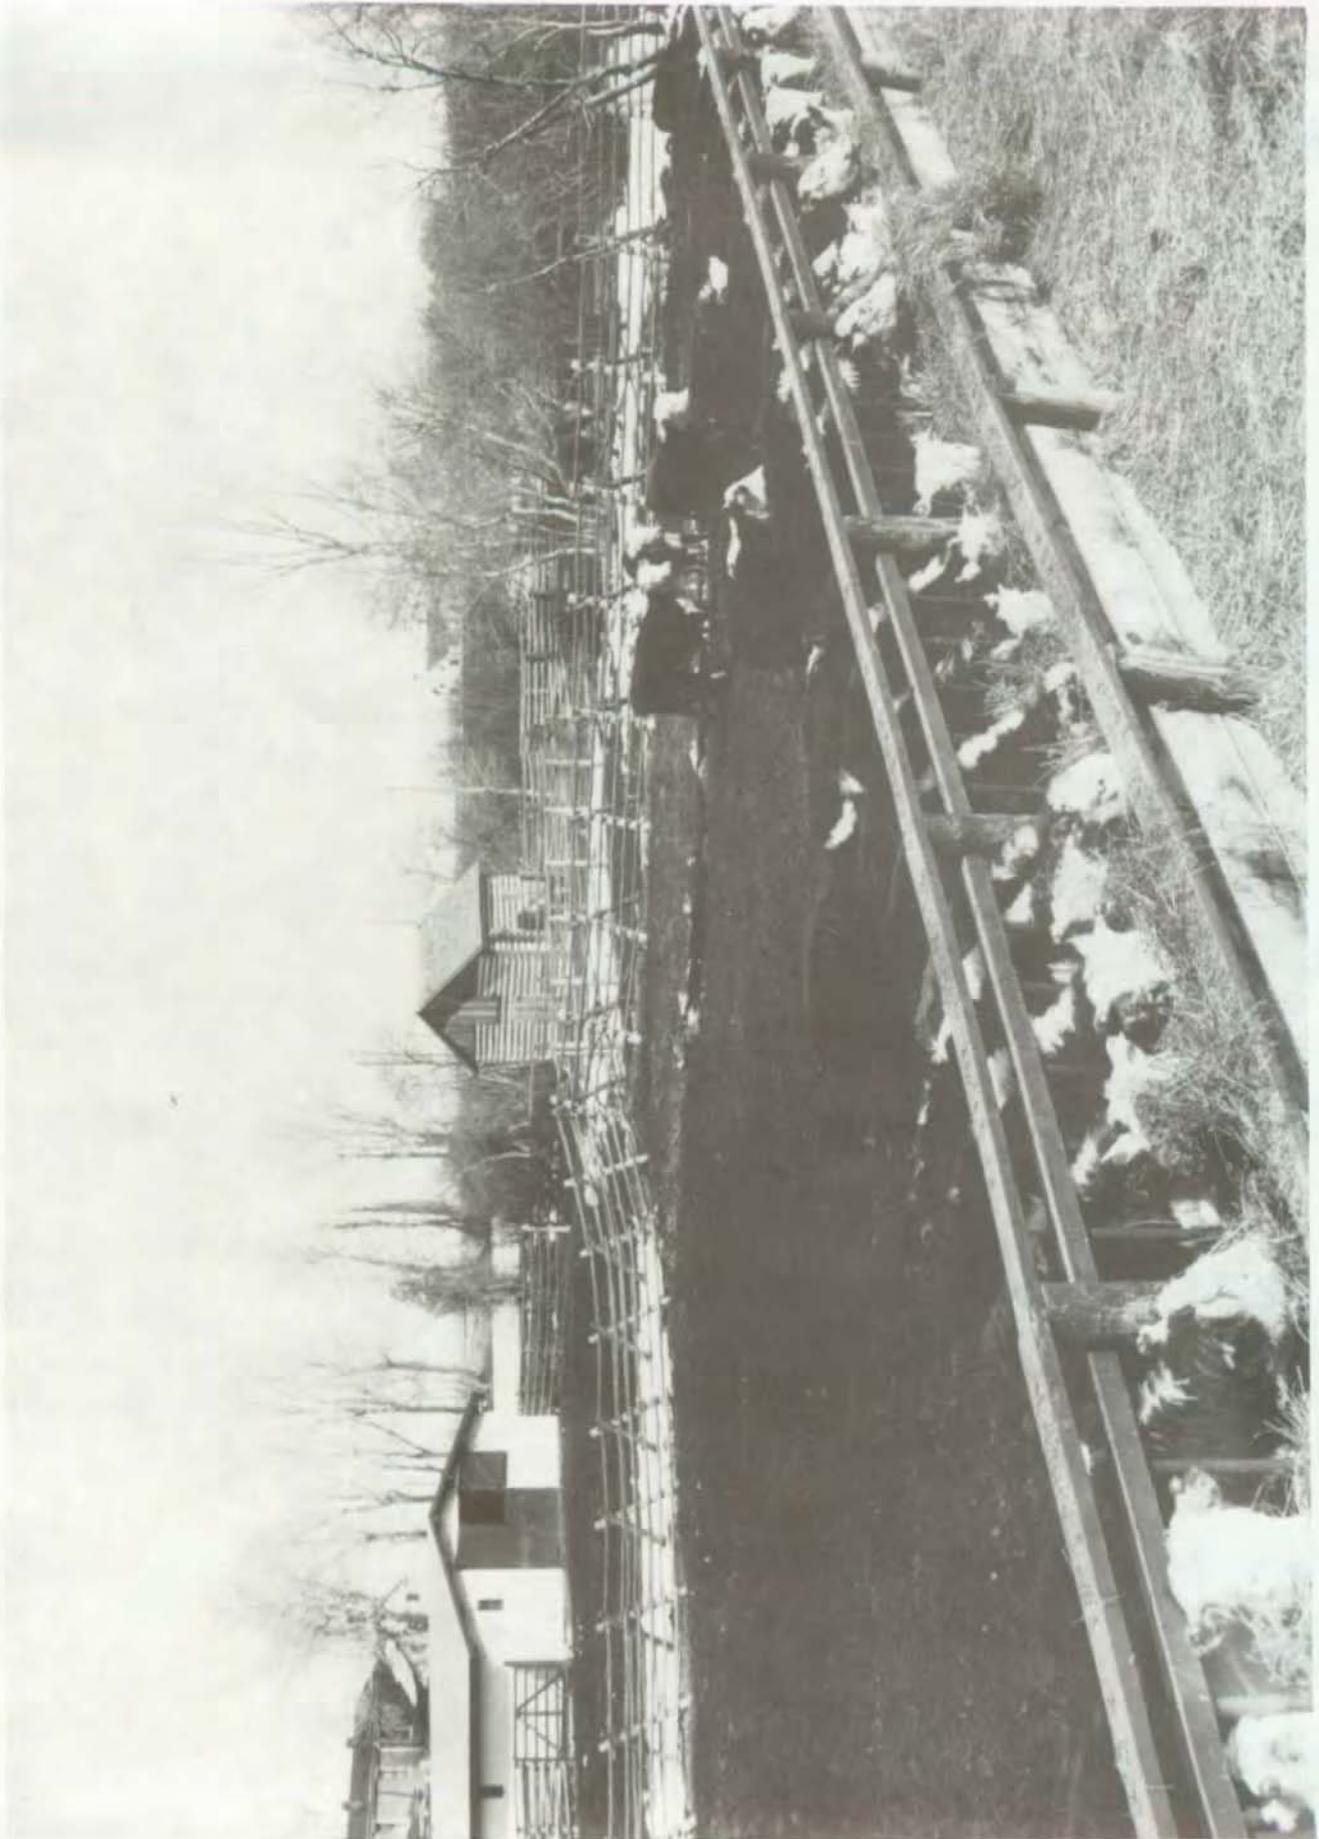
Figure 3. West feed lot in 1940.
Compare with "Home Ranch Complex"
figure 7.

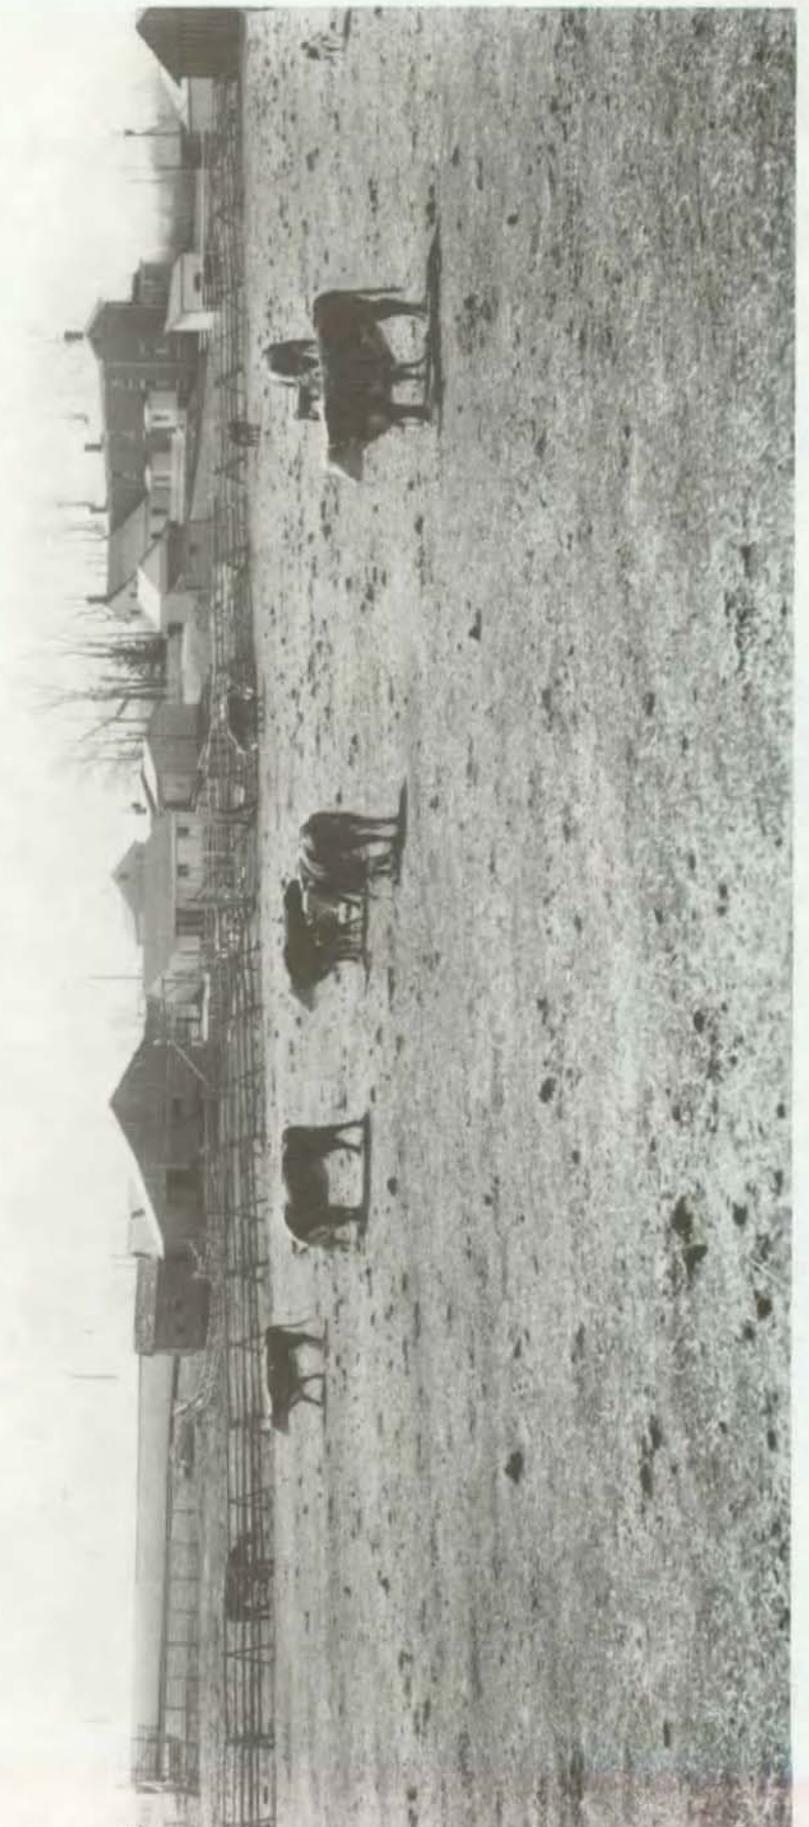
Figure 4. Corrals looking southeast to ranch house on the right in 1940. Note trees in front yard of house.
