# **WHITE GRASS STABLIZATION**

## **Phase I Report**

## **GRAND TETON NATIONAL PARK**

**HISTORIC STRUCTURES RECORD OF TREATMENT**  
**National Park Service**  
**Western Center for Historic Preservation**  
**Grand Teton National Park**  
**P.O. Drawer 170**  
**Moose, Wyoming 83012**

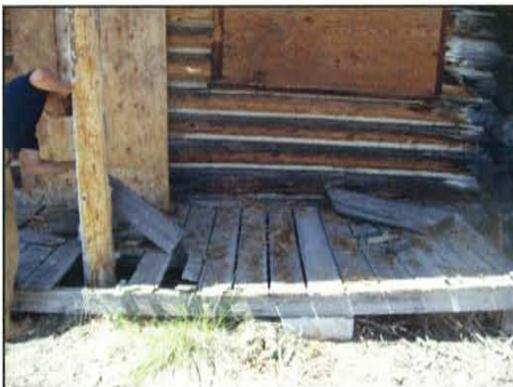
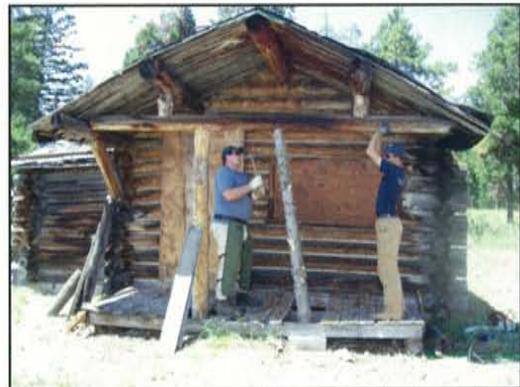
The above two photos show a porch on Cabin 1159 in need of stabilization before the winter season. Two YCC group members took the initiative to correct this problem.

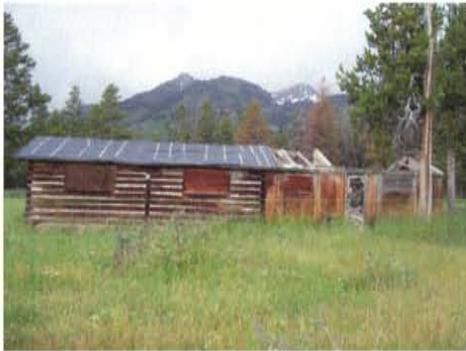
Office Cabin prior to the addition removal and completed roof work

During the week of July 24<sup>th</sup> roofing work continued on the structure. The addition had been completely removed and the interior of the structure was clean. By the end of the week, the roof had been completed with the added support of plywood and ice and water shield to protect the historic fabric from weather damage.

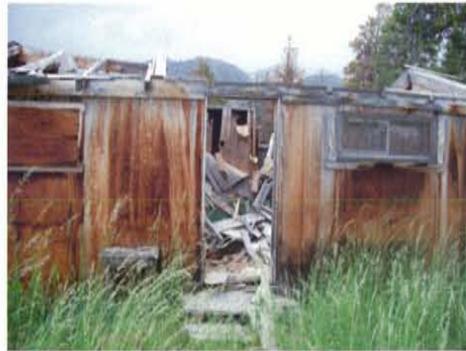
Addition showing the roof caved in and the room filled with debris

Before work could continue on the roof an inventory of supplies had to be made, so the crew turned their attention to the bathroom addition. Due to the fact that the bathroom was a non-historic part of this cabin, the crew began to disassemble the addition. At some point, the roof had caved into the room at this end and the entire addition was filled with boards and roofing material. Most of the debris was taken to a burn pile on the east or west elevation of the cabin and what could not be burned was thrown in the trash. Once enough debris had been removed to allow a person to enter the addition, disassembly of the bathroom walls began.

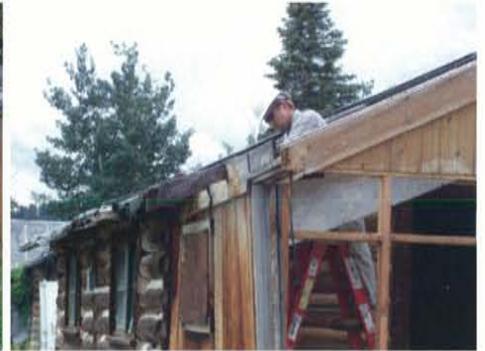
WCHP employee using saw-zall to disconnect wall from main structure

It took a two person crew a week to complete the removal of the bath addition. A qualified craftsman arrived on site toward the end of the week to remove the asbestos tile. After the job was complete, the team spent an additional four days removing the concrete foundation that had supported the addition. On July 19<sup>th</sup>, the vegetation abatement crew arrived and while some started on vegetation, others helped load the broken concrete to be taken off site.

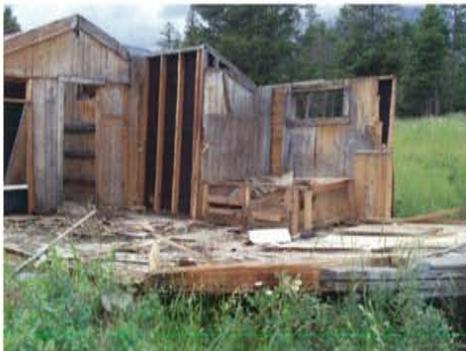
Partially finished addition removal

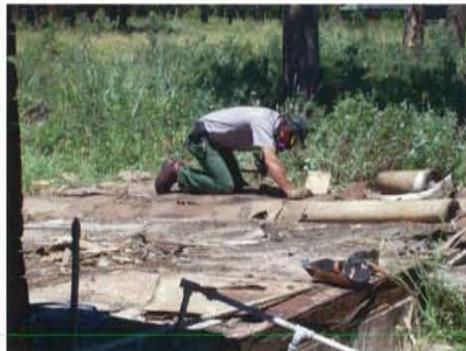
WCHP employee removing tile from bathroom area

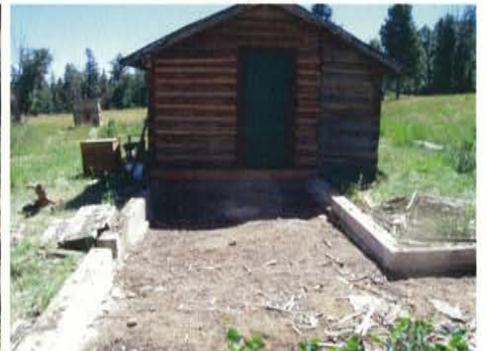
Remaining foundation

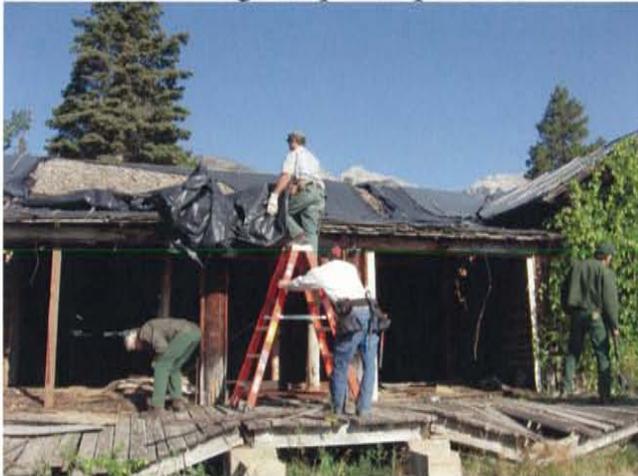
3.

Stripping roof off porch on Main Lodge

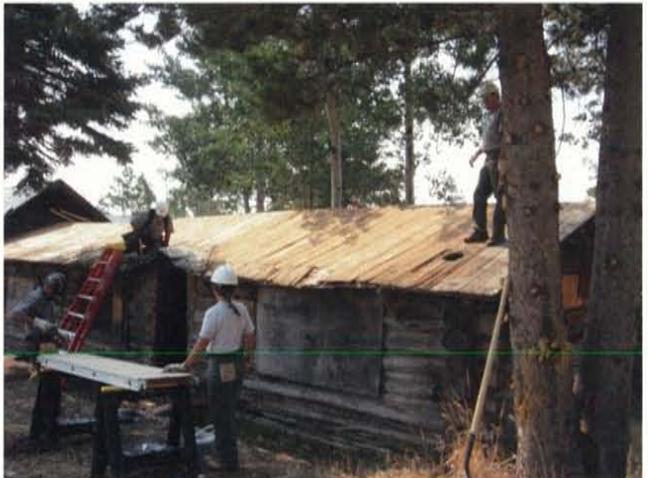
6.

Replacing deteriorated roof decking

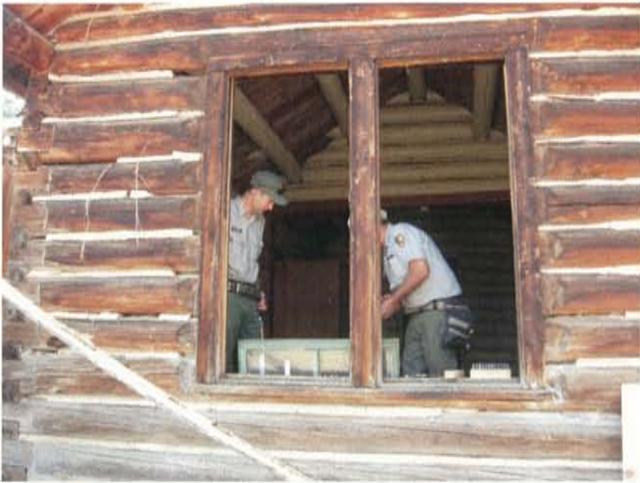
7.

Exhibit Specialist Sterling Holdorf assists with the removal and glazing of windows from the Main Lodge at White Grass

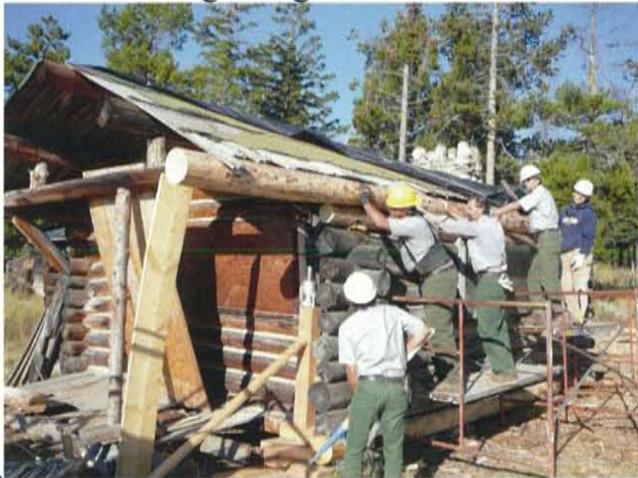
9.

Cabin 1157 gets a new log fabricated and installed by the PAST participants

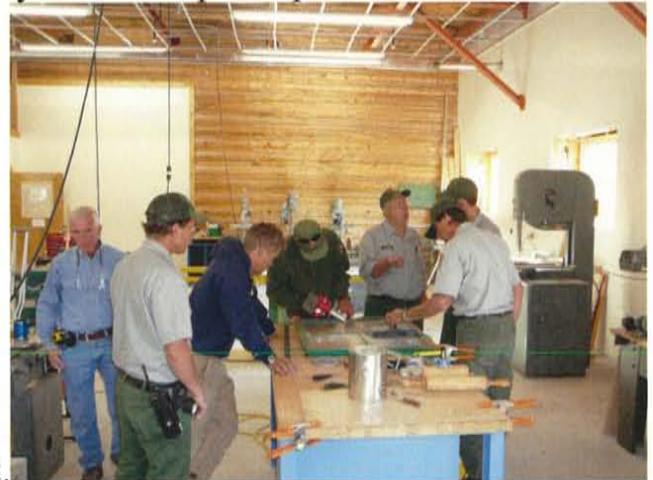
12.

A group works on window glazing while in the JY Shop
