## White Grass Ranger Station Completion Report

**Start Date:** May 27, 2008

**Completion Date:** October 15, 2008

**Project Leader:** Robert Williams, WCHP Project Manager

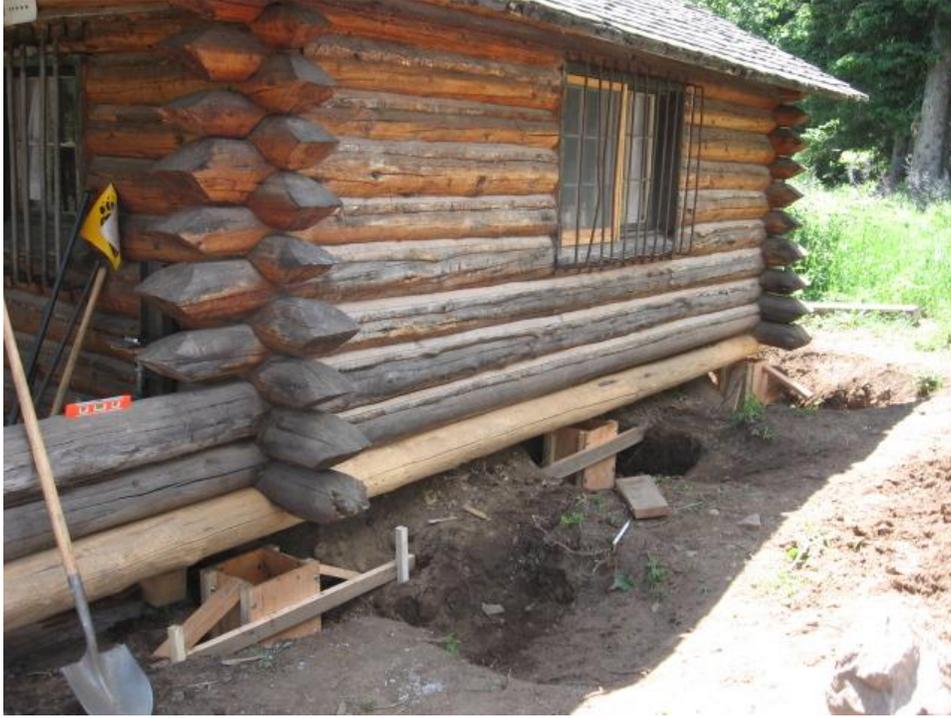
Photo 1: Replacement of north wall sill log.

The ranger station was then raised and supported by wood cribbing and jacks. Log work began on the north wall. The north side sill log was deteriorated and needed full replacement. An appropriate replacement was located, planed, sized, and cut to match the existing log. The

deteriorated log was removed and the preservation crew installed the new native lodgepole pine sill log.

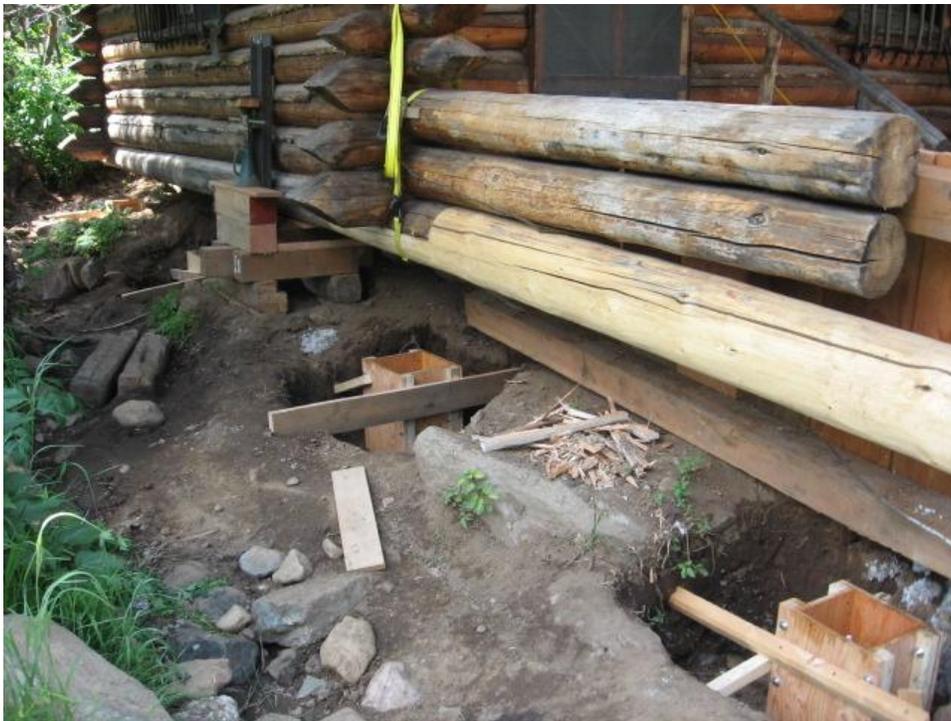
Photo 2: Partial replacement of south wall sill log using half-lap joinery.

Along the south wall, the sill log needed partial replacement. The damaged section of the sill log was from the southeast corner of the cabin to the southeast corner of the porch. This deteriorated section of the log was removed and the partial replacement installed using half-lap joinery. Sill log work was completed on June 12<sup>th</sup>.

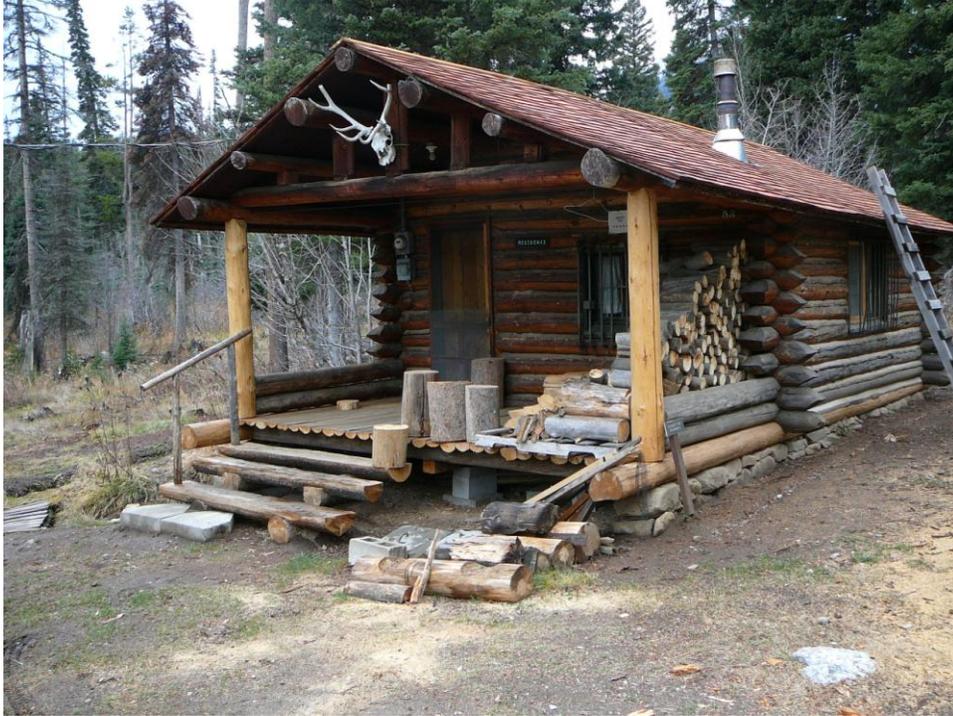
Photo 3: Completed project, porch and north wall.

Research for the White Grass Ranger Station project revealed the earliest known photograph of the station from a 1949 park building inventory. This photograph showed the original appearance of the cabin, including the original porch constructed of half-logs running parallel to the north and south walls. The existing porch flooring of 2x6 boards running perpendicular to the north and south walls was removed and replaced to replicate historic conditions. The porch installation was completed on July 29<sup>th</sup>.

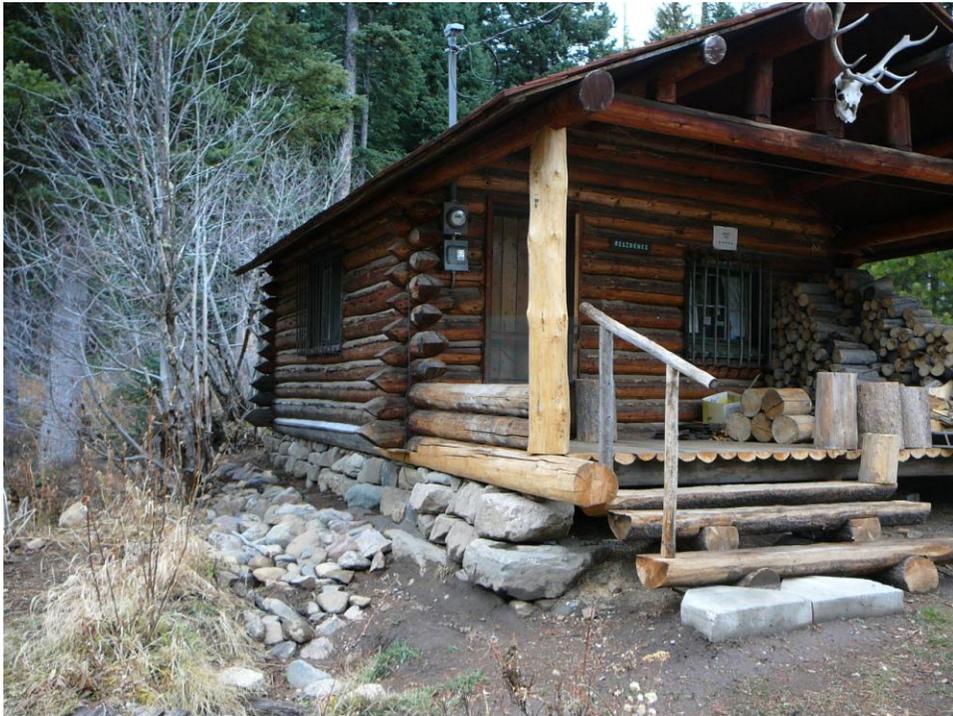
Photo 4: Completed project, porch and south wall.

Next, the stone foundation was replaced. New concrete piers were poured to add structural support. The stones were reinstalled, shielding the new piers from public view. Missing stones were added to the foundation under the south wall. Foundation work was completed on July 24<sup>th</sup>.
