Project Completion Report – Zion National Park

Preservation Treatment & Craft Assistance for Grotto Museum & Pine Creek Residence #3

Zion National Park

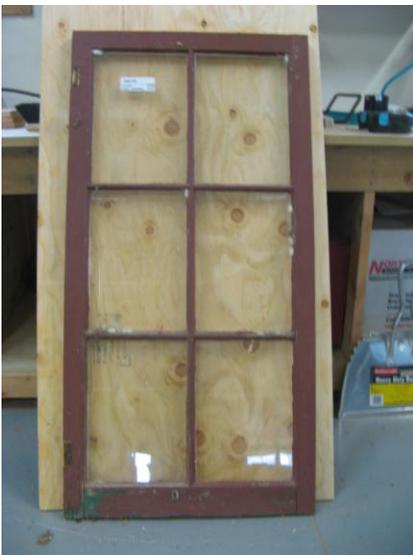
Window in the WCHP shop, prior to restoration.

The windows that were removed from the Grotto structure were stripped of their lead paint and repairs to their structure were made where necessary. New glazing compound was applied as well.

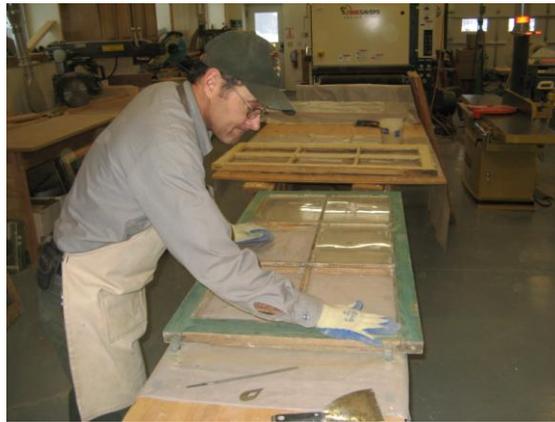
Window repairs, WCHP shop, Moose, WY

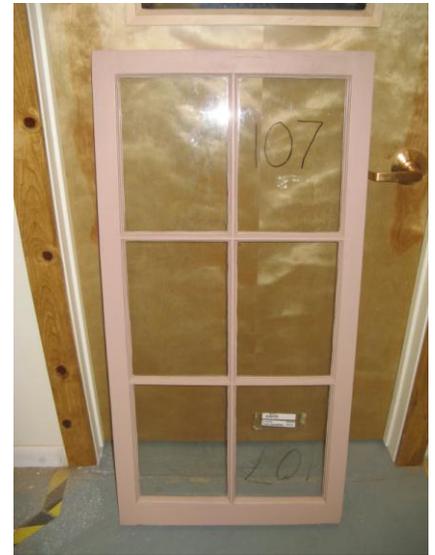
Window in the WCHP shop after repairs and priming

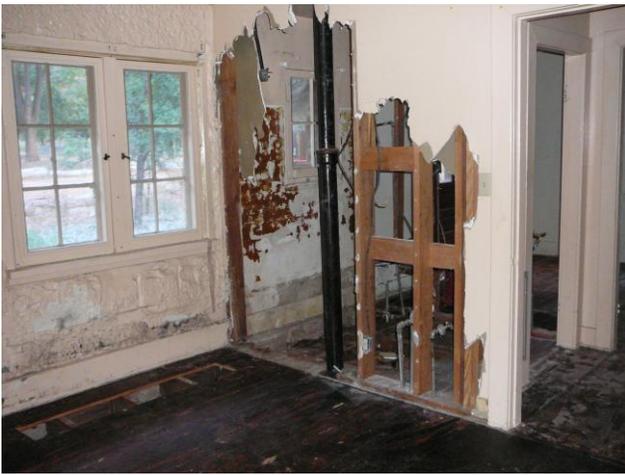
Existing interior conditions, north wall

Beginning in November of 2008, the Zion maintenance staff worked to complete the remainder of Phase 1. Zion staff began with the removal of the existing floor, floor joists, all interior walls and wall board ceiling for replacement with new in-kind materials. Lead abatement procedures were also completed by the Zion staff for paint that existed on the walls. Beginning in January 2009, the Zion staff adjusted existing or installed mid-span floor framing piers. Following the leveling of the piers, the Zion staff completed installation of the moisture barrier and floor joists before the arrival of the WCHP crew in March 2009. Additionally, in order to prepare for the arrival of WCHP staff in March 2009 to begin Phase 3, Zion park staff began the procurement of the materials necessary for other in-kind replacements.

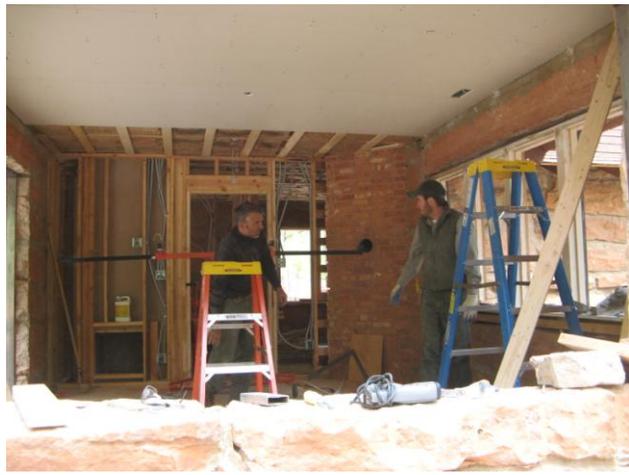
Drywall in progress, living room

WCHP concentrated their efforts on finishing the exterior and interior mortar work, installing screens, finishing some detail work in the kitchen and fabricating a gate for the HVAC privacy fence. WCHP then began clean up of the area for mobilization back to GRTE. The Zion maintenance crew finished HVAC hook ups and electrical connections. Zion then completed tape and texture, and finishing of windows, doors, walls, floors and cabinets.

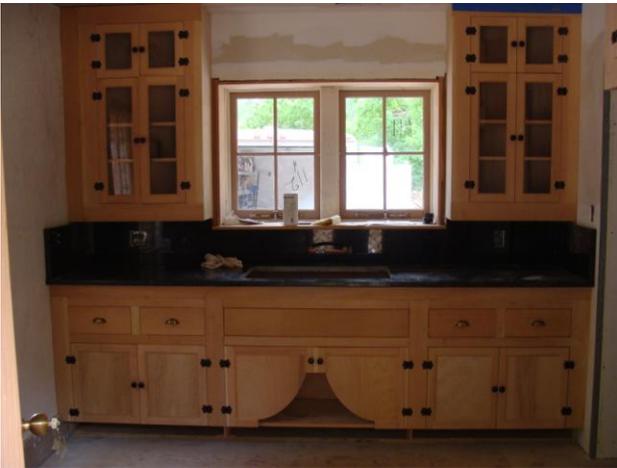
Completed kitchen cabinets

The existing cabinetry in the Grotto kitchen was beyond repair and needed replacement. The craftsmen at the WCHP drew up plans for new cabinetry that reproduced the existing cabinetry in appearance yet allowed for the installation of modern appliances. The cabinet faces and doors were fabricated at the

WCHP workshop and completed in February 2009. Phase 2 of the preservation treatment was completed in February of 2009.

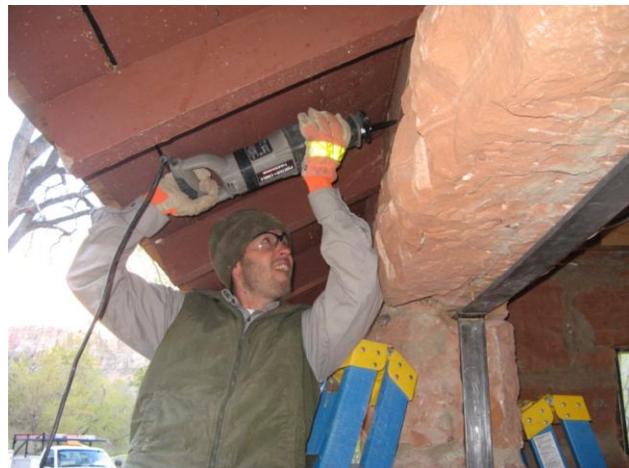
Attic ventilation being installed

- Insulating the ceiling
- Cut for floor outlets
- Attic catwalk
- Roof vents
- Shop for kitchen countertop
- Change orientation of bathroom window
- Adjust kitchen cabinet faceframe sizes

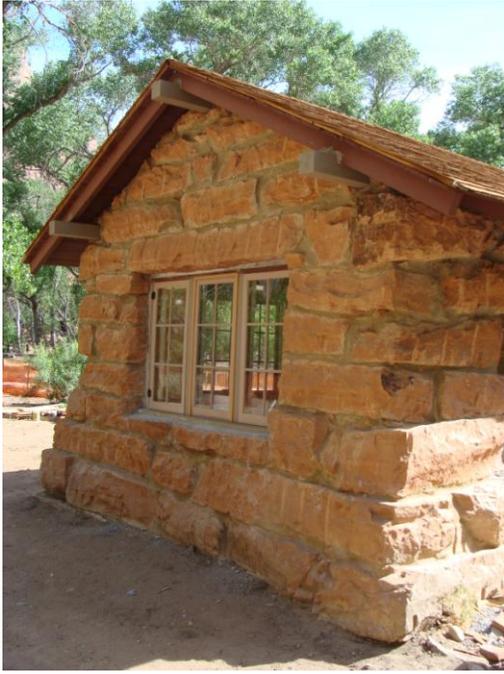
Completed Grotto

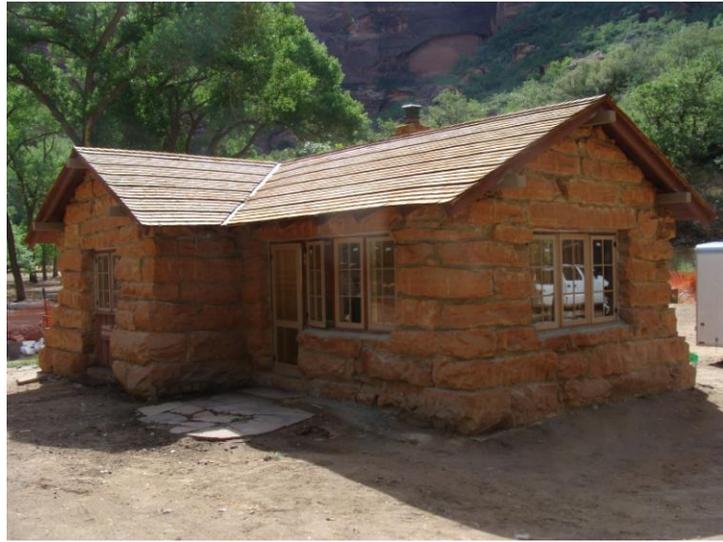
Completed Grotto

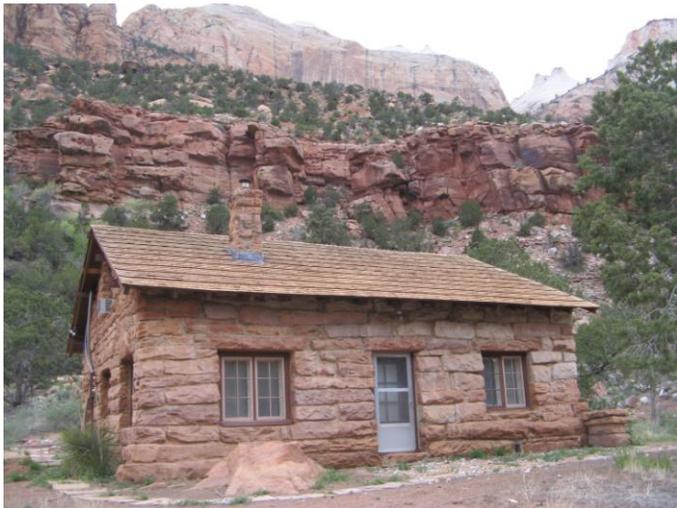
Pine Creek Residence #3 with replacement windows, East Front

All Phase 2 work was completed by trained WCHP preservation staff at the workshop in Moose, WY. Work commenced with the construction of 16 new sashes for the Pine Creek Residence #33. Three 24"x36" / 4-light window sashes were constructed for the kitchen and 1st floor bath. Eight 24"x48" / 6-light window sashes were constructed for the dining nook, living room, and first floor bedroom. Two 24"x48" / 8-light windows were constructed for the second floor south bedroom.

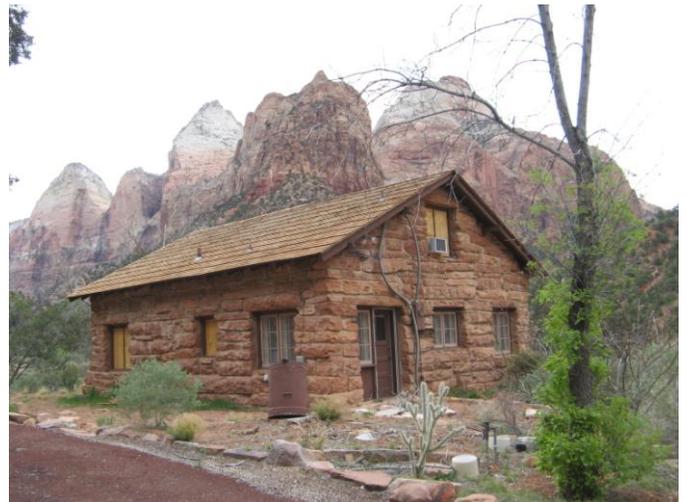
Pine Creek Residence #3 with replacement windows, Southwest Corner
