Grand Teton National Park

Bicycle Road Safety Audit

Gros Ventre Junction- US Highway 26/89/191

Audit Conducted September 17-19, 2012

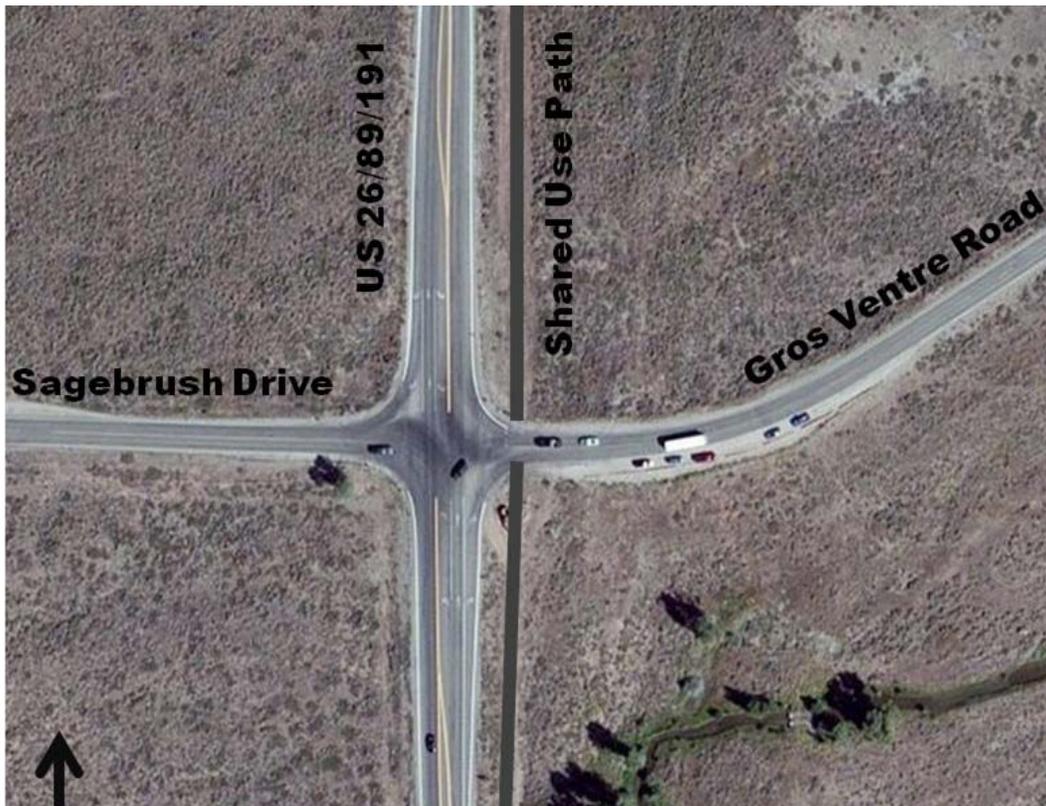
Figure 4. BRSA Site

The study area consists of the intersection of Gros Ventre Road/Sagebrush Drive and US Highway 26/89/191 and the intersection of the shared use path with Gros Ventre Road, as shown in Figure 4. The roadway intersection is two-way stop controlled with stop signs along Gros Ventre Road and Sagebrush Drive. The intersection of the shared use path and Gros Ventre Road is also two-way stop controlled with stop signs along the pathway.

Gros Ventre Road and Sagebrush are both two lane roads. The speed limit on the Gros Ventre Road is 45 MPH, on Sagebrush Drive it is 35 MPH. The Gros Ventre Road consists of two approximately ten-foot wide lanes. US Highway 26/89/191 is an approximately 32-foot wide, undivided highway with two 11 foot lanes and two five foot shoulders and a speed limit of 45 MPH through the intersection. At the intersection, the highway width is approximately 60 feet with both left- and right-turn lanes in the northbound and southbound directions. The closest edge of the 10-foot wide shared use path is located approximately 10 feet east of the roadway edge of pavement at the intersection.

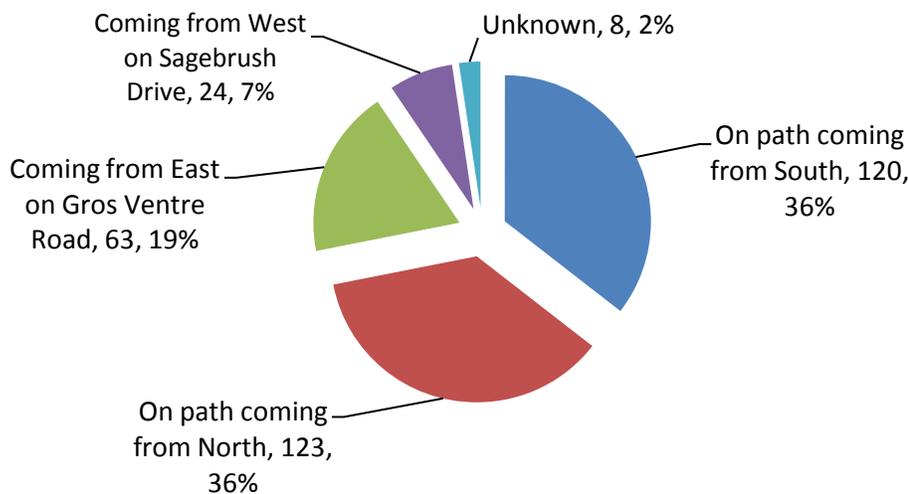
At the Gros Ventre Junction intersection, US Highway 26/89/191 has an AADT of approximately 10,761 vehicles per day (VPD).⁸ An in-person bicycle count conducted by park staff over the four days of August 20th-24th of 2012 indicated that pathway usage averaged about 23 cyclists per hour. This count was conducted during the peak pathway use season and at peak times during the day. During the 14.5 hours in which the pathway was monitored a total of 333 cyclists, two (2) pedestrians and three (3) other users (rollerbladers, skateboarders, etc.) were observed. Figure 5 shows pathway user direction of travel for each day the volumes were recorded; the average direction of travel; 36 percent on the path coming from the south, 36 percent on the path coming from the north, 19 percent from Gros Ventre Road, and seven (7) percent from Sagebrush Road. Traffic records show that peak roadway and pathway traffic volumes coincide both in time of year and time of day, accentuating safety concerns due to vehicle-pathway user conflicts.

Figure 5. Pathway User Direction of Travel (August 20-24, 2012).

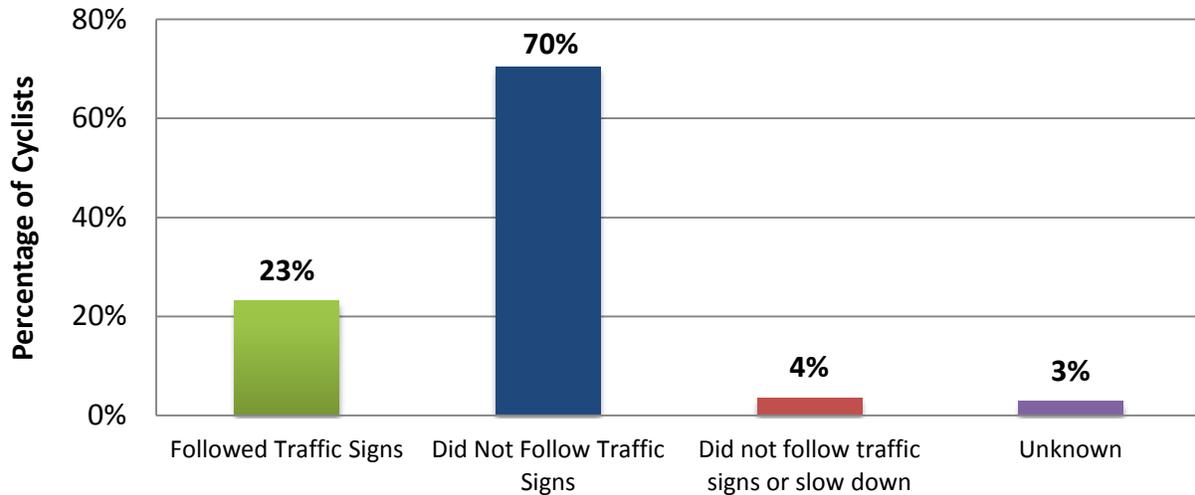
To better understand cyclist exposure and behavior, the park recorded observed path volumes, travel direction, and behaviors. Regarding cyclist behavior, 23 percent of observed riders obeyed the traffic signs, 70 percent did not obey the traffic signs, 4 percent did not follow traffic signs or slow down when approaching the intersection, and 3 percent were unknown. Notes from the data collection that of those 4 percent that did not follow traffic signs or slow down, many did not appear to look for traffic, and at times cut through moving vehicles so as to not slow down.¹² Figure 6 shows a summary of those observations.

Figure 6. Percentage of Cyclists Adhering to Traffic Signs

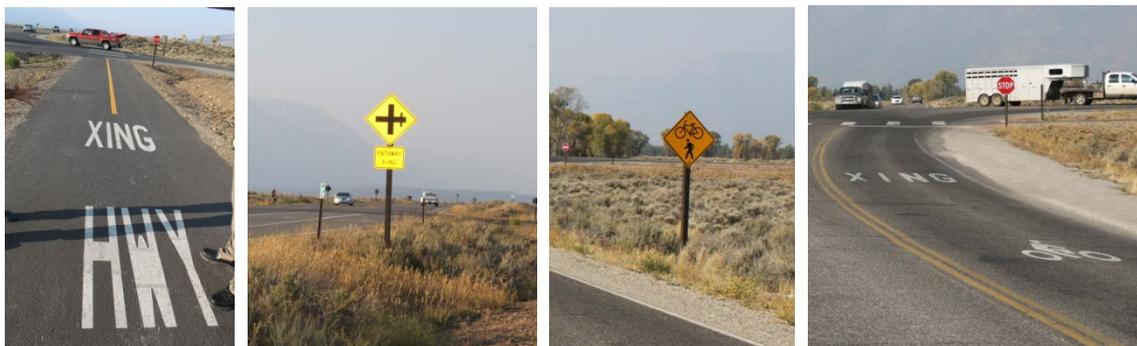
- **Pavement condition:** Both the roadway and the shared use paths had surfaces that were free of cracks and were in generally good condition.
- **Maintenance of vegetation:** Vegetation was adequately trimmed so that it wasn't protruding onto the shoulders or pavement, or obstructing sight distance.
- **Sight triangles:** Intersection sight distance was not obstructed by signs or other obstacles for most of the intersection approaches.
- **Positive warning and guidance:** Signs and pavement markings were installed to indicate the location of the pathway crossing to motorists and to alert pathway users of the upcoming intersection.

Examples of positive warning and guidance. From left to right – northbound shared use path pavement markings, sign along US Highway 26/89/191 indicating pathway crossing location, pedestrian and bicycle crossing warning sign along Gros Ventre Road, pavement markings on Gros Ventre Road.

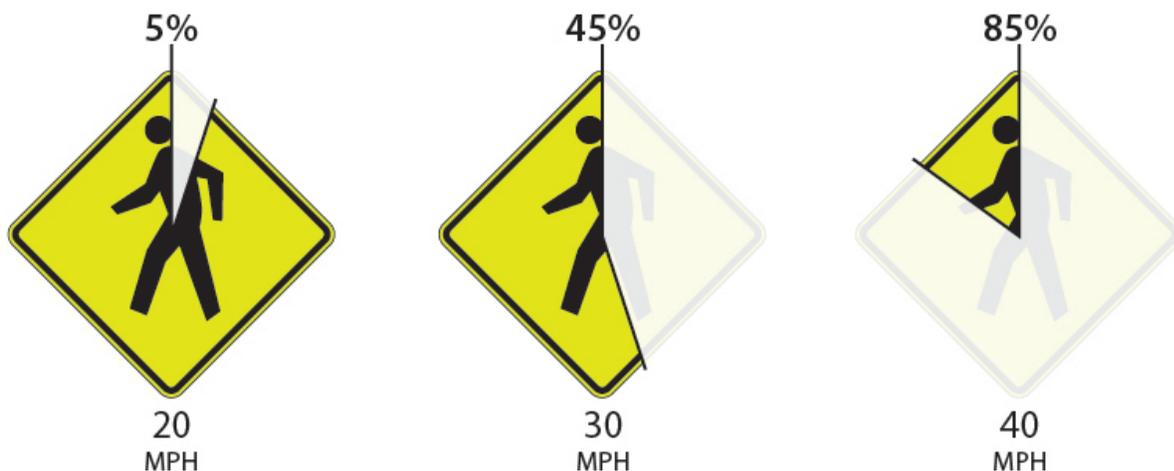
As witnessed during the BRSA and supported by field reviews and data collection, vehicles frequently travel above the posted 45 MPH speed limit on US Highway 26/89/191 through Gros Ventre Junction. This is of particular concern to cyclists whose bicycles do not have the crumple zone safety feature that is provided with motor vehicles. Increased speeds require additional perception and reaction time for drivers and an increased braking distance to avoid collisions. Additionally, as Figure 7 illustrates, the higher the speed, the greater chance of injury or fatality.¹⁴

Figure 7. The probability of a pedestrian being killed in a collision with a vehicle increases dramatically with speed. At 20 MPH, a pedestrian has a 5-percent chance of being killed in a collision with a motor vehicle; at 30 MPH, the probability of a pedestrian being killed increases to 45 percent; and at 40 MPH, the probability that a pedestrian will be killed in a collision with a motor vehicle is 85 percent.¹⁴

- *Increased enforcement.*
- *Additional speed feedback sign.*
- *Converting the existing intersection to a modern roundabout.*

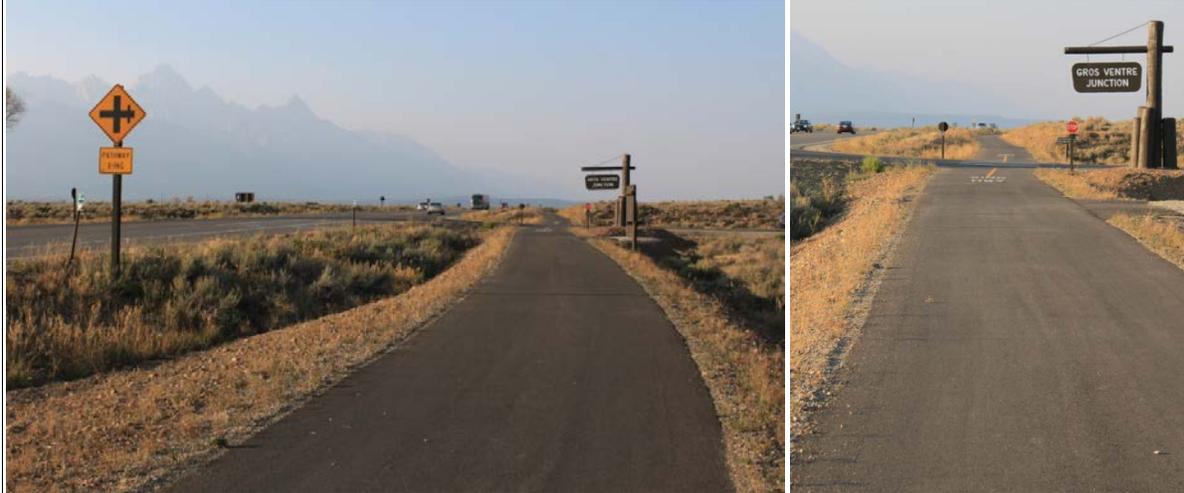
Pathway users have good sight distance to the front and to the right or left, but they have a hard time seeing vehicles that are traveling in the same direction on the highway that is parallel to the pathway – especially as those vehicles are traveling at high speeds.

Traveling northbound on the shared use path and approaching Gros Ventre Junction. It is difficult for cyclists to see vehicles traveling parallel to them from the south who may be turning onto Gros Ventre Road. Also, the pavement markings are not visible until the pathway user is close to the intersection.

Pathway users approaching the intersection do not see the existing pavement markings far enough in advance of the intersection to adequately react when travelling at higher speeds. There are no advance warning signs to alert pathway users of the intersection. There is a single advanced pathway crossing side road warning sign for northbound vehicles approaching the intersection. Approaching the intersection southbound the highway has a single general warning sign for bicycles.

- *Move/extend pavement markings in combination with additional warning signage along the shared use path.*
- *Use of additional warning signs/beacons.*
- *At-grade crossing further east on Gros Ventre Road.*
- *At-grade crossing in combination with a modern roundabout.*
- *Grade-separated crossing under Gros Ventre Road.*

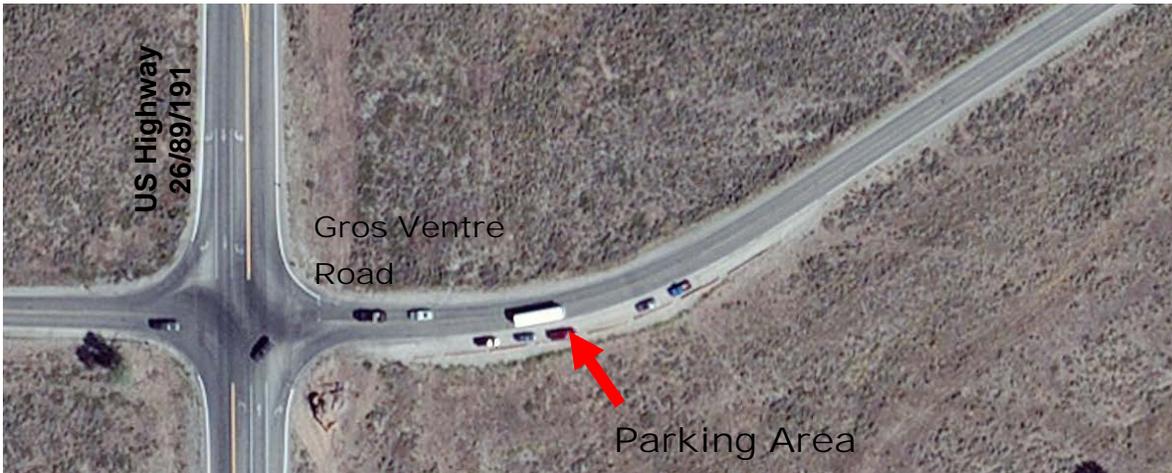
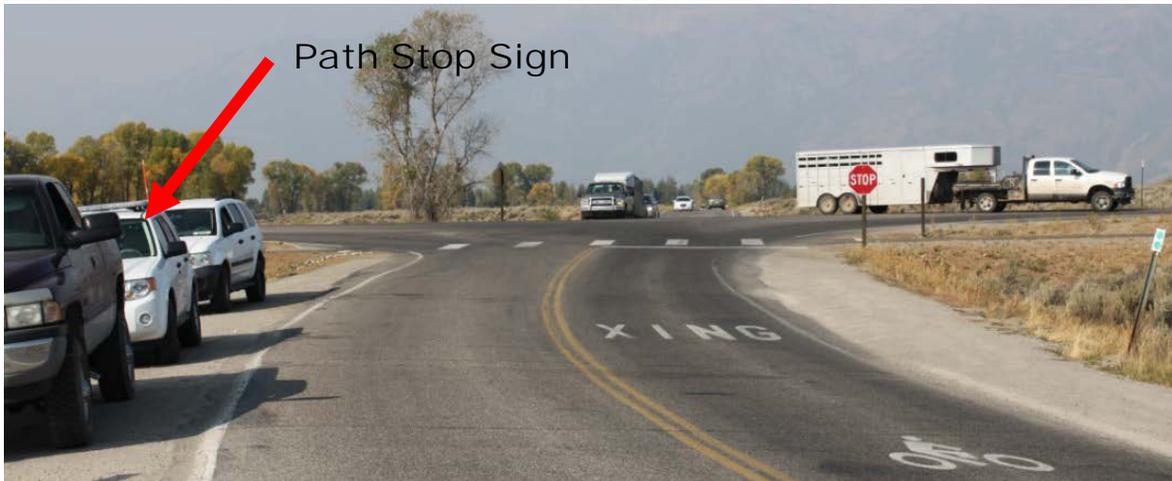
Along the southern portion of Gros Ventre Road, just east of the Junction, there is an unofficial gravel parking area. The parked cars, particularly those closest to the intersection, can obstruct the view of the shared use path.

This parking area creates an additional safety concern. As many of the cars pull out from the parking area eastbound, they make a U-turn in the roadway to return back to Gros

Ventre Junction. Or, some of the vehicles will drive farther east on Gros Ventre Road and then make a U-turn. This maneuver adds to the confusion of the intersection and drivers turning onto Gros Ventre from US Highway 26/89/191 may not expect a vehicle conducting a U-turn.

Parking Area at Southeast Corner of Gros Ventre Junction.

Restricting parking near the shared use path crossing would help to facilitate use of the intersection and would improve visibility of the pathway.

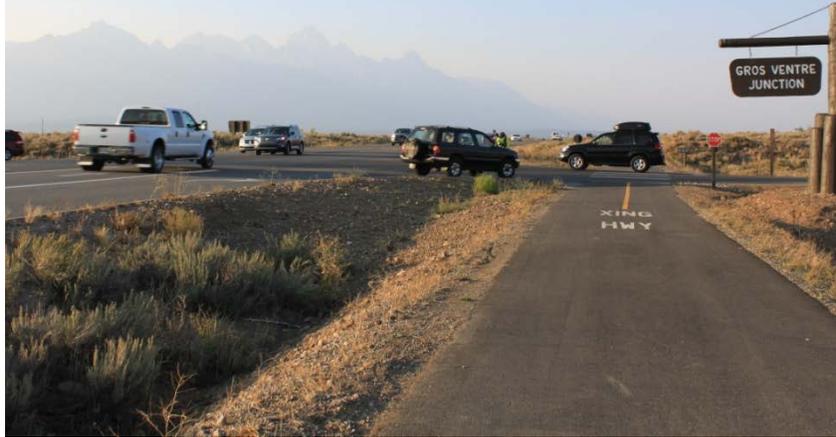
The BRSA team witnessed multiple incidences of vehicles approaching the intersection from Gros Ventre Road, stopping on the crosswalk, and blocking the pathway. This reduces the visibility of both the pathway and the roadway.

A vehicle stopped on the crosswalk and blocking both the view of the pathway and the roadway.

Along Gros Ventre Road, additional signage instructing drivers not to block the crosswalk would help to improve visibility of the pathway.

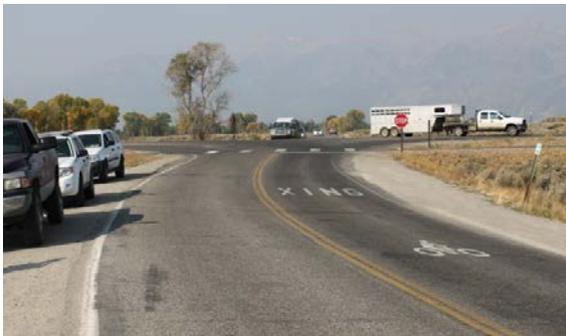
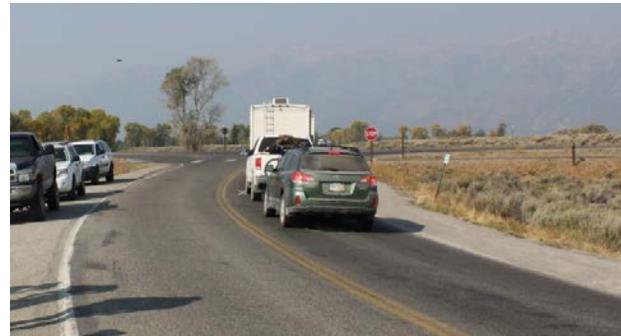
In combination with the stopped vehicles blocking the pathway, the crosswalk markings and the pathway crossing warning pavement markings are not as visible traveling west on Gros Ventre.

Vehicles stopped on Gros Ventre Road at Gros Ventre Junction. The parked vehicles on the left and the stopped vehicles on the right obscure visibility of the pathway, the pathway crossing pavement markings, and the crosswalk.

- *Move/extend pavement markings in combination with additional warning signage along the shared use path.*
- *Use of additional warning signs/beacons.*
- *Additional pavement markings along Gros Ventre Road.*
- *Signage along Gros Ventre Road instructing motorists to not block the crossing.*
- *At-grade crossing further east on Gros Ventre Road.*
- *At-grade crossing in combination with a modern roundabout.*
- *Grade-separated crossing under Gros Ventre Road.*

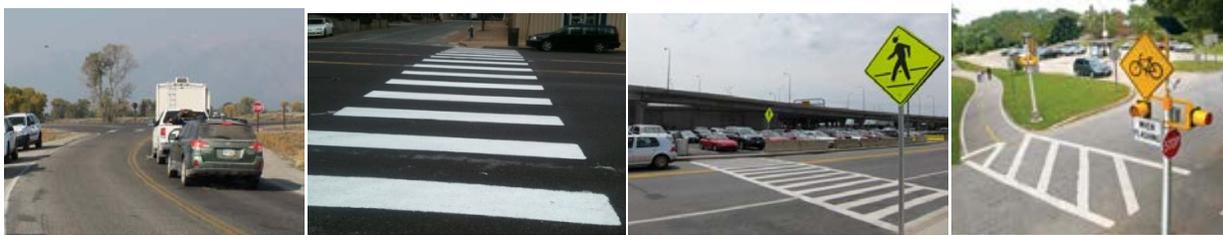
The existing crosswalk along with examples of crosswalk pavement markings. From left to right – view of the existing crosswalk traveling westbound on Gros Ventre Road, an example of a continental crosswalk with pavement markings closer together, ladder crosswalk pavement markings, and zebra crosswalk markings.

Add additional pavement markings such as “BIKE XING AHEAD”, farther east on Gros Ventre Road and consider modifying the crosswalk pavement markings to a more visible design (see MUTCD Figure 3B-19). The crosswalk currently is marked with a continental pattern.¹⁶ Placing the markings closer together or using a zebra or ladder pavement marking may improve the visibility of the crosswalk.

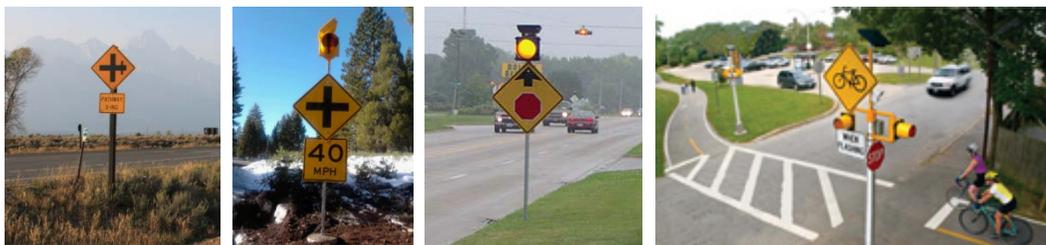
The existing warning sign along the US Highway 26/89/191 along with a variety of warning and stop beacons.

On the US Highway 26/89/191, the pathway crossing location is currently shown on the warning signs located to the north and south of the intersection (see photo). Add additional warning signs or beacons (see Section 4L.03 of the MUTCD) along the highway for turning vehicles to be aware of crossing pathway users.

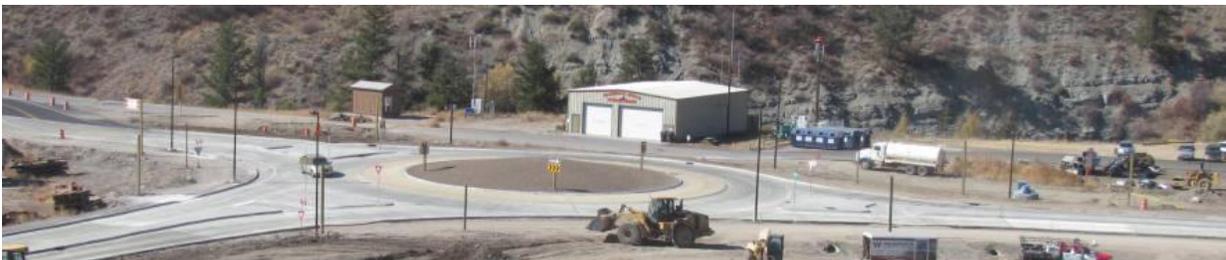
Modern Roundabout: Hoback Junction; South of Jackson, WY.

Construct two new at grade shared use path crossings surrounding a modern roundabout. The roundabout would provide multiple benefits; provide an intersection with less conflict points and would also allow for cyclists to cross one lane at a time with a splitter island serving as a median refuge. See Concept Drawing #3 in Appendix A.

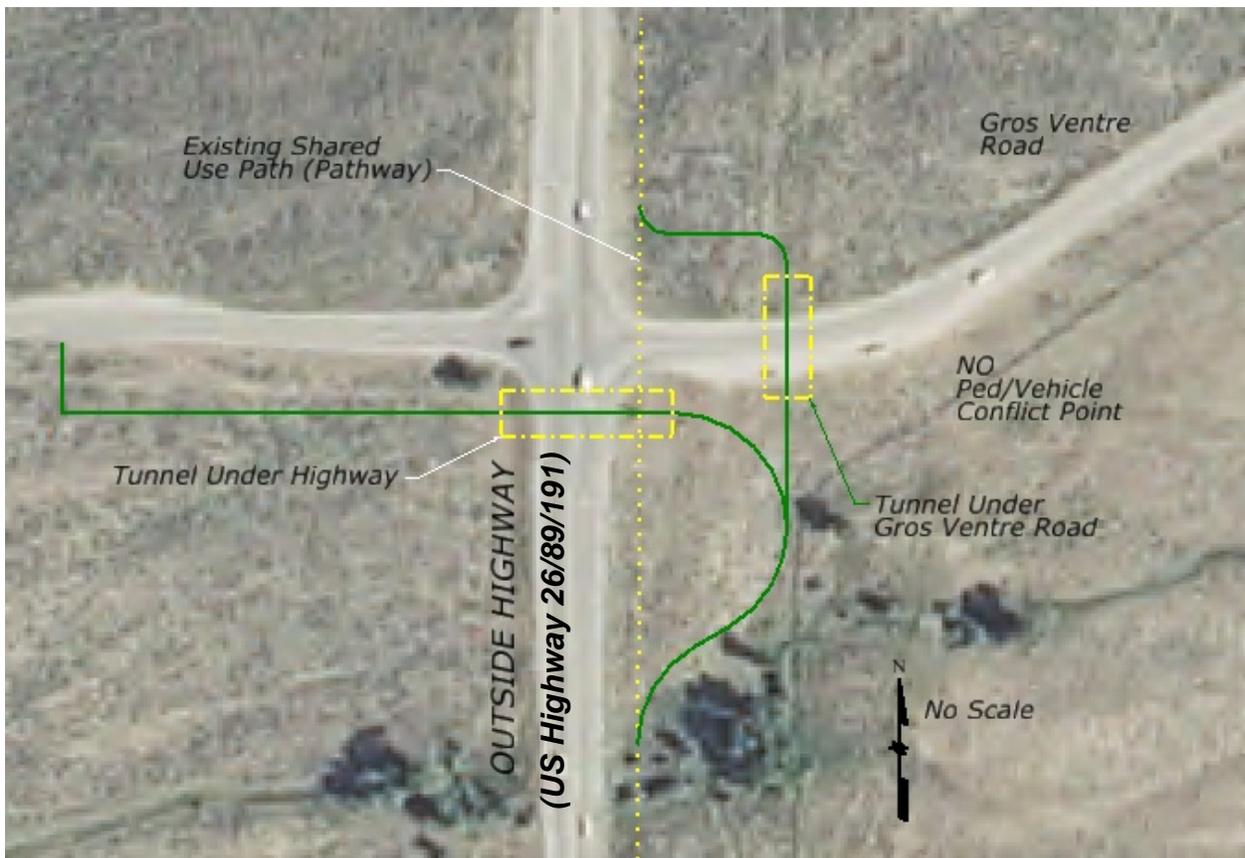
Figure 8. Concept Diagram: Two New Grade Separated Pathway Crossings.

Figure 8 shows the potential location of two separate tunnels. One under the highway south of Gros Ventre Junction and another under the Gros Ventre Road east of the intersection. These tunnels would allow for both motorized and non-motorized traffic to flow freely and by separating the two traffic flows would greatly reduce conflicts between pathway users and motorized vehicles at the intersection. There is a nearby example of a grade separated shared use path crossings using an underpass in the park at Moose Junction.

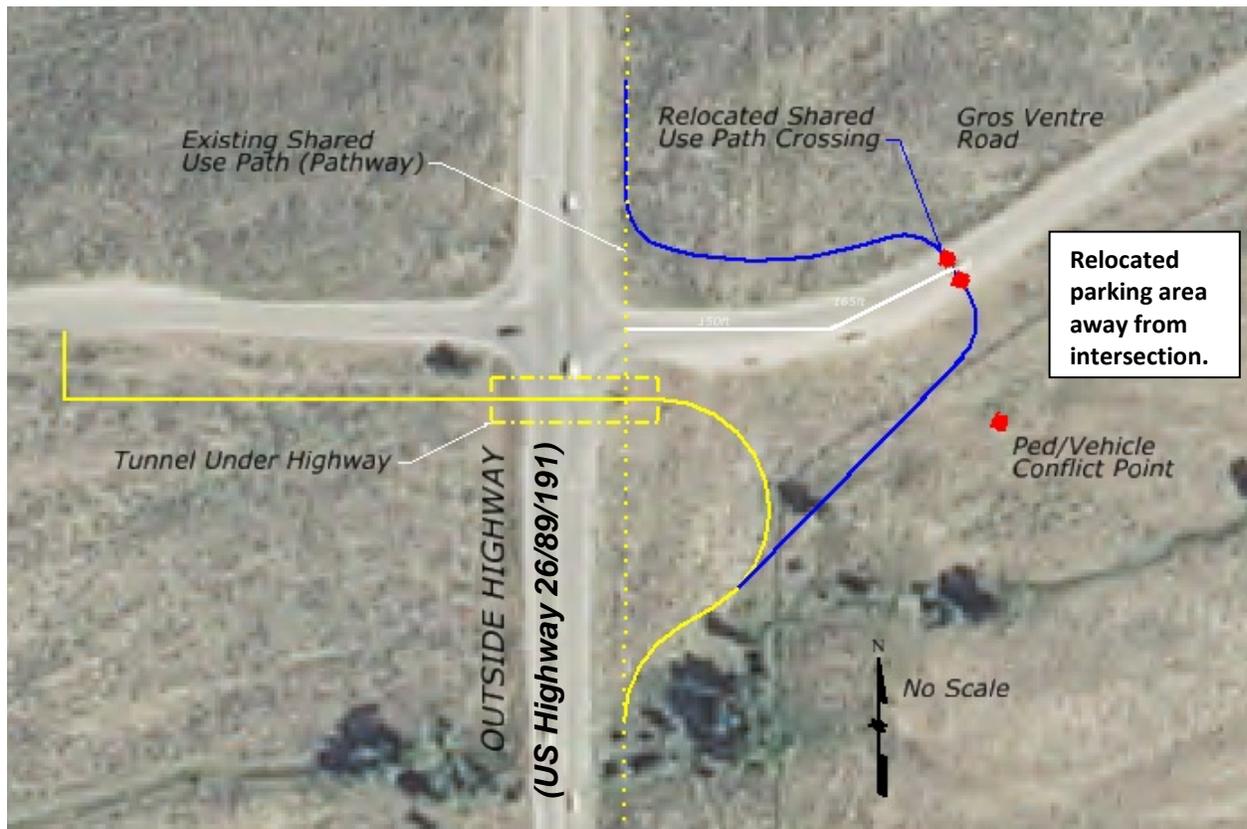
Figure 9. Concept Diagram: New Grade Separated and Relocated At-Grade Pathway Crossings.

In the second concept, shown in Figure 9, the existing at grade crossing of the Gros Ventre Road would be relocated farther east of the intersection. The new at grade crossing location would reduce the number of pathway-vehicle conflicts in the intersection, provide additional time for drivers to recognize and respond to the pathway crossing before approaching the intersection or after turning onto Gros Ventre Road, and would provide stacking space for vehicles after the crossing so the crossing is not blocked by vehicles waiting at the intersection. There is an example of an at-grade shared use path crossing in the park near the Taggart Lake Trailhead on the Teton Park Road. A grade separated crossing of the highway would be very similar to that proposed in Concept #1.

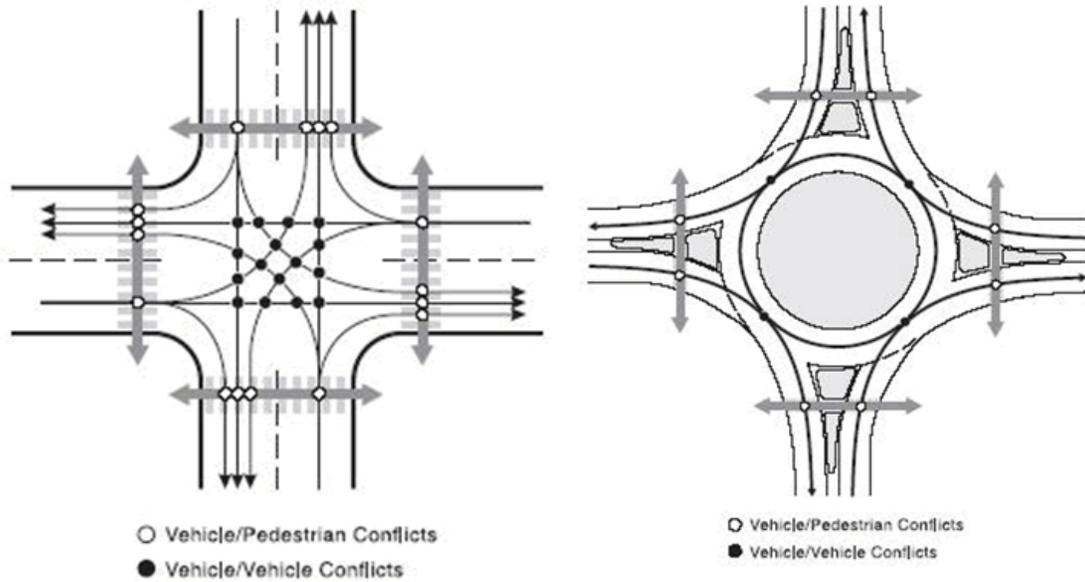
Figure 10. Roundabouts Reduce Pathway User-Vehicle Conflict Points.²⁰

Figure 10 shows the reduction in conflict points associated with converting a traditional four-legged intersection to a roundabout.

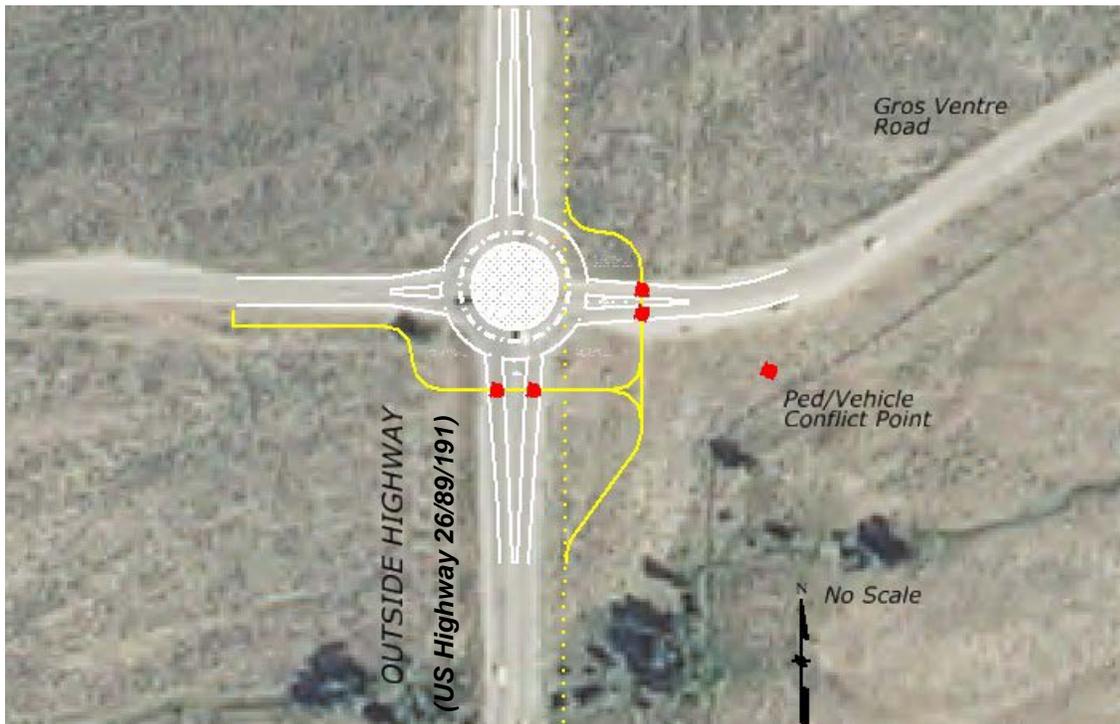
Figure 11. Concept Diagram: Two At-Grade Pathway Crossings Integrated Into a Modern Roundabout with Conflict Points.

This concept involves at-grade pathway crossings of the Gros Ventre Road and southern leg of the US Highway 26/89/191 integrated into a modern roundabout. A modern roundabout is not a traffic circle, such as what can be found at the Jackson Hole Airport or in Idaho Falls. There is an example of a modern roundabout at Hoback Junction south of the town of Jackson, WY. The modern roundabout would improve pathway user safety in multiple ways including;

Figure 11 shows the approximate roundabout footprint with crossings for pathway users.
