National Park Service
Cultural Landscapes Inventory
2010

Murie Ranch Historic District
Grand Teton National Park

**Department of Landscape Architecture and Environmental Planning
Utah State University, Logan, Utah 84322**

May, 2010

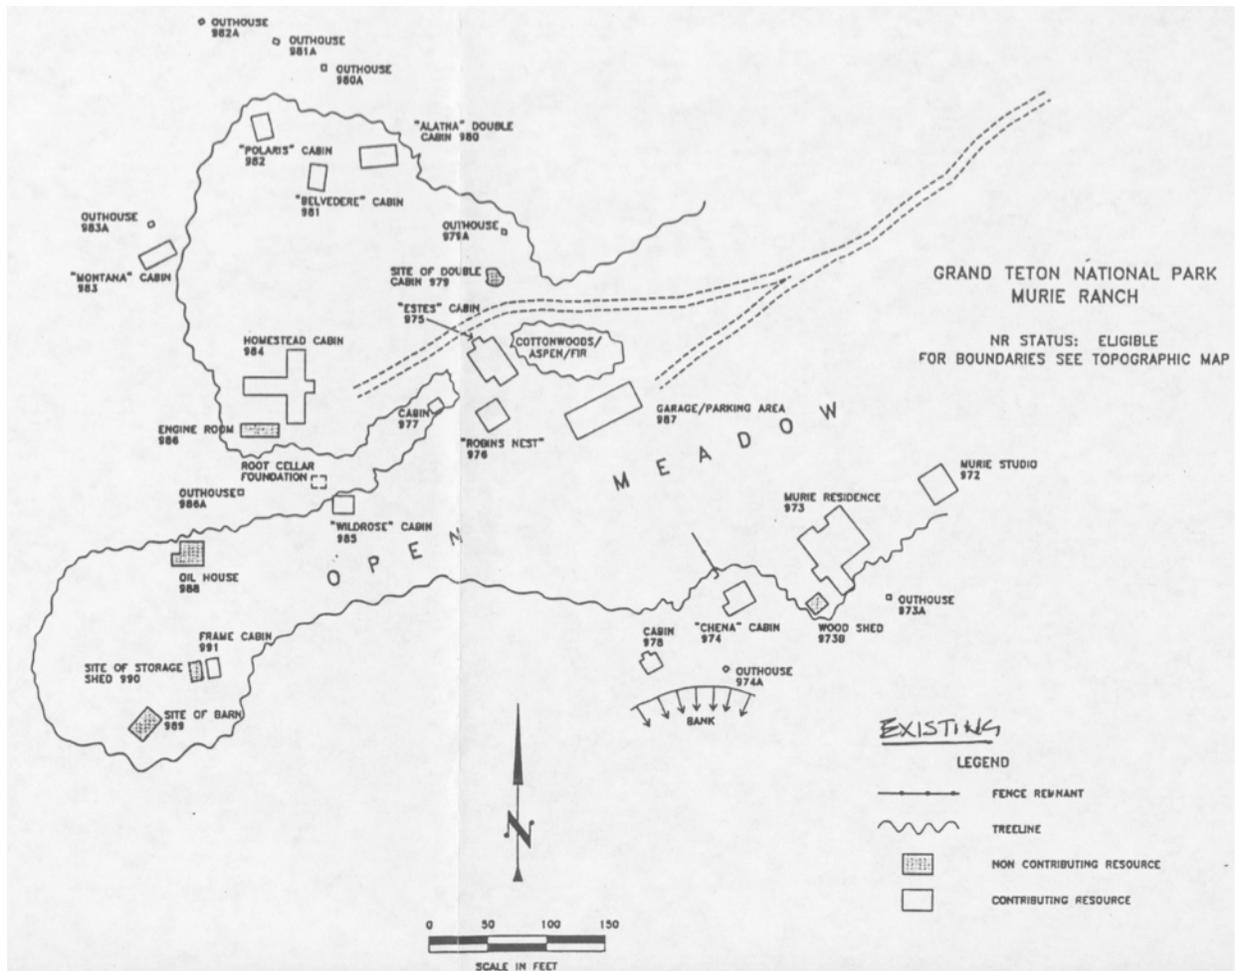
Location of buildings on the site (GRTE Archives)

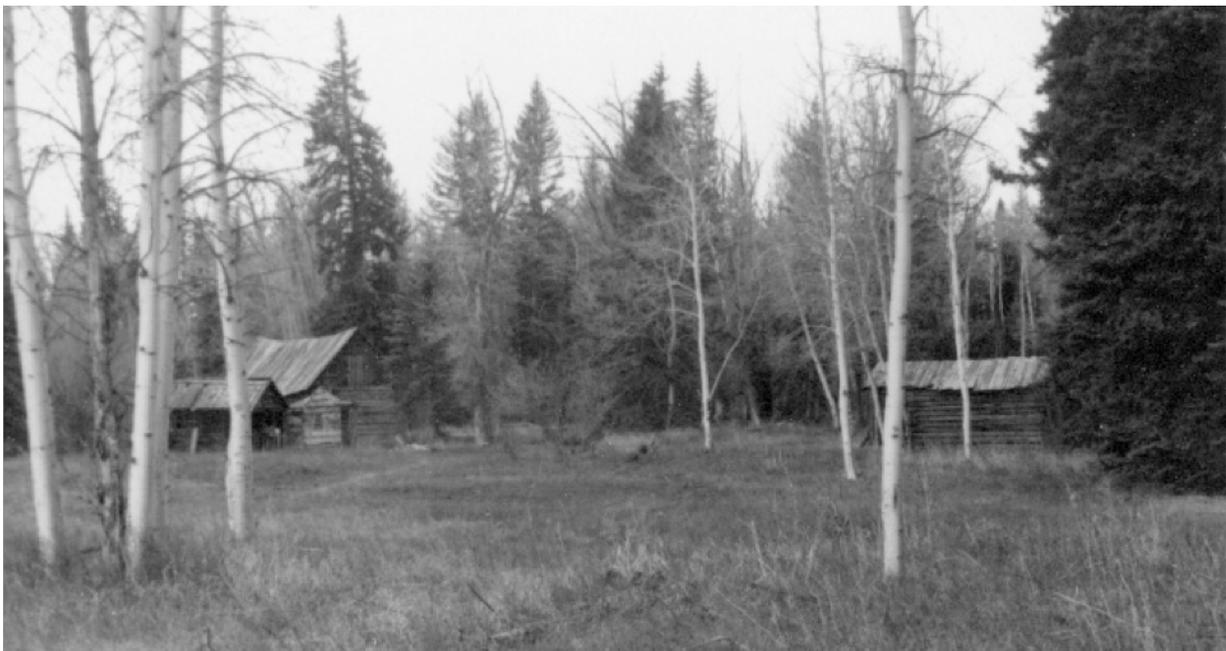
View of western portion of Murie Ranch Historic District. Only the Frame Cabin, #991 (far left of cluster) survives. The adjacent Barn, #990 and Storage Shed, #989 (barely visible between barn and Frame Cabin), were removed in the late 1970s, and the non-contributing Oil House, #988 (far right) has been burned since 1998. (Photo taken 1977; GRTE archives)

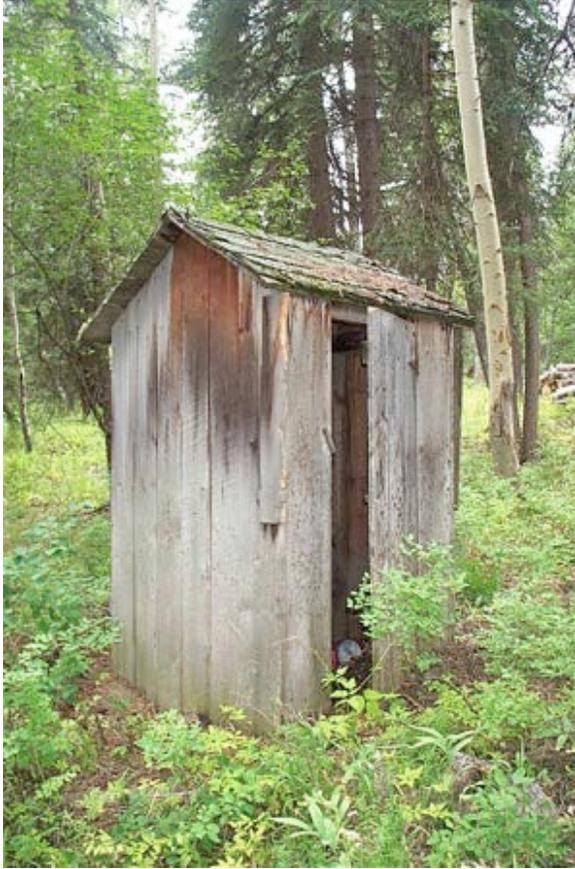
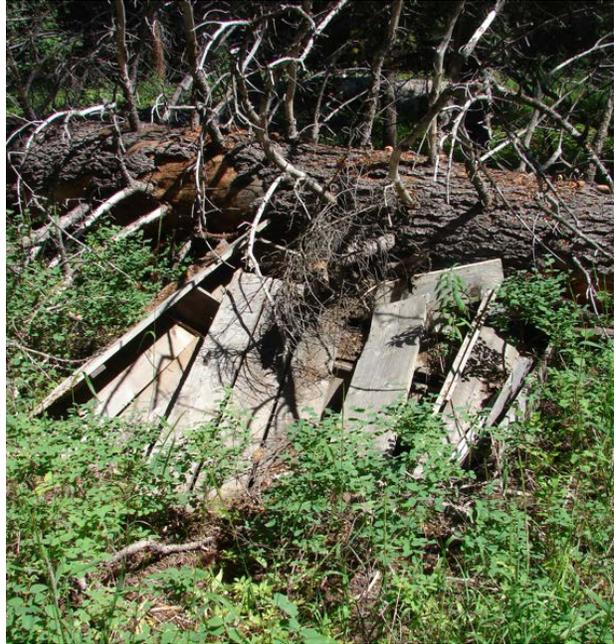
Left: Murie outhouse, #973A – photo in LCS database

Right: Murie outhouse, August 1, 2009

Since completion of the NHL in 2006, five contributing structures have been lost. The Polaris Outhouse, #982A, apparently met with a similar fate as the Murie Outhouse, and no longer exists. Four deteriorating outhouses were removed and reconstructed in 2009 as non-functioning replicas, and are described above as non-contributing structures. As noted in the 1998 National Register listing, “while minor resources such as outhouses do not define site layout or site significance to the same degree as the more substantial buildings, they remain an indicator of the degree of historic development and of the amenities offered ranch visitors: Murie Ranch was an unobtrusive, unpretentious human toe-hold at the edge of the West’s undeveloped lands. If the scenery failed to remind visitors of that fact, the outhouses almost certainly would have.”

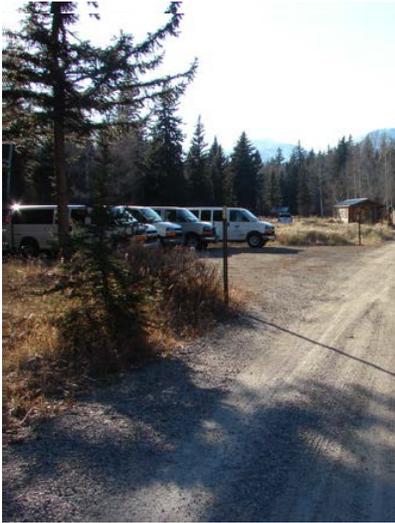
Left: New parking lot visually dominates entrance to site

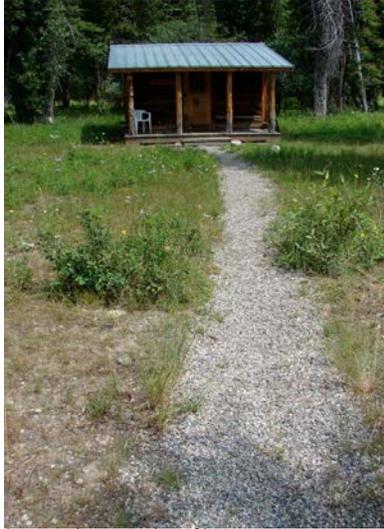
Center: recent surfacing of paths with crushed gravel contradicts Murie preference for natural paths

Path materials –Several of the walks are edged with rows of large cobbles, which, according to Nancy Shea, is a recent addition done during the Murie Center period. Most paths have recently been accentuated by addition of crushed gravel, which is a non-contributing material even though alignment of the paths in original locations is contributing. According to Nancy Shea, this was done following her tenure as director of the Murie Center, probably between 2005-2008.

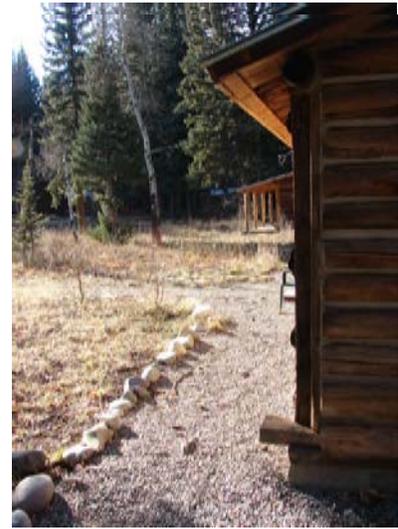
Right: lining of cabin walks with cobbles

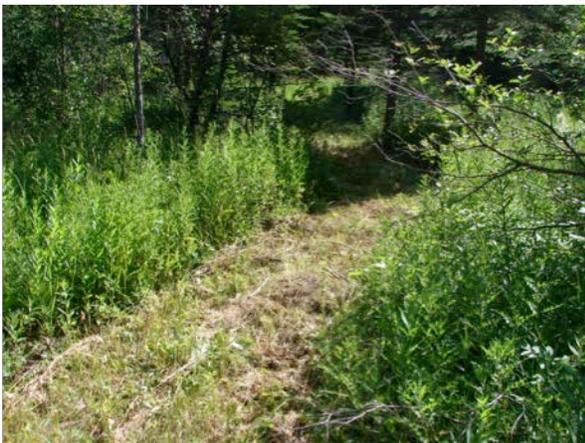
Bottom: informal paths Several paths three to four feet in width have been cut through and routes, and are contrary to the Murie philosophy of treading lightly on the land and following the natural paths of wildlife.

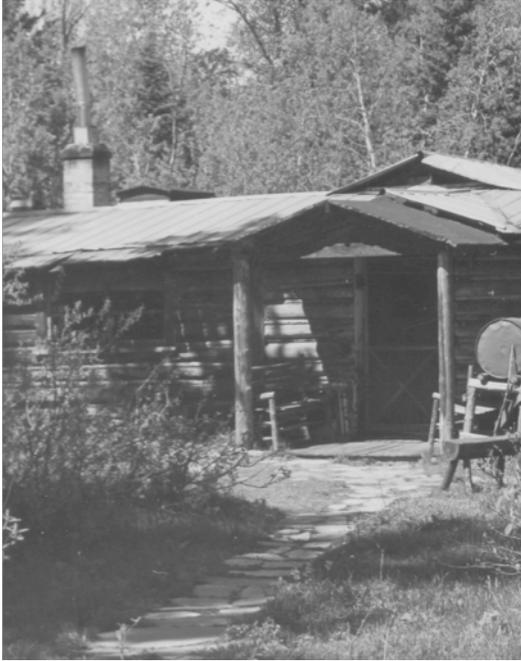
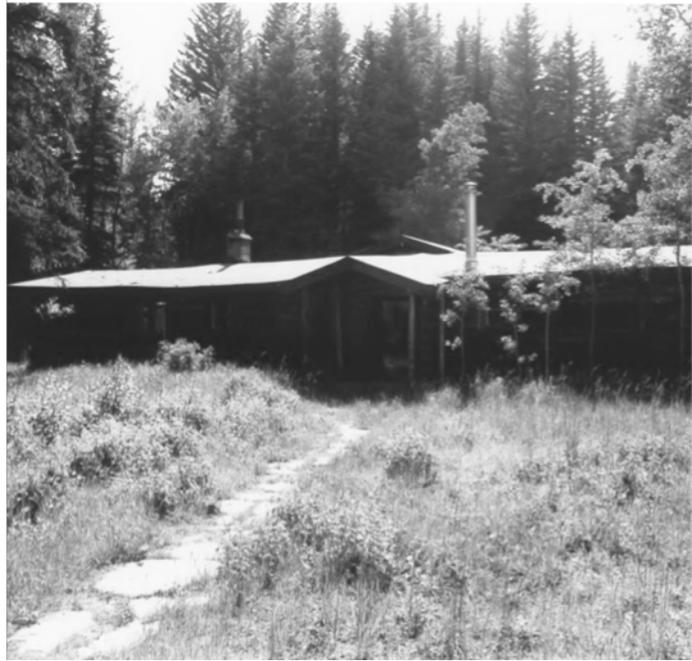
Left: View of Homestead Cabin, 1947, showing stone walk (Photo courtesy of the Murie Center archives; cropped image) Right: Similar view, 1995 (NRHP nomination package)

Missing stone path – Stone paths were constructed as part of the infrastructure improvements during the STS Dude Ranch era. These paths are clearly visible in photographs taken early in the period of significance, but are not in evidence today. They are not recalled by Nancy Shea or Steve Duerr (former and current Murie Center Directors). A stone path leading to the Homestead Cabin is clearly visible as recently as 1995, in a photograph submitted with the NRHP nomination filed in 1997. There is a good possibility these walks exist beneath surface accumulation, as the effort to remove them would have required significant effort of which there is no mention in Murie memoirs.

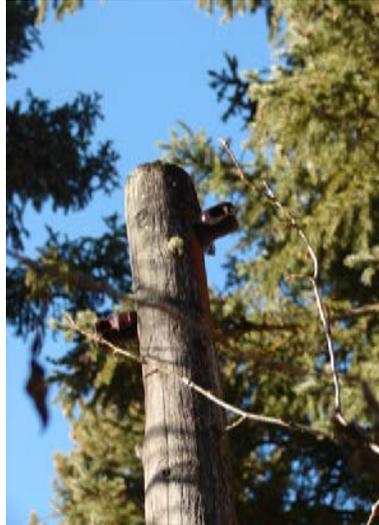
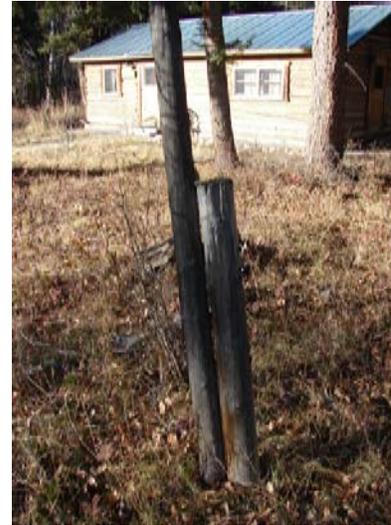
Early utility pole - only one pole survives the early years of electrification, southeast of the Alatna Cabin. The pole is trimmed and peeled lodgepole pine, approximately 6" diameter, provided with extra support with second shorter pole. A brown ceramic insulator remains at the top. This pole was listed as a contributing structure on the NHL nomination form.

Early electric pole: left image shows the top, with ceramic insulator, and right shows base supported by extra post.

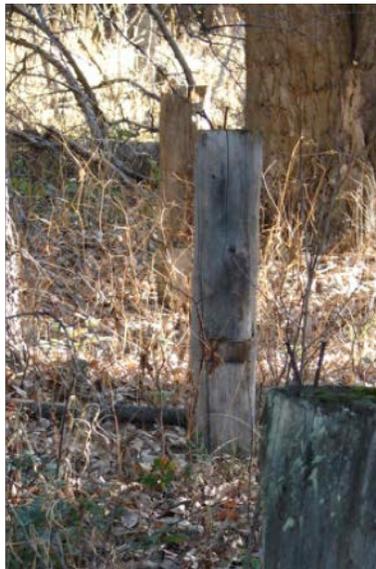
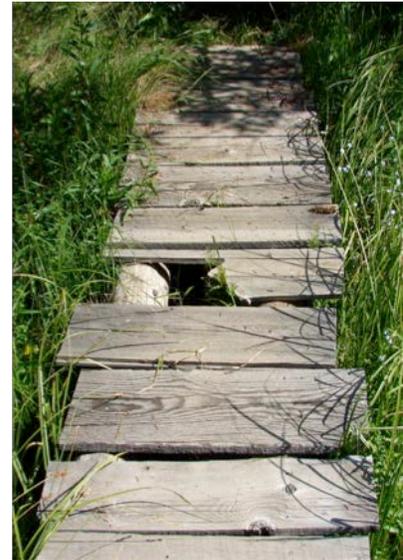
**Left: remnant fence posts behind Murie and Chena cabins
Right: plank boardwalk along Snake River Trail**

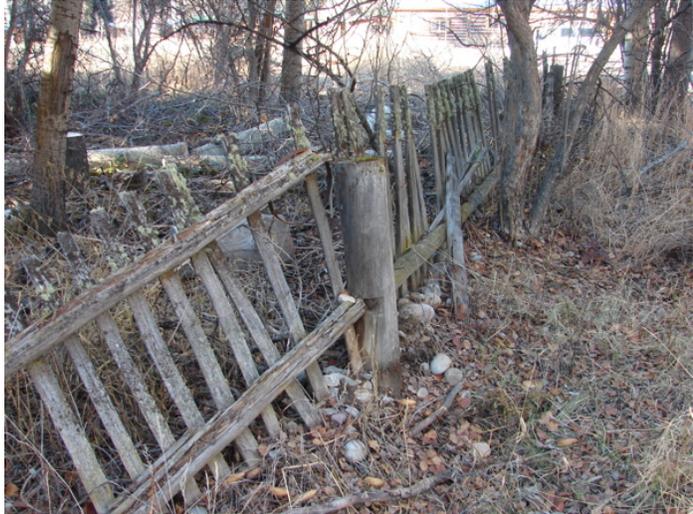
Chena fence, now gone, photographed in October, 2008

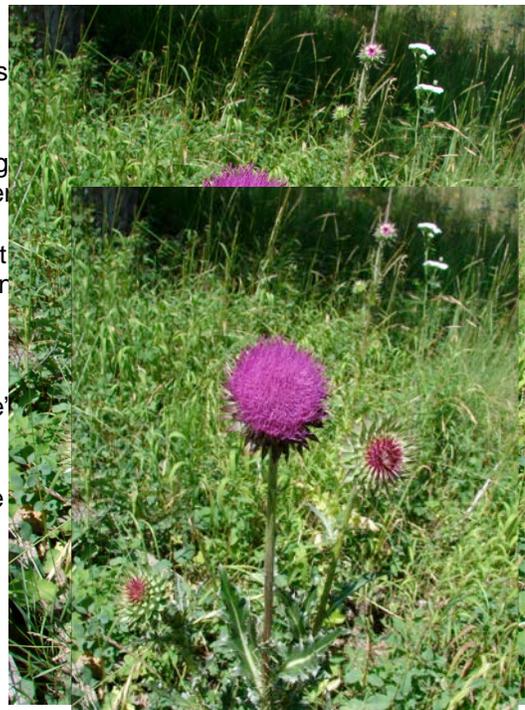
Invasive musk thistle growing on Murie Ranch site, August, 2009

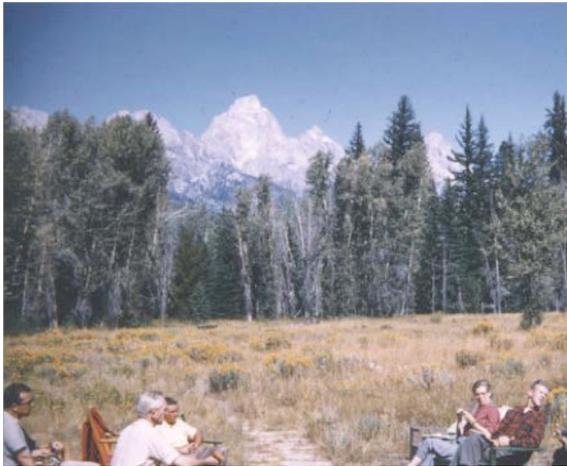
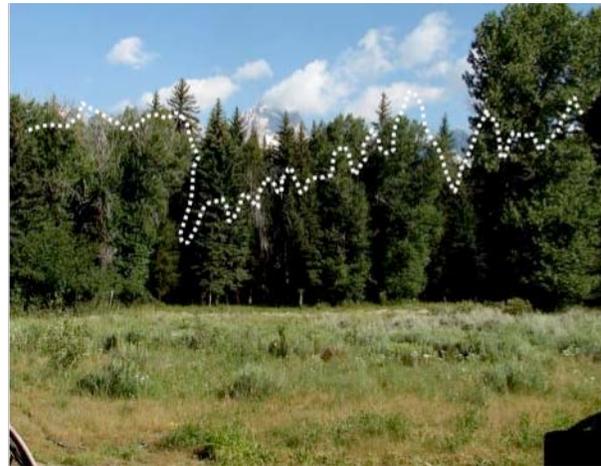
Off-site vista - The dominant, imposing view of the Grand Teton is viewed from the front porch of the Olaus and Mardy Murie Cabin. This view was significant enough to dictate the original placement of the cabin by Mrs. Woodbury, who had the log structure built in the late 1920s. (Meehan, 14) The central axis of the roof ridge, and hence the front porch and walkway extending from it, forms a perfect alignment on the majestic peak. Mardy described this view, stating that “the front porch looks across the opening to another forest wall in the middle of which there is a natural gap where the trees are shorter and there the Grand Teton is framed. Hundreds of people have asked, ‘Did you trim those trees like that?’ The explanation for the openings I have still to find” (*Thus at Moose*, 4). It is apparent from photographs of gatherings at the ranch that many informal meetings occurred in the front of this cabin, in full presence of the looming Grand Teton. Significant growth of vegetation across the meadow from the cabin, confirmed

View from front porch of Murie Cabin in 1955, left, and 2009, right. White line indicates vegetation growth since 1955 (Historic photo courtesy of the Murie Center Archives; cropped image)
