## Advanced Redoubt of Fort Barrancas

## Guide to the Advanced Redoubt

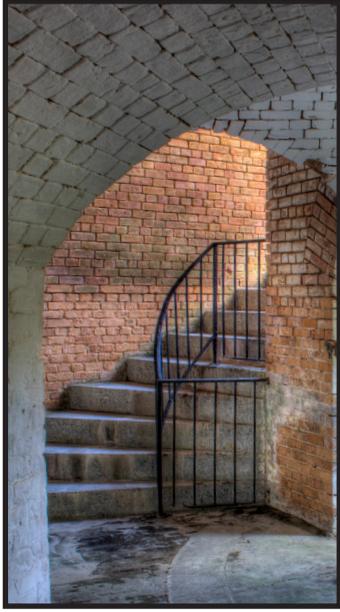
Walk around the Advanced Redoubt to learn about the outer works of this fort. Do not move bricks. Help preserve your fort by practicing "Leave No Trace" principles.

1. You are on an open slope called the glacis. As an attacker, you are exposed to cannon and musket fire from the main wall (scarp) as well as musket fire from the top of the outer wall (counterscarp). The solution is to dig a series of trenches to provide cover. The trenches must be big enough for cannon and infantry to advance.
2. As a rush of infantry from the trenches overwhelms the counterscarp, defenders would fall back to these traverses. Defenders are still protected while the attackers are now exposed. The two traverses allow the defense to fall back gradually while offering stubborn resistance.
