National Park Service
U.S. Department of the Interior
www.nps.gov/hagr

Hamilton Grange National Memorial Restoration Update – July 12, 2011

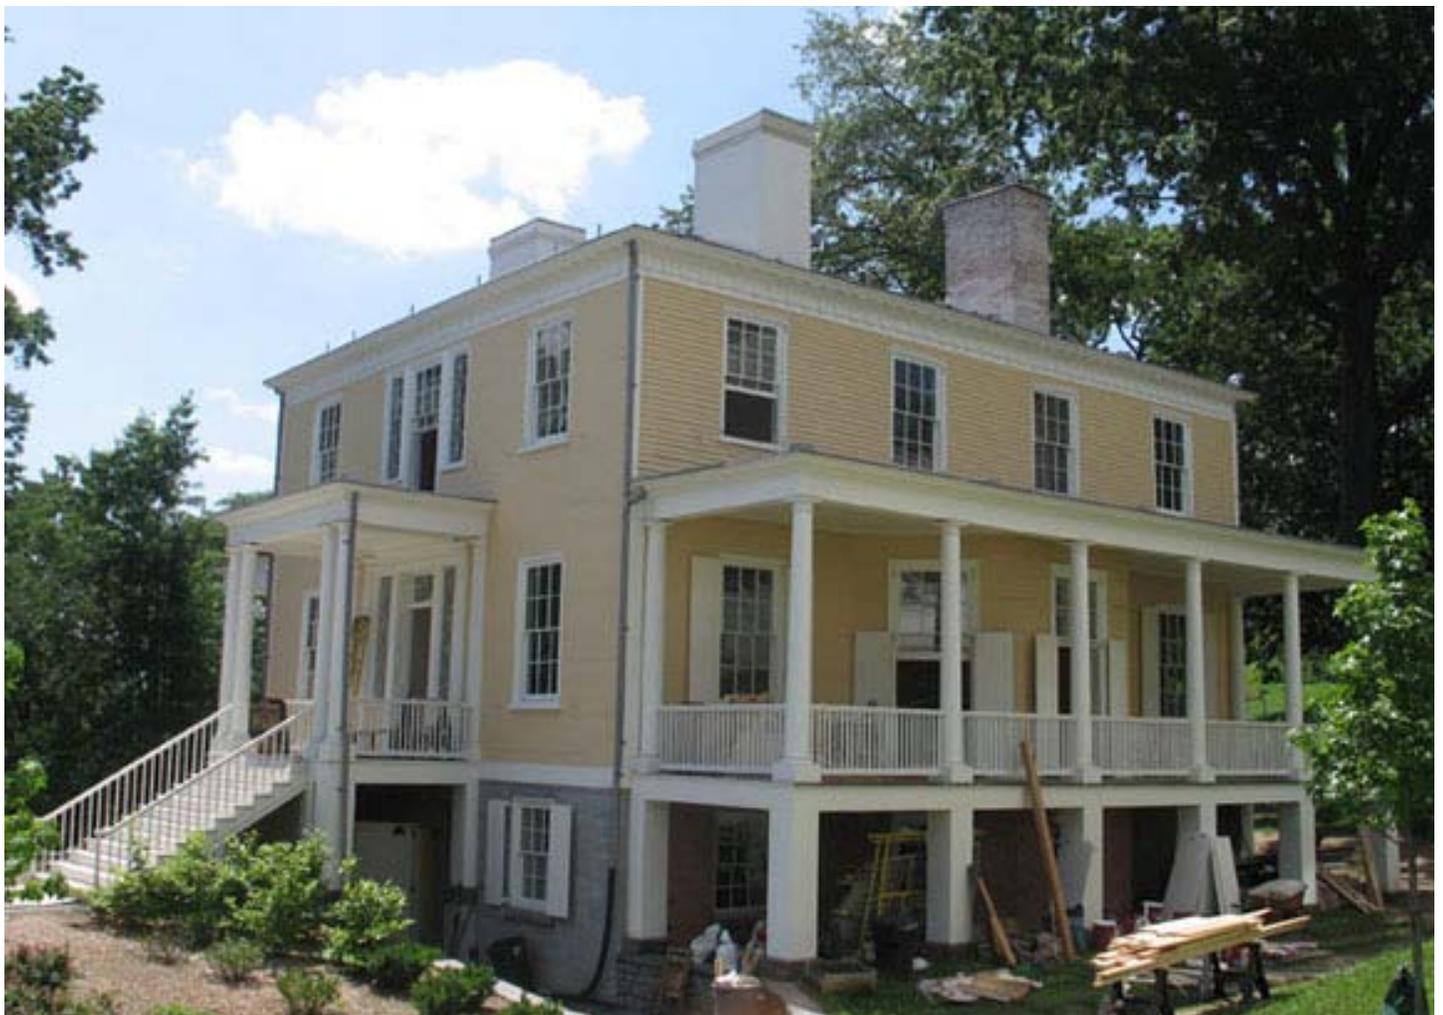
The first level of shutters can be seen on the eastern piazza (side porch) of the Grange. The rest of the functional shutters are scheduled to be installed in the coming weeks.

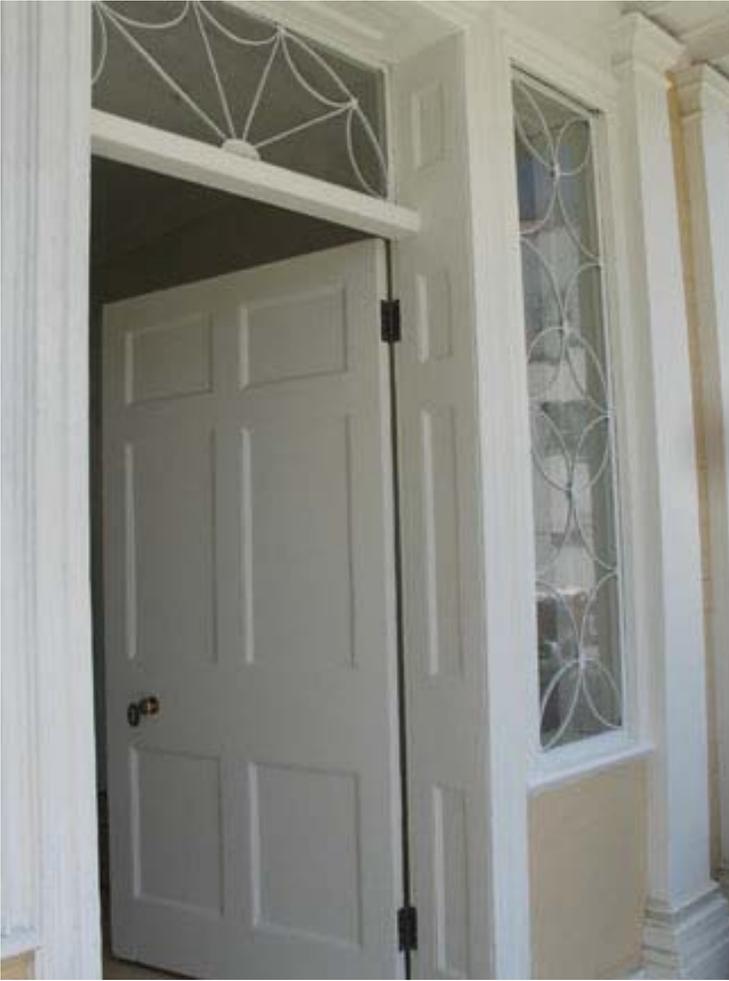
The historic front door of the Grange, complete with transom and sidelights was lovingly restored by the restoration contractor and has been re-installed at the Grange.

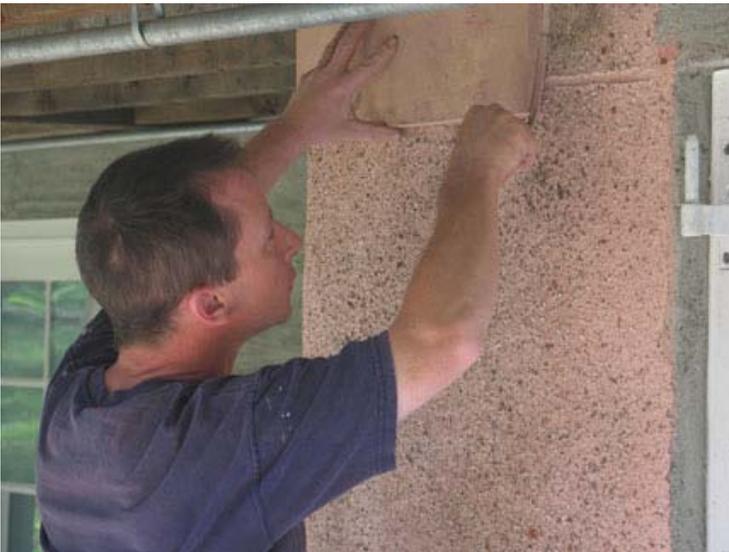
Sean O'Keefe, preservation craftsman with the National Park Service, scores a fresh layer of stucco on the ground floor of the Grange to create the illusion of stone blocks. This is the same technique that was used when the Grange was first constructed.

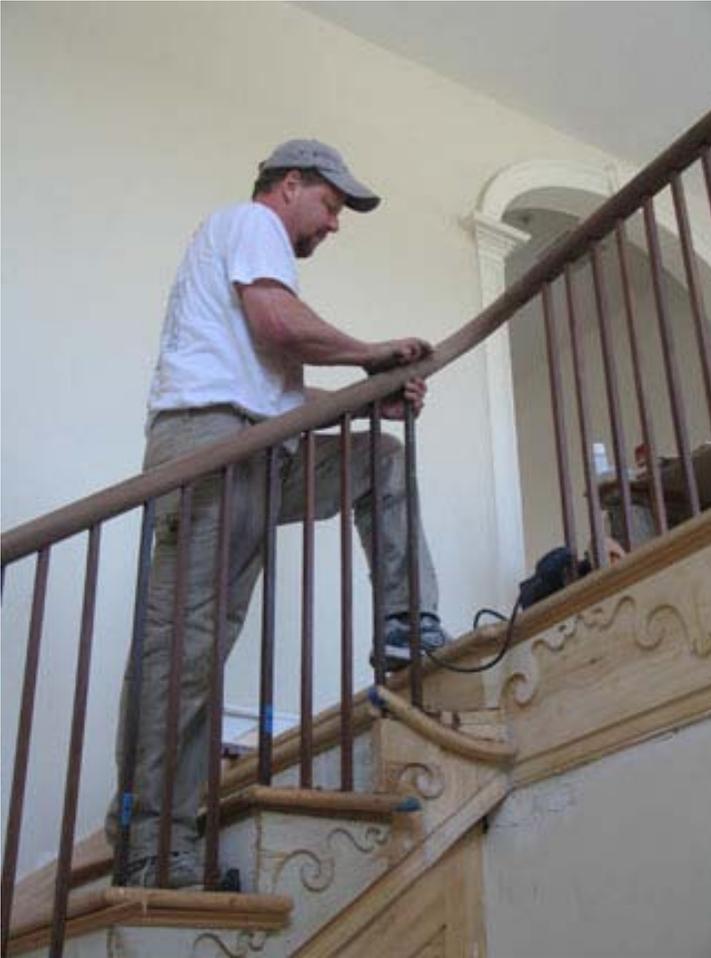
Greg Law, senior preservation specialist with the National Park Service, works on the re-constructed banister of the staircase at the Grange. While much of the staircase is original to the house, the stairs were reconfigured to a new shape following the Grange's first move in 1889 and pieces of it were altered to accommodate the new configuration and other pieces were lost. In restoring the staircase to its original shape, the restoration team was able to incorporate some of the original, but altered pieces back into the finished stairs. Two of those pieces are the balustrades marked by blue painter's tape.

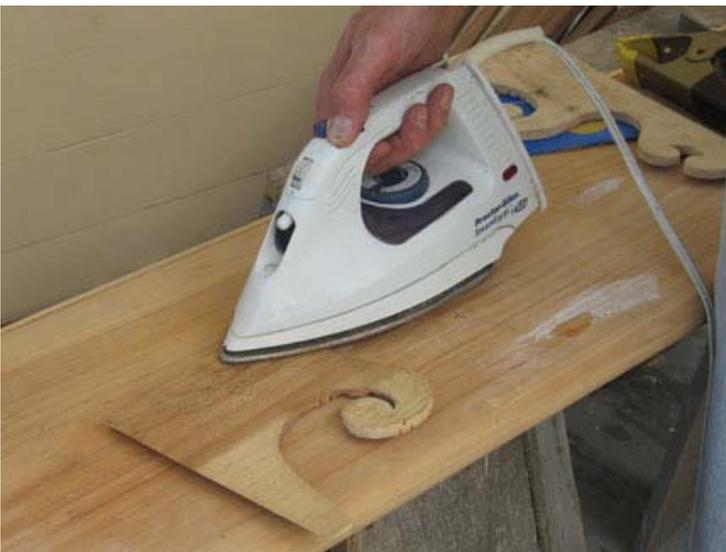
Paul Atchison, preservation woodcrafter from the National Park Service's Northeast Regional Architectural Preservation Engineering and Maintenance office applies steam to a piece of trim destined for a curving

portion the Grange's main staircase. Steaming the piece in combination with other techniques allows it to bend to fit the place where it will go but still maintain its structure and strength.

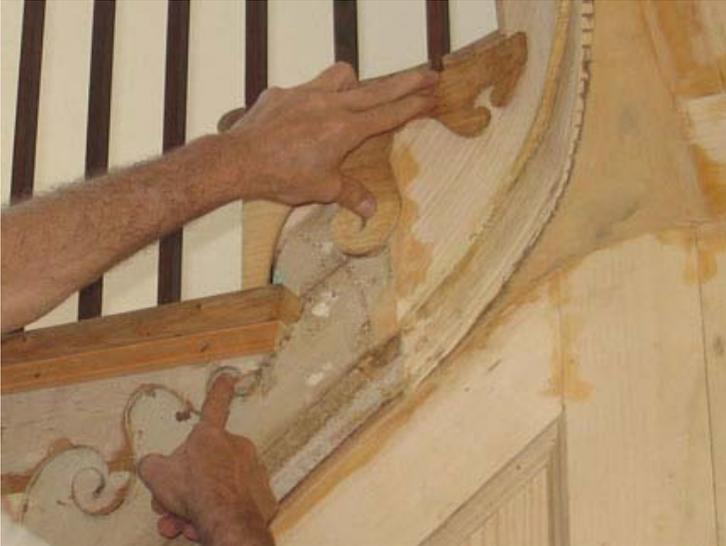
After getting itself “ironed out,” a piece of trim (top) is test fitted into the well of the staircase at the Grange.

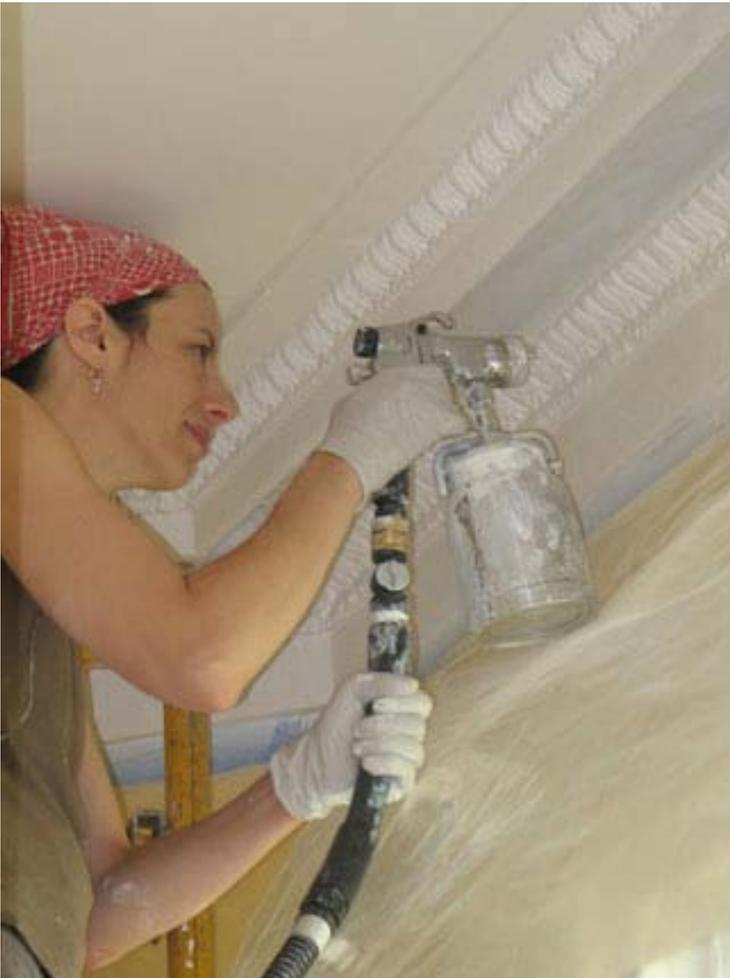
Naomi Kroll Hassebroek, architectural conservator with the National Park Service, gently sprays primer onto the cornice in the dining room of the Grange. Kroll Hassebroek's work began with her and a team of interns removing 200 years worth of paint from the cornices using modern stripping agents, steam and dental tools to reveal the intricate details of the plaster moldings. Once the final coat of paint goes on, the white cornice

moldings will stand out against the dining room's yellow walls as they did when Alexander Hamilton lived at the Grange.
