**National Park Service  
Cultural Landscape Inventory  
2006**

**Crater Rim Historic District  
Hawaii Volcanoes National Park**

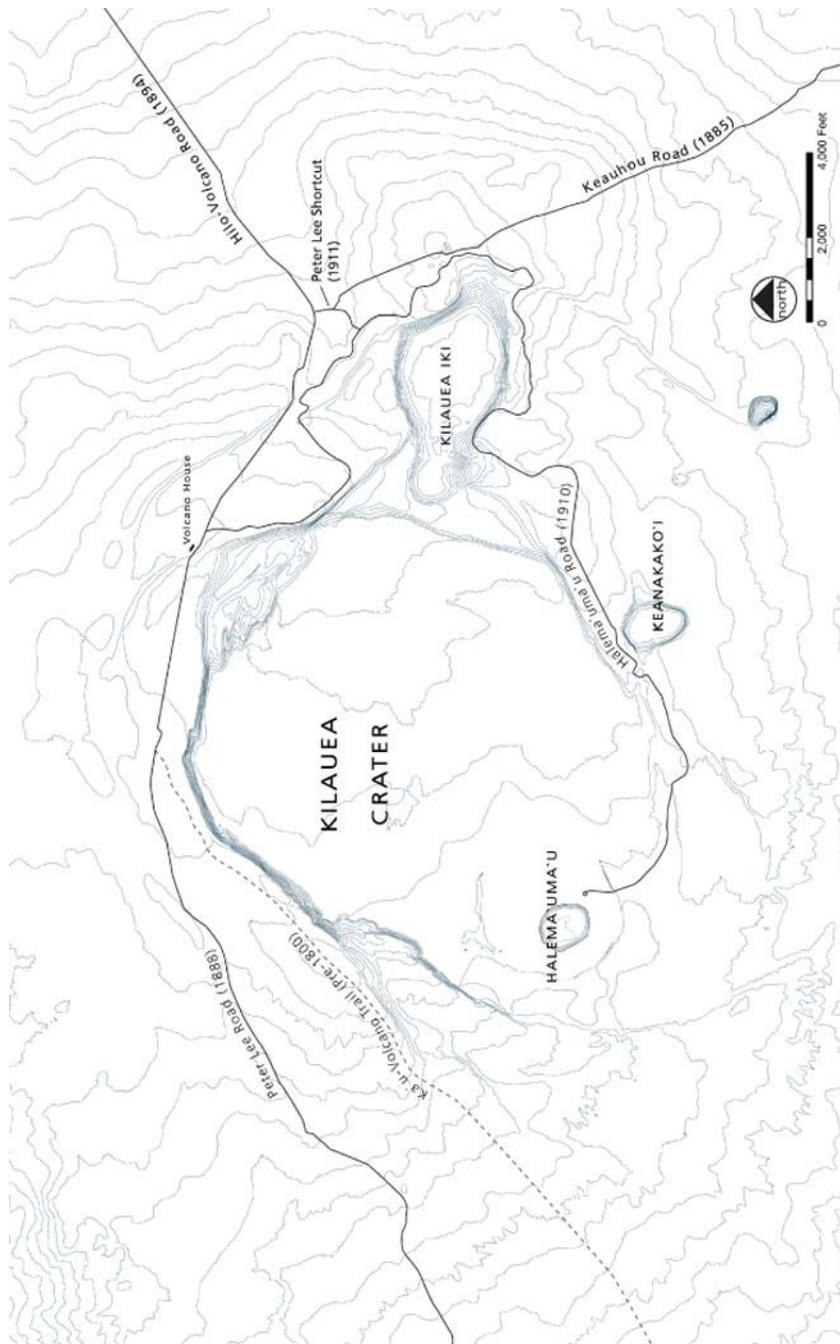
Site Map #2. Site map showing the Kilauea Caldera rim area at the beginning of the period of significance in 1916. (See Appendix for larger map.)

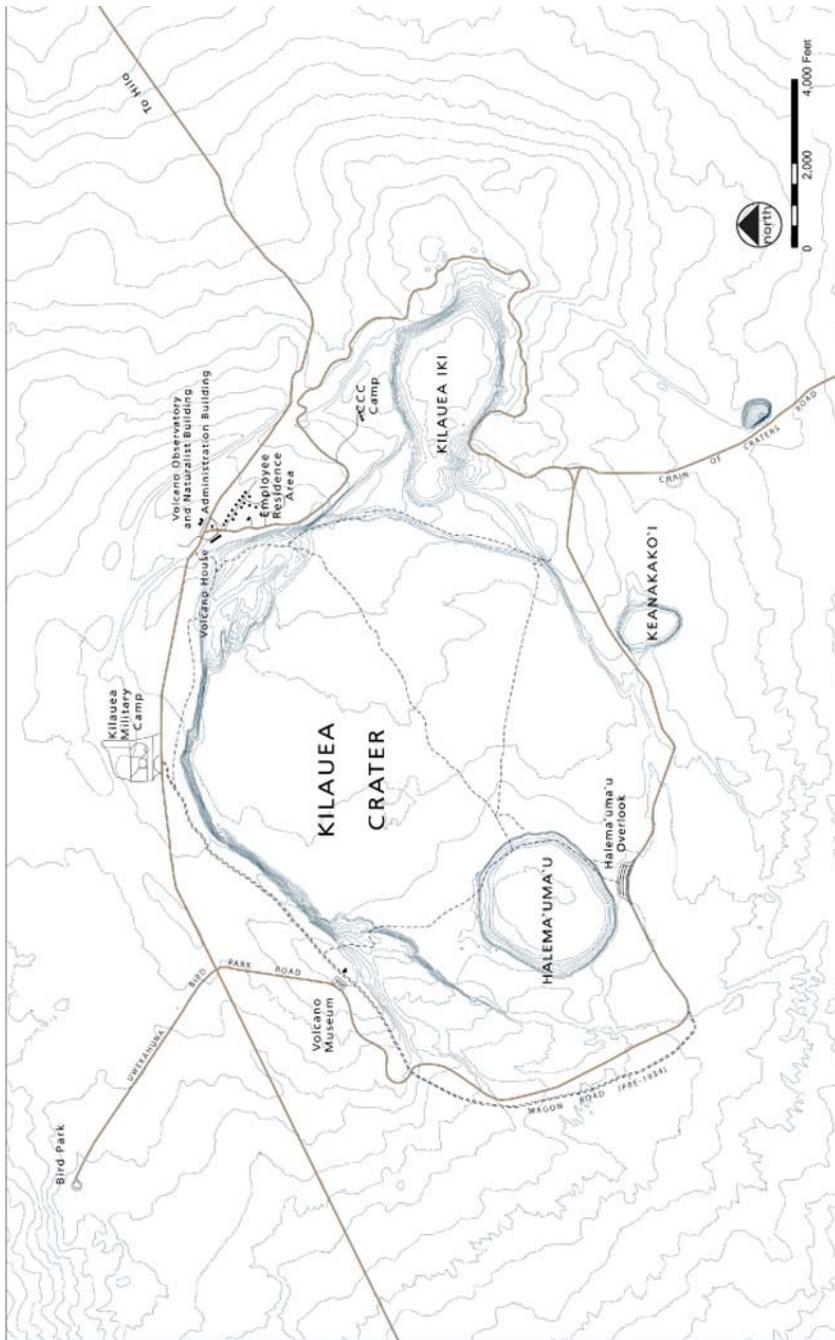
Site Map #3. Site map showing the Kilauea Caldera rim area at the end of the period of significance in 1941. (See Appendix for larger map.)

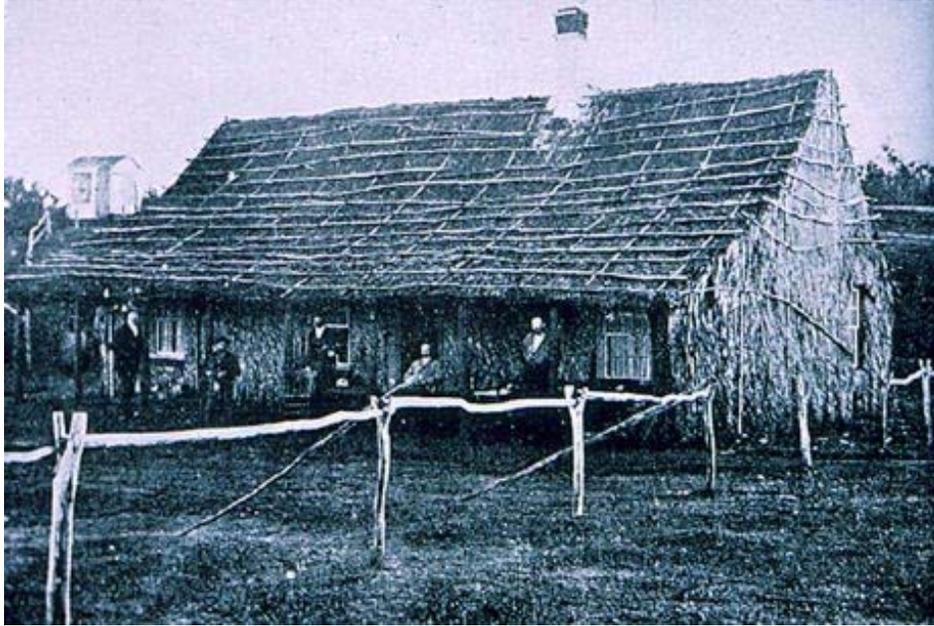
History #1. The grass thatch and ohia pole Volcano House built in 1866. It was here that Mark Twain stayed during his visit to Kilauea the same year. (Olson 1941)

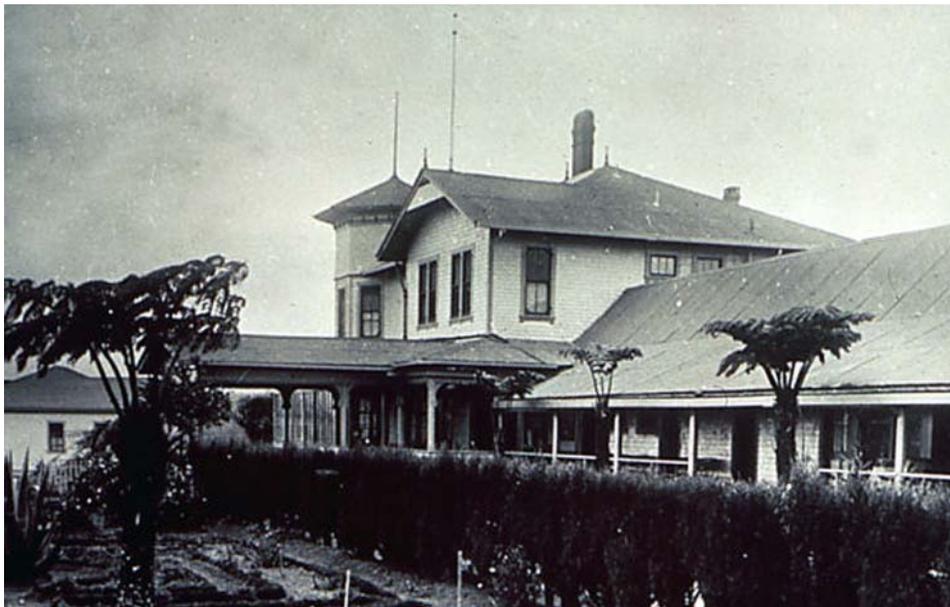
History #2. The Volcano House 1896-1921. The 1877 structure is visible on the right side of the photo; on the left is the two-story 1896 addition with the porte-cochere. (Olson 1941)

In 1877, the ohia pole and grass thatch Volcano House was replaced with a larger wooden hotel of Western architecture (see photo History #2). Mill work, such as doors and windows, hardware, and shingles, plus some other building materials and furniture, were landed at Keauhou Landing in Puna and transported via mule and horseback to Ainahou stables, part way between the ship landing and the hotel. At Ainahou, the materials were loaded onto two-wheel carts and hauled to the construction site. Rafters, studs, and posts were cut locally from ohia lehua trees. (Old Volcano House National Register Nomination)

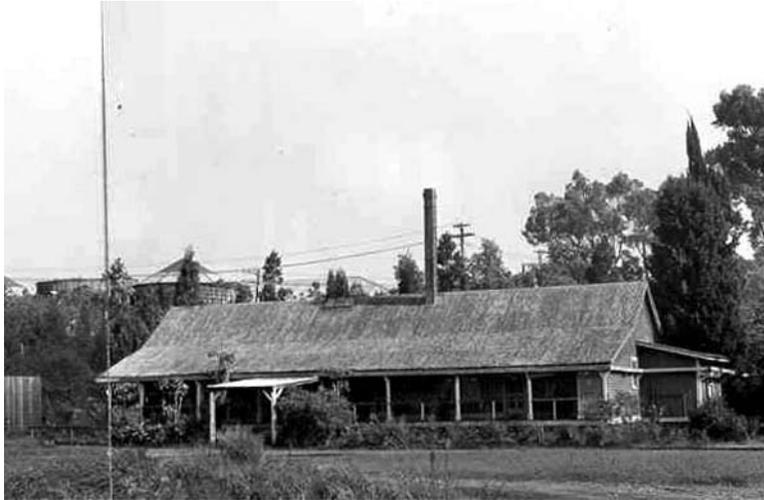
History #3. The 1877 Volcano House structure was moved approximately 90 feet from its original location when the 1921 additions were added. The 1877 Volcano House is seen here ca. 1945. (NPS Travelogue 1945)

The Volcano House continued to expand to accommodate the increase in visitor numbers. In 1921, the original 1877 structure was detached from its 1891 addition and moved further back from the caldera rim to its present location, a distance of about 90 feet (see photo History #3). Two large wings were added to the 1891 structure in place of the 1877 structure, significantly increasing the size of the Volcano House and giving it an up-to-date modern appearance. Part of the building materials for the 1921 wings to the 1891 structure came from the dismantled Crater Hotel, which had stood further east on the Hilo road.

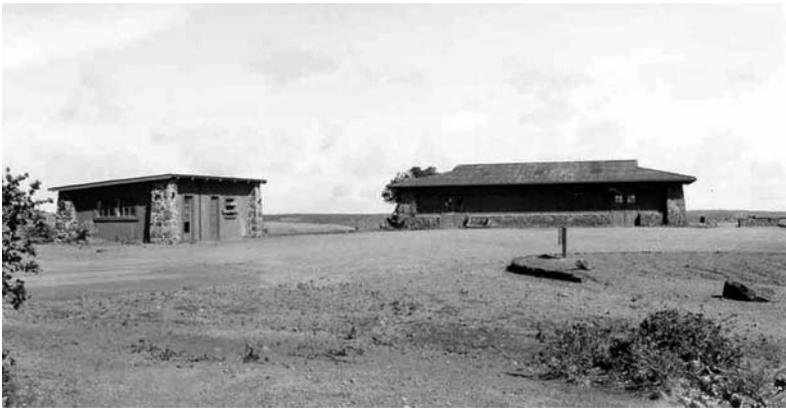
History #4. The museum (right) and comfort station (left) at Uwekahuna Bluff. These original buildings were built in 1927 by the Hawaii Volcano Research Association. (NPS Travelogue 1945)

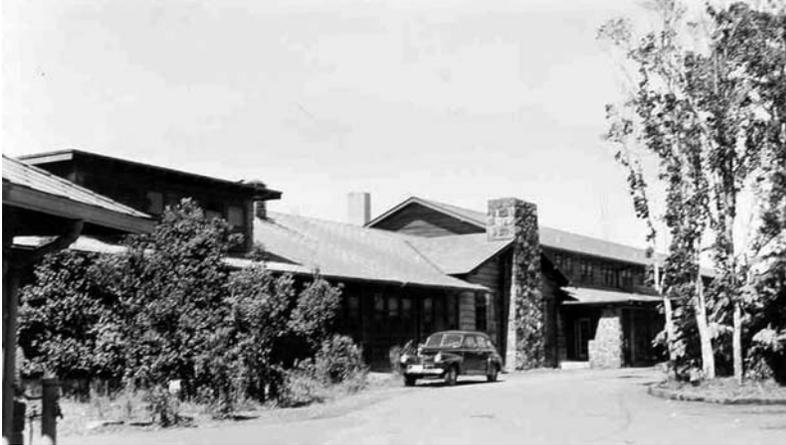
History #5. The current Volcano House, built in 1941, is shown shortly after completion, ca. 1945. (NPS Travelogue 1945)

In 1940, the issue was forced when a fire ignited in the hotel kitchen and the building burned to the ground. The hotel was a complete loss, with only a few of the cottages and the original 1877 hotel structure, which had been moved from its original site in the 1921 renovation, surviving. When the hotel company rebuilt, they chose a site on the other side of the highway near the rim of the caldera. The new site offered more room for expansion of the hotel and more spectacular views of the volcano. A number of structures, including the volcano observatory building and volcanologist's residence, were located here, but with the new observatory building being built nearby, the structures were no longer needed and could be replaced. The new Volcano House was built on this site in 1941, opening in November of that year.

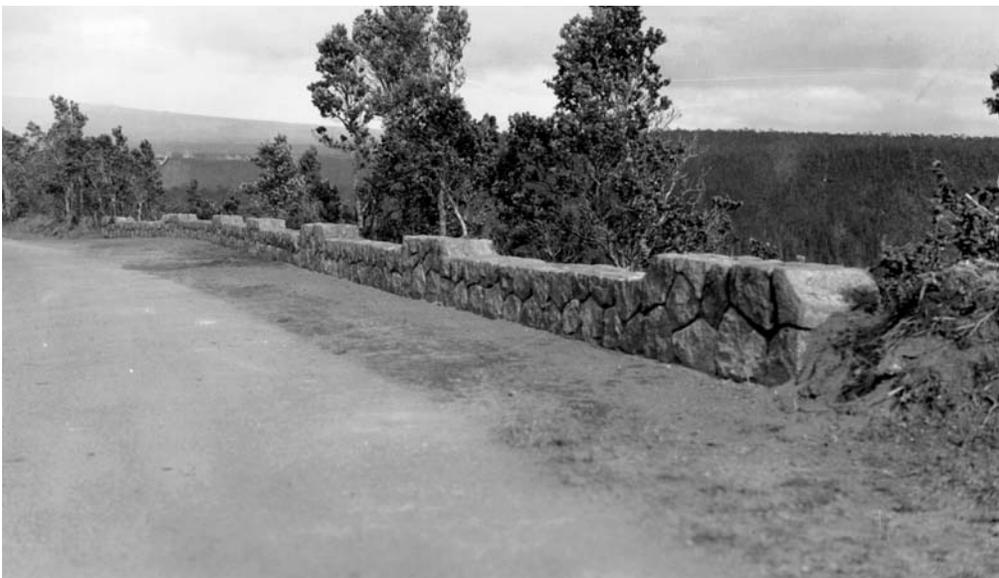
History #6. 1934 photo of the Kilauea Iki parapet guard wall. (HAVO Landscape Architect's Reports 1934)

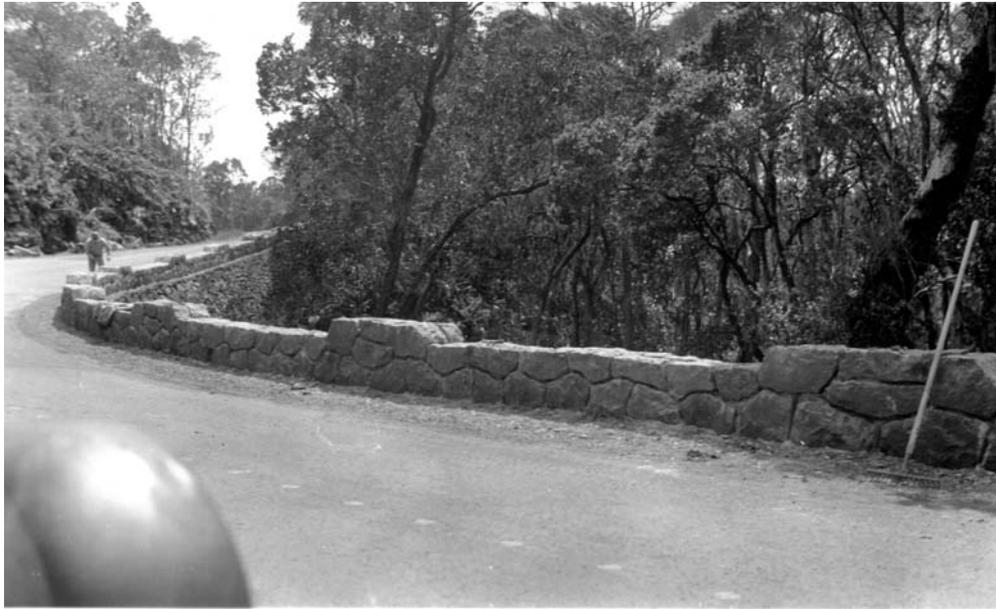
History #7. 1934 photo of the parapet guard wall at Thurston Lava Tube parking lot. The earlier stone retaining wall on which the guard wall was built is visible on the outside of the wall. (HAVO Landscape Architect's Reports 1934)

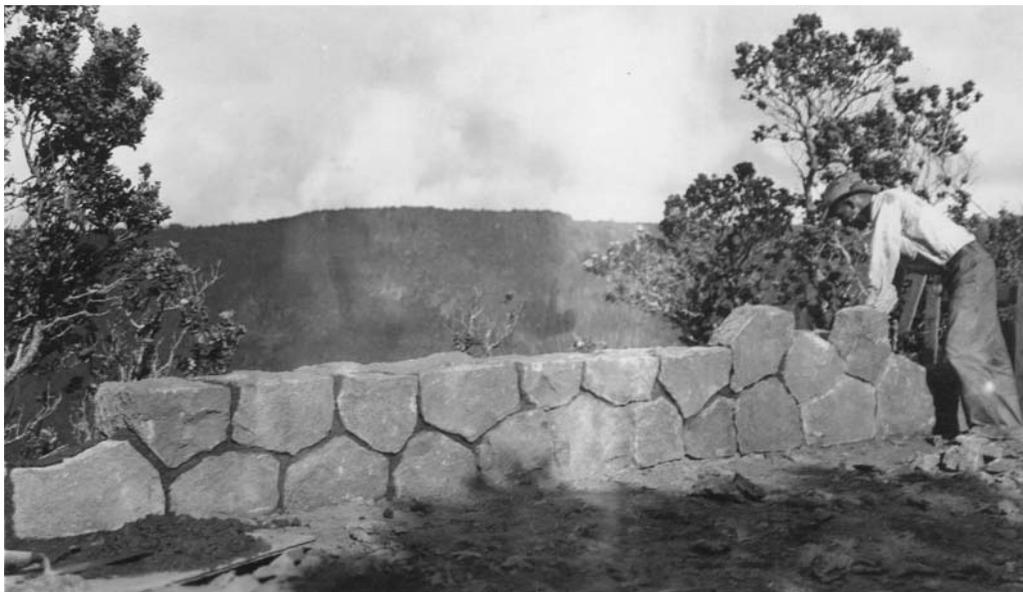
History #8. Parapet guard wall under construction in 1934. All of the guard walls constructed along Crater Rim Drive conformed to the specifications for the Type 2 guard wall developed by the NPS landscape department. (HAVO Landscape Architect's Reports 1934)

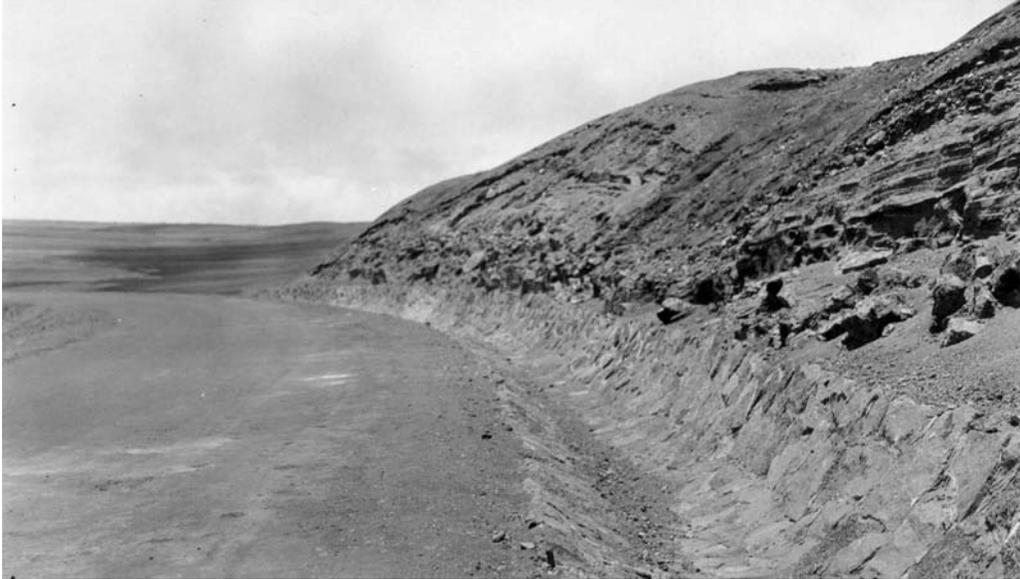
History #9. This stone-lined ditch was built by the CCC after heavy rains damaged the newly-built Uwekahuna-Bird Park road. This ditch is located on the grade just west of Halemaumau. (HAVO Landscape Architect's Reports 1934)

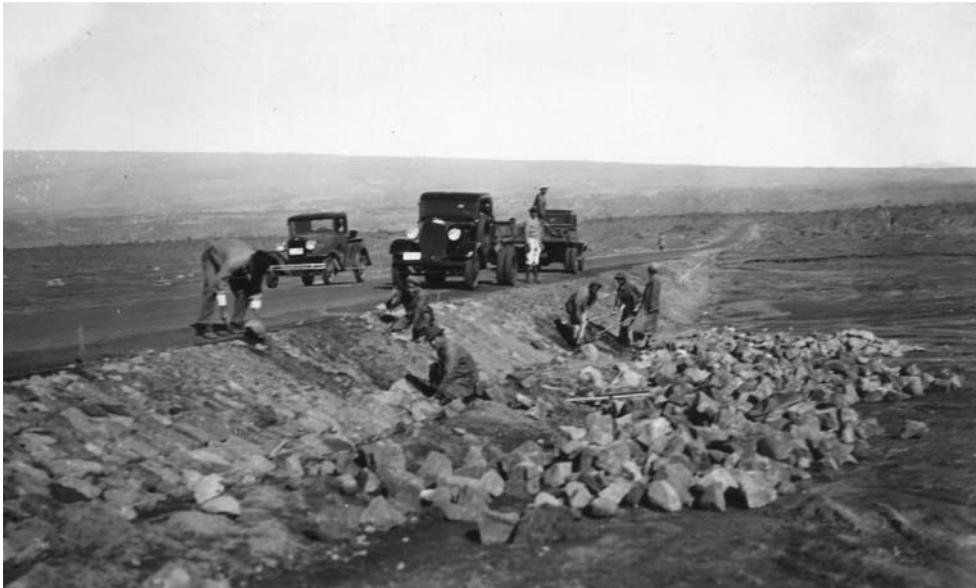
History #10. CCC crews installing mortared stone embankment facing on a section of Crater Rim Road in the Southwest Rift Zone in 1934. (HAVO Landscape Architect's Reports 1934)

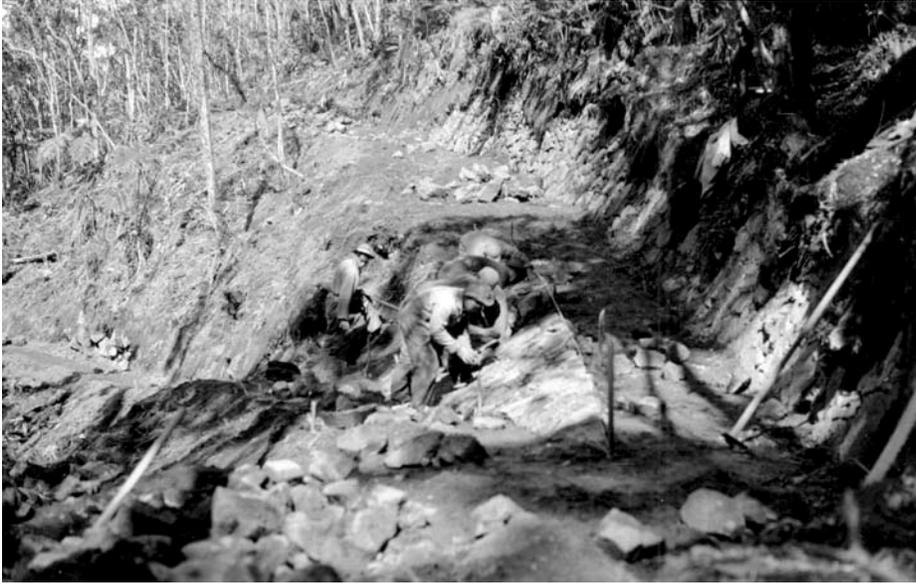
History #11. CCC crew laying stone embankment facing on a switchback of the Kilauea Iki trail in 1934. (HAVO Landscape Architect's Reports 1934)

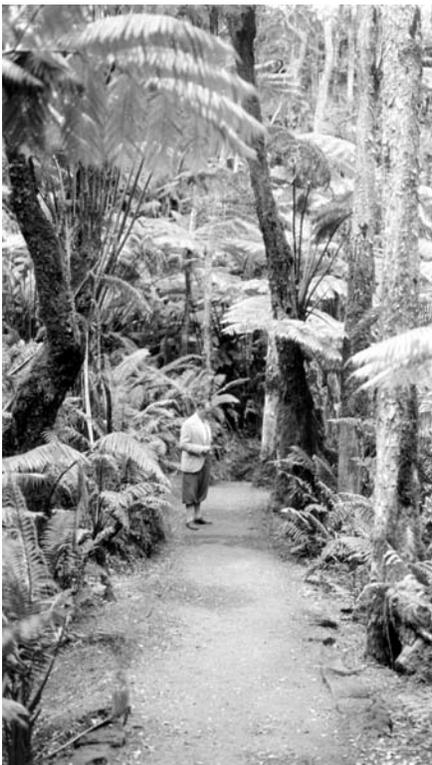
History #12. The Thurston Lava Tube trail as it appeared in the 1930s. The lush fern forest contrasted sharply with other parts of the caldera rim area. (HAVO Landscape Architect's Reports 1934)

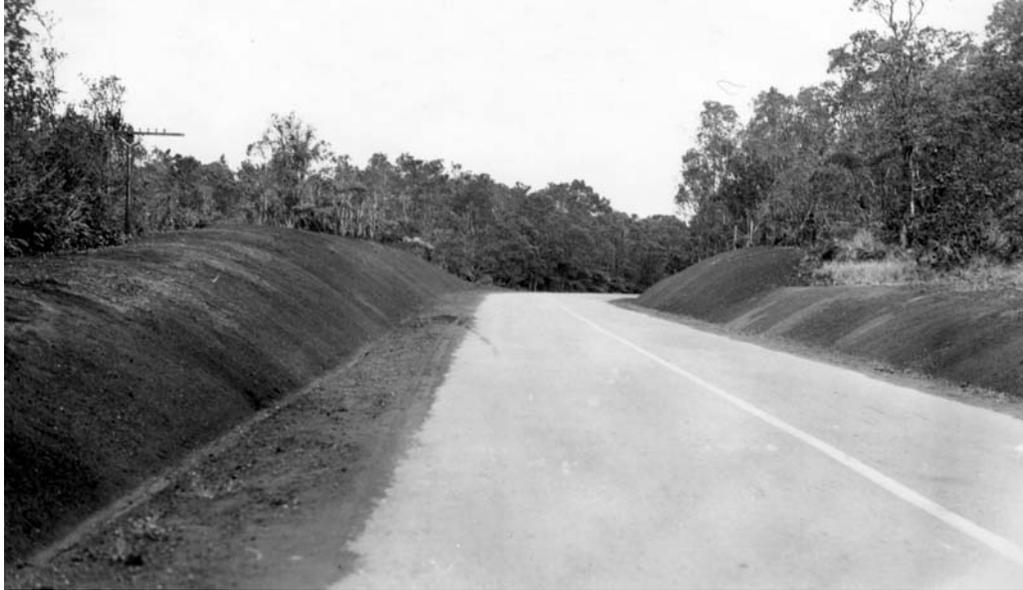
History #13. CCC crews rounded the slopes of road cuts and planted them with native vegetation to create a more naturalistic appearance and reduce erosion. The slopes are shown here in c. 1934, after they were rounded but before replanting. (HAVO Landscape Architect's Reports 1934)

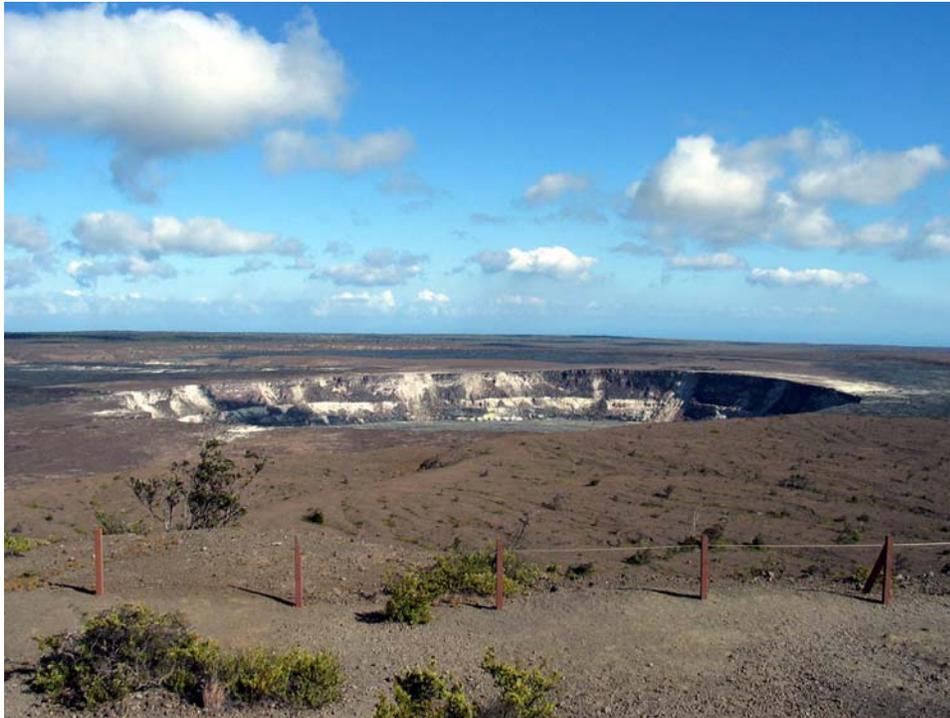
Natural Systems and Features #1. Prior to the 1930s, Halemaumau Crater, located on the floor of the Kilauea Caldera, was very active, spewing lava in fountains high above a lava lake that covered the crater floor. Halemaumau more than tripled in diameter in 1924 after a series of explosions sent rocks and debris thousands of feet in the air. Today the crater is much less active, quietly smoking on the caldera floor. (PWRO 2005)

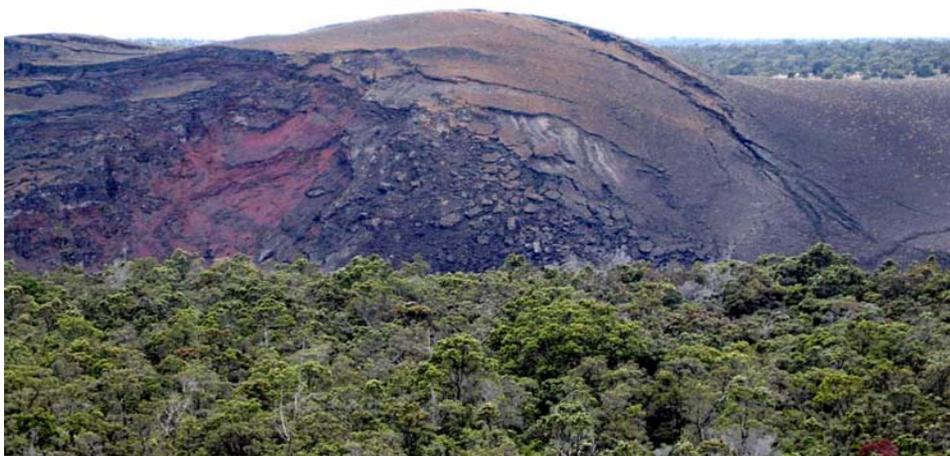
Natural Systems and Features #2. Puu Puai, the large spatter cone formed during the 1959 Kilauea Iki eruption. The spatter cone is nearly 200 feet above the rim of Kilauea Iki. (PWRO 2005)

The trade winds also blow gasses and ejected material to the southwest during eruptions. When Kilauea Iki erupted in 1959, for instance, the ash and cinder blew to the southwest, forming the large spatter cone and burying the road. Visitors could safely view the eruption from the Kilauea Iki overlook on the northeast edge of the caldera. In general, this pattern has led to contrasting surficial geology around the caldera. Surface soils along the eastern side are much older and can support more vegetation. To the west, the volcanic soils are younger and more coarse with little organic matter. The vegetation communities sustained on these thin soils are stunted and spare, resembling desert communities.

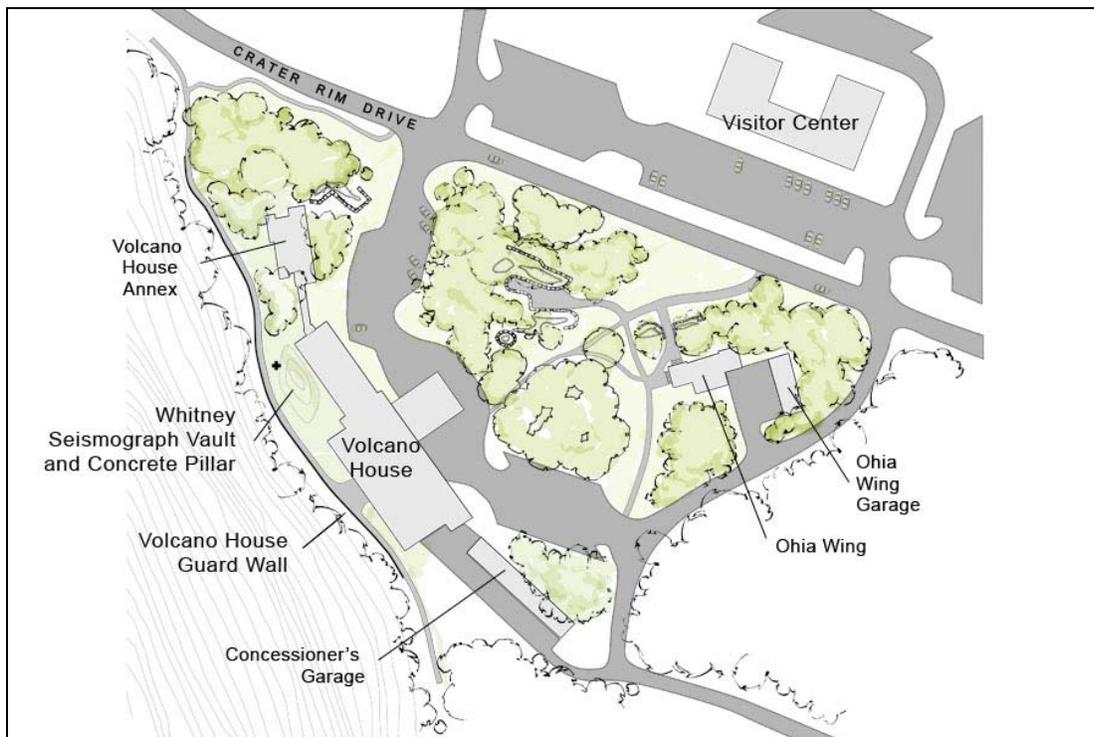
Spatial Organization #1. Diagram showing the Volcano House and Whitney Seismograph Vault on the rim of Kilauea Caldera. (PWRO 2006)

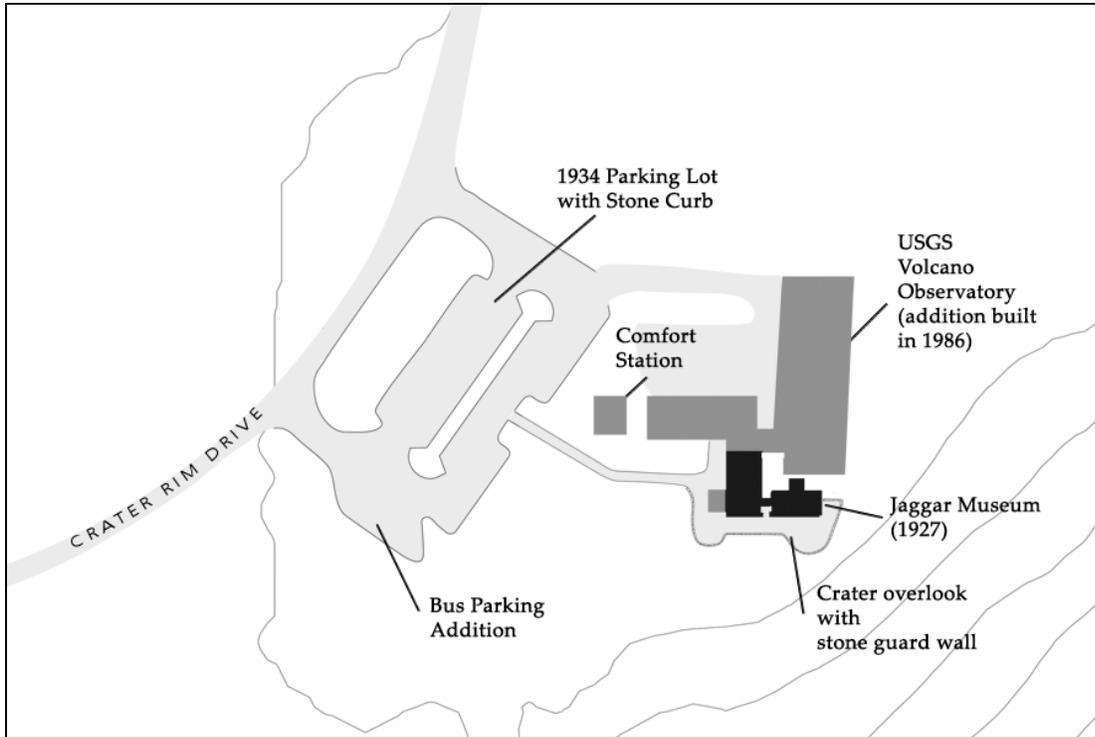
Spatial Organization #2. Diagram showing the Jaggar Museum and Volcano Observatory on Uwekahuna Bluff. (PWRO 2006)
