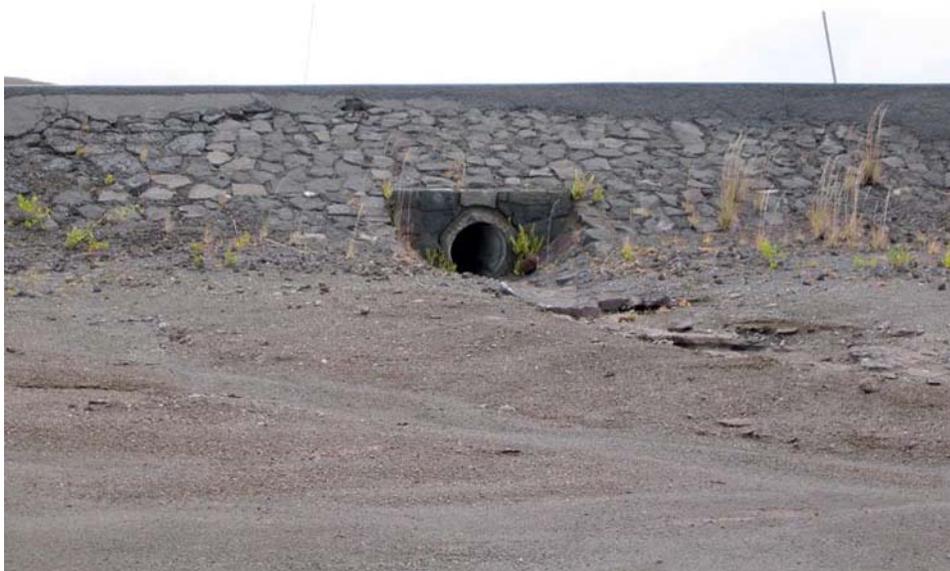
Circulation #1. Contemporary photo of the mortared-stone embankment facing and raised roadbed with culvert, located in the Southwest Rift Zone. Asphalt covers the top of the embankment from successive road paving. (PWRO 2005)

Along the Southwest Rift area of Crater Rim Drive west of Halemaumau, two sections of mortared stone embankments retain the road fill. These embankments are between 3 and 8 feet in height and sloped. The stone embankments were constructed in 1934 by the CCC to stabilize the new road and prevent erosion damage. One of the embankments is on the caldera side of the road, and the other is on the non-caldera side. The embankment on the non-caldera side – the larger of the two – has a culvert built into it to carry water from one side of the road to the other. The culvert is concrete with mortared stone headwalls on both the inlet and outlet.

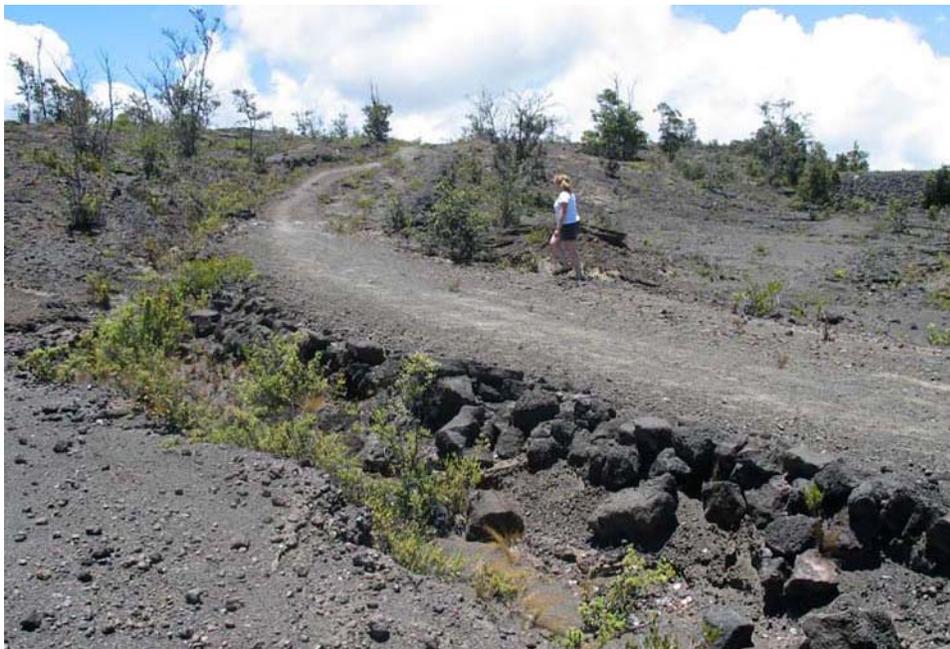
Circulation #2. Road traces and remnant retaining walls, most likely from Leavitt's Road from Uwekahuna to Halemaumau built in 1931, are today part of the Crater Rim Trail in the northwest corner of the caldera. (PWRO 2005)

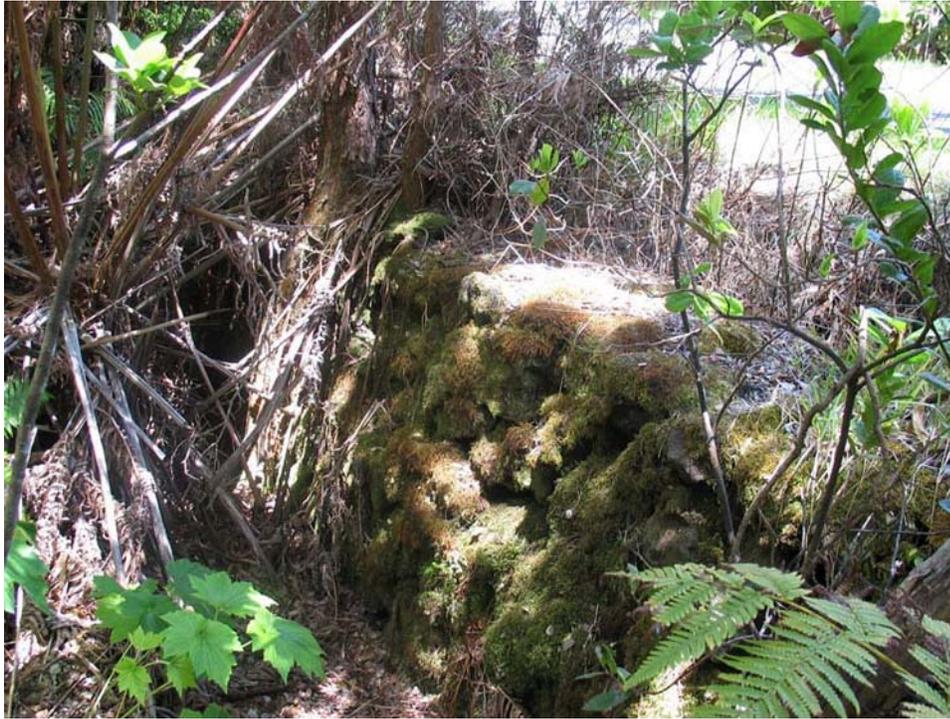
Circulation #3. Several remnants of retaining walls mark former road alignments of Crater Rim Drive. The wall remnants, which date to before the 1920s, are mostly hidden in the dense vegetation near the current road south of Thurston Lava Tube. (PWRO 2005)

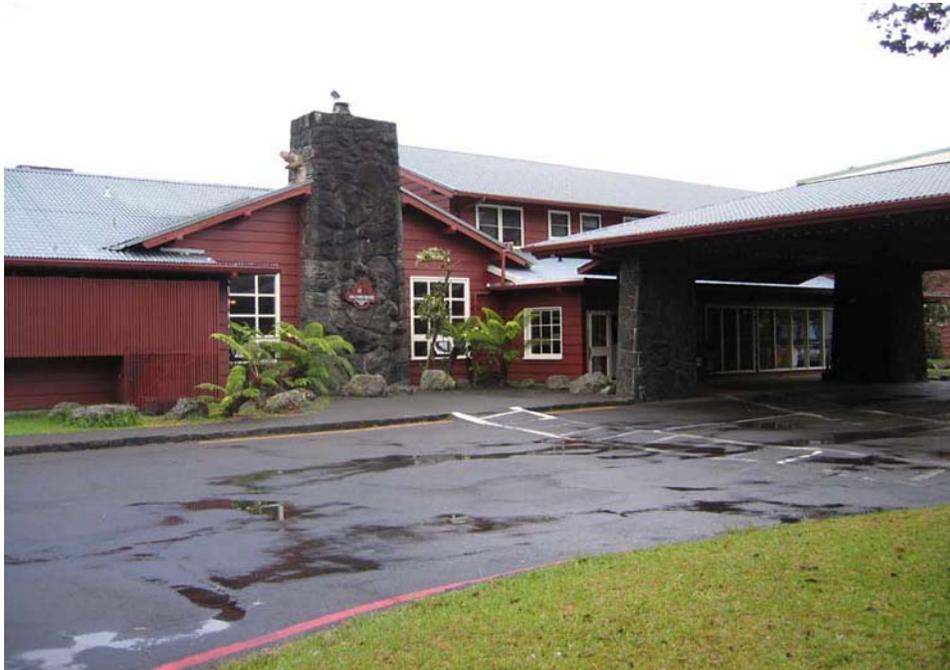
Buildings and Structures #1. Contemporary photo of the Volcano House, built in 1941. (PWRO 2005)

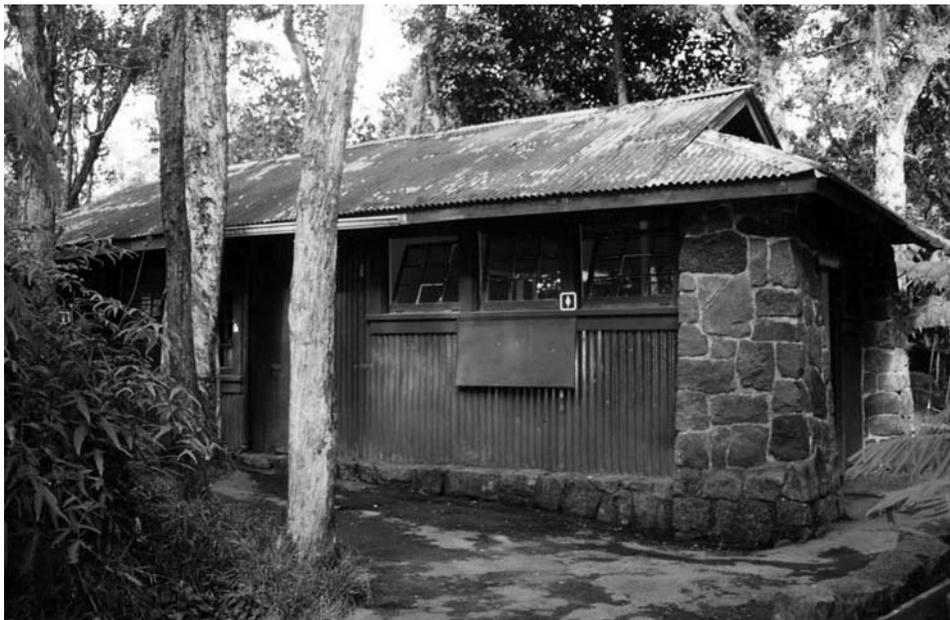
Buildings and Structures #2. Contemporary photo of the Thurston Lava Tube comfort station, built in 1933. (Carey and Co. 2002)

This one-story restroom structure is rectangular in plan with corrugated metal cladding, a concrete foundation, and a corrugated metal-clad, gable-on-hip roof. Each corner features a large, battered lava stone pier. The structure is divided into two equal restroom sections with a small water storage/janitor's closet between. Each restroom section has a row of three nine-lite hopper windows on each side.

Constructed in 1933-1934, the comfort station was part of a Public Works Administration-funded project to improve the lava tube developed area shortly after it was acquired by the NPS. The detailed plans, received from the Branch of Plans and Design in late 1933, were of a design that blended standard Park Service Rustic design elements of the 1920s and 1930s with local Hawaiian design features. The project was begun in late 1933 and completed the following August.

The Thurston Lava Tube comfort station has changed little since it was constructed. Its design is characteristic of the style favored in Hawaii National Park in its early decades, revealing elements of both Park Service Rustic style and Hawaiian vernacular design. The comfort station retains its design elements, spatial layout, and relationship to other resources, and contributes to the district's integrity. (See photo Buildings and Structures #2.)

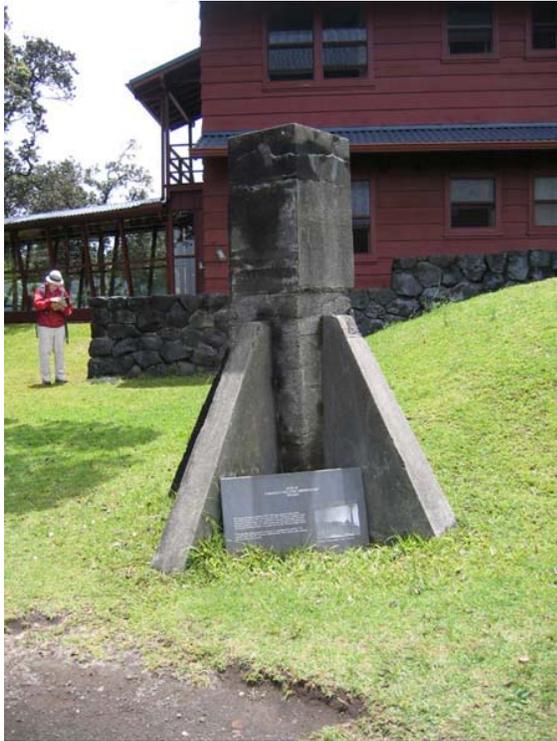
Buildings and Structures #3. Contemporary photo of the concrete pillar at the Whitney Seismograph Vault. The vault is beneath the mound in the background. (PWRO 2005)

The seismograph vault underwent substantial alterations in 1941, when the current Volcano House structure was built. The wooden walls and ceiling were replaced with concrete and the whole structure buried beneath an earth mound. The volcano observatory building was razed, but the concrete pier was retained. Today this pier functions as a visual marker for the vault, with a small interpretive sign explaining its function and significance.

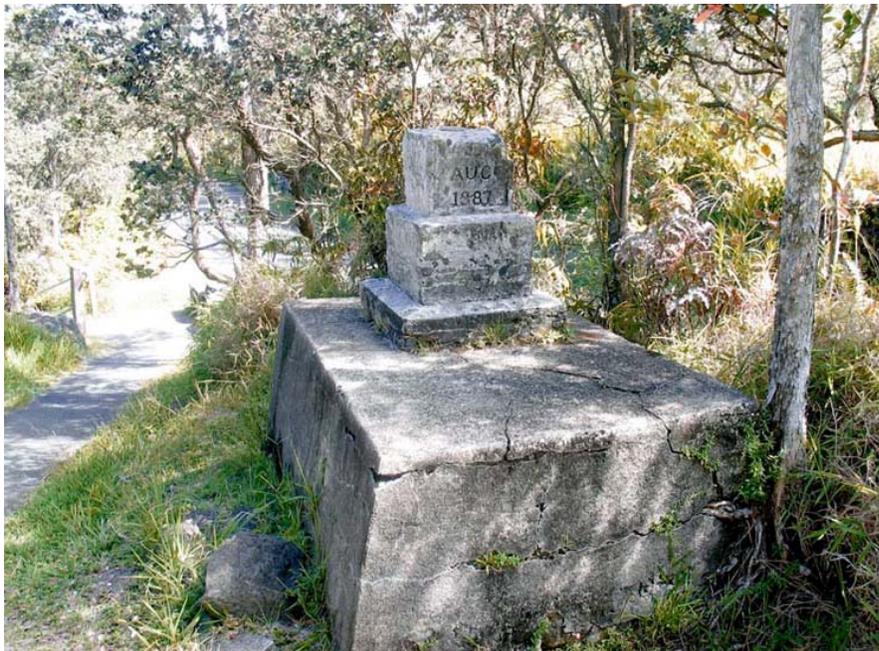
Buildings and Structures #4. The concrete marker, inscribed “AUG 1887”, may be a monument marking the completion of Peter Lee’s road from Pahala to the Volcano House. (PWRO 2005)

Today the monument is cracked and worn from exposure to the elements. Vegetation, including a substantial ohia lehua tree, is growing in the cracks and exacerbating the damage. Graffiti from visitors has been scratched into the monument as well. Despite this damage, the monument is an important link to the earliest development of Kilauea summit and one of the first completed segments of Crater Rim Drive. (See photo Buildings and Structures #4.)

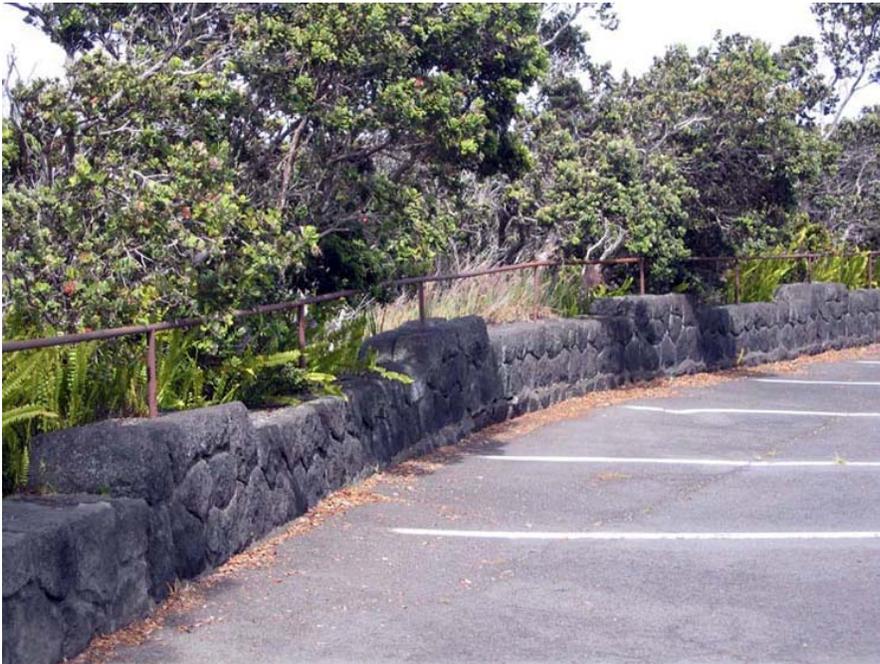
Buildings and Structures #5. The stone guard wall at Puu Puai parking lot was once along the Crater Rim Drive alignment. The metal guard rail was installed after the period of significance. (PWRO 2005)

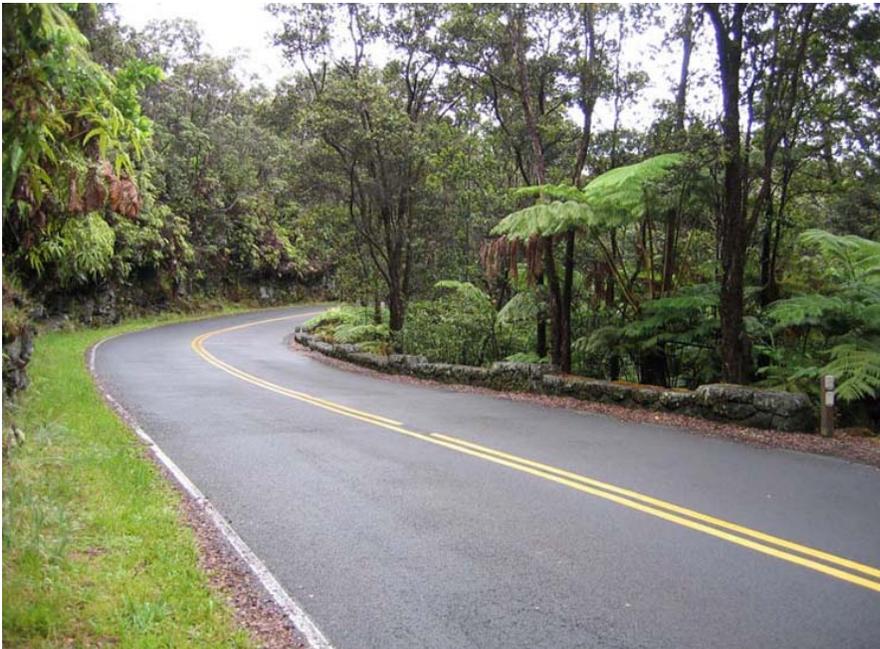
Buildings and Structures #6. The guard wall at the Thurston Lava Tube parking lot is lower than when it was constructed, either from settling, a build-up of paving matrix, or a combination of both. Compare with photo History #7. (PWRO 2005)

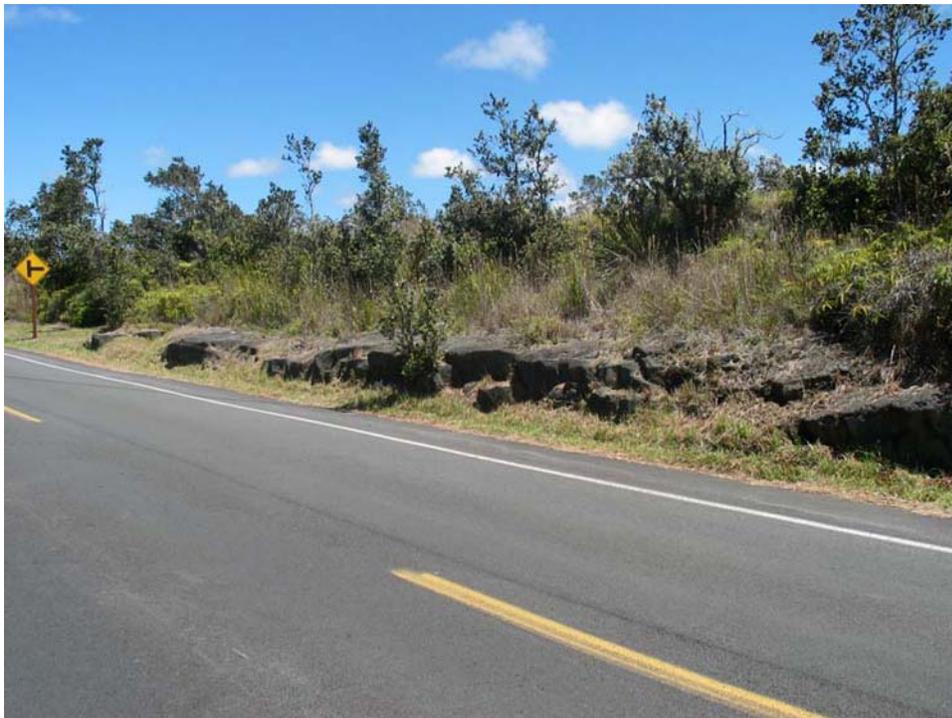
Topography #1. Rock cuts in the dark volcanic rock west of the headquarters site look like natural rock outcroppings. (PWRO 2005)

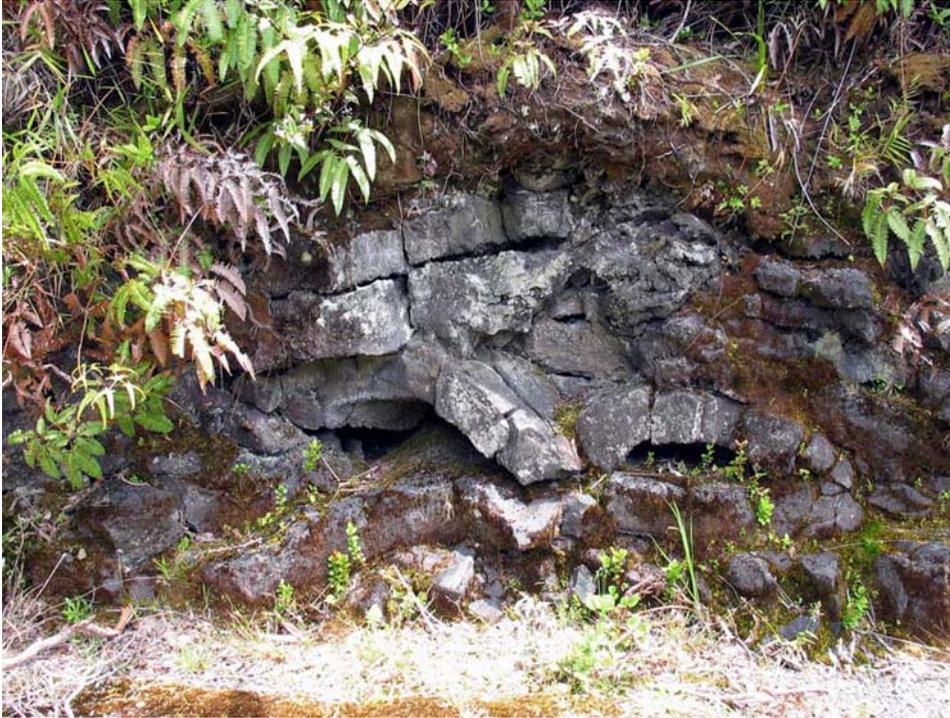
Topography #2. Rock cuts near Kilauea Iki reveal unique volcanic formations. (PWRO 2005)

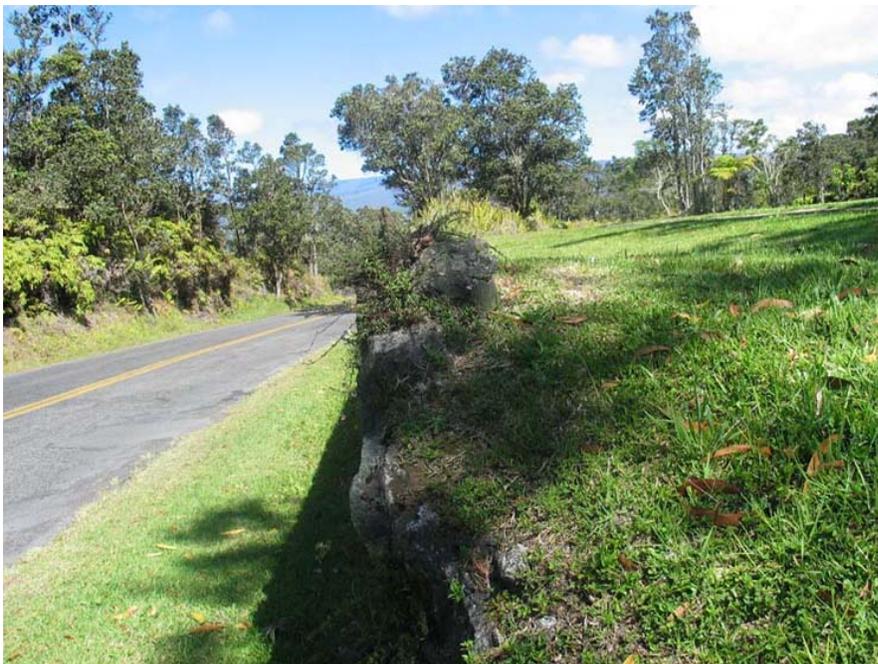
Topography #3. The terrace that held the Volcano House before 1940 is retained by a combination of stone retaining wall and natural rock cut. (PWRO 2005)

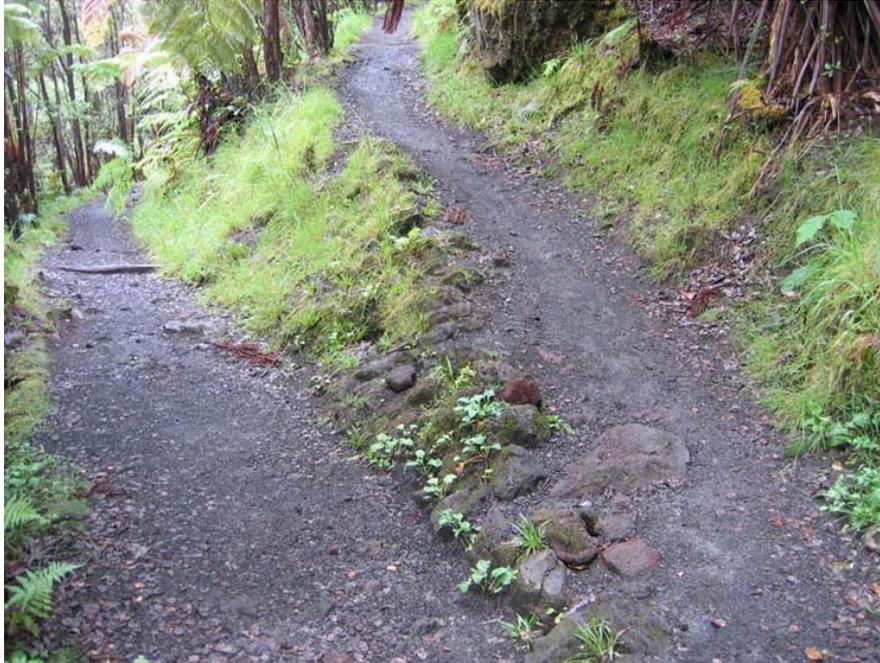
Topography #4. Contemporary photo showing grading on the Kilauea Iki Trail, built by the CCC in 1934. Stone riprap and dry-stacked retaining walls were used to support the steep slopes and switchback corners. (PWRO 2005)

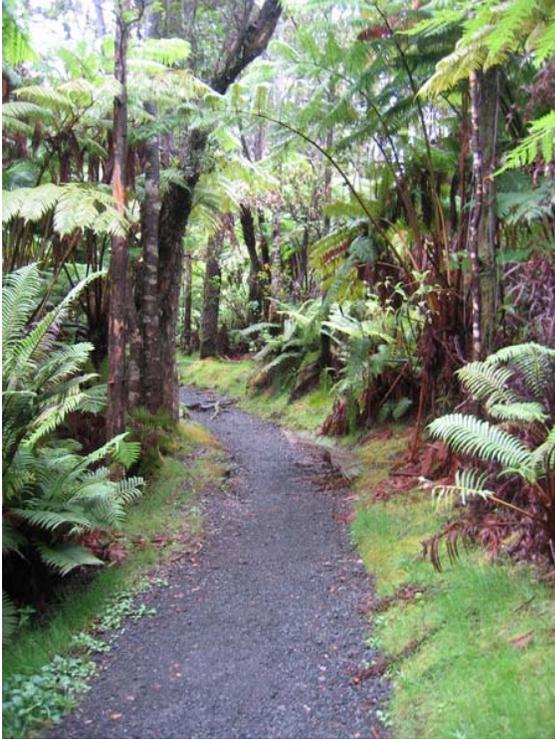
Vegetation #1. Photo of the Kilauea Iki Trail demonstrates how natural vegetation communities, in this case ohia lehua and hapuu forest, are used in developed areas to create a distinctive character. (PWRO 2005)

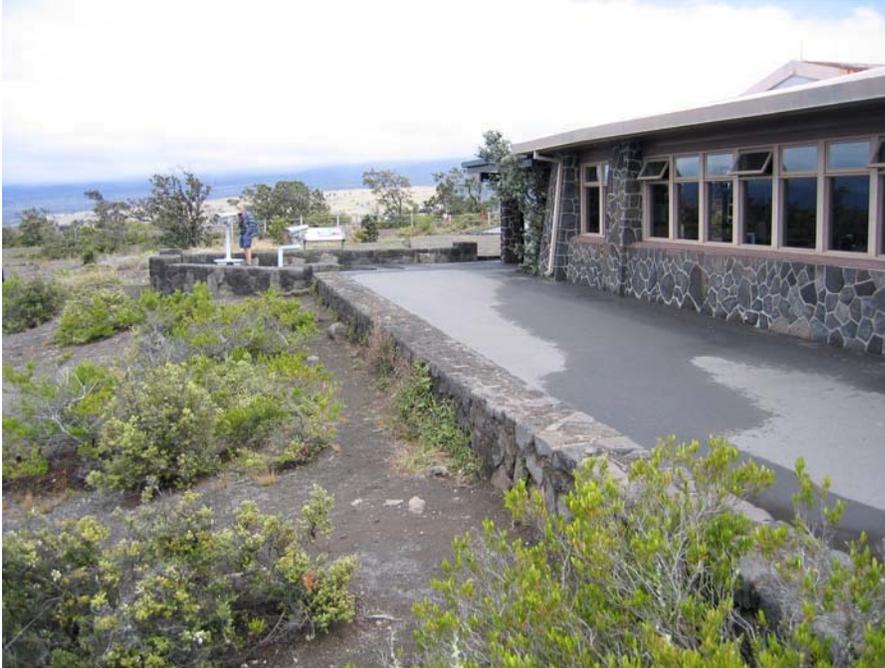
Vegetation #2. The open ohia lehua and dry shrub vegetation at Uwekahuna Bluff establish the character at the Jaggar Museum. (PWRO 2005)

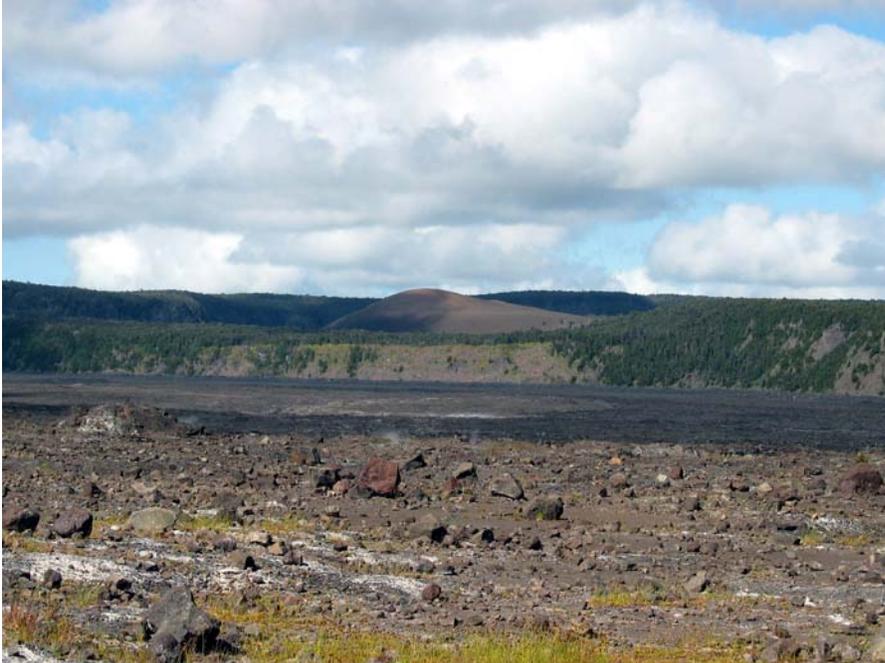
Vegetation #3. The barren rock-strewn caldera floor near Halemaumau is notable for its lack of significant vegetation. (PWRO 2005)

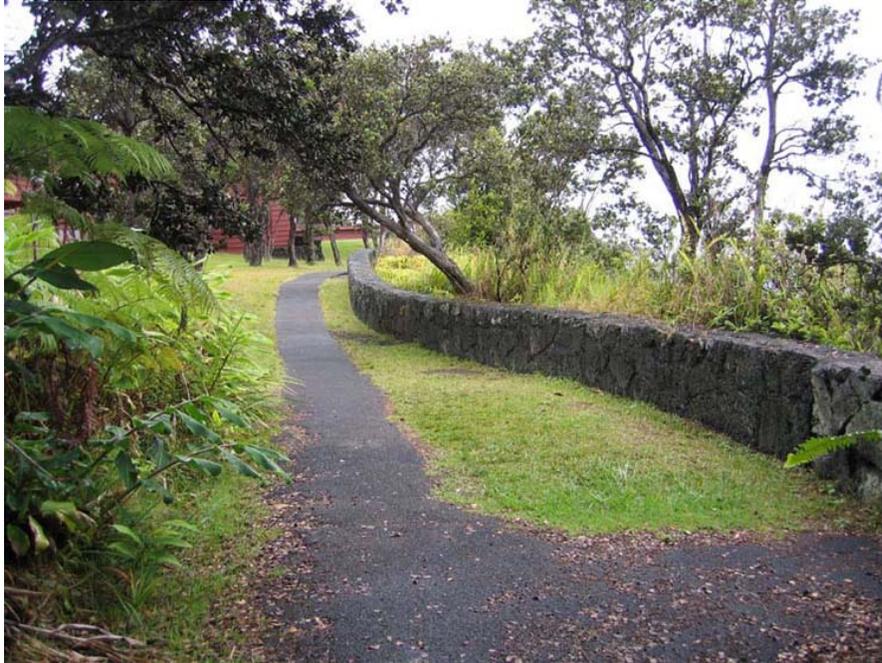
Vegetation #4. A combination of naturally occurring and planted vegetation composes the landscape around the Volcano House. (PWRO 2005)

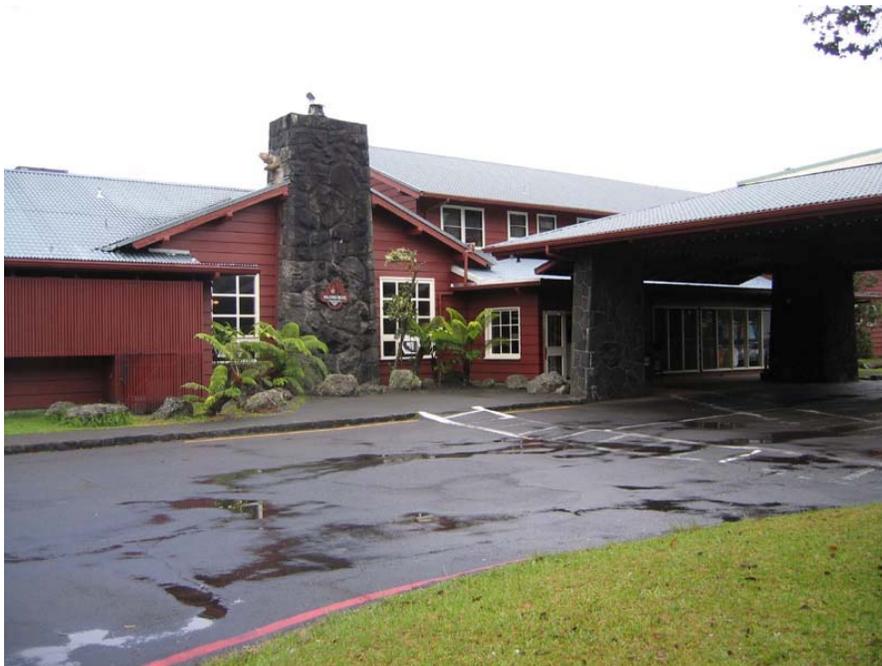
Vegetation #5. A small number of native foundation plants adorn the front of the Volcano House. (PWRO 2005)

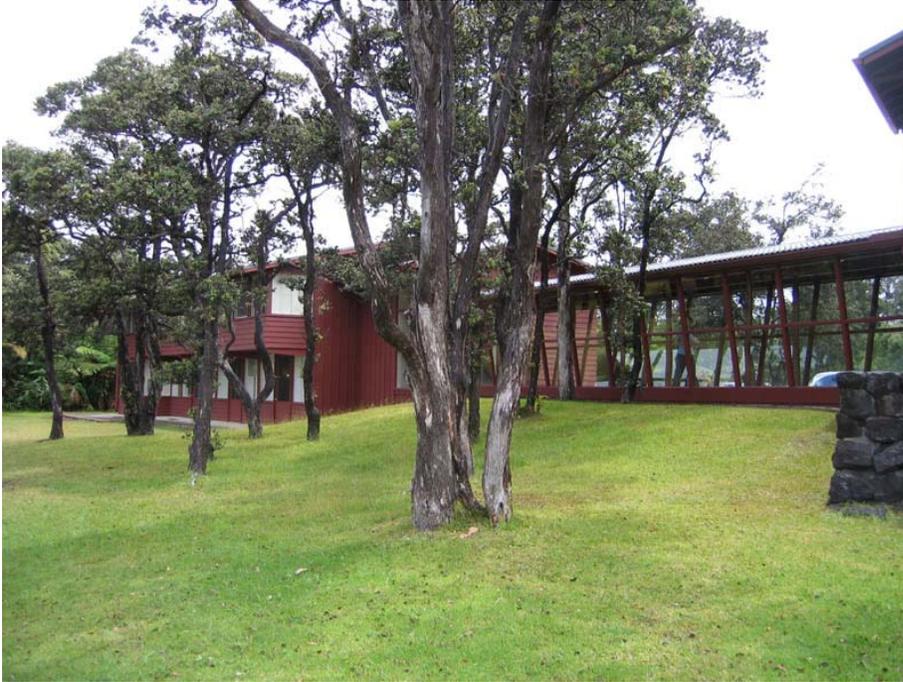
Vegetation #6. Behind the Volcano House, ohia lehua trees are planted over Bermuda grass lawn, creating an open character. (PWRO 2005)

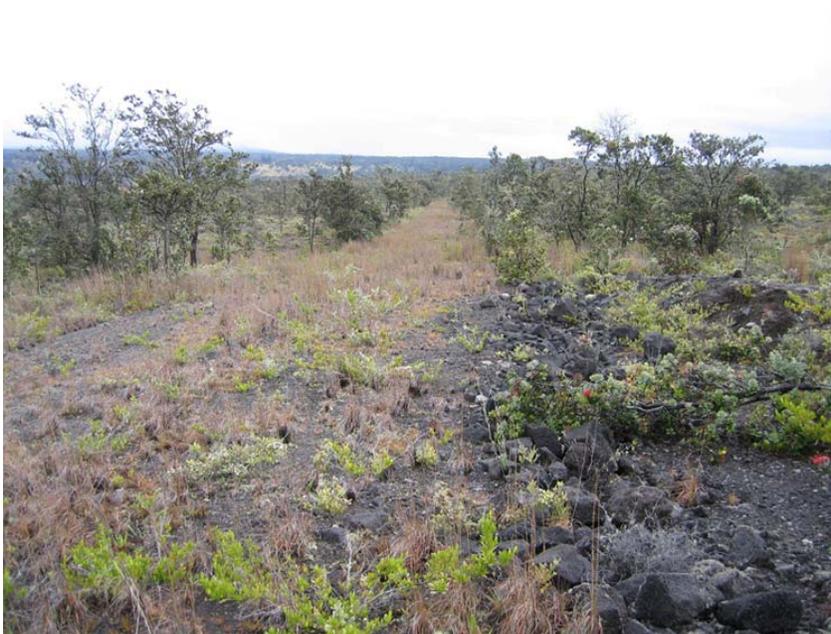
Archeological Sites #1. Although not visible from Crater Rim Drive, the Uwekahuna-Bird Park Road trace is evident from the topography and vegetation patterns. (PWRO 2005)

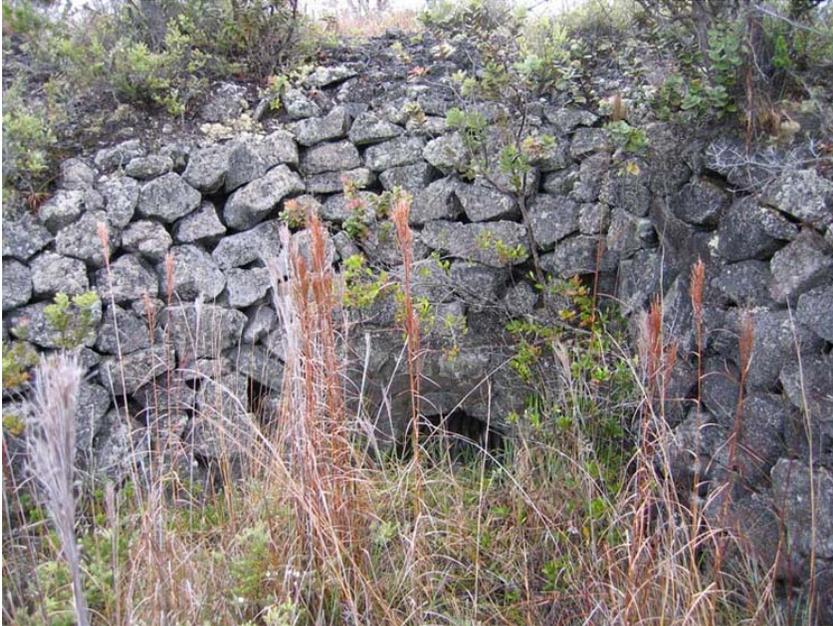
Archeological Sites #2. Several culverts, including this one with a dry-stacked retaining wall above it, remain on the abandoned Uwekahuna-Bird Park Road trace. (PWRO 2005)

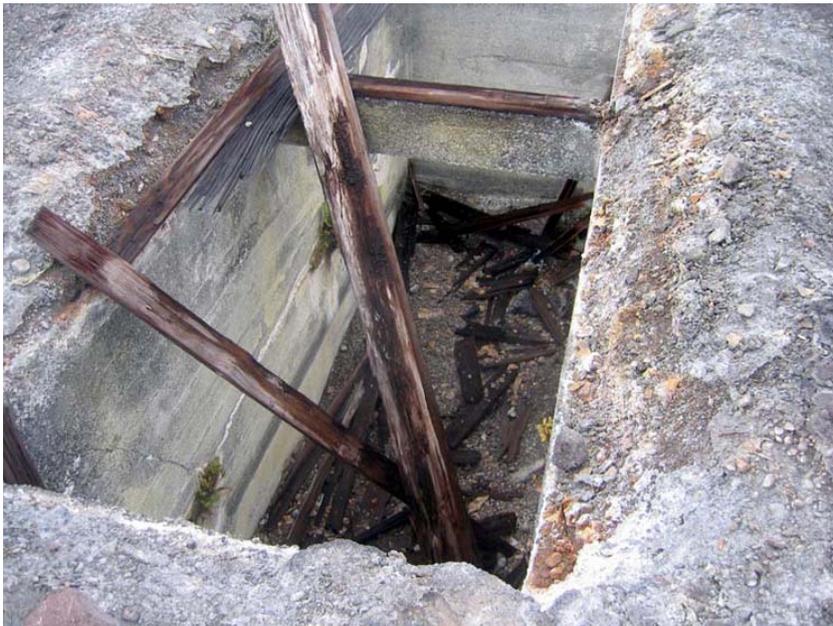
Two concrete vault located near the Halemaumau parking lot are likely the remnants of restrooms that were located there in the 1930s. The vaults are approximately 4 feet by 10 feet and 6 feet deep. Remnants of timber framing are in and near the vaults.

Archeological Sites #3. One of two concrete vaults cut into the lava near the Halemaumau parking lot. These vaults were likely the two comfort stations built sometime in the 1920s or 1930s. (PWRO 2005)

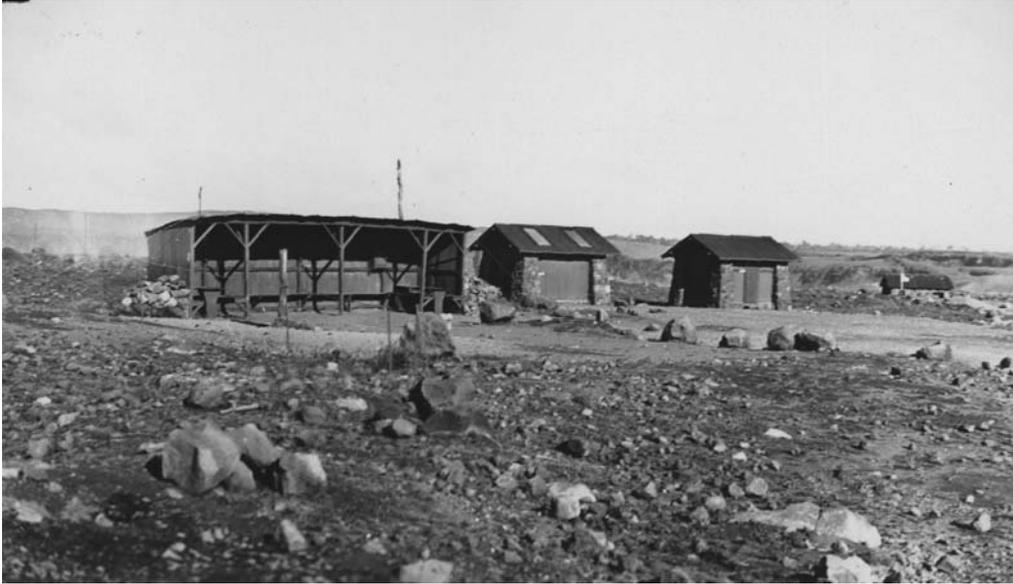
Archeological Sites #4. The shelter and two comfort stations at Halemaumau, c. 1934 (no longer extant).
(HAVO Landscape Architects Reports)

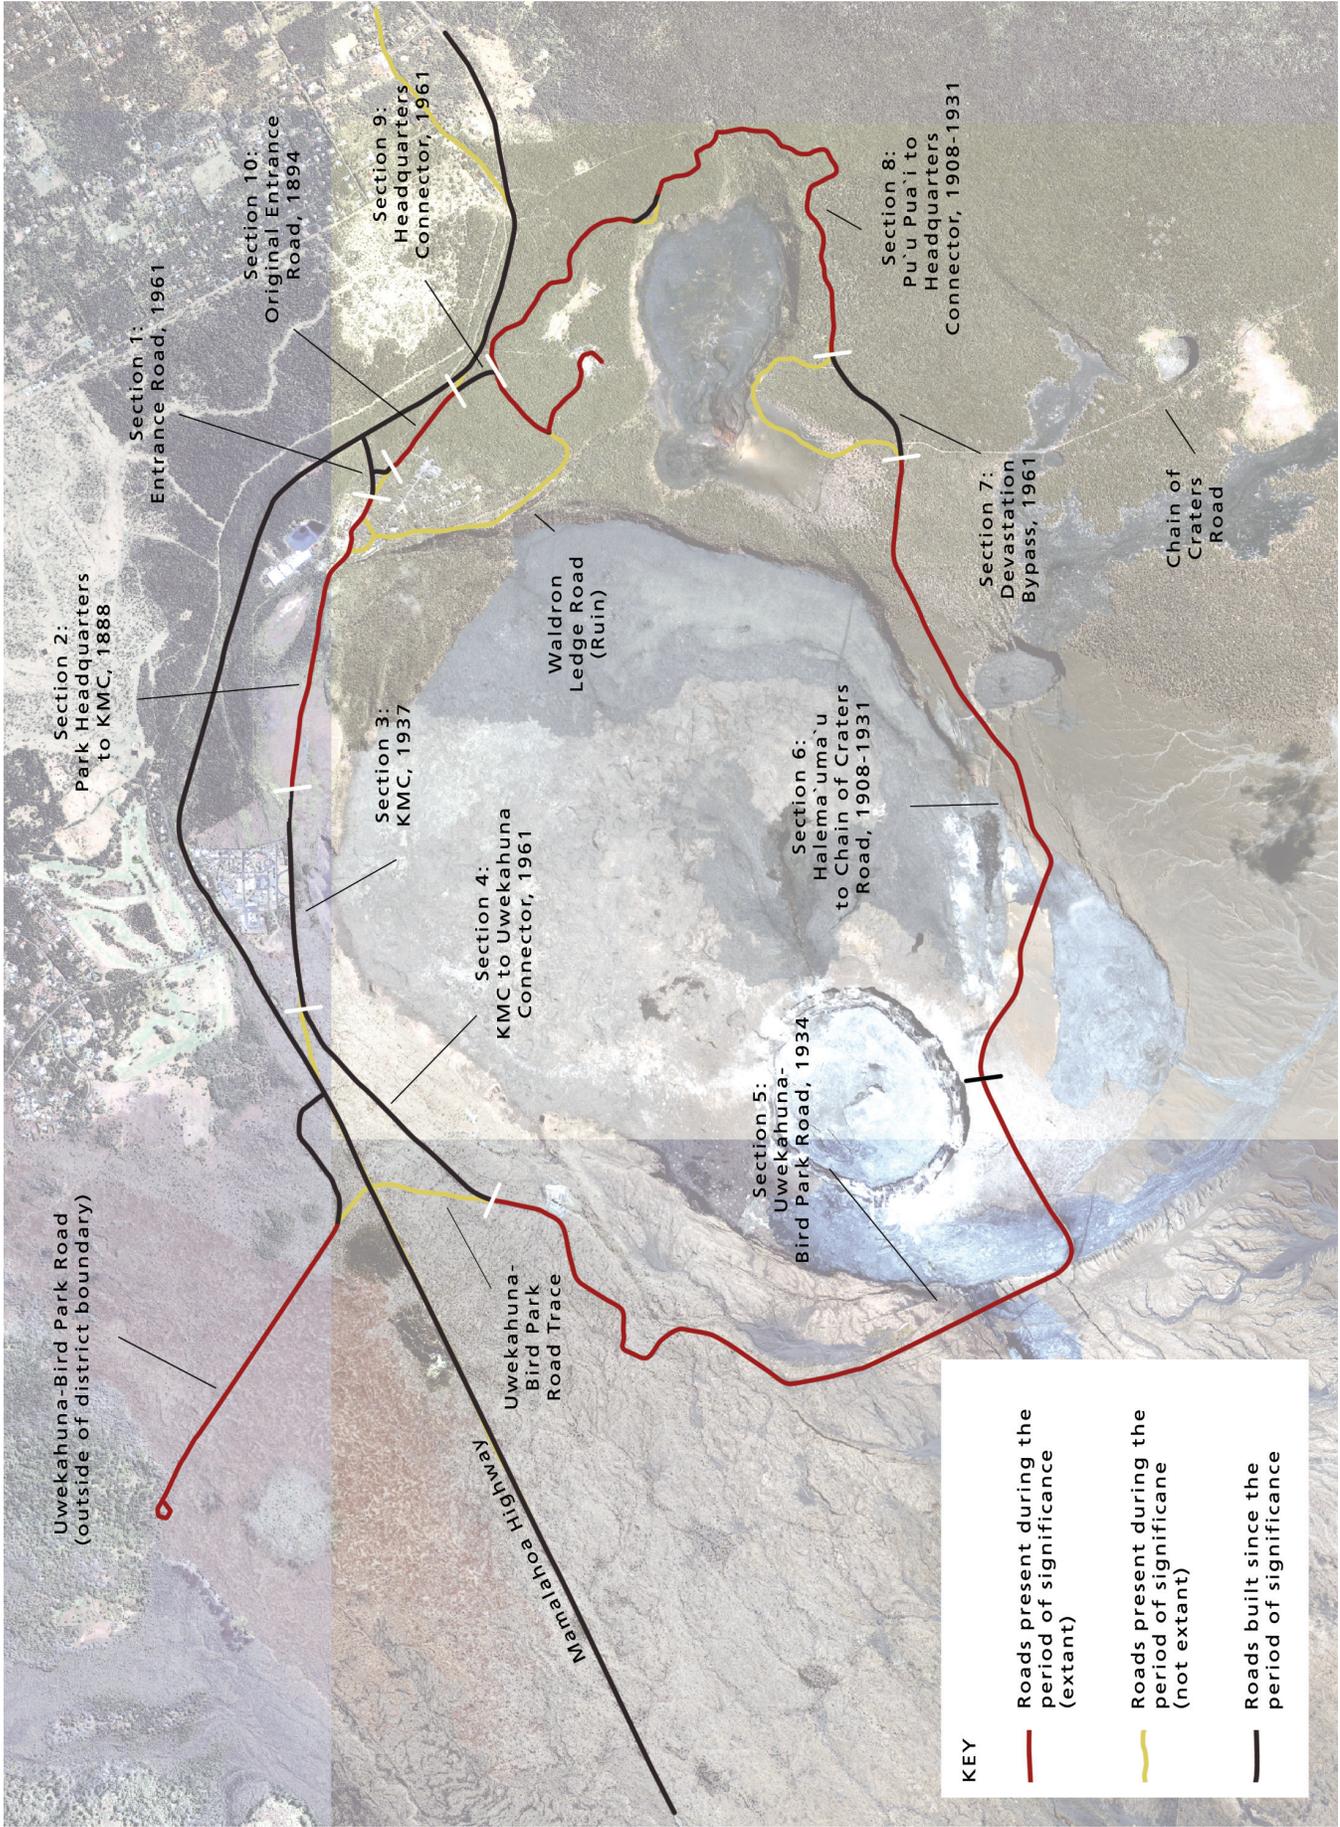
Contributing Features Map #1. Diagram showing the sections of Crater Rim Drive that still reflect the alignment of the historic period.
