Hawaii Volcanoes National Park
Kilauea Employee Housing and Administration Historic District

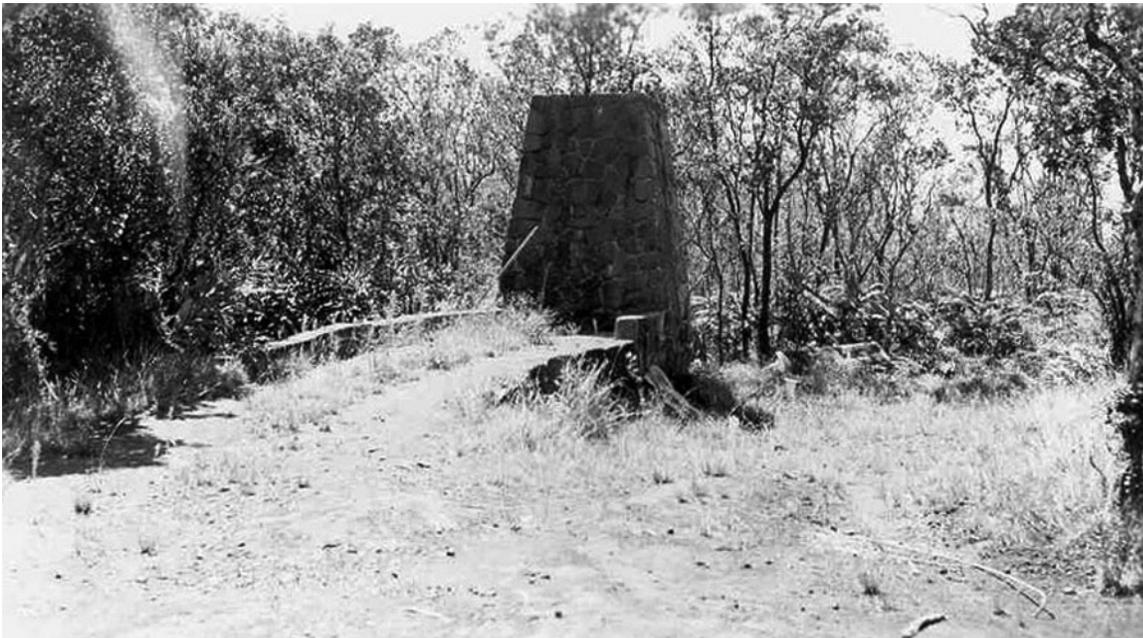
Figure 9. Abandoned incinerator located between CCC camp and NPS employee housing area. (PWR Staff—2005).

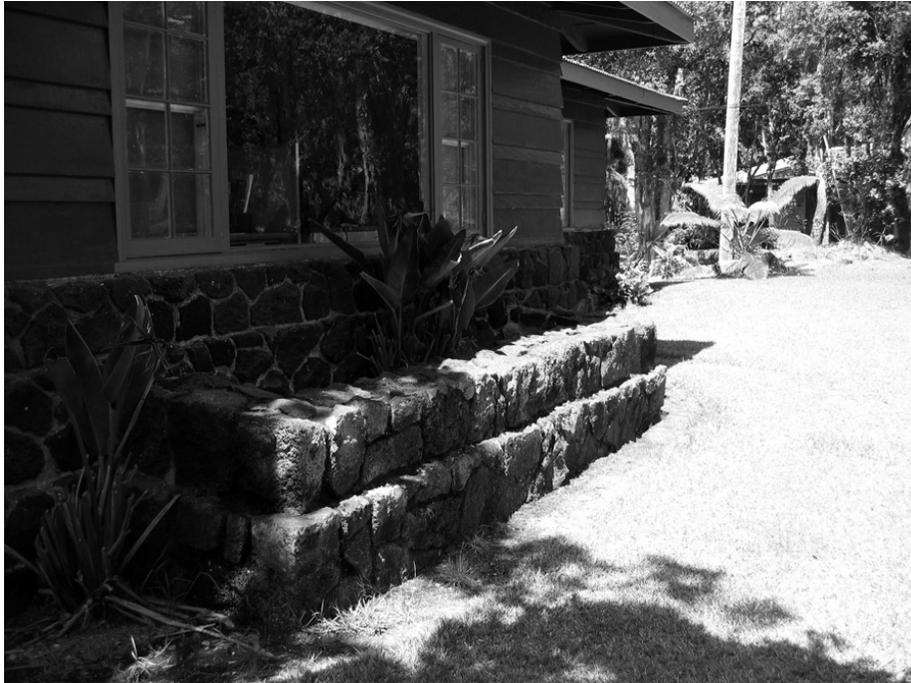
Figure 1. Example of a mortared lava-rock planter in employee housing area (PWR Staff—2005).

Several of the houses have lava rock planters flanking the front entrance of the house. These planters are typically rectangular in shape and roughly coursed. Most of the existing planters are currently planted with hydrangea, camellia or other exotic ornamentals. The landscape plan developed for Q27 in 1940 indicates native *hapuu* fern to be planted.

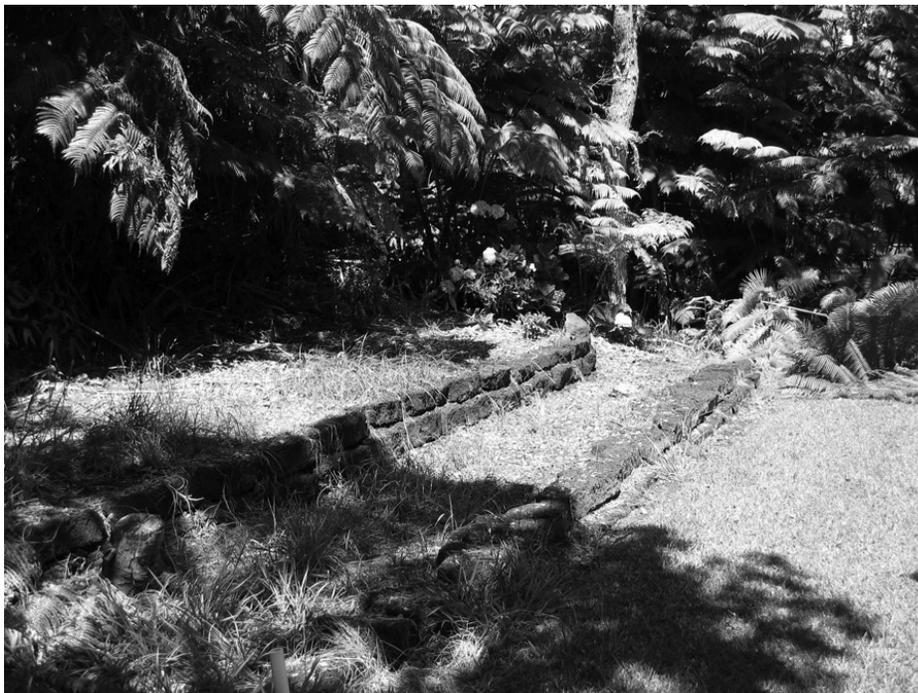
Figure 2. Example of a dry-lay, lava-rock, terraced planting bed in employee housing area (PWR Staff—2005).

Several of the houses also have single or double roughly -coursed, dry-laid lava rock planting bed borders in the backyard.

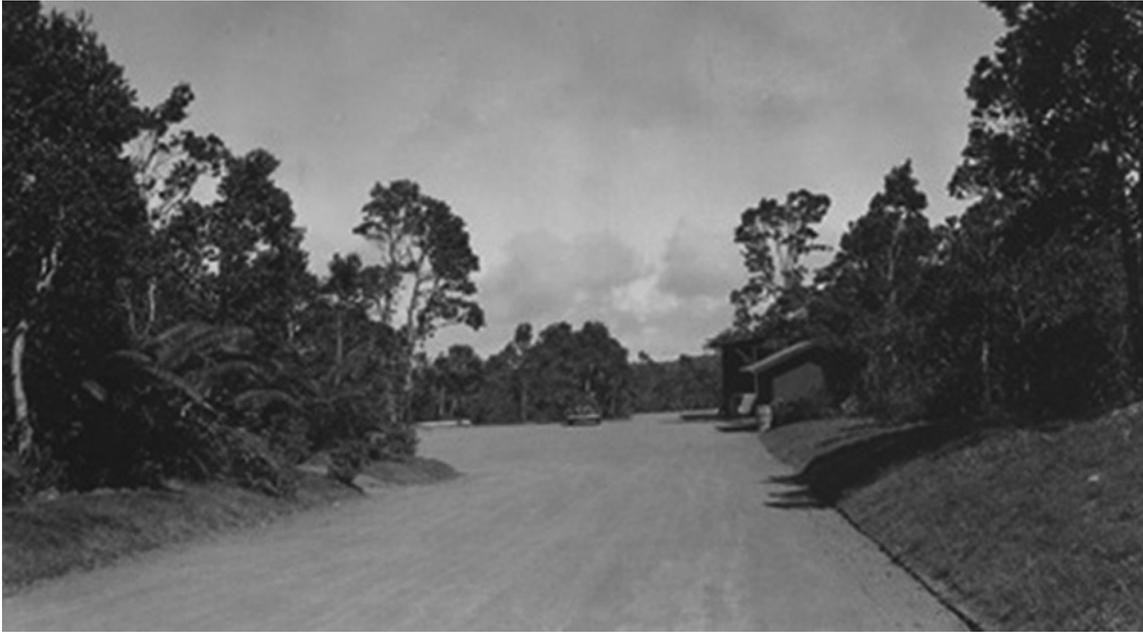
Figure 1. Main Residential/Maintenance Area Road facing maintenance area. Photo taken after surfacing was completed and shoulders were sloped and graded (1934 Landscape Architect Report, HAVO Archives).

The main residential/maintenance area road appears in the earliest 1931 master plan. The road is approximately 20-feet in width, is surfaced with asphalt, and has no shoulders. It is the only straight road in the district and it reflects early master plan efforts to create a grid within the residential and maintenance circulation system. The grid system would later be modified.

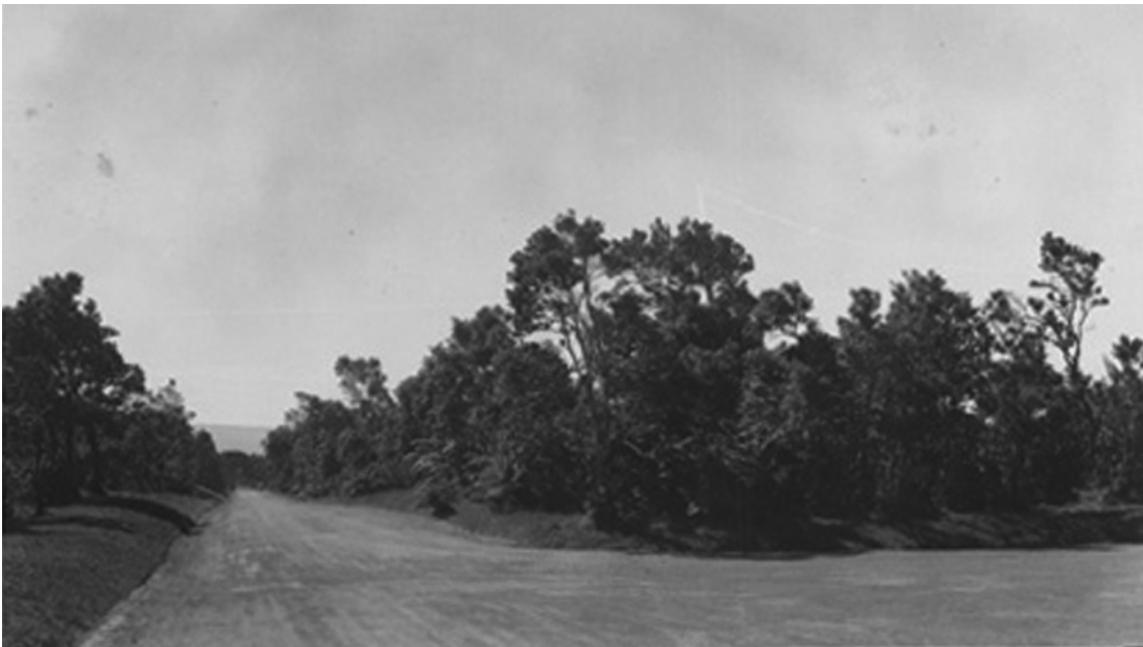
Figure 2. Main residential/ maintenance area road facing east from maintenance area (1934 Landscape Architect Report, HAVO archives).

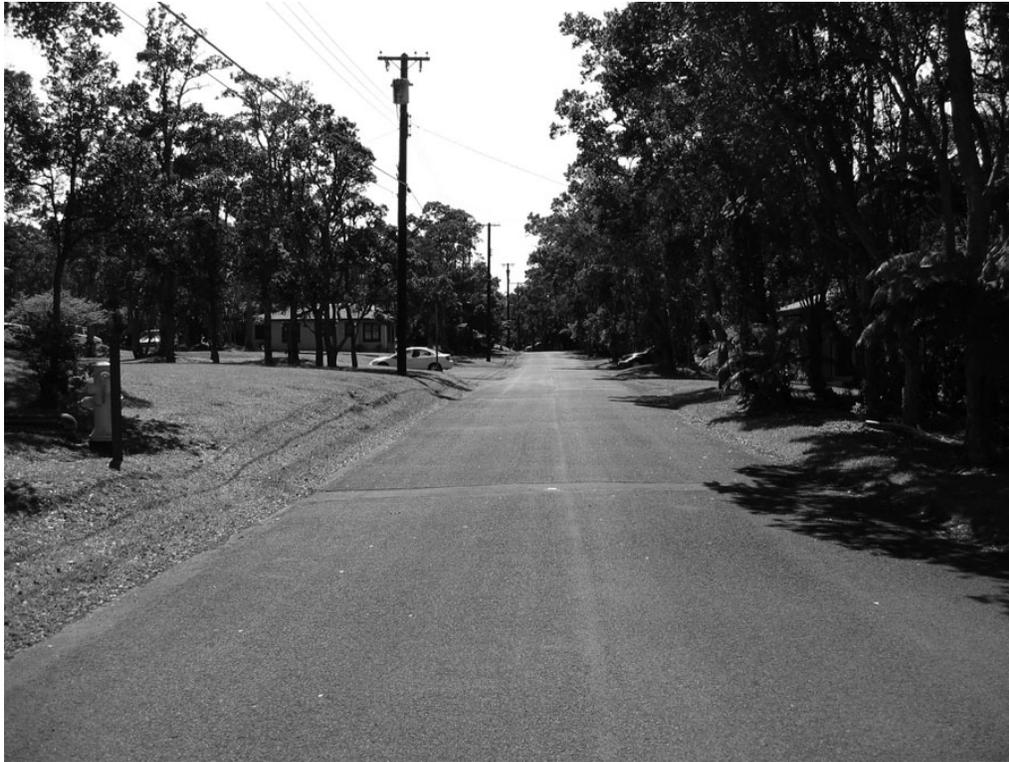
Figure 3. Existing conditions of main residential road facing northeast (PWR Staff—2005).

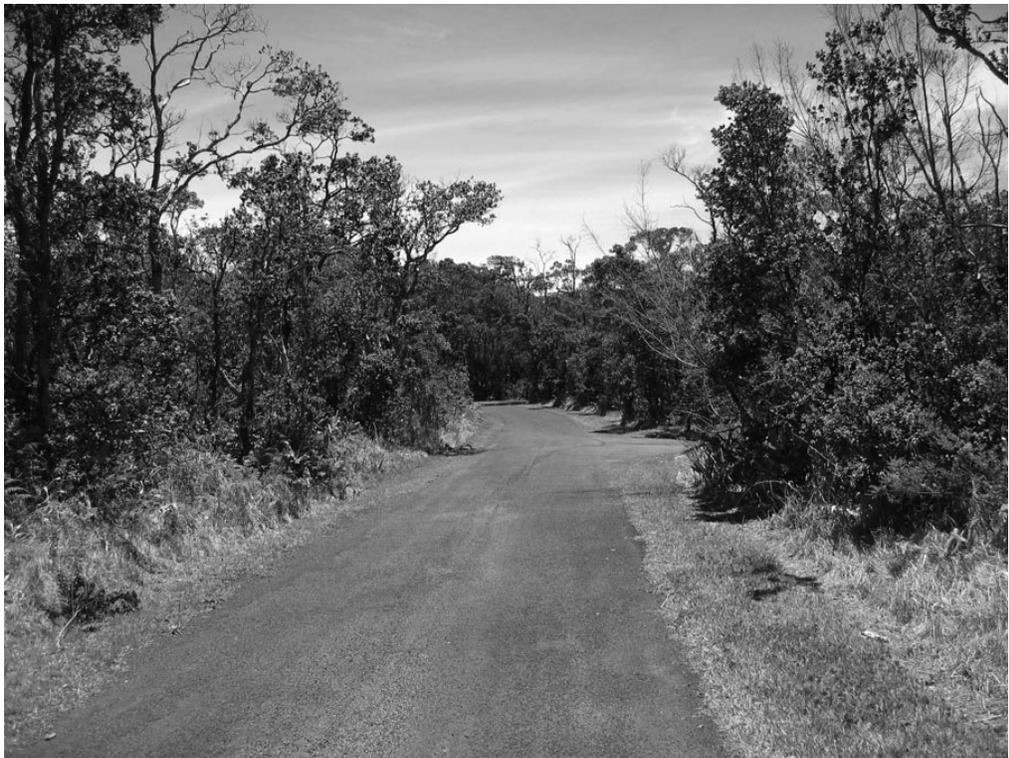
Figure 4. Existing conditions of residential loop road (PWR Staff—2005).

The residential loop road first appeared in the 1936 master plan after the superintendent's house required a reconfiguration of the circulation system. This road was built ca. 1939. and provides access to two historic residences and nine Mission 66 residences. Like the main residential road, the loop road is approximately 20-feet wide, surfaced in asphalt, with no shoulders. The portions of this road that do not have any development adjacent to them are closely bordered by dense, native vegetation. The road has retained its historic alignment and width.

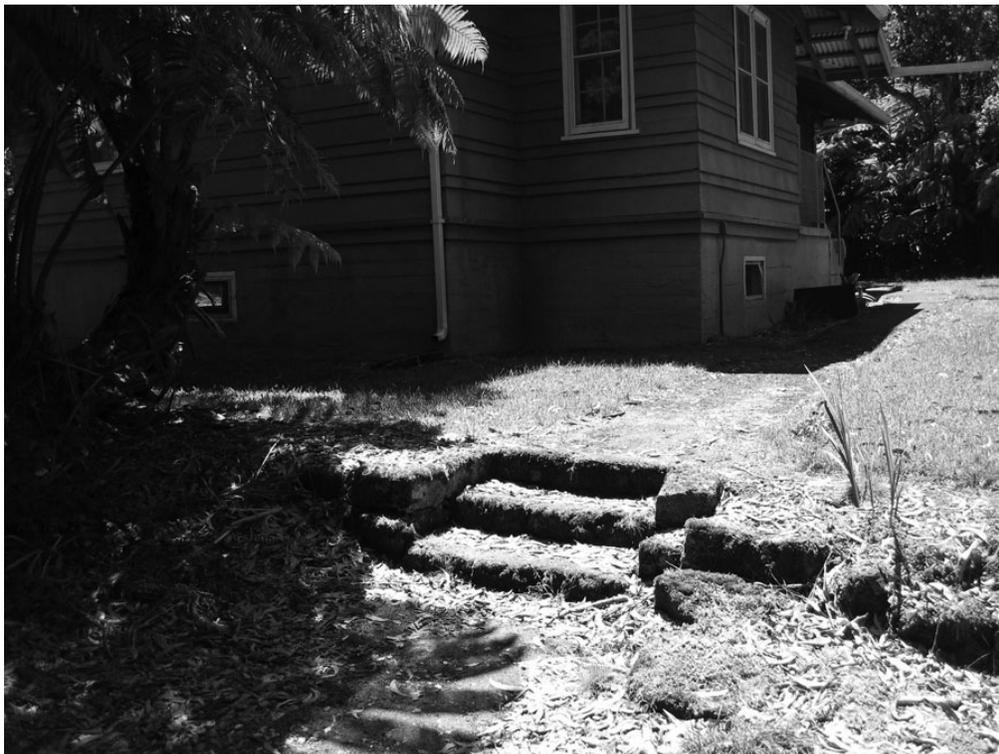
Figure 5. Example of mortared lava stairs and footpath leading from carport to backdoor of residence (PWR Staff—2005).

Lava rock steps are located along footpaths at several of the employee residences. The lava rock is squared and the face is smoothed and laid in a polygonal pattern with black mortar, recessed joints. These residential landscape features, probably constructed ca.1939 by the CCC, were designed to integrate the buildings with their surroundings and to emphasize the cohesive design elements of the park village. They are not indicated on the master plan drawings prepared for the area throughout the 1930s. The lava stone masonry work in particular is characteristic of the work being done all over Hawaii National Park during this early development period, and it helps the park village to blend naturalistically into the surrounding landscape. The construction date is uncertain but the work appears to be of the quality consistent with CCC development, the steps should be considered contributing until further research establishes their construction date.

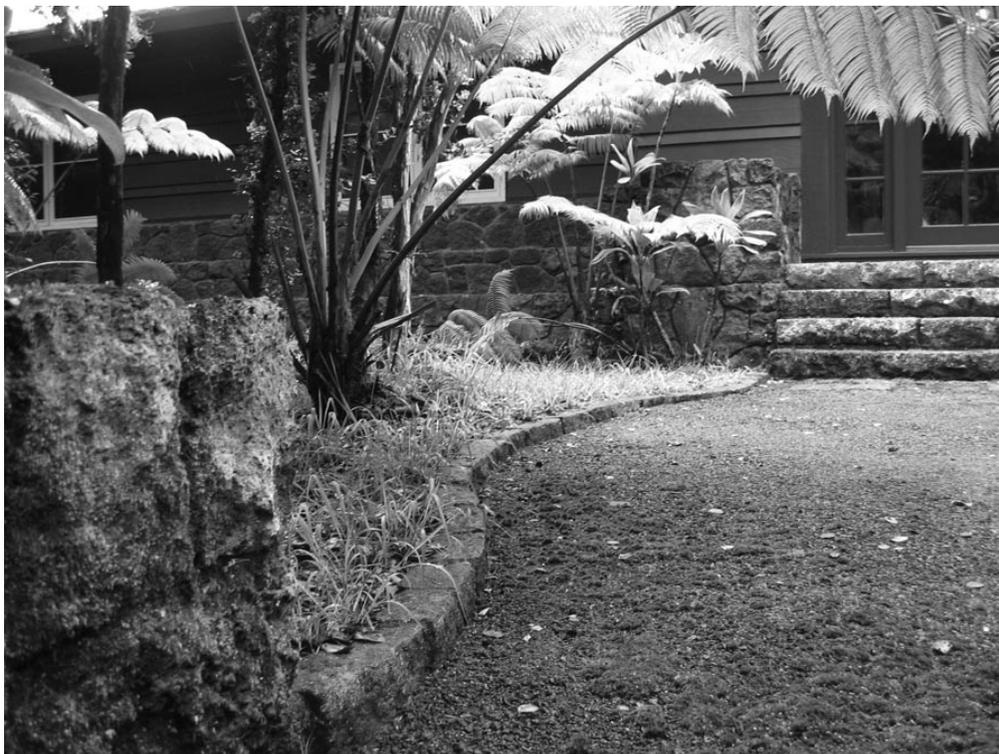
Figure 6. Stone curbing, wall and stairs at north entrance of the Ohia Wing (PWR Staff—2005).

Lava rock guard walls, constructed by the CCC (ca. 1934), line the asphalt paths that lead to the Ohia Wing and steam vents to the west of the building. The walls are 18-inches high, constructed of roughly coursed lava stones and white recessed mortar. The stones are cut to create a flat face. At the steam vents, the low walls are topped with a metal pipe railing. A small footbridge directly in front of the side, west entry of the Ohia Wing has similar stone walls. The curvilinear, asphalt-surfaced footpath ranges in width from two to six feet.

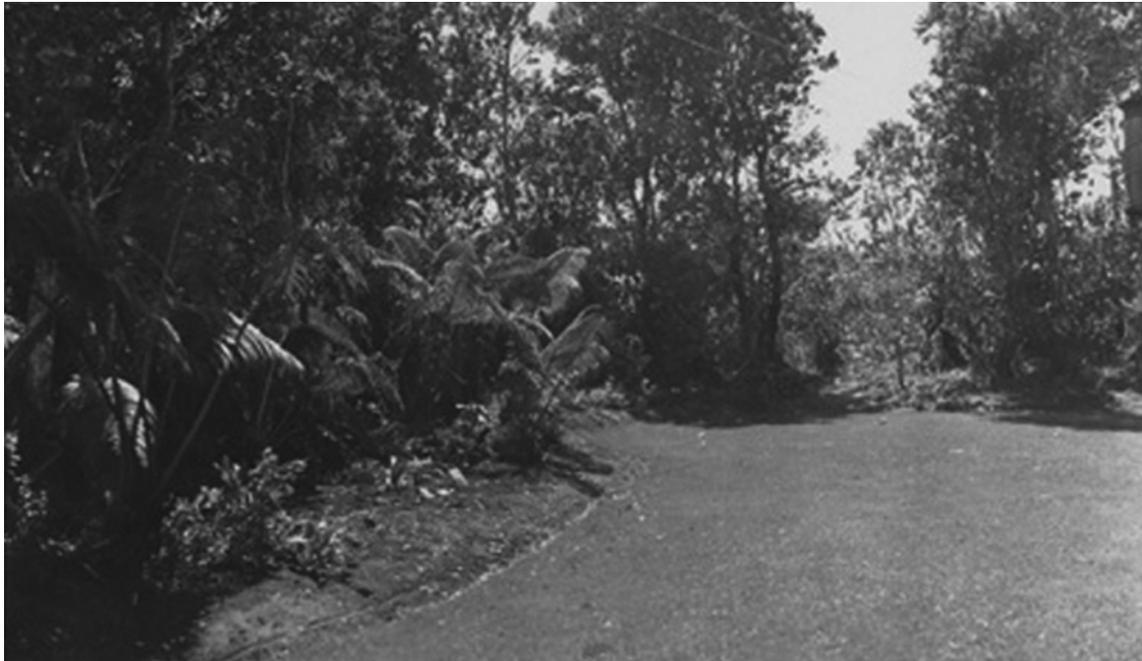
Figure 1. Typical residential landscape. Note how the edge of the natural area is being transitioned into the developed area through the use of tree ferns and other specimen natives. (Landscape Architect Report, August 1934, HAVO Archives).

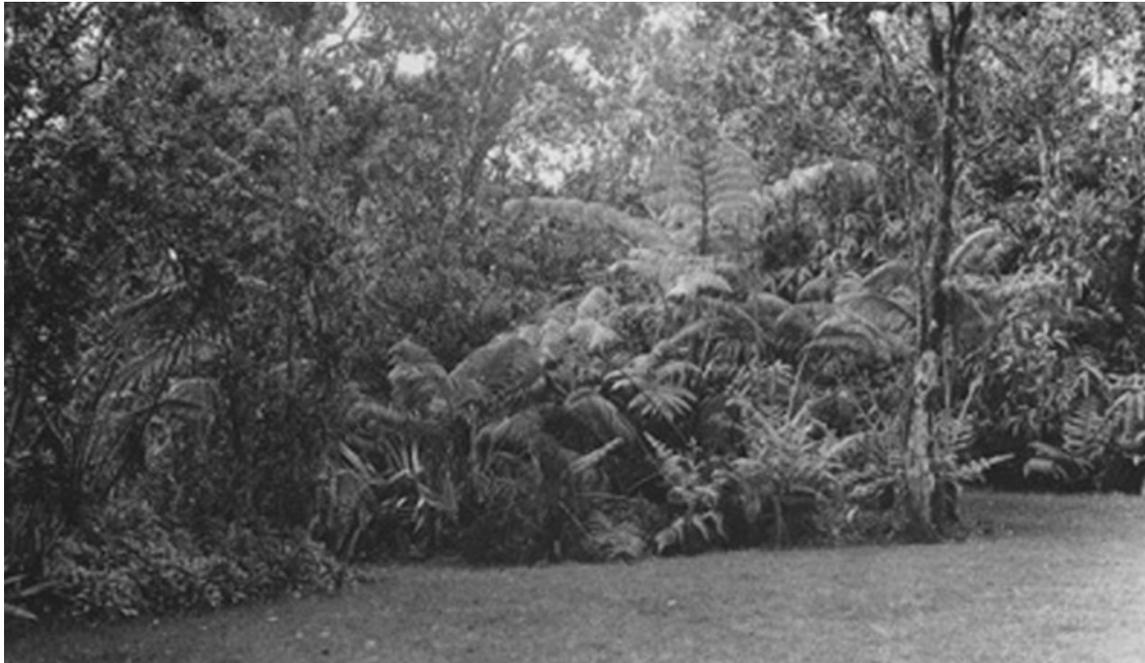
Figure 2. Planting with native materials in employee housing area. Note distinctive edge with the native forest created by the addition of lawn. (Landscape Architect Report, August 1934, HAVO Archives).

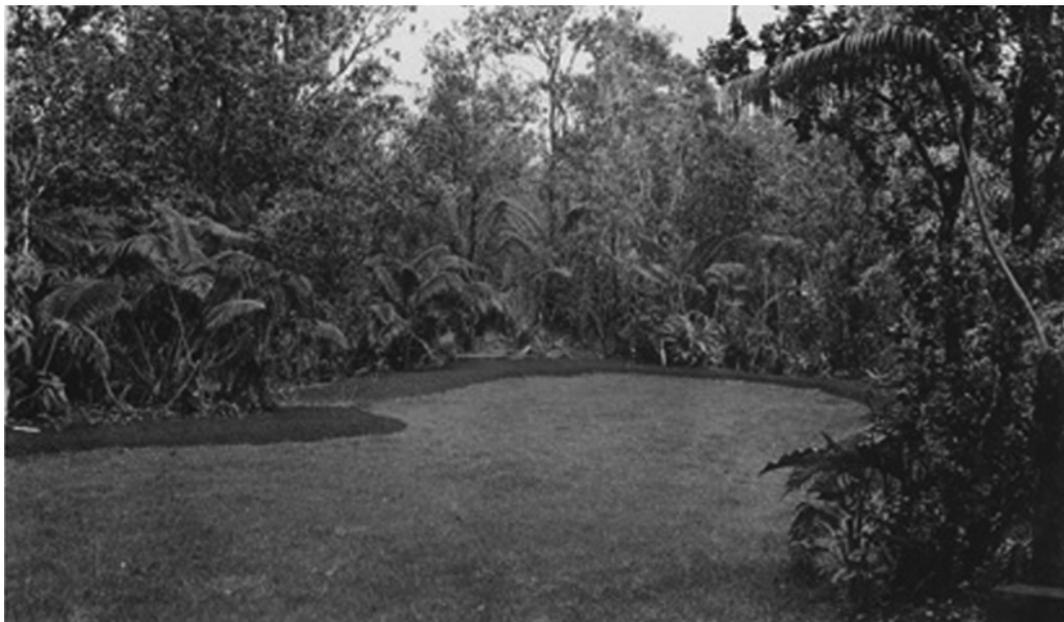
Figure 3. Planting with native material in employee housing area—note amended soil bordering the lawn (1934 Landscape Architect Report, HAVO Archives).

The CCC planted specific native species to function as ornamentals along the foundations, in planter boxes, and as a transition between the lawns and the vegetative screens such as *ti* and fern. Prior to planting, the crews graded and amended the shallow, rocky soil with large amounts of mud press (also known as bagas)—a waste product that was supplied for free from local sugar plantations (Landscape Architect Report May 25 to June 30, 1934, HAVO Archives).

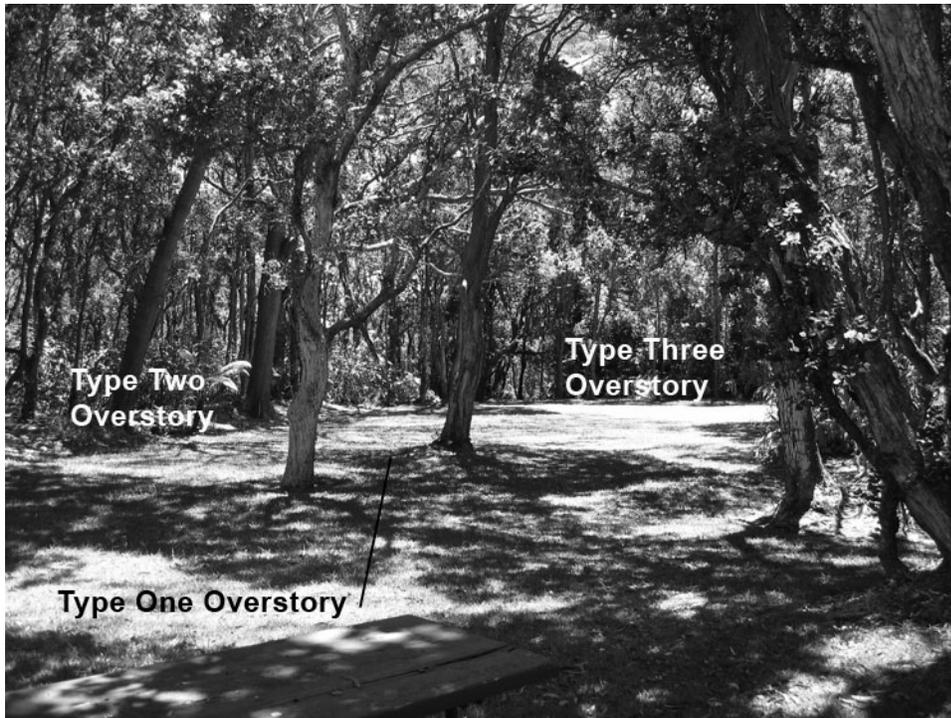
Figure 4. View of three types of overstory vegetation; photograph taken in backyard of Employee Quarters No.17, Superintendent's Residence (PWR Staff—2005).

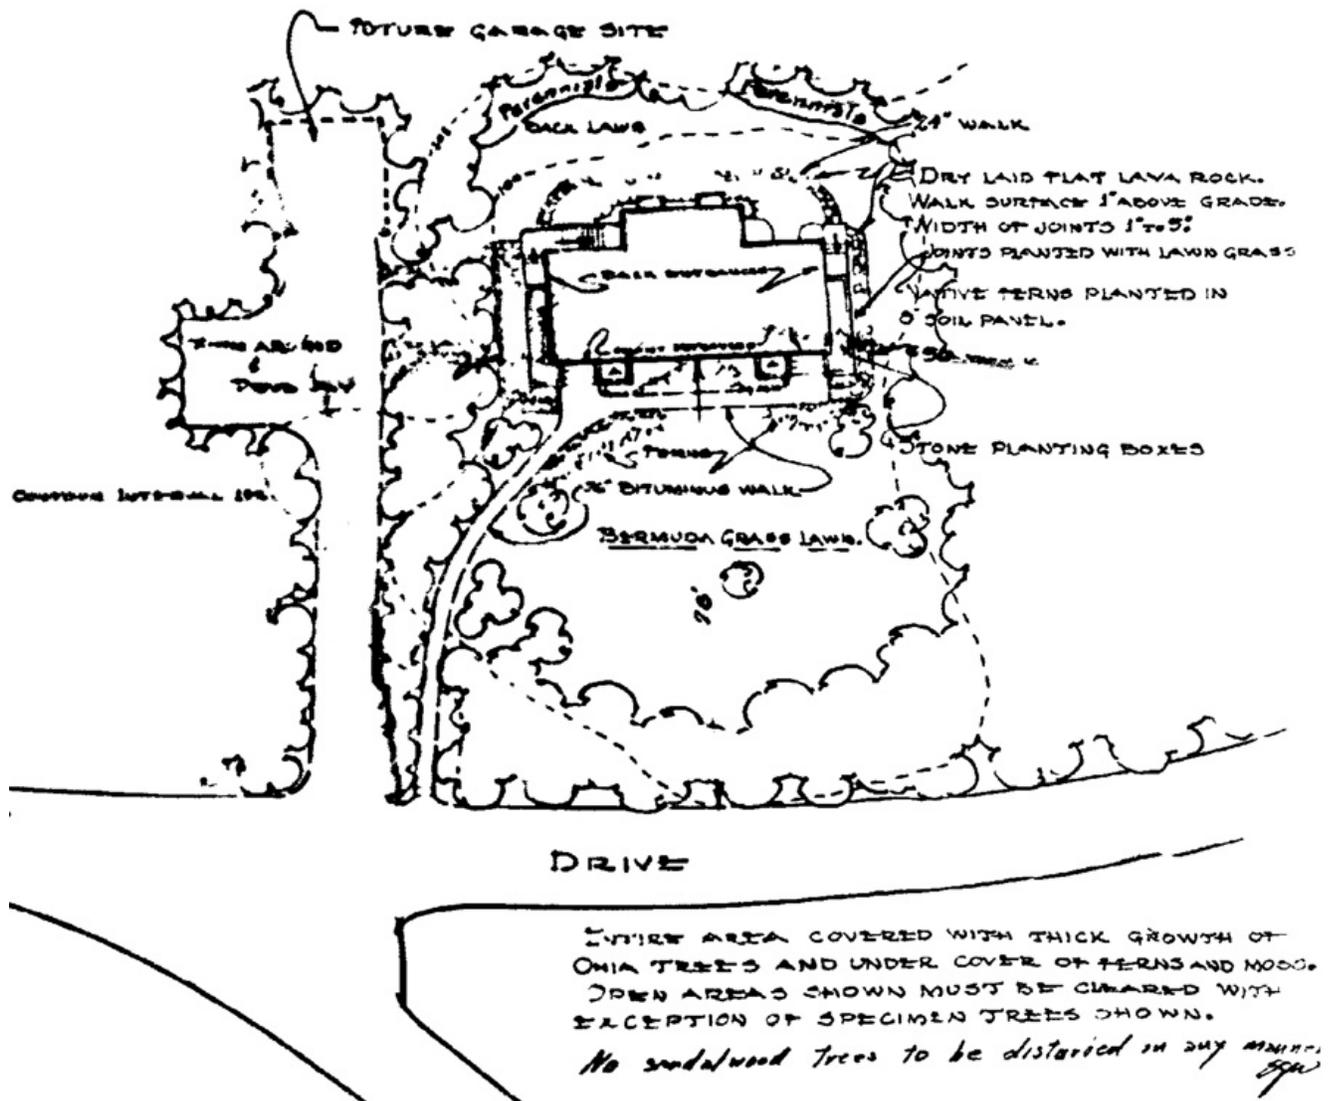
Figure 5. 1940 Landscape Plan for Employee Quarters No. 27. (DSC-TIC: HAVO 124-8071).

A 1940 landscape plan for Employee Quarters No. 27 states the “entire area is covered with thick growth of *ohia* trees and under cover of ferns and moss. Open areas shown must be cleared with exception of specimen trees shown. No sandalwood trees to be disturbed in any manner” (1940 DSC-TIC, drawing number: HAVO 124 8071). In addition to these notes, the drawing shows that a Bermuda grass lawn was to be planted in the front and backyards and bordered by the existing *ohia* forest. Native ferns were to be planted in the foundation planter boxes, and perennials (unspecified in plan) were to be planted as a transition between the backyard lawn and the existing forest. Although this particular drawing is of Employee Quarters No. 27, the drawing title is “Landscaping Undiff. Employees Quarters,” suggesting that this basic pattern of a planted Bermuda grass clearing within the forest, native ferns used as ornamentals, and the retention of native specimen trees such as sandalwood and *ohia*, is one that was intended to be repeated among all of the employee residences in the Kilauea Section of the park.
