HISTORIC AMERICAN ENGINEERING RECORD
BOSTON & MAINE RAILROAD, BERLIN BRANCH BRIDGE #148.81
(Moose Brook Bridge)
HAER No. NH-48

Structural Type: Howe boxed pony truss

Construction Dates: Built 1918; burned 2004; reconstructed 2011-2012; final assembly 2017-18

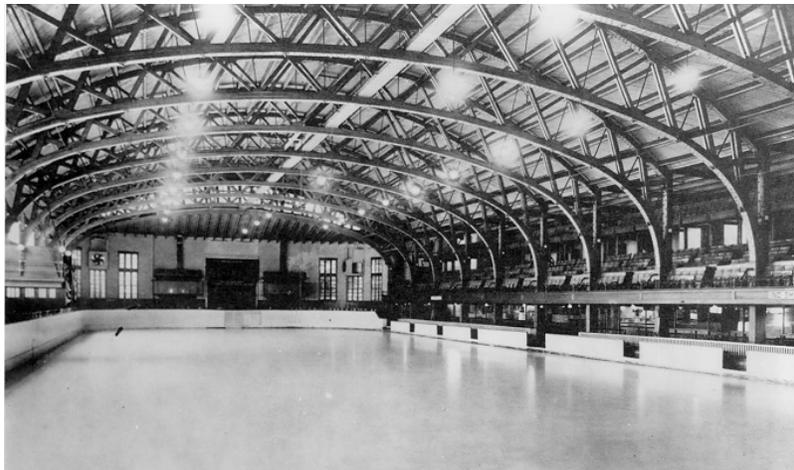
Figure 1. Roundhouse Howe truss roof. Harris & Briggs letterhead, Springfield, MA, 1856.

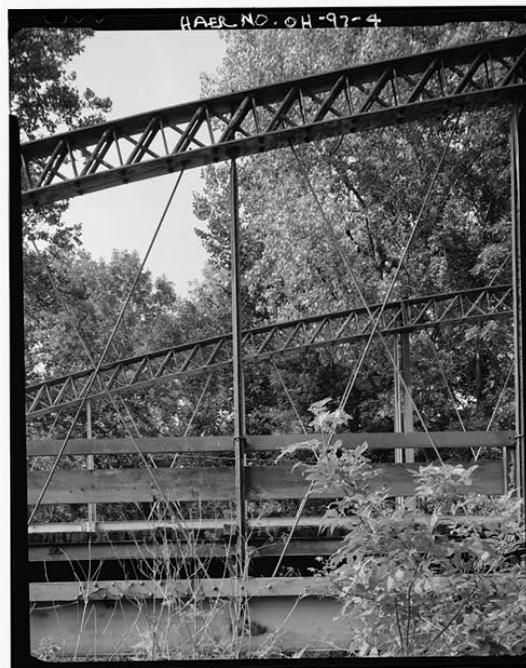
Figure 3. Massillon Bridge Company tied arch-truss, with an all-iron Howe truss on the ca. 1875 Junction Road Bridge, Preble County, OH. HAER OH-97-4, Joseph Elliott, photographer, 1992.

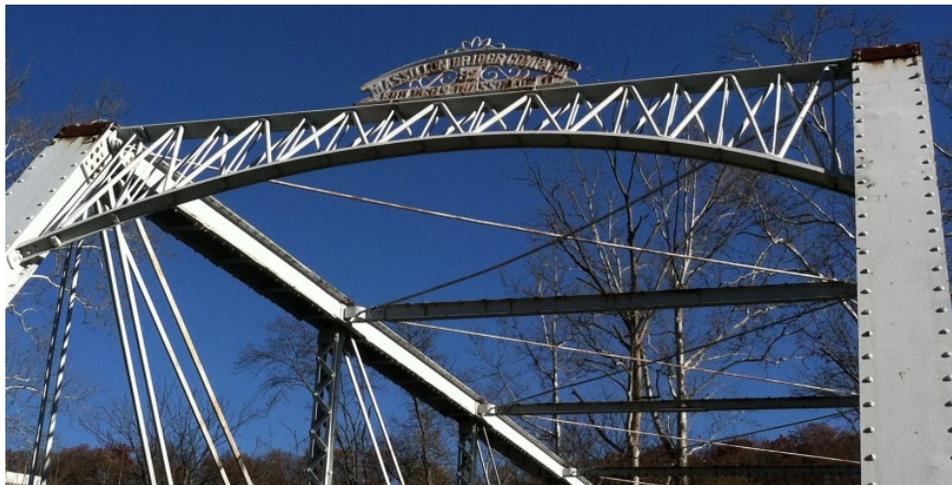
Figure 4. Massillon Bridge Company portal with an all-iron Howe truss on the 1881 Station Road Bridge, Cuyahoga County, OH. All subsequent photos and charts by Dario Gasparini unless otherwise noted.

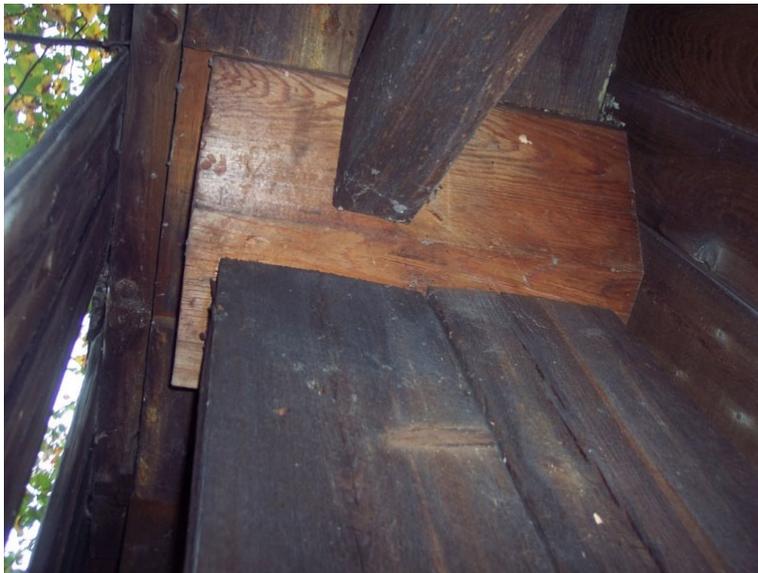
*Figure 7b. Snyder Brook Bridge; thrust block at top of end post and counter brace.
Photo by Christopher Marston.*

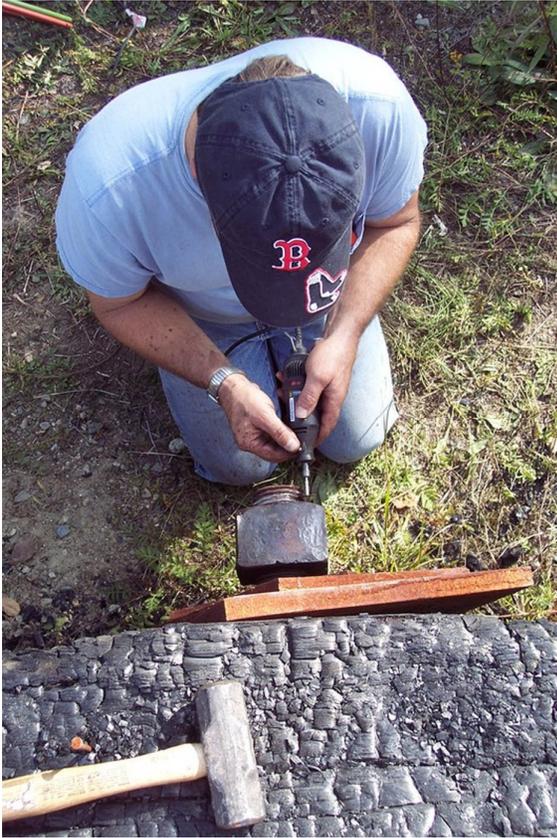
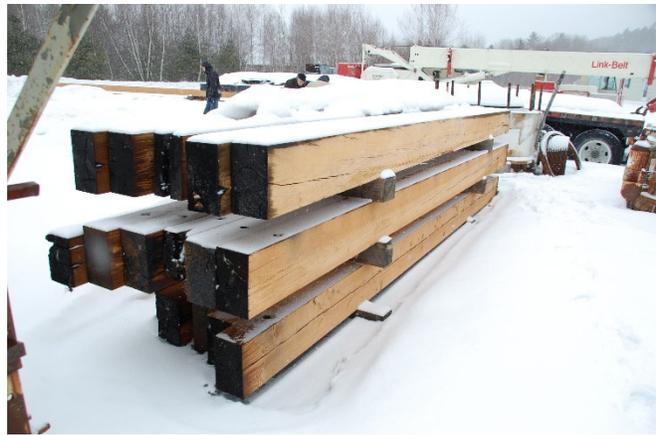
Figure 8a-b. Torching and grinding to loosen the bolts during disassembly of the burned timbers, October 2010. Right: Douglas fir timbers stacked for seasoning, March 2011.

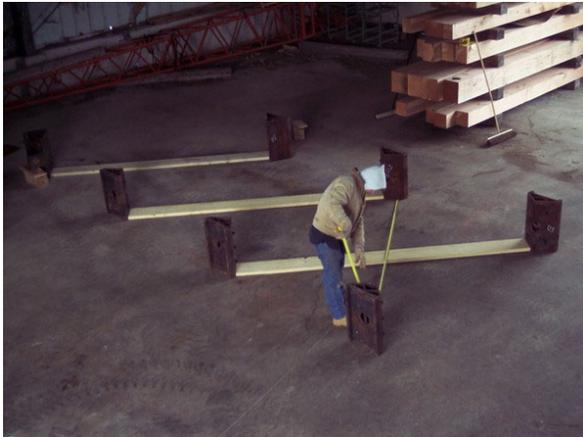
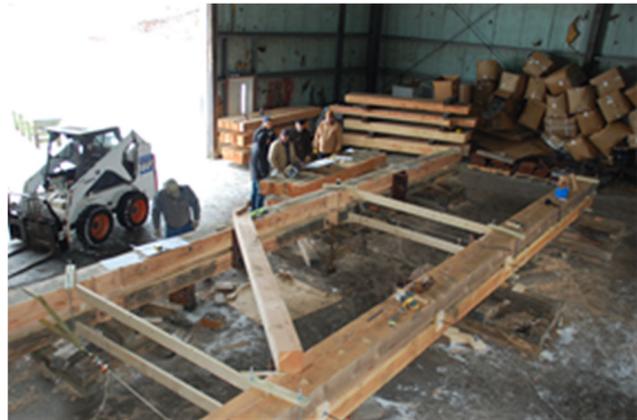
*Figure 8c-d. Aligning the castings with 2 x 8s to insure perpendicular fit as part of the lofting process, February 2011. Right: Fitting the center panel braces between the top and bottom chords, March 2011.
Photos by Will Truax, 2011.*

To achieve these these three conditions, BBofNE arranged the cast-iron blocks on the shop floor at their theoretical locations. Inexpensive 2" x 8" framing lumber (cut to the identical lengths as the braces) was used to confirm the theoretical locations of the blocks to achieve the $\frac{3}{4}$ " camber over the length of the truss (see Figure 8c). By lofting the members on the floor, Andrews and Truax could confirm the theoretical design of the trusses. There was no room for error: no extra timbers were in the budget to allow for any miscuts or mistakes.

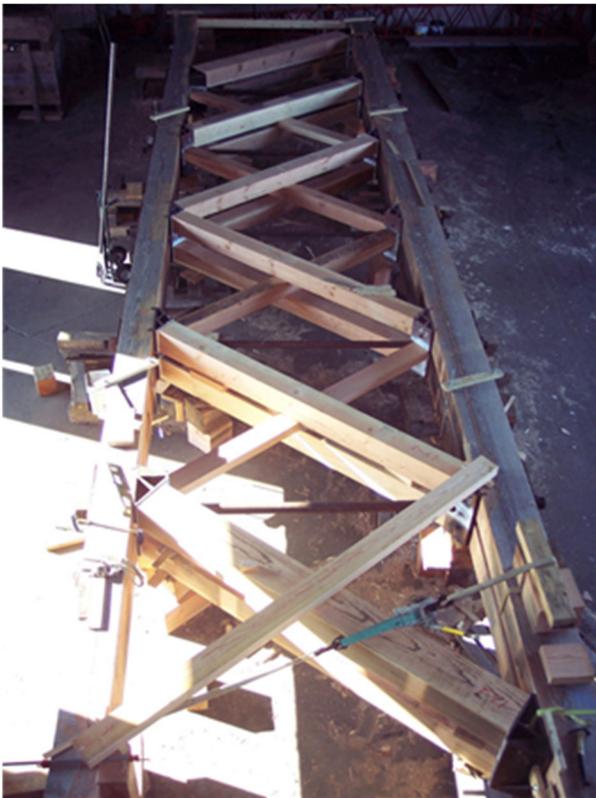
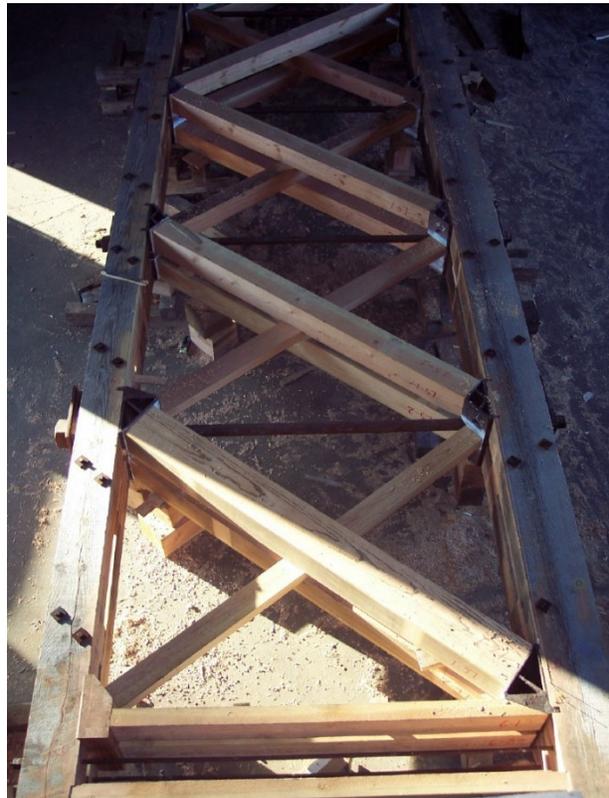
Figure 9c-d. Scribing end posts after all braces and counters were inserted. Right: Final assembly of first truss; note timber thrust block lower lefthand corner. Photos by Will Truax, 2011.

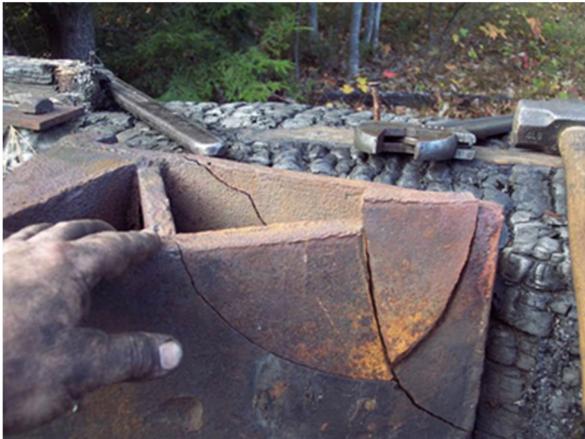
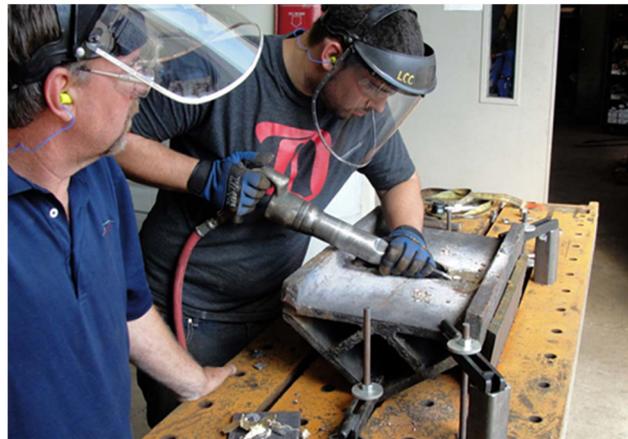
Figure 10a-b. Cracked casting found during disassembly, September 2010 (left). At Lansing, a pneumatic hammer was used to precisely cut the braze weld joint and produced a rough surface for good bonding.

Close inspection during the disassembly process revealed cracks in five of the cast-iron thrust blocks and distortion and bends in some of the tension rods. The damage to the castings appeared to be the result of the intense heat of the fire and being quenched with water by the fire department. The project team decided that all the cracks must be repaired prior to the testing at CWRU. Alpine Machine Company, a local metal shop, straightened the steel rods at an elevated temperature between 800 and 900°F. One slightly cracked casting was fixed; however several unsuccessful attempts to repair the other castings failed. On March 25, 2011, the team contacted Vern Mesler at Lansing Community College in Lansing, Michigan. An expert on iron and steel repair techniques, Mesler had rehabilitated several historic iron and steel truss bridges, and organized annual Iron and Steel Preservation conferences. Mesler offered a new methodology for the repair, but two more attempts by Alpine proved unsuccessful. In June 2011, Mesler

Preparation for the Moose Brook Bridge braze welding process began by using a dye-penetrant, non-destructive testing method to identify cracks in the cast-iron sections. Once all the cracks were identified, joint preparation began. For braze welding, joint preparation is a critical step in the process. Special attention is required for the joint profile to provide sufficient surface area for a successful braze weld.²⁸ A pneumatic hammer with a selection of sharpened chisels was used to precisely cut the braze weld joint; the action from the pneumatic hammer and chisels produced a rough surface creating a good bonding anchor pattern for the braze weld.

A steel box was fabricated to accommodate one cast-iron section at a time, along with hardwood charcoal. The casting was covered with a heat blanket and heated to about 800° F for approximately six hours to minimize thermal stresses that could lead to cracking. Once the casting reached the braze welding heat, the heat blanket was parted at the joint, and the braze welding began using Royal Tiger flux and Crown 125 (³/₈" bronze filler rod). The welding was finished while the casting remained in the firebox. The casting was then re-covered with the heat blanket and remained in the heat box until it was completely cooled. The procedures used provided a valuable case study on repair of large iron castings (see Figures 10a-f).²⁹

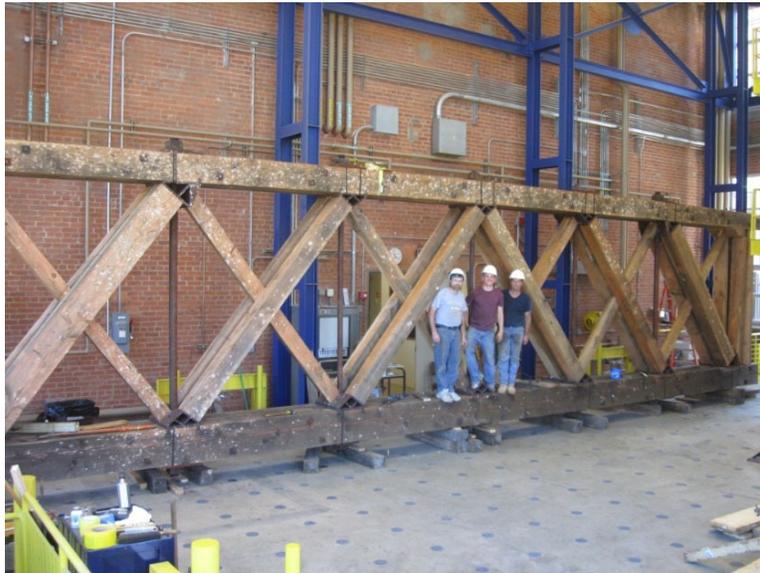
Figure 11a. First reassembled Howe truss (West truss) of Moose Brook Bridge in Vanderhoof-Schuette Structural Laboratory at Case Western Reserve University, August 2011.

To prepare for transport, BBofNE then disassembled the truss one last time, and shipped the timbers and metal components on a flatbed truck to Cleveland on August 15, 2011. Andrews traveled to Cleveland to lead the team of CWRU students in reassembling the truss, shown in Figure 11a.

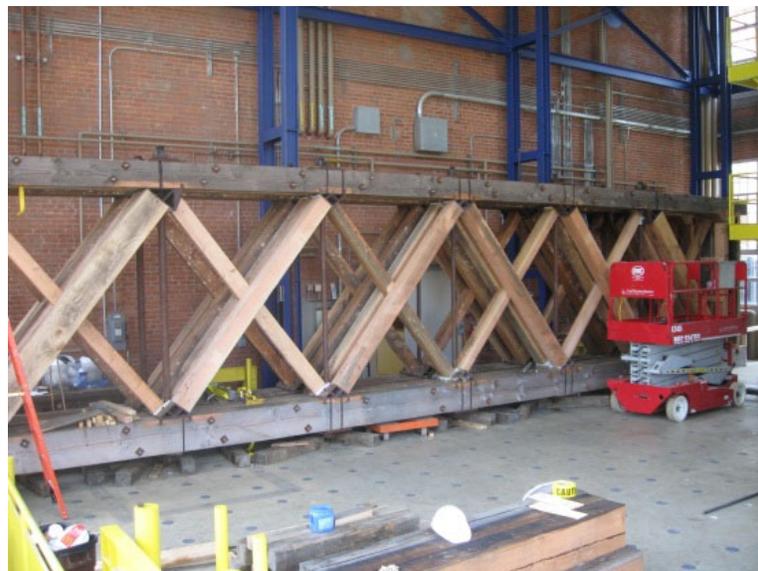
Figure 11b. Second Moose Brook Howe truss (East truss) reassembled in structural laboratory, March 2012.

Using the repaired nodal castings and the remaining timbers and hardware, BBofNE successfully fabricated the second truss over the winter of 2011-2012, following the same painstaking process used to build the other truss. The second truss arrived at CWRU on March 16, 2012, and was reassembled on March 19 in the Vanderhoof-Schuette Laboratory (Figure 11b).

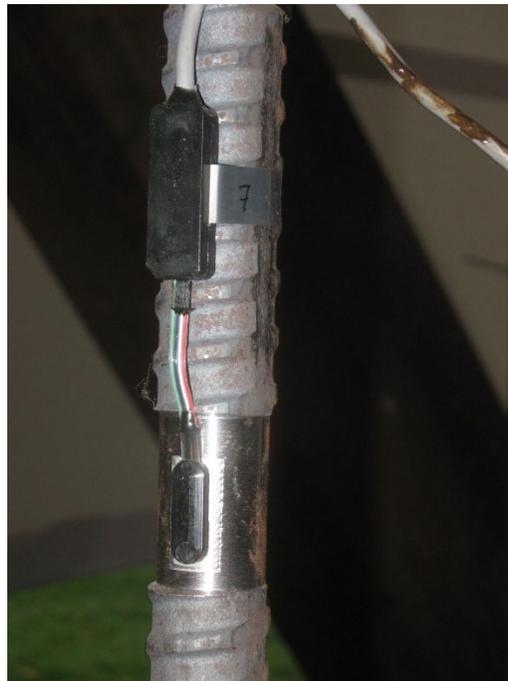
Figure 12. Weldable strain gauges on steel post-tensioning vertical bar.

Forces in all members of a Howe truss may be determined by equilibrium if forces in the vertical bars are measured. Therefore, the steel bars used for post-tensioning were instrumented with weldable, full-bridge strain gauges, specifically HPI model HBWF35-1256-10GP-TR-1" PC gauges as shown in Figure 12.

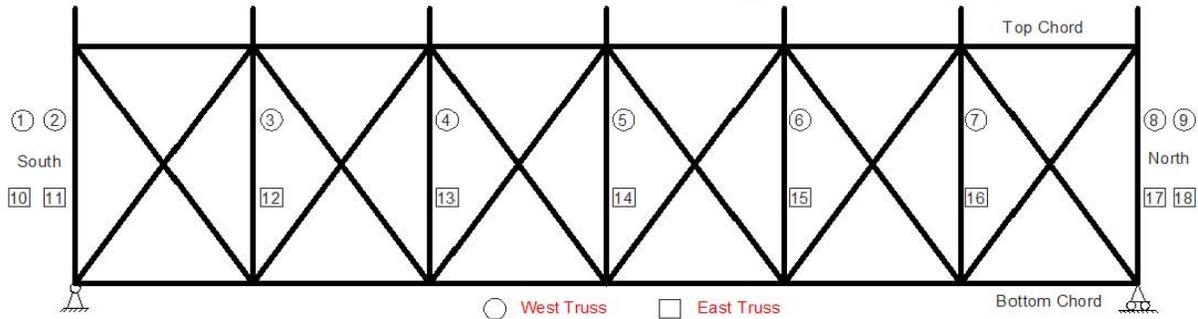
Figure 13. Numbering of strain gauges on Dywidag bars on trusses.

The sensors were numbered as shown in Figure 13.

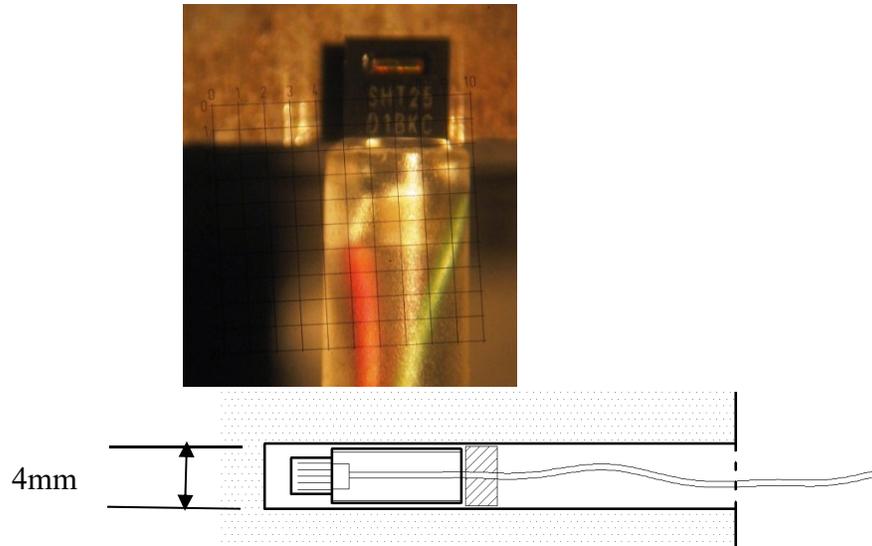
Figure 14. Sensirion SHT 25 temperature and relative humidity sensors.

An objective of the research was to measure wood moisture content at various locations over a long period of time. One possible technique, such as the one developed by Brischke, Rapp, and Bayerbach, is to embed two electrodes and measure the resistance between them.³⁰ The resistance measurement must then be correlated with known moisture contents. In lieu of this, Jim Berilla, CWRU's Civil Engineering Department engineer, suggested embedding solid state temperature and relative humidity (RH) sensors. An equilibrium wood moisture content could then be computed using Equation 4-5 (the Hailwood-Horrobin equation) in the *Wood Handbook* of the Forest Products Laboratory.³¹ Berilla chose Sensirion SHT 25 sensors. These are calibrated to read temperature and RH with an accuracy of 4 percent at the extremes. The Sensirion sensors were embedded as shown in Figure 14 and sealed with an epoxy adhesive. Therefore, the sensors measured temperature and RH in a small cylindrical volume, 4 mm in diameter.

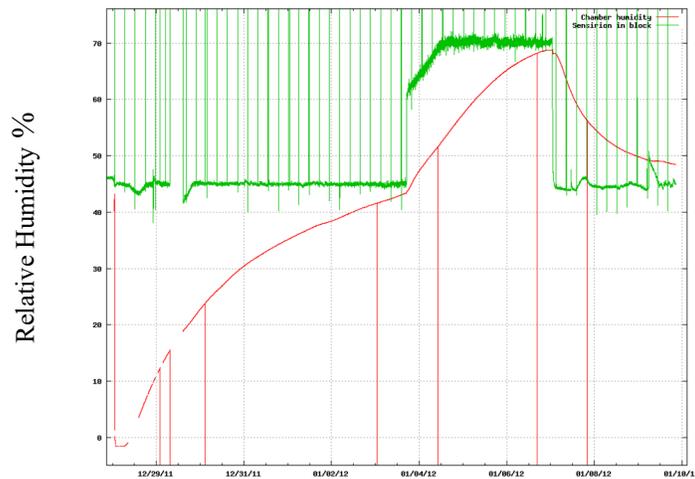
Figure 15. Sensirion SHT 25 RH reading and chamber RH reading versus time.

To check performance, one sensor was embedded at the center of a nominal 1-1/2" cube of Douglas fir. The wood block was dried at 85° C for twenty-four hours prior to insertion of the sensor. The block with the embedded sensor was then placed in a temperature and RH controlled chamber, with the temperature maintained at 15° C and the initial RH set at 45 percent. Figure 15 shows the RH output of the sensor versus time. After moisture diffused into the wood to nearly equilibrium conditions, the sensor RH reading was 43.3 percent. The chamber RH set point was then raised to 70 percent and the sensor, again after some time to achieve equilibrium, also rose to 70 percent RH. Therefore, in equilibrium conditions the RH in the small cylindrical volume in which the sensor is embedded equals the RH at the boundary of the wood. Using Equation 4-5 in the *Wood Handbook*, the equilibrium moisture content in the wood increased from 8.6 percent to 13.3 percent as the chamber RH was increased from 45 percent to 70 percent (at a constant temperature of 15° C).³² A total of fourteen Sensirion SHT 25 sensors were deployed in the wood members.

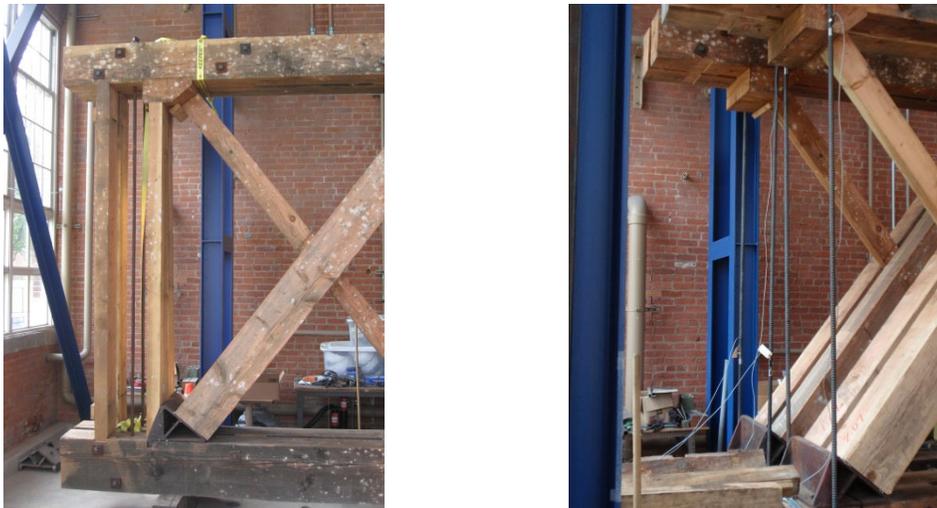
Figure 16a-b. Original and modified end panel conditions of Moose Brook Bridge Howe trusses.

To post-tension the Howe trusses, all the original steel threaded rods were replaced with high strength, 1"-diameter, Dywidag bars instrumented with strain gauges. In addition, the original end conditions of the trusses were modified by removing the wood endposts and 1"-diameter tension rods and replacing them with two Dywidag bars placed outside the wood thrust blocks, as shown in Figure 16a-b. (Note that the Case research team named the trusses “East” and “West” after moving them outside in September 2012.) First, they moved the 2012 reconstructed truss outside, and placed it nearest to the lab or west side. Then they moved the truss reconstructed in 2011 and placed it on the east side.

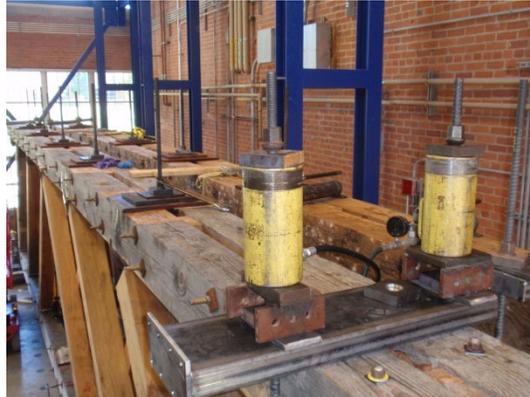
Figure 17. Post-tensioning setup using two 60-ton jacks from a single hydraulic manifold.

Post-tensioning of the 2012 truss with repaired castings (West truss) – The second reconstructed truss was delivered to CWRU on March 16, 2012, with repaired cast-iron nodes. Post-tensioning on this truss was performed on June 13, 2012, using the setup shown in Figure 17.

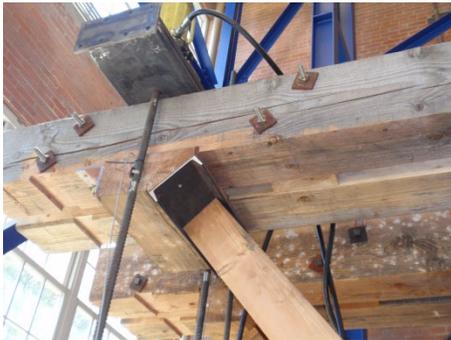
Figure 18. Added steel bearing channels.

As post-tensioning forces were gradually increased, bearing failures were noticed in the wood thrust blocks at the truss ends. Therefore, steel bearing channels and backup steel angles were added as shown in Figure 18 and 19.

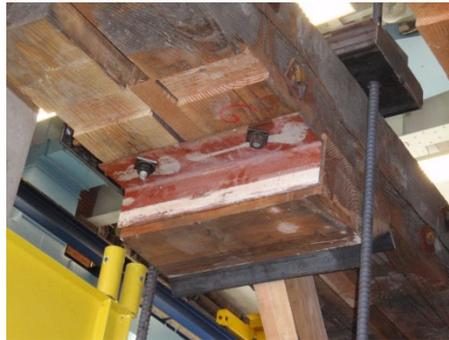
Figure 19. Added steel backup angles.

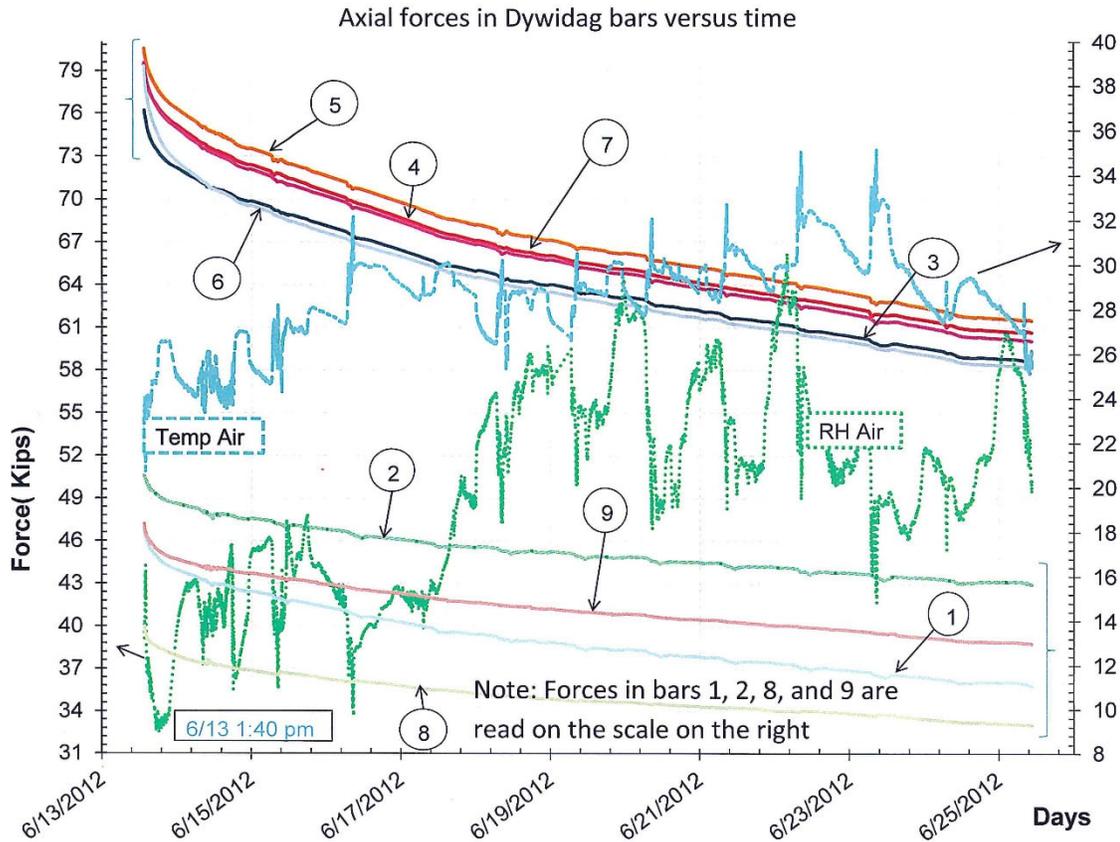
Figure 20. Axial forces in Dywidag bars 1 to 9 versus time.

Figure 20 shows the Dywidag bar forces, labeled 1 to 9, versus time for the period from June 13-25, 2012. Initial forces in the interior bars varied from 76 to 82 kips. These values decreased about 20-25 percent over two weeks because of the viscous behavior of the wood. It is important to emphasize that the prestress force caused stresses normal to the grain in the two chords and it is likely that these stresses caused most of the losses. This behavior was quickly recognized by

early builders, who then devised cast-iron tubular sleeves extending through the chord thickness, effectively eliminating stresses normal to the grain.³³

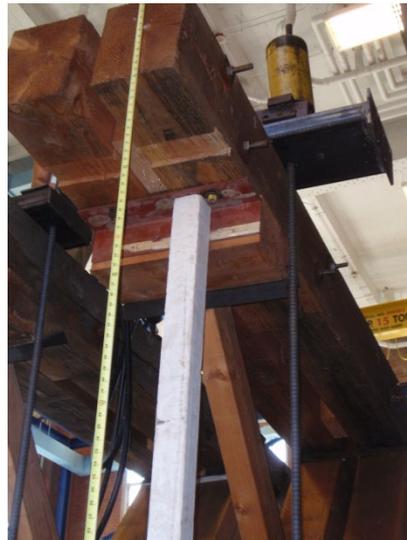
Figure 23. Post to decrease chord twist.

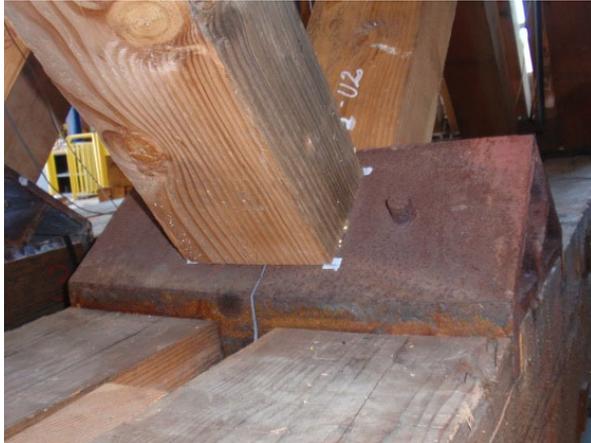
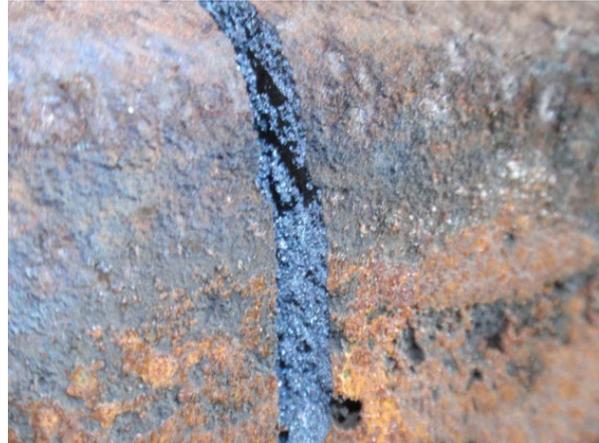
Figure 24. Cracked casting at middle node. Figure 25. New crack in middle casting of bottom chord.

Because of the twist and lateral motion of the top chords, the two Dywidag bar forces at the end nodes were very different. Post-tensioning on the East truss began on June 14, 2012. As forces were increased, the central casting on the lower chord cracked as shown in Figures 24 and 25.

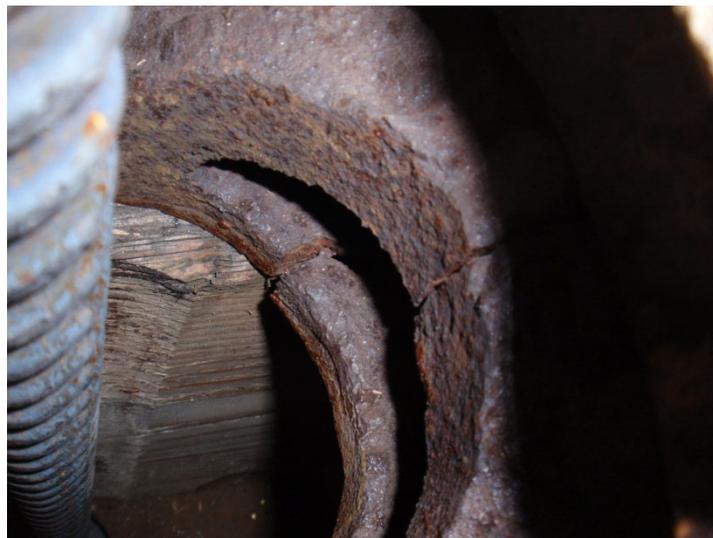
Figure 26. Detail of pre-existing crack showing surface corrosion in the middle bottom chord casting.

A visual and photographic inspection revealed an old crack in the casting with surface corrosion, as shown in Figure 26. It is likely that this undetected, pre-existing crack weakened the casting.

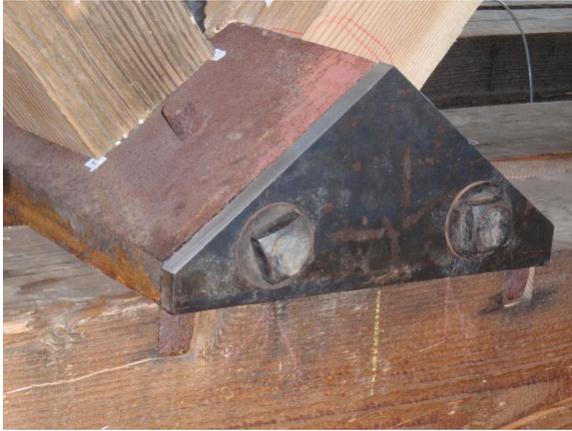
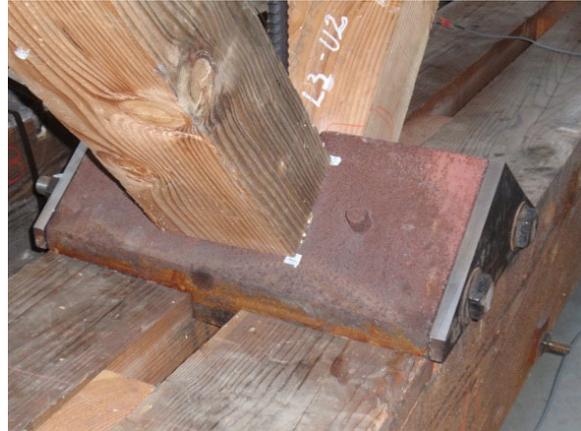
Figure 27. Repair of cracked casting.

Figure 28. Repair of cracked casting.

To repair the crack, two end plates were put in place and tightened with two 1-¼" steel bolts, as shown in Figures 27 and 28. Because of the cracked casting and the twist in the top chord, it was decided to limit the prestress of the East truss to approximately one-half that of the West truss.

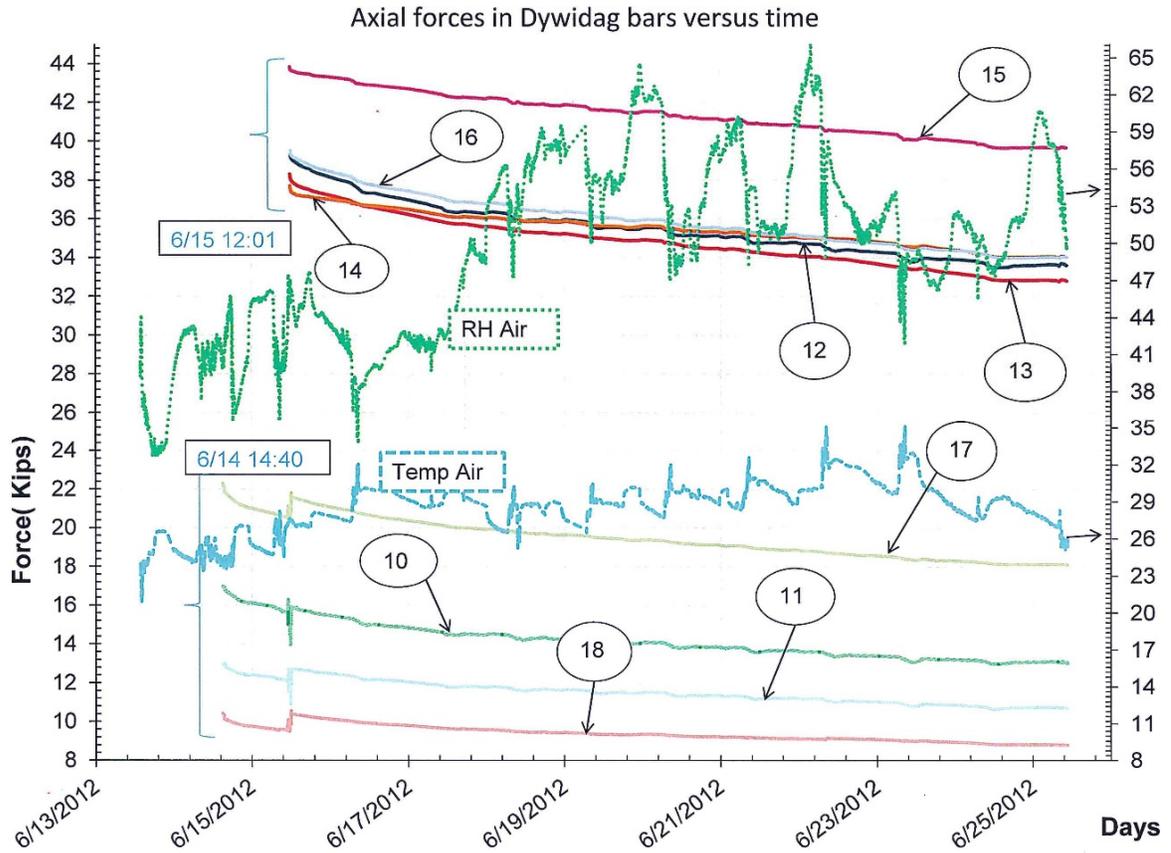
Figure 29. Axial forces in Dywidag bars 10 to 18 versus time.

Figure 29 shows time histories of the Dywidag bar forces in the East truss for the period from June 14-25, 2012. The bars are numbered 10 to 18. Again, viscous wood behavior caused a decrease in the member prestress forces.

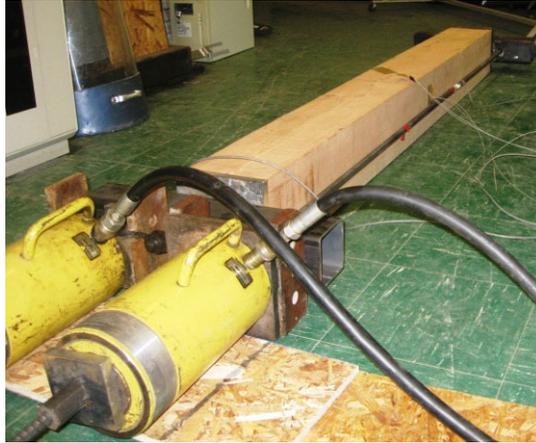
Figure 30. Post-tensioning an 8"x8" Douglas fir specimen.

An 8" x 8" Douglas fir specimen was instrumented and post-tensioned as shown in Figure 30 to help the team gain experience before working on the actual trusses.

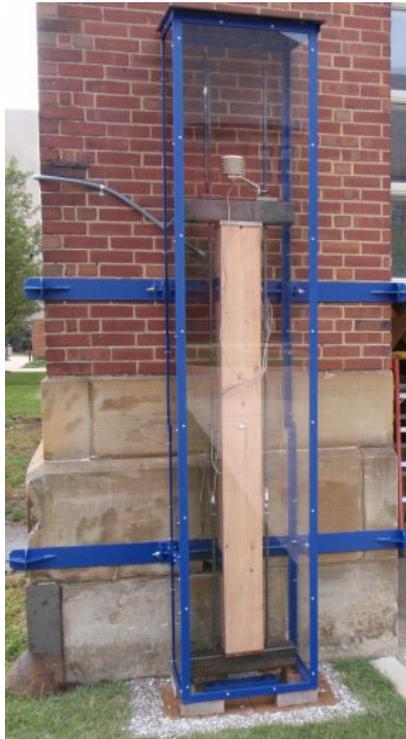
Figure 31. Prestressed 8" x 8" Douglas fir specimen in its outdoor enclosure.

The 8" x 8" timber was post-tensioned on April 3, 2012, and placed outdoors on May 7, 2012, as shown in Figure 31. The initial sum of the forces in the two bars was approximately 50,000 lbs, producing an initial compressive axial prestress in the wood of approximately 950 pounds per square inch (psi). Three Sensirion temperature (T) and relative humidity (RH) sensors were embedded in the wood, one at the center of the section, another at quarter depth, and one near the surface (about a centimeter from the surface). Atmospheric T and RH sensors were also deployed. A data acquisition system recorded data at a rate of two samples per minute. Figure 32 shows wood compressive stress data recorded from the time of initial prestressing to June 25, 2012. Viscous wood behavior caused a slow decrease in the compressive prestress of about 6 percent in the first month. This decrease is much smaller than that observed on the West truss because the 8" x 8" post-tensioned specimen had no stresses normal to the grain. Noticeable daily force fluctuations occurred after the specimen was placed in an outdoor environment. These fluctuations are due to the different coefficients of thermal expansion of steel and wood.

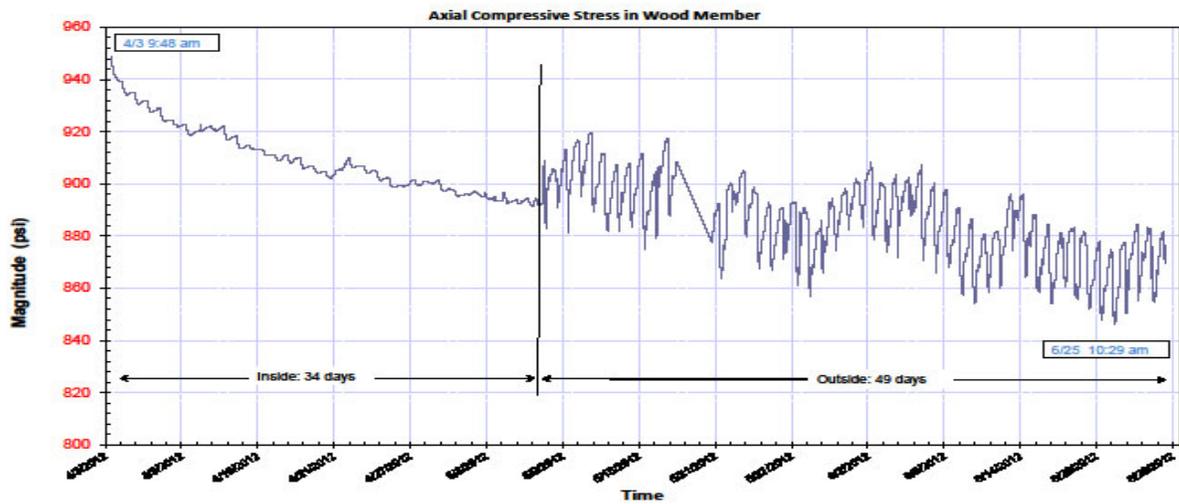
Figure 32. Axial stress in 8" x 8" Douglas fir specimen versus time.

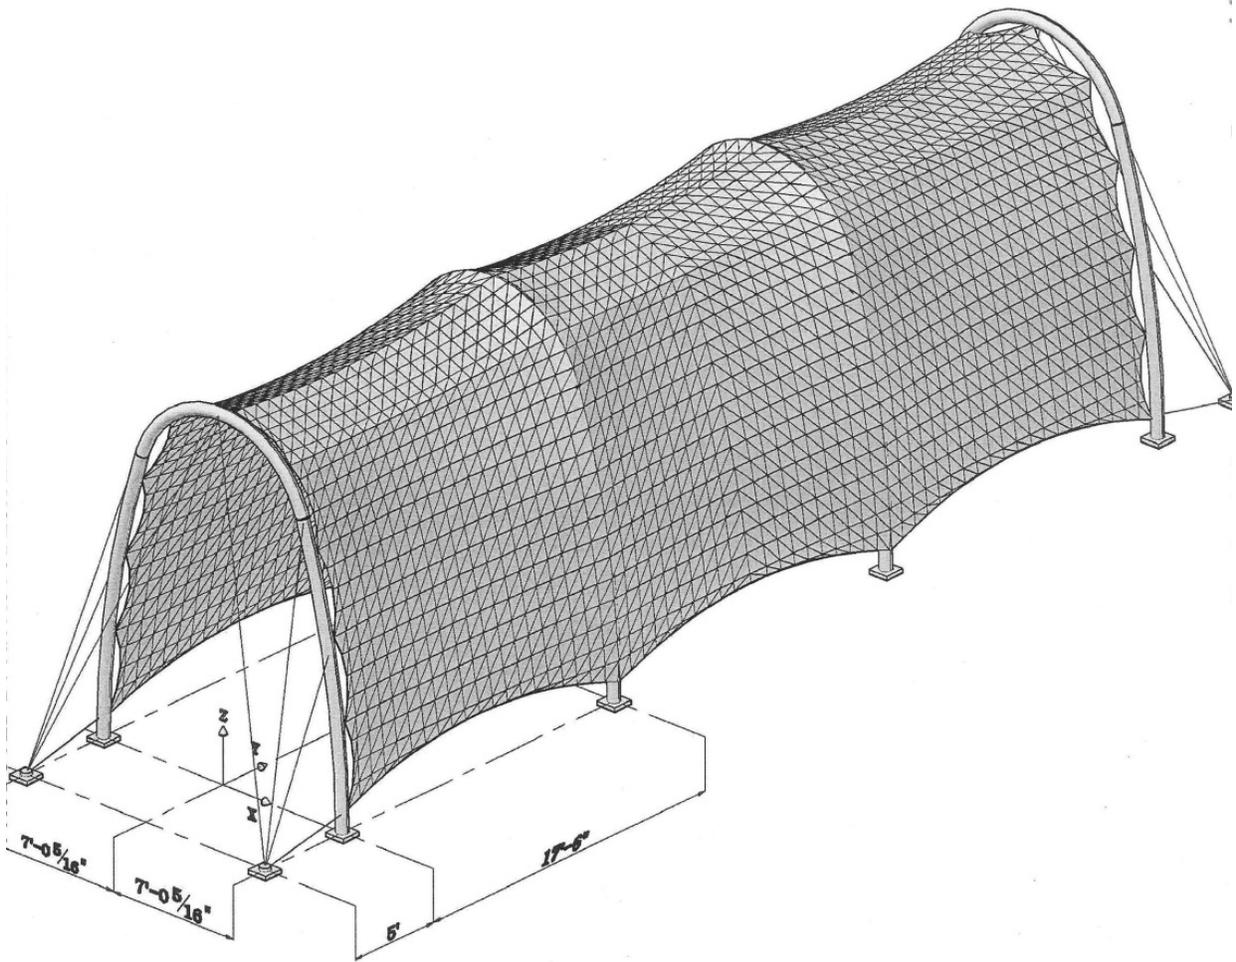
Figure 33. Conceptual design of cover for Howe trusses. Drawing by Pavel Gorokhov, 2012.

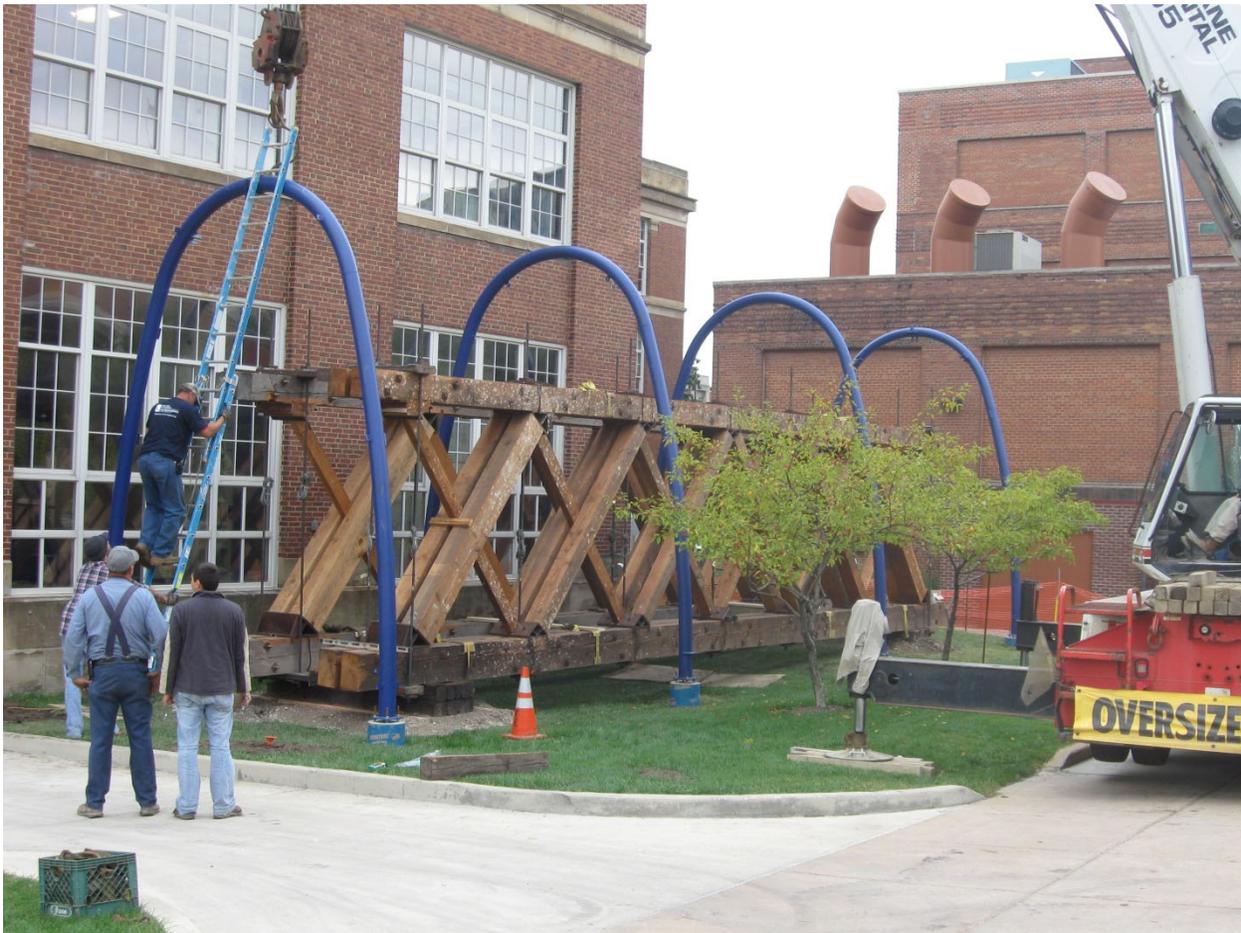
Figure 35. Outdoor installation of steel arch frames over Howe trusses. Note the East truss, reconstructed in 2011, positioned in the foreground. The West truss is behind, closest to the lab.

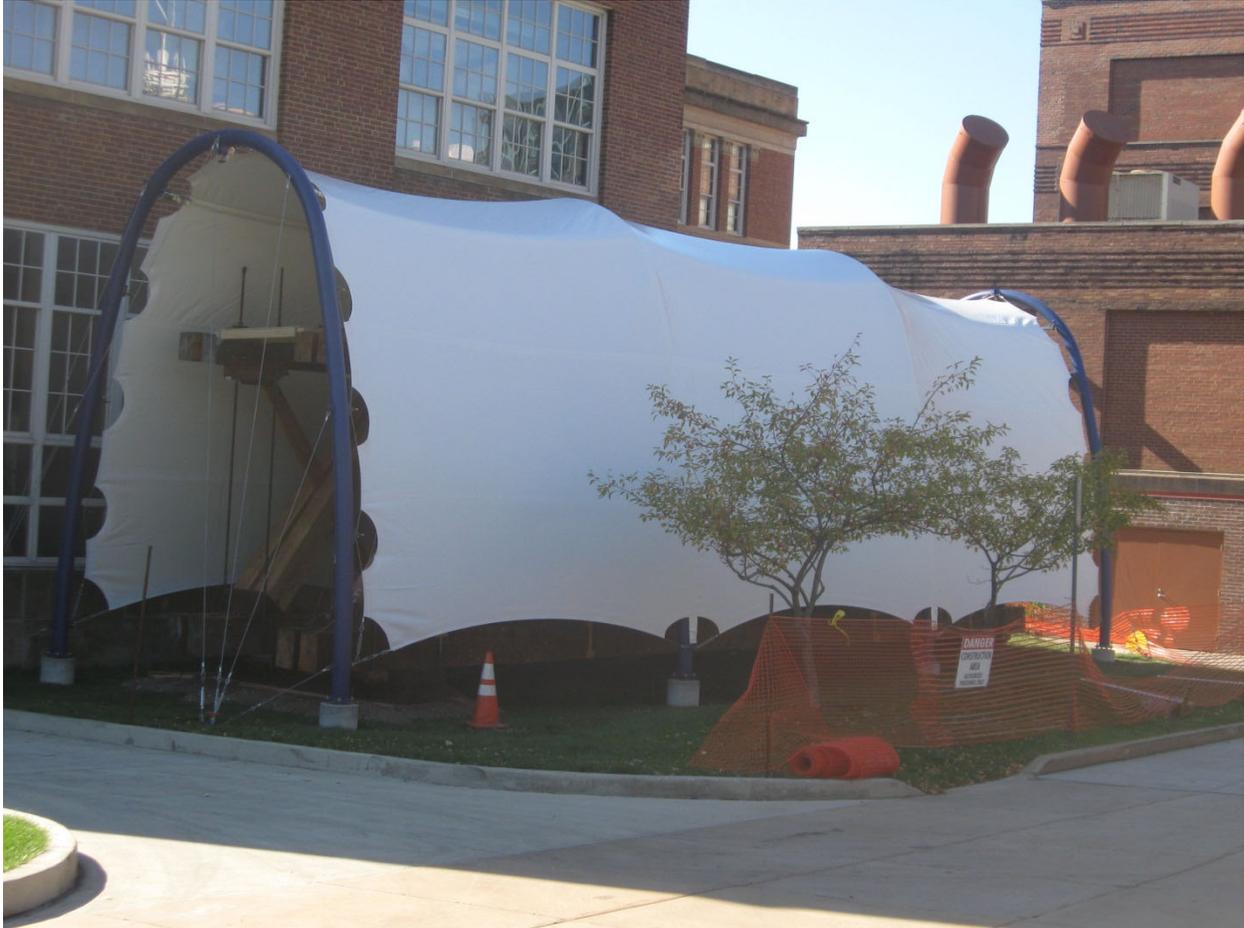
Figure 36. Protective cover for Howe trusses.

The protective cover shown in Figure 36 was erected beginning on October 3, 2012.

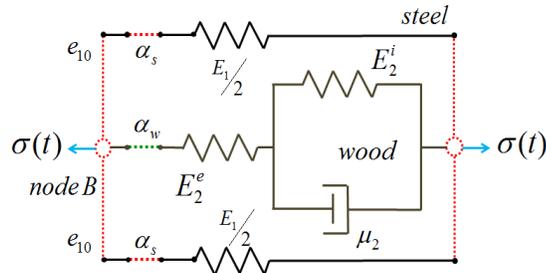
Figure 38a. Linear model for the post-tensioned system of Fig. 31; linear elastic model for steel; three-parameter-solid linear viscoelastic model for wood.

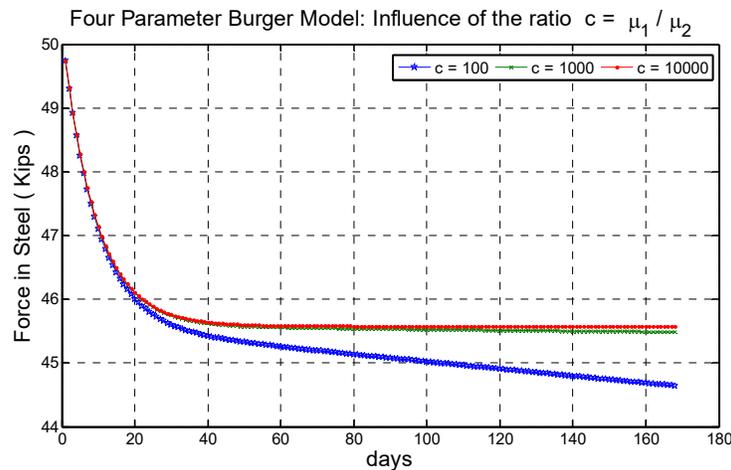
Figure 39. Predicted loss of prestress from linear viscoelasticity for system shown in Figure 31.

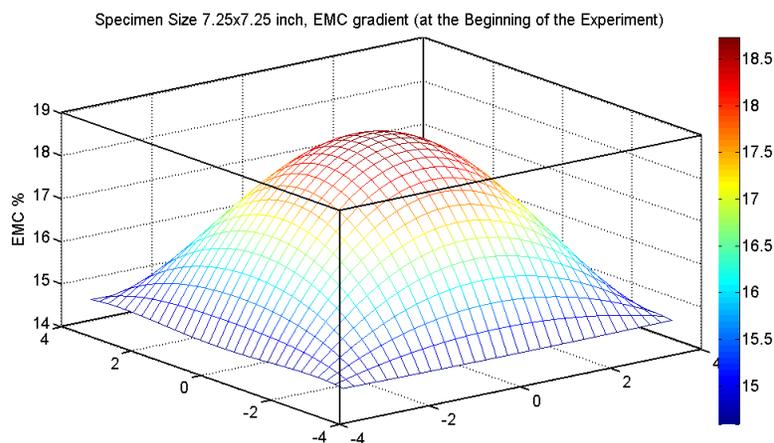
Figure 42. Assumed initial moisture content distribution within the cross-section.

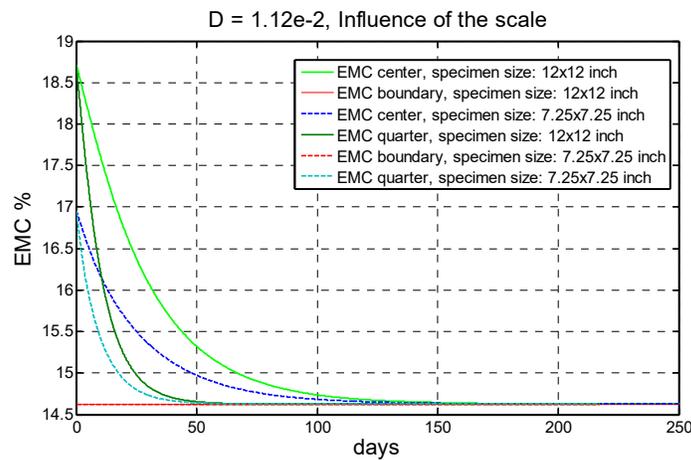
Figure 43. Time histories of moisture content at three points for two cross section sizes.

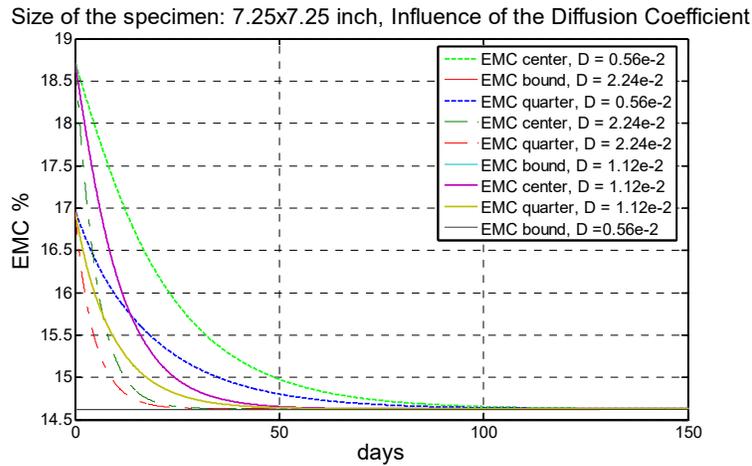
Figure 44. Influence of the diffusion coefficient on the time histories of moisture content.

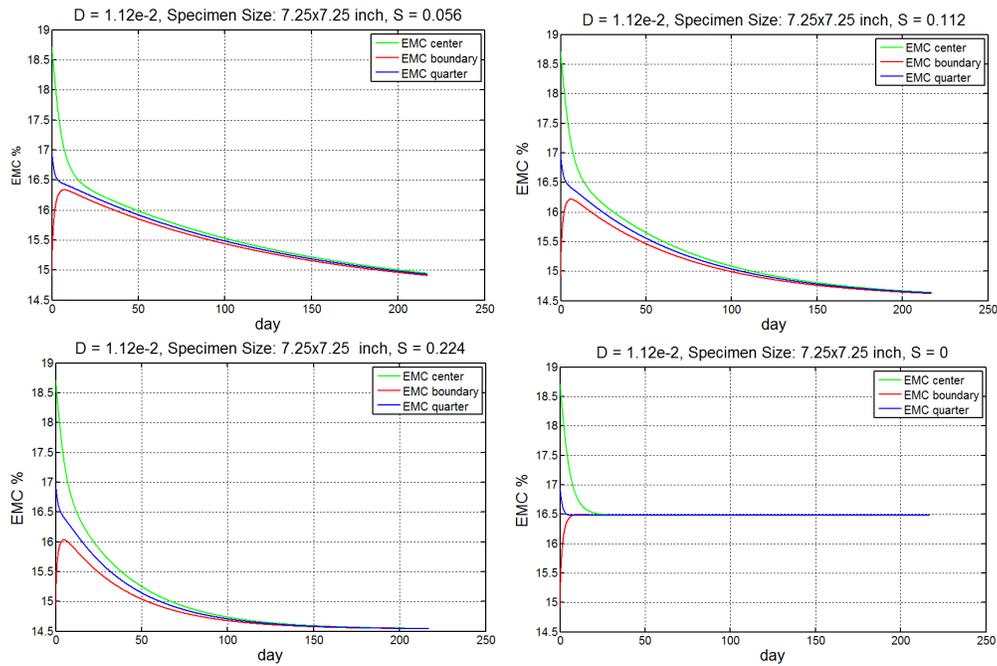
Figure 45. Influence of surface emission coefficient, S , on the time histories of moisture content.

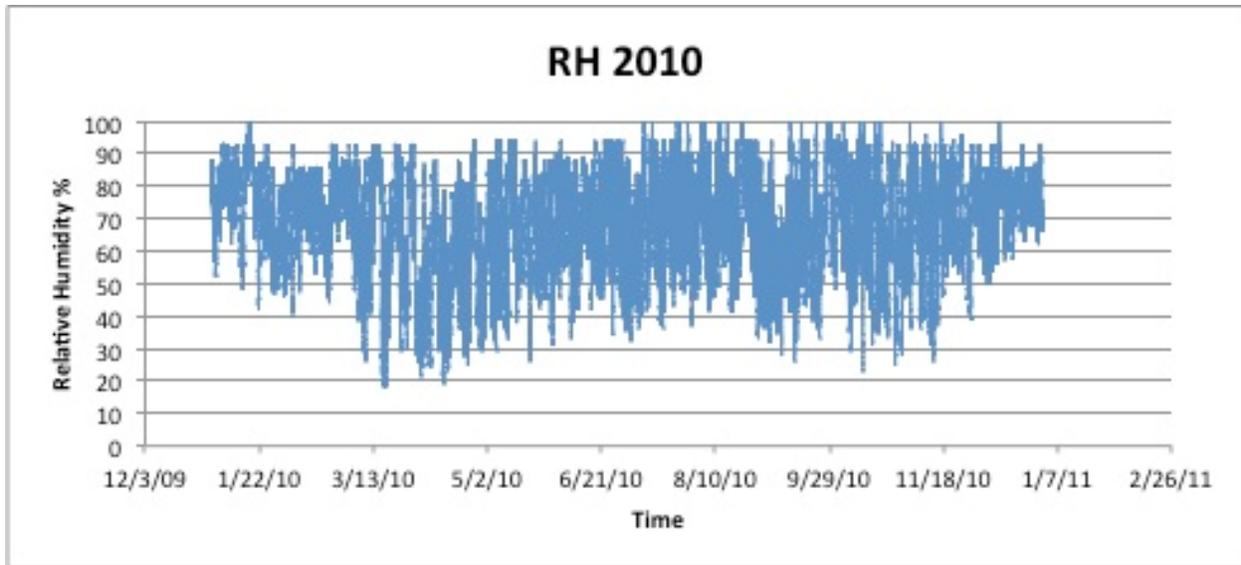
Figure 46. Cleveland Hopkins Airport Relative Humidity vs. Time in 2010.
