HISTORIC AMERICAN ENGINEERING RECORD
BOSTON & MAINE RAILROAD, BERLIN BRANCH BRIDGE #148.81
(Moose Brook Bridge)
HAER No. NH-48

Structural Type: Howe boxed pony truss

Construction Dates: Built 1918; burned 2004; reconstructed 2011-2012; final assembly 2017-18

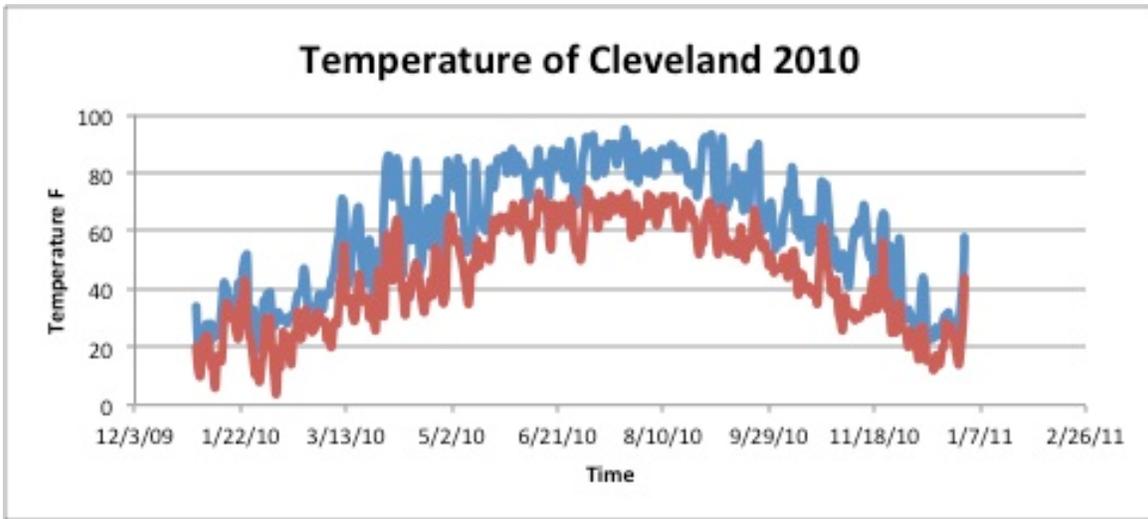
Figure 47. Daily Maximum and Minimum Temperatures in Cleveland in 2010.

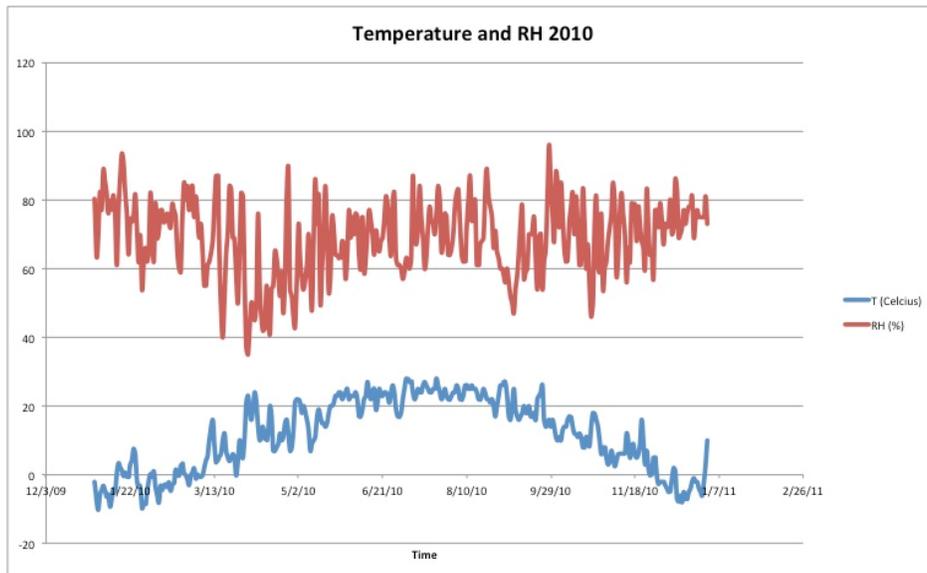
Figure 48. Daily Average Temperature and Relative Humidity vs. Time for the year 2010.

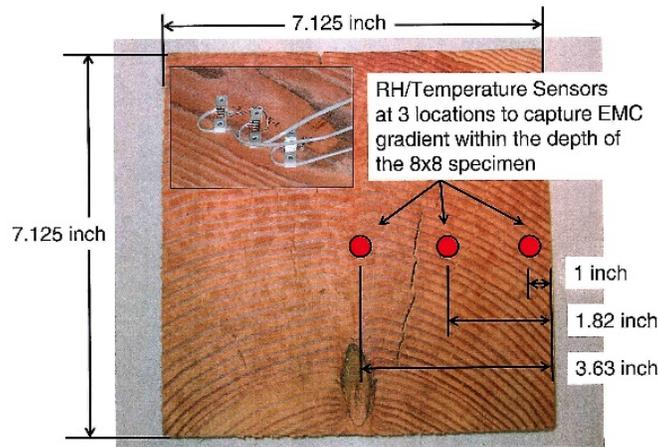
Figure 49. Sensirion SHT 25 sensors installed at three different depths of the 8" x 8" member.

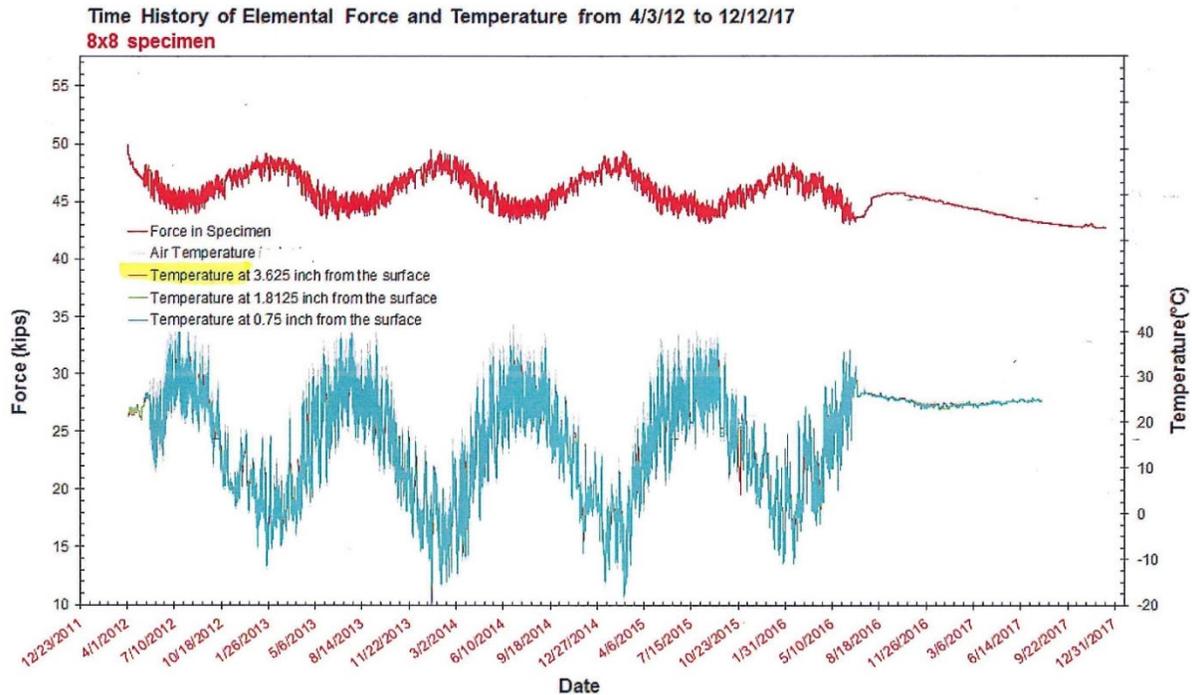
Figure 50. Force and temperature time histories.

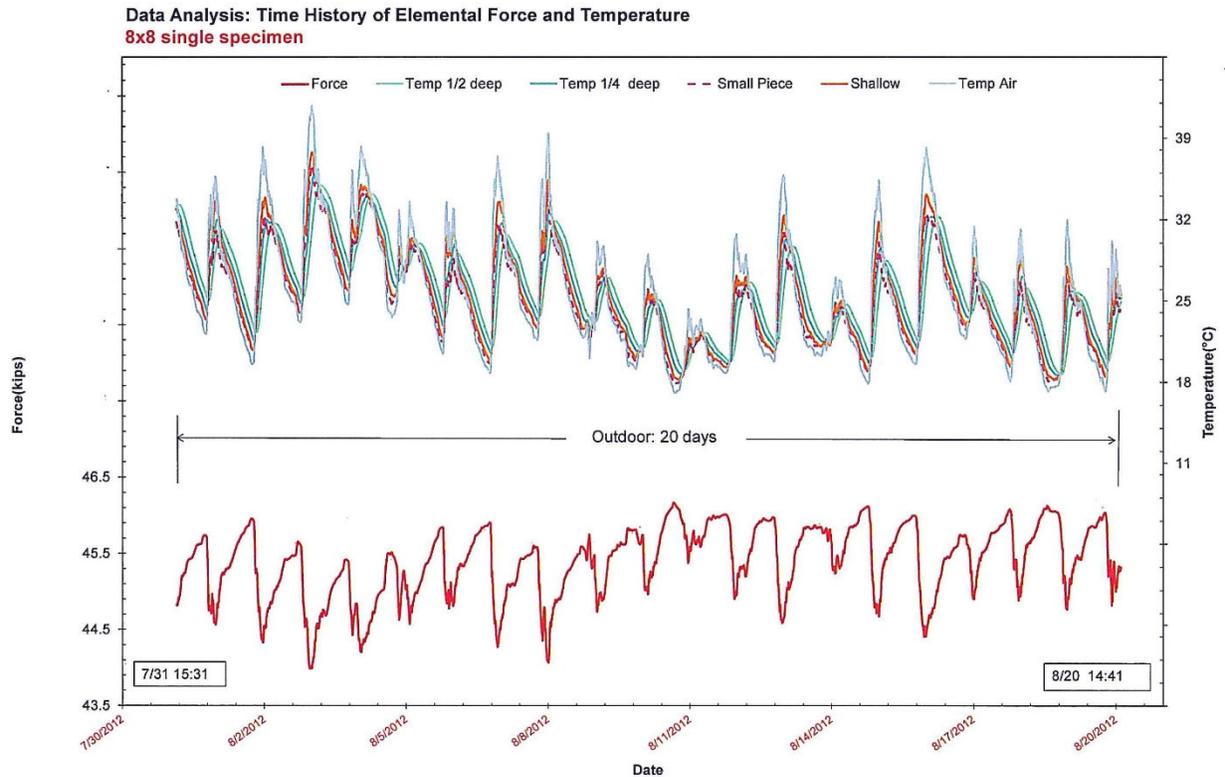
Figure 51. Time histories of force and temperatures for a period of twenty days.

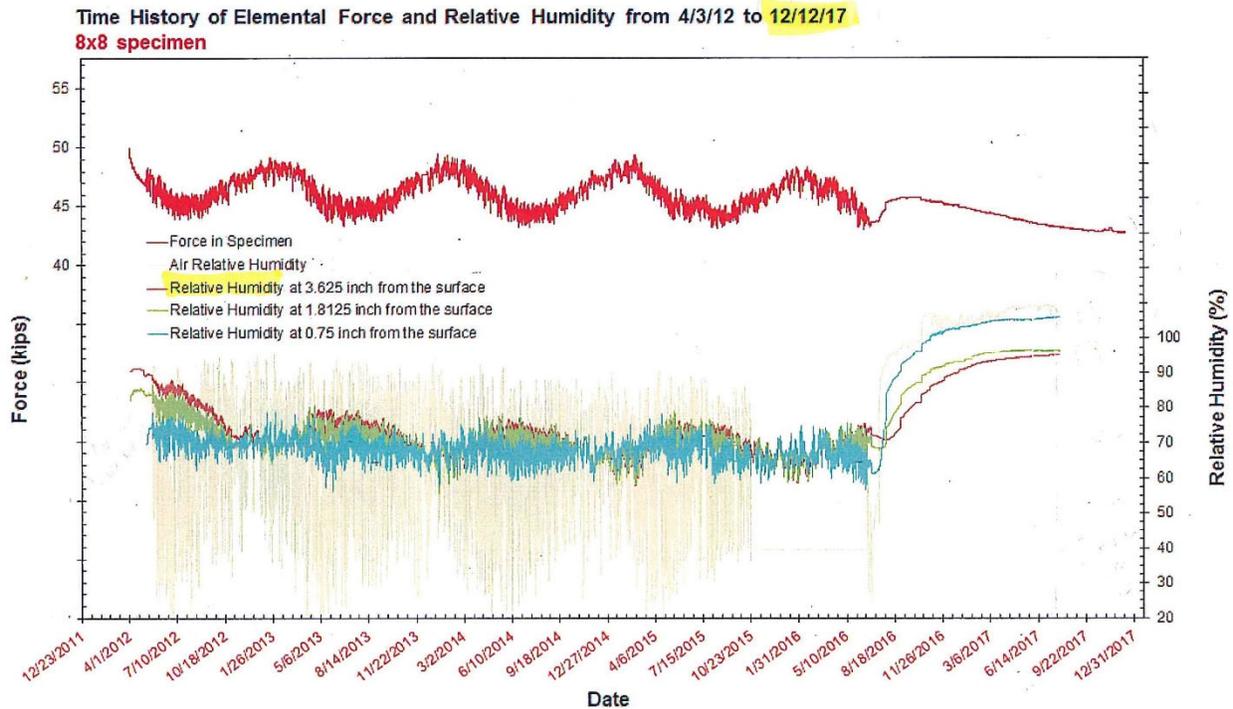
Figure 52. Time histories of force and relative humidity.

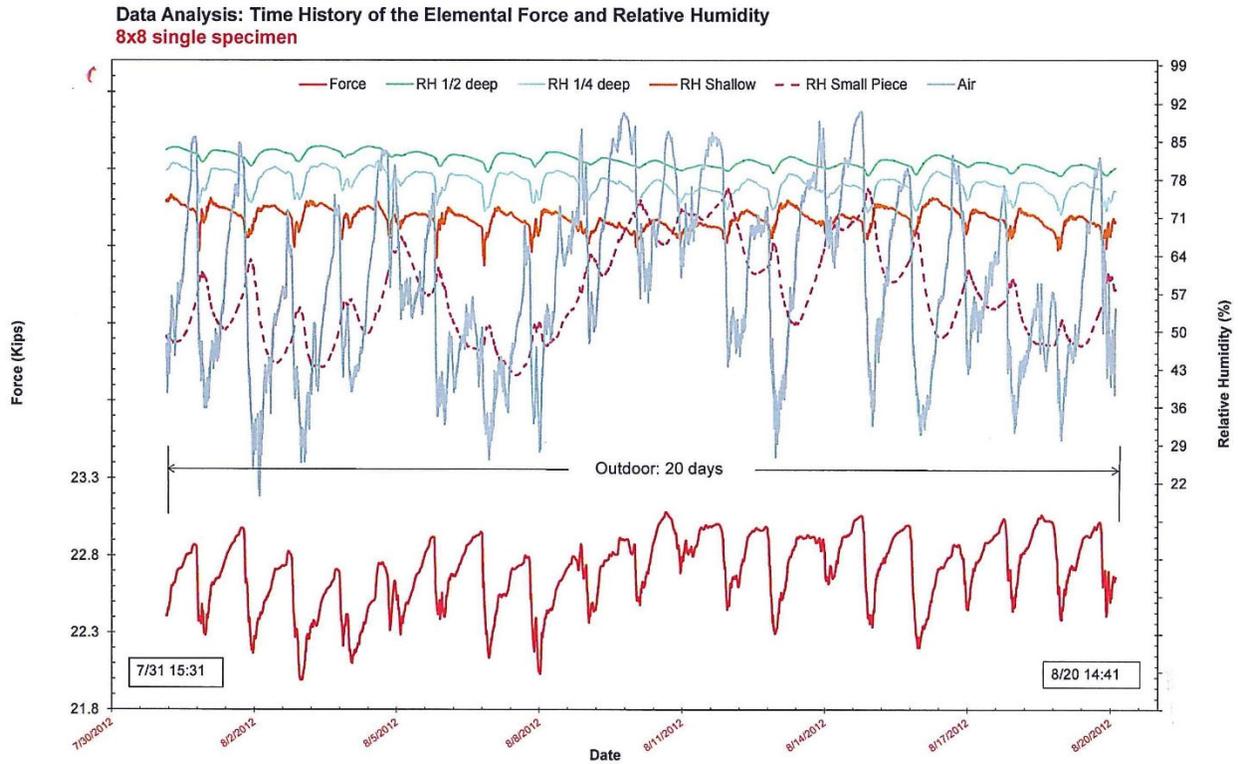
Figure 53. Time histories of force and RH over twenty summer days.

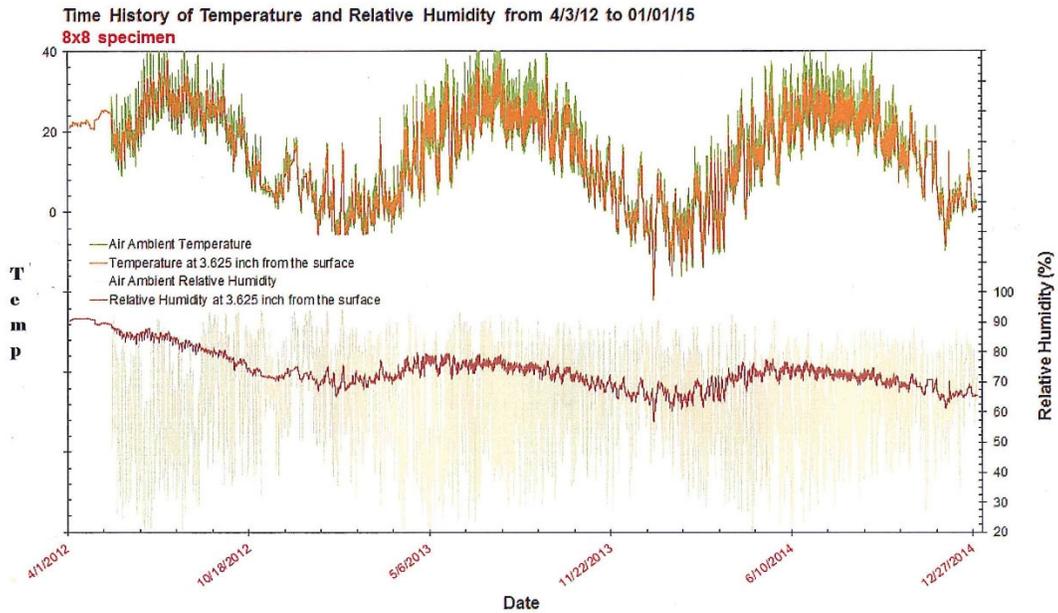
Figure 54. Time histories of RH for two years and eight months.

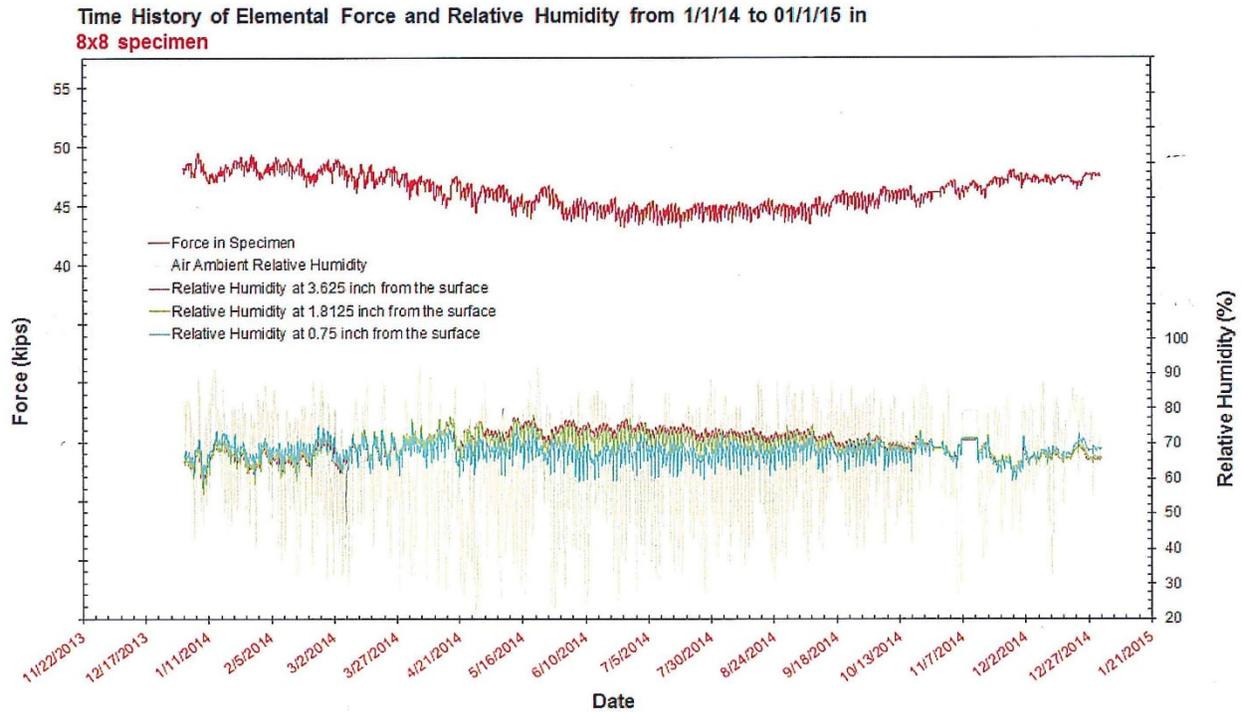
Figure 55. Time histories of RH over a period of approximately one year.

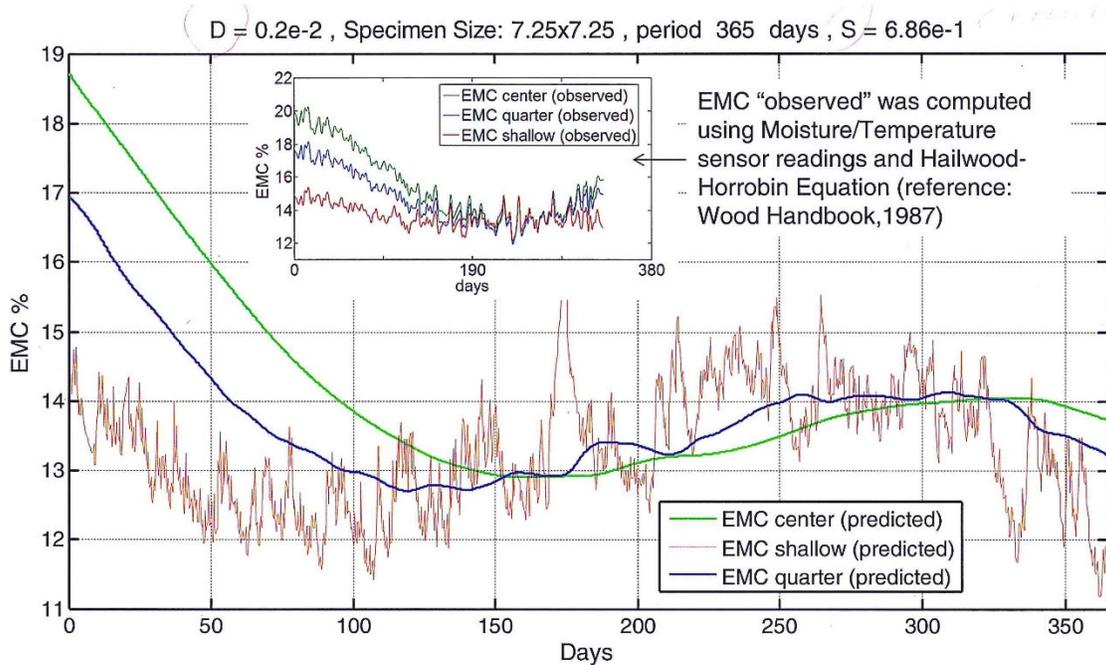
Figure 56. Time histories of equilibrium moisture contents.

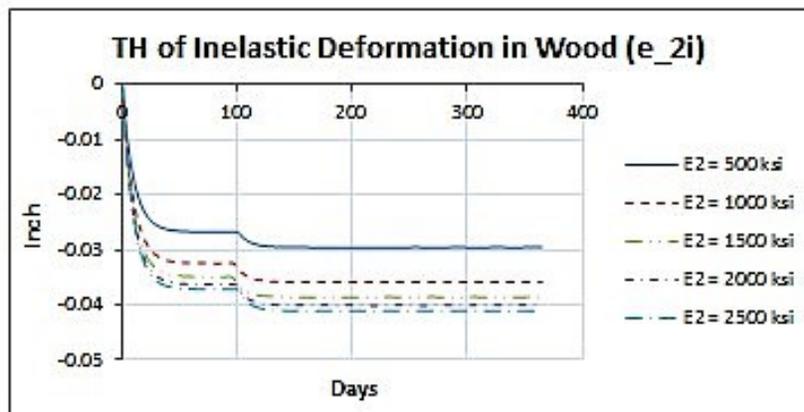
Figure 57. Time histories of viscous strain when re-tightening is done at 100 days.

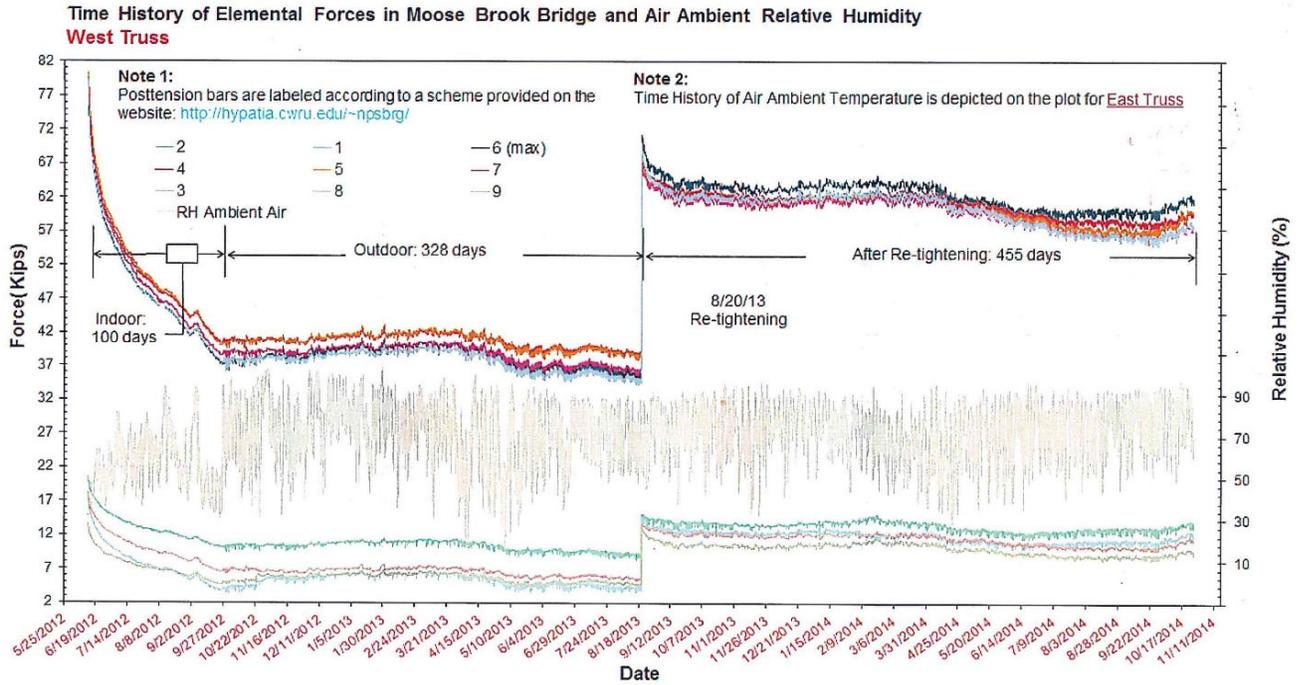
Figure 59. Time histories of member forces and atmospheric RH.

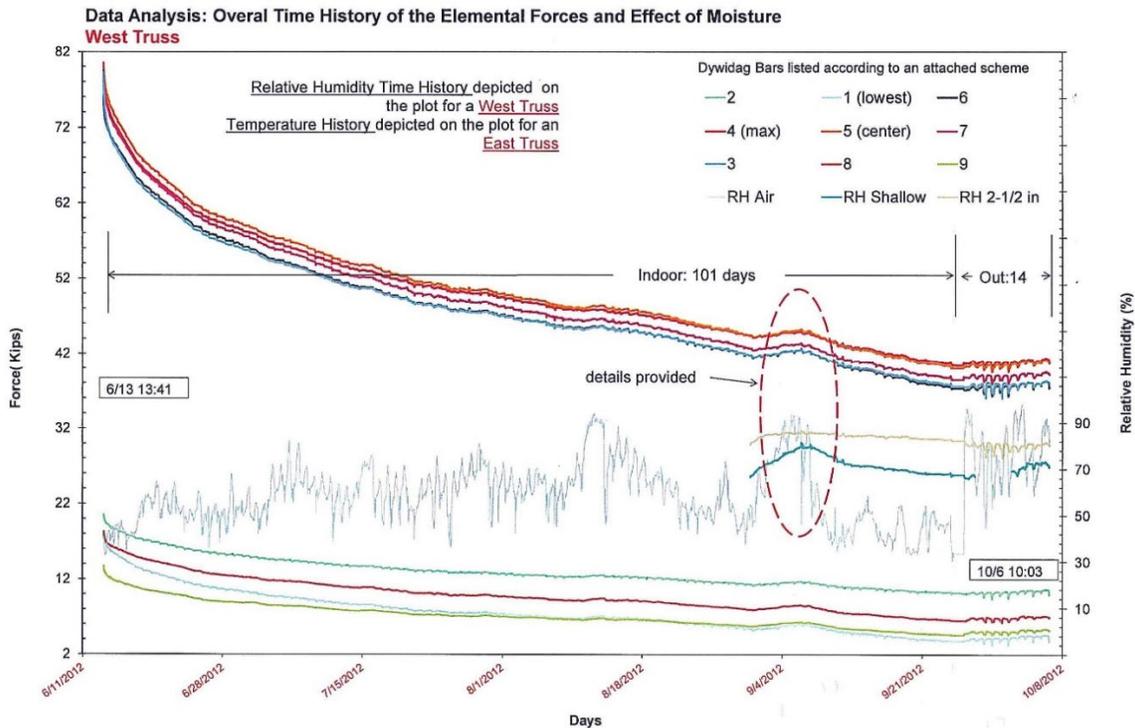
Figure 60. Time histories near the occurrence of a steam-return-line leak in the laboratory.

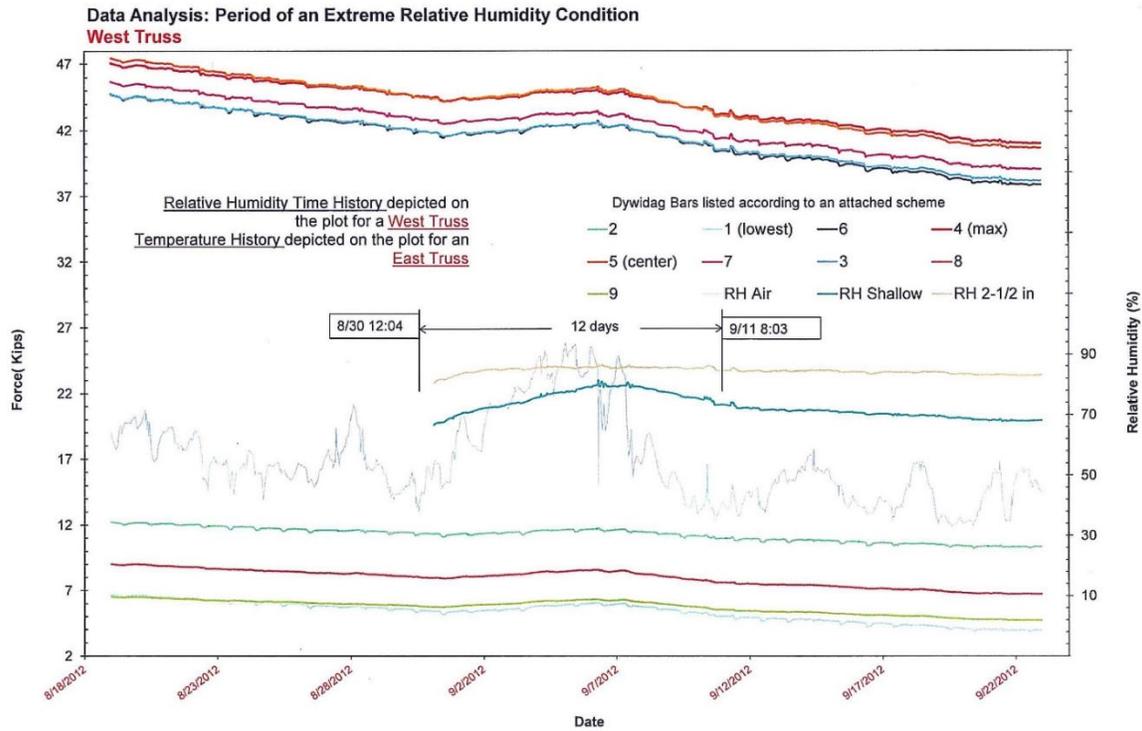
Figure 61. Time histories near the occurrence of a steam return line leak.

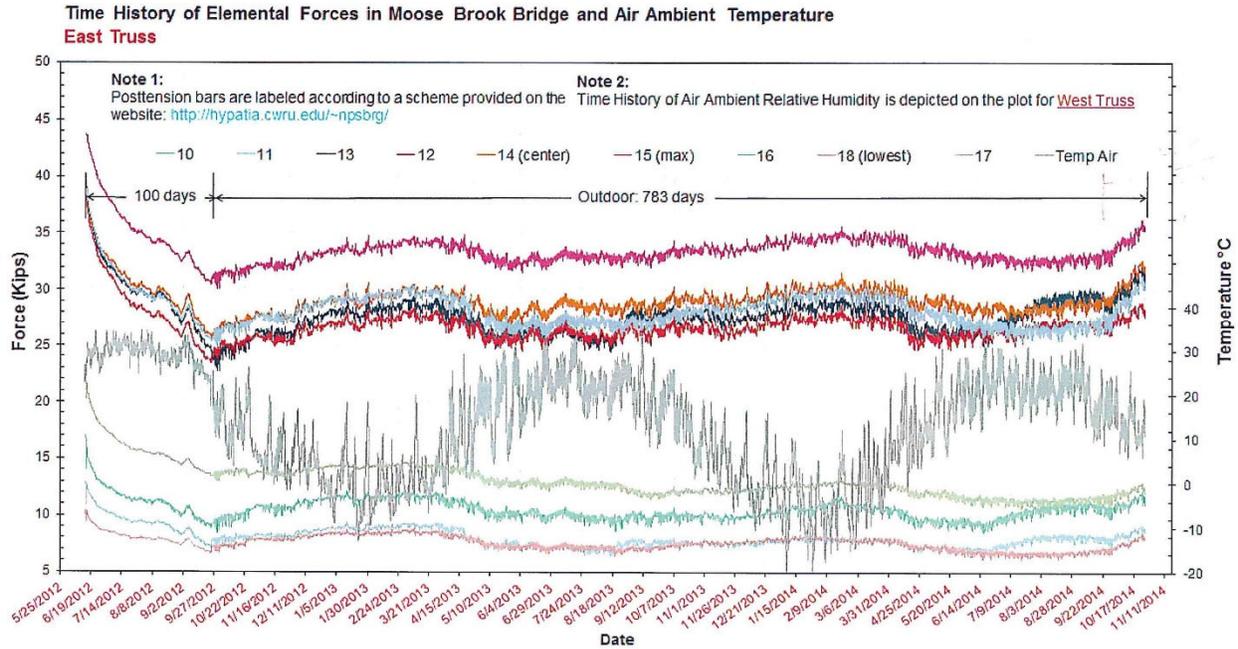
Figure 62. Time histories of bar forces and atmospheric temperature for the East truss.

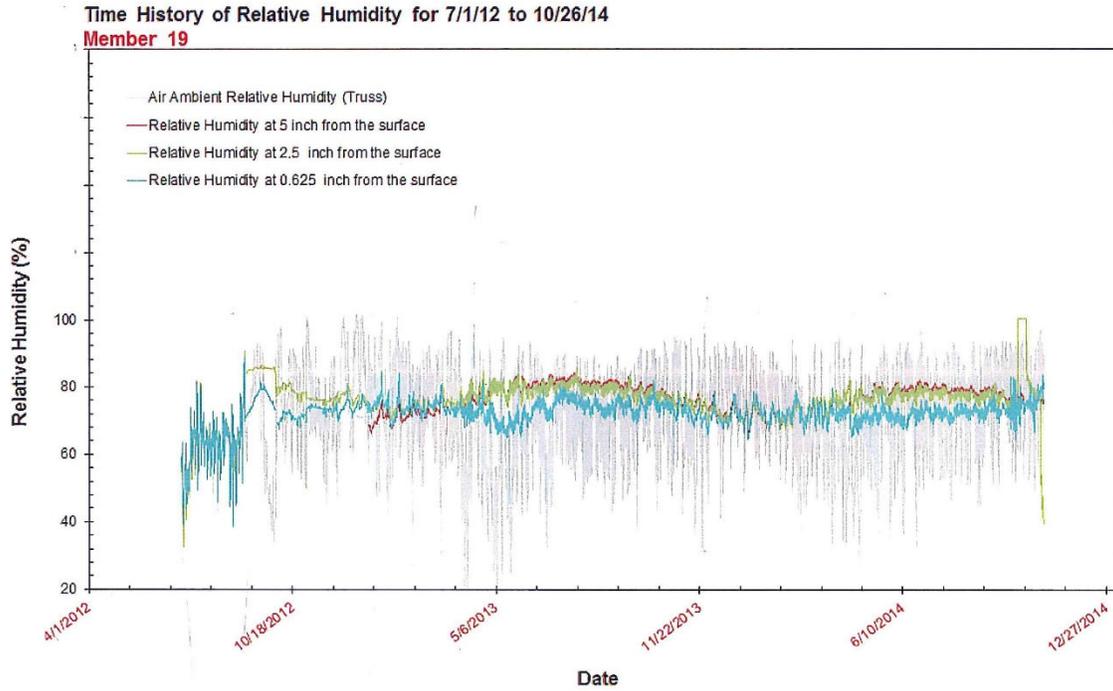
Figure 63. Time histories of wood RH at various depths.

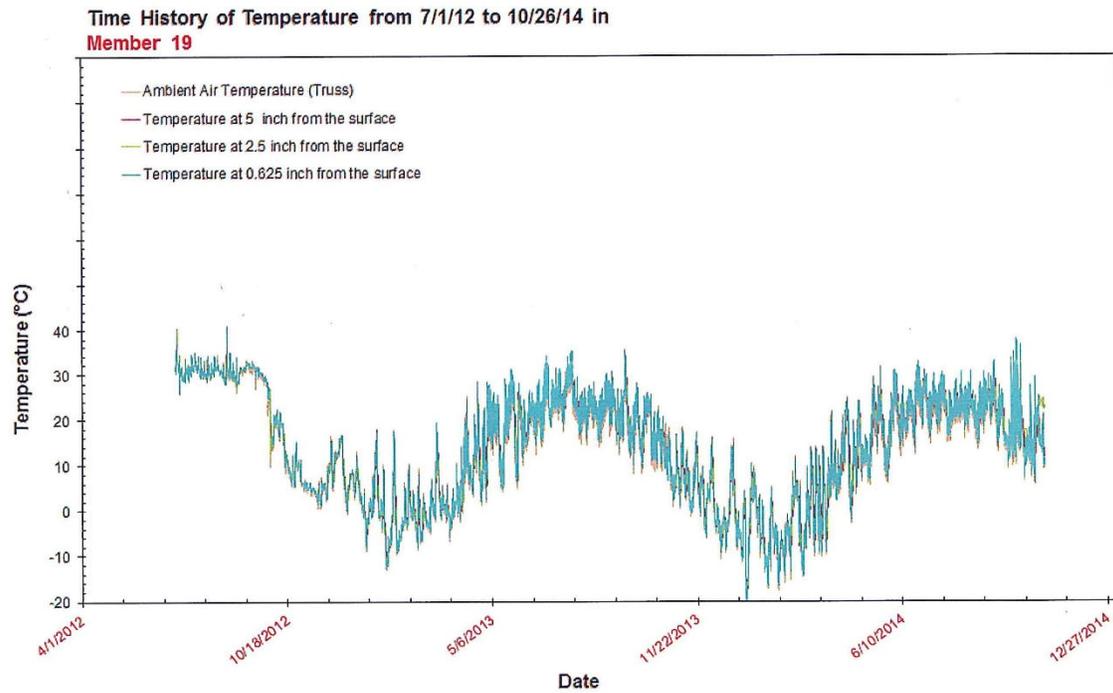
Figure 64. Time histories of wood temperature at various depths.

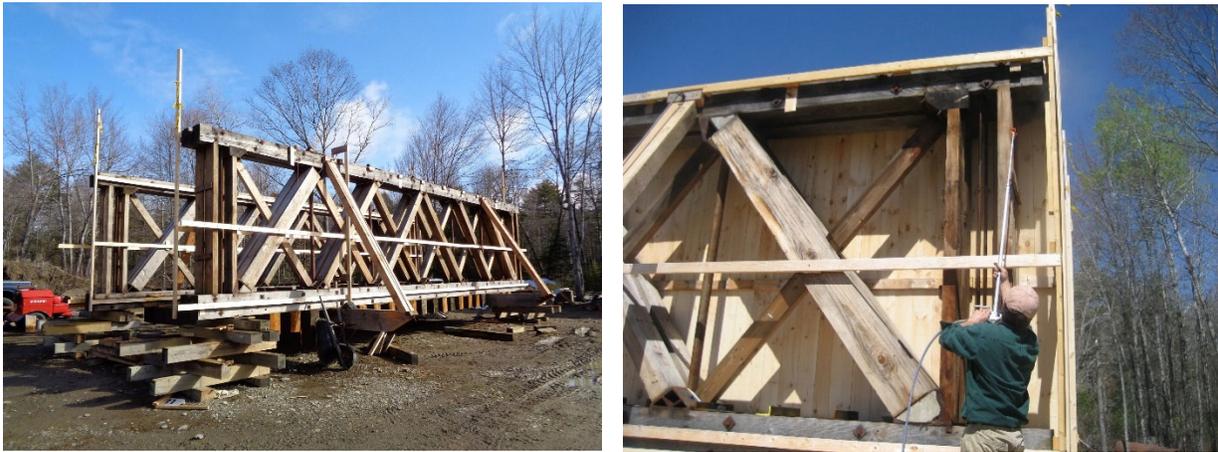
Figure 66a-b. Reassembled Howe trusses with outriggers. Timothy Andrews sprayed NoChar fire retardant on all truss members and planks of siding, May 2018.

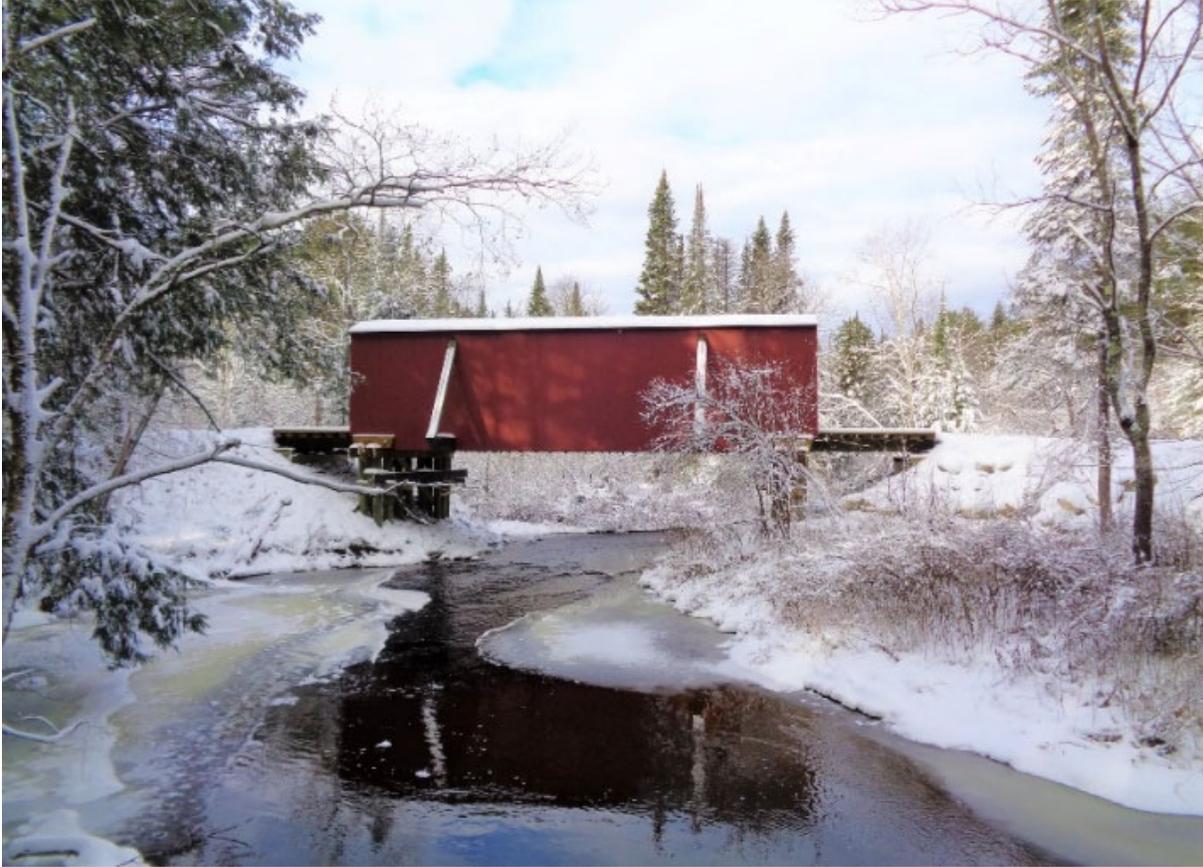
Figure 67. Completed Moose Brook Bridge over Trout Brook in Alna, Maine, on the future WW&F excursion line, December 2018. WW&F photo.
