**HISTORIC AMERICAN ENGINEERING RECORD  
ANALYZING COVERED BRIDGE FLOOR SYSTEMS  
HAER No. NH-53**

**LOCATION:** Beebe River Road, Campton Hollow, Grafton County, New Hampshire. The bridge model was located at latitude: 43.829946, longitude: -71.648767. This coordinate was obtained in October 2017, using a GPS mapping grade unit accurate to +/- 3 meters after differential correction. The coordinate's datum is North American Datum 1983. The bridge model location has no restriction on its release to the public.

**STRUCTURE TYPE:** Town lattice wooden truss bridge

**SIGNIFICANCE:** It has been observed that current methods of calculating the strength of the timber floor systems of covered bridges seem to underestimate the actual strength of these systems to a greater extent than would be explained by the factors of safety used in conventional calculations. If so, historic covered bridge systems may be unnecessarily replaced, or load limits may be set so low that bridge replacement becomes probable. To explore apparent differences between current design practices and actual floor performance, researchers instrumented the floor of a Town lattice covered bridge with transducers and th

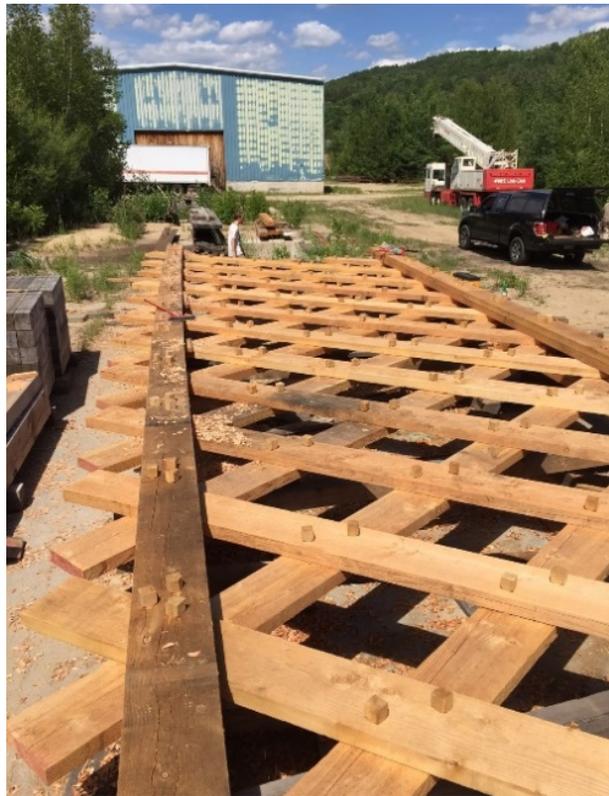
**Figure 1a.** Constructing the test bridge, a Town lattice truss, in the spring of 2016.

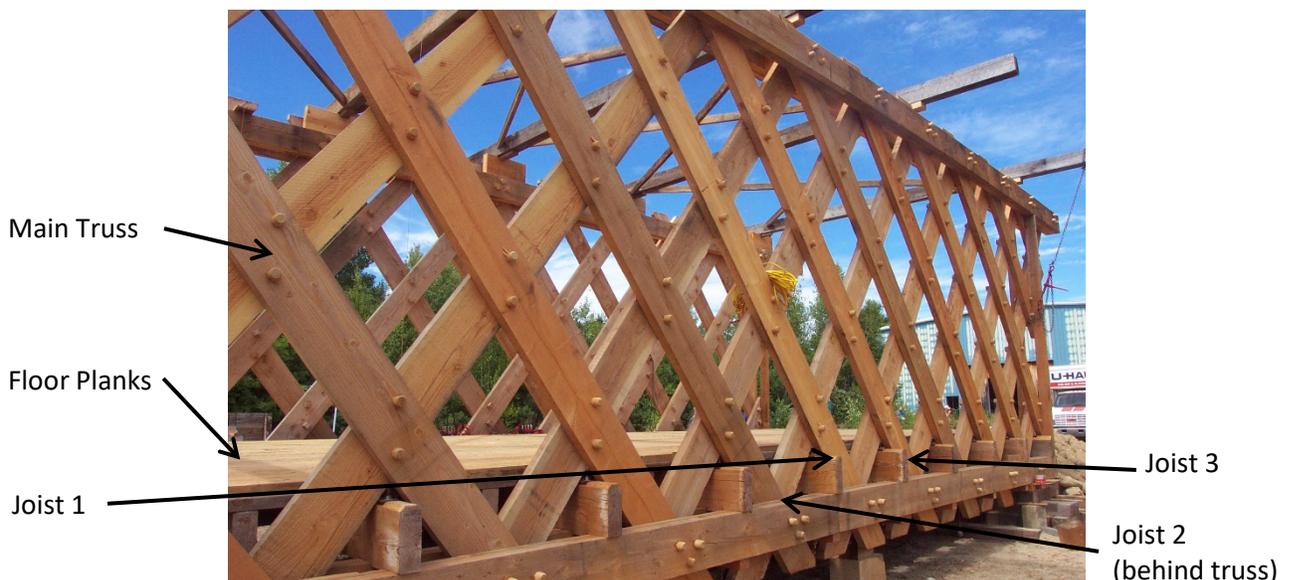
**Figure 1b.** The bridge is ready for testing in July 2016. Note alternate joists sticking through the lattice and sitting on the outer lower chord member.

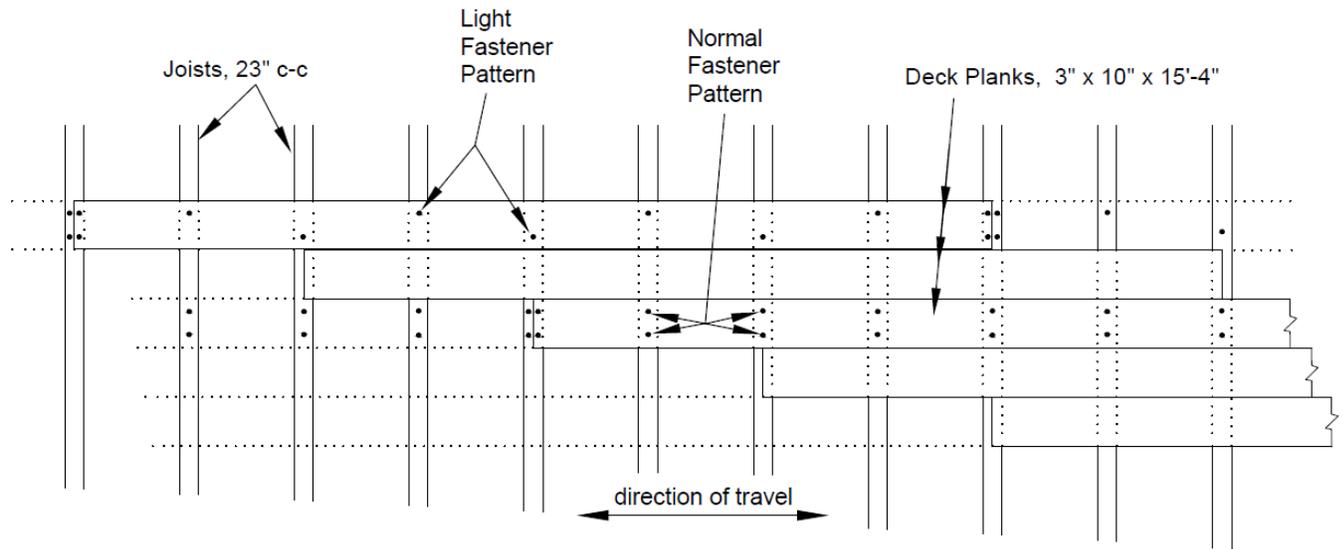
**Figure 3.** Plan view of deck, showing plank stagger and fastener patterns.

Then, three test runs were made with “light” screws used. This spatial density is occasionally found in covered bridge decks, but is less common than “normal” fasteners. The locations of light and normal fasteners are shown in **Figure 3**. Following the “light” fastener runs, the number of screws was almost doubled to get the “normal” screws configuration, and four more test runs were made. The screws used were 6" long GRK 5/16" RSS screws (**Figure 4**) having an actual shank diameter of 0.23". Screw holes were piloted through the deck boards so that the boards would be tightly clamped to the joists.

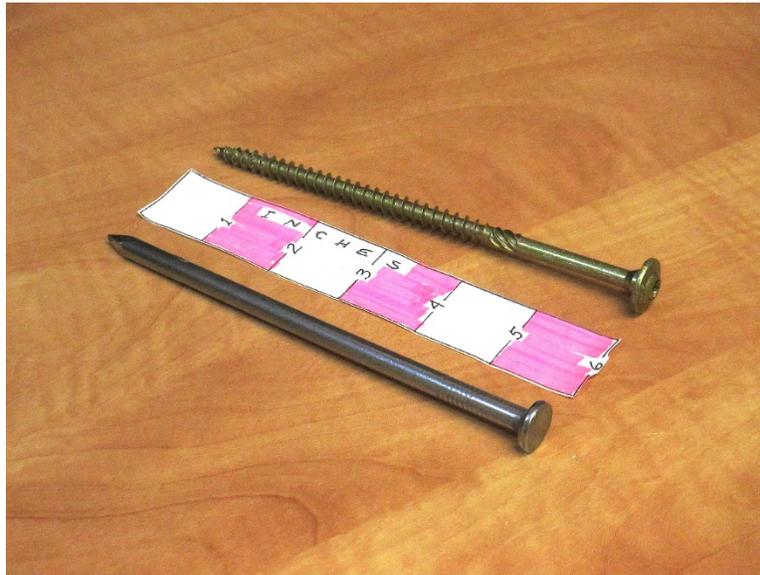
**Figure 4.** The two types of fasteners used to attach deck to joists. Top one is a 6" GRK screw. Bottom one is a 60 penny spike.

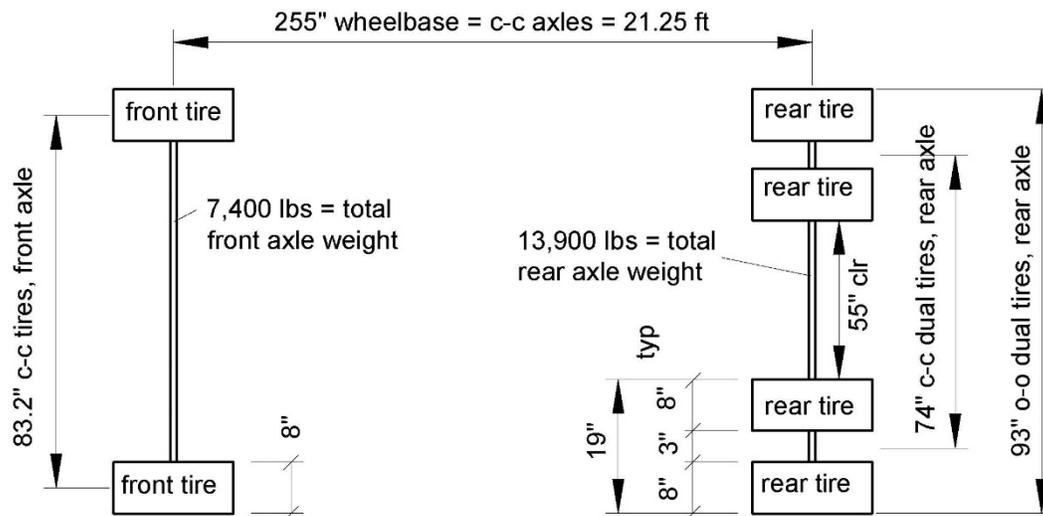
**Figure 5.** Tire geometry of test truck and weights of each axle during tests.

The day before the testing, the team rented truck scales and brought them to the test site (**Figure 10**). A box truck was also rented and its wheel locations carefully measured to the nearest inch (**Figure 5**). The morning of the test work, while some volunteers were attaching strain gauges, others loaded cribbing timbers onto the test truck until its front axle weighed 7,400 pounds (with driver) and the rear axle weighed 13,900 pounds. After testing was finished, the truck was reweighed and found to be a negligible 50 pounds lighter, possibly due to fuel usage. The rear axle weight of the test truck corresponded to that of a 9-ton AASHTO “H-truck”.

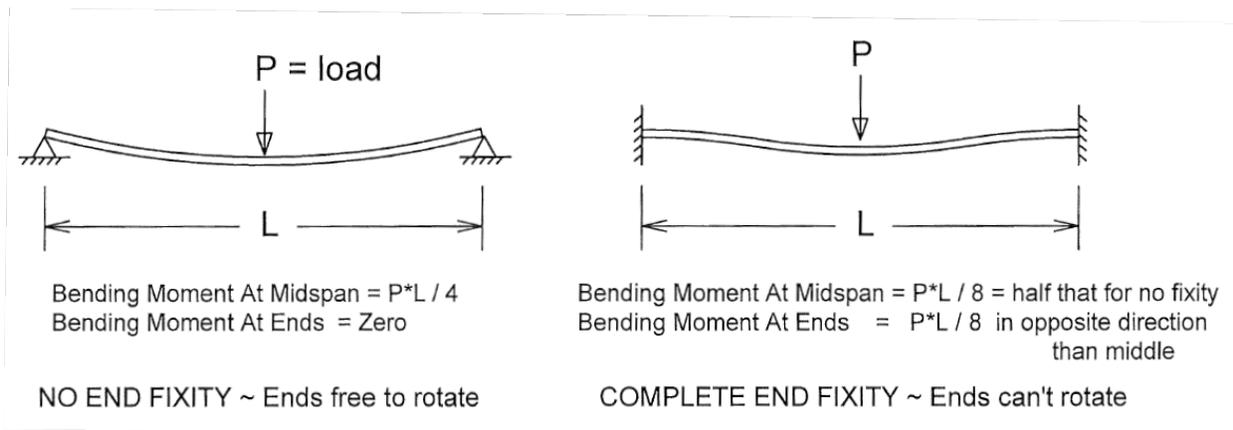
**Figure 6.** End fixity. Although vehicular loads are placed differently, this shows how fixing the ends of joists can reduce peak stresses in the joists. When joists are bolted to the supporting trusses, the trusses provide some resistance to rotation of the joist ends.

As briefly described in Section II, fixing the ends of joists so they can't rotate increases stresses and strains near the joist ends but decreases stresses near midspan. Since the ends of every second joist are bolted to the main trusses, the trusses might supply such end fixity. **Figure 6** illustrates the concept. The relative magnitudes and signs (tension or compression) of strains at the ends of the joists, strains at joist midspan and at strains under the wheel line should indicate whether or not end fixity was a significant effect. Finally, it seemed instructive to compare the rotations of the truss lower chords with the slopes of the joists there that would be required to produce the measured midspan deflections of the joists. Lower chord rotation could reduce the magnitude of any joist end fixity effect.

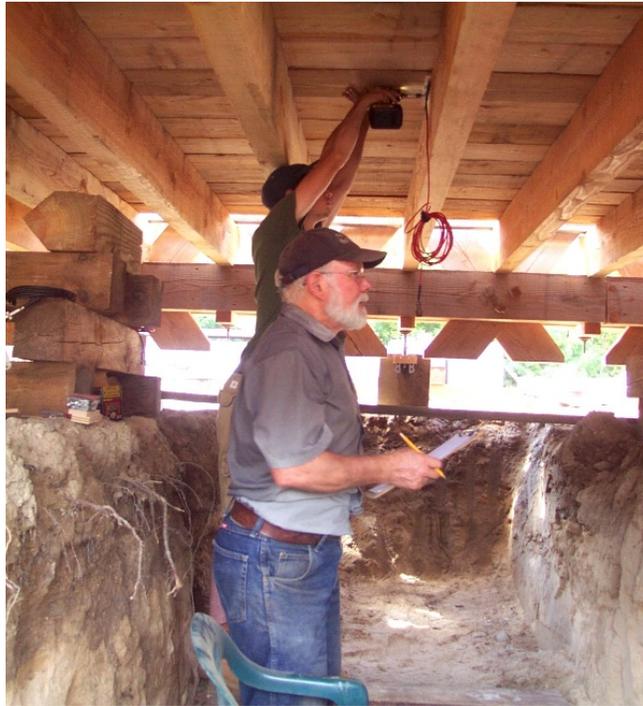
**Figure 7.** Starting to install strain transducers. The trench made it possible to access the joists without raising the deck much above the surrounding ground.

To facilitate the movement of the test truck at speed, the bridge was supported with bottom of joists only 30" above ground. Therefore a trench was dug (**Figure 7**) to facilitate installation of the gauges.

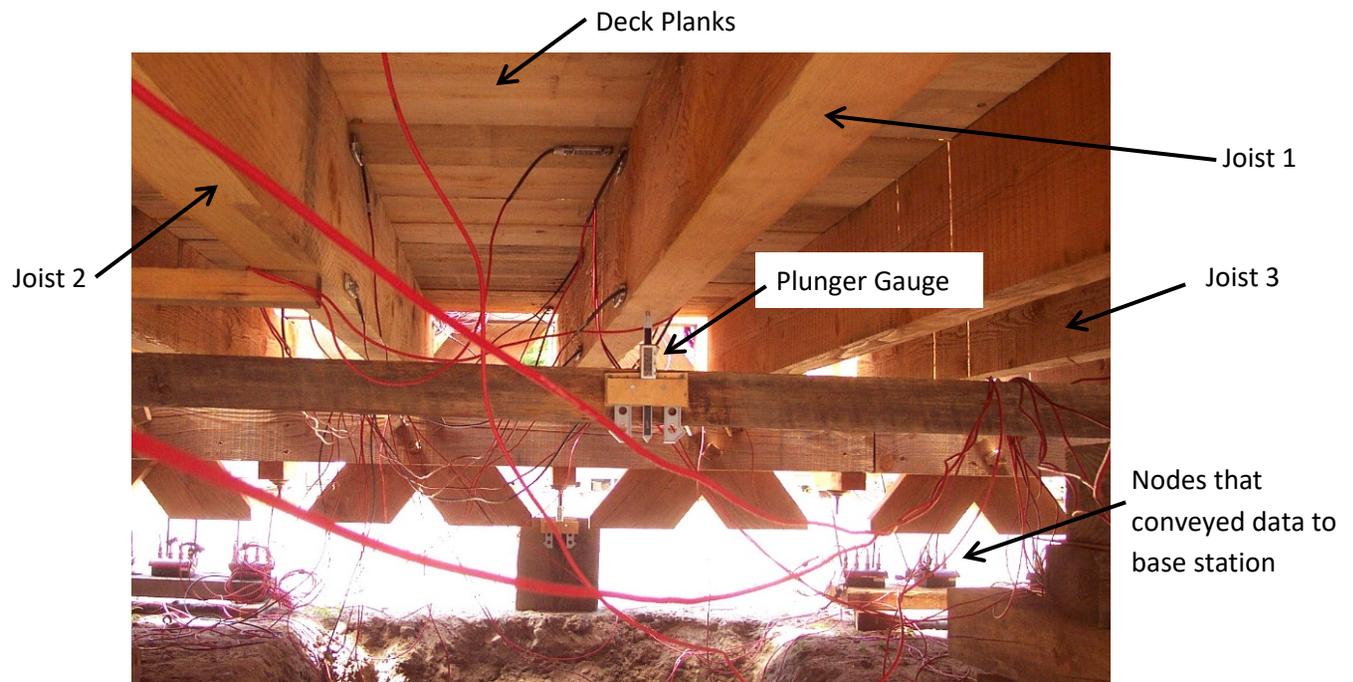
**Figure 8.** Transducers mounted on joists 1 (to right) and 2 (to left). Nodes that transmit transducer outputs to base station are visible, as are the plunger gauges at midspan and west end of joist 1. Each node can handle four transducers.

In addition to the strain gauges, plunger gauges measuring vertical deflections were mounted below joist 1 at midspan and at both ends. These (visible in **Figure 8**) provided direct readouts of the maximum deflection of joist 1. They also measured truss deflection and provided a connection between peak strain readings for joist 1 and its midspan deflection. They also provided independent measures of the effects of changing parameters such as increasing the density of fasteners or adding a second decking layer. Vertical deflections of the ends of the trusses were also measured, but proved to be so small that they could be ignored.

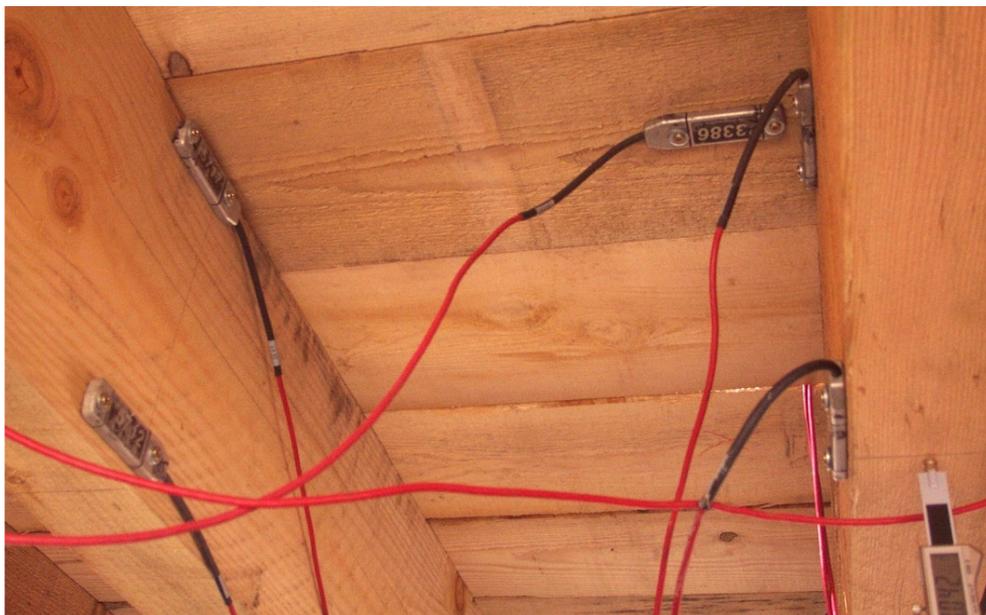
**Figure 9.** Detail view of strain transducers at midspan of joists 1 (to right) and 2, and one mounted on the bottom side of deck.

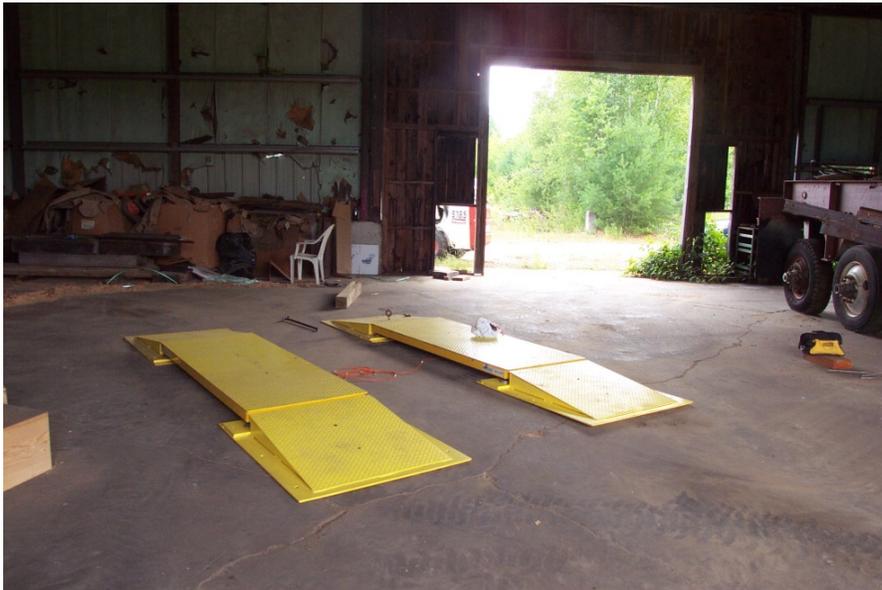
**Figure 10.** Truck scales leased to provide accurate weights of both axles.

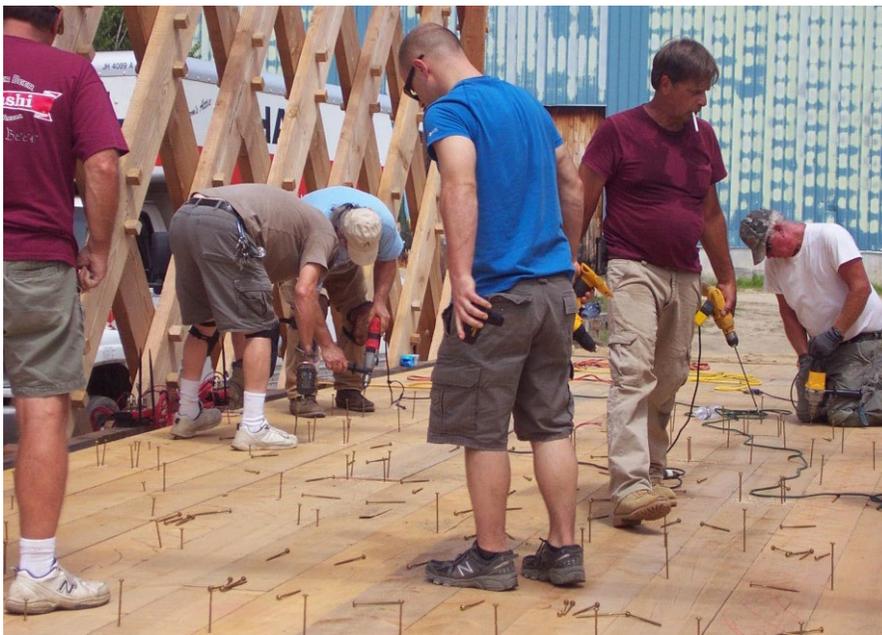
**Figure 11.** Attaching the first layer of deck using GRK timber screws.

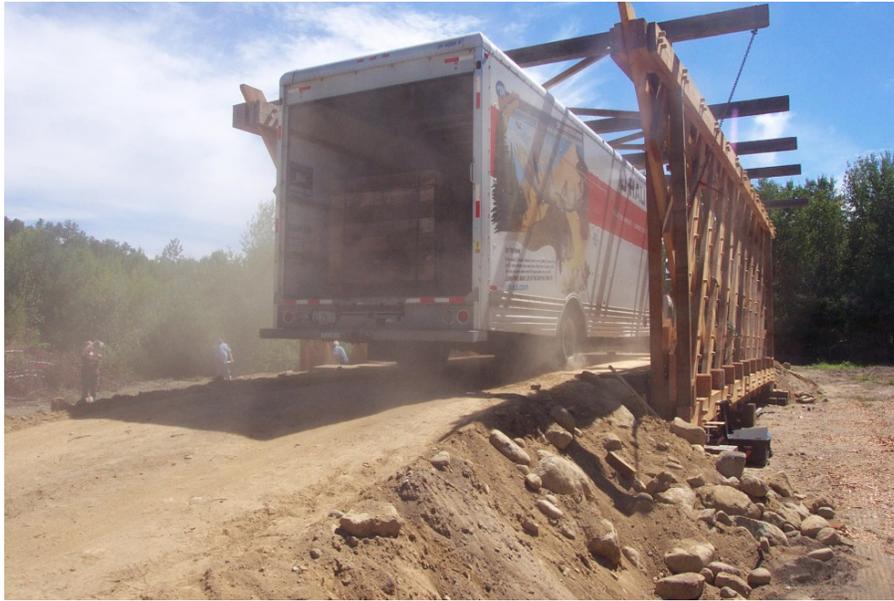
**Figure 12.** Test truck entering the bridge for one of the test runs.

sideways stiffness of the tires (duals on rear axle, **Figure 12**). Not anticipating this possible action, the sideways stiffness of the truck axles was not measured. But such a behavior could explain all results. It would explain why the difference between top and bottom strains was observed even for test runs made with an unfastened deck. This would require that friction between the deck boards and joist tops was significant when the tires were directly over that spot. It would also explain why the strain difference remained relatively the same for all fastened runs (**Table 2**), and why the upper joist strains were always less than the bottom strains.

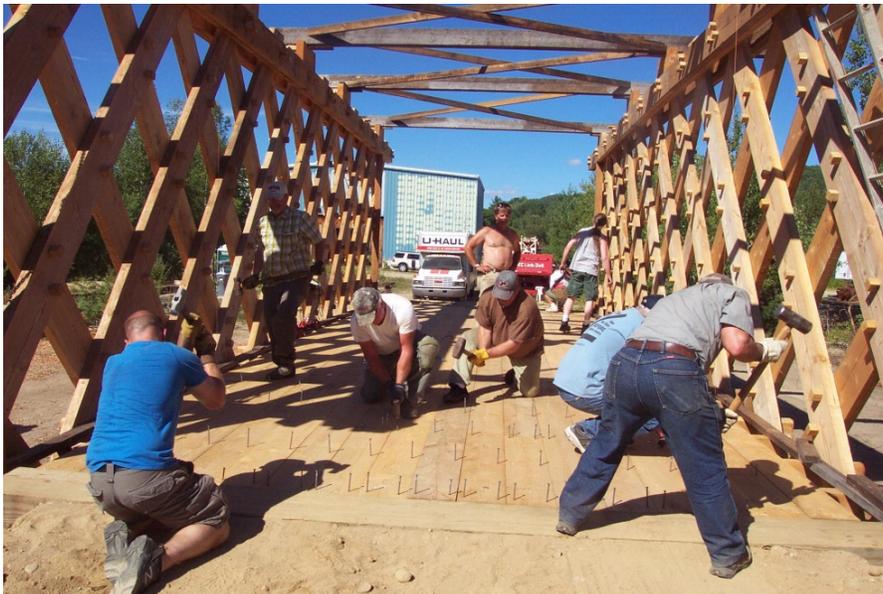
**Figure 13.** After removing the deck screws, reattaching the deck with the 60 penny spikes.

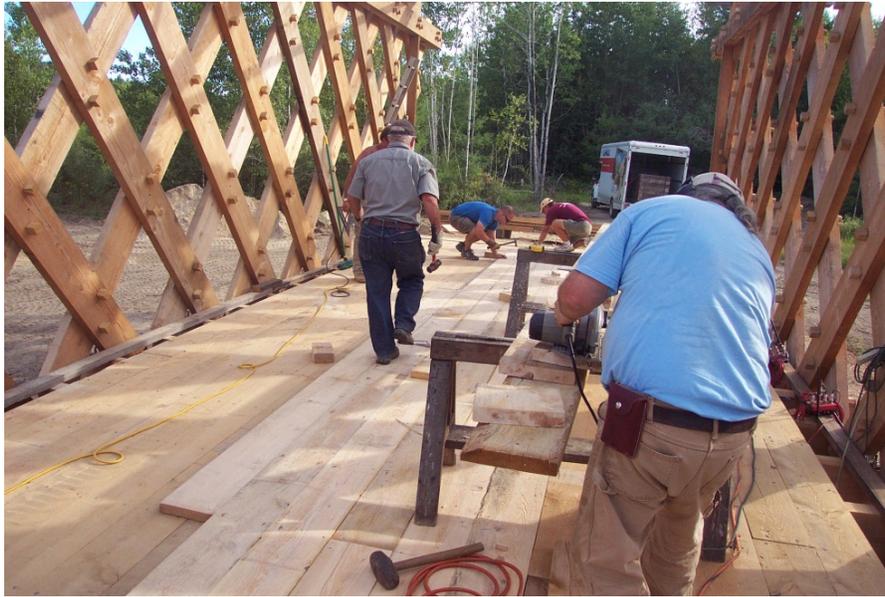
**Figure 14.** Installing the second layer of decking. Seams between top planks lie along mid-width of bottom planks.

Finally, a second layer of 2" x 10" deck boards was added. These ran parallel to the bottom boards, and had the same width, but the seams between top layer boards were placed along the mid-width of each bottom layer board. The top layer was attached using the “normal” configuration of spikes, which were two fasteners in each board at each joist. The top layer not only produced a thicker deck, but the upper layer provided a connection between adjacent bottom layer boards so the bottom layer boards could not act independently along the joists’ length by having small cracks between them open or close unhindered (the “seating effect”) as the joists deflected under load. Thus, it was expected that adding the second deck layer would produce observable changes to strains and joist deflections.

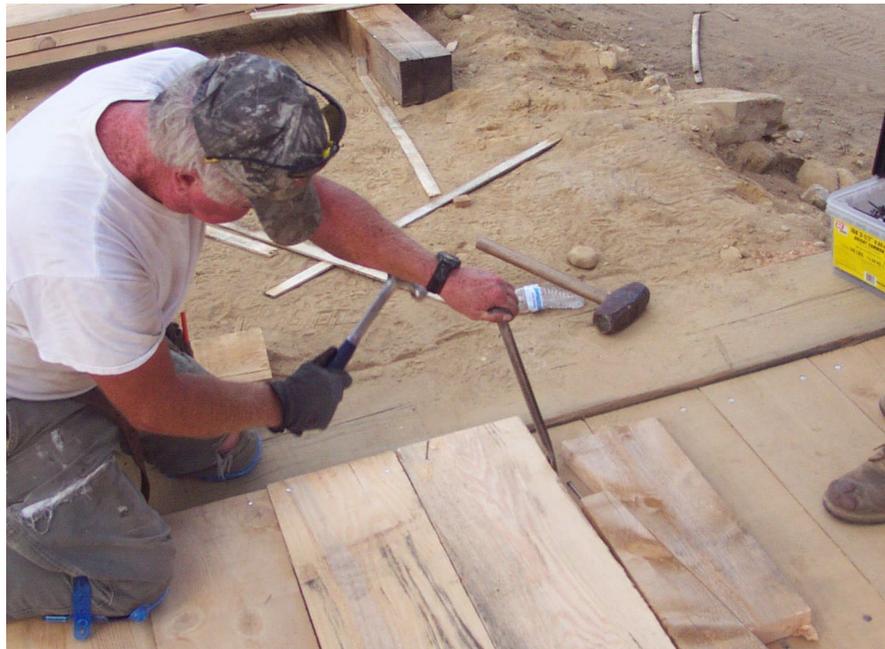
**Figure 15.** Installing the second layer of deck planks. A pry bar with tip embedded in bottom layer is used to make boards tight against one another as they are nailed.

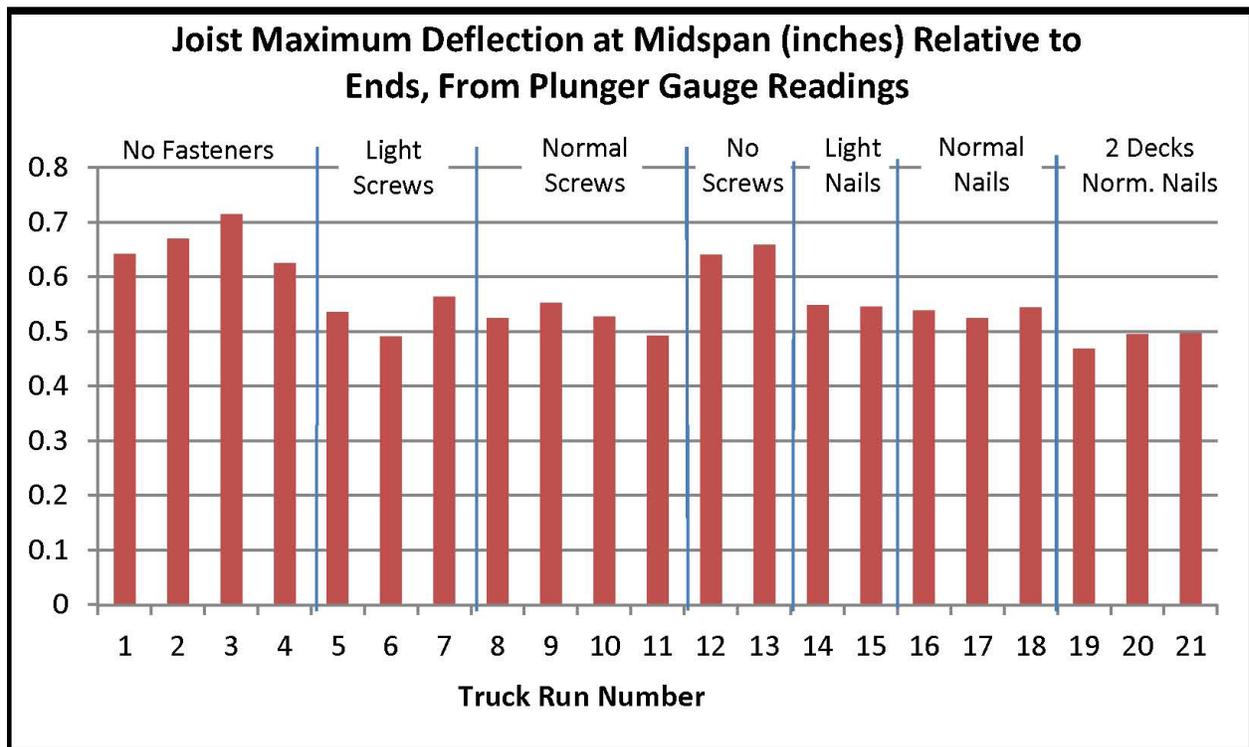
- 1) The no fasteners runs had the greatest deflections. This could be expected because load sharing with nearby joists would be reduced. Without fasteners, only floor planks directly under the truck tires would deflect with the load and thus transmit some load to adjacent joists. The other planks would just remain straight and transfer no load. Also, there could be no T-beam effect since the deck and joists were not connected. The no-fasteners condition is not an operational condition for covered bridges. However, for this testing it provided baseline data against which the magnitude of the beneficial effects of fasteners could be judged.

- 3) There were no significant differences in the deflections for any of the other test runs. Midspan deflections did not vary with type of fastener, density of fasteners, or truck speed, at least within the ranges of each variable tested.

**Figure 16.** Maximum deflection of joist 1 at midspan relative to average of truss deflections at joist 1, from each test run.

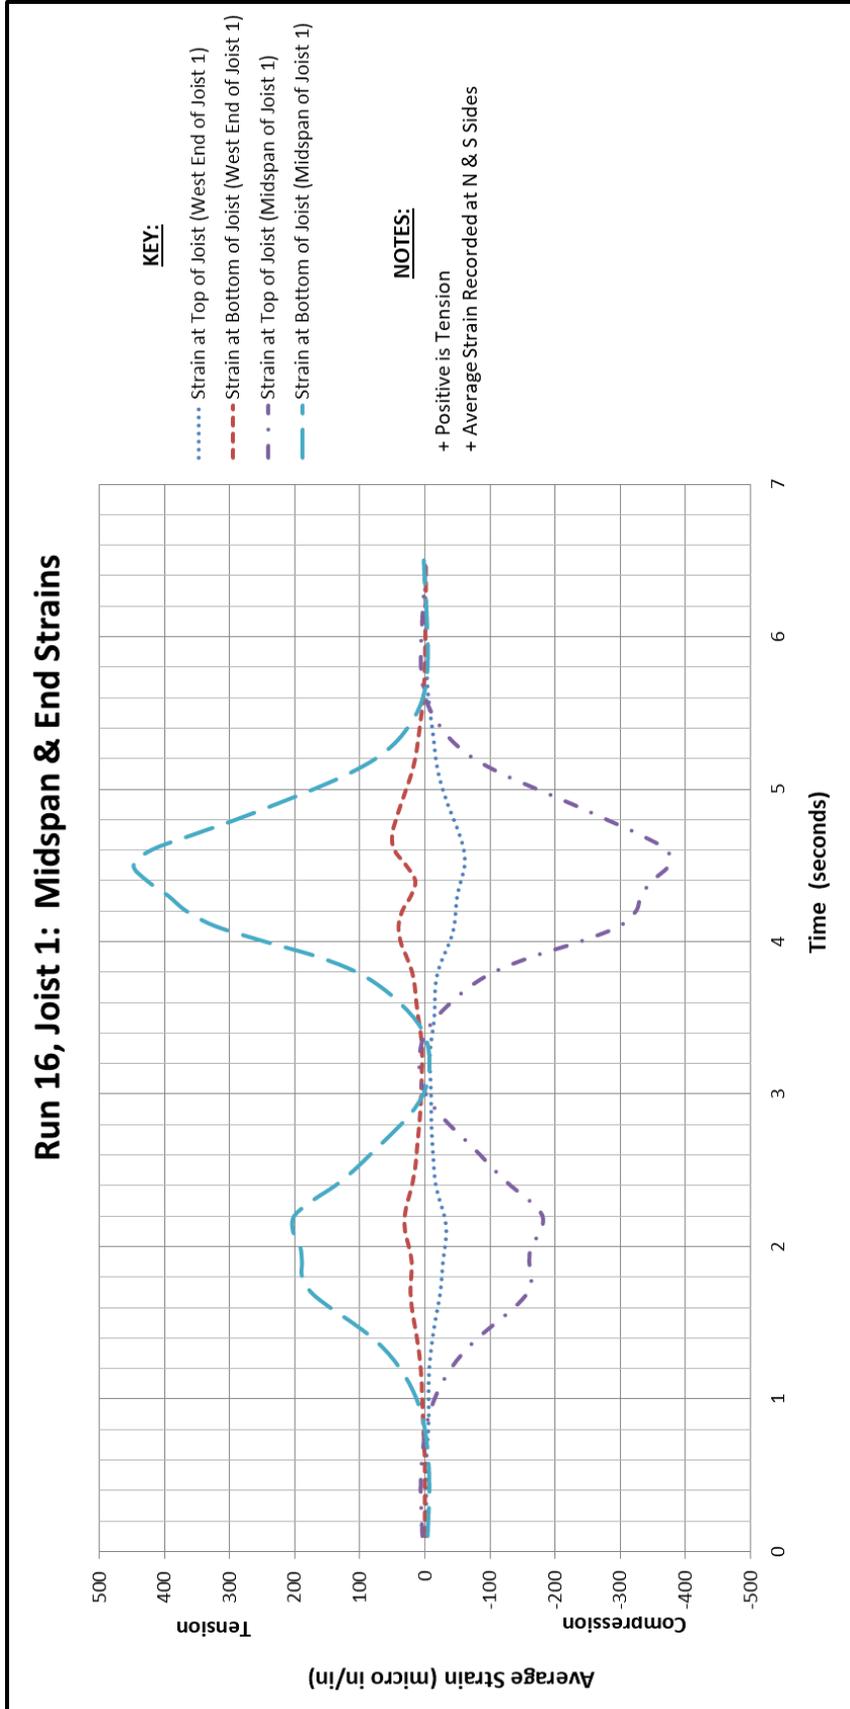
- a) The maximum strains at midspan are much greater than those at either end. Midspan strains reach about  $400 \times 10^{-6}$  in/in while the end strains all wiggle around close to zero. Yet, if the joist's ends were perfectly fixed, the end strains would be greater than the midspan strains. The most significant observation here is that there appears to be no end fixity. This hypothetical effect probably does not occur in Town lattice trusses. Furthermore, what little strains were found at the joist end, actually a few inches from the lower chord bearing point, were tension on the bottom and compression on the top, the opposite of the negative moment that would exist there if the joist ends were fixed. Truss rotation could explain that, but calculations based on **Figure 24** shows that the lower chord twist is insufficient to do so.

- b) The passage of each truck axle is distinguishable, allowing the truck's speed to be calculated based on its measured 21'-3" wheelbase.
- c) The maximum tension strain, the average of the gauge readings on both sides at the bottom of joist, is greater than the average compressive strain (gauges at top of joist). This was observed for all test runs.

**Figure 17. Strains in joist 1 at midspan and ends.** Peaks for front and rear axle are distinct. End strains are small compared to midspan strains, despite the fact that joist ends are bolted to truss.

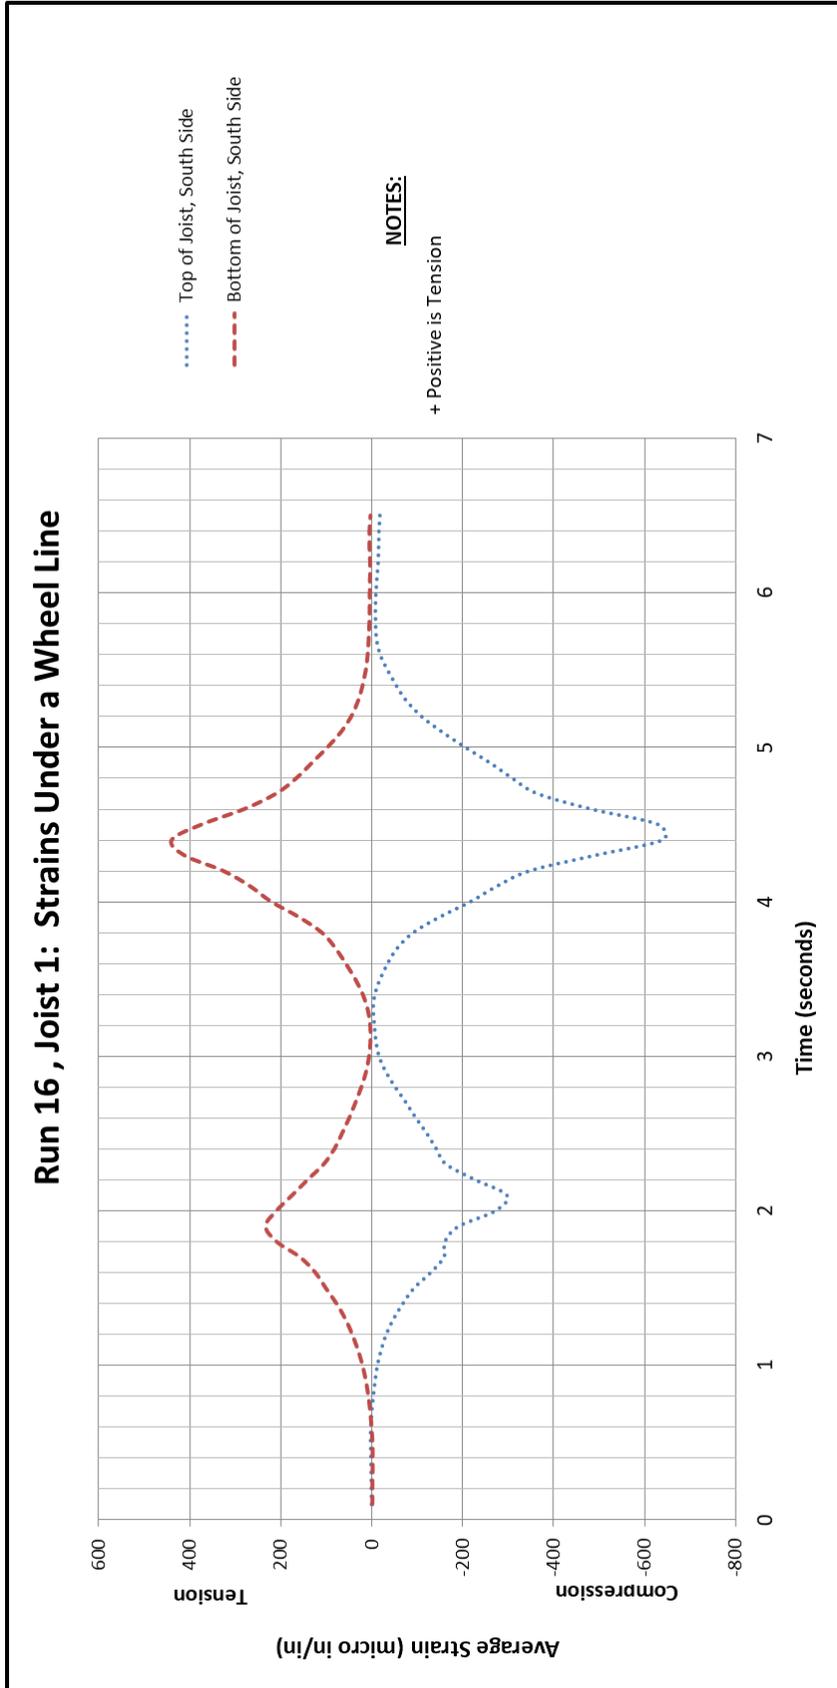
- a) The peaks here are sharper, more well-defined, than those at midspan of either instrumented joist. It is almost as if the strains get spread out the further from the application point they are measured. The base of the peaks, where strains approach zero, occupies about the same time span as those in Figure 17, but the shapes of the peaks are sharper.
- b) Maximum values of strain are about 30% greater than at midspan.
- c) The maximum value of compressive strain is greater than the maximum tension strain. This is the reverse of the situation at midspan, and was observed for every test run.

**Figure 18. Strains in joist 1 directly under a wheel line.**  
Peaks for front and rear axles are sharper than at midspan, and maximum magnitudes are greater.

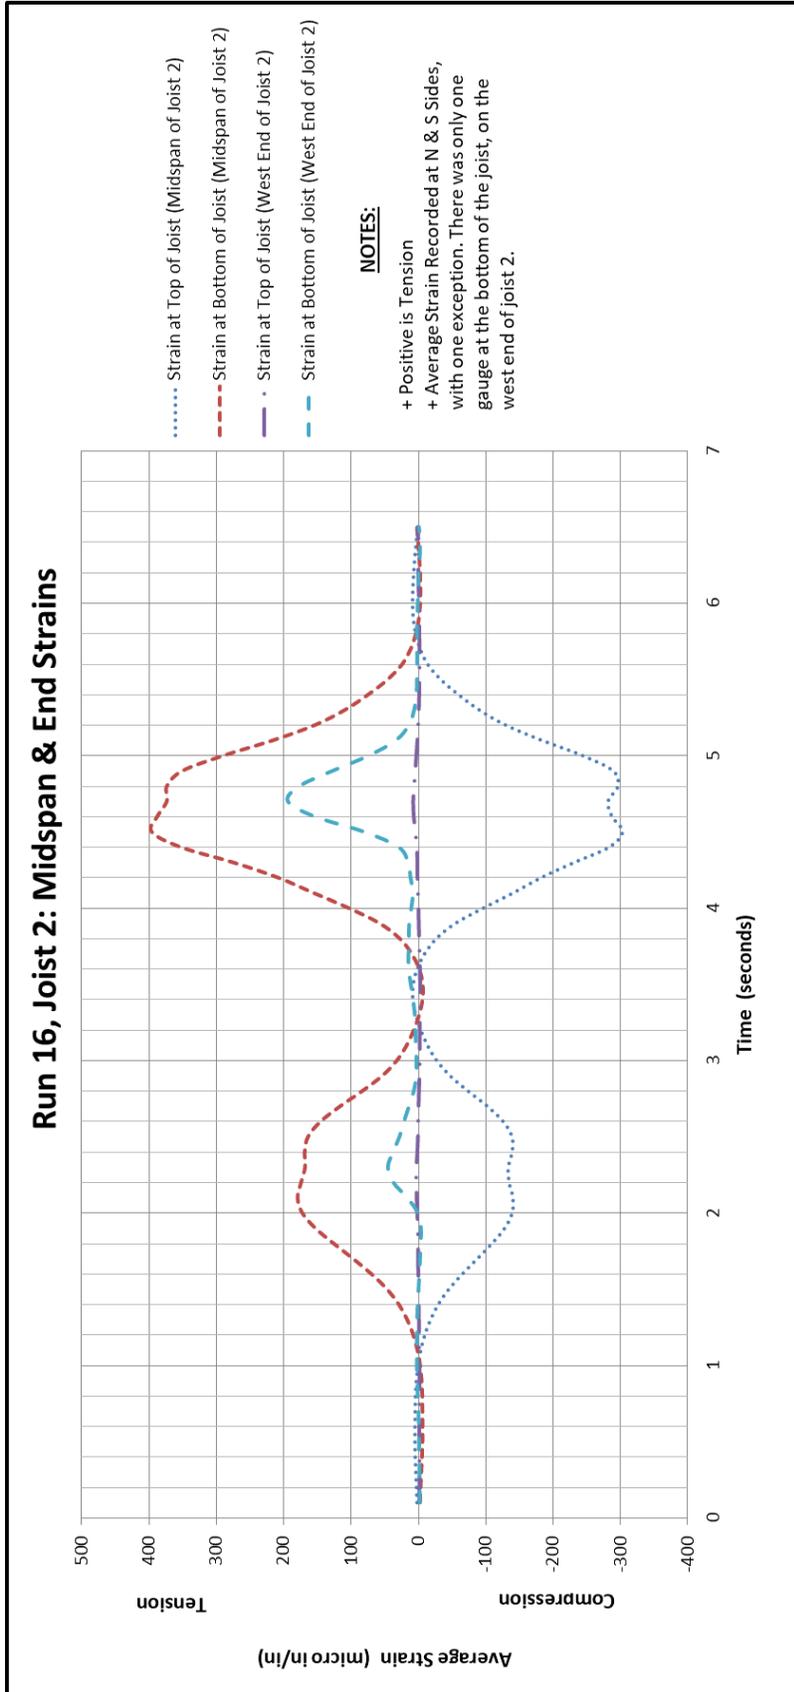
- c) The maximum strains show distinct, if minor, double peaks. The double peaks were evident to some degree in the midspan gauge records (but not by wheel line gauges) for test runs made on a deck that was fastened to the joists. The double peaks were absent on all runs made on an unfastened deck. Those runs produced perfect bell shaped curves. This suggests that the effect might be due to torsion induced by deflection of decking that is rigidly attached to the joists.

**Figure 19. Strains in joist 2 at midspan and ends.**  
 Peaks for front and rear axle are distinct. End strains are small compared to midspan strains.

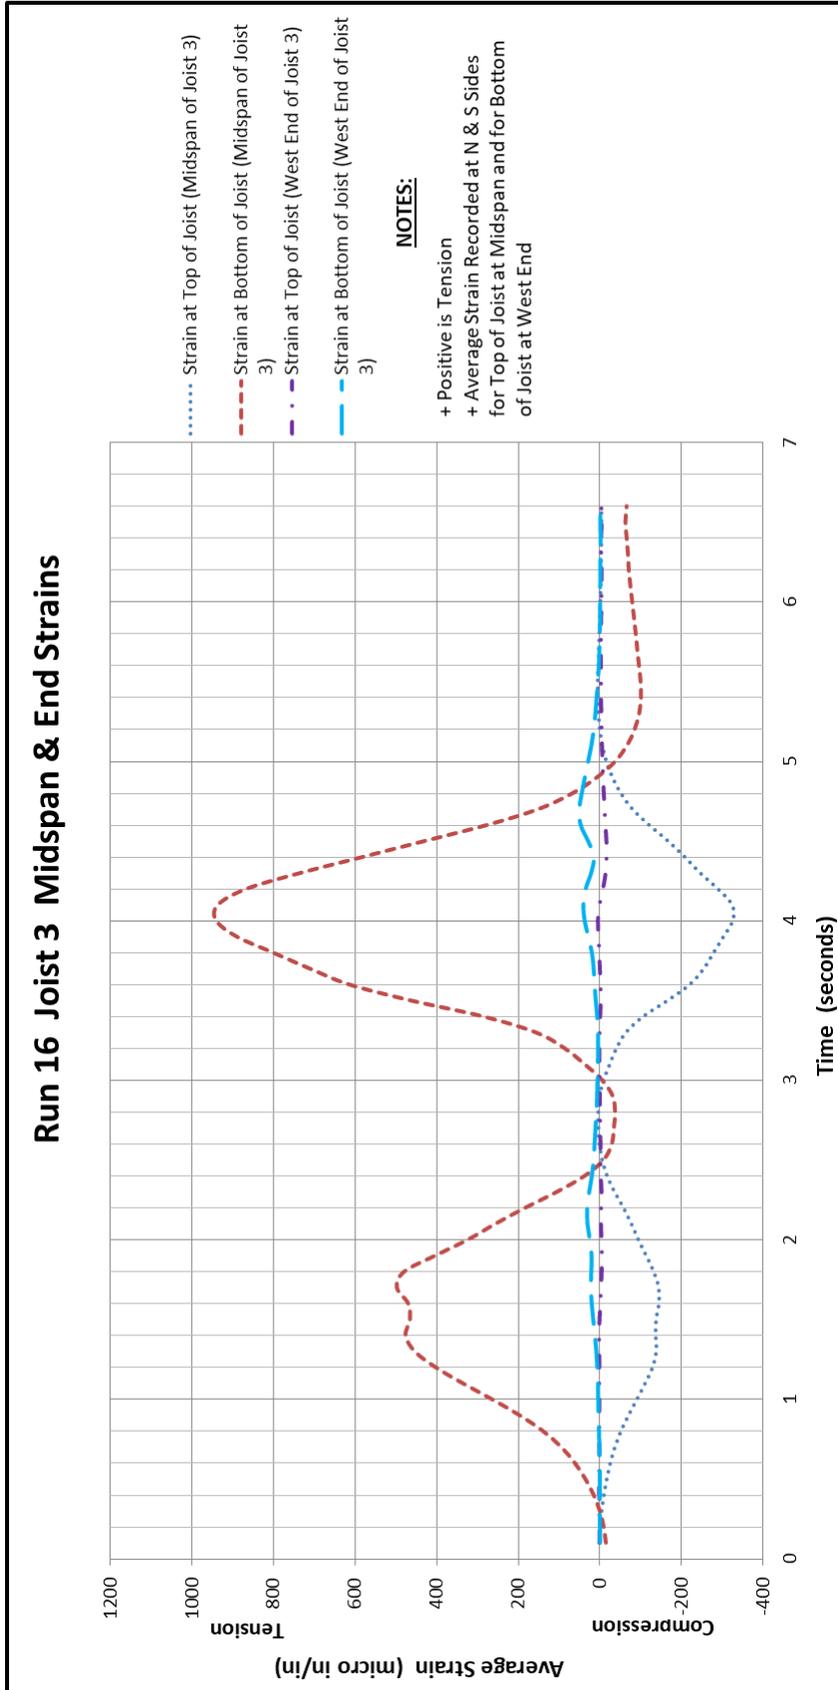
- a) Observations here are similar to those for joist 1, or would be if there weren't a problem with the bottom midspan strain transducer. Only one transducer was mounted there, on the north side of the joist. A quick glance shows the anomaly: that transducer's peak value was nearly  $1,000 \times 10^{-6}$  in/in instead of the 350 range for the top transducers. Furthermore, that transducer did not return to zero at the end of the test, even though it started out at zero. Investigation found that this gauge was mounted exactly where planned, at the bottom midspan of joist 3, on the north side of the joist. Unfortunately, there was an oblique knot there. **Figure A-16 of Appendix A** shows the knot. Since the knot and transducer were mounted in a tension region of the joist, the boundaries of the knot could open and close with stress. Returns from this transducer were ignored. They do, however, point out the difficulties of instrumenting an anisotropic, nonhomogeneous material (wood) that has random internal defects (knots, checks, etc.).

- b) The maximum compressive strain here (top transducers at midspan) peak in the range that joist 1 and (especially) joist 2 peaked.
- c) Strains at end of joist are essentially zero during entire test run.

**Figure 20. Strains in joist 3 at midspan and ends.**  
 Strains are similar to the nearly identical joist 1; except for fact that bottom midspan transducer (in tension zone) spanned a knot in the wood.

- 2) A few of the gauges had at least one mounting screw that was insufficiently tightened, which allowed slippage. **Figure 20** shows an example of this: the red line starts out at zero, but at the end did not return to zero. One end slipped during loading and the transducer finished with a  $50 \times 10^{-6}$  in/in strain. The other transducers in **Figures 17** through **23** correctly returned to zero after the test truck left. This defect only affected a few gauges, and those not every run. The plots give a good idea which ones are suspect because the properly fastened gauges returned to zero strain at the end of each test run.

- 3) The third defect was already mentioned. The bottom midspan transducer on joist 3 was attached across a knot, so the readings were exaggerated and unusable. **Figure 20** plots errant gauge reading along with other, usable, returns.

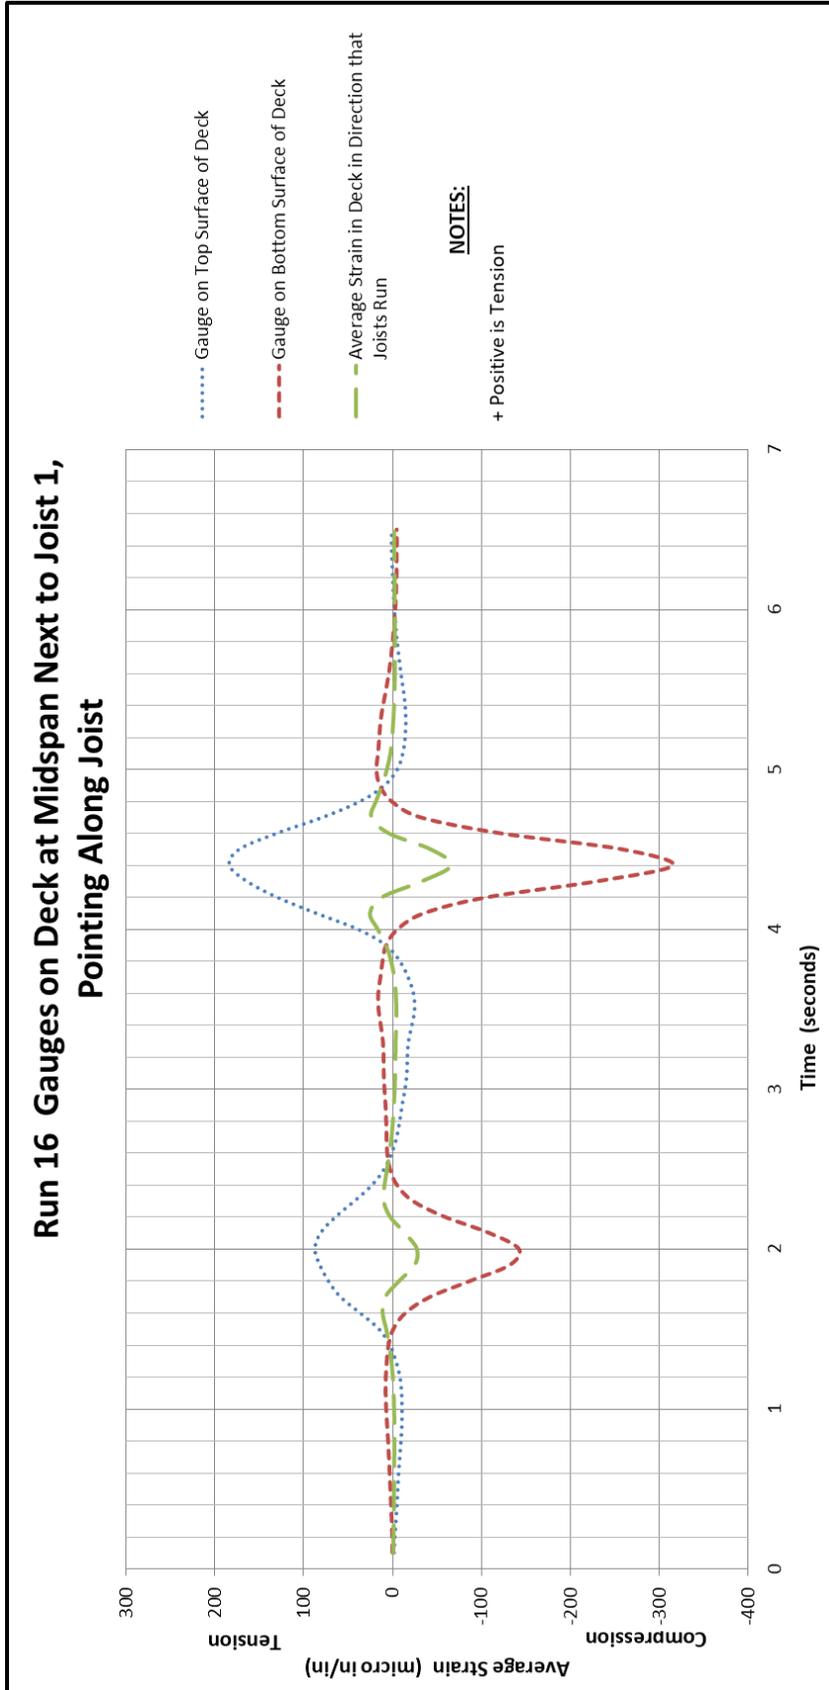
**Figure 21. Strains in deck planks at joist 1, in direction parallel to joists. Average peak strain is only  $70 \times 10^{-6}$  in/in, compared to  $380 \times 10^{-6}$  in/in a few inches away and in same direction in joist 1.**

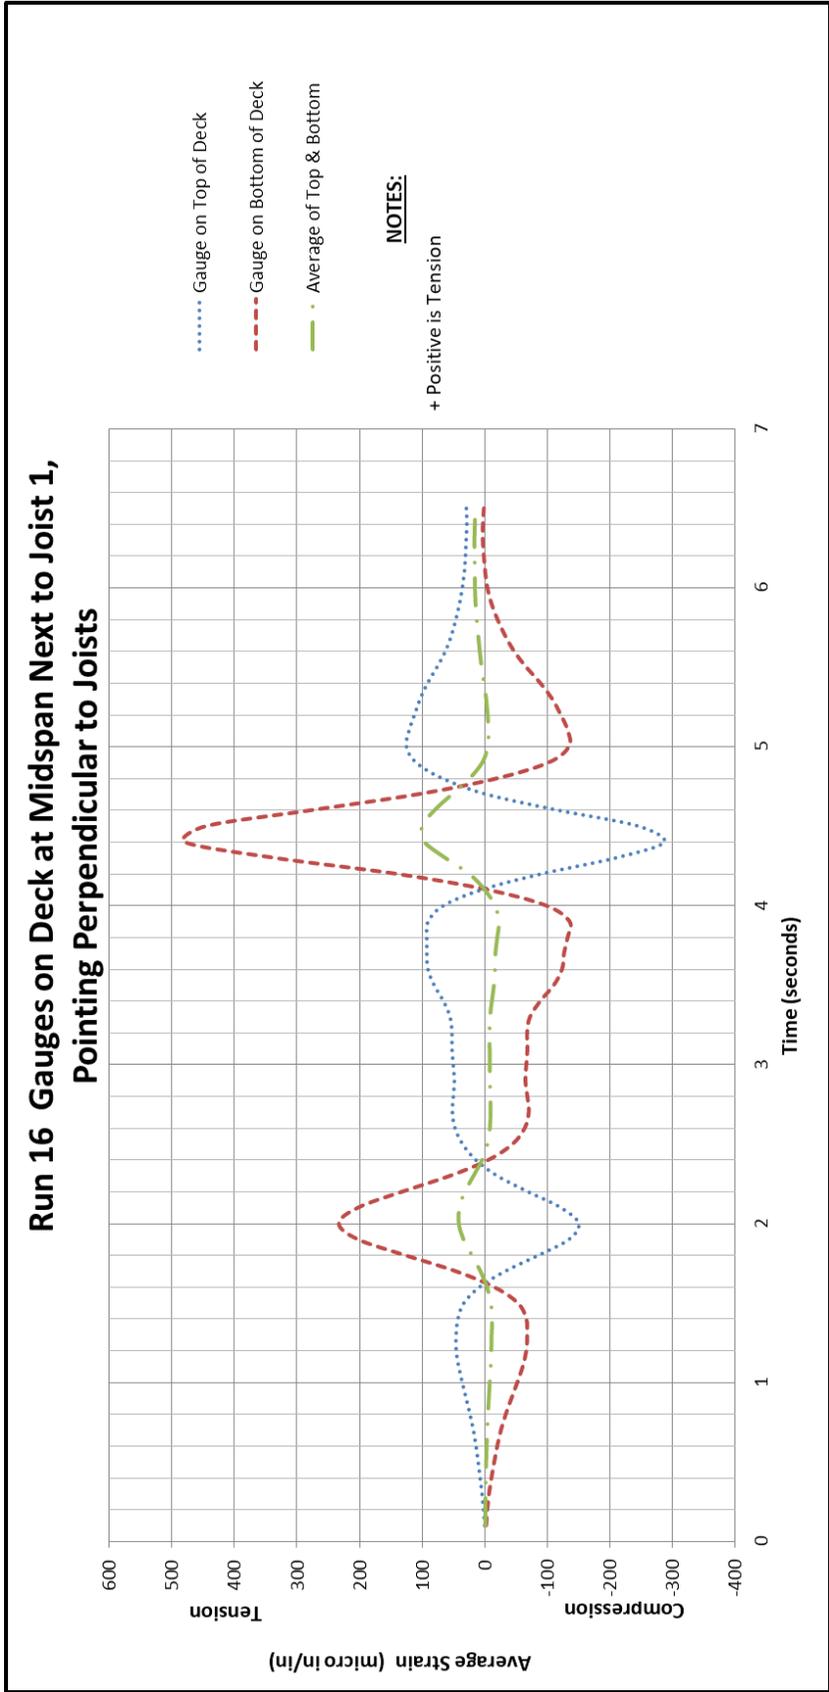
- a) There is indeed bending in deck boards perpendicular to joists, but it is not negative moment for gauges right next to joists. It is positive moment (tension on bottom and compression on top). But the tensile forces were larger, and the averaged or net strains were tension. This could be expected. As joist 1 deflected more than its neighbors the deck would be stretched, overall. But the lower graph shows that as the truck axle moved to be over the adjacent joists in either direction the net, average strain in the deck boards became zero or slightly compressive.
- b) A comparison of the average strains in Figures 22 and 21 indicates that the peak strains along the grain of the deck boards (i.e., perpendicular to joists) was greater than the average strains parallel to the joists. This could hardly be the case if there was a strong T-beam effect in operation.

**Figure 22. Strains in deck planks at joist 1 midspan, in direction perpendicular to joists.**  
Although transducers were mounted next to joist 1, they show evidence of bending, with average peak strain being not large.
