**HISTORIC AMERICAN ENGINEERING RECORD  
ANALYZING COVERED BRIDGE FLOOR SYSTEMS  
HAER No. NH-53**

**LOCATION:** Beebe River Road, Campton Hollow, Grafton County, New Hampshire. The bridge model was located at latitude: 43.829946, longitude: -71.648767. This coordinate was obtained in October 2017, using a GPS mapping grade unit accurate to +/- 3 meters after differential correction. The coordinate's datum is North American Datum 1983. The bridge model location has no restriction on its release to the public.

**STRUCTURE TYPE:** Town lattice wooden truss bridge

**SIGNIFICANCE:** It has been observed that current methods of calculating the strength of the timber floor systems of covered bridges seem to underestimate the actual strength of these systems to a greater extent than would be explained by the factors of safety used in conventional calculations. If so, historic covered bridge systems may be unnecessarily replaced, or load limits may be set so low that bridge replacement becomes probable. To explore apparent differences between current design practices and actual floor performance, researchers instrumented the floor of a Town lattice covered bridge with transducers and th

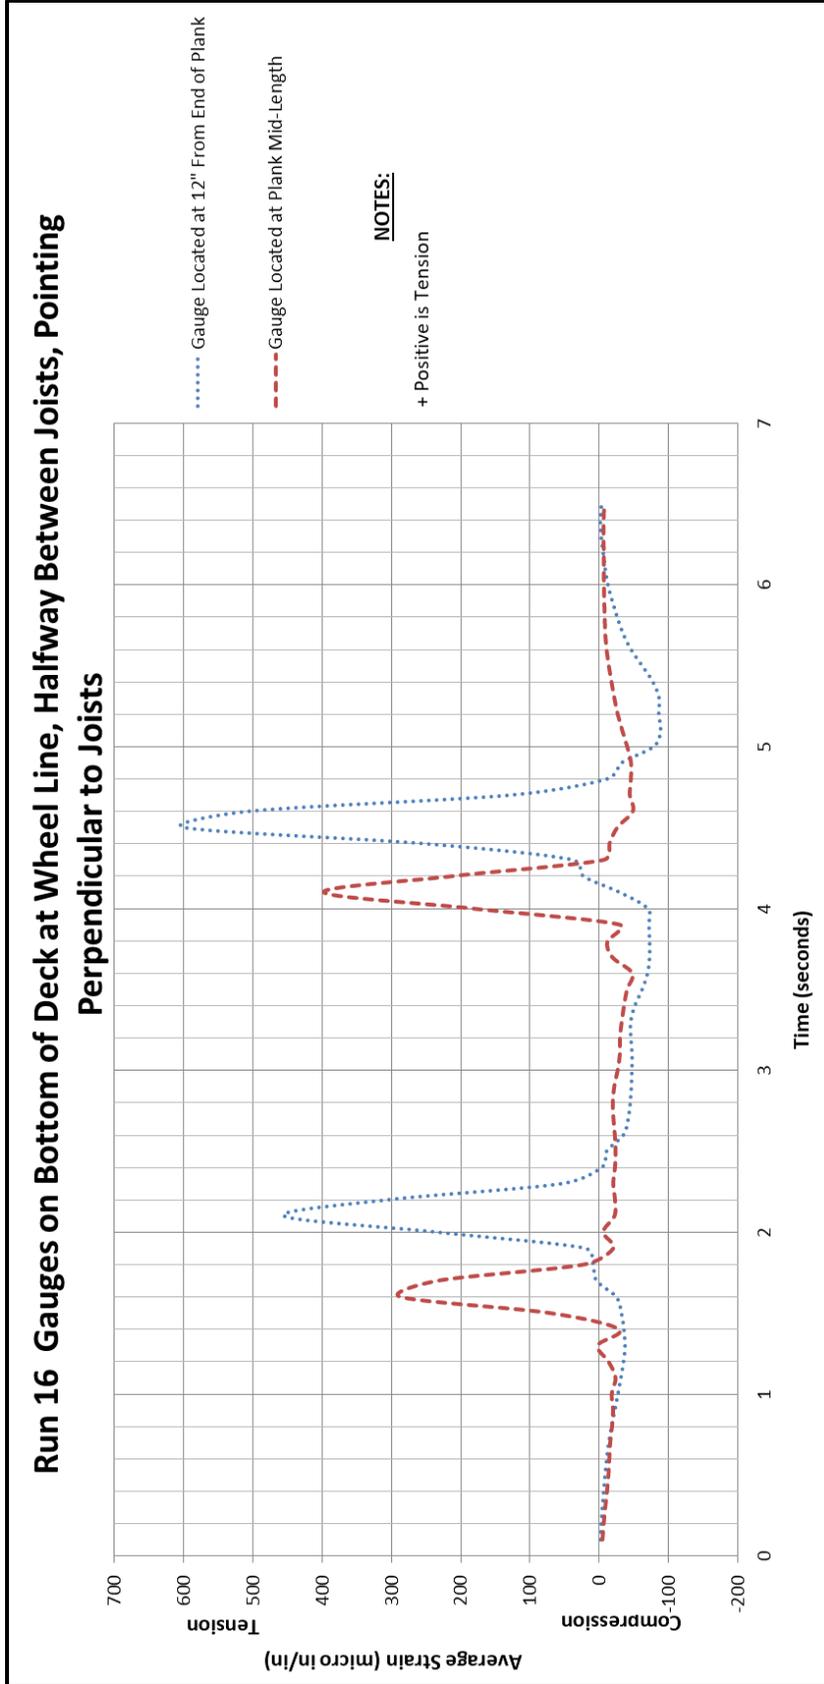
- a) The strains exhibited by both gauges were entirely tensile, as expected. The peaks of the two strains were separated by about half a second, this being the time it took for the truck to travel between gauges.
- b) The peak strain for the gauge near mid-length of the deck board was about 67% of the peak strain for the gauge next to the end of the plank. This supports the 80% guidance, at least to the extent that bending in the end span approximates simple span bending.

**Figure 23. Strains in deck planks, between joists, in direction perpendicular to joists. Transducers mounted halfway between joists, one next to end of deck plank and other near midspan. Strains where the plank is continuous are smaller than strains near an end.**

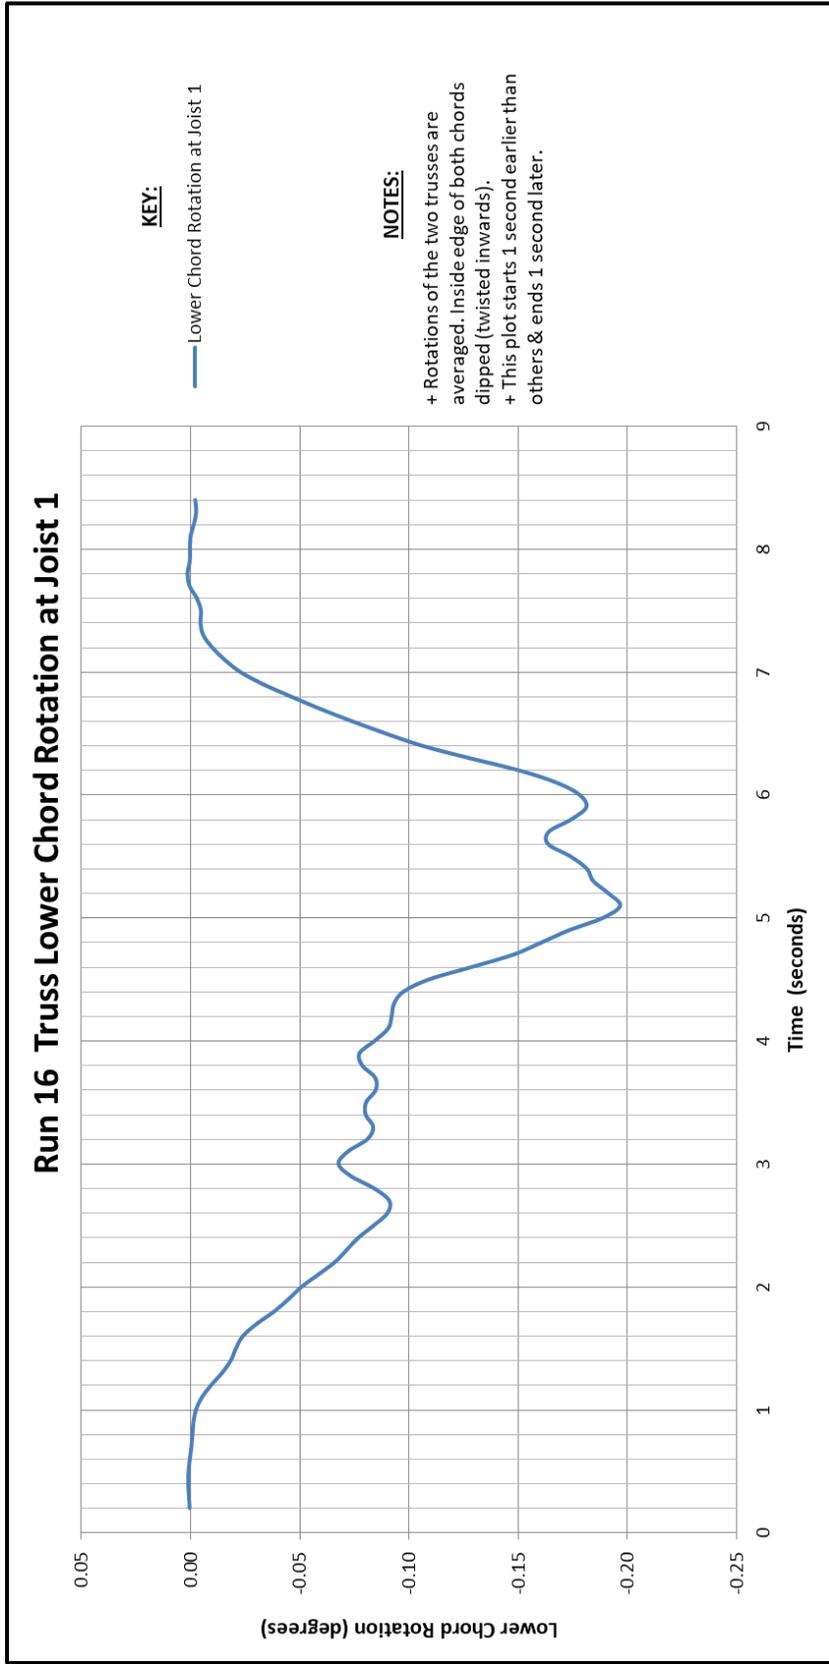
- a) Peak rotation equaled 0.20 degrees of arc. Later analysis would show that this was about 25% of the end rotation of the joists if simply supported and deflecting at midspan as the plunger gauges indicated. That is, truss rotations decreased the end fixity effect, but only by about 25%.
- b) Truss rotations extended six seconds without returning to zero between axle passages. This might be expected because loads anywhere on the span would deflect or twist the entire trusses, not just the regions of the trusses in the immediate vicinity of the axles.

**Figure 24. Truss lower chord rotation at joist 1.**  
 East and west truss rotations are averaged. Rotations do not return to zero as quickly as do strains in an individual joist because the presence of the test truck in any part of the bridge's midspan region causes rotation.

- a) The maximum strains at midspan are much greater than those at either end. Midspan strains reach about  $400 \times 10^{-6}$  in/in while the end strains all wiggle around close to zero. Yet, if the joist's ends were perfectly fixed, the end strains would be greater than the midspan strains. The most significant observation here is that there appears to be no end fixity. This hypothetical effect probably does not occur in Town lattice trusses. Furthermore, what little strains were found at the joist end, actually a few inches from the lower chord bearing point, were tension on the bottom and compression on the top, the opposite of the negative moment that would exist there if the joist ends were fixed. Truss rotation could explain that, but calculations based on **Figure 24** shows that the lower chord twist is insufficient to do so.

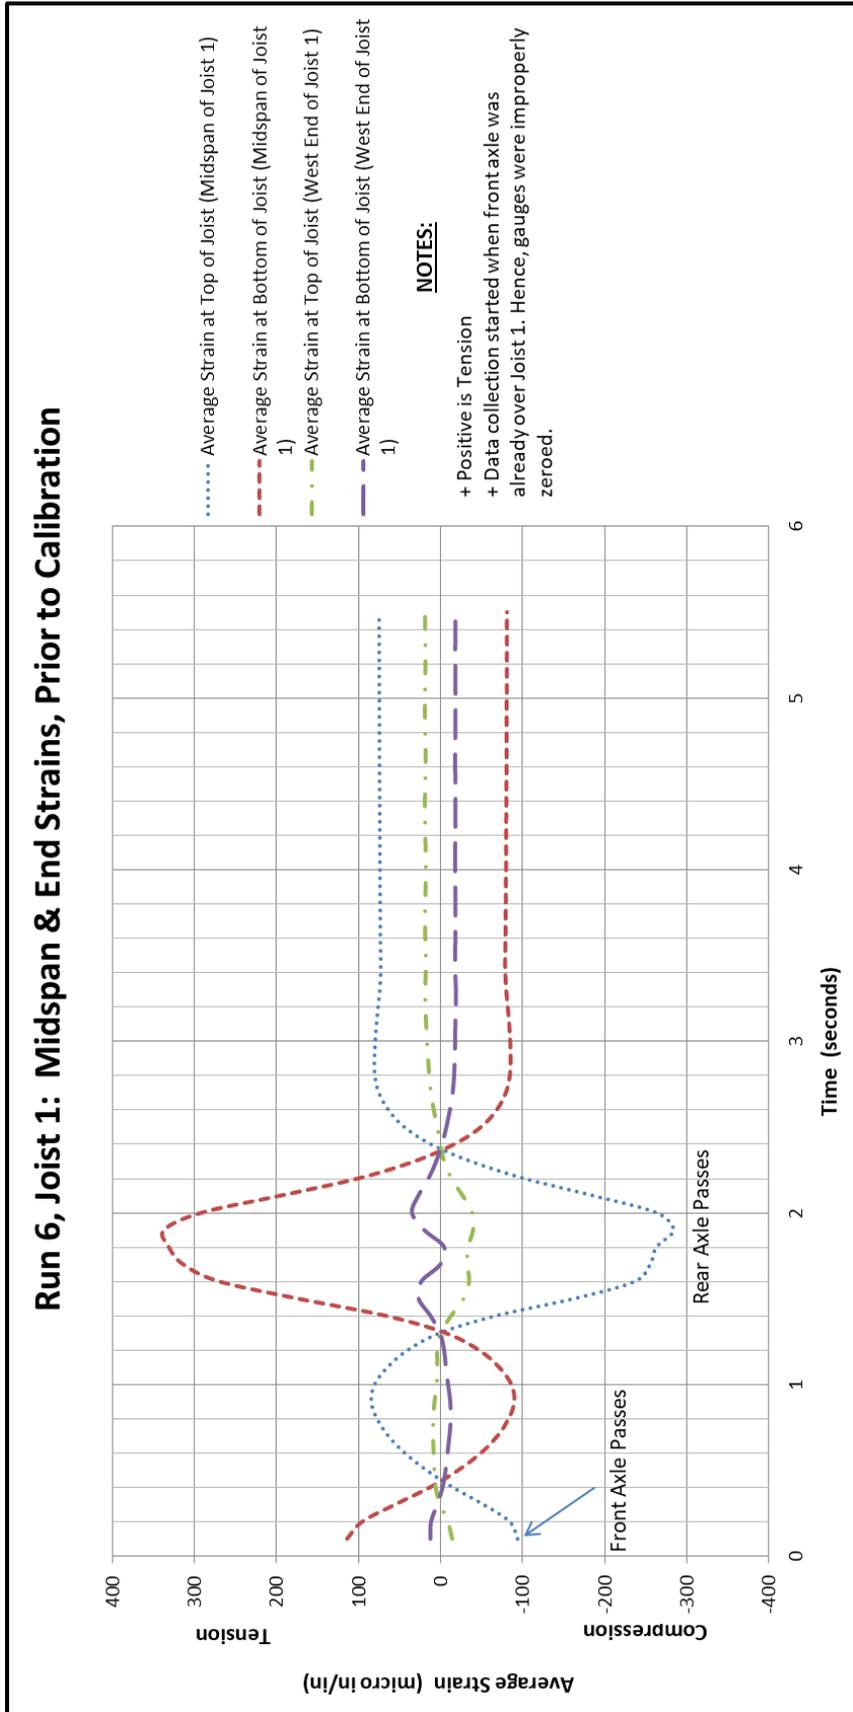
**Figure 25. Strains in joist 1 at midspan and ends, prior to calibration.**  
 Transducers started sending data to data logger when truck's front axle was already over joist 1. Data partly usable by adjusting plots so that end strains are at zero.

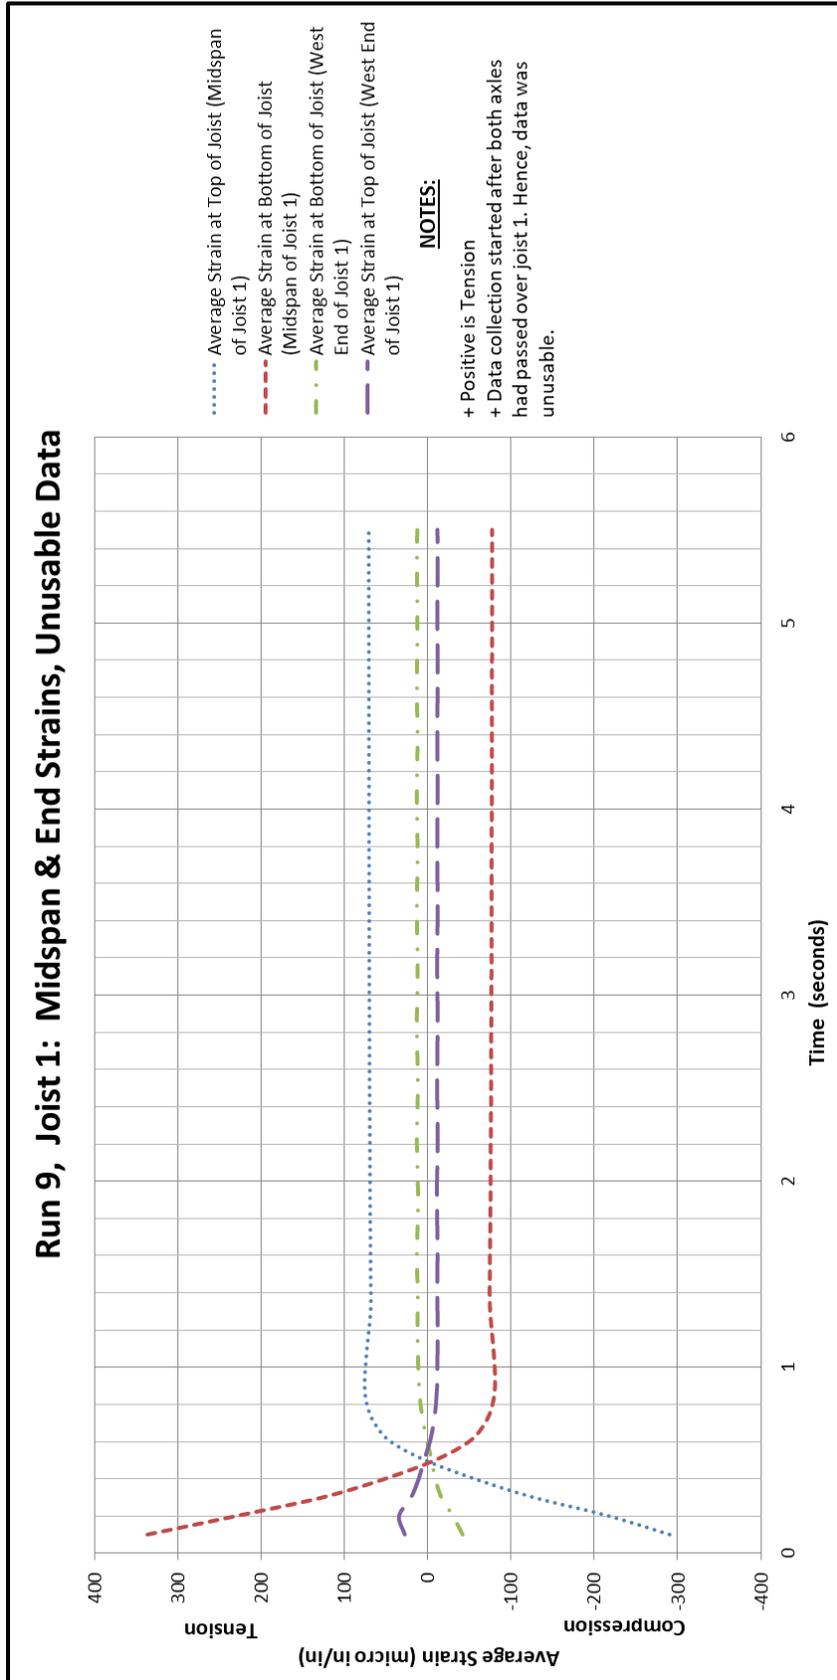
**Figure 26. Strains in joist 1 at midspan and end, unusable data.**  
 Transducers started sending data after both axles had passed joist 1. No usable data from this run.

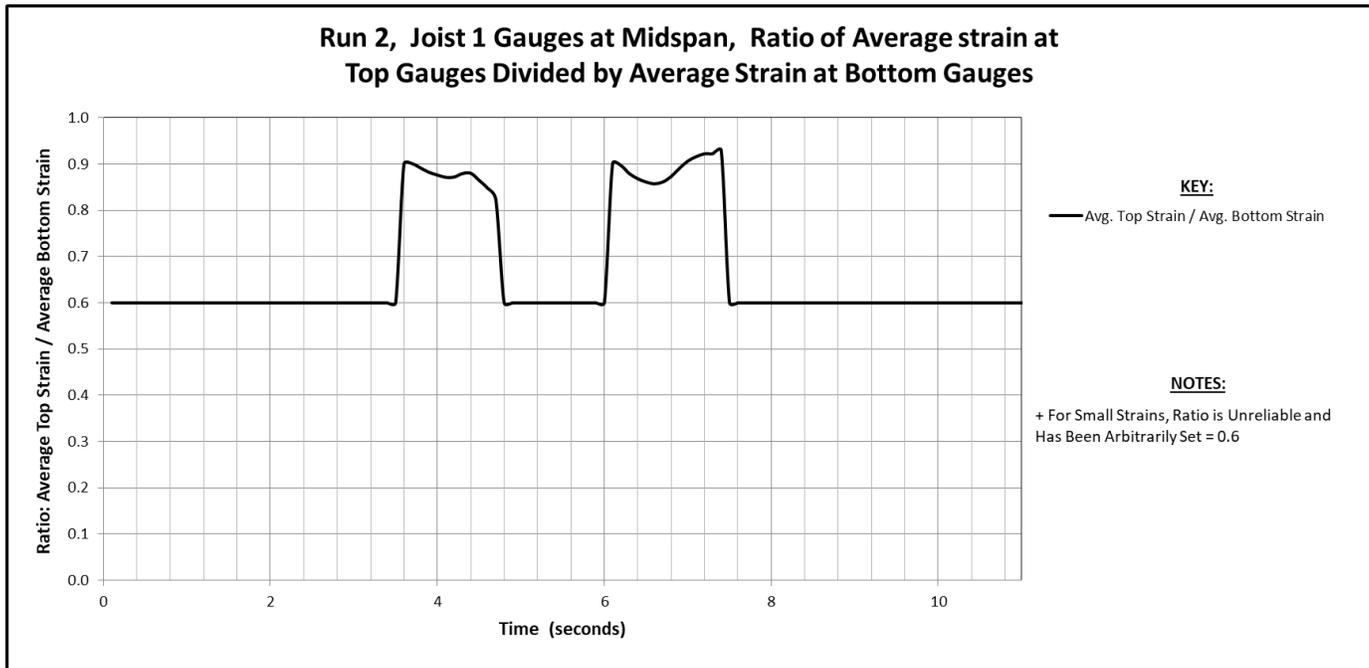
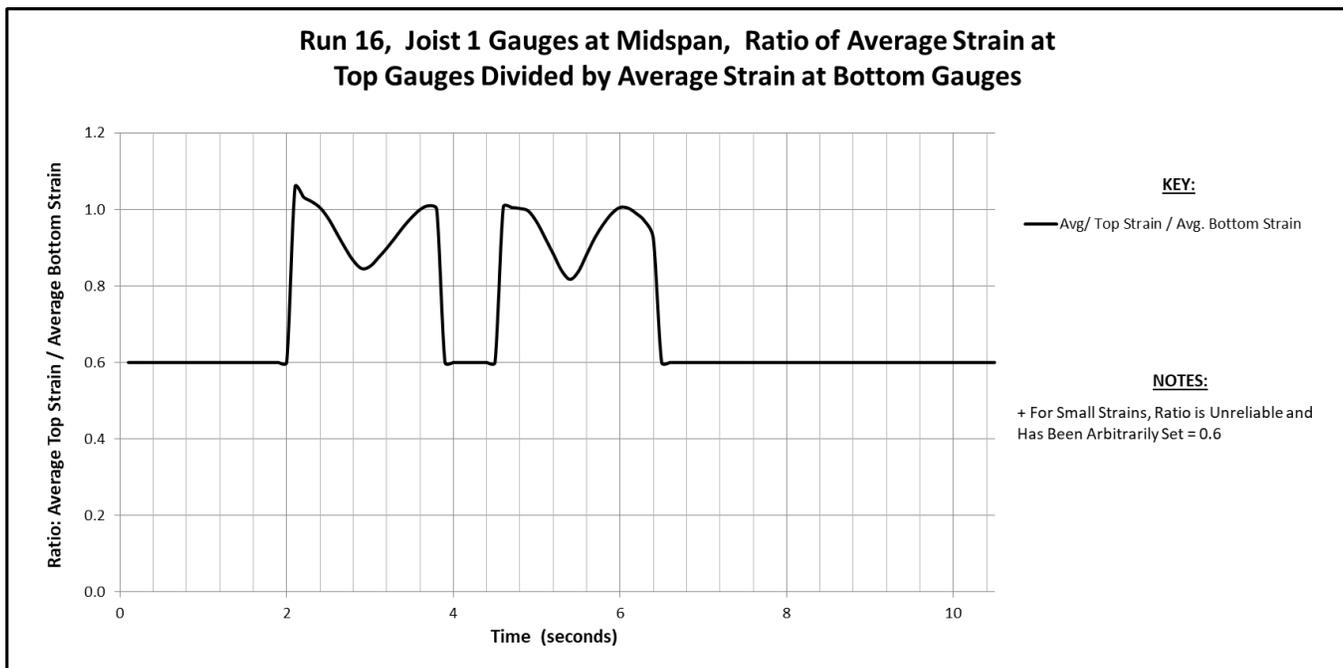
**Figure 27.** Ratio of top midspan strain to bottom midspan strain in joist 1 as truck axles pass by. Top graph is for a test run on unfastened deck boards. Ratio drops below 90% when an axle is over joist, and doesn't return to 100% as the axle moves away and before being masked. Bottom graph is for test run 16 and is similar to other runs on fastened decks. The ratio drops to 82 % when an axle is at the joist, but quickly returns to 100% as axle moves away from joist 1.

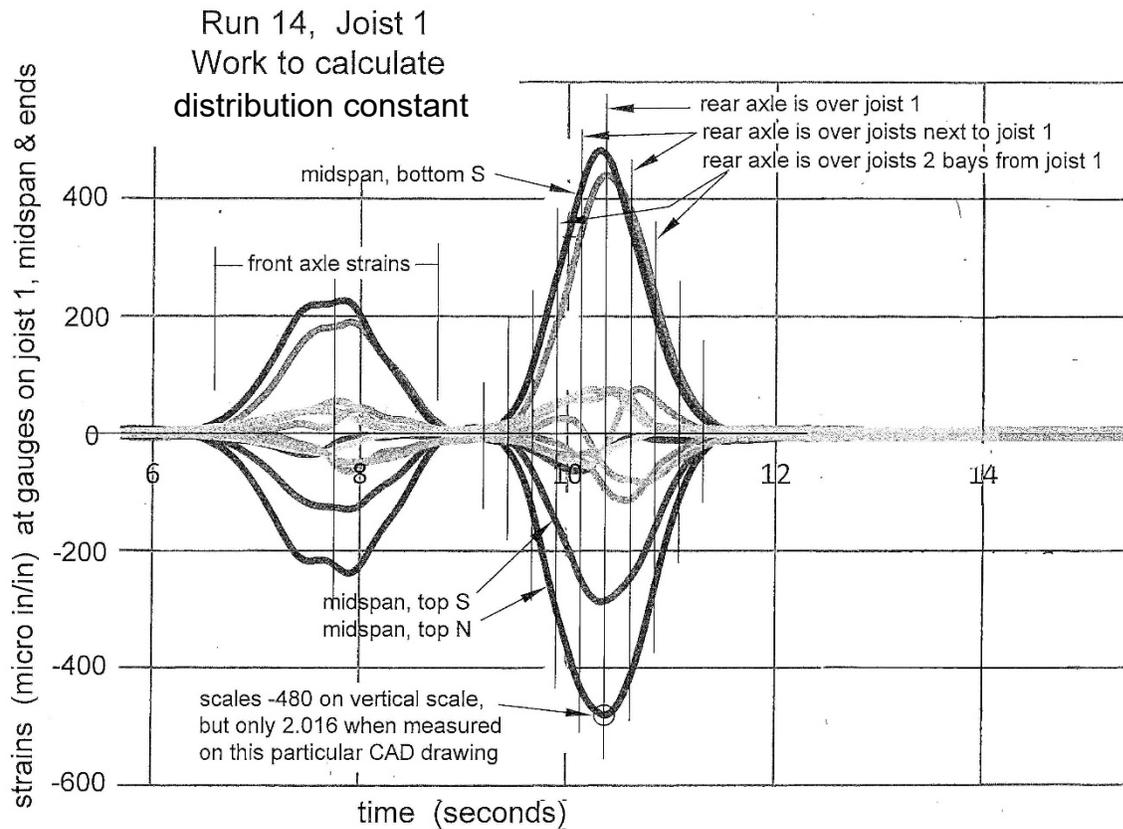
**Figure 28.** A plot of strain gauge readings used to calculate distribution constants for Joist 1. The vertical lines mark points in time when truck's rear axle is directly over neighboring joists. Those values are used in calculations in Figure 29.

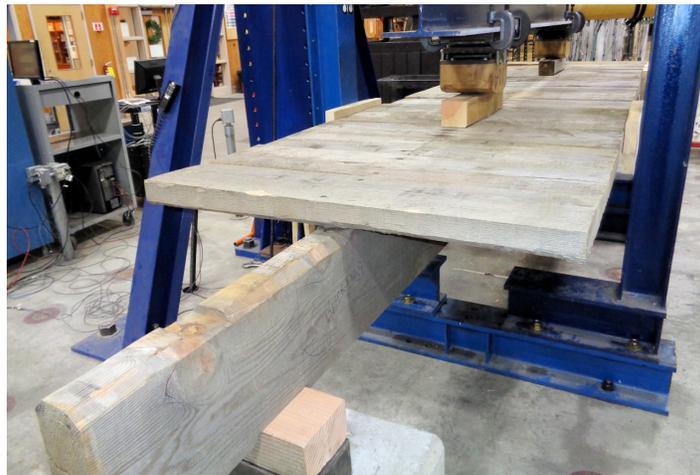
**Figure A-1. Joist #1 with deck attached, set up in test frame, before test.**

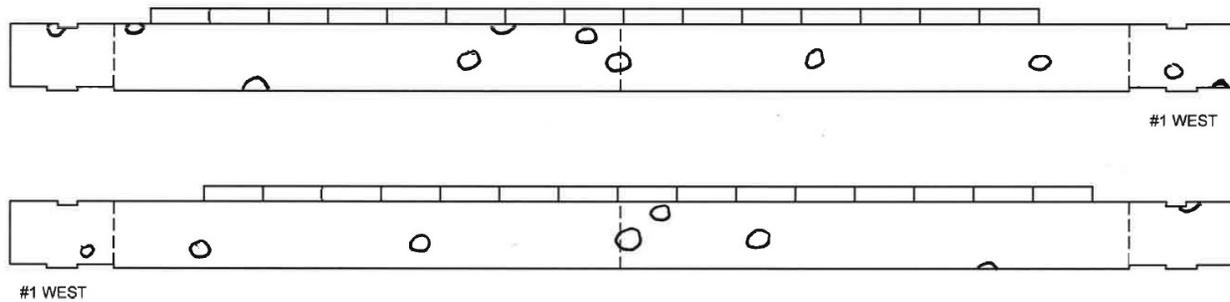
**Figure A-2. Joist #1; sketch showing locations of large knots. Dashed lines represent the bearing and mid-span locations.**

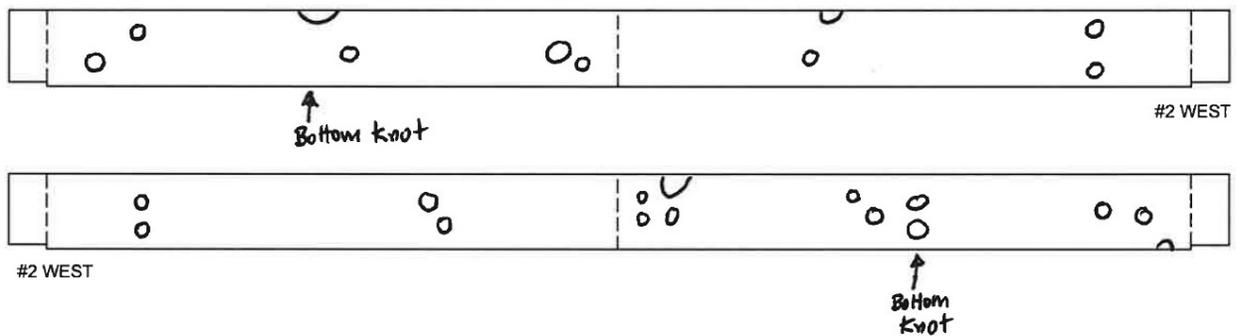
**Figure A-3. Joist #2; sketch showing locations of large knots. Dashed lines represent the bearing and mid-span locations.**

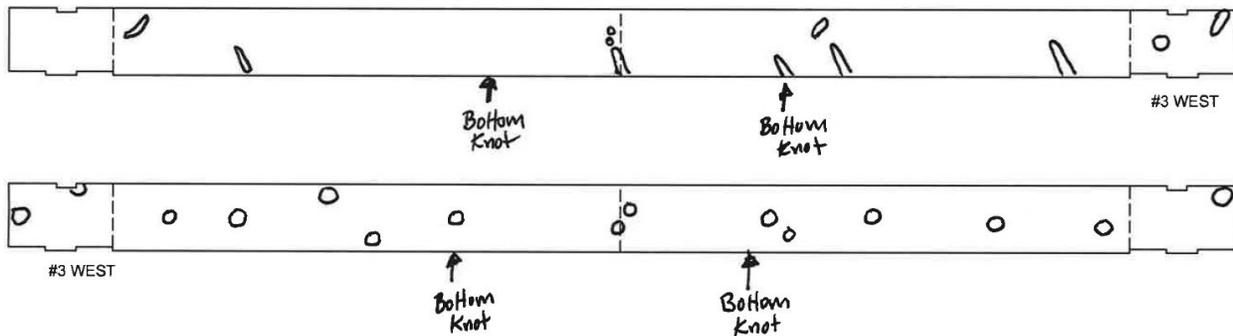
Figure A-4. Joist #3; sketch showing locations of large knots. Dashed lines represent the bearing and mid-span locations.

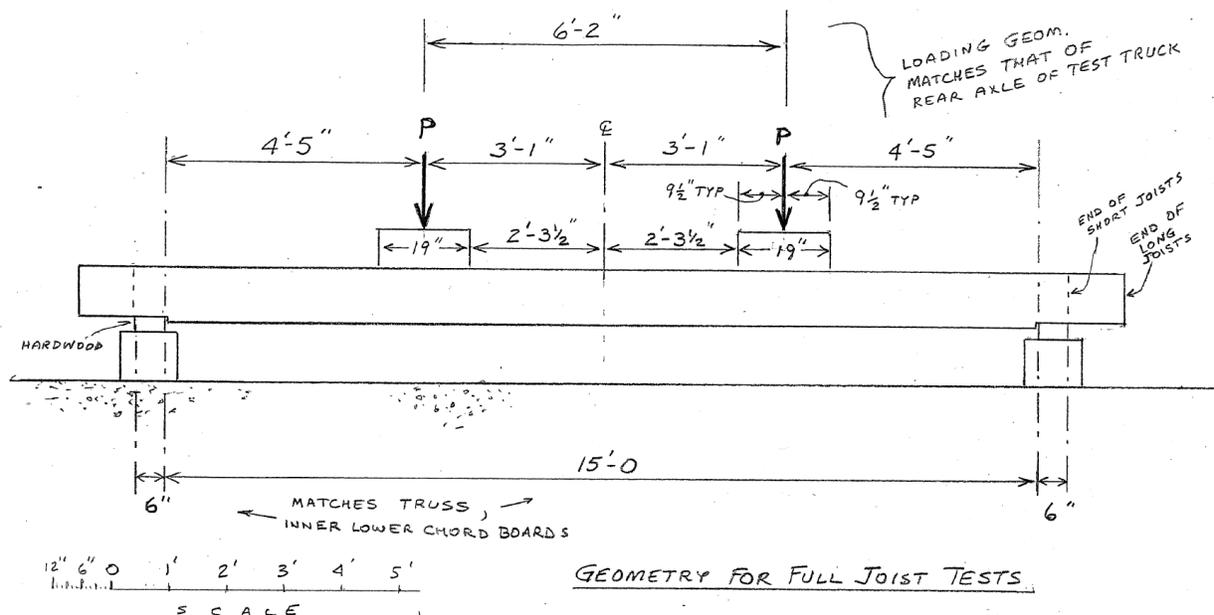
Figure A-5. Dimensions for bending tests as specified by BBofNE (BBofNE drawing).

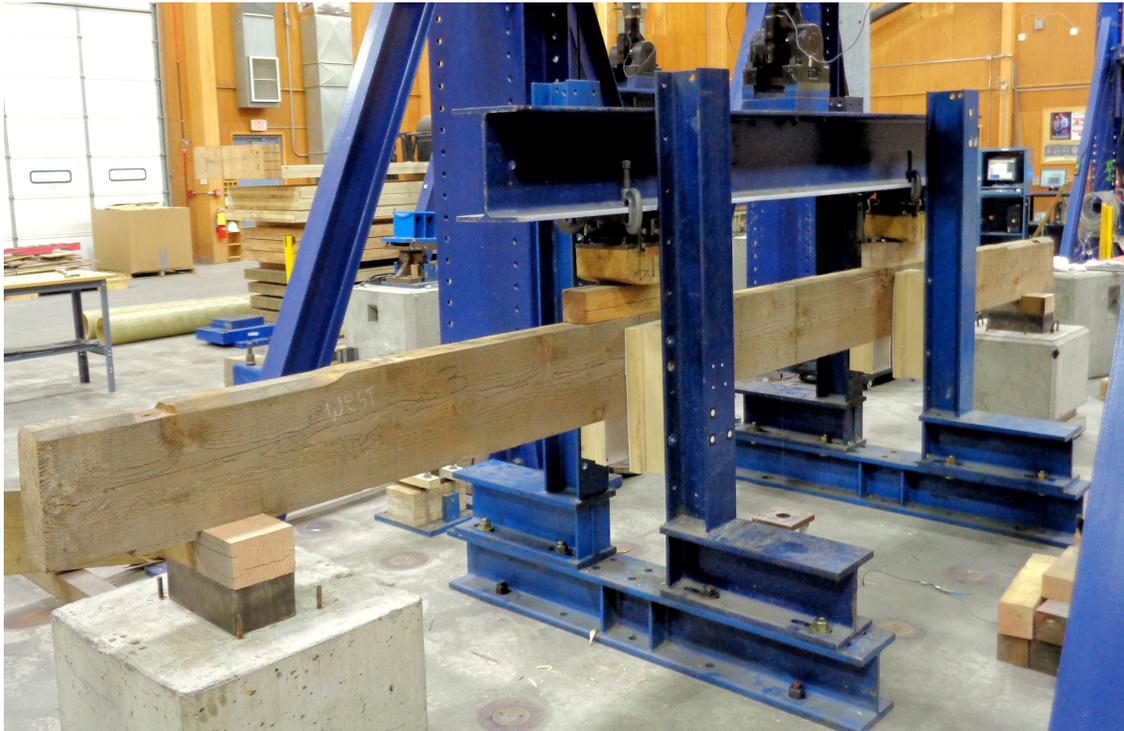
**Figure A-6. Bending test setup for joists #2 and #3 (Joist #3 shown)**

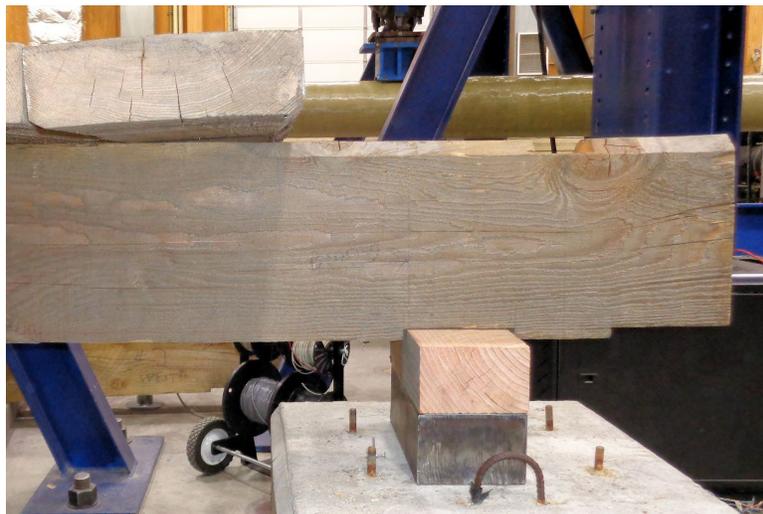
**Figure A-7. End support for joist tests (Joist #1 shown)**

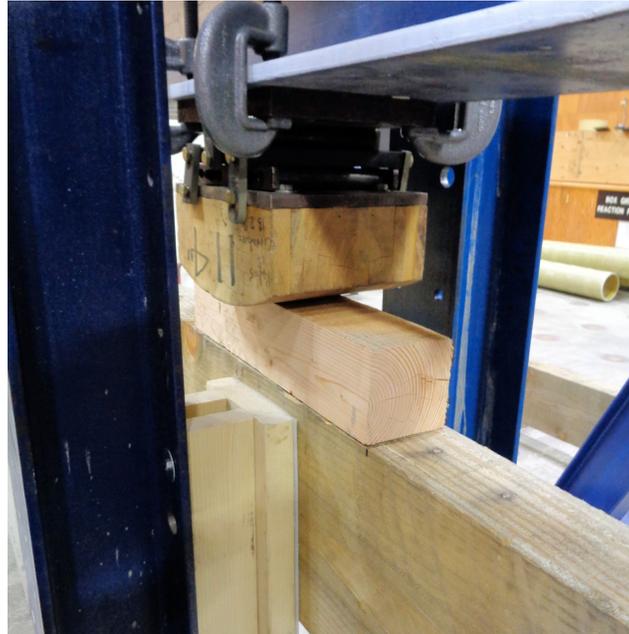
**Figure A-8. Load head and lateral support (Joist #2 shown)**

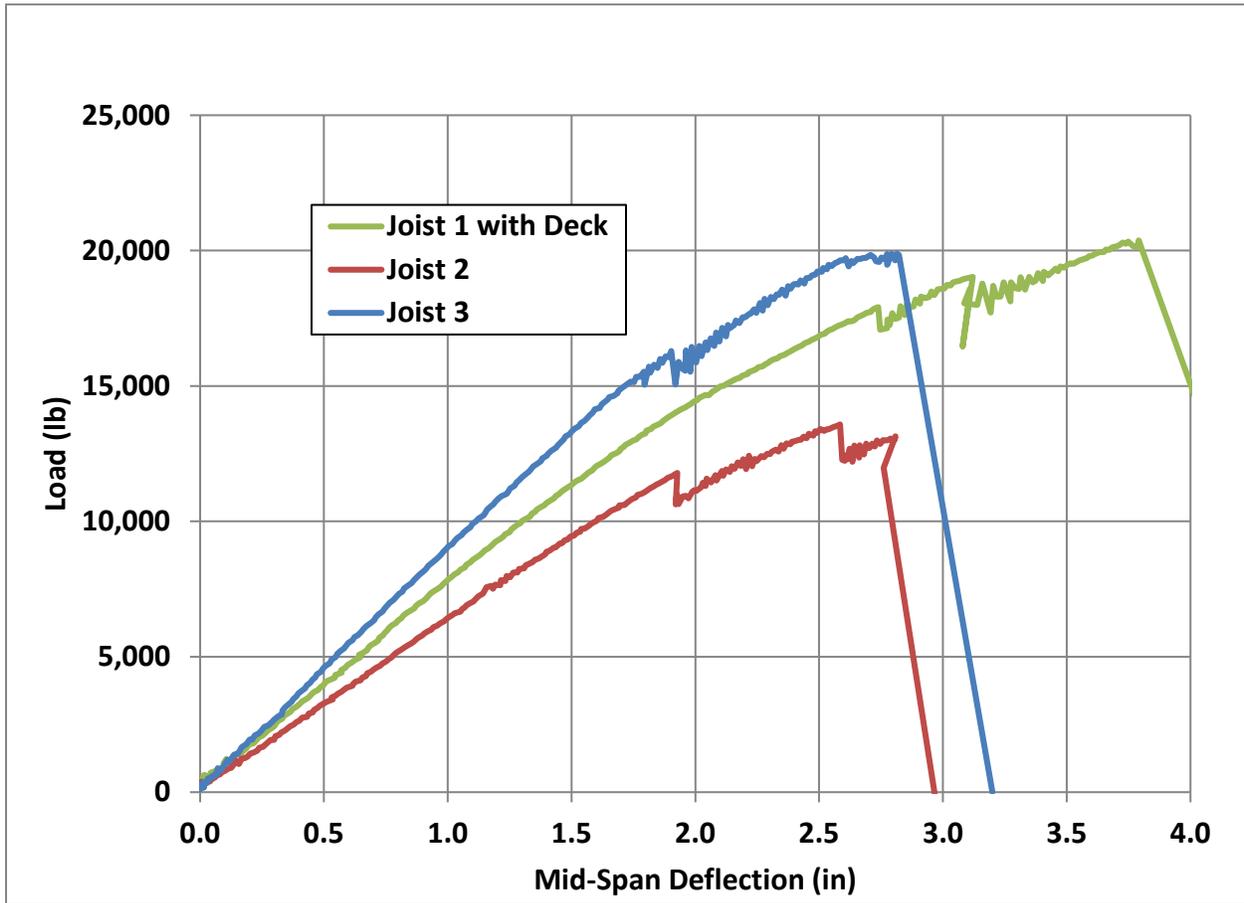
Figure A-9. Load vs. mid-span deflection plots for bending tests

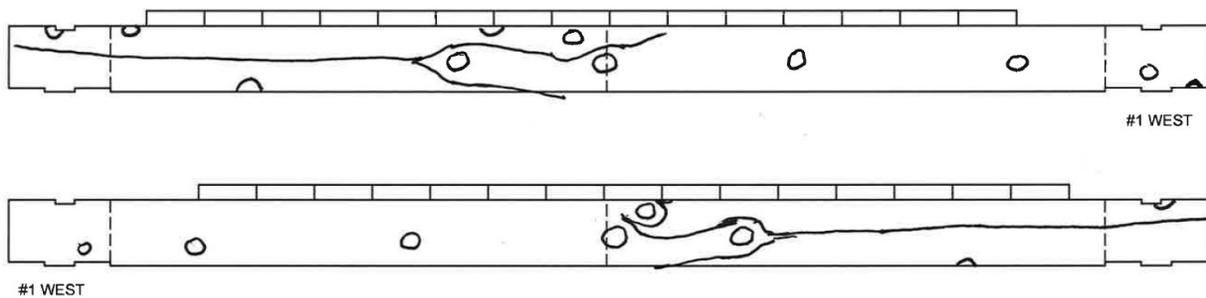
Figure A-10. Joist #1 bending test failure mode

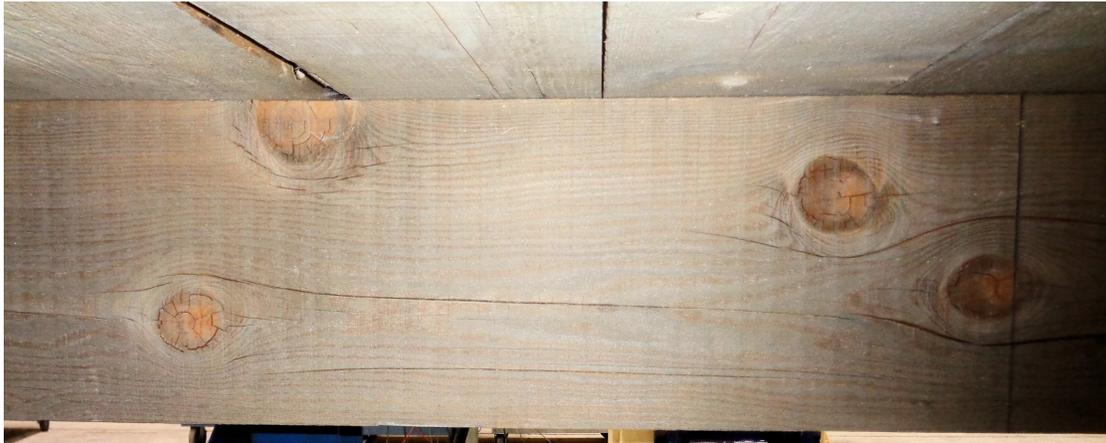
Figure A-11. Joist #1 failure zone shown prior to test

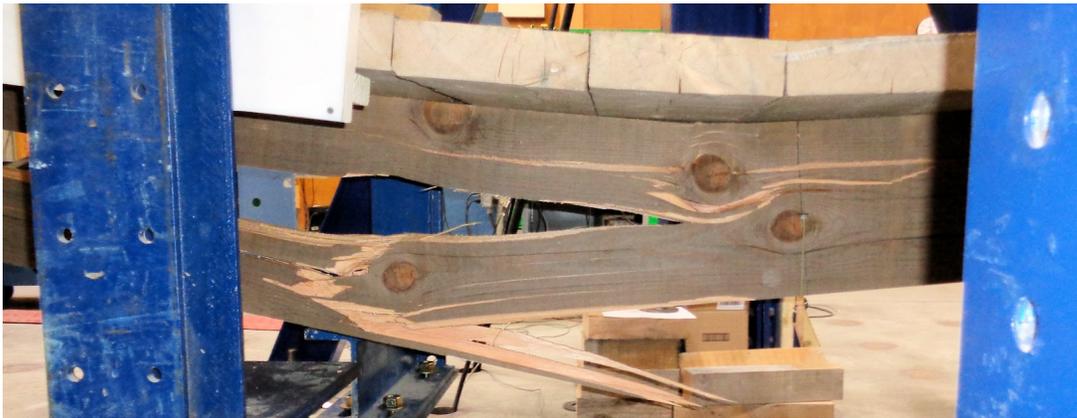
Figure A-12. Joist #1 bending test failure

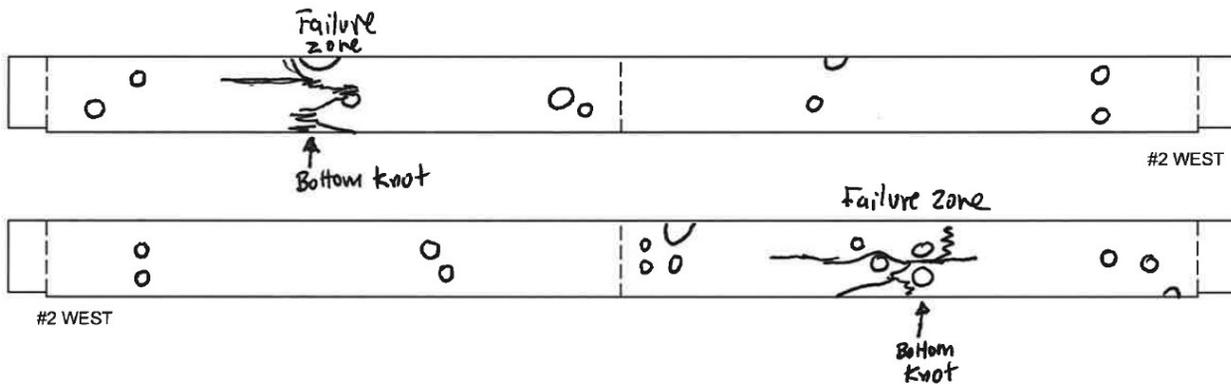
Figure A-13. Joist #2 bending test failure mode

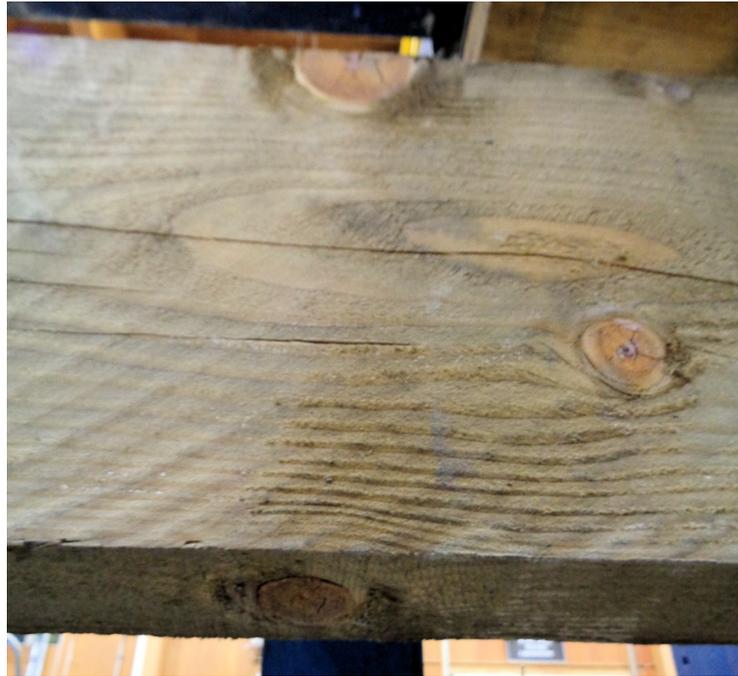
**Figure A-13. Joist #2 failure zone shown prior to test**

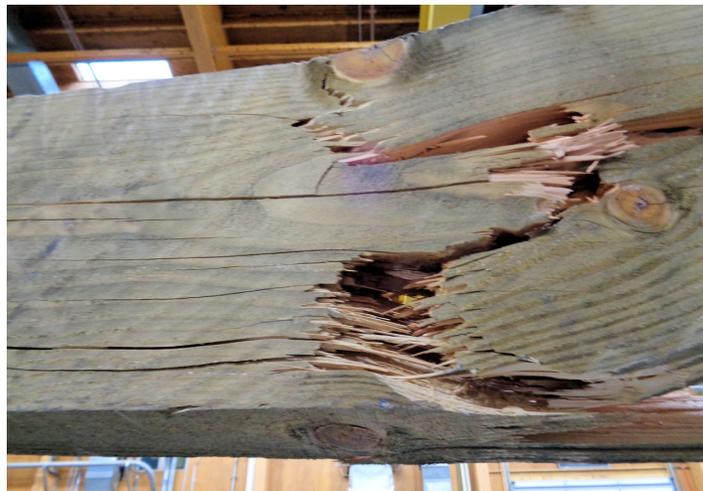
**Figure A-14. Joist #2 bending test failure**

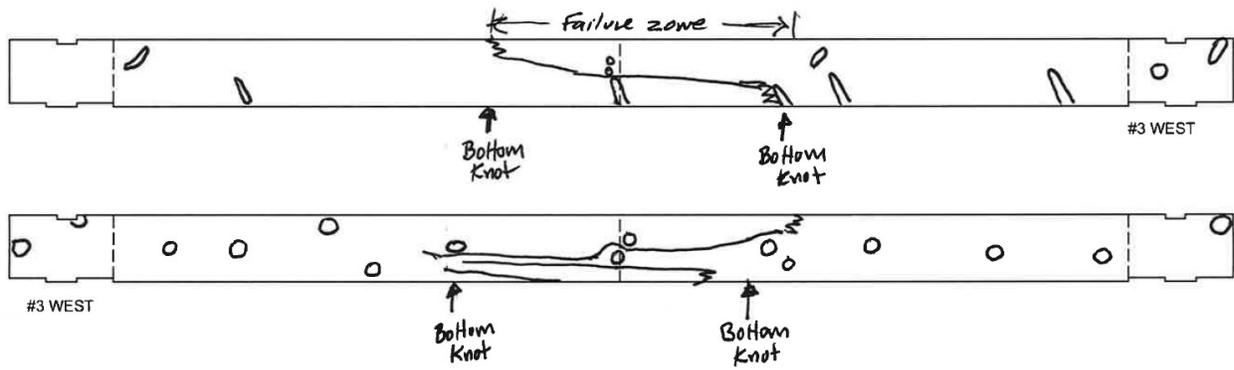
Figure A-15. Joist #3 bending test failure mode

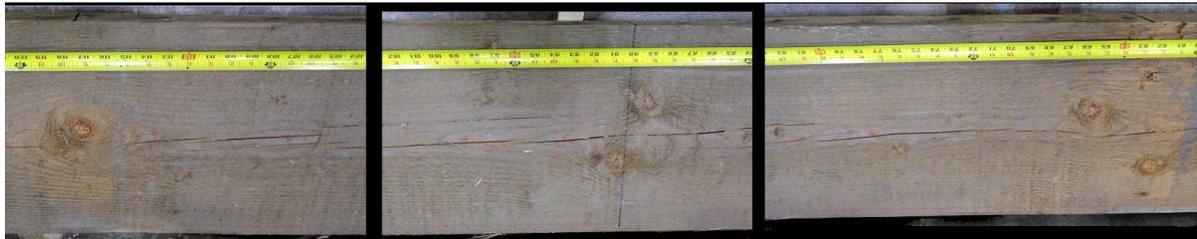
Figure A-16. Joist #3 failure zone before test (montage of three photographs)

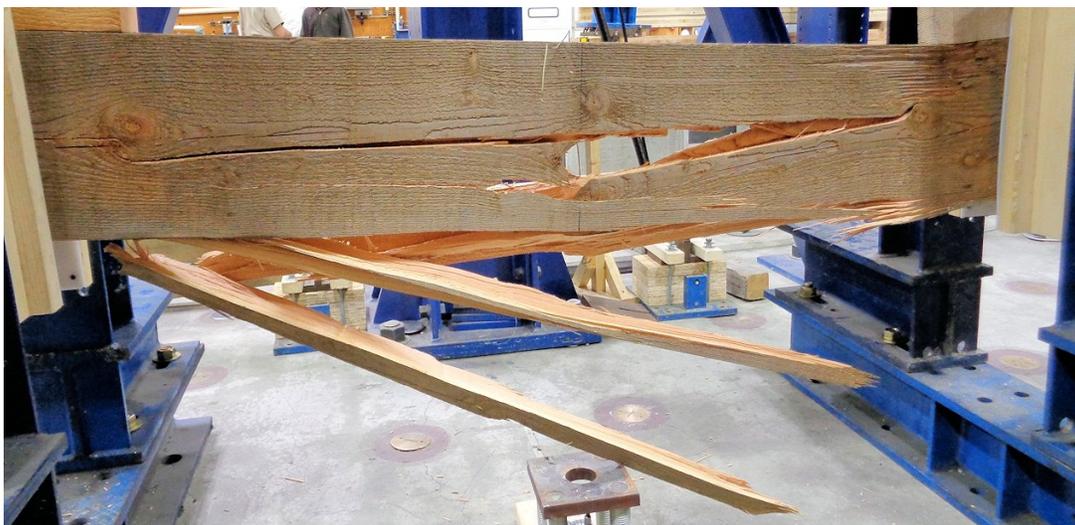
Figure A-17. Joist #3 bending test failure

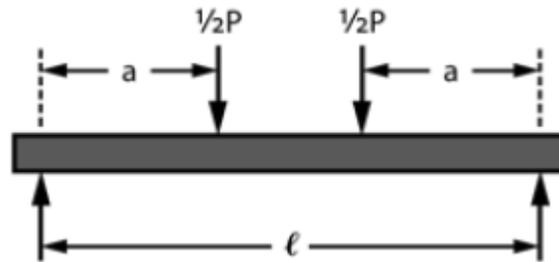
Figure A-18. Four-point bend test parameters (Image from ASTM D198-14)

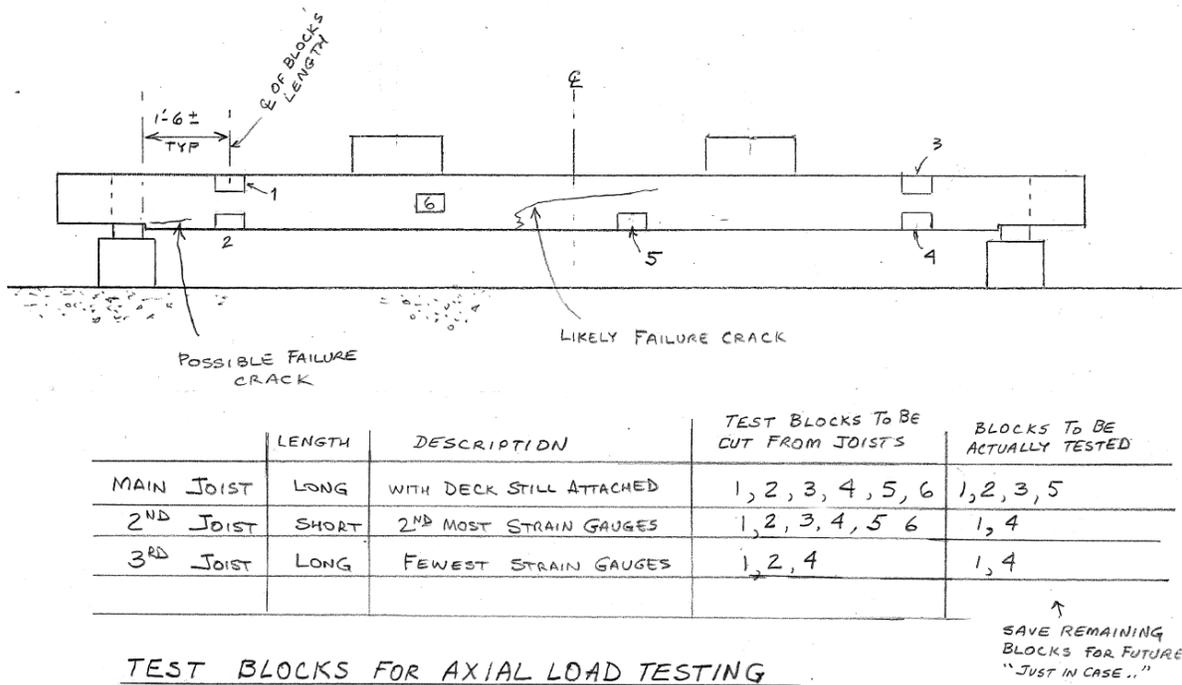
Figure A-19. Locations to obtain compression test specimens, as specified by BBofNE (BBofNE drawing)

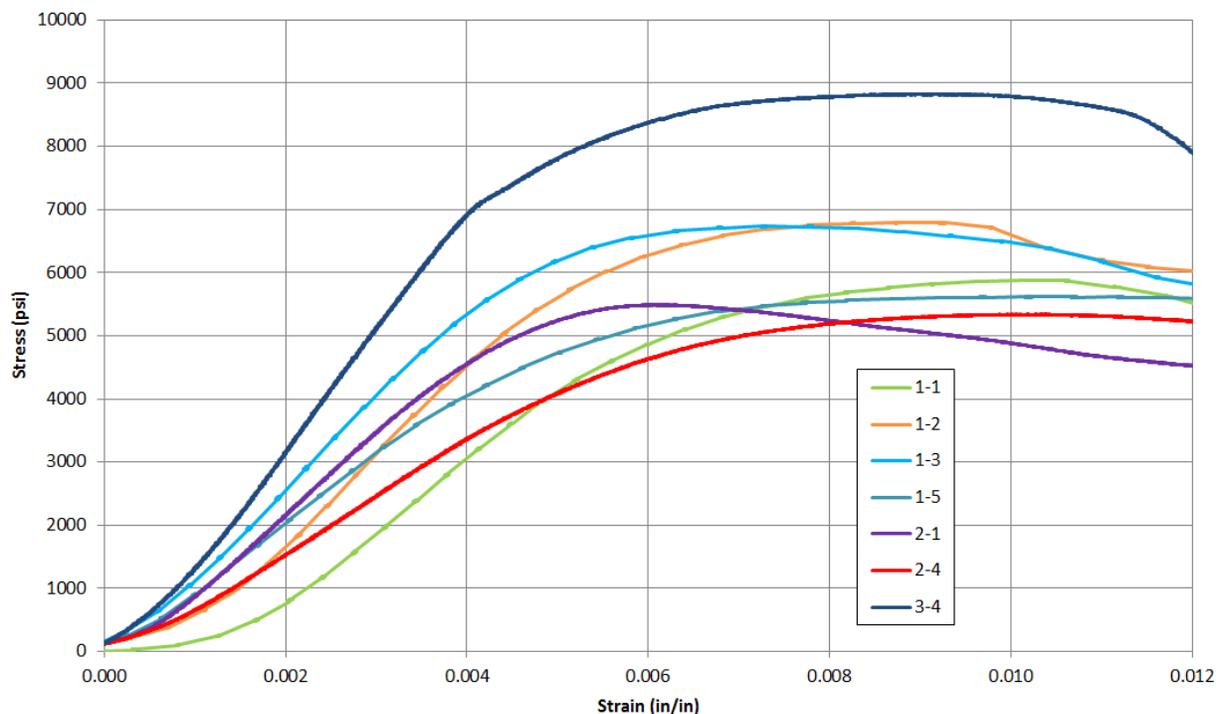
**Figure A-20. Stress vs. strain results for compression tests of joist specimens**

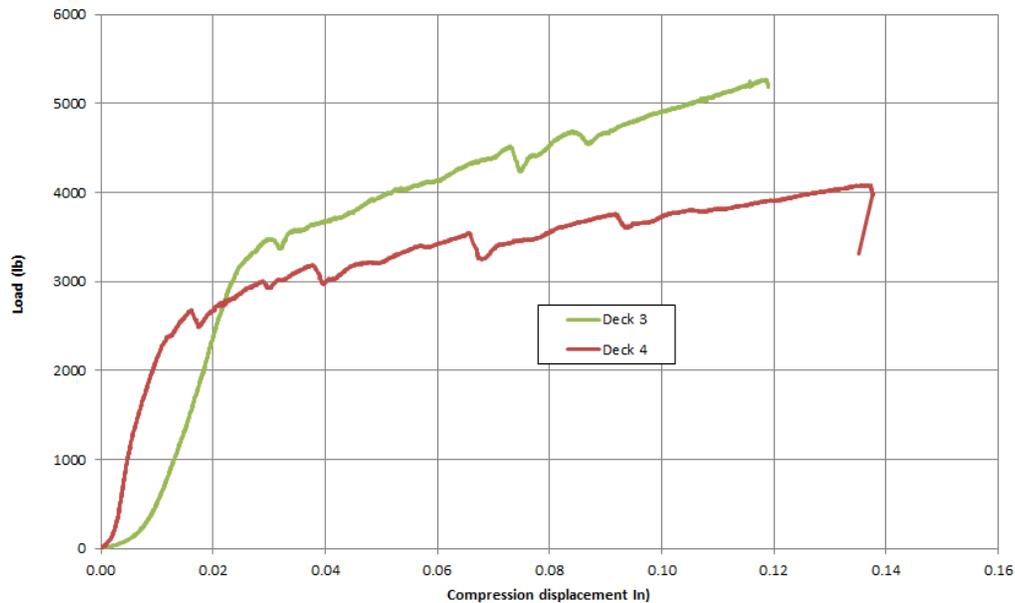
**Figure A-21. Load vs displacement plots for compression perpendicular to grain tests on specimens cut from deck planks.**

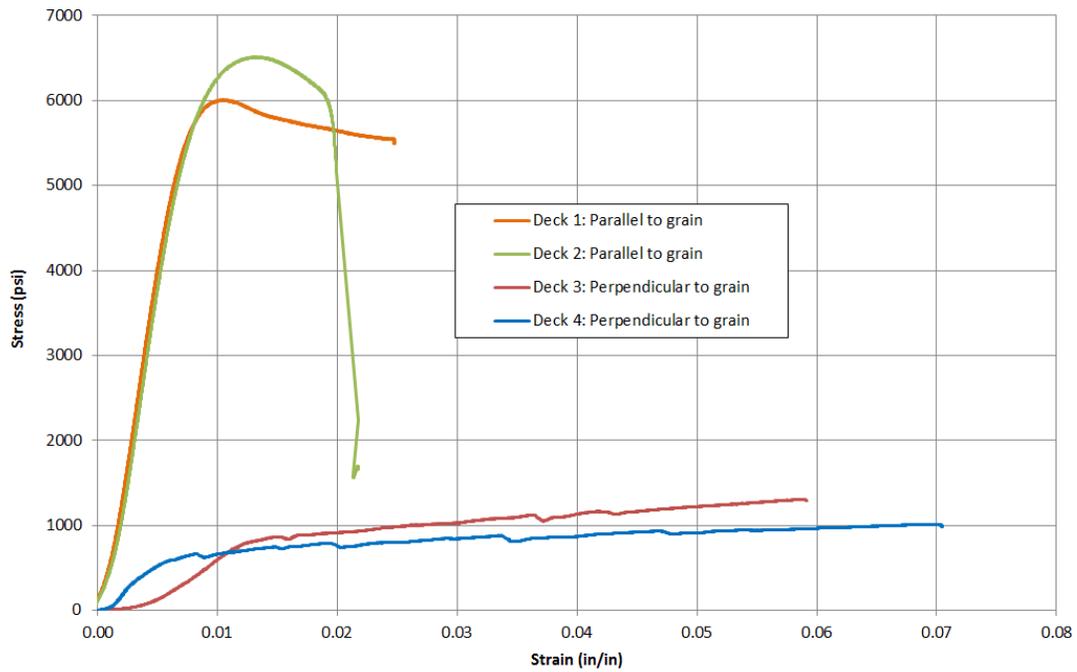
Figure A-22. Compression test results for deck planks; stress vs. strain.
