ARCHEOLOGICAL ASSISTANCE PROGRAM
Technical Brief No. 1

**FILTER FABRIC:
A Technique for Short-term Site Stabilization**

*By Robert M. Thorne
Center for Archaeological Research, University of Mississippi*

The Huffine Island Experiment

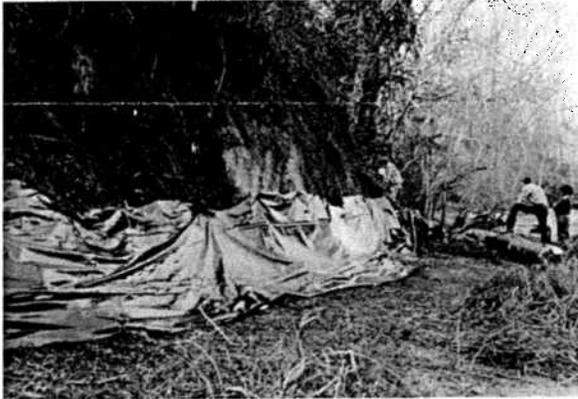
Figure 2. Installation of underliner

Installation of a short-term, relatively low cost stabilization treatment technology was deemed to be the most appropriate course of action to be followed. Since the material that would be installed would have to be transported to the site by boat, any material to be considered had a preselection weight and bulk requirement built in. Filter fabric appeared to be the material that would not be too heavy or bulky to move in a 16 ft boat. Manufacturer's specification sheets were consulted in an effort to select from some of the materials that were available. Further advice was sought directly from the manufacturer. The erosion control problem was explained, and a recommendation for the "best choice" material was requested. Stabilization conditions that had to be met were detailed, and after several telephone sessions the manufacturer recommended a nonwoven fabric that appeared to best suit the requirements of this particular effort. Because of the permeability of the material selected, it was necessary to determine if an impervious underliner was necessary or desirable. The purpose of the

underliner would be to protect the portion of the fabric that would be submerged by the lake water. It was considered possible that the submerged fill material in the mound would be melted during the period of submersion and the silt sized particles would then be trapped in the pores of the fabric. Filling of the pores would not only retard the passage of rainwater during low water periods, but the accumulated soil would add weight to the fabric. This added weight would then in turn put additional stress on the pins that hold the fabric in place. To prevent this situation from developing, an underliner of black polyethylene (6 mils) was installed along the face of the mound to a height of 4 ft, well above the high water line on the face of the mound.

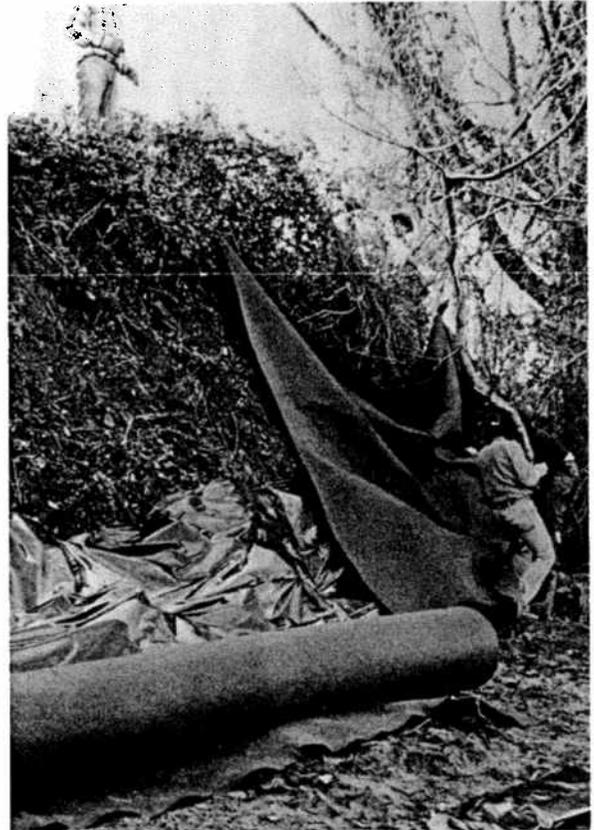
Figure 3. Installing filter fabric

Installation of the filter fabric was accomplished by cutting appropriate lengths of material off the roll and draping each piece down the cutbank like a curtain. The fabric measures 14.5 ft wide and can be cut to appropriate lengths with a sharp knife. Scissors are not recommended because the fabric will compress and pinch between the scissor jaws. In addition, the cloth will quickly dull the cutting edge of any implement, making frequent sharpening necessary.

The first piece of the material was installed on the downstream end of the bank and pinned into place using 18 inch steel pins that have a 1 1/2 inch washer affixed to the top. This washer keeps the pins from pulling through the fabric. Additional pieces of the fabric were added with a 6 to 8 inch overlap at the joints. Once all of the pieces had been properly located and temporarily pinned, additional pins were added at strategic points to insure that the fabric

conformed to the undulations of the cutbank. Obviously, the specific installation progression that was employed at Huffine Island will likely have to be adjusted to particular resources being treated in other places.

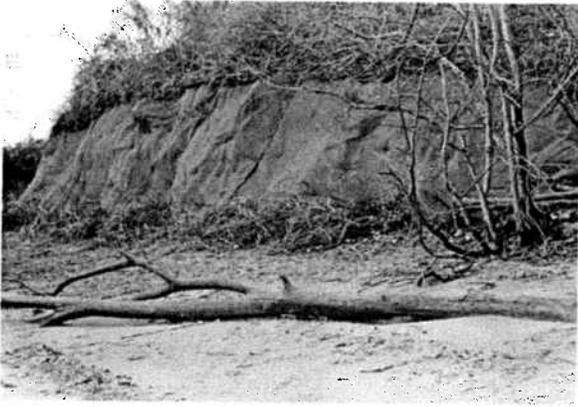
Figure 4. Present appearance of site

At Huffine Island, monitoring is completed on a quarterly basis. Responsibility for completion of the inspection process is shared by both the Center and TVA. On the basis of these regular inspections it will be possible to determine if the predicted five year life of the fabric will be reached. If and/or when failure of the material becomes evident, a new effort to further protect the site will be initiated. The material at Huffine Island has been in place for a year at this writing and is functioning in an excellent fashion.
