HISTORIC AMERICAN ENGINEERING RECORD

STRENGTH OF BURR-ARCH TRUSSES

HAER No. OH-138

LOCATION: 10900 Euclid Avenue, Cuyahoga County, Ohio

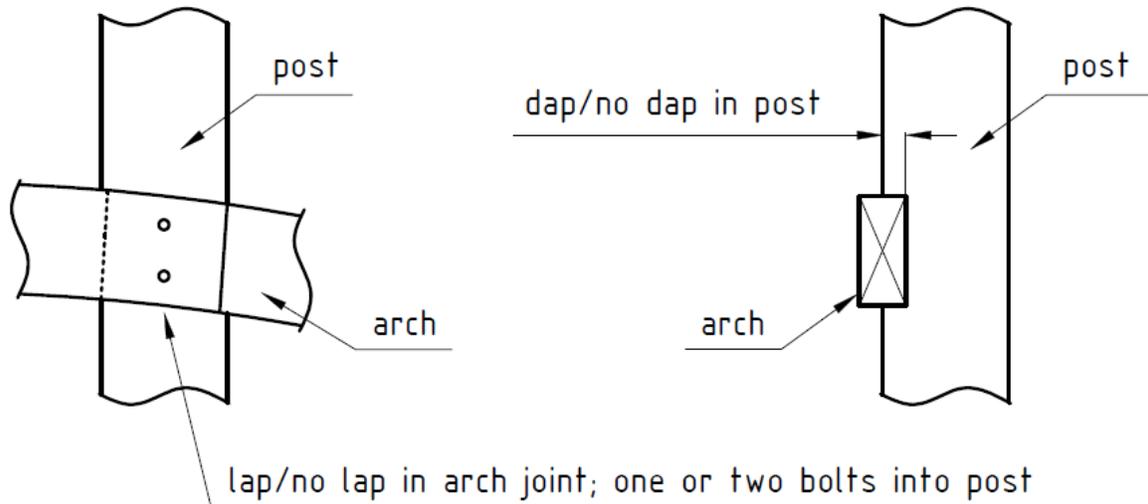
Arch-to-post – This connection controls the load transfer between the post and the arch. Fig. 2 shows the principal parameters.

Fig. 2 – Post-to-arch connection

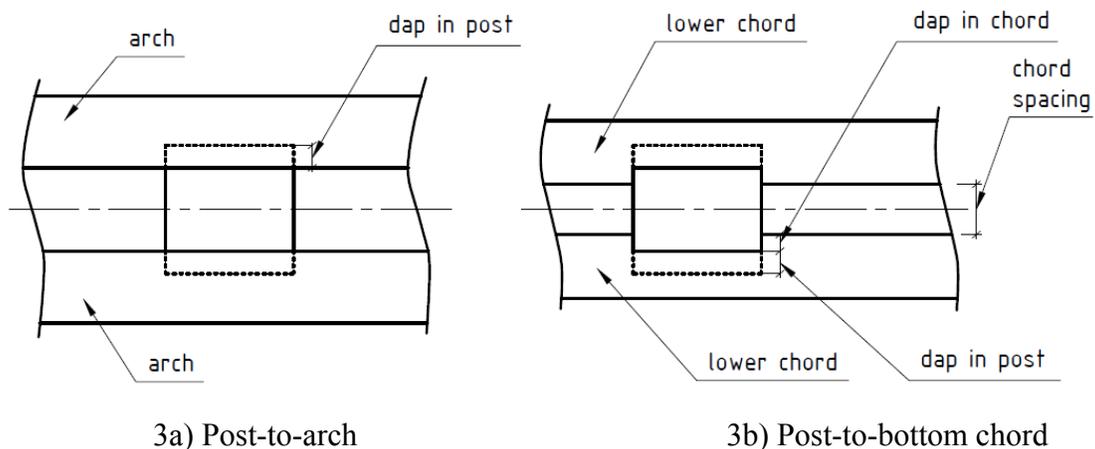
Generally one or two through bolts are used at the arch-post intersection. Splices between arch segments, usually required at every other post, may use laps or the sections may simply abut. The arch may or may not be dapped into the post. If daps are used, the ability of the connection to transfer gravity load into the arches is improved, but daps increase the difficulty of passing the arches by the bottom chord. This framing difficulty is illustrated by Fig. 3, which shows that, in practically all cases, the inner vertical faces of the arches are *inside* the outer vertical faces of the bottom chord.

Fig. 3 – Inner vertical faces of arches are generally inside outer vertical faces of chord members

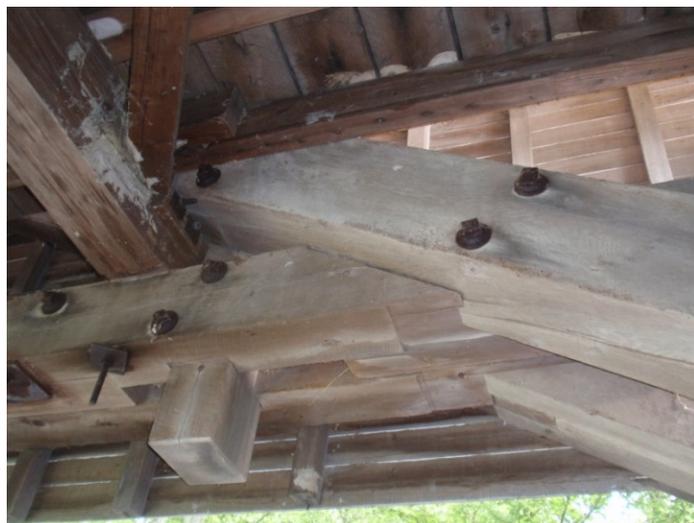
4c) Notch both the bottom chord and arch (Smith Bridge, Rush County, Indiana)

Fig. 4 – Three techniques for passing the arches by the bottom chord

Fig. 4a indicates that some builders simply splayed the arches using spacers on the post nearest the intersection (see, for example, the Mansfield Bridge in Parke County, Indiana). Splaying generally simplifies the framing since no daps are needed. However, the strength of the arches is reduced significantly because they are no longer planar. A second technique, shown in Fig. 4b, is to increase the thickness of the arches in the panels adjacent to the intersection and then use (relatively deep) notches only in the thickened arches. As for the splaying technique, the effective centroidal axis of the thickened arch is no longer planar. The third common technique, shown in Fig. 4c, is to dap or notch both the arch and the bottom chord, a more time-consuming method. In most cases, one or two through bolts are placed at this intersection.

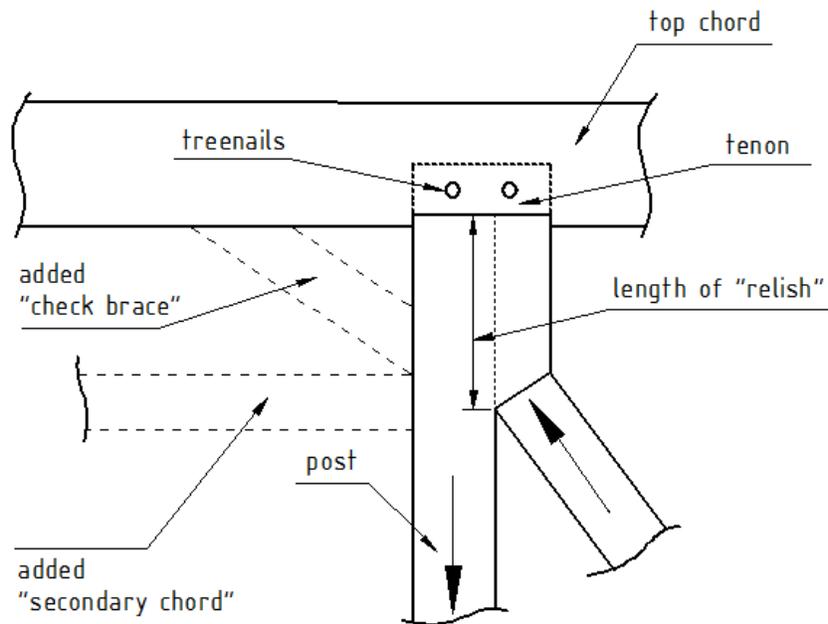
Fig. 6 – Post to single top chord connection

These effects of the eccentric brace force were sometimes decreased by adding “check braces” or “secondary chords,” as shown in Fig. 6 (see, for example, the Turner Bridge in Pennsylvania). If the top chord consists of two sticks, as shown in Fig. 8, (see, for example, the Barrackville Bridge in West Virginia) the relish can extend above the top chord and the eccentricity can be made much smaller, as for the post-to-bottom-chord connection. A double top chord is used for longer-span bridges; it effectively increases the lateral stiffness of a planar Burr-arch truss.

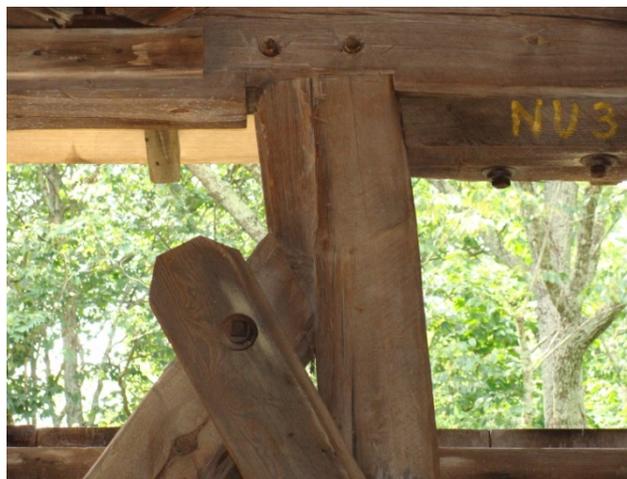
A sufficient “relish” length is required to transfer the vertical component of the brace force into the post. Therefore the brace axis does not meet at the point of intersection of the post and chord axes. That is, there is an eccentricity that produces shear and bending moment in the post. Fig. 7 appears to show shear and bending deformation in the post caused by the eccentricity of the brace.

Fig. 7 - Deformation at the brace-to-post connection, at the Bebb Bridge, Ohio. (The added brace connected to the diagonal is probably unique to the Bebb Bridge.)

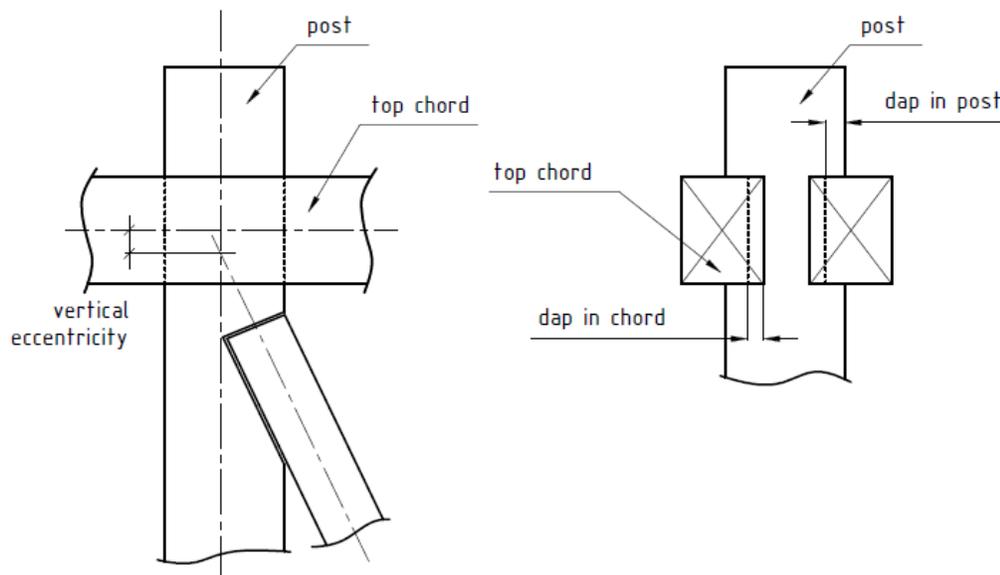
Fig. 8 – Connection between a post and a two-member top chord

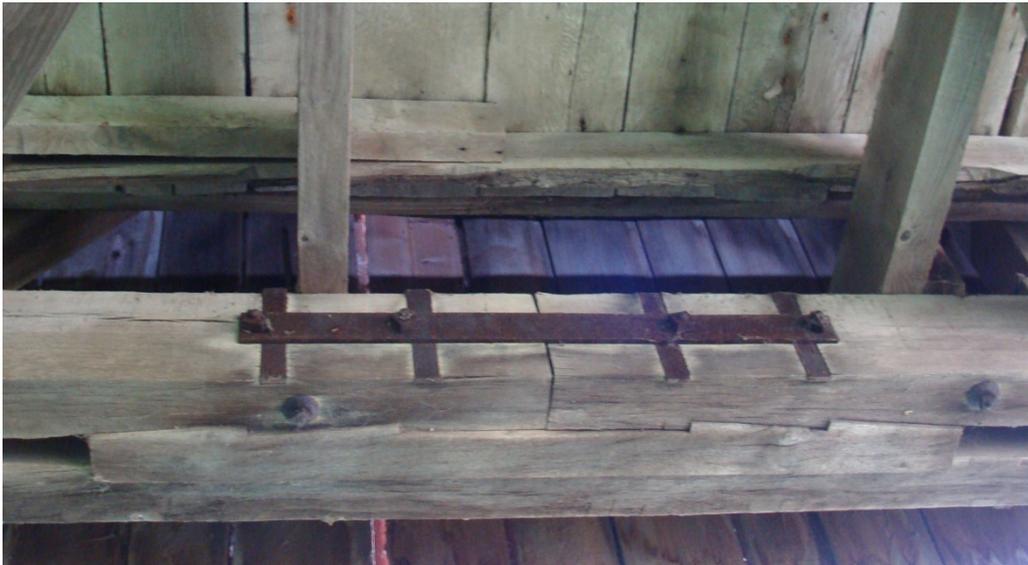
Fig. 11 – Daniels' bottom chord splicing detail (Deer's Mill Bridge, Indiana)

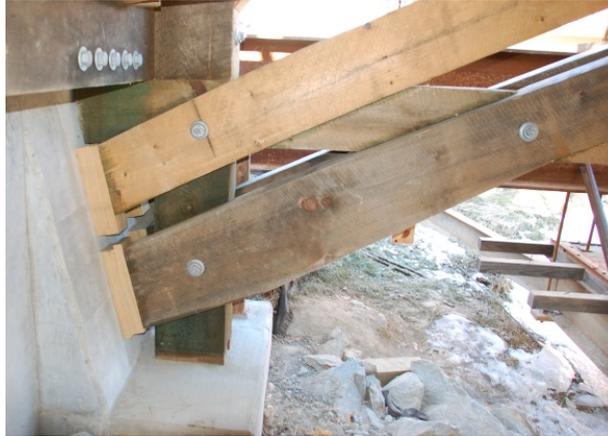
Fig. 15 – Arch bearings for Gilpin's Falls Covered Bridge. Photo by Christopher Marston, 2010.

NHCBP funding also enabled Rachel Sangree and Hannah Blum to perform structural studies of the Gilpin's Falls Covered Bridge in conjunction with its rehabilitation by timber framer Tim Andrews in 2009.³³ Joseph G. Johnson built the 98' span in 1860. It has a single stick for the top chord; therefore, the eccentricity of the diagonals needs to be modeled. Each truss has "double arch ribs" with end conditions as shown in Fig. 15.

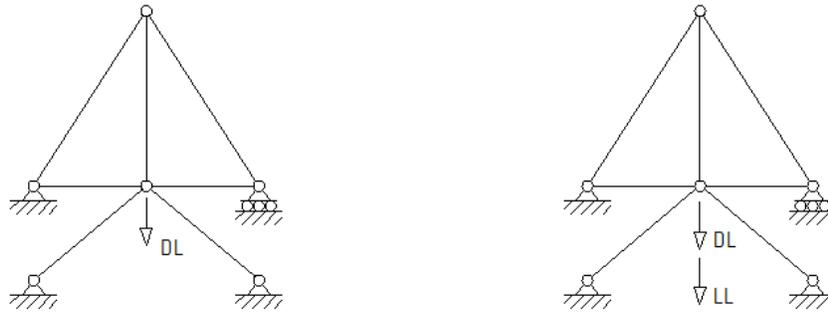
19a) Truss carries all DL

19b) Arch is added; LL is shared by arch and truss

19c) DL is shared by arch and truss

19d) DL and LL are shared by arch and truss

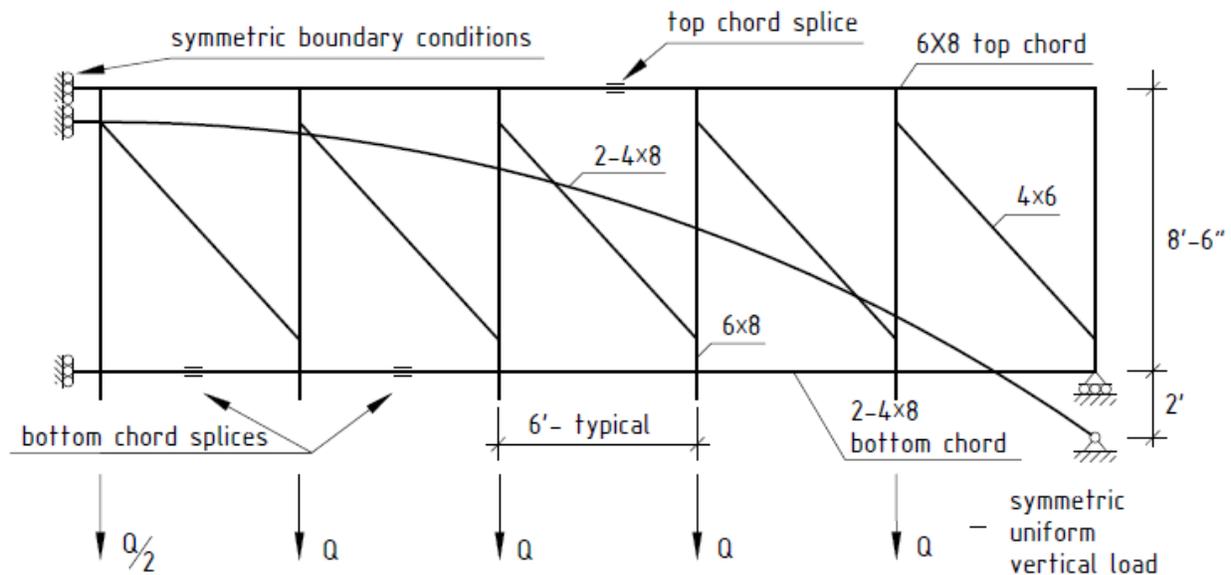
approximately a 2/3 scale model of a 90' long Burr-arch truss. Use of a symmetry model implied an important constraint. Since a Burr-arch truss has compression-only diagonals, it cannot be assumed that it will behave antisymmetrically under antisymmetric loads. Therefore the symmetry model cannot be used in conjunction with an antisymmetric load or with an asymmetric load such as an AASHTO-type truck load at the quarter-span only. The research funding allowed only one specimen to be fabricated and tested to failure, under one loading condition (unless repairs could be affected, allowing a retest of the repaired specimen). The model initially proposed is shown in Fig. 20.

Fig. 20 – Preliminary proposed model design (planed full-size dimensions are given)

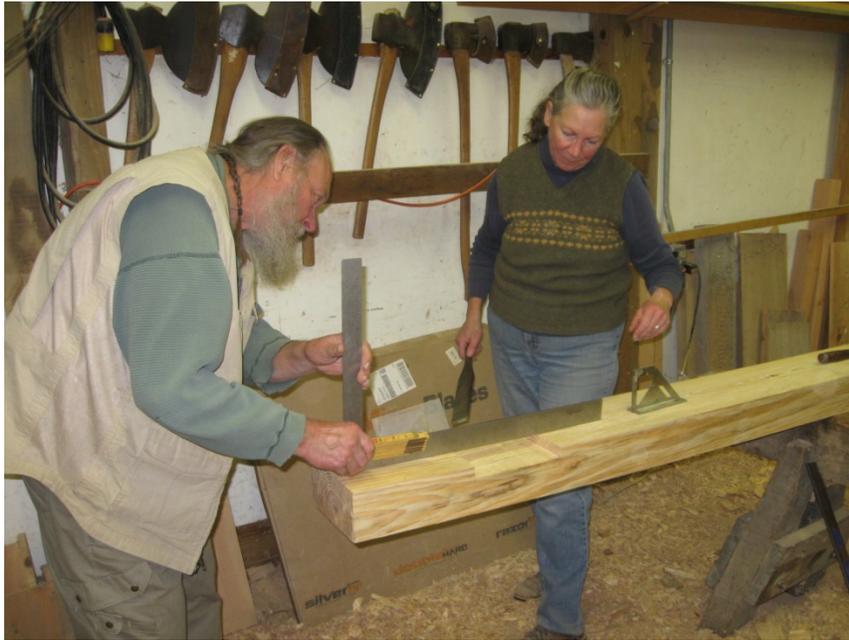
Fig. 21 – Fabrication of timber sections by Rudy and Laura Christian

Timber framers Rudy and Laura Christian of Burbank, Ohio, assisted by Andrew Schaeffer, fabricated the members (see Fig. 21). On December 10, 2014, the members were picked up and brought to the Vanderhoof-Schuette Structural Laboratory at CWRU (see Fig. 22).

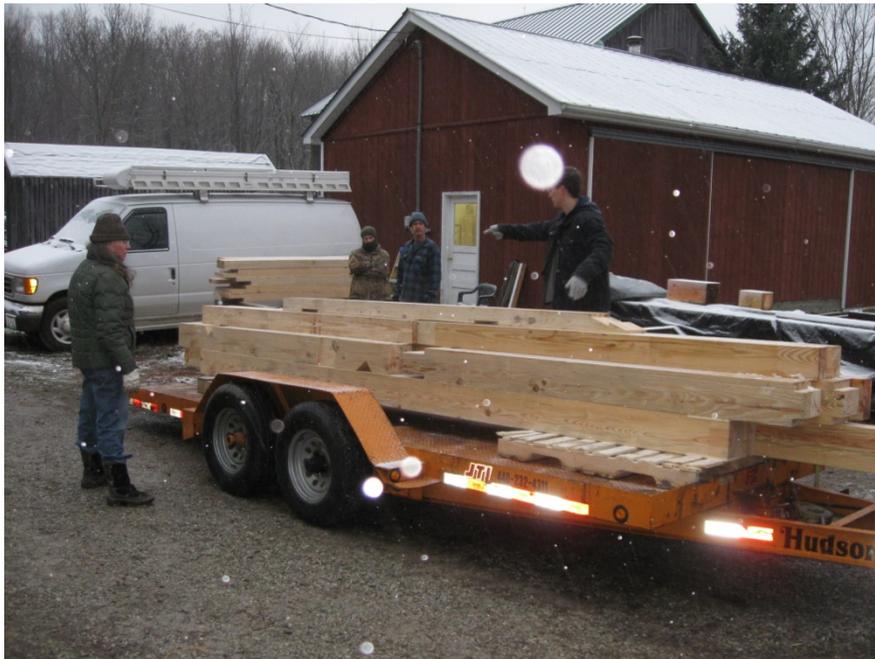
Fig. 22 – Fabricated members being picked up at Burbank, Ohio on December 10, 2014

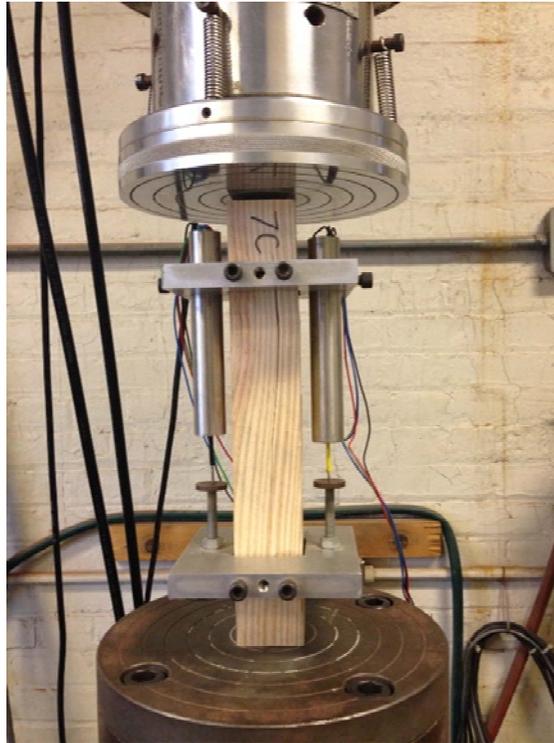
Fig. 23 shows the test setup.

Fig. 23 – Uniaxial compressive test setup

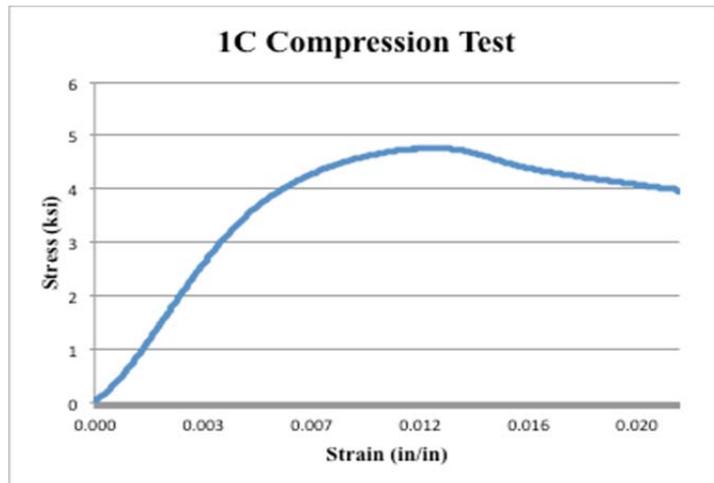
24a)

Displacements on two sides of the specimen were measured using direct current differential transformers (DCDTs). The average of the two values was found and divided by the gauge length of 7" to obtain strain values. The stress-strain curves for specimens 4C and 1C are shown in Fig. 24.

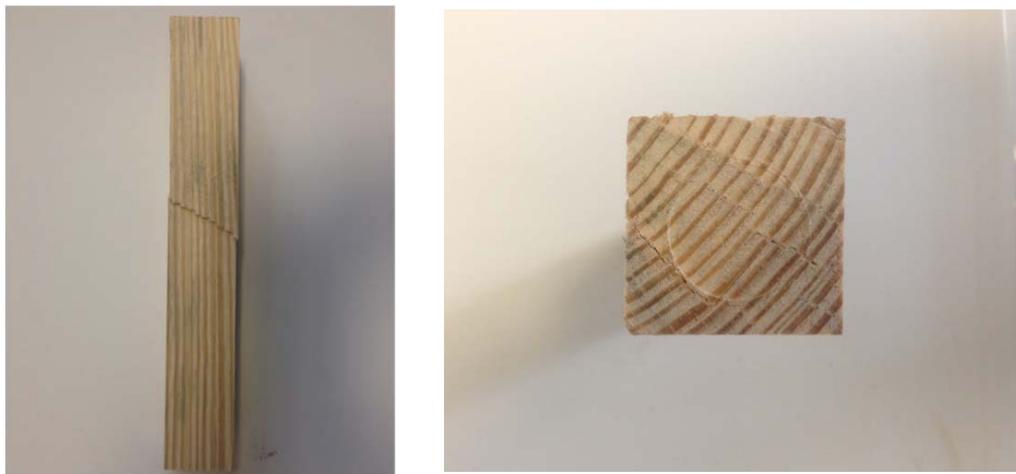
It was observed that properties were correlated with the unit weights and flaws. Specimen 1C had the fewest growth rings, the smallest unit weight and, correspondingly, the smallest strength and modulus. Table 6 shows the variability in properties of wood of the same species and grade. Specimens 7C and 2C, which had small knots, had smaller strengths. Figs. 25(a) and 25(b) show cross-sections and failure modes for specimens 4C and 1C, respectively.

Fig. 25a – Cross section and failure mode for specimen 4C

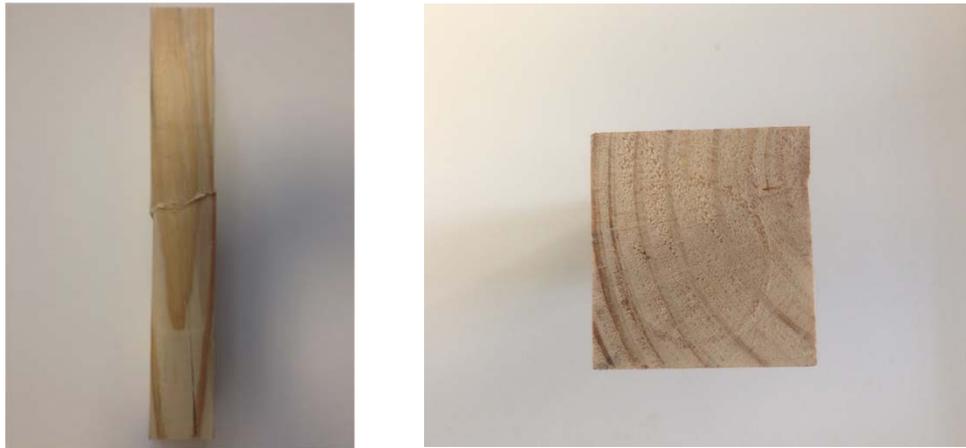
Fig. 25b – Cross section and failure mode for specimen 1C

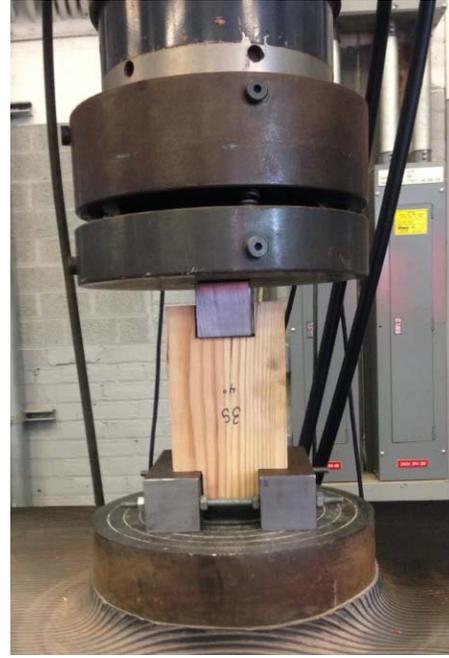
Fig. 27 – Shear test set-up

Shear tests parallel to the grain – The shear test specimen that was used and the test set-up are shown in Figs. 26 and 27. Dimensions of the specimens are given in Table 8. All specimens had a nominally zero grain angle.

testing machine in displacement control. The specimens were loaded with a steel block in the notch as shown in Fig. 27. Two steel blocks, tied horizontally to minimize normal stresses perpendicular to the grain of the wood, were used as bearings at the bottom.

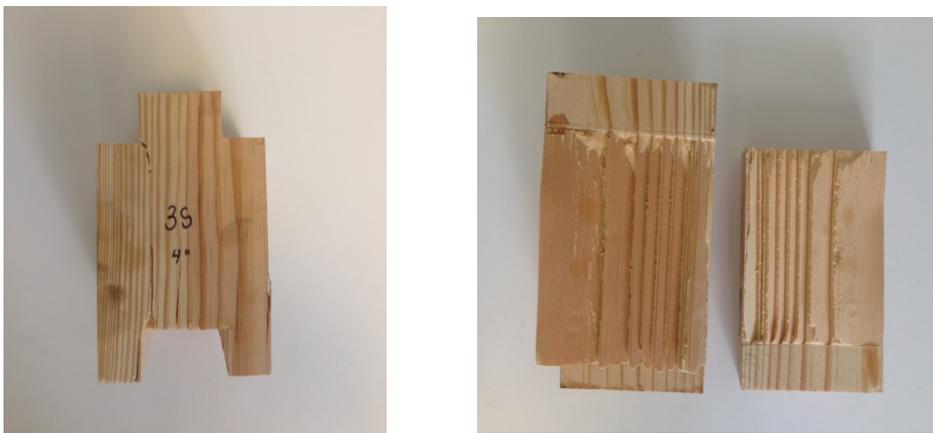
Fig. 29 – SYP failed shear specimen 3S.

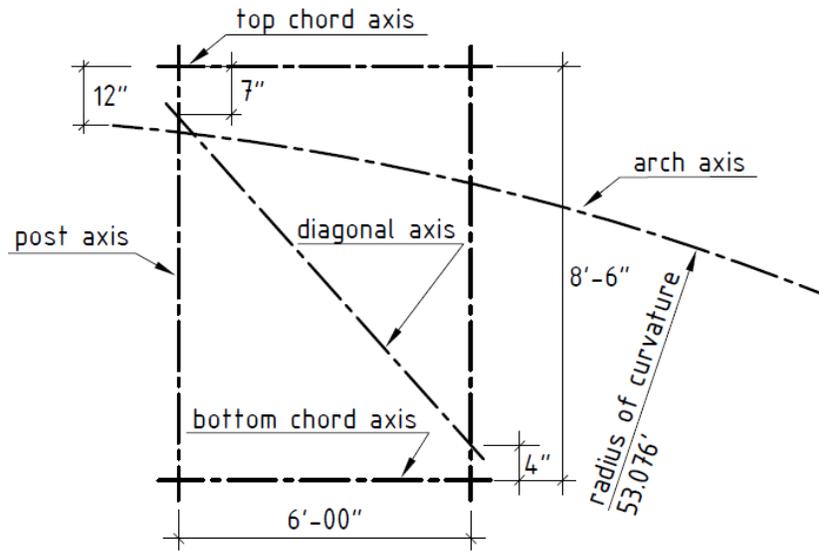
Fig. 30 – Geometry of panel and vertical position of arch at axis of symmetry

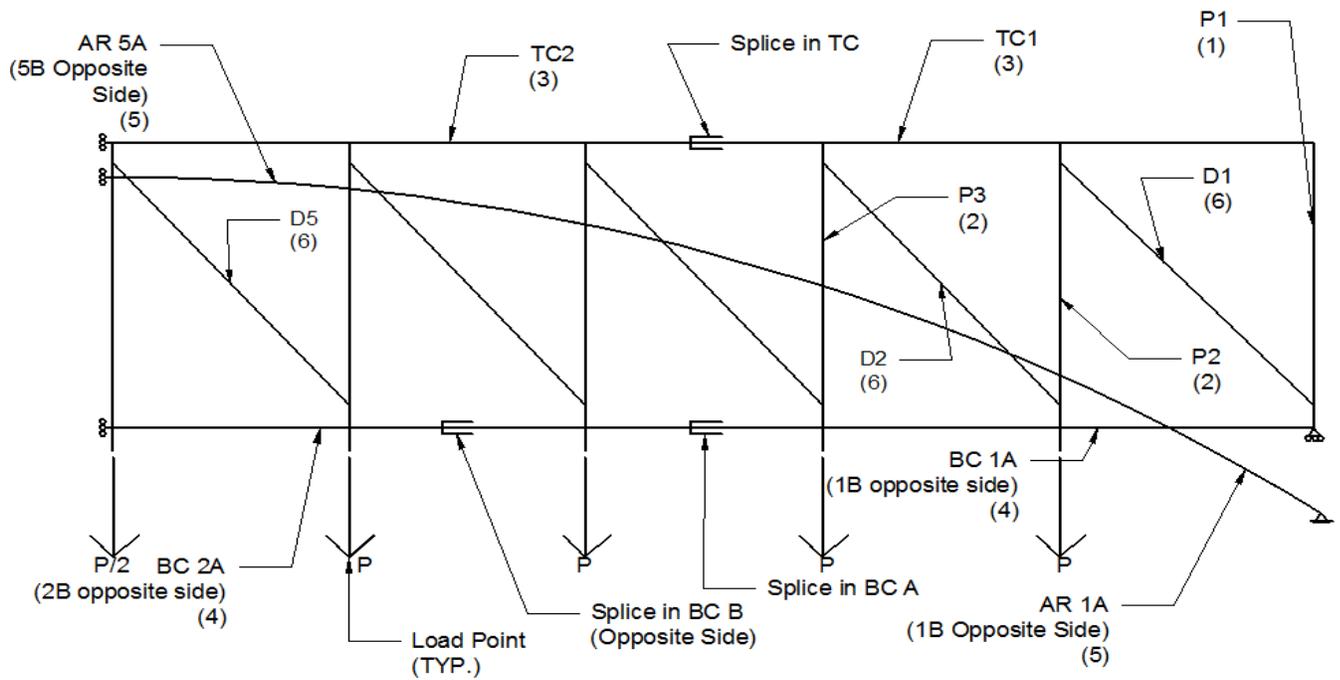
Nonetheless, to determine forces for the particular proposed model geometry and loading condition, a plane frame linear elastic model was defined using SAP2000. The symmetry model has five 6' panels. The geometry of one panel is shown in Fig. 30, which also shows the eccentricities of the diagonals with respect to the post-chord intersections. The radius of curvature was 53.076'. The boundary conditions and the member labeling are shown in Fig. 31.

Fig. 31 – Member labeling and symmetry boundary conditions

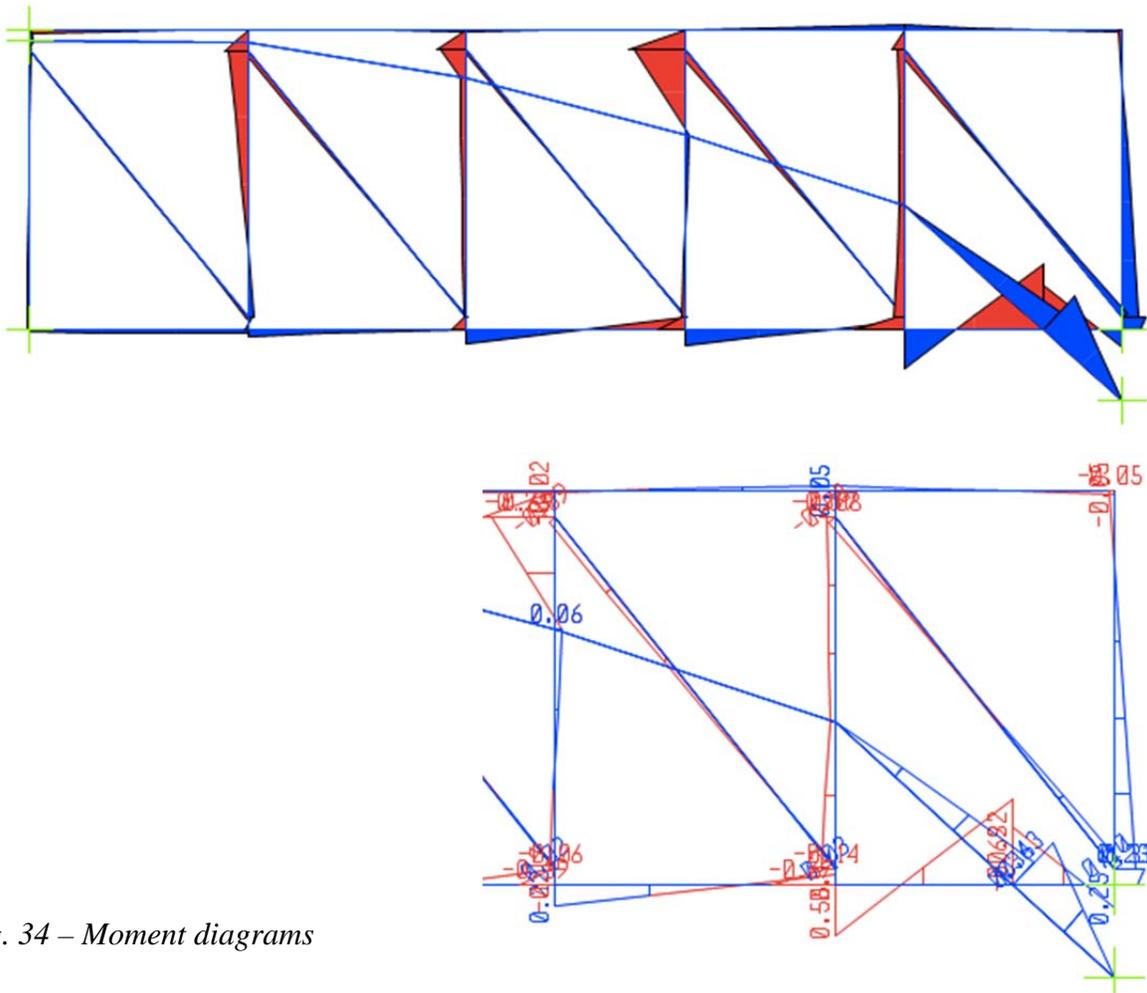
Considering the butt connection at the top chord to be a rotational hinge, the simple plane frame model as defined was statically indeterminate to the 35th degree. Figs. 32, 33, and 34 show the resultant axial force, shear, and moment diagrams from the analysis. The vertical reaction at the arch thrust bearing is essentially equal to the total vertical load. This vertical reaction would decrease if the bearing had a finite stiffness. There is shear in the arch segment below the bottom chord intersection, which means that the resultant reaction at the thrust bearing is not in the direction of the arch axis at the spring point. Diagonal D1 has a very small compressive axial force.

Fig. 34 – Moment diagrams

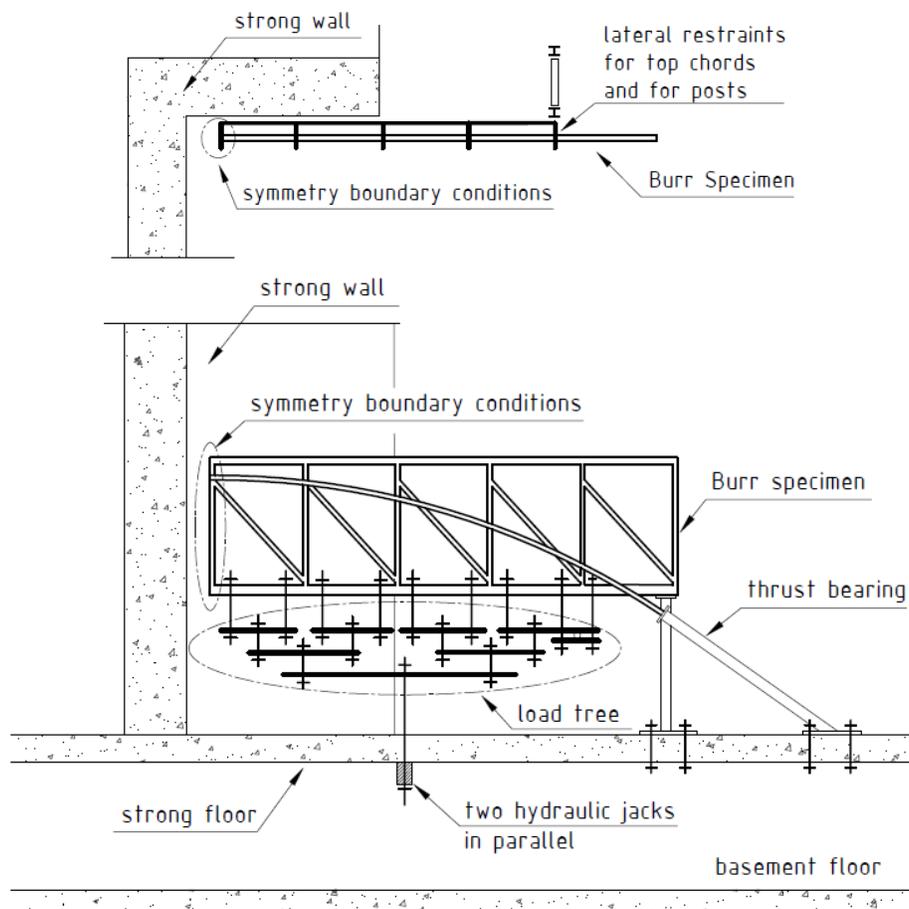
The Vanderhoof-Schuette Structural Laboratory at Case Western Reserve University has both a “strong floor” and a “strong wall.” The L-shaped, cellular strong wall is 8' thick, with 18"- thick flanges with tie-down points at 2' on center. The 10'-deep cellular strong floor also has 18"-thick flanges with tie-downs at 2' on center. The overall arrangement of the Burr-arch truss specimen was as shown in Fig. 35.

Fig. 35 - Burr specimen layout

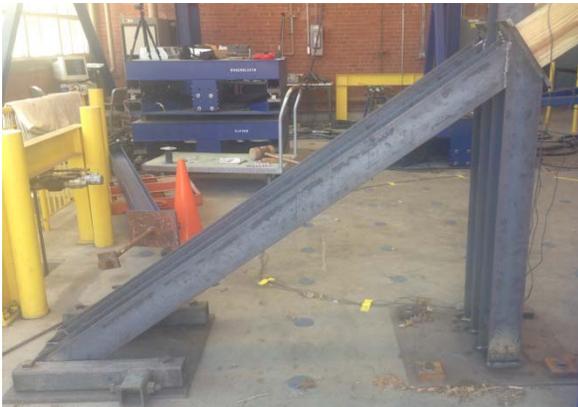
Thrust bearing – Details of the thrust bearing are given in Appendix drawings A-6 to A-9 and in Figs. 36 and 37.

Fig. 36 – Thrust bearing

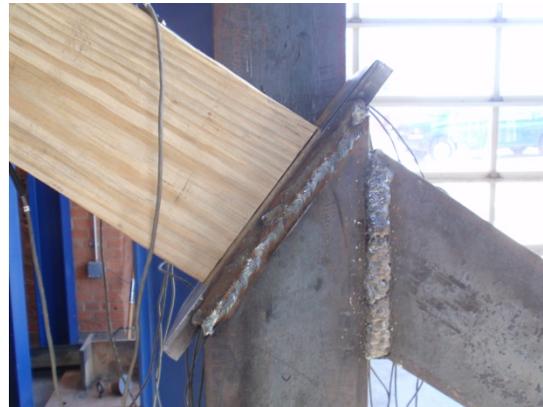
Fig. 37 – Arch springing

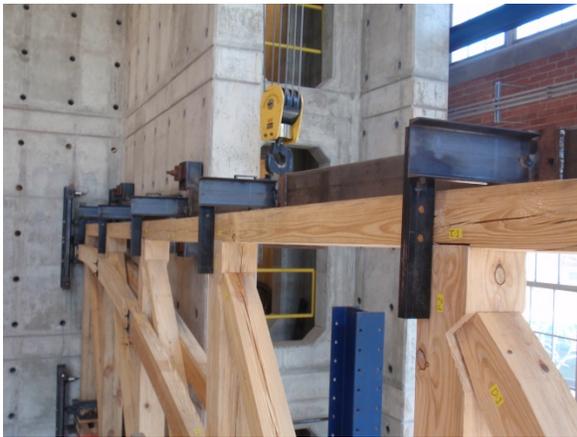
Lateral bracing – Ten lateral restraints were installed to preclude out-of-plane motion of the truss. All were custom-fit, U-shaped restraints made of welded steel channel sections. Fig. 38 shows the five lateral restraints at the top nodes. Fig. 39 shows the five lateral restraints placed at accessible locations on the lower half of the posts. The top end node, at post P1, was not braced laterally.

Fig. 38- Lateral restraints at top nodes

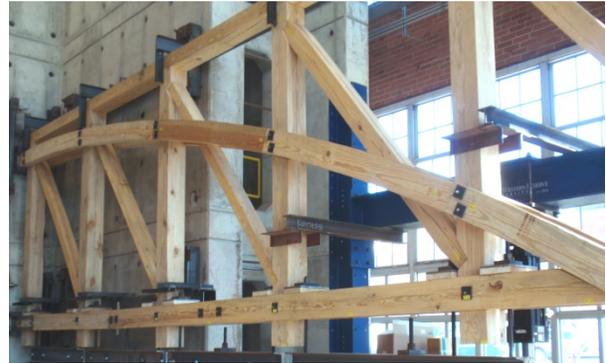
Fig. 39 – Lateral restraints on posts

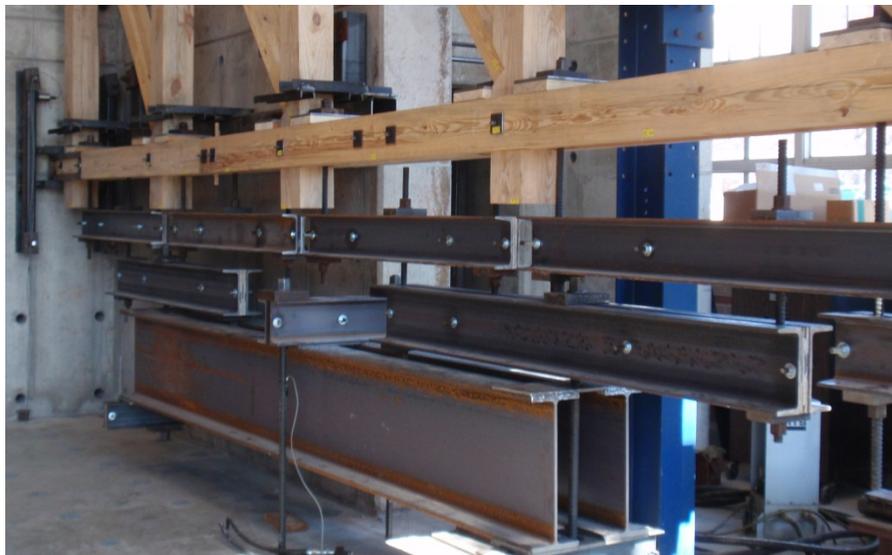
Load tree – To apply a uniform loading, a “load tree” was fabricated as detailed in Appendix drawings A-10 to A-15 and shown in Fig. 40.

Fig. 40 - Load tree

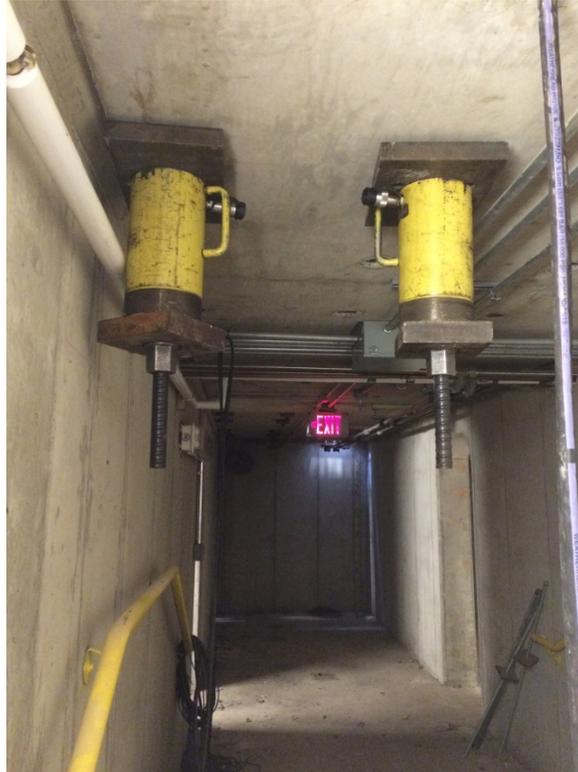
the bottom chord through bearings as shown in Appendix drawing A-15. The total load was affected by two equal 60-ton hydraulic through jacks connected to a common manifold pressurized by one electric pump. The loading system was effectively displacement controlled. Fig. 41 shows the two hydraulic jacks in the strong floor; extension of the jacks caused tensile forces in two calibrated high-strength Dywidag bars.

Fig. 41 – Two hydraulic jacks in the strong floor

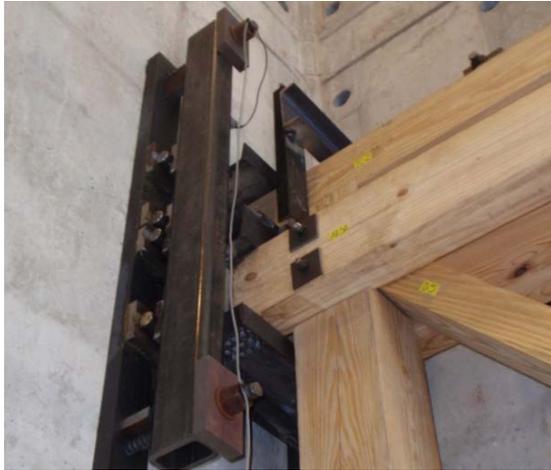
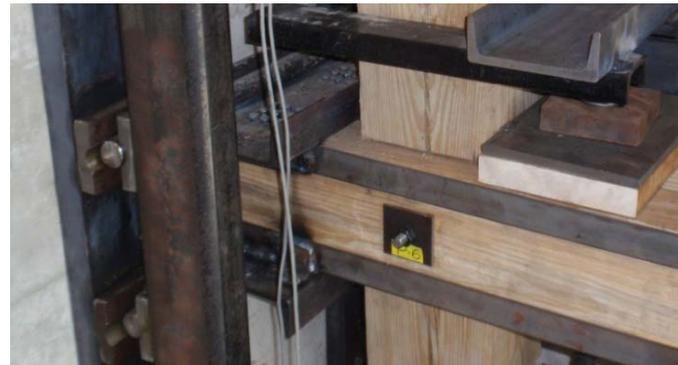
load. To preclude shear in this center post a vertical steel plate was inserted between the top chord and the arch as shown in Appendix drawing A-1. In addition, 1½"-diameter steel bars, which were previously welded to the channels, terminated in two bearings restrained between the strong wall and HSS (hollow structured sections) 3x5x1/2 tubes as shown in Figs. 42 and 43. In total, the two chords and the arch had twelve greased horizontal bearings.

Fig – 42 Top bearings at axis of symmetry Fig 43 – Bottom bearings at axis of symmetry

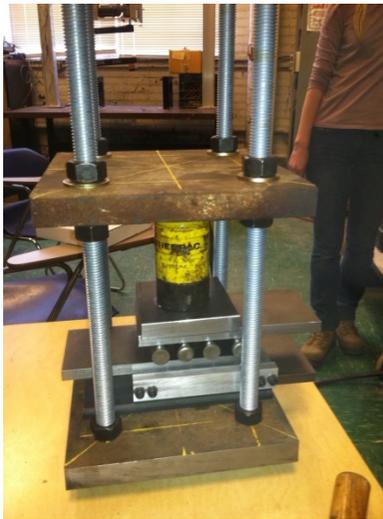
Fig. 44 - Pre-compression of a small-scale bearing assembly

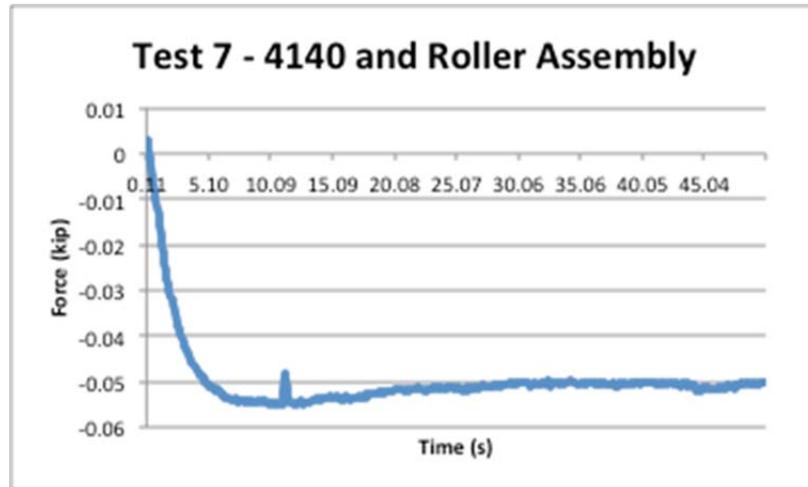
The load versus time curve for the bearing consisting of the 4140 steel with greased roller nests is shown in Fig. 47.

Fig. 47 – Load versus time curve for 4140 steel plates with roller bearing assembly

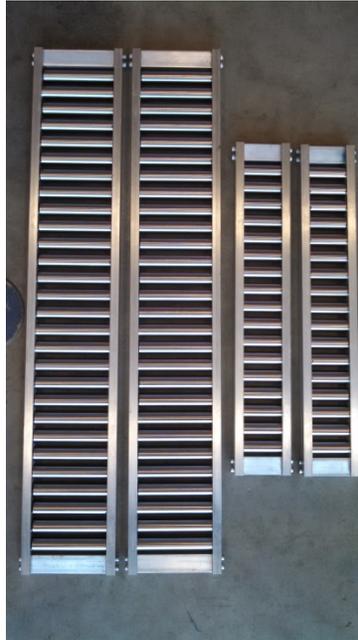
Fig. 48 – Nested roller bearings

Results for all seven tests are summarized in Table 13, which shows that the 4140 steel with the greased rollers had the smallest effective coefficient of friction, producing an essentially negligible frictional force in comparison with the envisioned magnitudes of the applied vertical loads. Therefore, nested rollers replaced the sliding bearings. Four nests of rollers were fabricated; the top bearings consisted of twenty-eight dowel-pin rollers in a “cage” while the bottom bearings consisted of seventeen dowel-pin rollers in a cage, as shown in Fig. 48.

Tests 4 and 5 – The truss was again tested on April 8 and 13, 2015. The test on April 8 was stopped because of an observed rotation in the load tree and unequal axial forces in the two Dywidag bars. No damage was observed. The test on April 13 was stopped because the bearings were clearly not displacing freely in the vertical direction. It was then decided to replace the bearings. As described in a previous section, a series of tests was performed to verify the effectiveness of alternate designs. The selected replacement bearings were nested rollers as shown in Fig. 48 and Fig. 65 below.

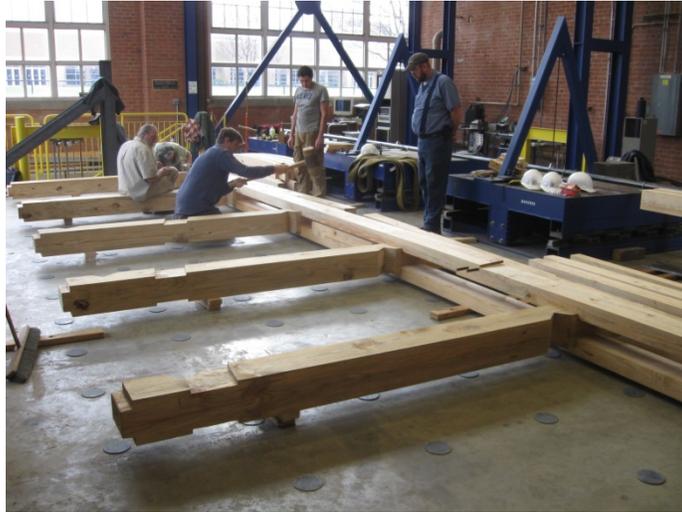
Fig. 49 – Assembly of bottom chord to posts

- Layout of posts;
- Assembly of bottom chord sticks with posts;
- Assembly of top chord with posts;
- Rotation of frame to vertical position;
- Insertion of diagonals and activation of truss self-weight; and
- Placement of arch segments, starting from the axis of symmetry and proceeding to the thrust bearings.

The process is illustrated by Figs. 49 through 52.

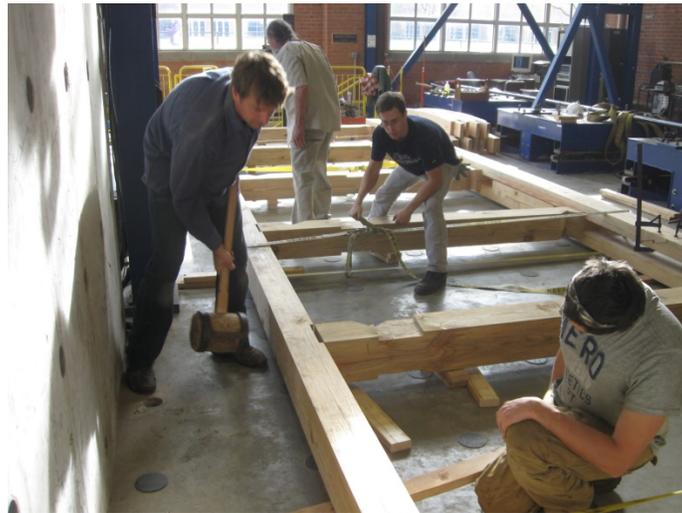
Fig. 50 – Assembly of top chord to posts

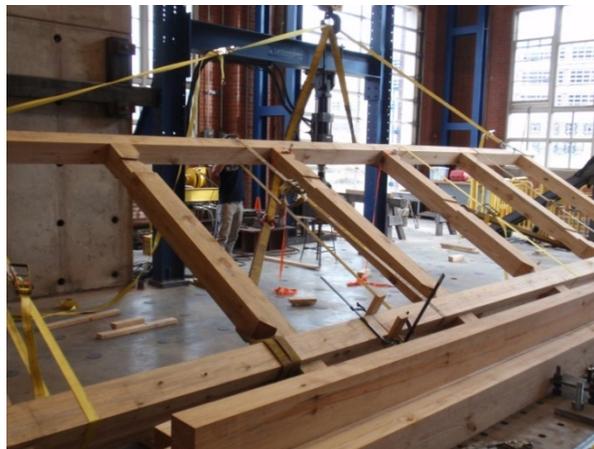
Fig. 50a – Rotation of frame to vertical position

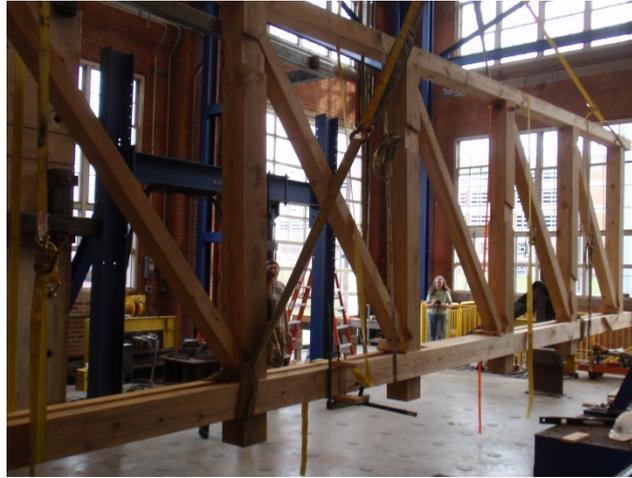
Fig. 51 – Insertion of diagonals; self-weight partially active

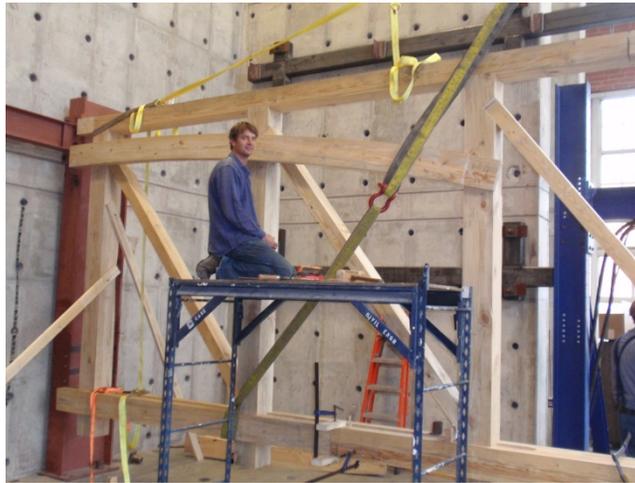
Fig. 52 – Placement of arch segments

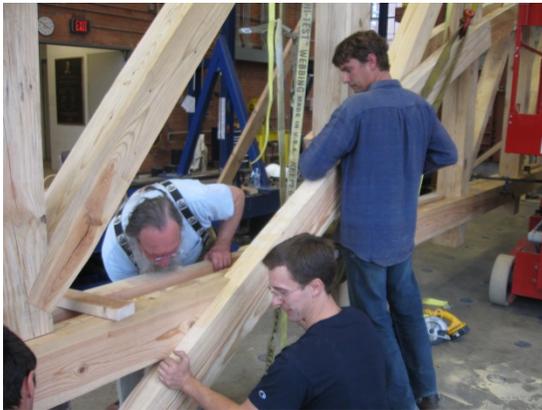
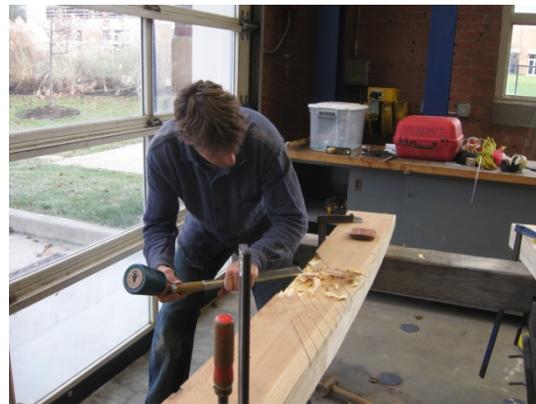
Fig. 53 – Measuring and cutting daps for arch-bottom chord intersection

The geometry of the daps in arch segments AR-1A and AR-1B at their intersection with the bottom chord was measured in the laboratory and then cut to fit as shown in Fig. 53.

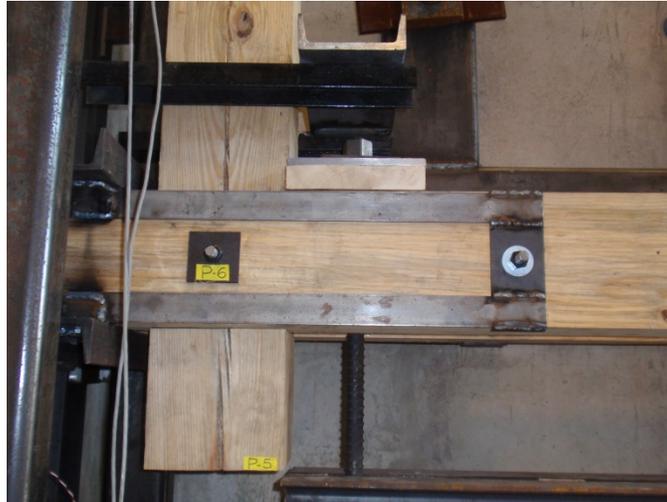
Fig. 54 – Steel straps and shear plate to help transfer bottom chord tensile force into bearings

Arch segments AR -1A and AR-1B (see Appendix drawing A-0) were fabricated approximately 12" longer than required. They were custom-cut later to match precisely with the steel thrust bearings. After the specimen was assembled, considerable time was spent placing the through bolts, installing the lateral bracing, and attaching the steel fittings at the axis of symmetry. In addition, to help transfer tensile force, steel straps and shear plates were installed on the bottom chord sticks at the axis of symmetry as shown in Fig. 54.

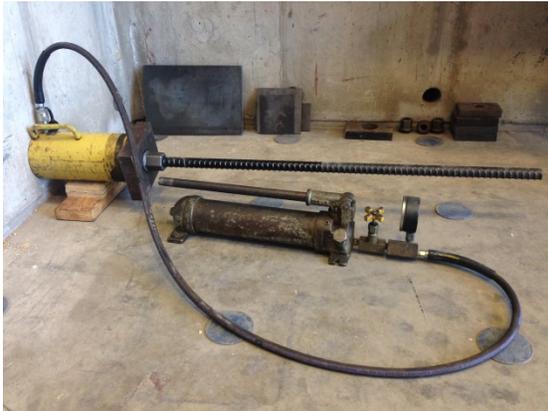
Calibrated load cell

Fig. 55 – Set-up for calibration of Dywidag bars as force transducers

To use the Dywidag bars as force transducers, they were instrumented with spot-welded, 350 Ω strain gauges manufactured by Hitec Products, Inc. and then calibrated. The calibration setup is shown in Fig. 55. A calibrated load cell was placed in series and the bars were stretched through the 18" thick face of the strong wall.

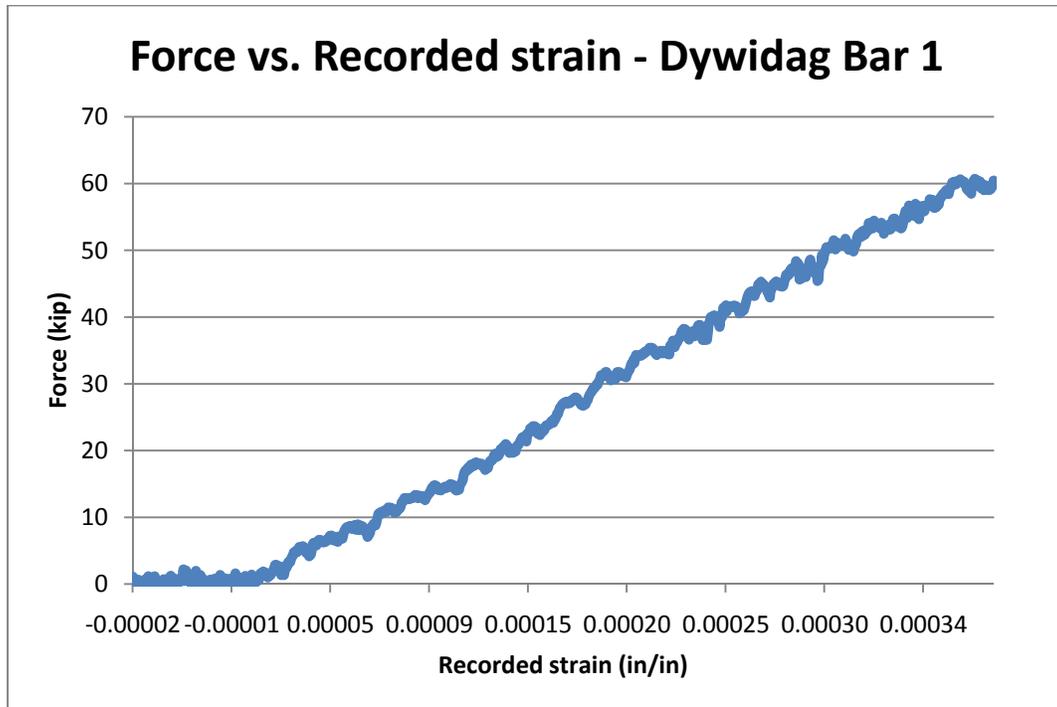
The force versus recorded strain curves are given in Figs. 56 and 57. The slopes of the two calibration curves are given in Table 14.

Fig. 56 – Calibration curve for Dywidag bar 1

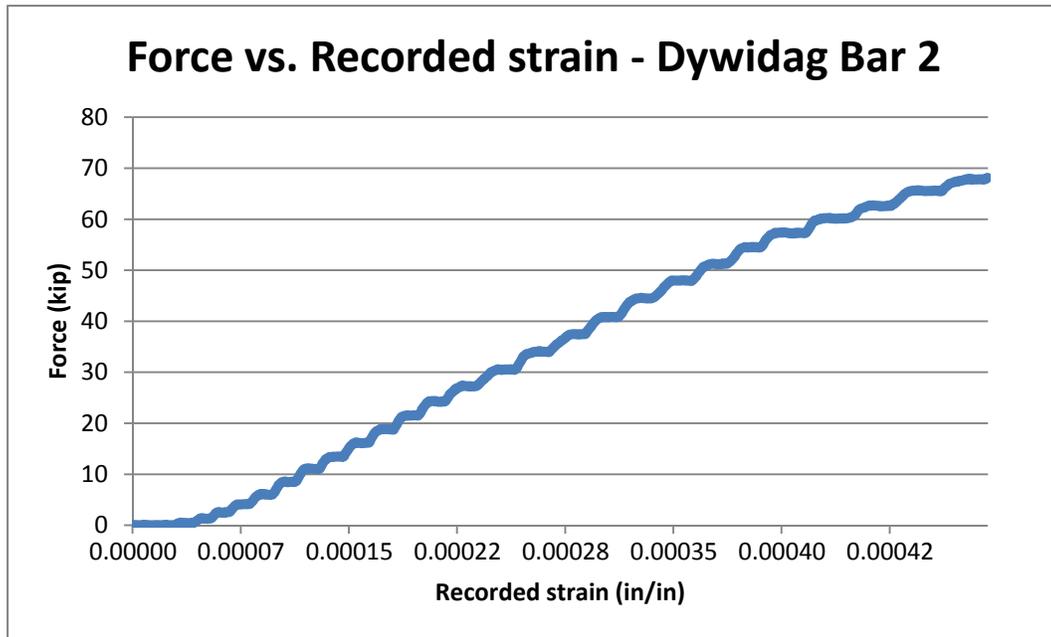
Fig. 57 – Calibration curve for Dywidag bar 2
