HISTORIC AMERICAN ENGINEERING RECORD

STRENGTH OF BURR-ARCH TRUSSES

HAER No. OH-138

LOCATION: 10900 Euclid Avenue, Cuyahoga County, Ohio

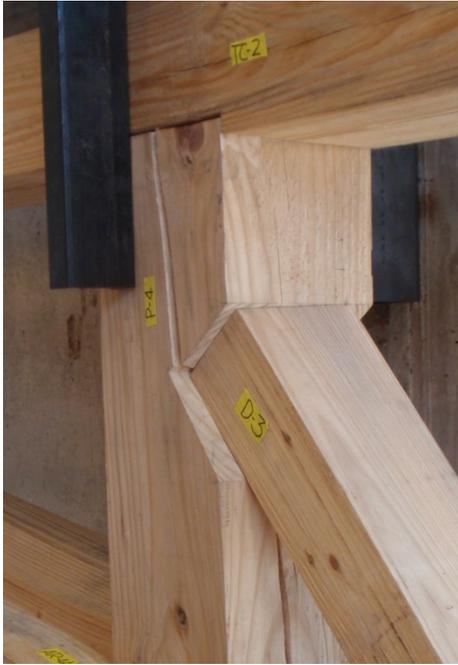
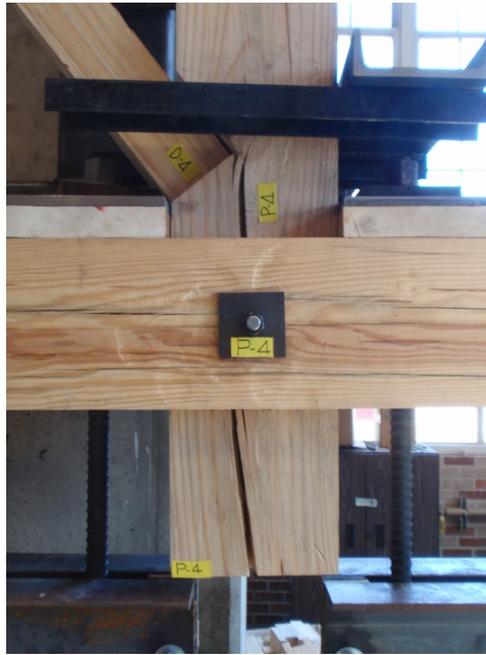
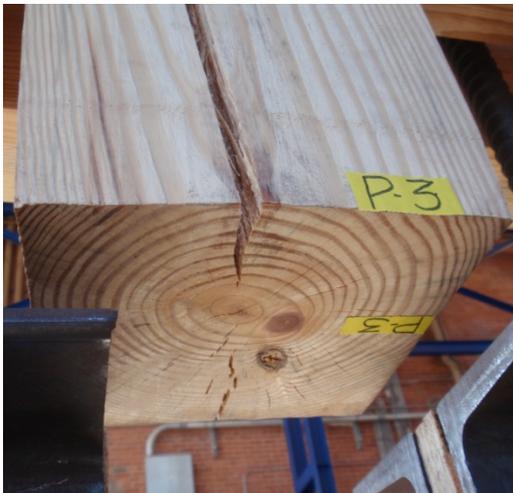
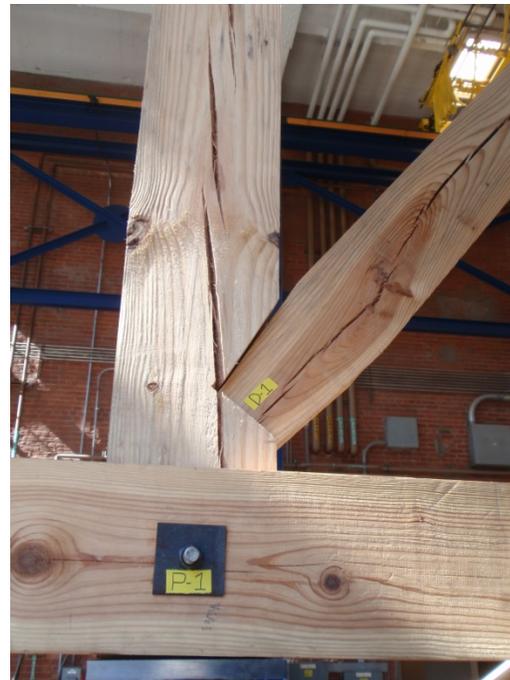
Preparations for testing were not completed until the third week of March 2015. Therefore the Burr specimen spent the entire 2014-15 winter in the dry conditions of the Structural Laboratory. As a consequence, extensive shrinkage cracking occurred in the wood sections as the moisture content of the wood decreased. Fig. 58 shows shrinkage cracks (heart checks) in the posts, at the notches for the diagonals and at their bottoms.

Fig. 58 – Cracking (heart checks) in posts after dry (winter) conditions in laboratory

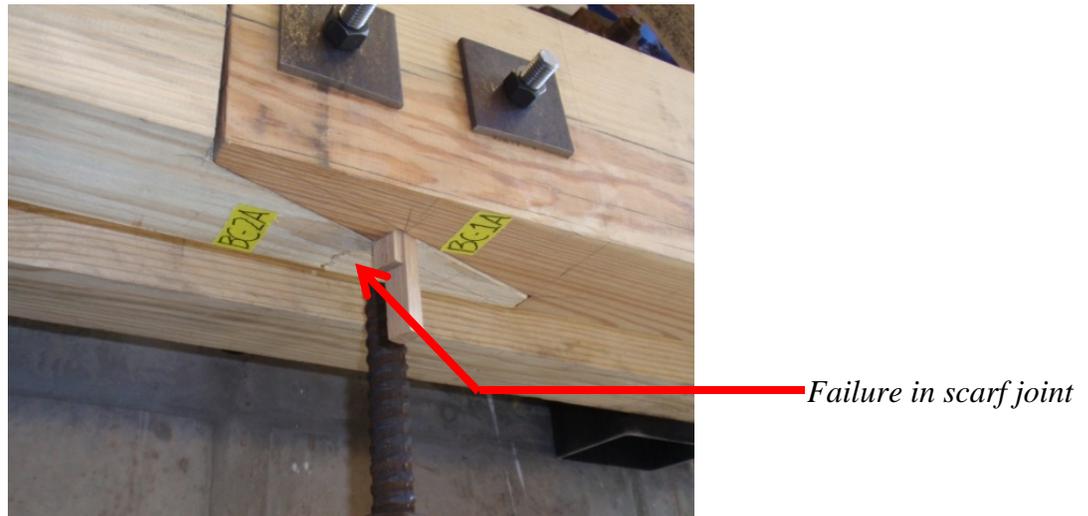
Test 1 – The first test was performed on March 24, 2015. The load was applied by “jogging” the electric pump and thus extending the hydraulic jacks. After approximately six minutes, at an applied load of 13.4 kips (for a total load of $4.7+2.5+13.4 = 20.6$ kips) the tabled scarf joint in panel 4 failed, as shown in Fig. 59.

Fig. 59 – Failure in scarf joint in truss panel 4

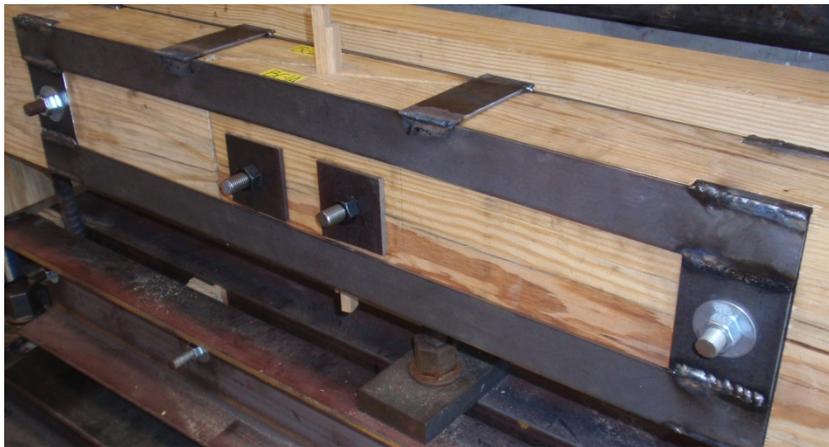
The scarf joint was repaired as shown in Fig. 60, after a deliberate effort to draw the failed parts together before welding the steel straps.

Fig. 60 – Repair of scarf joint

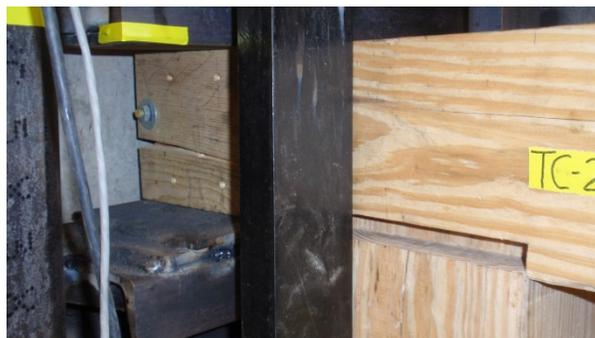
Test 2 – After the scarf joint repair was completed, the truss was tested again on March 31, 2015. At an applied load of 27.4 kips (total load of 34.6 kips) a localized failure occurred near the bearings of the top chord and arch at the axis of symmetry. A bearing weldment broke, and a separation occurred between the top chord and the post, as shown in Fig. 61. No other damage was observed in the specimen.

Fig. 61 – Localized failure at top chord

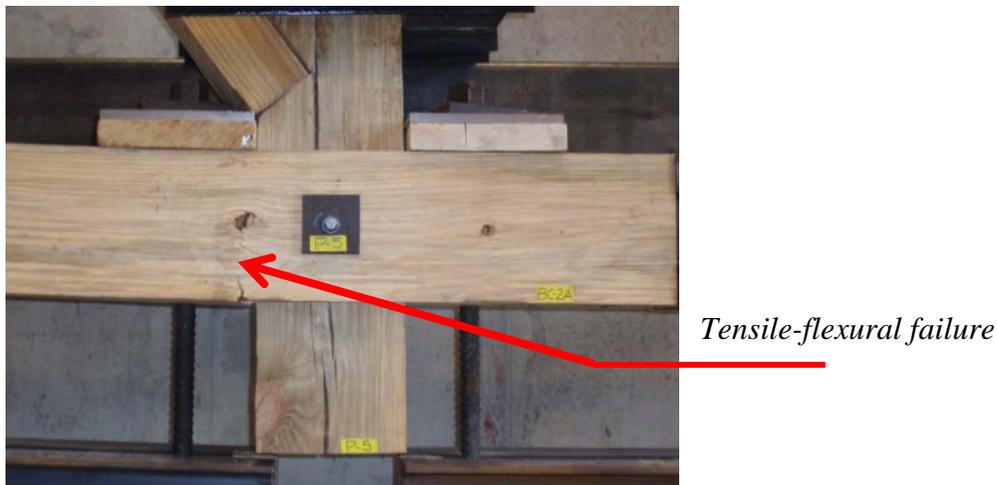
Test 3 - The truss was tested again on April 1, 2015. At an applied load of 51.7 kips (total load of 58.9 kips) a tensile-flexural failure occurred in one of the bottom chord sticks as shown in Fig. 63. The wood section at this location was reduced because of the dap; moreover, it had two small knots, one of which is visible in Fig. 62.

Fig. 62 – Tensile-flexural failure in one of the bottom chord sticks

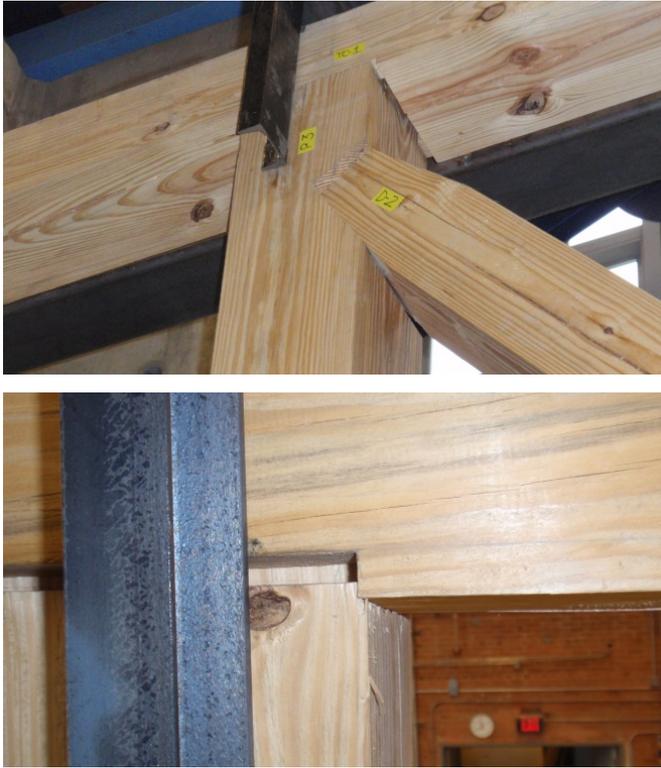
The brittle rupture of one chord stick did not lead to a significant drop in the applied load, because the second chord stick was able to “take over.” The axial force and moment that caused the failure are uncertain, both because the relative axial and flexural stiffnesses of the two sticks were not measured and because some of the bearings were not moving freely in the vertical direction. Damage also occurred at the mortise-and-tenon joint at the top of post 3. Fig. 63 shows crushing perpendicular to the grain and permanent horizontal displacement. The load that initiated this bearing failure is uncertain because the failure was localized, ductile, and produced no observed loss of system stiffness.

Fig. 63 – Localized bearing failure at mortise-and-tenon joint at top of post 3

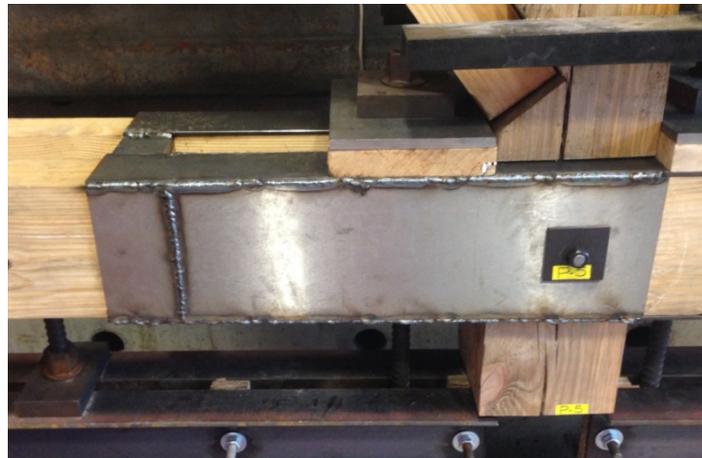
The tensile-flexural failure was repaired as shown in Fig. 64, again after a deliberate effort to draw the broken segments together.

Fig. 64 – Repair of tensile-flexural failure in bottom chord stick

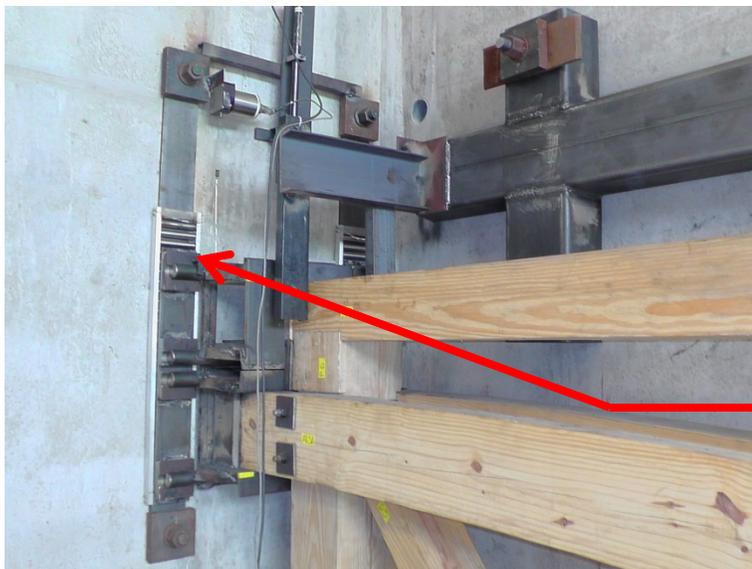
Tests 4 and 5 – The truss was again tested on April 8 and 13, 2015. The test on April 8 was stopped because of an observed rotation in the load tree and unequal axial forces in the two Dywidag bars. No damage was observed. The test on April 13 was stopped because the bearings were clearly not displacing freely in the vertical direction. It was then decided to replace the bearings. As described in a previous section, a series of tests was performed to verify the effectiveness of alternate designs. The selected replacement bearings were nested rollers as shown in Fig. 48 and Fig. 65 below.

One of four new roller bearings fabricated to assure free vertical motion at axis of symmetry

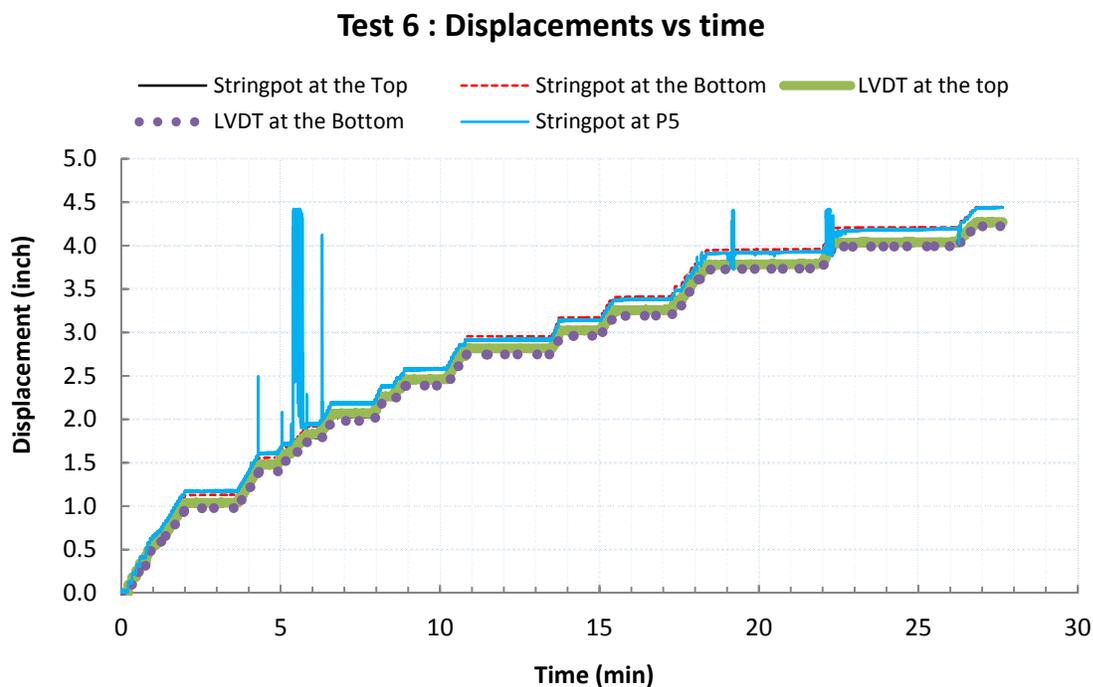
results. The vertical displacement under post 5 is very close to the vertical displacements at the axis of symmetry. These displacement data indicate that the bearings at the axis of symmetry indeed allowed the specimen to displace freely vertically at the axis of symmetry. The horizontal portions of the plots reflect times at which the displacement was maintained constant to inspect the specimen. Fig. 66 indicates that the test lasted approximately 27 minutes and 39 seconds. The last constant displacement region began at approximately 26 minutes and 49 seconds and lasted approximately 50 seconds, until failure occurred.

Fig. 66 – Vertical displacements versus time

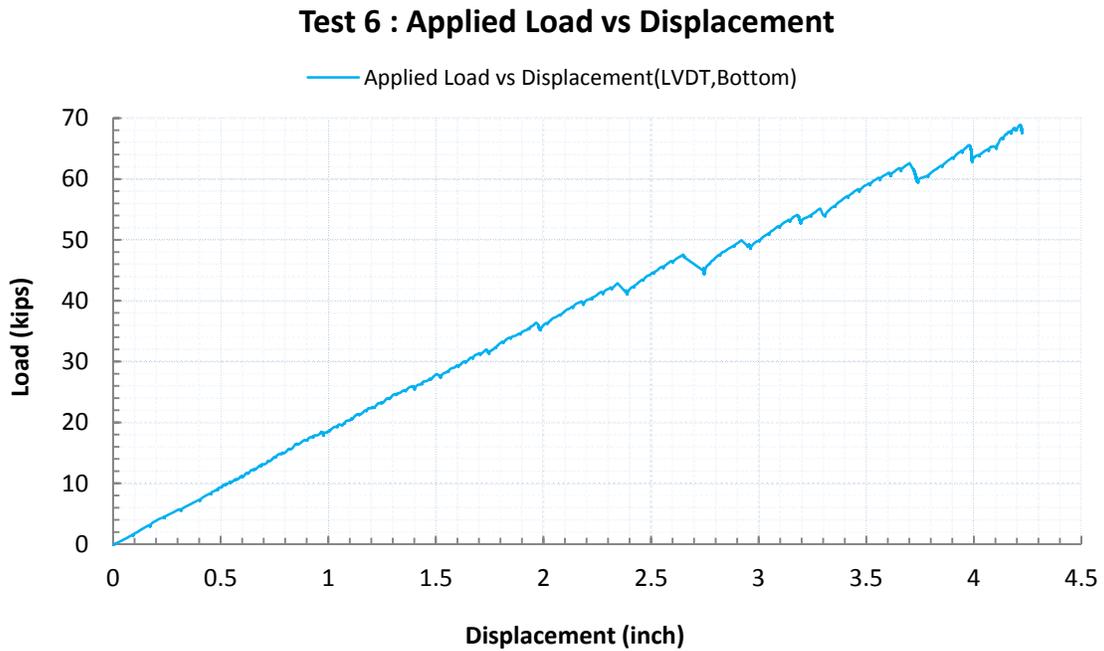
failure, which occurred at a midspan displacement-to-span ratio of approximately 1/170, a relatively large value.

Fig. 67 – Applied load versus vertical displacement at axis of symmetry

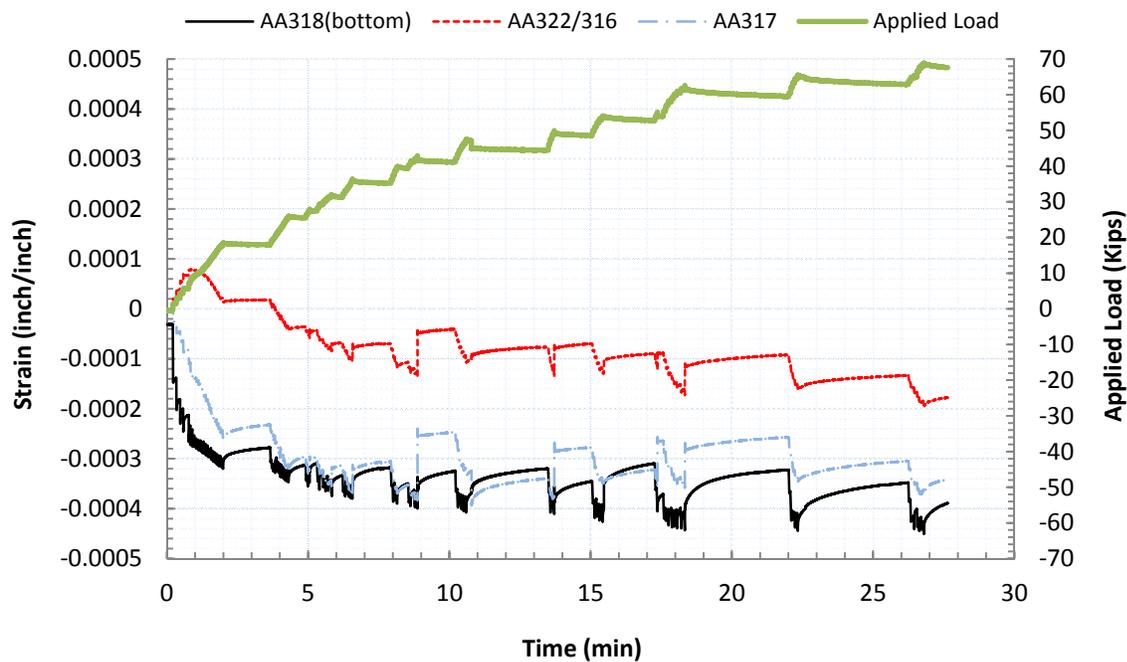
Fig. 68 shows time histories of applied load and three strains, two from transducers attached to arch member AR-1A (AA318 and AA316) and one attached to arch member AR-1B (AA317) (the fourth strain transducer did not function). All three strain transducers were near the spring point.

Fig. 68 – Time histories of force and strains

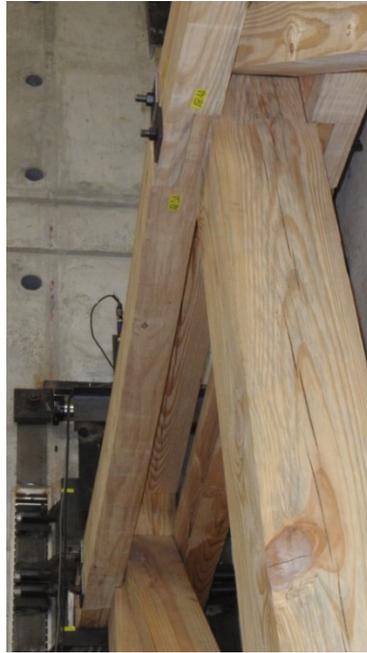
During one of the periods at which the displacement was maintained constant, small out-of-plane displacements were observed in the arch sections, specifically in panel 5, as shown in Fig. 69.

Fig. 69 – Small out-of-plane displacements of arch section in panel 5

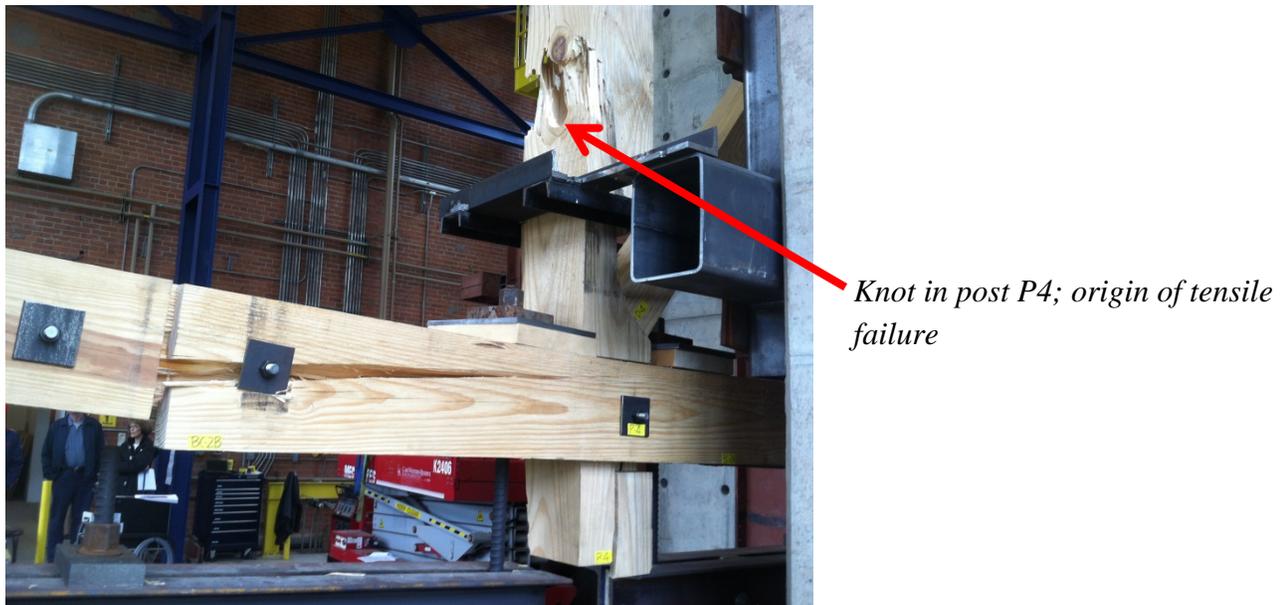
Fig. 70 shows the origin of the failure at a knot in post P4. Because the failure was sudden, a *dynamic* release of elastic strain energy occurred, principally from the arch, causing the arch and the entire truss to displace vertically upward, which led to several other secondary failures. Figs. 70 and 71 show the splitting failure and the shear failure in bottom chord BC-2B at the fishplate joint.

Fig. 70 – Tensile failure in post P4

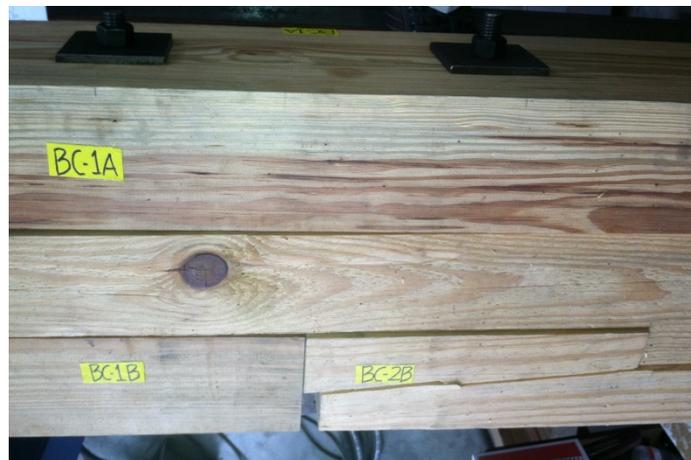
Fig. 71 – Secondary shear failure in bottom chord BC- 2B at fishplate joint

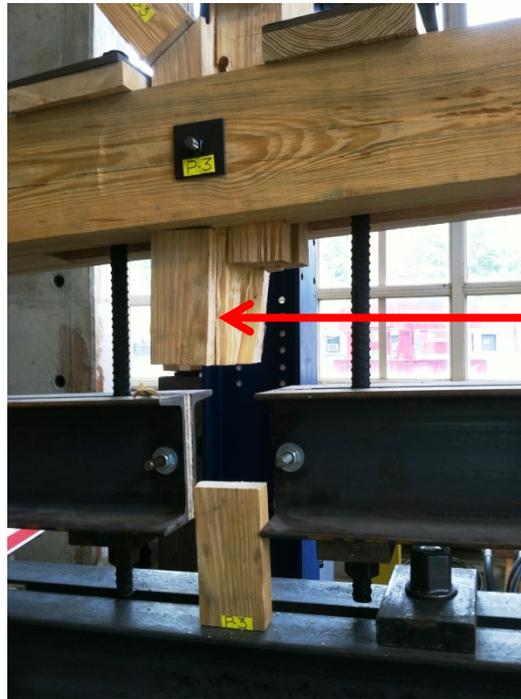
A secondary shear-tensile failure also occurred at the end of post P3, as shown in Fig. 72.

Location of secondary shear failure

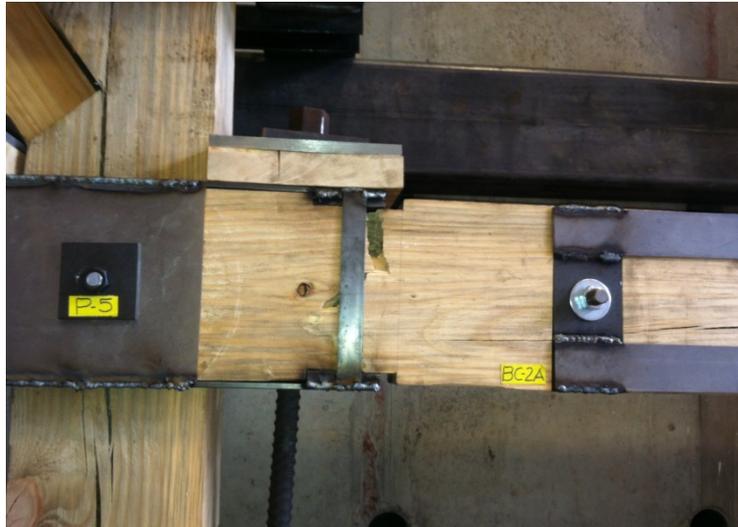
Bottom chord BC-2A also had a tensile-flexural failure where the cross-section had been reduced to affect a repair, as shown in Fig. 73. An overall view of the failed truss can be seen in Fig. 74.

Fig. 73 – Secondary tensile-flexural failure in bottom chord BC-2A

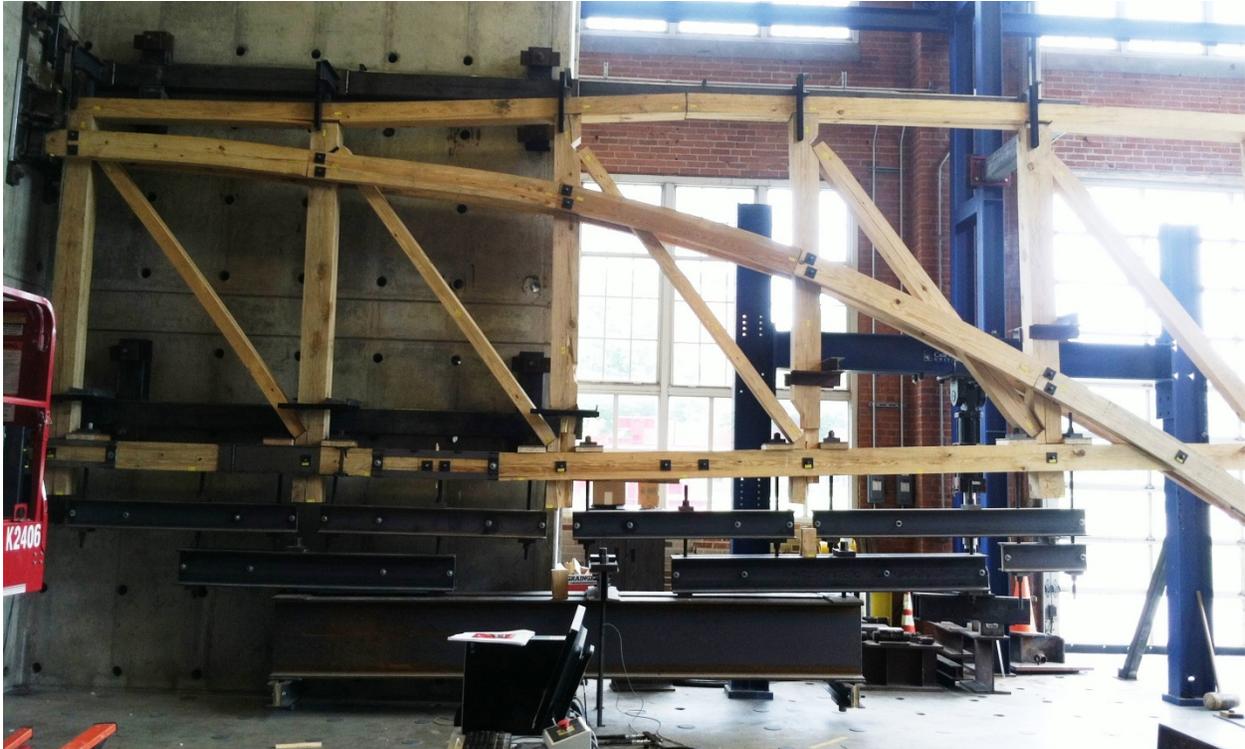
Fig. 74 – Overall view of failed Burr-arch truss specimen

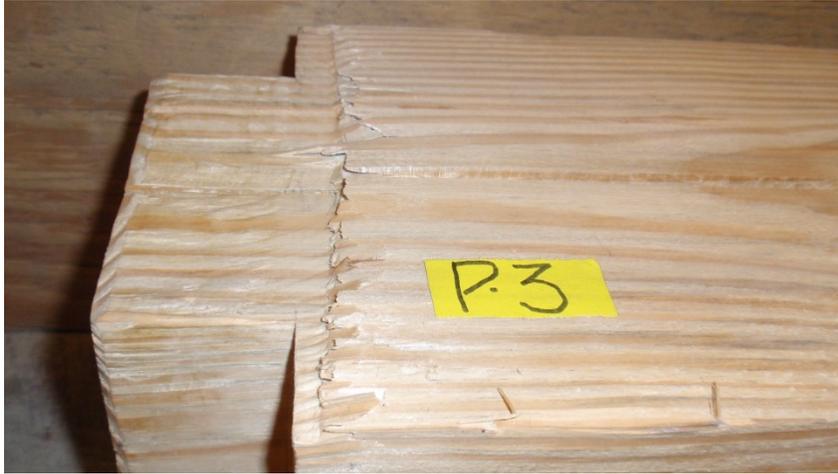
During disassembly of the truss, observations were made on additional, less-visible damage caused by the total load of 76 kips. Crushing perpendicular to the grain was observed at several locations as shown in Fig. 75 through 77.

Fig. 75 – Crushing perpendicular to the grain in post 3, at its tenon housing

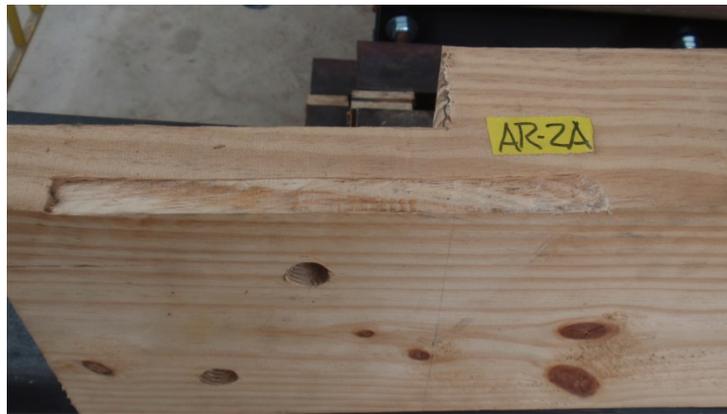
Fig. 76 – Crushing perpendicular to the grain in arch segment at its intersection with post

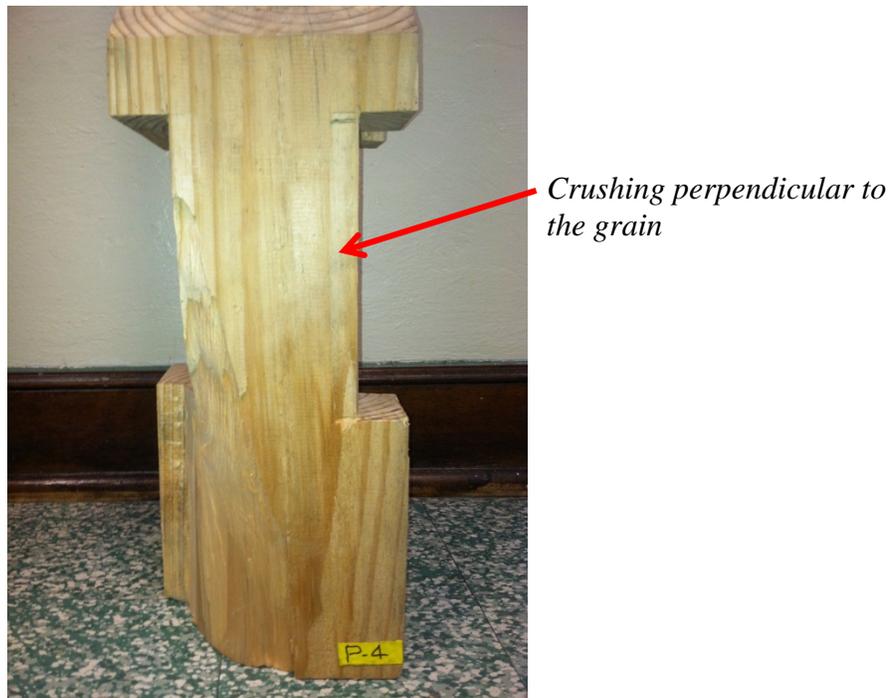
Fig. 77 – Crushing perpendicular to the grain in post P4 at its intersection with the bottom chord
