# MORE THAN MEETS THE EYE

## The Archeology Of Bathhouse Row, Hot Springs National Park, Arkansas

Midwest Archeological Center  
Technical Report 102

United States Department of the Interior  
National Park Service  
Midwest Archeological Center  
Lincoln, Nebraska  
2008

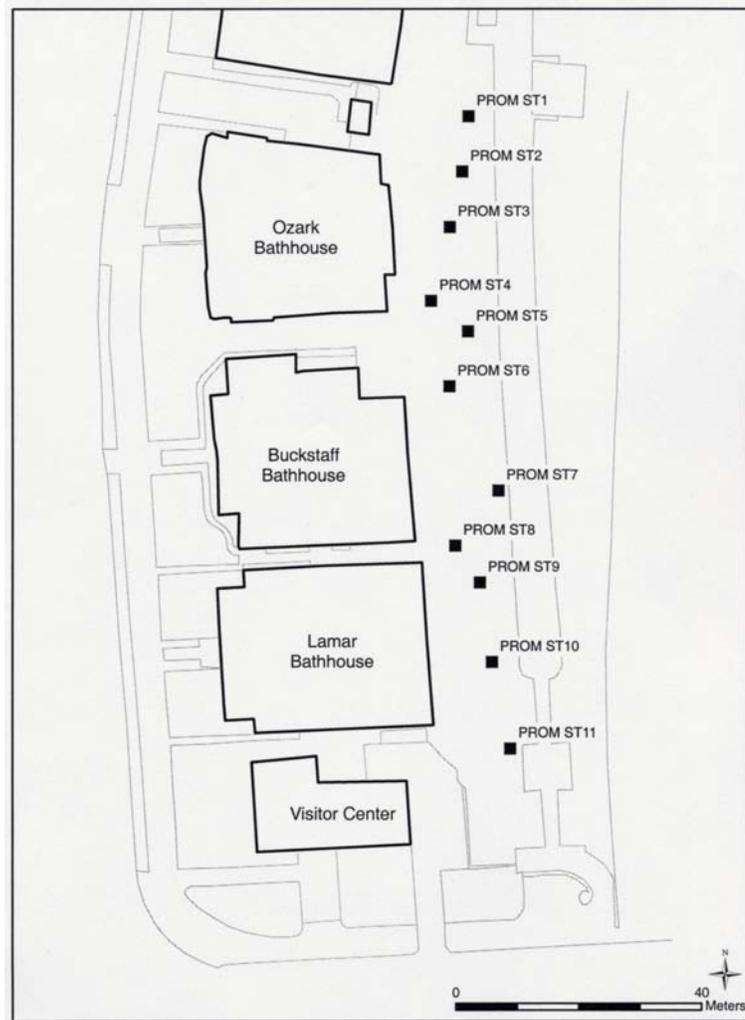
Figure 10. Shovel test locations along the south Promenade.

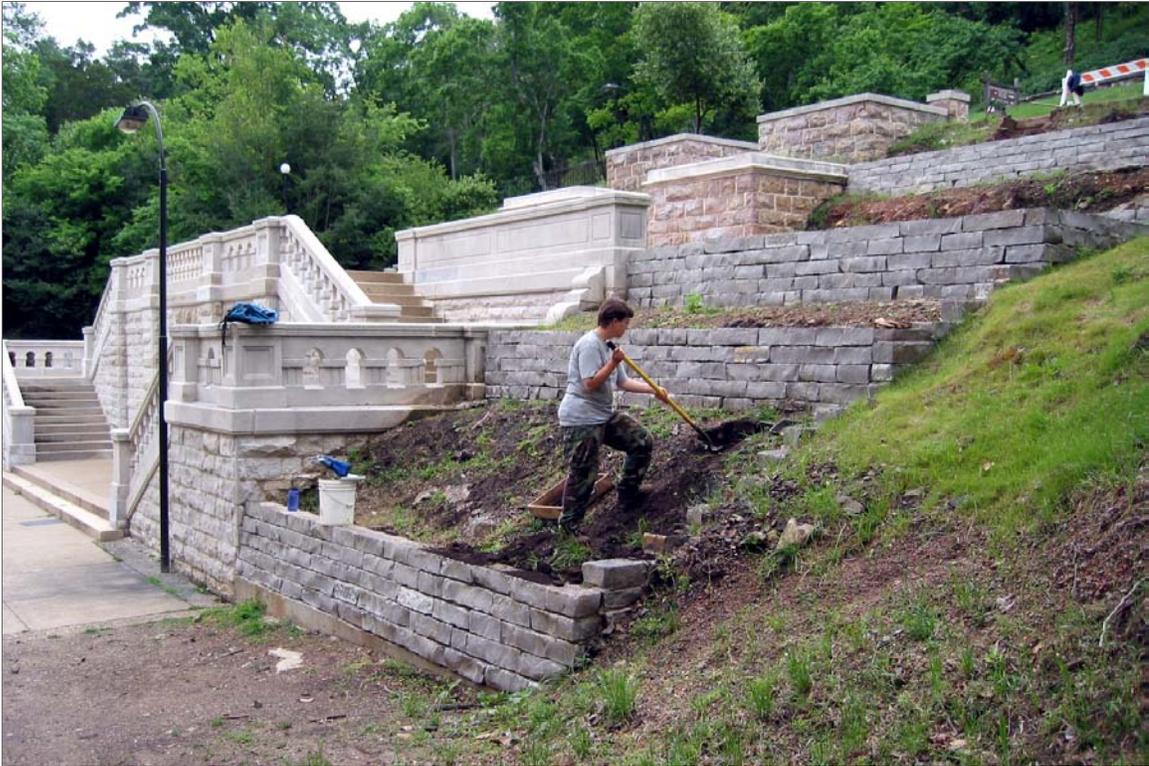
**Figure 11.** 2003 additions on the south side of the Stevens Balustrade. MWAC Archeological Technician Megan Young is excavating a test unit on the lowest of four newly created terraces.

As noted earlier, highly noticeable modifications were initiated on the Balustrade in March 2003, which were based on a landscape design commissioned by the Friends of the Fordyce (Figure 5). Five retaining walls of roughly shaped gray limestone were raised in north-south trenches on concrete footers to create four terraces. Two walls were built above (east of) the Balustrade's brick Patio and west of the Grand Promenade. Three additional walls were constructed between the west edge of the Patio level and the formal walkway/entrance west of the Balustrade (Figures 11-12).

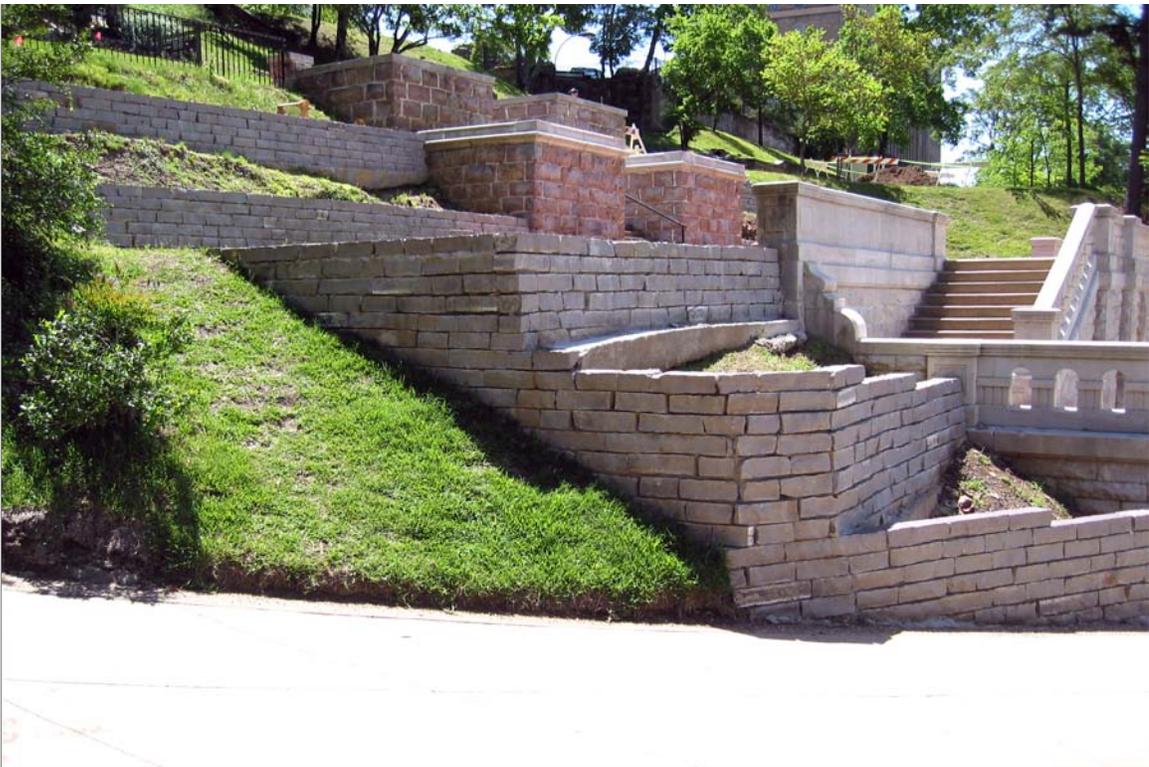
**Figure 12.** 2003 additions to the north side of Stevens Balustrade showing the five newly created terraces which existed at the time of MWAC's archeological investigations.

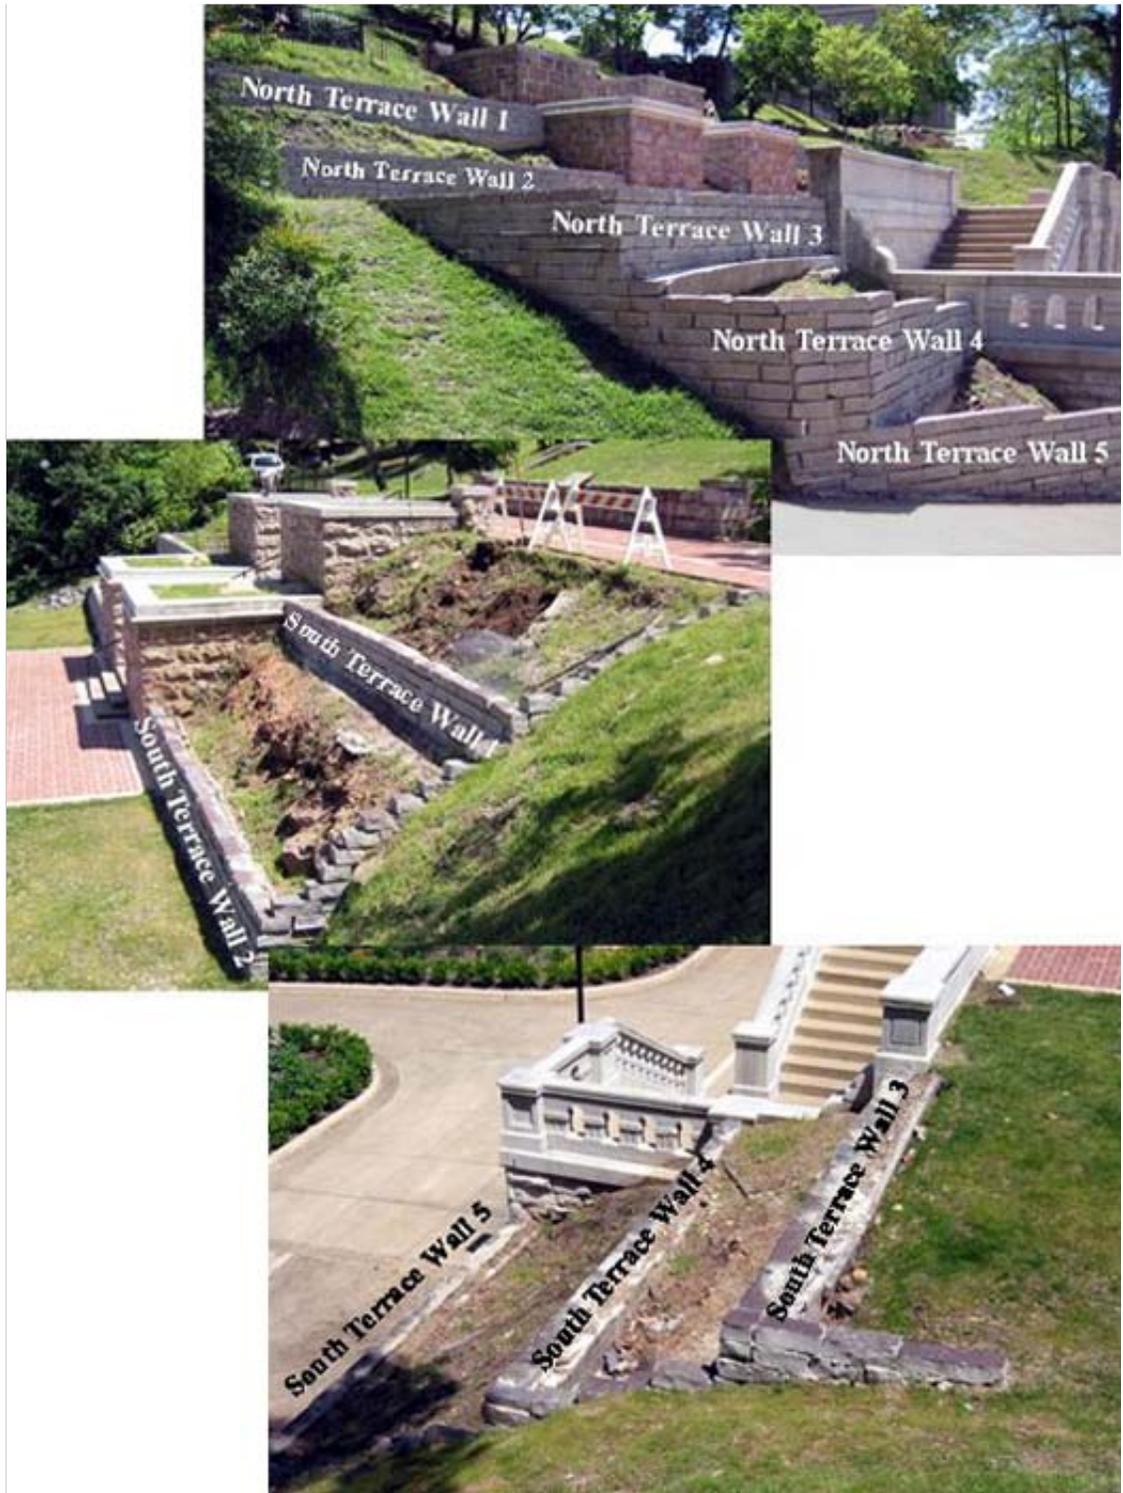
Figure 13. Terms used in this report to reference 2003 wall additions.

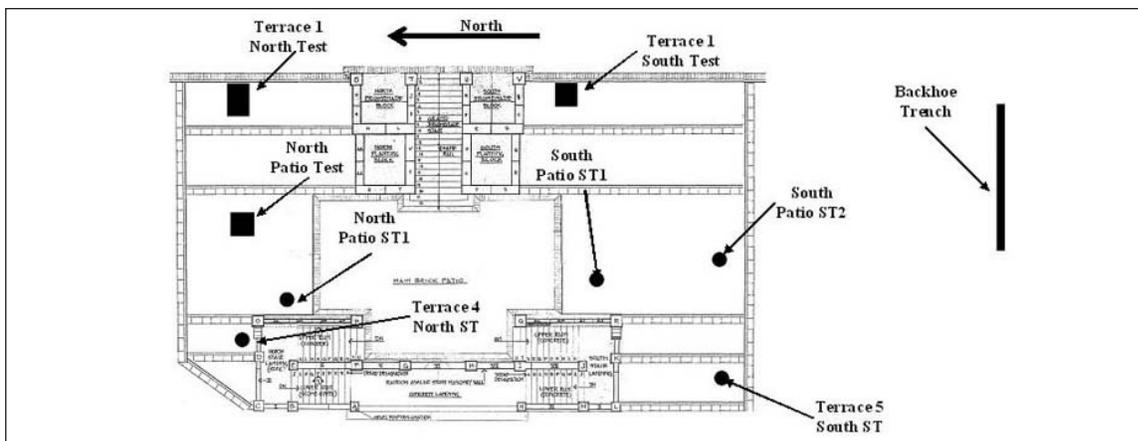
**Figure 14.** Schematic (not to scale) illustration of the Balustrade and appended terrace walls showing relative locations of test units (adapted from Hot Springs National Park 1986).

Significant archeological materials were also identified during excavation of the North Patio Test (see Figures 11 and 14). All test units on the Patio level encountered horizontal tufa bedrock between 40 and 60 cm sd. The tufa bedrock in North Patio Test differed, however, in that it resembled Swiss cheese rather than the plain smooth surface encountered elsewhere. The vertical columnar holes varied in size from 10 to 40 cm in diameter, appeared water worn (Figure 17), and contained large amounts of angular gravels mixed with highly organic black loamy fill. The holes were originally believed to be due to hot spring discharge but a site visit by Arkansas Geological Commission Chief Geologist John David McFarland suggested otherwise. He identified them as by-products of dripping water and noted that such features commonly occur in the Ozark region's limestone caves.

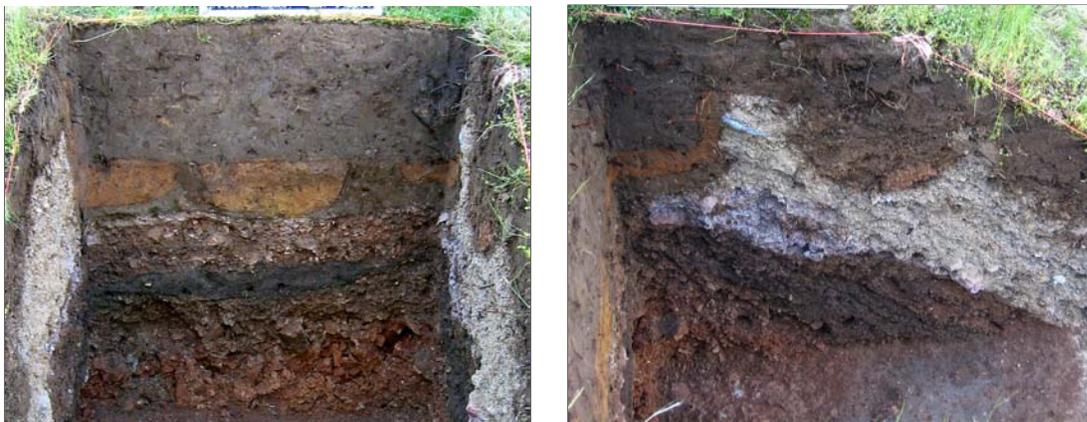
**Figure 15.** Profiles of east face (left) and south face (right) of Terrace 1 North Test showing lunate-shaped clay features and cup-shaped depressions down slope from the clay features.

Terrace 1 North Test and Terrace 1 South Test lay on either side of Stevens Balustrade's Grand Promenade Stair and Planting Blocks at the south margin of the Grand Promenade. While neither of these units contained pre-modern artifacts, both had identical curious features. After removing the first soil stratum, a very dark grayish brown (2.5Y 3.2) loamy sand, excavators encountered a bright yellowish brown (10YR 5/6) sandy clay loam. In plan view, the yellow brown layers appear as a series of 36 cm (about 14 in) diameter circular forms with a 5-15 cm (2-6 in) space between each circle. When viewed in profile, the deposits appear to be lunate or cup-shaped features, the latter filled with soil from the upper stratum (Figure 15). About 11-22 cm (4-10 in) down slope from these were other cup-shaped depressions. At first, the author was at a loss to explain the curious features except as perhaps reflecting the former positions of decorative plantings.

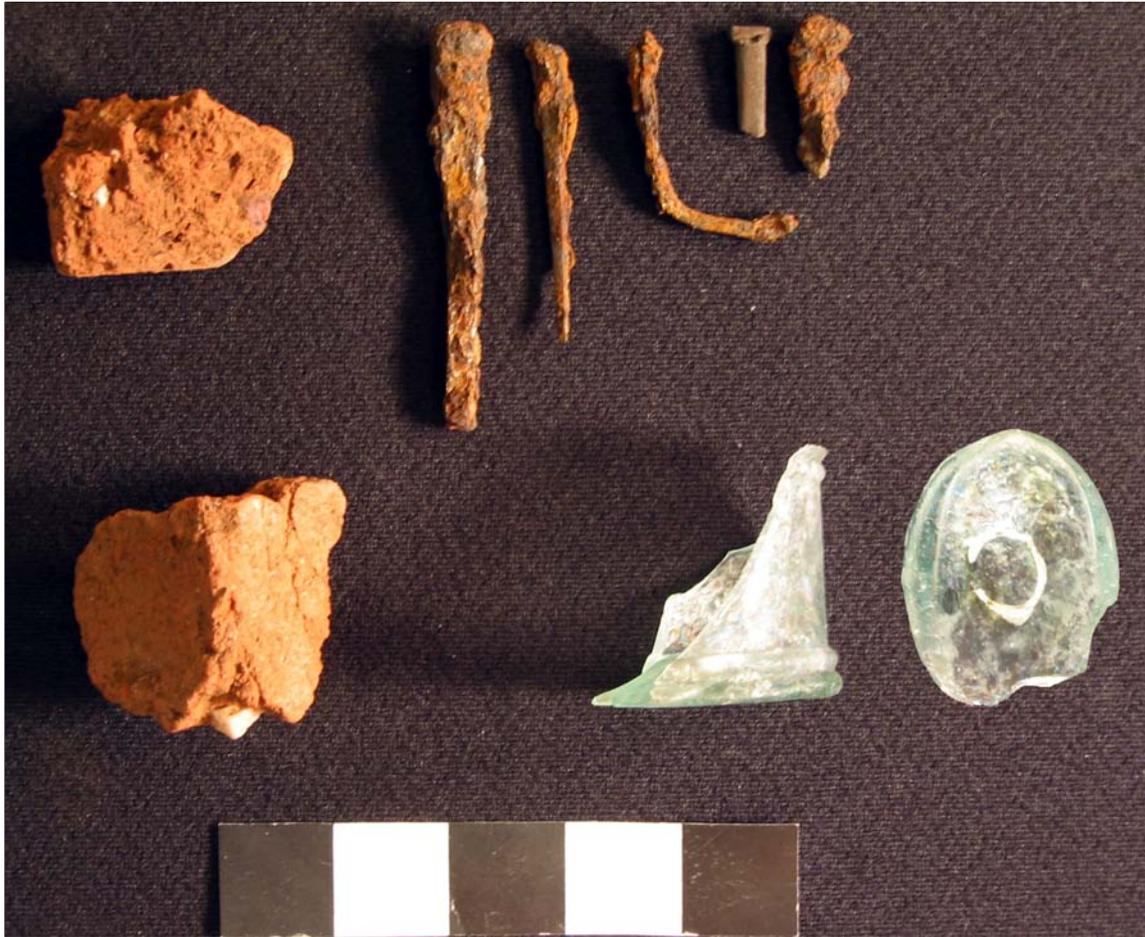
**Figure 18.** Artifacts retrieved from the North Patio Test Unit: glass ointment jar, cut nails and nail fragments, soft red brick fragments.

telling item is a fragment of an extremely thin-rimmed ointment jar whose base bears a glass pontil mark. Pontil scars are usually found on American-made utilitarian bottles that date to or before the American Civil War (mid-1860s). Pontil scars of all types became ever increasingly unusual as the 1860s progressed and largely disappeared by the late 1860s or early 1870s (Lindsey 2006a). If so, the small jar may be one of the oldest historic artifacts directly associated with the park's tourist activities.

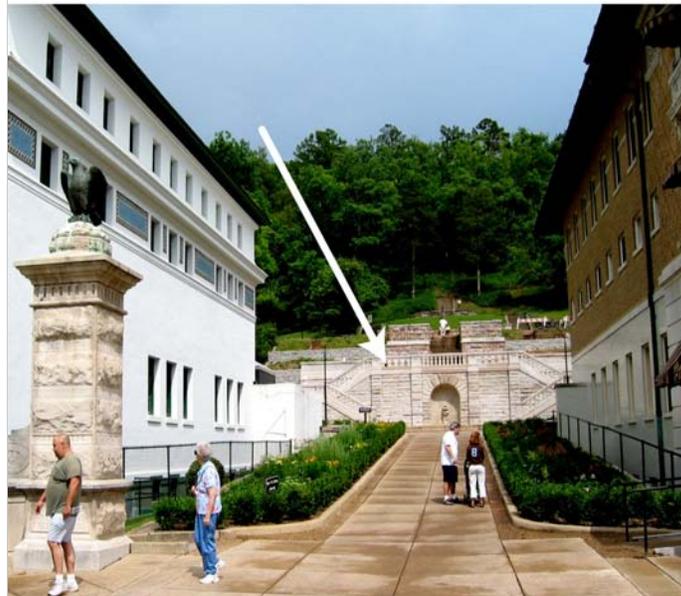
**Figure 20.** Comparison of the circa 1878 location illustrated for the Corn Hole shanty behind the Independent Bathhouse (later renamed the Maurice) and a modern view showing artifact recovery location (arrow) at North Patio Test excavation unit behind the modern Maurice Bathhouse built on the same location.

An early illustration of the Independent Bathhouse (built in 1880 and renamed the Maurice in 1892-1893) provided by Shugart shows the position of the Corn Hole shanty on the terrace (Figure 20). Its apparent location is the same as or just north of this investigation’s North Patio Test unit on the modern Balustrade Patio.

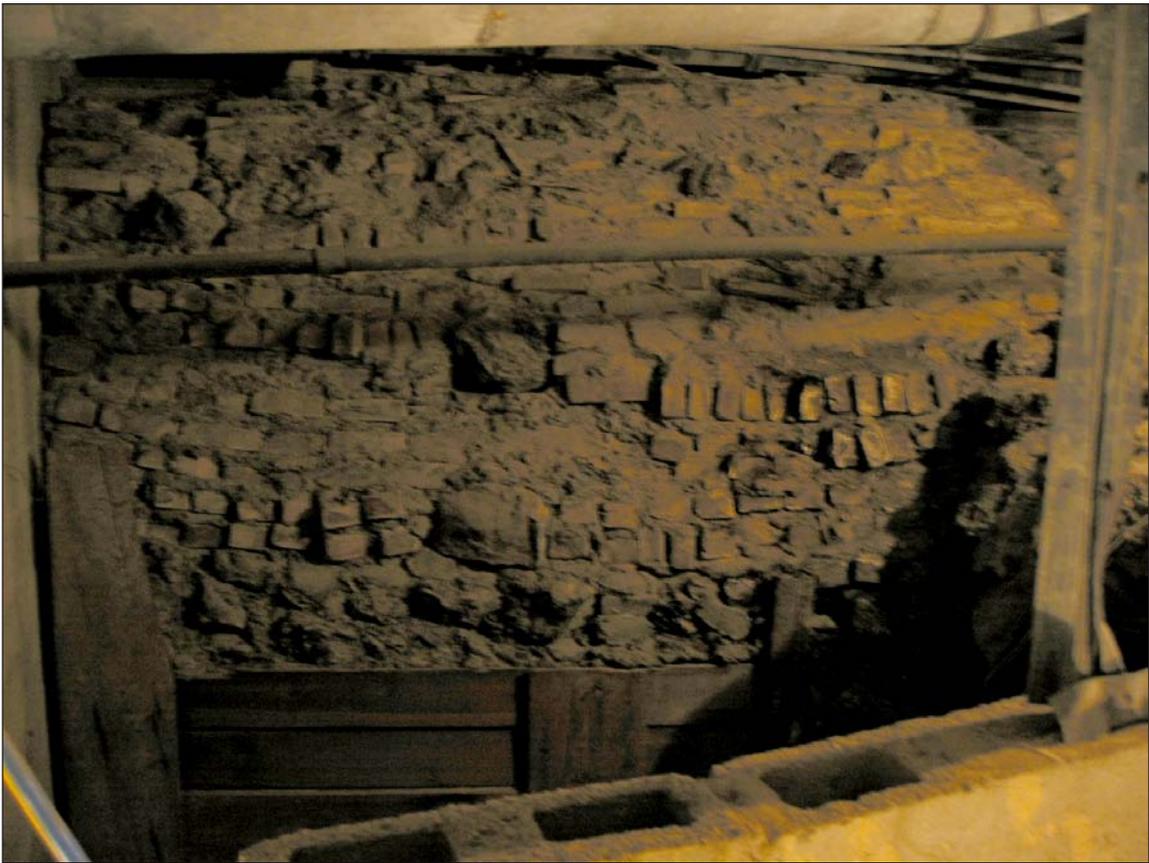
**Figure 21.** Brick and mortar "Indian cave" built over a hot spring in the south end of Quapaw Bathhouse.

Two structures south of the Maurice and immediately south of the Fordyce Visitors Center is the Quapaw Bathhouse. The Quapaw was built in 1922 on the former sites of the Horse Shoe and Magnesia bathhouses both of which were constructed around 1887 (Shugart 2002). The on-site tour of the Quapaw demonstrated this building has an extensive unexcavated crawl space which covers virtually half the basement. Travertine deposits and flowing water were observed in the northern portions of the fill. Further, and although site plans didn't indicate it, unexcavated fill occurs within a series of rooms which extend the full north-south width of the building on the structure's west side. Some of these rooms have window-like entries which are sealed. A rough vaulted structure composed of mortared brick and rock, a "re-creation" of the famous "Quapaw Cave" (Shugart 1997) occurs over a hot spring in the south-central portion of the basement (Figure 21). The interior of this structure is plastered with mortar and painted with crude pictographs to create a cave-

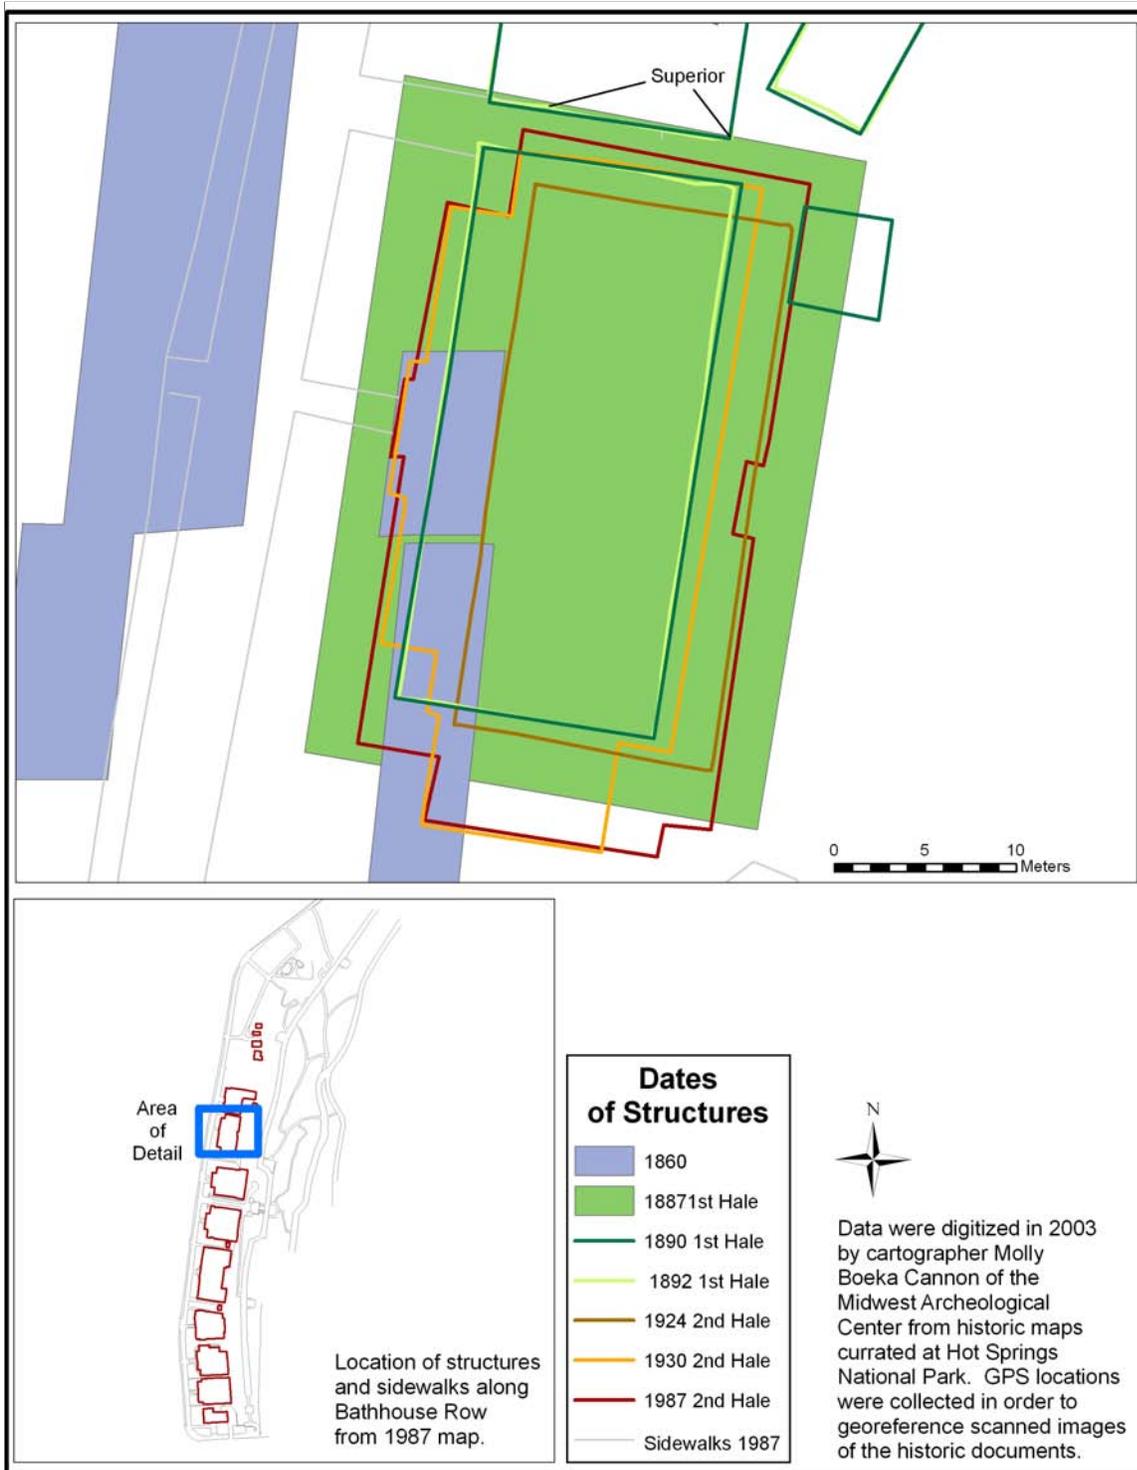
**Figure 23.** Digitized and georeferenced map overlays for the Hale Bathhouse location.

Digitized and georeferenced map overlays for the Hale Bathhouse location indicate that the pre-1882-1892 Hale Bathhouse footprint is almost wholly contained within the current structure (Figure 23). Only its northwest corner may have extended beyond the present bathhouse's northwest corner. The previous bathhouse's exact position remains uncertain although it is known to have been built on the same lot spanning Hot Springs Creek. Remnants of the bathhouse portion of that structure, on the east side of the creek, may also exist within the current building. Other frame structures which have yet to be identified also occurred on this site in the 1870s.

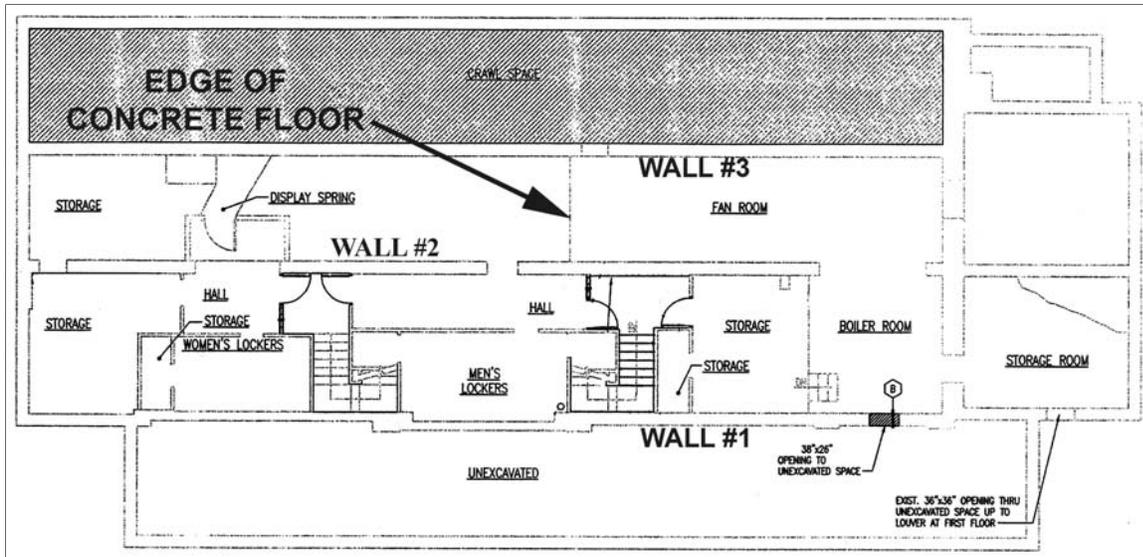
**Figure 24.** Plan of the Hale Bathhouse basement showing walls #1-3 (adapted from National Park Service 2002a:Sheet AS1.H).

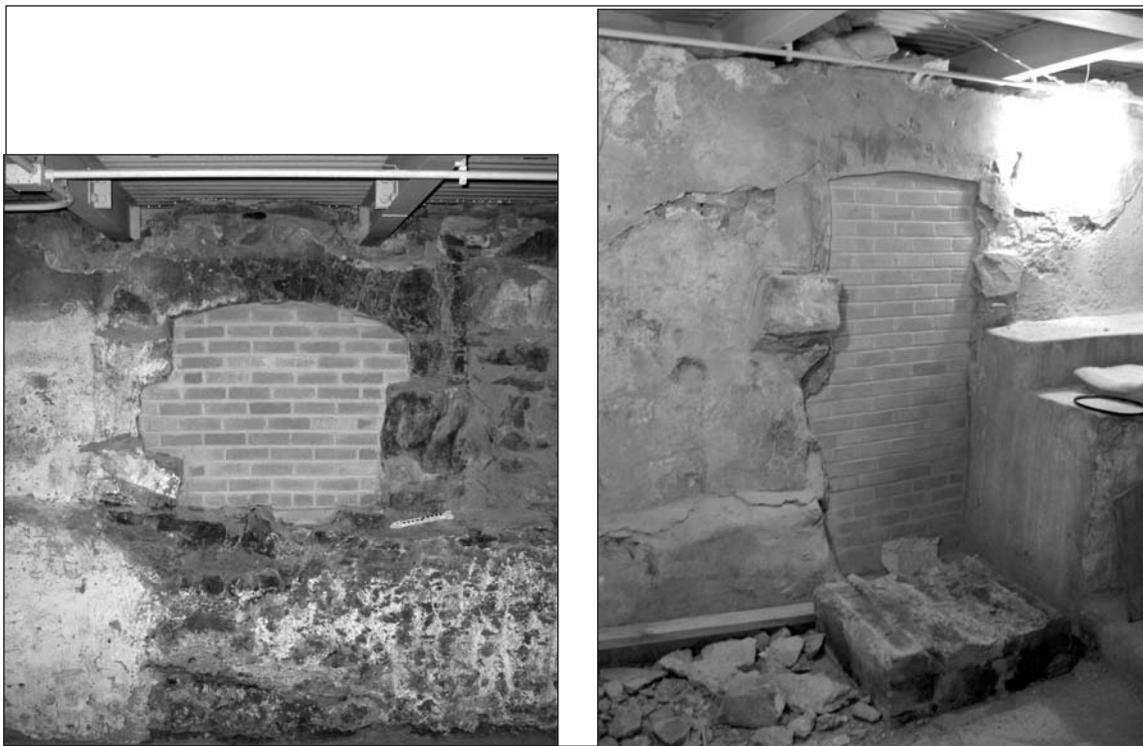
**Figure 25.** A sealed arched brick window (left) and sealed arched brick doorway (right) in Wall #3 of the Hale Bathhouse basement is associated with the bathhouse's 1882 predecessor structure.

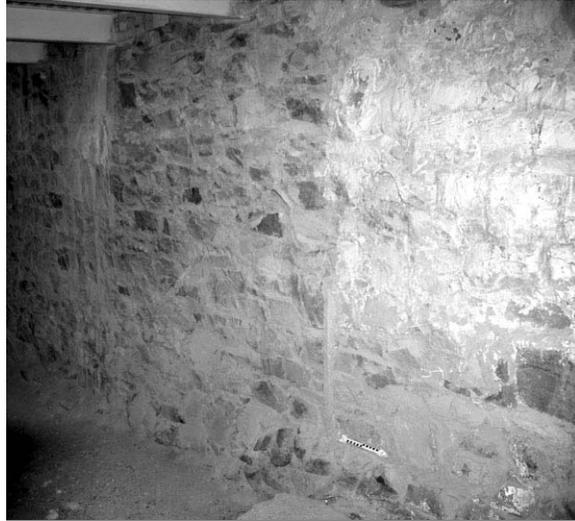
**Figure 26.** “Ghost wall” on the east face of Wall #2 is marked by a vertical cut in the stone foundation bordered on the north side by whitewash and a change from concrete to earthen floor immediately below.

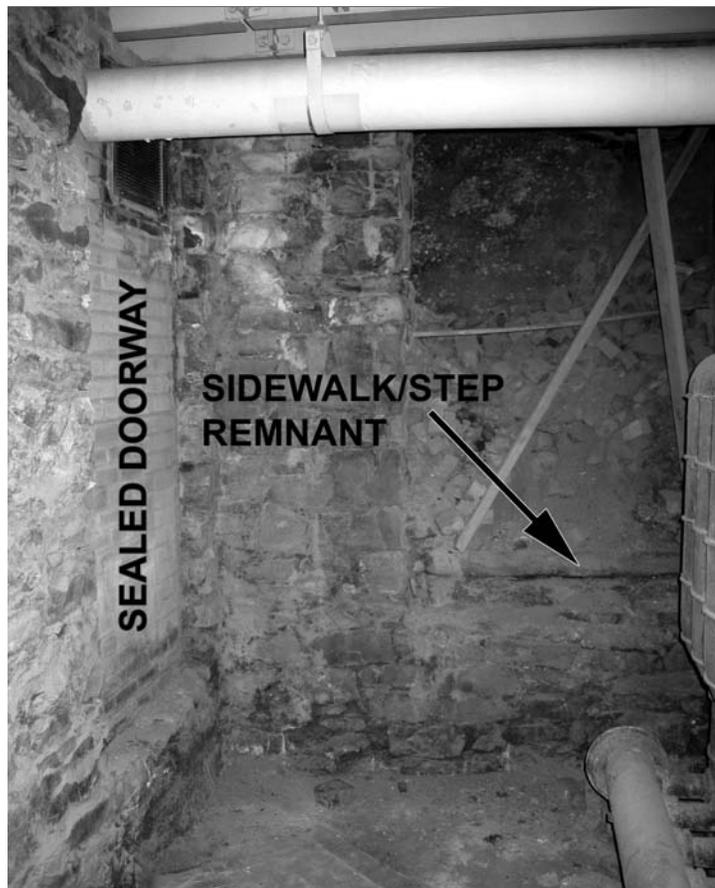
**Figure 27.** Rubble-filled opening at the south end of the Hale Bathhouse basement that may be associated with the 1882 structure. Stone slab at the base of the opening may be a sidewalk or step remnant.

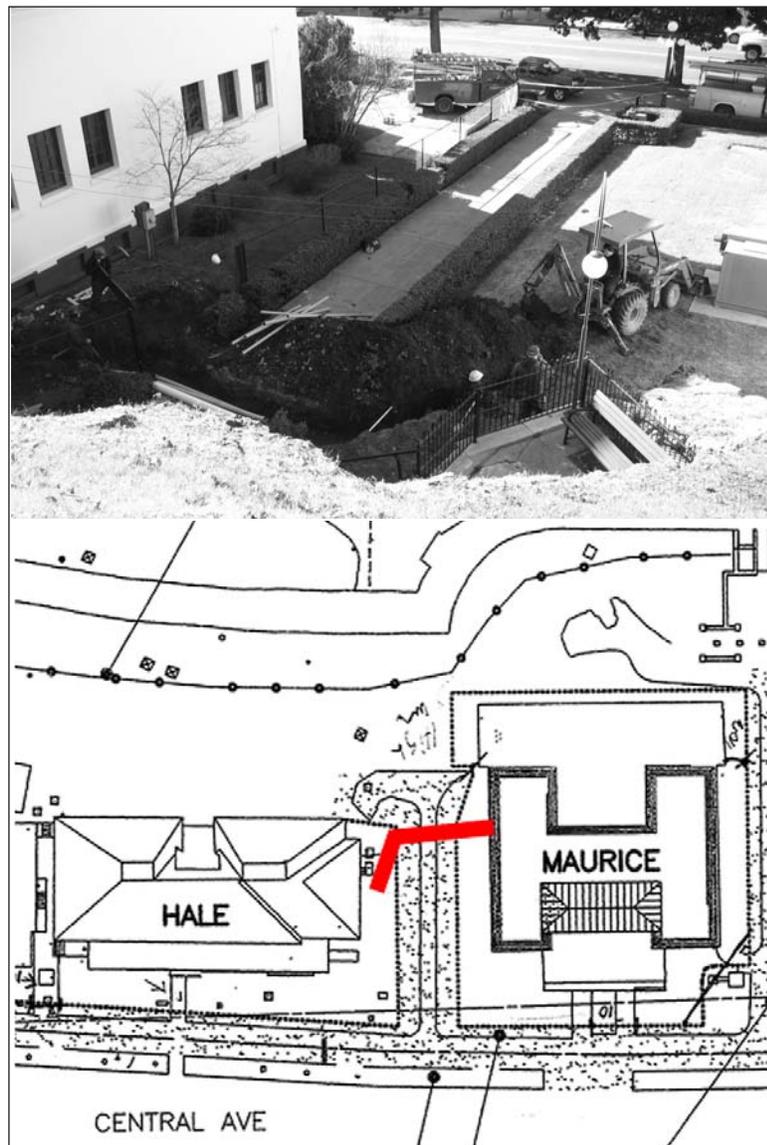
**Figure 28.** Trenching on January 19, 2004, to install an electrical line from the Maurice Bathhouse north to a transformer box next to the Hale Bathhouse. Top: view southwest toward trench excavation. Bottom: map of approximate trench locations (adapted from National Park Service 2002a:Sheet C1).

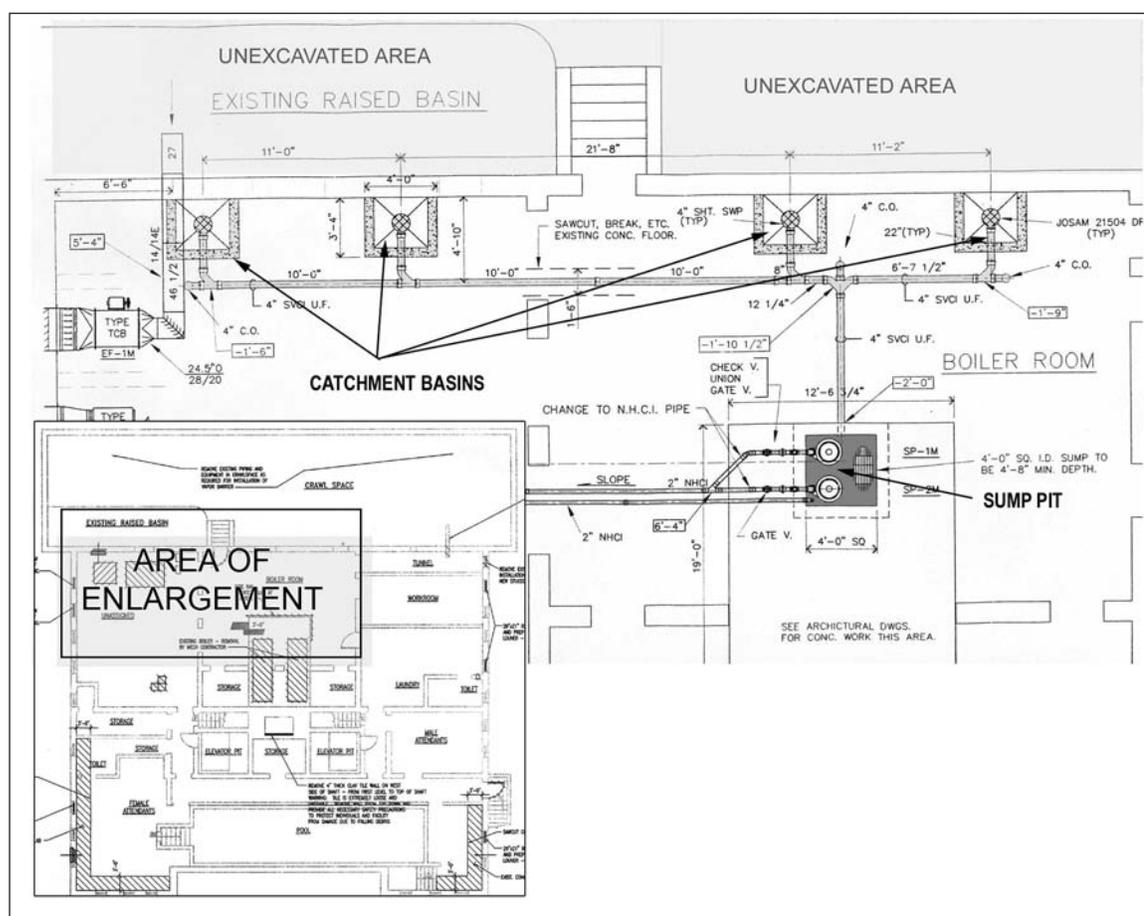
**Figure 32.** Maurice Bathhouse basement plan and water collection pit construction area.

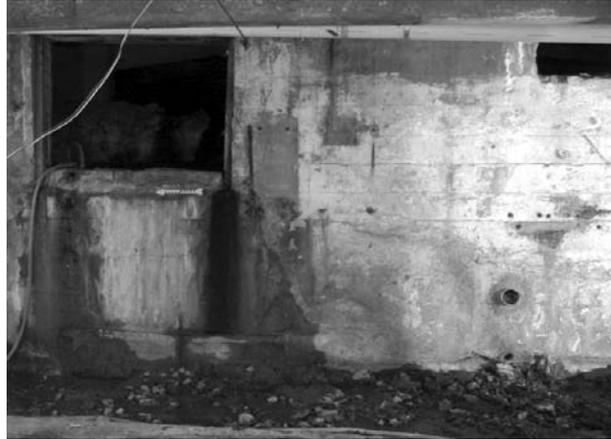
**Figure 36.** Partially sealed door on north end of Maurice Bathhouse's east basement wall.

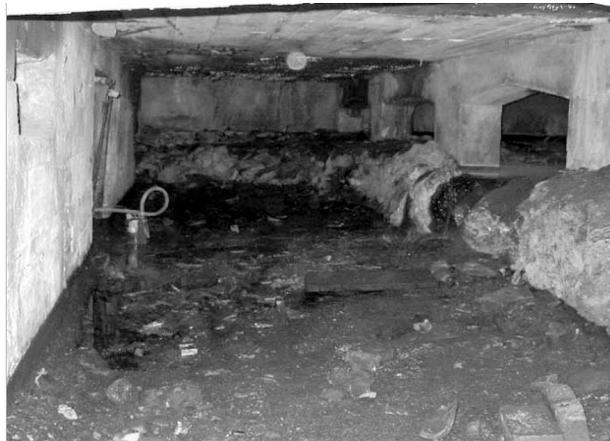
**Figure 37.** The north end of a crawlspace on the east side Maurice Bathhouse basement. Door and window openings on left same as in Figure 36. Photo taken from stairway in Figure 38.

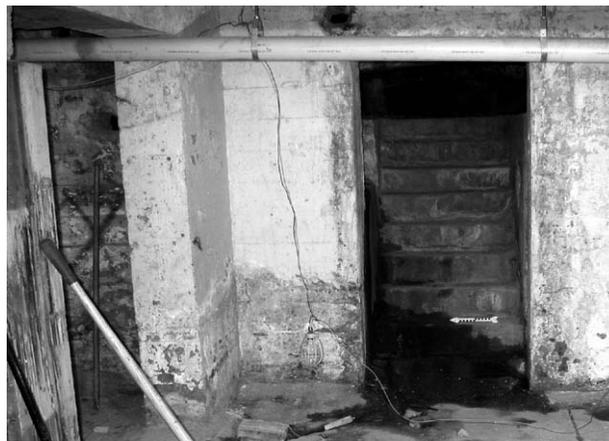
**Figure 38.** Abandoned and sealed exit rising from the basement to the east. The top of this structure is only a couple of feet below the first floor supporting structures

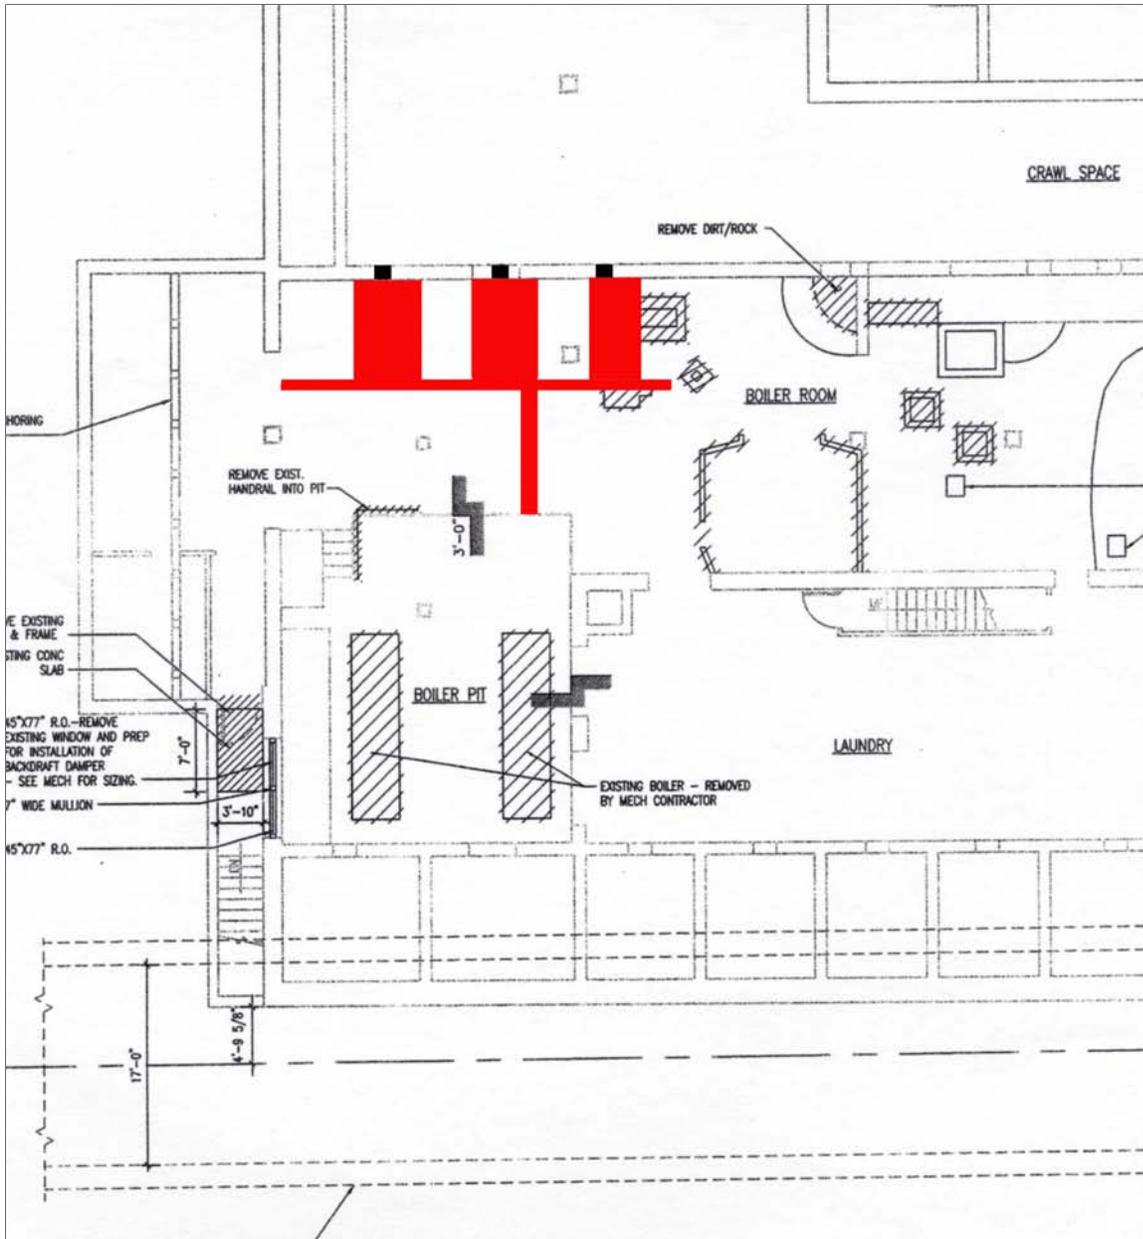
**Figure 43.** Detail of Quapaw Bathhouse basement showing locations of openings cut through the concrete wall (black rectangles) and floor (red) to enable installation of hot spring drains (adapted from National Park Service 2002a:Sheet AS1.Q).

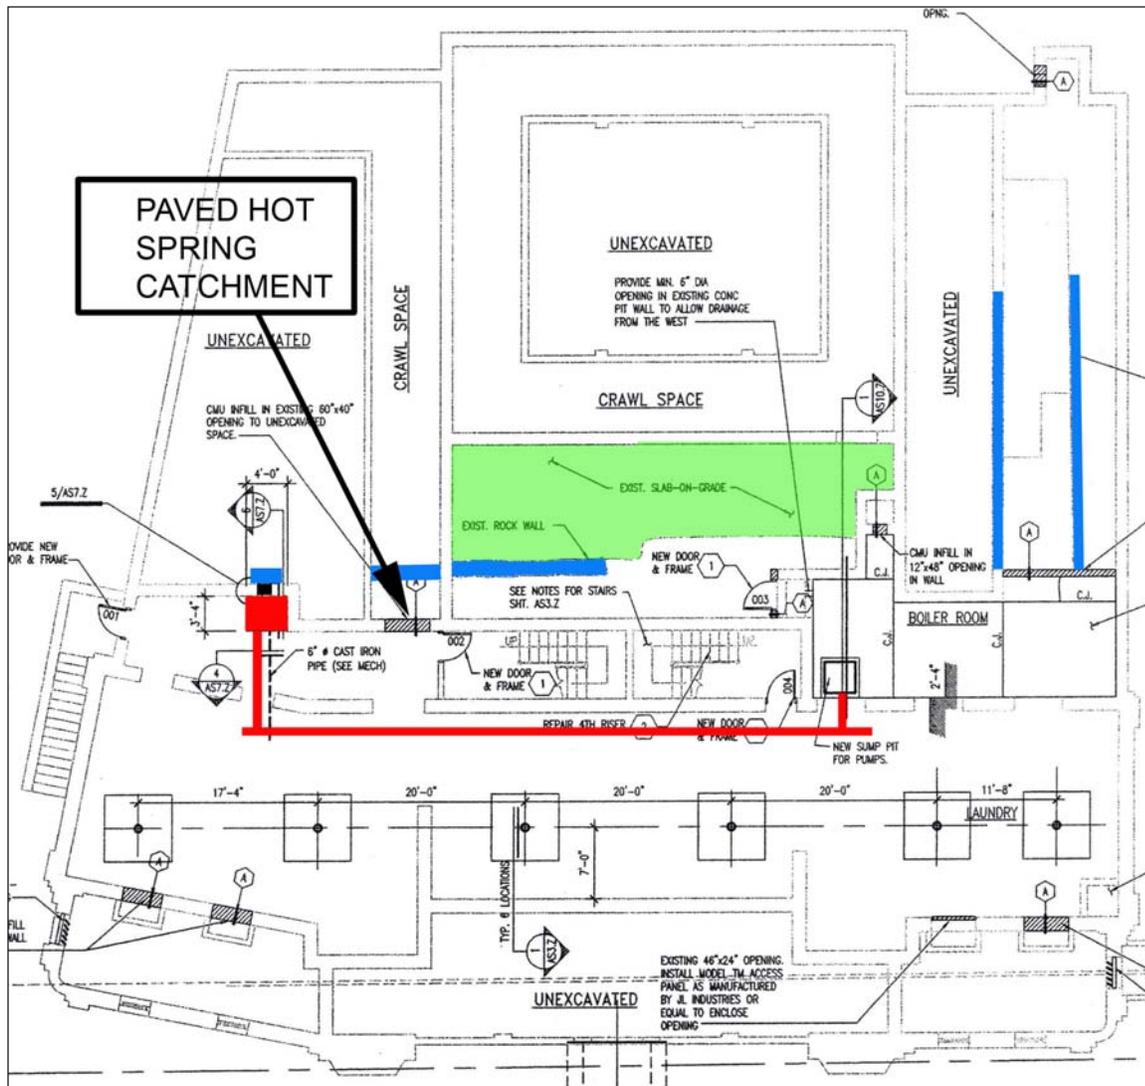
**Figure 49.** Ozark Bathhouse basement plan showing location of wall cut (black), catchment box and drain line (red) into sump pit (adapted from National Park Service 2002a:Sheet AS2.Z). “Fossil” tile floor (green) and stone walls (blue) may be from the Weir and George’s Iron and Magnesia Bathhouse.

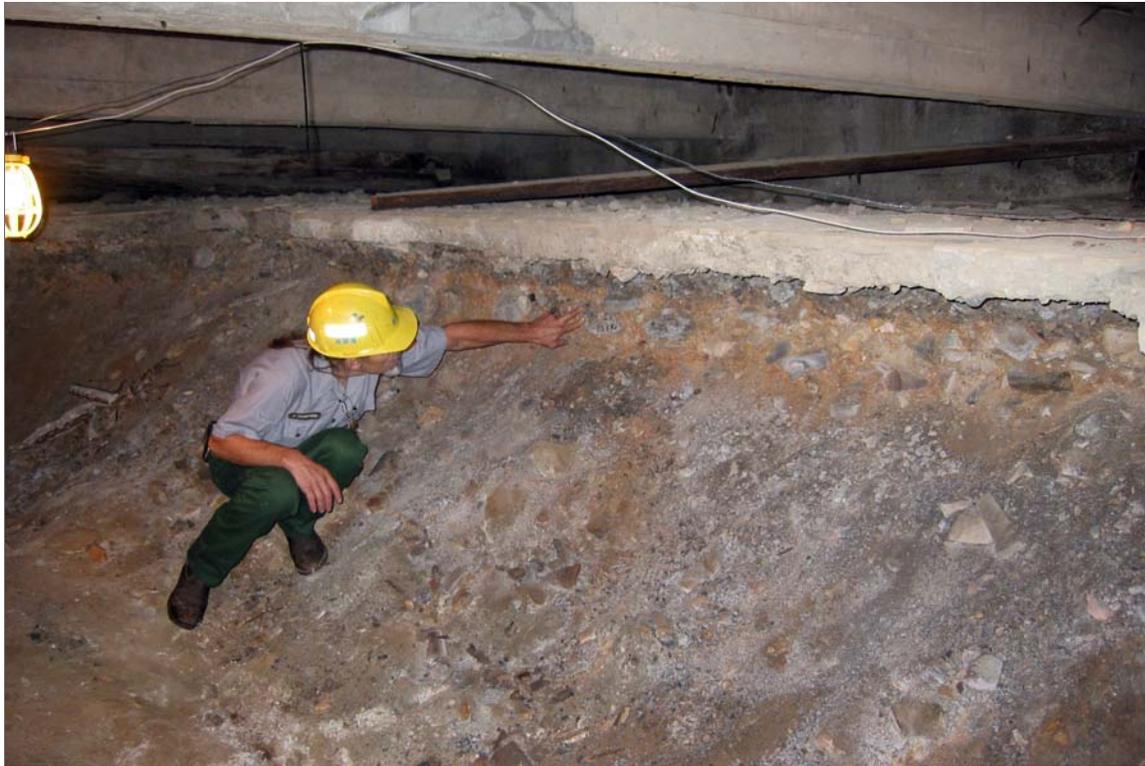
**Figure 50.** HOSP Maintenance Mechanic Jack Thompson in the Ozark Bathhouse basement examining “fossil” tile floor associated with the first (circa 1880-1921)

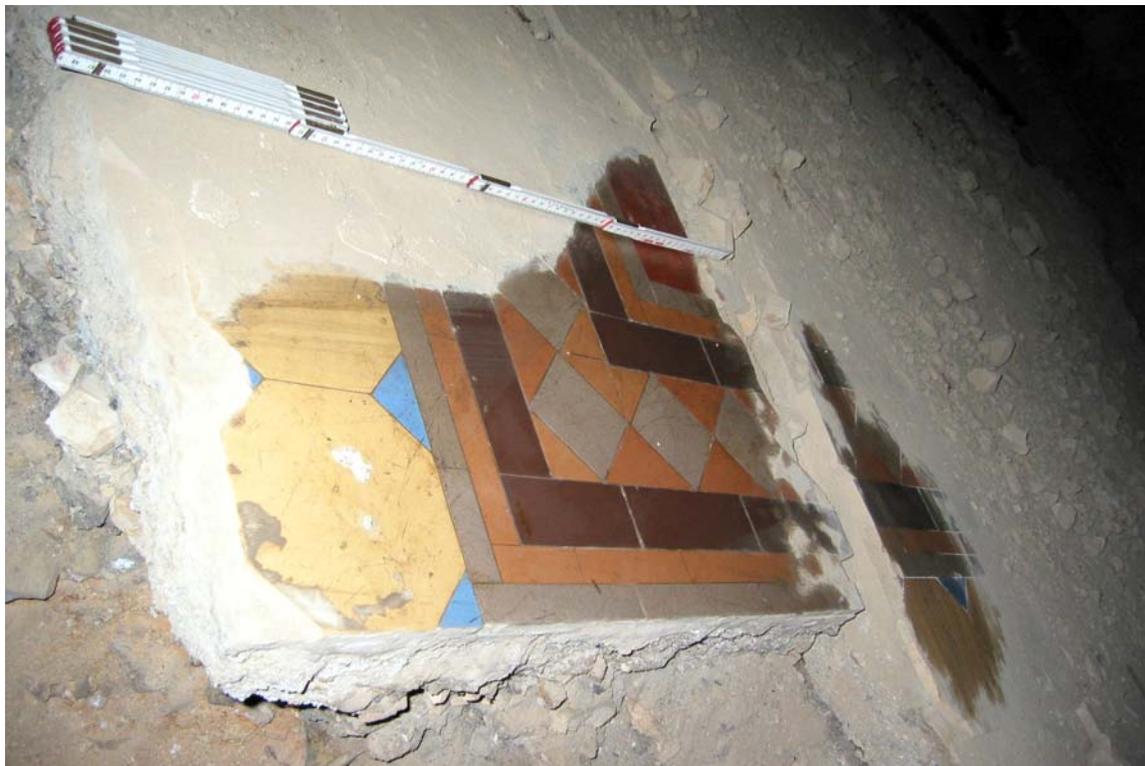
**Figure 51.** Washed section of the north end of the “fossil” tile floor which retains both observed tile patterns.

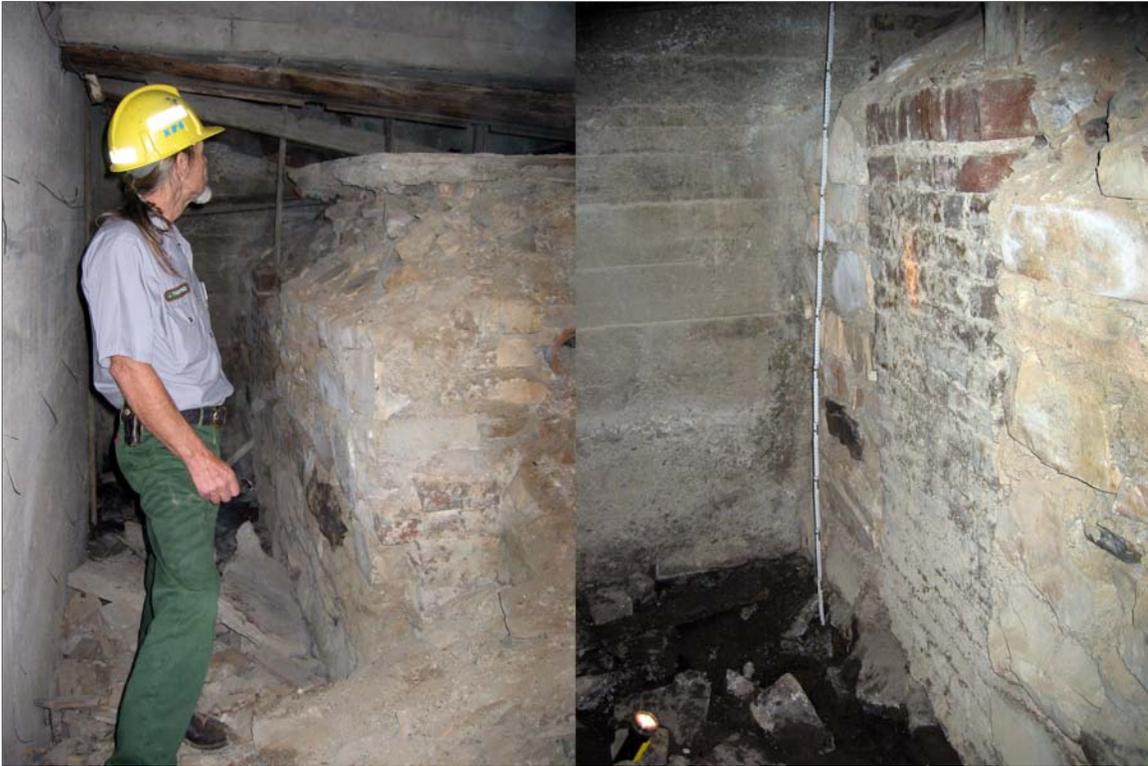
**Figure 52.** A foundation in the Ozark Bathhouse under the “fossil” tile floor is probably associated with the Iron and Magnesia Bathhouse and exhibits a sealed arched opening in its north end.
