# MORE THAN MEETS THE EYE

## The Archeology Of Bathhouse Row, Hot Springs National Park, Arkansas

Midwest Archeological Center  
Technical Report 102

United States Department of the Interior  
National Park Service  
Midwest Archeological Center  
Lincoln, Nebraska  
2008

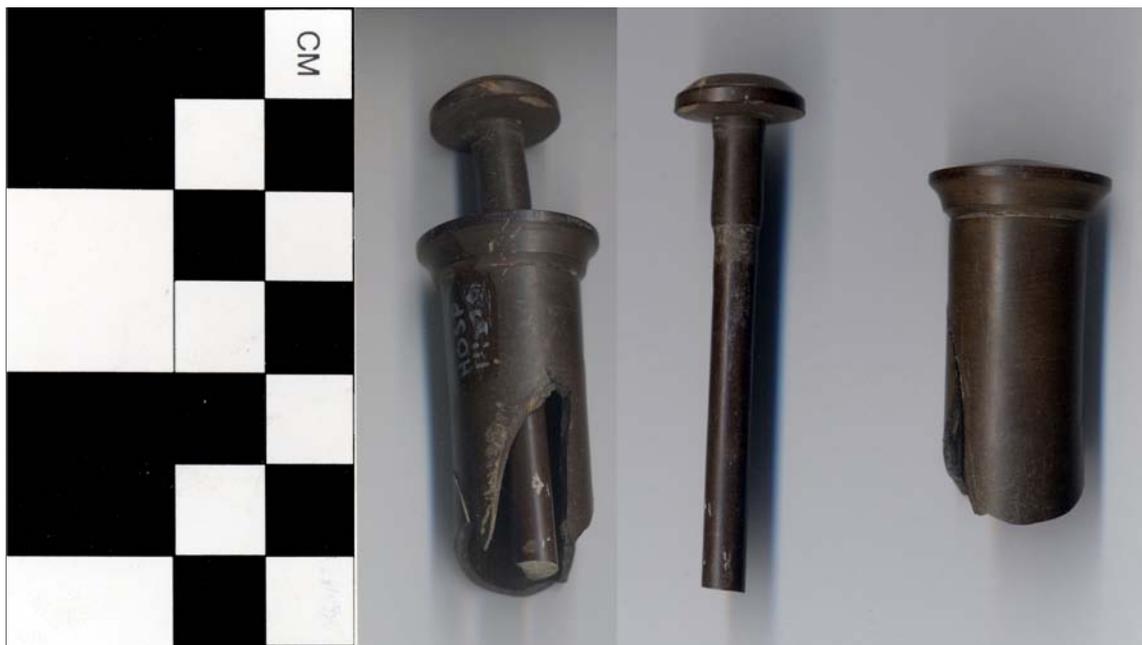
**Figure 54.** Hard rubber syringe (Cat. 14339) recovered from under the Ozark Bathhouse basement floor.

to “P” syringes offered in Harold Surgical Corporation catalogs during the 1920s (Harold Surgical Corporation 1927:32). Harold Surgical Corp. syringes came in 3/8 and 1/2 oz. sizes and priced at \$2.50 the dozen. They appear on the same page as urethral syringes and with arsphenamine and neo-arsphenamine, both of which were remedies for the treatment of syphilis. A syringe nearly identical to that in the Harold Surgical Corp. catalog is in the Medical Museum Collection at Oregon Health and Science University. That specimen was manufactured by I.R. Comb & Co. under a patent by Goodyear. Its manufacture is attributed to between 1851 when Goodyear patented the process for manufacturing hard rubber (Kemp and Malm 1935) and 1890 (Oregon Health and Sciences University 2005). Similar objects are also found in early 20th century Sears, Roebuck and Co. catalogs and are suggested for use as urethral and vaginal syringes (Sears, Roebuck and Co. 1969a, 1969b, 1970, 1973).

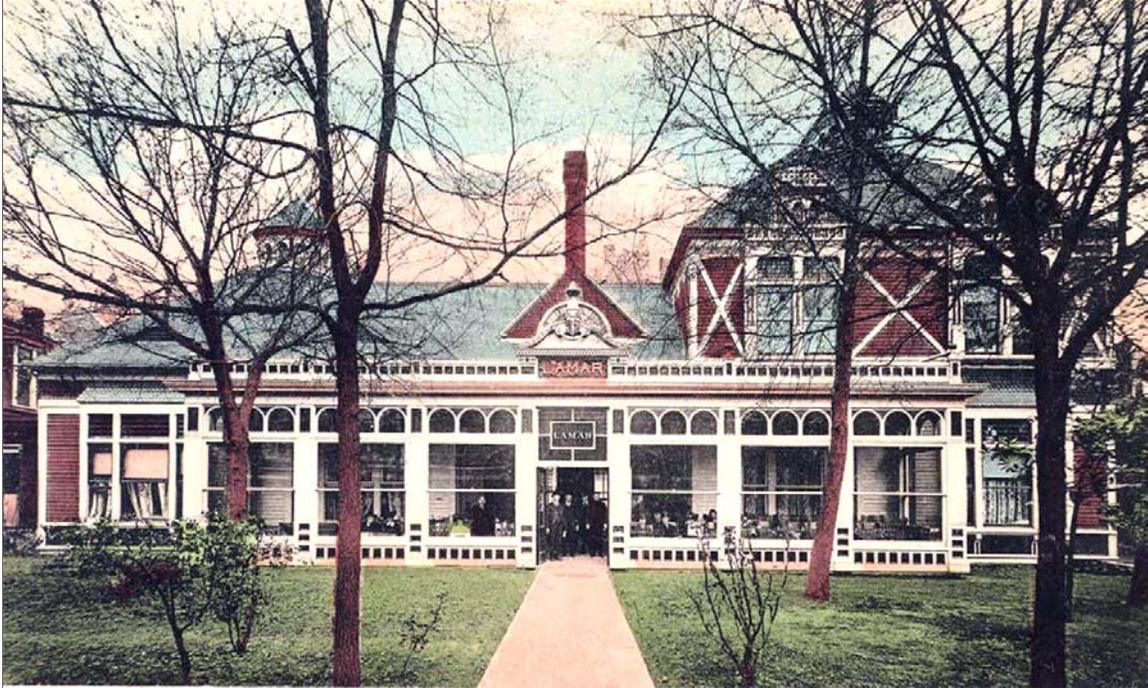
Figure 55. The first Lamar Bathhouse, constructed in 1887-1888 and razed in 1922.

The third structure on this site was the first Lamar Bathhouse. Its overall footprint was virtually identical with that of the present structure. GIS mapping data suggests a possibility that this earlier Lamar and the current building have the potential to share north and south exterior walls. In addition, mapping data indicates the first Lamar Bathhouse’s central opening (courtyard?) occurred wholly within the modern structure. These features,

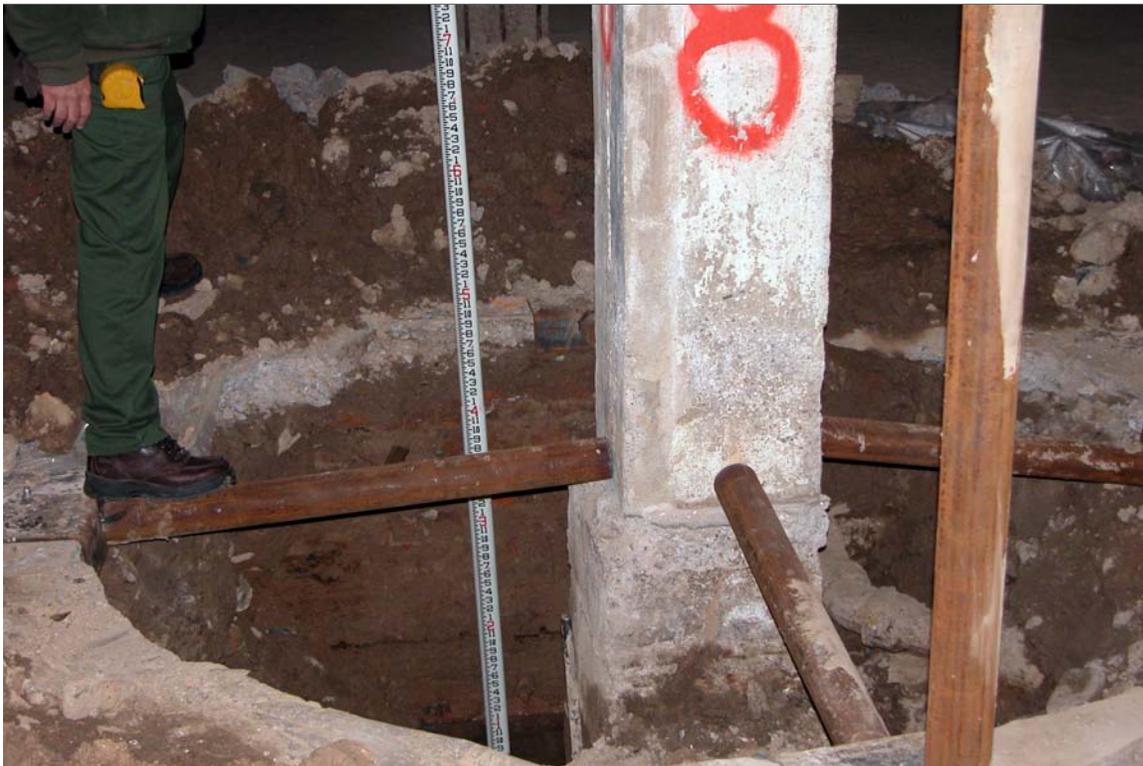
**Figure 58.** Contractor's excavation around Column 8 showing 1887-1888 basal column with offset 1922 column poured on top. The brick foundation (Feature 2) exposed by the construction crew is at the back of the hole behind the concrete column.

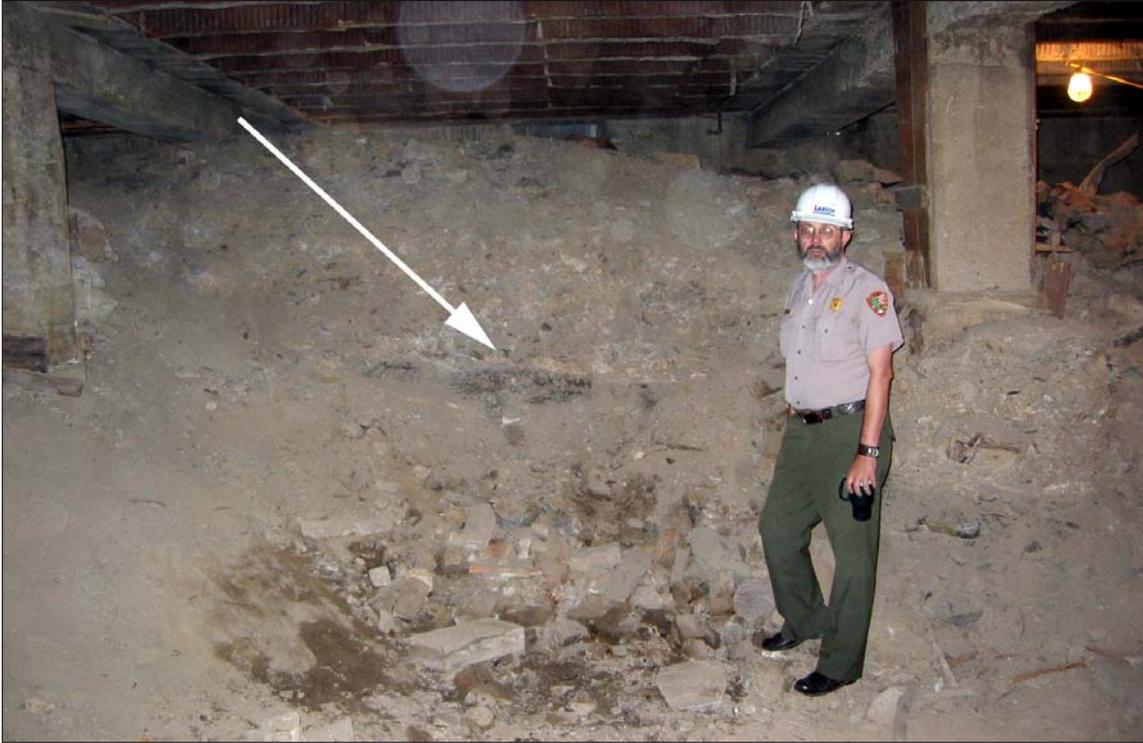
**Figure 59.** HOSP Park Ranger Mark Blaeuer standing next to Feature 1 in the south end of the Lamar Bathhouse basement at the time of its discovery.

The necessity for both the construction and archeological teams to work together and at the same time stay out of each other's way more-or-less focused initial archeological investigation on the stratified deposit and ash and clinker feature, hereafter referred to as Feature 1. This work was begun with documentation of the stratigraphy of the soil exposure which included Feature 1 (Figure 59).

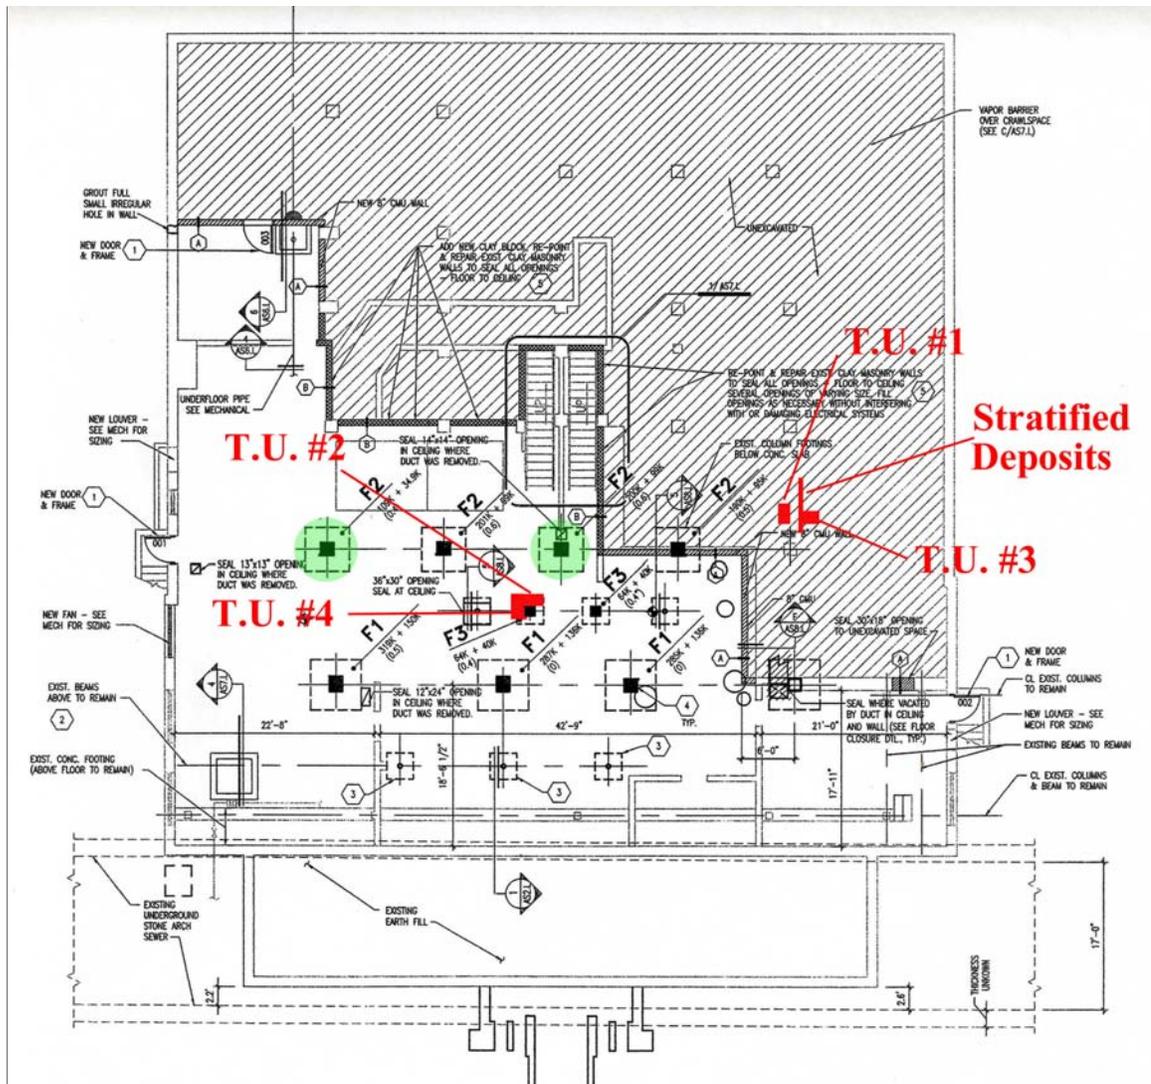
**Figure 60.** Approximate locations of archeological excavations (red) and artifact find spots (green) in the Lamar Bathhouse basement (adapted from National Park Service 2002a:Sheet AS2.L).

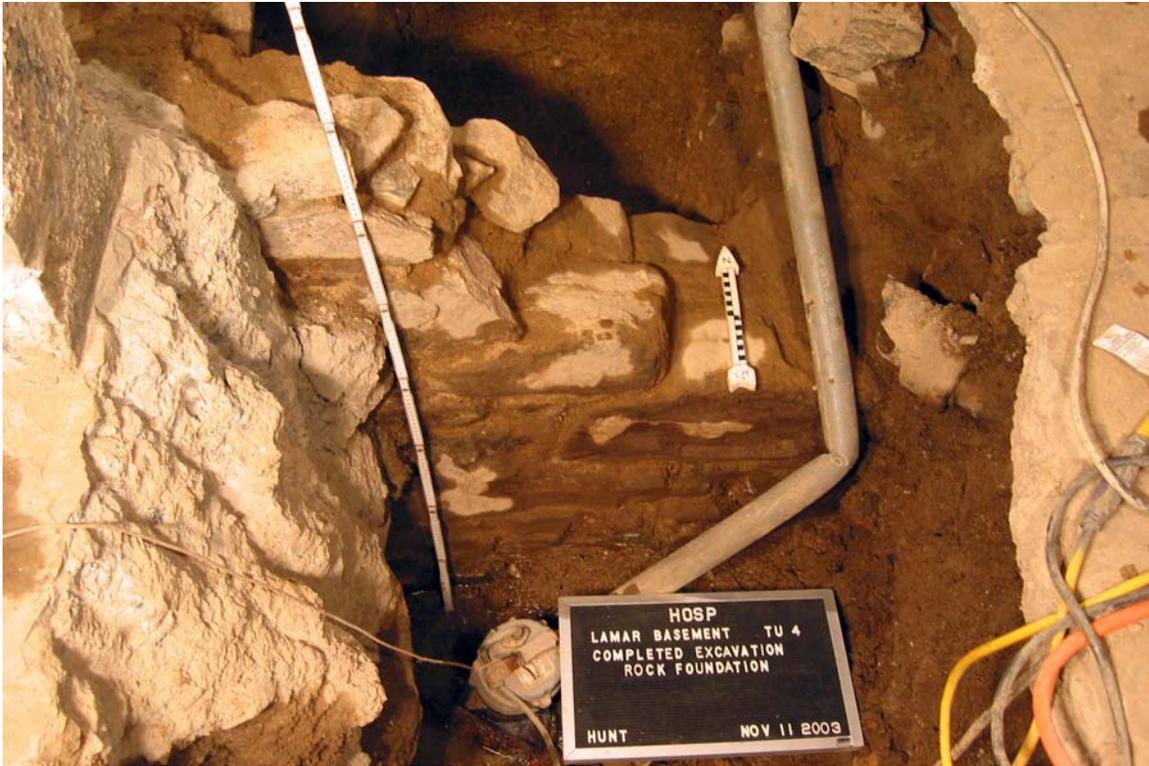
**Figure 61.** South face of stone and mortar foundation (Feature 3) exposed between T.U.s 2 and 4 (note intrusion of cast-iron pipe at right partially destroyed Feature 3).

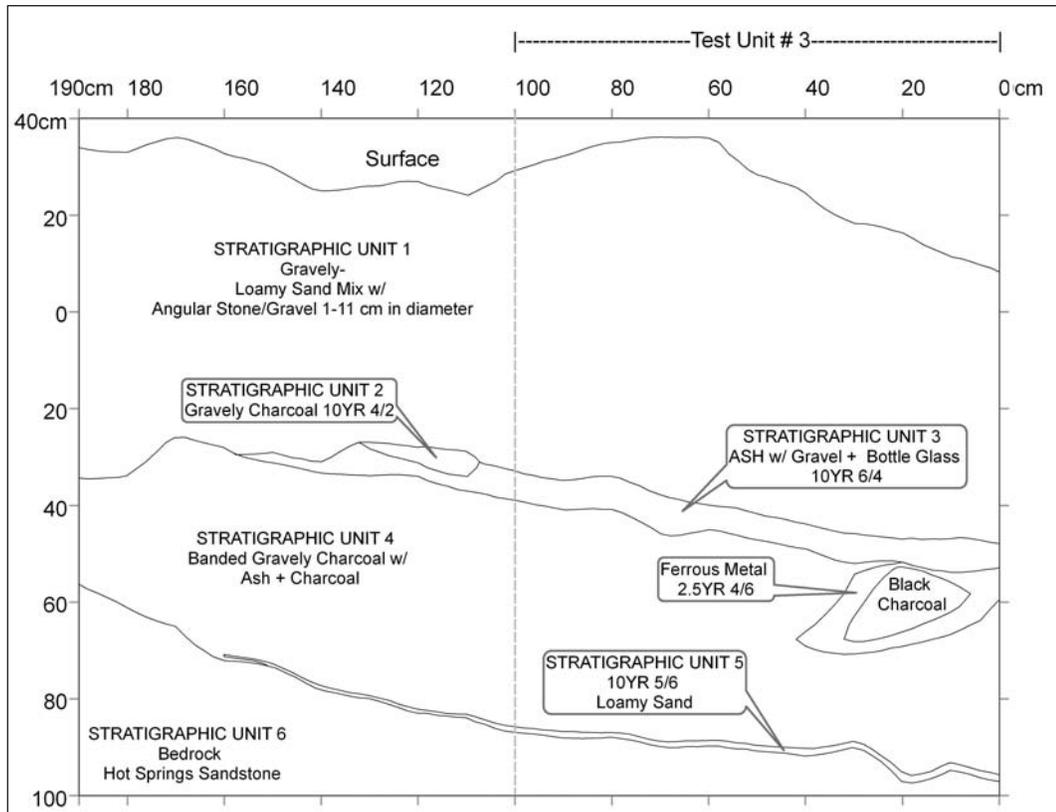
**Figure 62.** Profile drawing of stratified deposits at the south end of the Lamar Bathhouse basement.

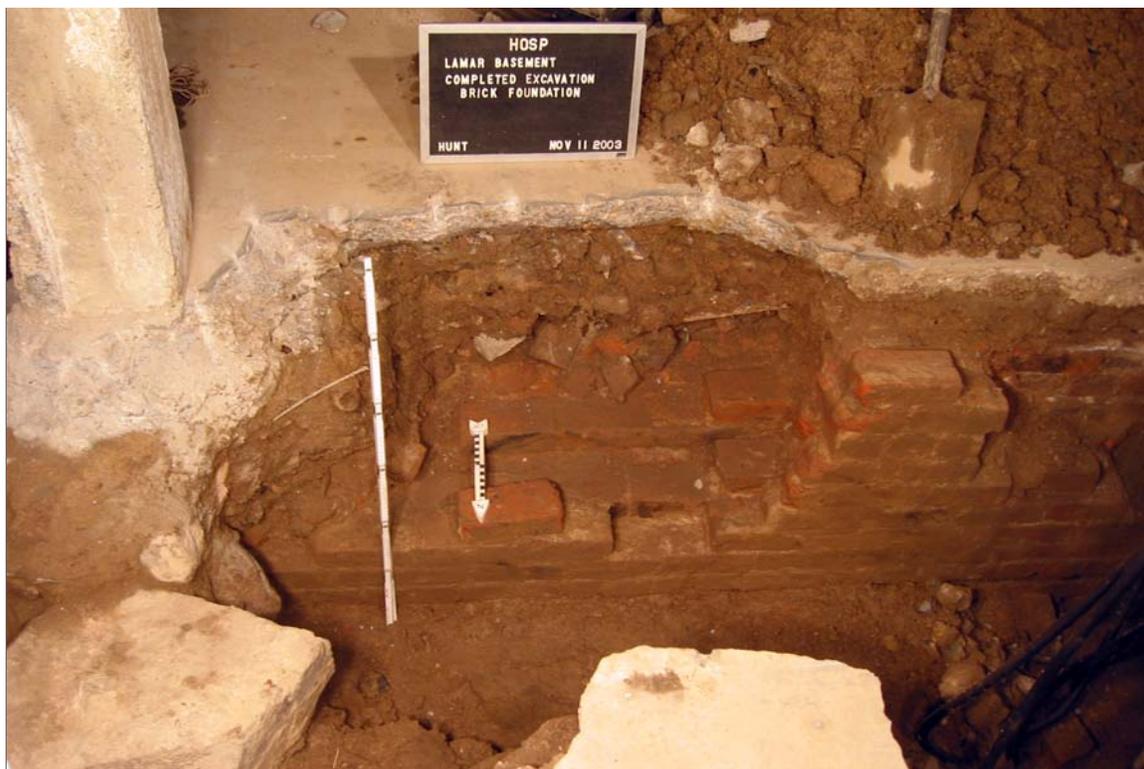
**Figure 63.** North face of brick foundation (Feature 2) west of Column 5.

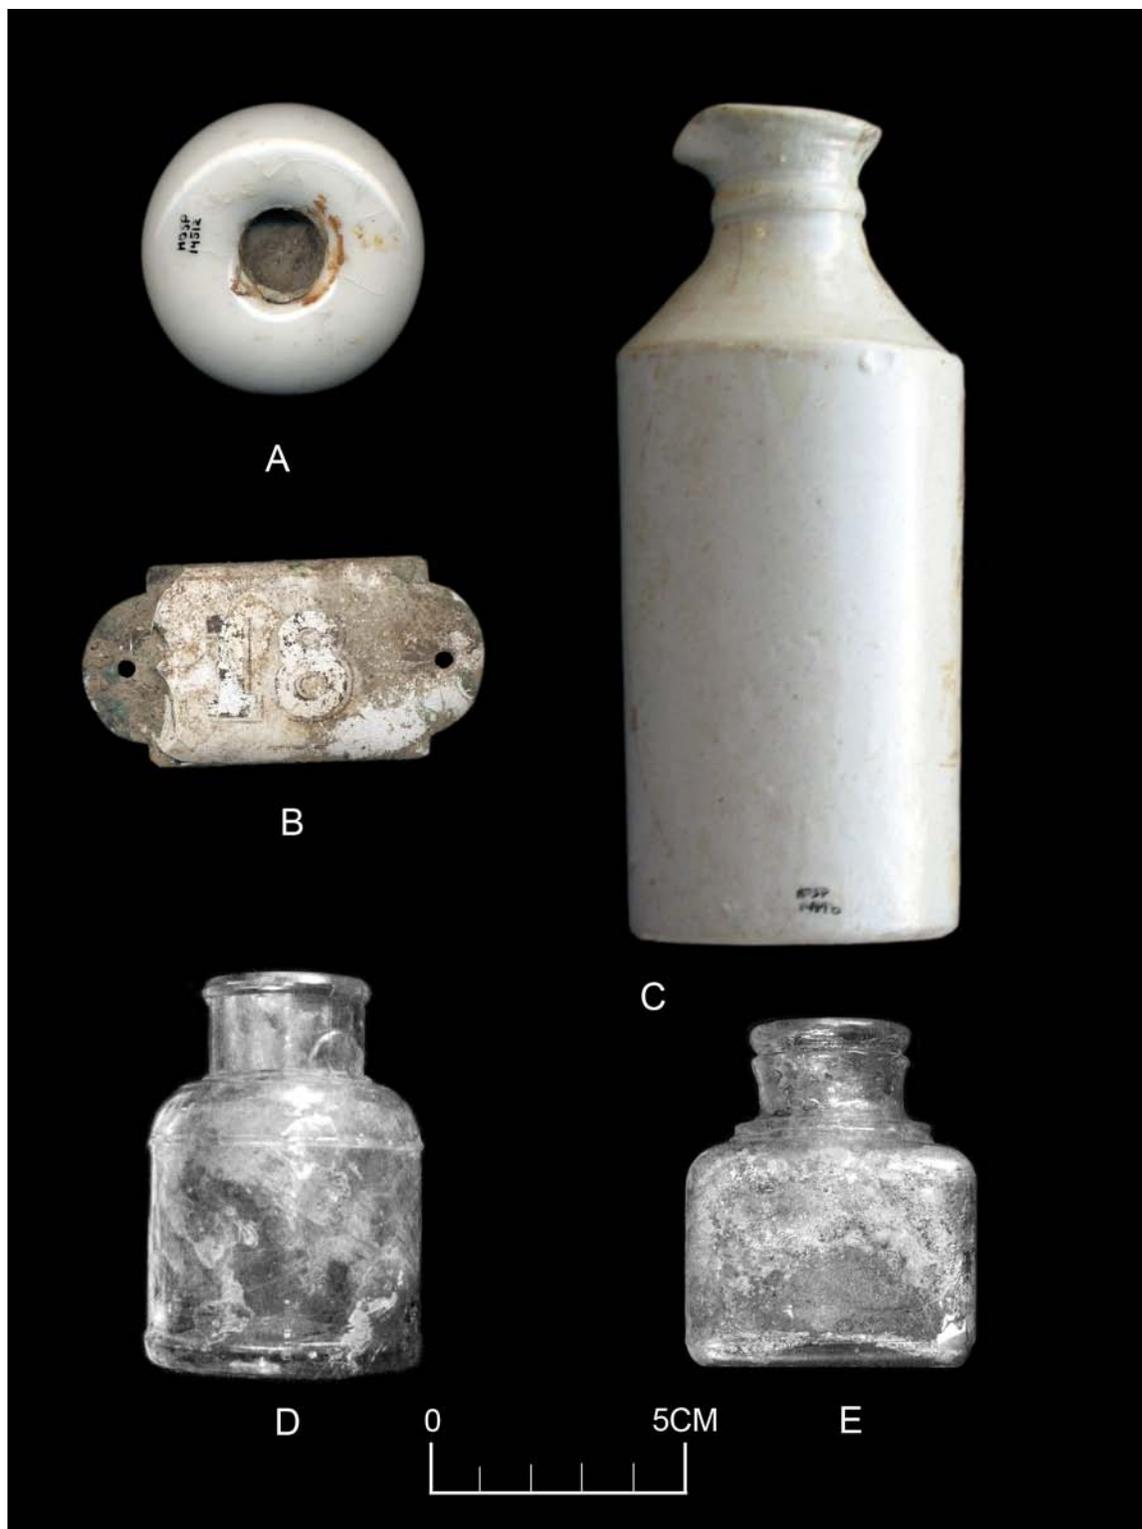
**Figure 64.** Artifacts associated with architecture and business record keeping recovered from the Lamar Bathhouse basement excavations: A) ceramic ink bottle (Cat. 14496); B) doorknob (Cat. 14512); C) door number plate (Cat. 14507); D) Carters Ink bottle (Cat. 14065); Sanford Ink bottle (Cat. 14063).

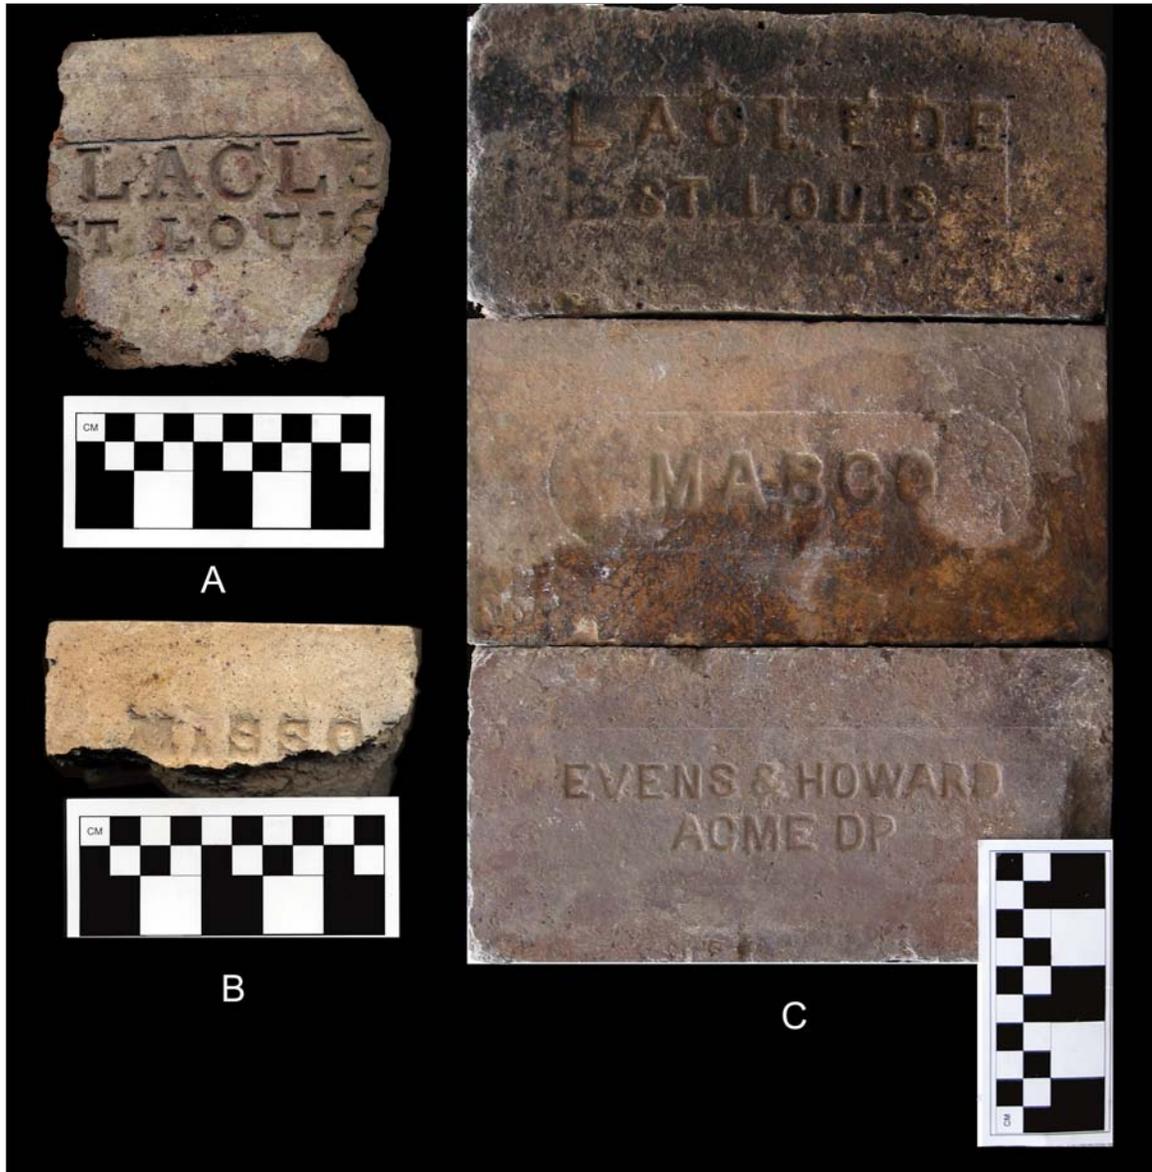
**Figure 65.** Bricks recovered from the Lamar Bathhouse basement excavations: A) “LACLEDE/ST LOUIS” (Cat. 14473) and B) “MISSOURI” (Cat. 14515); and bricks in HOSP curation from Lamar: and C) (top to bottom) “LACLEDE/ST LOUIS”, “MAPCO”; [in rectangular cartouche], “EVENS & HOWARD/ACME DP” [in lozenge-shaped cartouche].

Karl Gurcke (1987:258) indicates that bricks marked “LACLEDE KING” but without “ST LOUIS” were manufactured 1904-1942.

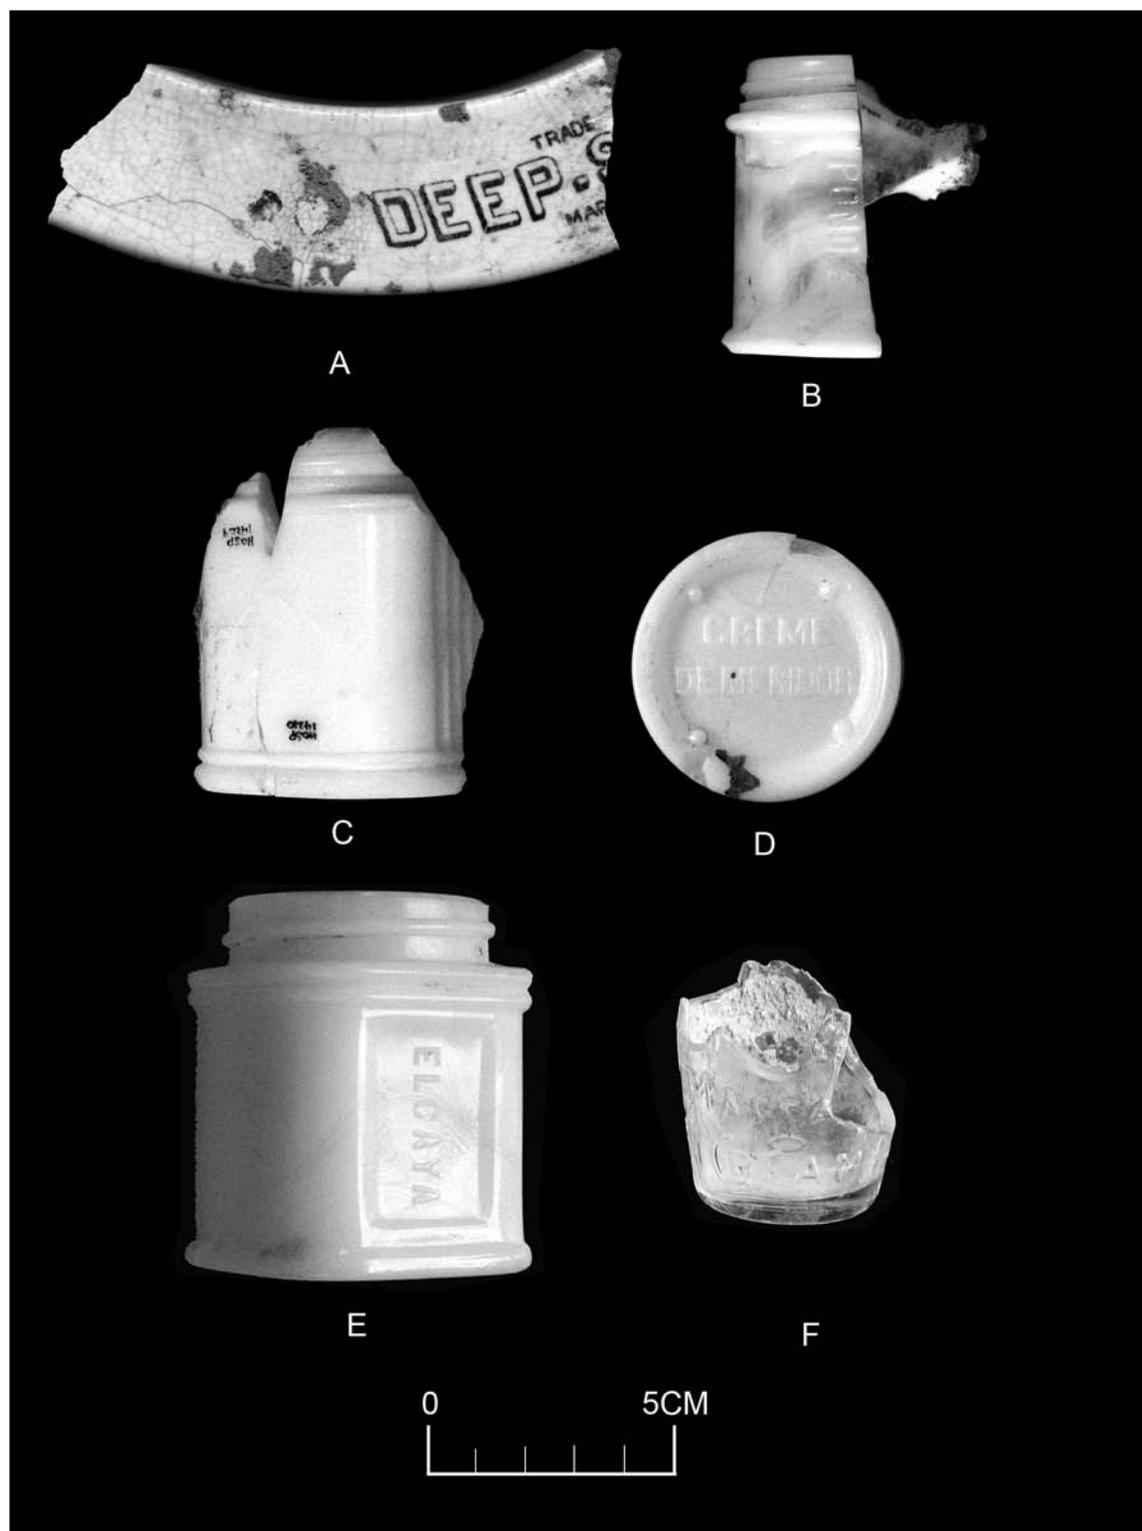
**Figure 66.** Artifacts associated with plumbing/sanitation and commercial grooming: A) toilet base (Cat. 14499); B) Ponds jar (Cat. 14200/14216); C) cold cream jar (Cat. 14209/14210); D) Creme de Meridor jar (Cat. 14205); E) Creme Elcaya jar (Cat. 14204); and F) Pompeian Massage Cream bottle (Cat. 14140).

A third brand of beauty cream represented by a single square vessel with rounded corners (Cat. 14204) is Crème Elcaya (Figure 66E). The opposing indented panels on the body are marked "ELCAYA//ELCAYA" with a basal mark "JAMES C. CRANE/1/NEW YORK." James Crane was the sole agent of this product and advertised it widely through the first decades of the 20th century. The company was purchased in 1925 by Chesebrough-Ponds Inc. (United States Patent and Trademark Office n.d.).

One clear base and lower body fragment (Cat. 14140) somewhat similar to Jersey Milk shape bottles (Putnam 1965:232) is marked "MASSA.../CREAM" (Figure 66F). A bottle identification guide (Hunt 1995) on the MWAC web site suggests the complete label is "POMPEIAN/MASSAGE/CREAM." This identification was confirmed by comparing the Lamar specimen with bottles offered for sale on the Internet. The soothing aftershave massage cream was created by Pharmacist Fred W. Stecher in a small drugstore on the outskirts of Cleveland, Ohio, in the late 19th century. The cream was made and distributed by the Stecher's Pompeian Manufacturing Company and was a favorite with barbers and hairdressers serving both men and women. Early 19th century advertisements sold on the Internet suggest the product was used much in the same way as beauty or cold cream. In 1927, the Pompeian Manufacturing Company was sold to Colgate Palmolive Peet for \$1 million. Six months later the entire Pompeian line of products was discontinued (Calvert 2005).

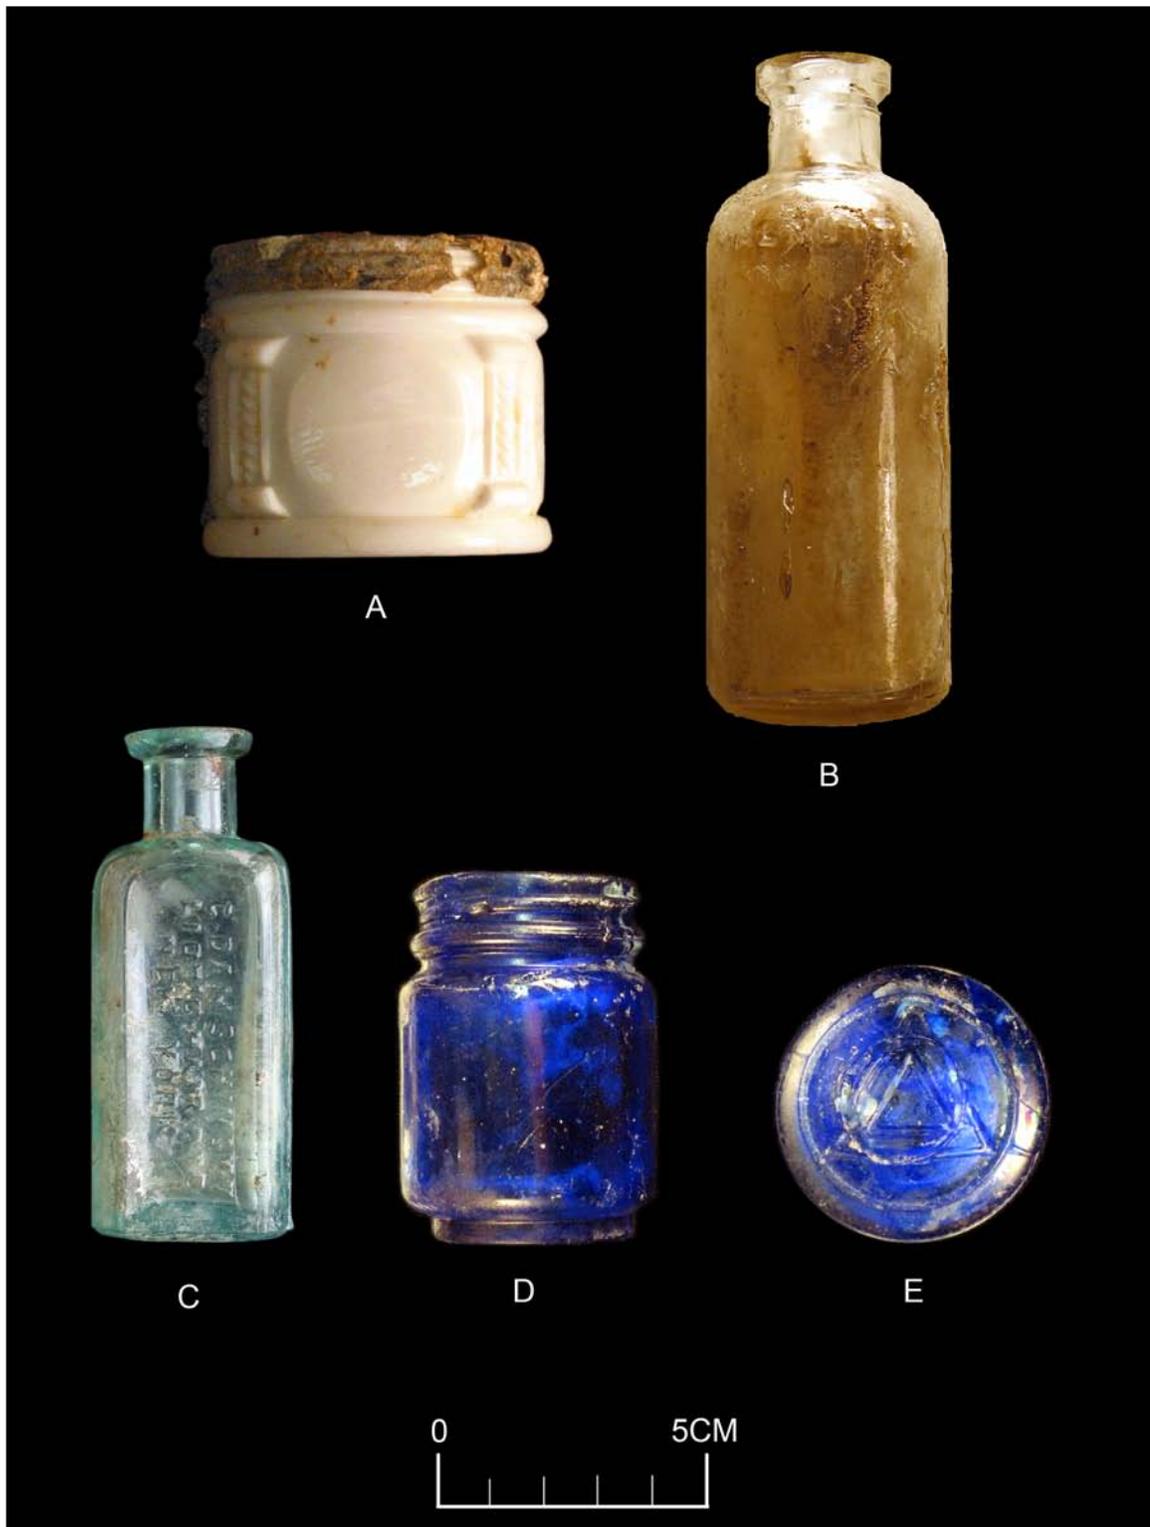
**Figure 67.** Artifacts associated with commercial grooming: A) cold cream jar (Cat. 14212); B) Walnutta hair dye bottle (Cat. 14061); C) C. Damschinsky's Liquid Hair Dye bottle (Cat. 14055); and D,E) Pomeade bottle and base (Cat. 14105).

This identifies the manufacturer as Whitall Tatum & Company of Millville, New Jersey, which operated between 1857 and 1901. This company made glass containers in a very large variety of shapes and sizes. After the firm name was changed to “Whitall Tatum Company” in 1901, the marking then became “W.T.CO.” (Whitten n.d.). One round jar (Cat. 14212) has raised circular areas on four sides bounded by raised corded columns (Figure 67A). It retains its aluminum screw cap closure.

*Hair products* (n = 4) used at Lamar include fragments of two bottles that once contained hair dye and two bottles which held hair dressing. A clear, round extract shape bottle (Putnam 1965:106) is embossed “WALNUTTA” across its shoulder (Figure 67B). Walnutta was a hair “stain” or dye made by the St. Louis-based Pacific Trading Co. The product was sold in the first decades of the 20th century as a “purely vegetable hair restorer free from all injurious drugs and chemicals” and cost “60 cents for a full size bottle” (Fike 1987:185; *The Haute Magazine* 1904). The second hair dye bottle is a small aqua paneled container (Cat. 14055) labeled “C.DAMSCHINSKY/LIQUID HAIR DYE/NEW YORK” in raised molded letters (Figure 67C). Carl Damschinsky marketed his hair dye from at least 1890 and continued in operation through 1948 (Fike 1987:122-3; Reynolds 1983:197). Both Walnutta and Damschinsky dyes contained pyrogallol (pyrogallic acid) a poisonous compound commonly used in printing and in photographic development.

A fourth jar (Cat. 14105) is small (2.4” diameter x 1.7” high) and of cobalt glass (Figure 67D). It was assigned to this functional category due to its shape; i.e., a round pomade shape bottle with screw top (Putnam 1965:44). It is possible, however, that it held seltzer or some other medicinal product. The base is marked with a symbol consisting of a molded triangle within triangle which has been altered slightly by an Owens scar from the automatic bottling machine which created it. This mark has not been identified.

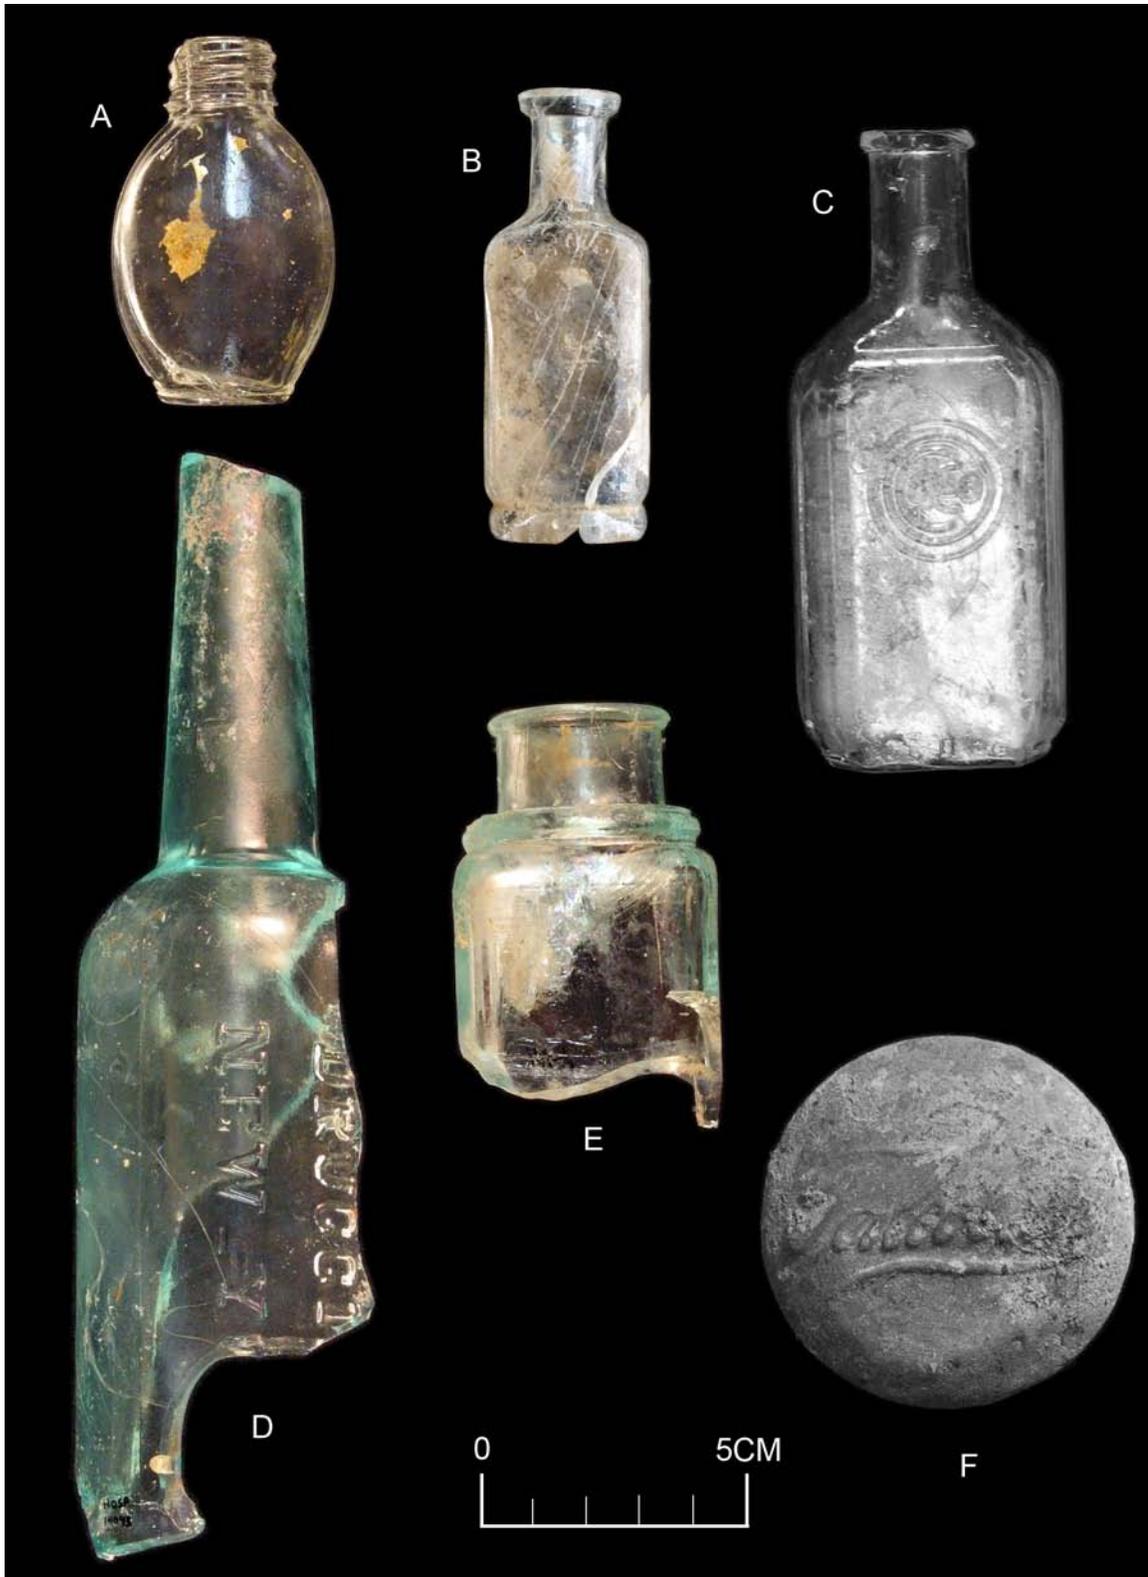
**Figure 68.** Artifacts associated with commercial grooming: A) perfume bottle (Cat. 14097); B) perfume bottle (Cat. 14103); C) possible Colgate's Violet Water bottle (Cat. 14078); D) Florida Water bottle (Cat. 14093); E) shoe polish bottle (Cat. 14139); and F) Talcolette body powder bottle cap (Cat. 14160).

Two small bottles and one bottle fragment were interpreted as perfume bottles (Figure 68A-B) although it is possible that one (Cat. 14103) may have contained medicine or hair dye. None have product labels identifying their contents although two (Cat. 14103, 14135) have molded labels identifying content volume ( $\frac{1}{2}$  and  $1\frac{1}{4}$  ounces). One vessel (Cat. 14097) was closed with a screw cap and another (Cat. 14103) with a stopper or cork. One bottle (Cat. 14097) has a molded makers mark "O (in square) 60" on its base identifying its manufacturer as the Owens Bottle Co. which operated 1911-1929 (Toulouse 1971:393).

Another specimen (Cat. 14078) is a clear bottle of the Chicago Toilet Water shape (Putnam 1965:80). The front panel bears a molded monogram "C & Co" within two concentric circles (Figure 68C). Although Fike (1987:54) identifies a similar monogram used by Colgate for Colgate's Violet Water in 1877 and 1935, it is possible the monogram on the Lamar specimen represents a different product. In 1806, William Colgate opened up a soapmaking concern in New York called Colgate & Company and the business continued to operate under this name until 1928 when it merged with the Palmolive-Peet Co.

One aqua bottle body/neck fragment and another neck sherd (Cat. 14093, 14147) are part of a single elongated vessel of the Florida Water shape (Putnam 1967:81). The body fragment bears the molded letters "DRUGGI.../NEW-Y..." (Figure 68D). Comparison with embossed labels in Hunt (1995) and references found four matches with the words "druggist" and "New York." A review of references for the four labels and comparisons with the Lamar bottle color and shape resulted in the most likely identification of the complete label on the Lamar specimen as "FLORIDA WATER/MURRAY & LANMAN/DRUGGISTS/NEW-YORK" (see Fike 1987:112, 244; Herskovitz 1978:19; Munsey 1970:157; Wilson 1981:70). Murray and Lanman Florida Water Cologne was first manufactured in 1808 by Robert I. Murray in New York City. In 1835, Murray was joined by D.T. Lanman and the name of the business was changed to Murray & Lanman. In 1835 the firm name was changed once again to David T. Lanman and Co., and once more in 1861 to Lanman & Kemp. That company continues to manufacture Murray and Lanman Florida Water to this day and offers its product as an astringent and skin lotion, personal deodorant, sickroom deodorant, rubdown for the sick, perfume and many other uses (Lanman & Kemp-Barclay & Co., Inc. 2005).

*Shoe polish* (n = 3). One bottle may be represented by light aqua finish, body, and basal fragments (Cat. 14139, Figure 68E). While this may be an ink or glue bottle, it is believed to most favorably compare with the square polish bottle shape (Putnam 1967:64). A tinned ferrous base and slip-on cap (Cat. 14429) is from at least one 3½" diameter x ¾" deep can. Like modern shoe polish cans, the base of this container has a recessed face. Similar tins, however, were utilized to package rouge, face powder and other cosmetic treatments throughout the late 19th and 20th centuries.

The second glass vessel is eight-sided and represented only by the upper shoulders of the vessel and a cuprous metal cap embossed with the word "Talcolette" in script (Figure 68F). Vessels pictured on the Internet have bases marked "H B G CO/TALCOLETTE/BALTIMORE." This identifies its manufacturer as the Baltimore firm Henry B. Gilpin Company. This company was founded in 1845 and was an early importer of drugs, chemicals, and essential oils. Originally, it operated primarily as a distributor which packaged drugs under the Gilpin label. Later, it manufactured its own products including cosmetics, insecticides, and hospital and surgical supplies. The Gilpin company was the first firm in America to manufacture a tinted face powder and this was distributed under the name Talcolette (Allen 1977).

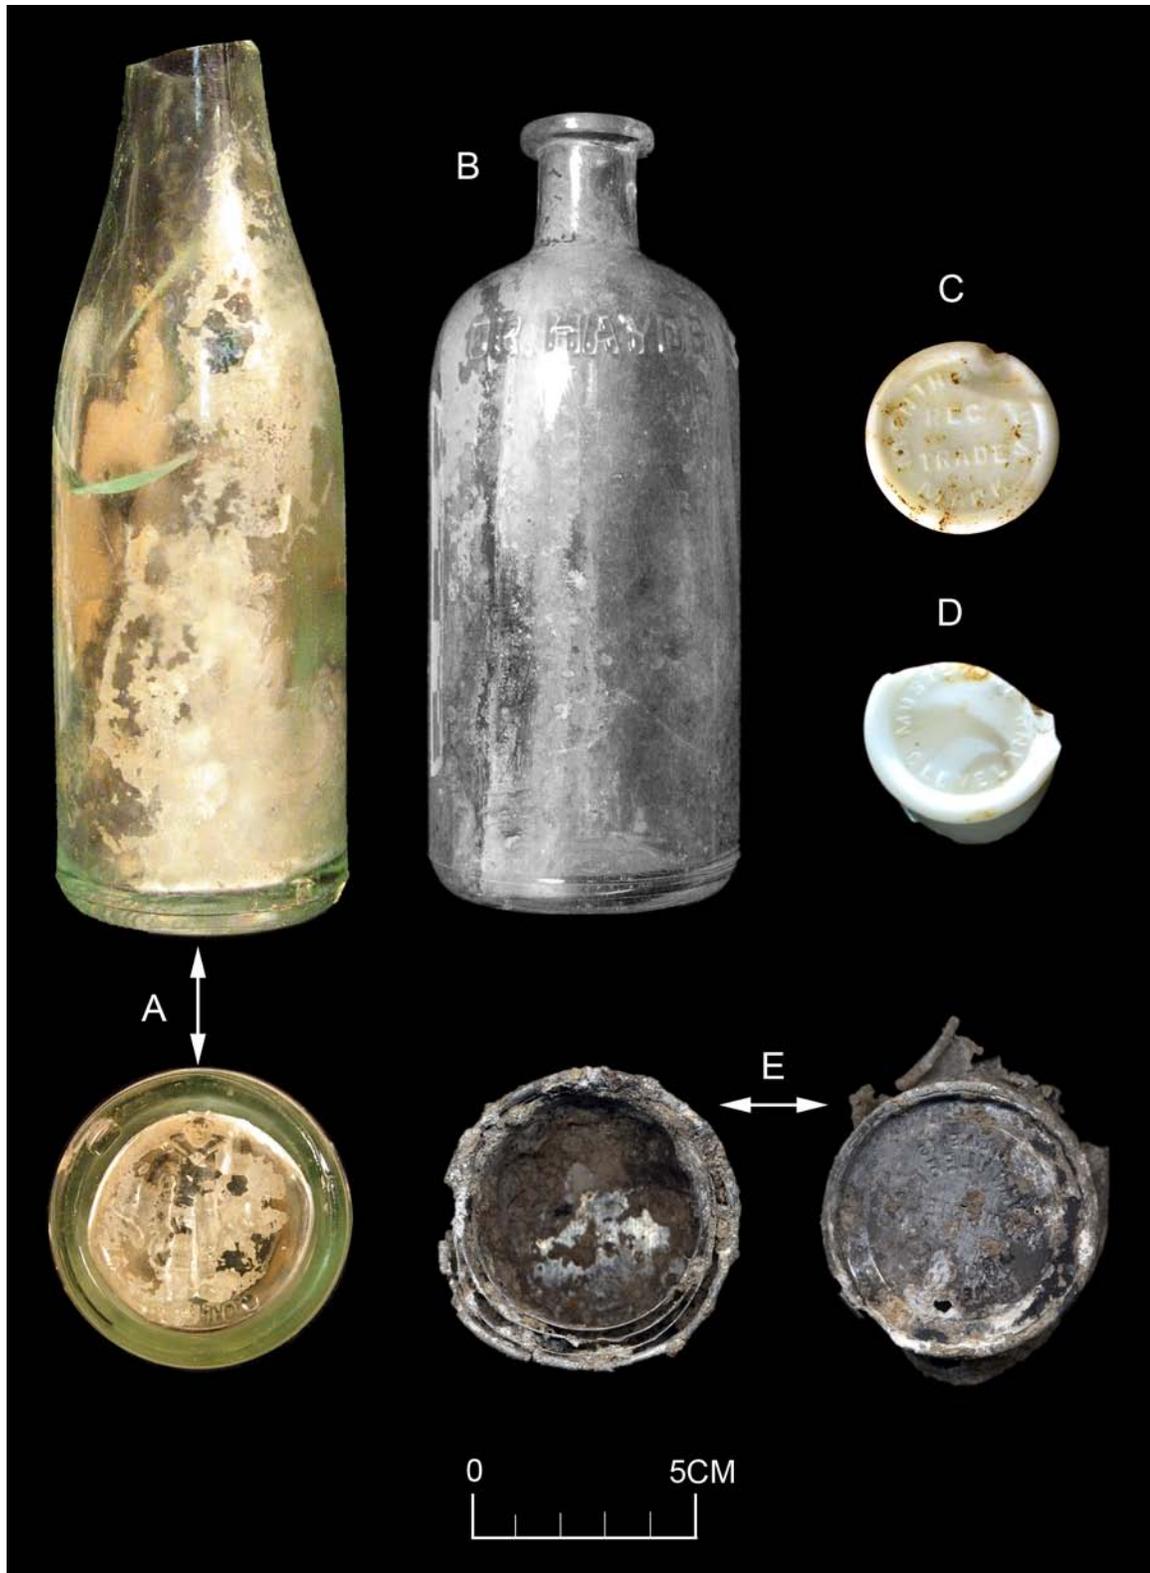
**Figure 70.** Medical/pharmaceutical artifacts: A) Pluto Water bottle and base (Cat. 14101); B) Dr Hayden's Viburnum Compound bottle (Cat. 14112); C) Mentholatum jar (Cat. 14206); D) Musterole jar (Cat. 14547); and E) Van Vleet Mansfield Drug Co. can and interior (Cat. 14404).

One light green Appolinaris shape body/base fragment (Cat. 14101) and a finish (Cat. 14170) may represent a single mineral water bottle. Its base exhibits a molded image of a devil with the legend "9/PLUTO" below (Figure 70A). "Pluto Water" was put out by the French Lick Springs Hotel Company, in French Lick, Indiana. The company operated a resort promoting the mineral water as having healthful benefits with visitors to the hotel taking the waters both internally and externally as a bath. In 1905, Pluto Water was advertised as being available from Henry Drug Company, Louisville, Kentucky (Digger Odell Publications 1999). Advertised as a purgative or a purging medicine for stimulating the evacuation of the bowels, Pluto water naturally contained Epsom salts and glauber salts.

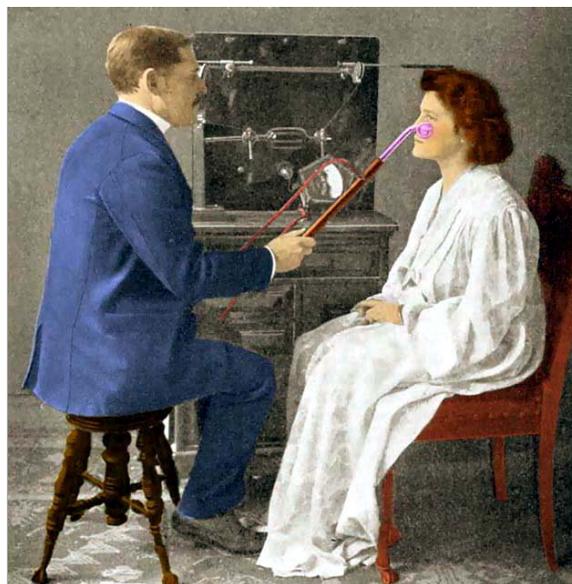
**Figure 73.** In the last half of the 19th century, electrical energy was promoted as a therapeutic tool to promote and maintain health. (Image courtesy Jeff Behary, The turn of the Century Electrotherapy Museum, West Palm Beach, Florida.)

in different colors depending upon the gas used. The most popular gas was argon which glowed a brilliant purple. The next most popular gas was neon which glows bright red, just as it does for neon signs. The high frequency of the output of the electrical charge (400-500KHZ, just under the range of radio very high frequencies) can not be felt as it passes through the body. The devices also emitted a small amount of ultraviolet light at the point of spark and a quantity of ozone. The combination of high frequency electrical energy, magnetic field, small amount of ultraviolet and quantity of ozone, led to the many claims of medical cures. Small violet ray sets, while expensive became very popular for home use, while huge sets with up to 2 dozen different electrodes were utilized by physicians (Rutecki 2002).

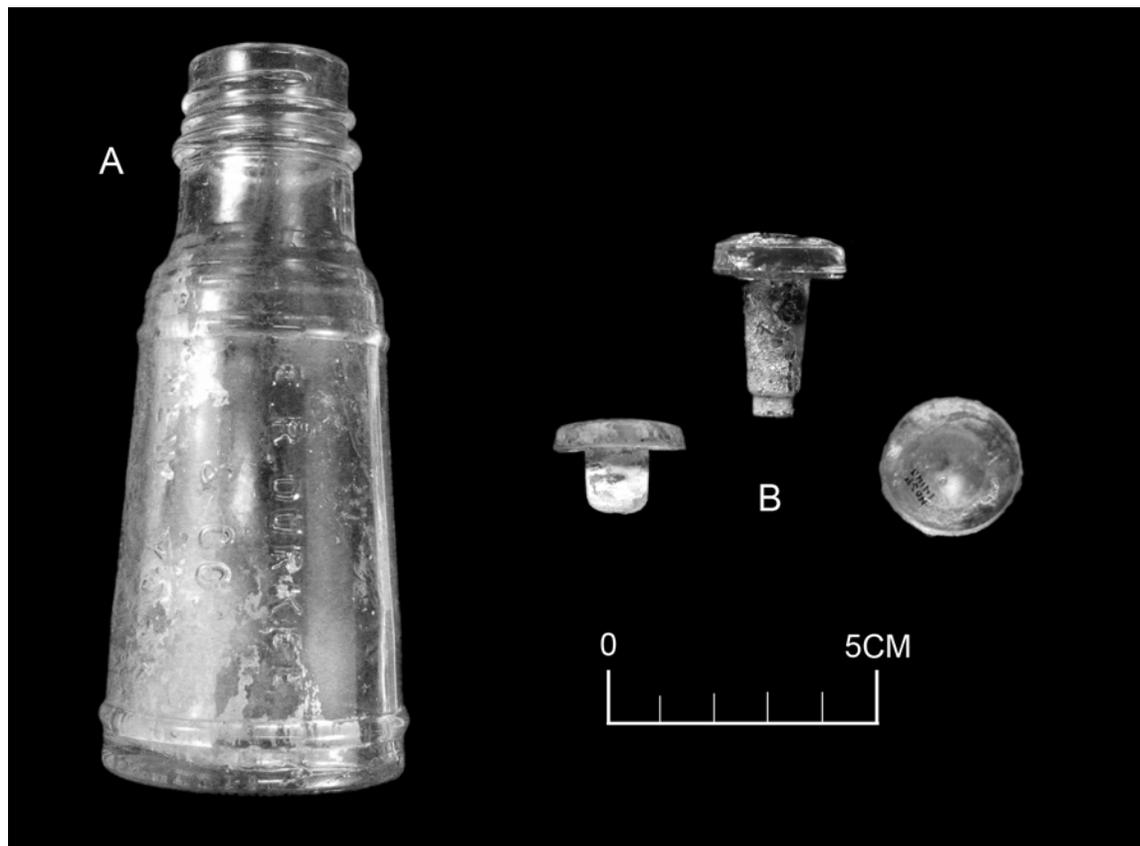
**Figure 79.** Condiment bottle and glass stoppers: A) Durkee's bottle (Cat. 14100); and B) stoppers (Cat. 14135, 14137, 14140).

Durkee's Famous Sauce and/or Durkee's Celery Salt (n = 2) were product(s) once contained in two complete bottles (Figure 79A). Although both are of the post-1877 variety which were made for screw caps (Tolouse 1971:182-184), they are marked differently. One

(Cat. 14100) exhibits "E. R. DURKEE/& CO./NEW YORK" on its side with the base marked "BOTTLE PATENTED/[registry mark]/APRIL 17 1877." The other specimen (Cat. 14107/14197) has no markings on the body but bears similar base marks. This latter specimen has an Owen's cut-off scar on the base and may have had a paper label.
