ARCHEOLOGICAL EXCAVATIONS
AT THE MANITOU FISH CAMP,
APOSTLE ISLANDS NATIONAL LAKESHORE, 1983

by
Jeffrey J. Richner

Midwest Archeological Center
Technical Report No. 4

United States Department of Interior
National Park Service
Midwest Archeological Center
Lincoln, Nebraska
1991

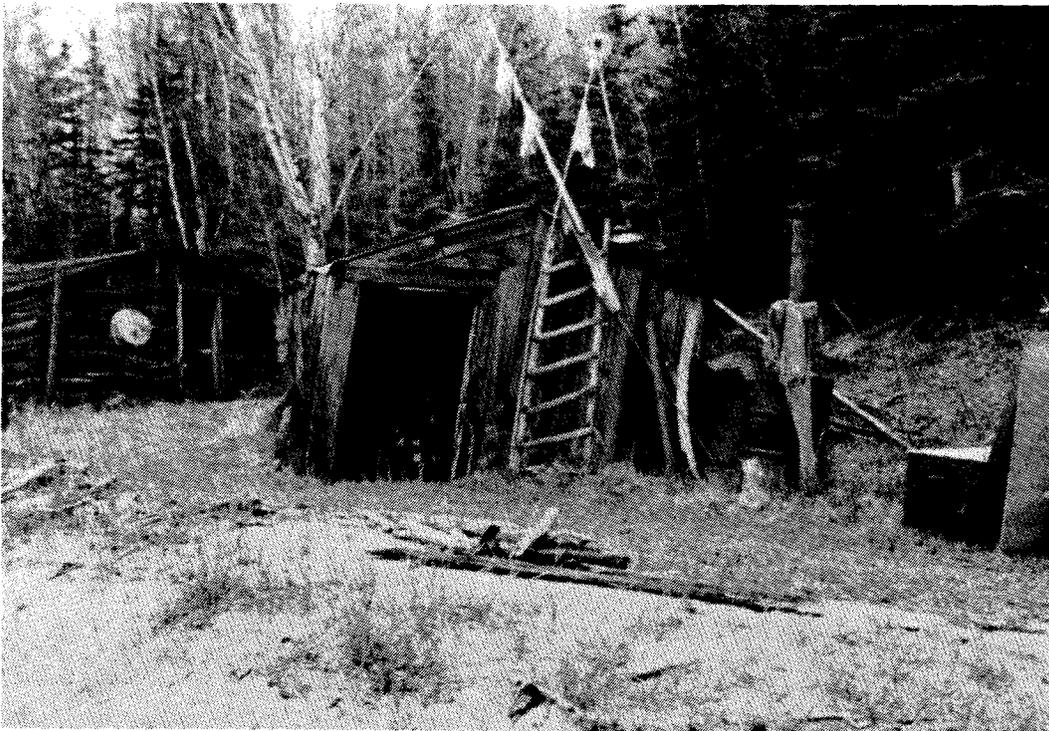
Figure 4. Historic Structure 2.

Structure 2, a twine shed, was built in the early 1900s by John Hanson, a Swedish logger who remained on Manitou Island to fish after the initial logging efforts were completed (Figure 4). The structure is of simple frame construction with wide vertical plank siding. The structure is 17 x 11 feet in extent and apparently served numerous functions including a stable for Hanson's horse and storage space for nets and fishing equipment. Prior to National Park Service restoration, the structure had suffered deterioration of wooden elements at ground contact, and considerable settling was also apparent.

Attempts to excavate around the perimeter of this vertical plank structure were severely limited due to the saturated condition of the soil. Standing water on the east and west sides precluded any excavations in those areas, given the available field equipment. Two units (21 and 23) were excavated on the south side of the structure where sand fill reduced the problem of standing water to some degree. In addition, a large shovel test (No. 4) was excavated along the north wall. Results of this excavation were rather meager with regard to artifact recovery. Test Unit 21 yielded nails, a fragment of twine, 15 pieces of tarpaper, a cartridge case, 31 pieces of window glass, and 14 pieces of bottle glass. Since gray, green, brown, and purple tinted, along with colorless glass fragments are present, it appears that at least five different vessels are represented by the bottle glass. The bottle(s) bearing the purple tint was likely made between about 1880-1915, and suggests a relatively early age for the structure. Cultural material from Unit 23 was more limited than from Unit 21, and consisted only of one nail, two leather fragments, and a double-bitted ax. The ax has a small segment of wood from the handle remaining intact. Since Hanson, the builder of the cabin, initially came to Manitou Island to conduct logging, it is tempting to suggest that the ax belonged to him. However, the extensive use of the structure after Hanson's occupation of the site precludes a firm association of the tool with Hanson.
