THE FURNACE GROUP

HISTORIC STRUCTURE REPORT

**Hopewell Furnace National Historic Site
Elverson, Pennsylvania**

Barbara A. Yocum

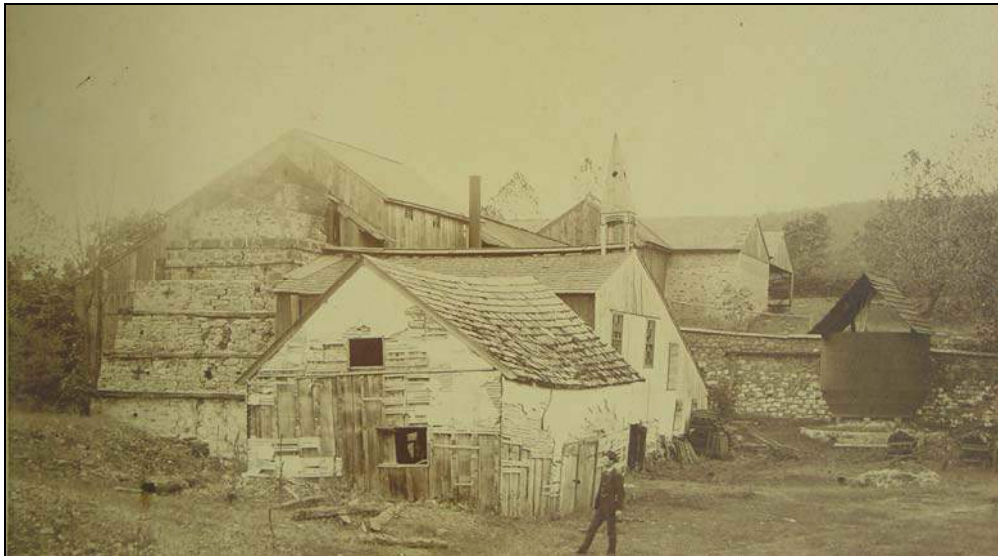
Figure 7. Earliest known photograph of Hopewell Furnace, October 10, 1887.

The earliest-known photograph of Hopewell Furnace was taken in 1887, four years after the furnace fired its last blast in 1883 (figs. 7 and 17). This view has come to be known as the “Stokes” photograph because it is in the Stokes collection at Hopewell Furnace NHS. The collection was probably obtained from the family of Mary Brooke Stokes, daughter of A. Louise Brooke and wife of Edward L. Stokes. The photograph may have been one of several described in 1935 by NPS Historian Roy Appleman as having been taken “several years ago when the furnace was pretty largely intact,” then in the possession of the E. & G. Brooke’s Iron Company of Birdsboro, PA.⁷⁰ Knowledge of the photograph appears to have been lost for the next 20 years until 1955, when it was said to have “first” come to the attention of NPS researchers.⁷¹ It is a paper-printed copy mounted on cardboard, with the following handwritten notation on the back side: “Hopewell Furnace, Chester [sic: Berks] Co., Pennsylvania, Oct. 10th, 1887, Edward B. Hardin, Photo[grapher].” The view, looking towards the northwest, features an unidentified man standing next to a small gable building in front of an assemblage of structures of the former Hopewell Furnace.

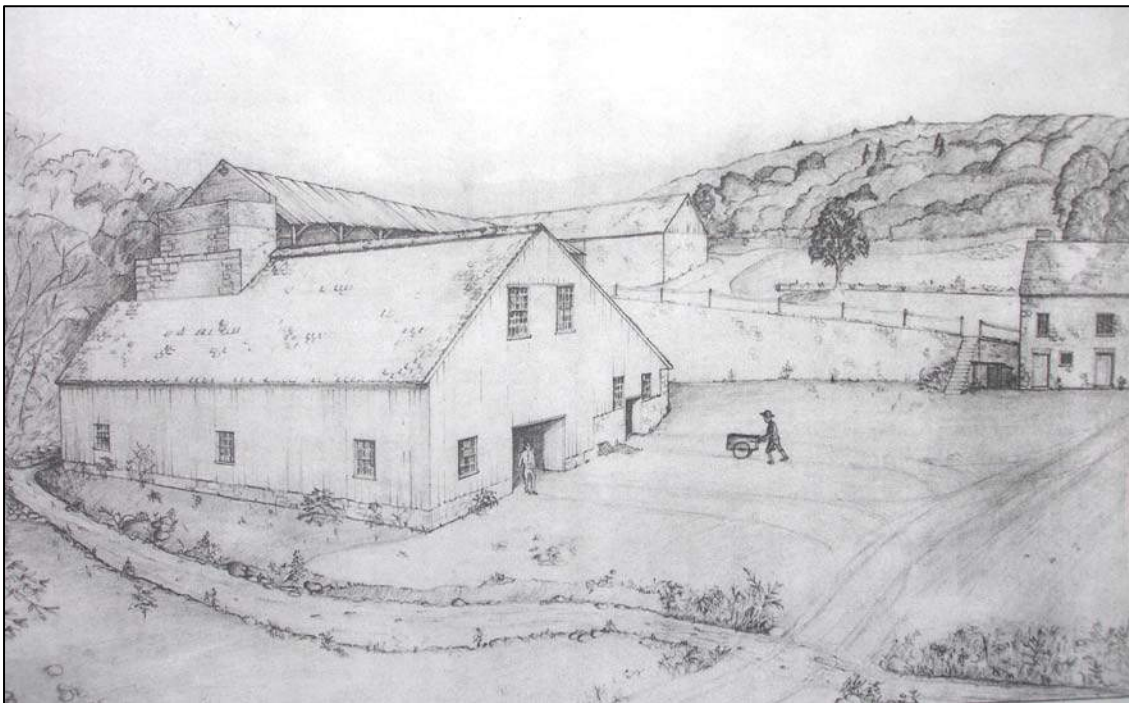
Figure 13. Conjectural sketch of Hopewell Furnace as it may have looked about 1800.

The sketch of the furnace stack as it may have looked about 1800 shows a stepped structure mostly enclosed by a wood- framed building that is assumed to be the cast house. Beyond the cast house can be seen the long bridge house with gable roof and open sides that connected with a stone charcoal house on the furnace bank; the cooling shed had not yet been constructed. Hidden from view by the cast house were the early north- south water wheel and bellows that provided a cold blast of air to the furnace.

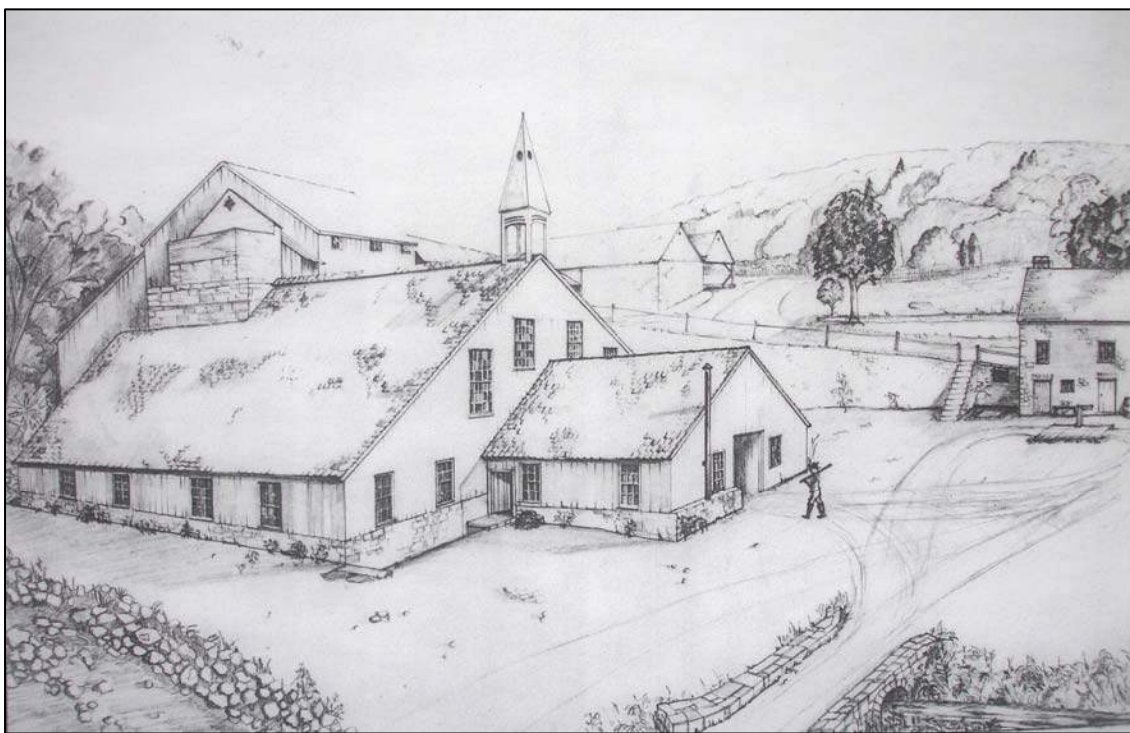
Figure 14. Conjectural sketch of Hopewell Furnace as it may have looked about 1840.

Norman Souder's conjectural sketch of circa 1840 shows several changes to the Furnace Group since 1800 (compare figs. 13 and 14). These include an enlarged cast house with a new belfry and east annex, a roofed enclosure over the water wheel, a remodeled bridge house, and a new charcoal-cooling shed north of the charcoal house. While helpful in envisioning the general physical appearance of the furnace about this time, several details merit discussion. First, Archeologist Leland Abel concluded in 1964 that the cast house had been completely rebuilt around 1816. Souder, on the other hand, depicts the building as an existing structure with newly added south extension, east annex, and belfry. Second, the roof of the wheel house is shown as continuous with the roof of the bridge house – a change that did not occur until 1879, according to Harker Long. Third, the enclosed portion of the bridge house nearest the furnace resembles that shown in the earliest known photograph dated 1887. This is more likely the configuration of the bridge house after extensive work was undertaken in 1847- 48, and is therefore not a true representation of its earlier 1840 appearance. Finally, it is possible, but not certain, that the cooling shed existed by 1840.

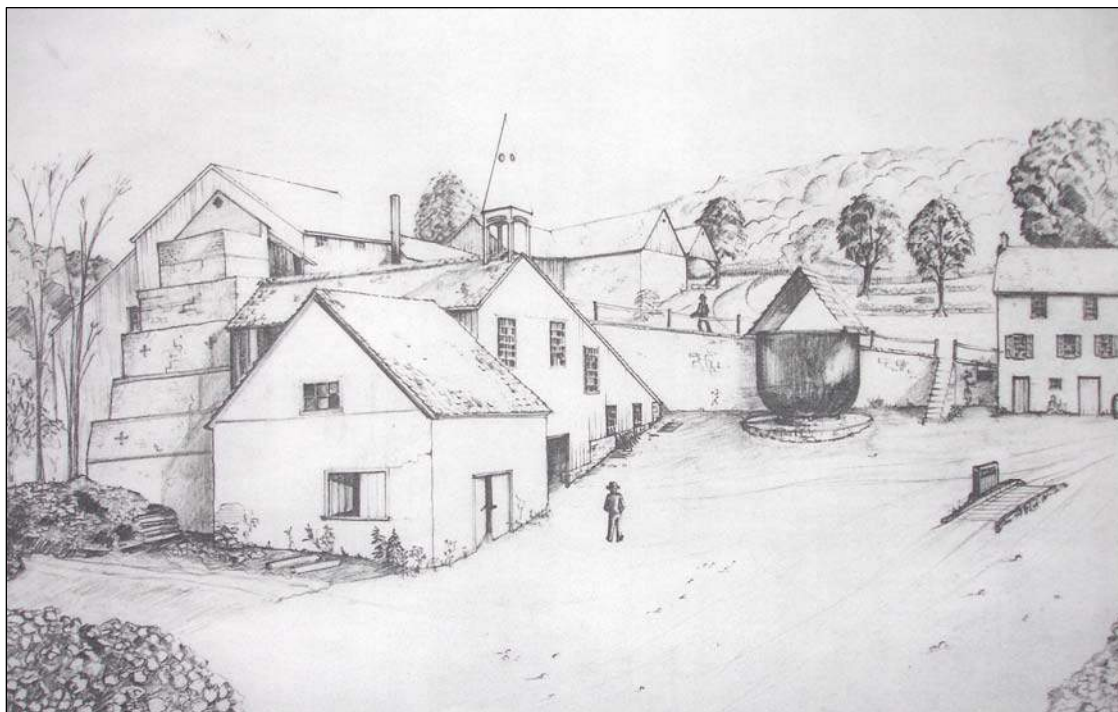
Figure 15. Conjectural sketch of Hopewell Furnace as it may have looked about 1880.

A conjectural sketch of Hopewell Furnace for the year 1880 was prepared by Architect Norman Souder around 1964 (fig. 15). This view was based primarily on the earliest known photograph of Hopewell dated 1887, four years after its last blast in 1883 (figs. 7 and 17). The primary difference between the sketch and the photograph is that the structures of the furnace were depicted by Souder in less- decrepit condition. The south portion of the cast house and its east annex had both been removed by 1867, and therefore do not appear in either the sketch or photograph.⁵⁹ A small gable- roofed structure south of the cast house is believed to have been the structure described by Harker Long as the “wheelwright- carpenter shop.”⁶⁰ The south extension of the charcoal house had been completed by this time, as had the east portion of the cooling shed, both constructed in 1880. Two inaccuracies postdating 1880 are a chimney for a later steam boiler, and an ore roaster situated east of the cast house.

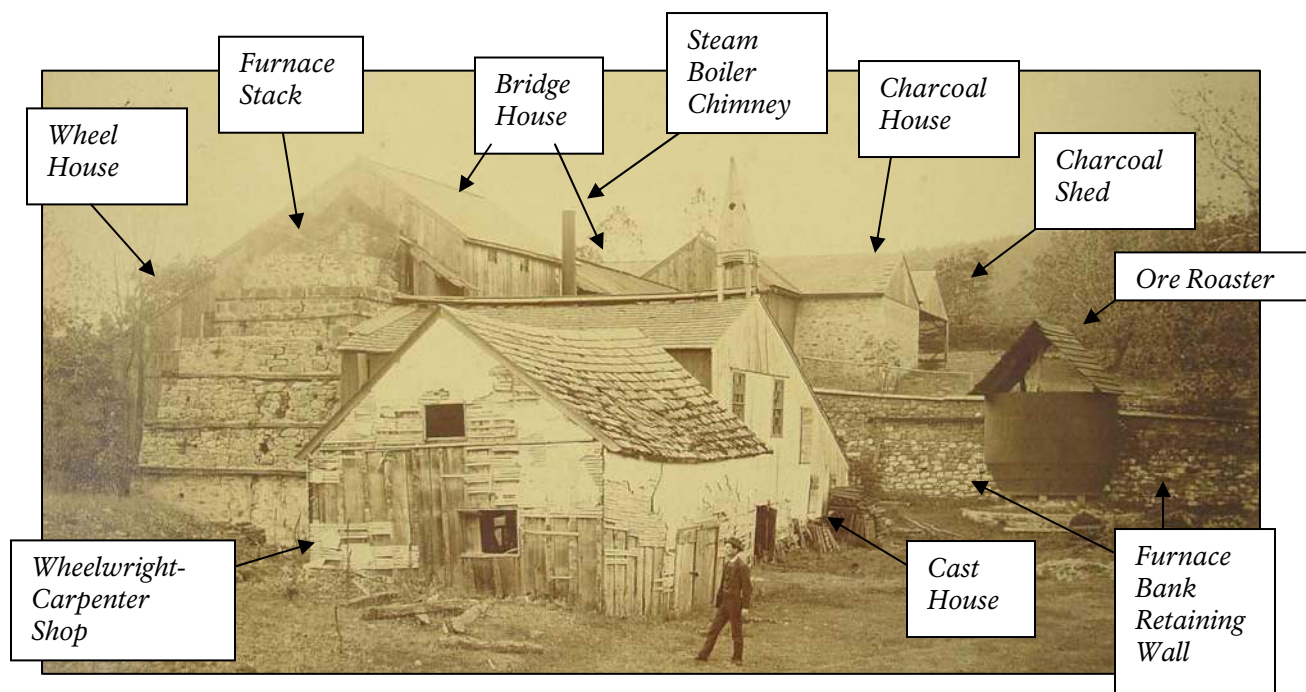
Figure 17. Annotated photograph of the Furnace Group, looking northwest, 1887.

The earliest-known photograph of Hopewell Furnace was taken by photographer Edward B. Hardin on October 10, 1887, four years after the furnace fired its last blast in 1883 (figs. 7 and 17).⁶³ The assemblage of structures captured by Hardin were those making up the Furnace Group, except for a small gable building in the foreground, identified as a wheelwright-carpenter shop, and a kettle-shaped ore roaster adjacent to the furnace bank. The south portion of the cast house had been removed by this time, as had the east annex. Deterioration of the remaining structures is evident by the wide masonry cracks in the furnace stack, missing siding, cracked windows, and patched roofing.

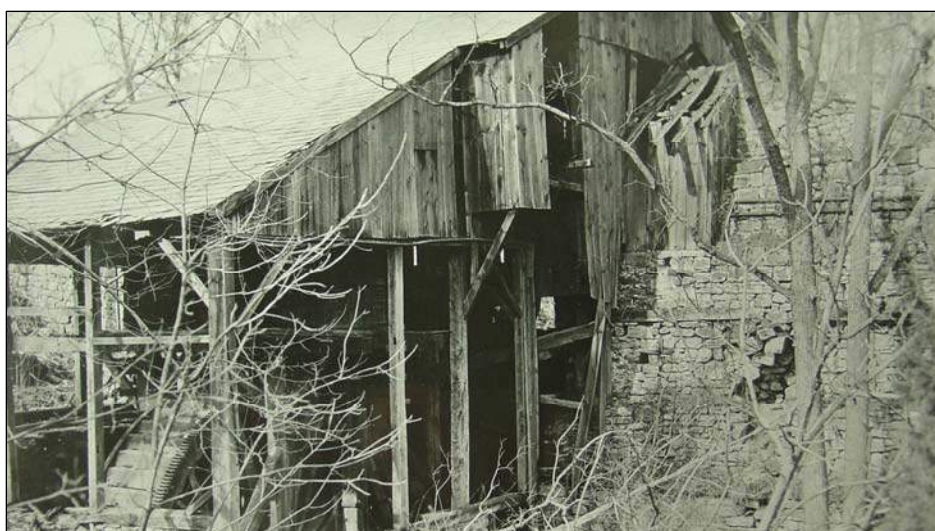
Figure 21. Remains of the wheel house and bridge house, April 1920.

Deterioration of the Furnace Group continued in the ensuing years, as illustrated in two photographs by “Stauffer” taken in April 1920 (figs. 20 and 21). The stone furnace was still standing, as was the enclosed portion of the bridge house. Some boards are missing from the east wall of the bridge house, however, and the sheet metal chimney of the boiler had disappeared. Nature was also beginning to reclaim the site, with a number of trees sprouting in the former location of the cast house and shed. Stauffer also documented the rarely photographed back (west) side of the furnace, showing the wood- framed wheel house (fig. 21). The roof and south side walls of this structure are seen to be surprisingly intact, as is the interior water wheel. The back side of the adjacent furnace stack, on the other hand, exhibits large areas of missing stonework and open mortar joints.

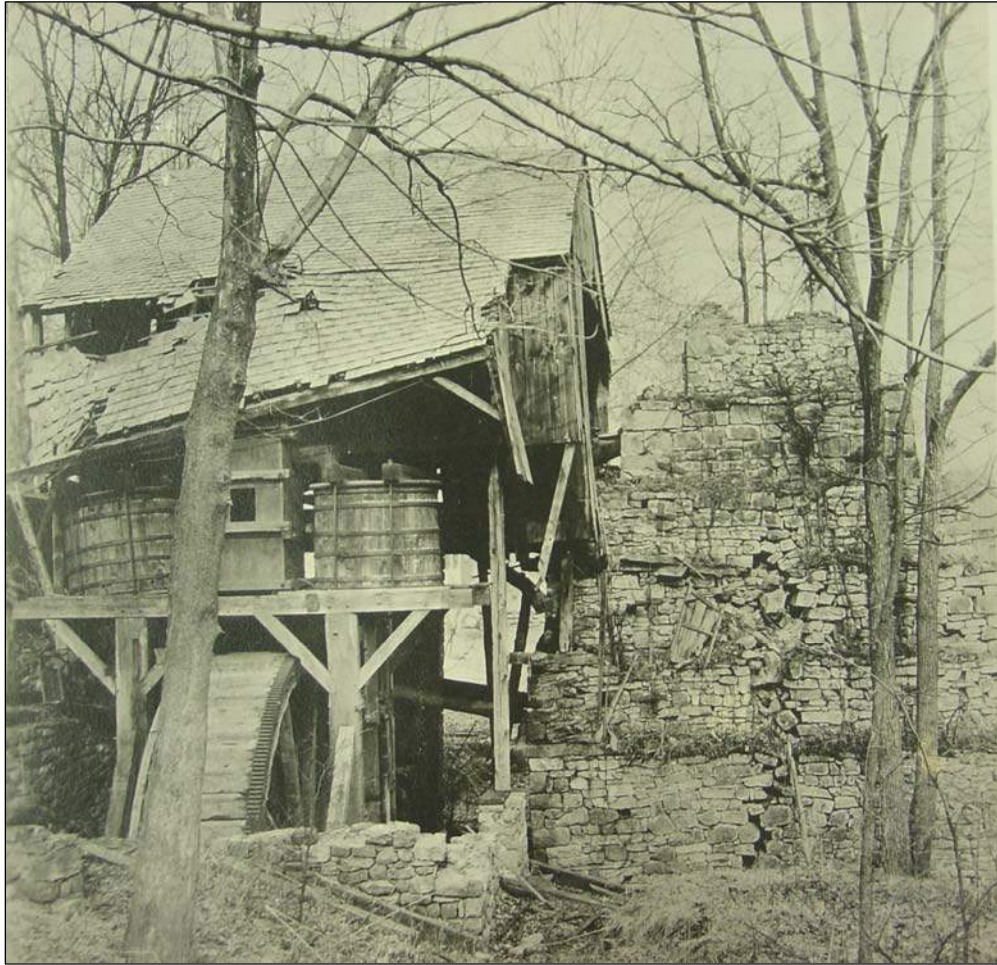
Figure 22. The wheel house and west elevation of the furnace, circa 1925.

An undated photograph taken sometime after Stauffer's views in 1920, roughly dated "circa 1925" by this report, captures the initial collapse of the wheel- house roof (fig. 22). It also provides the first clear view of the intact water wheel and the platform above it supporting the blast machinery. In a similar state of disrepair is the adjacent furnace stack, which has assumed the appearance of a crumbling mass of stones with a progressively widening vertical crack. By 1926, the roof of the wheel house had completely collapsed, leaving the water wheel and blast machinery exposed to the weather (fig. 23). It remained in this precarious state until the early 1930s.

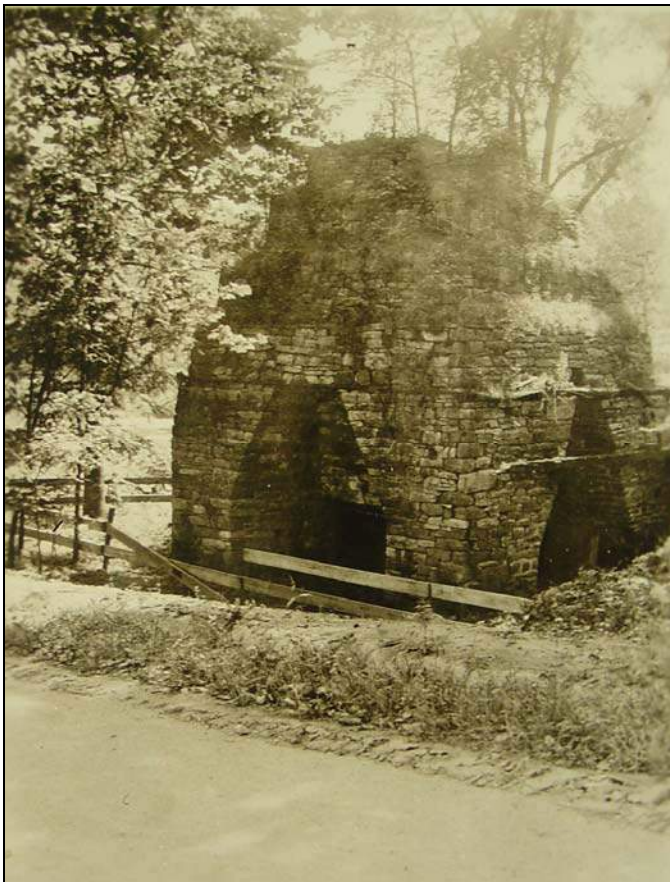
Figure 26. Northeast view of the furnace stack, taken sometime after the old Birdsboro- Warwick road was realigned in 1932, but before the start of furnace stabilization work in 1936.

Following the collapse of the bridge house and wheel house around 1932, all that remained of the Furnace Group structures were the stone walls of the furnace, the charcoal house, the furnace bank, and some stone foundations. More loss was sustained in 1932 when the old Birdsboro- Warwick road that passed through the village was realigned and paved by the Commonwealth of Pennsylvania.⁶⁷ The new path of the straightened road passed to the east of the furnace and over the foundations of the former cast house and wheelwright- carpenter shop. The raised roadbed included a stone retaining wall and gutter (figs. 26- 27). The road also destroyed a large portion of the furnace bank retaining wall northeast of the furnace.

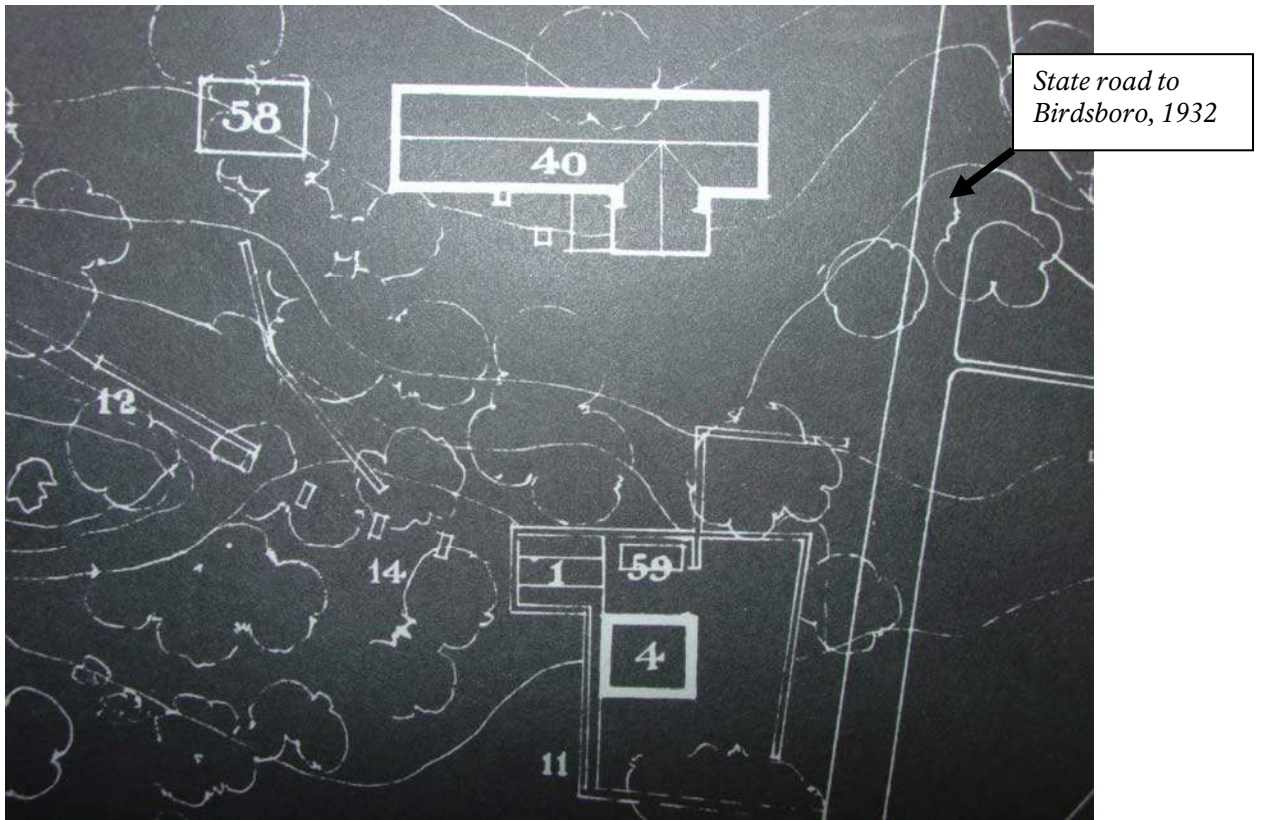
Figure 27. Detail of “Hopewell Village & Ruins” map, December 31, 1935, showing the remnants of the Furnace Group, including the water wheel pit (1), furnace (4), tail race (11), west head race retaining wall (12), forebay piers (14), charcoal house (40), and boiler (59). Located west of the charcoal house was a “temporary blacksmith shop” used by the CCC (58). Not shown in this detail are the “ruins of East Head Race” (50).

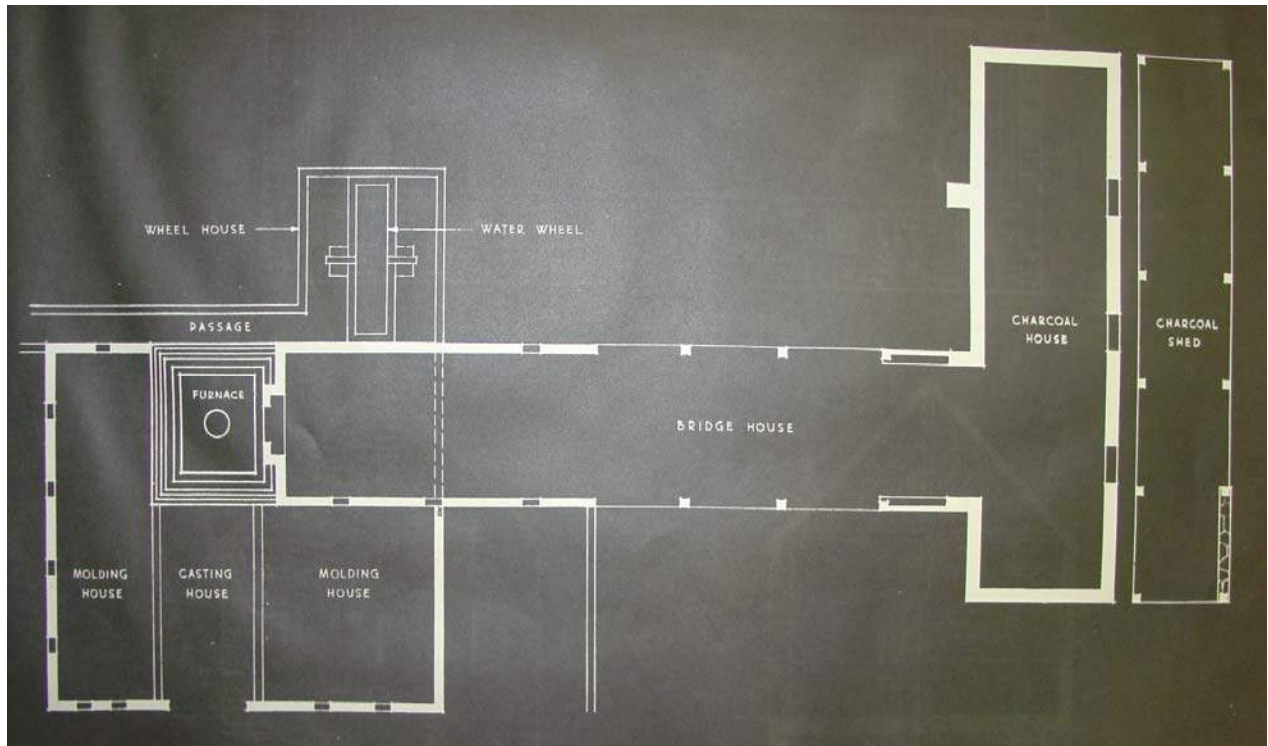
Figure 28a. Conjectural plan of the Furnace Group and cast house, December 31, 1935.

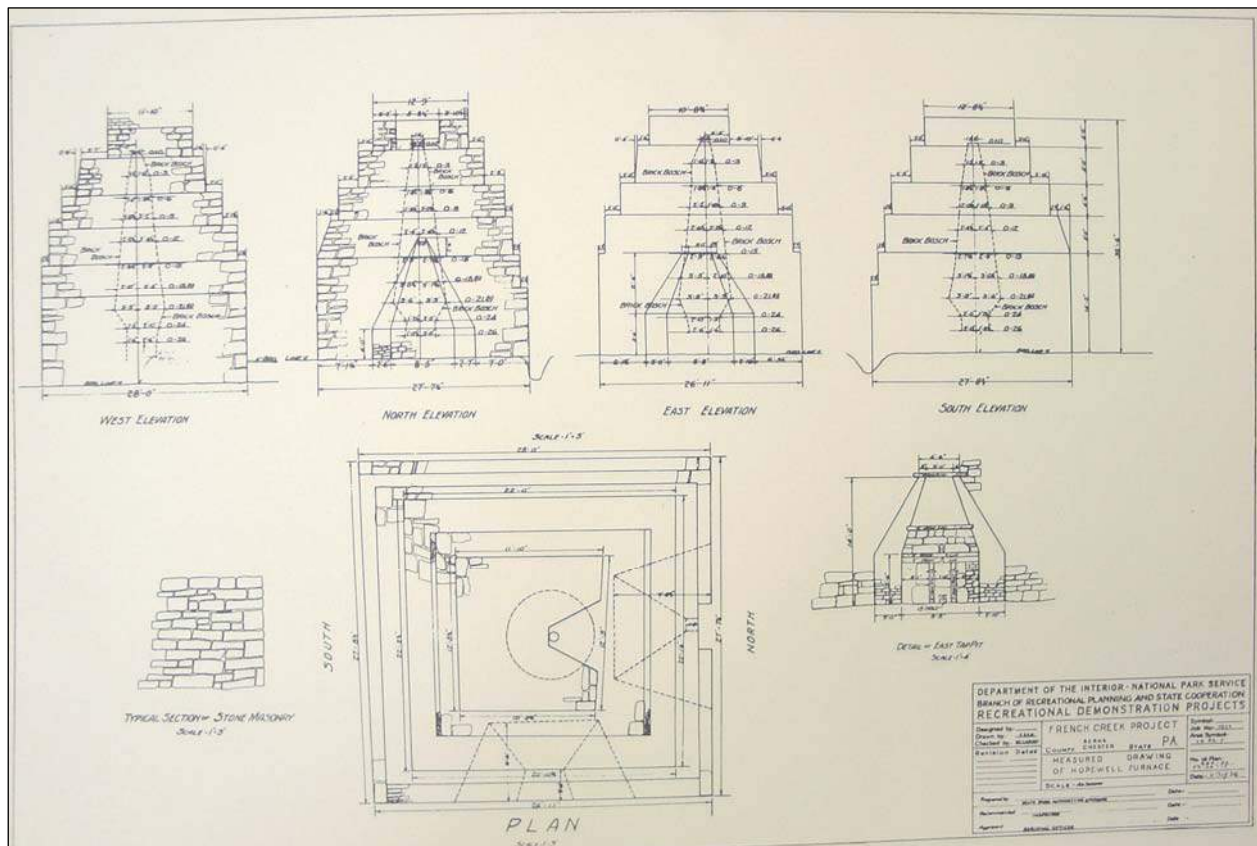
Figure 29. “Measured Drawing of Hopewell Furnace,” documenting the existing exterior and interior dimensions of the furnace, November 30, 1936.

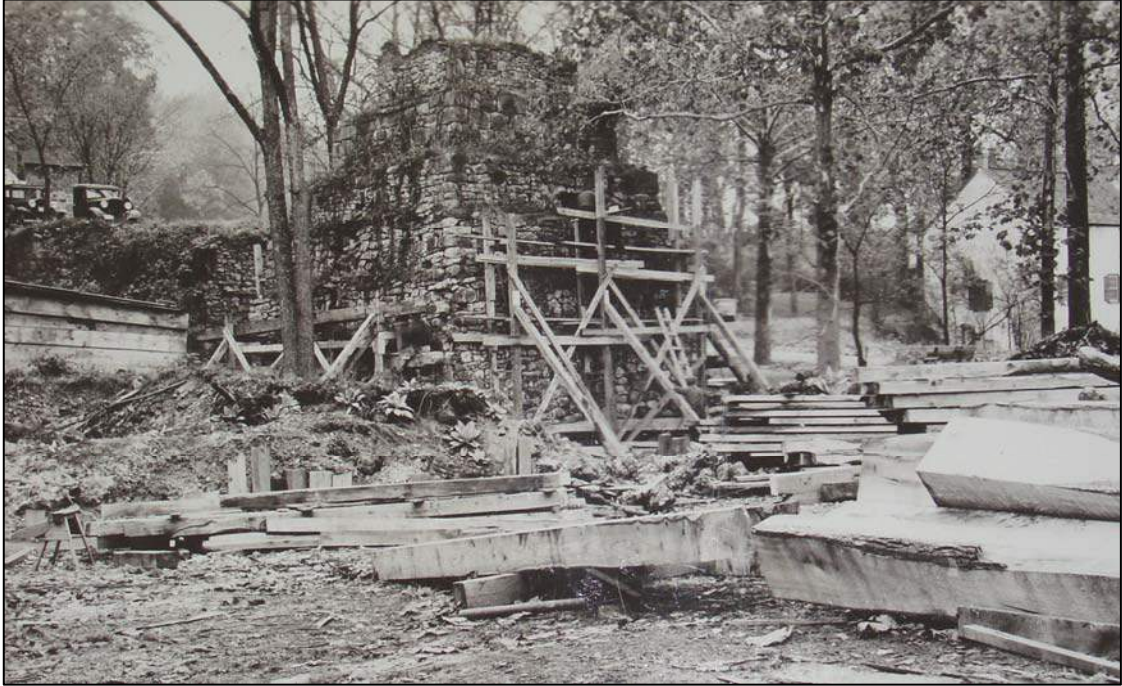
Figure 30. Installation of shoring on the south and west elevations of the furnace stack, October 1936.

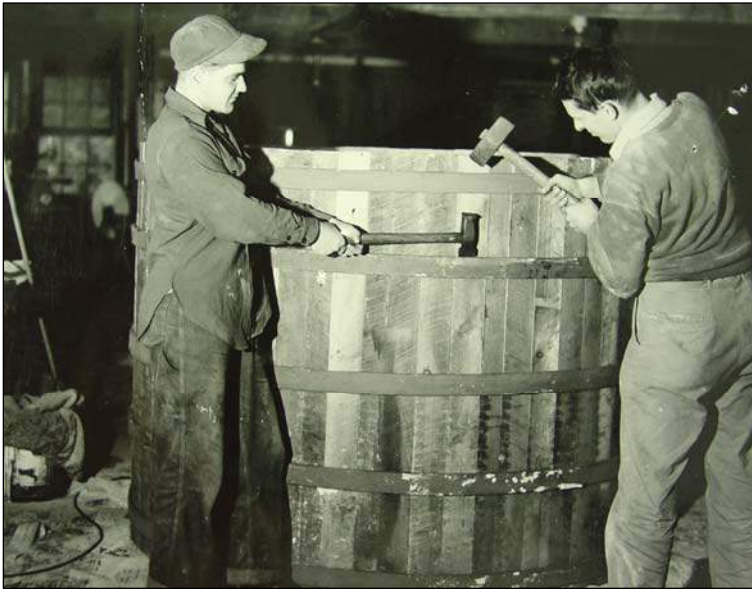
Figure 42. Workers installing iron bands around repaired blast tub, September 22, 1950.

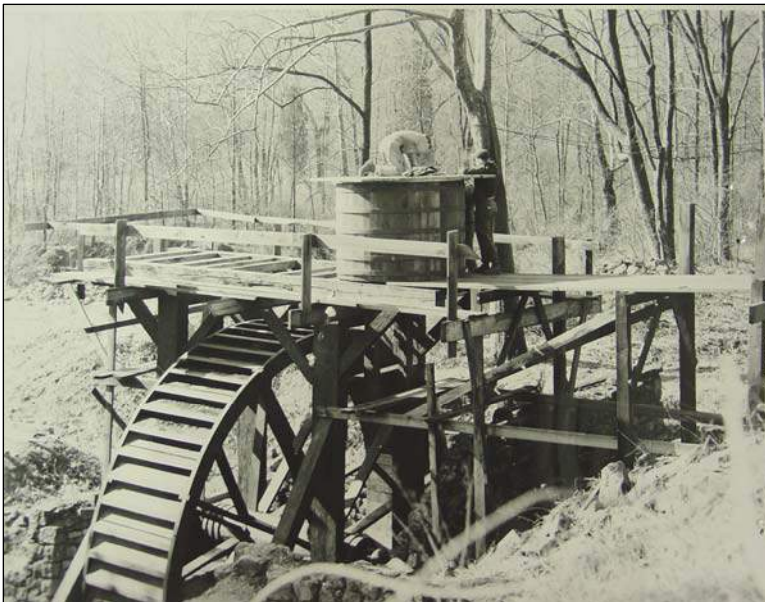
Figure 43. Water wheel and one blast tub installed on new platform, March 5, 1951.

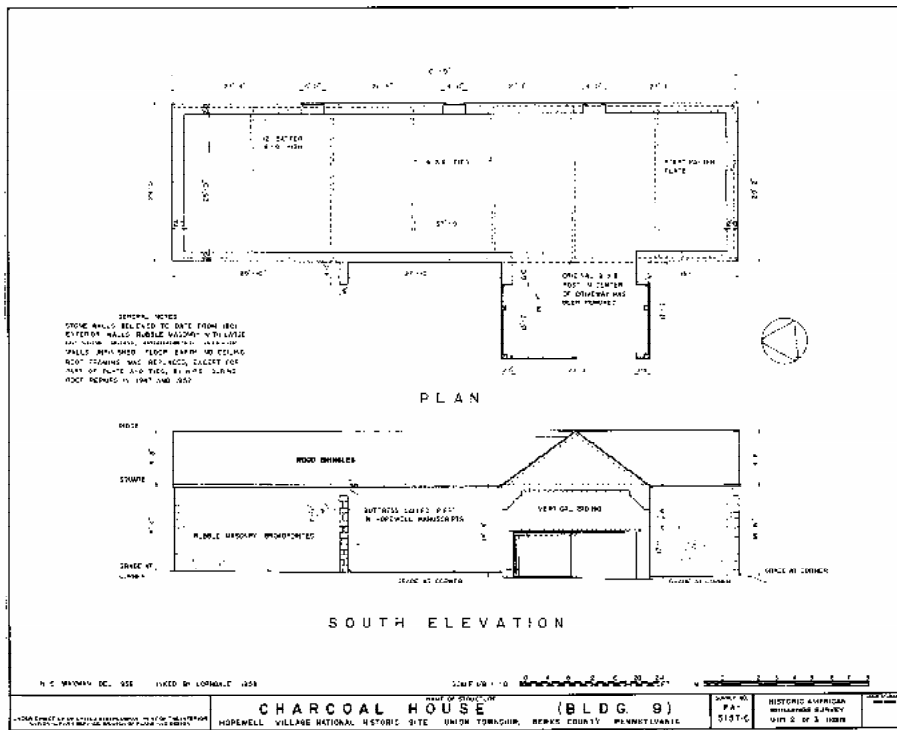
Figure 49a. Existing- conditions drawings: plan and south elevation of the charcoal house, 1956/1958.

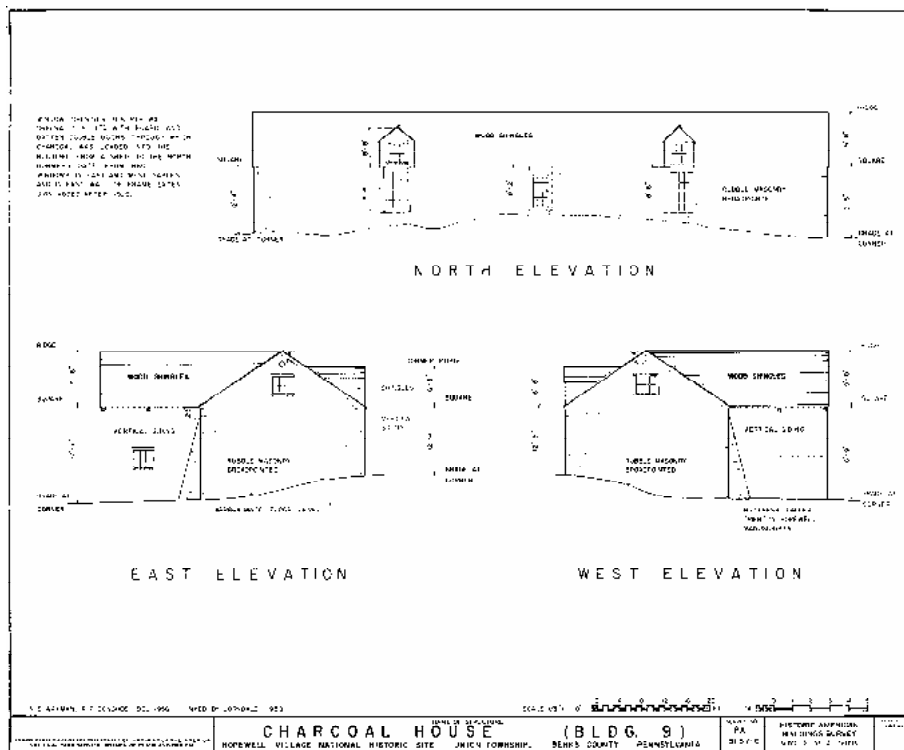
Figure 49b. Existing- conditions drawings: north, east, and west elevations of the charcoal house, 1956/1958.

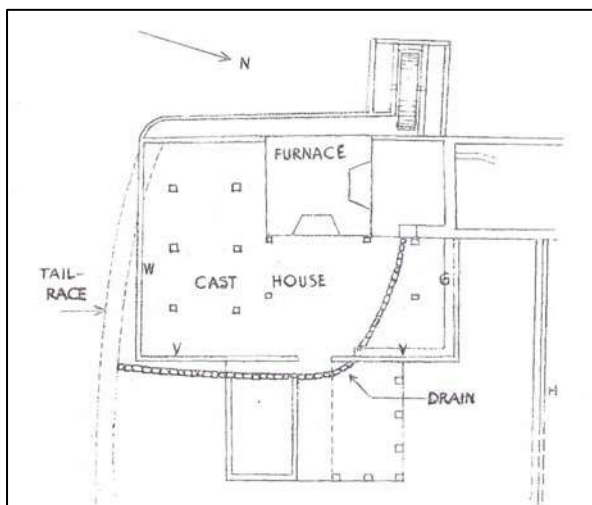
Figure 57. Plan of Hopewell Furnace, showing the 1962- 63 archeological findings of the cast house and east shed after the 1816 enlargement, including stone walls and a stone drain.

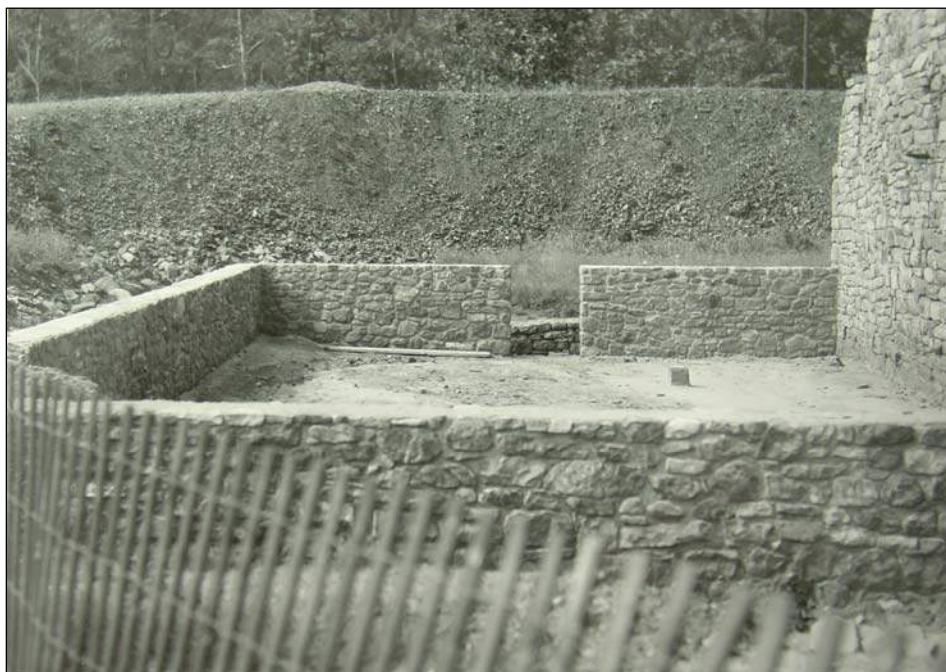
Figure 58. Rebuilt stone foundation walls of the cast house, south of the furnace, October 1962.

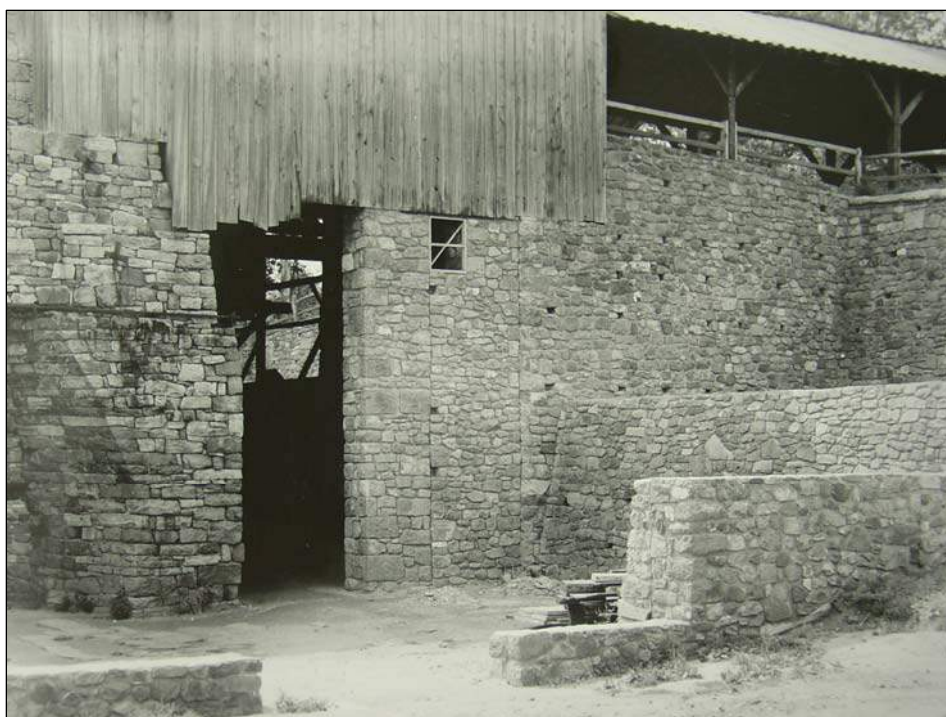
Figure 59. Partially rebuilt west wall of the cast house, north of the furnace, September 1963. The new wall is left of window below the bridge house.

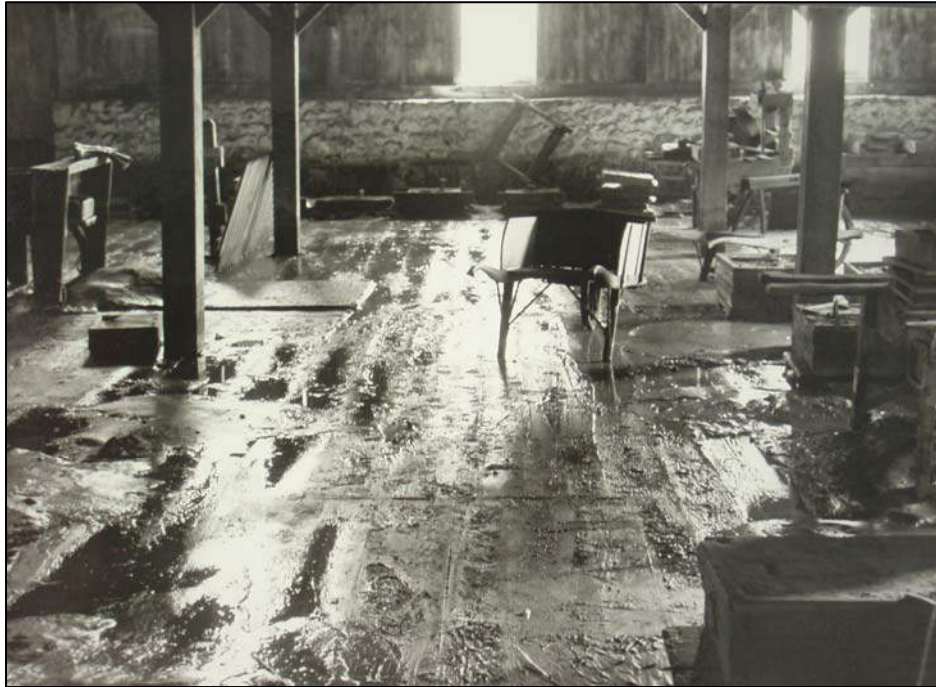
Figure 73. Post- hurricane damage in the cast house, 1987.

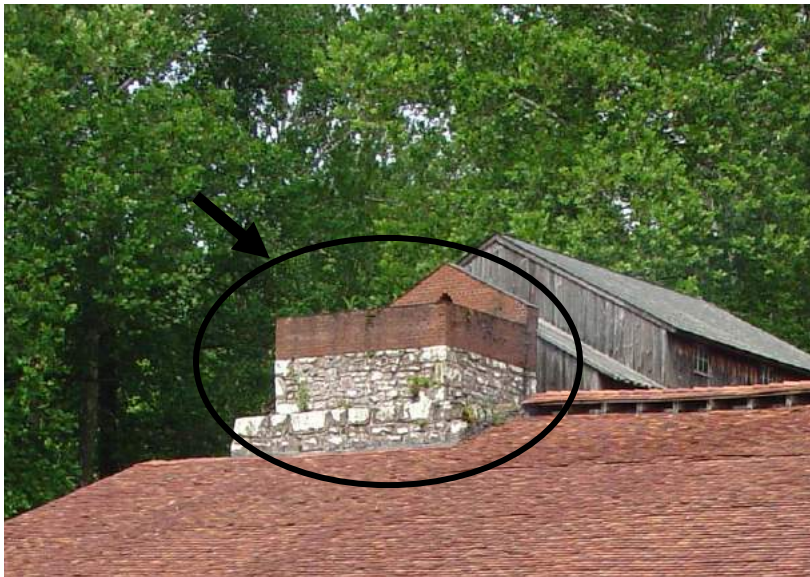
Figure 78. South and east exterior elevations of the upper furnace stack, July 2006.

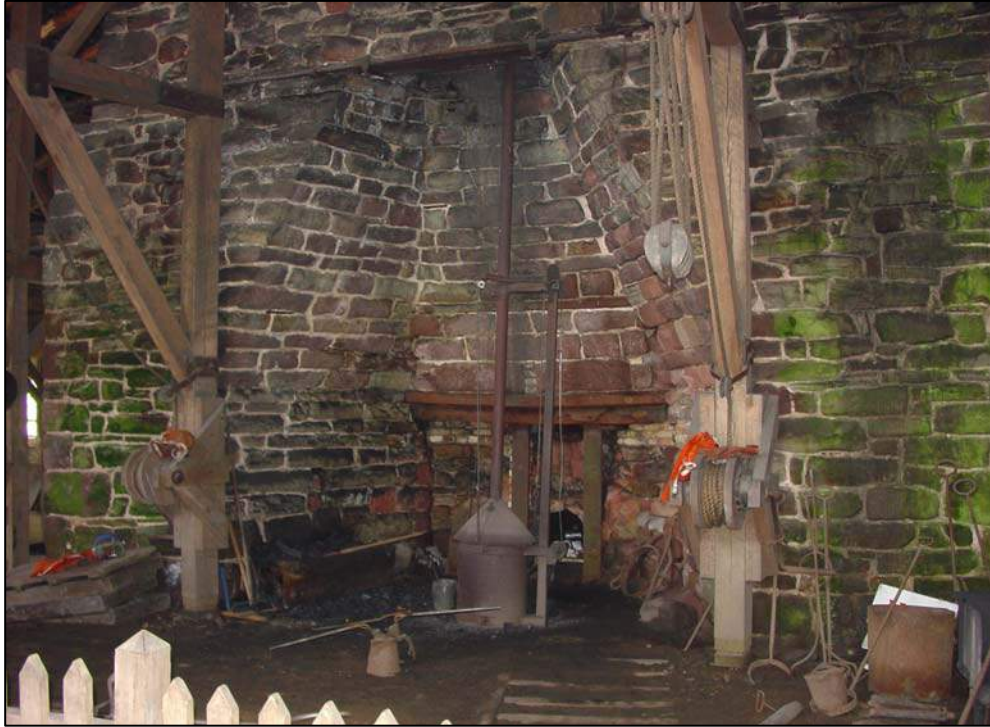
Figure 79. Cast arch on the east side of the furnace, July 2006.

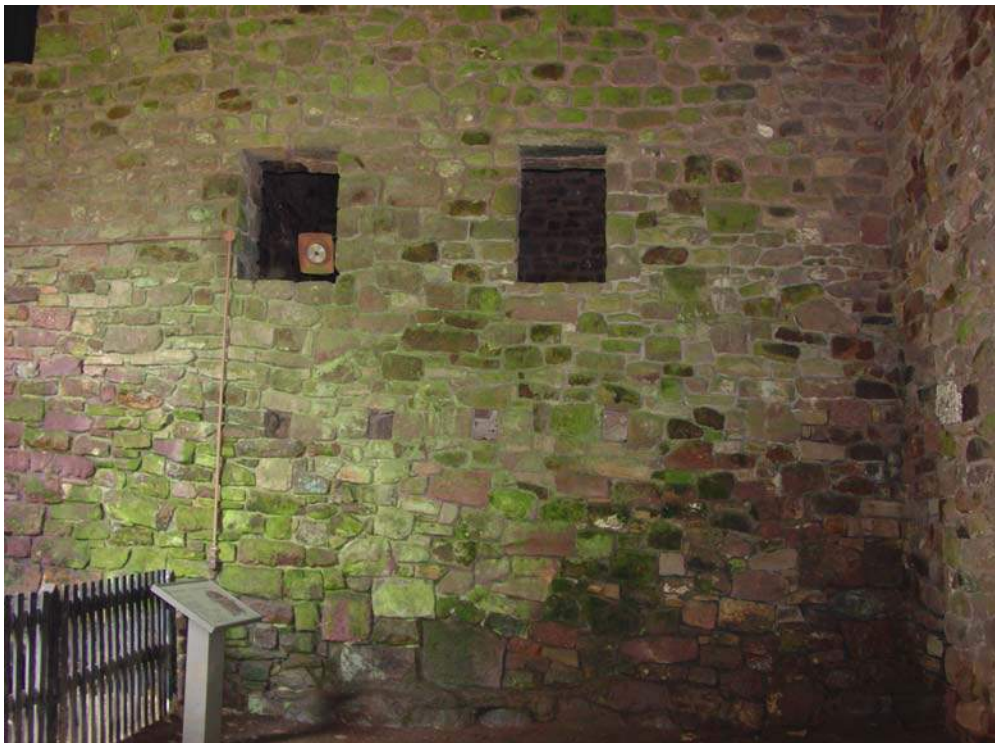
Figure 94. Reconstructed north wall ("Wall A") supporting the north end of the enclosed bridge house, July 2006.

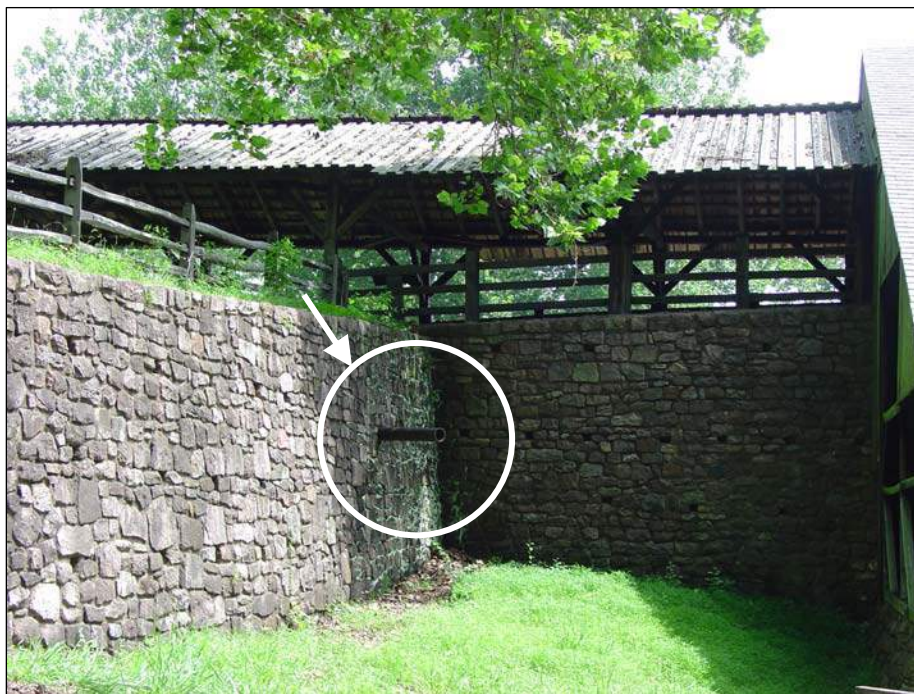
Figure 105. Truncated pipe (at arrow) that conveyed water from the east head race to a wooden flume (now missing) north of the water wheel, July 2006.

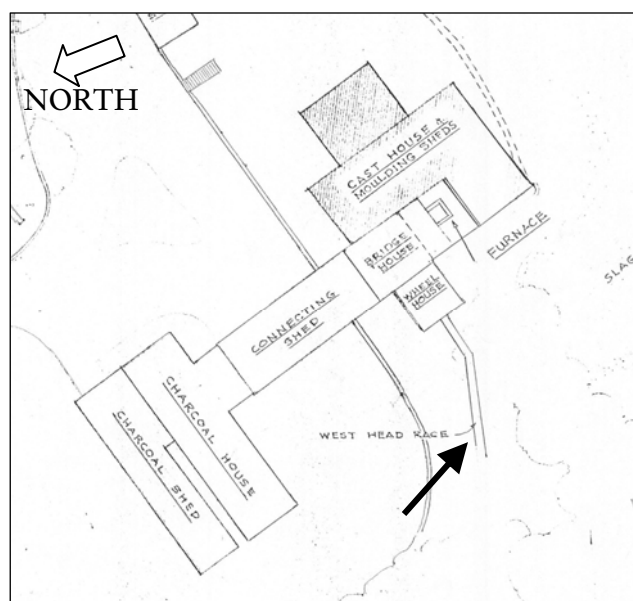
Figure 106. Plan of the reconstructed Furnace Group, showing the eastern terminus of the west head race (at black arrow).

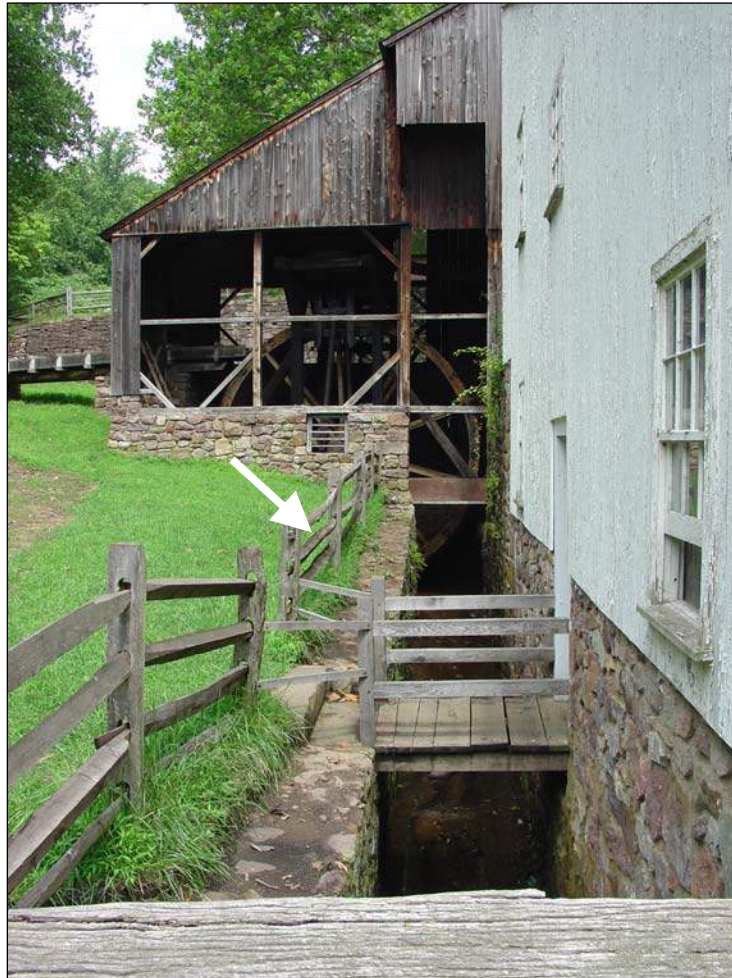
Figure 109. Open portion of the tail race (at arrow), on the west side of the cast house, July 2006.

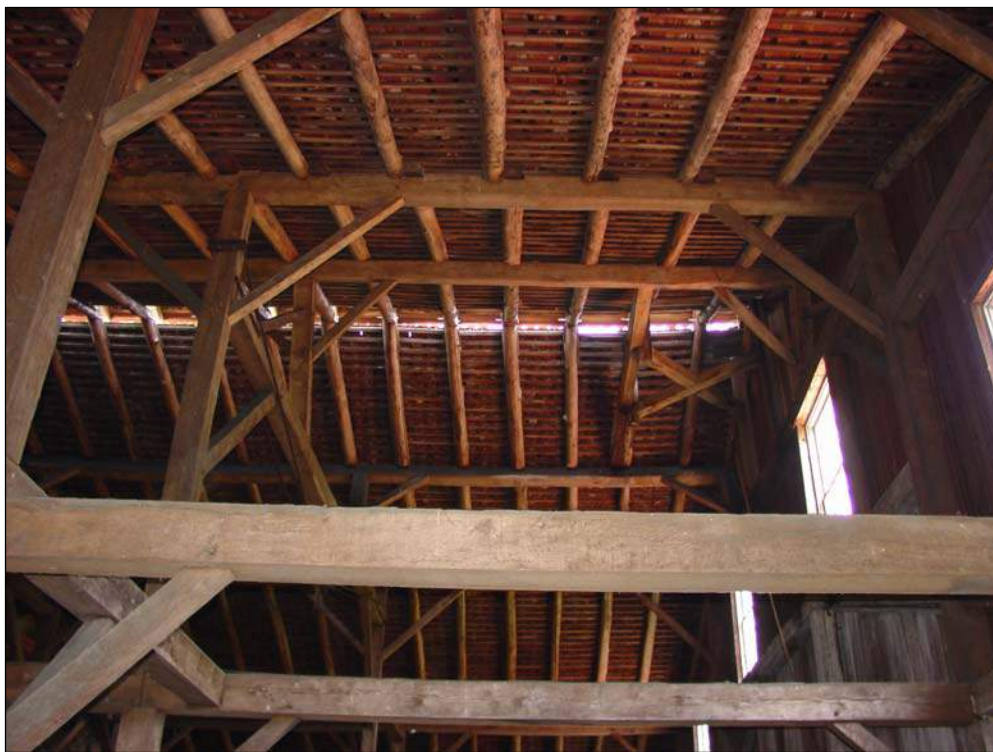
Figure 119. Detail of interior roof framing of the cast house at main ridge, July 2006.
