National Park Service
Cultural Landscapes Inventory
2003

Hopewell Furnace Landscape
Hopewell Furnace National Historic Site

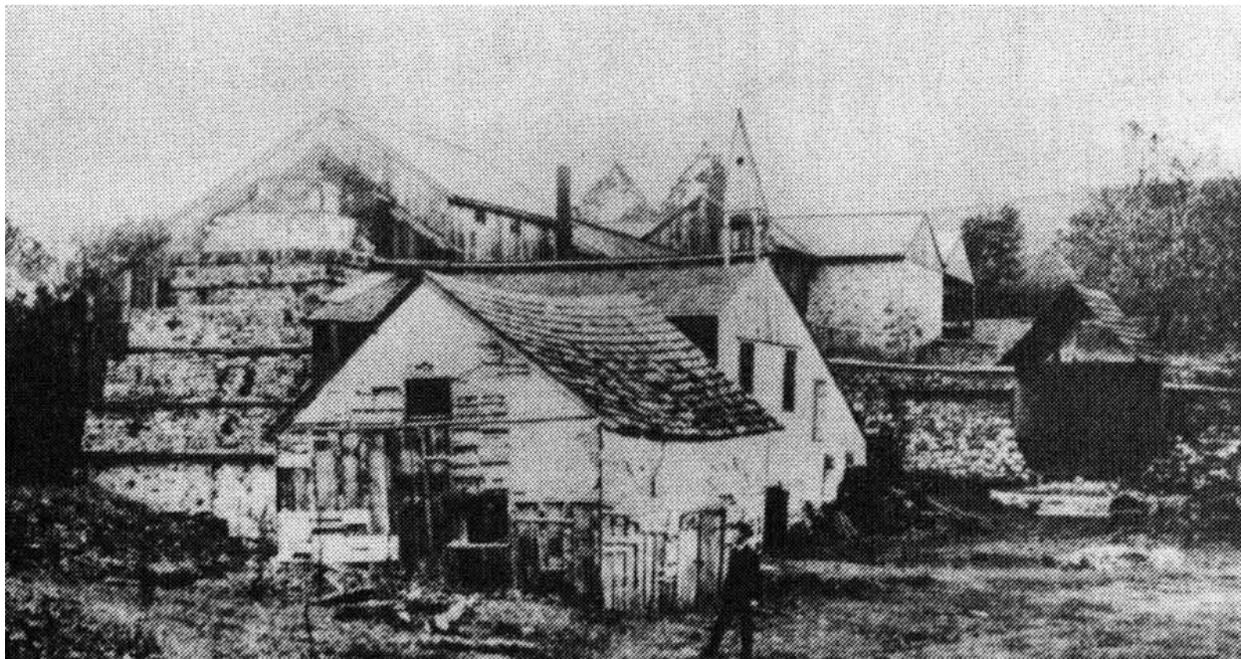
View of furnace grouping including Carpentry/Wheelwright Shop in foreground (Bldg. 35, demolished), Ore Roaster on right (Bldg. 34, stabilized ruin), and Furnace (Bldg. 7) with Cast House (Bldg. 33) and Charcoal House (Bldg. 9) looking north, ca. 1887.

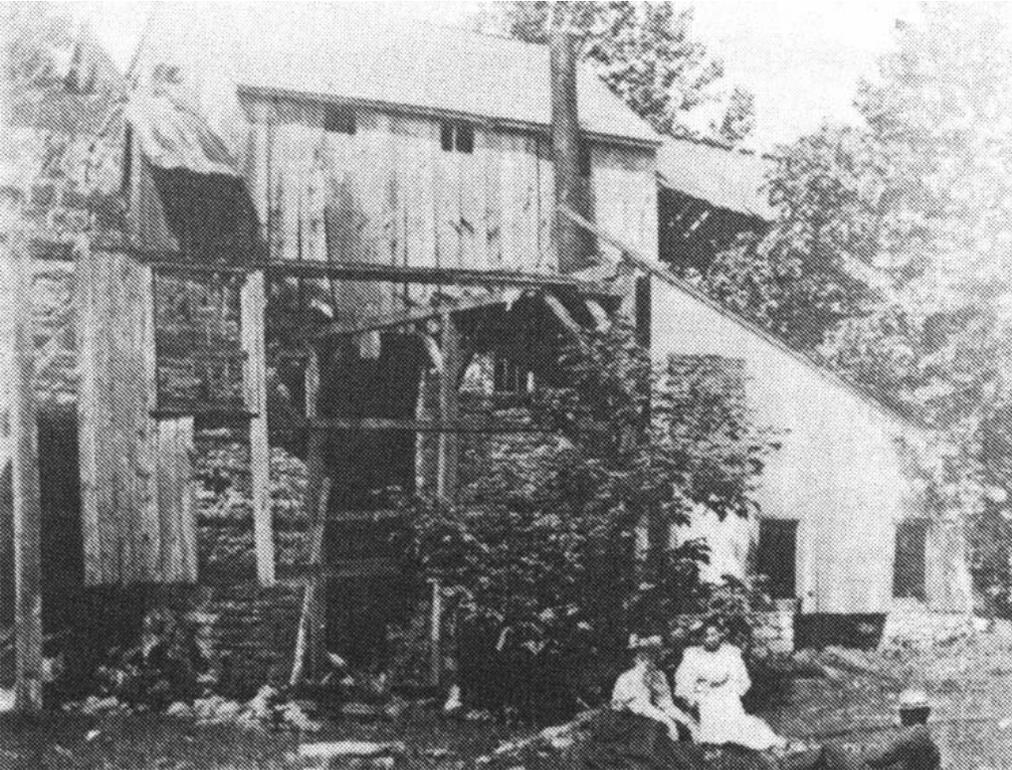
View of Furnace (Bldg. 7), Bridge House (Bldg. 10), and remains of Cast House (Bldg. 33) looking west, ca. 1896. HOFU archive photo.

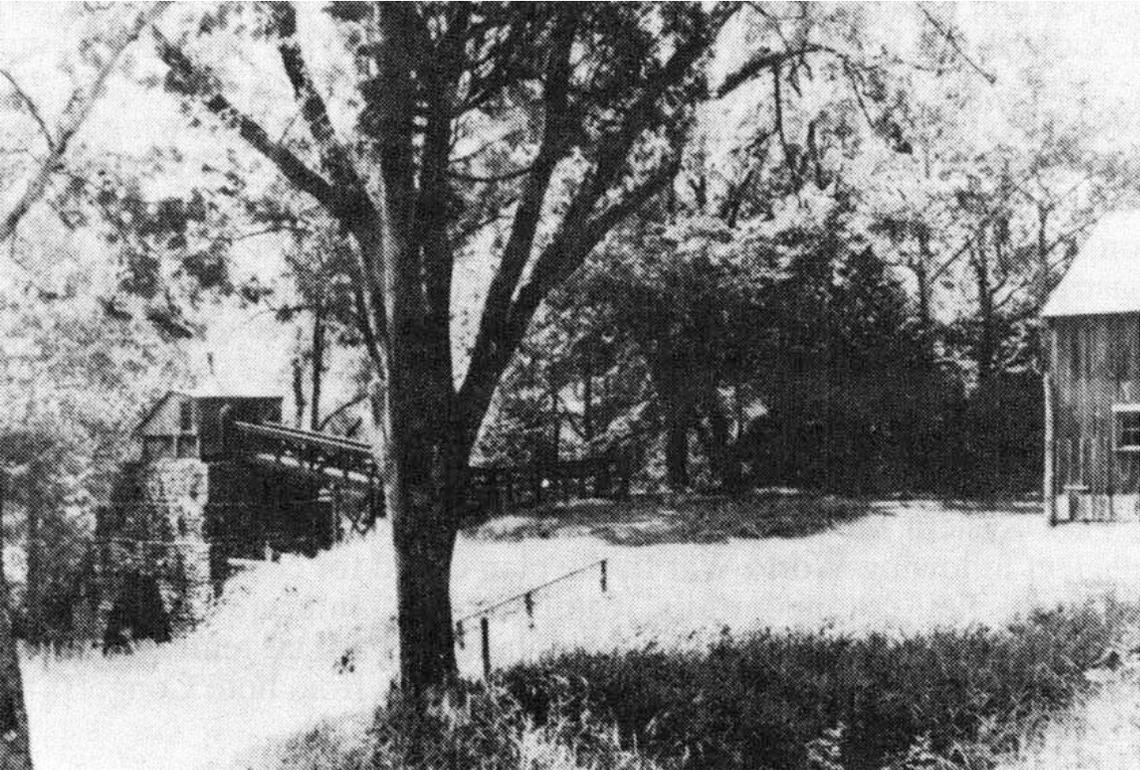
View of Furnace remains (Bldg. 7) and Bridge House prior to reconstruction, ca. 1949. HOFU archive photo.

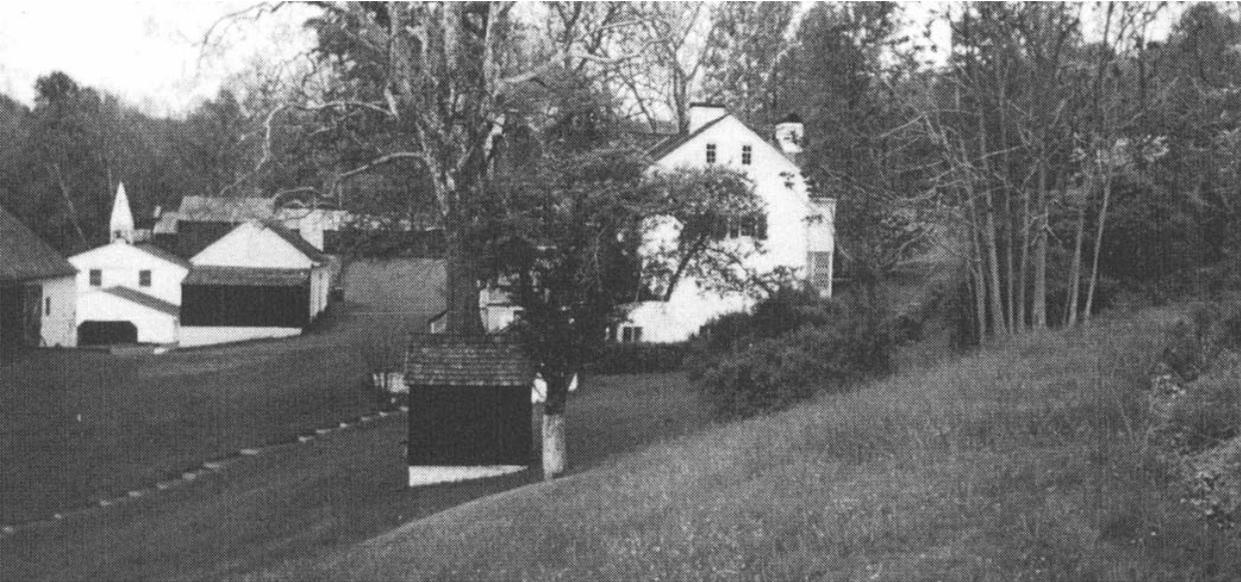
The topography made it simpler to load raw materials into the furnace from above. The Ironmaster's House occupies a commanding position above the furnace complex. The East Head Race (right) carries water to the furnace. Menke & Menke photo 1995.

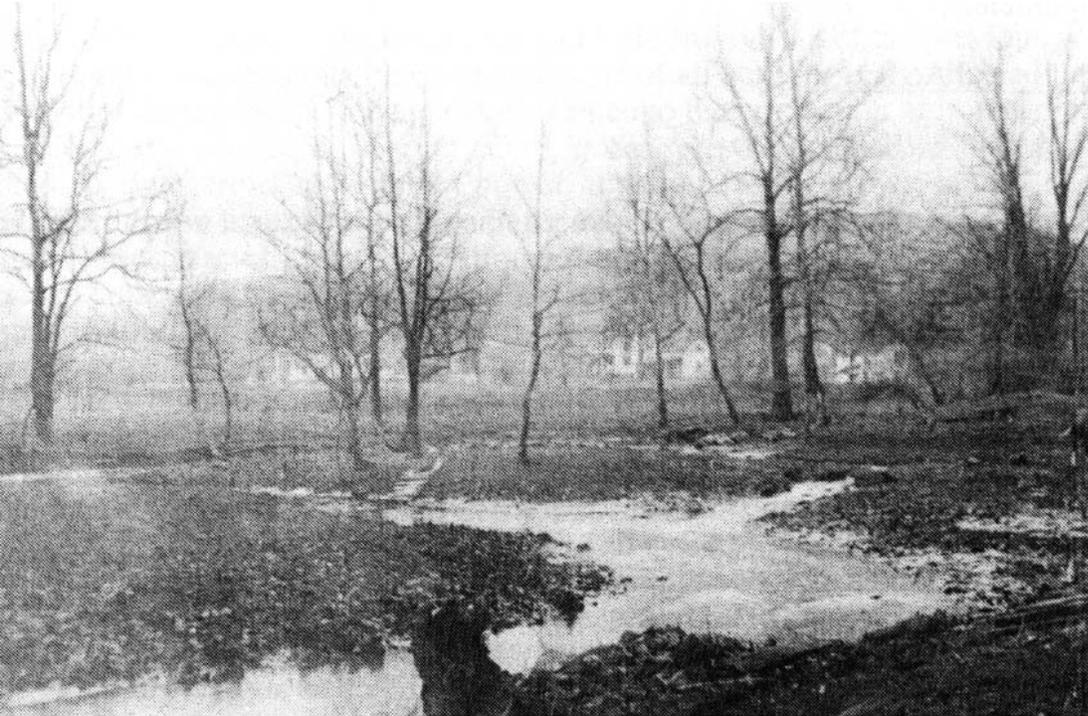
French Creek in Hopewell Village in 1936. View to southwest toward Boarding House and Tenant Houses. HOFU archive photo.

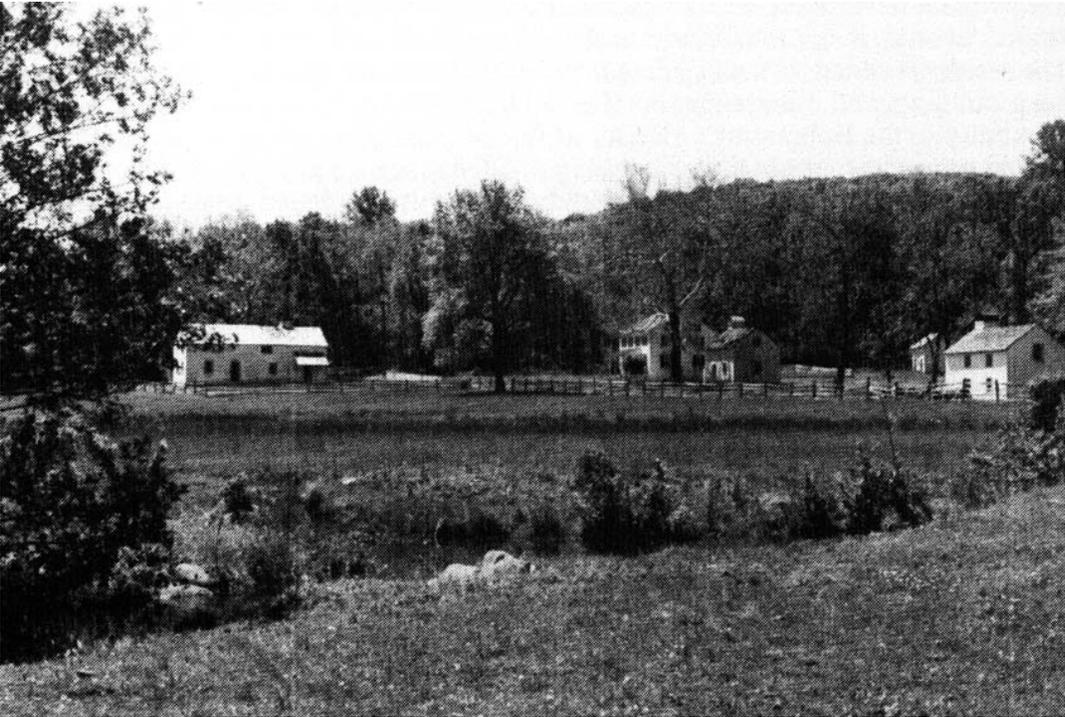
French Creek in Hopewell Village in 1995. Though presently viewed as an aesthetic amenity, the Creek played a vital role in the economy of the Village and Furnace. Menke & Menke photo.

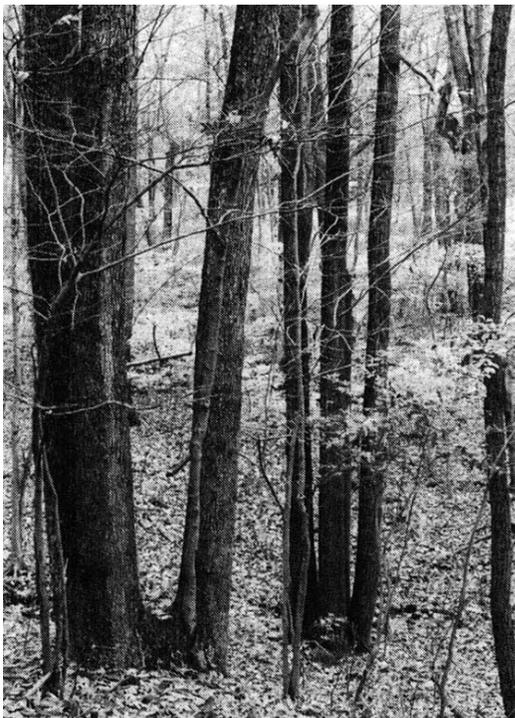
An example of tree stumps sprouting new timber near the Nathan Care House, 1995. Menke & Menke photo.

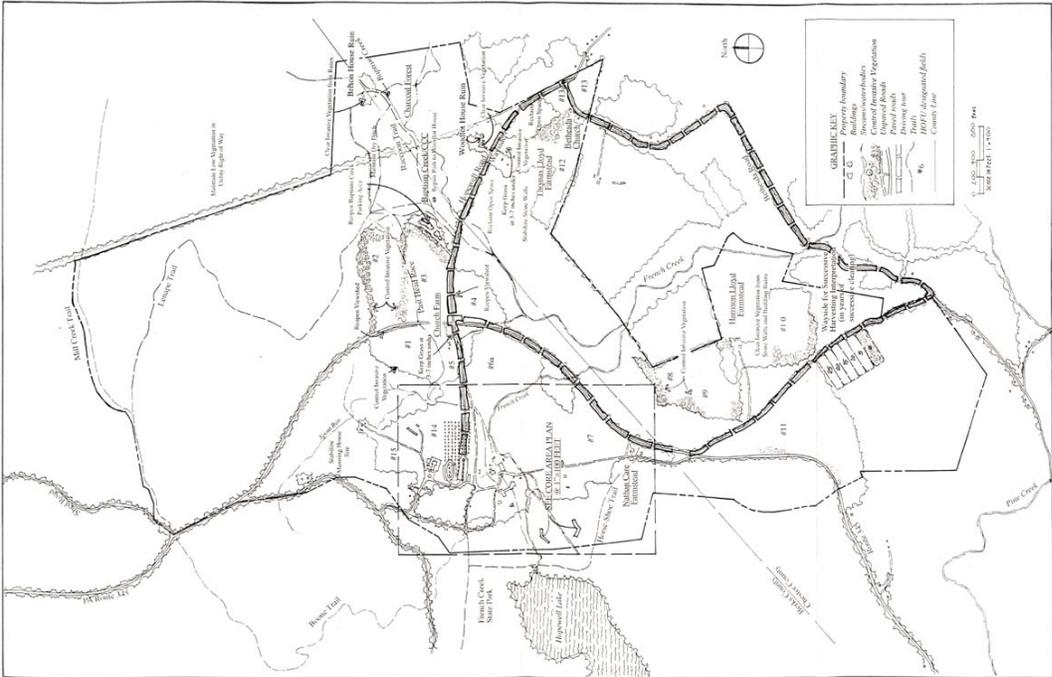
Figure 6.3. Hopewell Furnace Treatment Recommendations.

Hopewell Furnace Field Map (See addendum for enlargement).

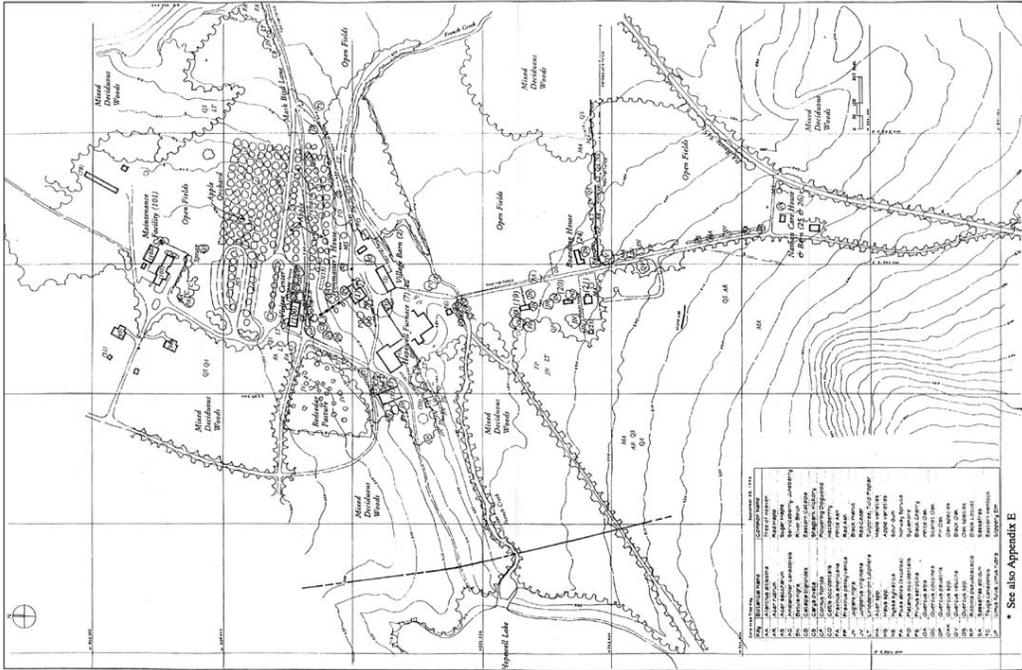
Figure 4.21. Hopewell Furnace Core Area Vegetation, 1995.

Hopewell Furnace 1995 Core Area Vegetation (See CLR for enlargement).

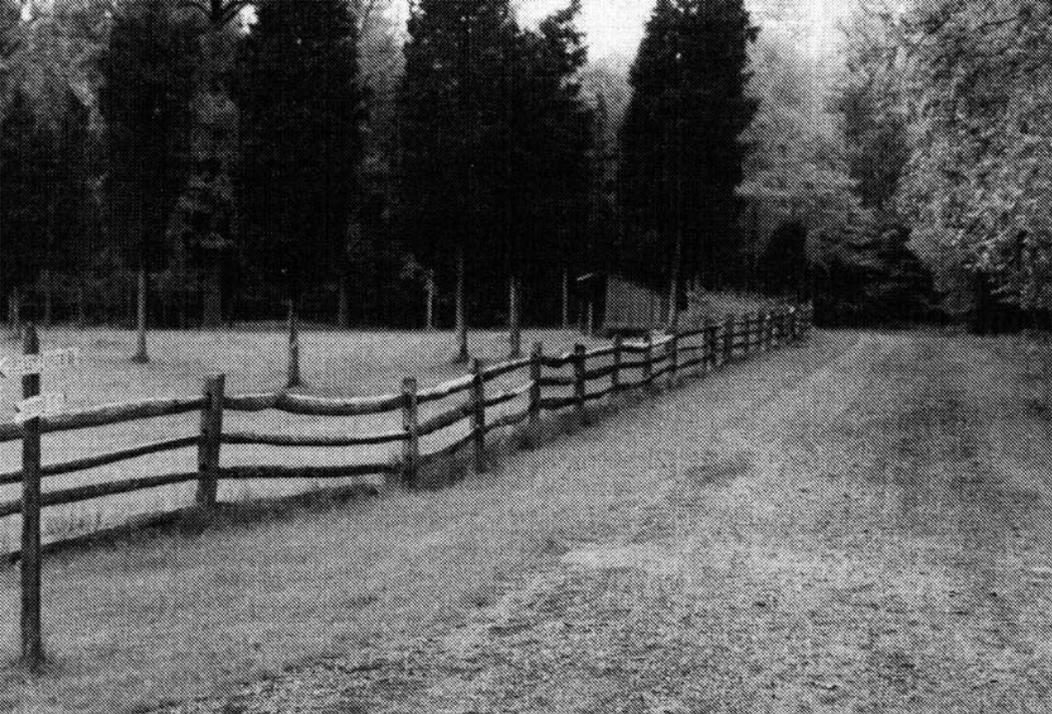
The Cedar Pasture looking west, 1990. All other vegetation has been removed either by deer or by the National Park Service. The pasture is fenced and contains a small outbuilding. Menke & Menke photo.

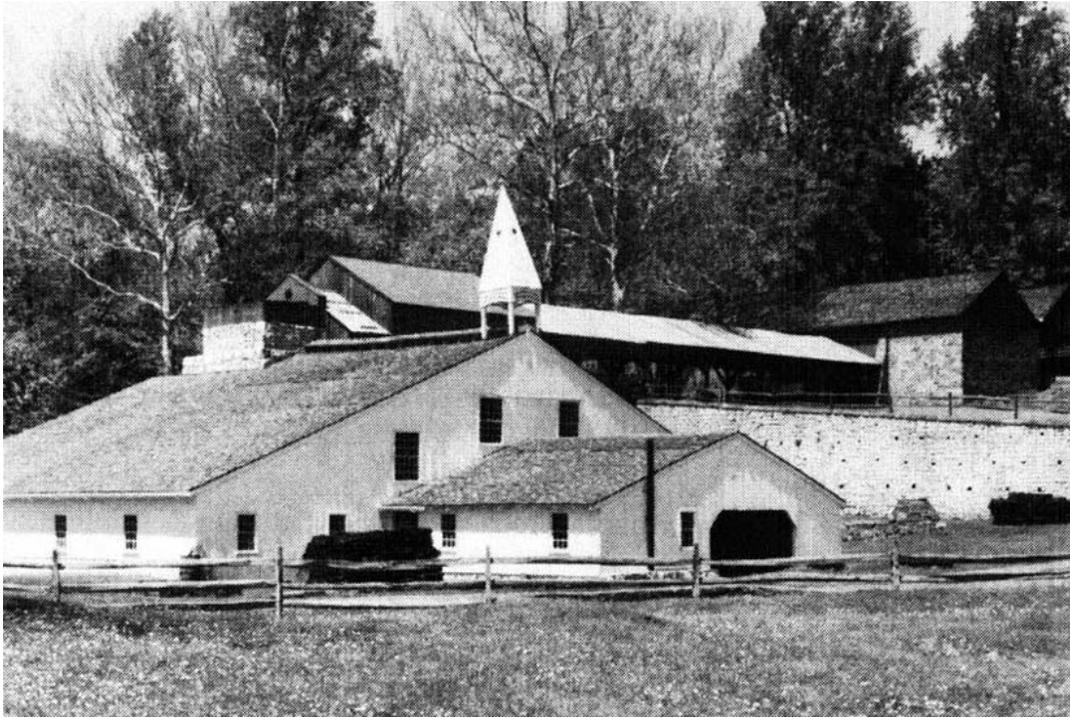
1995 view of reconstructed furnace complex. Menke & Menke photo.

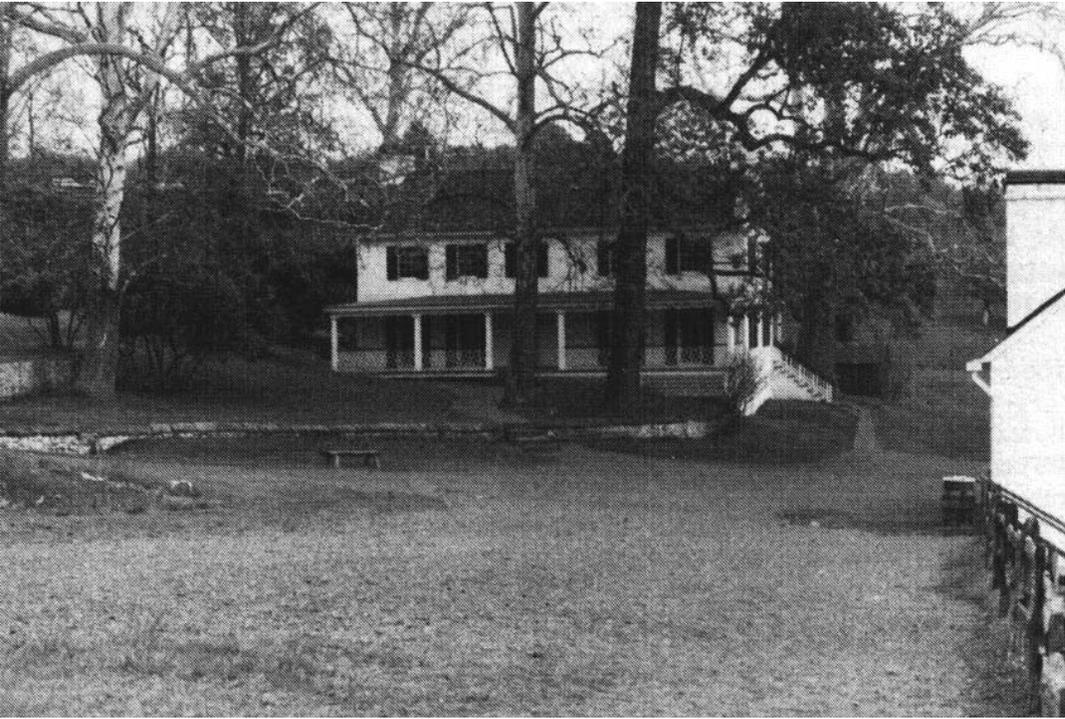
Ironmaster's House in 1995, with manicured landscape and small-scale elements (fence, bench, and barrel). Menke & Menke photo.

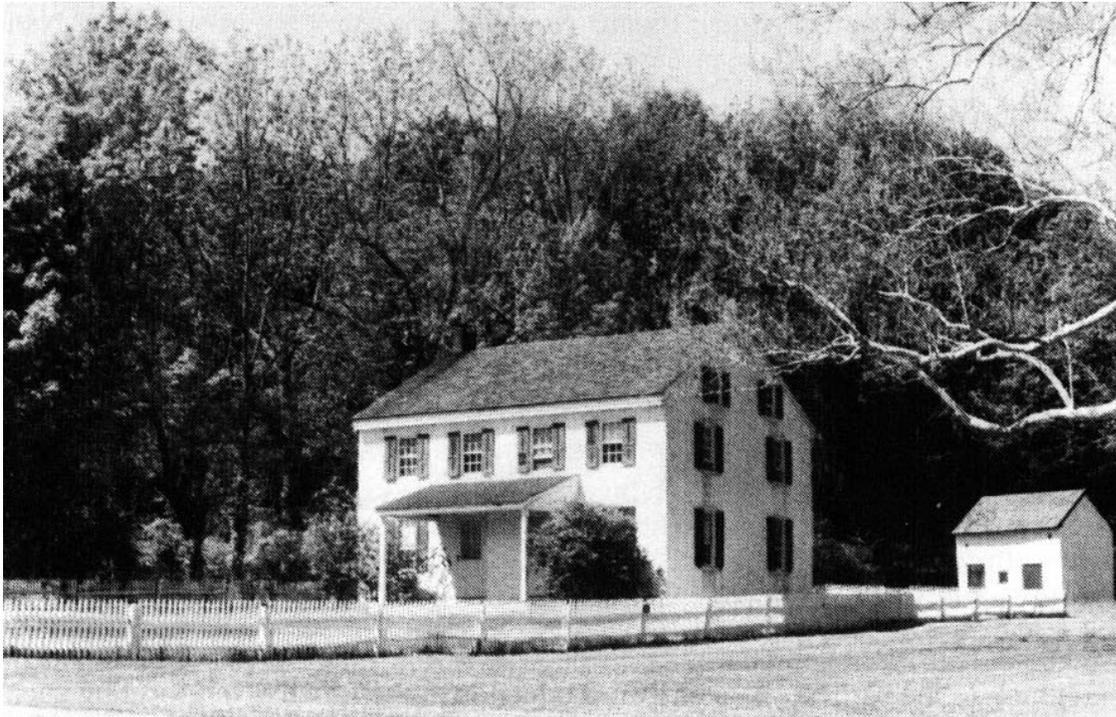
View of Tenant House No. 3 in 1995. A small grain silo, privy and a shed addition to the outbuildings are no longer extant. Menke & Menke photo.

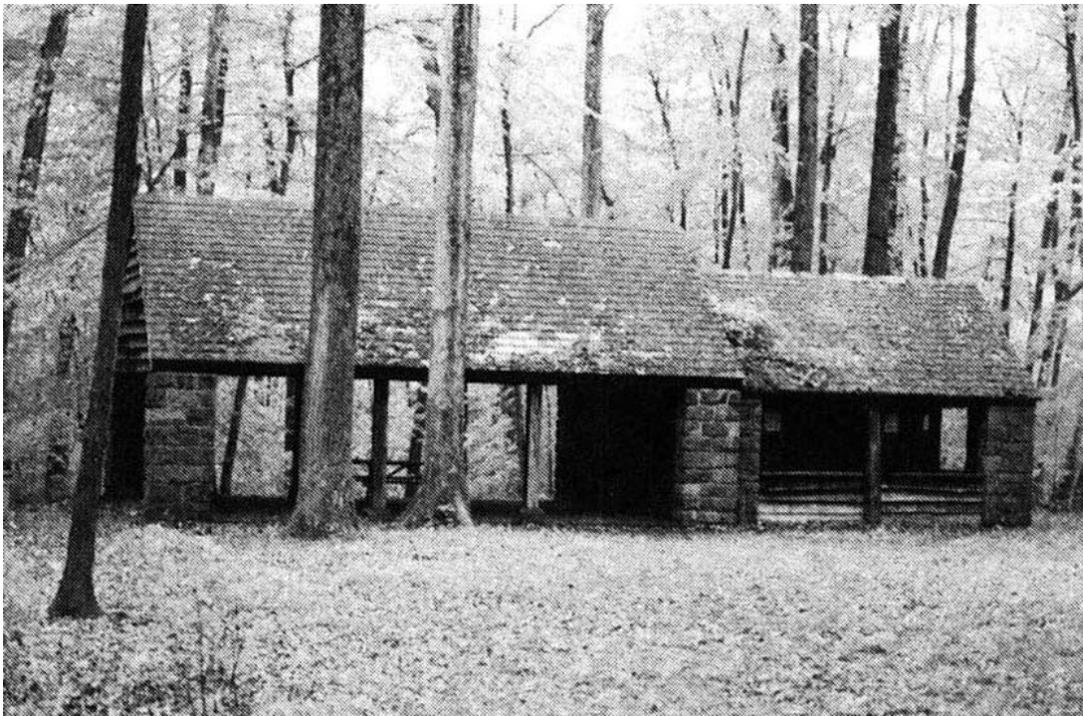
CCC Picnic Shelter in the Environmental Study Area near Baptism Creek, 1994. Menke & Menke photo.

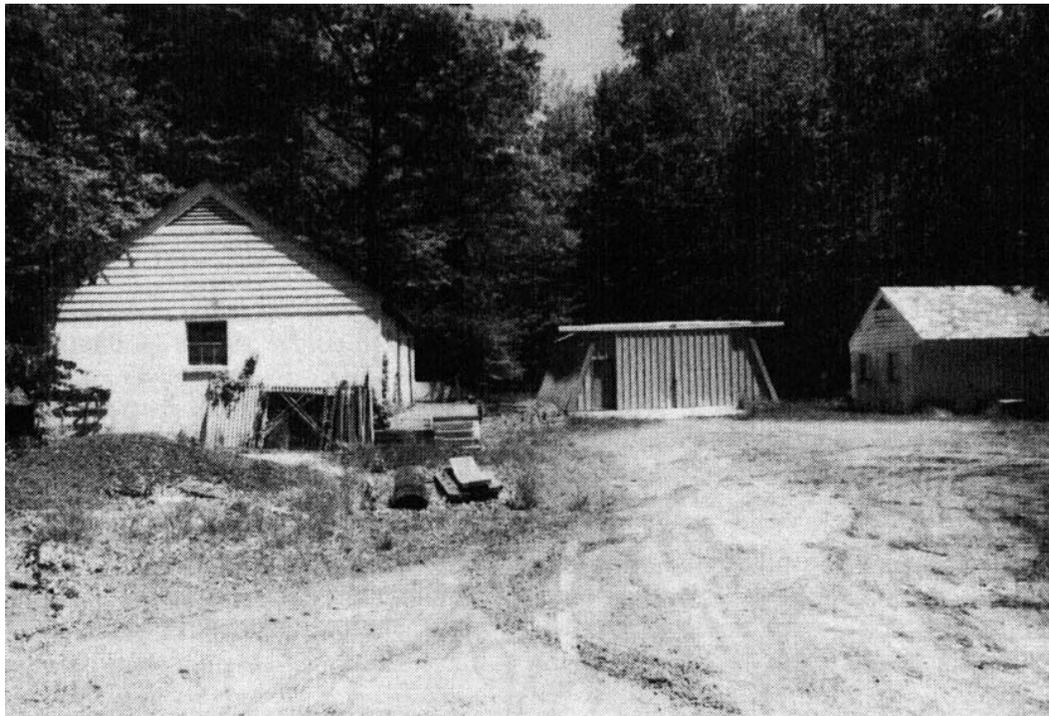
Two of three buildings from the vicinity of CCC SP-17 Camp (on the left and right), 1995. Menke & Menke photo.

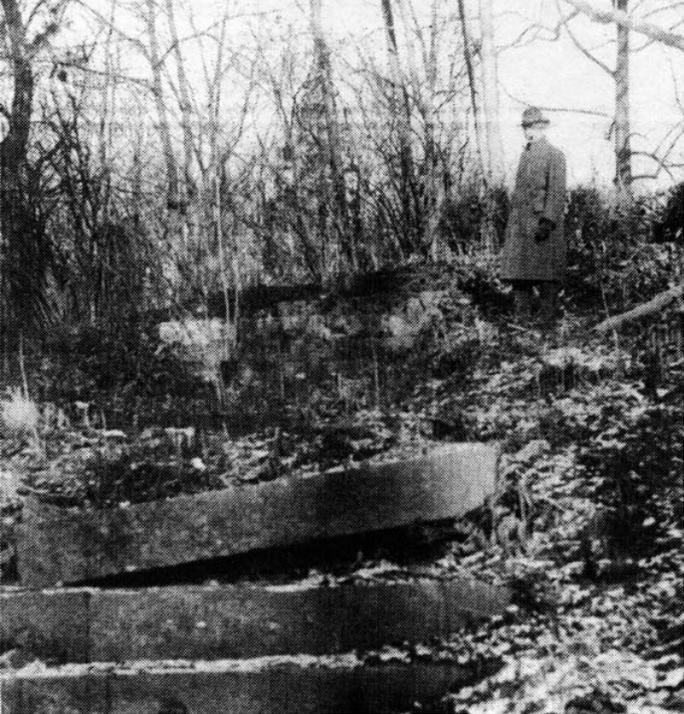
Ironmaster's terrace garden steps in ruins, 1936. HOFU archive photo.

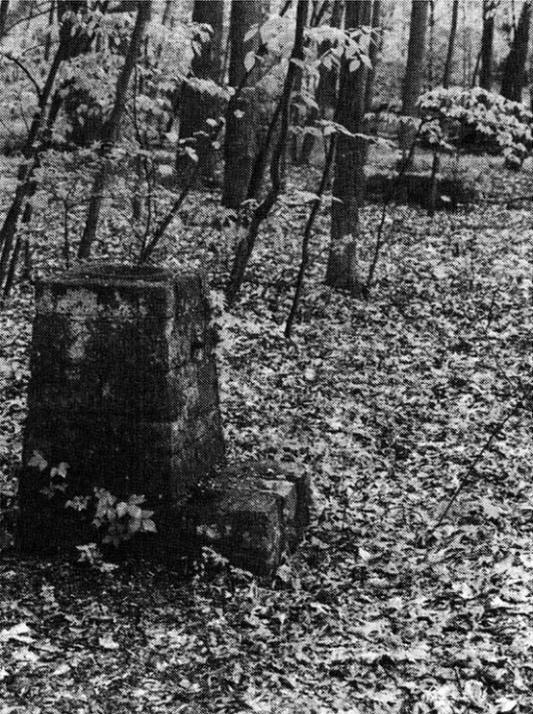
Drinking fountain and fireplace site elements dating from ca. 1940 at the Baptism Creek Picnic Area north of Hopewell Road. Menke & Menke photo, 1995.

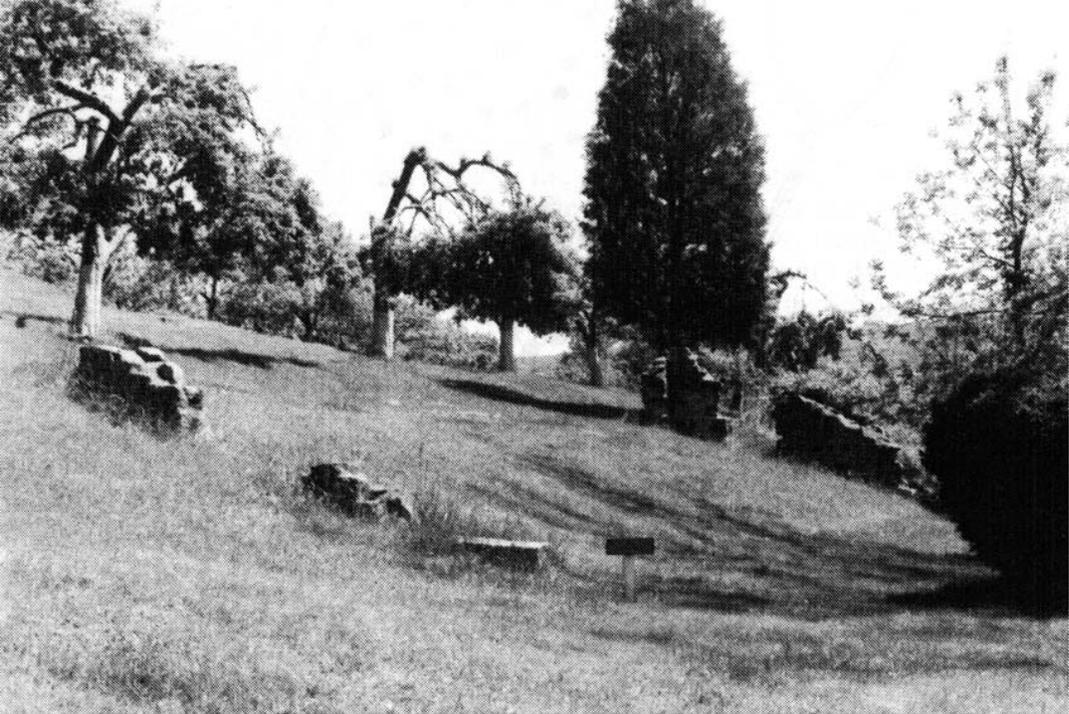
Greenhouse Ruins, 1995. Menke & Menke photo.

The remains of a Greenhouse, portions of the north, east, and west walls of the building, are located in the garden area, adjacent to the 1757 road (Reading-Valley Forge Road). In the 1950s Park Historian Russell A. Apple reviewed the extant furnace records and concluded that large purchases of glass in March 1829 related to the construction of the greenhouse. The appearance of this building remains unknown. Oral tradition holds that part of the Greenhouse was used as a vineyard. If this tradition is accurate the payments noted in furnace records to a "vine dresser" in 1832 tend to confirm the ca. 1829 construction date for this building.(25)

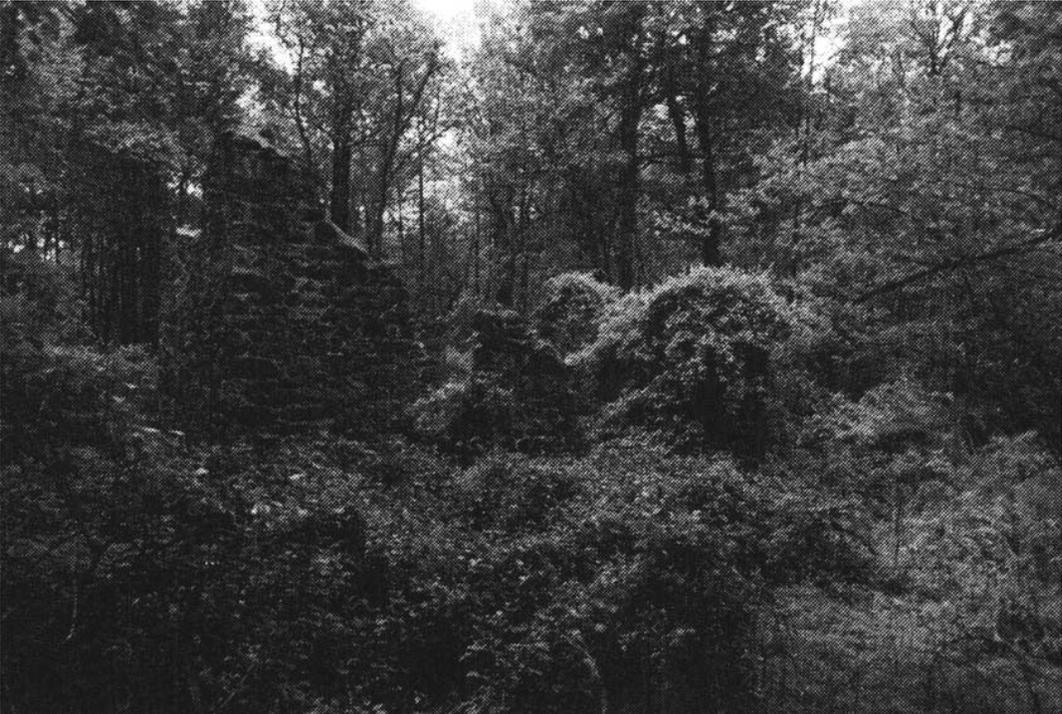
Woodlot House ruins in enveloping vegetation, 1995. Menke & Menke photo.

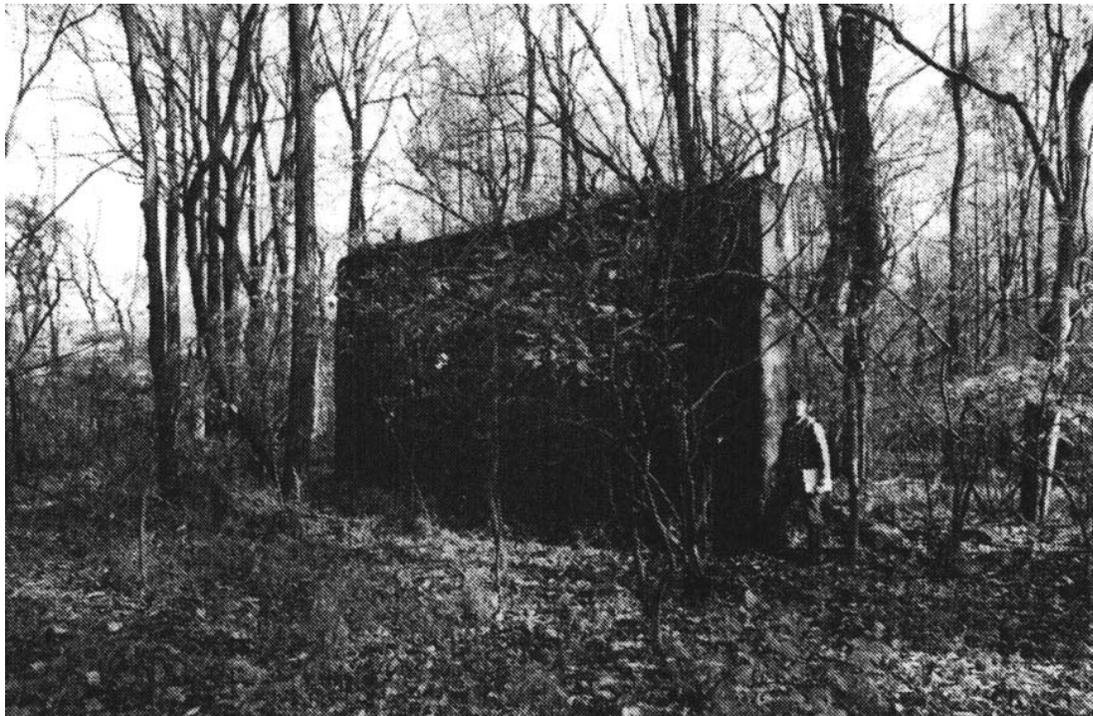
Harrison Lloyd Farm; ruins of former barn, 1995. Menke & Menke photo.
