1 **Chapter III: Existing Conditions / Affected Environment**

2
3 This chapter describes existing conditions within the Quincy Unit at two levels of detail.
4 Unit-wide existing conditions are those that relate to the overall Quincy Unit (Figure 3-1
5 illustrates the boundaries and existing conditions of the Quincy Unit). Unit-wide conditions
6 addressed include land use, vegetation, circulation, archaeological resources, wetlands, special
7 status species, socioeconomics, visitor experience, and park operations at a broad scale,
8 providing a context for understanding the overall unit. The remainder of the chapter provides
9 descriptions of existing conditions in each of the landscape character areas within the Quincy
10 Unit.

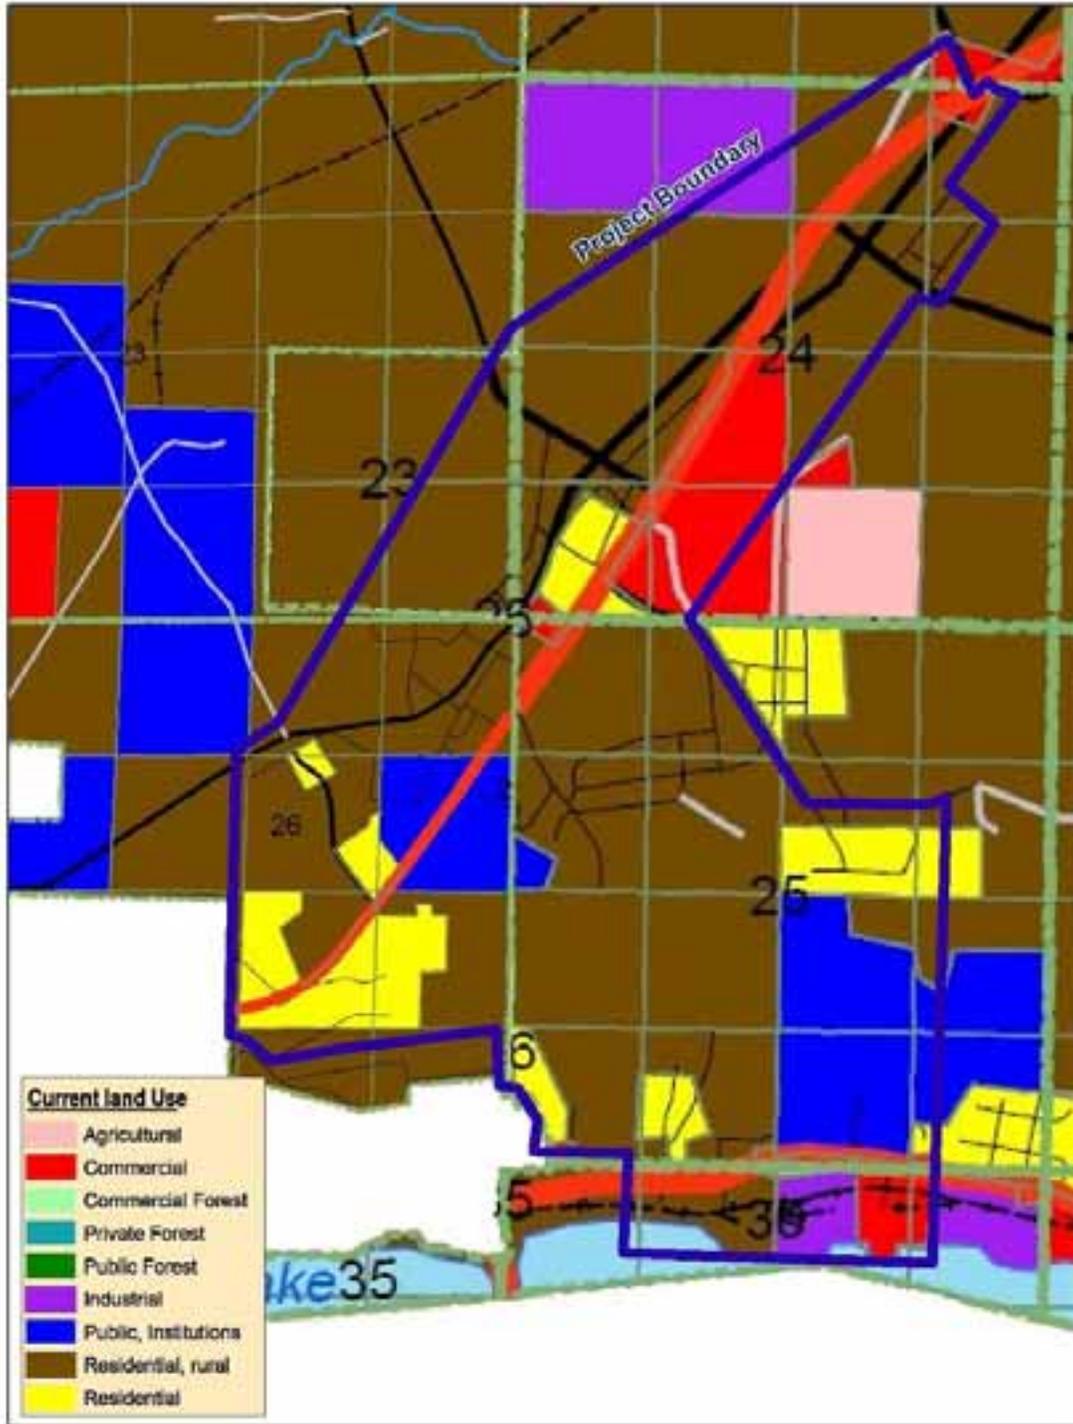
1
2 **Figure 3-2: Houghton County Land Use Plan, Current Land Use, 2006** (source: Houghton County,
3 Michigan Land Use Plan)
4
5
6
7

7 The current land use designation in the Quincy Unit is mainly rural residential with
8 scattered residential (see Figure 3-2). Public uses are identified at US 41 and Pewabic Location
9 Road and the Mt. Ripley Ski Area. Commercial is identified at US 41 and Lake Annie Road.
10 Commercial and Industrial activities are identified south of State Hwy 26 adjacent to Portage
11 Lake. Site specific land use descriptions are in the Land Use portion of the Cultural Resources /
12 Cultural landscape section.

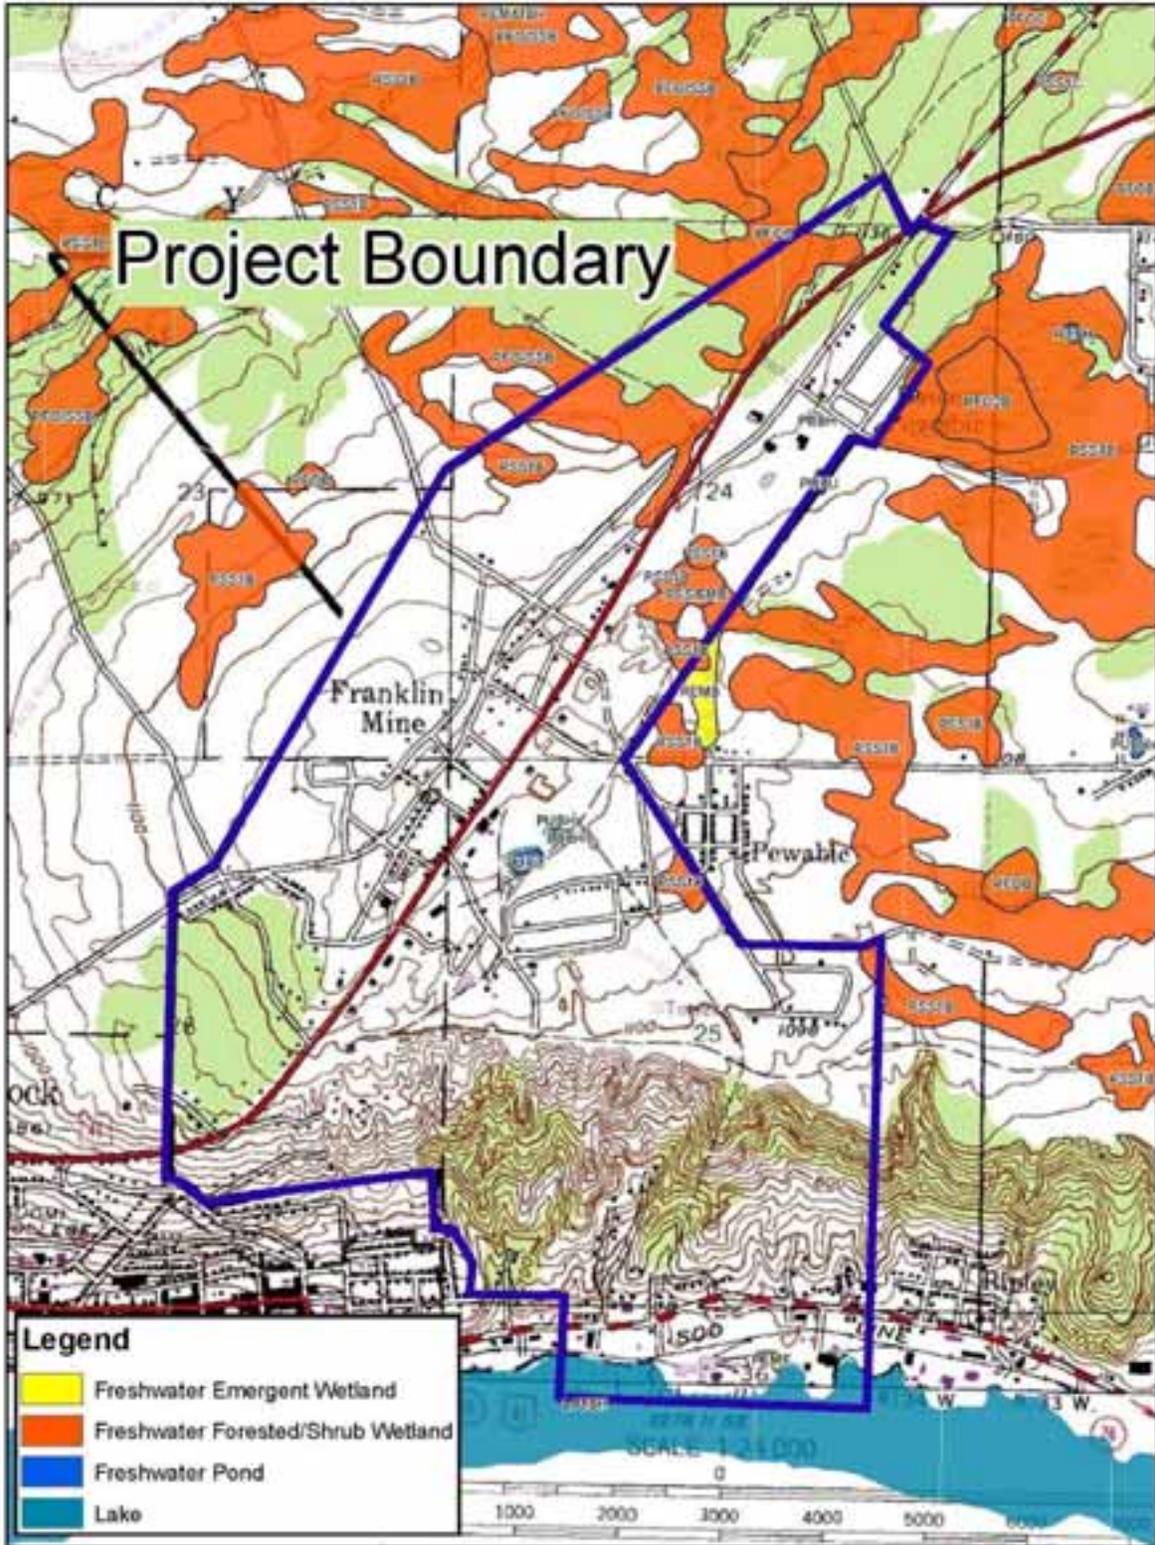
1
2 Figure 3-7: Extent of Potential Wetlands within the Quincy Unit (source: Woolpert, Inc., 2007)
3

3 Large areas of palustrine forested and scrub-shrub wetlands are mapped west of US 41
4 at the north end of the Quincy Unit while a large area of palustrine scrub-shrub and emergent
5 marsh wetlands is mapped between US 41 and Glass Road, north of Sunshine Road. A
6 moderate size palustrine scrub-shrub wetland is mapped west of the intersection of Franklin
7 Tram Road and Glass Road, while a small palustrine emergent marsh is mapped along the
8 north edge of Portage Lake within an inlet east of the former salt storage site. Figure 3-7
9 illustrates the extent of potential wetlands within the Quincy Unit.

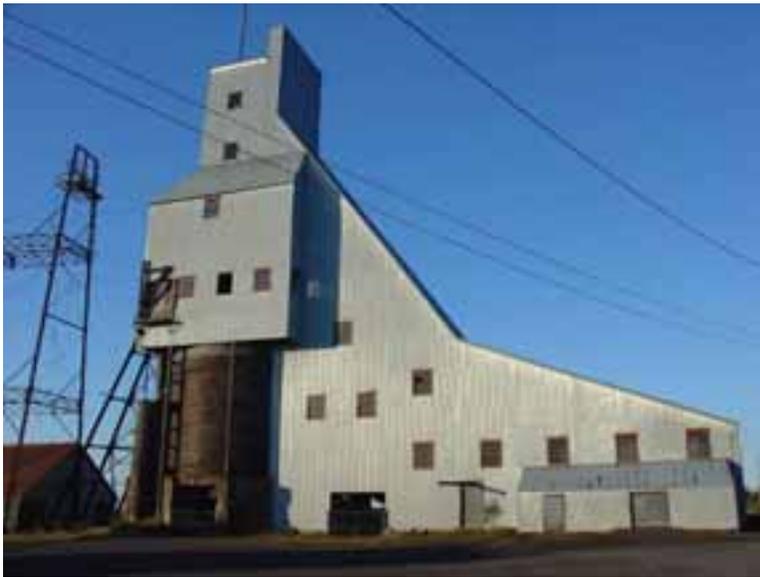
14
15 Figure 3- 11: North elevation of the No. 2 shaft-rockhouse at Quincy Mine, 2006 (source: QEA)
16

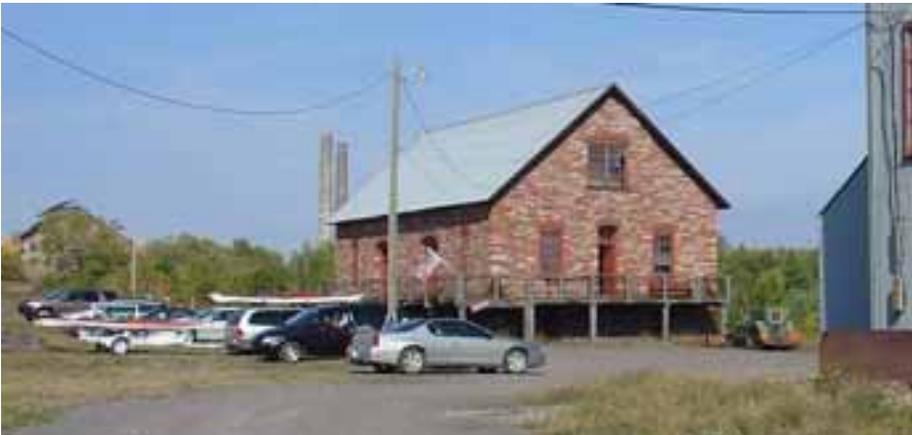
Figure 3-14: South elevation of gift shop and parking area, 2006 (source: QEA)

- 14 • **The Gift Shop:** Once a supply office, the building now functions as the Quincy Mine
15 Hoist Association gift shop and houses a seasonal visitor information desk staffed by
16 the National Park Service (see Figures 3-13 and 3-14).
17

- 36 • **The Parking Lot:** This area between the supply house and the No. 2 shaft-rockhouse is
37 utilized for undefined gravel parking (see Figures 3-13 and 3-14).
38

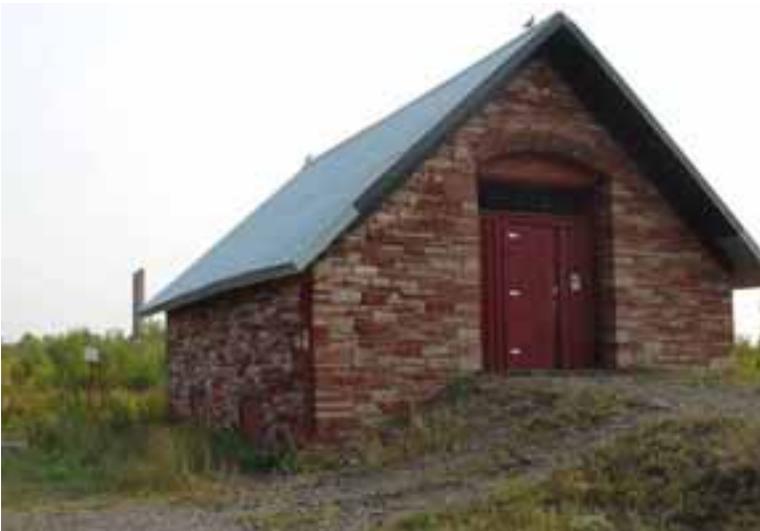
Figure 3-15: South elevation of the restroom and seasonal blacksmith demonstration area, 2006 (source: QEA)

- 18 • **Public Restrooms:** Once an oil house, the building now houses public restrooms on the
19 upper level and a seasonal blacksmith demonstration below (see Figure 3-15).
20

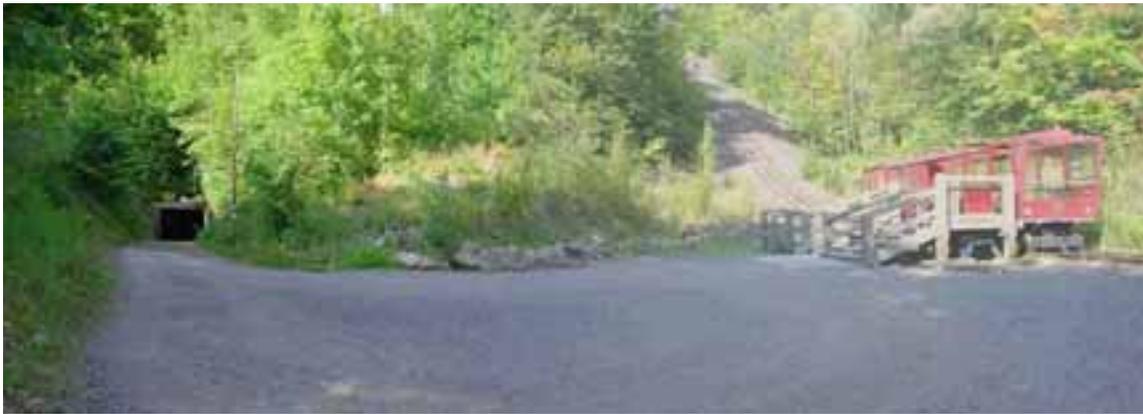
4
5
6
Figure 3-17: View looking north toward tram at the adit, 2006 (source: QEA)

- 25 • **The Cog Rail Tramway:** The tramway provides a link between the No. 2 hoist house
26 and the mine adit for visitors experiencing the mine tour (see Figure 3-17).
27

- 28 • **The Adit:** The adit is an entrance to the underground mine tour and links the surface to
29 the seventh level of the mine (see Figure 3-17).
30

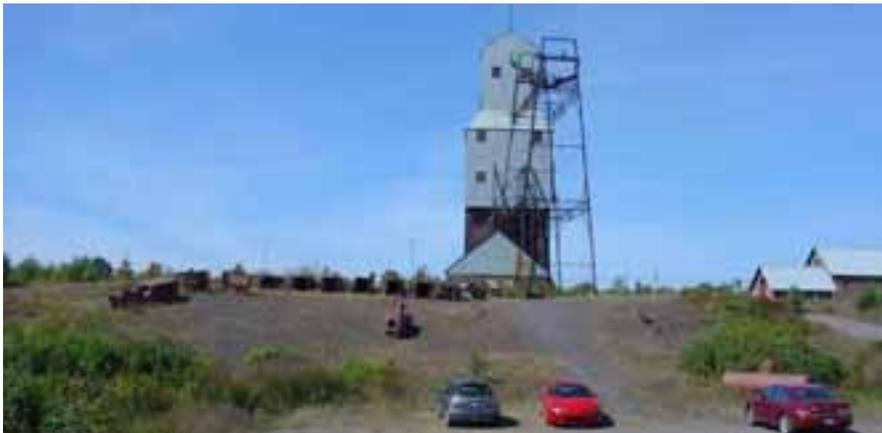
7
8
9
10
Figure 3-18: The area between the No. 2 hoist house and the shaft-rockhouse is used for parking and as a display area for mining artifacts, 2006 (source: QEA)

- 31 • **The area between the No.2 shaft-rockhouse and No.2 hoist houses:** This is a display
32 area of mine-related artifacts. A complete inventory of the artifacts was prepared by
33 Scott See of Michigan Technological University. The eastern portion of the area is used
34 for parking (see Figure 3-18).
35

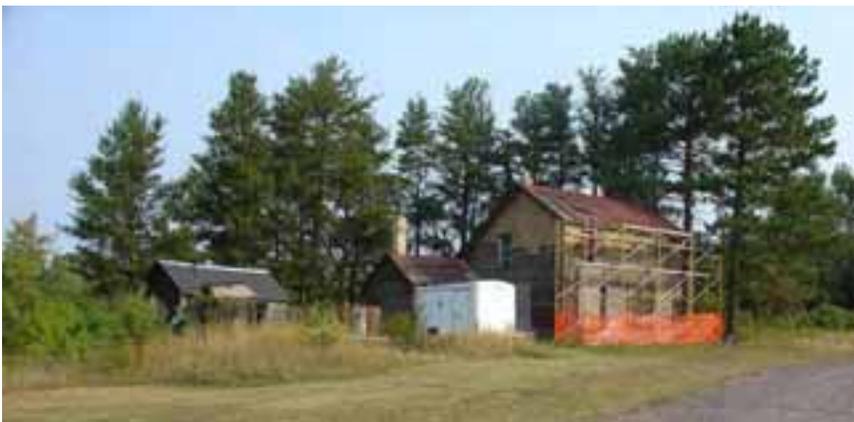
36
37 **Figure 3- 21: Southeast view of Martin House Property, 2006** (source: QEA)

- 15 • **Martin House Site:** The property includes a house, privy and barn (see Figure 3-21).
16 The Quincy Mine Hoist Association would like to use it for interpretation of a miner's
17 domestic life. It has been stabilized by NPS workers but requires further structural
18 repairs.
- 19 • **Cooling Ponds:** The cooling ponds are two connected concrete-lined pools that feature
20 pipes and remnants of wooden piers located along the centerlines of the pools (see
21

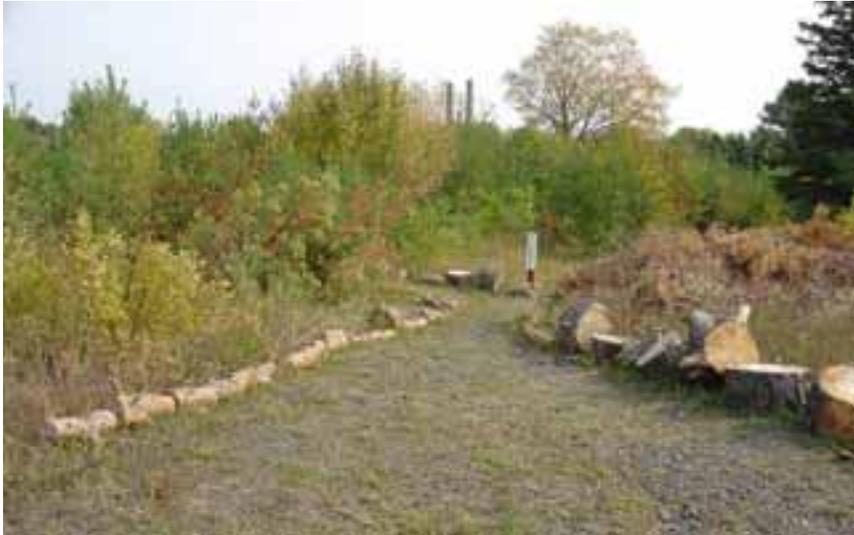
Figure 3- 23: The area between the cooling ponds and the supply house includes a recently added informal trail and sign for blacksmith, 2006 (source: QEA)

- 4 • **Area between the Cooling Pools and the Supply Office:** This area contains dense
5 second-growth vegetation and extensive remains of railroad tracks, building
6 foundations and discarded materials, and utility trenches related to the Quincy Mine
7 operations (see Figure 3-23). The ground is extremely uneven and foundations and piles
8 of pipes and bricks are disguised by the vegetative growth. Views in this area are also
9 obscured by vegetation.

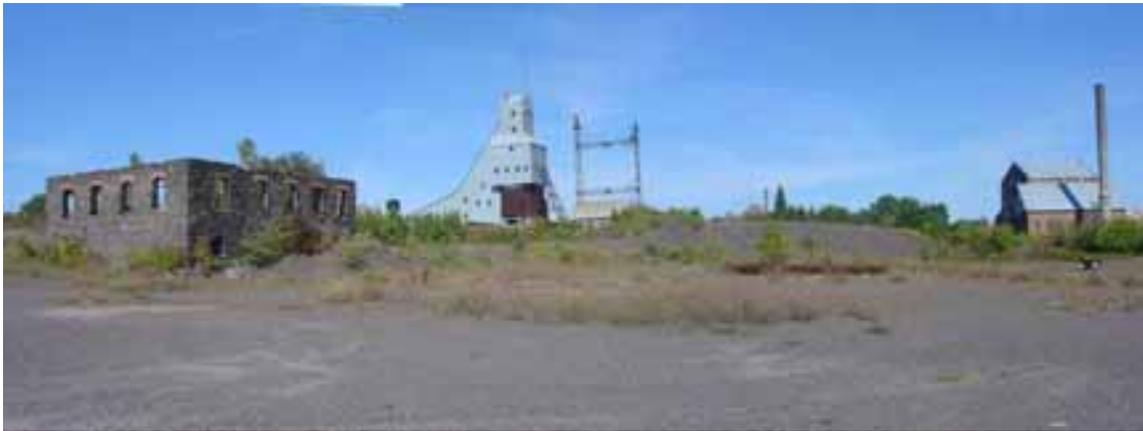
1
2 **Figure 3- 25: View looking north at the area south of No. 2 shaft-rockhouse with foundations and**
3 **ruins, 2006 (source: QEA)**
4

- 14
- 15 • **Area south of the No. 2 shaft-rockhouse with foundations and ruins:** This area
16 contains remnants and foundations of several substantial mining buildings that are
17 surrounded by a rocky landscape with uneven topography (see Figures 3-25 and 3-26).
18 The area contains remnants of poor rock piles that have been mined recently to provide
19 fill for road projects and gravel in the region. The removal of the rock has left an
20 unusual landscape with rock piles and cut out areas. Some small plants are present.

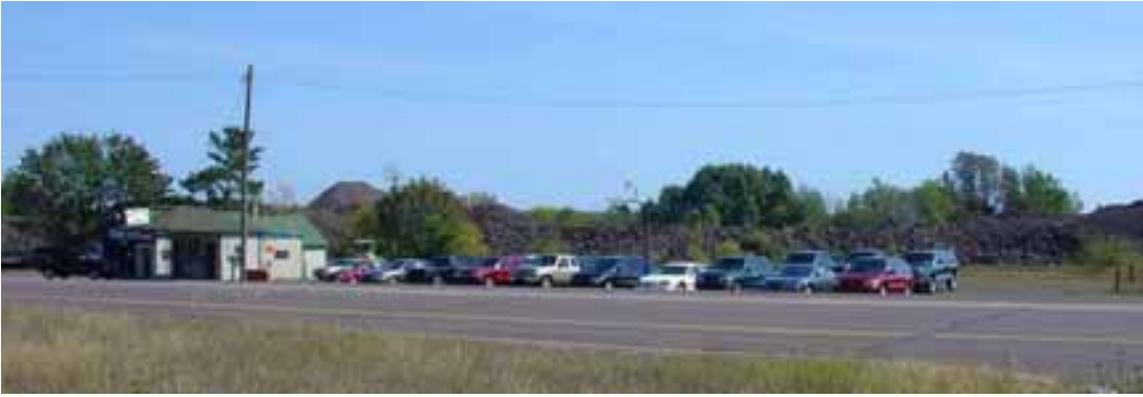
1
2 **Figure 3- 28: Used car lot east of Highway 41 with privately owned poor rock pile in the background,**
3 **2006 (source: QEA)**

- 30
- 31 • **Rock Piles:** Throughout the region poor rock piles are being mined for road
32 construction, and in some cases they have been disguised by vegetation (see Figure 3-
33 28). Their loss as a visual landscape feature is changing the region's identity to one that
34 is not as easily associated with its historic mining activities.

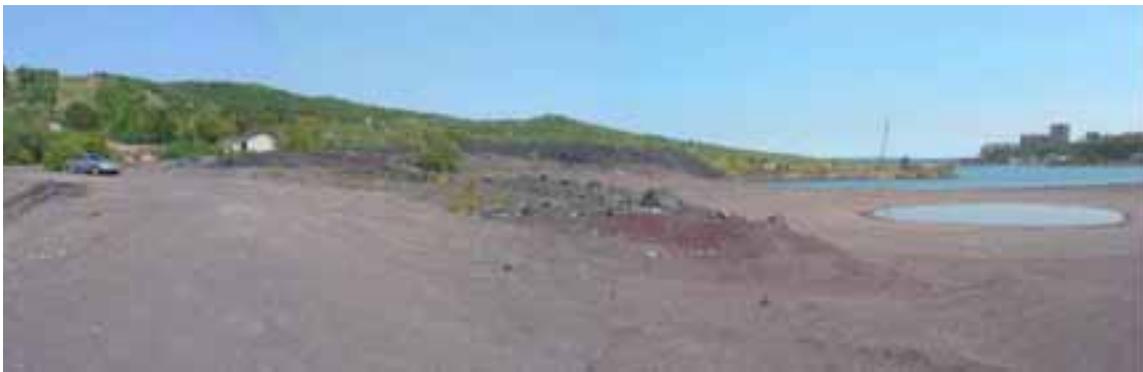
8
9 **Figure 3- 31: View looking east from the Quincy smelter railroad grade toward slag pile and former**
10 **salt storage area (source: QEA)**

12 A portion of the site was used previously for salt storage and handling. The EPA
13 conducted a remediation project that involved placing geotextile fabric and rock rip-rap
14 armoring along the shoreline of this large flat area to stabilize the shore and keep pollutants
15 from entering Portage Lake. A slag pile is northeast of the circular asphalt pad that marks the
16 former salt storage location. Adjacent property uses include a Houghton County Road
17 Commission, Mount Ripley downhill ski area, salvage yard, and marina. Storm water from the
18 ski hill previously ran through the smelter site undirected. A recent EPA project installed
19 culverts with large rock aprons below the existing railroad grade to direct and contain the storm
20 water, keeping it from further impacting the smelter site. Check dams were installed
21 downstream to slow water movement and trap sediment before entering Portage Lake.

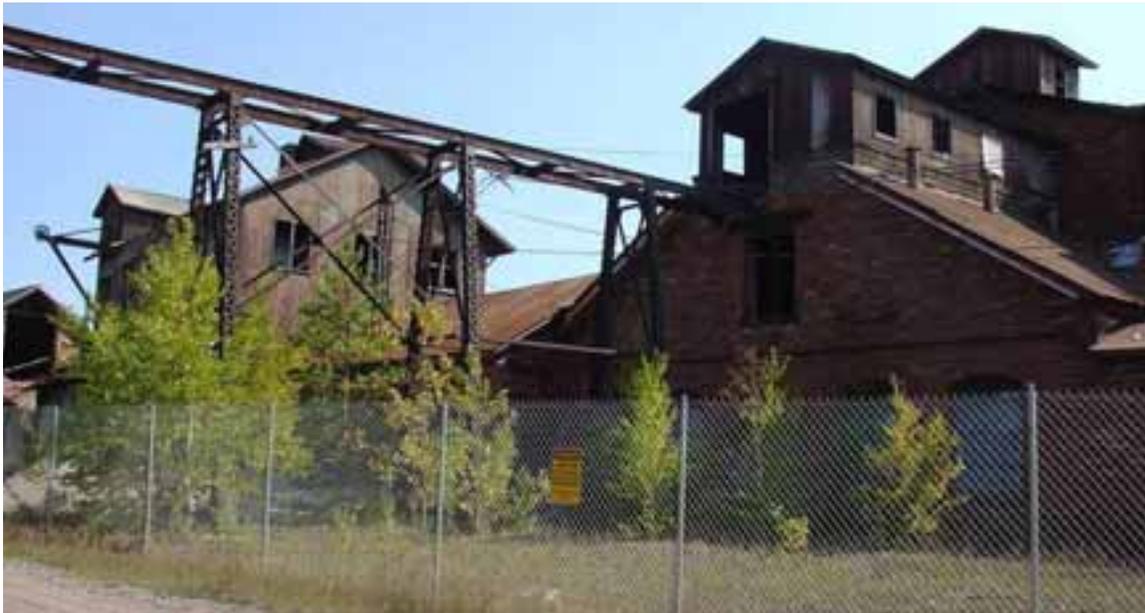
4
5
Figure 3- 33: North elevation of the cupola furnace building at the Quincy smelter (source: QEA)

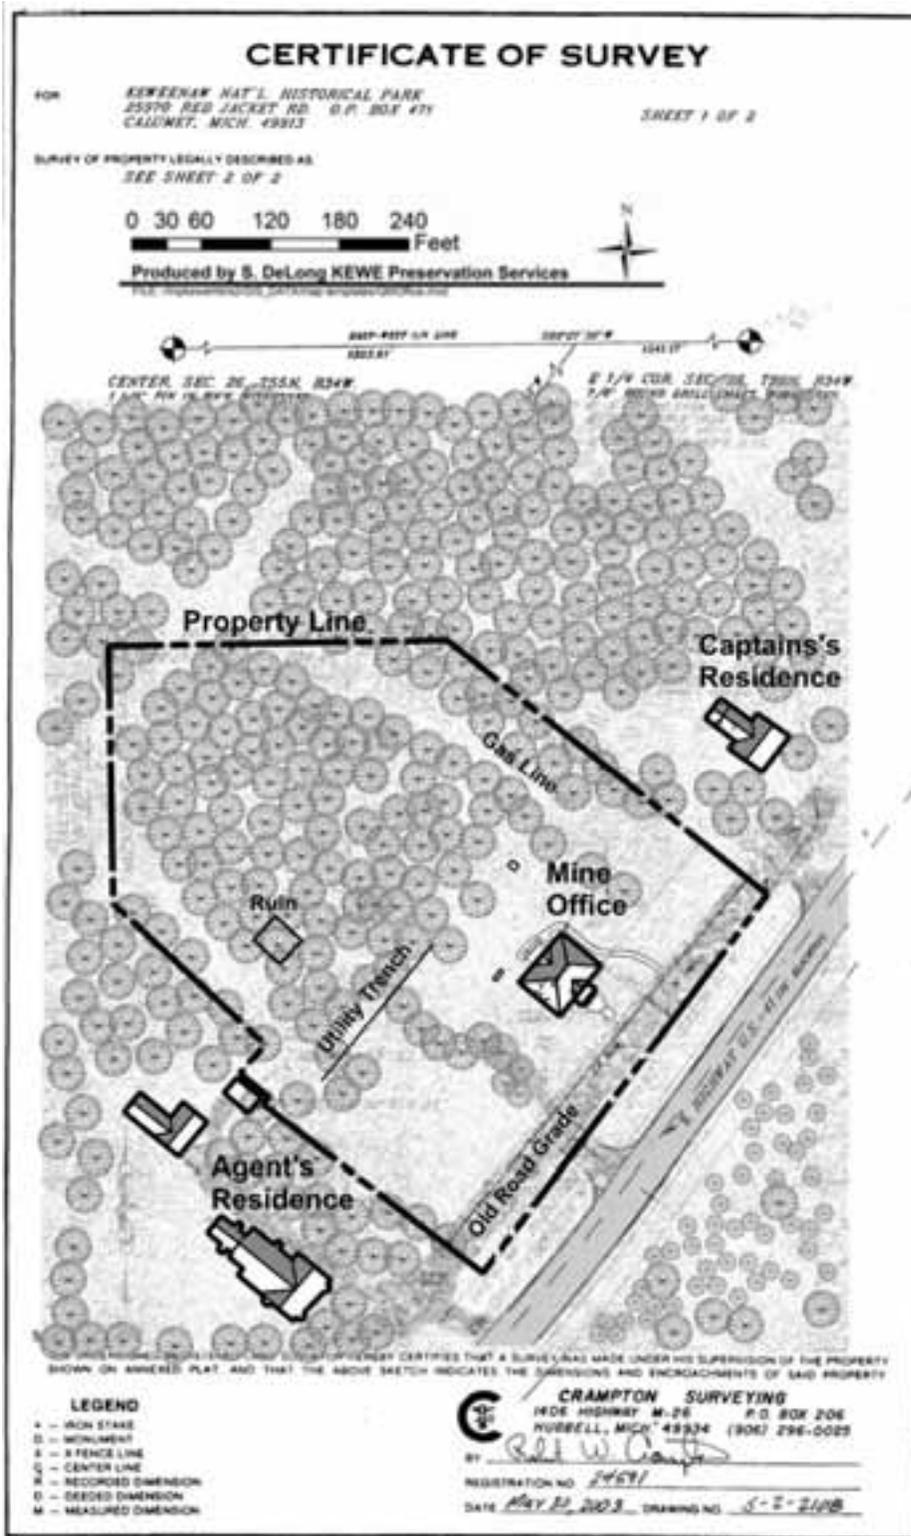
1
 2 **Figure 3-34: Quincy Mine Office Cultural Landscape, Existing Conditions, 2006** (source: CLI, Quincy
 3 Mine Office, MWRO)

12 foundation. In addition, there are remnants of a short sandstone curb/wall and portions of a
13 historic wood picket fence. The area immediately surrounding the Mine Office consists of lawn
14 and the northwest portion of the property behind the building is wooded. Rows of trees are
15 present running perpendicular to the road as they once separated historic land uses and defined
16 the property boundaries. A portion of the historic Quincy Mining Company surface works is
17 visible from the property. In addition, the property affords long, fenestrated views of Portage Lake
18 and the Huron Mountains to the southeast.

19 The Quincy Mine Agent's House/Superintendent's Residence is located on the northwest
20 side of Highway 41, across the highway and north of the MDOT wayside. It is a private residence,
21 associated with the character area. It appears to have extant landscape features including a
22 concrete walk, wooden fence and vegetation along the former county road trace. Within the
23 property mature shade trees are present along with a gravel drive, garage/outbuilding and
24 remnants of a fence surrounding the property.

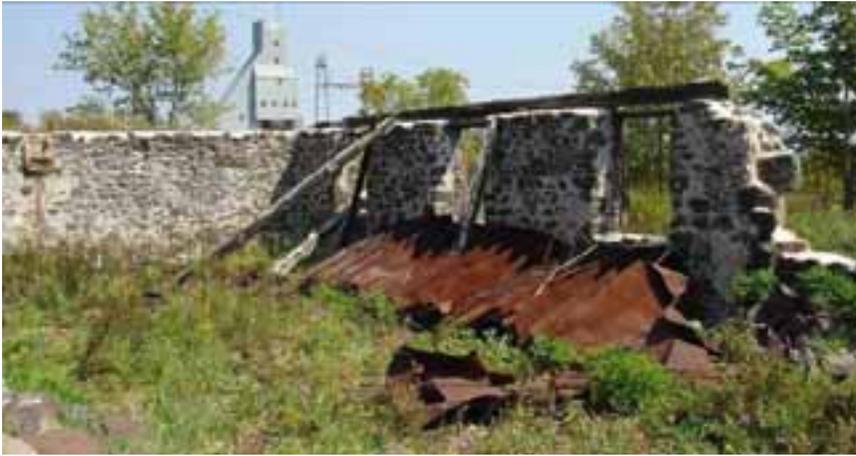
3
4 **Figure 3-35: Northeast interior view of dryhouse foundation with No. 2 shaft-rockhouse in**
5 **background, 2006 (source: QEA)**
6

2 The Quincy dryhouse is located within the historic mine/industrial landscape character
3 type on the northwest side of Highway 41, directly across the road from the Quincy Mine site
4 (see Figures 3-35 through 3-37). This area is divided by the No.2 Road, which leads from
5 Highway 41 to Frenchtown Road. The area contains the foundation and partial walls of the
6 dryhouse, as well as foundations of a mine captain's office and other historic structures
7 identified as houses in earlier company maps. The dryhouse and other foundations were
8 stabilized in 2005. The repair mortar offers greater visual contrast against the basalt stone than
9 unrepaired or unstabilized portions of the structure, however, time and weathering may reduce
10 the contrast in materials. The mortar used for these repairs was carefully selected to ensure that
11 it would not damage historic materials. In order to stabilize the dryhouse ruin, a mortar wash

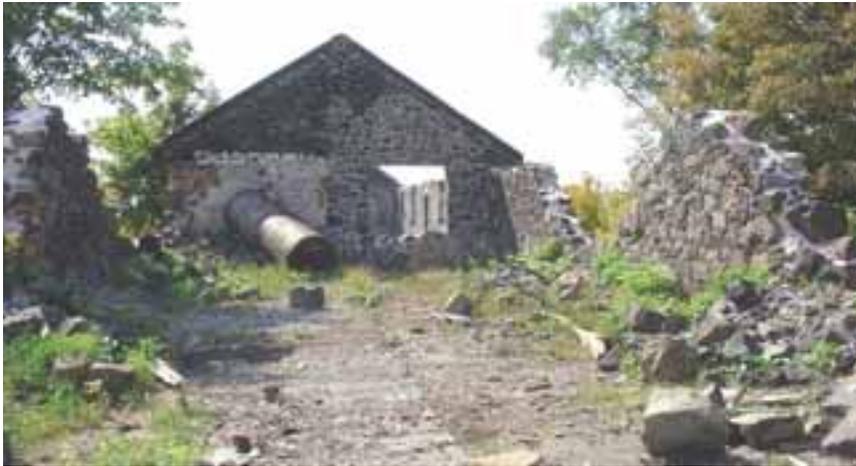
7
8 **Figure 3-36: View looking south at interior of dryhouse foundation, 2006 (source: QEA)**
9

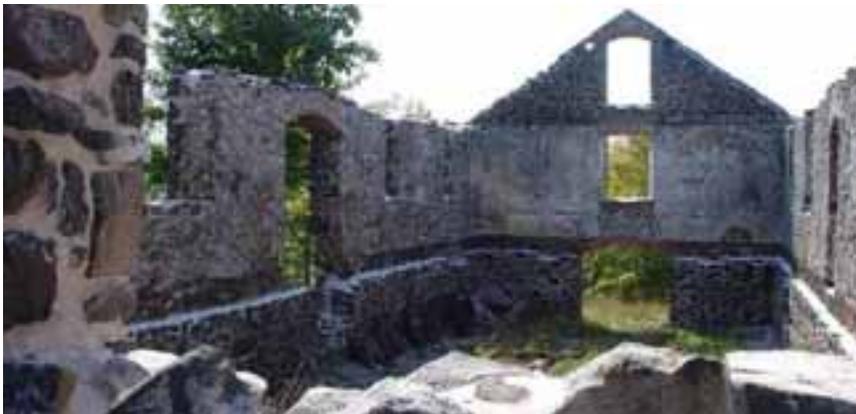
10
11 **Figure 3-37: View facing south interior of dryhouse foundation after stabilization, 2006 (source: QEA)**

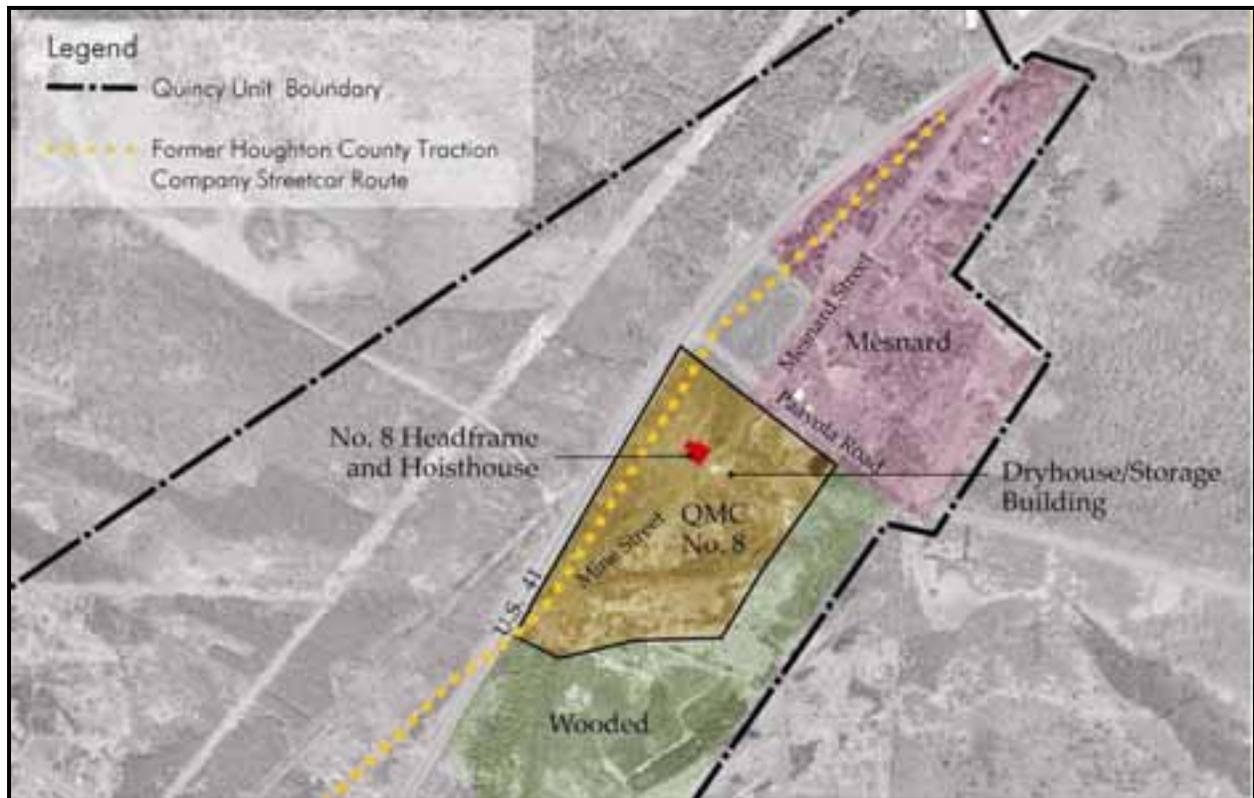
Figure 3- 41: No. 8 Landscape Character Area

The No. 8 landscape character area is located in the northern portion of the Quincy Unit at the end of Mine Street (see Figure 3-41). Positioned on the east side of Highway 41, the area is separated from the road by dense vegetation. Mine Street is an asphalt road that is in poor condition. Historic resources located in this area include the No. 8 headframe and hoisthouse, as well as a large dryhouse/storage building (see Figures 3-42 through 3-43). This area was re-used and altered by Homestake during their 1976 mining operation and therefore provides a more recent view of copper mining on the Keweenaw than the No. 2 area. Vegetation growing here is mostly deciduous volunteer species, with some fruit trees.

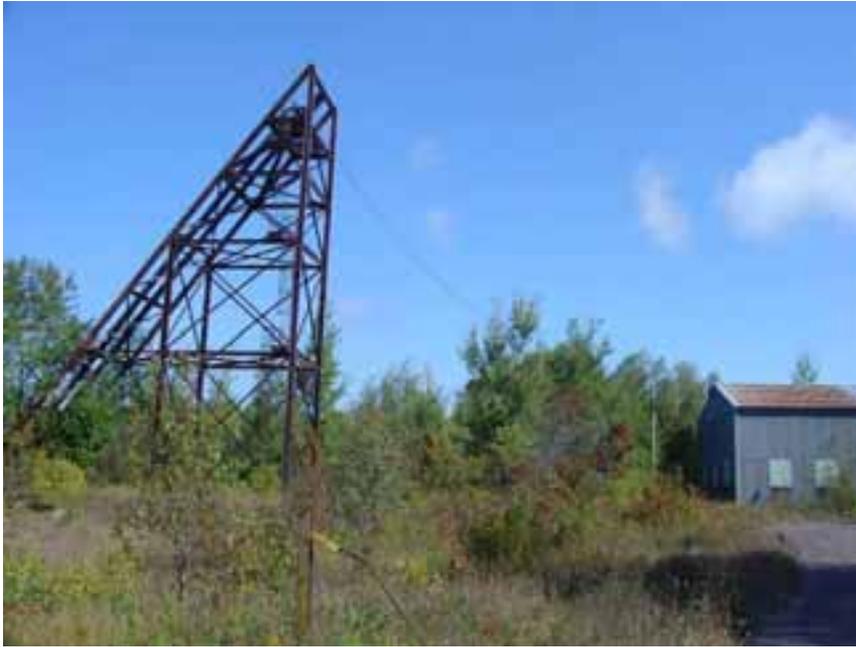
Figure 3- 42: No. 8 headframe and hoist house at No. 8 (source: QEA)

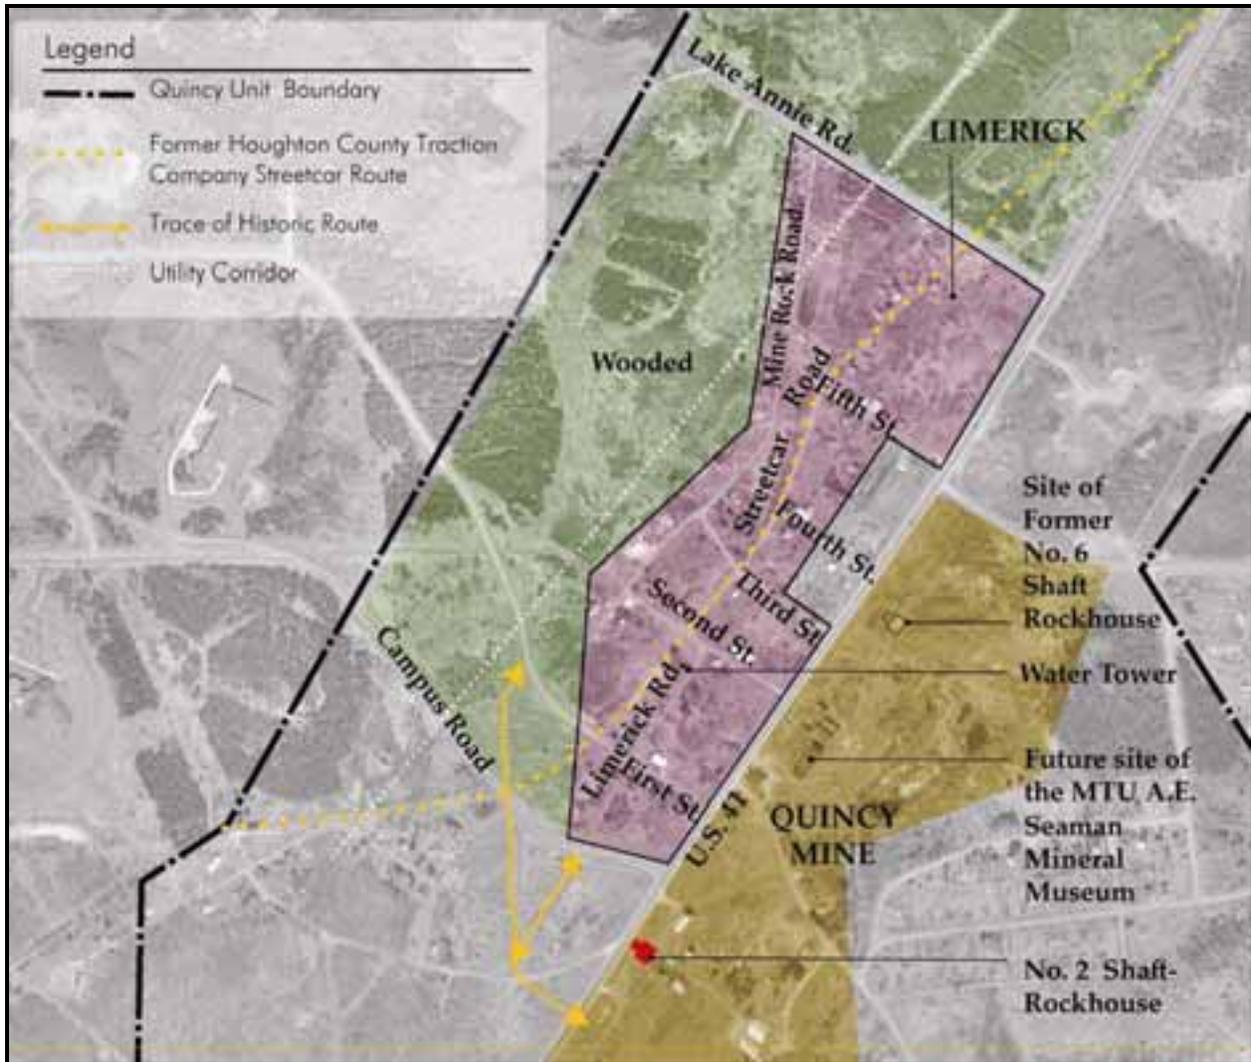
Figure 3- 45: Limerick Landscape Character Area

The Limerick location is a rugged residential locality of mixed character connected by a grid of streets (see Figure 3-45). Some properties within the location convey a strong sense of history through their integrity and setting while others introduce layers of varied land uses, building additions and landscape alterations unrelated to their historic character.

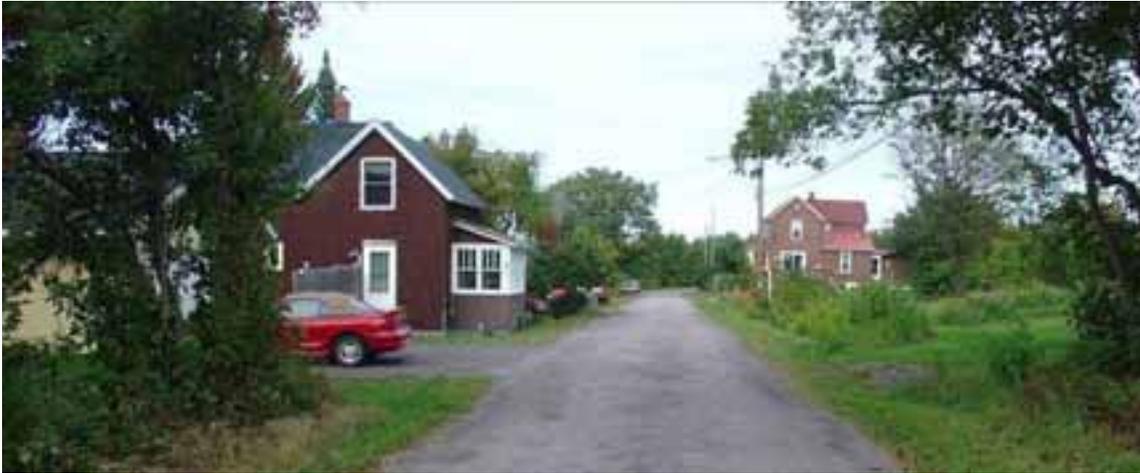
Figure 3- 47: North portion of Streetcar Road, facing North, 2006 (source: QEA)

15 At *Streetcar Road* the majority of the residences are historic, occupied, and in good
16 condition (see Figure 3-47). This is a small, dense, rural residential street with play areas,
17 outbuildings (mostly non-historic) vegetable gardens, flower beds, lawn ornaments, and
18 successional woodland vegetation surrounding mown lawns.

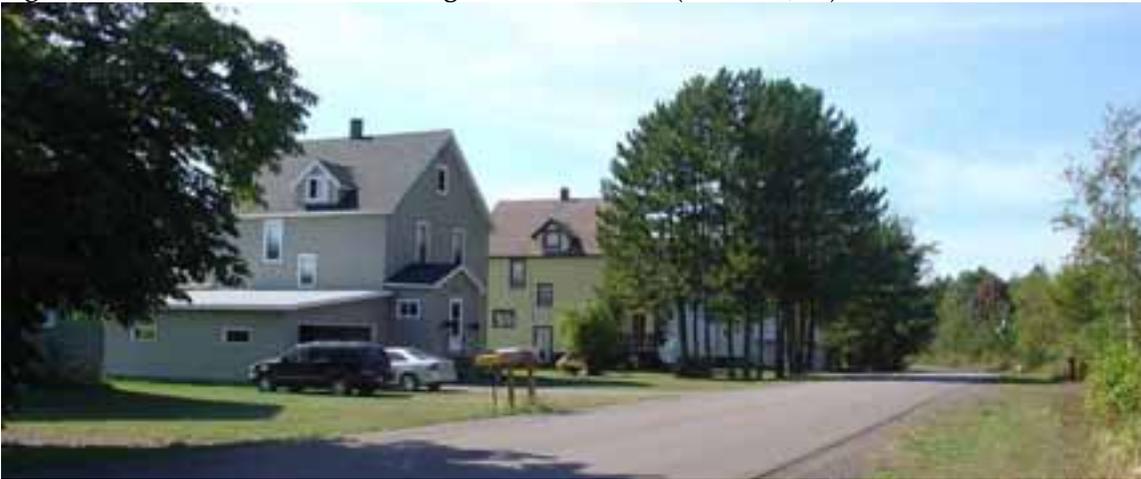
3
4 **Figure 3- 61: Lower Pewabic residences, 2006 (source: QEA)**
5

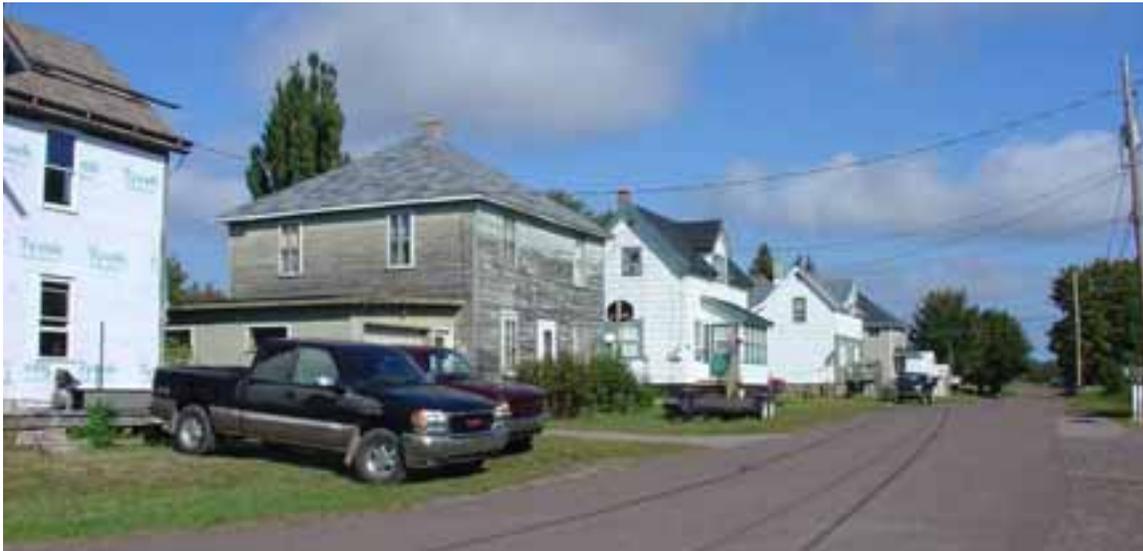
10 Quincy Street, in particular, has the feeling of a company town due to the regular
11 rhythm of mining homes facing the street and their compact regular yards defined by hedges,
12 fences, posts and arrangement of woodpiles or stored materials and outbuildings (see Figure 3-
13 63). Foundation plantings of lilies, shrub roses, and other plants are present and often
14 accompanied by lilacs and apple trees as specimens in the landscape. Some of the apple trees
15 are arranged in small orchardlike fashion and this is most visible in a garden between

7 Alterations to this historic setting include the introduction of modern construction
8 materials, building additions, and road signs.

Figure 3- 63: Quincy Street in Coburntown, 2006 (source: QEA)

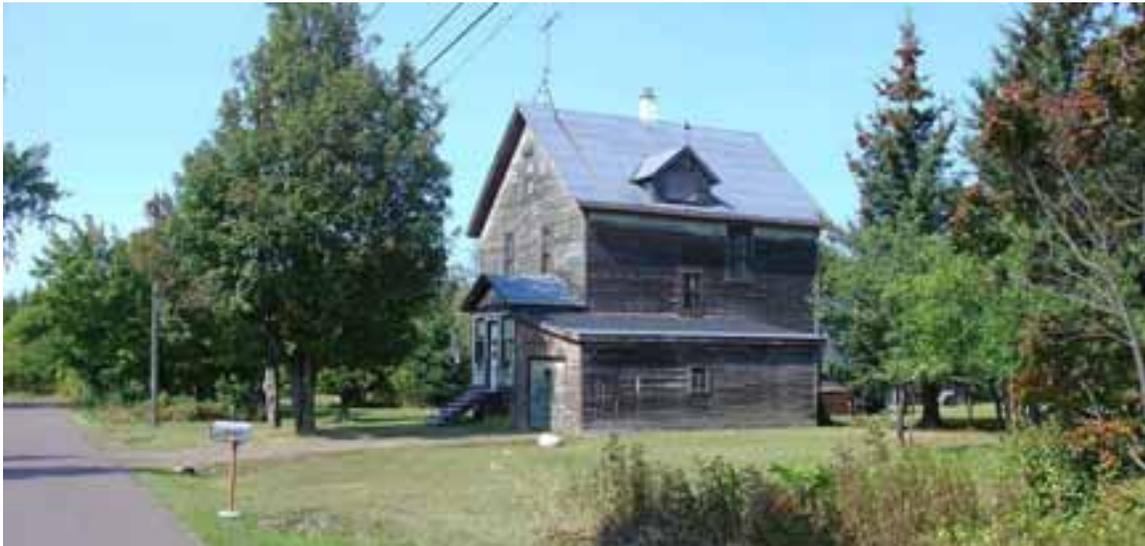
1 saunas and sheds. Wood piles for residential heating appear in two forms: neatly stacked and
2 arranged in rows along a property boundary, or piled in mounds, for future stacking or use.
3 Ornamental plantings are sparse but include apple trees or an occasional grouping of lilies.
4 Other vegetation includes mixed successional woodland species of maples, poplars and a few
5 spruce and pines.

6 The nearby Raasio Road includes several newer homes that appear inconsistent with the
7 character of the historic Sing Sing structures. Their spacing, setbacks and angled site
8 arrangement combined with contemporary residential forms, massing, low sloped roofs, and
9 the presence of modern materials, highlight their presence as recent additions to the landscape.

10
11 **Figure 3- 65: Sing Sing Neighborhood, 2006** (source: QEA)

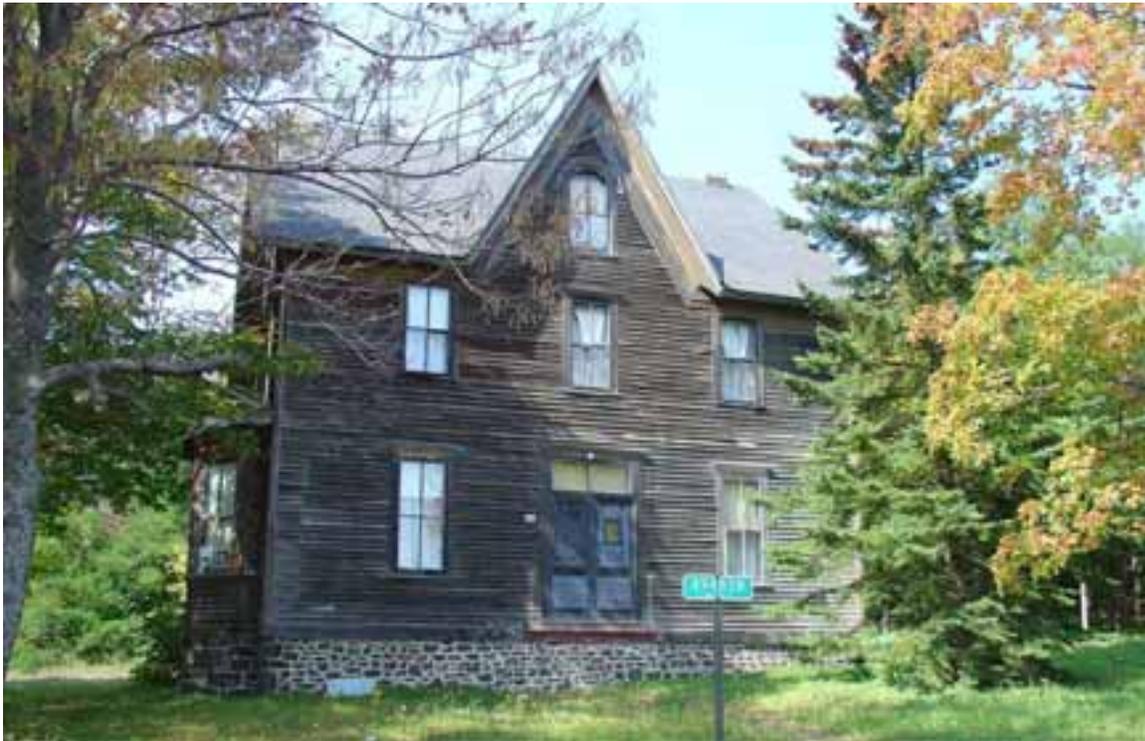
1 Frenchtown road and Highway 41 is a vacant mine captain's home that remains with few
2 alterations and displays high integrity, including the mature shade trees presumed to be from
3 the period of occupation. To the north is a slightly smaller structure than once housed Quincy's
4 assay office but is now a residence. The exterior of this structure has been altered within the
5 last ten years as modern windows and doors have replaced the originals and adjusted their
6 openings.

7
8 **Figure 3- 67: Mine Captain's home in Frenchtown, Highway 41 and Frenchtown Road, 2006** (source:
9 QEA)
10

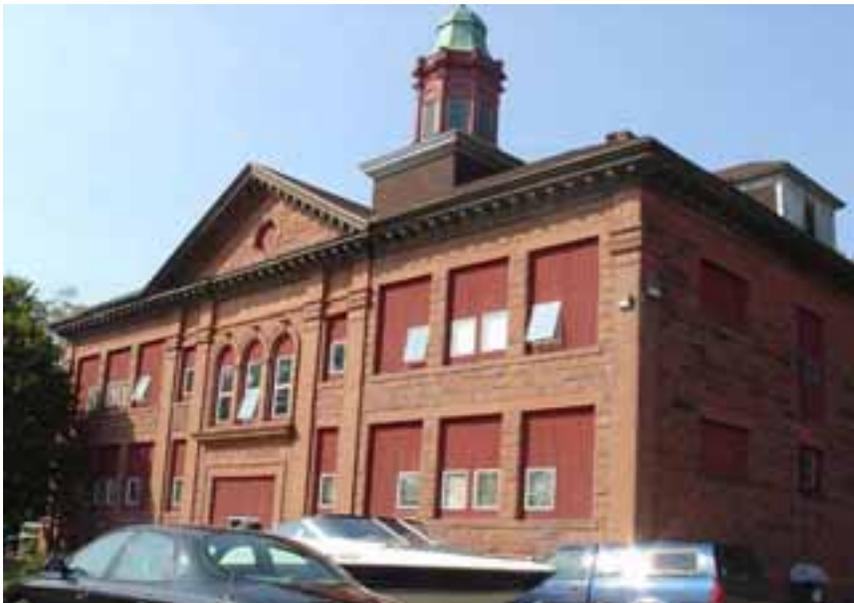
11 The historic Ripley school is located at the east unit boundary, west of existing
12 housing. The school has been converted into apartments and reinforces the historic character of
13 the adjacent neighborhood, and provides a strong architectural centerpiece for neighbors.

8
9 **Figure 3- 69: Looking northwest toward former historic Ripley school, converted to apartments, 2006**
10 (source: QEA)

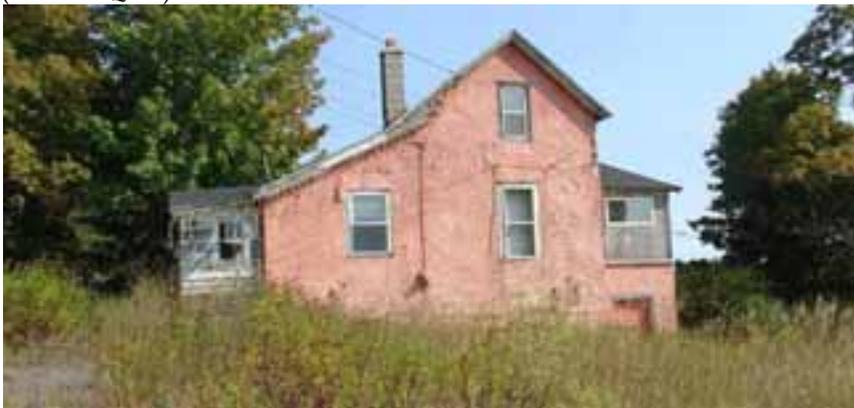
1 Ripley is built around a compact grid system of streets oriented north-south and east-
2 west. The homes and lots are compact and establish an urban character with their evenly
3 spaced, uniformly shallow, front yard setbacks flanking narrow asphalt roads. Where garages
4 or outbuildings are present they occupy a small portion of the site and are typically detached.
5 Landscape features include decorative fences, wooden posts, woodpiles, and ornamental
6 plantings including hedges, foundation plantings, vegetable and flower gardens and shade
7 trees.

11
12 **Figure 3- 70: Ripley historic residence, 2006** (source: QEA DSC06703)

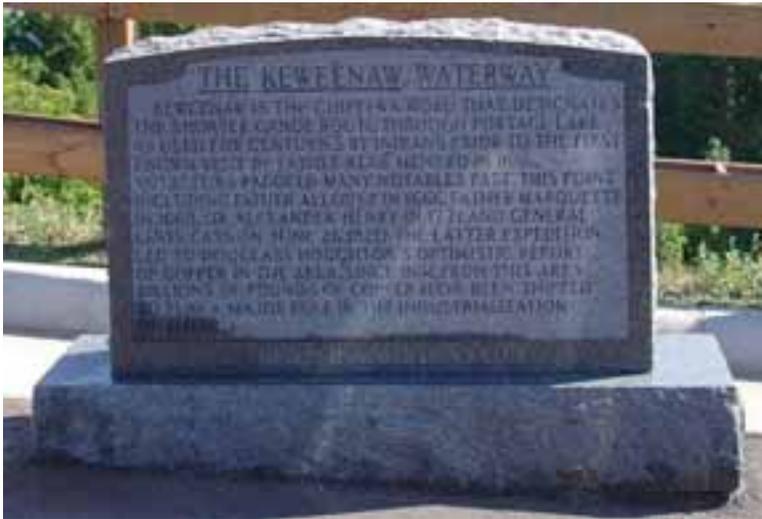
1 road edged with wood bollards and a safety rail. There are two features. One is a cut granite
2 slab with engraved text titled “The Keweenaw Waterway” (see Figure 3-75). The text briefly
3 explains the meaning of the word Keweenaw and identifies early European and American
4 explorers to the area. The second feature is an eclectic sign consisting of a carved wood slab on
5 an angled mortared stone base. Two sets of three wood poles of varying heights frame the sign.
6 Also titled “The Keweenaw Waterway,” the sign provides visitors with a geographic map and
7 text related to extant copper mining resources (see Figure 3-76). The style, materials,
8 workmanship, and scale of the interpretive signs and other materials at the wayside do not
9 reflect the historic Quincy industrial landscape.

10
11 **Figure 3- 75: “The Keweenaw Waterway,” granite sign at MDOT wayside, 2006 (source: QEA)**
