1 **Chapter III: Existing Conditions / Affected Environment**

2
3 This chapter describes existing conditions within the Quincy Unit at two levels of detail.
4 Unit-wide existing conditions are those that relate to the overall Quincy Unit (Figure 3-1
5 illustrates the boundaries and existing conditions of the Quincy Unit). Unit-wide conditions
6 addressed include land use, vegetation, circulation, archaeological resources, wetlands, special
7 status species, socioeconomics, visitor experience, and park operations at a broad scale,
8 providing a context for understanding the overall unit. The remainder of the chapter provides
9 descriptions of existing conditions in each of the landscape character areas within the Quincy
10 Unit.

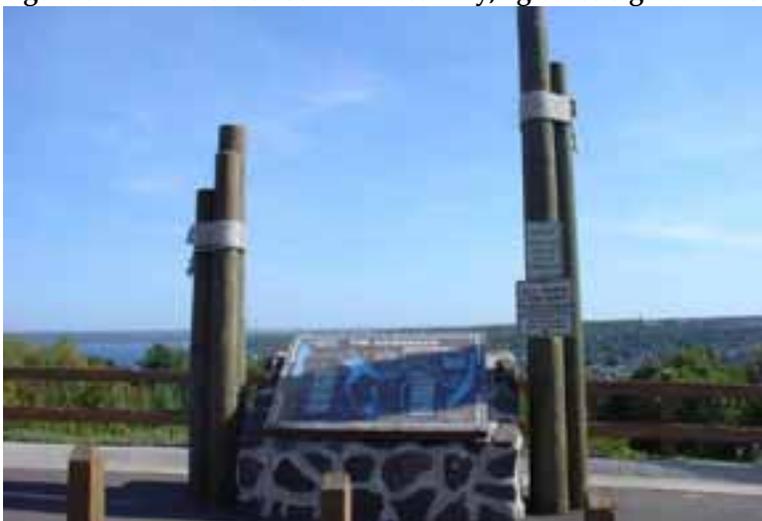
12
13 **Figure 3- 76: MDOT interpretive display at the MDOT wayside, 2006 (source: QEA)**

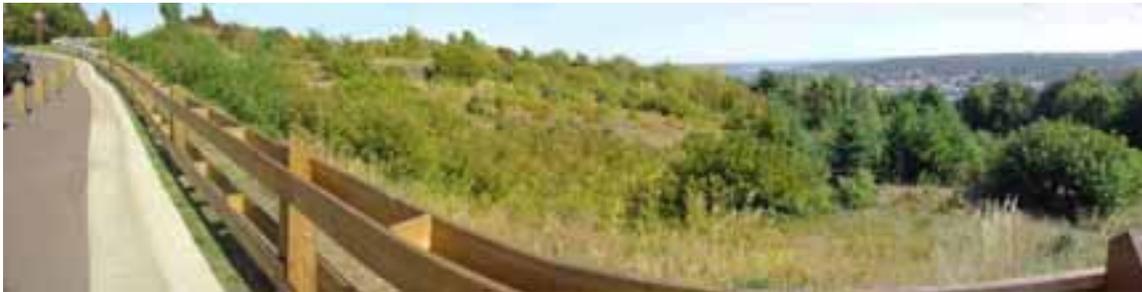
1 The topography drops off at a very steep slope from the southeastern side of the
2 wayside and climbs at a steep angle to the northeast. For the most part, the hill on the eastern
3 side of the highway is covered with vegetation which hides any remaining traces of the historic
4 mining activities in this area (see Figure 3-77). To the southeast of the wayside, about forty feet
5 below, is a fairly flat terrace that retains a rural character not present near the highway. To the
6 northeast of the wayside a large pile of mine rock has been recently placed by MDOT as part of
7 a stormwater retention system. The view of the rock pile is reflective of the historic character of
8 the hill during more active mining activities (see Figure 3-78).

9
10 **Figure 3- 77: Panoramic view from MDOT wayside to the southeast, 2006** (source: QEA)

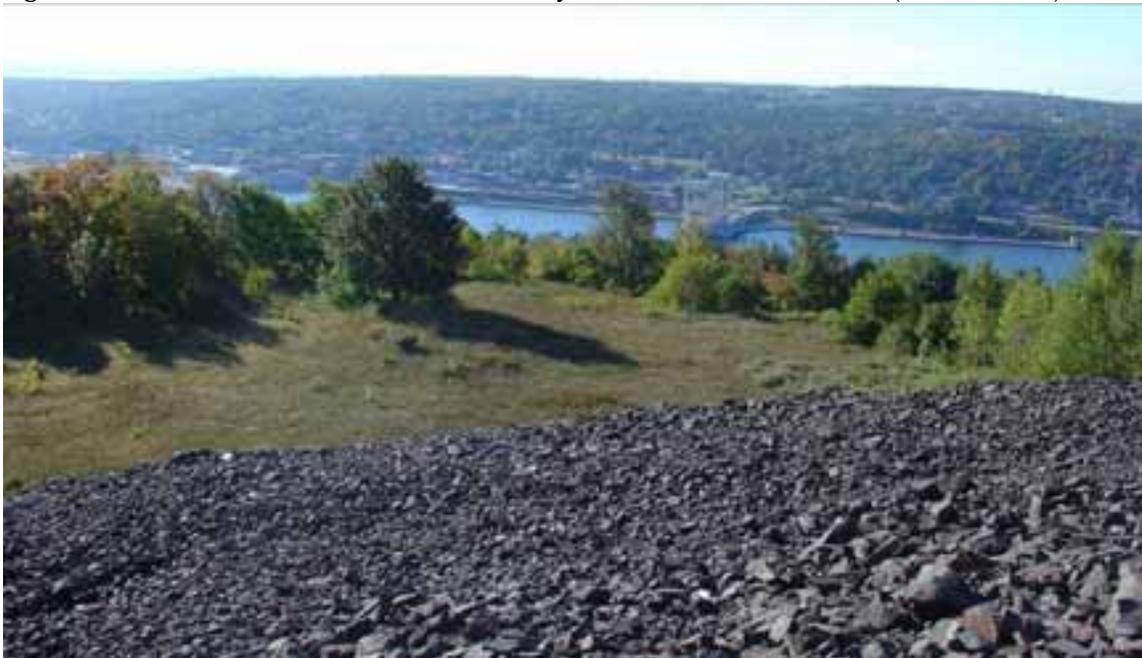
11
12 **Figure 3- 78: Flat area south of MDOT wayside, view from large pile of mine rocks toward the lift**
13 **bridge, Portage Lake and the city of Houghton, 2006** (source: QEA)

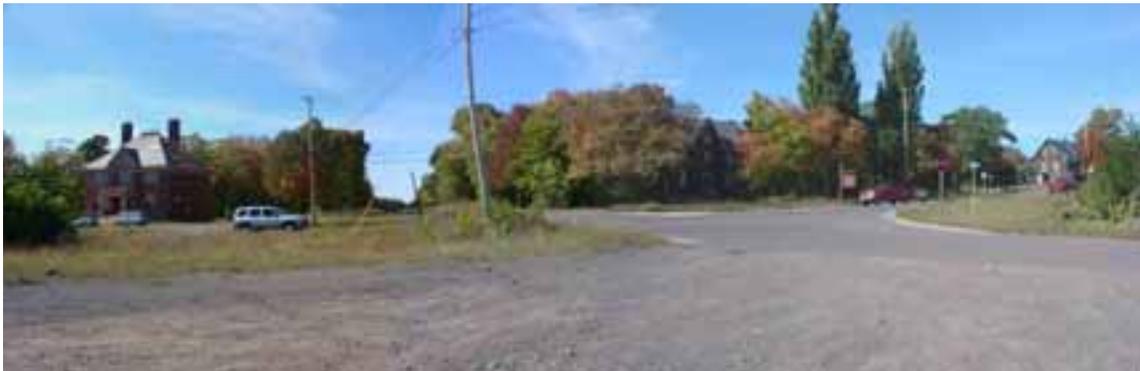
12 and small scale features like fences, posts and artifacts once common in the area. Non-historic
13 features include commercial storage facilities, modern signs, billboards, automobile dealers and
14 repair shops, a church, and a fire department (see Figures 3-79 through 3-83).

15
16 **Figure 3-79: View looking west at Highway 41 at the intersection of Kowsit Lats Road, the Quincy**
17 **Mine office is on the left, 2006 (source: QEA)**
18

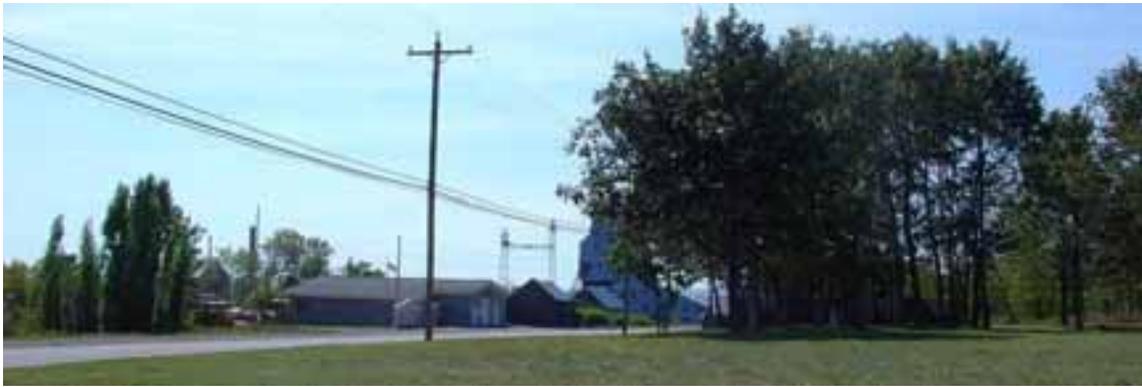
1
2 **Figure 3- 80: View of Highway 41 southeast toward the Quincy Franklin Township Fire Department**
3 **building, the captain's house, and No. 2 shaft-rockhouse, 2006 (source: QEA)**
4

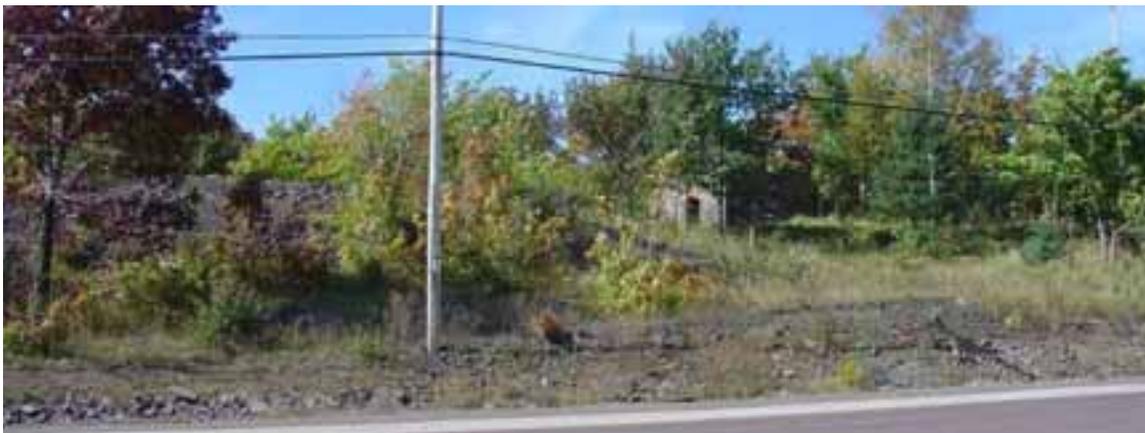
5
6 **Figure 3- 81: Poor rock-pile west of Highway 41, south of the Quincy dry house ruins (source: QEA)**
7

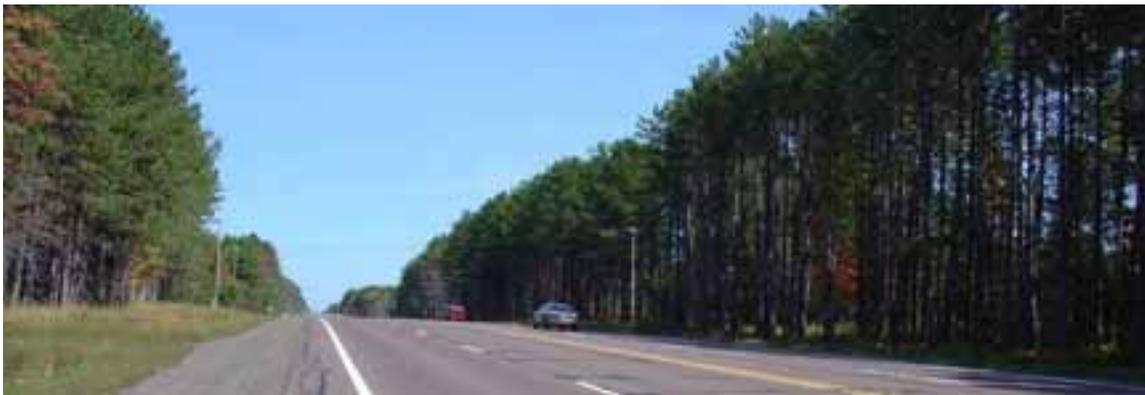
8
9 **Figure 3- 82: Highway 41 pine planting, 2006 (source: QEA)**
10

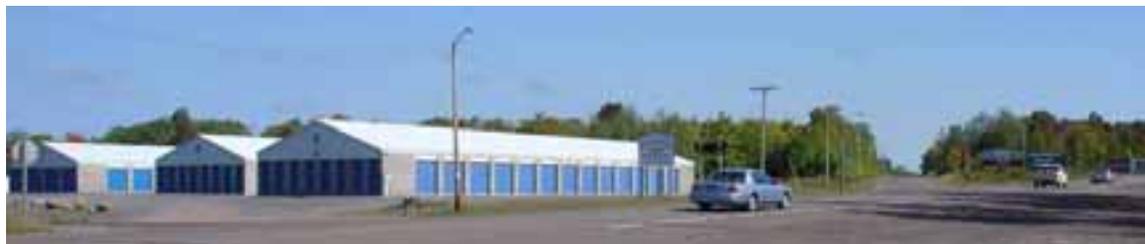
11
12 **Figure 3- 83: Storage facility and billboards west of Highway 41 at the northern end of the Quincy**
13 **Unit along Highway 41 (source: QEA)**

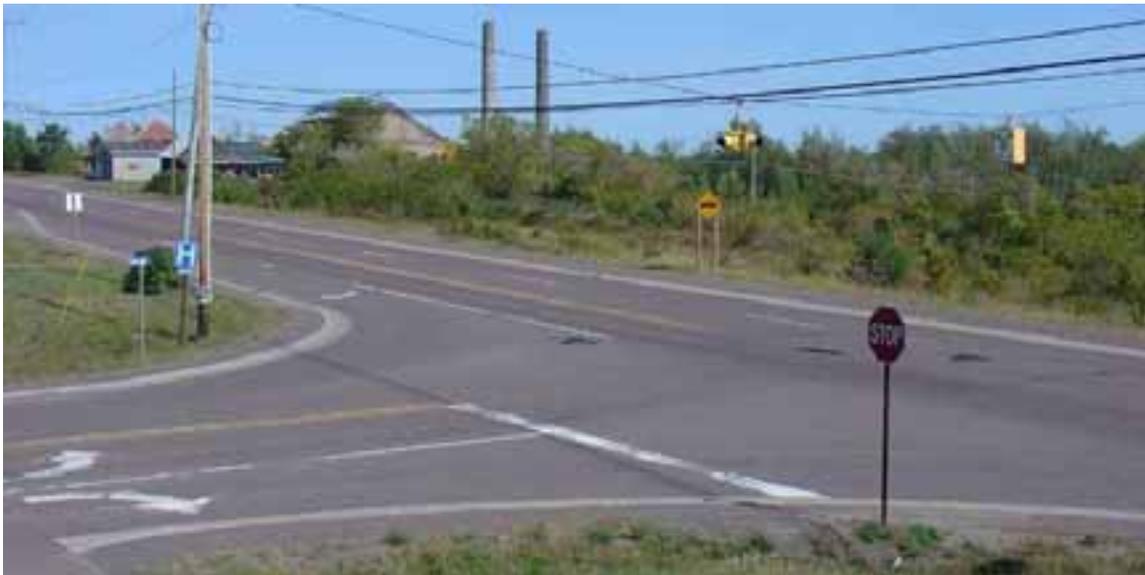
2 Campus Drive is a bi-directional, two lane, asphalt road that bisects the northern
3 portion of the NHL district traveling west from Highway 41, opposite the Quincy Mine
4 entrance (see Figure 3-84). Flanked by historic and volunteer vegetation, Campus Drive was
5 constructed to provide vehicular access for increased development in the area. A new high
6 school and the Portage Health System facility, as well as residential areas and an elementary
7 school are present along the route. The development of the road altered the topography of the
8 area and also bisects secondary historic circulation network of gravel roads, paths and a
9 streetcar route. Subsequent to its development, Portage Health Care System demolished the
10 former Quincy bathhouse creating a gap in the historic fabric upon the hill. Later they erected a
11 large internally lit sign and MDOT added blinking yellow traffic lights.

12
13 **Figure 3- 84: The intersection of Campus Drive and Highway 41 viewed from the southwest, 2006**
14

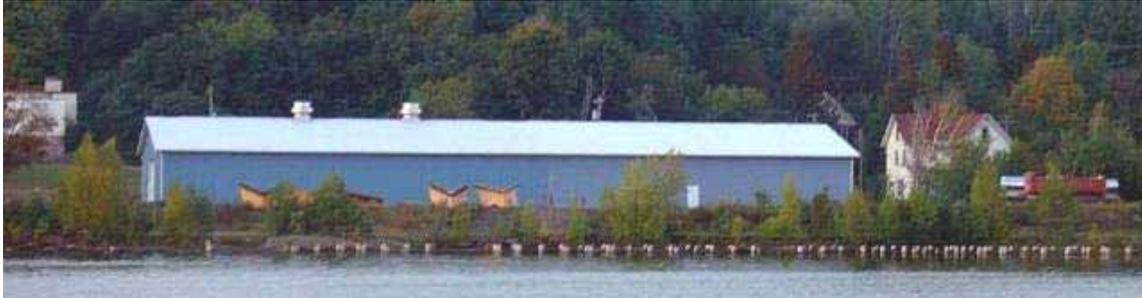
1 Canal (see Figure 3-85). The property is open and industrial in character. Additions and
2 changes to the site, new structures and open storage of vehicles equipment and supplies convey
3 a non-historic use that appears incompatible with the waterfront.

4
5 **Figure 3- 85: Houghton County Road Commission storage facility west of Quincy Smelting Works,**
6 **2006 (source: QEA)**
7

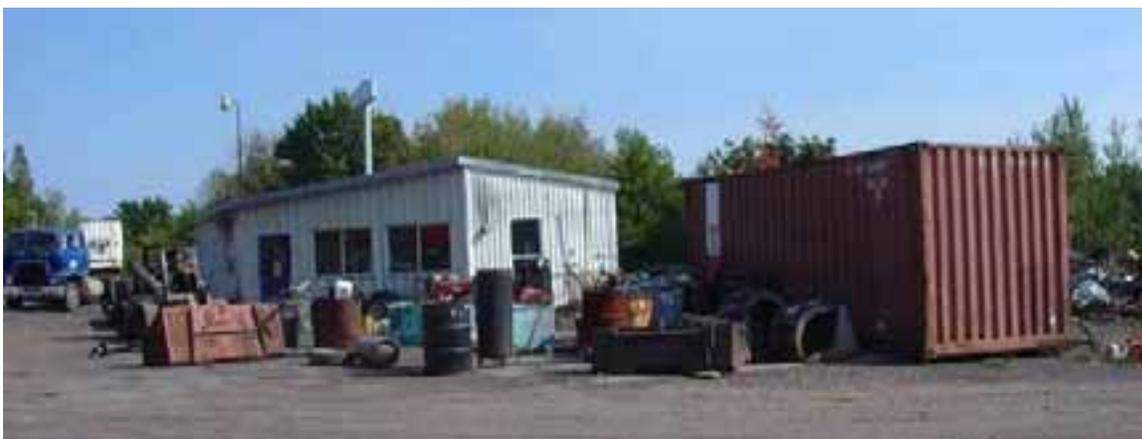
9 Located directly east of the Quincy Smelting Works, the salvage yard borders the
10 Portage Lake Canal. Julio Contracting also provides residential, commercial, and industrial
11 construction services. Like the Houghton County Road Commission property, the Julio
12 property impacts the visual character of the northern shore of Portage Lake. A mixture of scrap
13 metal, debris, roughly graded land and open storage of supplies and equipment present a stark
14 contrast to the environmental conditions people seek in the Keweenaw (see Figure 3-86).

15
16 **Figure 3- 86: Southeasterly view of part of the Julio Contracting, salvage yard east of Smelter Site**
17 **(source: QEA)**

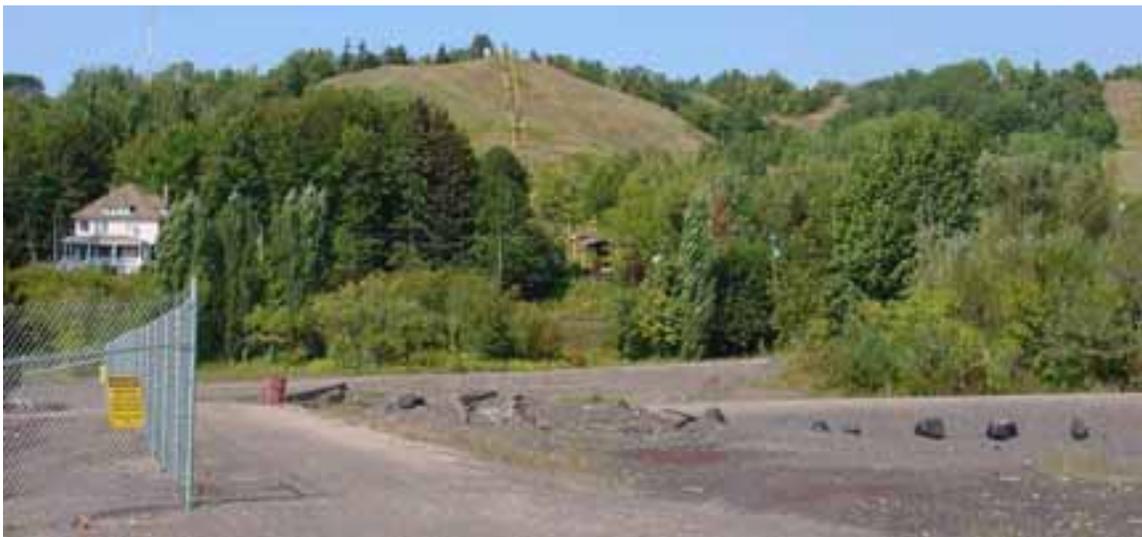
2 Mont Ripley is a downhill ski area located northeast of the Quincy Smelting Works and
3 west of the town of Ripley (see Figure 3-87). The 35 acre site is owned by Michigan
4 Technological University. The topography offers skiers a vertical drop of 440 feet, largely
5 reflecting the varied relief present along the entire Portage hillside. Although this is the former
6 location of the Franklin Tram, the route is no longer easily discerned. The absence of woody
7 vegetation on the ski runs makes this topographic relief visible in all seasons. Red pine
8 plantings present near the top of the hill provide a wind buffer with pockets of successional
9 woodland vegetation found between ski runs and to the east and west of the hill. Infrastructure
10 includes the Mont Ripley Ski Chalet at the base of the hill, 24 ski runs, and a t-bar lift that
11 bisects the hill and a chair lift to the west. Large poles are positioned on the hill to support

12 lighting for night skiing. In recent years a pumphouse and waterline were installed east of the
13 smelter to convey water for snowmaking on the ski hill. The underground pipeline extends
14 beneath state highway M-26 into the ski area. Overflow visitor parking is located on a rough
15 graded gravel lot south of M-26, opposite the ski hill. This can present conflicts between
16 pedestrians crossing the road and motorists.

17
18 **Figure 3- 87: View looking north to the Mont Ripley Ski Area from the Quincy Smelting Works, 2006**
19 (source: QEA)
