## 1 **Chapter IV: Landscape Analysis**

3  
4       The historic landscape of the Quincy Unit of Keweenaw National Historical Park  
5 developed as a result of a world-wide demand for copper in the nineteenth and early twentieth  
6 centuries. The dense forests of the region gave way to an industrial landscape that extended  
7 along the spine of the Pewabic Lode from the crest of Quincy Hill to just beyond the shores of  
8 Portage Lake over the northern boundary of the company housing location of Mesnard. Other  
9 company housing locations were also clustered around the mining operations.

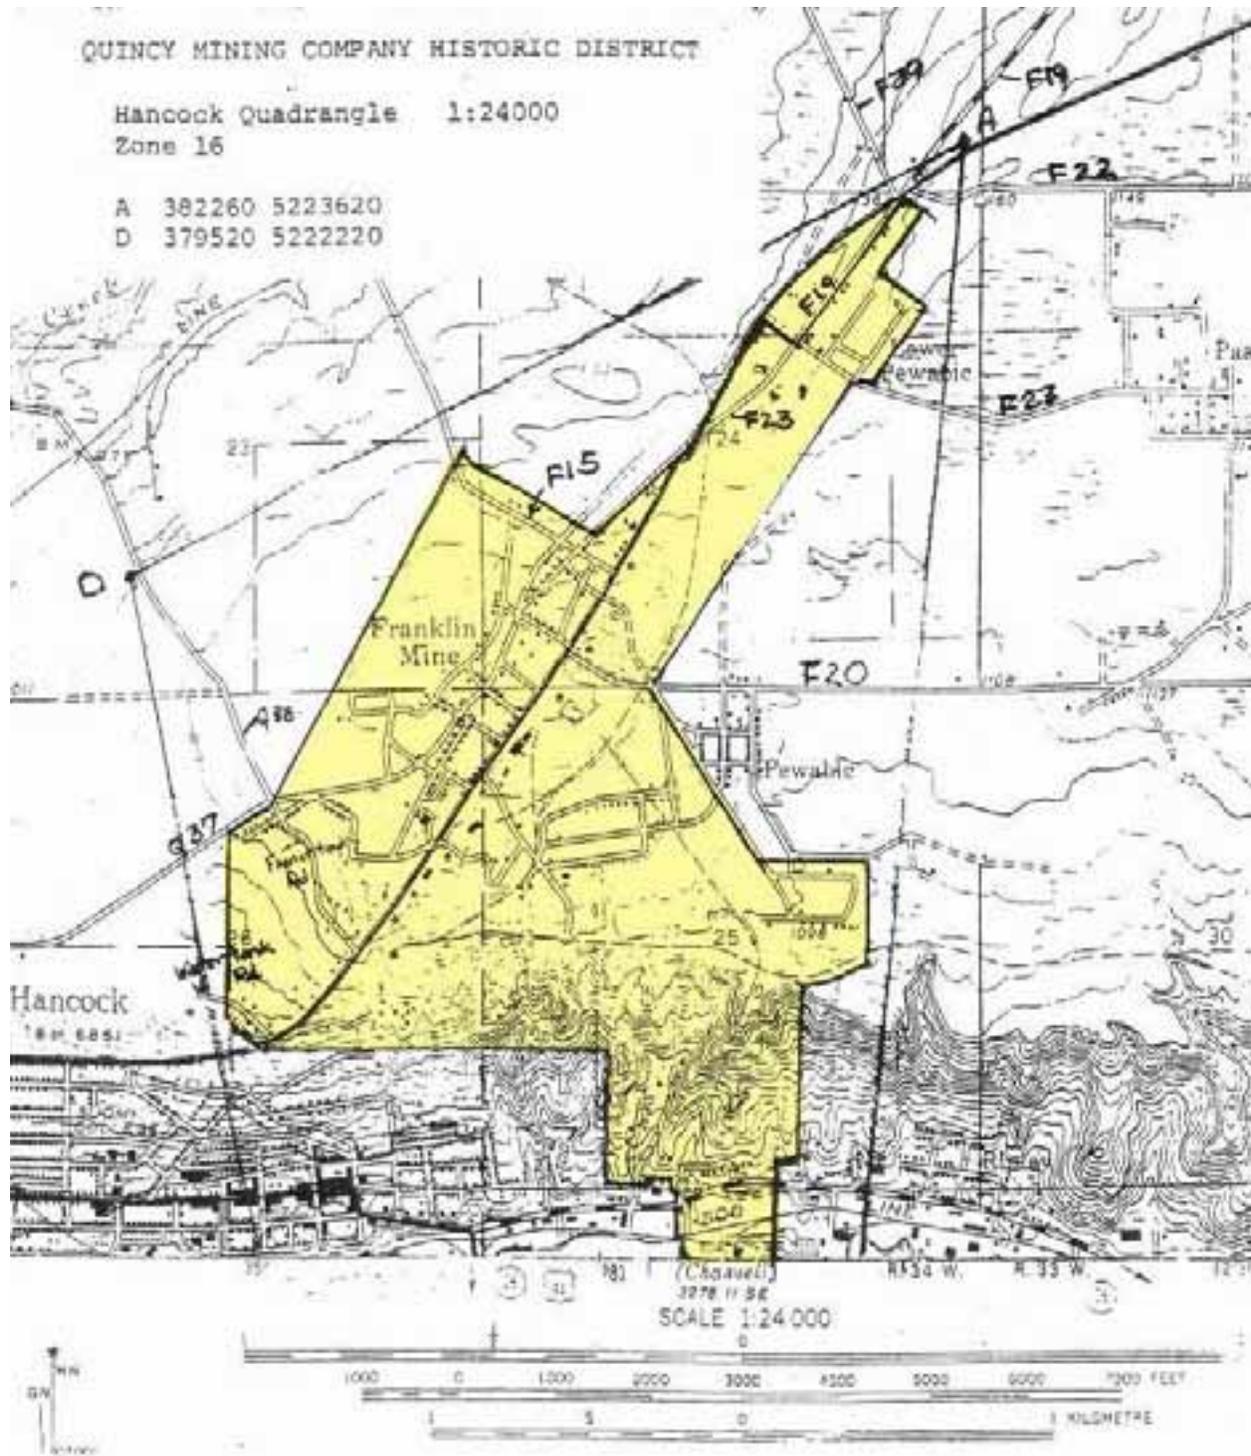
1  
2 **Figure 4-1: Quincy Mining Company Historic District, NHL boundary (district highlighted in yellow**  
3 **by QEA)**  
4  
5

11                    The district boundary includes extant resources directly connected with the Quincy  
12 mining operations including locations of mine shafts and buildings. In addition, it includes part  
13 of Quincy Hill, which connects the mining area with the Quincy Smelting Works and the  
14 administrative and residential structures that represent the support services necessary for the  
15 mining operations. The nomination includes both a detailed written description of the  
16 boundary and a map illustrating its location (see Figure 4-1). When Keweenaw National  
17 Historical Park was established in 1992, the boundaries of the Quincy Unit of the park were  
18 defined to closely reflect the National Historic Landmark District boundary.  
19

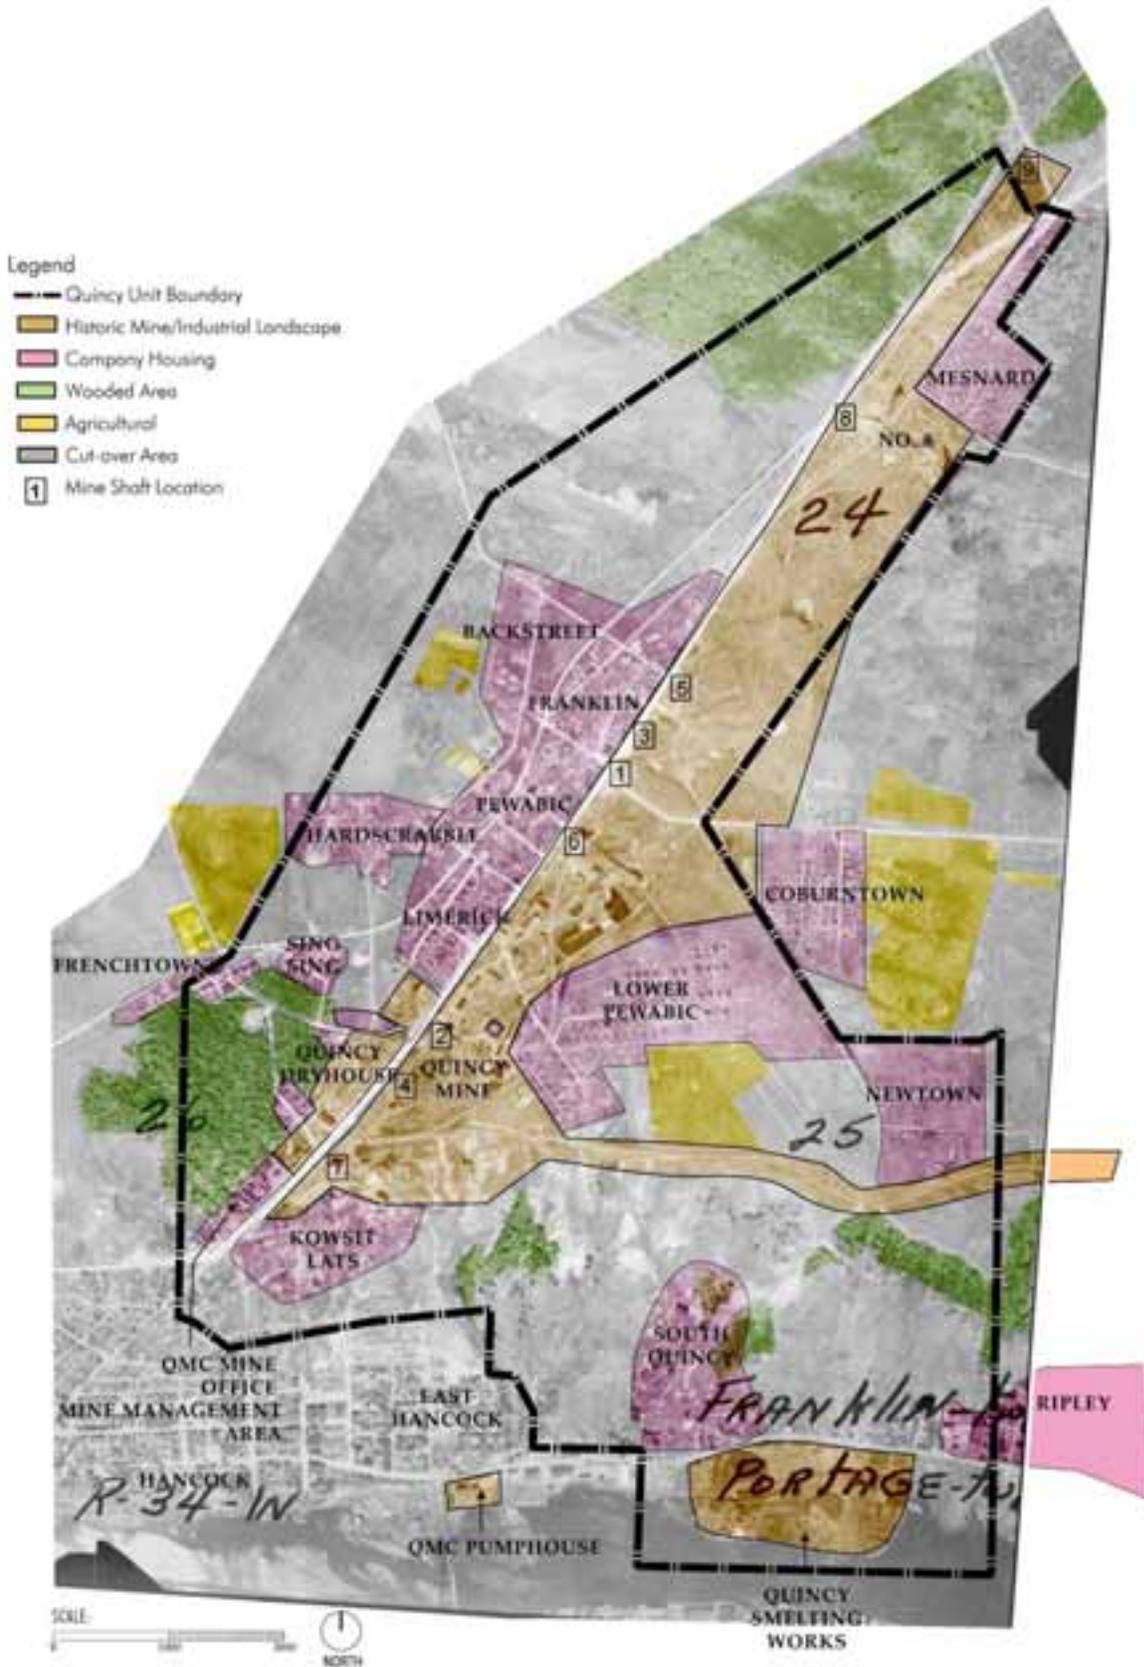
1  
2 Figure 4- 2: Quincy Unit Land Use, Peak Mining Period 1900-1910

4           During the peak mining period between 1900-1910 for the Quincy Mining Company  
5 (QMC), the majority of the Quincy Unit landscape was comprised of two distinct land uses,  
6 industrial/mine related and company housing. The industrial/mine land-use areas consisted  
7 of numerous shaft-rockhouses, hoist houses, other mine related buildings, a multitude of  
8 railroad tracks and trestles, cooling ponds, the Quincy Smelting Works, and expansive poor  
9 rock piles. The company housing consisted of several QMC housing locations on Quincy Hill  
10 and South Quincy and Ripley near the Quincy Smelting Works. Many of these housing  
11 locations were developed with uniform housing and fenced yards. Other housing locations  
12 contained less regimented layouts with varying architectural styles, lot sizes and setbacks.  
13 From 1900 to 1920 industrial/mine related and company housing land uses dominated the unit

14 and agricultural land use was also present (see Figure 4-2).<sup>5</sup>

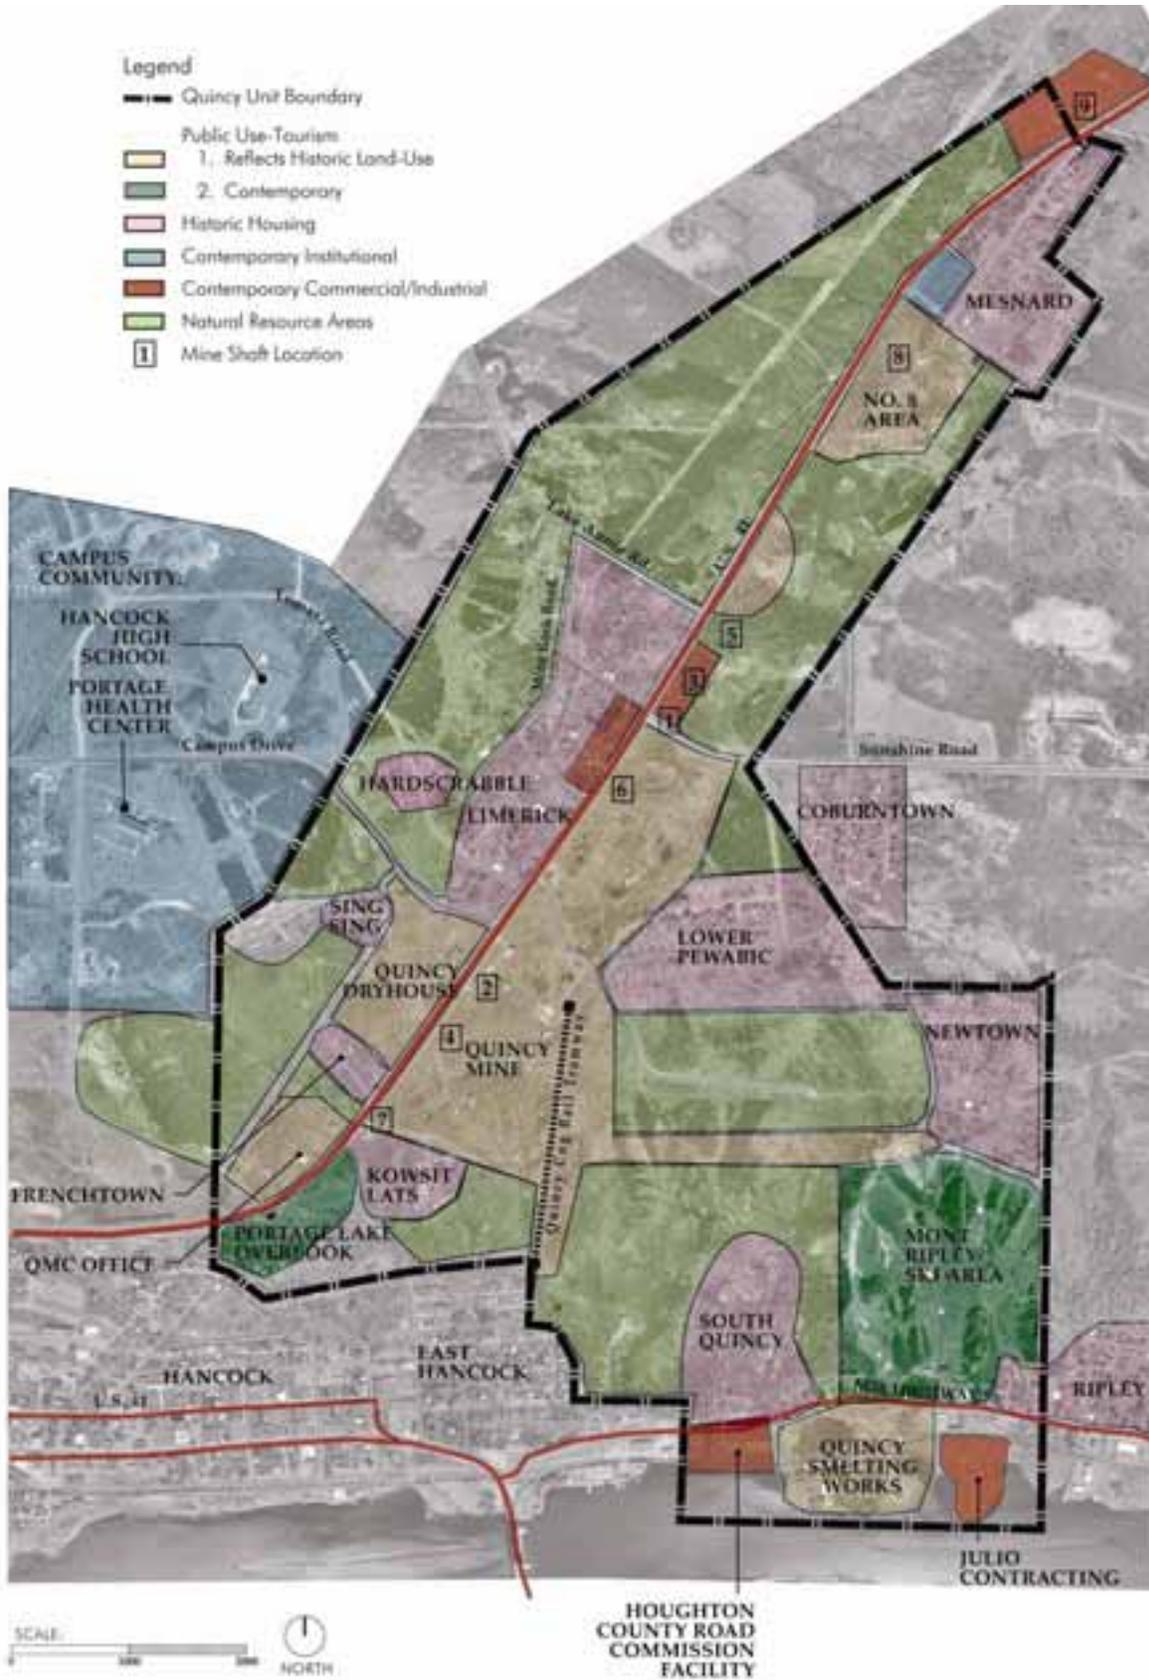
1  
2 Figure 4- 3: Quincy Unit, Existing Land Use

15           With the decline of the copper industry beginning in the late 1920s, the Quincy Mining  
16 Company progressively scaled back mining operations and eventually closed in 1945. Today,  
17 the landscapes within the Quincy Unit are used for residential, commercial, industrial,  
18 institutional and recreational purposes (see Figure 4-3).

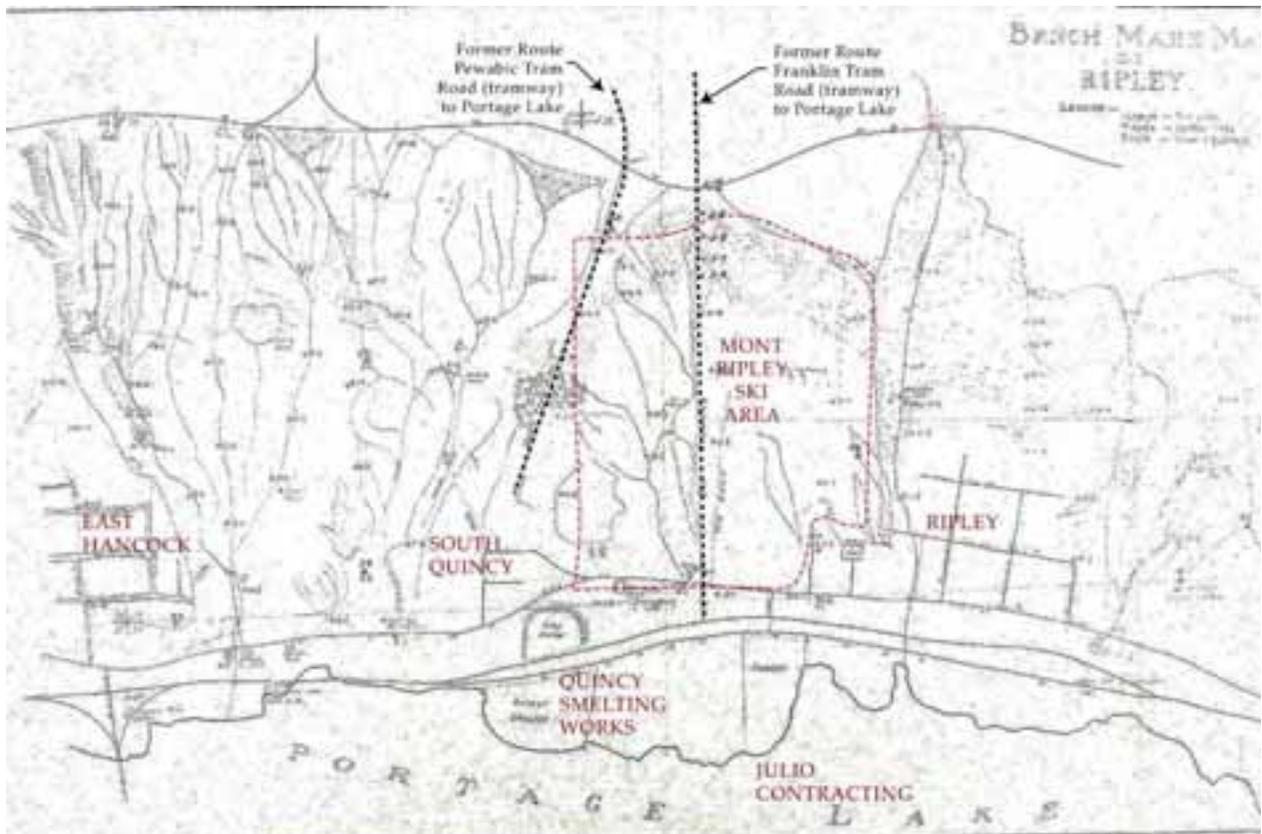
11 Figure 4- 4: Map titled, "Bench Mark Map of Ripley 1932," with text and graphics added by QEA,  
12 2007. The current location of the Mont Ripley Ski Area is outlined in red (source: KEWE archives)  
13  
14  
15

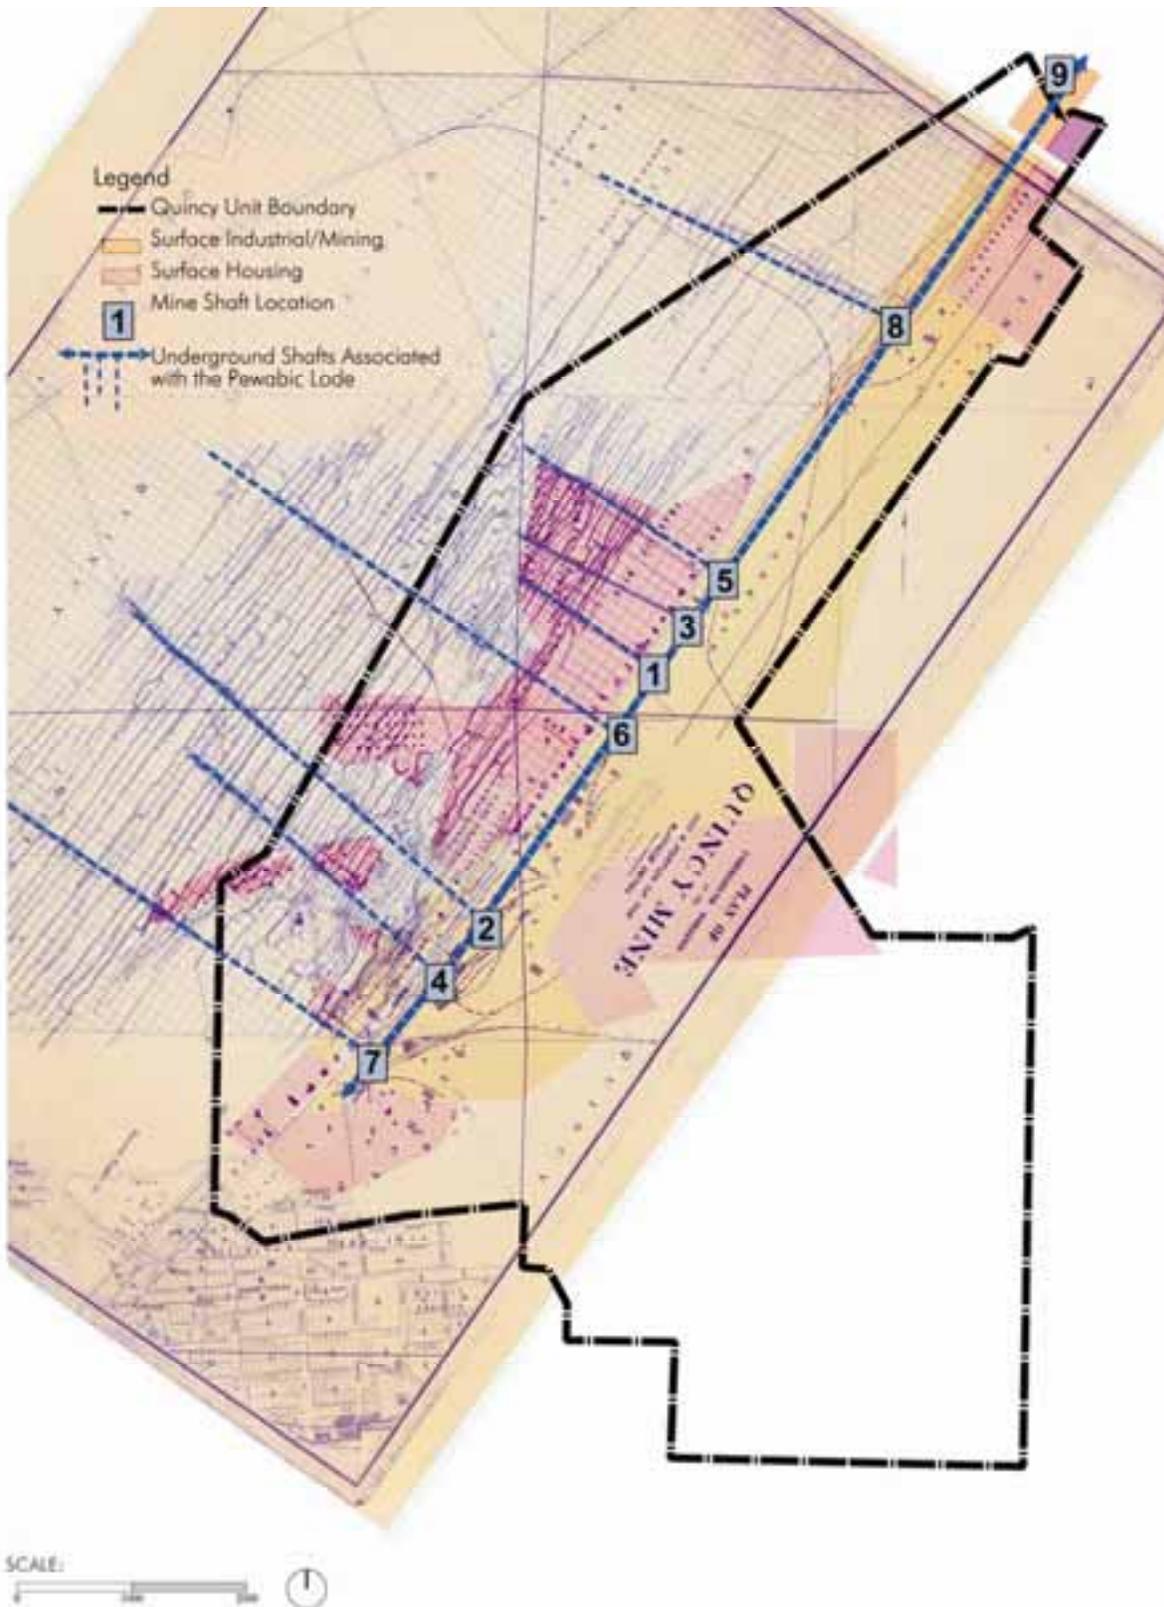
Figure 4- 9: Quincy Unit 1920 land use overlaid on “The Underground Workings of the Quincy Mine and a Portion of the Surface Detail,” ca. 1900s (added graphics by QEA 2007).

2  
3 Historically, the underground resources of the Pewabic, Franklin, and Quincy mining  
4 companies determined the broad-scale aboveground spatial organization of landscape features  
5 related to the mining operations. Belowground the Pewabic Lode extended from shaft-  
6 rockhouse No. 7 at the crest of Quincy Hill, northward to shaft-rockhouse No. 9 in Mesnard.  
7 Shafts led to drifts that extended a network of horizontal tunnels perpendicular to Highway 41  
8 amidst the Pewabic lode and beneath the extensive company housing locations to the west. The  
9 intense network of rock crushing shaft-rockhouses, hoist houses, multitude of railroad tracks  
10 and trestles, cooling ponds, and expansive poor rock piles were located east of the spine of the  
11 Pewabic Lode (see Figure 4-9).

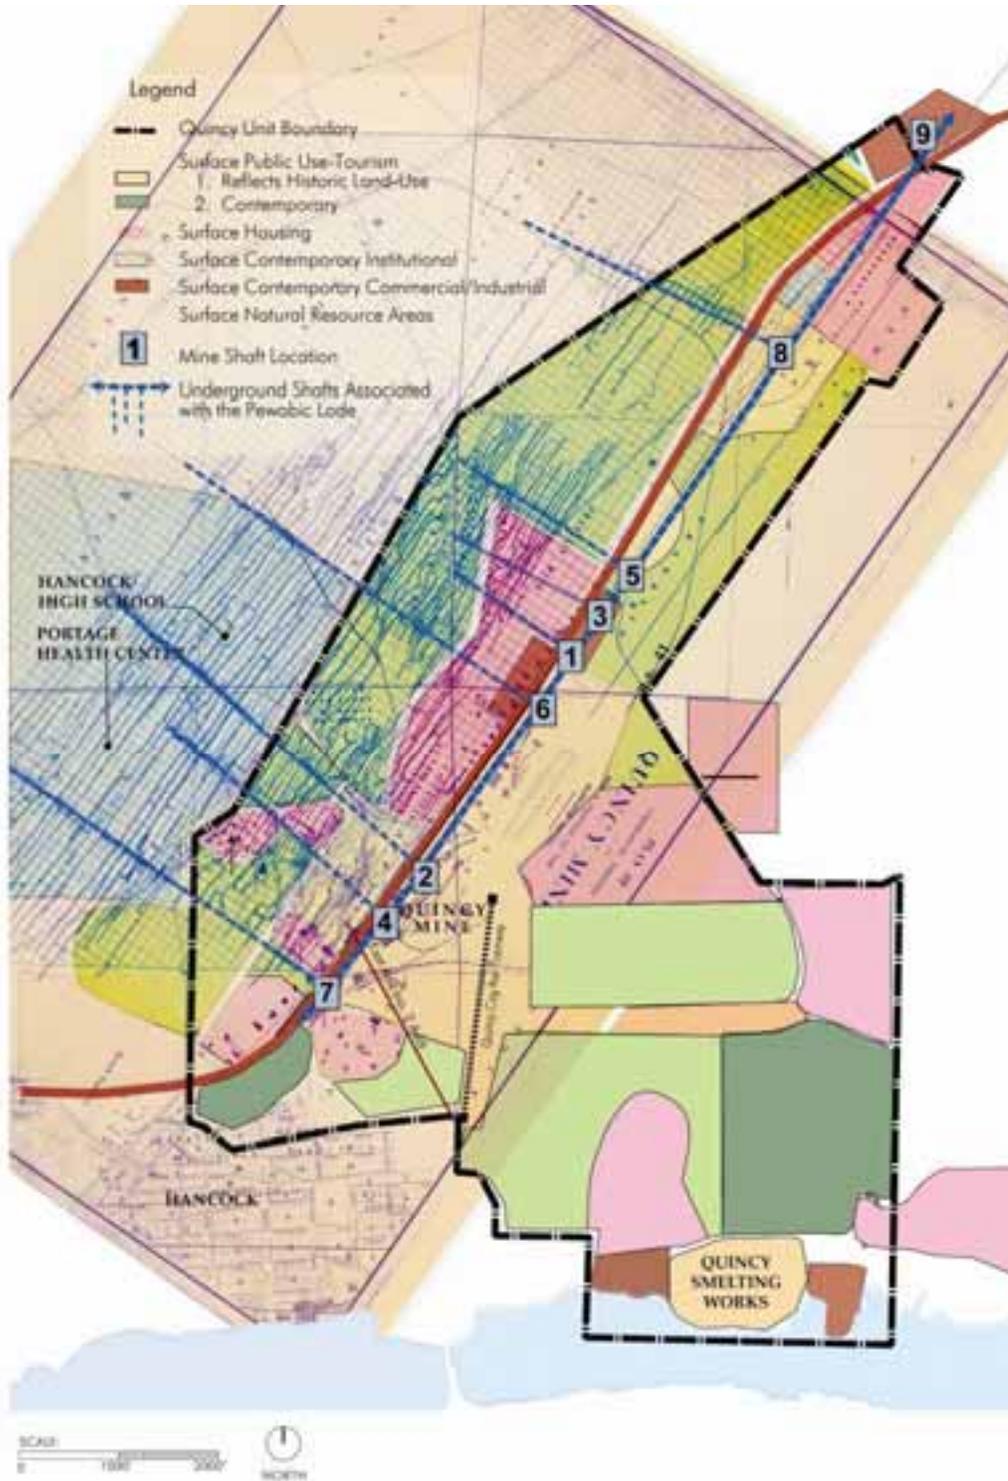
1  
2 Figure 4-10: Quincy Unit, Spatial Organization Analysis, Existing Land Use overlaid on "The  
3 Underground Workings of the Quincy Mine and a Portion of the Surface Detail," ca. 1900s (additional  
4 graphics by QEA 2006).

12 Today, the relationship of the below ground mining operations with the above ground  
13 spatial organization has been somewhat obscured, but upon consideration the general  
14 relationships remain intact (compare Figures 4-9 and 4-10). Highway 41 cuts through the  
15 Quincy Unit marking the early circulation route and indicating the location of the Pewabic  
16 Lode. Institutional land use, including the Campus Community of the Portage Health Center  
17 and Hancock High School straddle the underground copper veins historically associated with  
18 the Quincy No. 2 and No. 4 mine shafts. However the existing mine related landscape and the  
19 remnant company housing locations still maintain their historic spatial relationship with the  
20 historic locations of the underground mine. At present, mining tours conducted by the Quincy  
21 Mine Hoist Association, take visitors on the Quincy Cog Tramway near the No. 2 hoist house

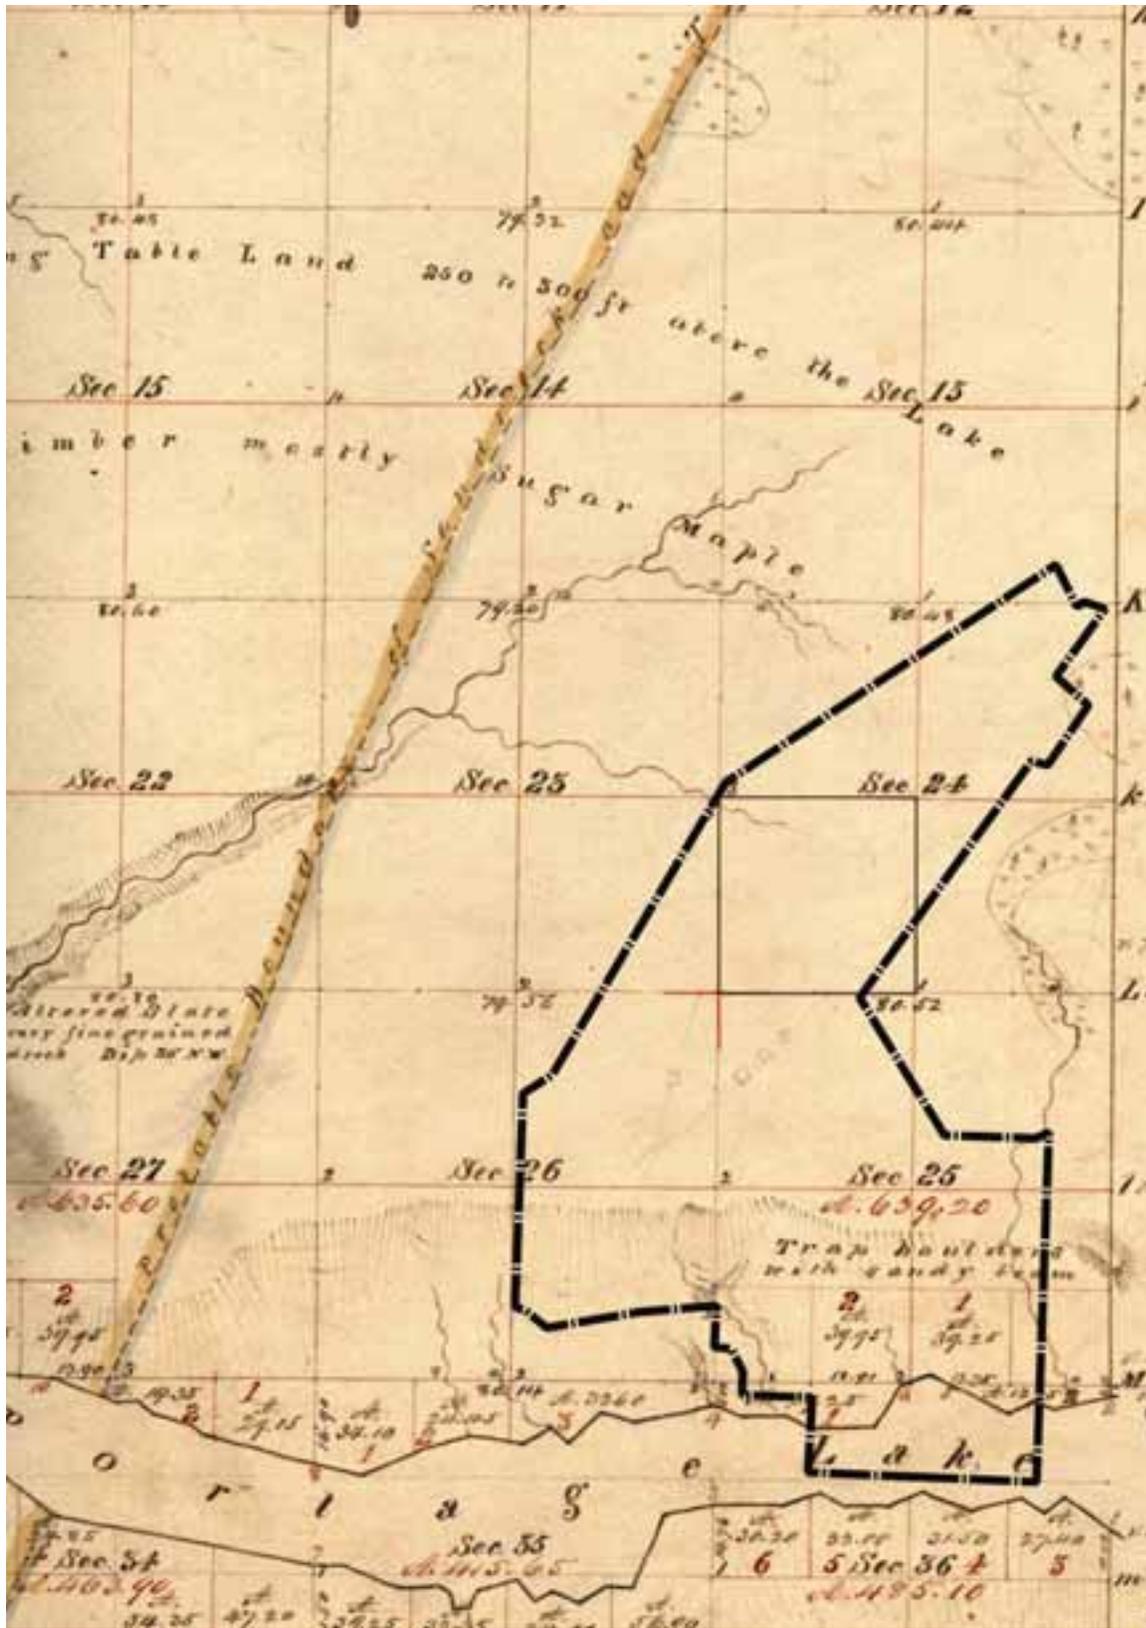
1  
2 Figure 4-11: Portion of the William A. Burt and Bela Hubbard survey drawing (1845) with the  
3 existing Quincy Unit boundary added by QEA 2007 (source for map: KEWE archives)

When Hubbard and Burt surveyed the Keweenaw in 1845, they indicated the presence of an abundant growth of sugar maple, birch, fir, oak and white pine as well as some swamp or marshland. Although their notes regarding vegetation are not detailed, one can gather from the survey drawing notations that the area now within the Quincy Unit included the general vegetative features described (see Figure 4-11).

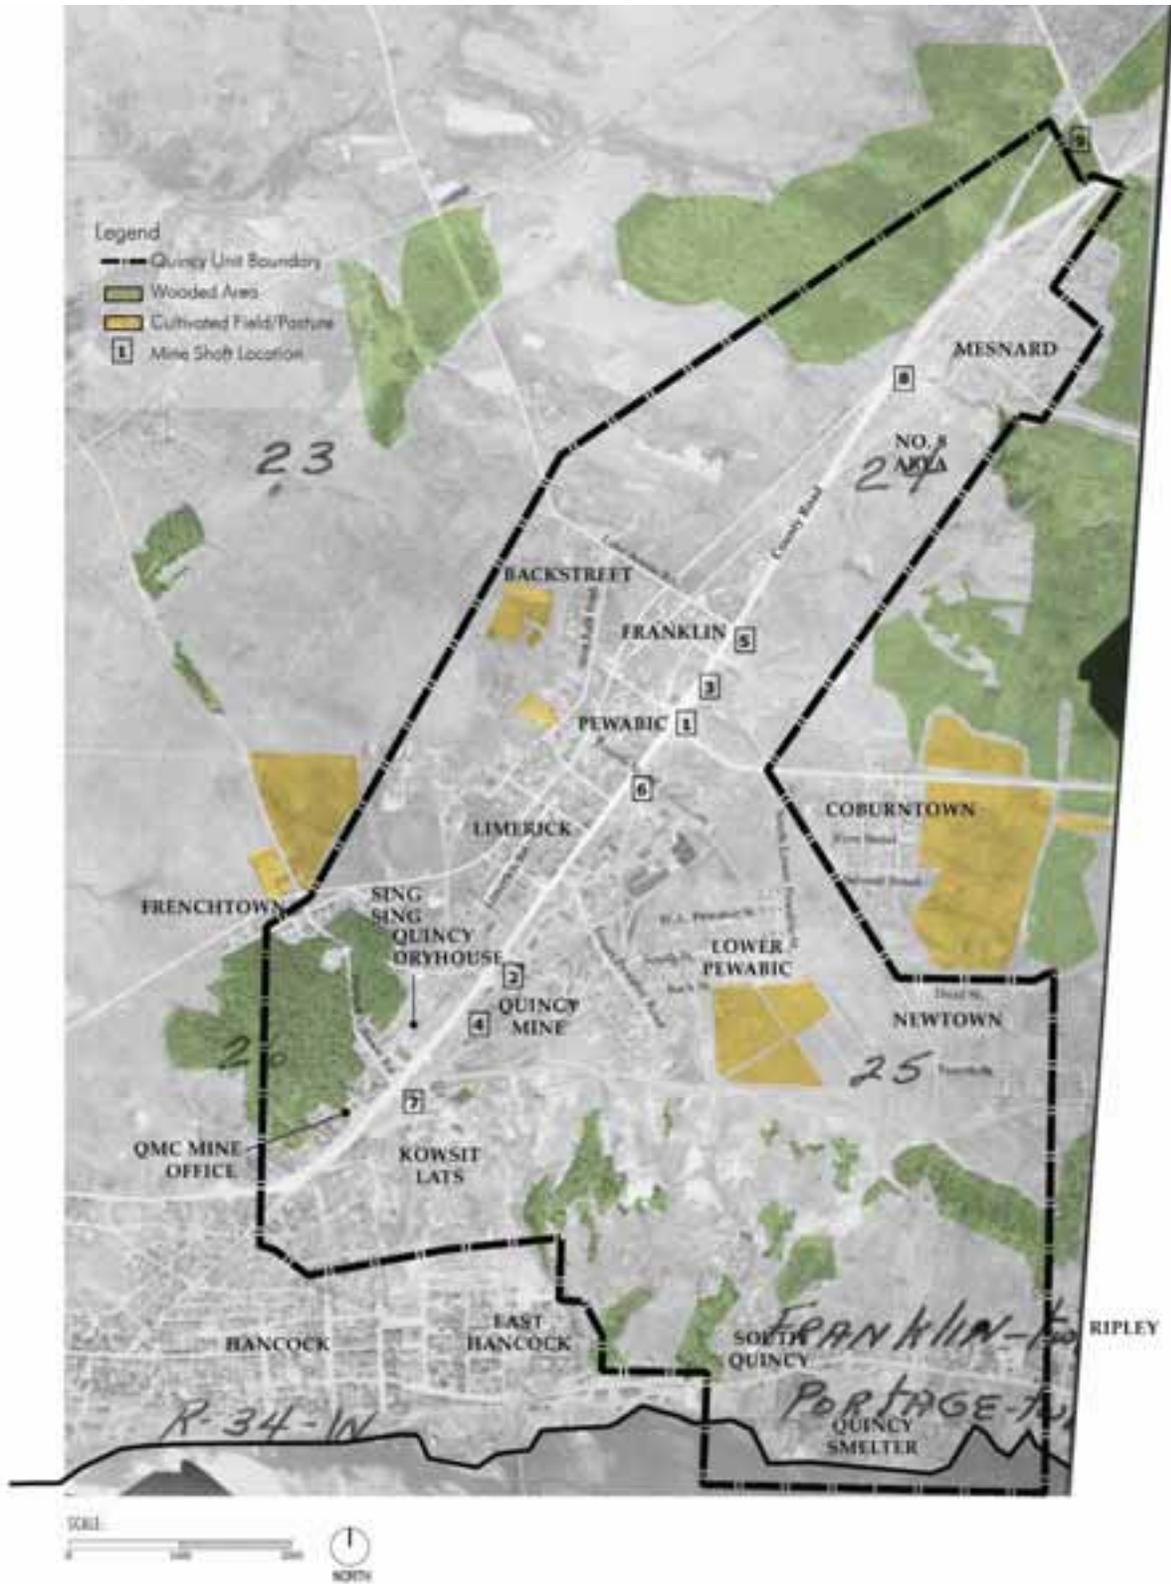
1  
2 Figure 4-12: Quincy Unit, Vegetation 1920s-1930s

Large portions of native vegetation were gradually removed with the spread of mining operations and development of housing locations on Quincy Hill. Trees were cut to clear land for development and to provide building materials and fuel.<sup>6</sup> By the peak of the mining period, only small clusters of woodland remained. These were surrounded by an industrial landscape which included practically no vegetation, and residential areas that included small amounts of ornamental plants, fruit trees, and vegetable gardens. Although areas were set aside for agriculture, it is not clear how much of the Quincy farm was located within the current Quincy Unit. Nevertheless, agricultural uses occurred in the close vicinity. These included small orchards, pasture and cultivated fields. Analysis of an aerial photograph taken in ca. 1920s-1930s shows the approximate extent of wooded and agricultural vegetation during that period (see Figure 4-12).

Within the Quincy Unit today vegetation is much more prevalent than it was during the height of mining activities (compare Figure 4-12 to Figure 4-13). Abandoned industrial and company housing sites are overgrown with volunteer herbaceous and woody plants that can obscure cultural patterns on the landscape including ruins of buildings, poor rock piles, views,

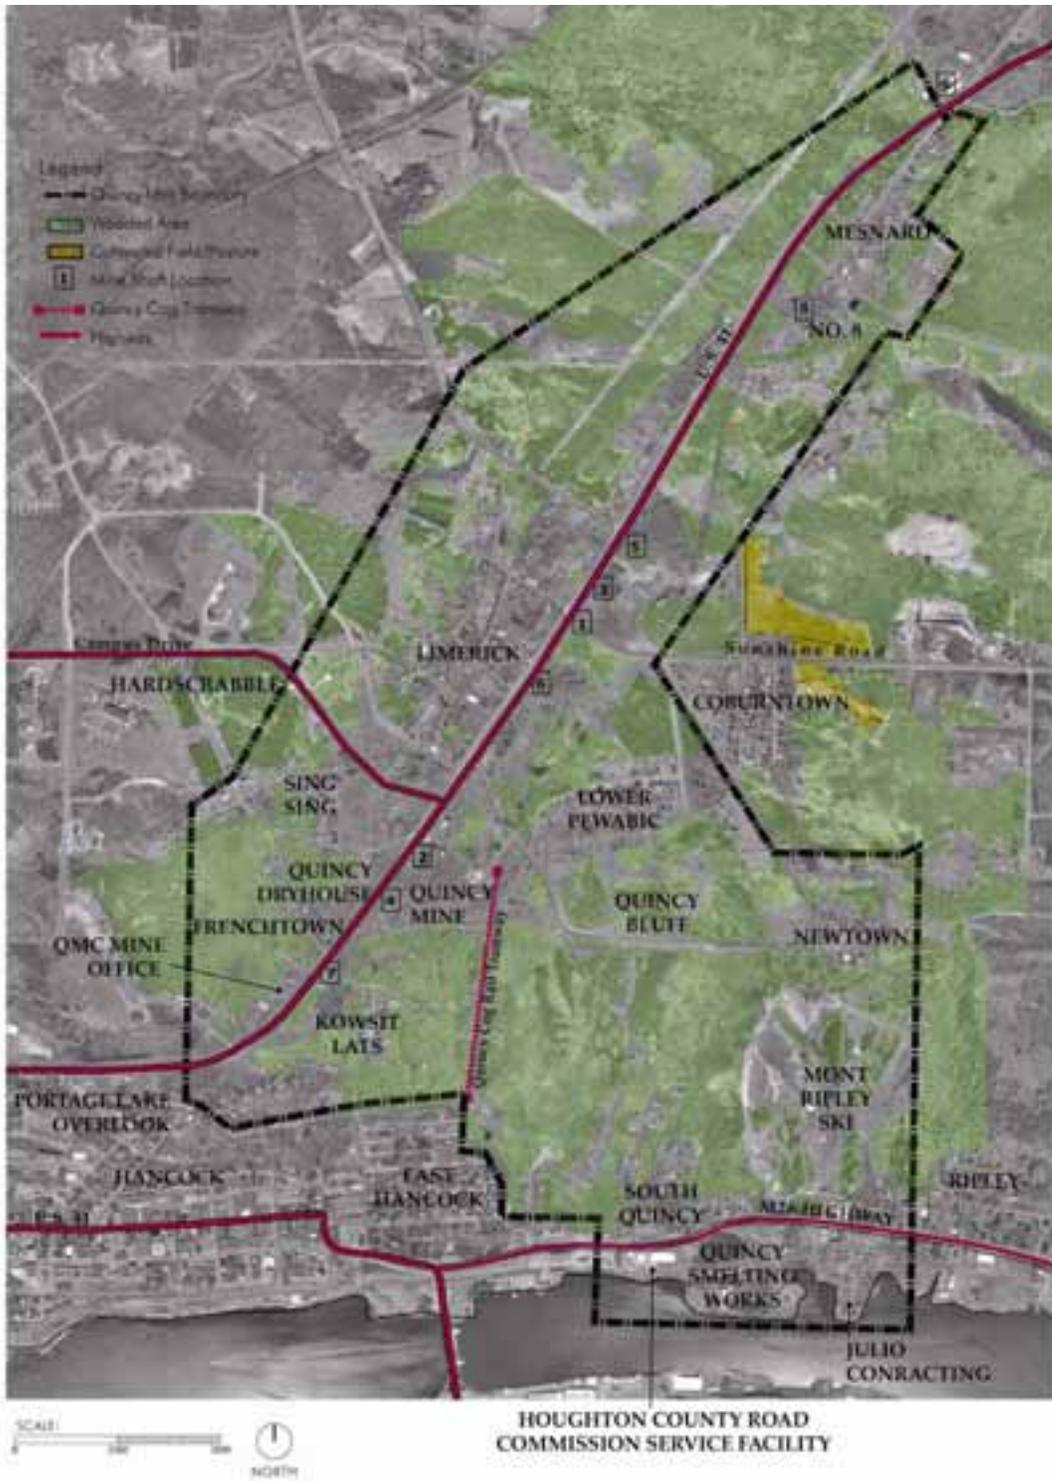
1  
2  
3  
Figure 4-13: Quincy Unit Current Vegetation

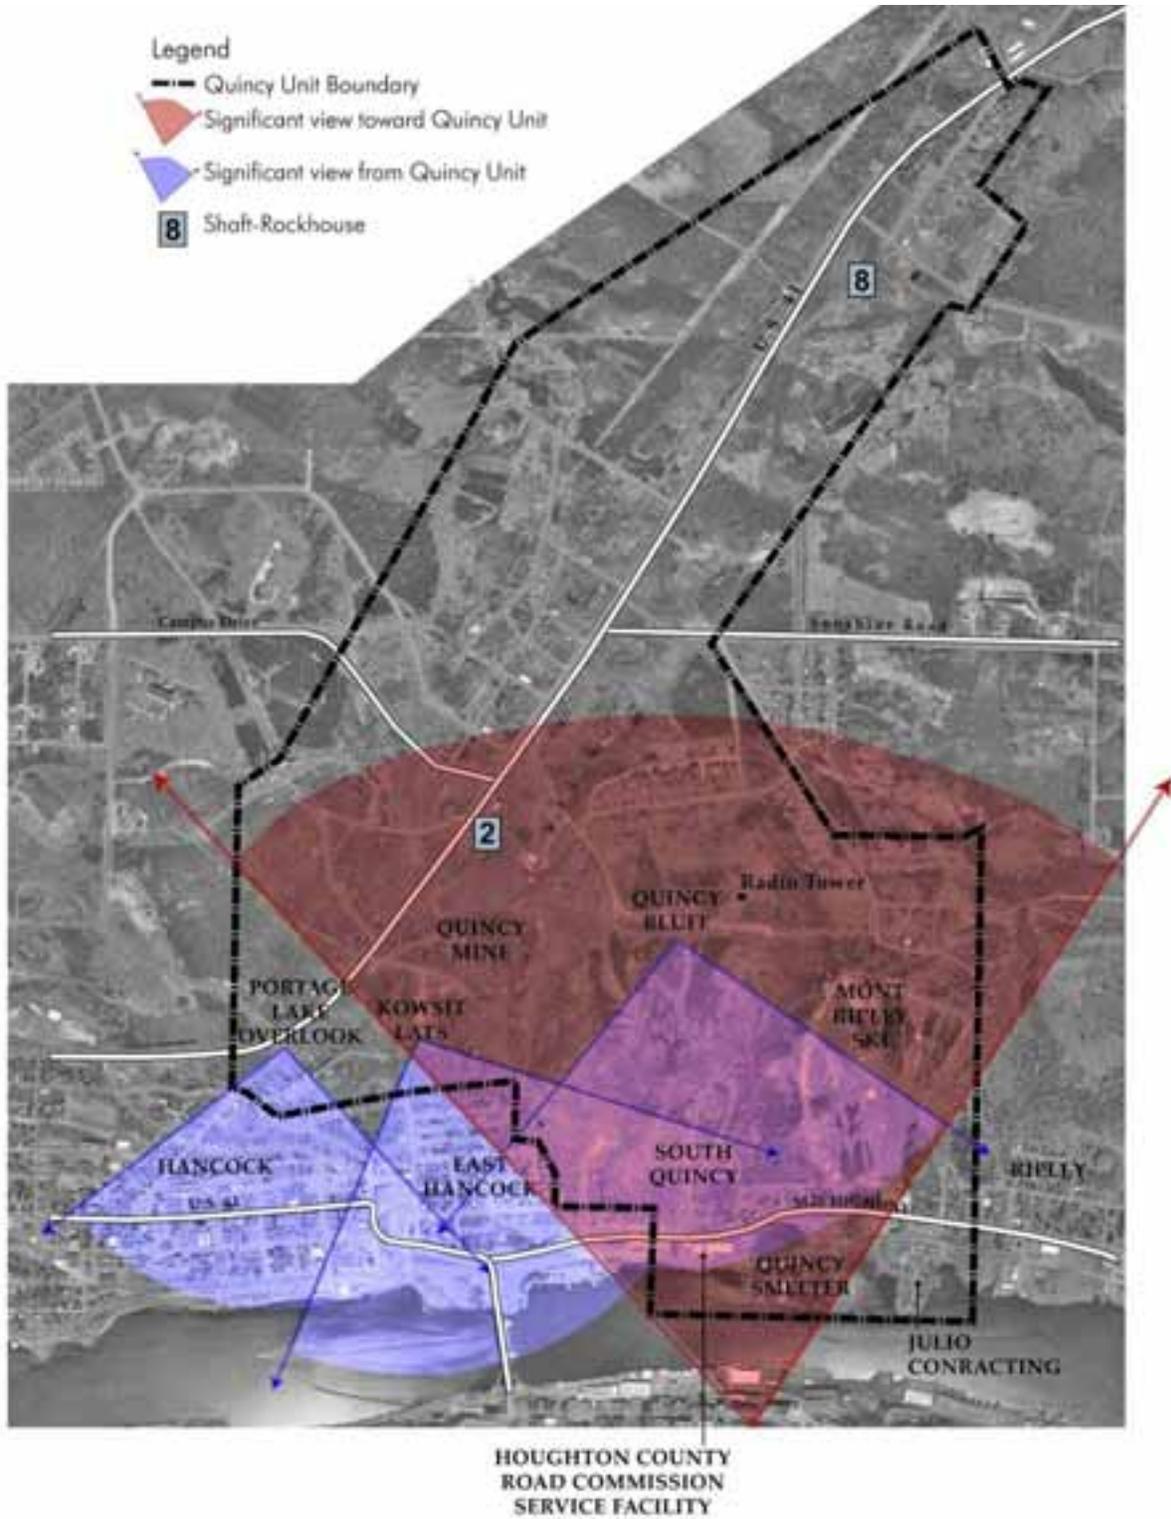
1  
2 Figure 4-14: Quincy Unit, Significant Views

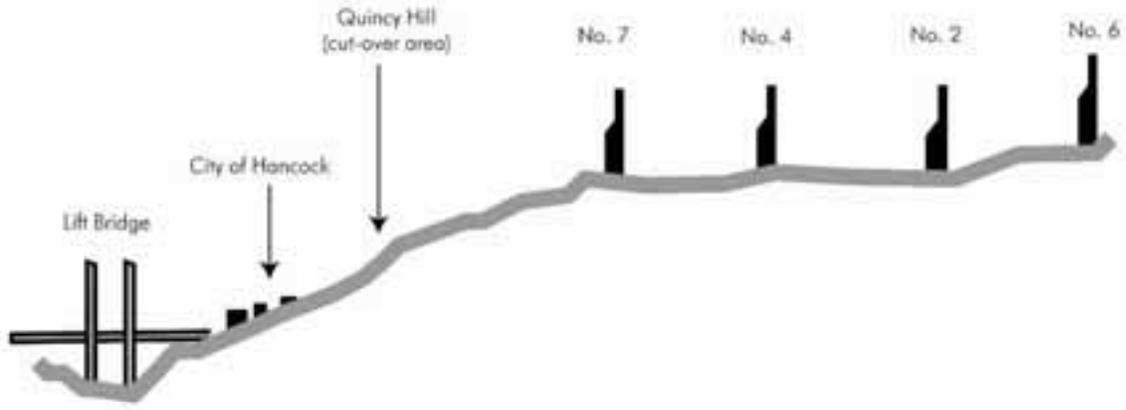
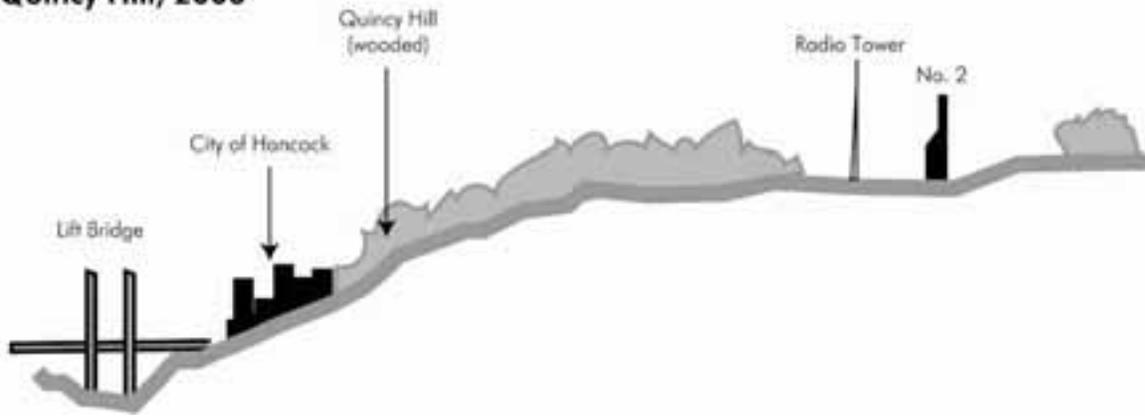
Figure 4-15: Section View of Quincy Hill, Topography and View Analysis

**Quincy Hill, 1913**

**Quincy Hill, 2006**

12 dominated mining operations on Quincy Hill. Today the No. 2 shaft-rockhouse is the dominant  
13 visual legacy of this previous mining era (see Figures 4-15 and 4-16). In particular, the No.2  
14 shaft-rockhouse provides an identifiable visual landmark from as far away as Chassell when  
15 traveling on U.S. 41 and the from the South Range when traveling on M-26.

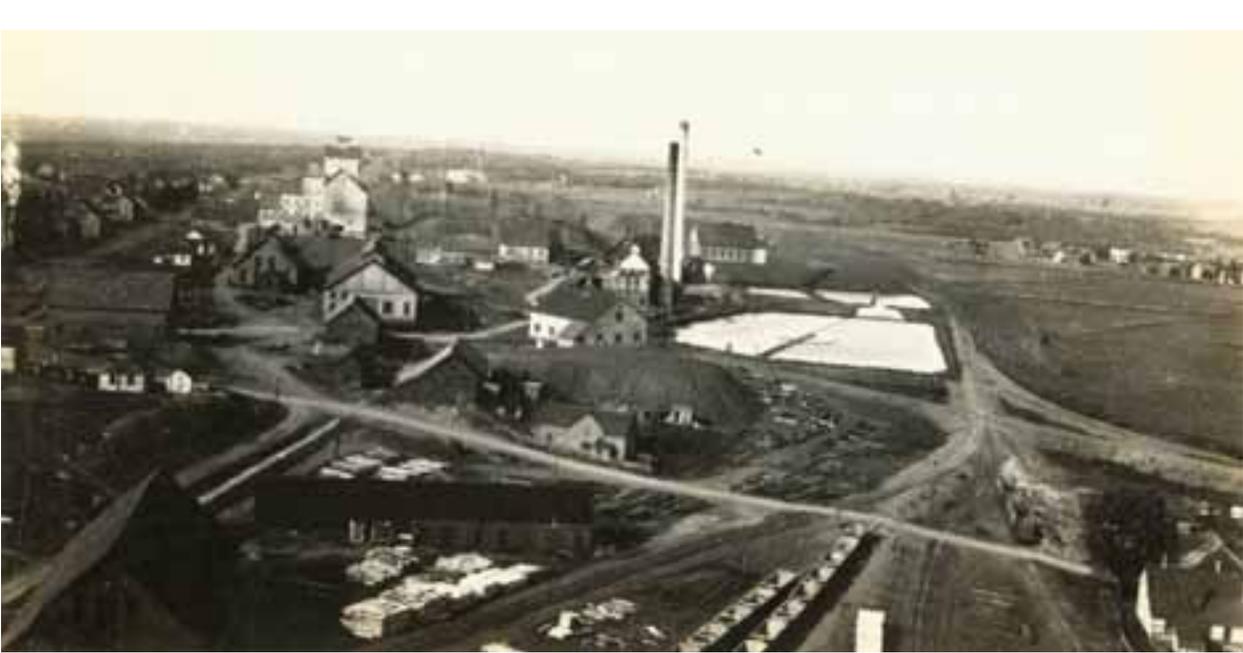
Figure 4- 20: View north from No. 2 shaft-rockhouse toward No. 6; the Blacksmith Shop and Machine Shed are on the left, railroad routes bisect the site, ca 1915 (source: KEWE archives)

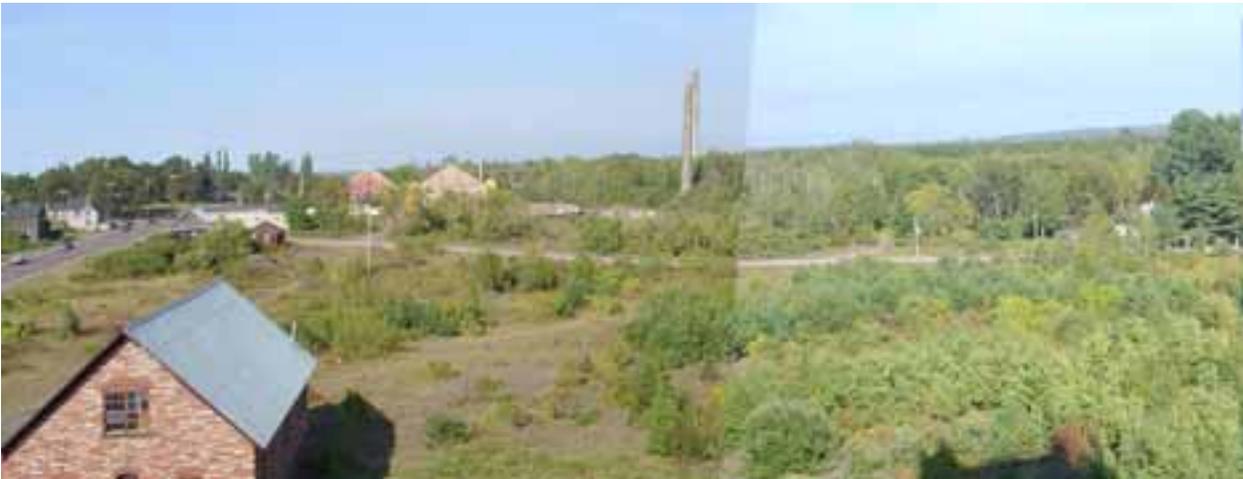
Figure 4- 21: View north from No. 2 shaft-rockhouse toward the former location of No. 6, subtle railroad grades are the only remnants of a concentrated network of railroad routes that historically was present, 2006 (source: QEA)

1           The 1880s brought the railroad to the Keweenaw Peninsula. In 1886 the Mineral Range  
2 Railroad constructed a branch line to Quincy (see 1886-1888 Period of Change Plan in Chapter  
3 II). By the 1890s a complex network of rail routes bisected the Quincy Mine, linking the various  
4 functions of the mine operations (see Figure 4-20).<sup>7</sup> Today only a few remnants of this network  
5 are extant. These include traces of railroad grades, the few remaining rail lines, remnants of  
6 trestles, and some rolling stock (see Figure 4-21).
