Caring For A Monumental Sculpture

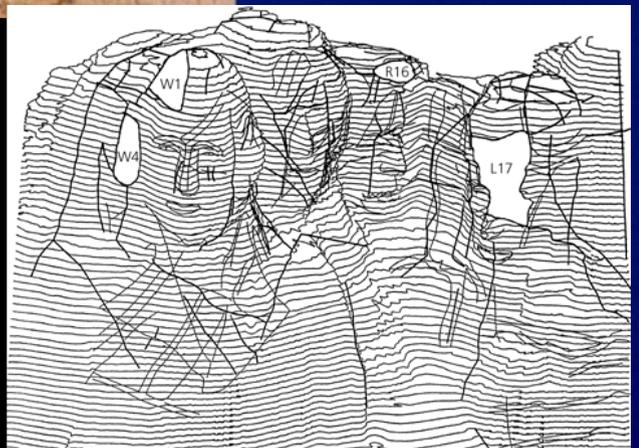
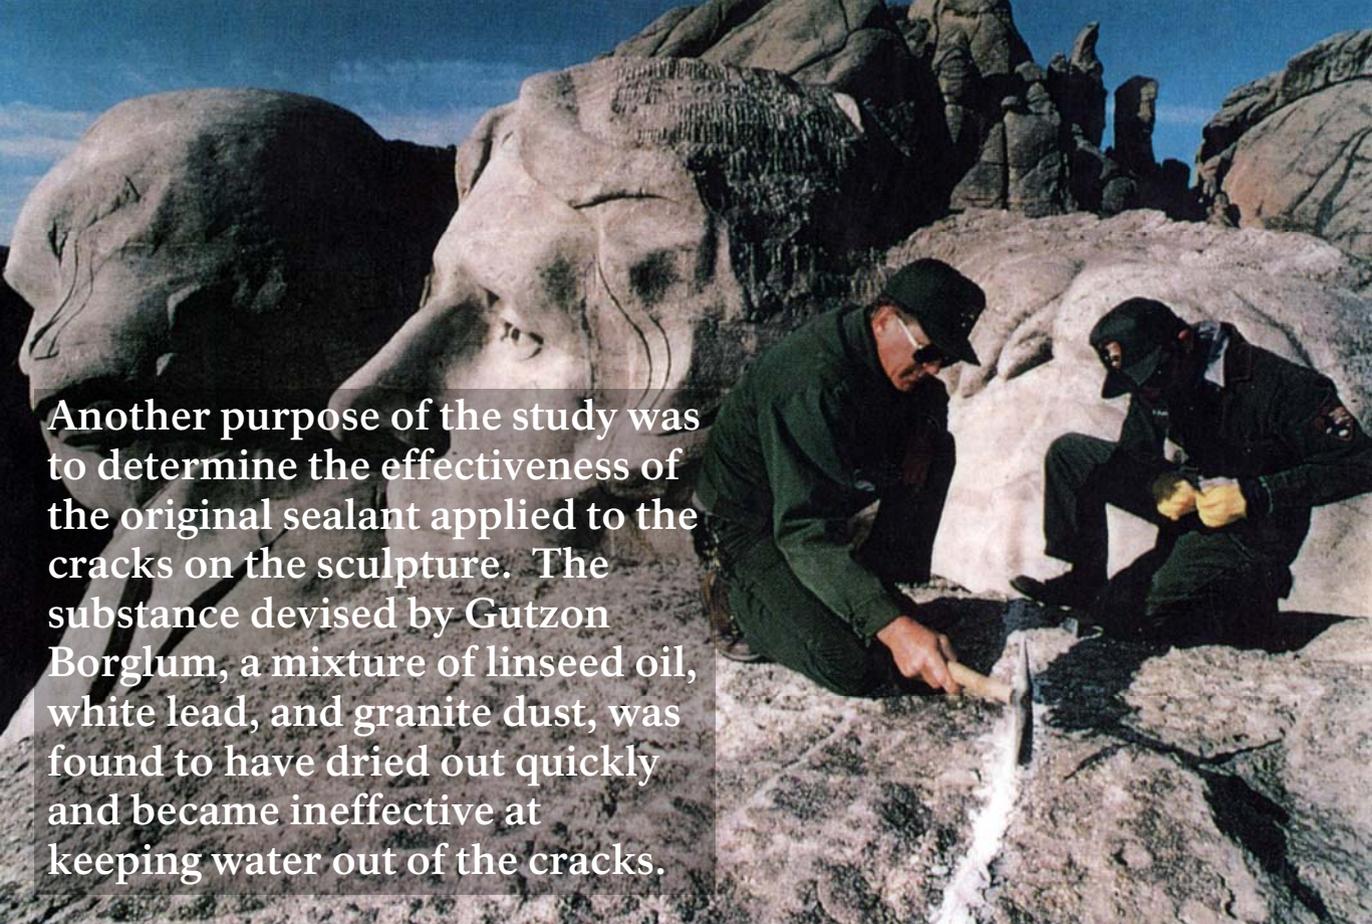
Using a method known as Key Block Analysis, the blocks of granite in the sculpture were identified and categorized. Four blocks have been identified as potential key blocks, and are located in the sculpted faces of George Washington, Abraham Lincoln, and Theodore Roosevelt. If any of three of these potential key blocks were to move, it is believed this would allow other blocks of granite to move also.

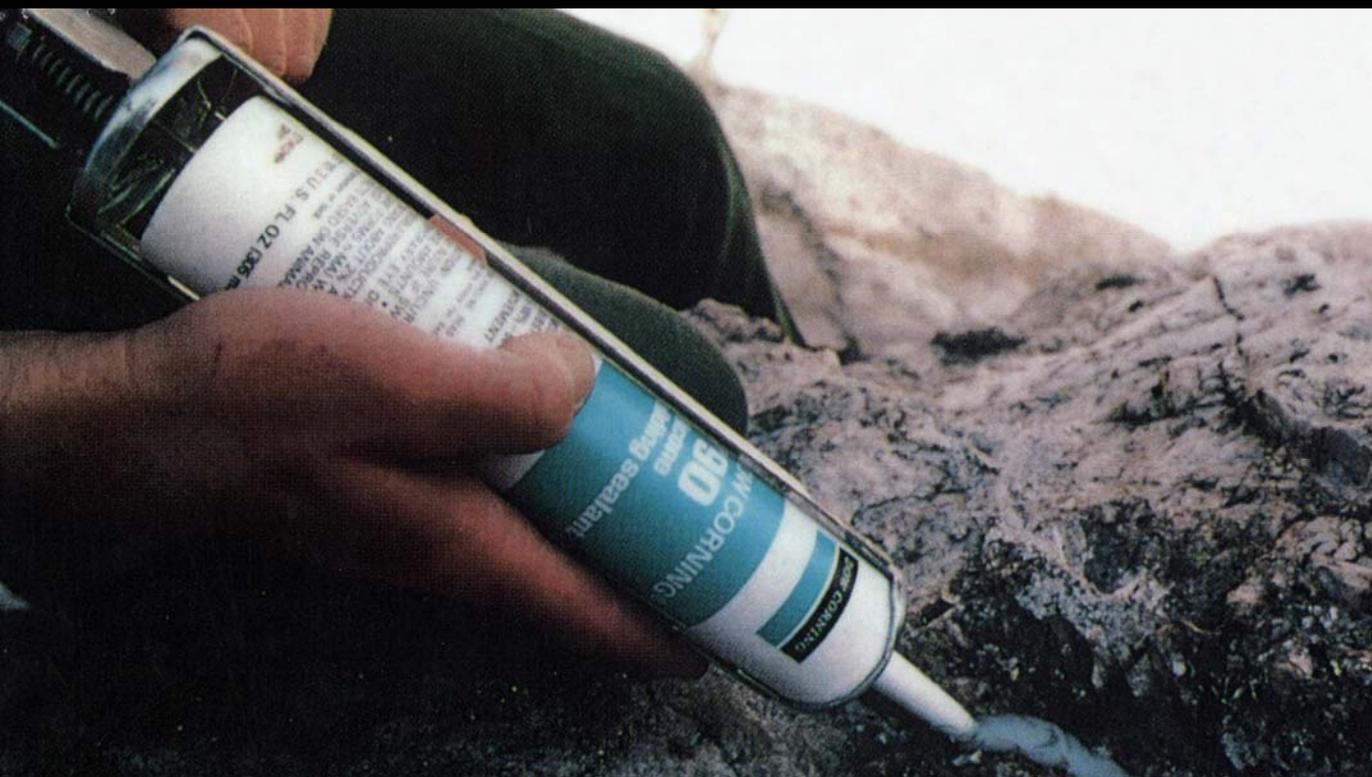
Another purpose of the study was to determine the effectiveness of the original sealant applied to the cracks on the sculpture. The substance devised by Gutzon Borglum, a mixture of linseed oil, white lead, and granite dust, was found to have dried out quickly and became ineffective at keeping water out of the cracks.

National Park Service staff began removing the old sealant and replacing it with a modern silicone sealant. Modern sealants are better able to withstand the extreme temperature and moisture variations that occur on Mount Rushmore. Similar to what Borglum had done, the silicone is camouflaged after it is applied by sprinkling granite dust on its surface.

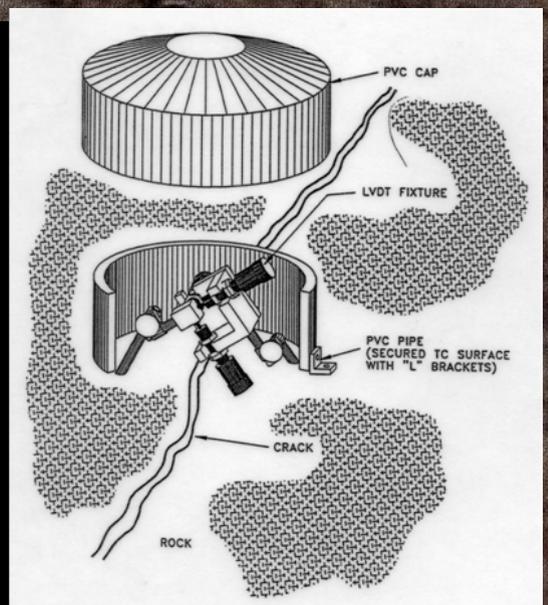
As part of the efforts to preserve Mount Rushmore National Memorial, a monitoring system was installed in 1998. Electronic instruments capable of measuring even slight movement in three dimensions were placed along some of the major fractures. The instruments also record the temperature of the air and the rock surface.

The instruments are attached directly to the sculpture and are capable of measuring movement of less than 0.0001 inches. Measurements are recorded four times a day and relayed to a central computer.
