National Register of Historic Places Registration Form

historic name Peirce Mill (expanded nomination)

street & number NW corner of Tilden Street and Beach Drive, N.W. (Rock Creek Park) not for publication

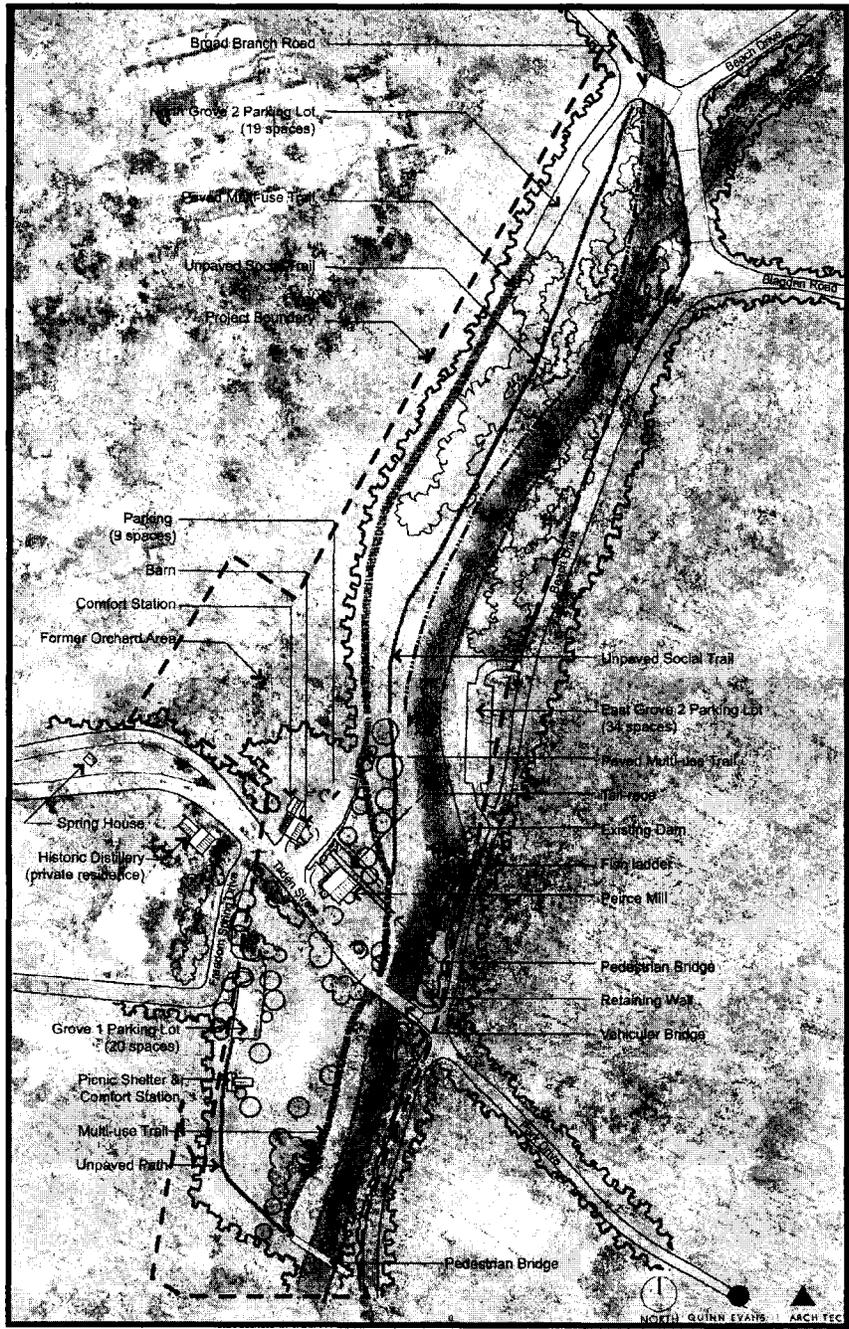
Site Plan, Peirce Mill

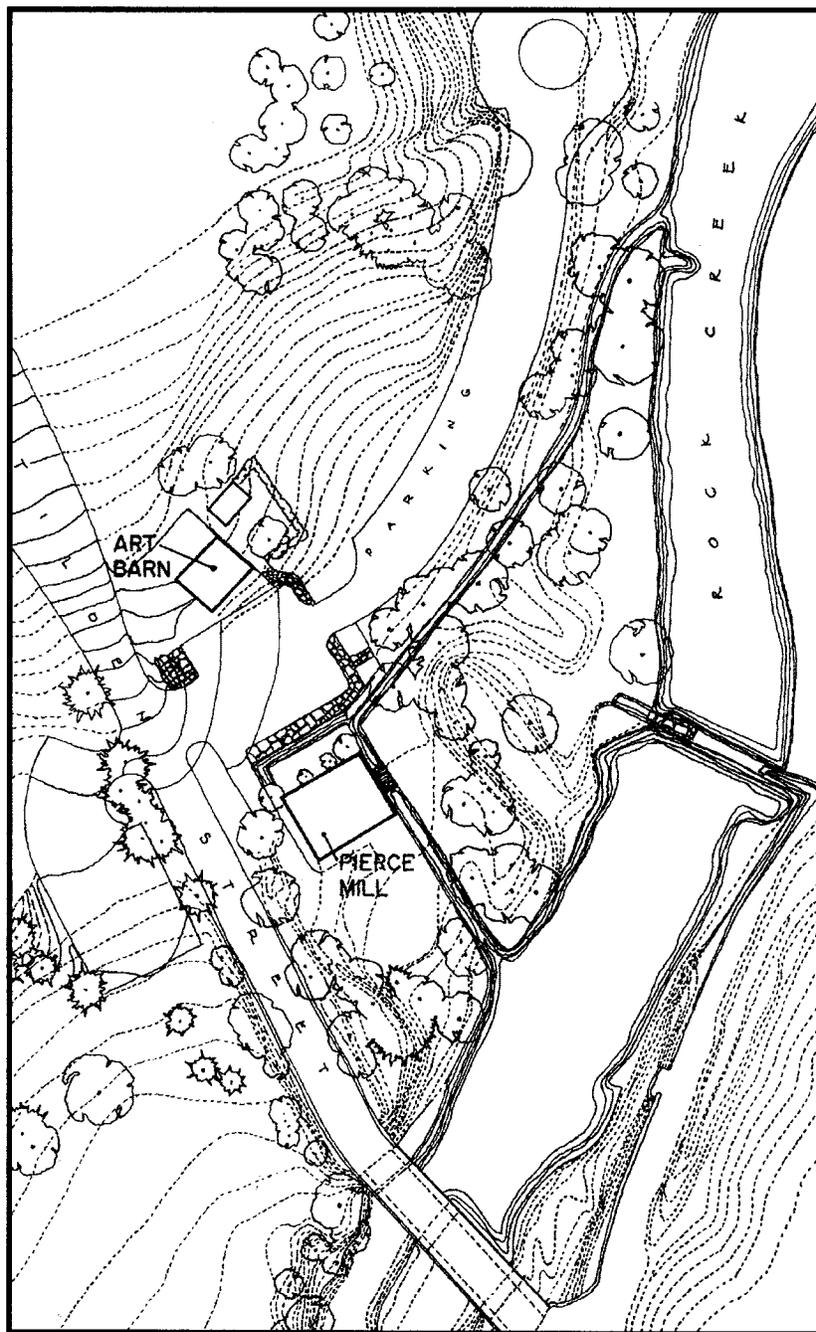
Peirce Mill, Schematic, 1990

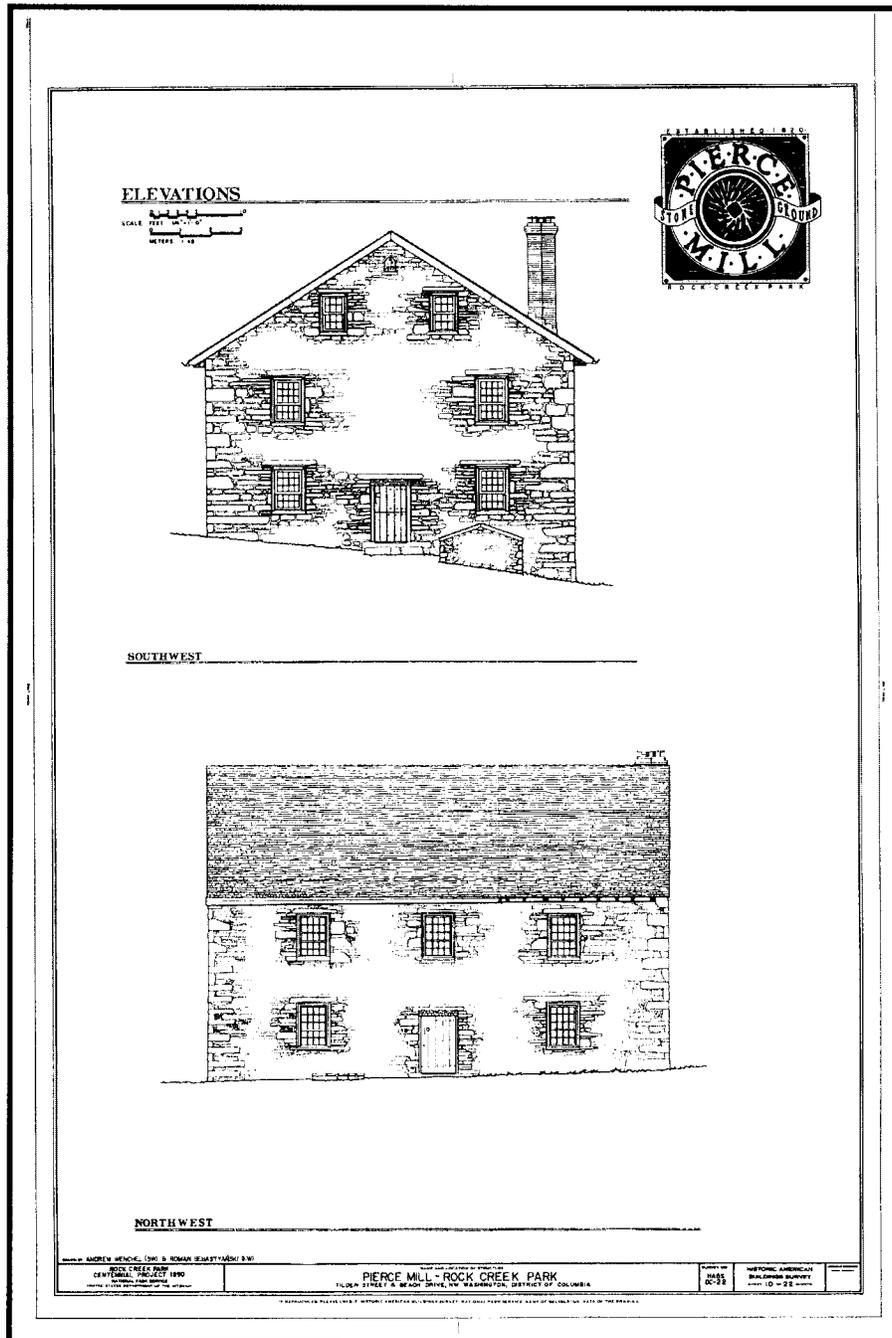
Peirce Mill, Elevations, 1990

Peirce Mill is a large two-and-one-half-story, three-bay structure easily identifiable in the typical form of an early-nineteenth-century stone mill. Set on a solid granite foundation, this rectangular building is 50 feet and 1 inch wide by 40 feet deep. Laid with lime mortar, the building has blue granite walls of randomly coursed and sized stones. At the corners of the building, quoins are created using oversized stones, some with the veins

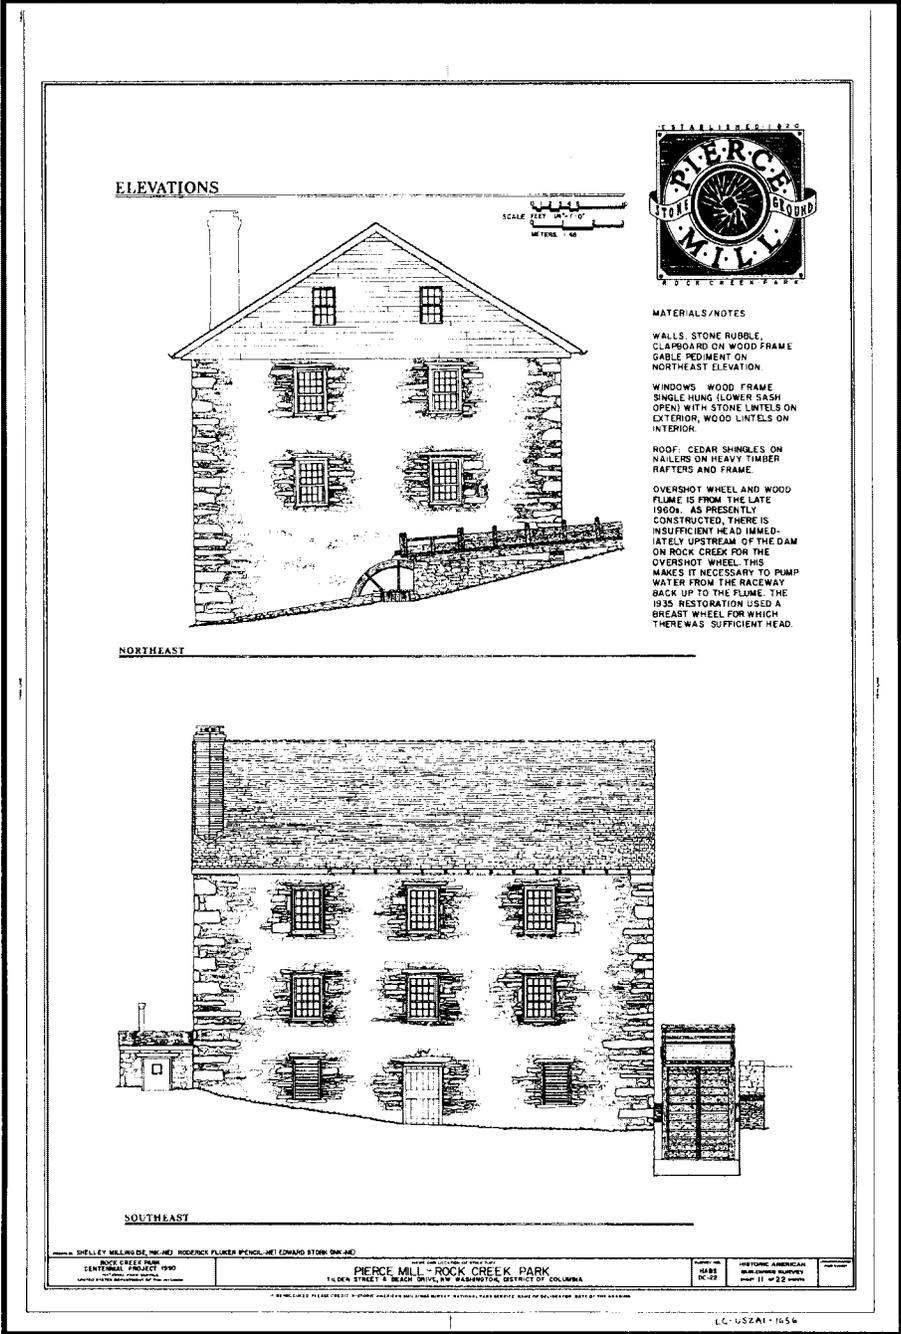
Peirce Mill, Elevations, 1990

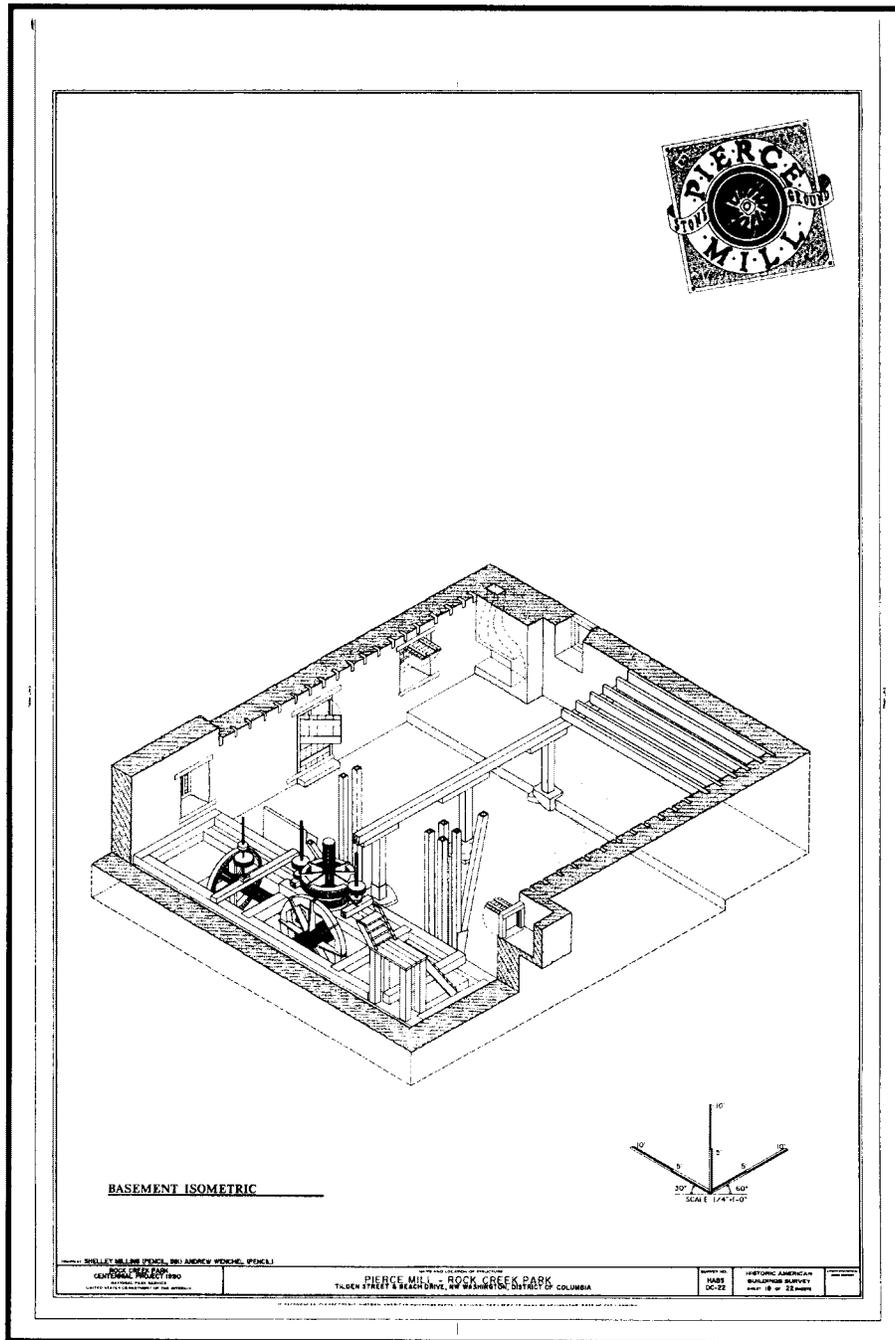
Peirce Mill, Basement Isometric, 1990

Basement: The basement has a poured concrete floor, on which the support columns have been placed. The northwest wall has an approximately 3 feet high knee wall that extends to form the mill wheel pit in the northeastern end of the basement. Due to the building's stone construction, the interior walls are canted as the width of the wall decreases in proportion to height. The window openings on the southeast and northwest walls are canted and have stone sills and wide wood lintels. An air-conditioning unit has been installed in an opening on the southwest wall, and a rectangular fireplace is located in the southern corner. Located in the northern corner is a simple boxed staircase. The stair has solid pine treads, open risers, and a 2x4 handrail. The top of the stair forms a dog-leg, resulting in an L-shaped stair opening confined by a simple two-board railing.

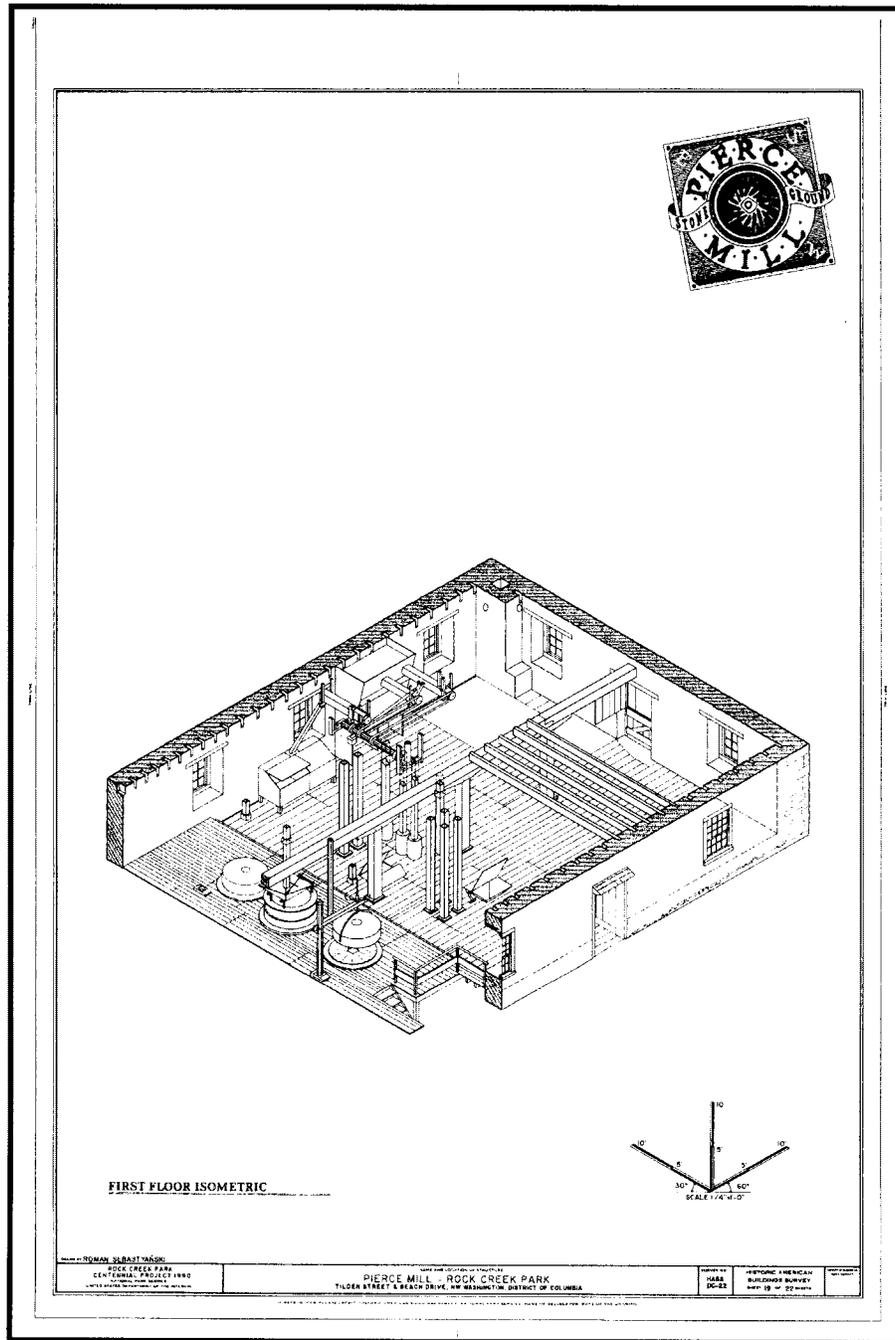
Peirce Mill, First Floor Isometric, 1990

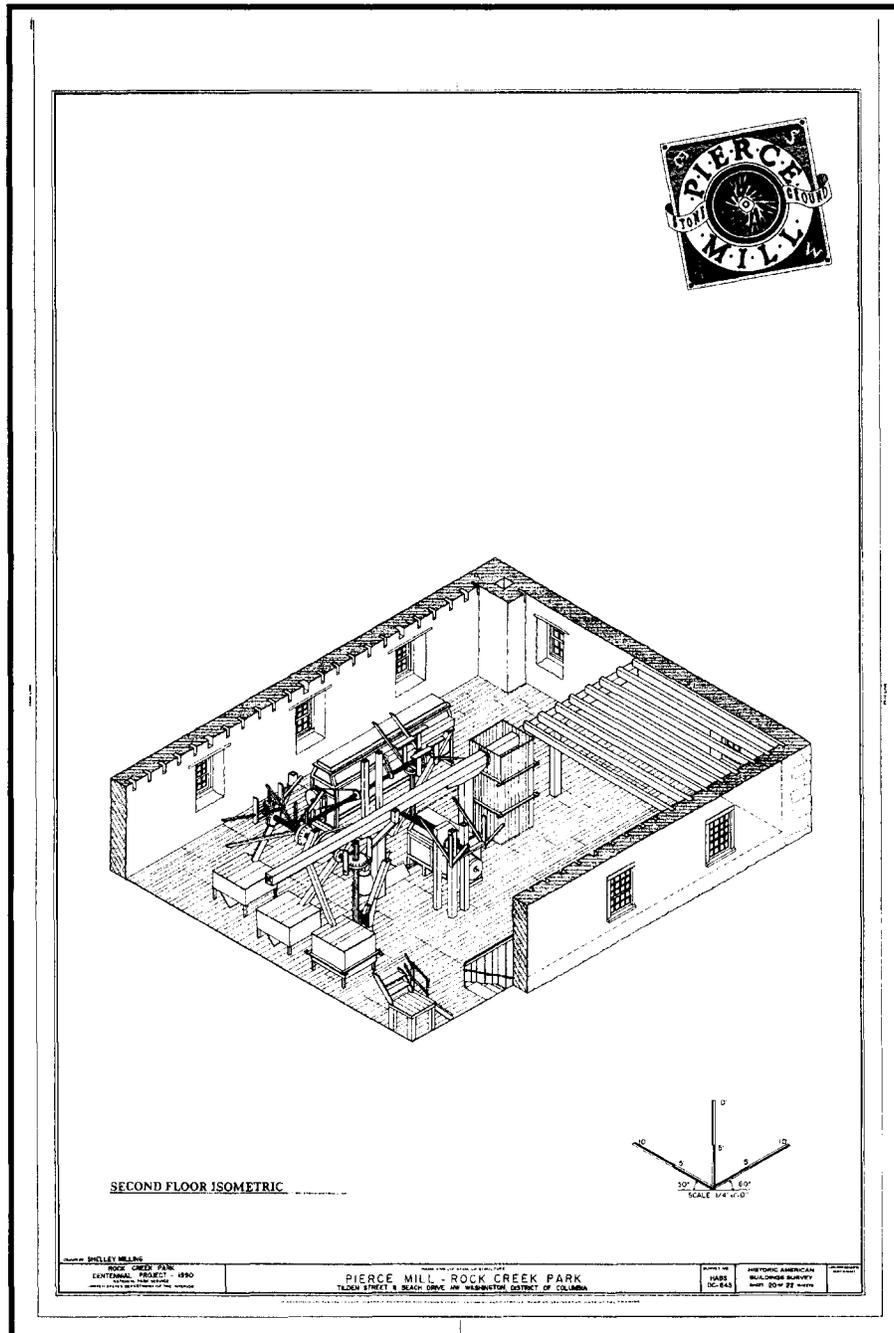
Peirce Mill, Second Floor Isometric, 1990

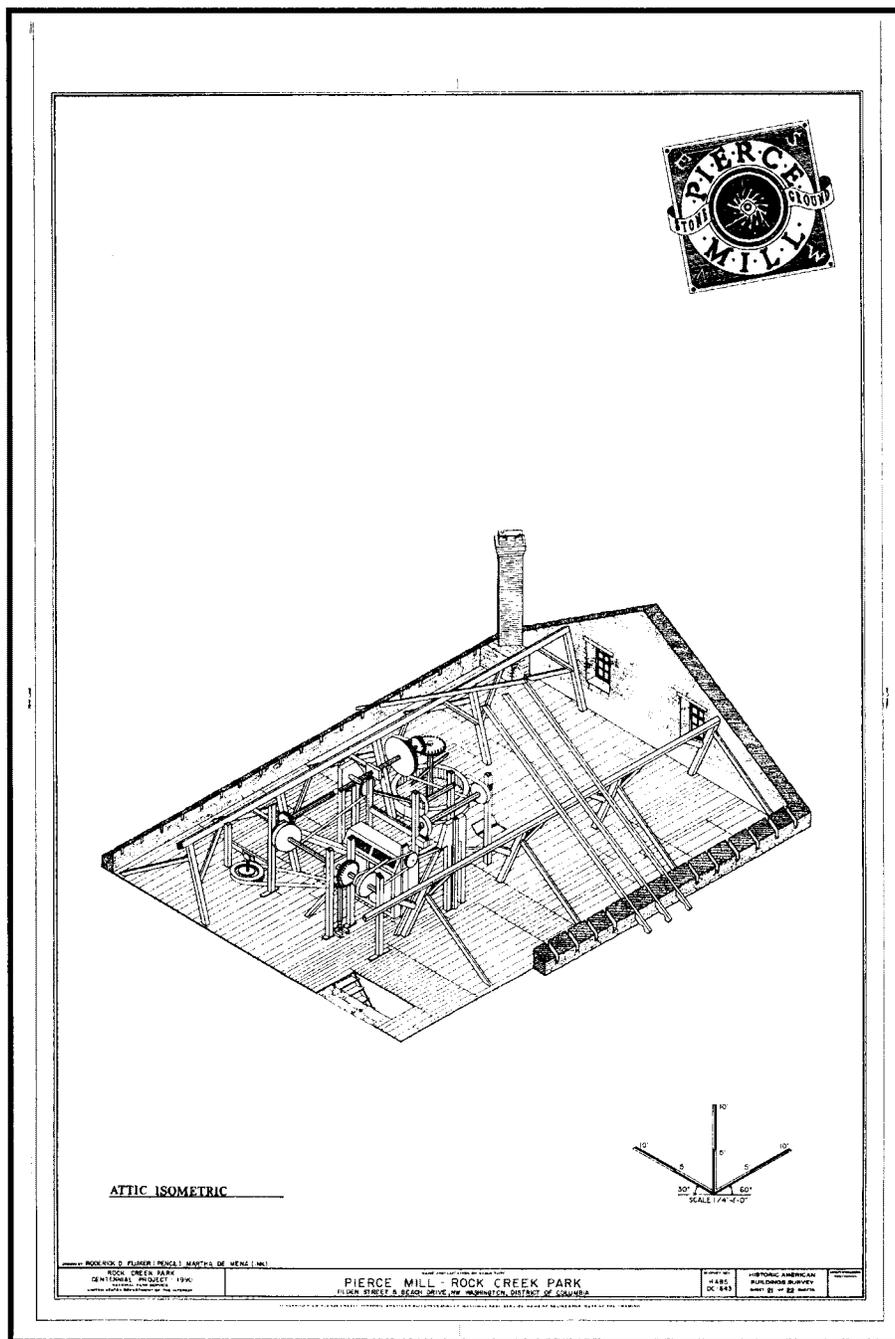
Peirce Mill, Attic Isometric, 1990

Third Floor (Attic): The upper floor of the Peirce Mill has been finished with wood flooring and two window openings on each gable end. Like the openings on the first and second floors, these feature stone sills and wood lintels spanning only the interior half of the opening. Characteristic of early colonial construction techniques, the ridge beam was omitted. The rafters are joined at the ridge with mortise-and-tenon joints with large wooden pegs. Most of the framing system is oak, with pine utilized for a few repairs. Rafters penetrate the stone walls that rise slightly above the third floor. These ends extend out and rest on a sill plate which, in turn, rests on the third-floor joists that also penetrate the wall cap. At the mid-span of the rafters, a large timber queen post extends up at an angle from the regularly spaced large horizontal timbers in the attic framing. This post supports purlins, which run the length of the roof. Though the heavy timber construction forms a substantial bracing system, the design does not create a rafter truss, often found in other timber-framed attics. This design does, however, provide the maximum vertical clearance and usable space in the attic. The queen posts are placed at an angle so as to maximize the useable floor area in the attic. (Most barn-type structures would have these elements perpendicular to the roof plane.) There are two members that appear to have been added at approximately six feet above the attic floor. These heavy timbers appear to be reused members installed for the purpose of hoisting machinery or to stabilize the movements of the roof. Located in the southern corner of the floor is the top of the stone chimney shaft, partially parged and substantially tapered from the lower levels. The rotated brick stack is built on top of the chimney shaft.

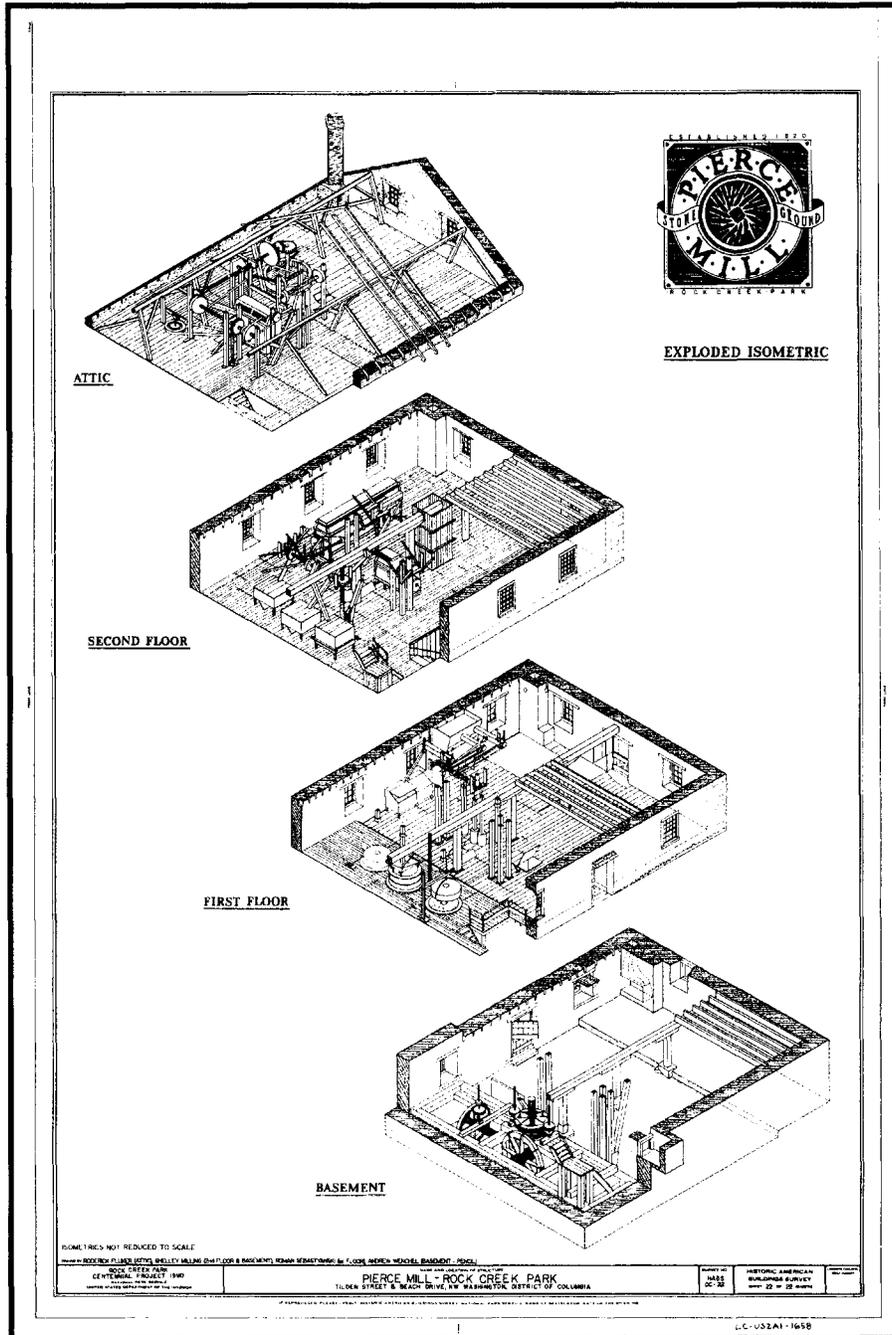
Peirce Mill, Exploded Isometric, 1990

The first, second, and third (attic) floors are supported on a wood joist system. Most of the timber framing appears to date from the original construction of the mill. The sizes, shapes, joining techniques, and chiseled numbering of individual elements all speak to early-nineteenth-century framing methods. There have been many repairs, and perhaps modifications, to individual wooden elements over the nineteenth and twentieth

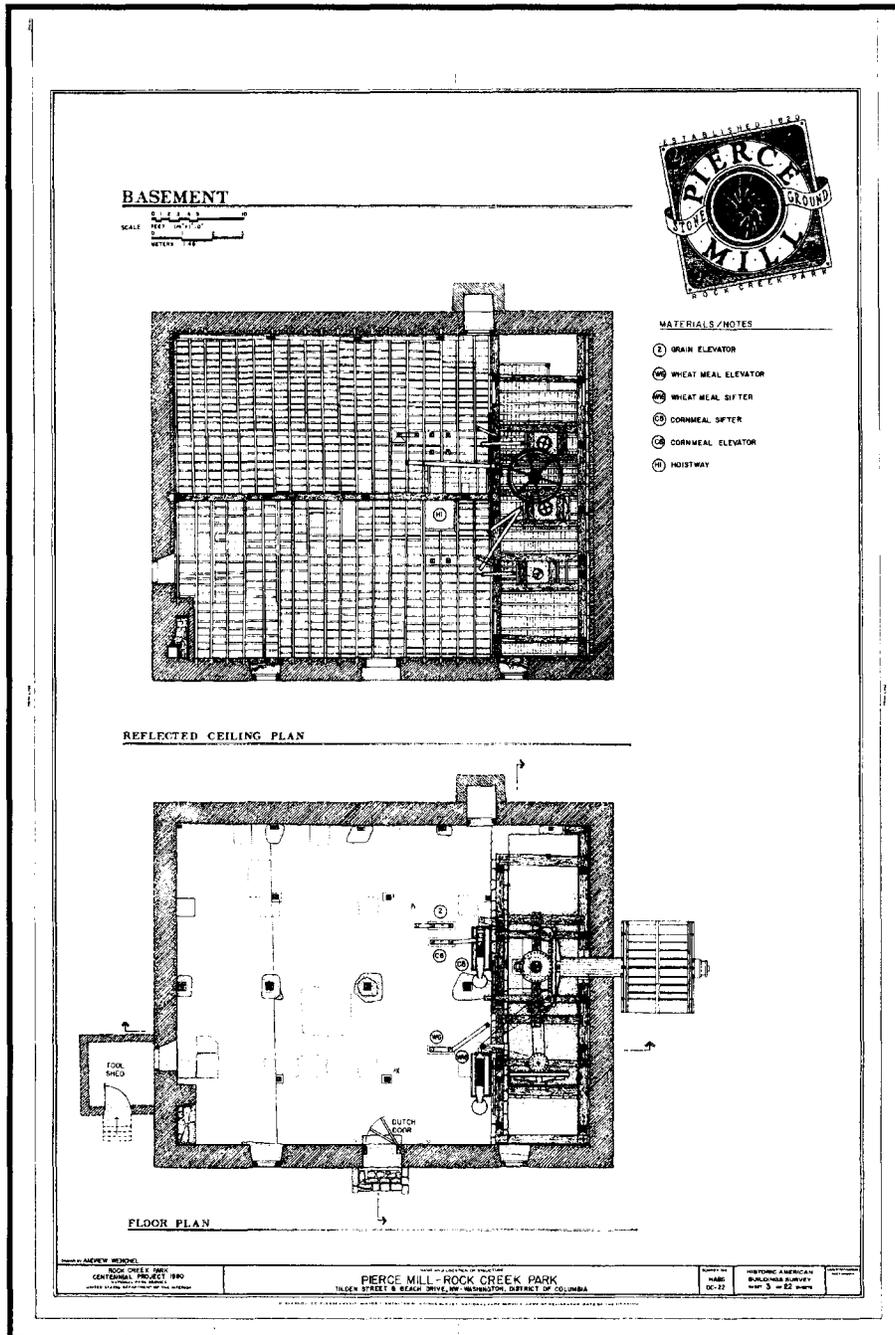
Peirce Mill, Basement Plan, 1990

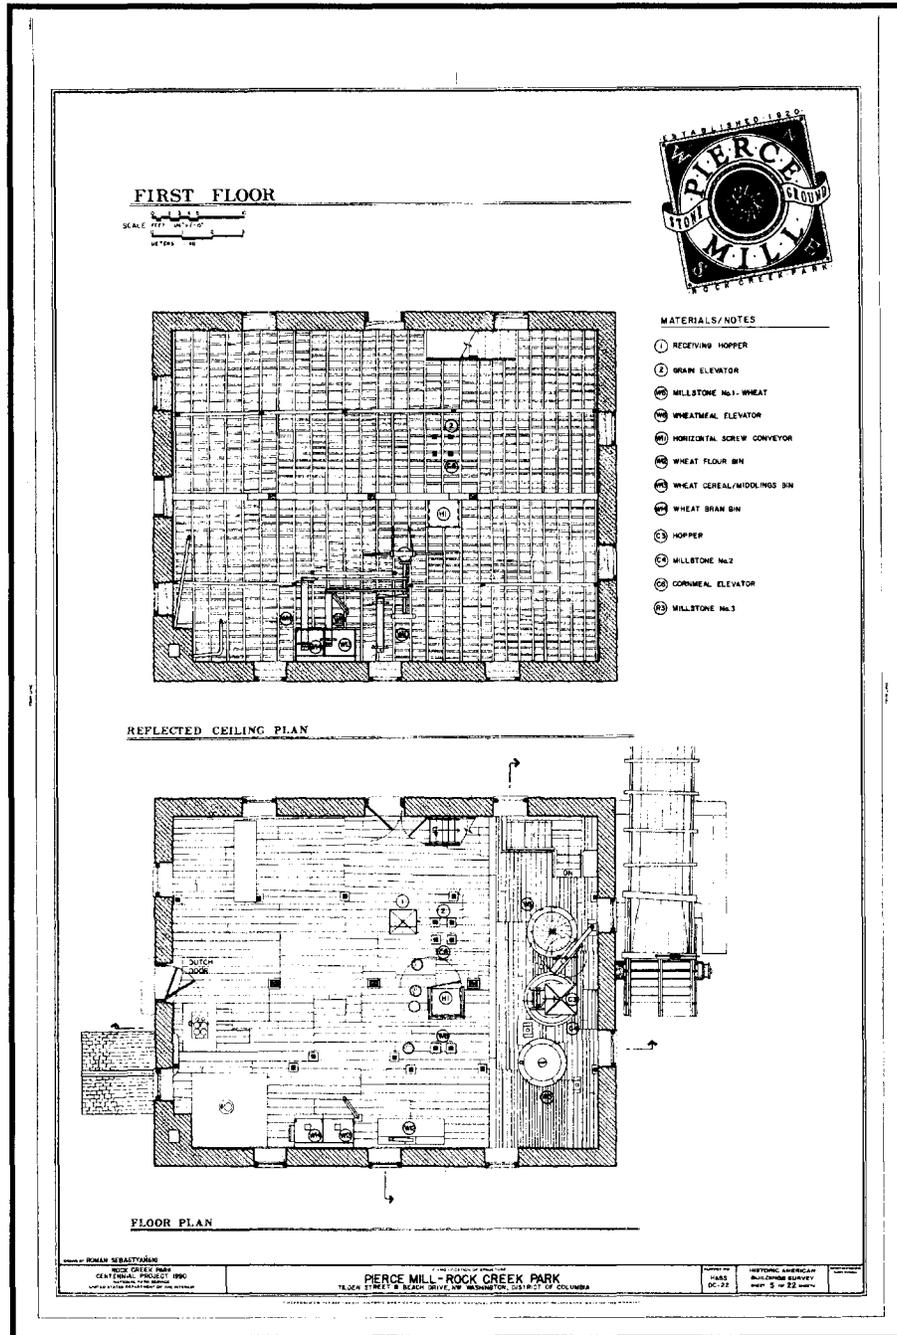
Peirce Mill, First Floor Plan, 1990

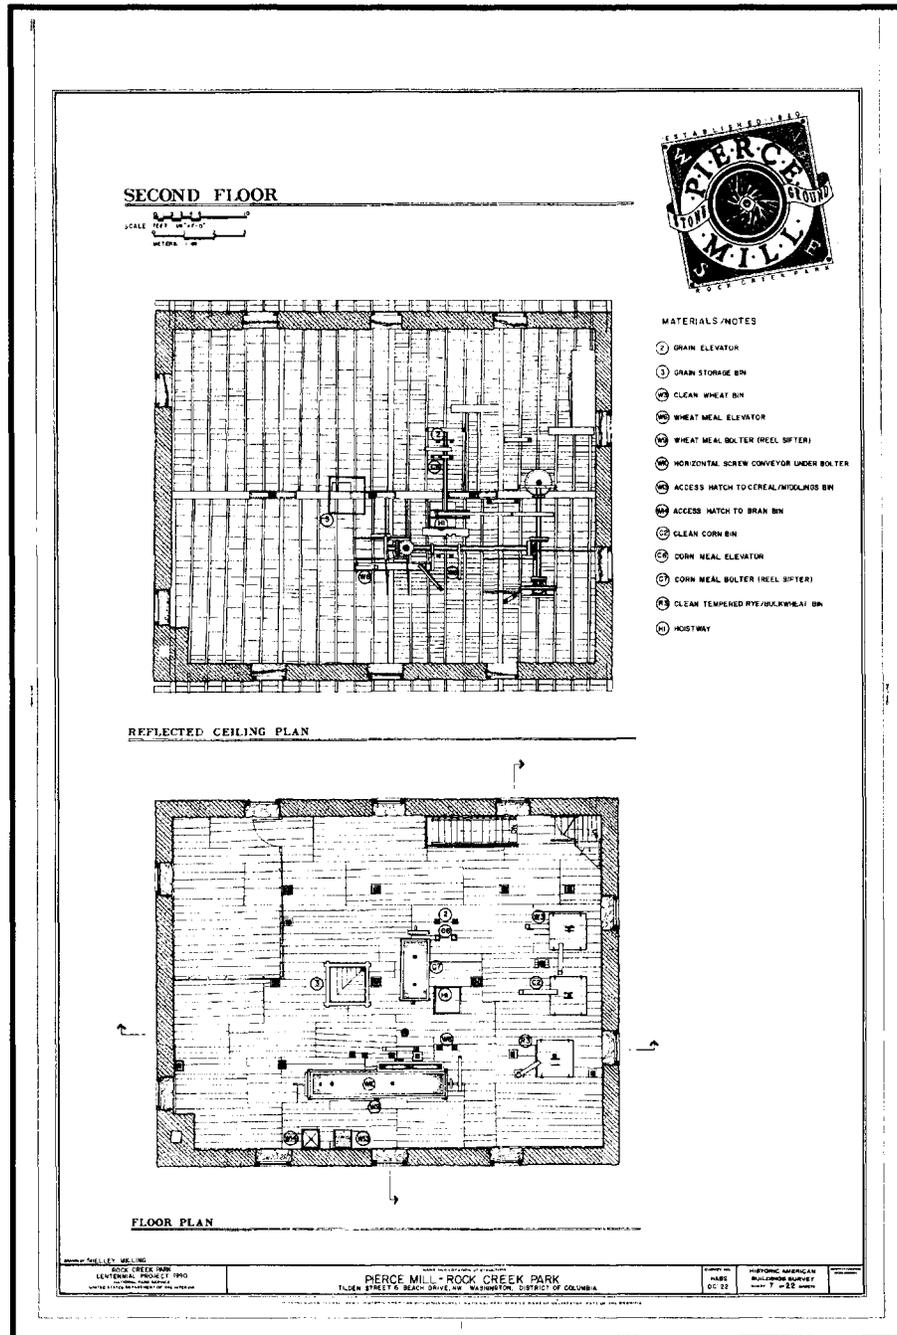
Peirce Mill, Second Floor Plan, 1990

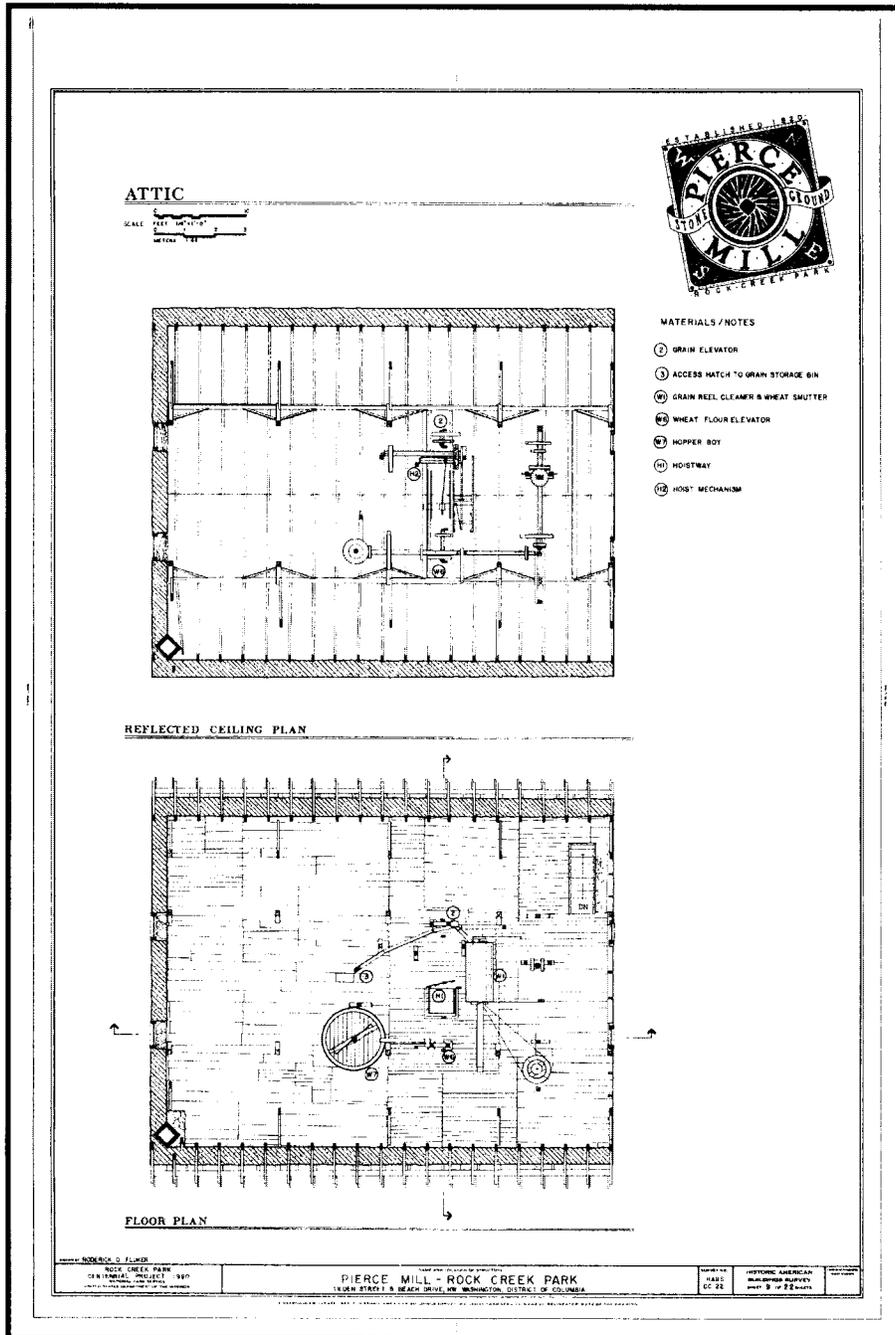
Peirce Mill, Attic Plan, 1990

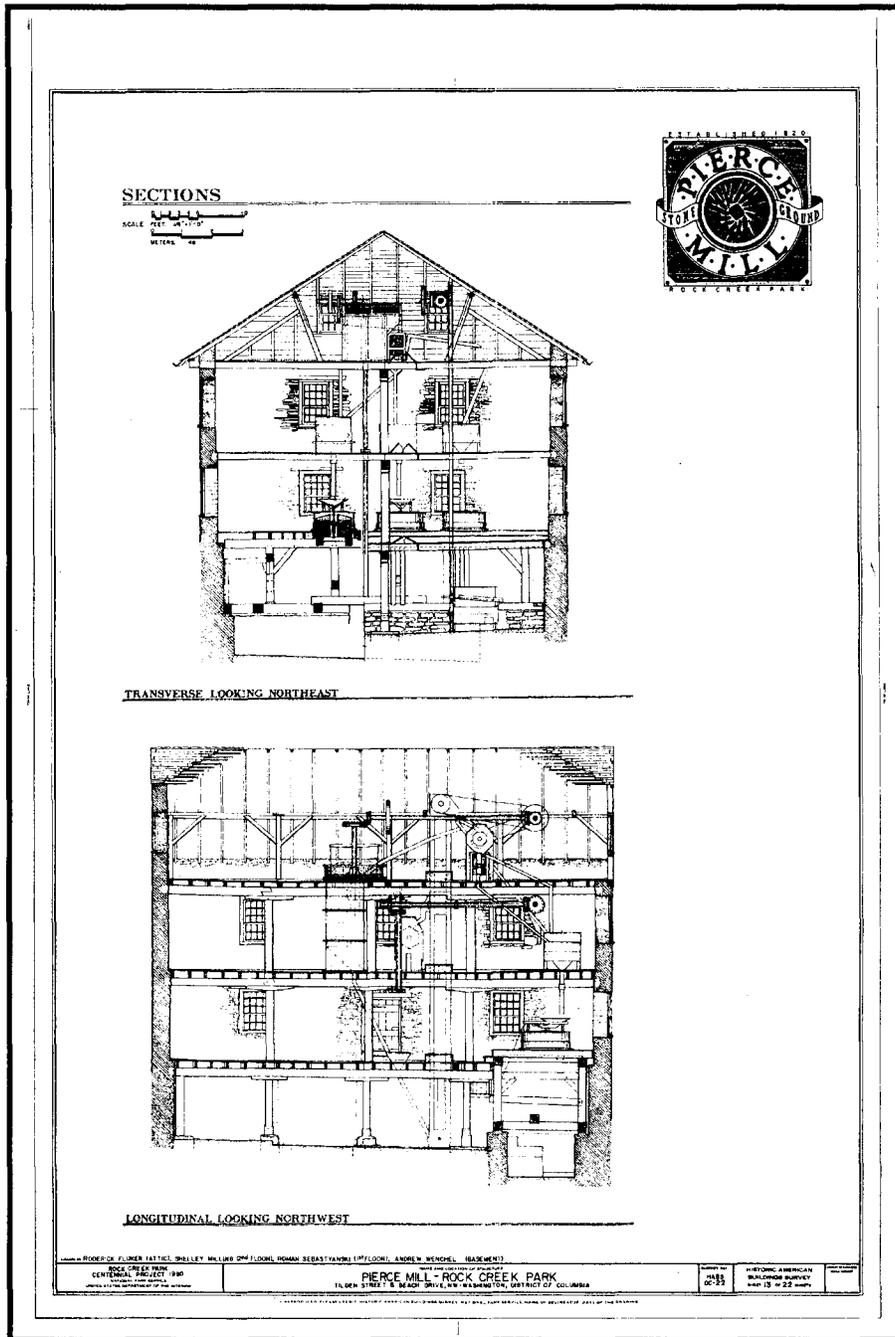
Peirce Mill, Sectional Views, 1990

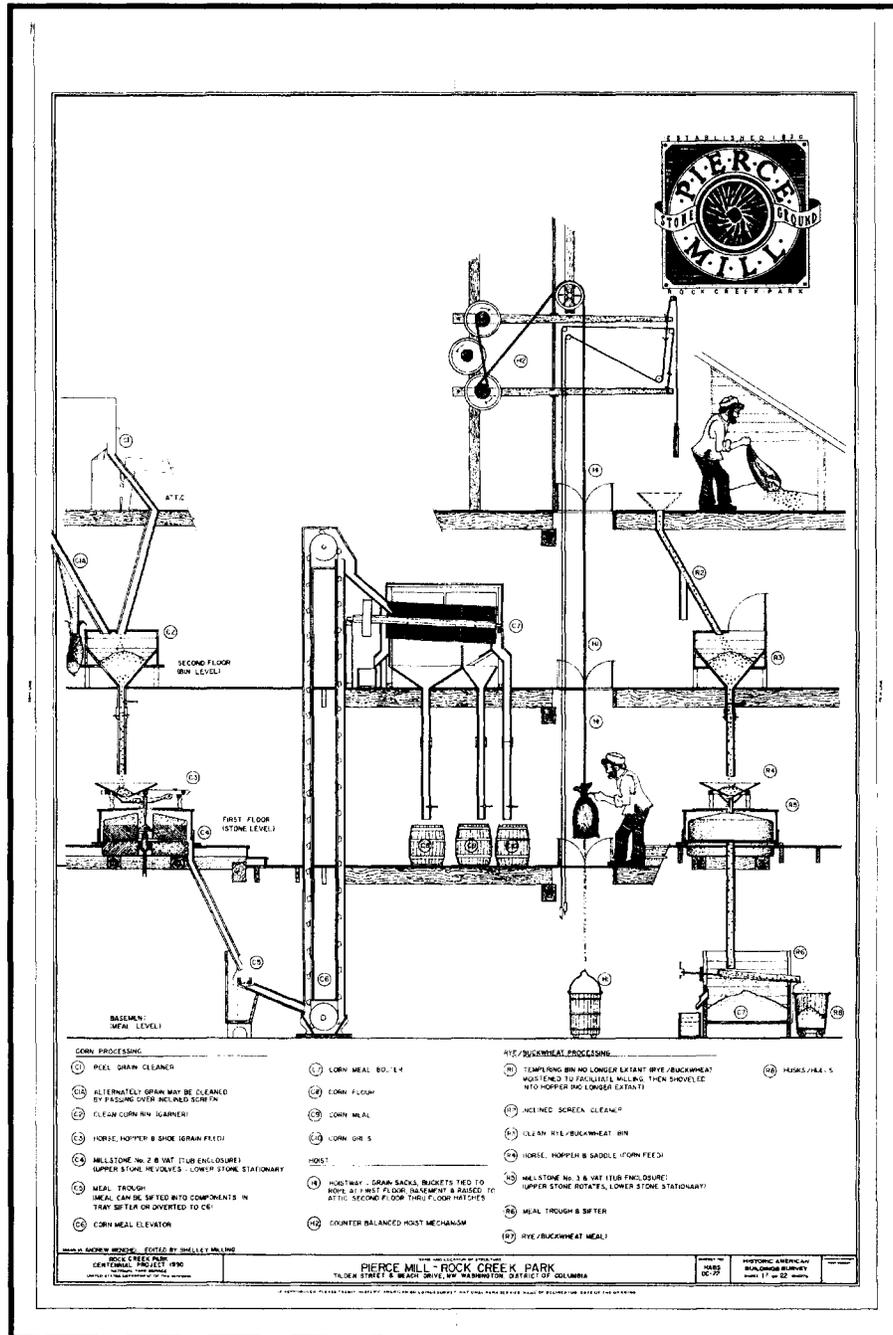
Peirce Mill, Milling Operations, 1990

The mill machinery is not original to the building. However, it is the product of a 1935 restoration that used technically skilled craftsman to reconstruct missing parts and incorporate parts from other milling machinery that came from similar mills in Pennsylvania and Maryland.

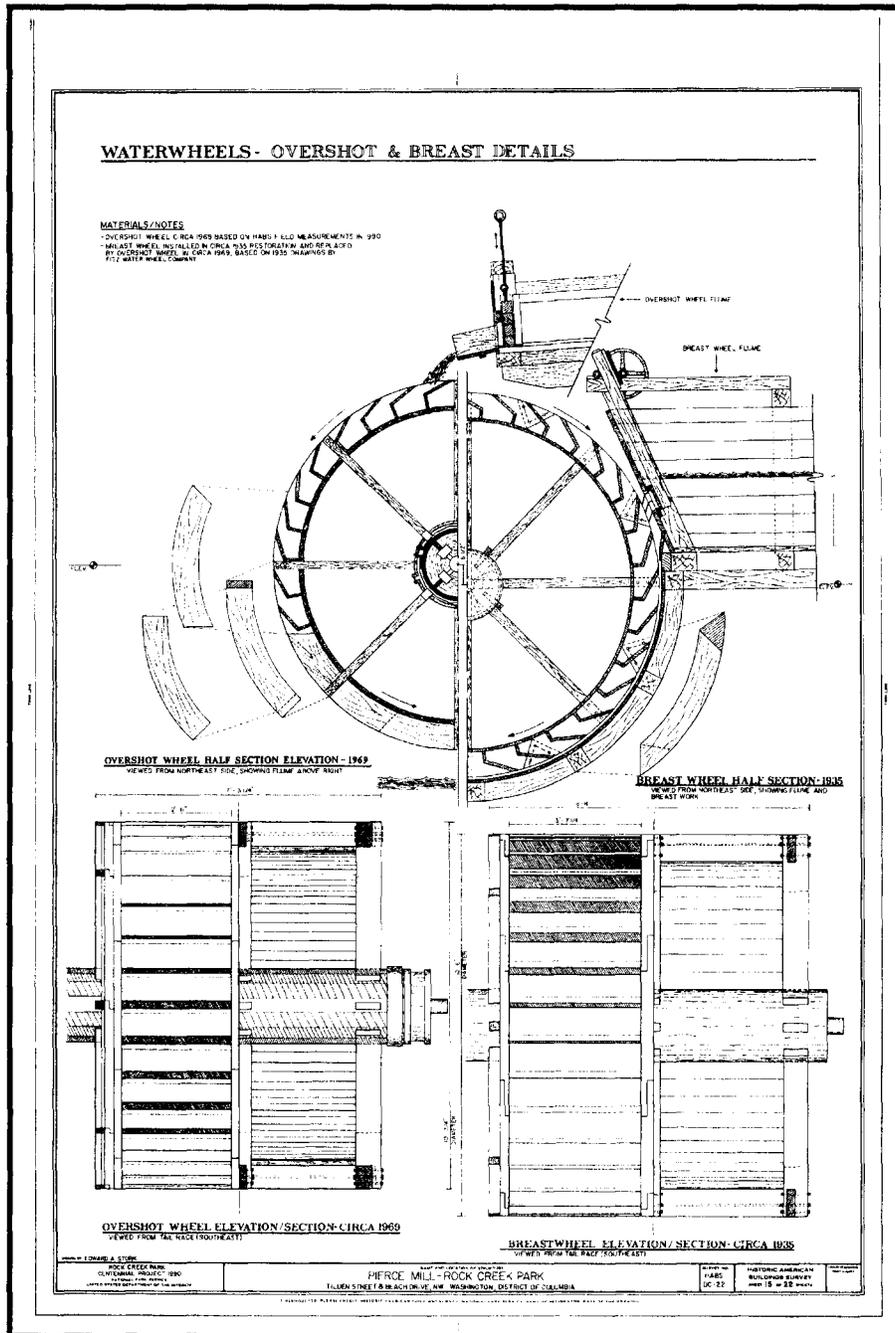
Peirce Mill, Waterwheel Operations, 1990
