# **AN ANALYSIS OF TOUR BUS OPERATIONS WITHIN THE NATIONAL MALL AND MEMORIAL PARKS**

**Phase 1: Off-Bus Data Collection and Photographic  
Documentation at Loading and Unloading Zones**

January 2013

### Technical Report Submitted to:

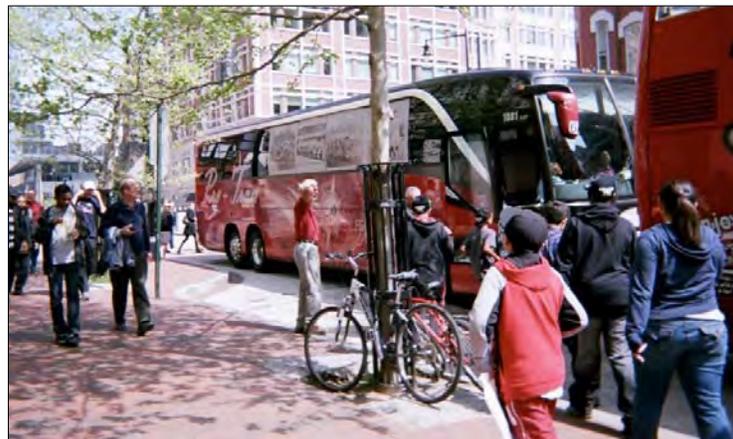
**PHOTO 3.9. DOUBLE PARKING (ZONE 13)**

Due partly to the varying sizes of motor coaches and partly to poor parking practices, such as when buses did not pull up far enough into the zone to allow room for another bus, some parking spaces were not quite big enough for a bus to use without blocking the traffic lane. Partial spaces were often used as passenger marshaling areas for buses that double-parked within the zone (Photo 3.9).

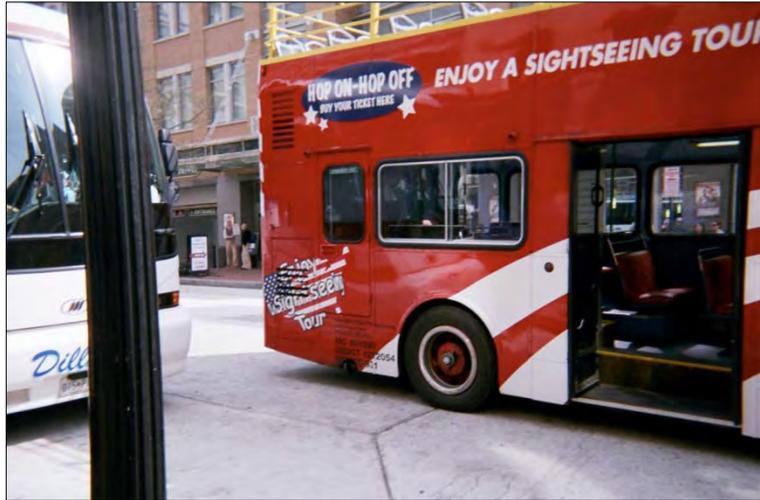
**PHOTO 3.12. DOUBLE PARKING (ZONE 13)**

Hop on-Hop off buses and others that quickly unload or load only a few passengers often double parked, even when a proper space was available (Photo 3.12).

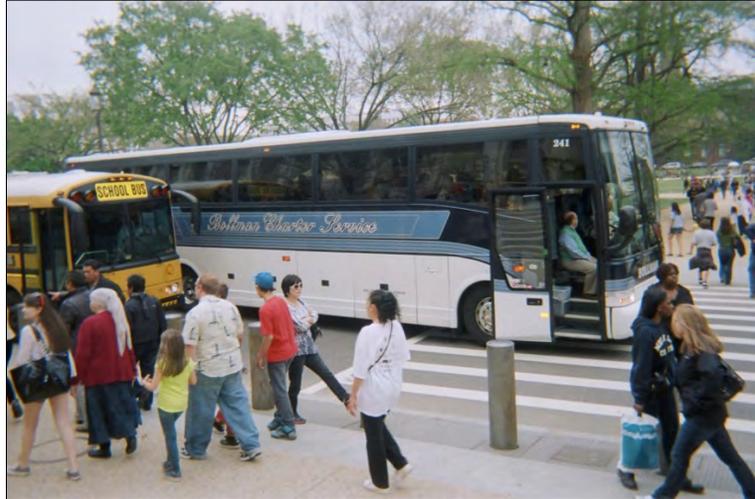
**PHOTO 3.13. DOUBLE PARKING (ZONE 4)**

For some tour bus drivers, unloading or loading in close proximity to the main entrance to a site/building was evidenced, even if it meant blocking another stopped bus or infringing on a crosswalk (Photo 3.13).

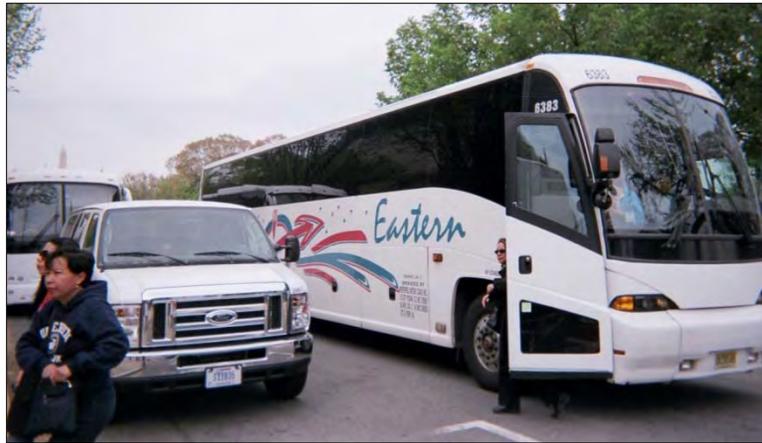
**PHOTO 3.14. DOUBLE PARKING (NEAR ZONE 5)**

Not all of the observed double-parking for loading/unloading was observed in designated zones. It often occurred slightly beyond the zone (Photo 3.14), near the entrance to a destination (Photo 3.15), or at a remote meeting place designated by an accompanying tour guide.

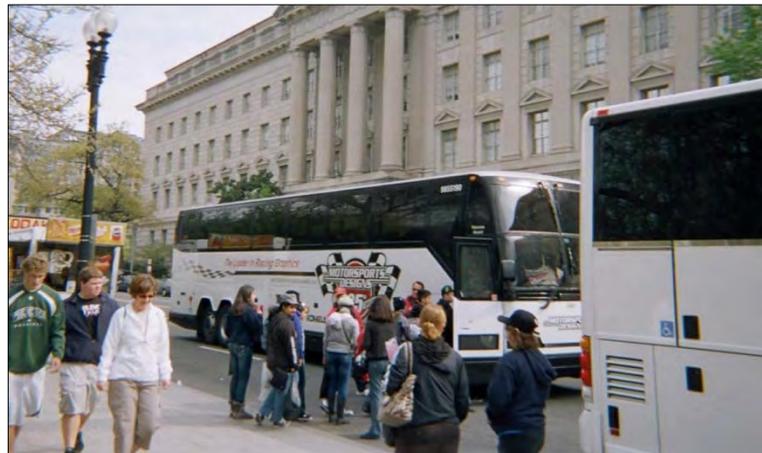
**PHOTO 3.16. DOUBLE PARKING (ZONE 7)**

Double-parking for loading/unloading was not always necessary. In some situations, passengers were loaded or unloaded without the bus pulling into an available designated space, potentially because the space was tight and difficult to navigate (Photo 3.16).

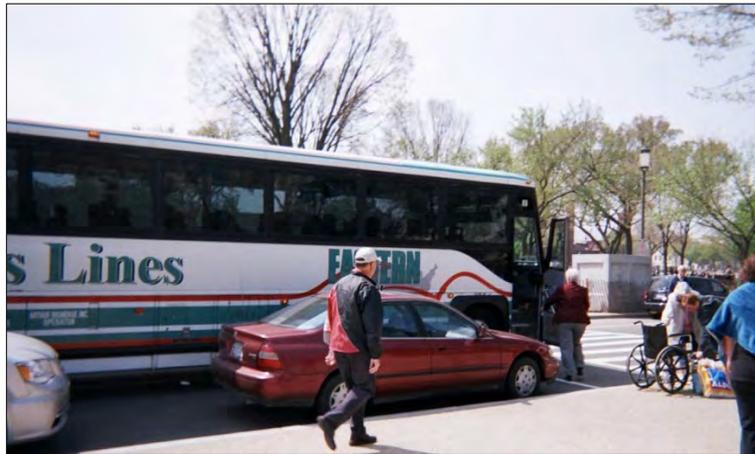
**PHOTO 3.20. LOADING IN NON-DESIGNATED ZONE (ZONE 4)**

Notable violations took place at Zone 18, the FDR & MLK Memorial area, which was temporarily closed to loading and unloading due to the National Cherry Blossom Festival, a change in policy which drivers either did not notice or elected to ignore. During the festival, this zone was clearly marked as a media only area and was frequently populated by security vehicles. At other times of the year, this area is identified as a legal loading/unloading zone, but was not identified as such during the festival. Therefore, drivers who traditionally used this zone to load/unload passengers during legal times chose to continue using the location during the Festival rather than attempting to determine a different locale. Drivers tended to stop before the marked out zone, rather than beyond it (Photo 3.17), or stopped in the traffic lanes, thereby slowing down or blocking other vehicles, including other tour buses (Photo 3.18). Tour bus drivers who could not find available stopping places and had passengers waiting curbside sometimes chose to stop in slower traffic lanes (e.g. turning lanes) for loading (Photo 3.19). Alternatively, to reduce the difficulties confronting seniors and passengers using assistive devices, tour bus drivers sometimes stopped close to site entrances, even if there was no designated loading/unloading zone. In so doing, they impeded traffic flow (Photo 3.20).

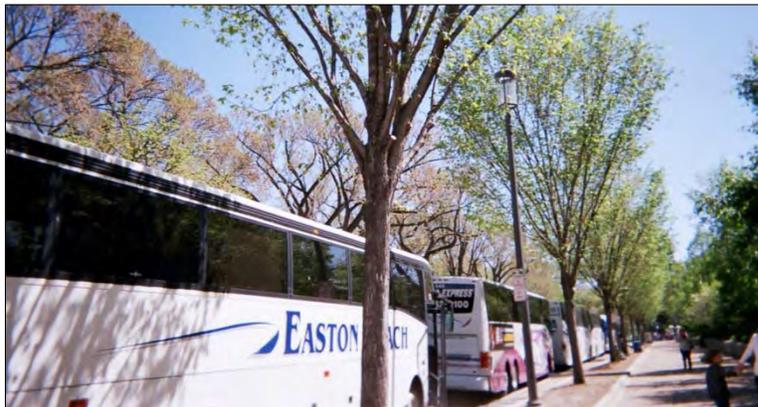
**PHOTO 3.23. WALL OF BUSES (ZONE 4)**

In some designated loading/unloading or parking zones, long lines of tall, tightly parked buses created visual barriers between pedestrians and the heritage vista. Walking along sections of Madison Drive or Jefferson Drive, for example, provided pedestrians with close up views of tour buses rather than the greenspace (Photo 3.23). Parked or stopped buses also block the views of motorists who often cannot see permanent or temporary traffic signs or signals (Photo 3.24).
